Rapid Replacement of Bridge Deck Expansion Joints Study – Phase I

**Interim Report
December 2014**

Sponsored by
Iowa Department of Transportation
Federal Highway Administration
(InTrans Project 13-451)

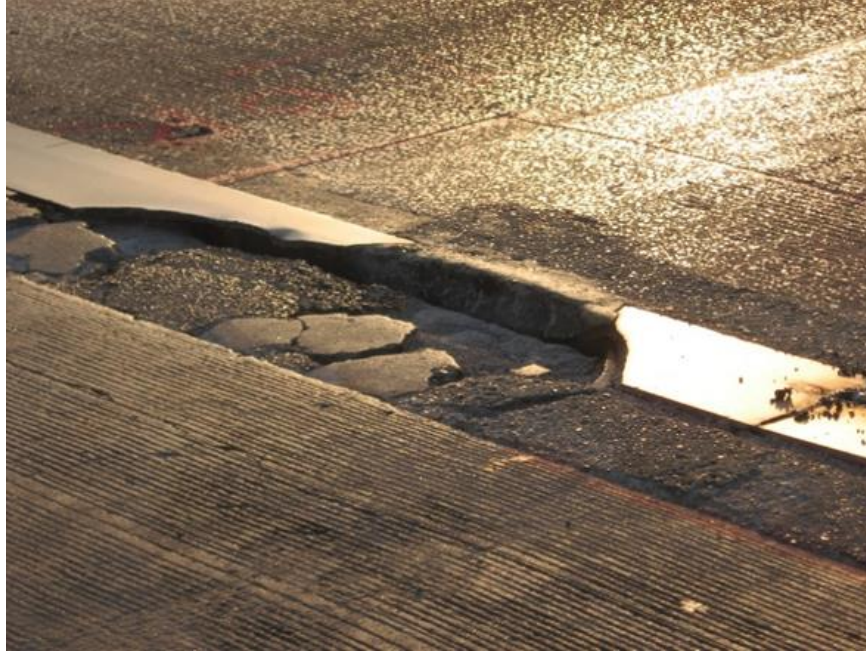
The combination of the plate losing structural section strength due to rust formation and the cyclical loads of heavy traffic eventually cause fatigue damage to the steel plate, and large sections of the plate may break loose as seen in Figure 2.1.

Figure 2.1. Large sections of a plate broken loose on northbound I-380 Exit 19A in Cedar Rapids, Iowa

The joint shown, now replaced, was present on Exit 19A, Northbound I-380 in Cedar Rapids. A processing plant was noted a few blocks from the exit and the Iowa DOT inspector had observed a considerable amount of heavy truck traffic on that exit. Most of the joints along that exit showed similar fatigue damage including one joint where nearly the entire top plate was missing.

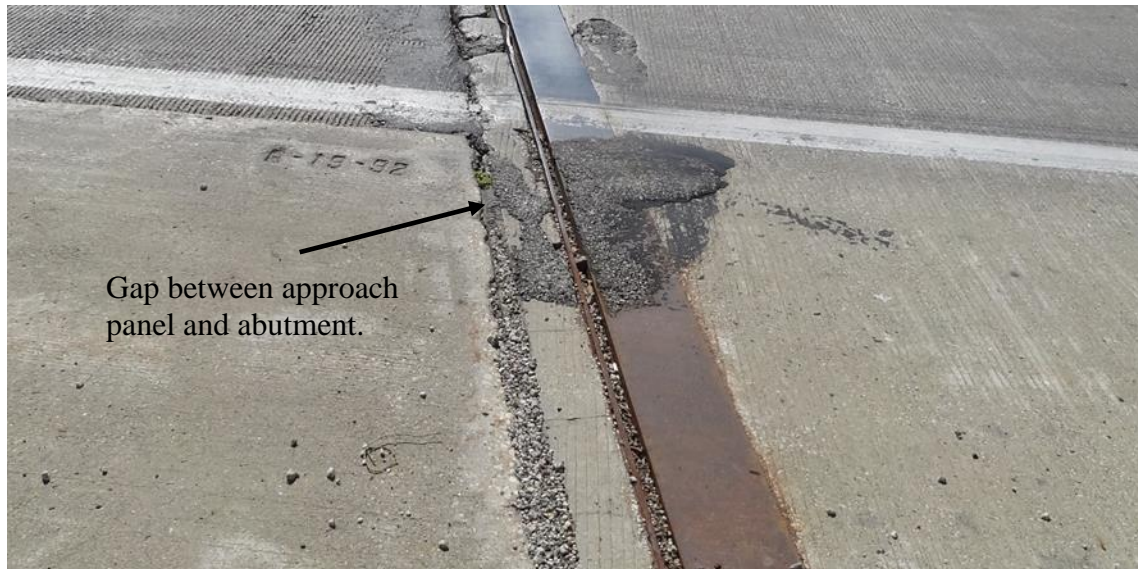
There are a few signs of an immobile joint that is pulling free from the abutment. The first sign is a gap gradually forming between the top of the abutment and the approach slab as shown in Figure 2.2.

Figure 2.2. Gap forming between top of abutment and approach panel on the I-80 over I-35 west abutment

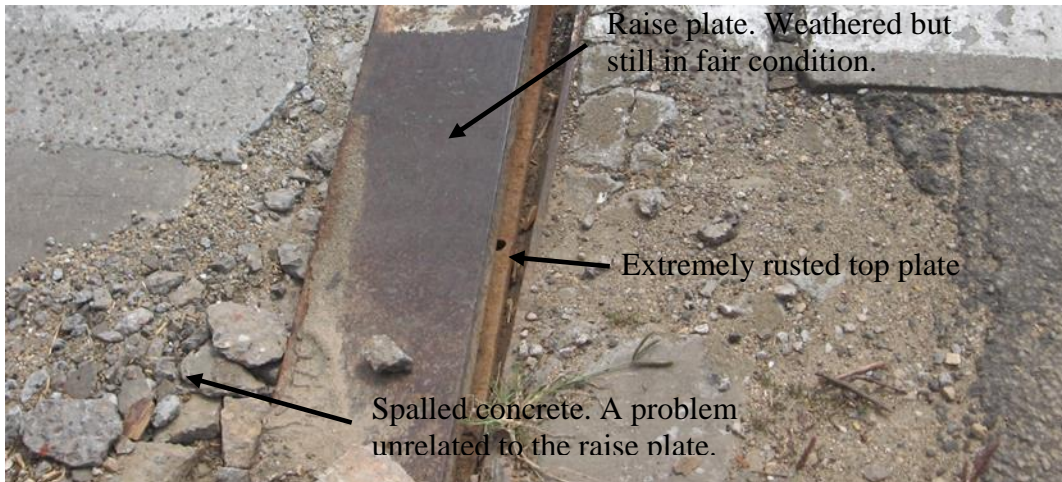
Years later, the original top plates are now beginning to fatigue, but the damage is hidden under a raise plate that usually appears to be in relatively good condition. This can be seen in Figure 2.3 (before replacement), where a badly rusted top plate can be viewed beneath a top plate showing relatively good conditions.

Figure 2.3. Rusted top plate beneath a raise plate showing relatively good condition on westbound US 20 over Catfish Creek in Cedar Rapids, Iowa

The portion shown is along the shoulder section of the highway. The top plate had come loose previously and been removed across the entire two lanes of traffic of the joint.

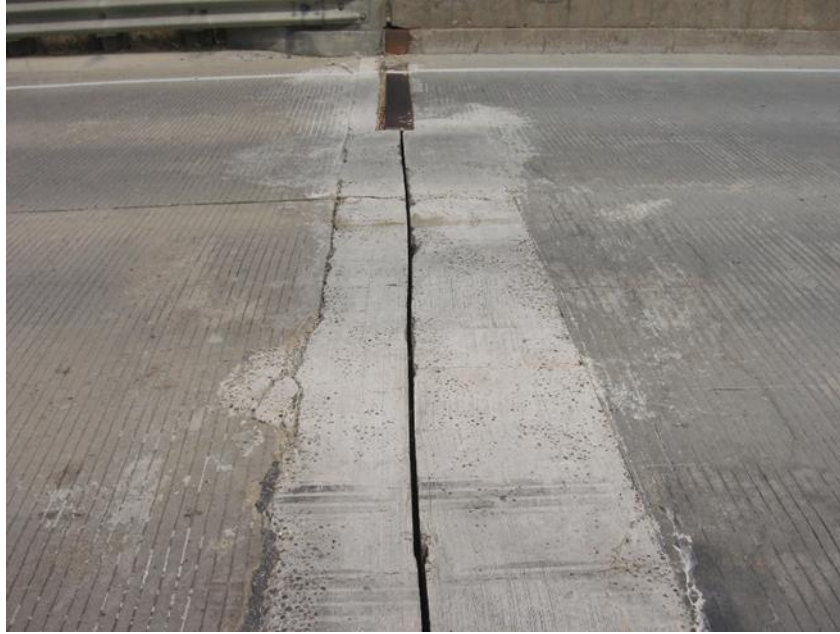
Damage where the joint has pulled loose from the abutment, or less commonly the bridge deck, is problematic. Such damage generally involves the removal of a substantial amount of concrete requiring a period of traffic closure to complete the repairs. These traffic closures are sudden and generally occur at a less than ideal time, requiring the roadway to be opened again in a rather short amount of time. To do this, the loose concrete and joint sections are removed in their entirety. The missing concrete and joint are then replaced by creating a flat open joint in the roadway. Essentially, the concrete is removed and new concrete is placed with a gap between the abutment and bridge deck allowing for bridge movement. An extreme case where both sides of the joint have broken loose is shown in Figure 2.4

Figure 2.4. Extreme case of sliding plate joint maintenance

Under the short duration of the closures, placing a new joint is not a feasible option. This repair may not create a good joint, but it is a functional solution in the time allowed and will not allow significantly more damage from water passage than previously allowed.

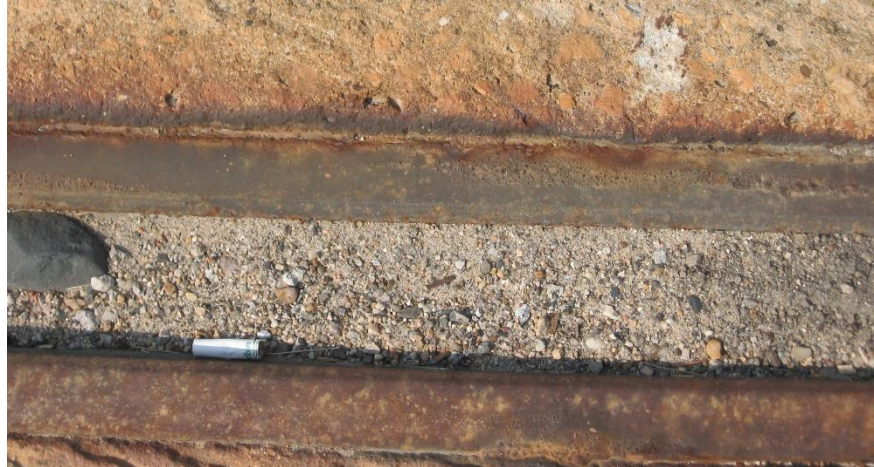
Both strip seal and compression seal joints have problems with debris building up in the seals, as seen in Figure 2.7.

Figure 2.7. Badly weathered, but still functioning, strip seal joint

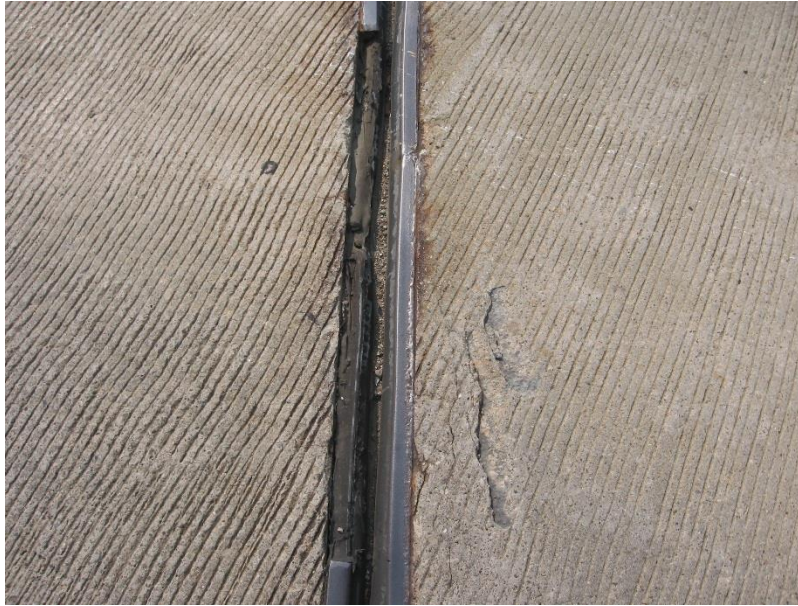
Several different repairs for extrusions were examined during the investigation. Figure 2.8 shows a strip seal joint with a missing section of the extrusion.

Figure 2.8. Strip seal joint with missing extrusion section

was then used to both hold the neoprene seal against the concrete and to again create a watertight seal where the extrusion was now missing. This repair had been in place for several years and, with occasional maintenance, this repair was performing at an acceptable level.

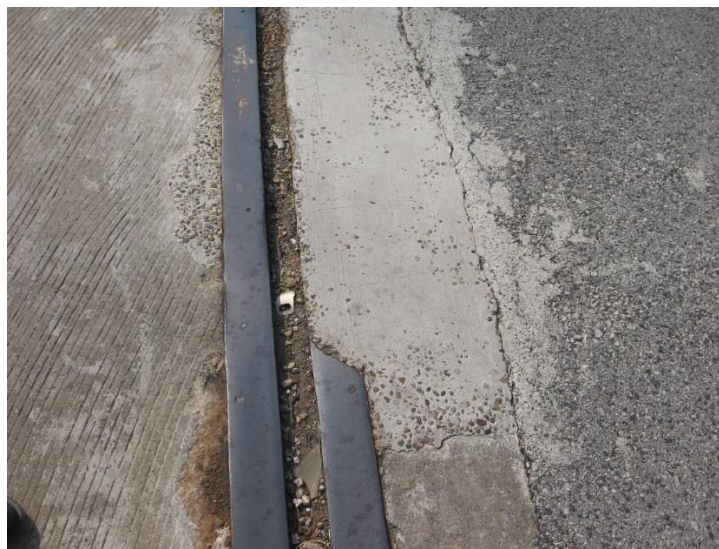
Figure 2.9. Compression seal joint with failed section of armoring

Broken sections of compression seal armoring are fixed much in the same way that sliding plate joints are fixed, by replacing the broken armoring, and any loose concrete, with new concrete to provide a flat, smooth riding surface. In this situation, compression seals have the advantage of still maintaining a well-functioning seal provided the concrete header is still largely in good condition and there is no damage to the neoprene gland. The steel armoring is merely present to protect the concrete edge and increase the durability of the joint. The armoring does not actually contribute to the ability of a joint to be watertight or accommodate expansion and contraction. This type of repair is shown in Figure 2.9

These repairs tend to be completed in several hours as there is no major removal of concrete involved. The longest schedule element is the required cure time for the new concrete.

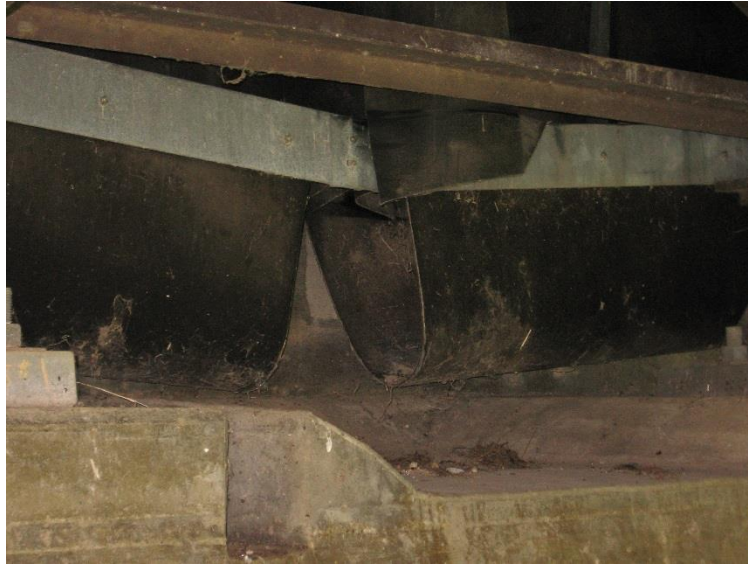
Another problem relating to these troughs is the flow of water. Where strip seal, compression seal, and modular joints prevent water from passing through the joint entirely, finger joints merely divert the water after it flows through the joint. Some troughs divert water away from the center of the abutment, while a neoprene trough below a finger expansion joint, as shown in Figure 2.12, diverts water to a catch basin at the center of the footing.

Figure 2.12. Neoprene trough below finger expansion joint

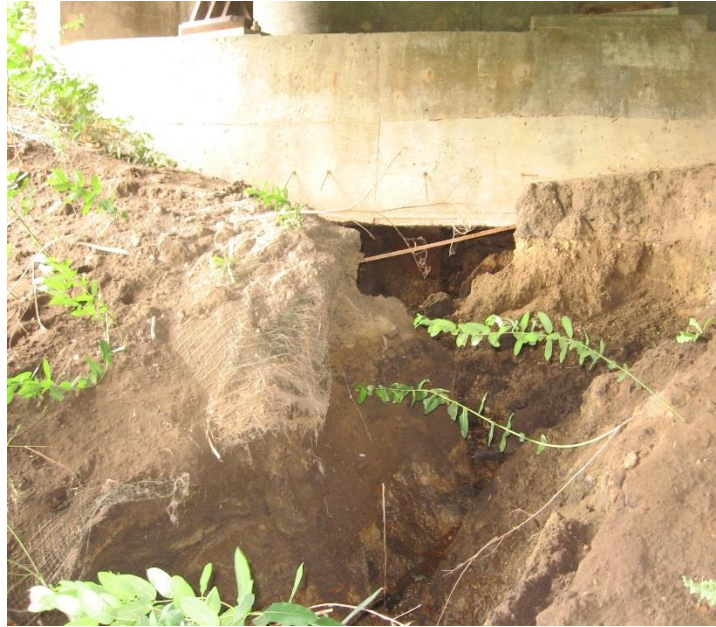
The water should then flow harmlessly into the stream below without damaging the steel components of the substructure. However, many older Iowa bridges have no form of slope protection on the slope beneath the bridge. During periods of heavy rain, this continued water flow may eventually erode away the slope exposing the steel piling as seen in Figure 2.13. At least two pilings were exposed when the image in Figure 2.13 was captured.

Figure 2.13. Exposed piling from slope erosion

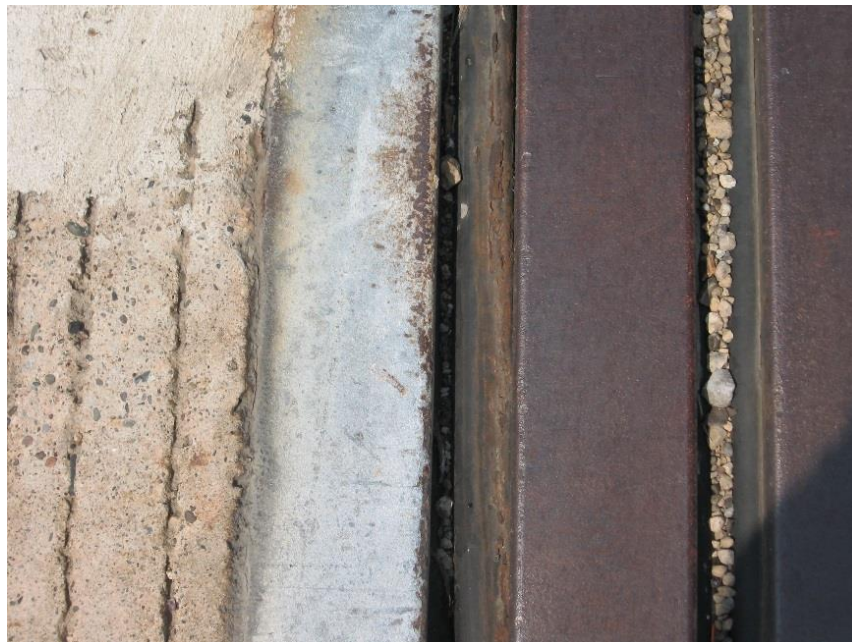
Modular expansion joints show many of the same problems that strip seal joints show. Neoprene glands again begin to fail at about year 15 and, as shown in Figure 2.14, incompressible debris collects in the joint.

Figure 2.14. Debris collection in modular expansion joint preventing full closure of the joint

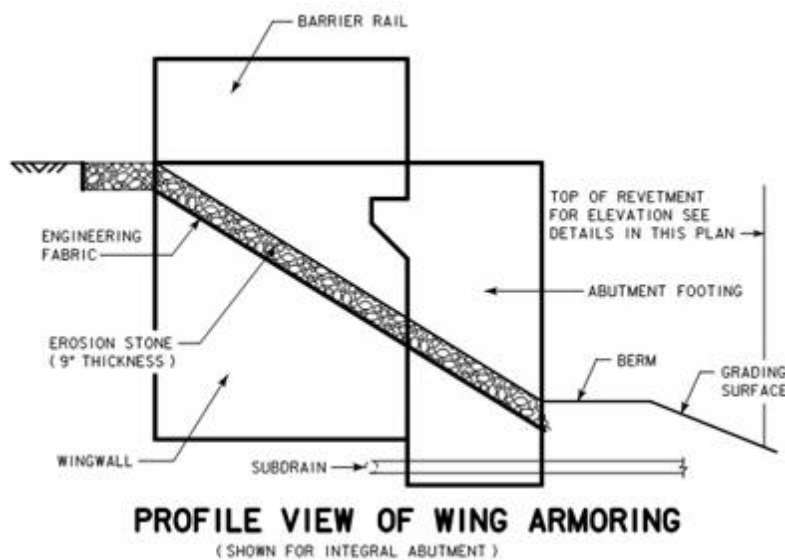
Figure 2.15. New Iowa DOT standard detail for wing wall armoring

This erosion problem is known to Iowa DOT staff who are currently working on implementing a new detail for wing armoring on bridges. The detail for new bridges includes a bed of erosion stone atop a layer of engineering fabric atop the compacted subgrade and following the slope of the subgrade. This layer of stone should act as a drain allowing the runoff to quickly flow around the abutment and footing without eroding the supporting soils. A profile view of this new detail is shown in Figure 2.15. Erosion is repaired in the same fashion as it is for finger joints. Eroded soil is replaced, compacted, and monitored for any future problems.

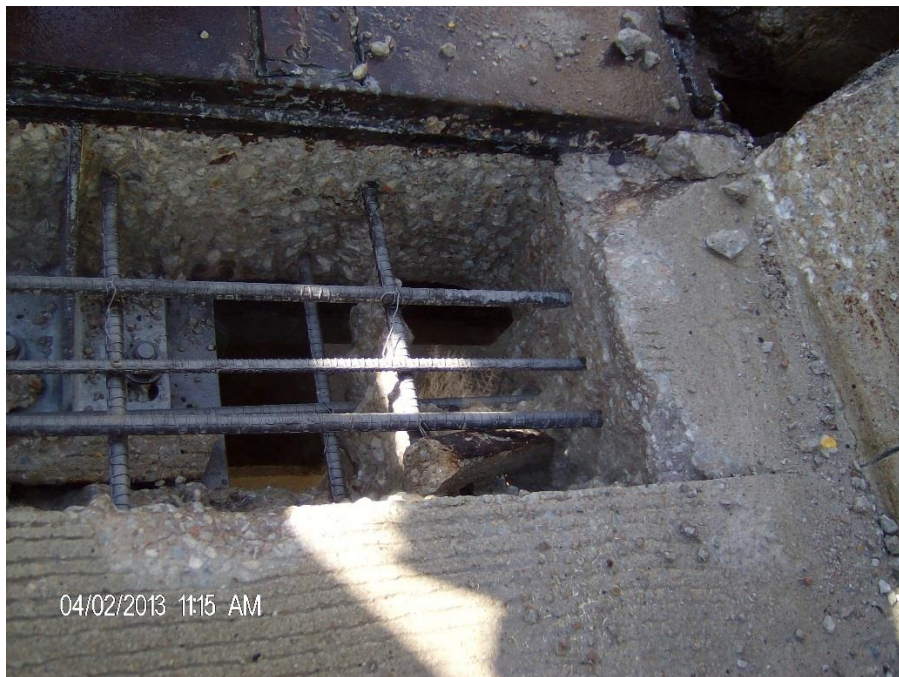
be larger if the joint is at a skew to the curb. There was also a small section of concrete beneath the existing joint that could not be removed with the aqua cutter (see Figure 3.6).

Figure 3.6 Concrete remaining after hydrodemolition
