# Investigation of Deterioration of Joints in Concrete Pavements:

# Field Study of Penetrating Sealers

**Technical Report**  
**March 2016**

**National Concrete Pavement  
Technology Center**

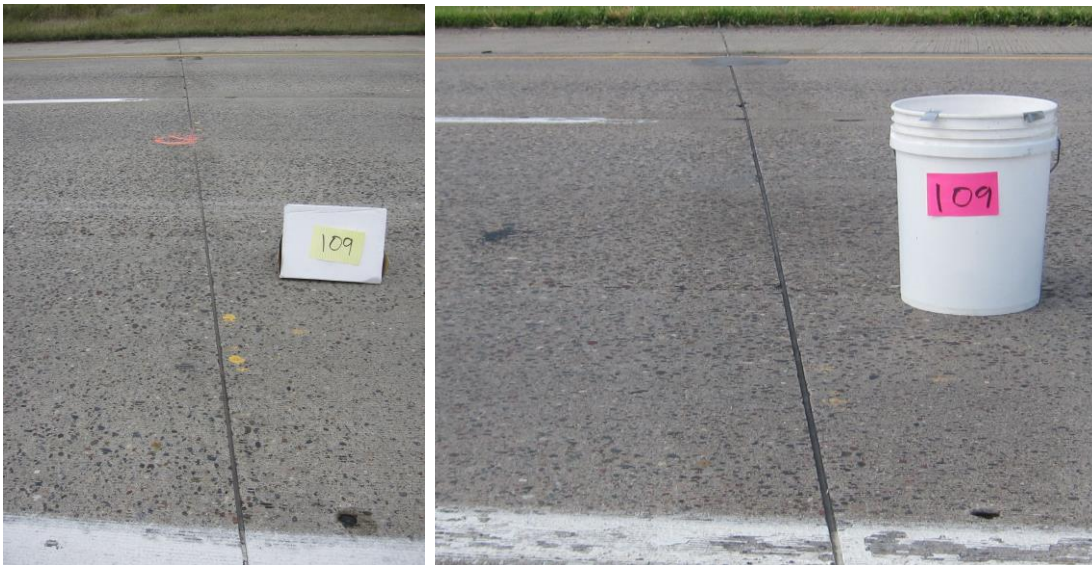
**Figure 46. Visible persistence of sealer after two years: Joint 109 in 2013 prior to treatment with sealer S4 (left) and Joint 109 in 2015 after treatment with sealer S3 in 2013 (right)**

Staining caused by application of waterproofing sealers was evident on some of the joints inspected in 2015. An example is shown in Figure 46.

The visible shadowing in the image on the right in Figure 46 is residual sealer. This suggests that components of the sealers persisted even after two years of service.

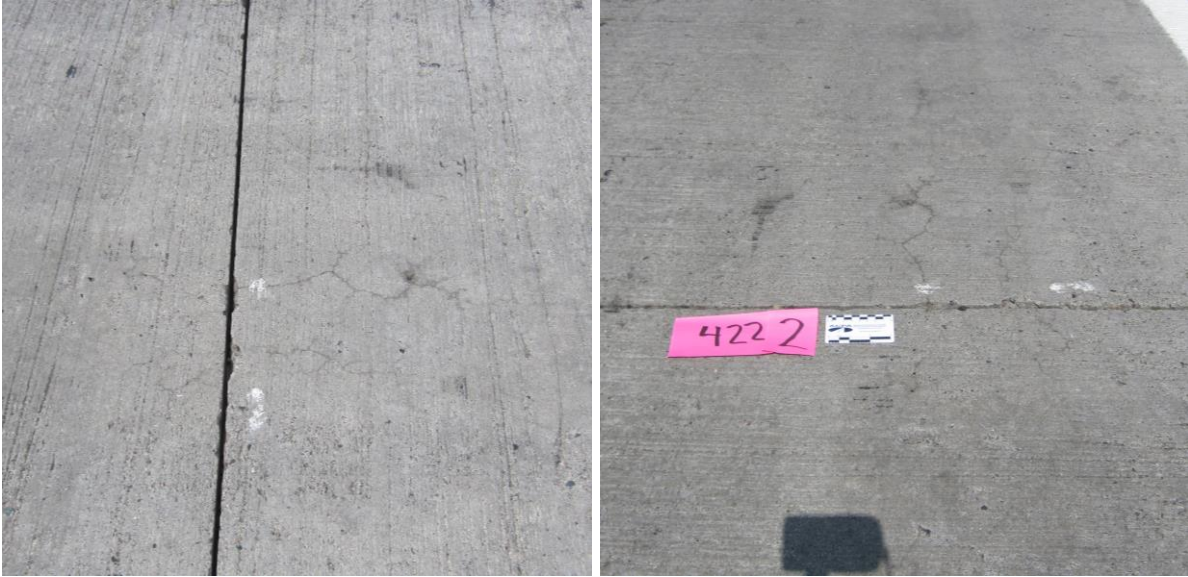
**Figure 47. Cracking in the wheel path observed in Cell 505, an unbonded concrete overlay**

Figure 47 provides examples of this observed cracking. The same cracking was not detected in 2013.

In many cases, the cracking was pronounced. Staining in the cracks was observed in some cases, but not in every case; no exudate was noted. The cracking had the appearance of a materials-related distress crack rather than a structural crack. There is reason to suspect there was an increased moisture content in the concrete overlay that led to freeze-thaw deterioration.

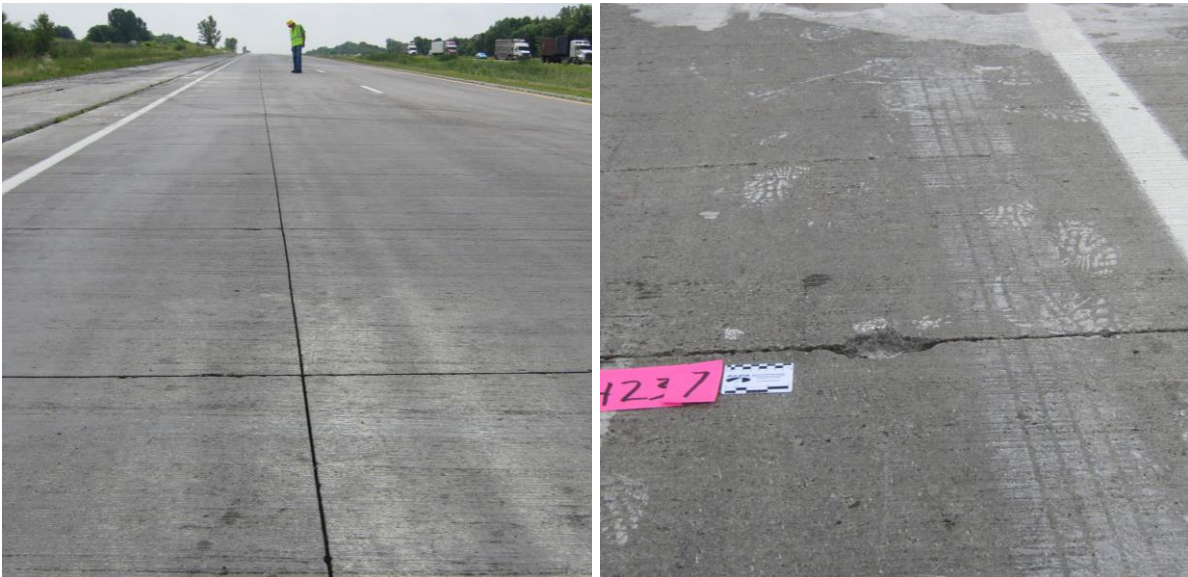
**Figure 48. Edge breaks observed just outside the wheel path in Cell 505, an unbonded concrete overlay**

The other observation regarded edge breaks on the traverse joints slightly out of the wheel path. As seen in Figure 48, the edge breaks were in a line and occurred on nearly every joint.

The edge breaks were observed in both lanes, typically in the left wheel path. No evidence of abrasion or other damage that might be attributed to winter maintenance operations was observed.
