Road Safety Audit for Prince of Wales Island, Alaska

October 25-27, 2010

Sponsored by
Federal Highway Administration
Road Safety Audit
Peer-to-Peer Program

ROAD SAFETY AUDIT FOR PRINCE OF WALES ISLAND, ALASKA

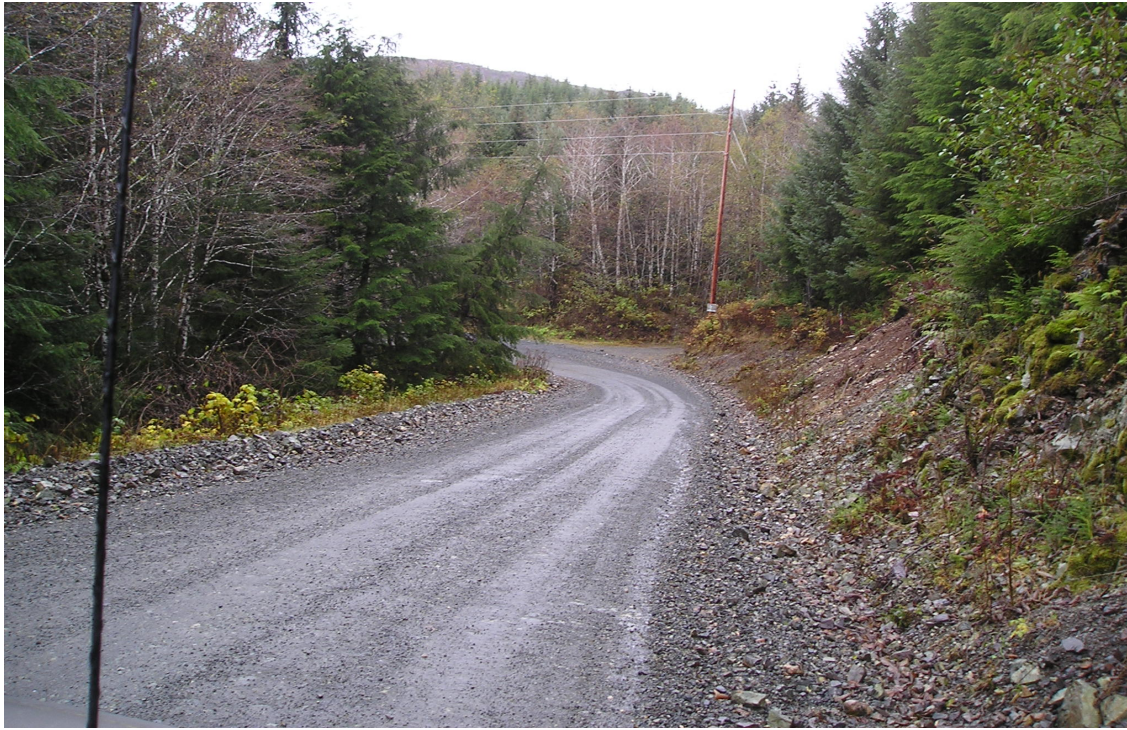
Figure A.1. Typical section on Kasaan Road

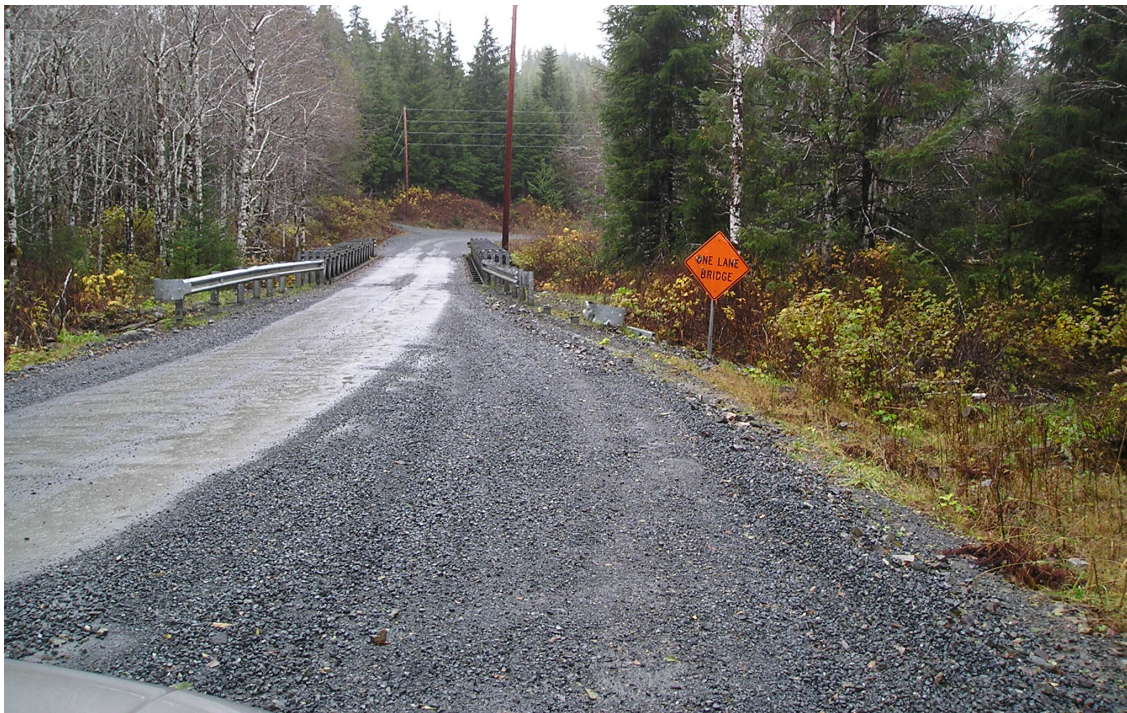
Figure A.2. Narrow bridge on Kasaan Road

1. Replace all narrow bridges, possibly with reinforced concrete box or pipe culverts to reduce future maintenance needs. Realign roadway as needed at these sites to eliminate severe curvature of approaches.
2. Study existing intersections, especially Ellen Lake Road and Ron's Road, for realignment needs and sight distance improvement. Also study current visibility to and from higher-traffic intersections, such as the Thorne Bay Solid Waste Site, for needed improvements and undertake those upgrades.
3. Reconstruct all roadway sections with a top width less than 24 ft to a minimum of 28 ft or more as design standards dictate. Realign road through those areas as well.
4. Complete reconstruction of all remaining sections to a minimum of 28 ft wide or more, as design standards dictate. Realign where needed.
5. Pave road when traffic volumes warrant and funding becomes available.

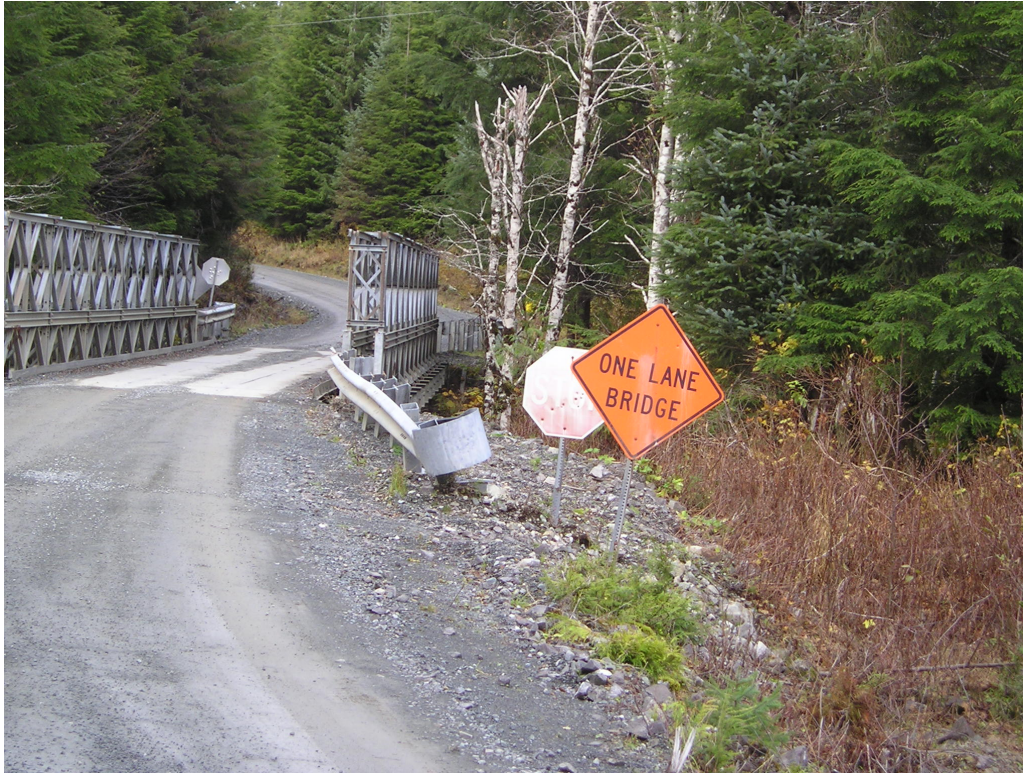
Figure A.3. Signing and beam guardrail at narrow bridge on Kasaan Road

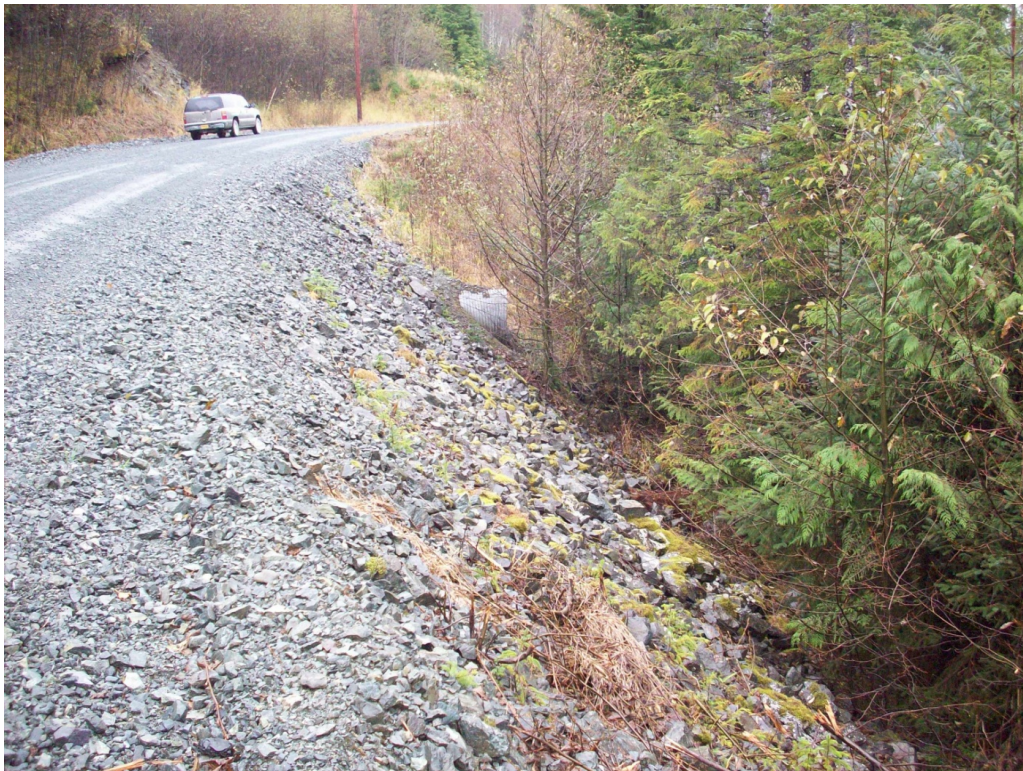
Figure A.4. Steep foreslope on Kasaan Road

4. Review all noted potentially-hazardous side hazards, especially steep slopes, for need of additional shielding with guardrail, either w-beam or high-tension cable rail.

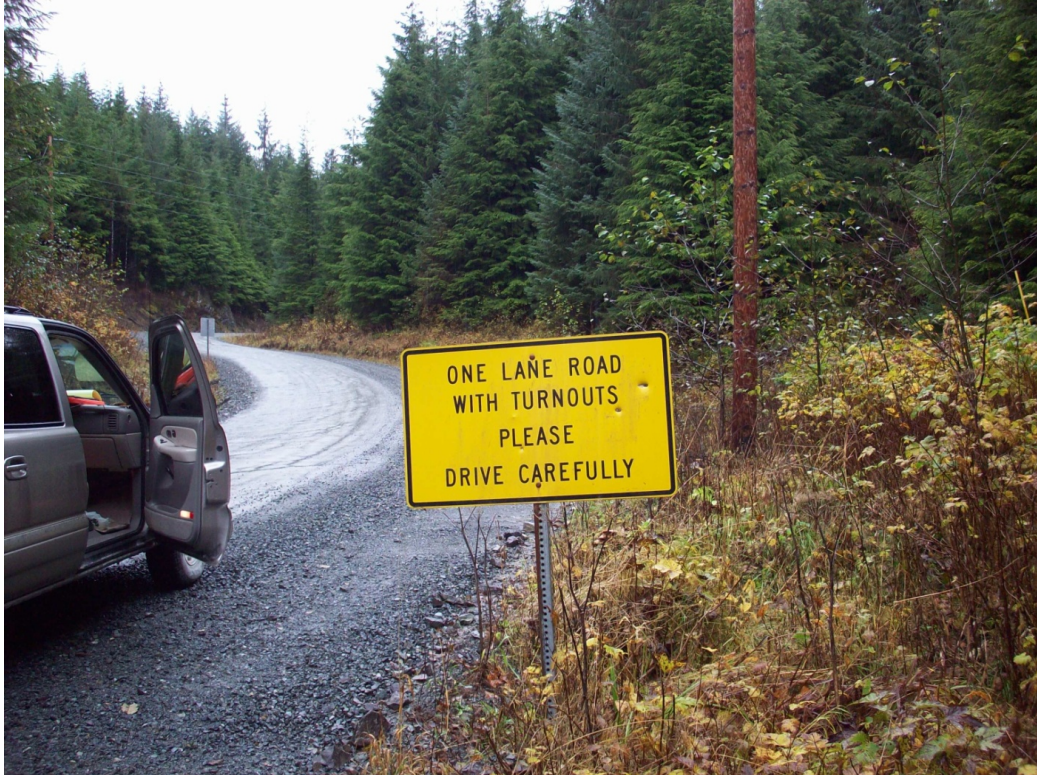
Figure A.5. Warning Sign on Kasaan Road

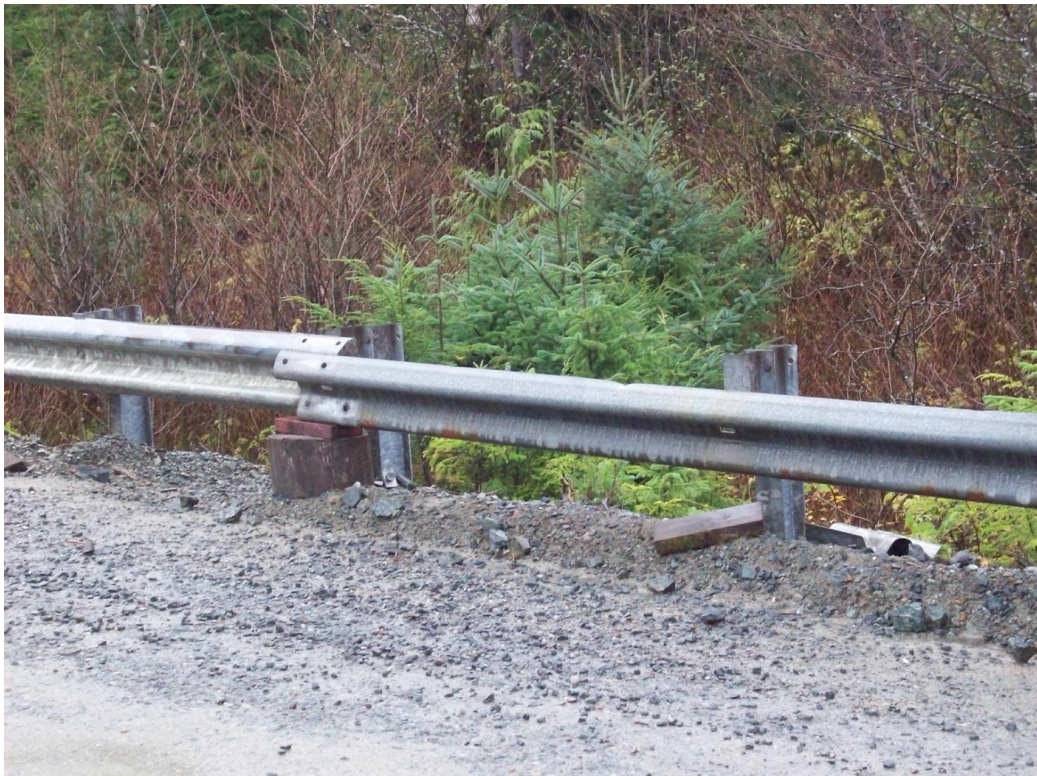
Figure A.6. Damaged beam guardrail on Kasaan Road

10. Review all guardrail installations and upgrade to current design standards as needed. Consider removal of existing installations where hazards do not warrant shielding. Review noted locations for installation of additional w-beam guardrail where hazards justify shielding. Enhance nighttime guidance at guardrail locations using delineation in or behind the rails.

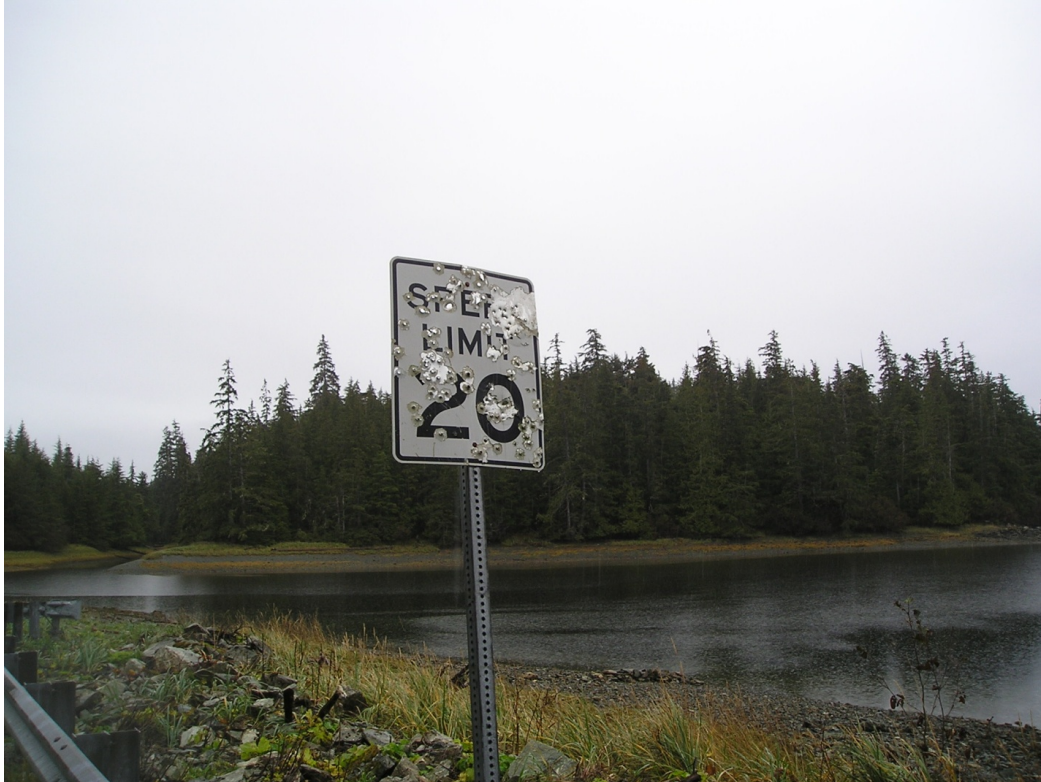
Figure A.7. Vandalized regulatory sign on Kasaan Road

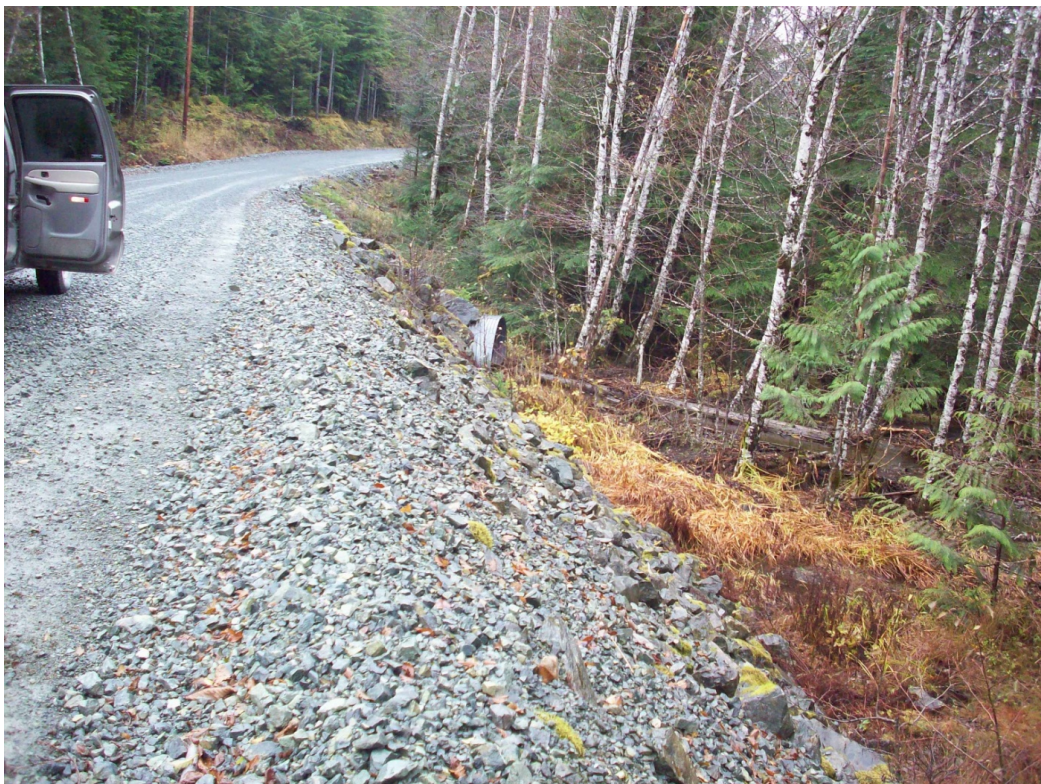
Drainage under the roadway is conveyed by corrugated metal pipes, mostly 30-36 in. in diameter. Condition is unknown.

Figure A.8. Pipe culvert outlet on Kasaan Road

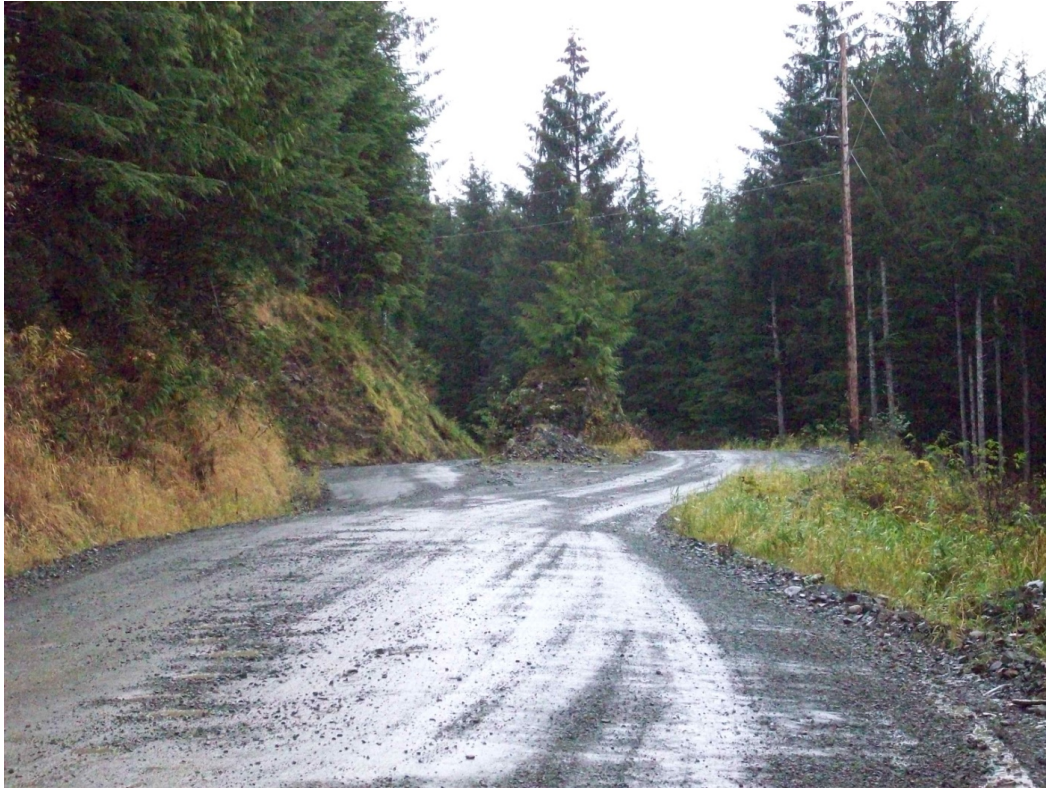
For Kasaan Road, Sgt. Brown thought the most-hazardous locations were the several narrow bridges and the large rock in the middle of the road that should be removed. Some roadway lighting would be effective at locations, such as the intersections of Ron's Road, Salt Chuck Road, and South Thorne Bay Road, the waste-disposal site, and the narrow bridges. Many areas should be reviewed for regulatory speed modifications.

Figure A.9. Large rock in center of Kasaan Road

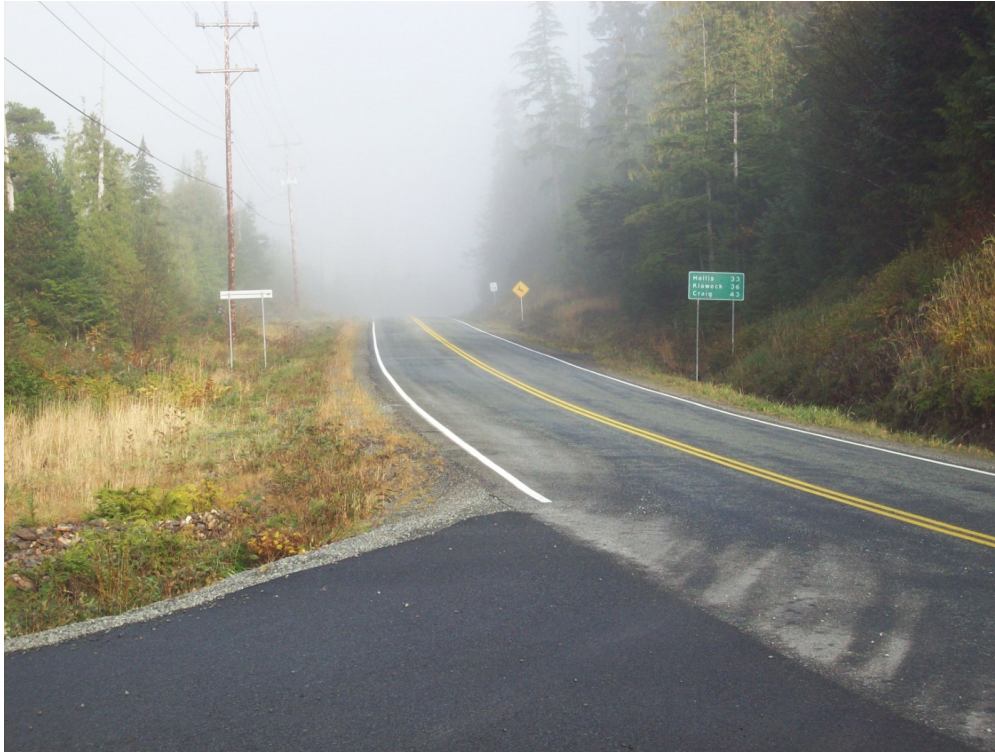
Figure A.11. Roadway section on Hydaburg Highway

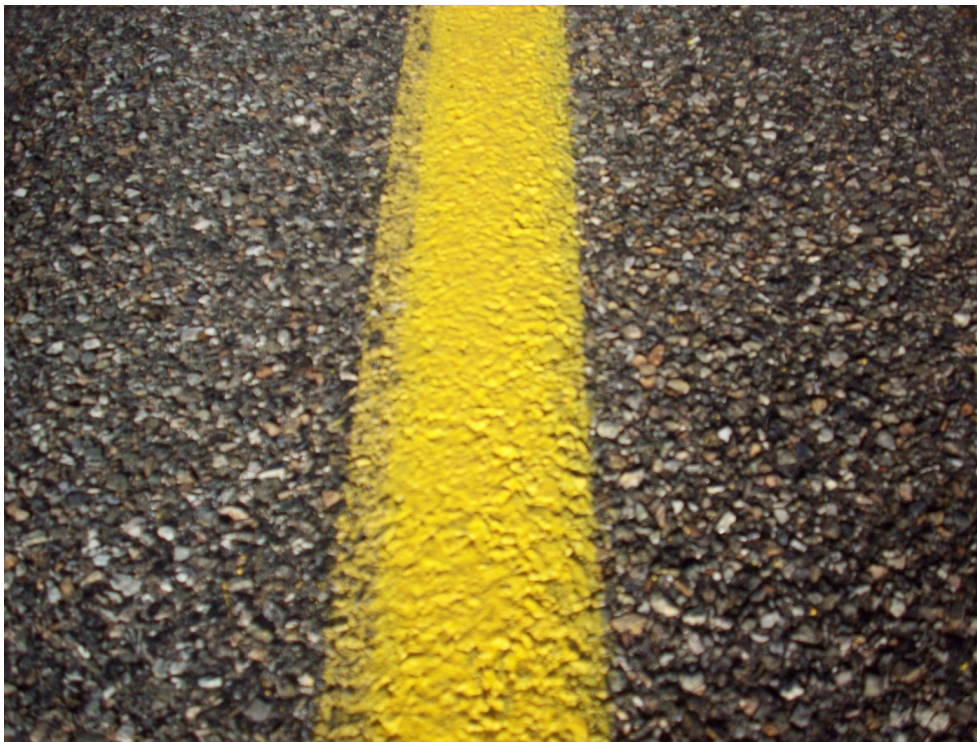
Figure A.12. Typical pavement marking on Hydaburg Highway

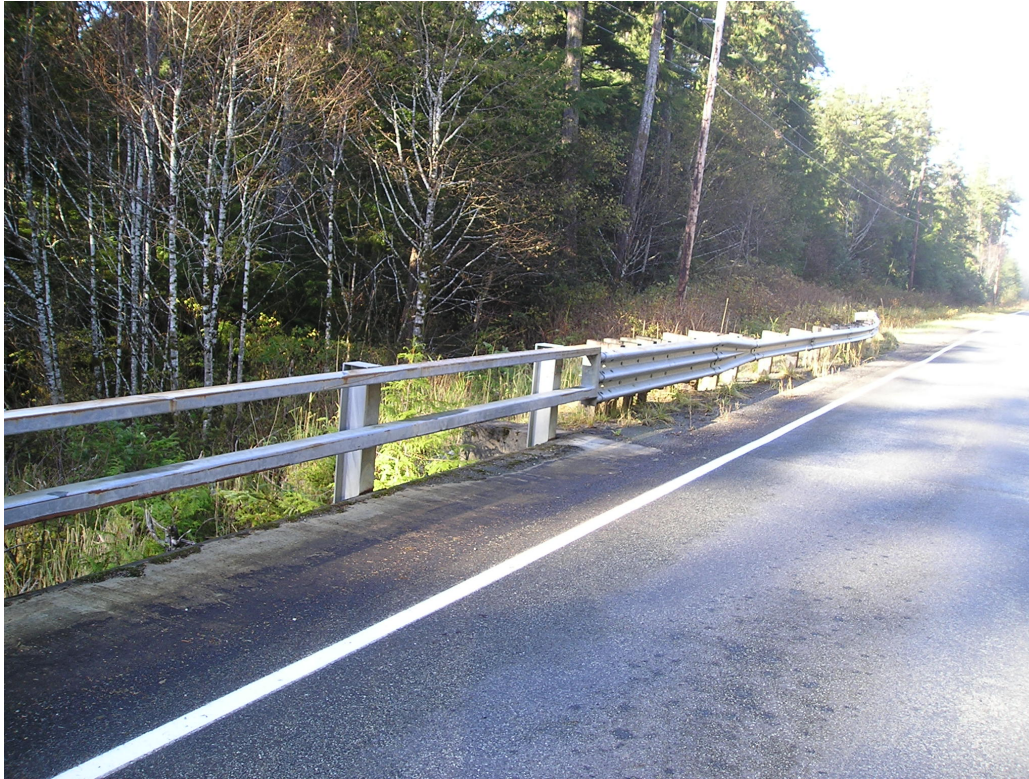
Figure A.13. Beam guardrail and bridge rail on Hydaburg Highway

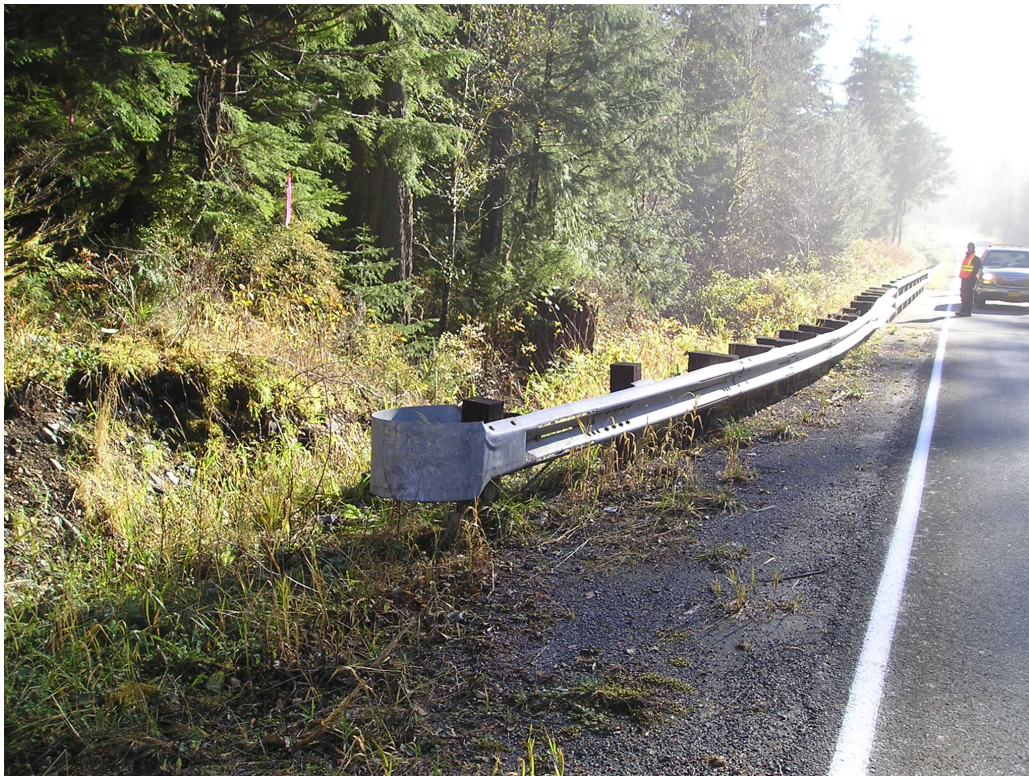
Beam guardrail is installed in several locations to shield potential hazards at high fills and at bridge approaches. Guardrail terminals are not of current design, but installations are connected to bridges. Bridges are all shoulder-width. Right-of-way appears open and wide in most areas, with a 20-30 ft area cleared of trees and brush adjacent to the shoulders.

Figure A.14. Beam guardrail terminal section on Hydaburg Highway

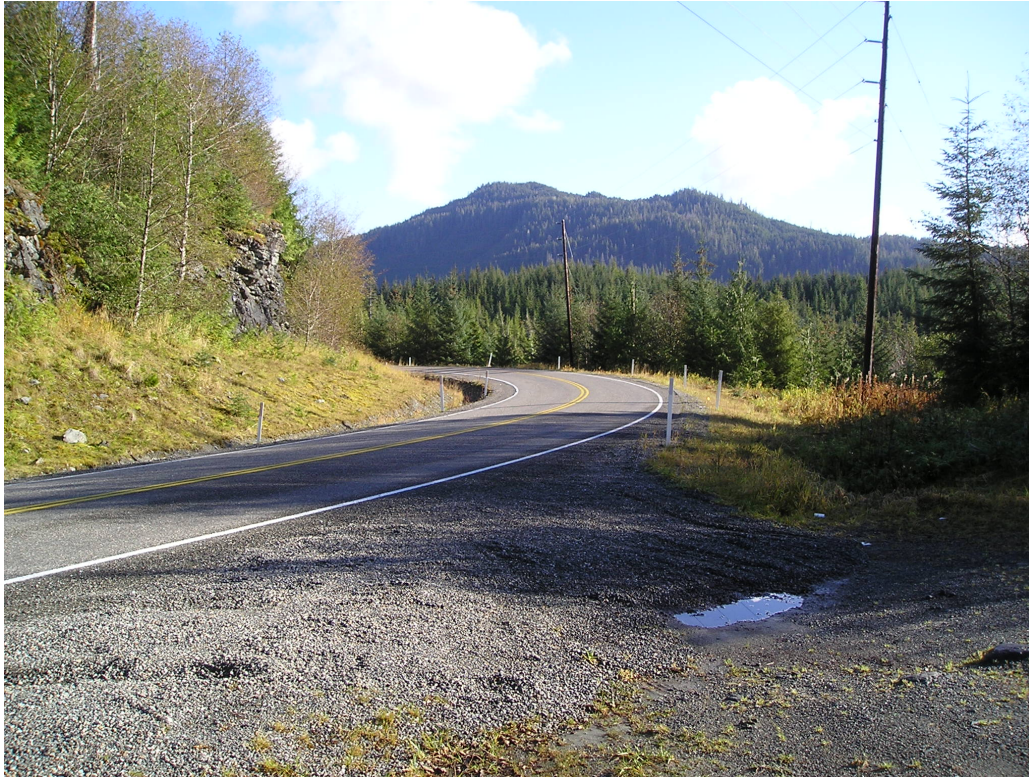
Figure A.15. Delineators at horizontal curve on Hydaburg Highway

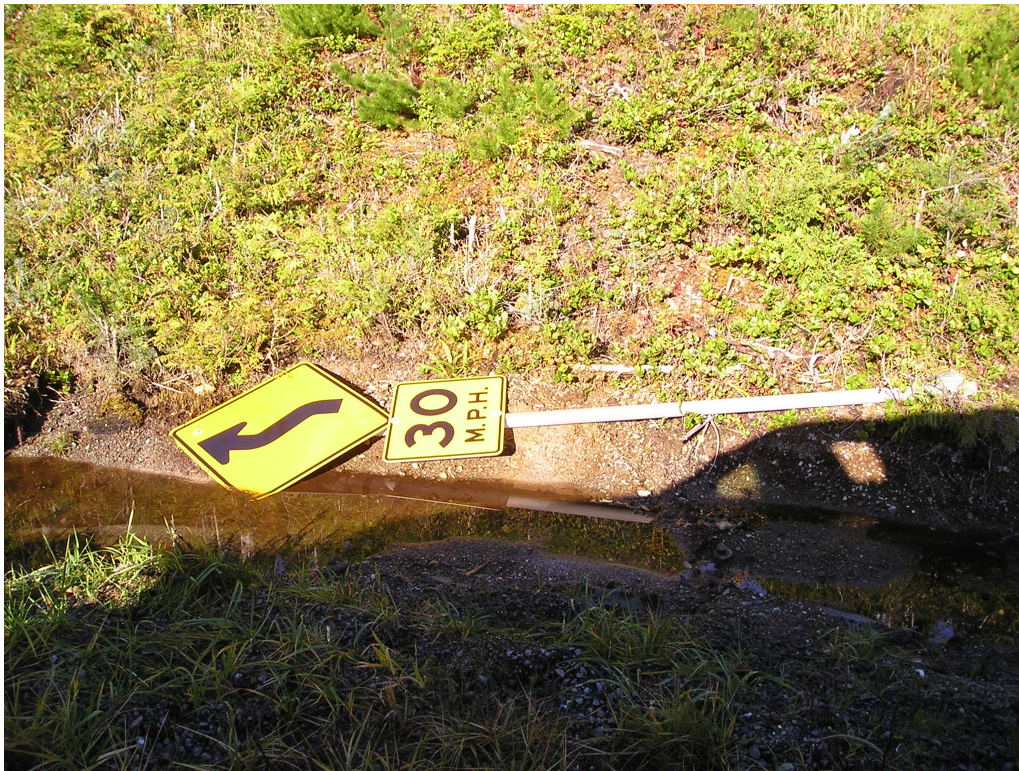
Figure A.16. Damaged warning sign on Hydaburg Highway

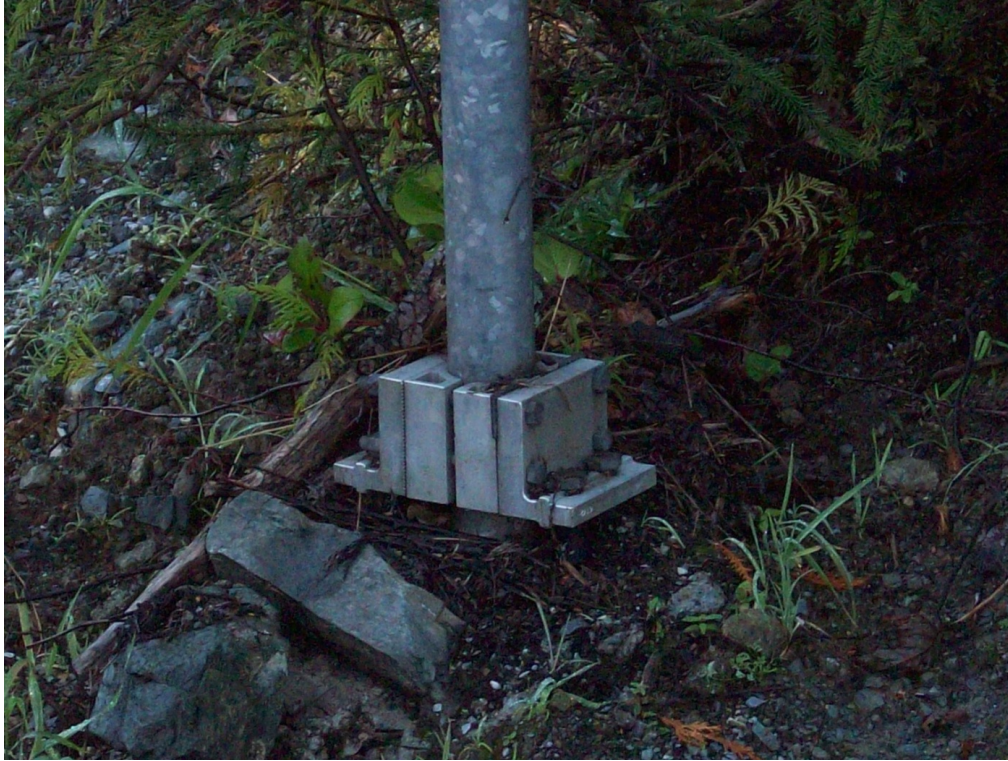
Figure A.17. Breakaway sign support base on Hydaburg Highway

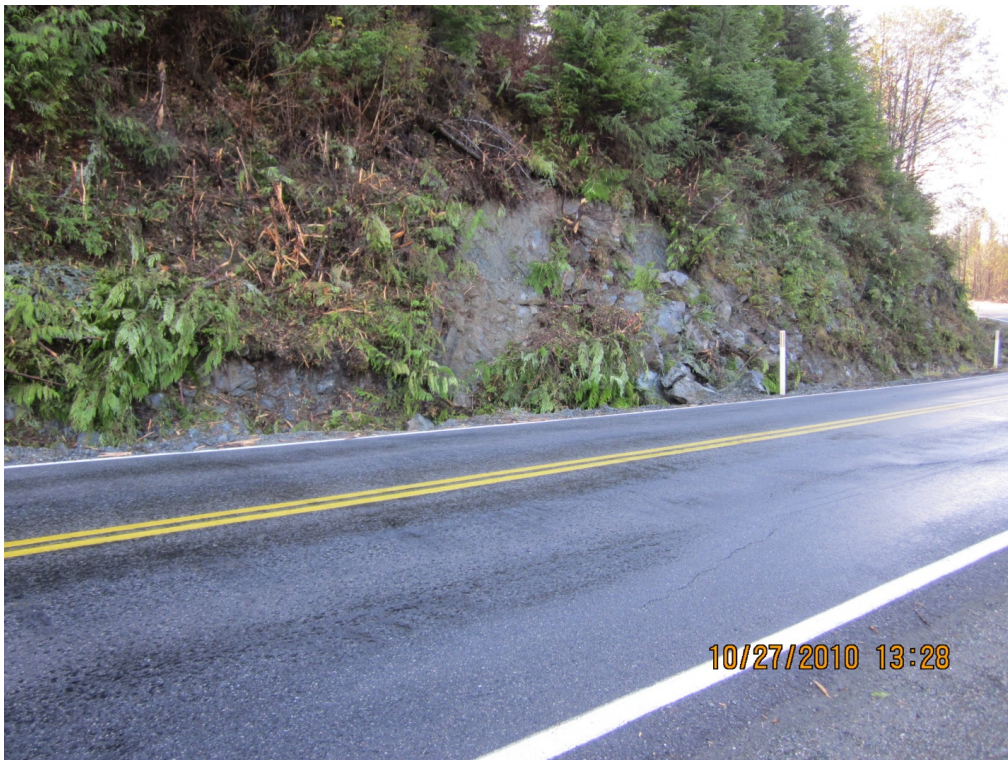
Figure A.18. Road cut backslope on Hydaburg Highway
