Evaluating Roadway Subsurface Drainage Practices

Final Report
May 2013

IOWA STATE UNIVERSITY
Institute for Transportation

Sponsored by
Iowa Highway Research Board
(IHRB Project TR-643)
Iowa Department of Transportation
(InTrans Project 12-428)

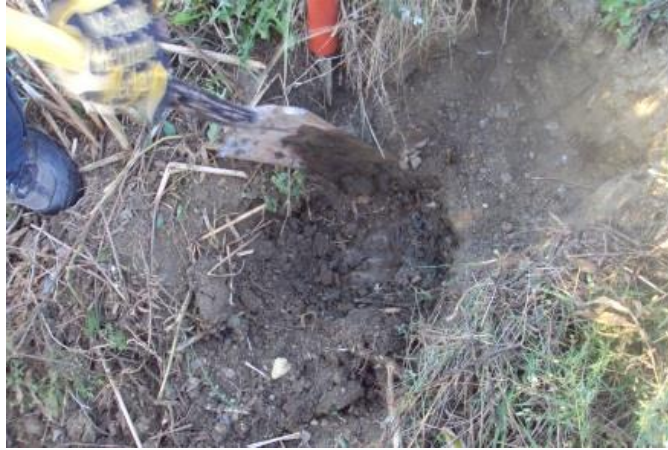
Figure 15. Clearing debris surrounding subsurface drainage outlet in I-35/N/MP140.35

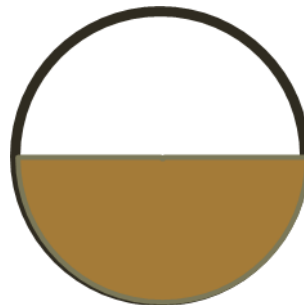
Among these items, the condition of the outlet opening was rated in terms of percentage of blockage caused by coarse/fine materials accumulation. For instance, Figure 16 illustrates a 50 percent outlet blockage rating. Any pavement distresses observed near inspected drainage spots were also recorded (pictures and videos). Pavement distress records for selected sites were also extracted from the Iowa DOT Pavement Management Information System (PMIS) and organized with field inspection results.

Figure 16. 50 percent blockage of subsurface drainage outlet condition

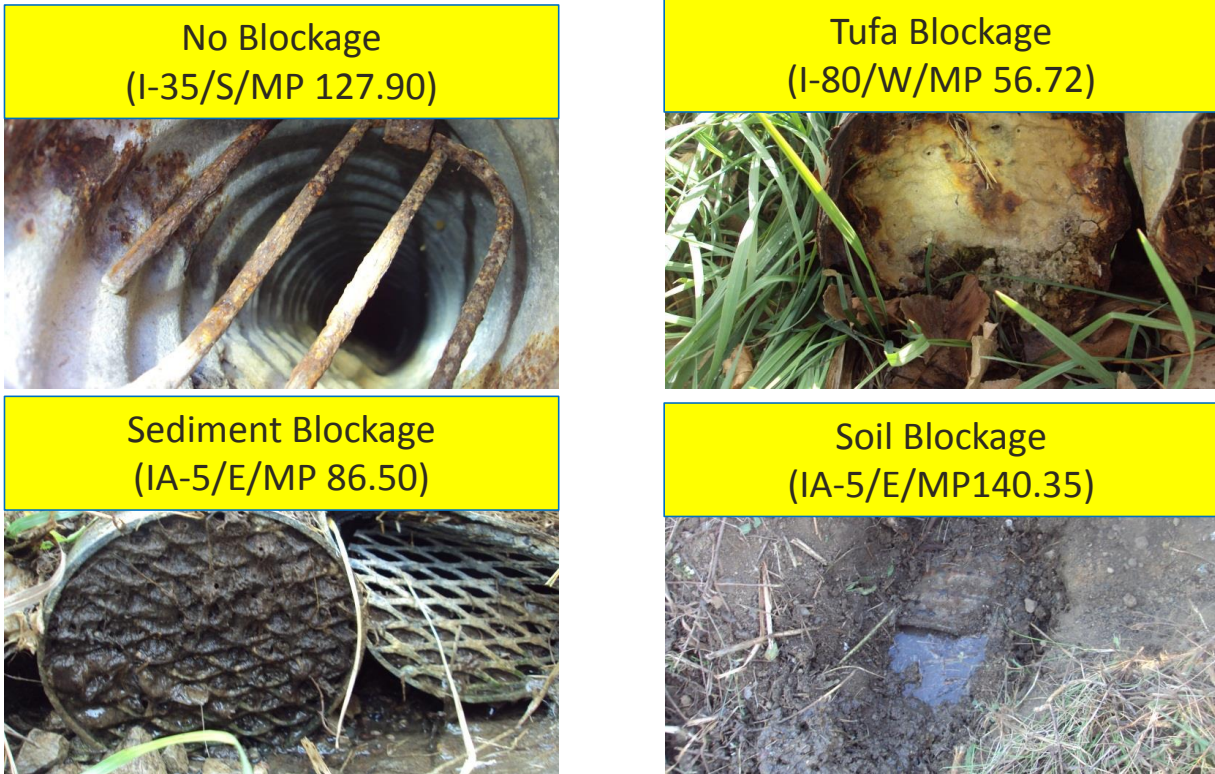
No blockage was reported when the inside outlet pipe was in very clean condition. Tufa blockage was reported when there was build-up of calcium carbonate observed either inside the outlet pipe or near rodent guard screens. Tufa blockage was only observed in JPCP containing RPCC base materials. Sediment blockage was reported when dirty or debris materials were deposited inside the outlet pipe or nearby rodent guard screens. Soil blockage was reported when an end of the outlet was not exposed outside but covered by soil or aggregate.

Figure 18. Typical roadway subsurface drainage outlet conditions in Iowa

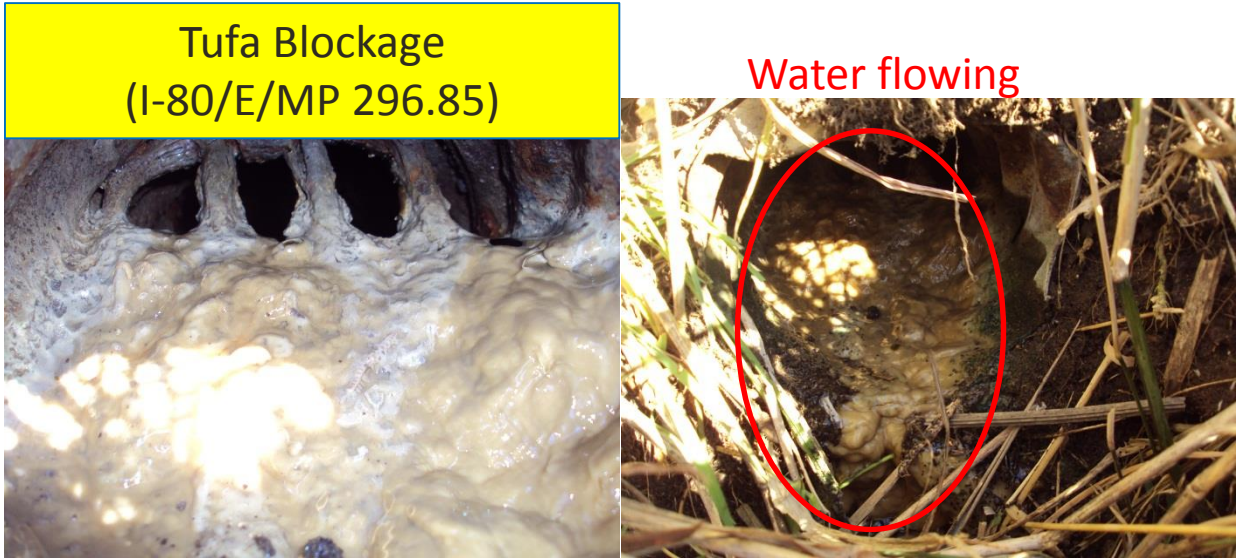
Higher outlet blockage rates lead to slower discharge of water. However, higher blockage rates do not always stop the water from flowing from inside of the outlet pipe to outside of it, as shown in Figure 23, unless the outlet is completely blocked, i.e., 100 percent blockage rate. Note the free flowing drain outlet condition in Figure 23 was not evident at first sight, but was quite clear when viewing the recorded video.

Figure 23. Free water flowing under 75 percent blocked subsurface drainage outlet

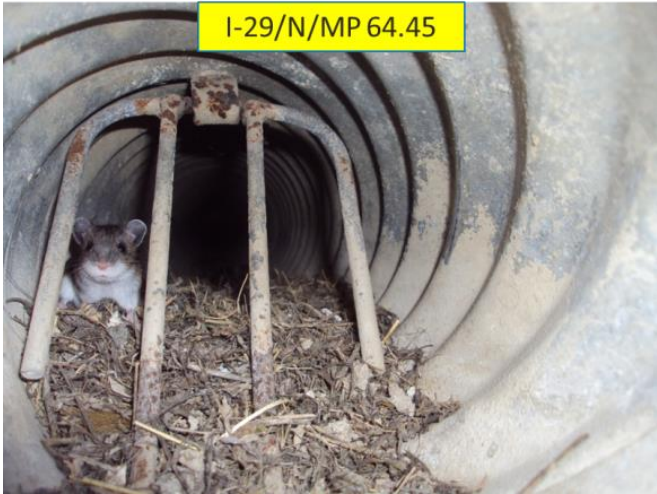
Rodent guards have been used in Iowa pavements to keep mice, rats, and other small rodents from entering subdrains. The two types of rodent guards used in Iowa are mesh screen and fork-shaped ones. Only one drainage spot, as seen in Figure 24, was observed as having rodent evidence.

Figure 24. Rodent evidence inside a subsurface drainage outlet during field investigations

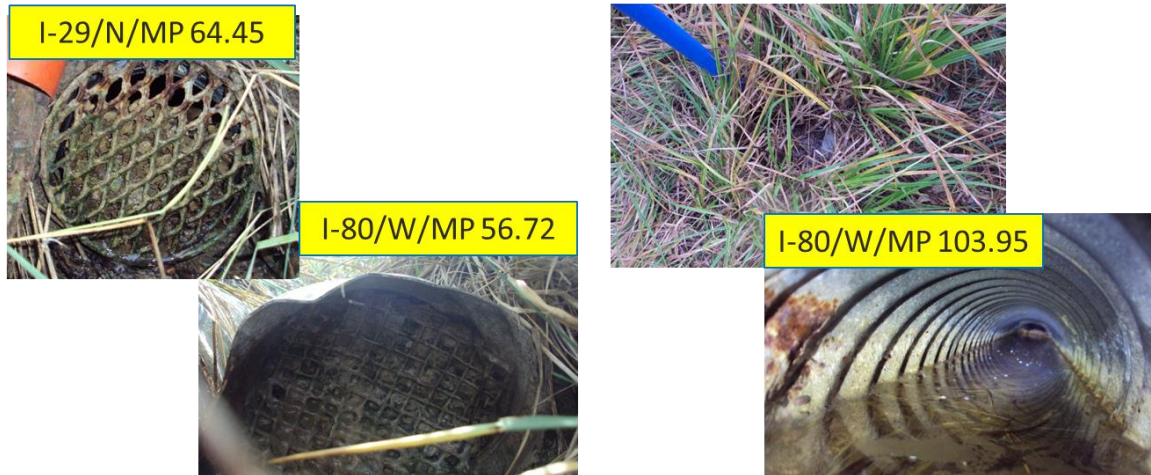
In light of the significant blockage caused by tufa or sediment in many of the investigated drain outlets further complicated by the presence of rodent guards, the question of whether or not we should be using rodent guards has become a moot point. The mesh screen-type rodent guards in some drainage outlets, as shown in Figure 25, is causing clogging with tufa or sediment by filtering the flow of water. Removal of the rodent guards, as shown in Figure 25, often prevents this clogging problem.

Blocked Outlet with Mesh Gate Screen Opened Outlet without Mesh Gate Screen

Figure 25. Subsurface drainage outlet conditions with/without mesh screen rodent guards

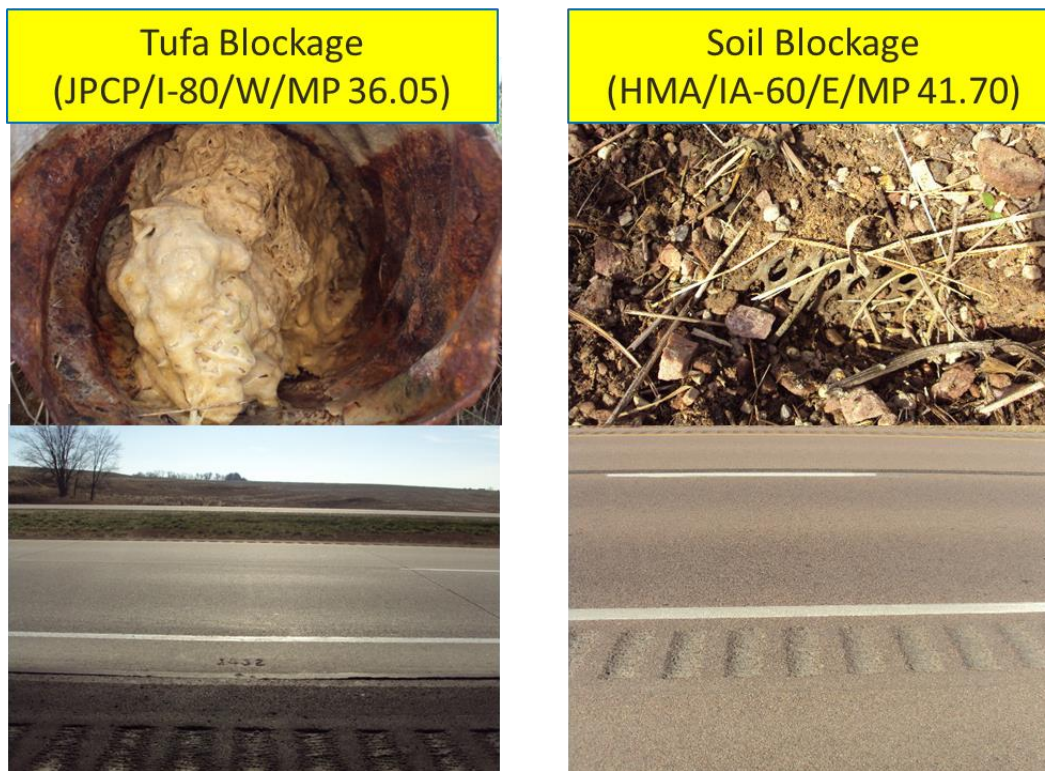
Most surface distresses were observed near open subsurface drainage outlet spots rather than blocked ones. The investigated JPCP sites with blocked outlet spots were constructed from 1990 to 2007 with PCC thicknesses ranging from 9 to 13 in. and AADTT ranging from 579 to 13,264. The JPCP sites with open outlet spots have similar ranges of pavement age, PCC thickness, and AADTT. The investigated HMA sites with both blocked and opened outlet spots were constructed from 1998 to 2006 with HMA thicknesses ranging from 9 to 15 in. and AADTT ranging from 738 to 1,730. As shown in Figure 27, no surface distresses were observed on

blocked outlets in JPCP and little surface distress was observed on blocked outlets in HMA. Only one blocked outlet spot in HMA (US 61/E/MP173.00) had transverse cracking.

JPCP I-80/W/MP 36.05: construction year 2005, AADTT 8,093, PCC thickness 11.5 in.; HMA IA 60/E/MP 41.70: construction year 2006, AADTT 831, HMA thickness 14 in.

Figure 27. No surface distress near blocked subsurface drainage outlet

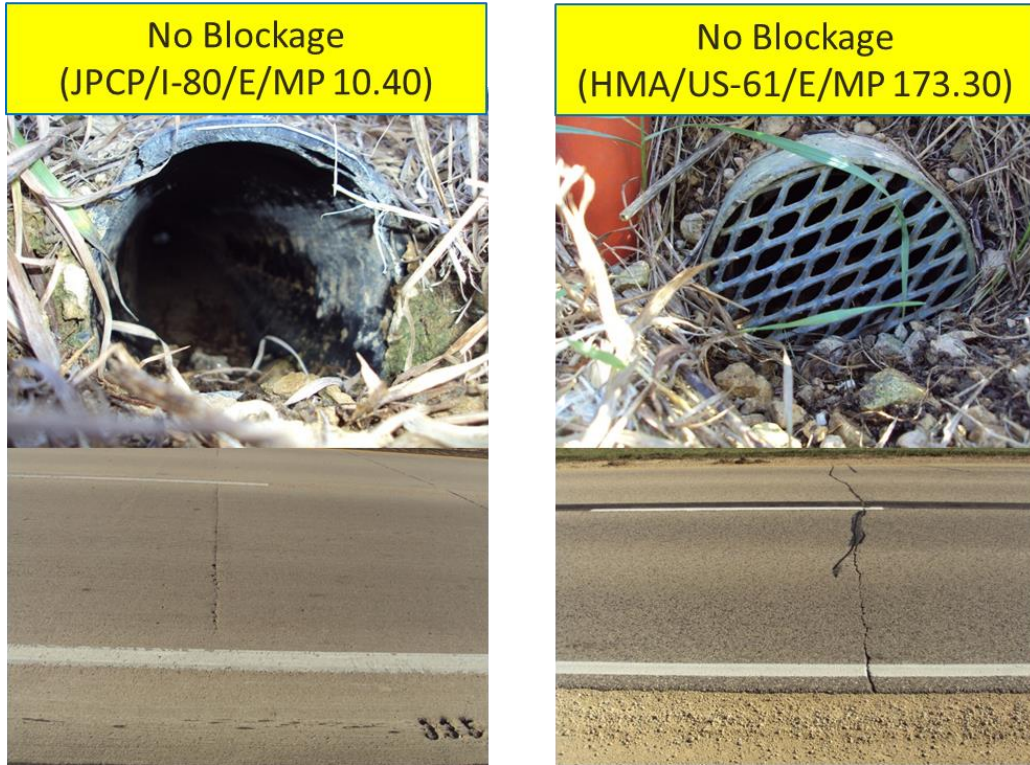
However, open subsurface drainage outlet spots in both pavement types had transverse cracking as shown in Figure 28. Especially note, the opened outlet spot in HMA (US 61/E/MP173.30) in Figure 28 is at a location near to the blocked outlet spot in HMA (US 61/E/MP173.00) that has transverse cracking. Transverse cracking was observed near several culverts (see Figure 29) rather than drainage outlet spots. These results indicate that blocked drainage outlet conditions do not have significant effect on pavement surface distress development.

JPCP I-80/E/MP 10.40: construction year 2003, AADTT 6,825, PCC thickness 12 in.; HMA US 61/E/MP 173.30: construction year 1999, AADTT 1,211, HMA thickness 12 in.

Figure 28. Transverse cracking observed near opened subsurface drainage outlet

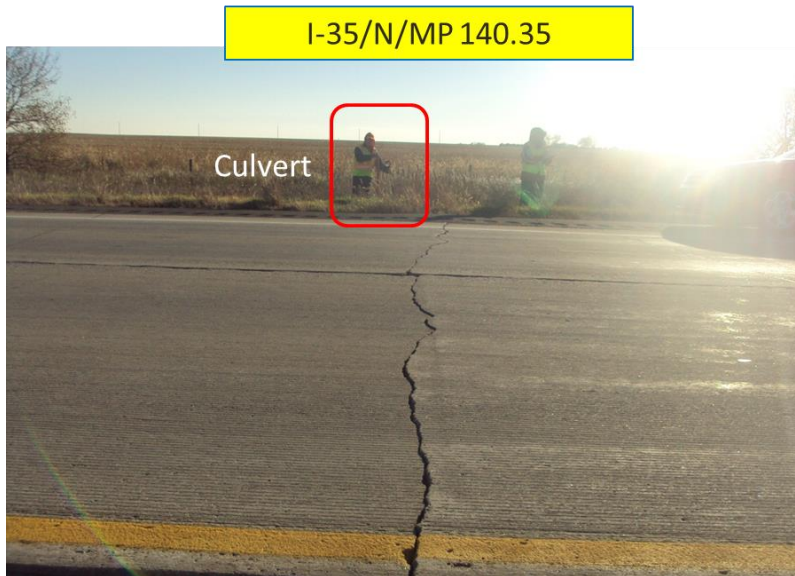
Figure 29. Transverse cracking observed near culvert

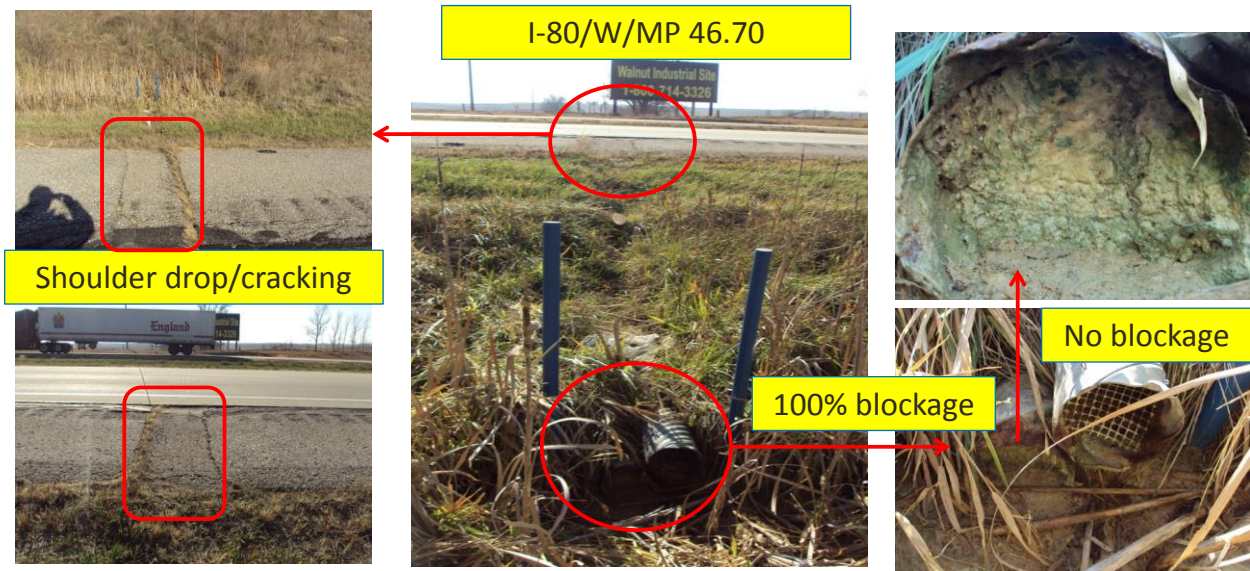
Rather than surface distresses, more shoulder distresses (shoulder drop or cracking) as shown in Figure 30 were observed near blocked drainage outlet spots. Note that the opened outlet captured in Figure 30 was newly installed to replace the 100 percent blocked outlet. Figure 31 compares frequency of outlet spots with observed shoulder distress under opened and blocked outlet conditions. More than 10 percent of the blocked drainage outlet spots have shoulder distresses while only 2 percent among opened drainage outlets have shoulder distresses.

Figure 30. Shoulder drop/cracking observed on blocked outlet in Iowa JPCP
