Deicer Scaling Resistance of Concrete Pavements, Bridge Decks, and Other Structures Containing Slag Cement

Phase 1: Site Selection and Analysis of Field Cores

Final Report September 2008

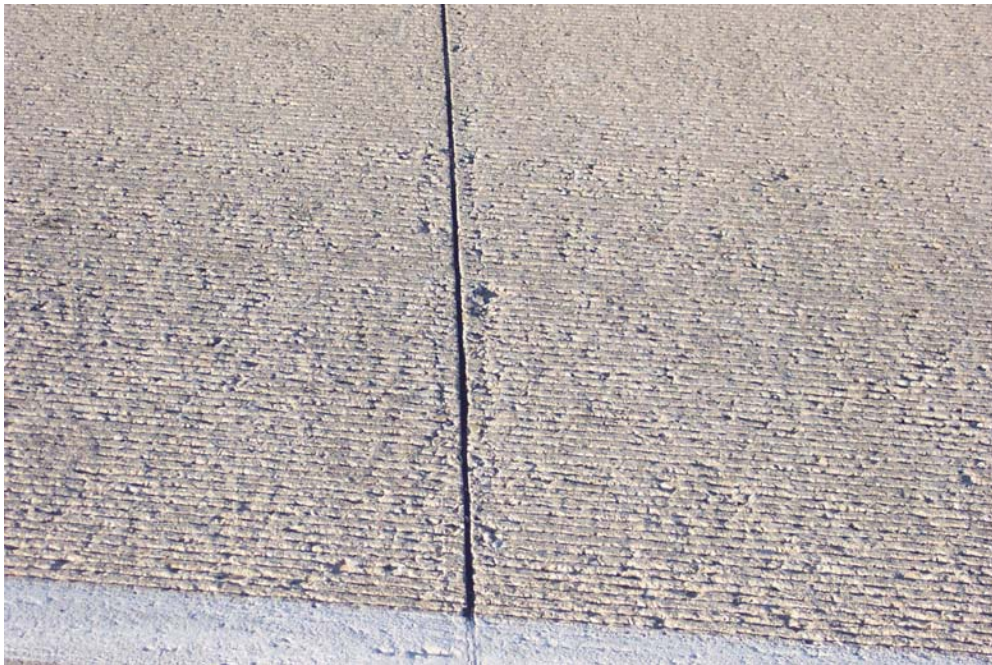
The joint region of a section of the pavement from mile post 156.45 is shown in Figure 1. This section of pavement was paved on October 12, 1999. Subtle features near the joint (roughly parallel to the joint) suggested some paving problems. Likewise, poorly finished areas were evident on the pavement placed on October 14, 1999 (mile post 157.20), shown in Figure 2. However, these discrepancies disappeared later in the paving process, evident in the pavement placed on October 15, 1999, at mile post 157.85 (Figure 3).

Figure 1. Highway 520 eastbound at mile post 156.45 (note features parallel to joint)

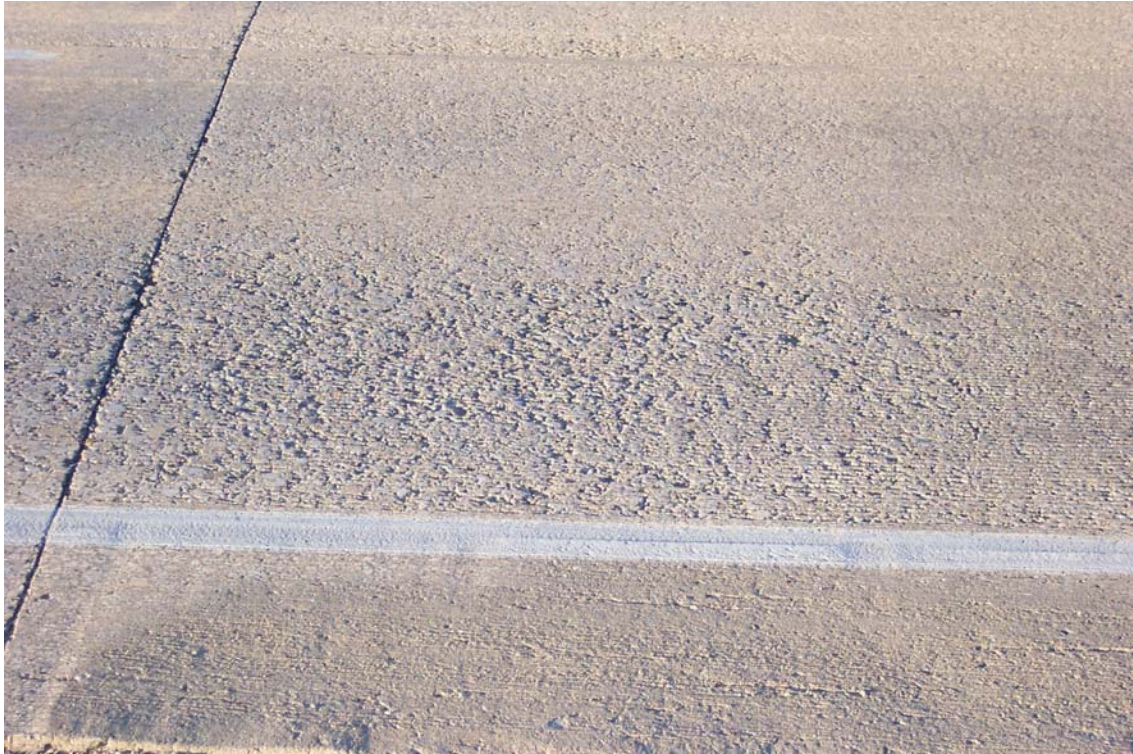
Figure 2. Highway 520 eastbound at mile post 157.20 (note poor surface finish in driving lane)

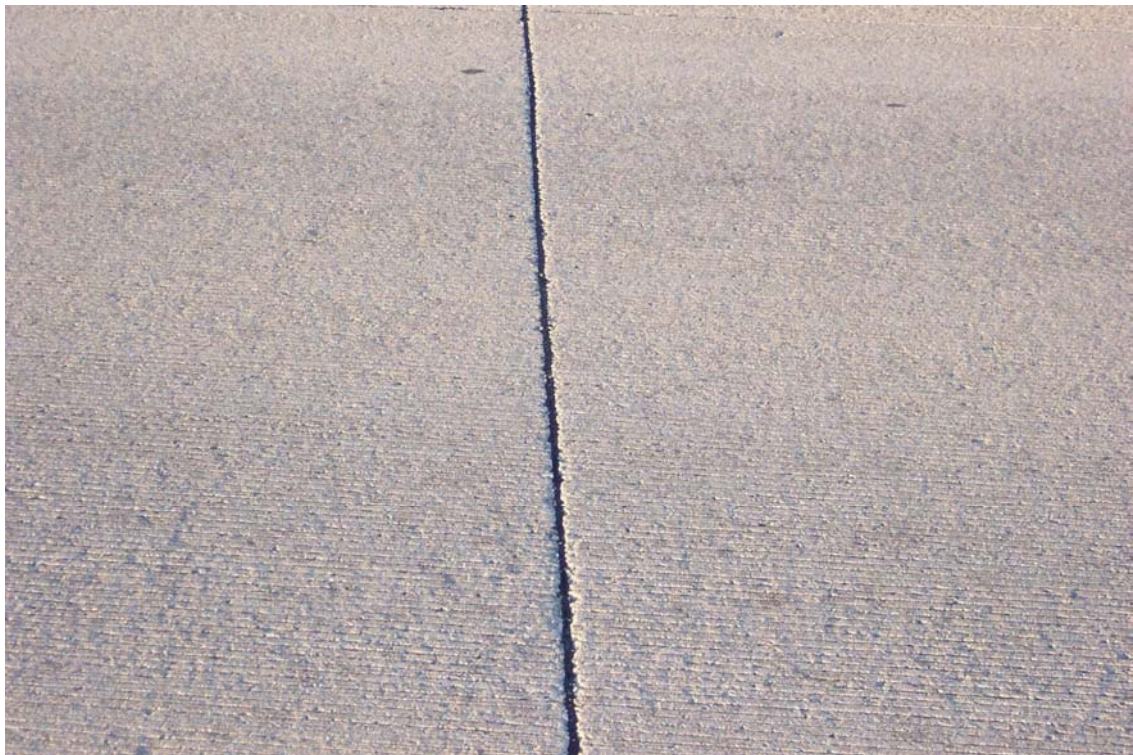
Figure 3. Highway 520 eastbound at mile post 157.85

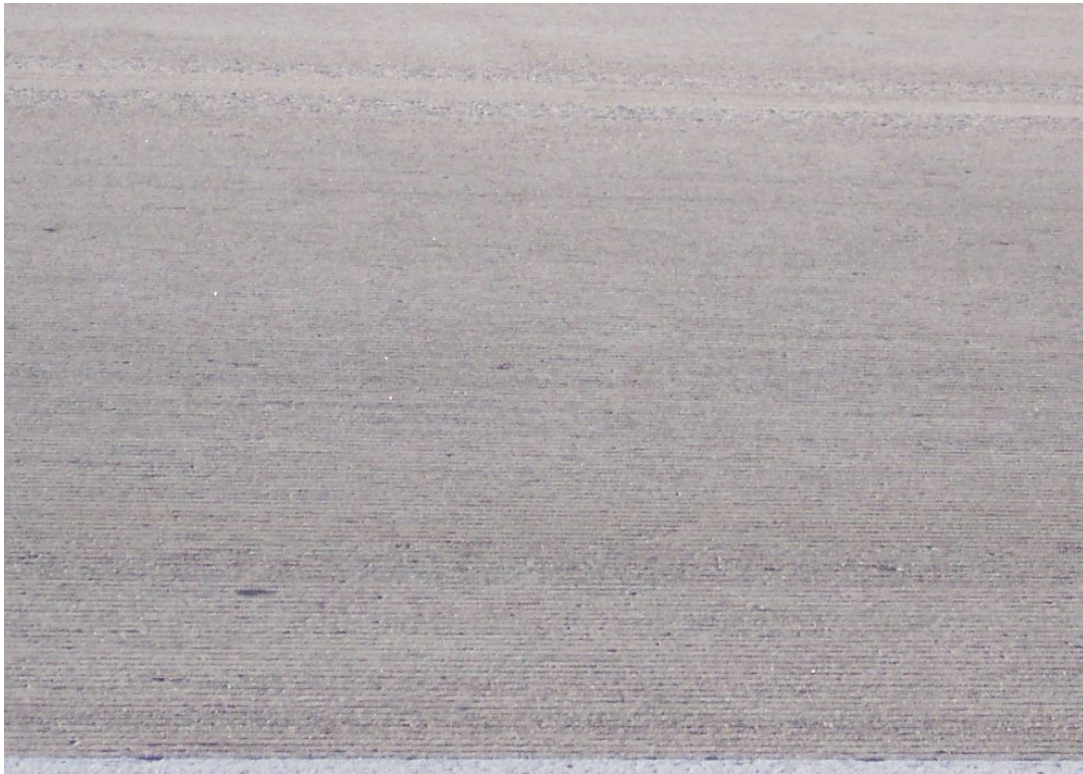
I-35 is a four-lane interstate highway that passes through Hamilton County. The northbound roadway was inspected from mile post 143.3 through 143.6. This stretch of pavement was placed in summer 2003. The cementitious materials used consisted of a blended cement (Type IS) plus an additional 15% of Class C fly ash. This pavement was in excellent shape. No evidence of surface scaling was observed, and the only distress feature that was noted appeared to be snow plow abrasion on the crown of the pavement.

Figure 4. I-35 northbound at mile post 143.45 (note snow plow abrasion on crown)

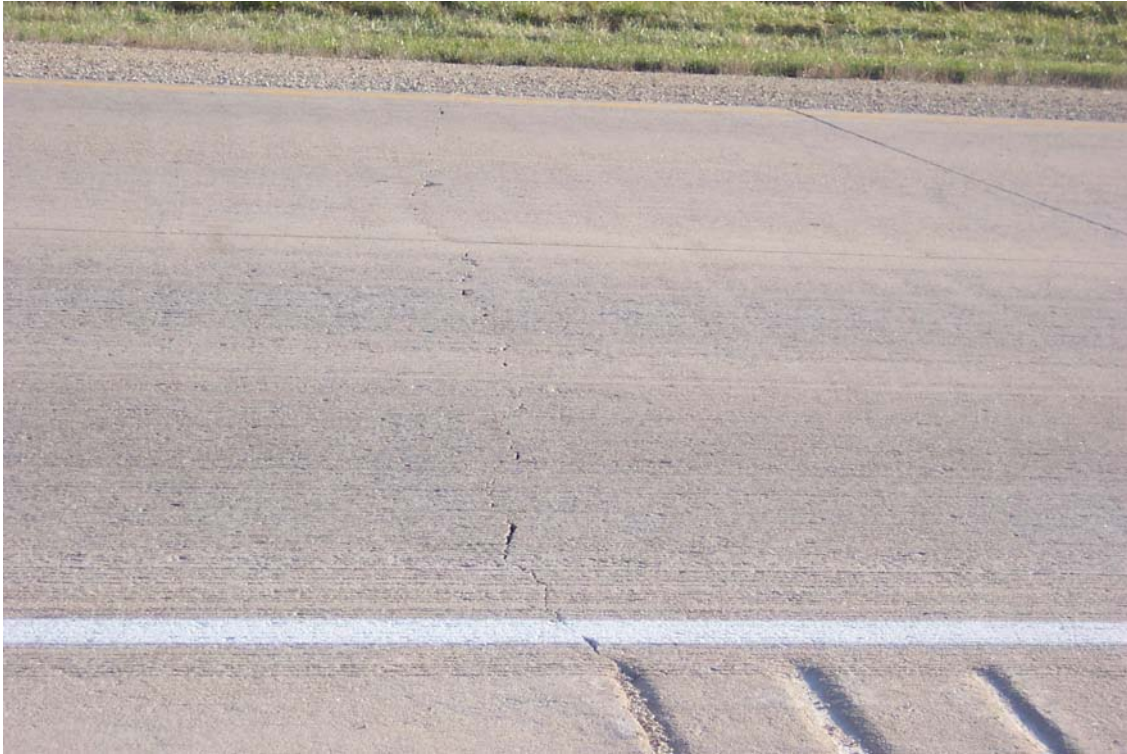
Highway 151 is a four-lane highway that passes through Linn County (just east of Cedar Rapids, Iowa). The southbound (westbound) roadway was inspected from mile post 45.50 through 47.77. This stretch of pavement was placed from June 15 through June 28, 2001. The cementitious materials used consisted of a blended cement (Type IS) plus an additional 15% of Class C fly ash. This pavement was in moderate shape. No evidence of surface scaling was observed. However, transverse cracking was noted on the pavement placed on June 20, 2001 near mile post 45.75 (Figure 5).

Figure 5. Highway 151 southbound at mile post 45.75 (note transverse cracking through panel)

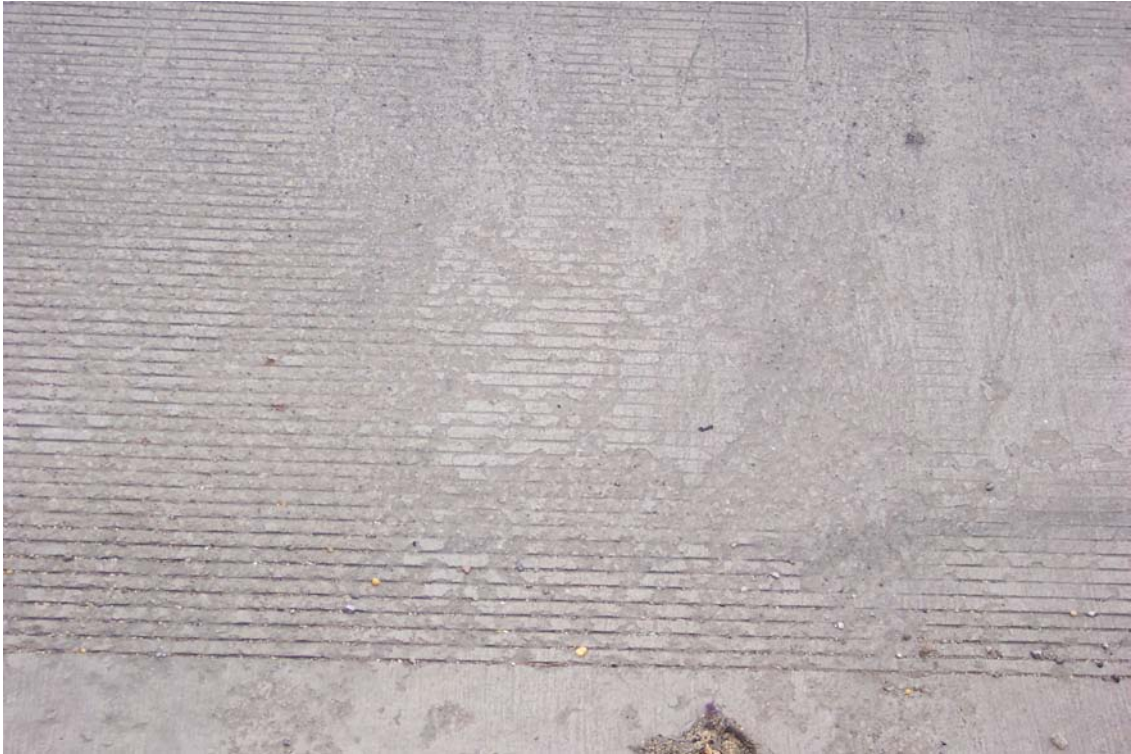
Figure 8. Euclid bridge, eastbound gutter driving lane (note scaling in the tined deck)

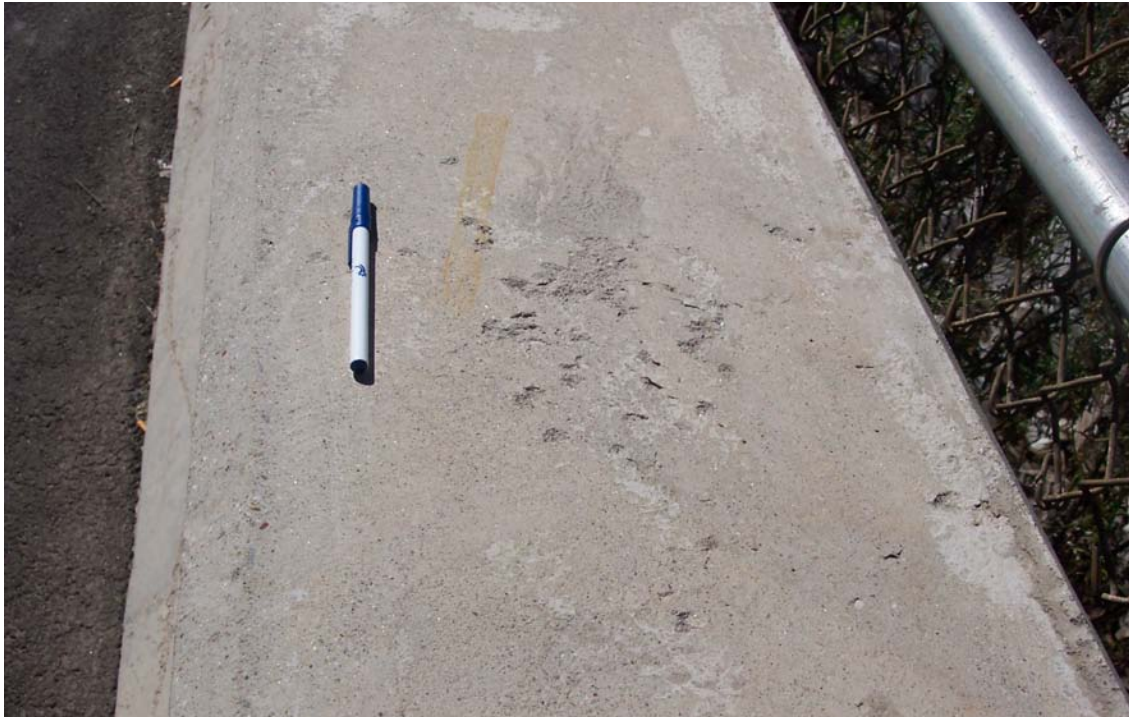
Figure 10 shows the top surface of the barrier wall. The pen in the photo is given for scale (length is 6 in.). The top surface of the barrier wall exhibited scaling that ranged from about 0.05 in. to 0.15 in. in depth. The extent of the scaling varied over the length of the project. However, it was estimated that about 15% of the top surface had scaled. The sides of the barrier wall did not exhibit scaling. This project had been monitored for maturity for a few days after placement.

Figure 10. Barrier wall adjacent to exit 29A, Hartford, Connecticut

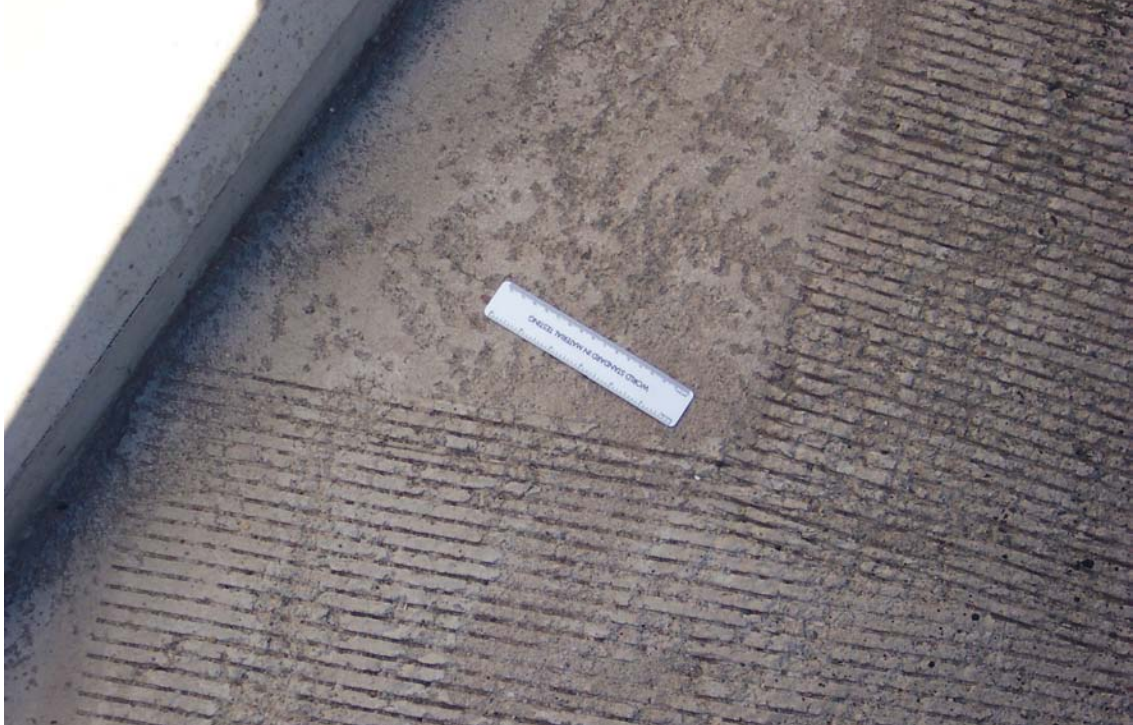
Figures 11 and 12 show typical features noted on the bridge deck. Scaling was most noticeable in the gutter region of the deck (scaling depth varied from about 0.05 to 0.15 in.). Transverse cracks were also noted on approximately 5 to 20 ft spacing along the length of the deck. The mixture design was a high-performance concrete that consisted of a blended cement (portland cement with about 5% silica fume) plus 20% slag. The deck was placed in 2005 in two different stages. Cracking and scaling were noted on both stages.

Figure 11. Scaling noted on bridge deck #1863, ramp to Whitehead Highway, SR 598

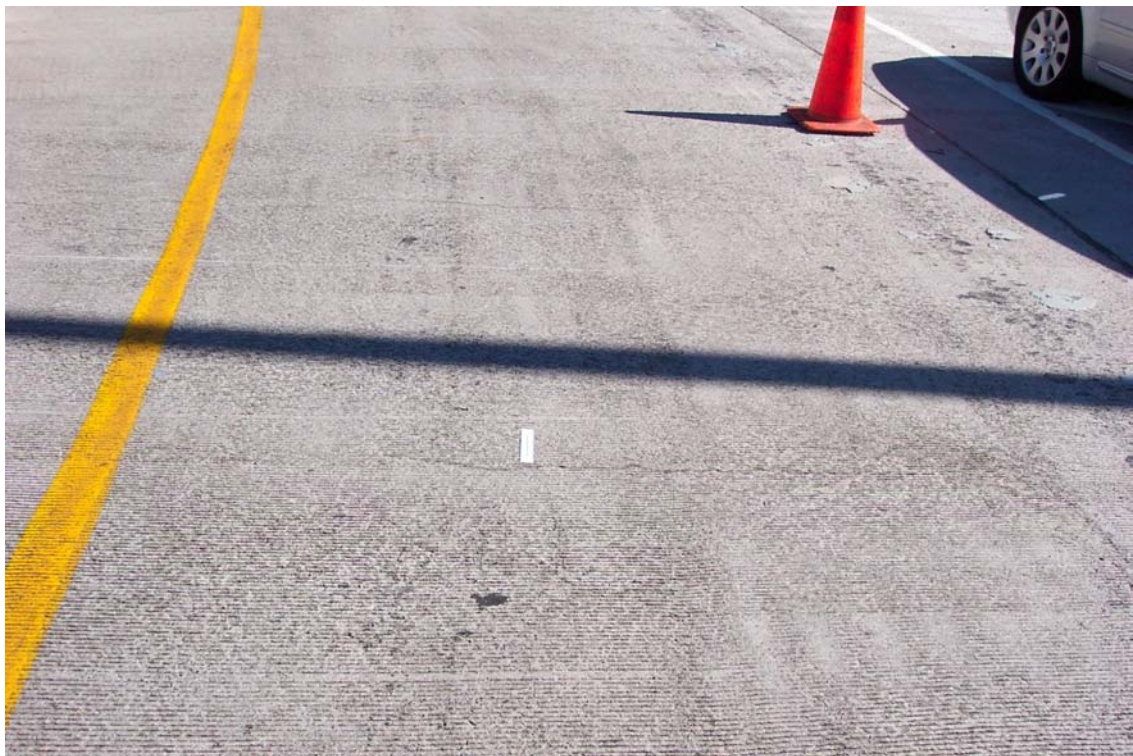
Figure 12. Bridge deck #1863, ramp to Whitehead Highway, SR 598

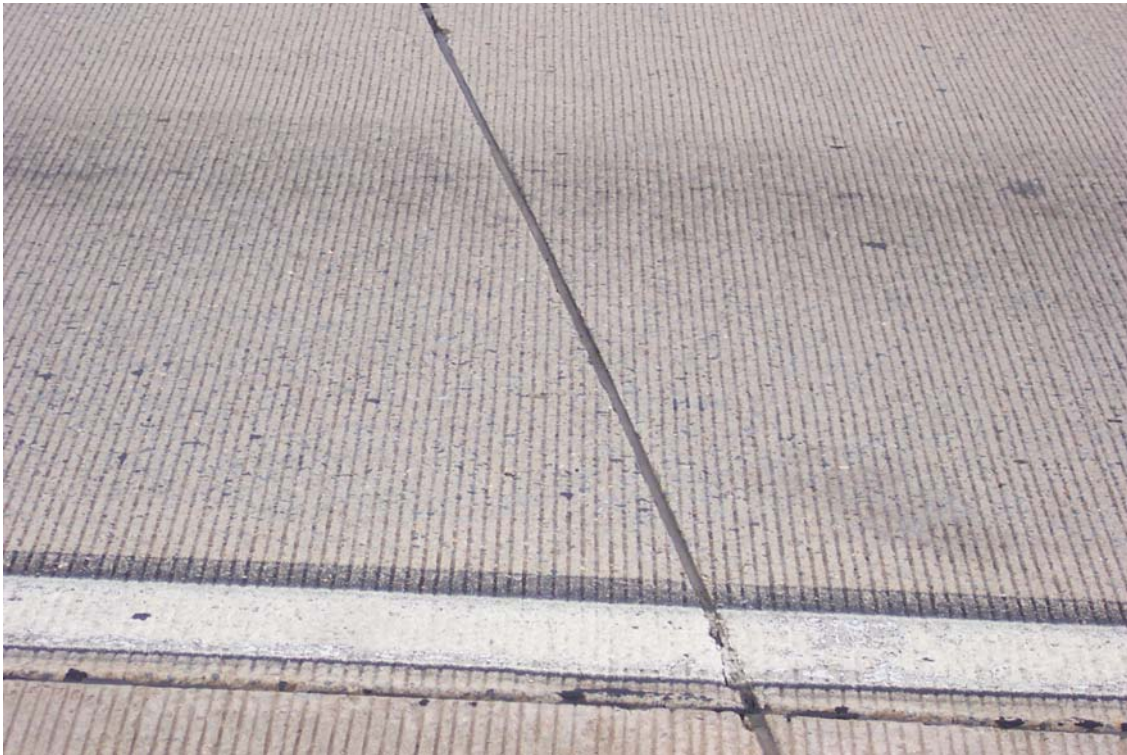
SR 1 is a four-lane divided highway that carries north-south traffic through the State of Delaware. This northbound site was constructed between 1988 and 1991 and represented a pavement that was approximately 15 years old. The cementitious materials used consisted of portland cement plus 35% slag. The nominal pavement depth was 12 in. The slabs were transversely tined and had skewed joints. Scaling was not evident on the surface of the pavement (see Figure 13).

Figure 13. Delaware SR 1, northbound (between Christiana Road and I-95)

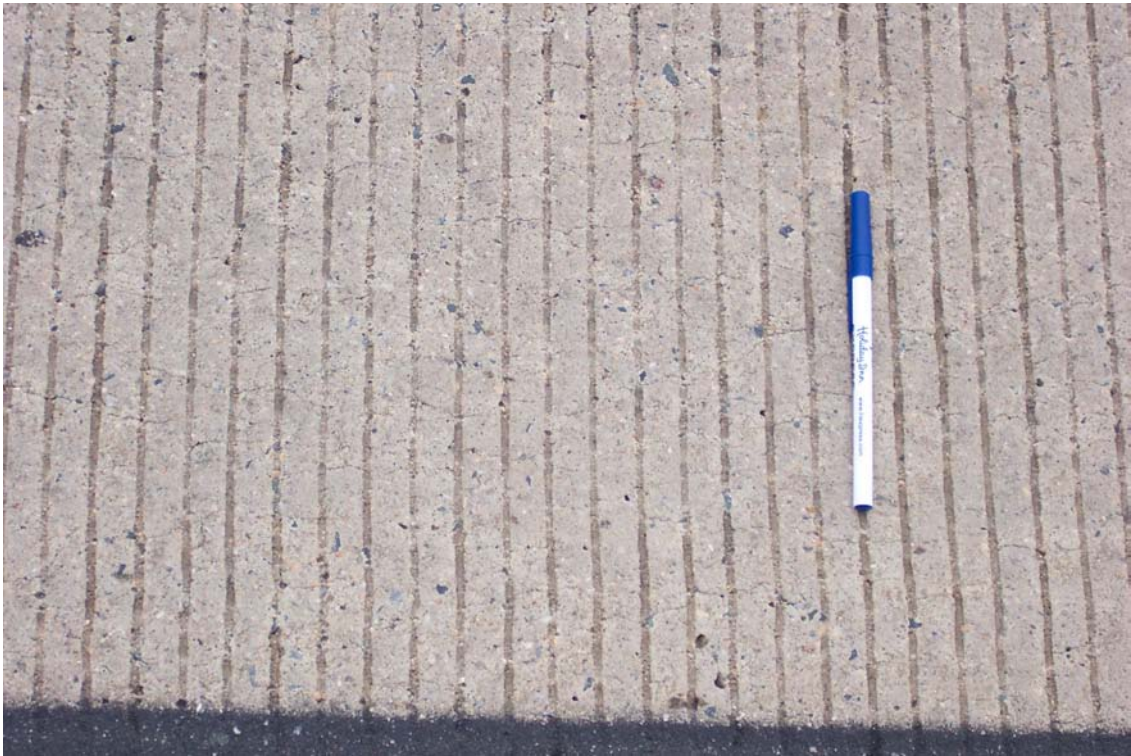
Figure 16. Delaware SR 896 southbound (between US 40 and Highway 71) (note faint cracking)

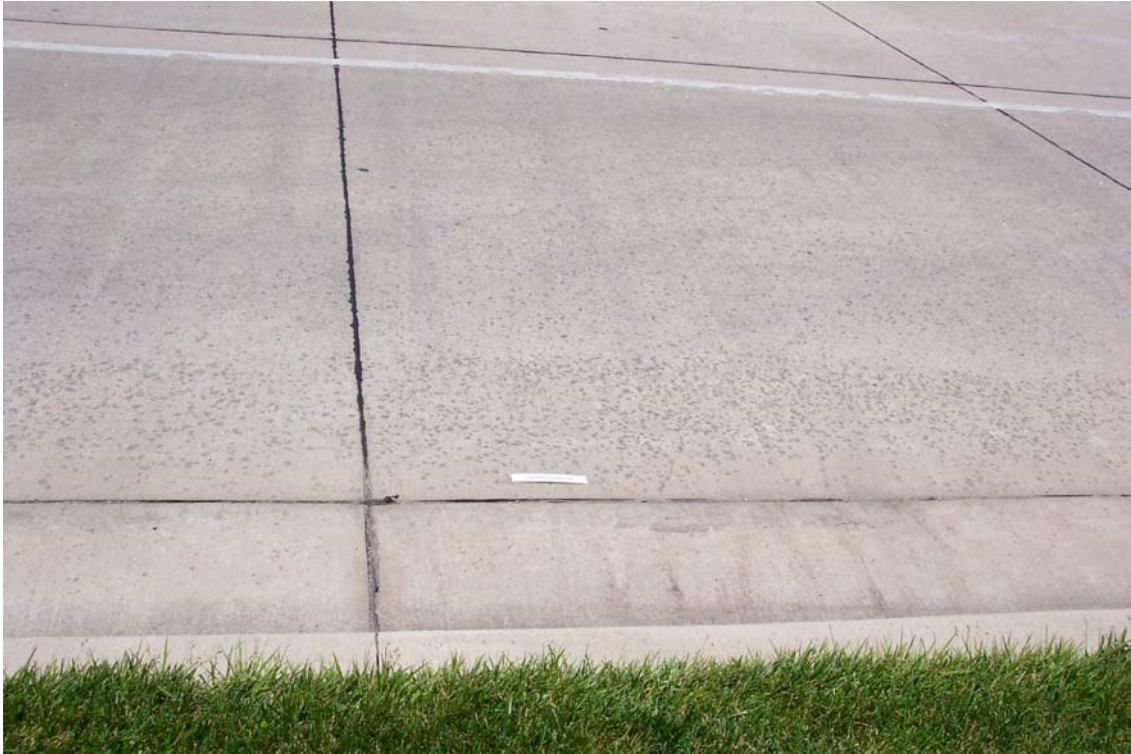
This is an urban street (single driving lane) in Overland Park that showed considerable scaling (see Figures 19 and 20). The pavement was about five years old. The cementitious materials consisted of portland cement plus 35% slag. Scaling was evident over the entire panel (roughly 10% to 20% coverage). However, the most severe scaling was typically observed in the section of the slab adjacent to the gutter. Faint random cracking was also noted on some regions of the panels. This appeared to be more prevalent near the pavement joints in the highly scaled areas.

Figure 19. 100th Street and Lamar Roundabout in Overland Park

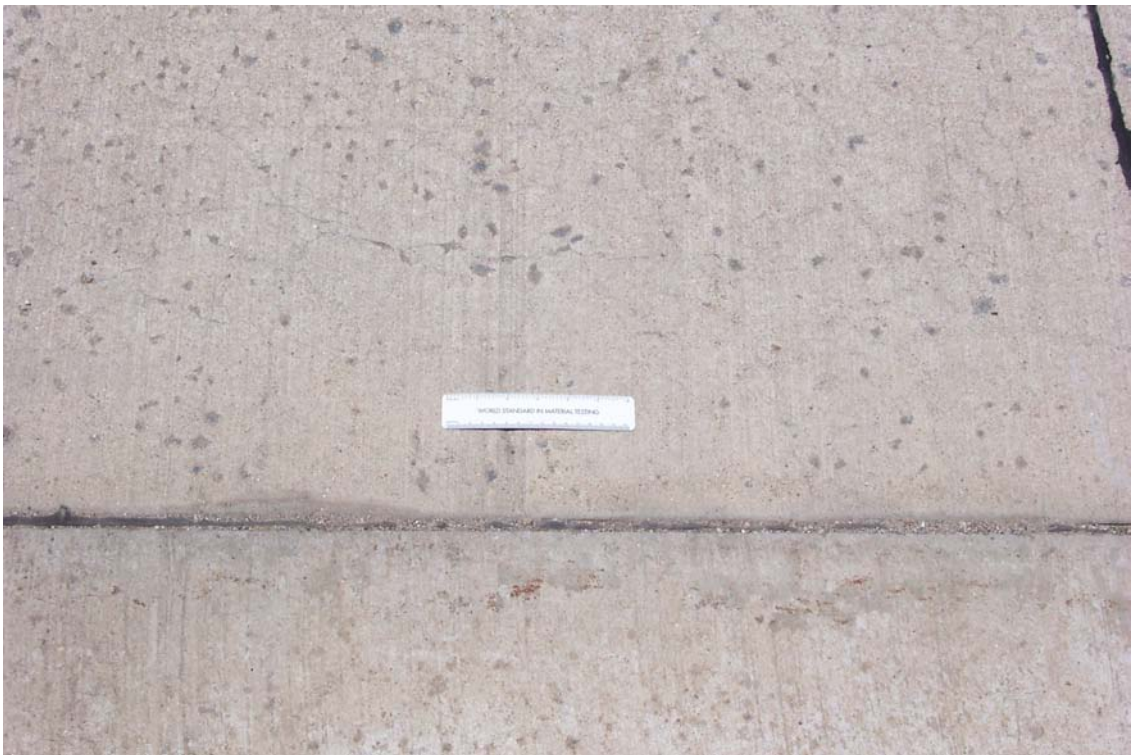
Figure 20. Close-up view of Figure 19 showing faint random cracking in the slab

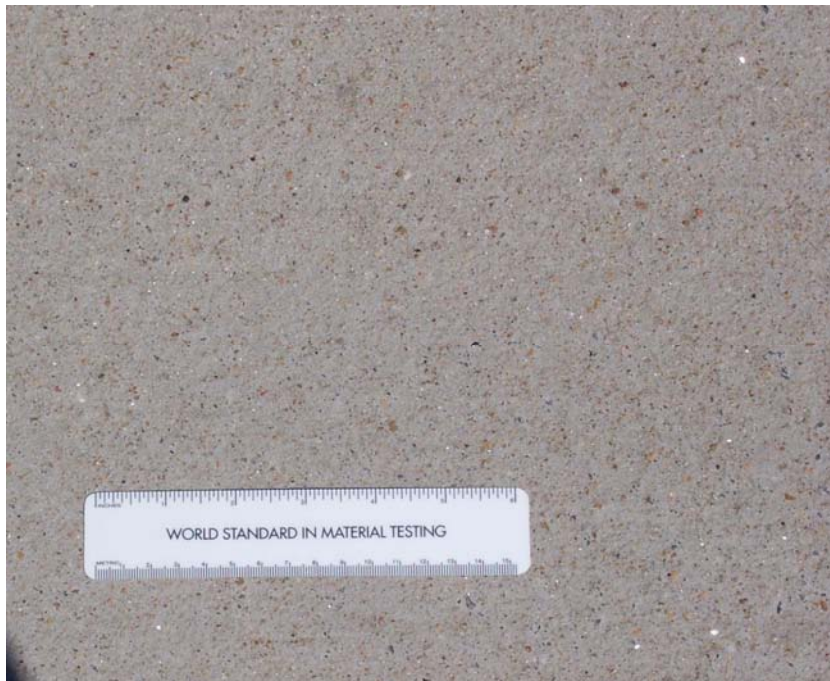
Figure 22. Close-up view of Figure 21 showing exposed fine aggregate particles in the slab

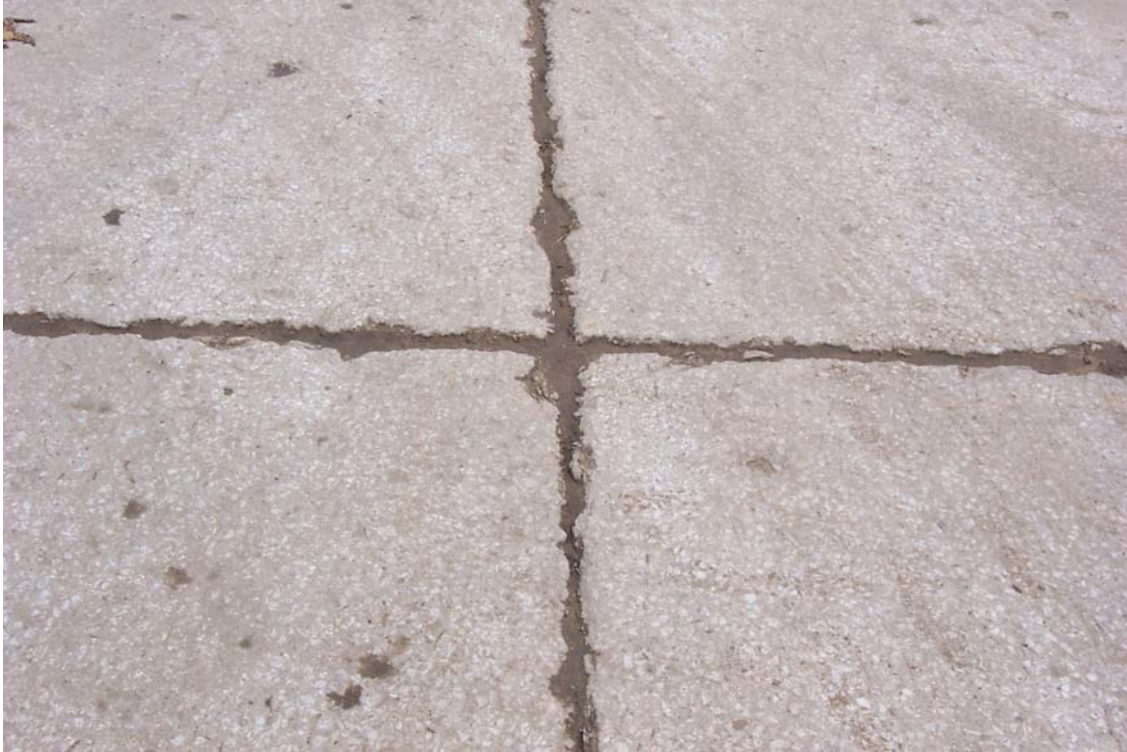
Figure 24. Close-up view of Figure 23 showing abrasion and joint breakage in the slab

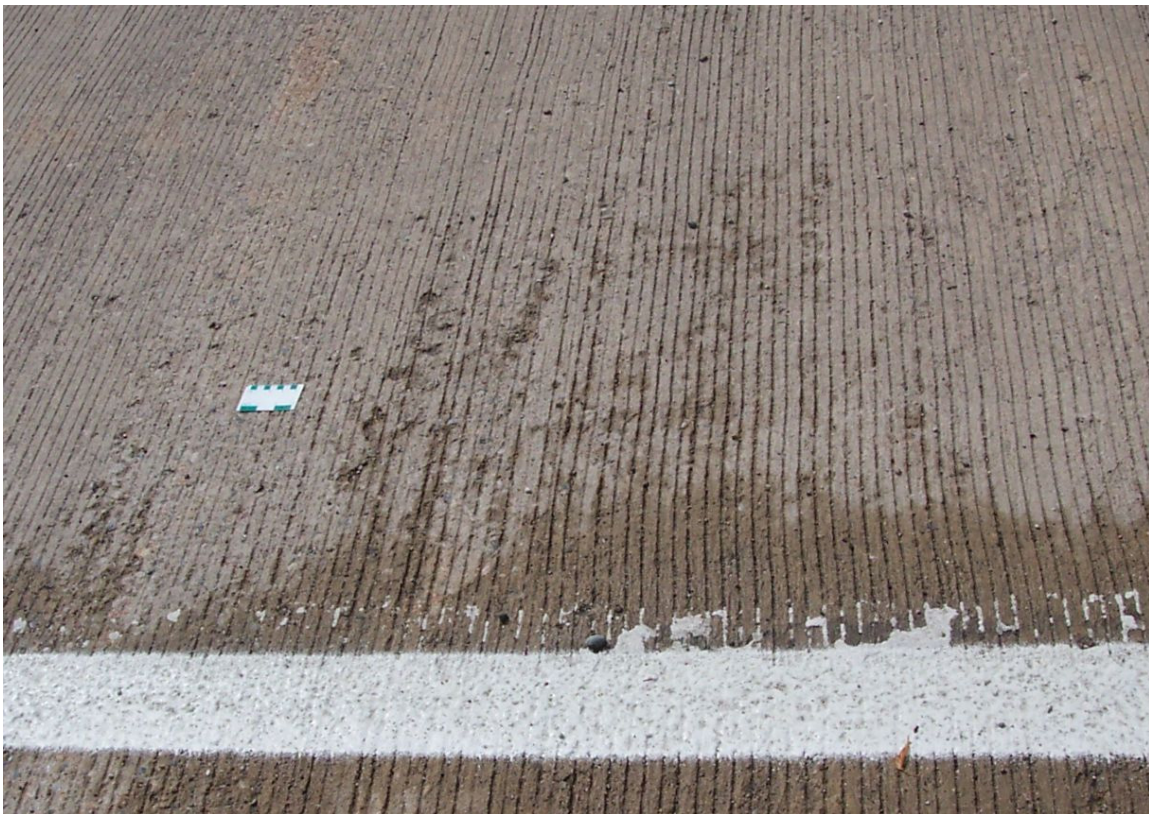
Figure 26. Close-up view of Figure 25 showing the varied tine depth across the deck

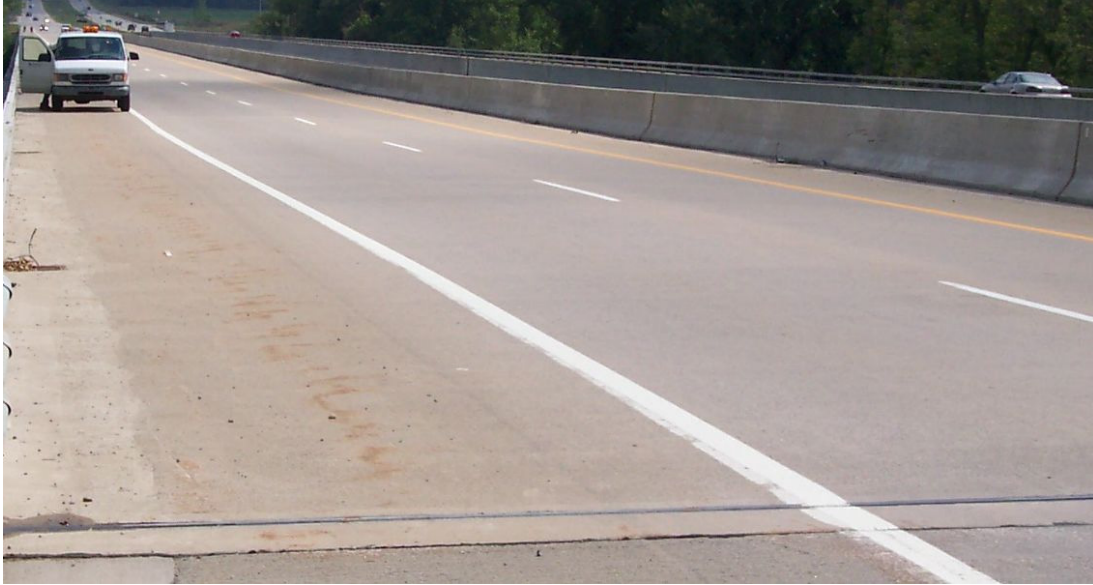
Figure 28. M 45 westbound bridge deck (note snow plow abrasion on shoulder)

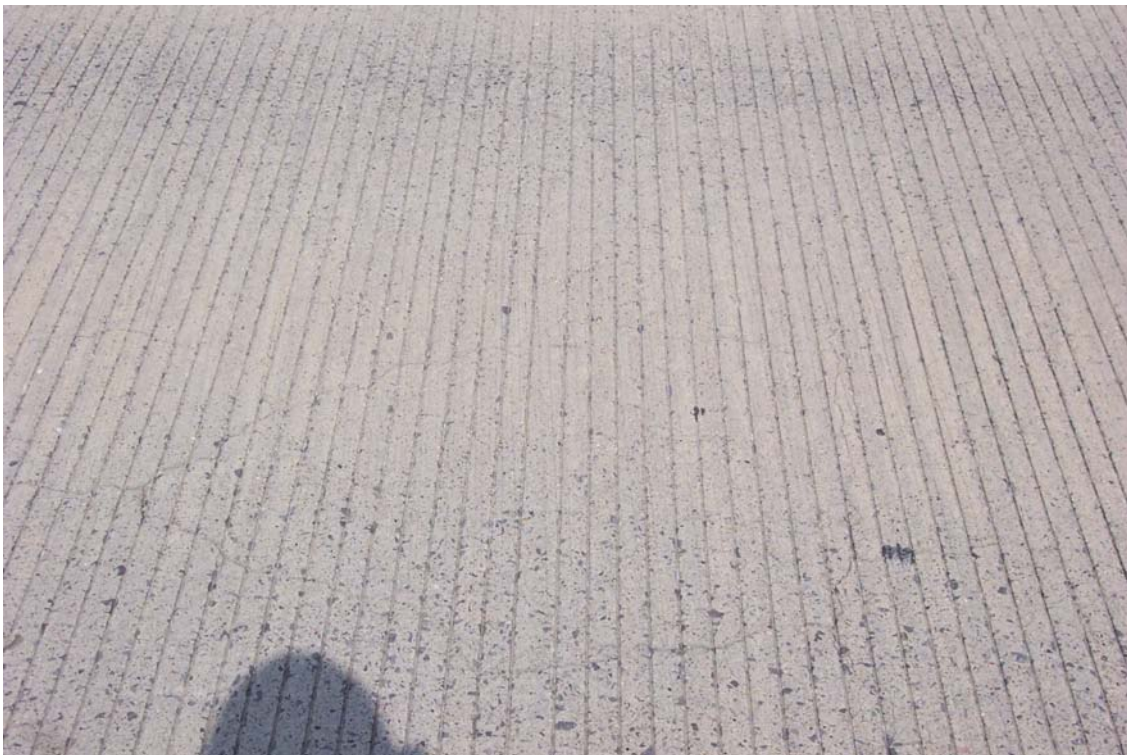
Slight scaling was observed, but it was difficult to distinguish it from the tire erosion noted in the wheel paths (see Figure 30, noted on both sides of deck). Very little evidence of scaling was observed in the south gutter region of the deck. Since drainage was primarily to the south, this seemed to indicate that scaling was very slight but that tire erosion was prevalent. Random cracking, possibly shrinkage, was noted on the surface of the deck. The south side fascia of the deck was showing good evidence of freeze-thaw deterioration (see Figure 31).

Figure 30. Close-up view of Figure 29 showing wheel abrasion on the slab

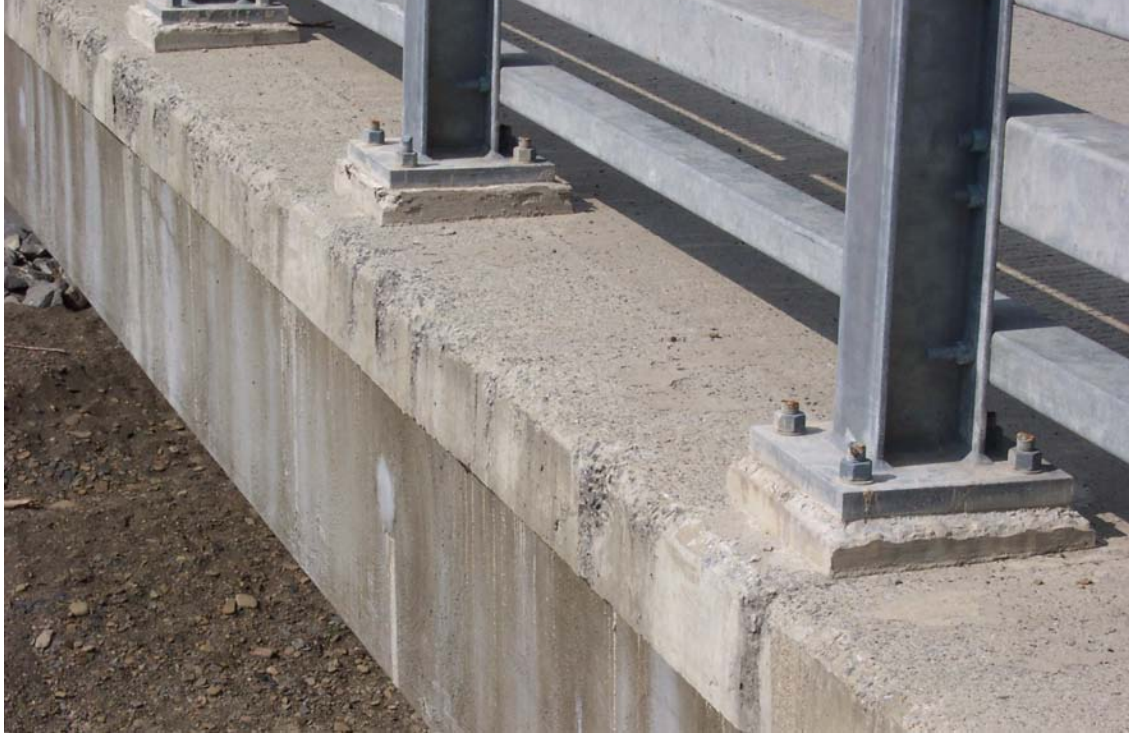
Figure 31. Closeup view of durability issues on the deck

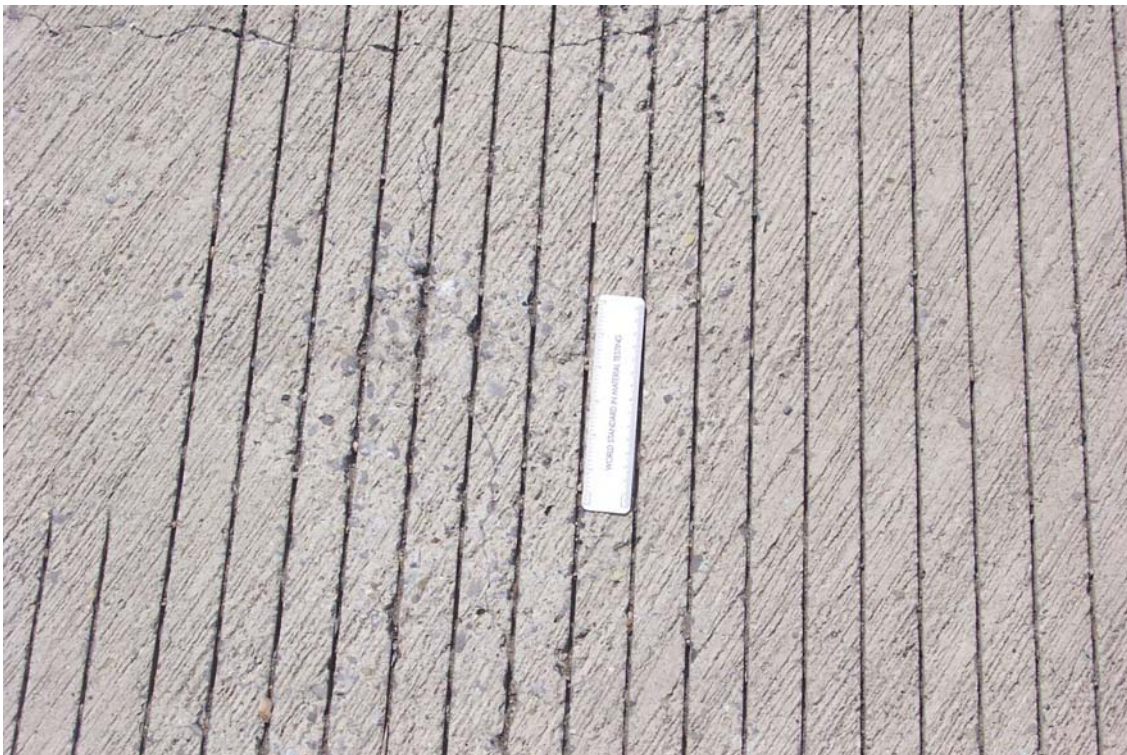
Little evidence of scaling was observed in the driving lanes or the north gutter region of the deck. However, some small areas were noted that did show exposed aggregate (see Figure 33), but this may have been caused by snow plows. Random cracking was noted over sections of the surface of the driving lanes. However, this cracking became less evident in the shoulder and gutter region. This seemed odd because the shoulder and driving lanes were poured together, but the cracking may also be related to structural restraint. The westbound lanes appeared to contain some cracks, primarily longitudinal. This was in contrast to the random cracks that were noted in the eastbound lanes.

Figure 33. Close-up of exposed aggregate on the Route 378 deck

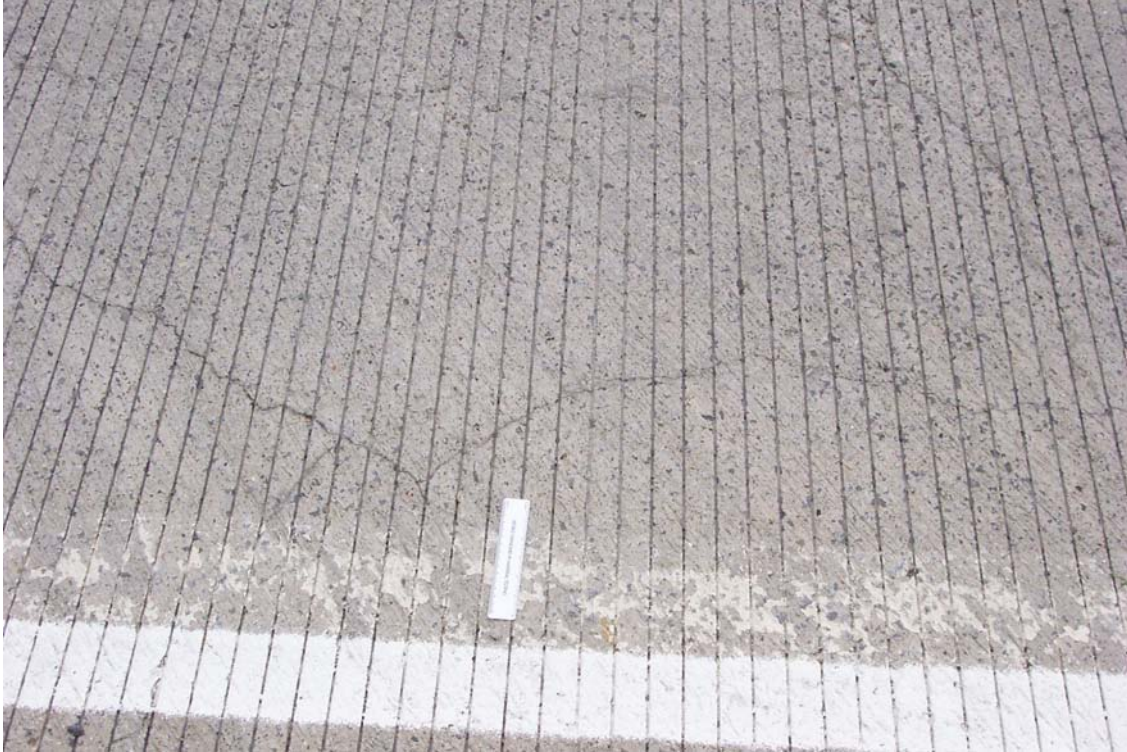
Figure 35. Close-up of exposed aggregate and random cracking on the Route 351 deck

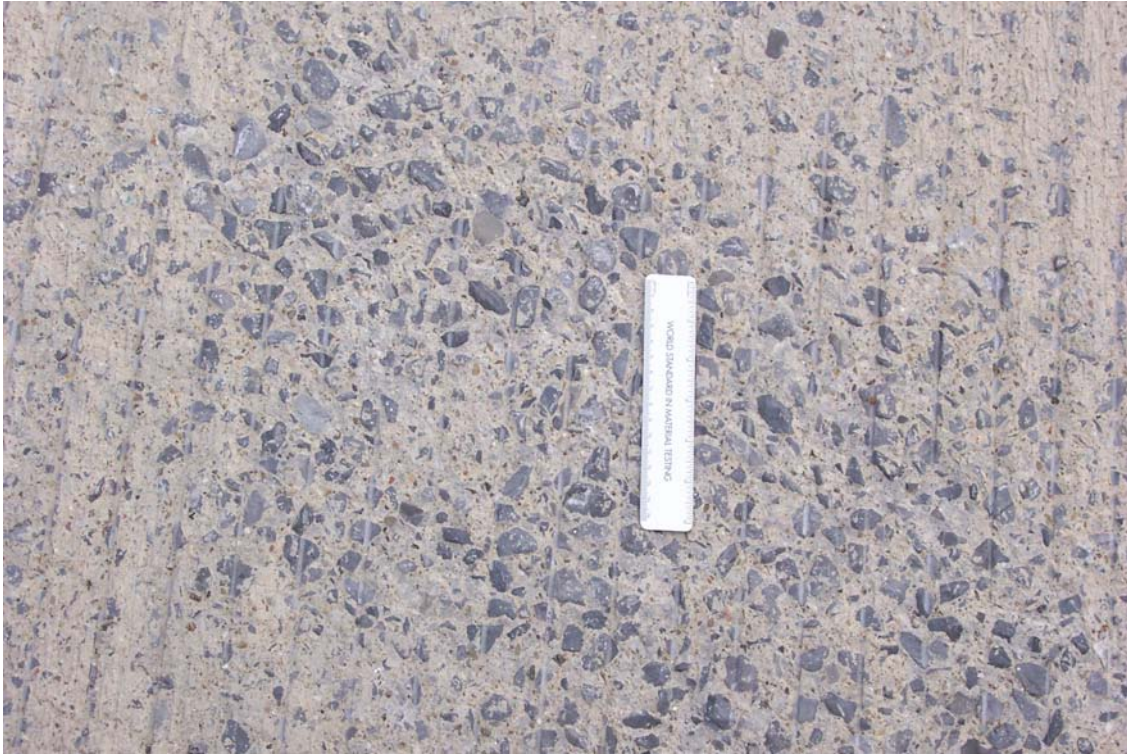
This pair of bridge decks was in good condition. Scaling was observed in several areas on the southbound deck. This became quite pronounced at the south end of the deck (see Figure 38), where the scaling depth had approached the depth of the deck tines (about 0.25 in.). It was estimated that about 10% of the southbound deck had scaled. However, this estimate was complicated due to tire abrasion, which was also noted on the deck. The scaling continued into the concrete approach to the deck. Close inspection of the gutter regions on the northbound deck failed to provide any evidence of scaling. Again, some random cracking was noted on the surface of each deck. However, the northbound deck appeared to be more affected than the southbound bridge.

Figure 38. Close-up of scaling on Taconic St. Parkway bridge, southbound deck

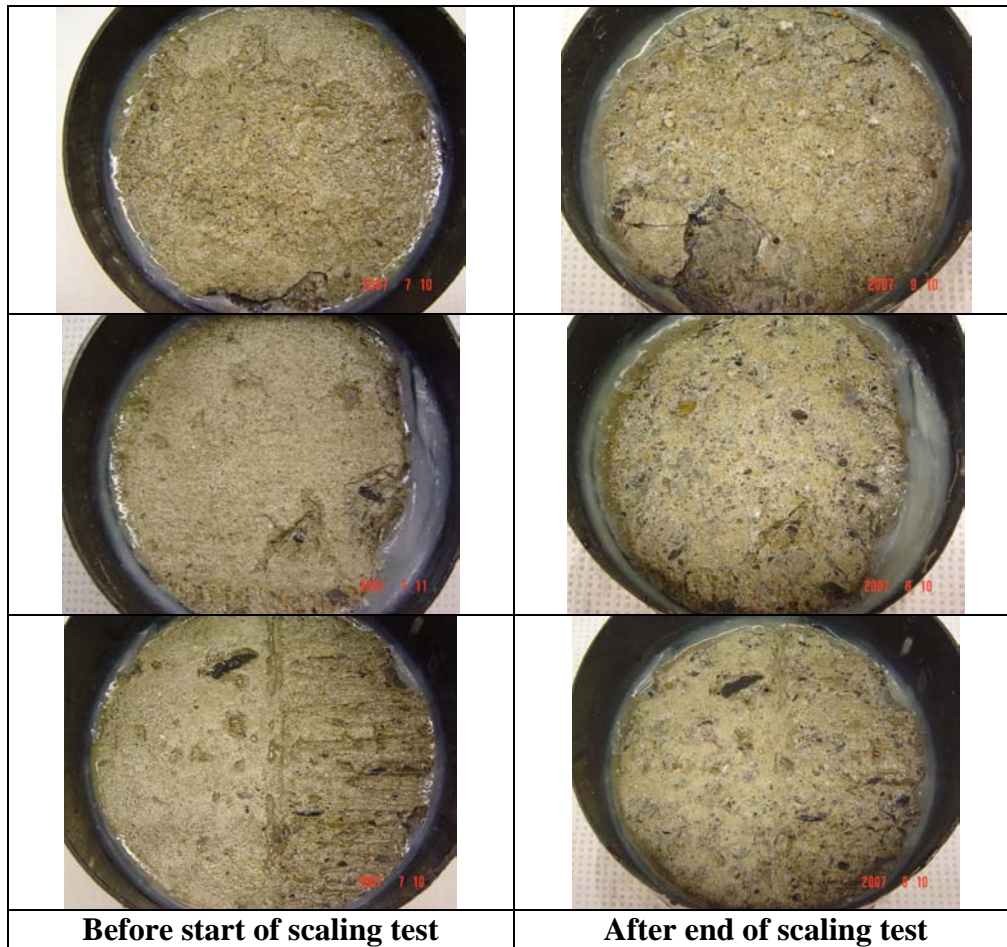
The scaling test results proceeded as expected, and little evidence of scaling was recorded during the 50 cycles of freeze-thaw with the 4% calcium chloride solution. Visual ratings tended to start and finish at zero (no scaling as defined in ASTM C 672). One set of specimens (Site 1b) started at 1 and ended at 1 (slight scaling as defined in ASTM C 672). The only specimens that exhibited scaling during the test were from Site 13. These specimens started with a visual rating of 1 and ended with a 2+ rating (slight to moderate scaling). Photographs taken before and after the scaling test are shown in Figure 39. Scaling was quite noticeable on all three test specimens.

Figure 39. Photographs of the three scaling specimens from Site 13 (before and after test)

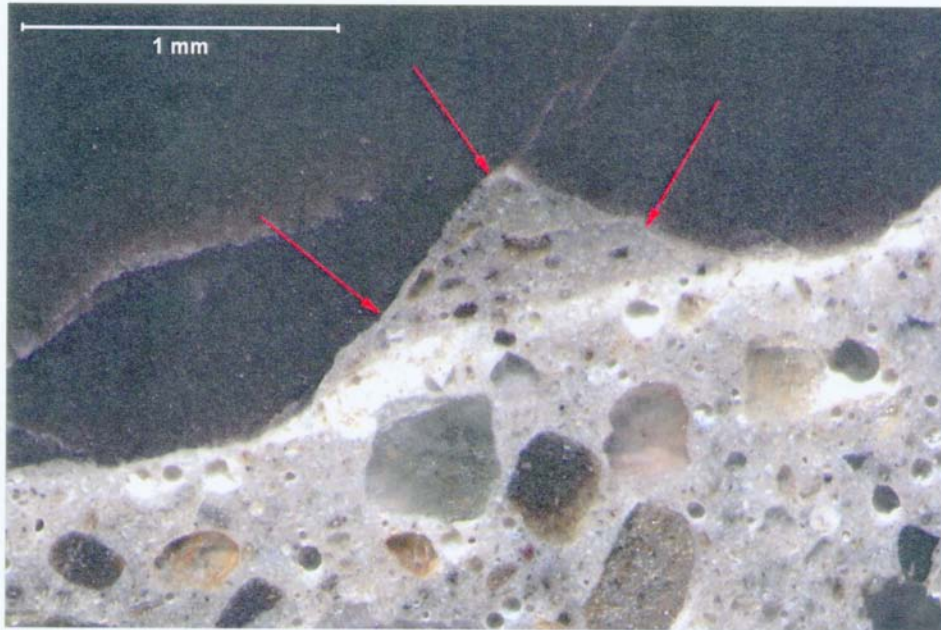
Scaling was noted at field Sites 3, 4, 8, and 13. Surface damage that could be attributed to scaling and/or abrasion was also noted at field Sites 6 and 12. Petrographic examination suggested that concrete at Sites 12 and 13 had been retempered (see Figure 42). Similar features were also noted in concrete from Sites 3 and 4; this is evidence of being retempered or of multistage batching. Hence, four of the six sites that exhibited field scaling had possibly been retempered. The scaling and/or abrasion at Site 6 is probably related to the fact that the concrete has been in service for more than 15 years. (This pavement has a nominal traffic loading [ADT] of over 37,500.) The scaling observed at Site 8 is still unexplained.

Figure 42. Example of retempering noted via petrographic examination

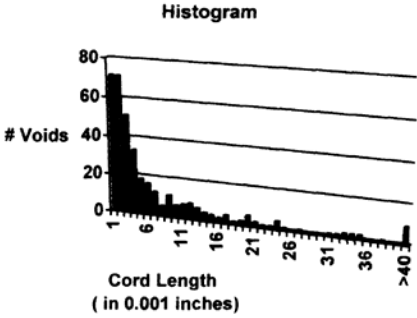
<p>General Physical Conditions:</p> <p>The present top surface has undergone severe mortar erosion exposing many coarse aggregate surfaces with the tines worn almost smooth. Several subvertical drying shrinkage microcracks proceed from the top surface up to 26 mm (1") depth. Many microcracks were observed scattered throughout the paste at various depths and orientations in a shrinkage type pattern. Carbonation ranged from negligible up to 14 mm (9/16") depth from the top surface along subvertical microcracking. The concrete was purposely air entrained.</p> <p>Aggregate</p> <p>Coarse: 19 mm (3/4") maximum sized crushed igneous and metamorphic rock made up of granite, gneiss, gabbro, schist, and diabase. Fairly well graded with good overall uniform distribution.</p> <p>Fine: Natural quartz, feldspar, and lithic sand that was fairly well graded. The grains were mostly sub-rounded with several sub-angular particles. Fair overall distribution.</p> <p>Cementitious Properties</p> <ol style="list-style-type: none"> 1. Air Content: 3.5% total 2. Depth of carbonation: Ranged from negligible up to 14 mm (9/16") depth from top surface along subvertical microcracking 3. Pozzolan presence: None observed. 4. Paste/aggregate bond: Poor 5. Paste color: Medium tan becoming mottled medium tan to bluish gray below 32 mm (1-1/4") depth from top surface 6. Paste hardness: Hard 7. Paste proportions: 24% to 26% 8. Microcracking: Several subvertical drying shrinkage microcracks observed penetrating from top surface to a depth of 19 mm (3/4"). Many microcracks were observed scattered throughout the paste at various depths and orientations in a shrinkage type pattern. 9. Secondary deposits: None observed. 10. Slump: Estimated, medium (2 to 4") 11. Water/cementitious ratio: Estimated at between 0.38 to 0.43 with approximately 5-7 % unhydrated or residual portland cement clinker particles and 4 to 6 % unhydrated slag cement particles. 12. Cement hydration: Alites-mostly well; Belites-negligible; Slag-negligible to well <p>Conclusions: The general overall quality of the concrete was poor.</p>
