Deicer Scaling Resistance of Concrete Pavements, Bridge Decks, and Other Structures Containing Slag Cement

Phase 1: Site Selection and Analysis of Field Cores

Final Report September 2008

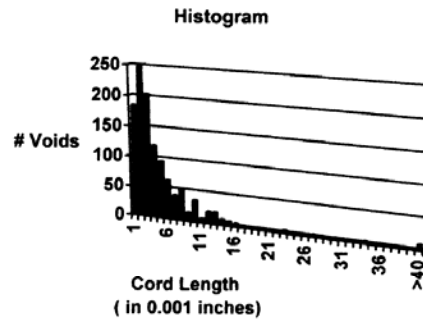
General Physical Conditions: The screeded top surface has undergone moderate mortar erosion exposing many fine aggregate particles. Many subvertical drying shrinkage microcracks proceed from the present top surface up to 20 mm (13/16") depth. Many microcracks were observed scattered throughout the paste at various depths and orientations in a shrinkage type pattern. Carbonation ranged from negligible up to 16 mm (5/8") depth from the present top surface along subvertical microcracking. The concrete was purposely air entrained and contains an air void system considered freeze thaw resistant. Good overall condition.

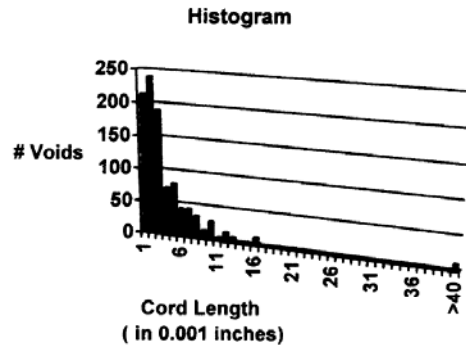
General Physical Conditions: The core was cut subhorizontal at approximately 116 mm (4-9/16") depth to the present top surface. The screeded top surface has undergone minor mortar erosion exposing many fine aggregate surfaces. An orangish brown stain was observed partially covering the present top surface. Several subvertical drying shrinkage microcracks proceed from the top surface up to 17 mm (11/16") depth. Carbonation ranged from negligible up to 36 mm (1-7/16") depth, intermittently, from the top surface along subvertical microcracking. The concrete was purposely air entrained and contains an air void system considered freeze thaw resistant. Good overall condition.
