IDENTIFICATION OF THE BEST PRACTICES FOR DESIGN, CONSTRUCTION, AND REPAIR OF BRIDGE APPROACHES

Iowa DOT Project TR-481
CTRE Project 02-118

Final Report

January 2005

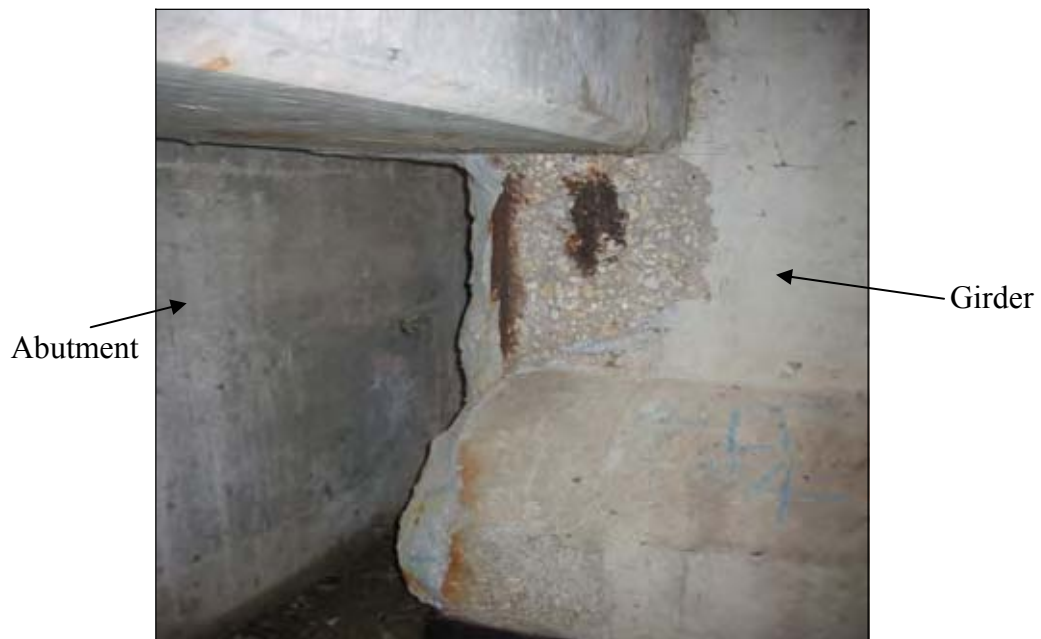
Figure 18. Deterioration of concrete with visible steel of the girders (South end NBL)

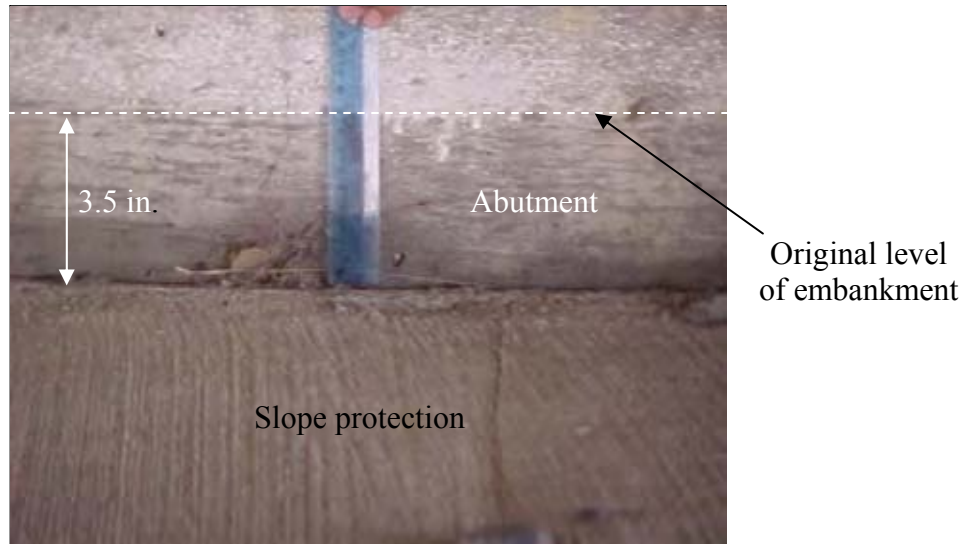
Figure 28. Settlement of embankment under the bridge

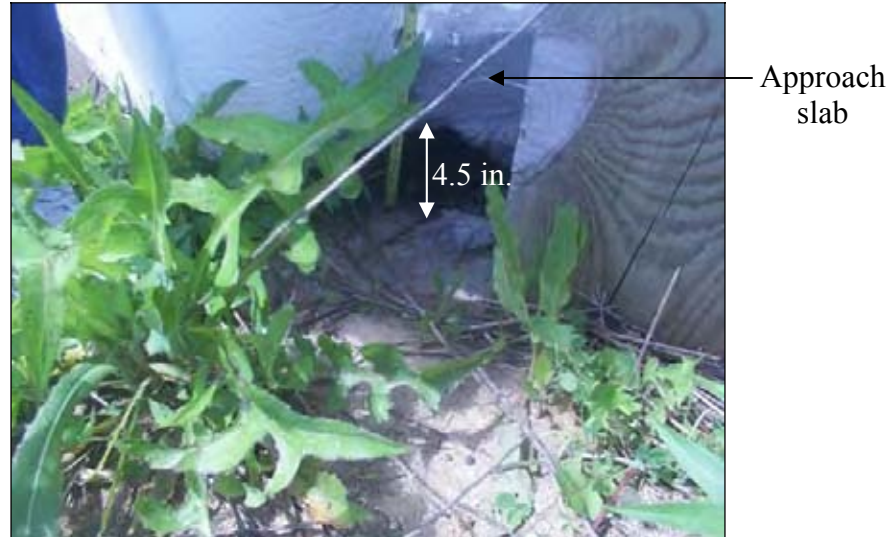
At the west end, a void has developed under the approach slab. The void was 5.5 inches at the expansion joint and 4.5 inches at the end of the wingwall (Figure 49). Furthermore, soil erosion at the abutment side was observed (Figure 50). Soil near the abutment sides is silty sand and is considered highly erodible. An aggregate slope protection cover was used at the embankment under the bridge and appeared to be in good condition.

Figure 49. 4.5 in. void developed under the approach slab (West end)

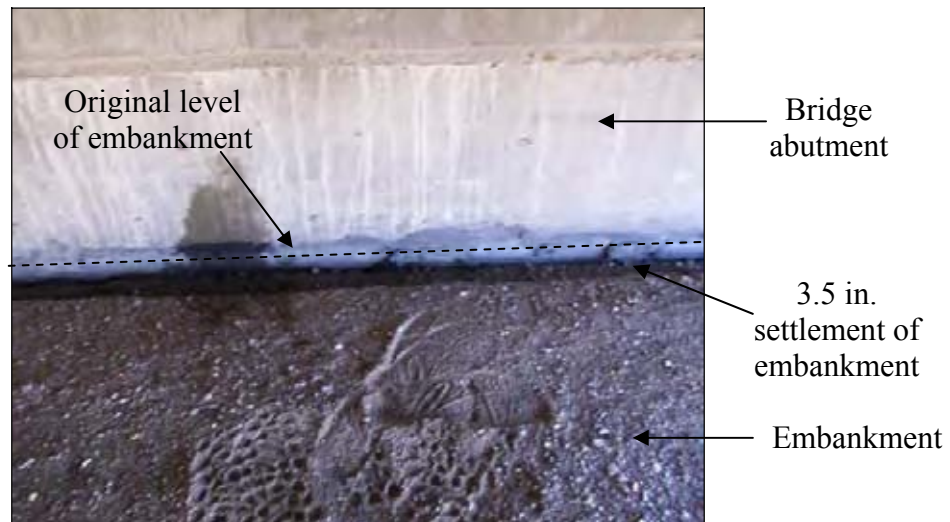
Figure 52. Settlement of the embankment under the bridge and a gap between the abutment and the embankment (East end WBL)

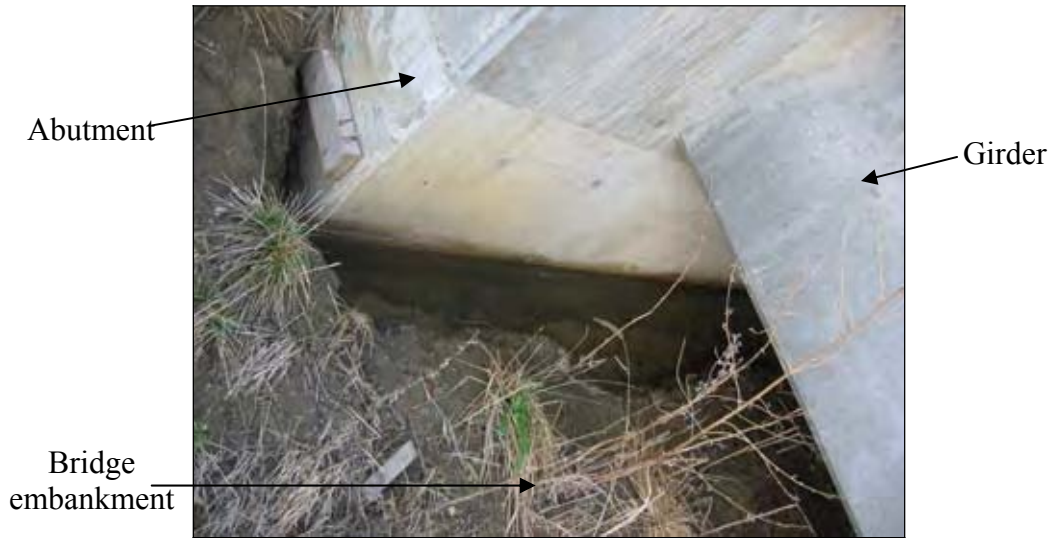
This bridge has integral abutments and prestressed concrete girders. A two-inch void was observed under the bridge approach slab. In addition, erosion of the embankments under the bridge was observed. Figure 65 shows water ponding between the embankment and the abutment.

Figure 65. Ponding water at the abutment under the bridge

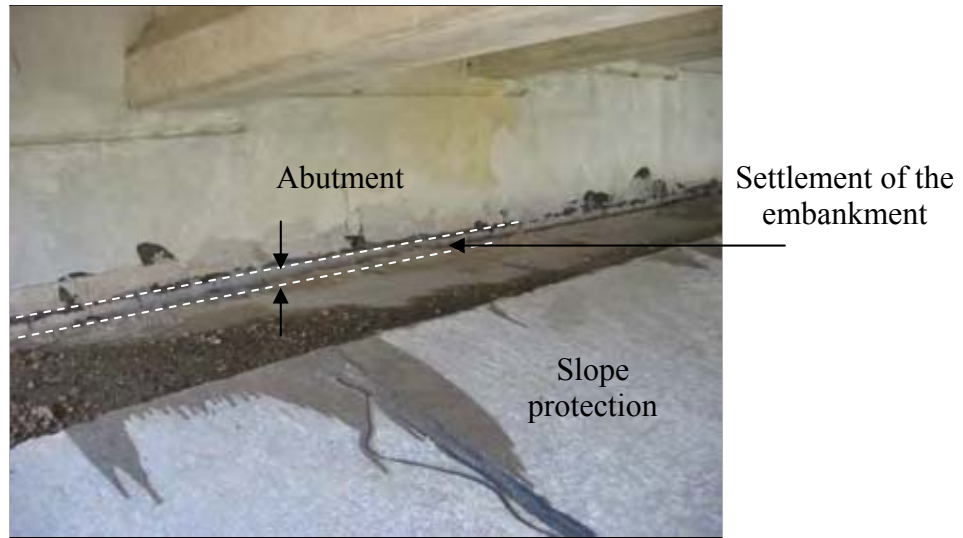
Figure 78. Settlement of the embankment under the bridge and a gap between the embankment and the abutment

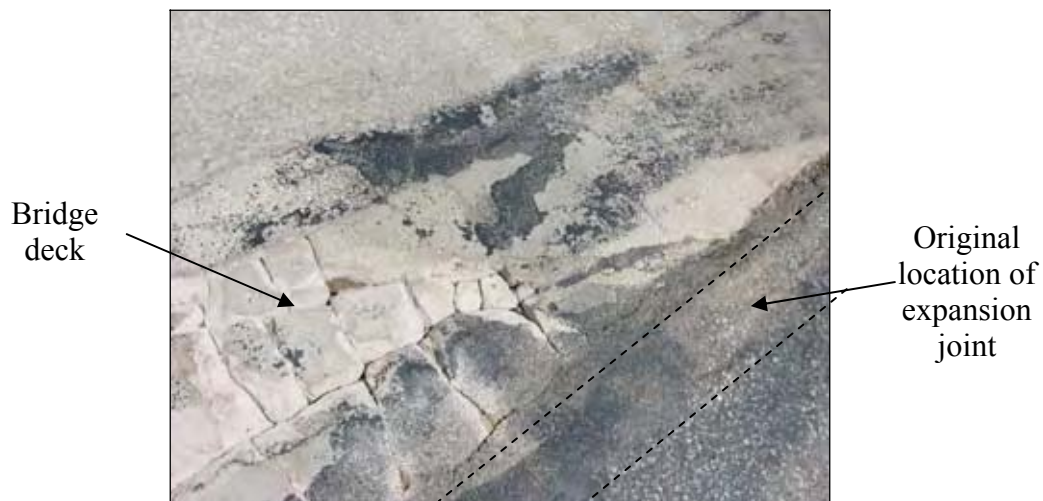
Figure 79. Breakage of bridge deck concrete

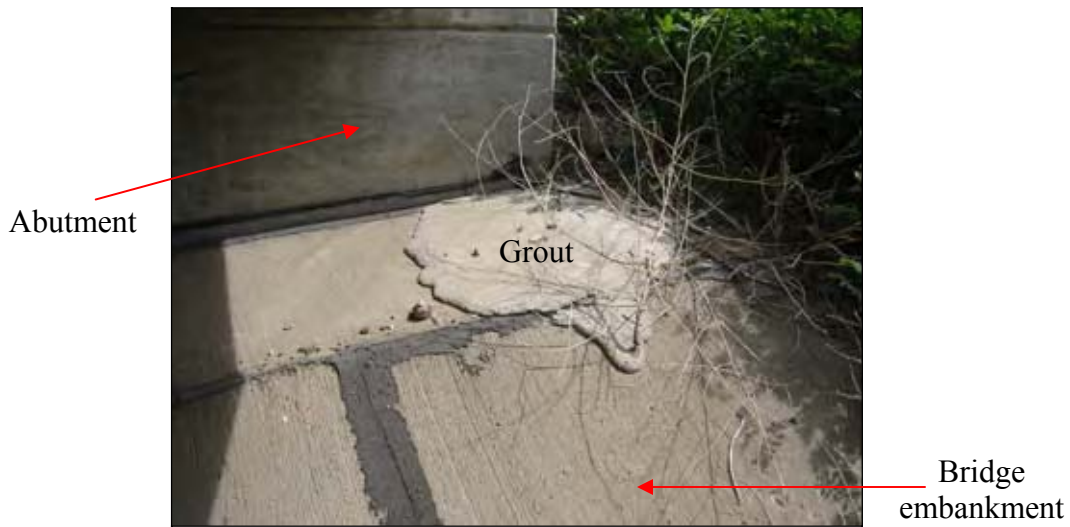
Figure 90. Grout observed on the concrete slope protection overlay indicating that void extended under the abutment

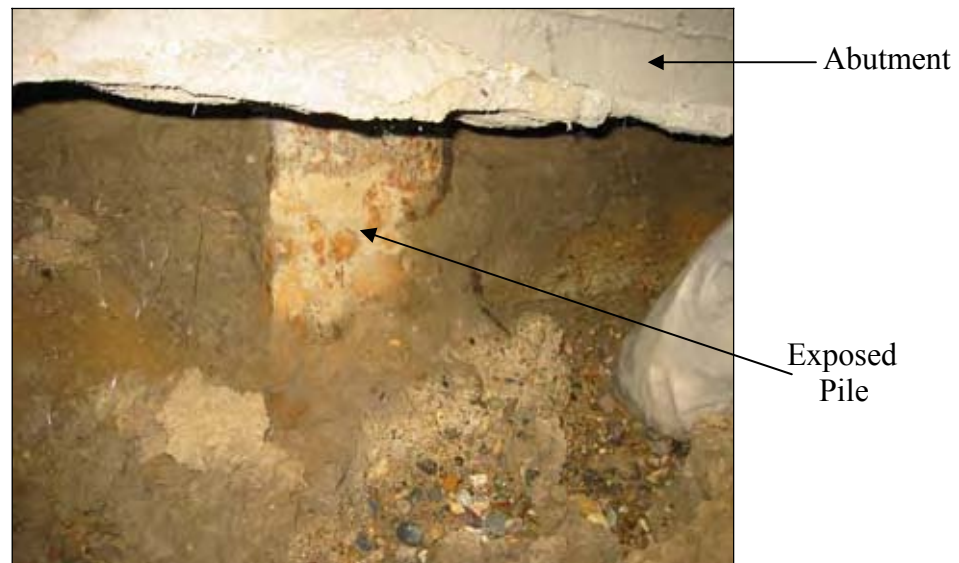
This is a three-span steel bridge with non-integral abutments. Differential settlement of about 4 inches was observed between the approach slab and wingwall. In addition, damage to the expansion joints was noted. Furthermore, soil erosion under the abutment was observed, which led to the exposure of H-piles supporting the abutment (Figure 105). No slope protection was used for the embankment under the bridge. In addition, it was observed that the approach slab panels were shaking under the impact of traffic loads, indicating a void under the approach slab.

Figure 105. Exposed H-pile caused by soil erosion under the abutment

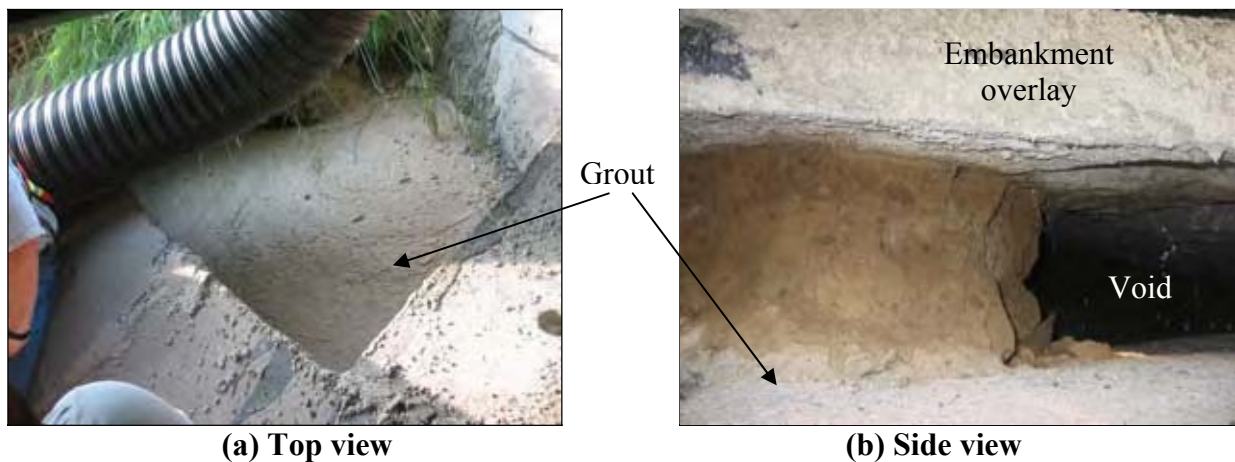
Figure 107. Grout pumped under the slope protection cover to fill the void caused by erosion

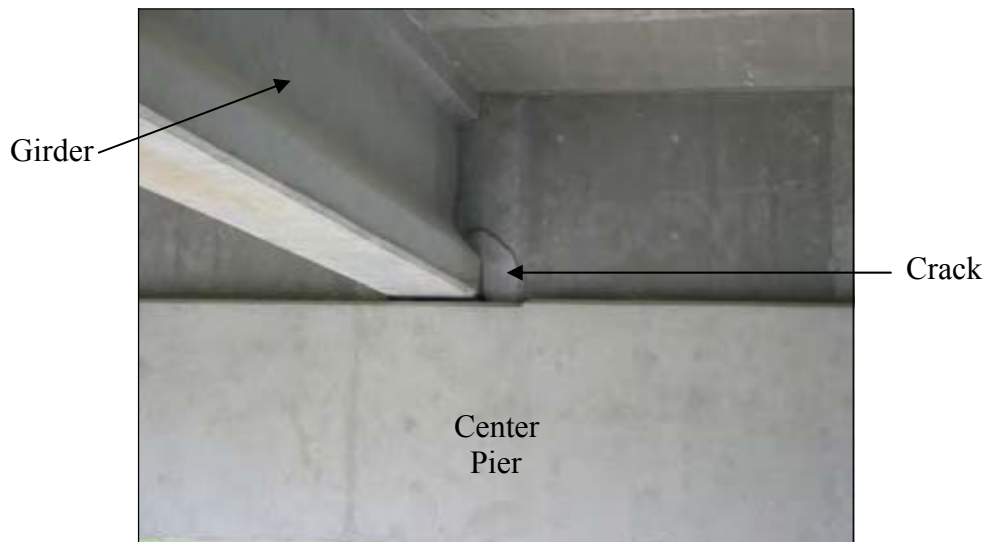
Figure 117. Cracked girder at the center pier

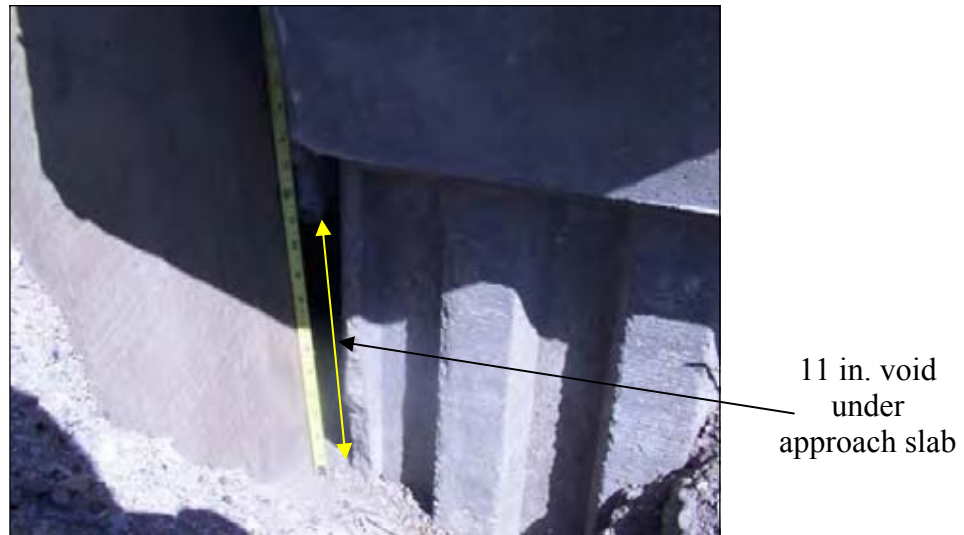
Figure 140. Void developed under the approach slab

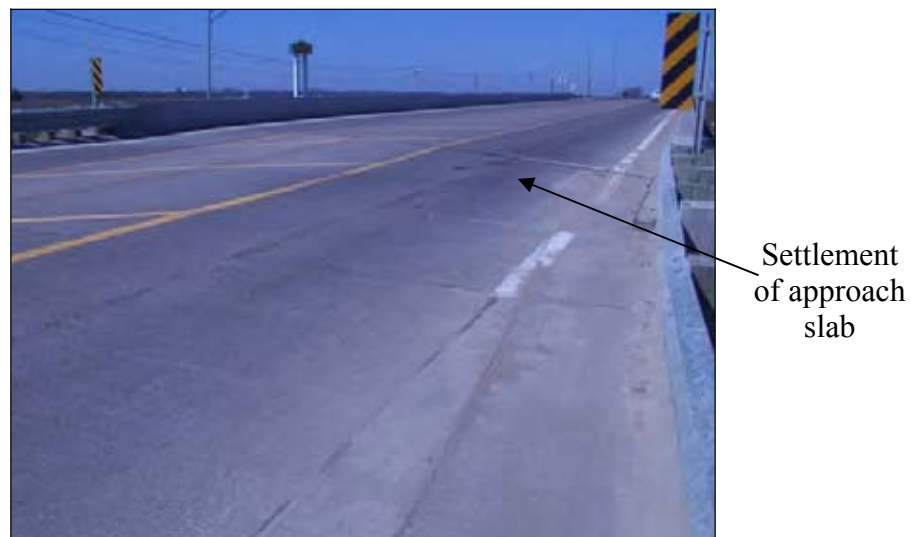
At the east end, differential settlement of about 1 inch between the approach slab and the bridge deck was measured (Figure 141). The expansion joint width was 5 inches. The sealer used to keep the joint filler in place deteriorated shortly after construction, and the forks used to hold the joint material in place were not found. As a result, the joint filler was missing leaving a large gap (Figure 142) allowing water to erode the backfill material under the approach slab. The void developed under the approach slab was about 4 inches deep (Figure 143). Another indication of poor water management was the observed erosion at the sides of the abutment (See Figure 144). Furthermore, concrete spalling was observed at the expansion joint.

Figure 141. Differential settlement at the bridge approach (East end)

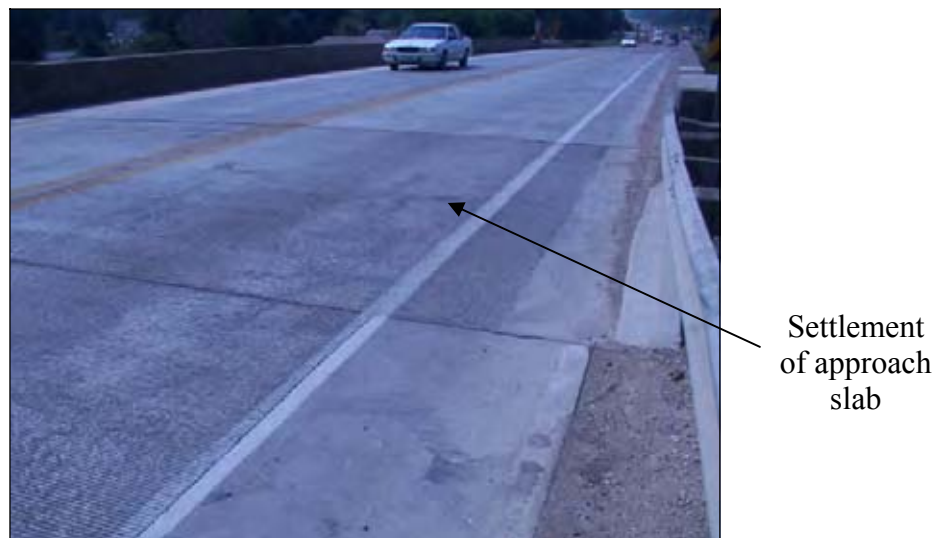
This is a three-span bridge with integral abutments. The approaches were replaced in May 2004 due to the failure of the paving notch. After replacing the approaches, the new expansion joints were 2.5 inches wide. Differential settlement between the bridge deck and the approach slab was observed (Figure 145). At the south end of the bridge, a gap 1 inch wide was observed between the abutment and slope cover (Figure 146), while the embankment settled 3 inches. At the north end of the bridge, concrete slope protection panels were removed for replacement due to uneven settlement, cracking, and failure. The soil used at the embankment under the bridge was silty clay. Aggregate were used at the sides of the abutment to minimize erosion. Similar to other bridges inspected in District 5, this bridge reportedly does not have a subdrain around the abutment.

Figure 145. Differential settlement at recently replaced bridge approach

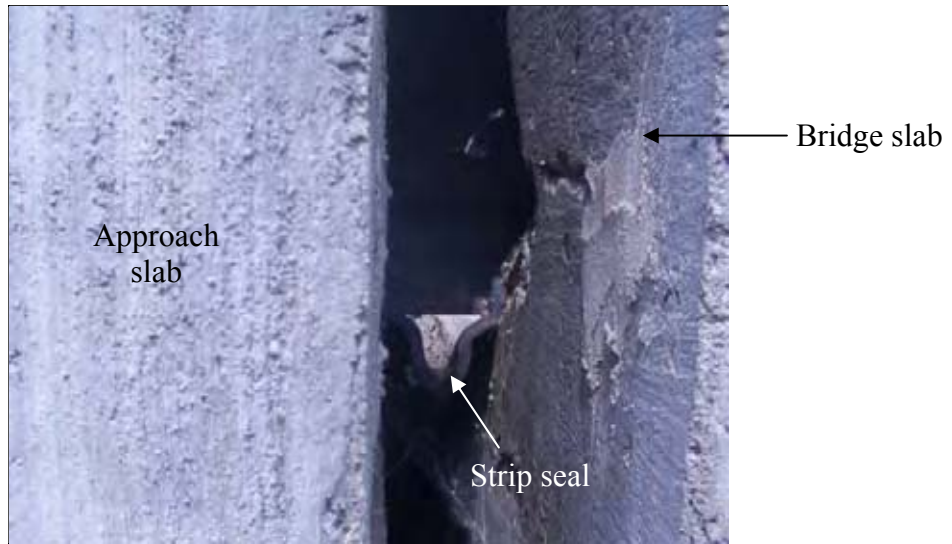
Figure 148. Side view of the strip seal which was cut short (South end of SBL)

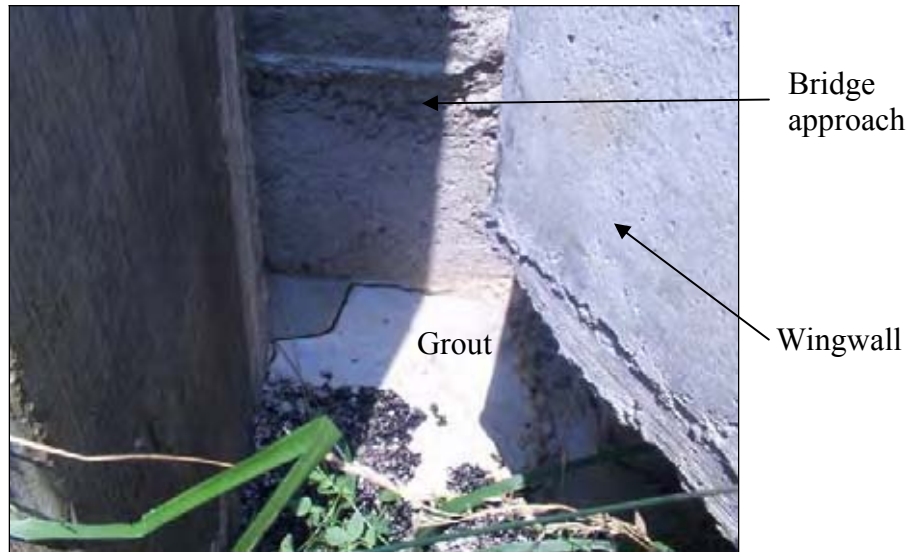
Figure 152. Grouting under the approach slab (South end of NBL)

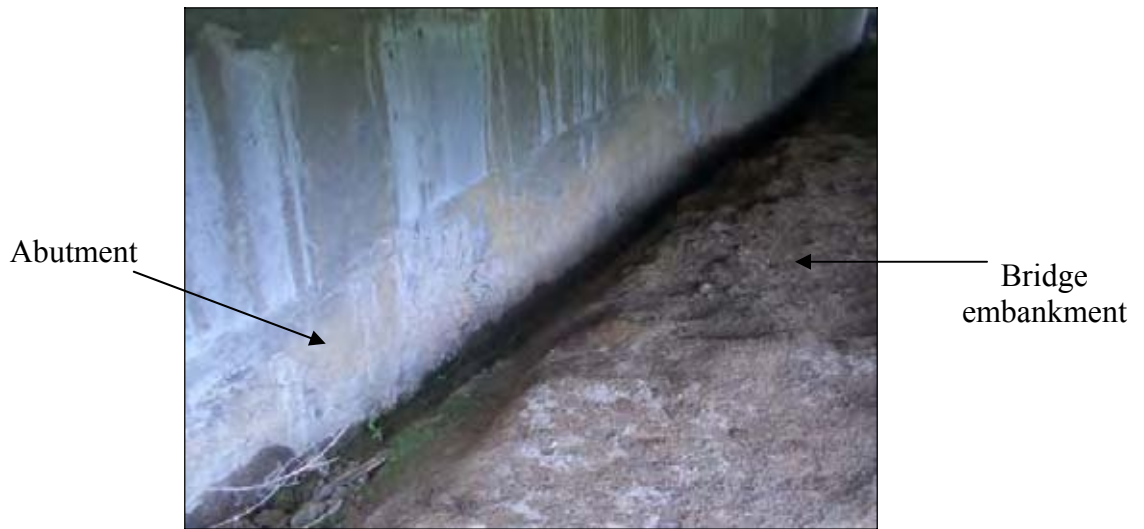
Figure 155. Erosion of the embankment soil (West end of WBL)

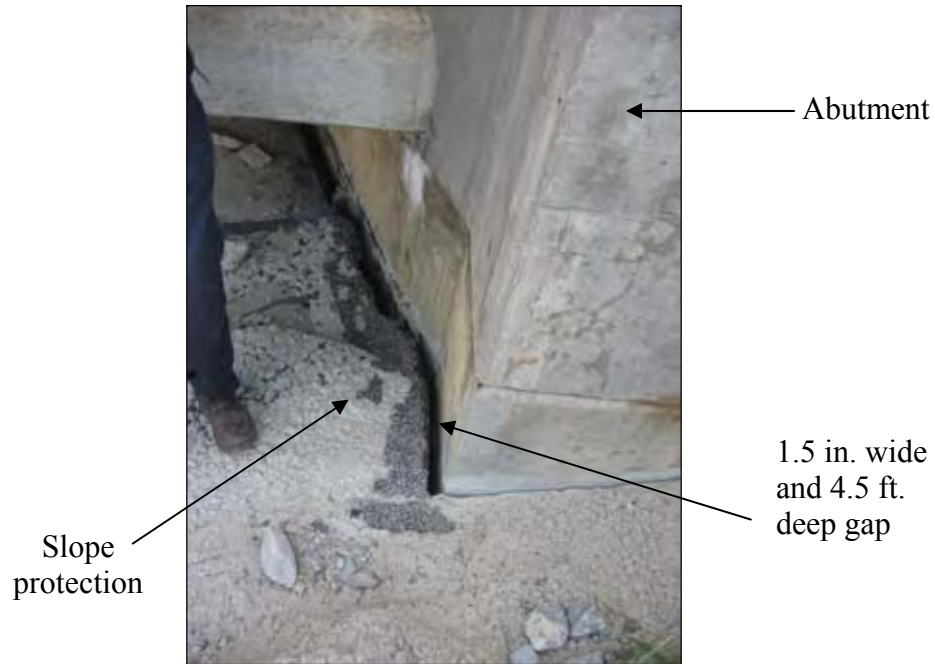
Figure 170. Gap between abutment and embankment

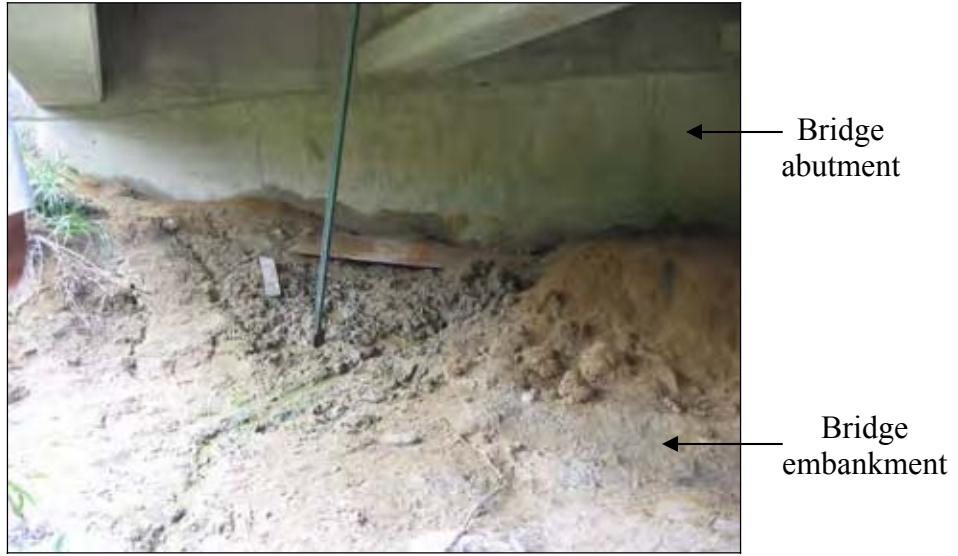
Figure 172. Soil erosion of the embankment under the bridge

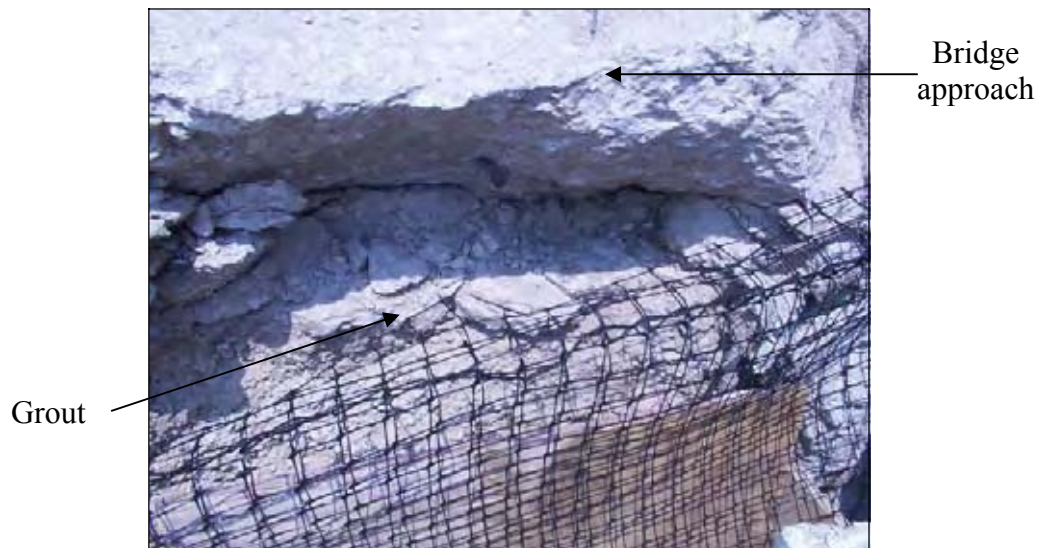
This bridge has three spans with steel girders and non-integral abutments. The bridge approach was grouted to fill a void (see Figure 236). During the field inspection, replacement of both approach slabs and the paving notch of the northbound lanes were in progress. The approach slabs were replaced due to excessive settlement and cracking, which is believed to be a result of severe erosion and subsequent void development. At the south end of the bridge, new granular backfill was placed and compacted in 8-inch-loose lifts using a vibratory base plate. The width of the newly constructed paving notch was 12 inches, with an expansion joint width of 2.5 inches (Figure 237). The bridge did not have subdrains and none were installed. The bridge embankment soil is mostly silty clay with no slope protection. At the north end of the bridge, reconstruction of the abutment was still in progress (Figure 238).

Figure 236. Grout pumped under existing approach (South end of SBL)

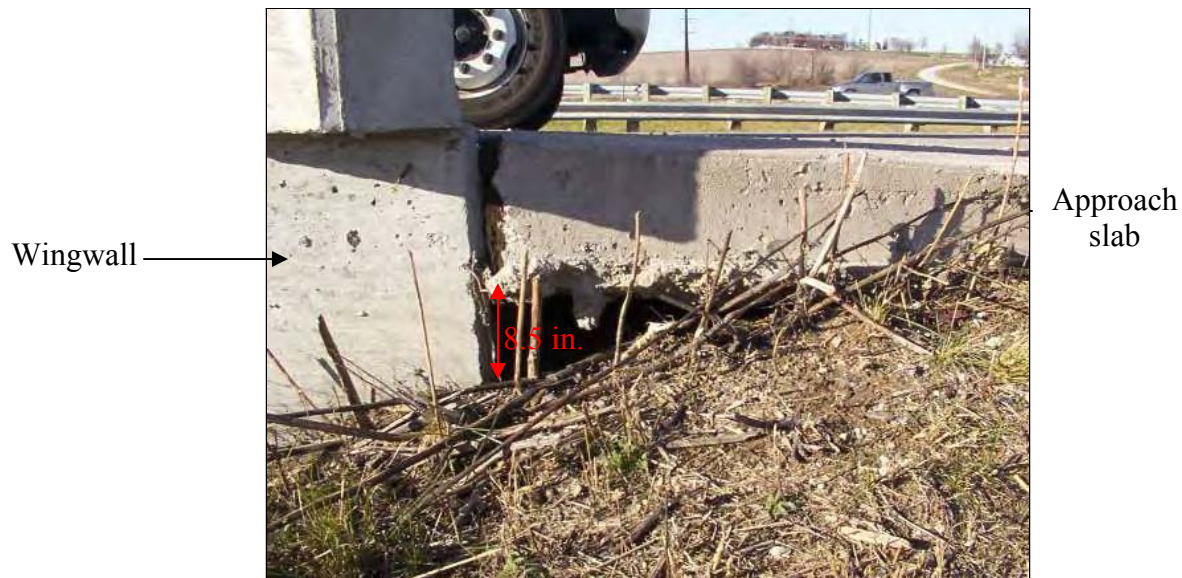
Figure 239. Void under approach slab (North end of SBL)

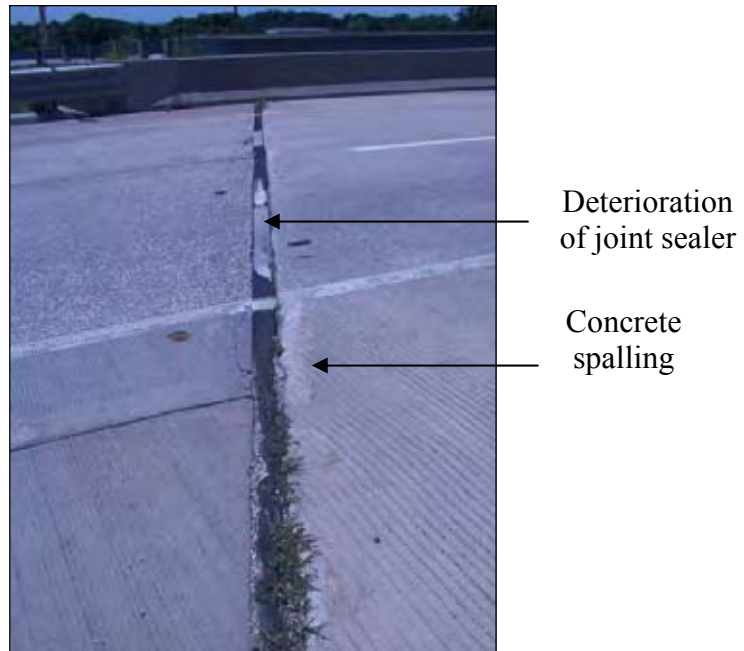
Figure 266. Deteriorated flexible foam used as joint filler (South end of NBL)

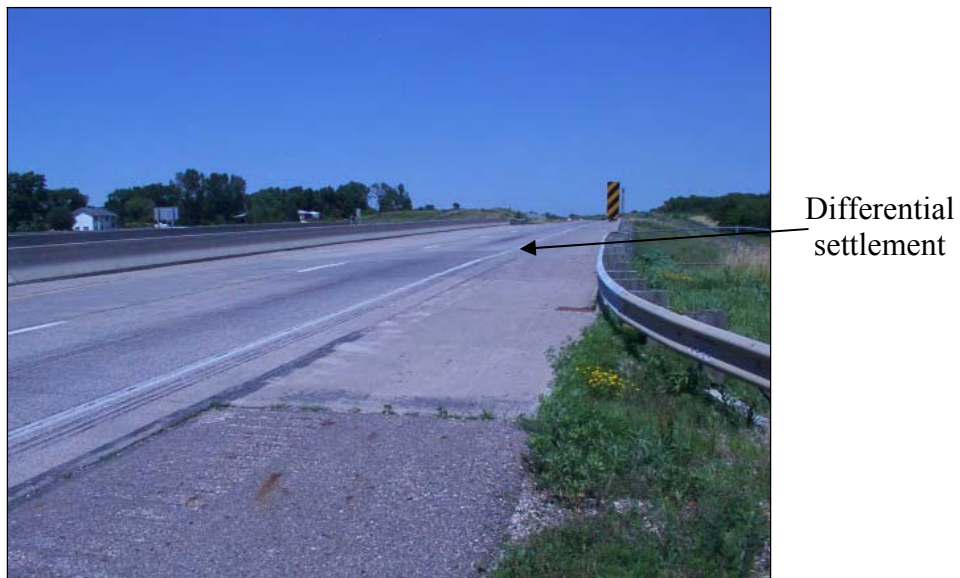
Figure 281. Differential settlement of the approach slab (North end of SBL)

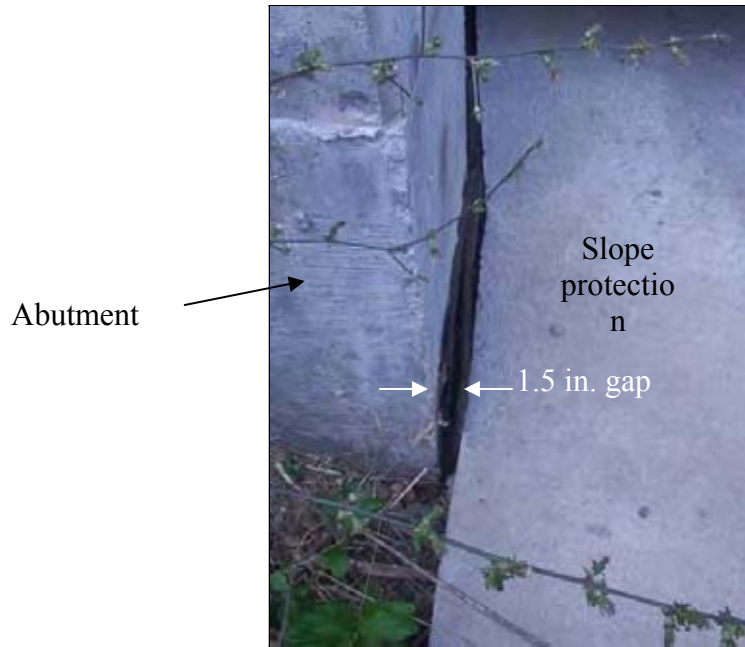
Figure 289. A 1.5 inch gap between abutment face and slope protection (South end of NBL)

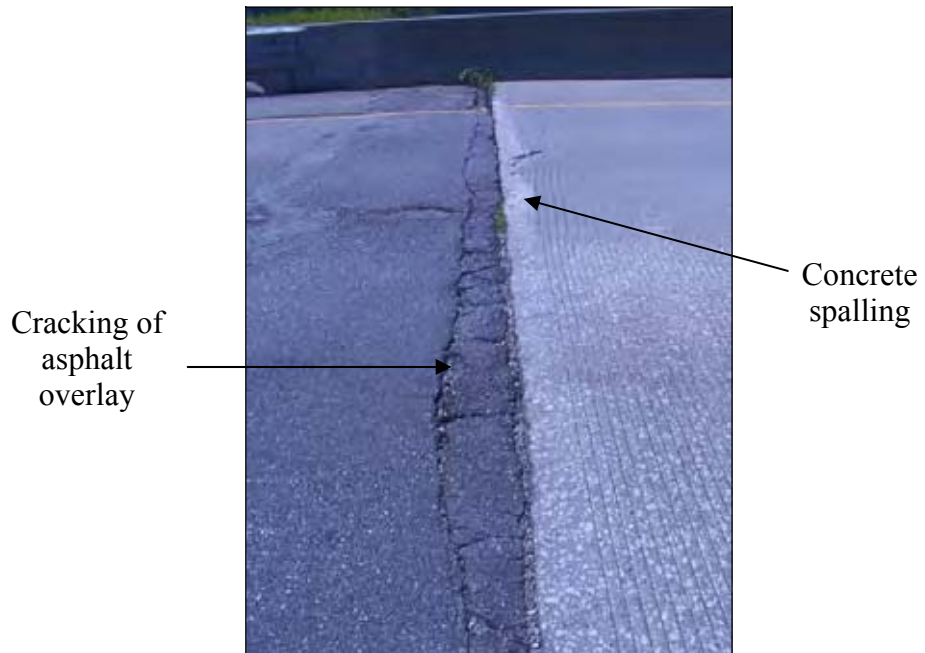
Figure 299. Concrete spalling and cracking of asphalt overlay at the expansion joint (South end of NBL)

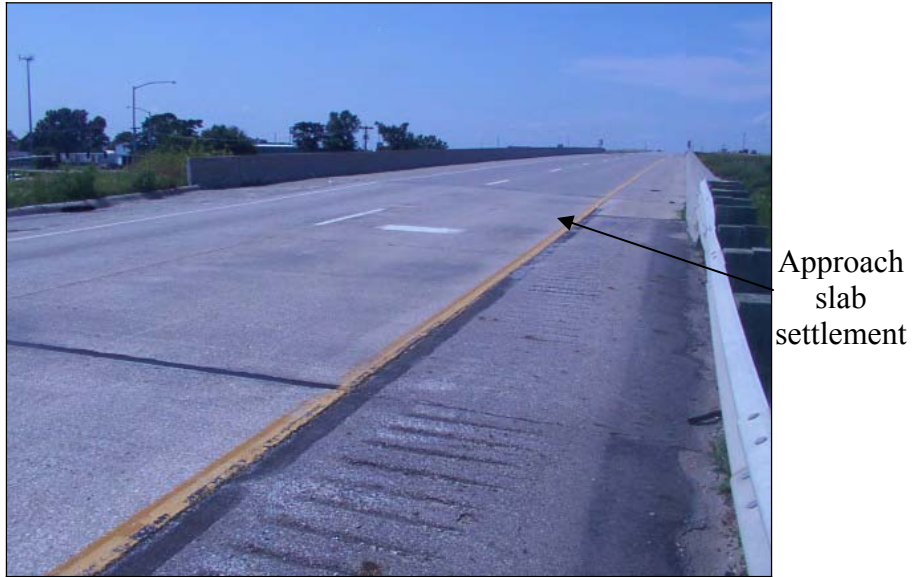
Figure 320. Bridge approach settlement (South end of SBL)

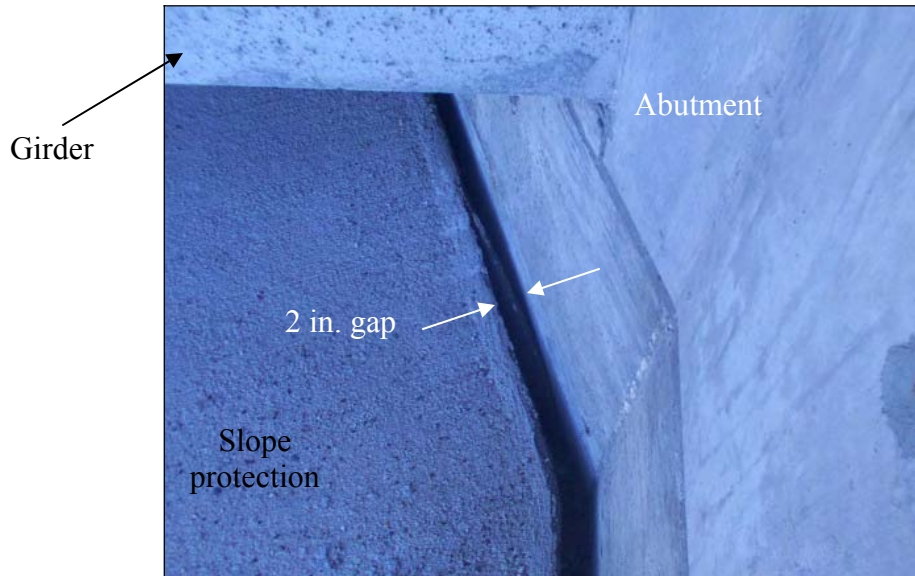
Figure 325. Lateral movement of the abutment away from the bridge embankment caused by expansion of the bridge structure (North end of NBL)

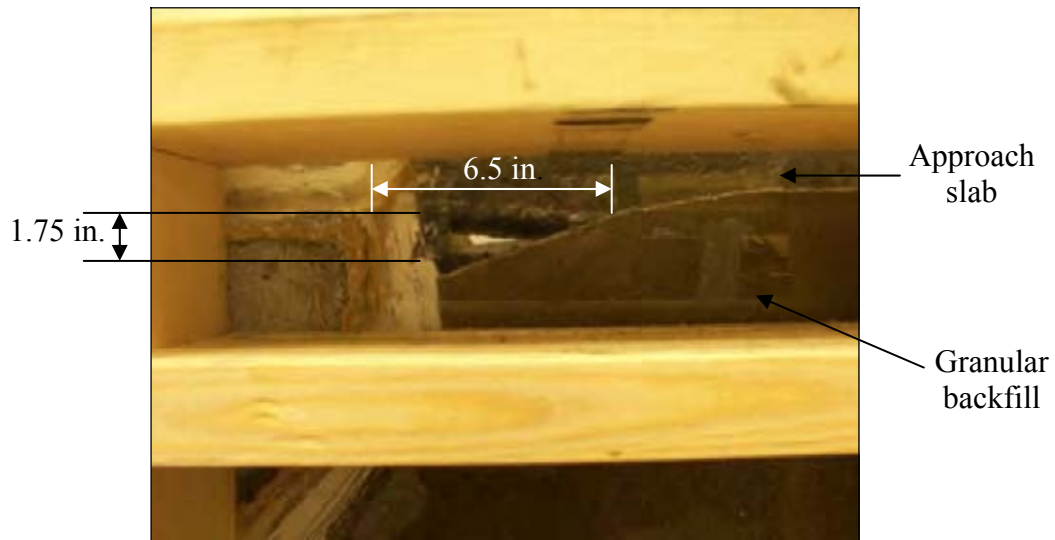
Figure 377. A void that is 1.75 in. deep and 6.5 in. long developed under the approach slab

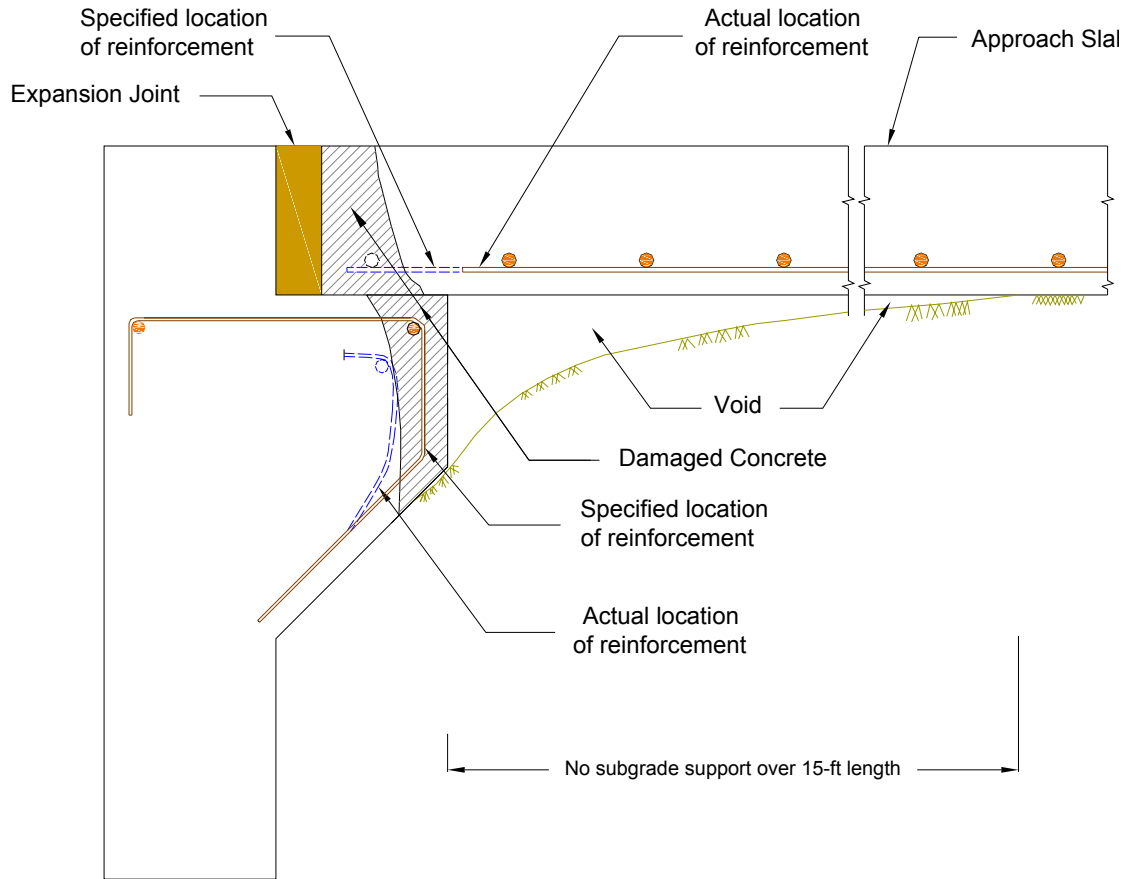
Figure 413. Inaccurate placement of reinforcing steel in the paving notch and the approach slab (Brakke 2003)
