Thin Maintenance Surfaces for Municipalities

Final Report
May 2007

Sponsored by
the Iowa Highway Research Board
(IHRB Project TR-507)
and
the Iowa Department of Transportation
(CTRE Project 03-161)

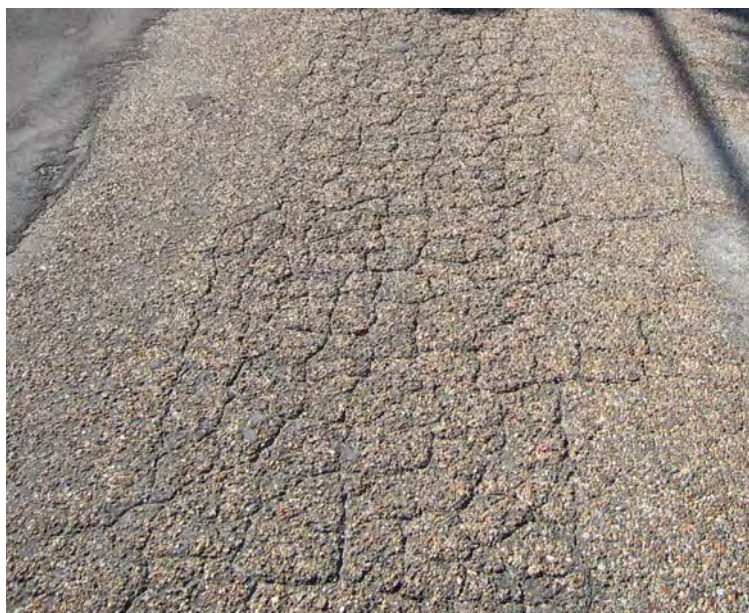
Figure 4. Alligator cracking on Vermont Avenue

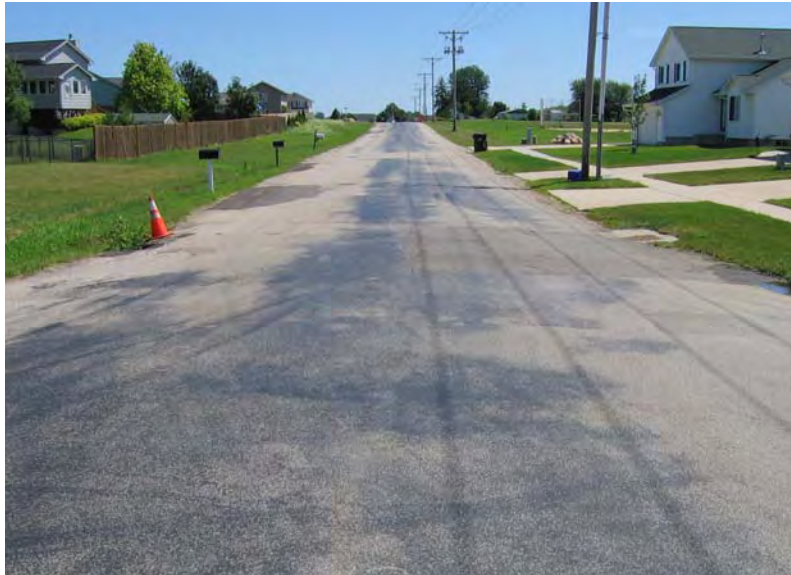
Figure 8. 74th Street (dark areas are bleeding)

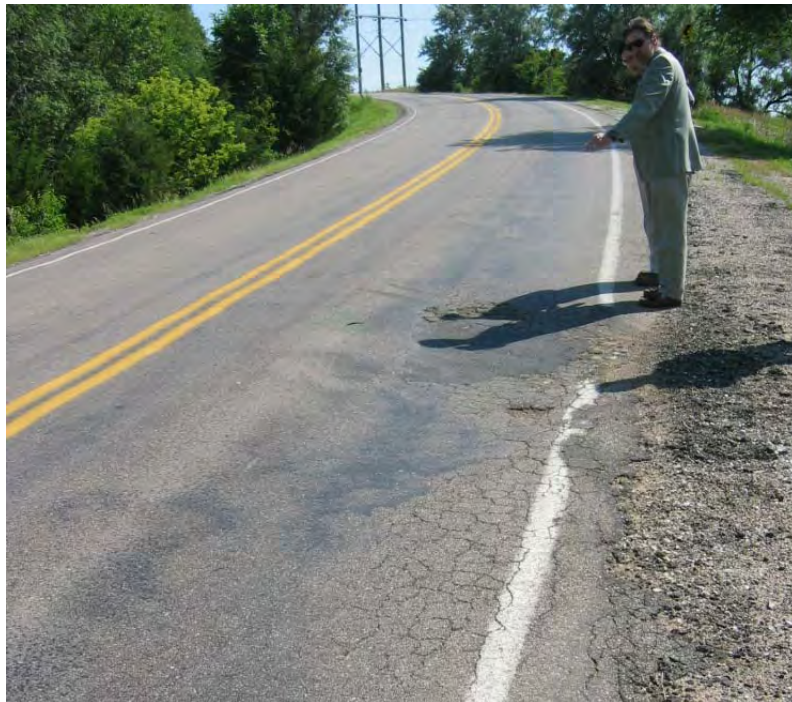
Figure 13. College Road alligator cracking, potholes, and bleeding

Researchers theorized that small cracks may be developing in the seal coat and allowing water to penetrate the base where it initiates instability problems. They recommended the use of a polymer-modified seal coat binder that could resist cracking to a greater degree, even if the base was yielding slightly under traffic. Originally, a high-float polymer-modified emulsion was recommended. However, that emulsion could not be locally manufactured. A cationic polymer-modified emulsion (CRS 2P) was available, so that emulsion was selected for use with this project.

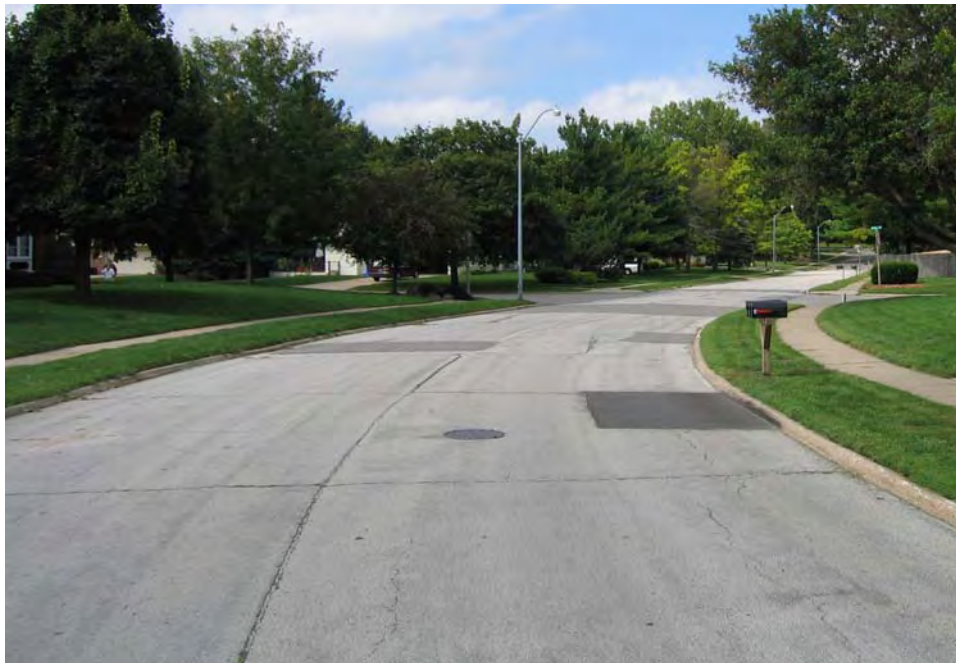
Aspen Drive is a residential street located in north-central West Des Moines (see Figure 15 and Figure 16). Before construction, Aspen Drive was a Portland concrete cement (PCC) pavement with an asphalt concrete cement (ACC) overlay of unknown thickness. The street has concrete curbs, gutters, and storm sewers which provide excellent drainage. The major distresses previous to construction were low- to medium-severity reflective cracking and L&T cracking (see Figure 17). Many of the reflective cracks had been sealed in 1991. The test section is located in a subdivision and, based on previous experience, city officials estimated an ADT of approximately 500. The PCI of the test section was 49. Citizen complaints about aesthetics were the main reason that a new surface was desired.

Figure 17. Aspen Drive before construction

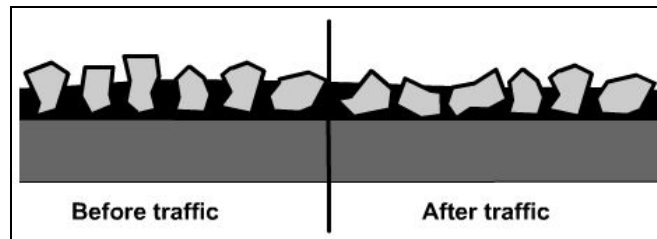
a requirement of making five passes with a pneumatic tire roller was specified in the contract documents for the construction project. However, during construction, researchers and city engineers concluded that there was no noticeable improvement in aggregate orientation, so the use of the roller was ceased.

Figure 18. Micro-surfacing aggregate before and after traffic

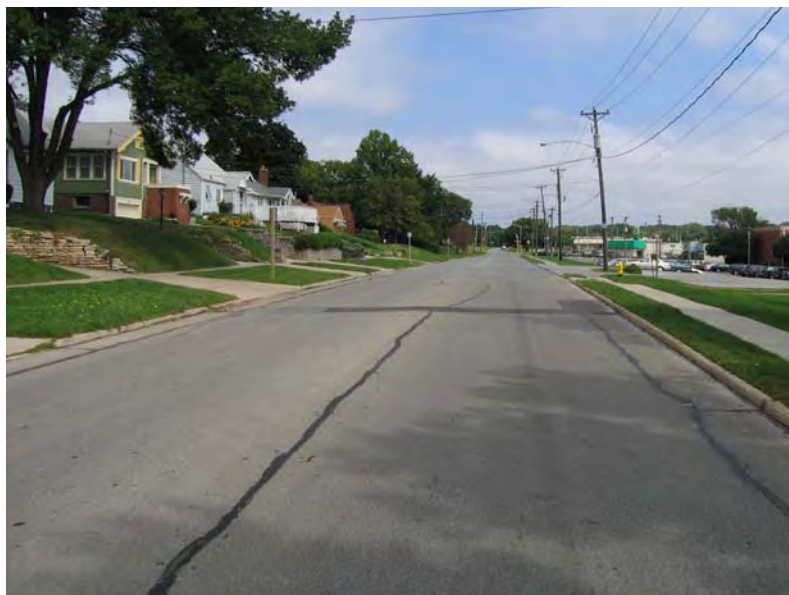
Figure 20. Fourth Street before construction

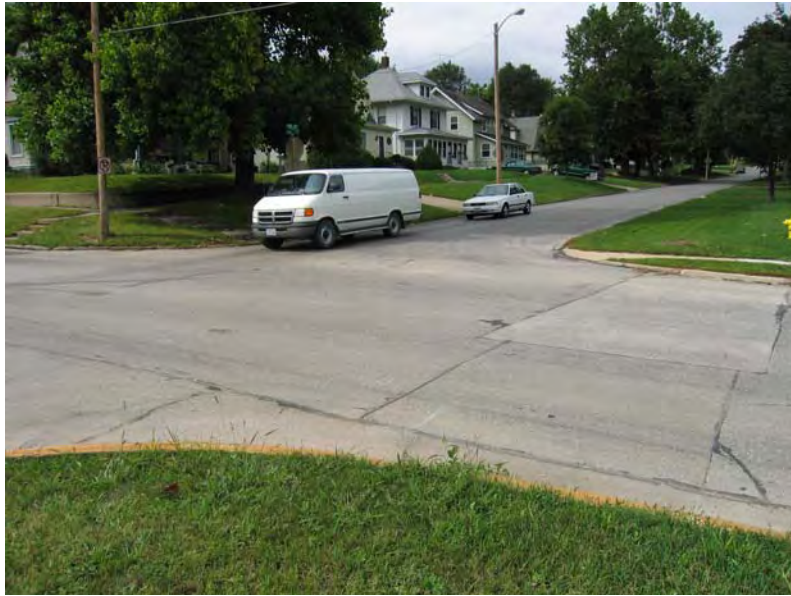
Figure 21. Vine Street before construction

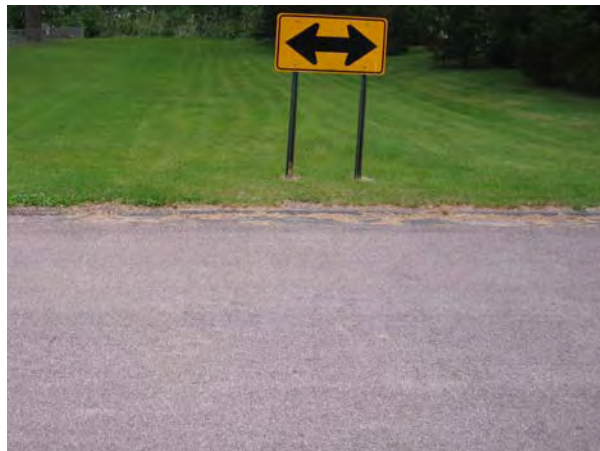
There were a few concerns with the chipmat: (1) it would not prevent reflective cracking, (2) it would not bond well to the existing seal coat, and (3) there would be noticeable bleeding over the chipmat. Inspection after the first winter indicated no such distresses had developed. The city engineer, very pleased with the chipmat, is considering the possibility of using it again in the future.

Figure 24. No reflected alligator cracking (chipmat)

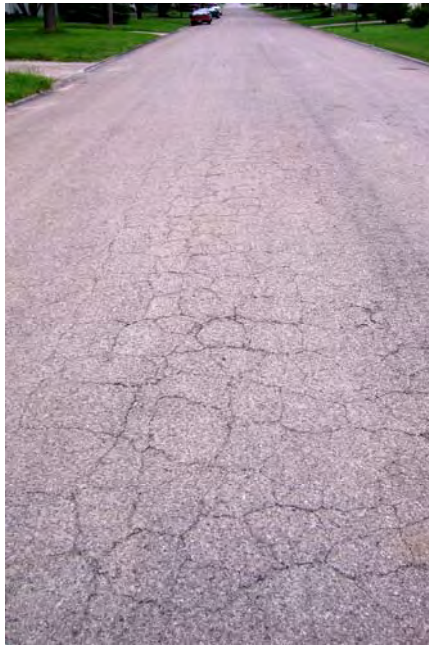
Figure 25. Reflected alligator cracking (no chipmat)

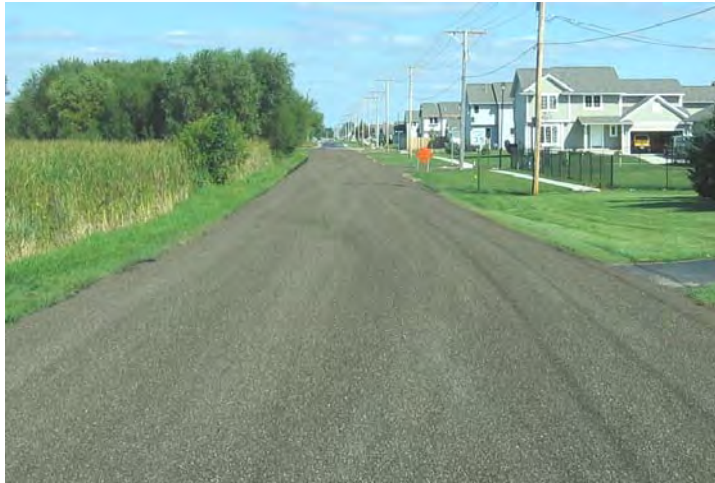
The section of seal coat that performed the best was the Section I (see Figure 28) with the 3/8-inch pre-coated aggregate. This section yielded a PCI of 81 (very good). Other than slight raveling, the seal coat was performing with no visible distress. The seal coat lost many PCI points because of rutting and other distresses that existed before construction of the new seal coat. Because a seal coat does not add any structure to a pavement, a seal coat does not address structural distresses. It is interesting to note that Section I included the 1000-foot section of the pre-coated aggregate that was not rolled until the day after the aggregate was applied. This is an indication that the emulsion and the pre-coated chips bonded to one another and is evidence of the robustness of the pre-coated chip and high-float emulsion combination.

Figure 28. 74th Street pre-coated chips

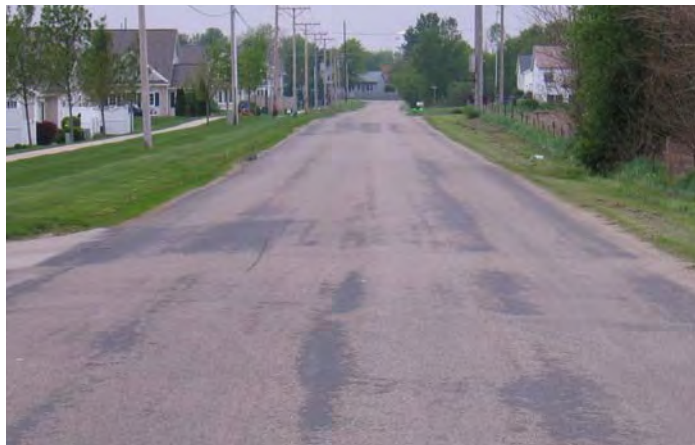
The 3/8-inch washed limestone chip section (see Figure 29) did not perform particularly well; its PCI rating was 63 (good). The relatively low PCI was caused by the large amounts of high-severity raveling. Other minor distresses included dips and low-severity rutting which were pre-existing. A large area of the seal coat was heavily raveled due to snowplow damage. The raveling problem might be attributed to poor bonding, caused by the dustiness of the aggregate that was used and the lack of the compaction by the pneumatic tire roller. The aggregate had been placed for three to four hours before the roller seated it. It is possible that the raveling may have been less severe had a roller been used immediately after placement, because much of the raveling was outside the wheel paths. (This is because the chips in the wheel path were seated in the emulsion by the passing traffic.) The city engineer also mentioned that this portion of the test section created large amounts of dust for several days after construction, which caused numerous citizen complaints. The city attempted to reduce the dust by washing the section with a water truck, but this effort resulted in limited success.

Figure 29. 74th Street washed limestone chip

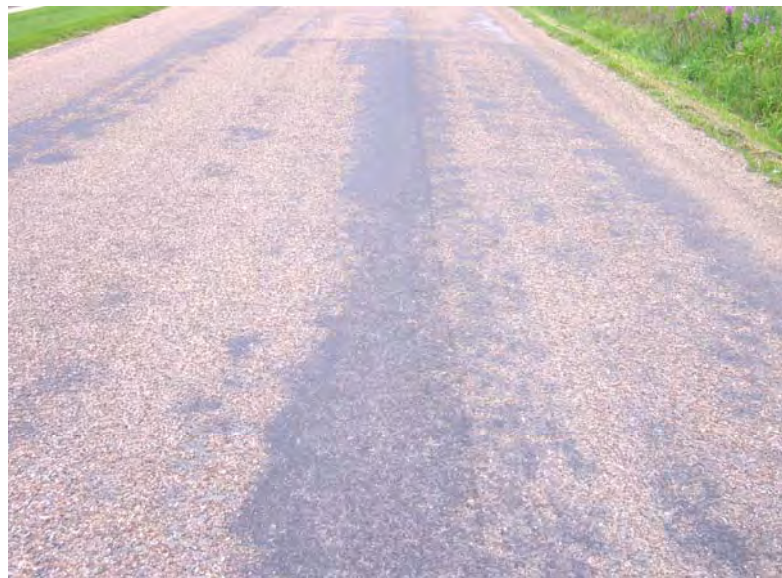
The 3/8-inch pea rock test section (see Figure 30) had more raveling problems in comparison to the test sections that used pre-coated limestone aggregate for the top course. The PCI rating for the 3/8-inch pea rock test section was 66, which is in the performance category of “good.” Most of the distress deducts resulted from large amounts of high-severity raveling. Other minor distresses included dips and low-severity rutting which pre-existed construction. This section was similar to the washed limestone chip section, in that there was considerable medium- to high-severity raveling. Again, the raveling in this section may have been caused by dirty aggregate and a lack of rolling by the pneumatic tire roller. Figure 31 shows how much fine material was on the chips, evidenced by the dusty residue left on a hand after handling the aggregate. This section was also the target of complaints by neighboring property owners regarding excessive dust generation.

Figure 30. 74th Street pea rock

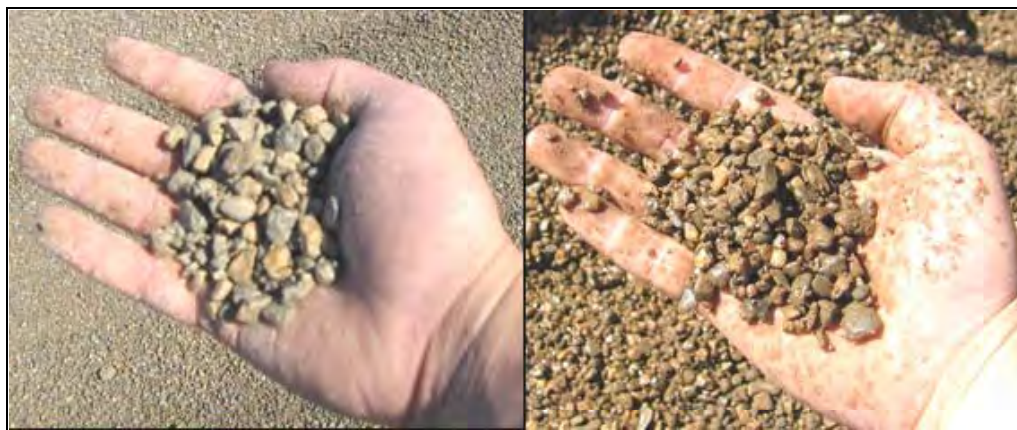
Figure 31. Dusty washed limestone and dirty pea rock chips

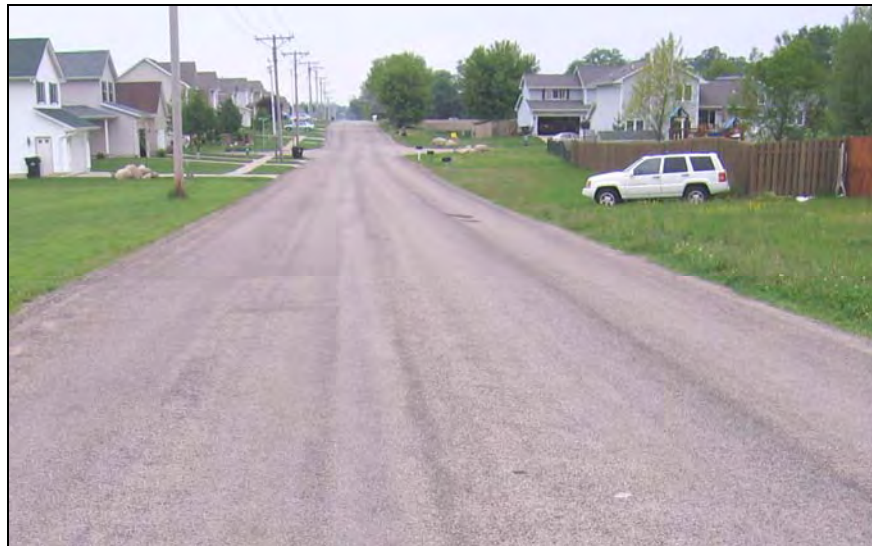
The double seal coat section—1/2-inch washed limestone chip base with a 3/8-inch pre-coated limestone chip—performed quite well, with an “excellent” PCI rating of 95 (see Figure 32). This section experienced only slight bleeding and other distresses that were present before construction, which cannot be addressed by seal coating. There was one area with medium-severity alligator cracking and rutting; however, these distresses were not included in the survey because they were outside the sample boundaries. The lack of raveling can be attributed to the fact that this test section was rolled by the pneumatic tire roller immediately after the application of both layers of chips. There were concerns that this section would have issues with bleeding; however, as of May 16, 2005, there was no bleeding on this section.

Figure 32. 74th Street double seal coat

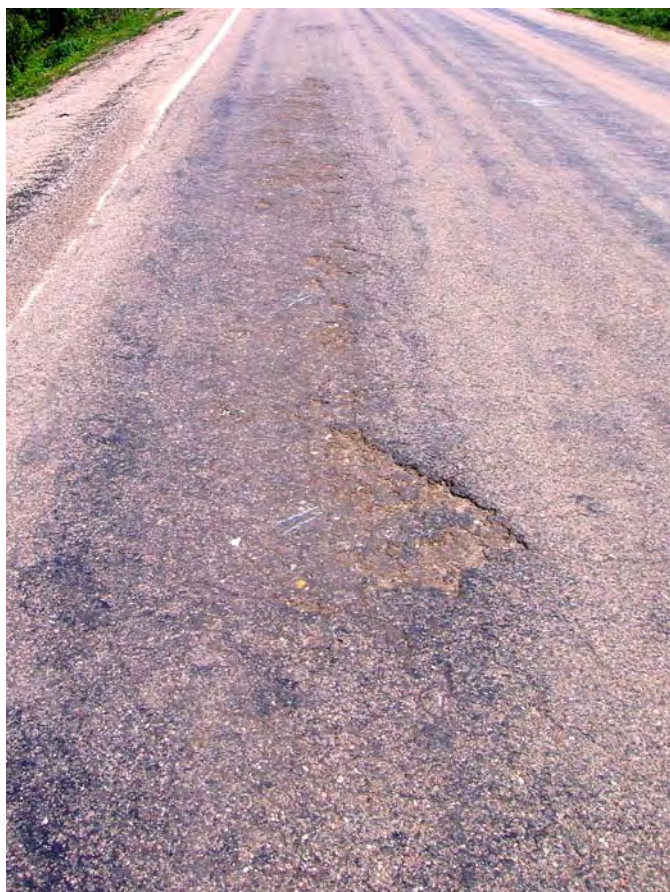
The distresses in the new seal coat were similar to that of the pre-construction condition (see Figure 34). Low- to high-severity rutting, alligator cracking, bleeding, and potholes had developed. When researchers compared a photo log of the test section before construction to the condition of the test section after construction, it was determined that the distresses in the new seal coat were located in the same regions as those of the original seal coat even though the entire road was re-stabilized. As with the original seal coat, the majority of the distresses were located in the outer lane, especially in the outer wheel path. The area adjacent to the entrance of the construction site had failed due to the heavy truck traffic. High-severity rutting, alligator cracking, bleeding, and raveling were the most prominent distresses near the entrance. Interestingly, the areas that were in excellent condition before construction were the same areas that were in good condition for the post-construction survey.

Figure 34. College Road alligator cracking

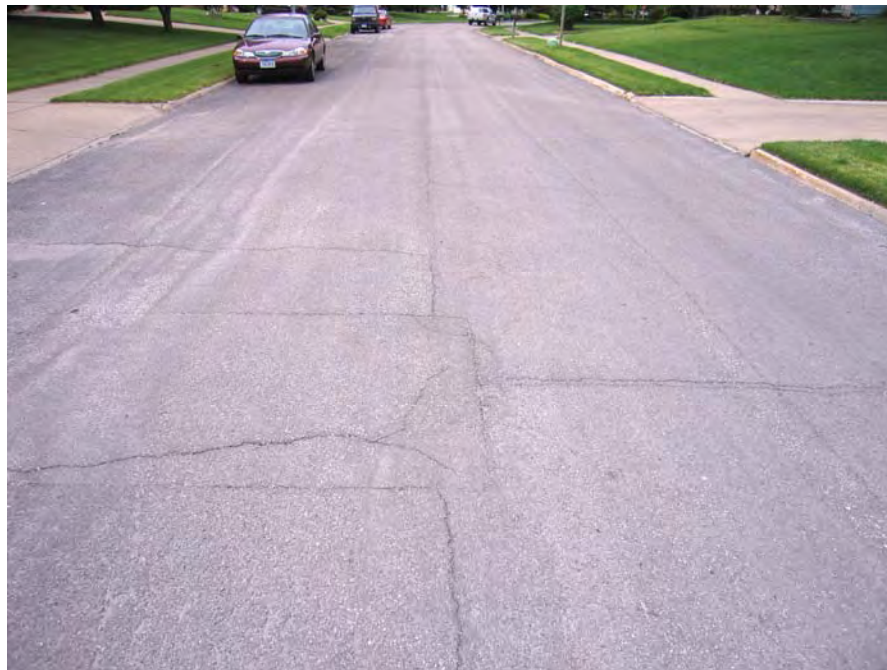
The post-construction survey revealed that there was considerable improvement in the condition of the road. The original PCI of the Aspen Drive was 49 and the new PCI was 82, an increase of 33 points to a “very good” rating. Figure 36 shows the average deduct values for the various surveys performed on Aspen Drive. Various reflected cracks were the only distresses present in the new micro-surfacing. Many of the original reflected cracks in the overlay also reflected through the new micro-surfacing treatment. This section was the only section for which researchers had the original surveys. (Recall that the others were lost in an auto theft). The original total for all of the cracks on six sample survey sections was 2,802 feet, which includes low-, medium-, and high-severity reflective and L&T cracking (see Figure 37). As of May 16, 2005, the total amount of cracking is 1,605 feet—a 43% decrease in cracking. This number only includes reflective cracking, because the PCC joint cracks as well as the L&T cracks in the overlay reflected through the micro-surfacing but no new L&T cracks will form in the micro-surfacing. This crack reflection is typical of micro-surfacing treatments. The only other distress in the original overlay was light-severity alligator cracking. As of May 16, 2005, none of the alligator cracking had reflected through the micro-surfacing. The micro-surfacing appears to be performing well (see Figure 38). In a few high spots, a snowplow sheared off the high parts of the limestone aggregate, but enough aggregate still remains to cover the original pavement.

Figure 38. Reflective cracking on Aspen Drive

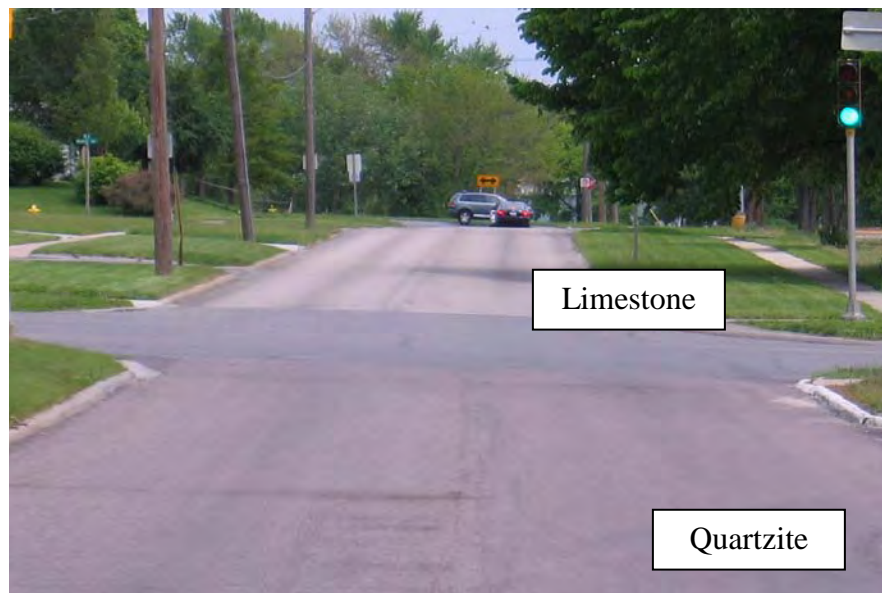
Both types of aggregate—quartzite and limestone—were used for both streets, and there was no noticeable difference in performance. The two mixes of micro-surfacing using different aggregates are experiencing the same types and amounts of distresses. The sections of micro-surfacing with limestone aggregate seemed to have a tighter surface texture because there were a higher proportion of fines in the limestone gradation. Figure 41 shows the color of the limestone aggregate in comparison to the quartzite aggregate, which has a pink color.

Figure 41. Micro-surfacing on Fourth Street

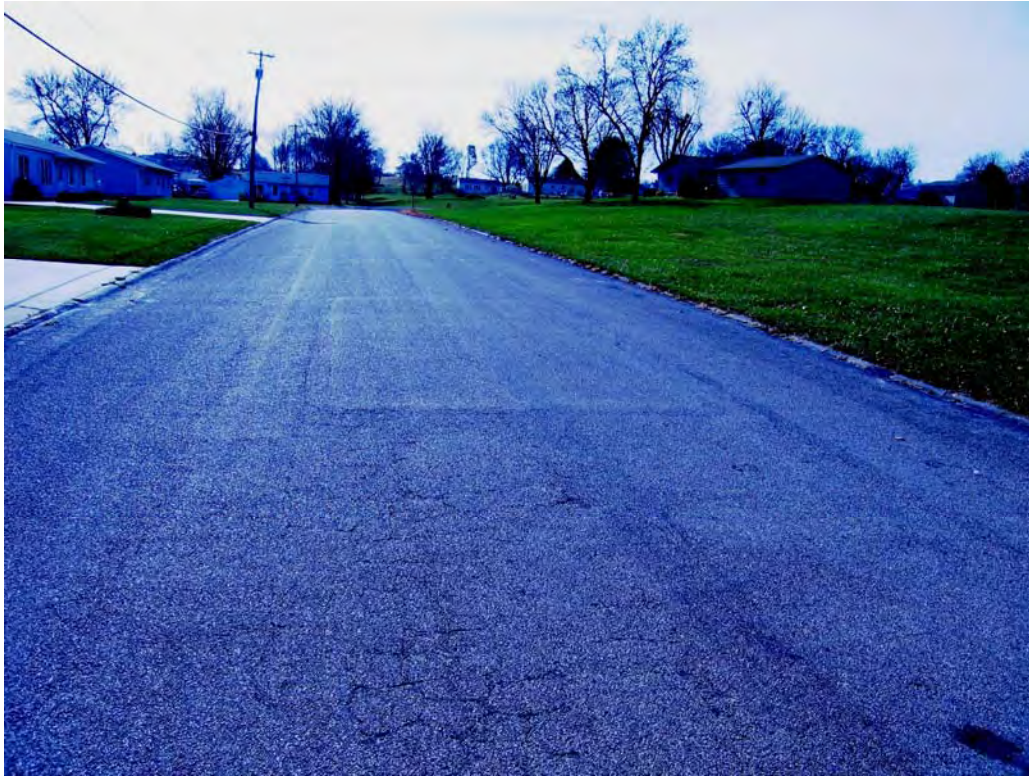
The PCI of Vermont Avenue in November of 2005 was 83, unchanged from that of May 2005. Figure F.1 summarizes how the PCI changed over the pre- through post-construction cycle. As the November 2005 survey was being conducted, the researchers noted the locations of the chipmat repairs and noted that alligator cracking had not yet reflected through in these locations. In contrast, the May 2005 survey had indicated that alligator cracks had reflected through in locations where chipmat was not applied (Figure F.2).

Figure F.2. Vermont Avenue in November 2005 (digitally enhanced photo)

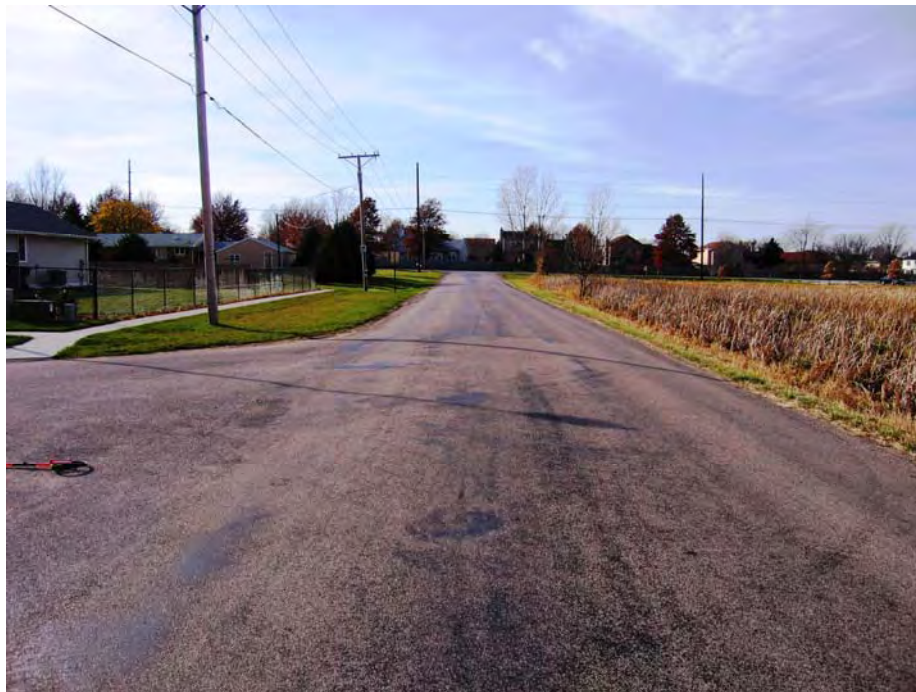
The washed limestone and pre-coated pea rock had the lowest PCIs (61 and 68, respectively), while the single pre-coated limestone and the double seal coat had the highest (76 and 75 respectively). Figure F.3 summarizes how the PCIs changed over the pre- through post-construction cycle, while Figures F.4 through F.7 provide representative images of each of the sections. In comparing these sections, the effects that rutting had on the PCI calculation were not included. This is because a seal coat is not intended to improve road performance with regard to rutting and because there were noticeable differences in the amount of rutting from one road section to another, which would have made comparisons difficult.

Figure F.4. Typical view of pre-coated limestone on 74th Street (digitally enhanced photo)

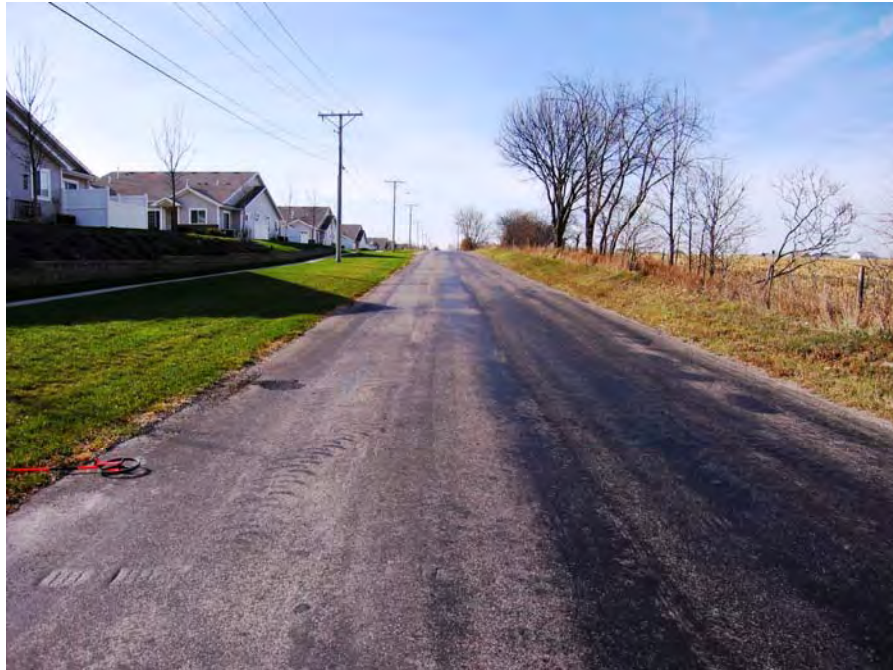
Figure F.5. Typical view of washed limestone on 74th Street (digitally enhanced photo)

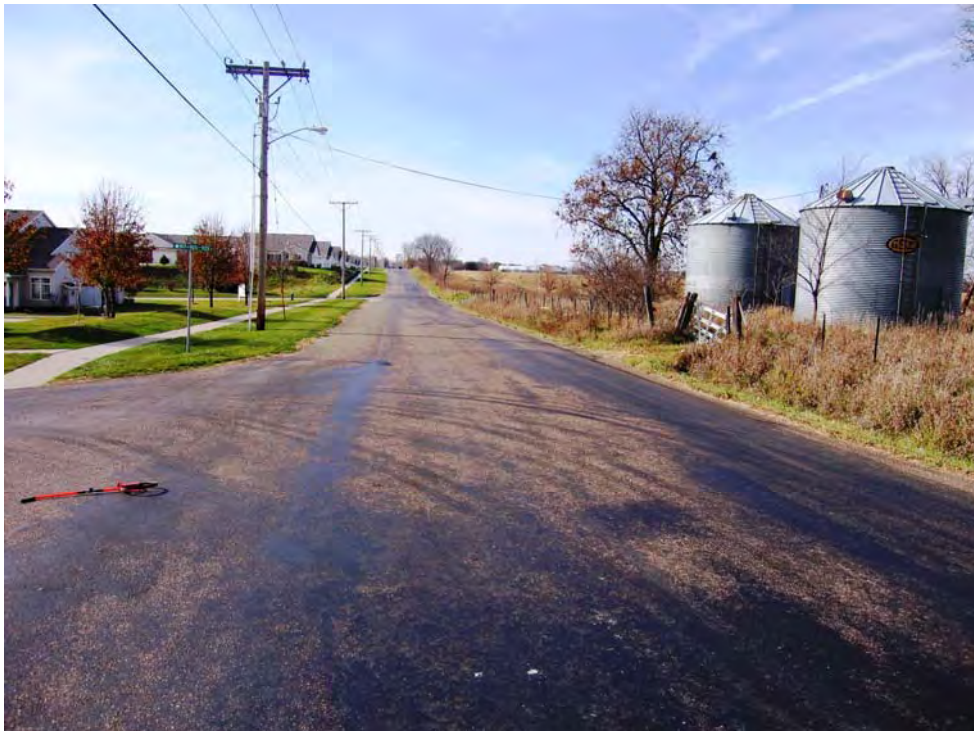
Figure F.6. Typical view of pre-coated pea rock on 74th Street (digitally enhanced photo)

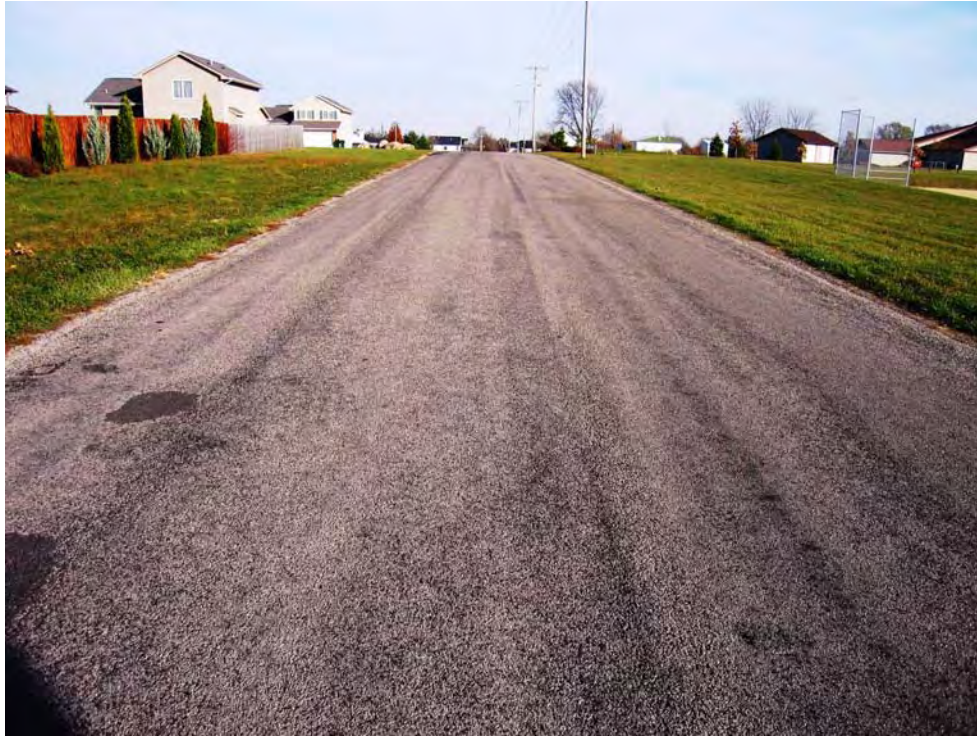
Figure F.7. Typical view of double seal coat on 74th Street (digitally enhanced photo)
