Pilot Construction Project for Granular Shoulder Stabilization

Final Report
September 2013

Sponsored by
Iowa Highway Research Board
(IHRB Project TR-634)
Iowa Department of Transportation
(InTrans Project 11-405)

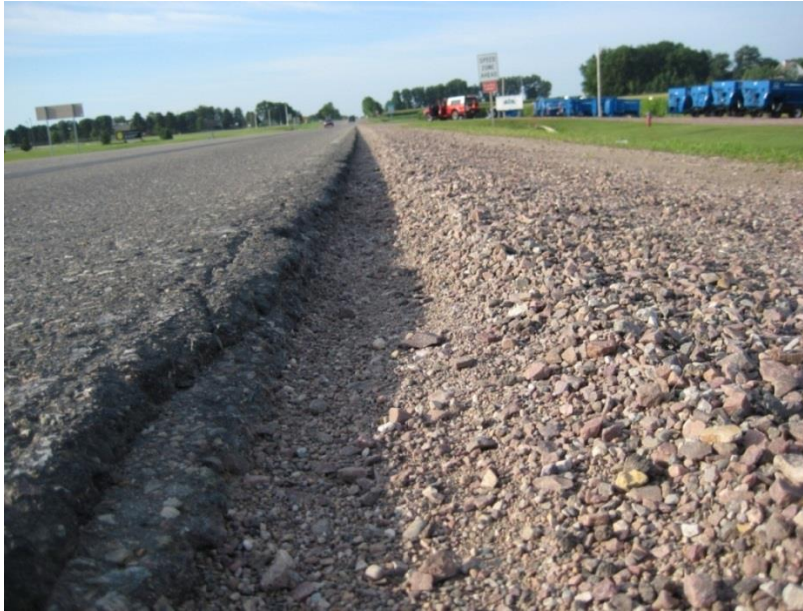
Edge rutting on granular shoulders, as shown in Figure 1, is a serious traffic safety issue because it can cause vehicles to run off the road, which can lead to loss of control and even loss of life (Jahren et al. 2011). Edge rutting is caused by three factors: wind and air currents, vehicle off-tracking, and drainage.

Figure 1. Edge rutting on granular shoulder (Jahren et al. 2011)

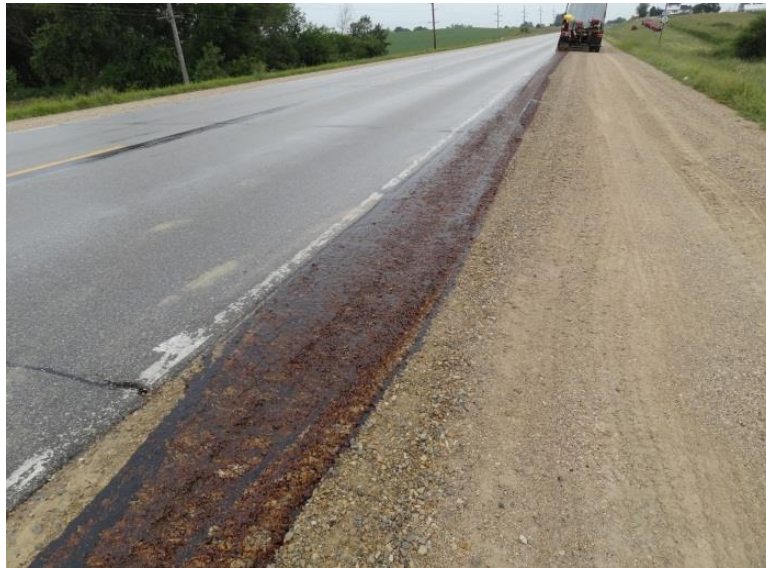
On August 18, 2011, rain occurred during the time that the application process was executed around Allison and Shell Rock. Figure 12 shows the result of the soapstock application on the westbound (WB) shoulder of IA 3 nearby and east of Allison during the rain.

Figure 12. Spraying in the rain on IA 3 near Allison, Iowa

- During the soapstock application, rain should be avoided because too much moisture can prevent soapstock from staying firmly on the shoulder. Too much or too little moisture compromises the effectiveness of the application. If the shoulder is too dry, water should be applied to add more moisture. If the shoulder is too wet, soapstock application should be delayed until it is dry enough.

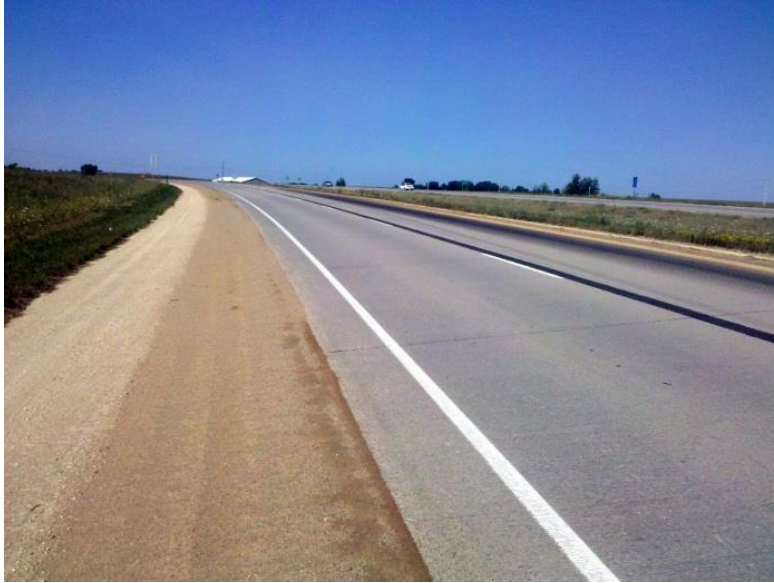
Section 2.02 was located on curves of US 63 near Denver. This highway is a four-lane divided highway with a traffic level (6,000 ADT) heavier than the targeted study level. Soapstock was applied on both outside and inside shoulders and adjacent to both SB and NB lanes. The result of one section of the treated shoulder is shown in Figure 13.

Figure 13. Soapstock and sand applied on the shoulder of US 63 near Denver, Iowa

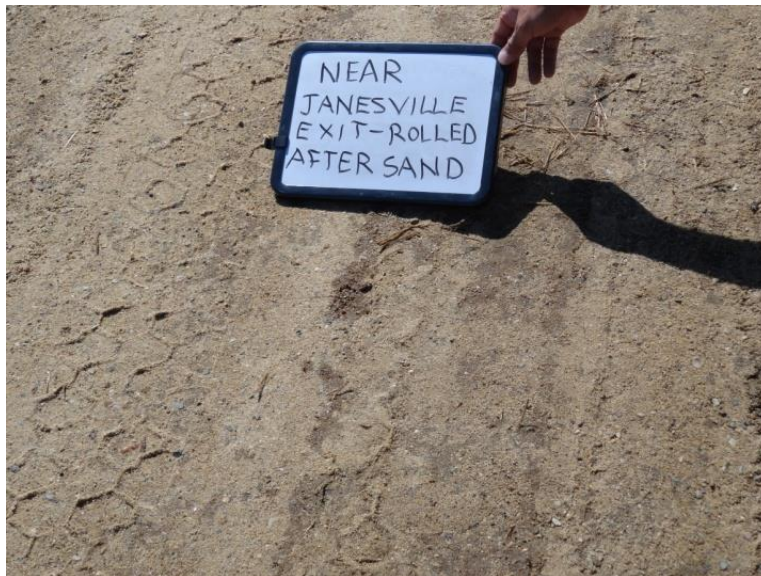
In the same location, Section 2.02, one action observed by researchers might be meaningful for a successful application. This was near the Janesville exit on US 63 near Denver, and the treated surface was rolled after the sand application. The result of this is shown in Figure 14.

Figure 14. Surface rolled after sand application for the shoulder of US 63 near Denver, Iowa

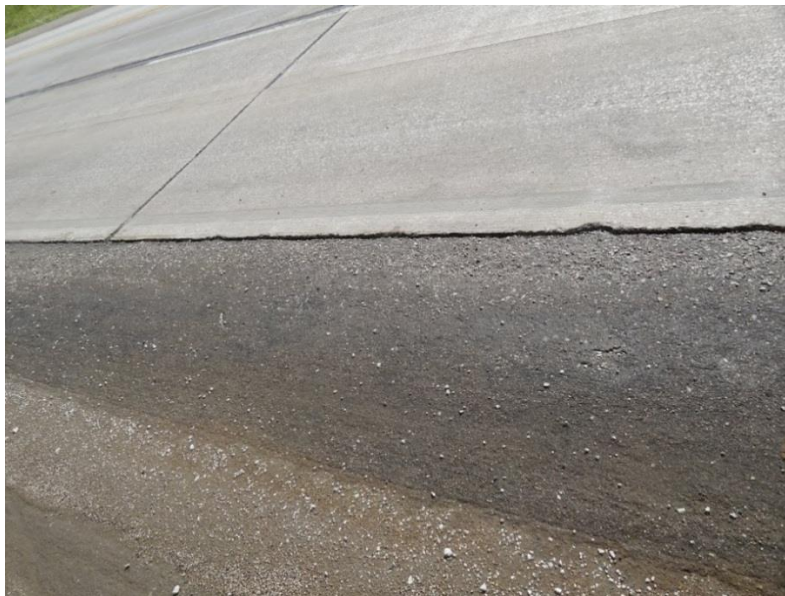
Figure 20 provides an example of good shoulder performance for this area. This shows a section of the US 169 shoulder adjacent to the SB lane just south of Algona, where a thin layer of soapstock remained firmly on the shoulder. Another example is shown in Figure 21. The shoulder section was on US 18 near Garner with a thicker layer of soapstock on surface.

Figure 20. Southbound shoulder of US 169 south of Algona, Iowa

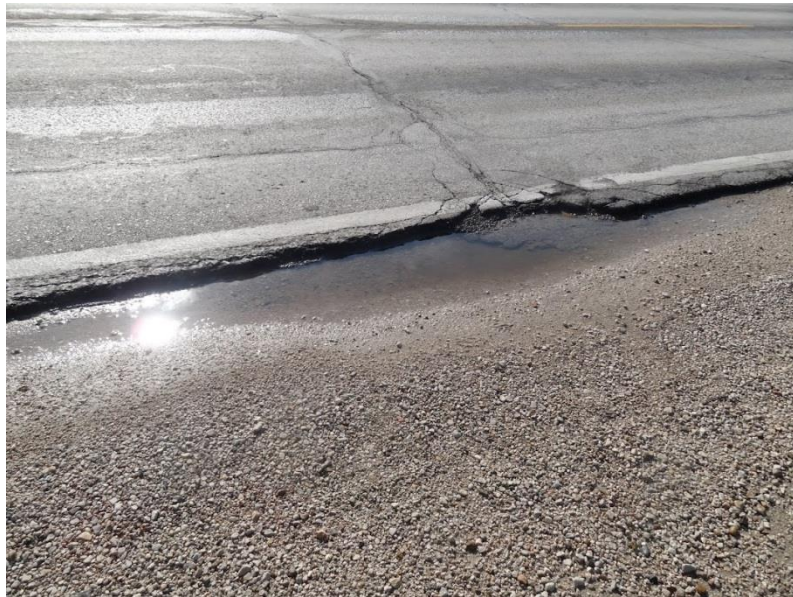
The possible reason for this failure might be water erosion. There is an uphill grade adjacent to this location, which results in water runoff that erodes the edge drop off area.

Figure 22. Edge rut developed south of Algona, Iowa

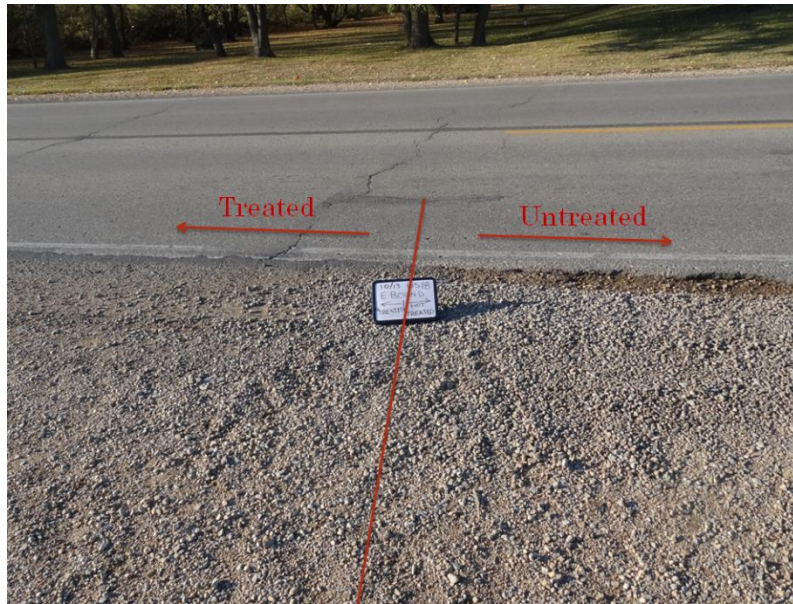
Figure 23 shows an example of a comparison of an untreated shoulder edge and the untreated one.

Figure 23. Results compared for treated and untreated shoulder edge

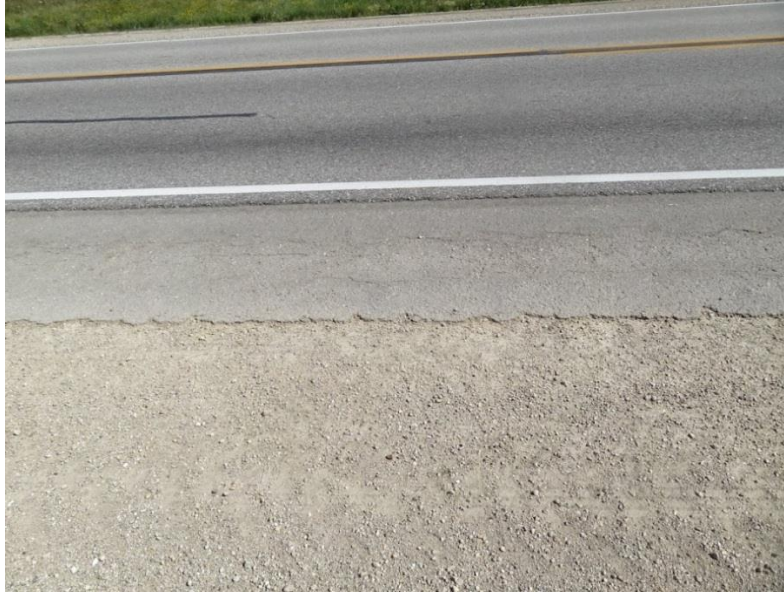
Figure 24 provides an example of good shoulder performance for this area. This shows a shoulder section of IA 3 on adjacent to the EB lanes just east of Waverly, where a thick layer of soapstock remained firmly on the shoulder. Another example is shown in Figure 25. This shoulder section was on US 63 near Denver, where soapstock had penetrated into the shoulder and could not be seen easily.

Figure 24. Eastbound shoulder of IA 3 east of Waverly, Iowa

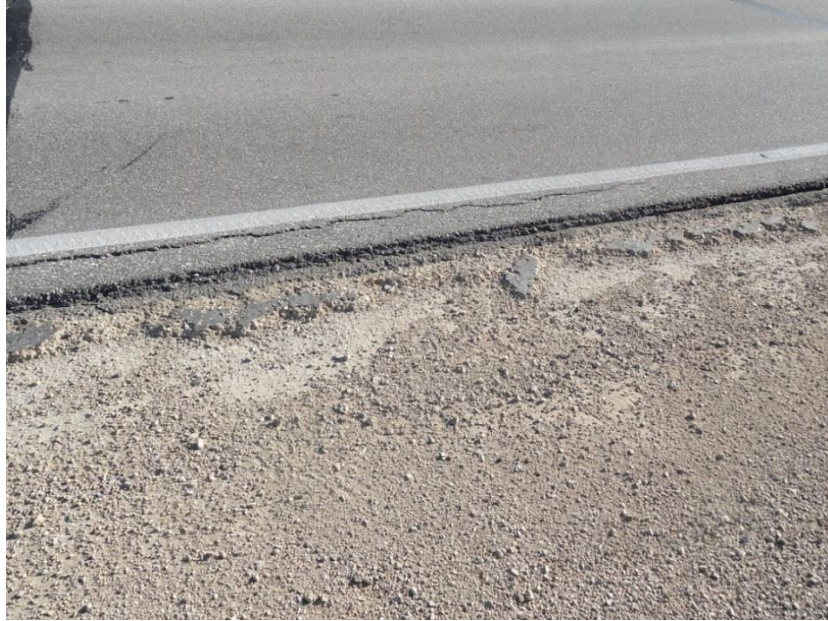
Figure 26 shows one example of an undesired situation where most soapstock was abraded away by traffic, although neither edge ruts or potholes developed. This was part of the shoulder of IA 3 EB east of Allison. However, an edge drop-off did exist because there was not enough shoulder aggregate in this area to maintain the designed cross slope and fill flush to the pavement edge.

Figure 26. Soapstock missing east of Allison, Iowa

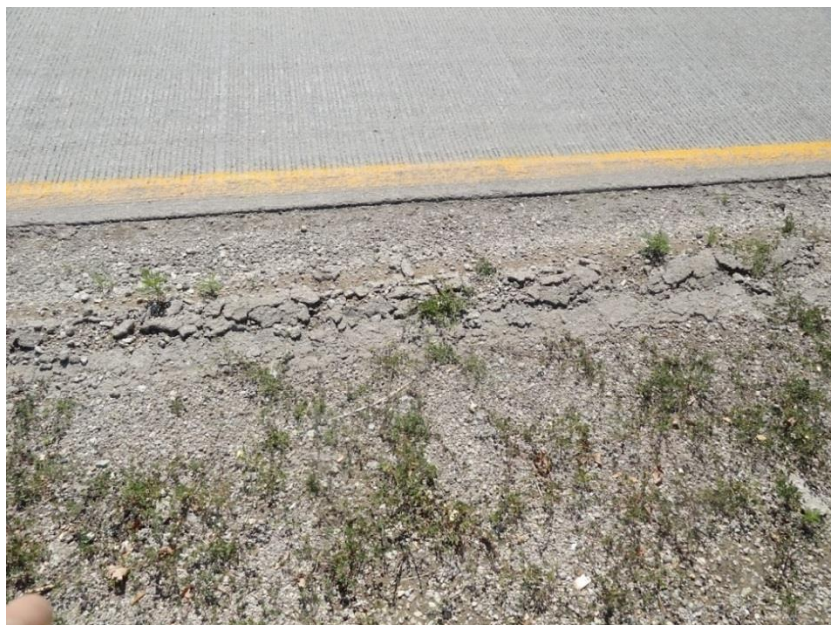
Figure 27 shows another undesired situation where the soapstock was not remaining on the inside shoulder of US 63 NB near Denver. Part of the shoulder materials had been displaced by traffic. Researchers observed that the inside shoulder material was less stable in comparison to the outside shoulder material and was easily prone to displacement.

Figure 27. Northbound inside shoulder of US 63 near Denver, Iowa

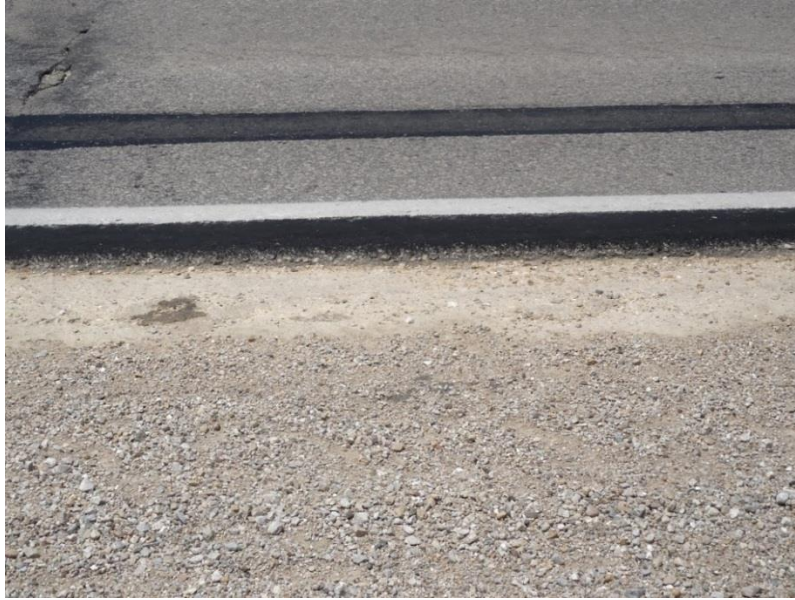
Figure 28 shows one shoulder section of US 18 EB east of West Union. Although the shoulder had been regraded, the hard surface resulting from the soapstock could still be observed. Another example is shown in Figure 29. The shoulder was also along US 18, west of Clermont, where the whole section was regraded with new gravel.

Figure 28. Shoulder of US 18 eastbound east of West Union, Iowa
