Evaluation of Pavement Markings on Challenging Surfaces

Minnesota
Department of
Transportation

March 2016

Research Project
Final Report 2016-08

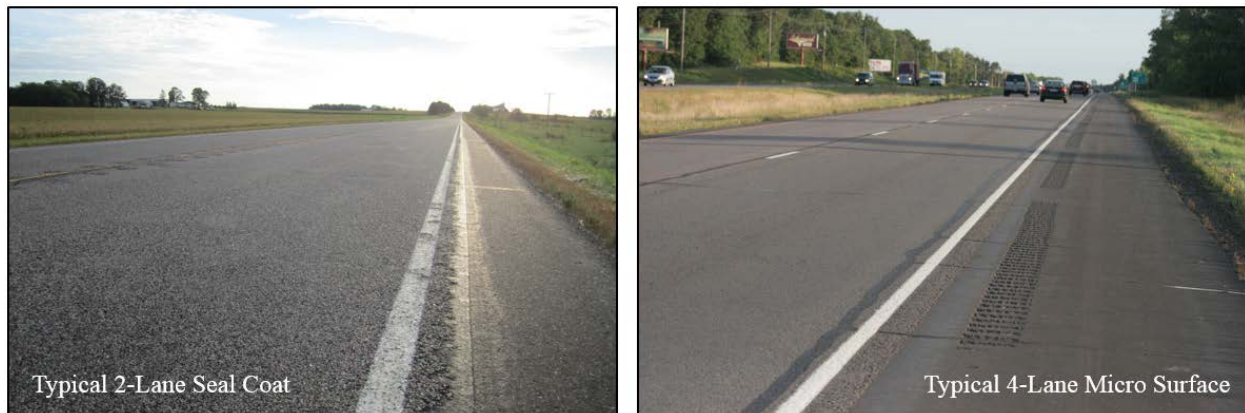
Figure 2-1. Typical MnDOT Challenging Surface Treatments

When considering roadways for resurfacing, MnDOT typically selects a seal coat surface for lower volume roadways with minimum rutting. In contrast, micro surfacing is selected for higher volume roads and/or roadways with moderate rutting. In general, most of the seal coat projects are for two-lane roadways with micro surfacing typically applied to the four-lane roadway sections as illustrated in Figure 1.

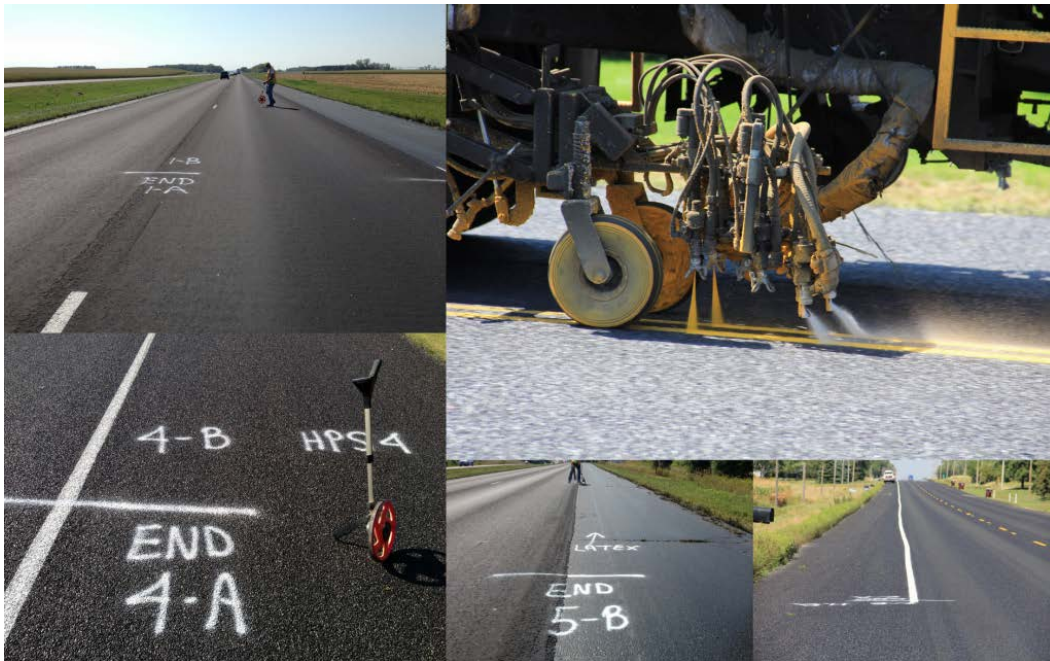
Figure 4-1. Test Deck Layout and Primer Installation

Based on the findings from Task 1A, the research team worked with paint vendors, bead manufacturers, and MnDOT staff to develop a final test deck layout plan, as shown in Figure 15.

From this plan, the research team worked to schedule the installations for the last week of August 2013. The installation included marking out the test sections, applying primer to appropriate sections, and then installing the pavement marking materials (Figure 14).

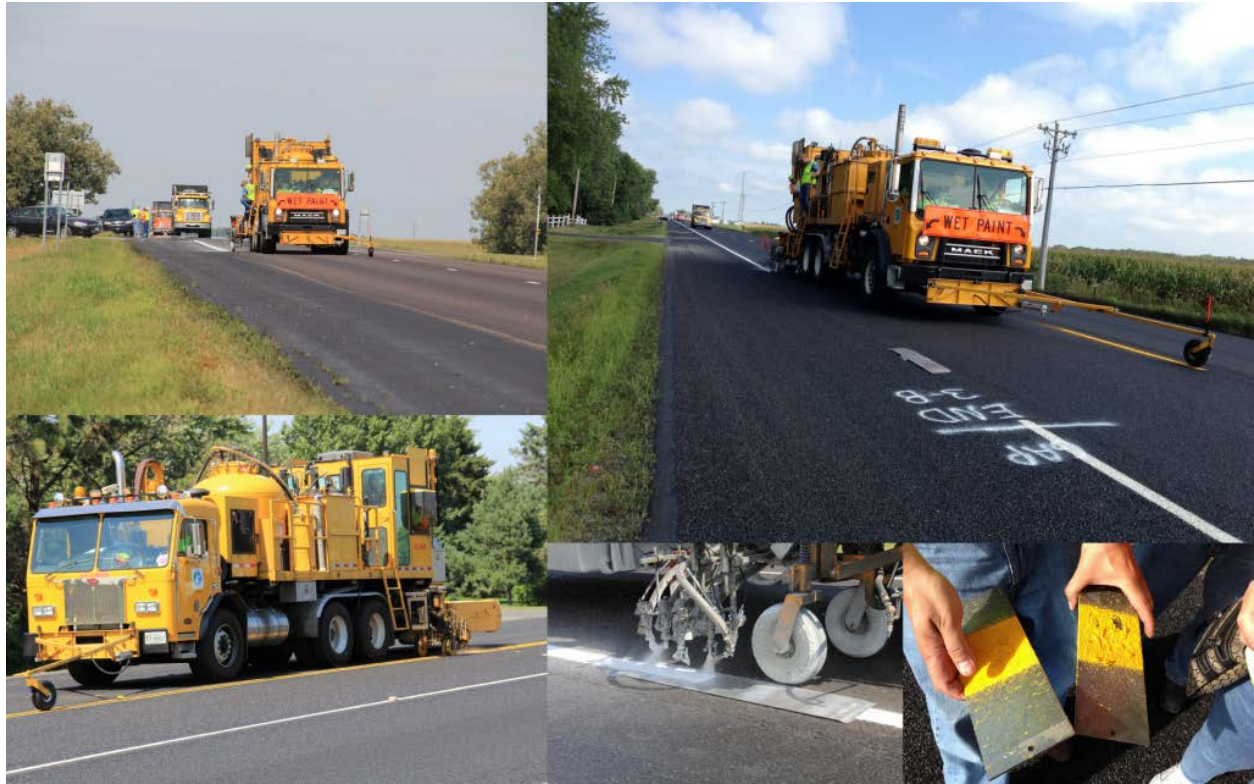
Figure 4-5. Installation

The installation for each section was completed without any equipment issues. Technical representatives for both the paint and bead products were either riding with the paint truck or along the roadside to make minor adjustments to ensure compliance with the desired evaluation plan. Figure 18 provides several images from the installations.

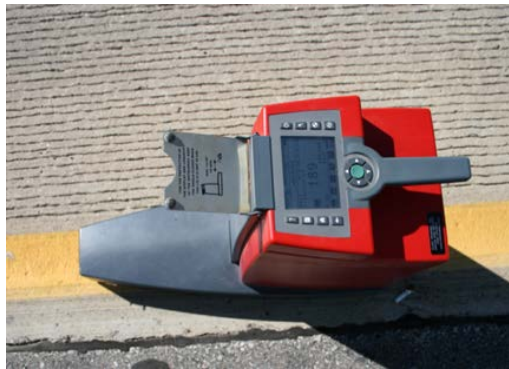
Figure 5-1. Handheld Retroreflectometer

Retroreflectivity readings were measured using a hand-held retroreflectometer (LTL-X) (see Figure 20).

The standard test procedure defined by ASTM 1710-11 was followed in determining the coefficient of retroreflected luminance of horizontal coating materials used in the test pavement markings.

1. Calibrate the handheld instrument according to the manufacturer recommendations.
2. Pre-load the section labels by roadway in the LTL.
3. Locate each field sampling section using the roadway markings in-place. Select areas that are typical of the marking section.
4. Take all measurements in the direction of travel.
5. Center the device on the pavement marking and for each edgeline, take 16 equally spaced readings within the 400-foot sampling area regardless of the condition of the line. On each lane line, take 2 readings on each skip for 8 consecutive skips.
6. Data entry for handheld instrument:

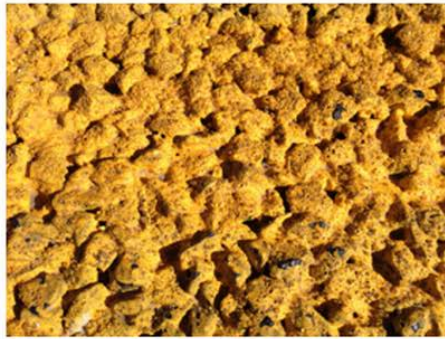
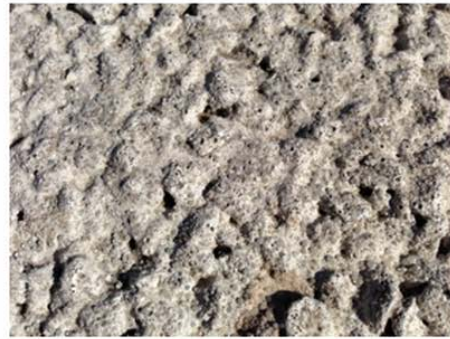
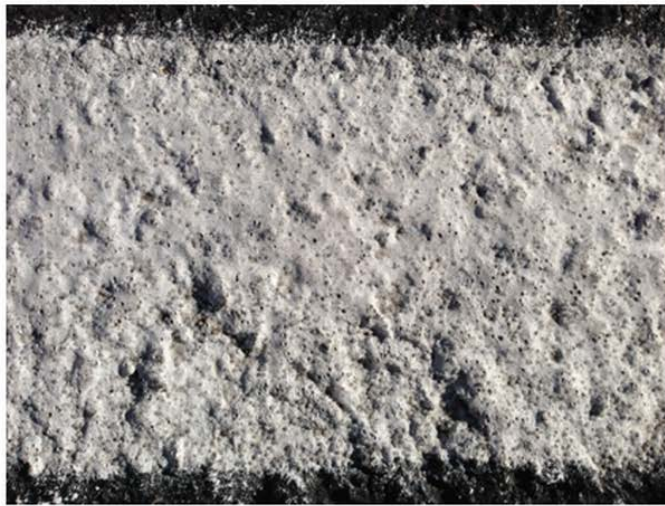
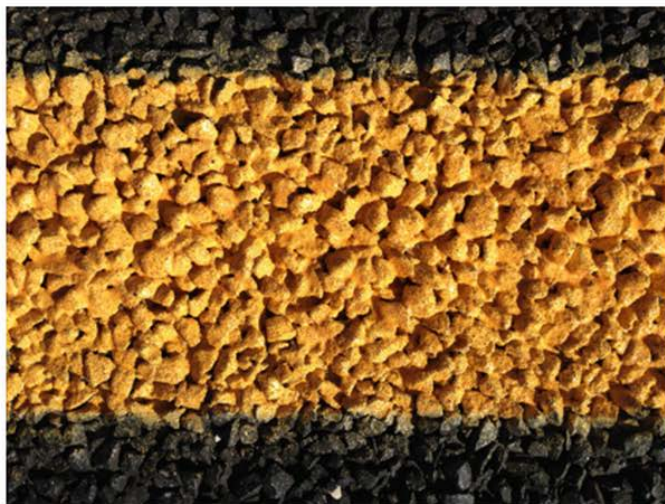
Figure 5-5. Initial Pavement Marking Conditions

Selected images from the 2013 measurements are shown in Figure 24.

US 61
2A

US 52
2A

US 61
4A

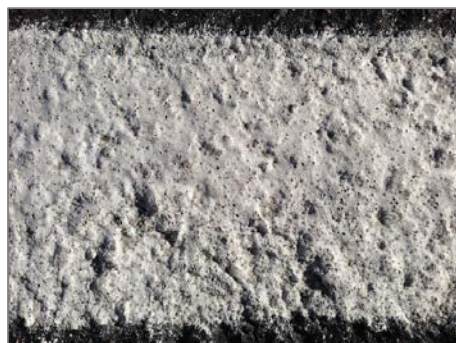
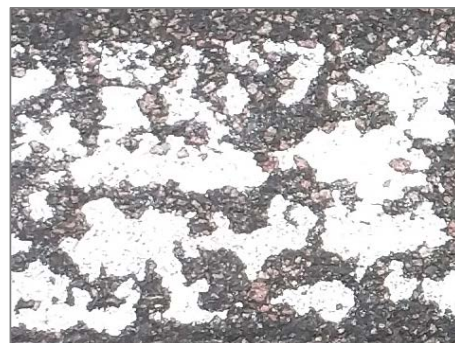
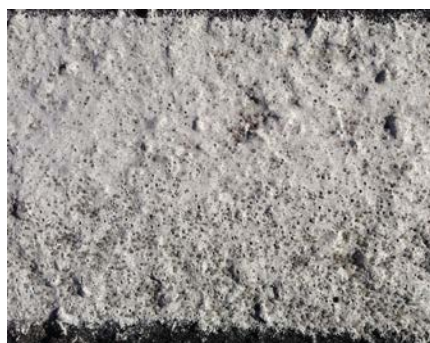
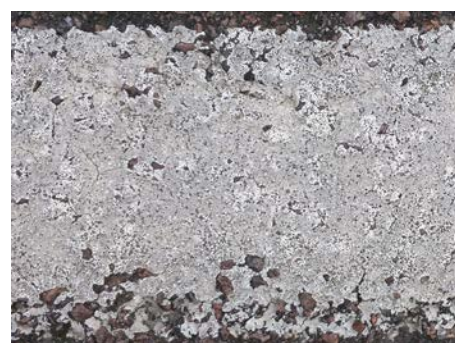
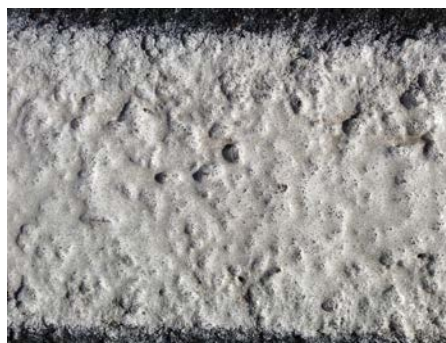
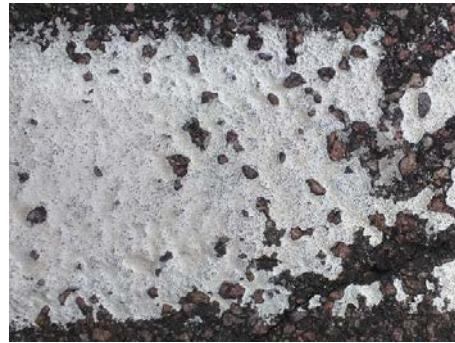
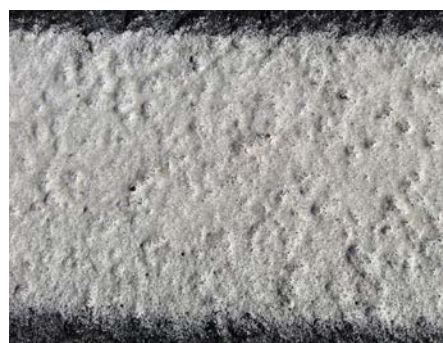
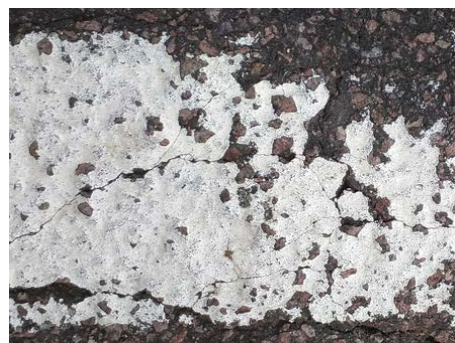
Figure 5-16. US 52 Pavement Marking Presence Initially and after Two Winters

Section 2
25 mil
High Build

Section 3
35 mil
High Build

Section 4
12 mil
HPS4

Section 5
12 mil
MFUA-10

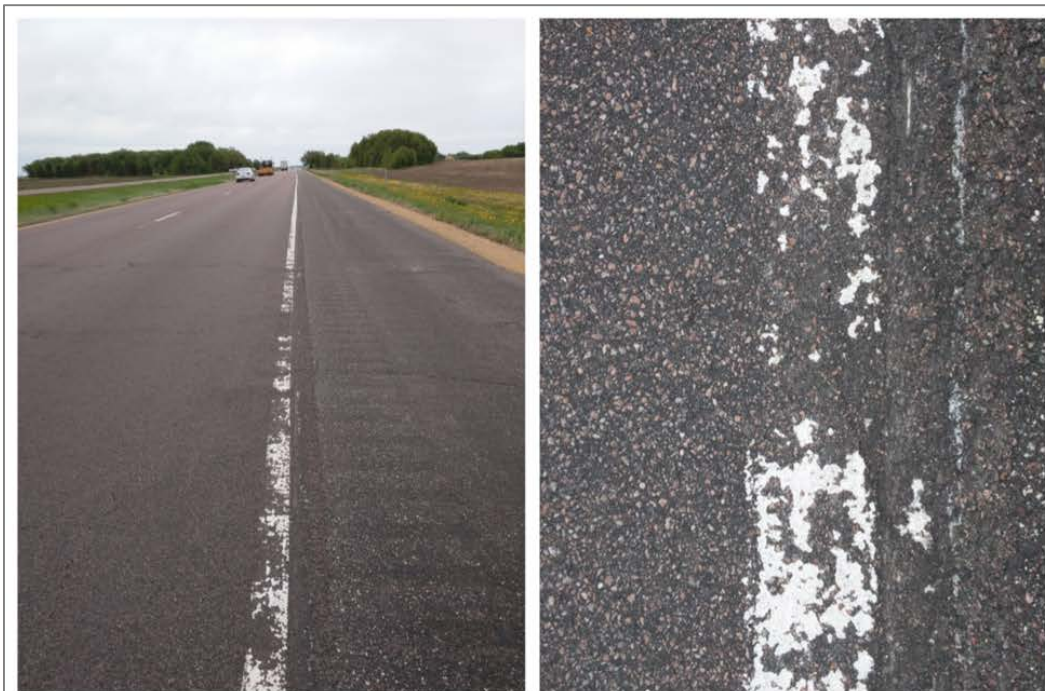
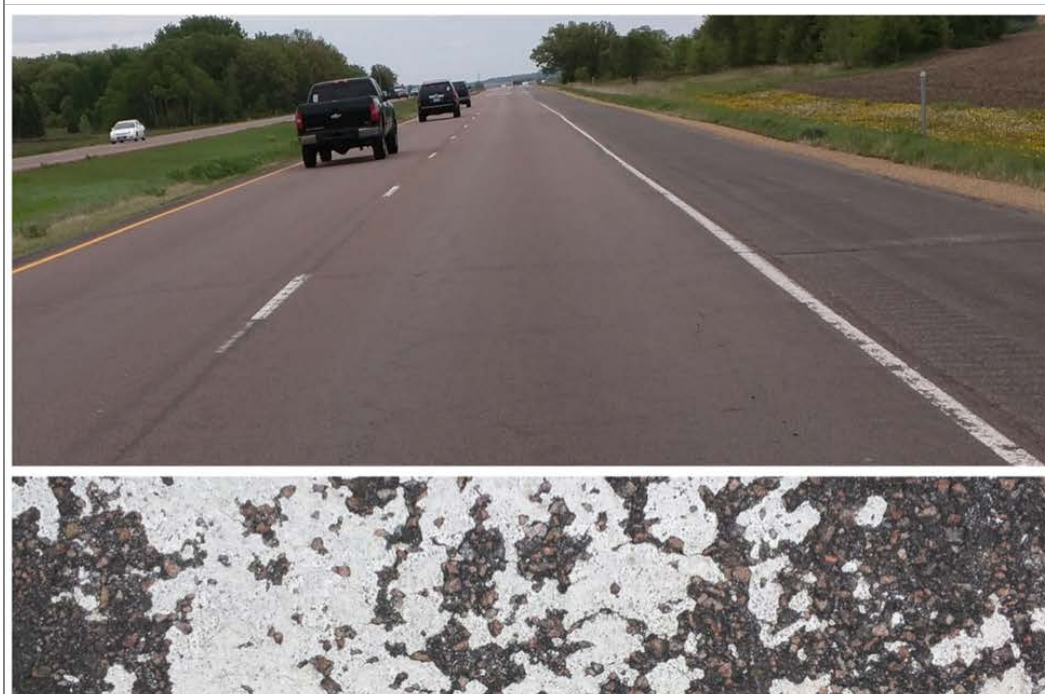
Figure 5-17. US 52 Section 2A after Two Winters

Section 2A Edge Line

Section 2A Center Line Skip

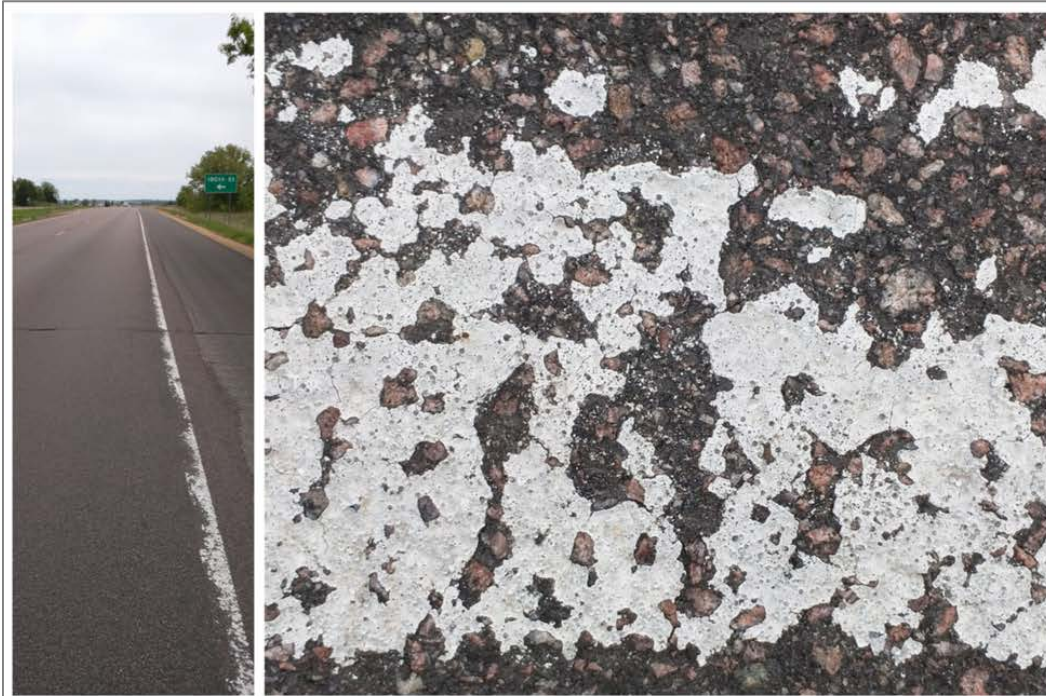
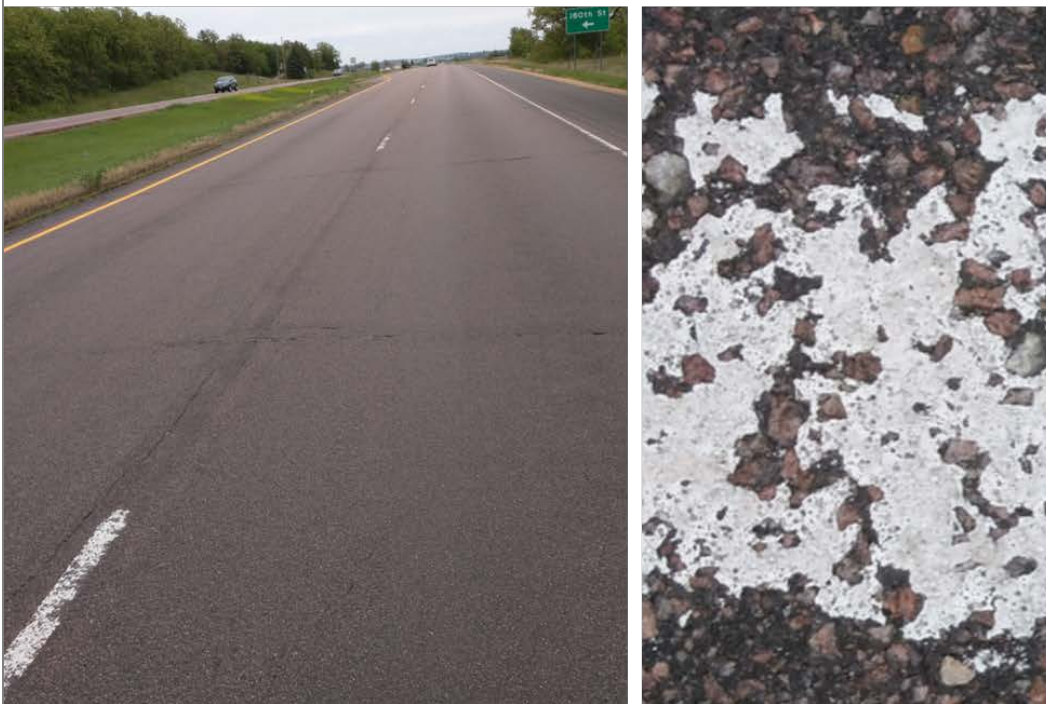
Figure 5-18. US 52 Section 2B-1 after Two Winters

Section 2B-1 Edge Line

Section 2B-1 Center Line Skip

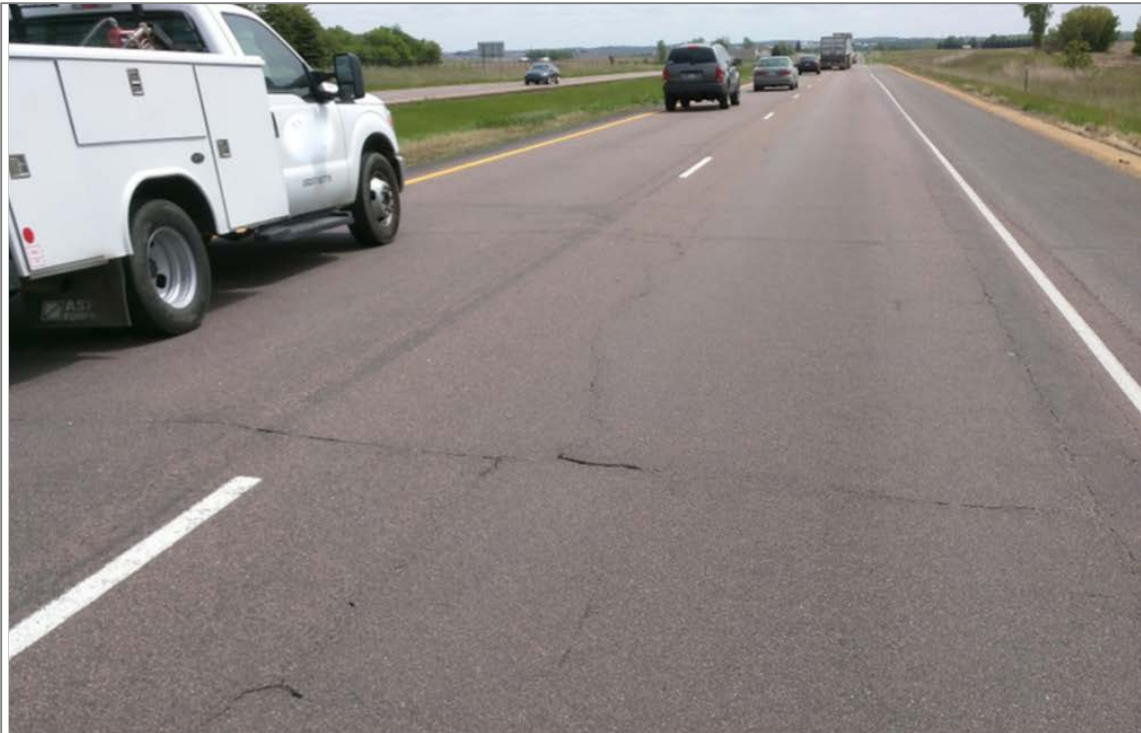
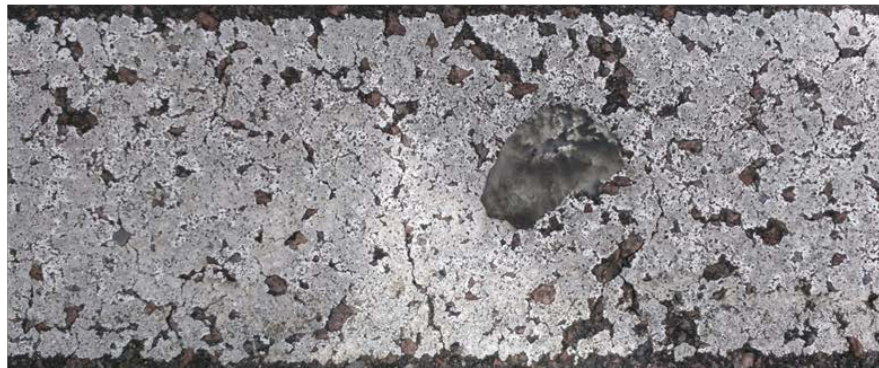
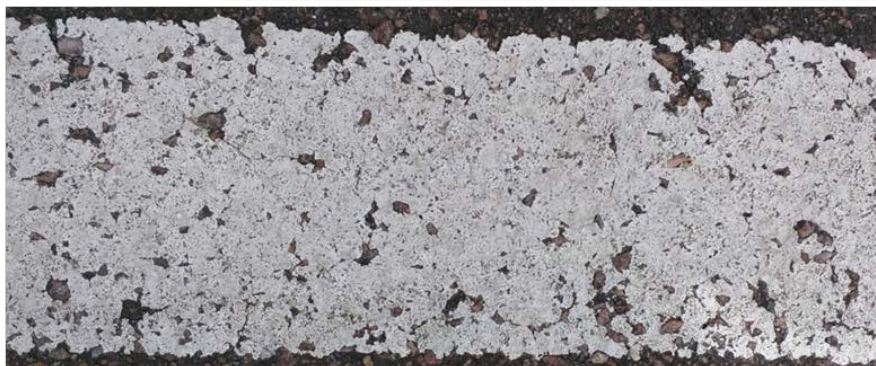
Figure 5-19. US 52 Section 2B-2 after Two Winters

Section 2B-2 Center Line Skip and Edge Line

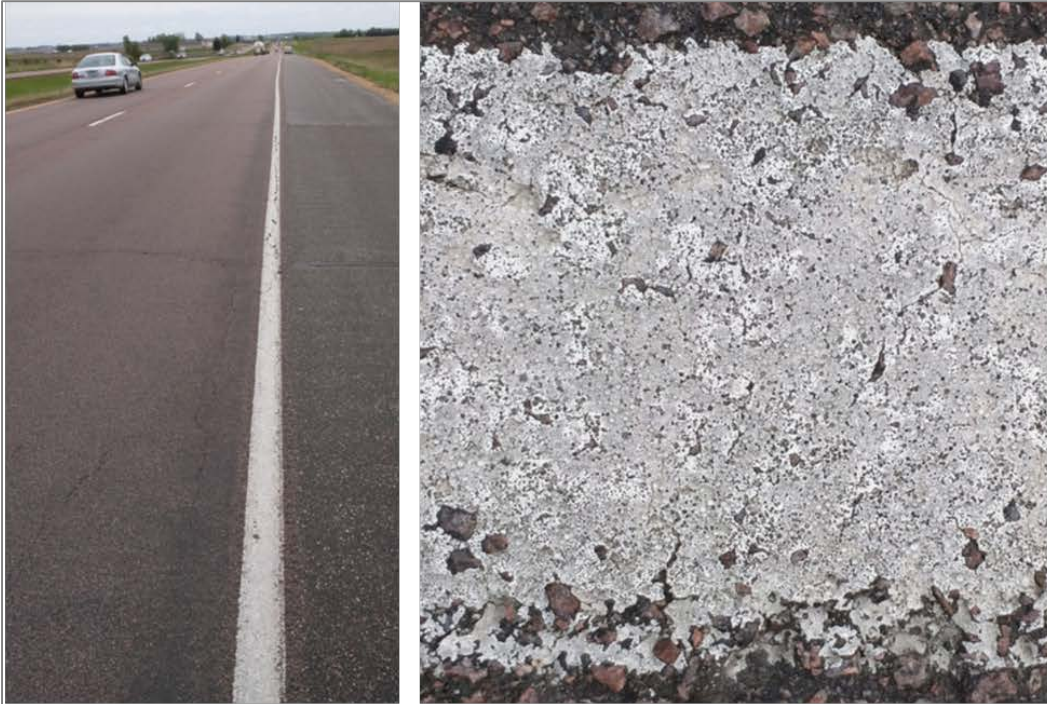
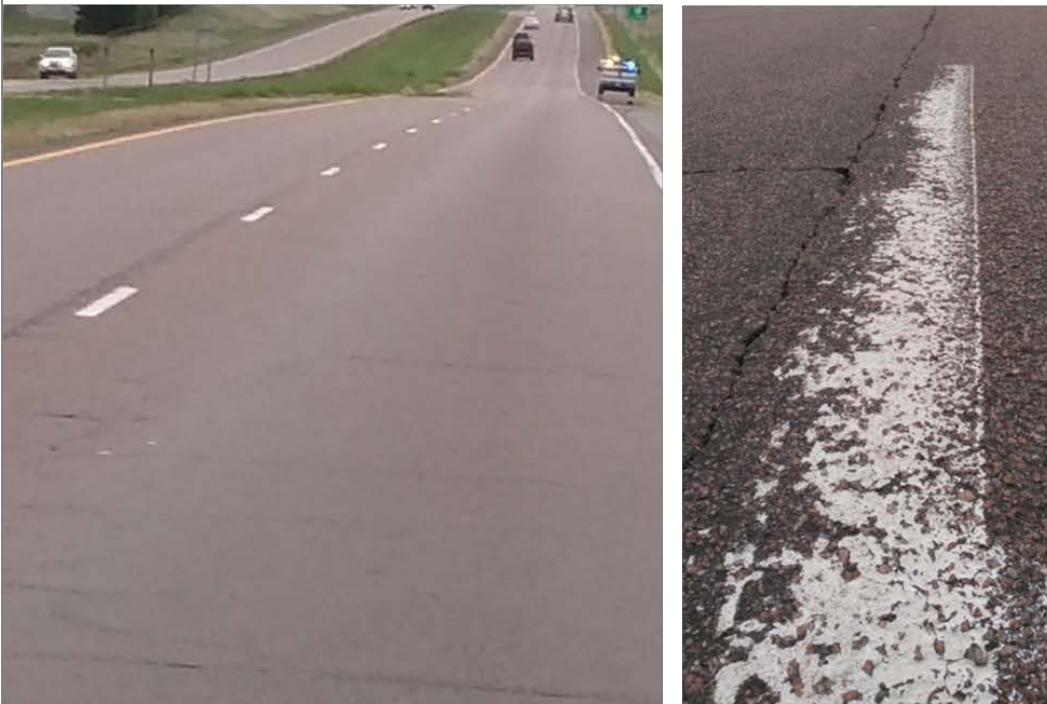
Figure 5-20. US 52 Section 3A after Two Winters

Section 3A Edge Line

Section 3A Center Line Skip

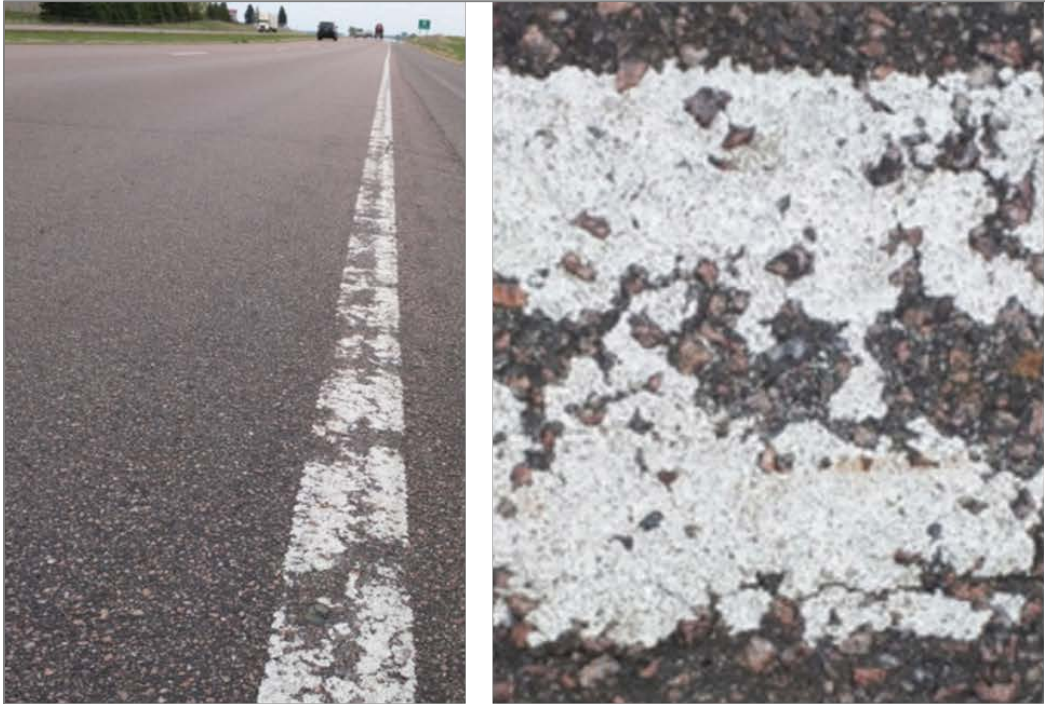
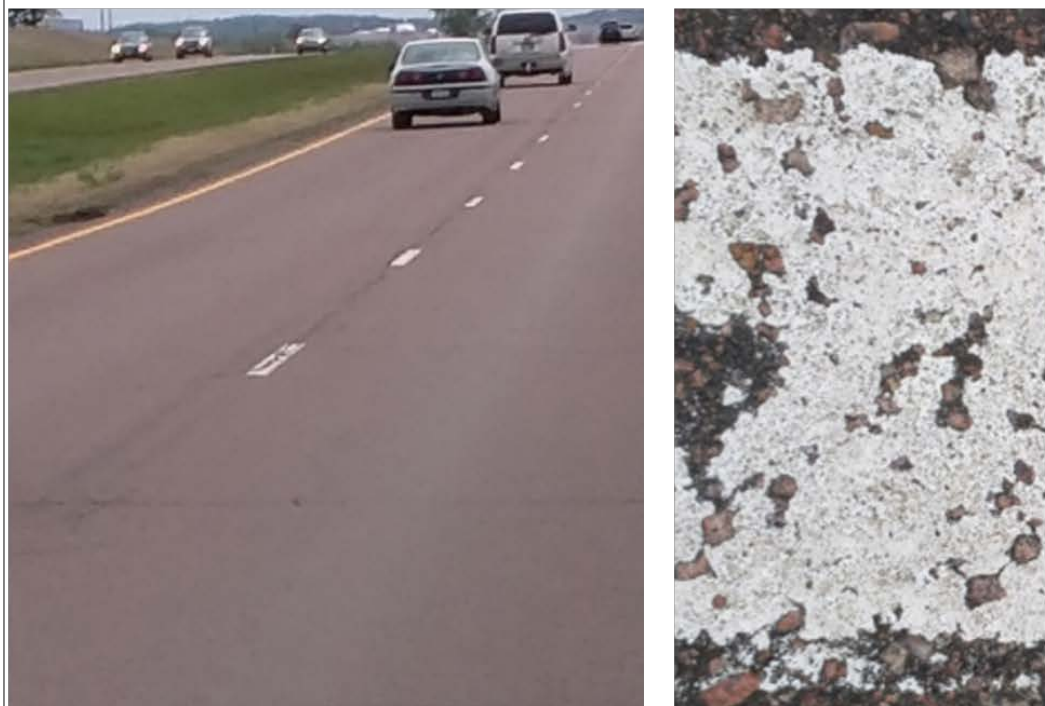
Figure 5-21. US 52 Section 3B-1 after Two Winters

Section 3B-1 Edge Line

Section 3B-1 Center Line Skip

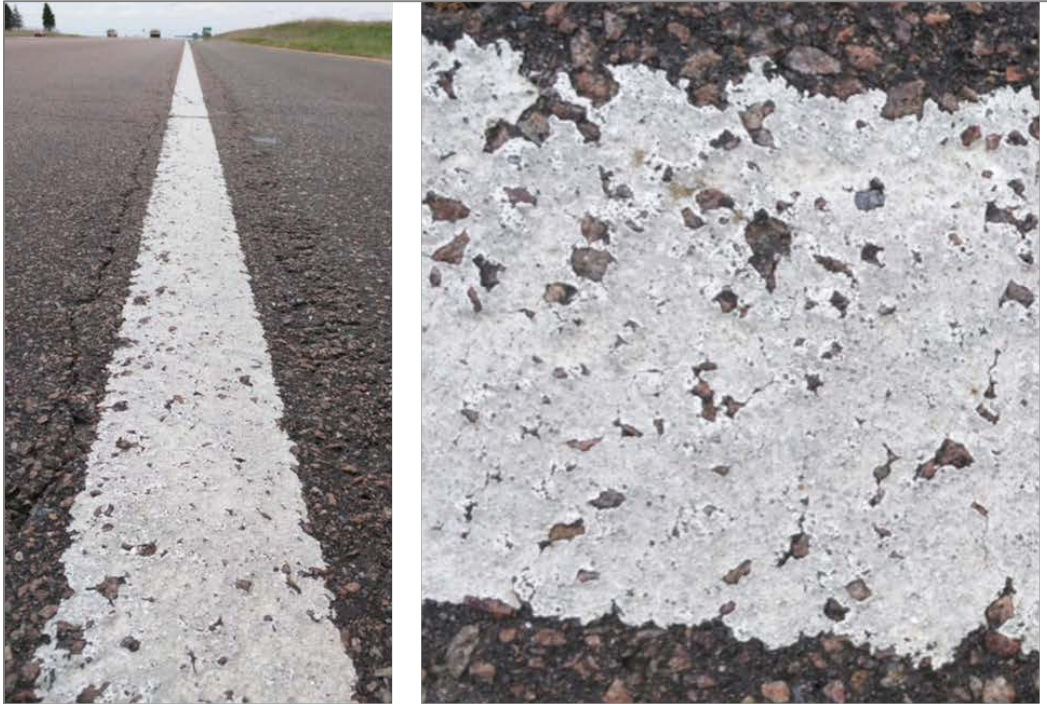
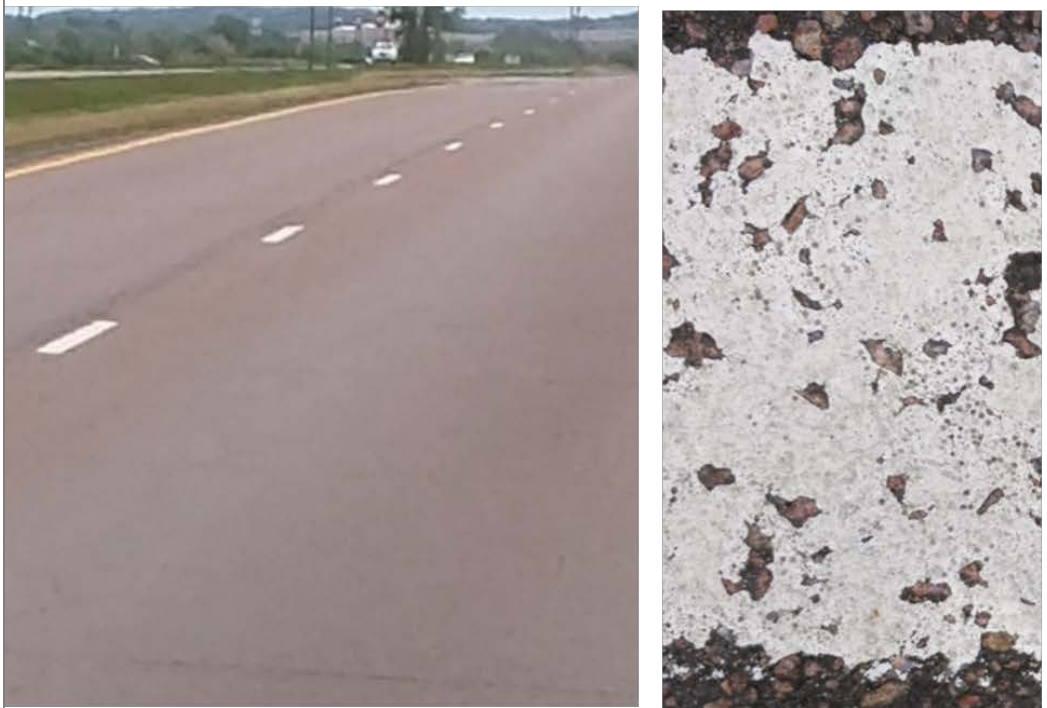
Figure 5-22. US 52 Section 3B-2 after Two Winters

Section 3B-2 Edge Line

Section 3B-2 Center Line Skip

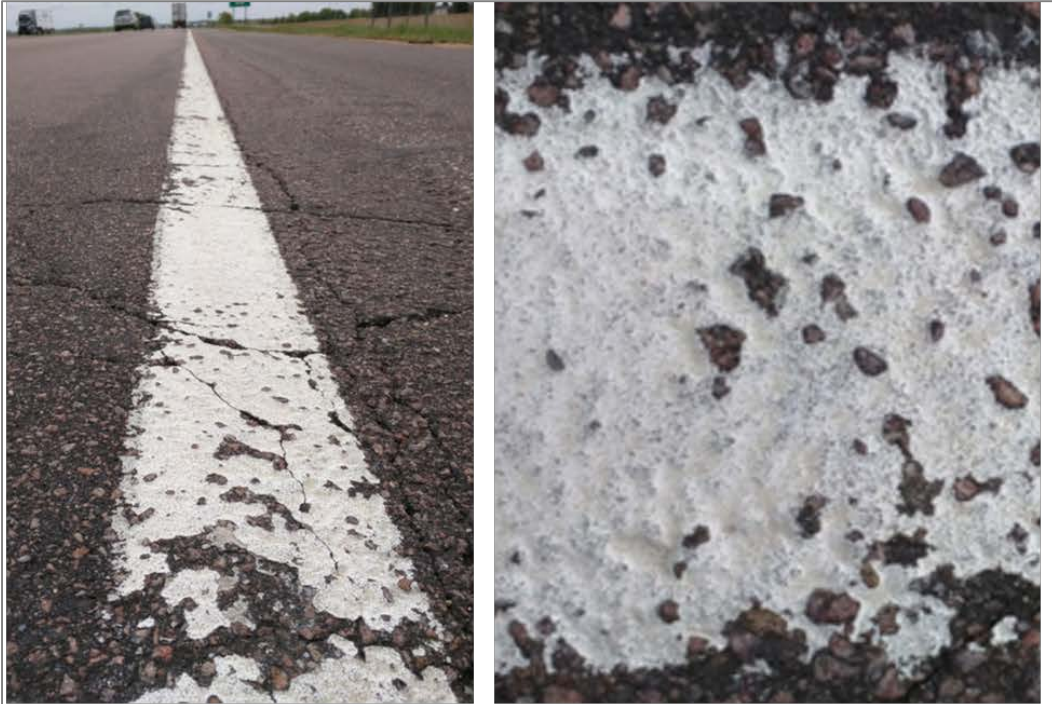
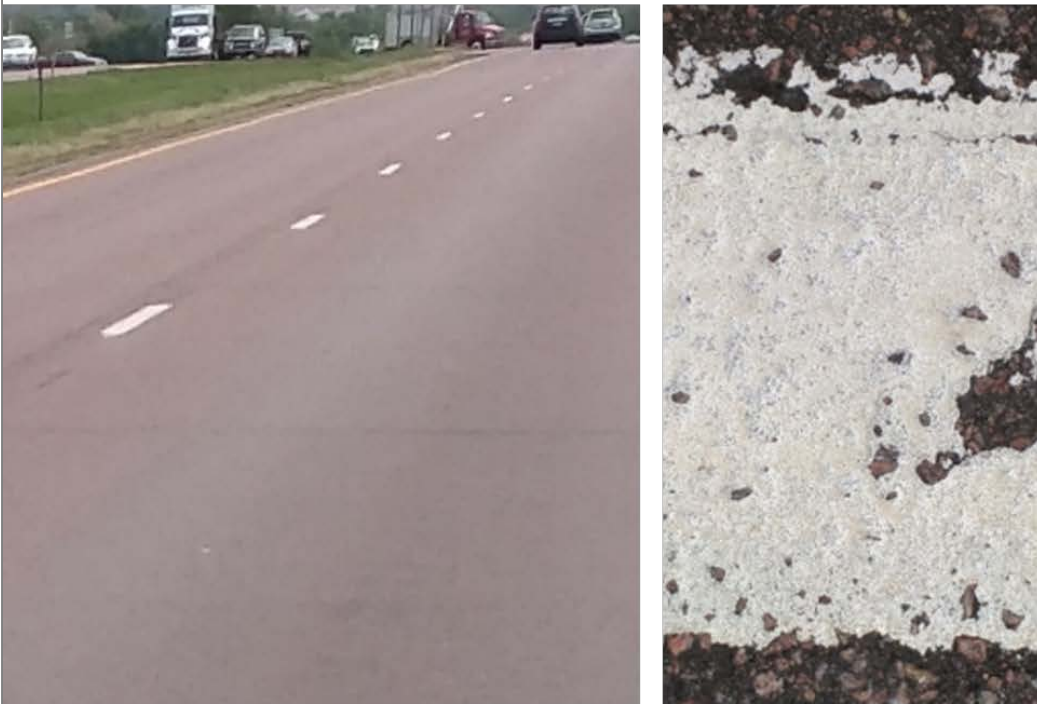
Figure 5-23. US 52 Section 4A after Two Winters

Section 4A Edge Line

Section 4A Center Line Skip

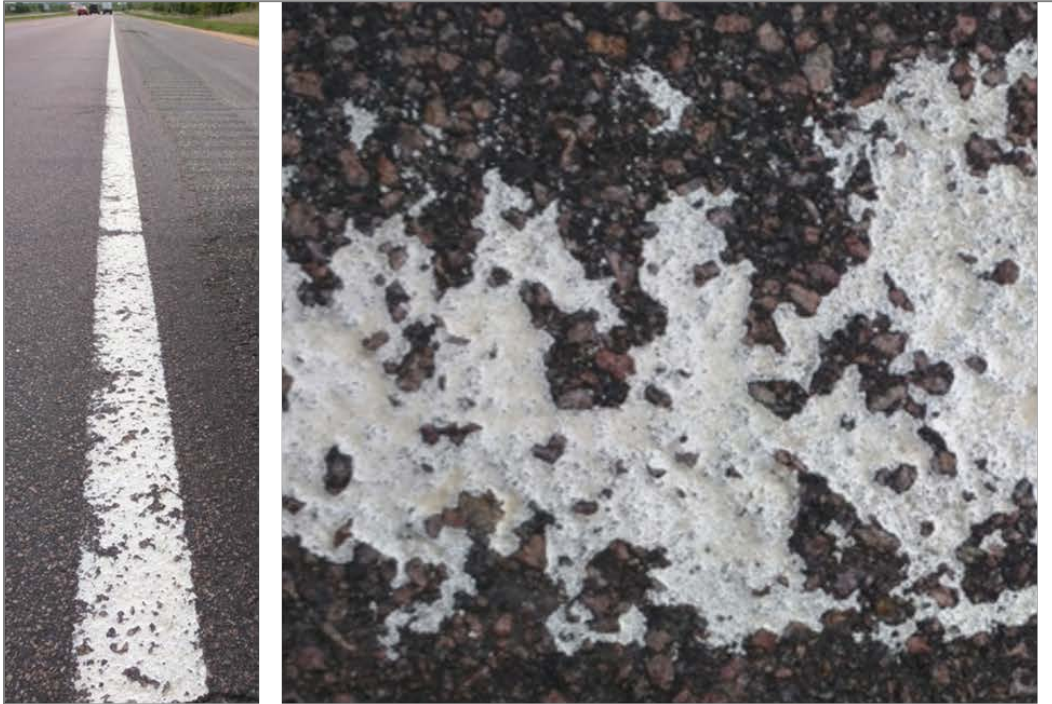
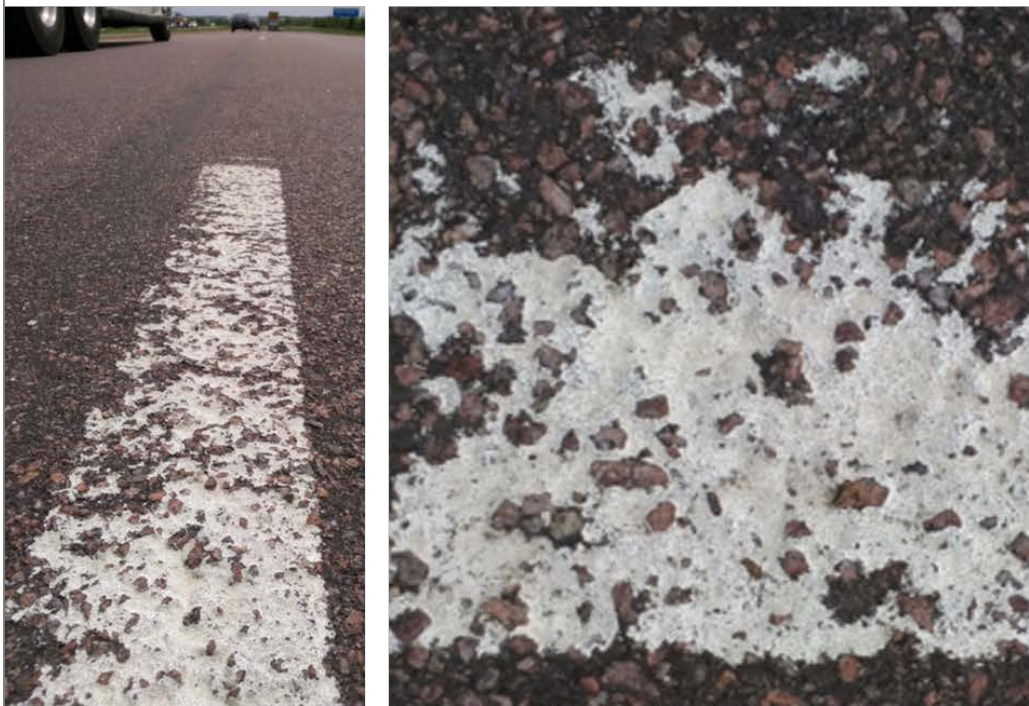
Figure 5-24. US 52 Section 4B after Two Winters

Section 4B Edge Line

Section 4B Center Line Skip

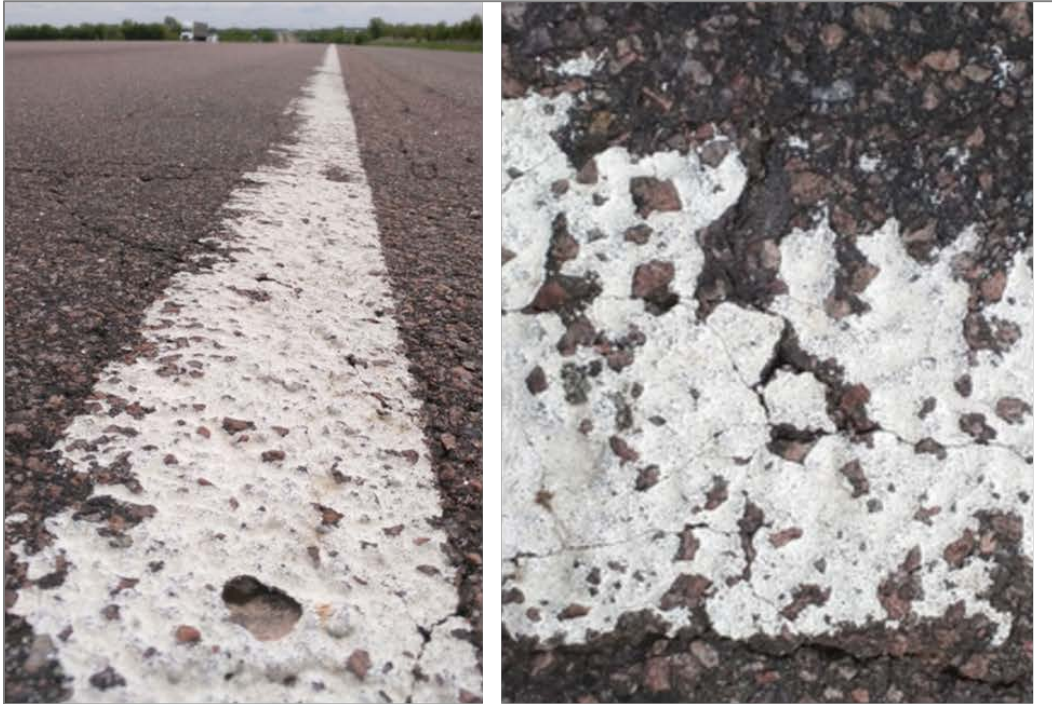
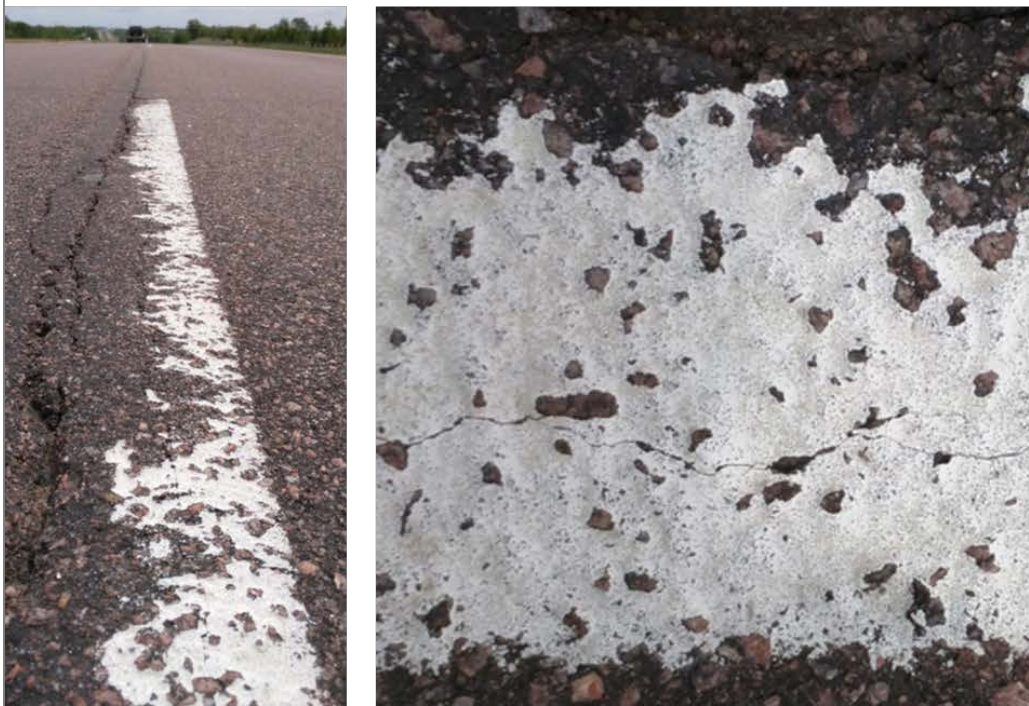
Figure 5-25. US 52 Section 5B after Two Winters

Section 5B Edge Line

Section 5B Center Line Skip
