Bridge Deck Integrity Measurements for Asset Management

Final Report June 2009

BRIDGE DECK INTEGRITY MEASUREMENTS FOR ASSET MANAGEMENT

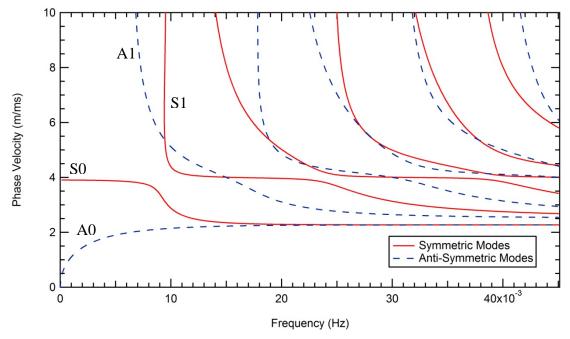
Figure 1. Symmetric and antisymmetric modes for a 20.3 cm (8 in.) thick concrete plate with free boundary conditions

Figure 1 shows that several propagation modes can exist. Symmetric modes (designated as S0 and S1) are shown with solid lines, and antisymmetric modes (designated as A0 and A1) are shown with dashed lines.

Lamb wave modes represent several different types of waves and the transitions between them. At high frequencies, the fundamental modes (A0, S0) approach the Rayleigh wave velocity of the material. At low frequencies, the fundamental symmetric mode approaches the plate wave velocity (quasi-longitudinal wave velocity), and the antisymmetric mode approaches the bending

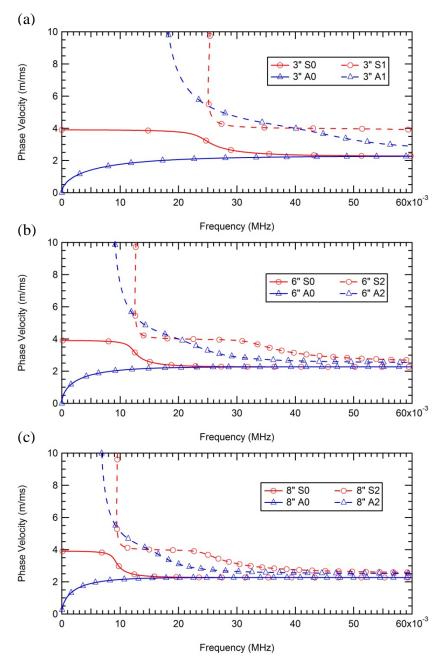
Figure 2. Theoretical symmetric and antisymmetric modes for (a) 7.62 cm (3 in.), (b) 15.27 cm (6 in.), and (c) 30.32 cm (8 in.) thick concrete plates

Calculations were performed on concrete plates with thicknesses of 7.62 cm (3 in.), 15.24 cm (6 in.), and 20.32 cm (8 in.) to represent different conditions of delamination depths. Figures 2a through 2c show the modal response in each case. These figures show that the high- and low-frequency portions of the symmetric mode dispersion curve are not sensitive to changes in plate thickness. However, the frequency range where the S0 mode transitions from the Rayleigh wave velocity to the plate wave velocity is strongly influenced by plate thickness. For example, for the 20.32 cm (8 in.) thick plate, this transition occurs around 10 kHz, while the transition occurs at approximately 26 kHz for the 7.62 cm (3 in.) thick plate. It is also interesting to note that this frequency corresponds with the cutoff frequency of the first, higher antisymmetric mode (A1). Figure 3 shows the theoretical symmetric mode dispersion curve for the four cases plotted in terms of wavelength. This figure shows that the wavelength where the S0 mode begins to increase in velocity is roughly equal to about 70% of the plate thickness.

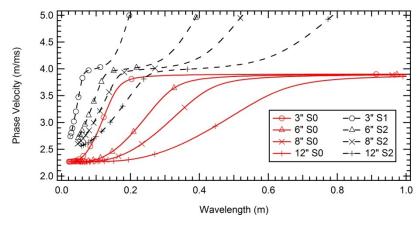
Figure 3. Theoretical modal response of symmetric modes plotted in terms of wavelength for 7.62 cm (3 in.), 15.24 cm (6 in.), 20.32 cm (8 in.), and 30.48 cm (12 in.) thick concrete

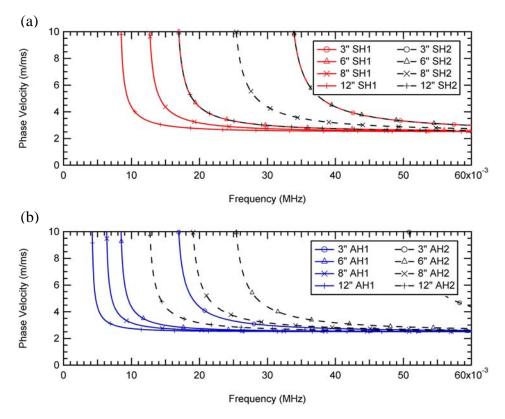
Figure 4. Theoretical dispersion curves for horizontally polarized shear waves for (a) symmetric modes and (b) antisymmetric modes of 7.62 cm (3 in.), 15.24 cm (6 in.), 20.32 cm (8 in.), and 30.48 cm (12 in.) thick concrete

Theoretical dispersion curves were also generated for the case of exciting a concrete plate using horizontally polarized shear waves. This mode of excitation produces different dispersion curves than the case of vertical excitation, as shown in Figure 4 for the cases of the 7.62 cm (3 in.), 15.24 cm (6 in.) and 20.32 cm (8 in.) thick plates. Figure 4a presents the first two symmetric mode dispersion curves, and Figure 4b presents the first two antisymmetric mode dispersion curves. At high frequencies, all modes approach the shear wave velocity of the material. At lower frequencies, each mode has a distinct cutoff frequency, which is a function of plate thickness.

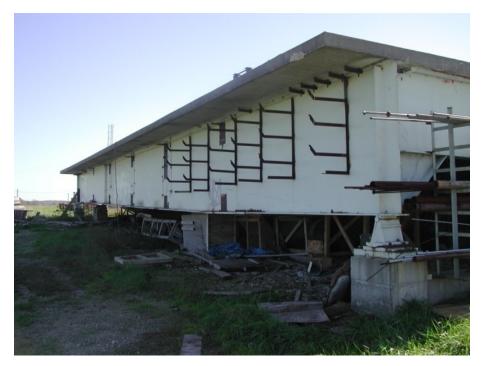
Figure 5. Full-scale bridge deck at the RTF prior to removal from site

The experimental phase of this project was planned to be performed on the full-scale bridge deck (Figure 5) located at the RTF operated by the civil engineering department at the University of Missouri, Columbia. However, prior to the beginning of the experimental measurements, the university decided to dismantle the bridge deck to make room for additional research facilities. Fortunately, a large section of the bridge deck with free boundary conditions remained on-site for a time after the bridge was dismantled. This allowed for experimental wave propagation measurements to be performed as described below.

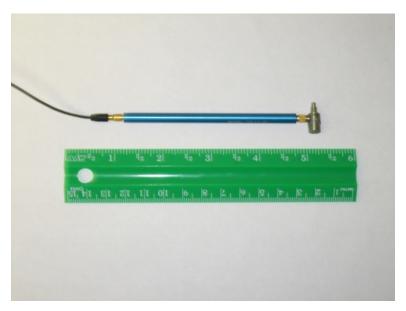
(a) Instrumented hammer manufactured by PCB Piezotronics (Model 086C02)

Figure 6. Instrumentation used to excite and measure waves at the RTF bridge deck site

The wave energy was excited using a small, instrumented impact hammer manufactured by PCB Piezotronics, Inc. (Model 086C02), as shown in Figure 6a. Wave motions were detected using high-frequency PCB piezoelectric accelerometers (Model 352C66), as shown in Figure 6b. Accelerometers were oriented in the transverse, radial, and vertical directions to make three component measurements. The sensors were secured to the bridge deck using a cyanoacrylate

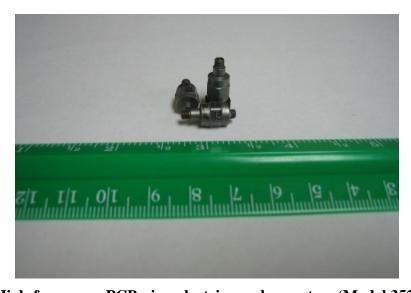
(b) High-frequency PCB piezoelectric accelerometers (Model 352C66)

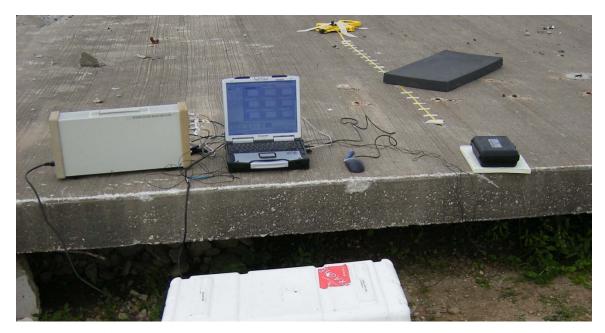
Figure 7. Experimental arrangement used to collect measurements at the RTF bridge deck site

Measurements were taken using both vertical and horizontal impacts excited in a direction that was transverse to the longitudinal axis of the array. The horizontal impacts were performed by gluing small studs to the deck and impacting the side of the stud. Measurements were performed for the case of the source and receiver on the same side of the deck, as well as the case of the

source and receiver on opposite sides of the bridge deck. A total of 36 impacts, spaced 5.1 cm (2 in.) apart, were collected for each setup. The hammer impact and response of the receivers were recorded using a 12-channel Data Physics Dynamic Signal Analyzer (Mobilyzer II No. 70204). Data were collected and averaged in the frequency domain. Typically, three hammer impacts were averaged for each impact location. Figure 7 shows a photograph of the experimental arrangement used to collect the measurements.

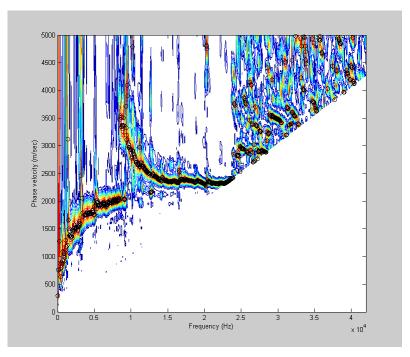
Figure 8. Phase velocity–frequency contour plot for Case 1: Vertical impact with vertical sensor; source and receiver on same side

In this study, the linear receiver array was assembled using one receiver location and stepping the source away from the receiver at fixed increments. The cross-power spectrum was measured between the source and receiver for each impact, and the spatio-spectral correlation matrix was assembled for each simulated receiver spacing. Figure 8 shows an example of the phase velocity–frequency contour plot developed from this processing procedure. The peaks in the plot represent the experimental dispersion curve.

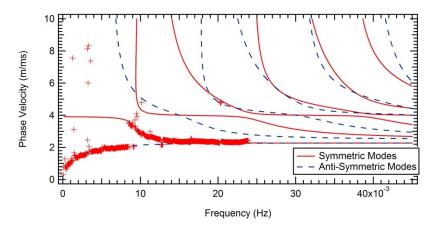
Figure 9. Case 1: Experimental dispersion curve with theoretical dispersion curve

The first case involved exciting the wave energy using a vertical source excitation and recording the surface motion using the vertically oriented receiver. Both the source and the receiver were located on the same side of the bridge deck, and all 36 impacts were used to develop the dispersion curve. In addition to the theoretical dispersion curve for this site, the experimental dispersion curve developed from this procedure is presented in Figure 9. The experimental results are presented up to a frequency of 25 kHz, above which spatial aliasing of the signal occurs. Figure 9 shows that the experimental and theoretical results are in good agreement. The experimental data followed the S0 mode dispersion curve to the frequency where it begins to approach the quasi-longitudinal wave velocity. Below this frequency, the experimental dispersion curve transitioned to the A0 mode.

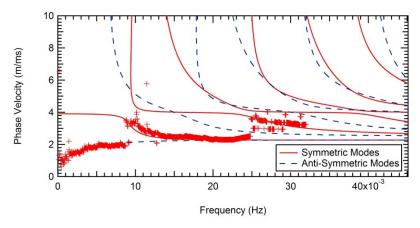
Figure 10. Case 1: Experimental dispersion curve (with theoretical dispersion curve) for first 18 impacts at 0 to 0.91 m (0 to 3 ft)

Figure 10 shows results from the same measurements using only the first 18 impacts (0 to 3 ft from the receiver) in the dispersion curve development. Figure 11 shows the results from the last 18 impacts (source to receiver offset of 3 ft). In both cases, the same dispersion trends are evident, although the quality of the dispersion curve, especially at low frequencies and near the S0 to A0 transition, is diminished. It is also interesting to note that the frequency where the transition from the S0 to A0 modes occurs is very close to the impact-echo frequency, as shown in Figure 12.

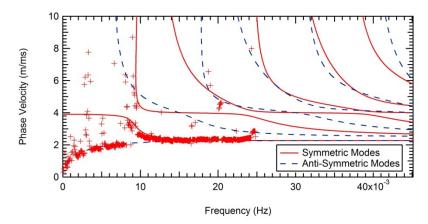
Figure 11. Case 1: Experimental dispersion curve (with theoretical dispersion curve) for last 18 impacts at 0.91 to 1.83 m (3 to 6 ft)

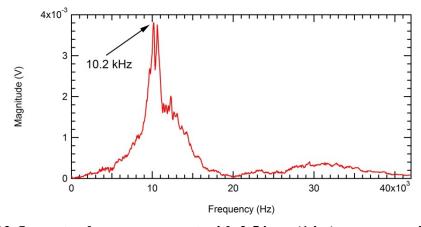
Figure 12. Impact-echo measurement with 2.54 cm (1 in.) source-receiver spacing

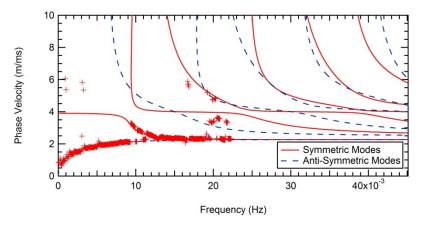
Figure 13. Case 2: Experimental dispersion curve with theoretical dispersion curve

The second case involved repeating the measurements described above but with the source and receiver located on opposite sides of the bridge deck. This simulates the case where sensors are placed on the underside of a bridge deck and energy is excited from the surface. Again, the energy was excited with a vertical impact and detected with a vertically oriented accelerometer. The experimental dispersion curve was generated using all 36 impacts, as shown in Figure 13. The dispersion image is nearly identical to the image in the case with the source and receiver on the same side of the bridge deck. Figure 14 shows the dispersion image generated using the first 18 impacts, and Figure 15 shows the dispersion curve obtained using the last 18 impacts. In both cases, the same dispersion trend is observed, but the quality of the dispersion curve is degraded, and the transition between the S0 and A0 modes is not as clear.

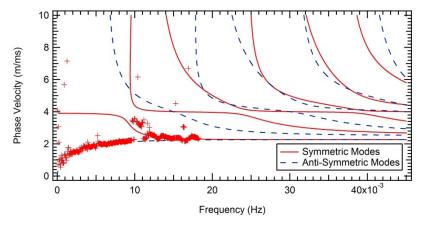
Figure 14. Case 2: Experimental dispersion curve (with theoretical dispersion curve) for first 18 impacts at 0 to 0.91 m (0 to 3 ft)

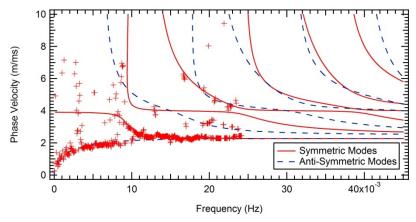
Figure 15. Case 2: Experimental dispersion curve (with theoretical dispersion curve) for last 18 impacts at 0.91 to 1.83 m (3 to 6 ft)

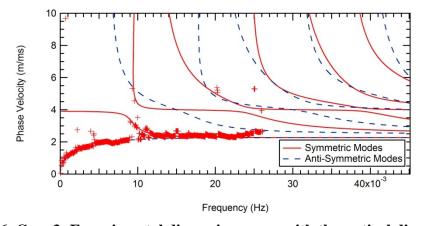
Figure 16. Case 3: Experimental dispersion curve with theoretical dispersion curve

Case 3 involved repeating the measurements made in Case 1 by exciting the wave energy using a vertical source but recording the surface motion using the receiver oriented in the radial direction. It was expected that the results for this setup would be similar to those obtained with the vertical orientation. The source and receiver were once again located on the same side of the bridge deck, and all 36 impacts were used to develop the dispersion curve. Figure 16 presents the experimental dispersion curve developed from this procedure, along with the theoretical dispersion curve for this site. In this case, the quality of the dispersion curve is not as good as when the vertical sensor was used. The transition between the A0 and S0 modes is not clear and appears to follow a single, continuous trend. The dispersion image from the first 18 impacts shows a more distinct separation between the A0 and S0 modes, as shown in Figure 17. Similar results were obtained when the final 18 impacts are used, as shown in Figure 18. Based on these results, it appears that the vertical sensor is a slightly better choice for developing the dispersion image.

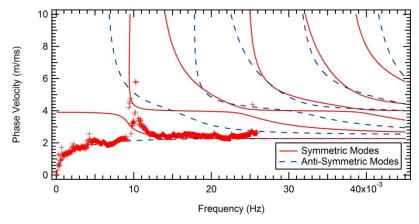
Figure 17. Case 3: Experimental dispersion curve (with theoretical dispersion curve) for first 18 impacts at 0 to 0.91 m (0 to 3 ft)

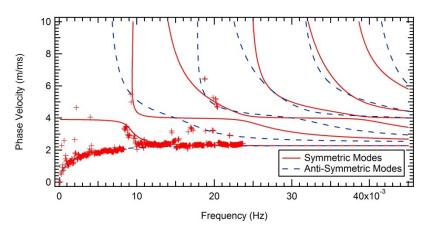
Figure 18. Case 3: Experimental dispersion curve (with theoretical dispersion curve) for last 18 impacts at 0.91 to 1.83 m (3 to 6 ft)

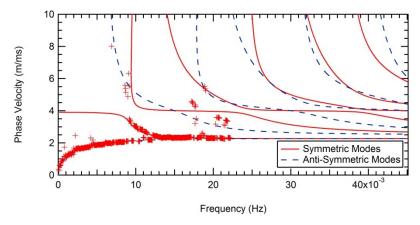
Figure 19. Case 4: Experimental dispersion curve with theoretical dispersion curve

For Case 4, the measurements of Case 3 were repeated using an impact on the opposite side of the bridge deck. A vertical impact and radial sensor were used in this case. Figure 19 shows the dispersion image from all 36 impacts, and Figures 20 and 21 show the results from the first and last 18 impacts, respectively. The results are similar to those for the source and receiver on the same side of the deck.

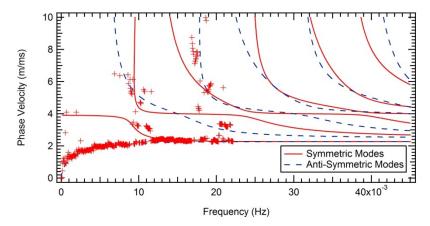
Figure 20. Case 4: Experimental dispersion curve (with theoretical dispersion curve) for first 18 impacts at 0 to 0.91 m (0 to 3 ft)

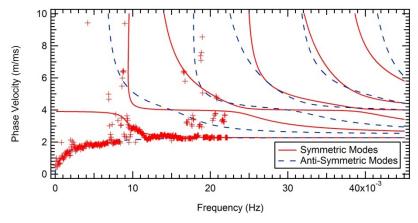
Figure 21. Case 4: Experimental dispersion curve (with theoretical dispersion curve) for last 18 impacts at 0.91 to 1.83 m (3 to 6 ft)

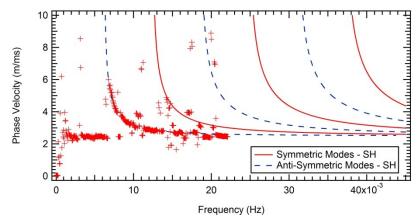
Figure 22. Case 5: Experimental dispersion curve (with theoretical dispersion curve) for horizontally polarized shear waves

The fifth case involved exciting horizontally polarized shear waves (SH) using a transverse impact source and recording the motion using a transversely oriented receiver. Using all 36 impacts to develop the dispersion curve, Figure 22 compares the results to the theoretical dispersion curve. In this case, the experimental dispersion curve follows the first antisymmetric mode. As shown in Figure 4, the cutoff frequency for this mode is a function of the thickness of the concrete plate and could potentially be used to identify the thickness of concrete over a subsurface delamination.

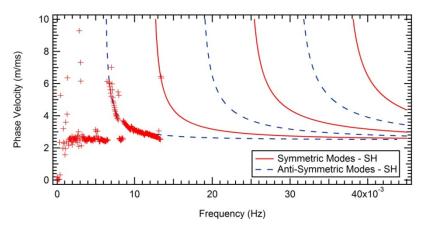
Figure 23. Case 6: Experimental dispersion curve (with theoretical dispersion curve) for horizontally polarized shear waves

The last case involved exciting SH waves on one side of the concrete deck and measuring the motions on the other side. The dispersion image produced from this measurement is shown in Figure 23. The points above 14 kHz were greatly scattered and were removed from the plot. Below 14 kHz, the dispersion measurement is in good agreement with the measurement performed with all instrumentation on the surface.

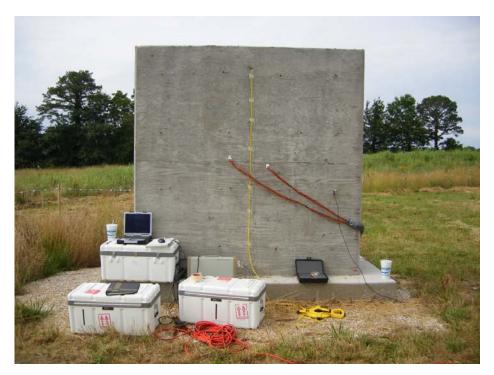
Figure 24. Concrete block with subsurface defects at the Midway site

The concrete block at Midway is shown in Figure 24. The block is 2.43 m (8 ft) high by 2.43 m (8 ft) wide and is 0.91 m (3 ft) thick. The concrete block was cast with simulated defects at depths of 2.54 cm (1 in.), 5.1 cm (2 in.), 7.62 cm (3 in.), and 12.7 cm (5 in.) below the surface. Each simulated defect was 0.3 m (12 in.) square and less than 2.54 cm (1 in.) thick. Figure 25 shows a drawing of the interior of the concrete block.

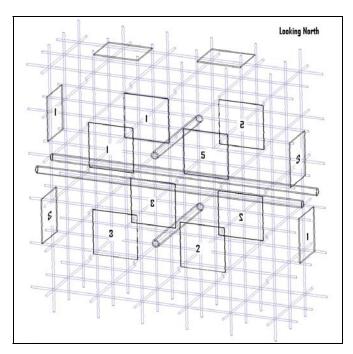
Figure 25. Drawing showing the interior of the Midway block and the locations of subsurface defects in relation to the block. Numbers shown indicate the depth of the simulated delamination in inches.

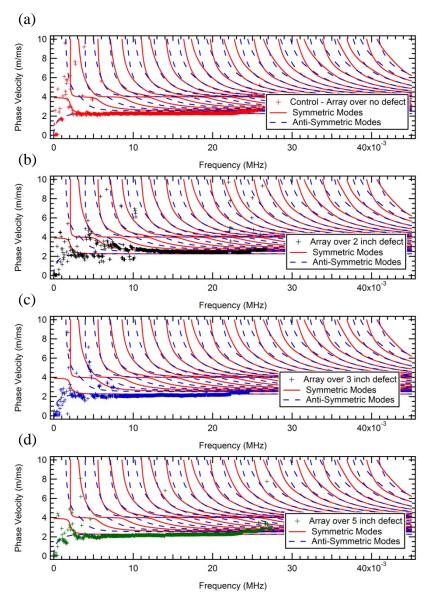
Figure 26. Experimental dispersion curve developed from vertical motions for (a) control with no defects and (b) 5.08 cm (2 in.), (c) 7.62 cm (3 in.), and (d) 12.7 cm (5 in.) deep defects. The theoretical dispersion curves for the control case are also shown.

To examine the influence of a defect on Lamb wave propagation, the measurement procedure performed at the RTF facility was repeated at the Midway site. First, measurements were taken along a section of the block that contained no defects using the same procedure employed at the RTF facility. The dispersion curve generated for this section using the vertical sensor is shown in Figure 26a, along with the theoretical dispersion curves for the 0.91 m (3 ft) thick concrete block. Next, the measurements were taken with the sensor located 0.36 m (1.2 ft) outside of the defect footprint. The hammer impacts were performed at 5.1 cm (2 in.) intervals, moving away from the sensor position and passing over and past the footprint of the defect. The objective of taking these measurements was to observe how the dispersion curves were influenced by the presence of the subsurface defect. The measurements were performed on the 5.1 cm (2 in.), 7.62 cm (3 in.), and 12.7 cm (5 in.) deep defects. The dispersion curves are presented with the control case of no defect in Figures 26b, 26c, and 26d. These figures show that only the 5.1 cm (2 in.) deep defect had any noticeable effect on the measured dispersion curves by causing a scattered response below about 10 kHz. The 7.62 cm (3 in.) and 12.7 cm (5 in.) deep defects caused no meaningful change in the dispersion curves as compared to the case with no subsurface flaws.

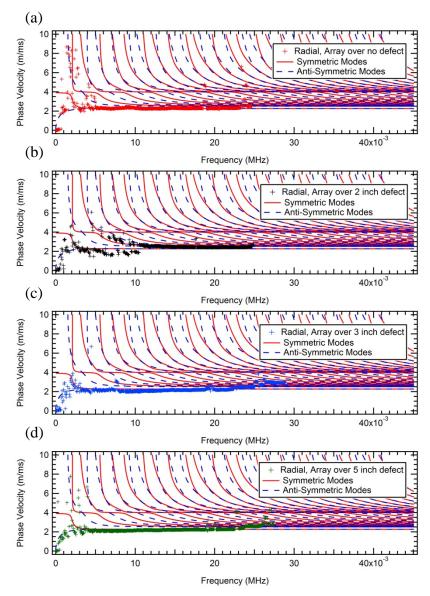
Figure 27. Experimental dispersion curve developed from radial motions for (a) control with no defects and (b) 5.08 cm (2 in.), (c) 7.62 cm (3 in.), and (d) 12.7 cm (5 in.) deep defects. The theoretical dispersion curves for the control case are also shown.

The radial component of motion was also used to develop dispersion curves over the three defects with similar results, as shown in Figure 27.

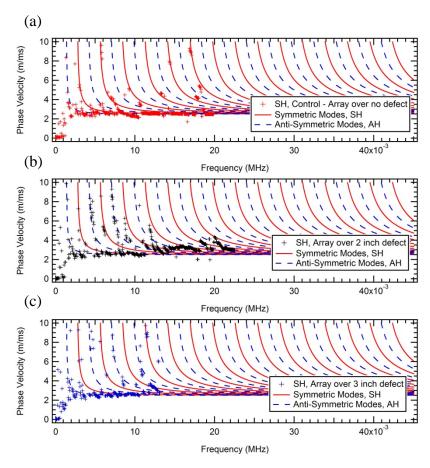
Figure 28. Experimental dispersion curve developed from SH motions for (a) control with no defects and (b) 5.08 cm (2 in.) and (c) 7.62 cm (3 in.) deep defects. The theoretical dispersion curves for the control case are also shown.

Measurements for SH (transverse) motions were next performed using the same procedure as described above. These measurements were performed on the 5.1 cm (2 in.) and 7.62 cm (3 in.) deep defects. The control case and the measurements from the two defects are shown in Figure 28. Other than increased scatter in the phase velocities, no meaningful change in the dispersion curves was observed for these cases.

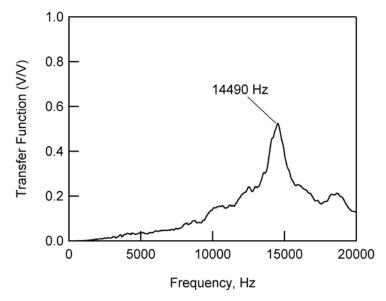
Figure 29. Impact-echo measurements recorded over the defect at a depth of 12.7 cm (5 in.)

As might be expected, the frequency content of the wave was altered as it passed through the region containing the defect. For example, Figure 29 shows the results of an impact-echo measurement performed directly on the 12.7 cm (5 in.) defect using a vertically oriented sensor placed on the void and a vertical hammer impact 2.54 cm (1 in.) away. The transfer function between the hammer and the sensor shows a clear frequency peak at 14.49 kHz, which is consistent with a void at a depth of 12.7 cm (5 in.) and a compression wave velocity of 3,700 m/s using the typical impact-echo relationship

$$D = \frac{V}{2 * f},\tag{4}$$

where *D* is the depth to the flaw, *V* is the compression wave velocity, and *f* is the measured frequency. A measurement was then taken by recording the transfer function between the hammer impact and a sensor located on opposite sides of the defect and separated by 0.97 m (3 ft 2 in.). The distance from the hammer to the near edge of the defect was 45.7 cm (18 in.), and the distance from the far edge of the defect to the sensor was 20 cm (8 in.). Figure 30 shows the transfer function recorded between the hammer and a radially oriented receiver, along with the transfer function recorded with the same measurement setup performed in a control area. This figure shows that frequencies near the impact-echo resonant frequency were amplified relative to the control. Results from the same measurement setup (hammer and receiver separated by 0.97 m and spanning the defect) performed on a 7.6 cm (3 in.) deep defect are shown in Figure 31. In this case, a frequency peak at 26 kHz was observed, which is close (within 10 %) to the value that is expected for an impact-echo measurement performed on this defect. These results demonstrate the potential to detect a defect from changes in the frequency content of waves propagating through the region containing the defect. Further studies are needed to validate the effectiveness of this approach.

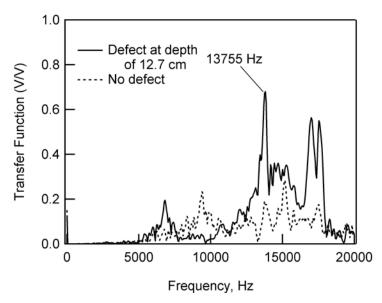
Figure 30. Transfer function recorded between hammer and radially oriented sensor separated by 0.97 m with a 12.7 cm deep defect present. The transfer function for the control is also shown.

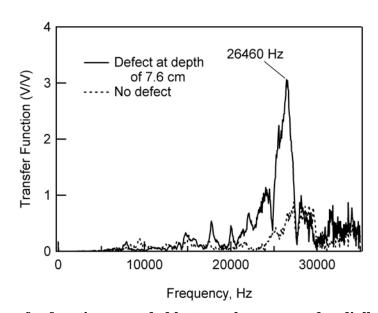
Figure 31. Transfer function recorded between hammer and radially oriented sensor separated by 0.97 m with a 7.6 cm deep defect present. The transfer function for the control is also shown.
