## Road Safety Audit for Marshall County Road E-35 (Main Street) from the ECL of Marshalltown, lowa, to Zeller Avenue

### Final Report February 2009

the Iowa Department of Transportation

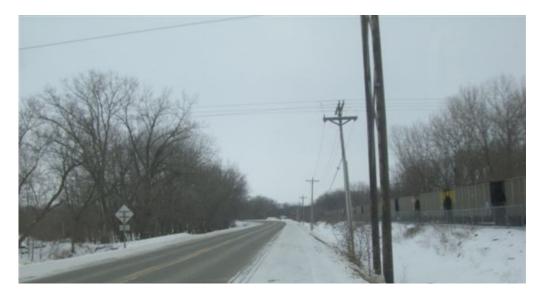
County Road E-35 (Main Street) at this location is composed of 26 ft wide asphaltic concrete pavement of unknown initial age, although the last major rehabilitation occurred in 1996. The current pavement condition is satisfactory, with signs of routine maintenance. Granular surfaced shoulders are approximately 10 ft wide, and right-of-way width is 100 ft. Foreslopes through this area are quite steep, and the elevation of the roadway is approximately 5–8 ft above the surrounding terrain. This area is in the Iowa River floodplain and has little variation in elevation. During the audit, pavement markings appeared quite worn. However, Marshall County engineer Fichtner indicated that annual replacement was routine, although edge lines were not replaced in 2008. The edge line markings are painted in about 2 ft from the pavement edge, resulting in two 11 ft wide travel lanes.

Figure C-1. Eastbound E-35 near beginning of review area

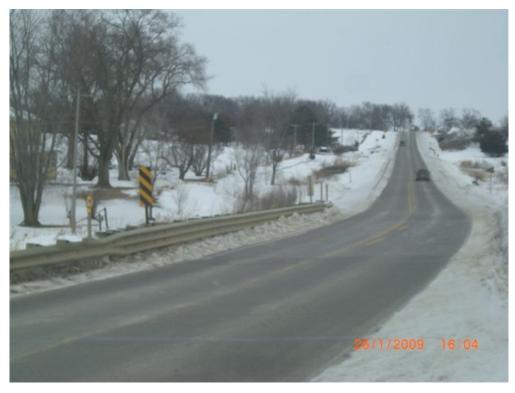
A bridge crossing a minor stream is located just easterly from Vine Avenue, approximately 28 ft in width and shielded with satisfactory-condition w-beam guardrail at all four corners. Three-beam guardrail continues through the bridge as a handrail. No signs of impacts were noted on the guardrail.

Figure C-2. Small bridge eastbound E-35 just east of Vine Avenue intersection

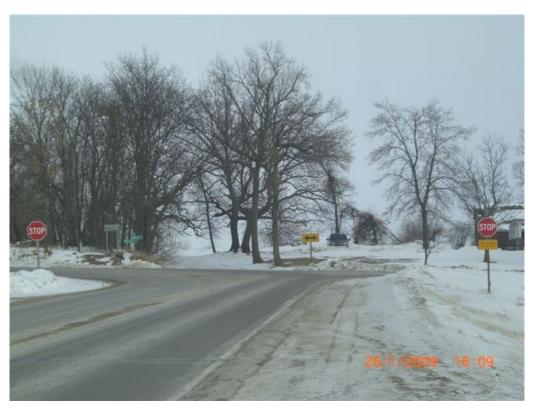
For drivers approaching the Wallace Avenue intersection, warning is provided by double 48 in. "Stop Ahead" warning signs in excellent condition. Rumble panels have been milled into the asphalt surface, but these have been distorted to the point of ineffectiveness. The existing route sign assembly and destination signs are in excellent condition. At the Wallace Avenue T-configuration intersection, double 36 in. "Stop" signs are in place for eastbound E-35 traffic, with an aging double arrow warning sign in place for that eastbound movement. The right-side "Stop" sign includes a black and yellow plaque advising that "Traffic from the Right Does Not Stop." Southbound Wallace Avenue, County Road T-29, is controlled with a single "Stop" sign with a black and yellow plaque advising that "Oncoming Traffic Does Not Stop." Both plaques were installed in 2006, and all signing in this intersection, including street name signs, appears to be in excellent condition, with the exception of the double arrow warning sign. Painted stop bars are well worn at all stop locations. Northbound (westbound) E-35 traffic approaching this intersection is not controlled.

Figure C-3. E-35 eastbound at Wallace Avenue intersection

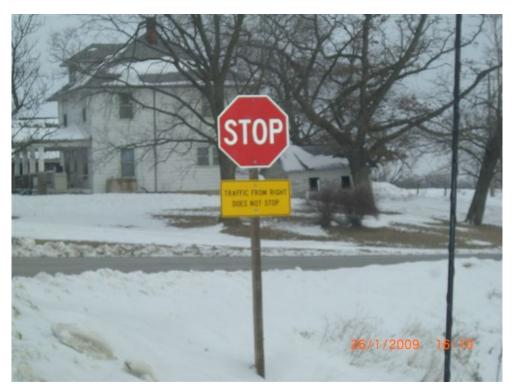
Figure C-4. Stop sign for eastbound E-35 at Wallace Avenue intersection

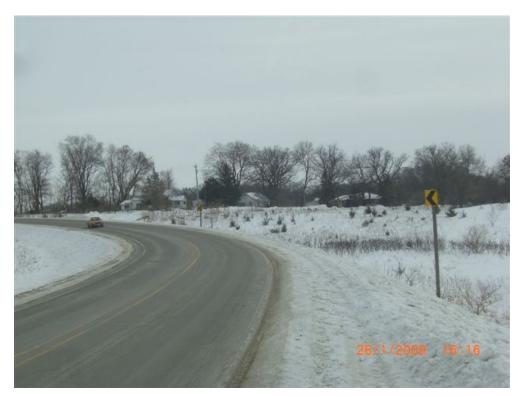
Southerly (easterly) from Wallace Avenue, E-35 features a horizontal leftward curve with 36 in. advance curve warning signs and small 40 mph advisory speed plaques. The curve is marked with small, widely spaced chevrons. The pavement width in this area is 22 ft, 6 in., with painted

edge lines that result in 11 ft travel lanes. Granular shoulders are approximately 3–4 ft in width. Through the curve area, foreslopes are quite steep and high. Some 2–3 ft wide shoulder paving has been accomplished along the low side of the curve (westerly-bound traffic). A granular surfaced minor roadway intersects with E-35 from the right side in a T-configuration near the middle of the curve. Sight distance to this intersection appears adequate for the low traffic volume.

Figure C-5. Eastbound E-35 just south of Wallace Avenue intersection

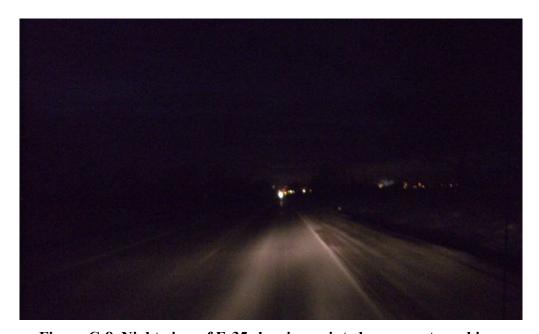
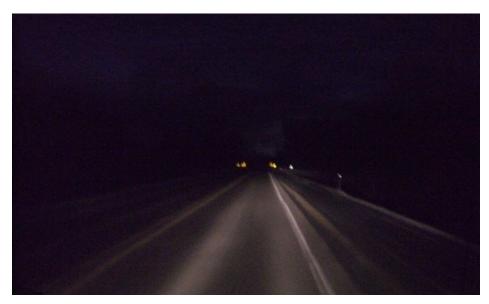
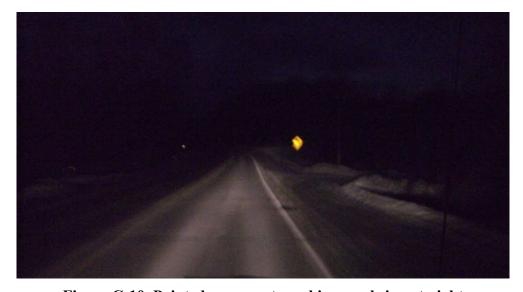
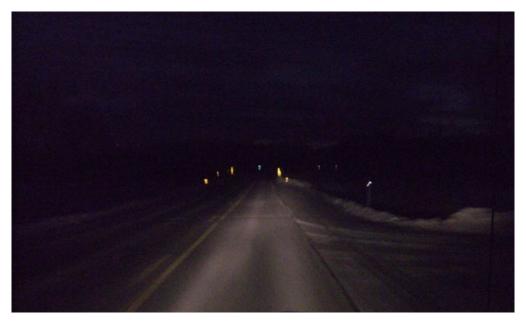
The audit team also conducted a review of the route in dark conditions to observe nighttime traffic operations and visibility. The conspicuity of signing was very good as a result of quality maintenance and the use of high-intensity sheeting. Pavement markings were visible for the most part, but they apparently lacked retro-reflective beads, and visibility in more adverse conditions would be hampered. Visibility of the "Stop" signs at the Wallace Avenue intersection was good for eastbound traffic, so installation of flashing red lights on these signs should prove effective.

Figure C-8. Night view of E-35 showing painted pavement markings

Figure C-9. Painted pavement markings at night on E-35

Figure C-10. Painted pavement markings and sign at night

Figure C-11. Painted pavement markings and traffic control devices at night
