Assessment of Asphalt Interlayer Designed on Jointed Concrete

Final Report
November 2014

IOWA STATE UNIVERSITY
Institute for Transportation

Sponsored by
Iowa Department of Transportation
(InTrans Project 13-475)
Federal Highway Administration

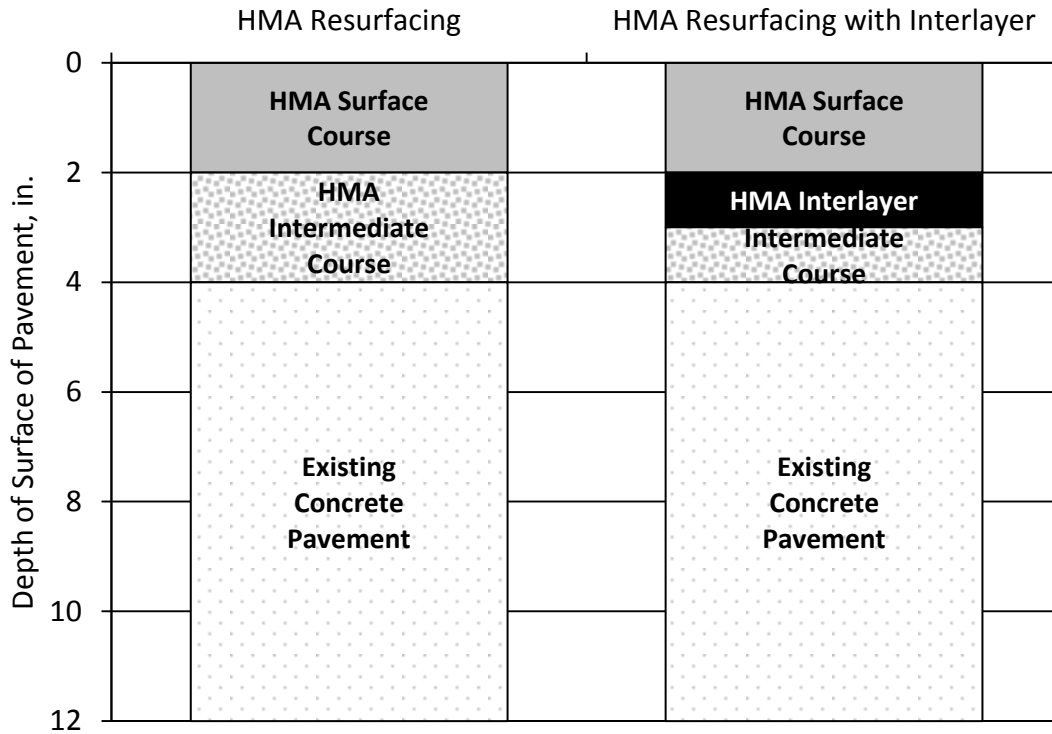
Figure 6. Cross sections of US 169 HMA resurfacing

The project was located on US 169 just north of the Adel, Iowa city limits, from the North Raccoon River to the South Raccoon River for a total length of 0.75 miles. The interlayer was part of Iowa DOT project MP-169-4(706)—76-25, an HMA resurfacing project which consisted of overlaying eight inches of a jointed concrete pavement with four inches of HMA. The project was divided into two sections: the northbound and southbound lane from station 101+63.5 to 121+39.5 was paved with a two inch surface course over a two inch intermediate course; the northbound and southbound lane from station 121+39.5 to 141+15 was paved with a two inch surface course over the one inch interlayer over a one inch intermediate course (Figures 6 and 7).

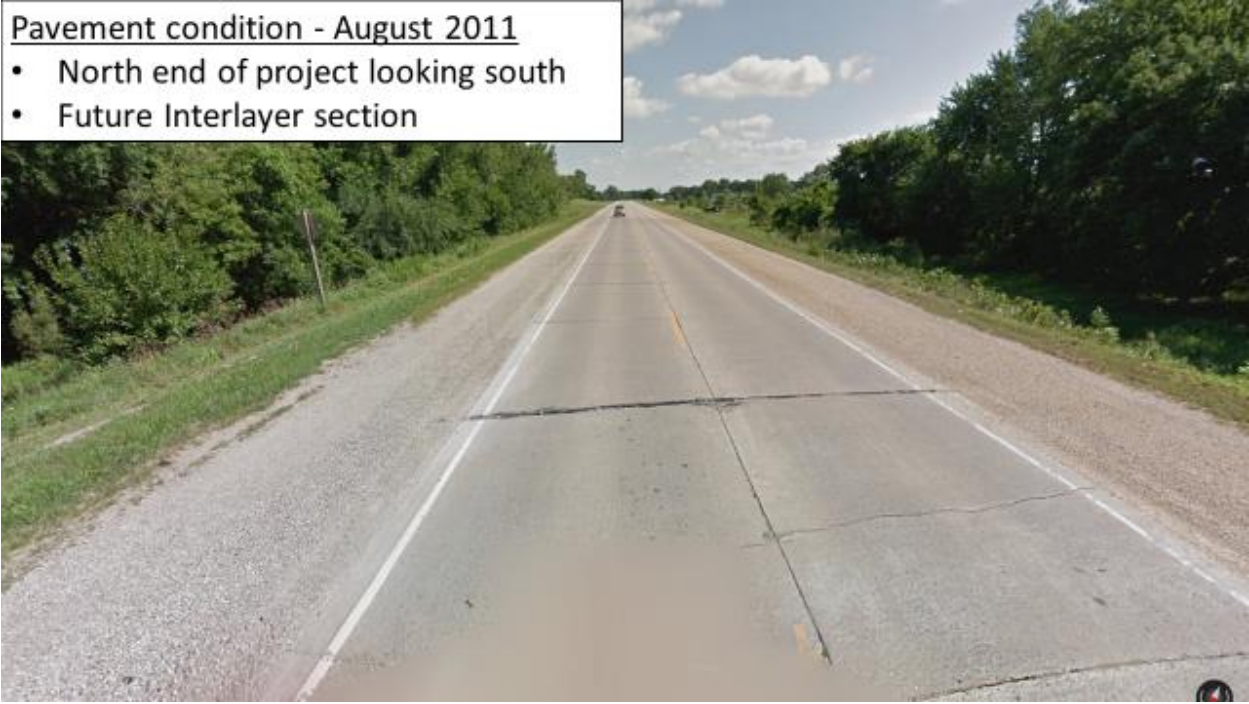
- North end of project looking south
- Future Interlayer section

Figure 10. Pre-construction view of interlayer overlay section on US 169

In Figure 10, a high level of joint deterioration can be seen in the future interlayer section. And unlike the non-interlayer section, the intermediate course is already cracking in the same construction season (Figure 11). The difference between the two different overlay sections is the thickness of the intermediate course. The intermediate course in the interlayer section was only one inch thick, not two inches thick, to provide room for the interlayer. This demonstrates just how quickly reflective cracks form in thin overlays (one inches) and is precisely the reason why overlays for distressed PCC pavements are designed to have a certain minimum thickness. In the case of this project, the overlay thickness design was four inches. However, by waiting several weeks between construction of the intermediate course and the surface course, the one-inch course was thin enough to crack prior to paving the second lift.

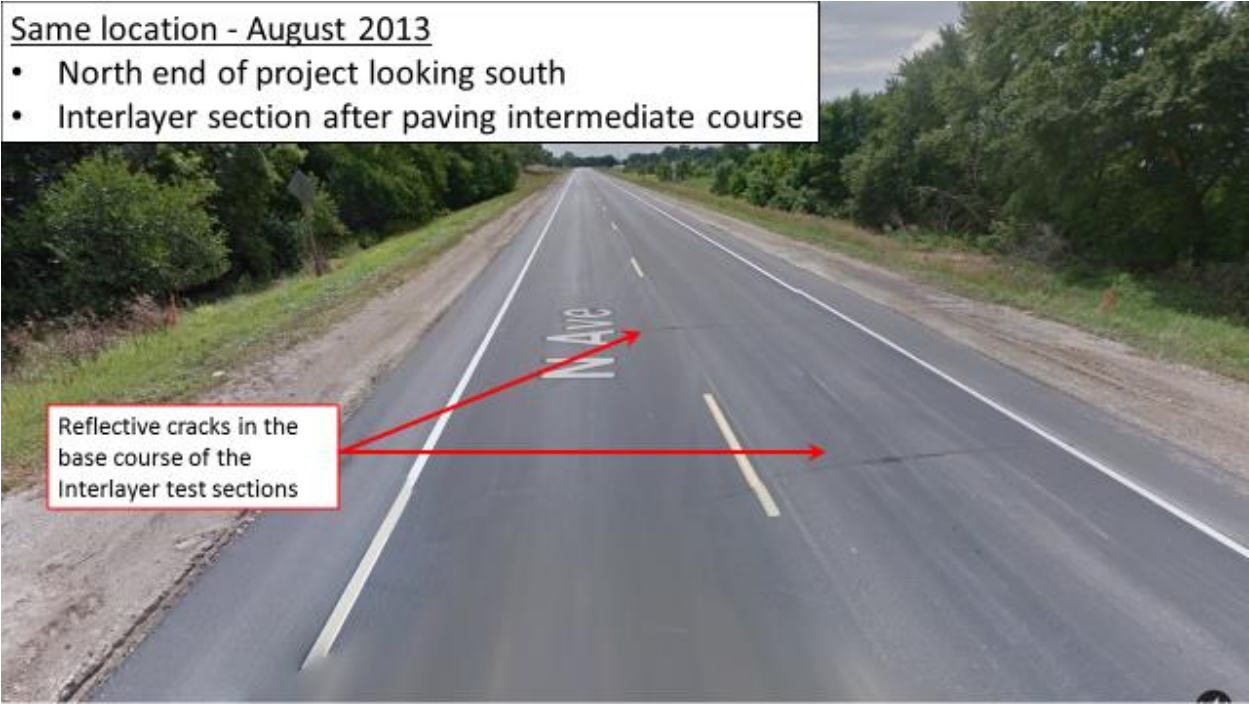
- North end of project looking south
- Interlayer section after paving intermediate course

Figure 11. Post-construction view of intermediate course in interlayer section on US 169
