# Feasibility Study for Detection and Quantification of Corrosion in Bridge Barrier Rails

**Final Report**  
**April 2013**

# **FEASIBILITY STUDY FOR DETECTION AND QUANTIFICATION OF CORROSION IN BRIDGE BARRIER RAILS**

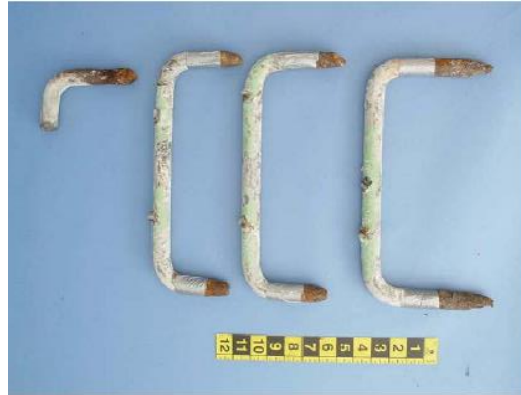
**Figure 1. Corroded conditions of several U-bolt anchors that were extricated from concrete bridge barrier rail (NTSB 2010)**

Figure 1 shows the corroded condition of U-bolt anchors from the NTSB recommendations to the FHWA. For this particular bridge construction, it was possible to detect the condition of a fully-fractured anchor using ultrasound techniques; however, the NTSB identified the need to detect intact but degraded anchors as a high priority need.

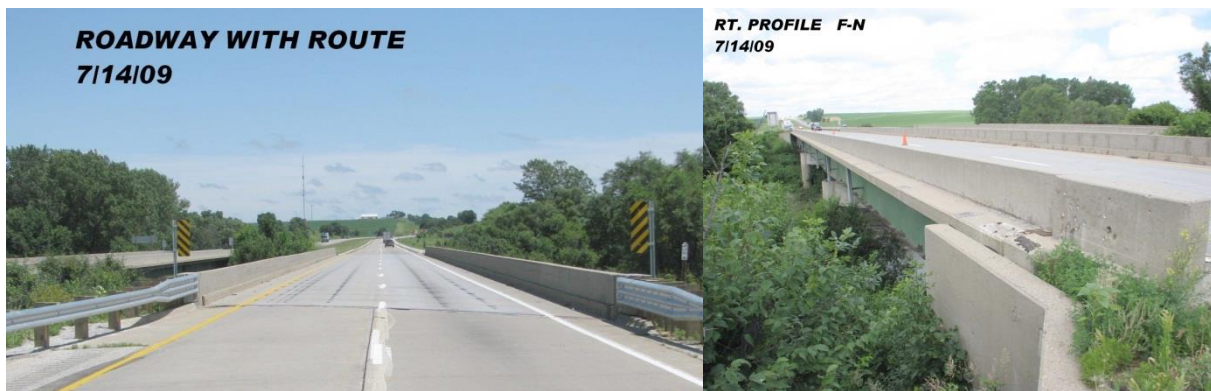
**Figure 2. Typical bridge barrier rail construction**

Through a series of discussions between members of the Iowa Department of Transportation (DOT) Office of Bridges and Structures and the researchers in early 2011, the inspection of bridge barrier rails, such as the ones shown in Figure 2, was identified as a high priority issue.

Concrete bridge barrier rails provide protection of passing vehicles and are critical to public safety. A cold joint exists between the barrier rail and the bridge deck, either with or without an overlay. At issue is the corrosion of the reinforcing steel within the barrier rail, particularly at the joint of the barrier rail with the bridge deck.

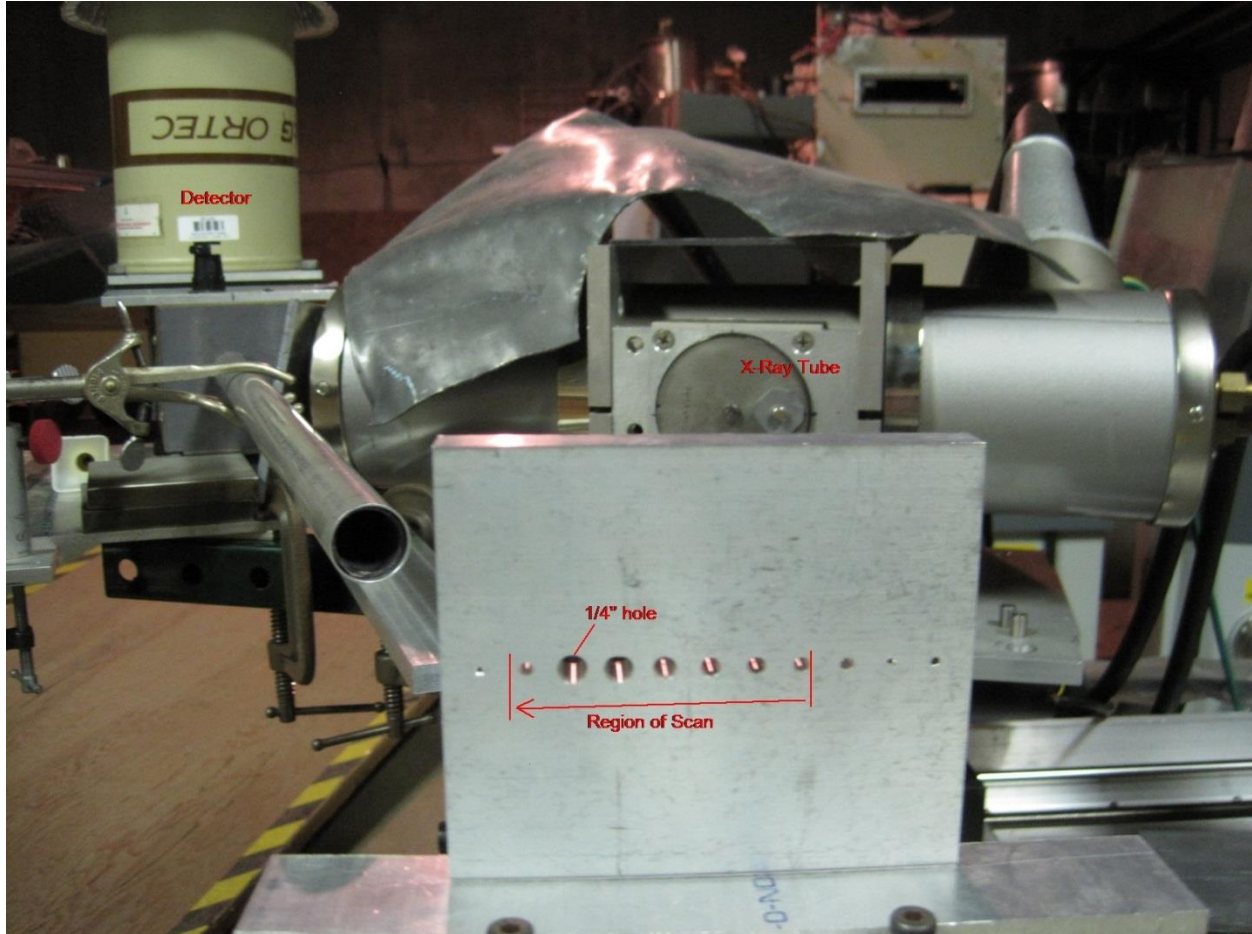
**Figure 6. Setup used for x-ray backscatter studies**

The method is used routinely, for example, in screening cargo at border crossings (Callera 2006) and has been used by the National Aeronautics and Space Administration (NASA) to inspect the space shuttle external rocket (Dugan et al.). To evaluate this method, we set up a tightly-collimated x-ray source and detector as indicated in Figure 6.

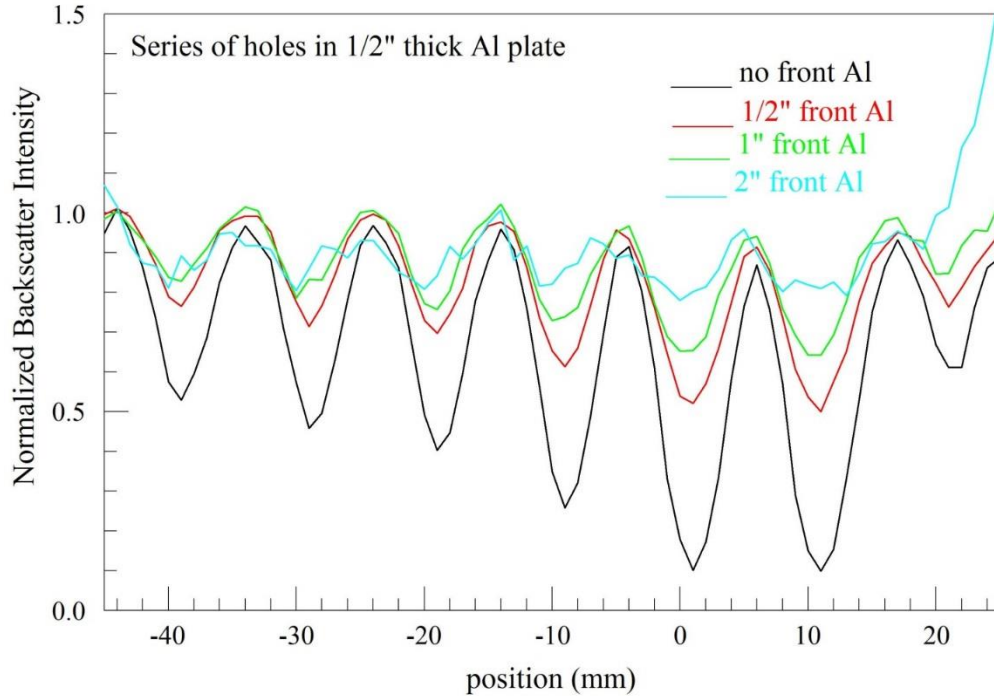
**Figure 21. X-ray backscatter contrast at detector as a function of material thickness**

However, the above spectra were obtained at relatively small depths in the samples. As the inspection point moves deeper into the sample, most low-energy x-rays are absorbed, regardless of material. At the higher energies, the contrast between materials is not as great. To test the effect of material thickness on contrast, we used a sample consisting of a 1/2 in. thick aluminum plate with a series of holes drilled in it (as shown earlier in Figure 6). We then placed different amounts of aluminum in front of this plate as we scanned the beam across the holes. The results are shown in Figure 21. With 2 in. of aluminum in front of the plate, the contrast is greatly reduced.

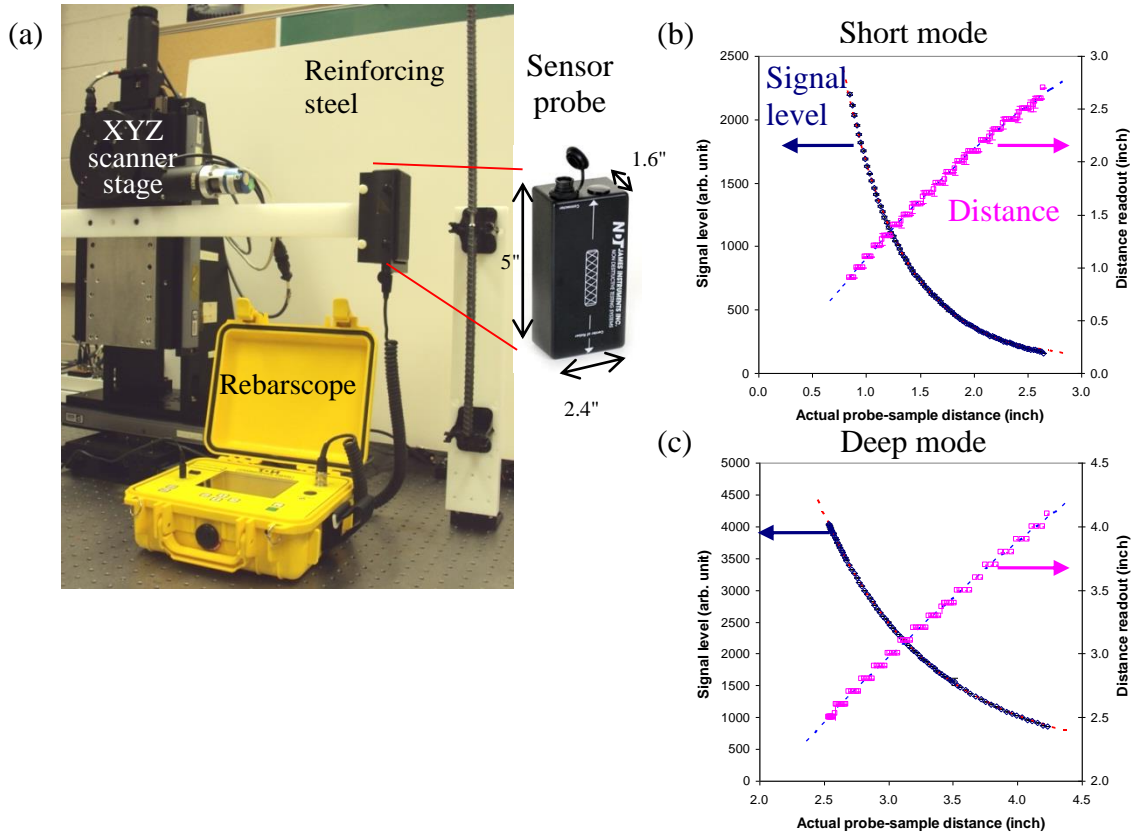
**Figure 23. (a) Setup for EC scans on bare #4 reinforcing steel specimens and (b) and (c) signal level and distance readings versus actual probe distance**

scanner stage (Figure 23a) that was under computer control for performing line or raster scans over the bare reinforcing steel or concrete test specimens.

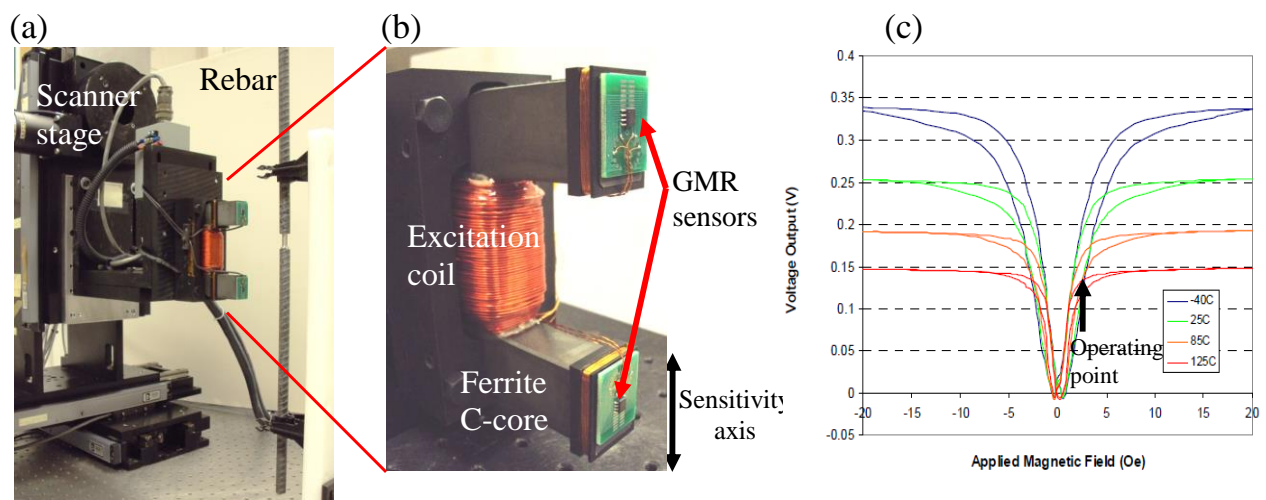
**Figure 26. (a) Experimental setup for performing MFL scans, (b) close-up of the MFL sensor probe and (c) nominal output of the GMR sensors versus magnetic field (Bligh et al. 1994)**

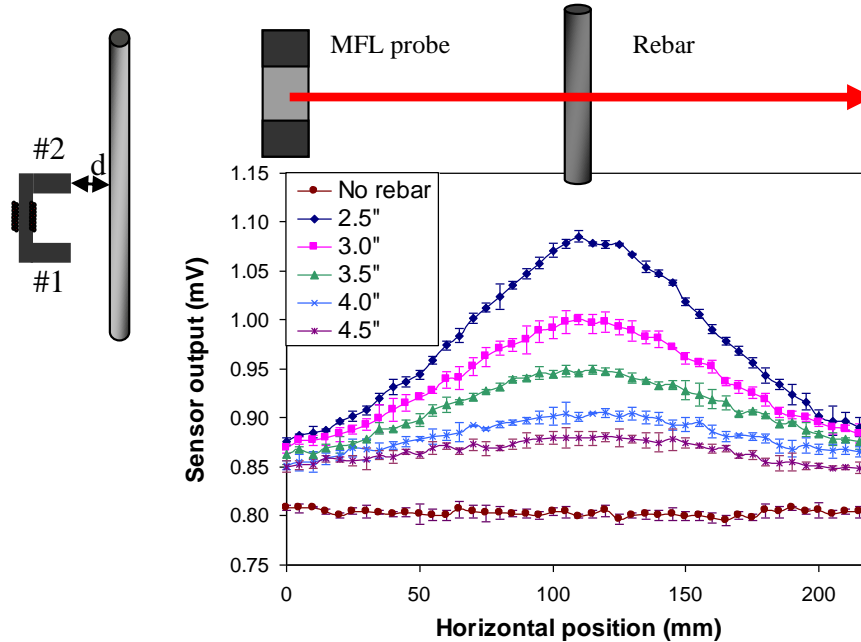
**Figure 28. GMR sensor output versus the horizontal position of the MFL sensor probe at various perpendicular distances from the reinforcing steel**

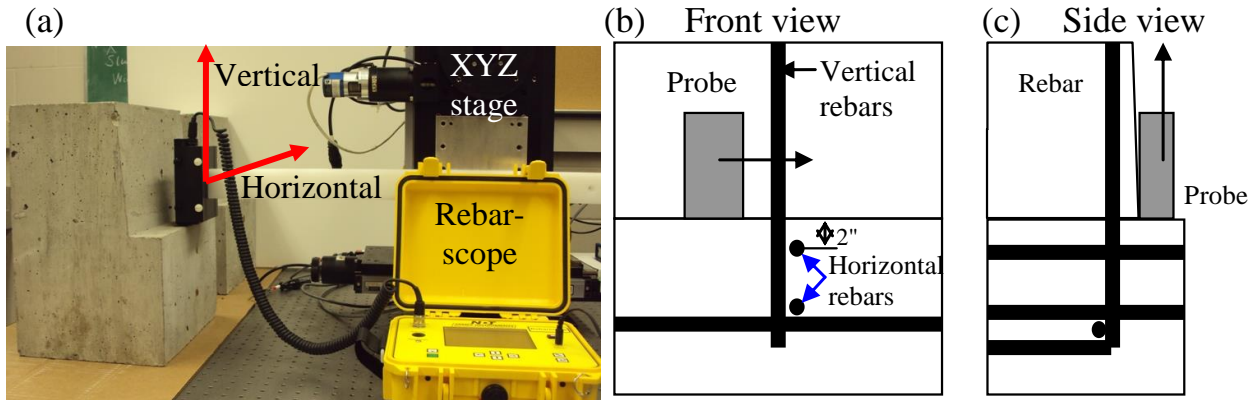
**Figure 31. Experimental setup for performing EC line scans on the concrete test specimens**

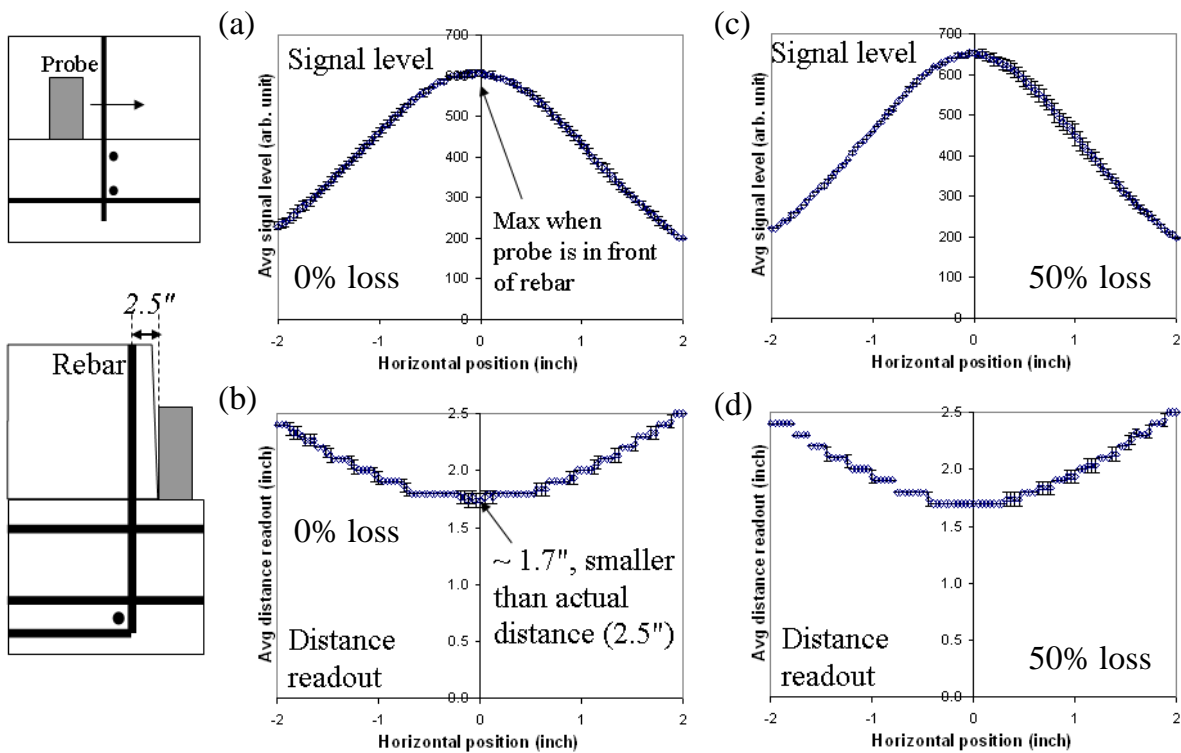
**Figure 32. (a and c) EC signal levels and (b and d) distance reading obtained from horizontal line scans over the concrete test specimens**

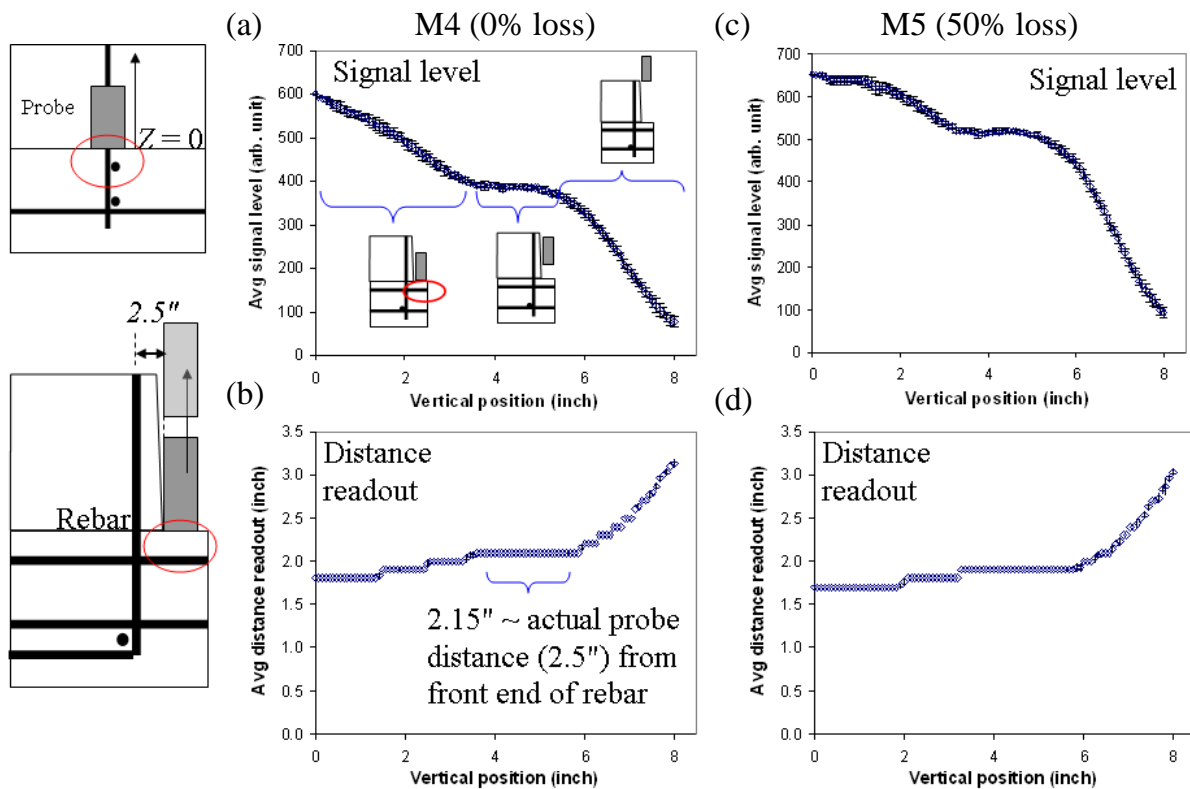
**Figure 33. (a and c) EC signal levels and (b and d) distance reading obtained from vertical line scans over the test specimens**

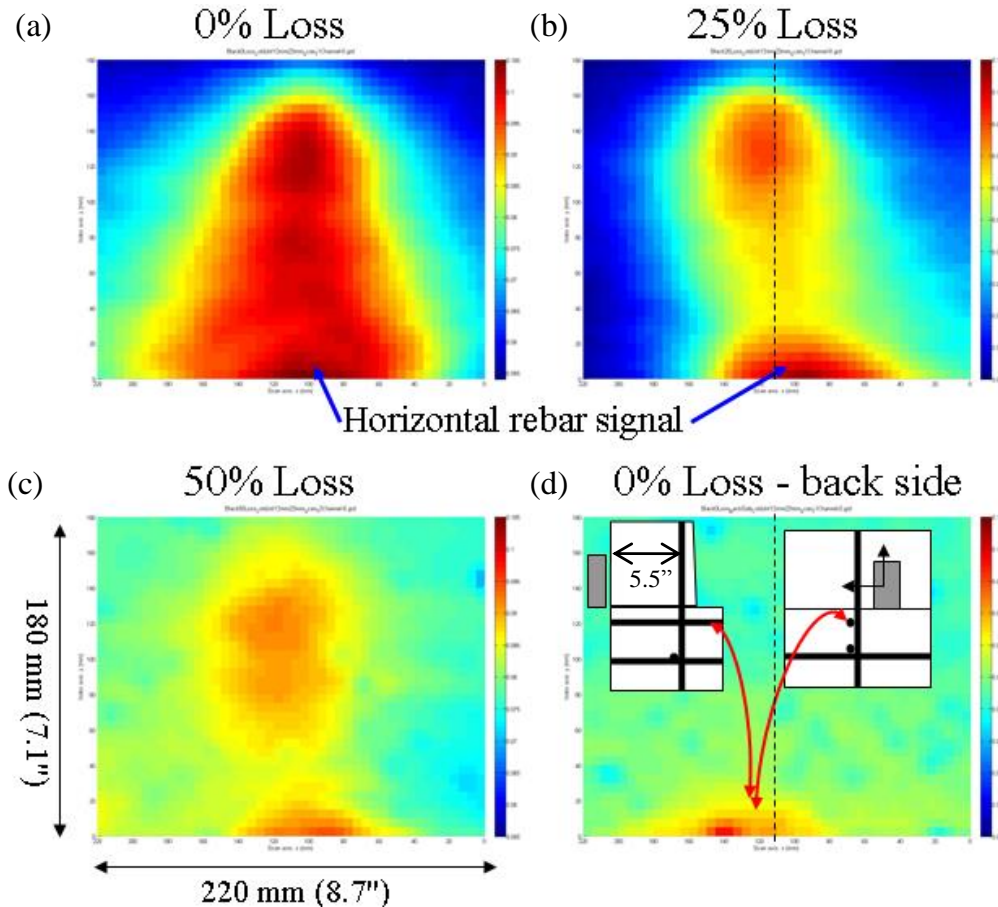
**Figure 35. C-scan images of test specimens and the regions of strong signal levels caused by the horizontal reinforcing steel**

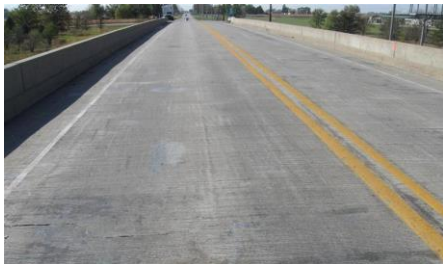
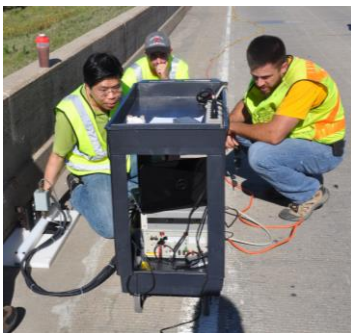
**Figure 37. Iowa Highway 210 Bridge MFL field testing**

Bridge: highway 210 over  
Interstate I-35, near Slater, Iowa

The upper right drawing in Figure 37 depicts the locations and numbering of the bridge barrier rail sections that were inspected using the MFL method: crown, east end, west end, and section between the crown and west end of the bridge (denoted as section 4). The MFL measurements were preceded by GPR tests performed by team members on the same sections for comparison.

Due to time constraints, only three to four reinforcing bars were selected from each section for MFL measurements. Two MFL line scans were carried out on each. The bottom right drawing in Figure 37 depicts two MFL line scans over a selected reinforcing bar.

Following the laboratory tests on bare reinforcing steel and concrete test specimens, a field test was conducted on the Highway 210 Bridge over I-35 near Slater, Iowa (see Figure 37).

The MFL measurement system was modified to improve its portability for the field test. Specifically, the outputs of the GMR sensors were amplified by a factor of 500 using instrumentation amplifier integrated circuits (ICs) (AMP02F, Analog Devices). The amplified signals were then acquired directly into a laptop computer using a multi-channel data acquisition card (USB-6251, National Instrument, Inc.). A LabView program was written for data acquisition and real-time signal analysis to obtain the amplitude and phase of the MFL signals. These modifications alleviated the use of lockin amplifiers to detect sensor outputs, thereby reducing the hardware needed for the field test.

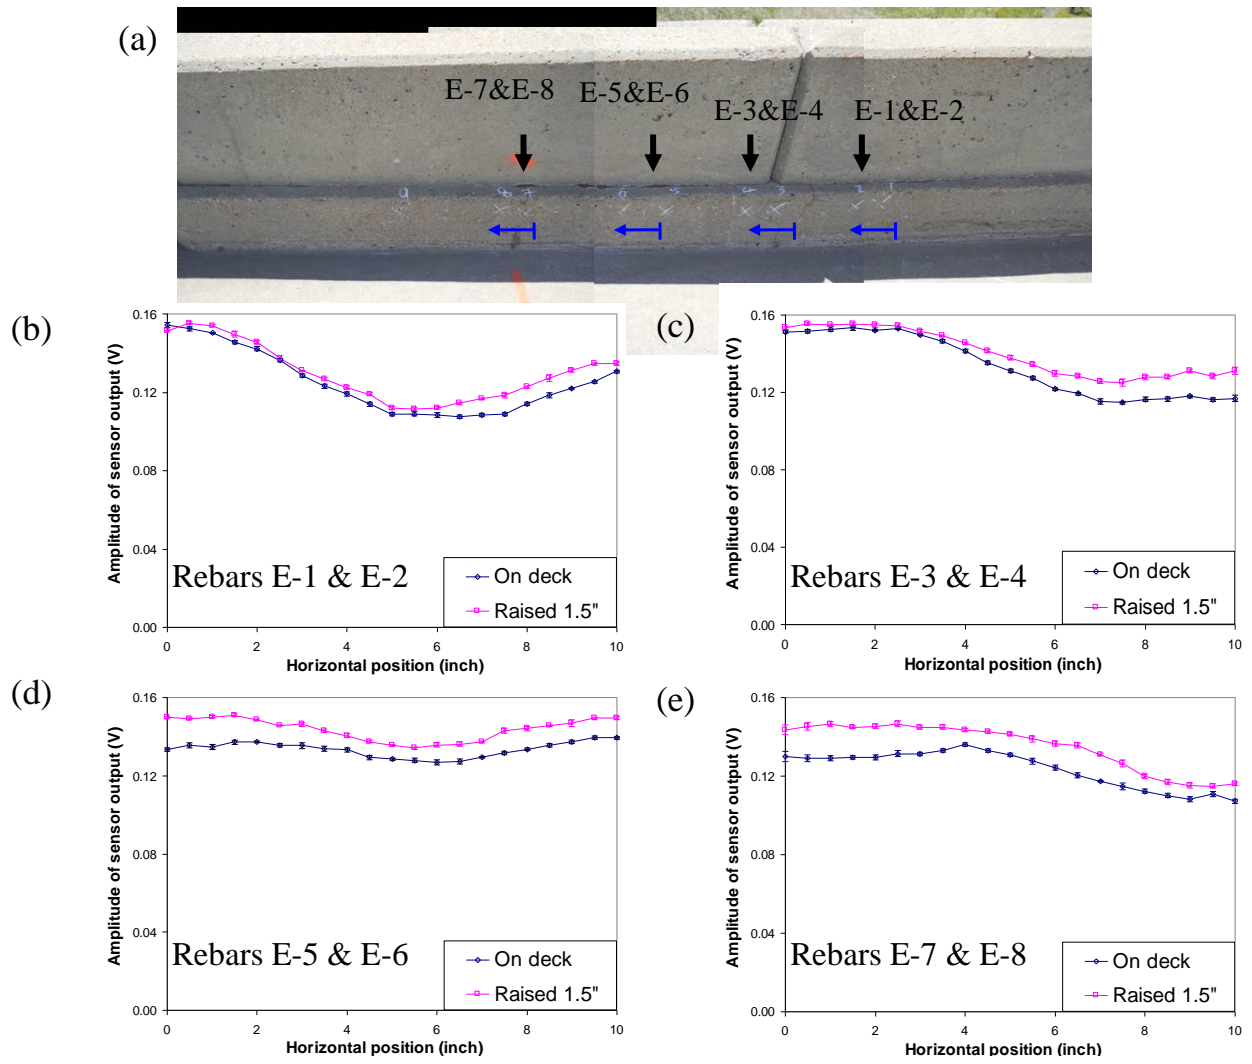
Figure 39. East-end section of barrier rail

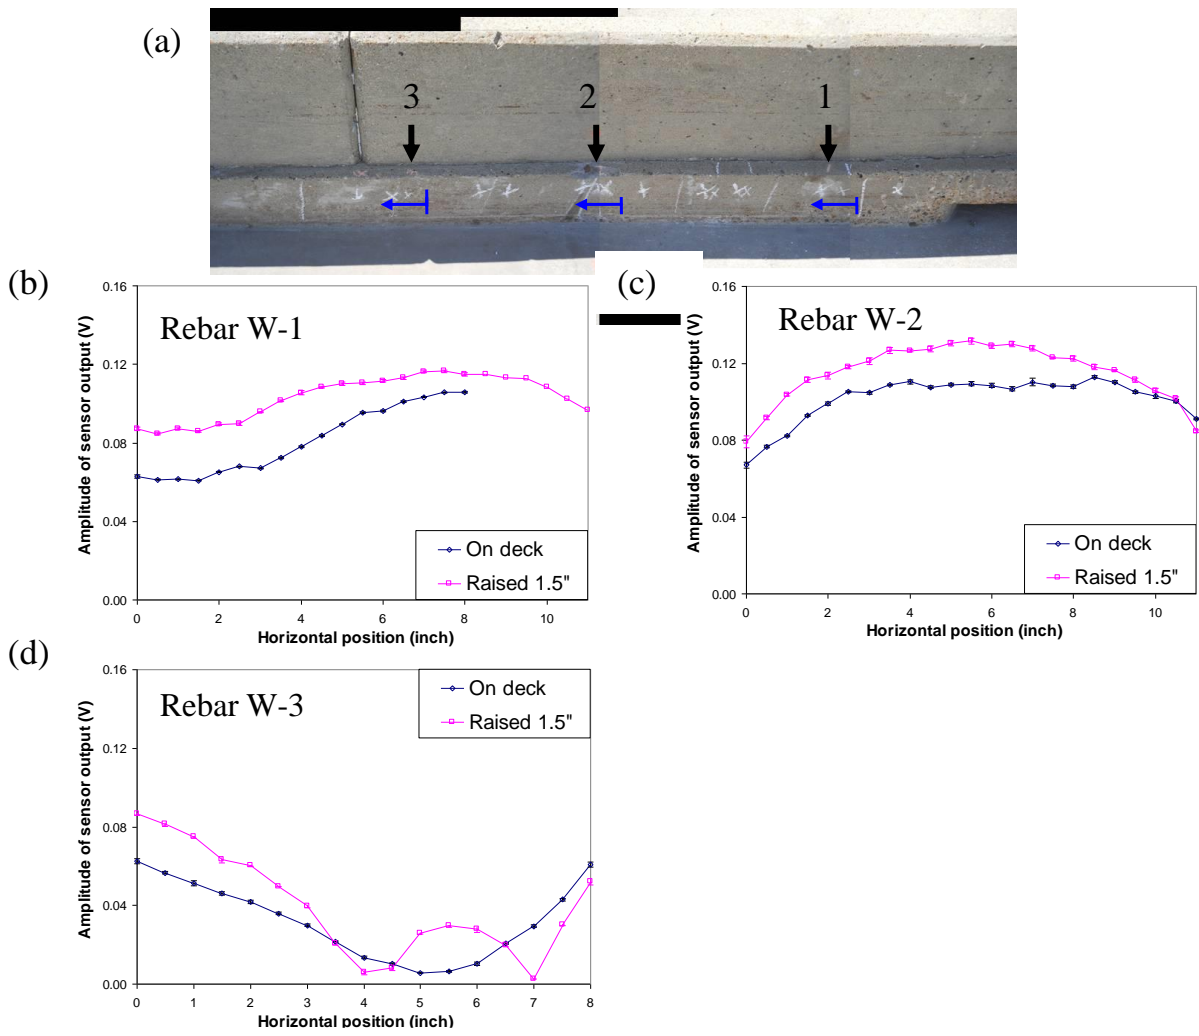
**Figure 40. West-end section of barrier rail**

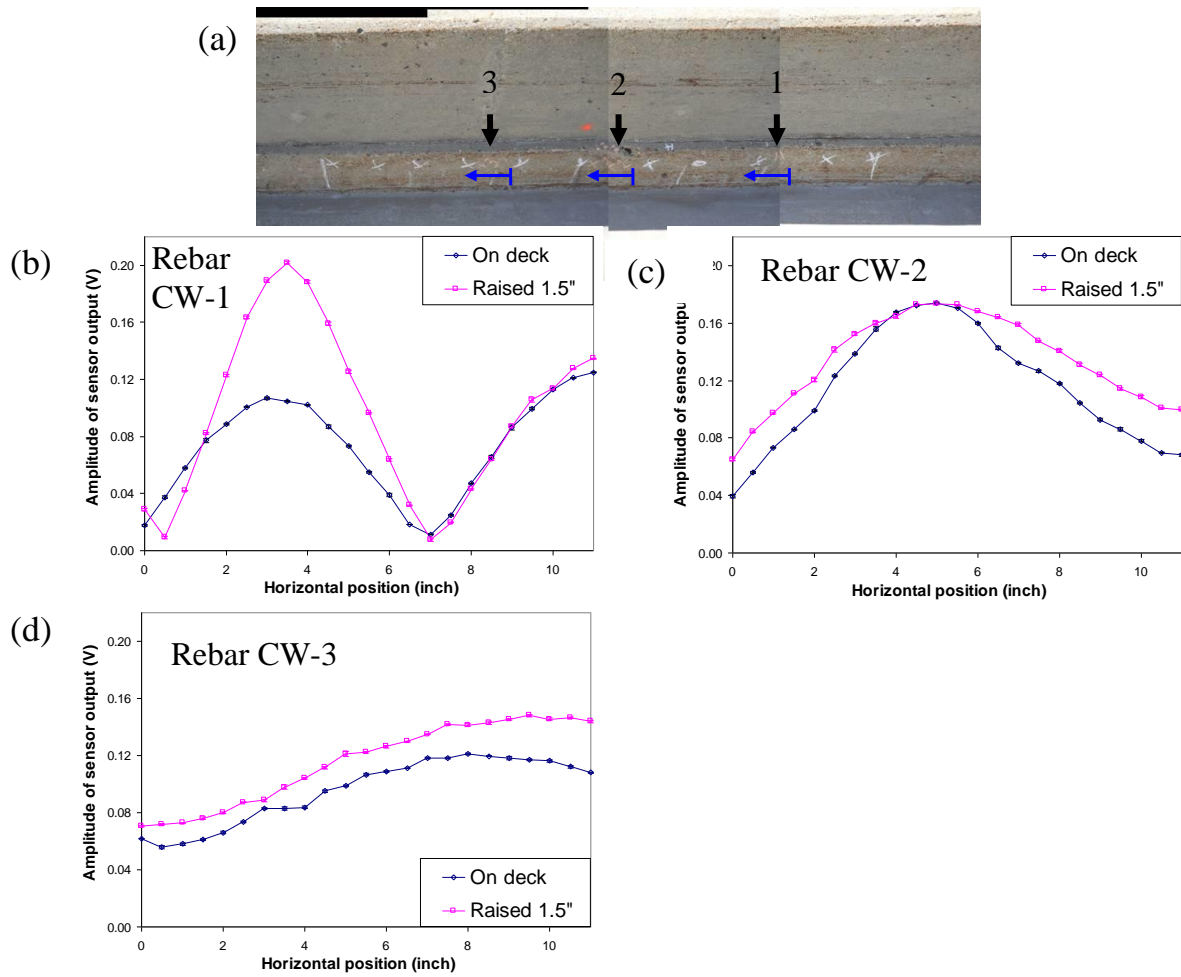
**Figure 41. Section 4 of barrier rail**

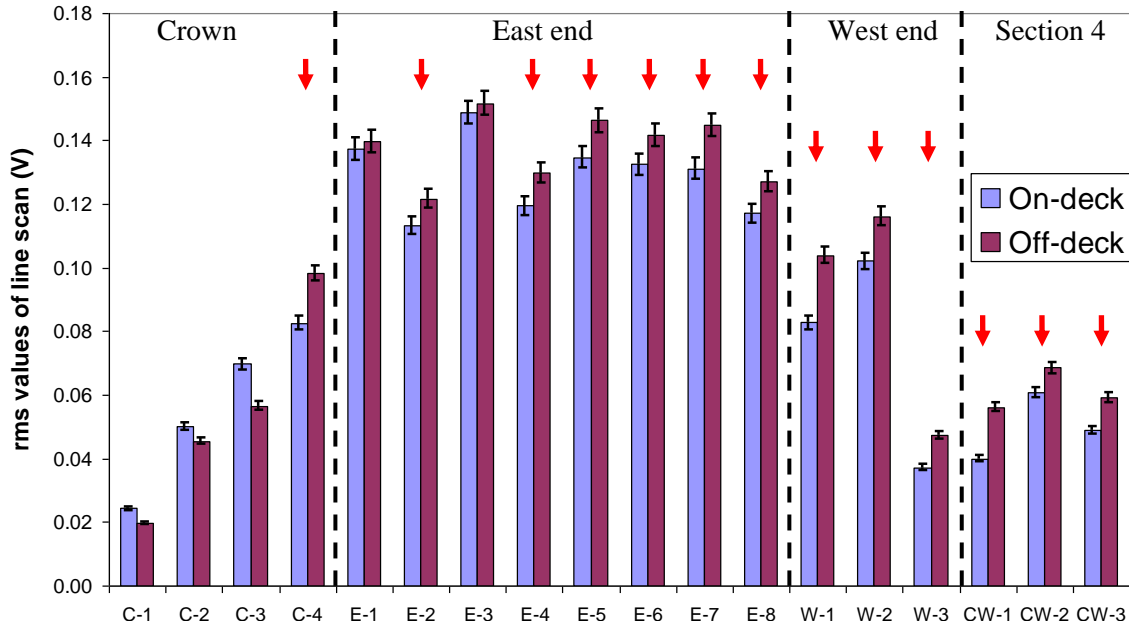
**Figure 42. rms values of the on-deck and off-deck MFL line scan data from the selected reinforcing steel in the field test**

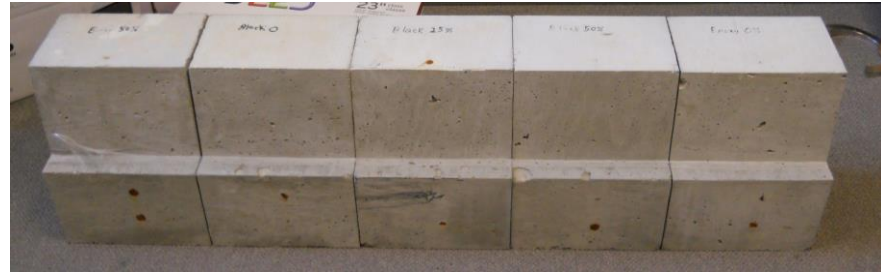
**Figure 45. B-scan (bottom) obtained by scanning the GPR antenna across the five aligned test specimens (top)**

Measurements were taken to determine whether the amplitude of GPR-reflected signals could be used to distinguish between the different reinforcing steel test specimens. The five specimens were aligned as shown at the top of Figure 45 so that that the antenna carriage could be scanned across them in a continuous fashion.

Two measurement tests were conducted: one in which the antenna carriage rolled right-to-left (J004) and one in which it rolled left-to-right (J005). The B-scan image for the second test is shown in the lower portion of Figure 45. There, the reflection from the air/concrete interface appears as the horizontal band near the top of the image.

Specimens  
Lined up.  
Two scans made:  
Left-to-right,  
Right-to-left

Note the perturbation of this band near the far right edge; this is a consequence of the change in the liftoff between the bottom of the antenna housing and the concrete surface. Such liftoff variations can occur when a carriage wheel slips off a surface or rolls over an obstacle. To a lesser extent, liftoff can also change due to unevenness of the rolling surface, or to compression of the carriage wheels when the hand-applied pressure varies while scanning. In this particular case, the liftoff change occurred when the front wheels of the carriage rolled off the right-most concrete block, causing the antenna to tilt slightly.

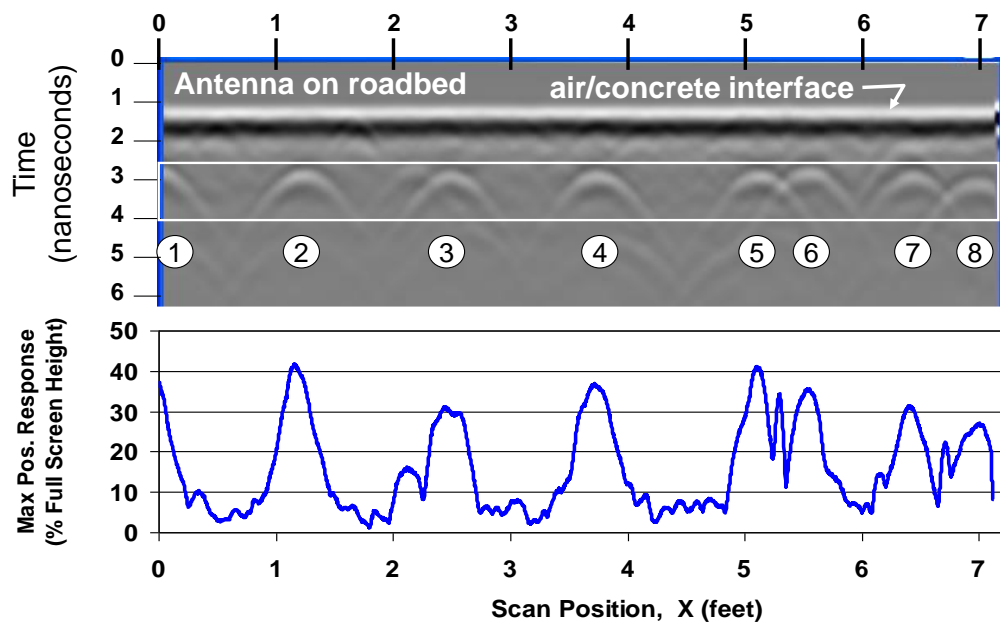
**Figure 49. Sample GPR data from field test**

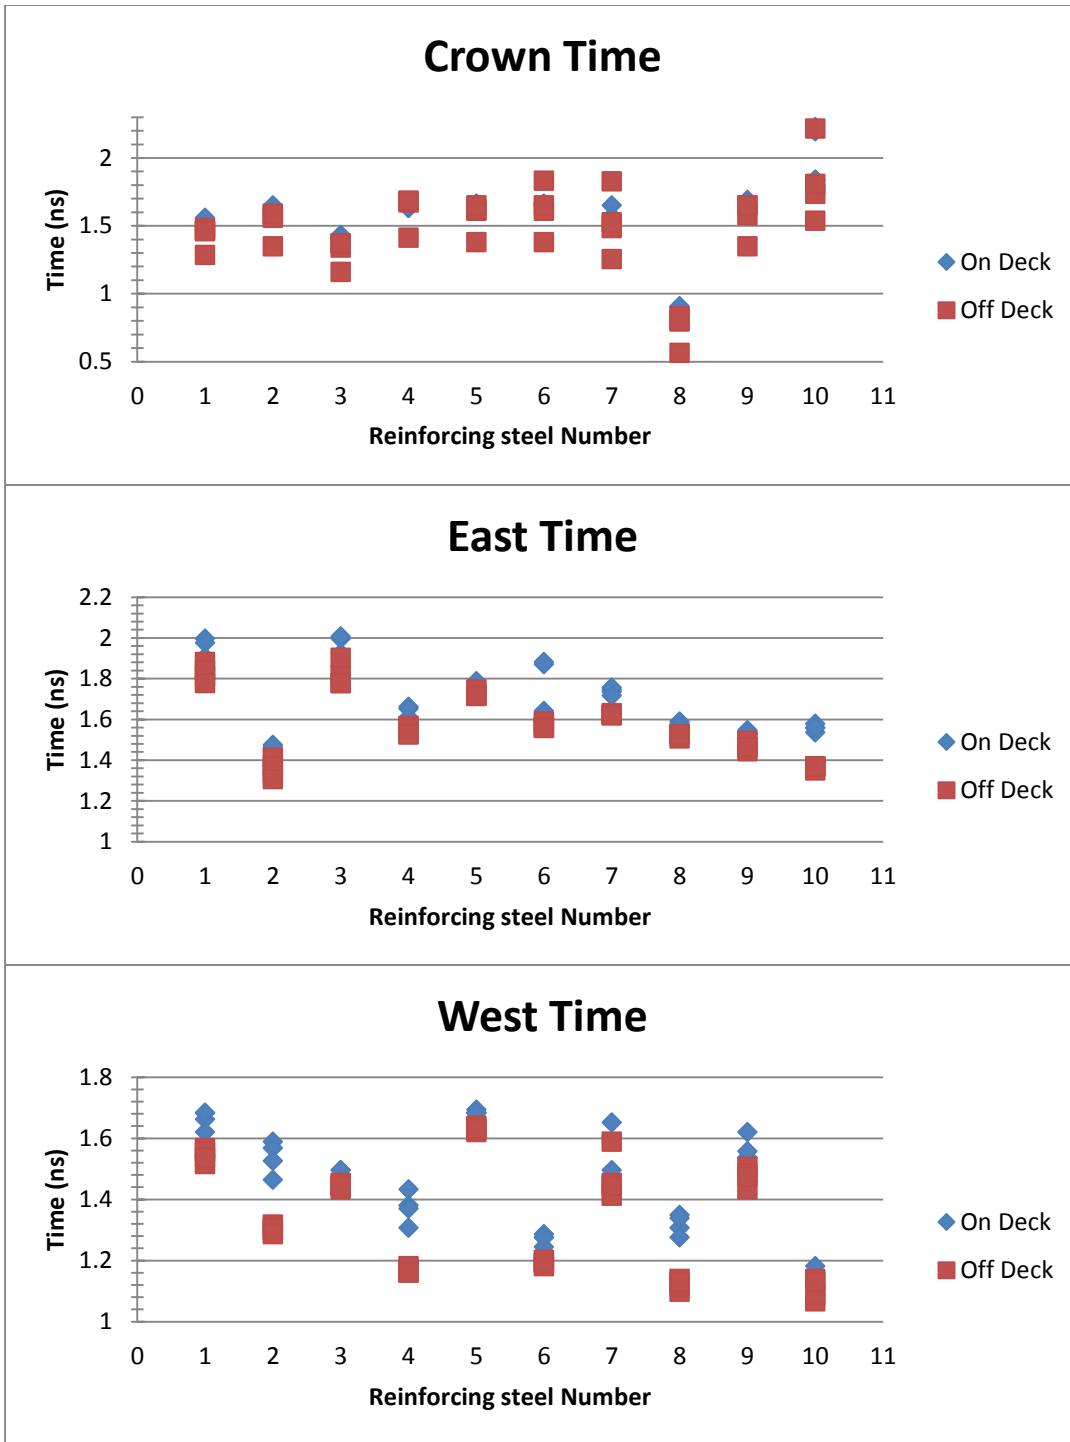
**Figure 52. Reinforcing steel signal time of flight on deck versus off deck number for locations near the east, crown and west end of the bridge**

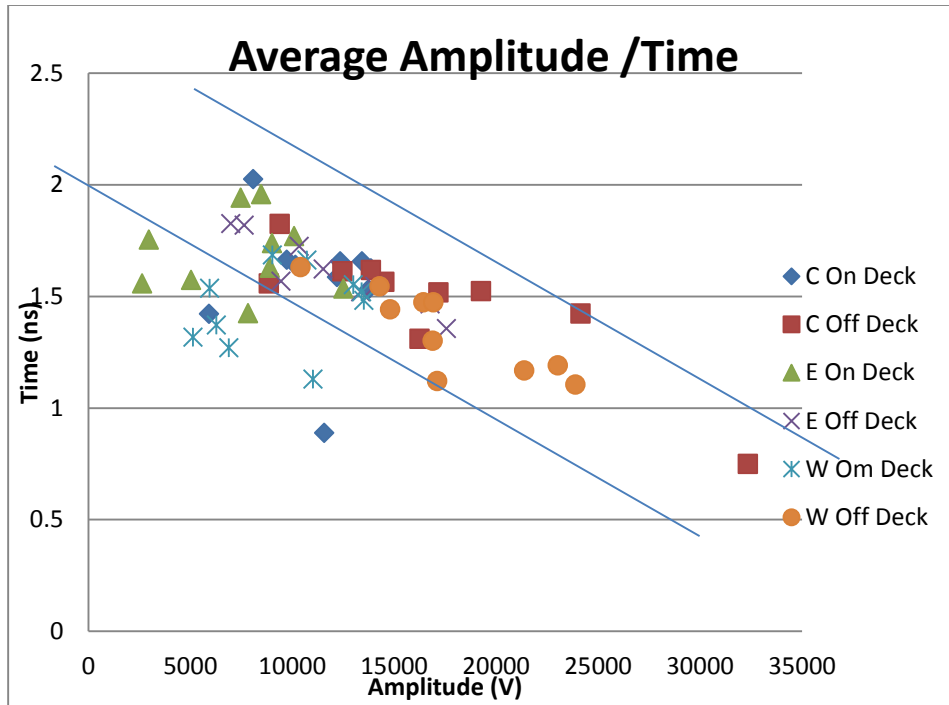
**Figure 53. Average time versus average amplitude for all reinforcing steel**

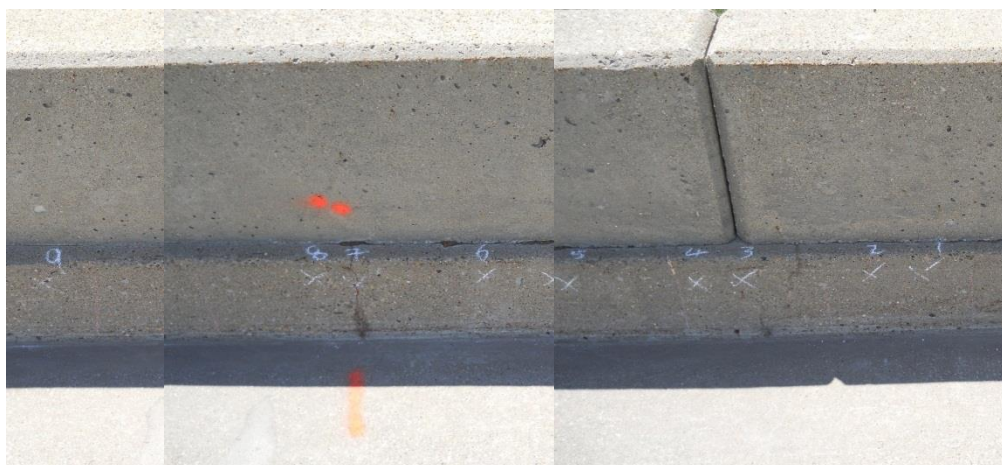
**Figure 57. Suspect locations on the east end of the bridge**

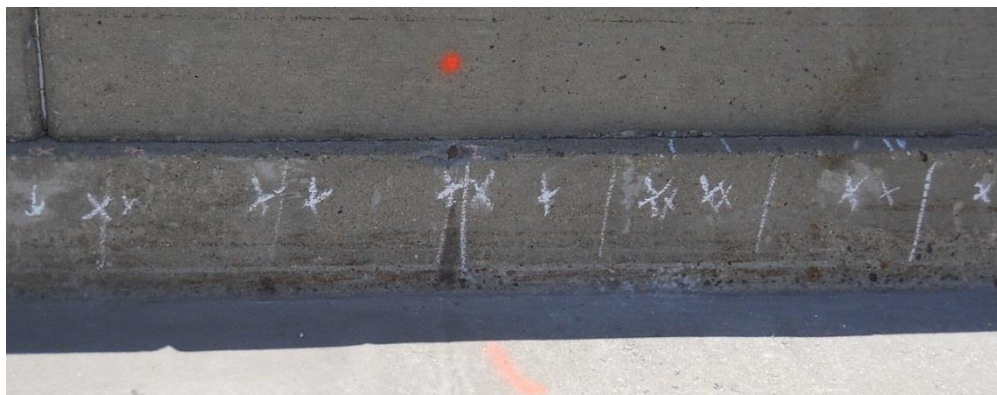
**Figure 58. Suspect locations on the west end of the bridge**

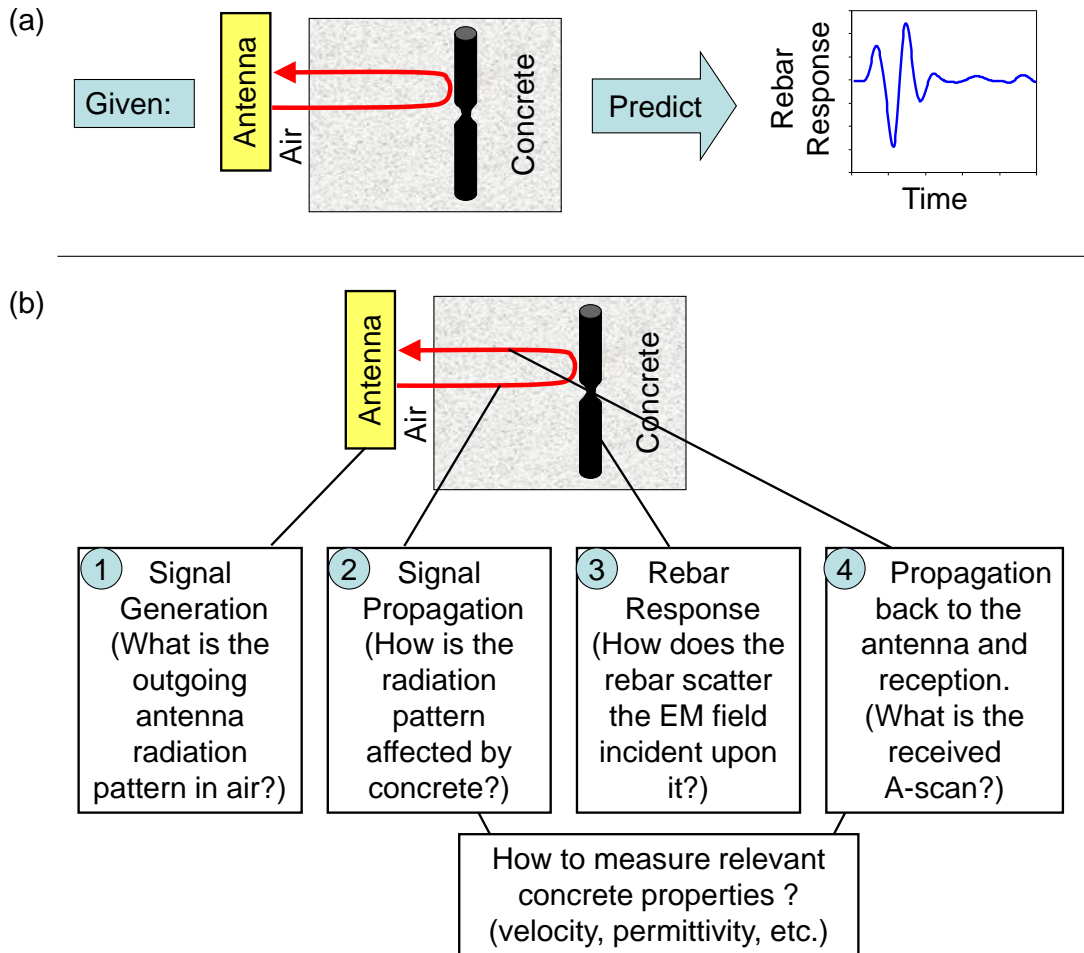
**Figure 59. (a) Simulation tools under development to predict GPR reinforcing steel responses and (b) several processes contribute to the measured response**

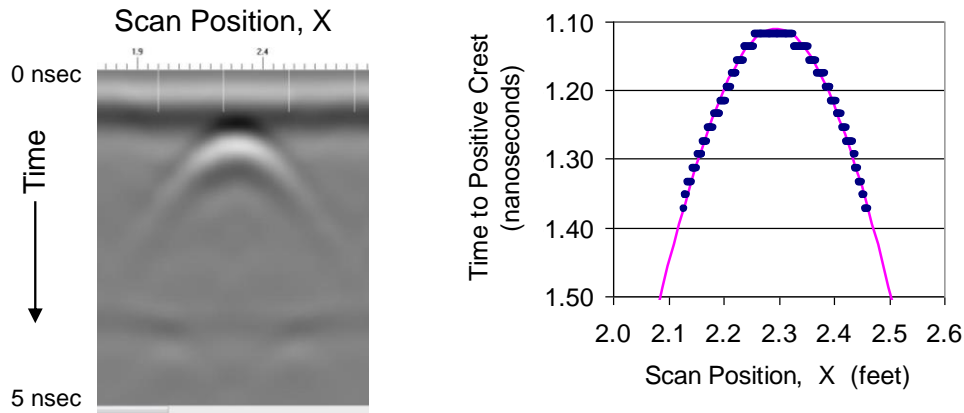
The B-scan image above shows the response obtained by scanning the antenna over a concrete test block containing one rebar target. Note the white crest (positive voltage crest) of the rebar response. At right we plot the pixel coordinates closest to that crest at each discrete scan position.

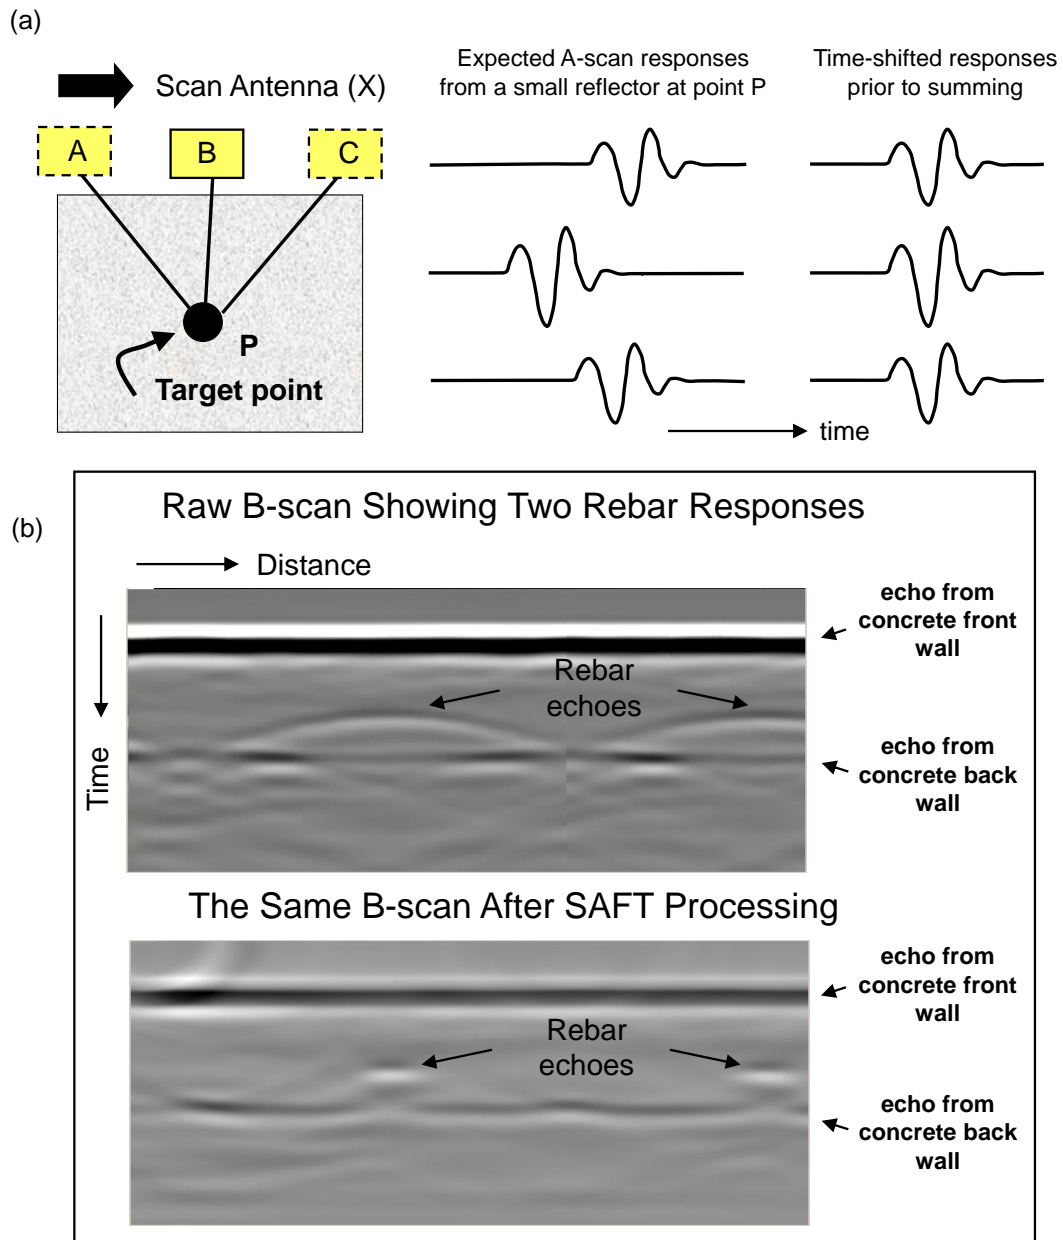
**Figure 62. (a) Principle underlying SAFT processing and (b) application of SAFT to a scan over abutting concrete test specimens containing two reinforcing steel targets**

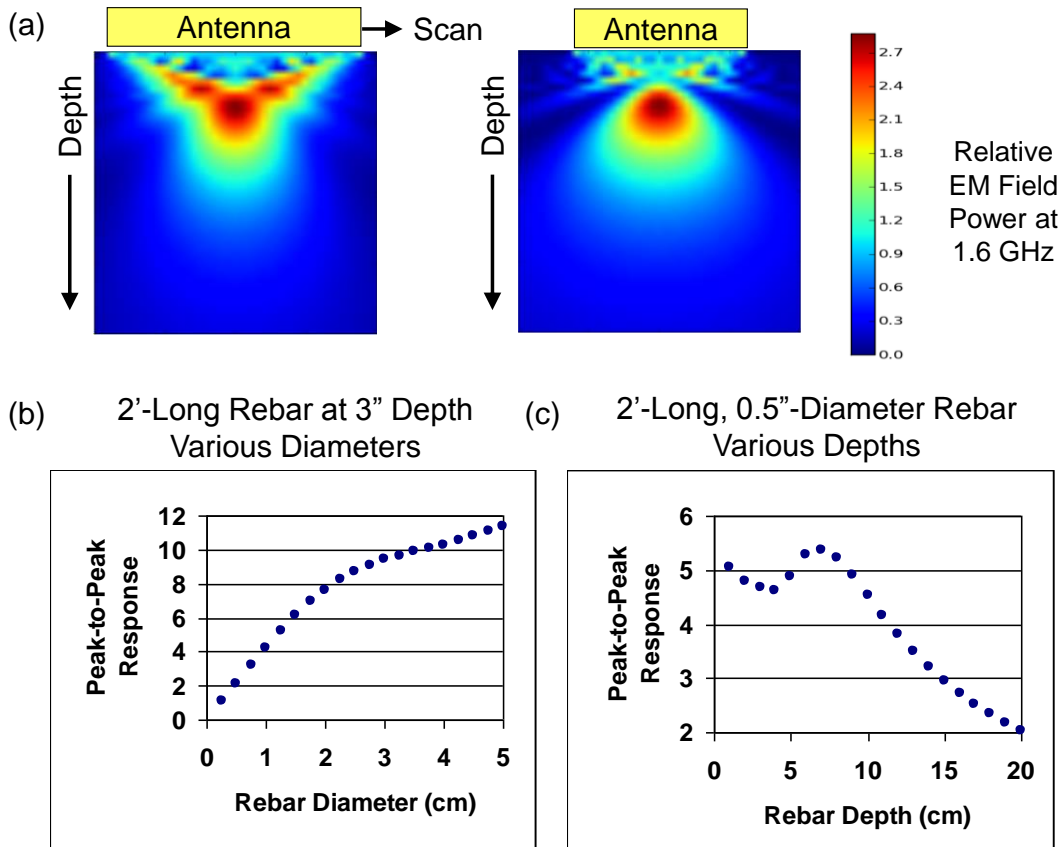
**Figure 64. (a) Predicted antenna radiation pattern at 1.6 MHz assuming antenna size parameters based on the physical dimensions of the antenna housing (b-c)**
