Iowa US Highway 65 – Embankment – July 2013

Intelligent Compaction Demonstration for Embankment Soils on Iowa US Highway 65

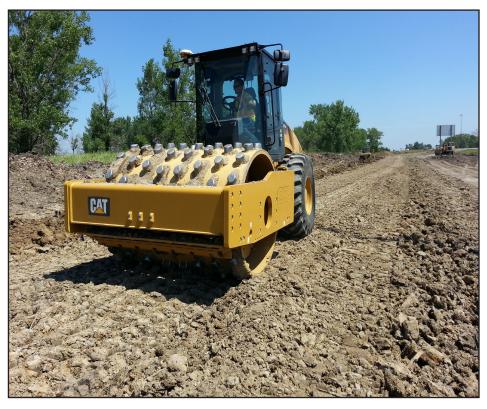
Figure 1. Caterpillar CS74B smooth drum roller with pad foot shell kit

The intelligent compaction (IC) system used on this project included a Caterpillar CS74B roller with padfoot shellkit (Figure 1) equipped with the machine drive power (MDP) based measurement technology. The machine was set up with real time

The roller used in this study is shown in Figure 1 and is equipped with MDP measurement technology. MDP technology relates to the soil properties controlling drum sinkage and uses the concept of rolling resistance to determine the stresses acting on the drum and the energy necessary to overcome the resistance to motion. MDP values can be obtained in both vibratory and static compaction operation modes. For the machine used in this study, the manufacturer reported the MDP values (that have units of kJ/s or lb-ft/s) as unit less index values over a scale of 1 to 150. Therefore, the values are reported herein as MDP* values. Additional information about MDP measurement technology is provided in White et al. (2011).

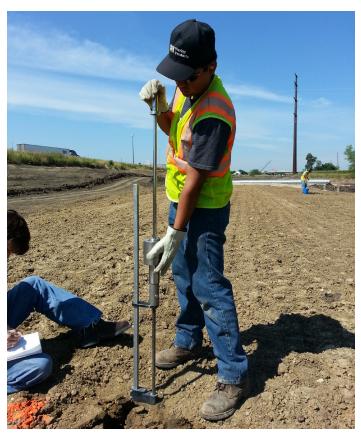
Figure 2. DCP testing

In situ point testing was conducted at selected locations to develop correlations with the IC measurements. Point testing included drive core testing for dry density (γ_d) and moisture content (w), dynamic cone penetrometer (DCP) testing for dynamic penetration index (DPI), and light weight deflectometer (LWD) testing for elastic modulus (ELWD). Zorn LWD testing was conducted with 200 mm diameter and 300 mm diameter plate setups. In situ testing devices are shown in Figures 2 to 4.

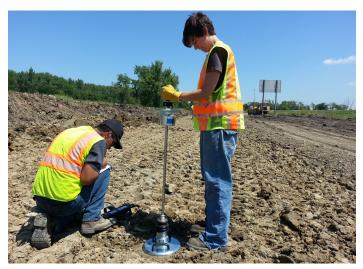
Figure 3. LWD testing
