Low-Cost Rural Surface Alternatives: Demonstration Project

**Final Report
June 2015**

IOWA STATE UNIVERSITY
Institute for Transportation

Sponsored by
Iowa Highway Research Board
(IHRB Project TR-664)
Iowa Department of Transportation
(InTrans Project 13-479)

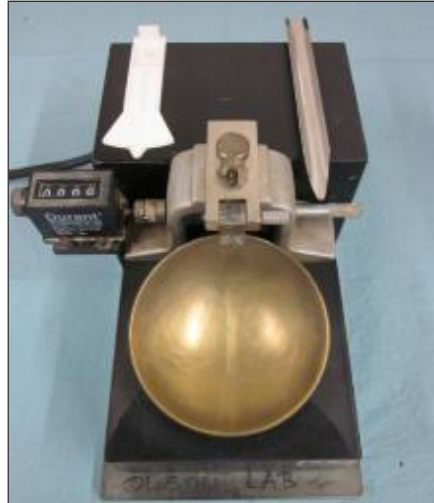
Figure 3. Liquid limit test device used in this study

The liquid limit (LL), plastic limit (PL), and plasticity index (PI) of geomaterials passing the No. 40 (425 μm) sieve were determined in accordance with ASTM D 4318-10e1 “*Standard Test Methods for Liquid Limit, Plastic Limit, and Plasticity Index of Soils.*” The wet preparation method was followed for preparing representative samples for the tests. Liquid limit tests were performed using the multi-point liquid limit test method, and at least three points were determined for each sample. Plastic limit tests were conducted using the hand method. Both LL and PL were rounded to the nearest integers for calculating the PI. According to the Standard, if either the LL or PL could not be determined, or if the PL was equal to or greater than the LL, the material was reported as nonplastic (NP). The liquid limit device used in this study is shown in Figure 3. A ground glass plate was used for the plastic limit test.

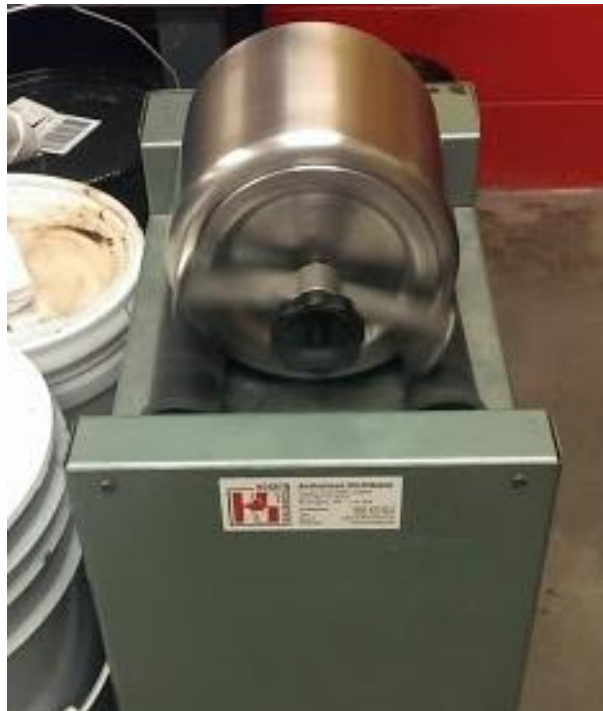
Figure 4. Micro-Deval testing machine used in this study

Micro-Deval tests were conducted on surface course materials from the project site in accordance with ASTM D 6928-10 “*Standard test method for resistance of coarse aggregate to degradation by abrasion in the Micro-Deval apparatus.*” The surface course materials used in Micro-Deval tests had smaller maximum particle sizes than the macadam materials used in the LA abrasion tests. Triplicate test specimens containing particles between 3/8 and 0.75 in. were tested to determine their abrasion resistance and durability under abrasion and grinding action of the Micro-Deval machine (Figure 4).

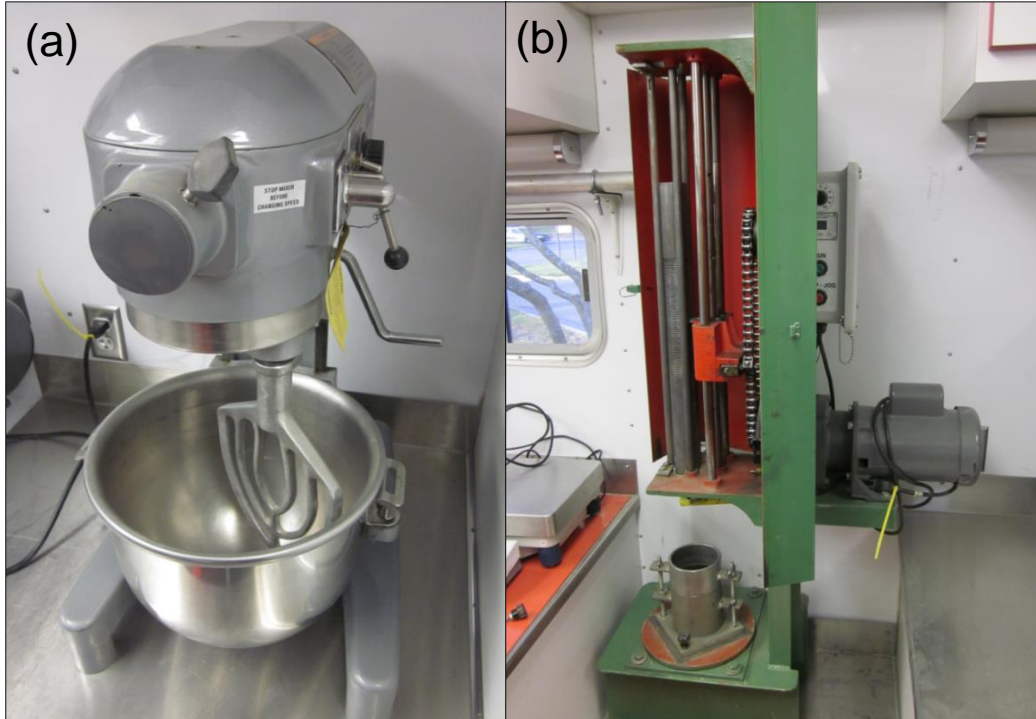
Figure 5. (a) Hobart mixer and (b) automated mechanical rammer used in this study

Standard Proctor compaction tests were performed to determine the relationship between water content and dry unit weight of geomaterials according to ASTM D 698-12e1 “*Standard test methods for laboratory compaction characteristics of soil using standard effort (12 400 ft-lbf/ft³ (600 kN-m/m³)).*” A Hobart mixer was used to prepare fine-grained geomaterials to predetermined moisture contents (Figure 5a), and an automated mechanical rammer was used to compact the specimens (Figure 5b).

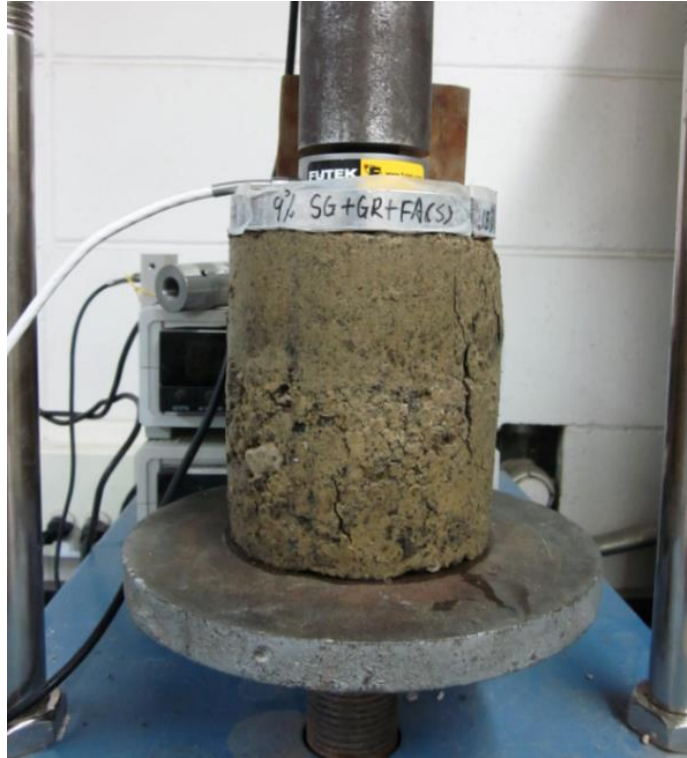
Figure 6. Unconfined compressive strength test on a fly ash-treated soil specimen

The unconfined compressive strength (UCS) of compacted untreated and chemically stabilized soil specimens was measured in accordance with ASTM D 1633-00(2007) “*Standard Test Methods for Compressive Strength of Molded Soil-Cement Cylinders.*” As specified in Method A of the standard, a specimen diameter of 4 in. and height of 4.6 in was used. The chemically stabilized specimens were extruded from the four inch diameter Proctor mold and wrapped with plastic film and aluminum foil to retain moisture during curing. The specimens were cured in a 38°C (100°F) controlled temperature environment for seven days. The compression device used in this study is shown in Figure 6.

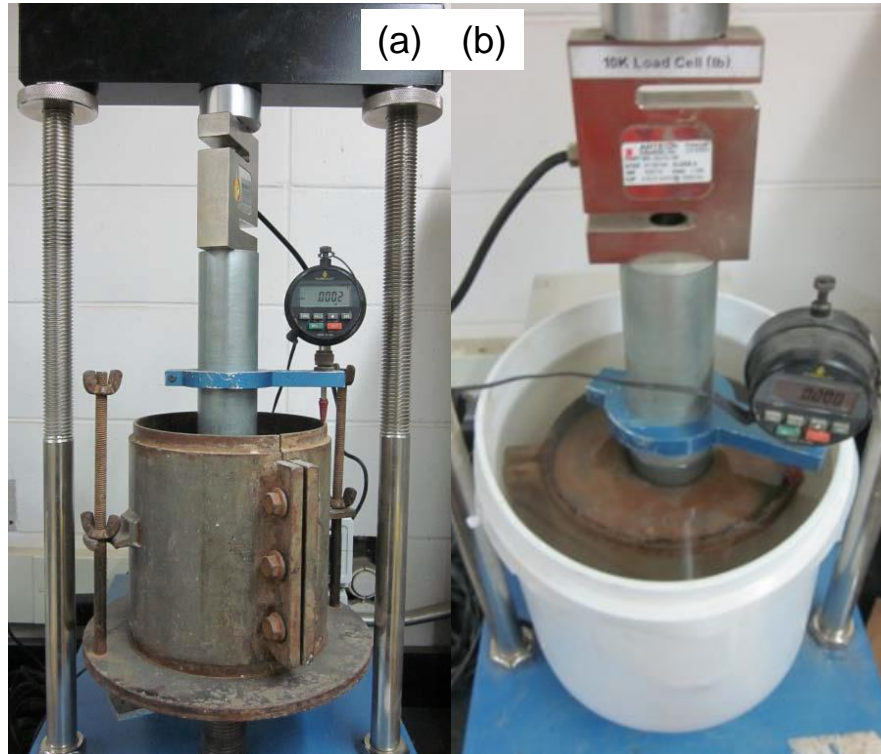
Figure 7. CBR tests conducted on (a) OMC and (b) saturated specimens

California bearing ratio (CBR) tests were used to evaluate the undrained shear strength of untreated and chemically stabilized subgrade and surface aggregate materials in accordance with ASTM D 1883-07e2 “*Standard Test Method for CBR (California Bearing Ratio) of Laboratory-Compacted Soils.*” CBR specimens were prepared and compacted at their optimum moisture content (OMC) according to ASTM D 698-12e1. Both as-compacted and soaked specimens were tested to determine how shear strength changes after soaking. The CBR test setup is shown in Figure 7.

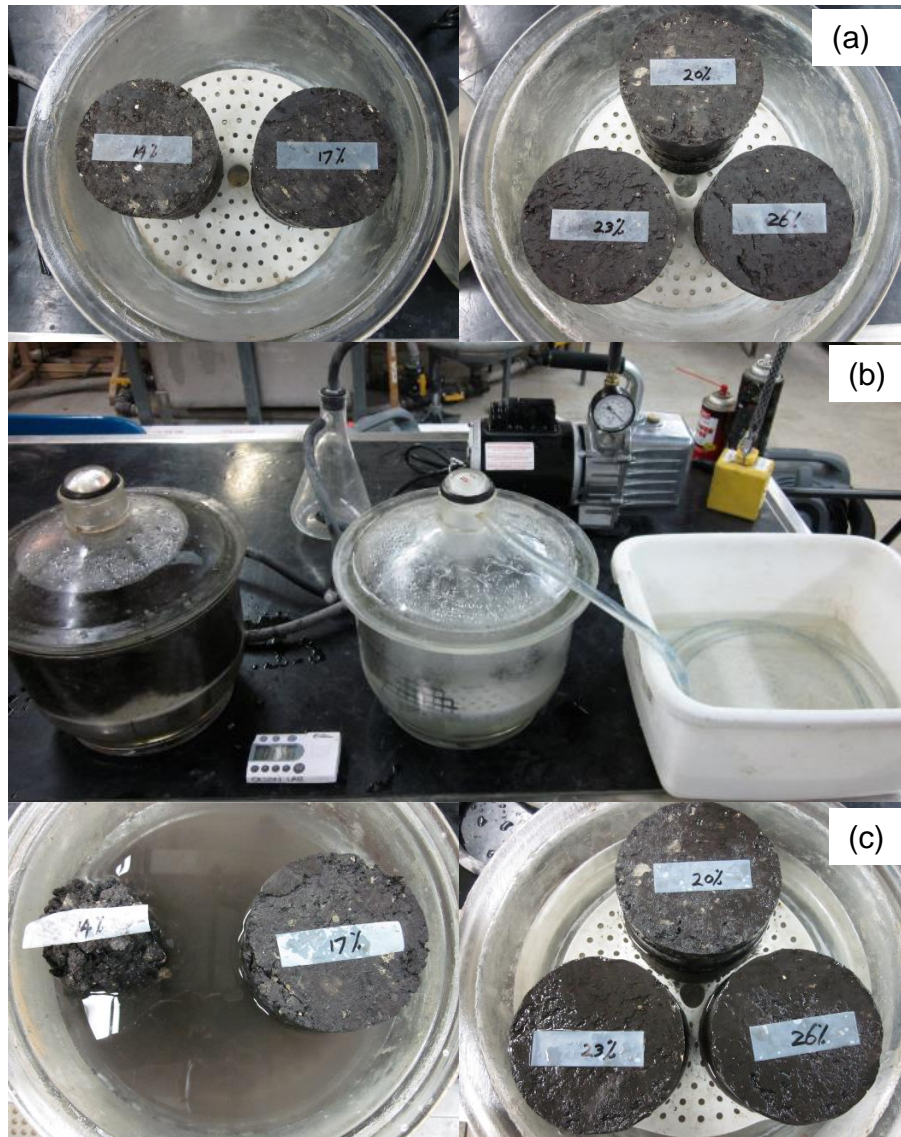
Figure 8. Vail Avenue subgrade specimens (a) before, (b) during, and (c) after vacuum saturation (compacted moisture contents are indicated on specimens)

Figure 8 shows the untreated Vail Avenue subgrade specimens before, during, and after the vacuum saturation process.

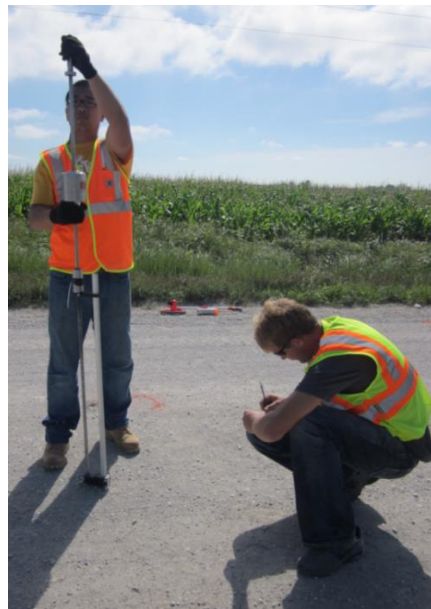
Figure 11. Dynamic cone penetrometer (DCP) test

The dynamic cone penetrometer (DCP) test was performed in accordance with ASTM D 6951-09 “*Standard Test Method for Use of the Dynamic Cone Penetrometer in Shallow Pavement Applications*” for estimating shear strength of surface course and subgrade materials of the Vail Avenue demonstration sections. The test involves driving a conical point with a diameter at the base of 0.79 in., using a 17.6 lb hammer dropped a distance of 22.6 in., and measuring the penetration distance per blow, referred to as the dynamic cone penetration index (DCPI).

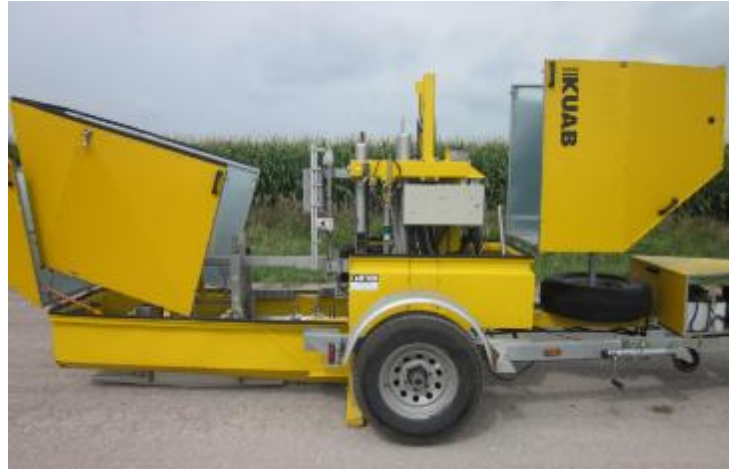
Figure 13. Kuab falling weight deflectometer setup

Falling weight deflectometer (FWD) tests were conducted using a Kuab Model 150 2m FWD (Figure 13) with an 11.81 in. diameter loading plate. A static seating load was applied, followed by four weight drops with measured loads normalized to 6,000, 9,000, 12,000, and 16,000 lb. A load cell recorded the actual applied forces while geophones recorded deflections of the roadway surface. A segmented loading plate was used to ensure a uniform stress distribution over the plate (Crovetti et al. 1989).

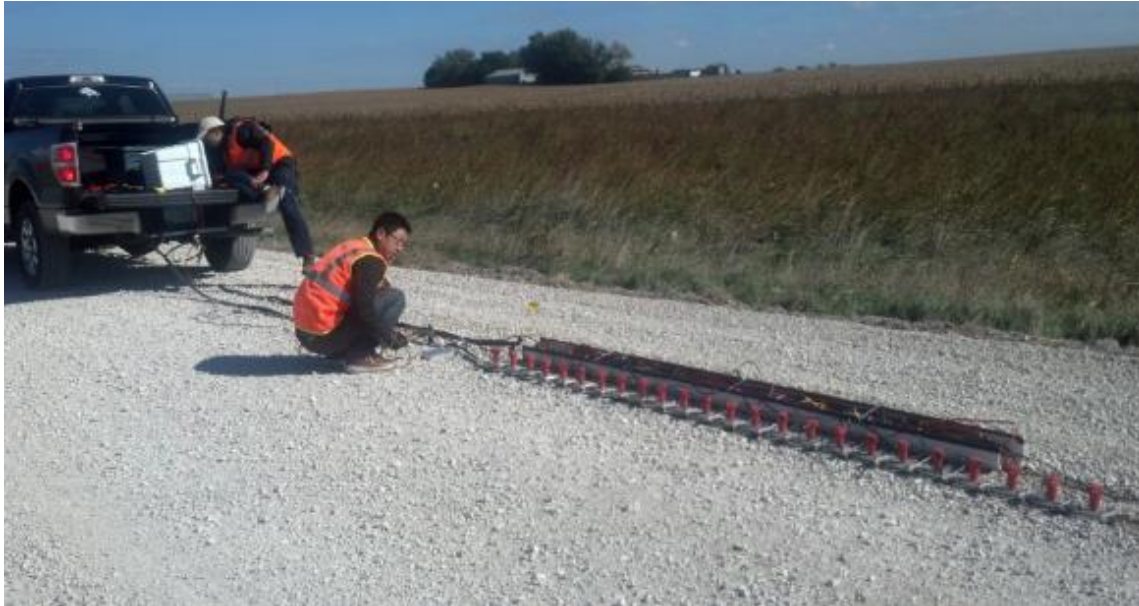
Figure 14. MASW test setup with landstreamer

The multi-channel analysis of surface waves (MASW) test was used to measure and compare stiffness of various road sections at relatively lower strain levels compared to the FWD test. Compared to the FWD test, a lower energy source and close receiver spacing was used to focus the measurements on the surface aggregate layer and top few inches of subgrade. The MASW test measures the seismic Rayleigh wave velocity as a function of frequency, from which the shear wave velocity, or alternatively, the small-strain shear modulus (G_{max}) can be determined as a function of depth for the surface course and subgrade (Lin and Ashlock 2011, Park et al. 1999). A triggered ball-peen hammer source was used to impact a 6 in. square by 1 in. thick aluminum plate resting on the road surface to generate the surface waves. The vertical velocity of the surface was measured by an array of twenty-four 4.5-Hz geophone receivers with 6 in. spacing using a custom-built land streamer. Data was recorded using a Geometrics Geode seismograph. The MASW test setup is shown in Figure 14. The MASW test configuration is summarized in Table 4.

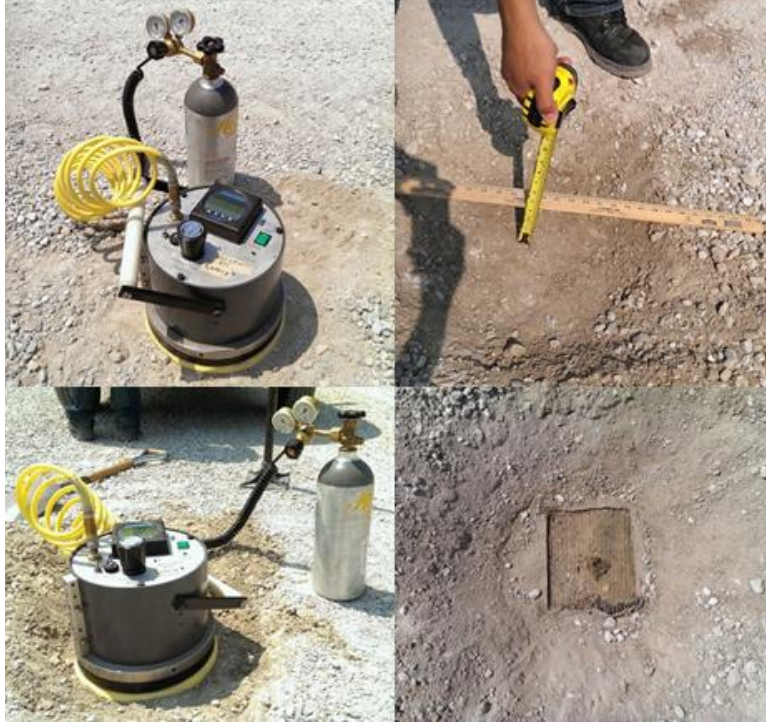
Figure 17. Air permeameter test

The air permeameter test (APT) was used to measure in situ saturated hydraulic conductivity as a function of depth for the surface course of the geocomposite drain section and a nearby control section. For the geocomposite section, after the last APT test, a piece of geocomposite was cut to examine whether it was damaged due to traffic loading. Figure 17 shows the APT test procedures used for this study.

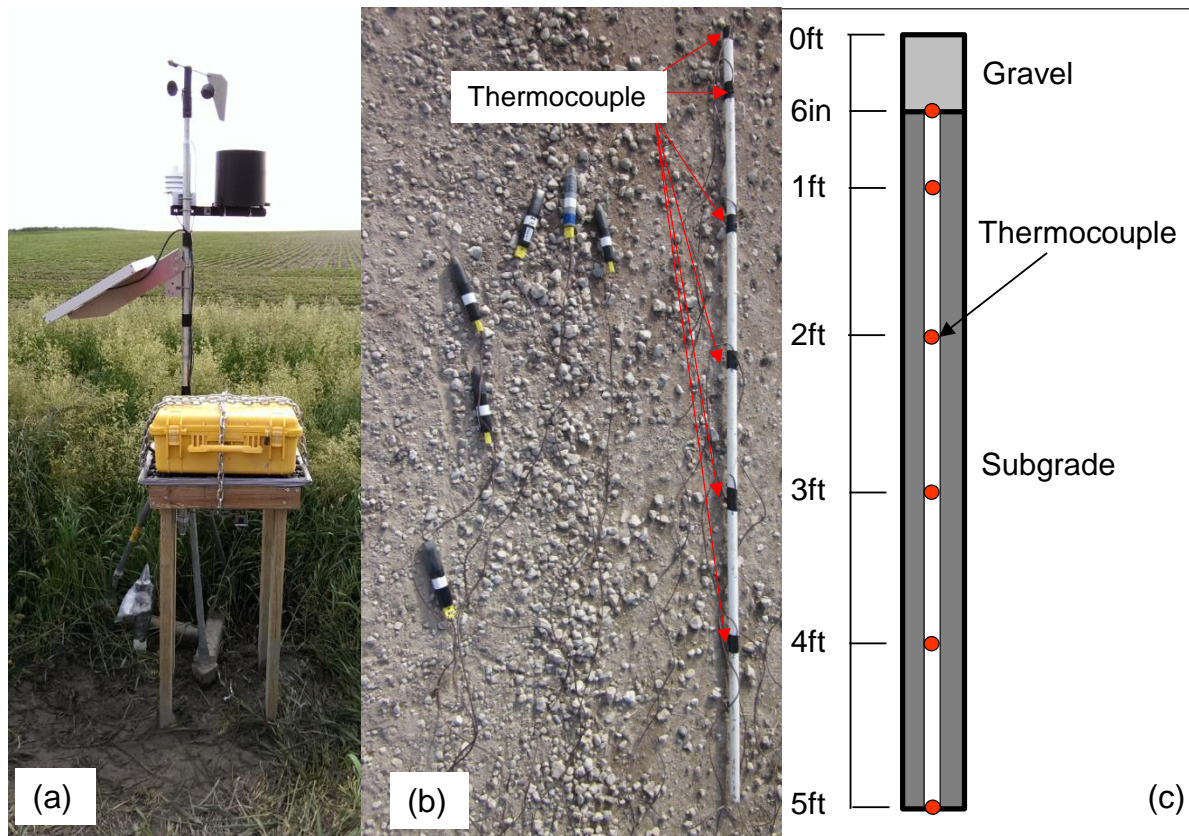
Figure 18. (a) Weather station, (b) thermocouples and data loggers, and (c) layout of thermocouples

To monitor the local weather conditions, ground temperature, and frost depth of a representative section of Vail Avenue, a weather station (Figure 18a) and six thermocouples (Figure 18b) were installed on November, 2013. The weather station (Novalynx model 110-WS-16) was installed to recorded average ambient air temperature, relative humidity, wind speed and direction, and precipitation at 15 minute intervals. Each of the type T thermocouples were connected to a separate battery-powered data logger that recorded ground temperature with 0.5 °F precision at 5 minute intervals. The locations of the thermocouples are shown in Figure 18c. The top sensor is at the boundary between the surface aggregate and subgrade, and the bottom sensor is 5 ft below the roadway surface

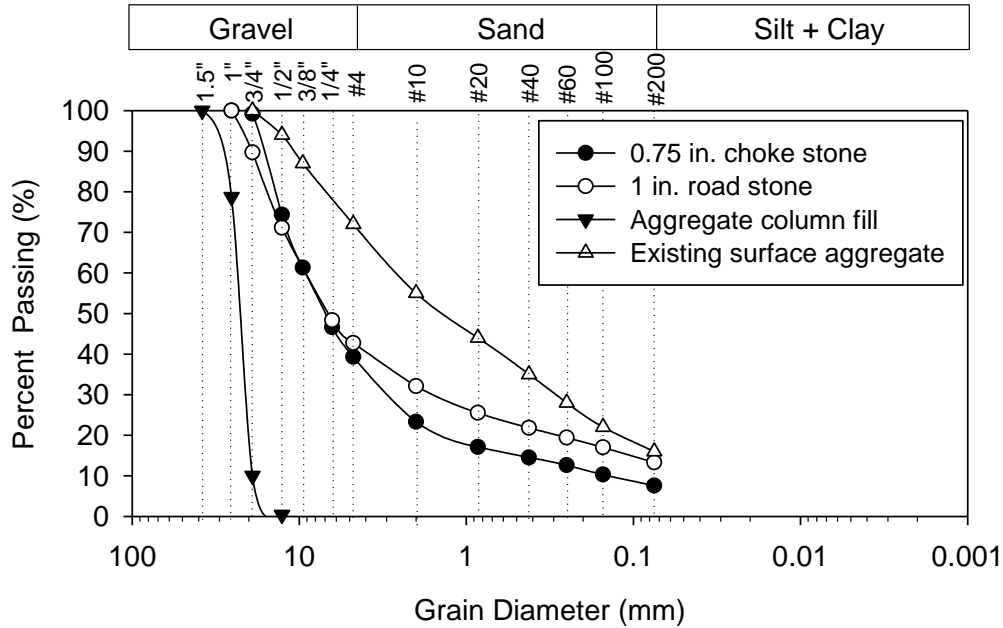
Figure 21. Particle size distribution curves of the four aggregate materials

Particle size analysis and Atterberg limits tests were conducted on the four types of aggregates to determine the material index properties. Particle size distribution curves of the four materials are shown in Figure 21. The gradation of the 1 in. road stone met the Iowa DOT specifications for Class A granular surfacing material (Gradation No.11 of the aggregate gradation table of Iowa DOT 2012). The gradation of the 0.75 in. choke stone met the Iowa DOT specifications for crushed stone base materials (Section 4122.02 of Iowa DOT 2012), which require 100% passing 3/4 in. or 1 in. and between 6% and 16% fines passing the #200 sieve.

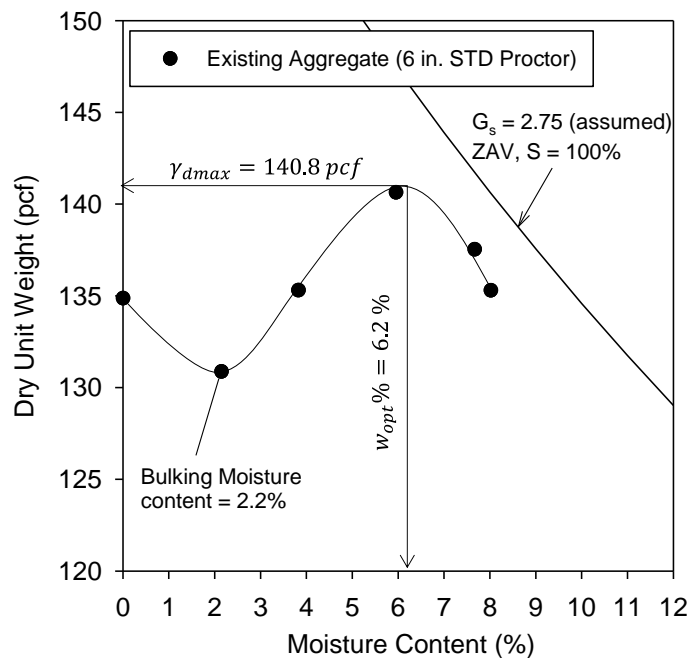
Figure 22. Proctor compaction curve for existing surface aggregate

The moisture-density relationships, optimum moisture contents, and maximum dry unit weights of the existing surface aggregate were determined using standard Proctor compaction tests with 6 in. diameter molds in accordance ASTM D 698-12e1. The bulking moisture content was determined to be 2.2% for this material, which corresponds to the lowest dry unit weight of the compaction curve. The optimum moisture content of the existing surface aggregate is approximately 6.2%, and the corresponding maximum dry unit weight is 140.8 pcf (Figure 22).

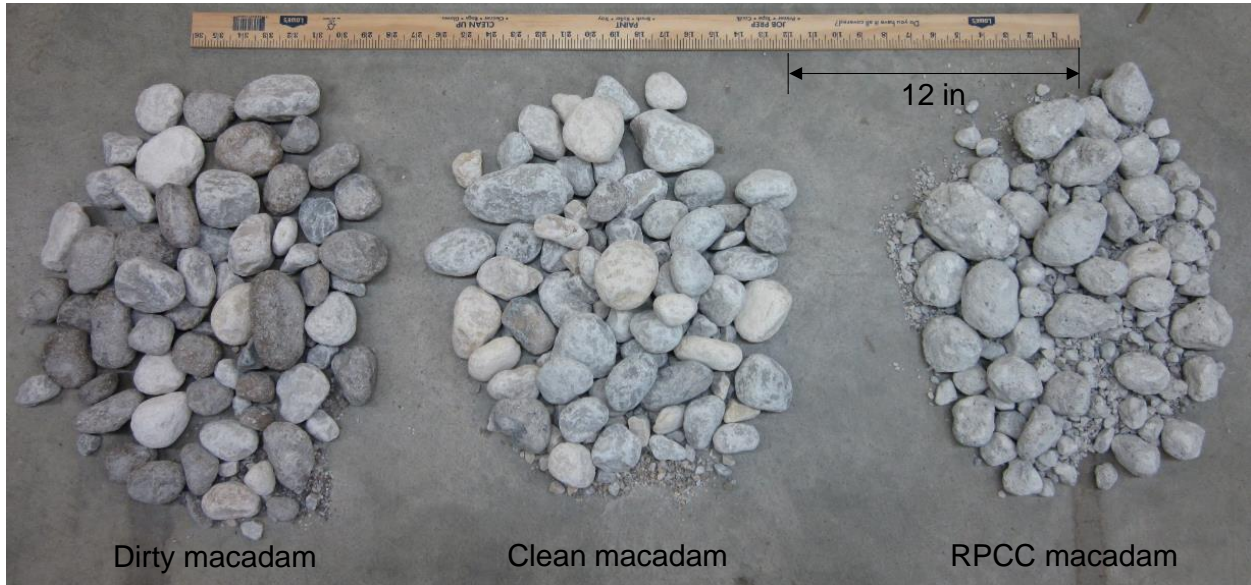
Figure 26 shows dirty, clean, and RPCC macadam specimens after the L.A. abrasion tests. Degradation of the RPCC macadam specimen was more severe than the clean and dirty macadam specimens.

Figure 26. Dirty, clean, and RPCC macadam specimens after L.A. abrasion tests

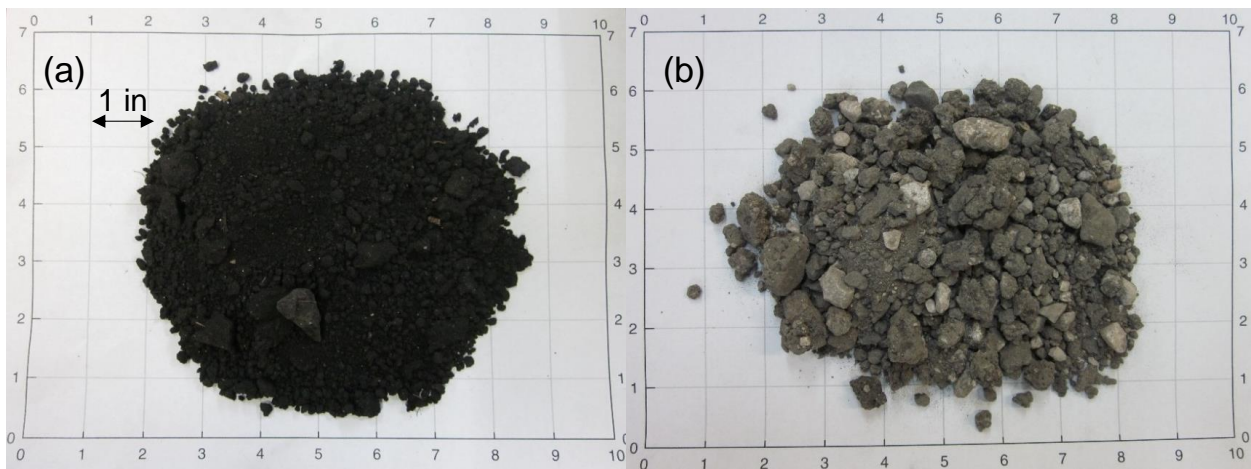
Figure 27. (a) Existing subgrade with 9.0% moisture content and (b) SG+AGG mixture with 1.0% moisture content

Representative samples of the subgrade and existing surface aggregate materials were collected from Vail Avenue. In this project, the subgrade (SG) was also mixed with the existing surface aggregate (AGG) for construction of the cement- and fly ash-stabilized sections. The SG+AGG mixture consisted of 63% SG (5 in.) and 37% AGG (3 in.) by volume. Figure 27 shows the two types of materials.

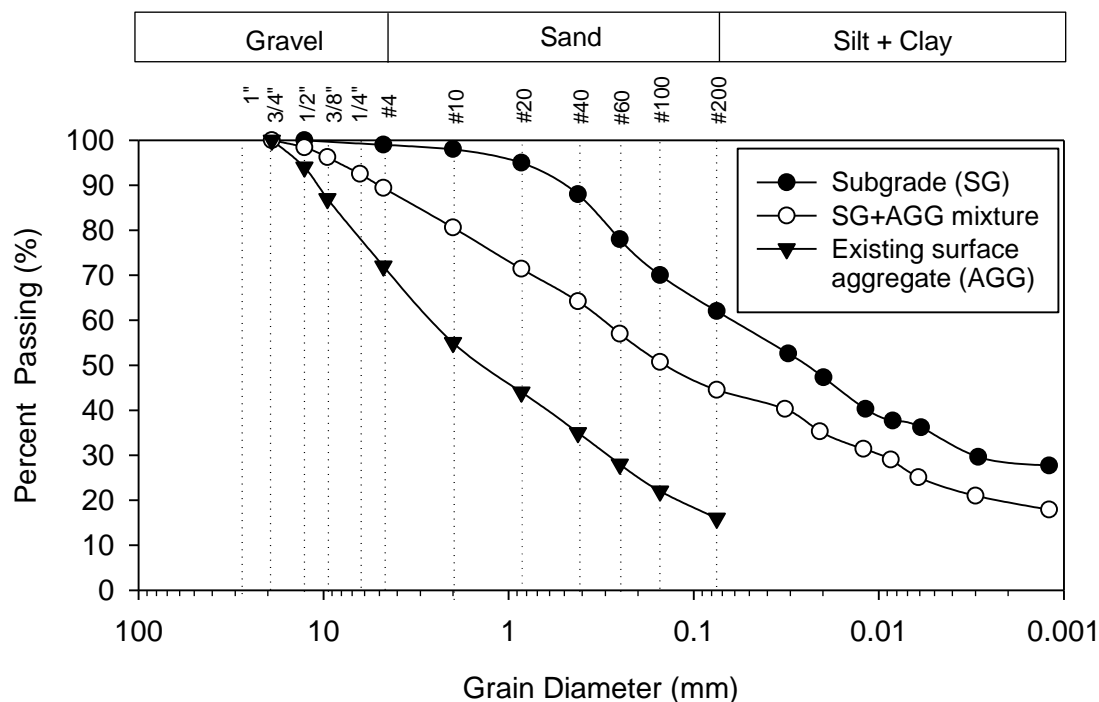
Figure 28. Particle size distribution curves of existing subgrade, surface aggregate, and subgrade-aggregate mixture

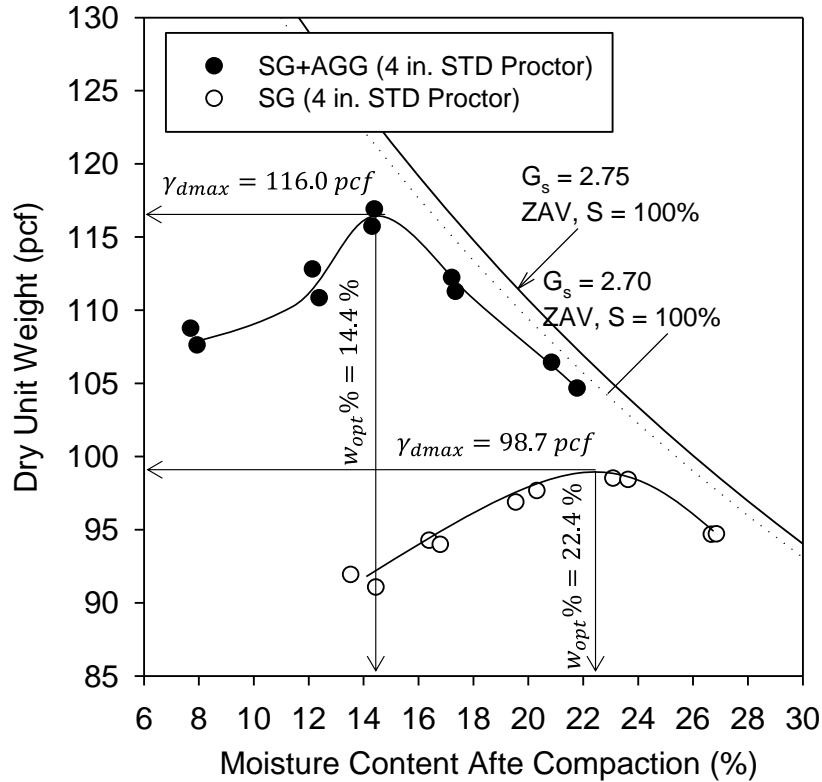
Figure 29. Proctor compaction curves for subgrade and subgrade-aggregate mixture.

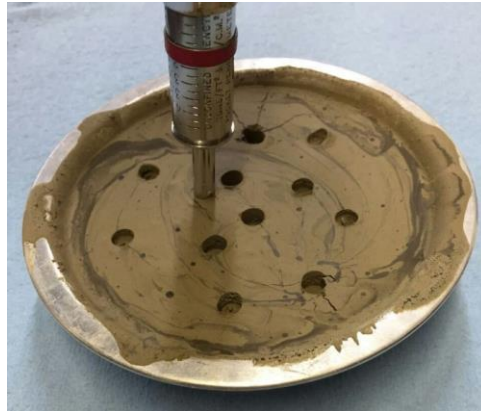
Figure 30. Fly ash set-time test

According to White et al. (2005a), the fly ash set time can significantly influence the compaction behavior and strength gain of the soil-fly ash mixture. White et al. (2005a) also found that class C fly ash is a highly variable material, with significant variation in set time between different fly ash sources. Representative fly ash samples were collected during construction of the demonstration sections and their set time was measured using the method of White et al. (2005a). Specimens were mixed to 27.5% moisture content in a shallow dish, and a pocket penetrometer was used to measure penetration resistance versus time as shown in Figure 30.

The measurement range of the pocket penetrometer was 4.5 tsf, so the final set time was recorded when the penetration resistance reached 4.5 tsf. Three replicate tests were conducted on representative fly ash specimens collected during construction of Section 16. The average initial and final set times were 5 and 9 minutes, respectively (Figure 31), which are quick relative to class C fly ash specimens from 13 different Iowa generation stations tested by White et al. (2005a).

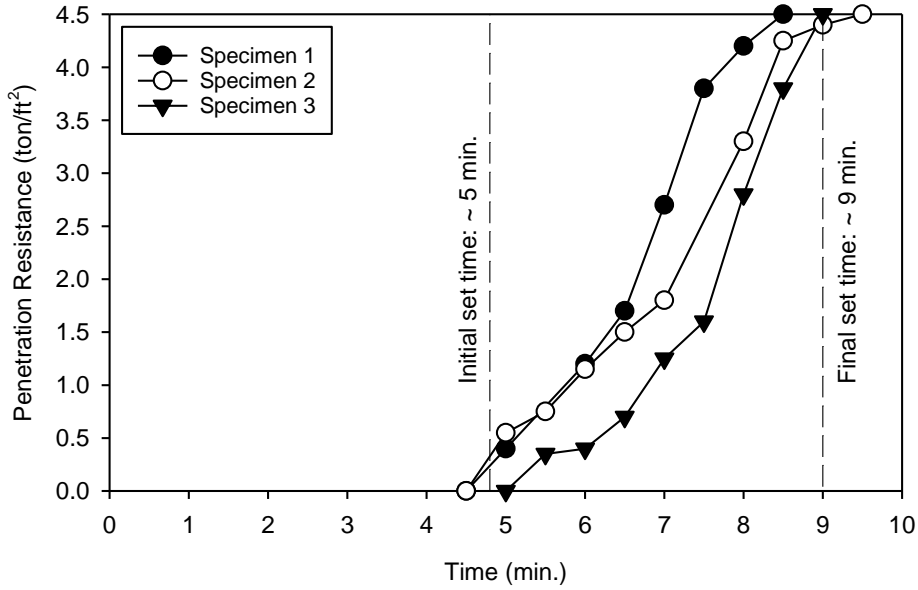
Figure 31. Set time of fly ash used for construction of Section 16

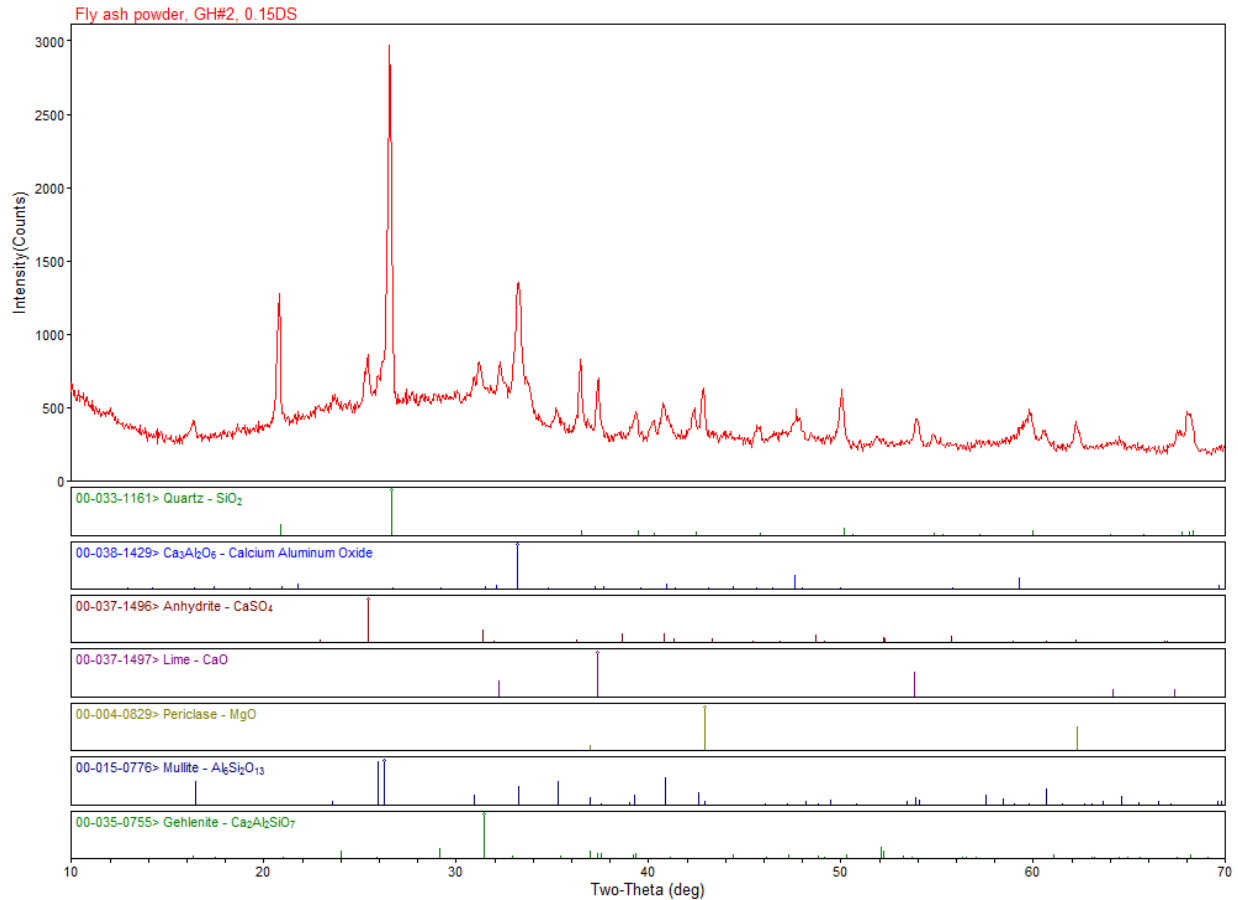
Figure 32. XRD results for fly ash of Section 16

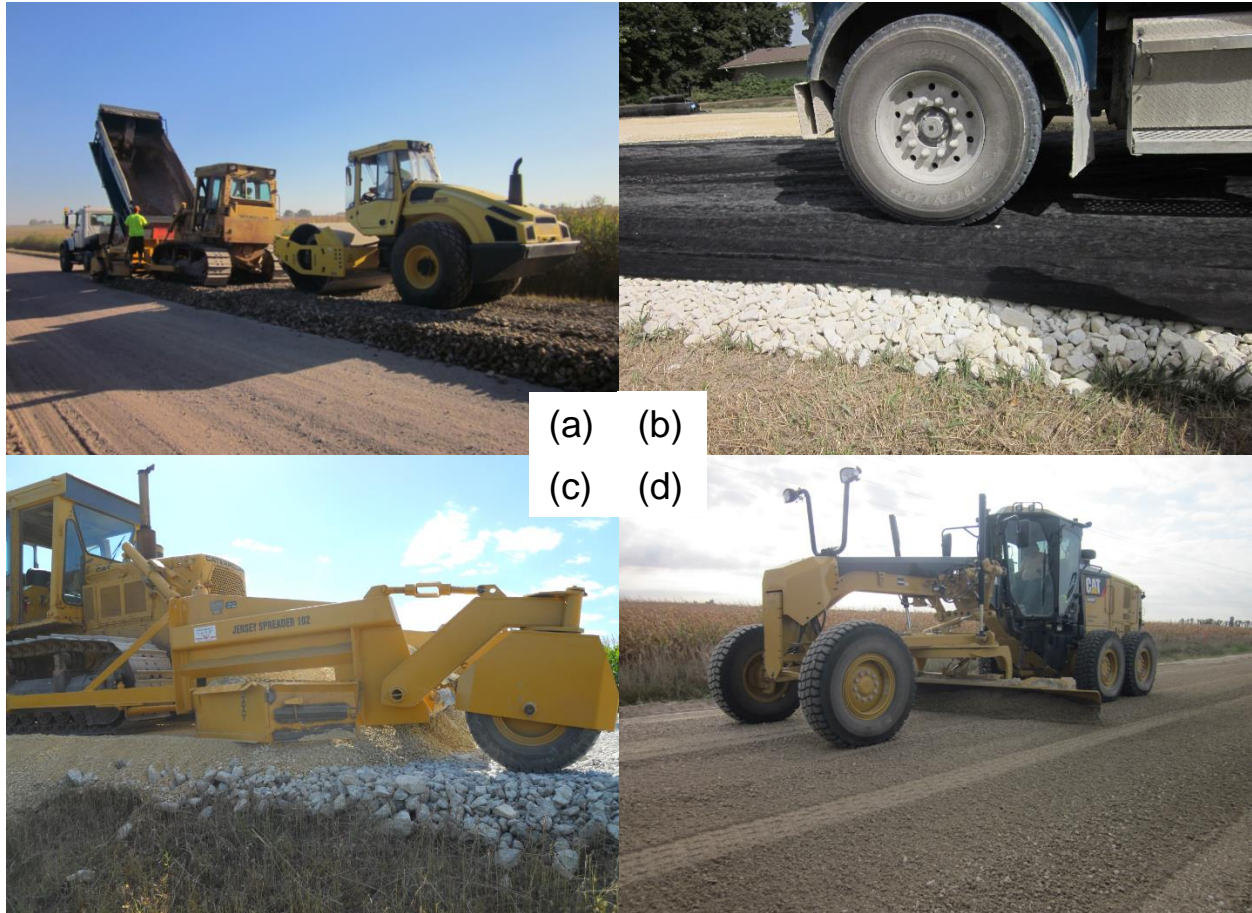
Figure 37. Construction procedures and equipment for Sections 1-8 with macadam base courses: (a) placing macadam with Jersey spreader, (b) non-woven geotextile interlayer, (c) spreading choke stone with Jersey spreader, and (d) shaping with motor grader

The construction procedures and equipment used for these macadam base sections are shown in Figure 37. The macadam materials were placed in one lift on top of the existing road surface using a Jersey Spreader (Caterpillar 102) and compacted by a smooth drum vibratory roller compactor (Bomag BW211-D40) as shown in Figure 37a. The thickness of the macadam base layer was approximately 6 in. after compaction. For Sections 3, 4, 5, and 8, the non-woven geotextile was placed on top of the macadam base layer to provide planar subsurface drainage and maintain separation between the macadam and choke stone layers (Figure 37b). The average thickness the choke stone layers in each section varied between 2 and 3 in. (Figure 37c). Above the choke stone layer, a road stone layer approximately 2 to 3 in. thick was built as a surface course for these sections. During construction, where the aggregate materials were very dry, a water truck was used to increase the water content and reach a greater degree of compaction. After compaction of the surface course, the road was shaped to a 4% crown using a motor grader (Caterpillar 12M2) as shown in Figure 37d. The construction speed for the macadam base sections depended highly on the availability of trucks for hauling materials from the quarry, which is 26 miles from the project site. For future projects, access to a quarry closer to the construction site can potentially provide significant savings on construction costs.

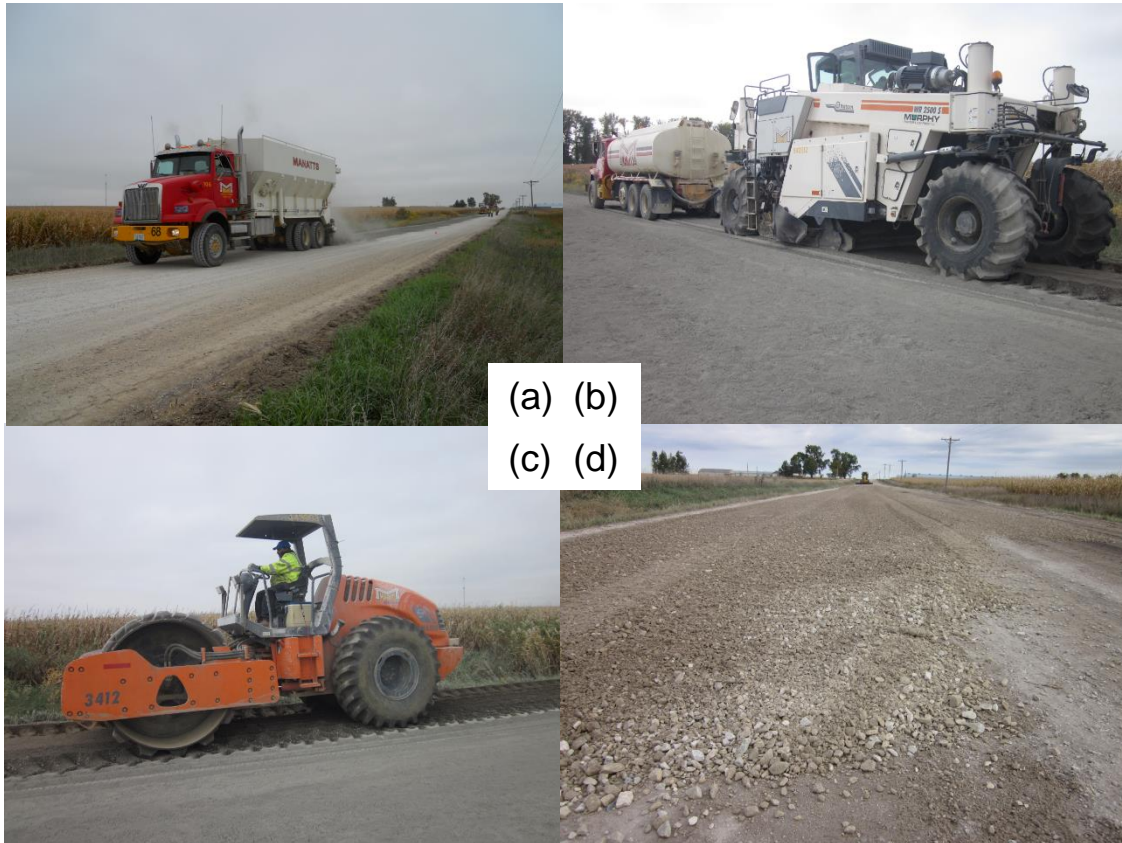
Figure 40. Construction procedures and equipment for chemically stabilized Sections 15, 16, and 17: (a) powder truck for spreading bentonite, fly ash, and cement, (b) full depth reclaimer connected to water truck milling chemical stabilizers to the specified depth and water content, (c) vibratory pad-foot roller following the full depth reclaimer, and (d) 1 in.-thick road-stone wearing surface

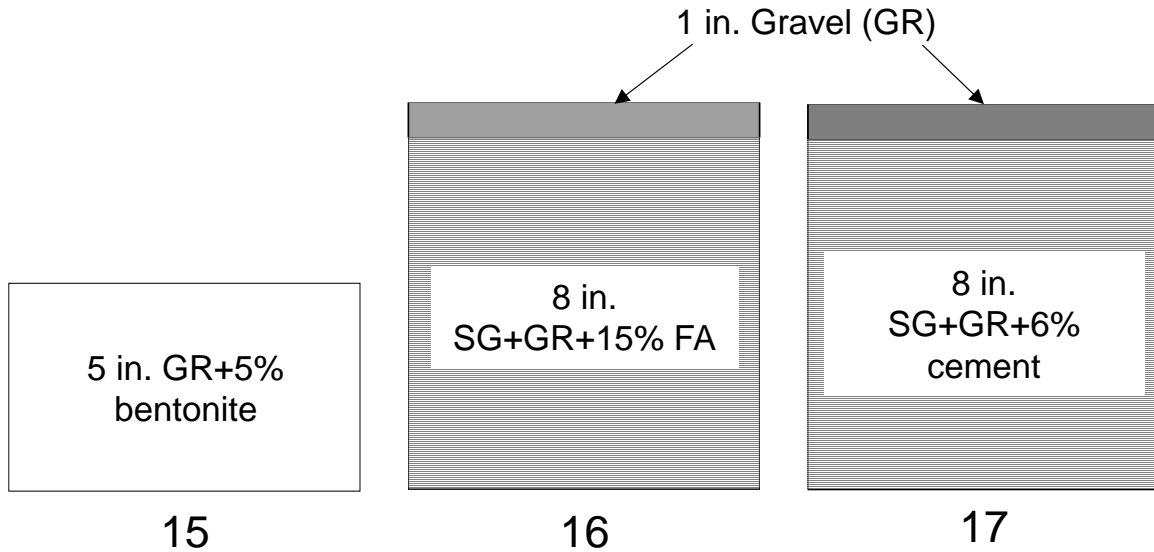
Figure 41. Typical surface course cross-sectional profiles of chemically-stabilized Sections 15, 16, and 17

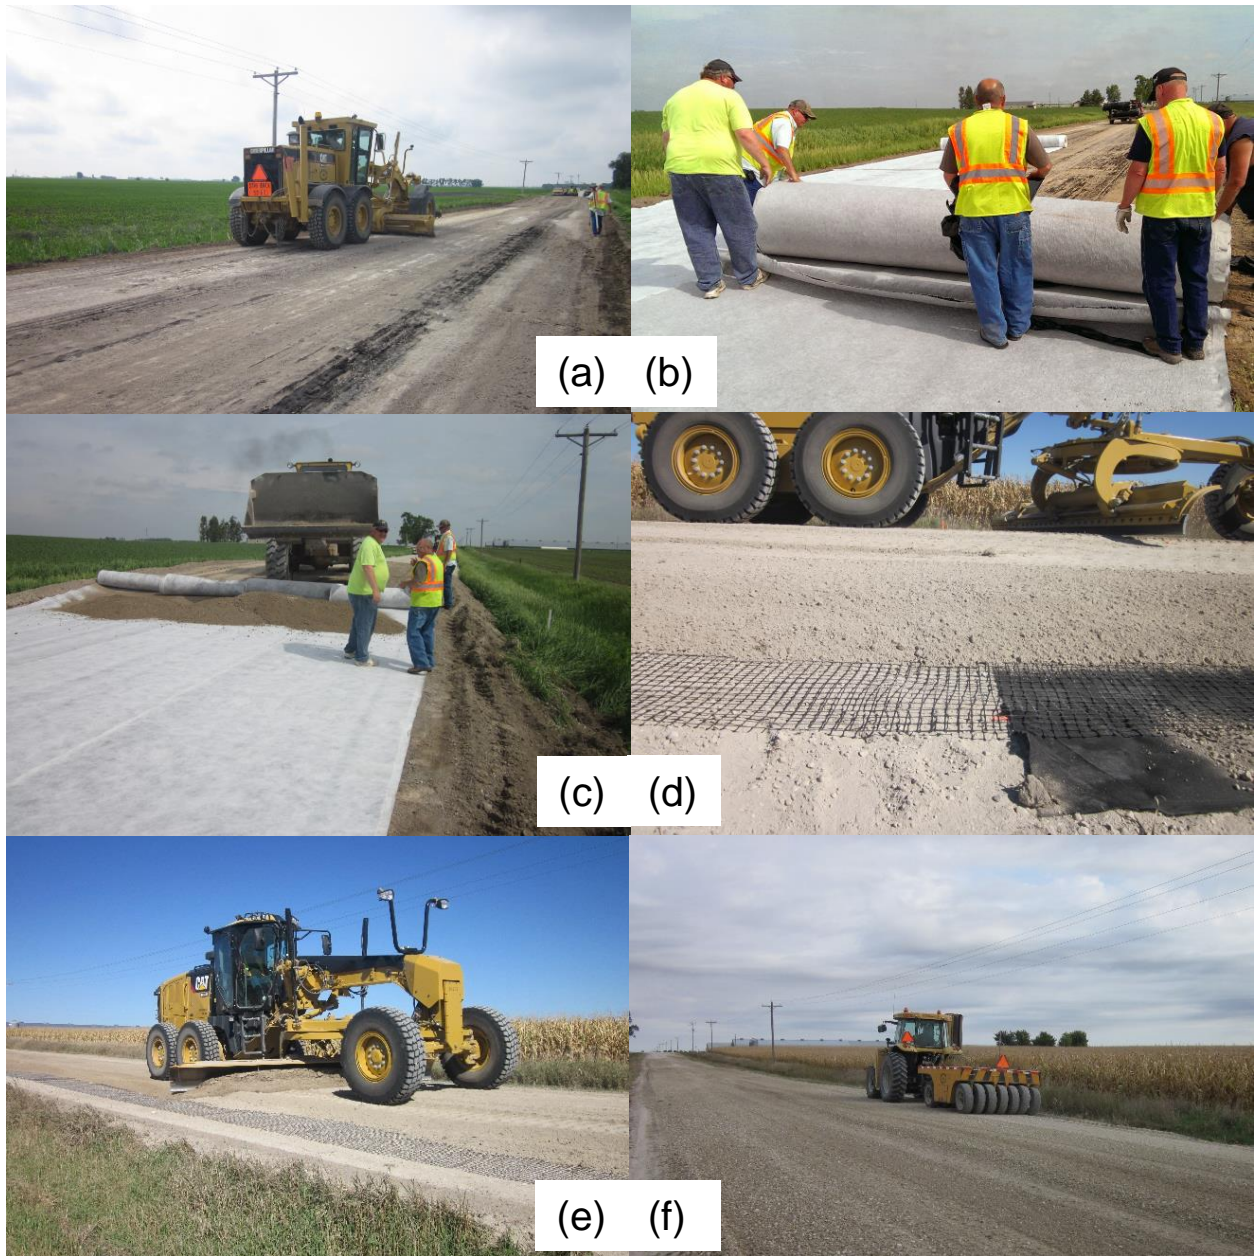
Figure 42. Construction procedures and equipment for geosynthetically stabilized sections: (a) removal of existing surface, (b) geocomposite in Section 18, (c) replacement of surface course by earth mover for geocomposite Section 18, (d) BX geogrid in Section 19B on left with added non-woven geotextile in Section 19A on right, (e) replacement of surface course by motor grader for Sections 19A and 19B, and (f) compaction by rubber-tire compactor

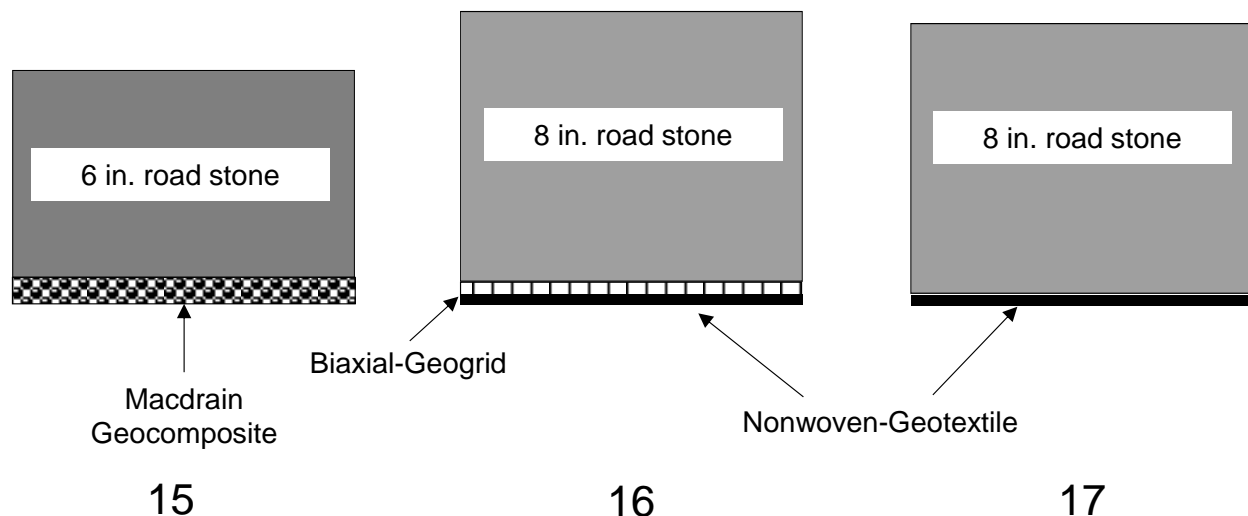
Figure 43. Typical surface course cross-sectional profiles of geosynthetically stabilized Sections 18, 19A, and 19B

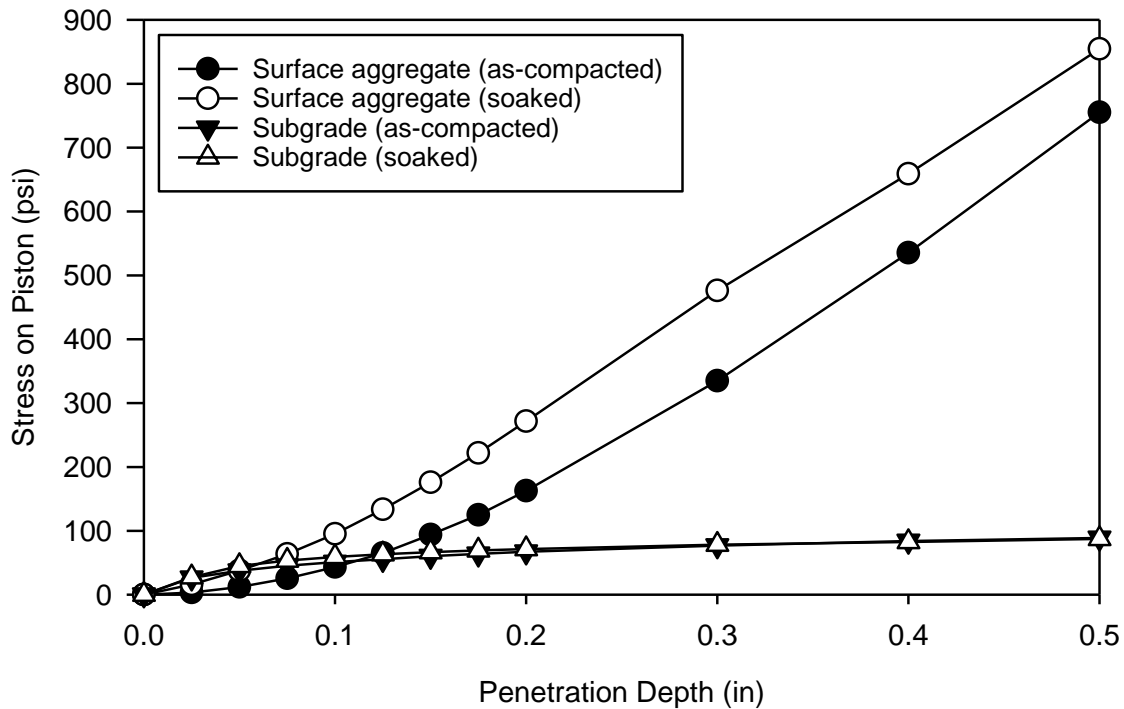
Figure 47. Uncorrected stress on piston versus penetration depth from CBR tests on surface aggregate and subgrade

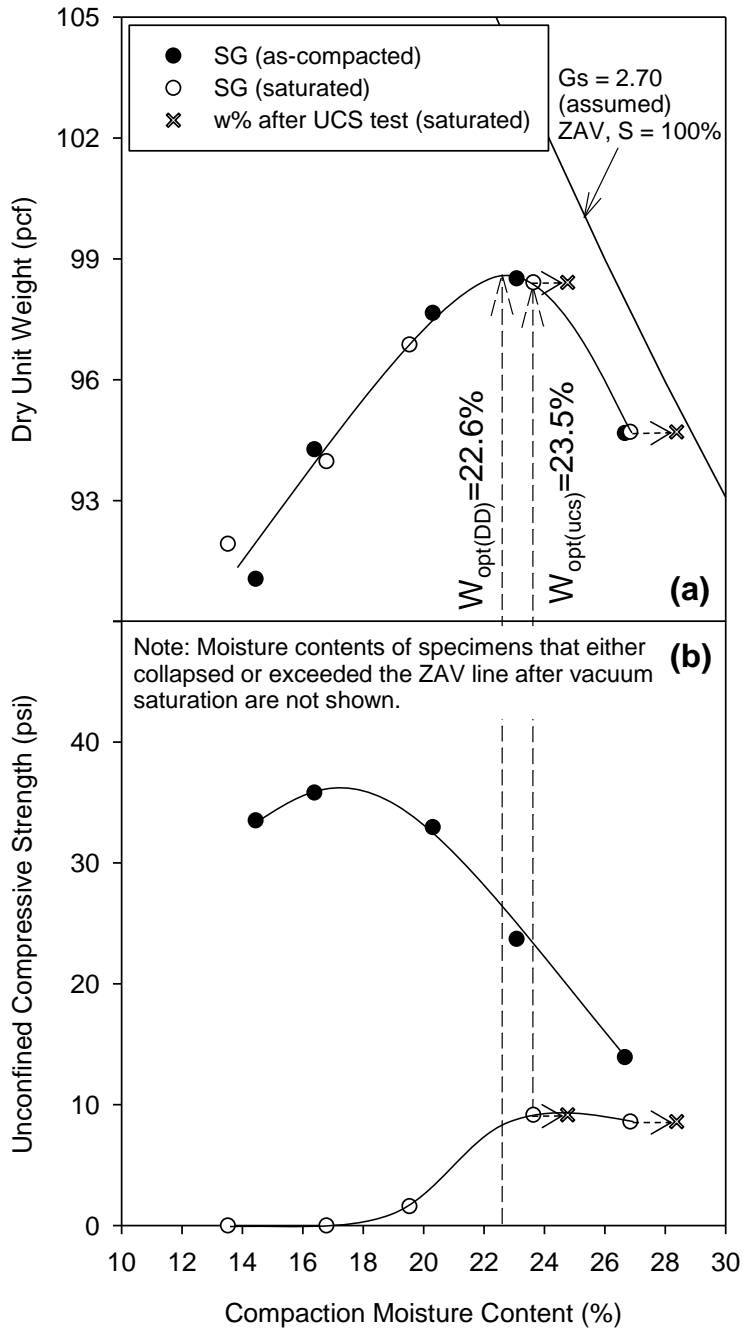
Figure 48. (a) Standard Proctor compaction and (b) UCS test results for the as-compacted and vacuum-saturated subgrade
