Low-Cost Rural Surface Alternatives: Demonstration Project

**Final Report
June 2015**

IOWA STATE UNIVERSITY
Institute for Transportation

Sponsored by
Iowa Highway Research Board
(IHRB Project TR-664)
Iowa Department of Transportation
(InTrans Project 13-479)

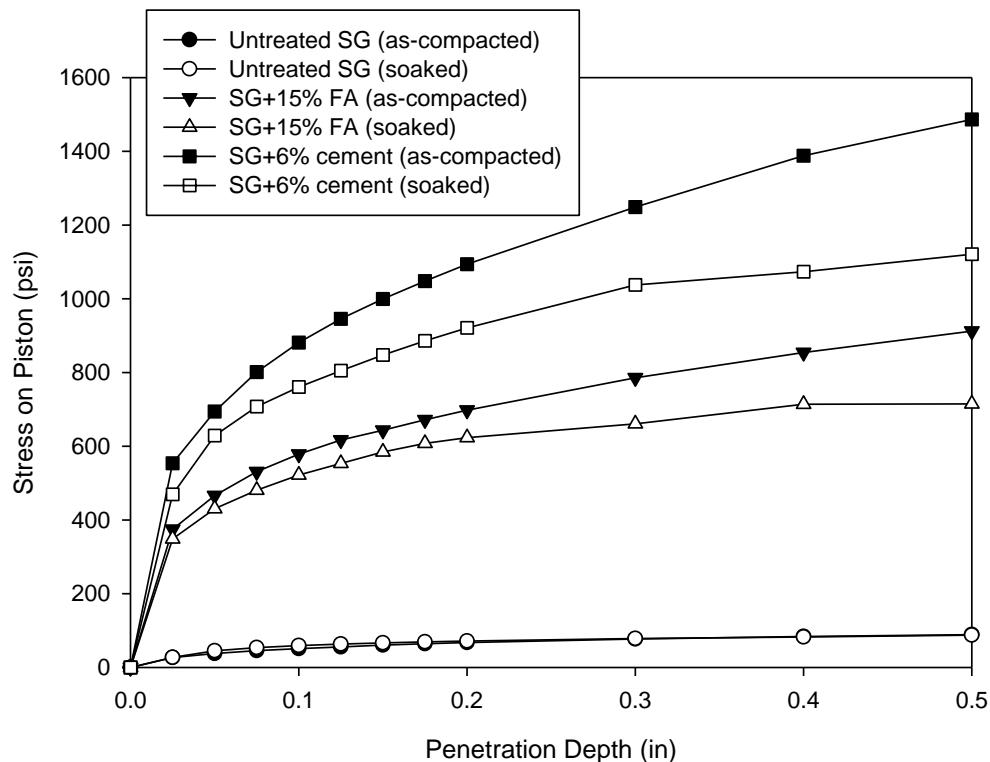
Figure 49. Uncorrected stress on piston versus penetration depth for CBR tests on untreated, fly ash-stabilized, and cement-stabilized subgrade

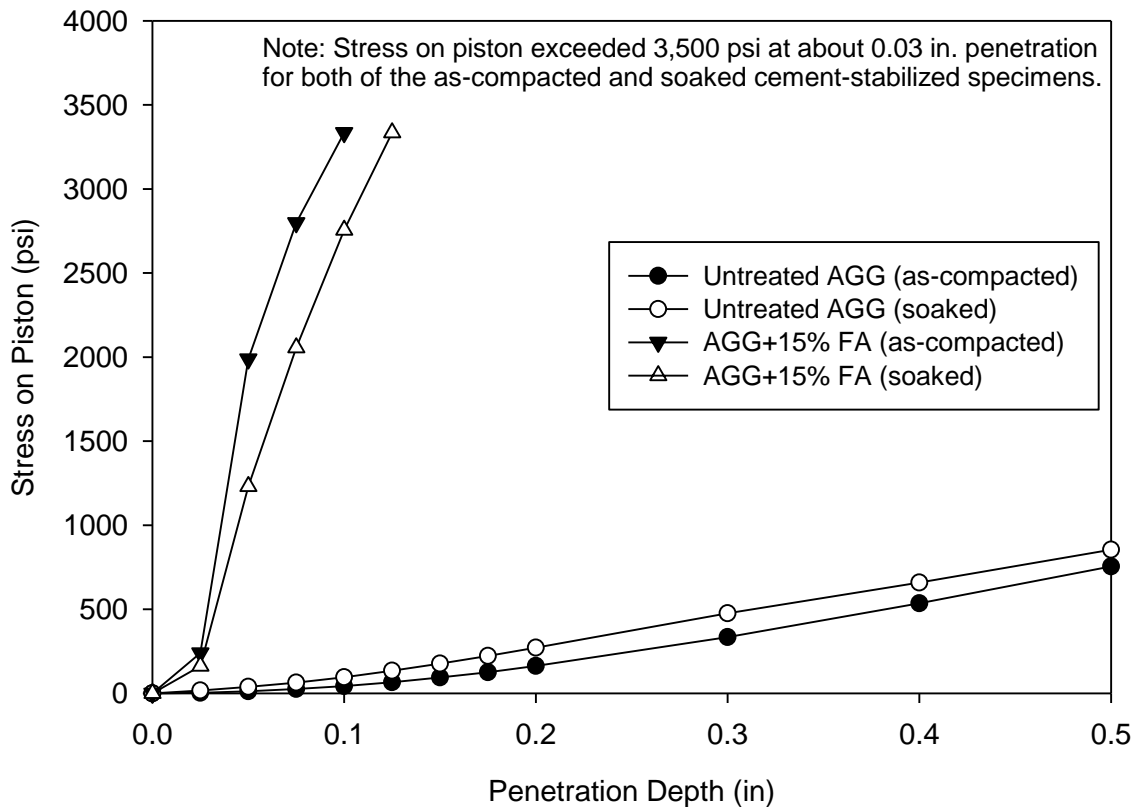
Figure 51. Uncorrected stress on Piston versus penetration depth for CBR tests on untreated and fly ash-stabilized surface aggregate specimens

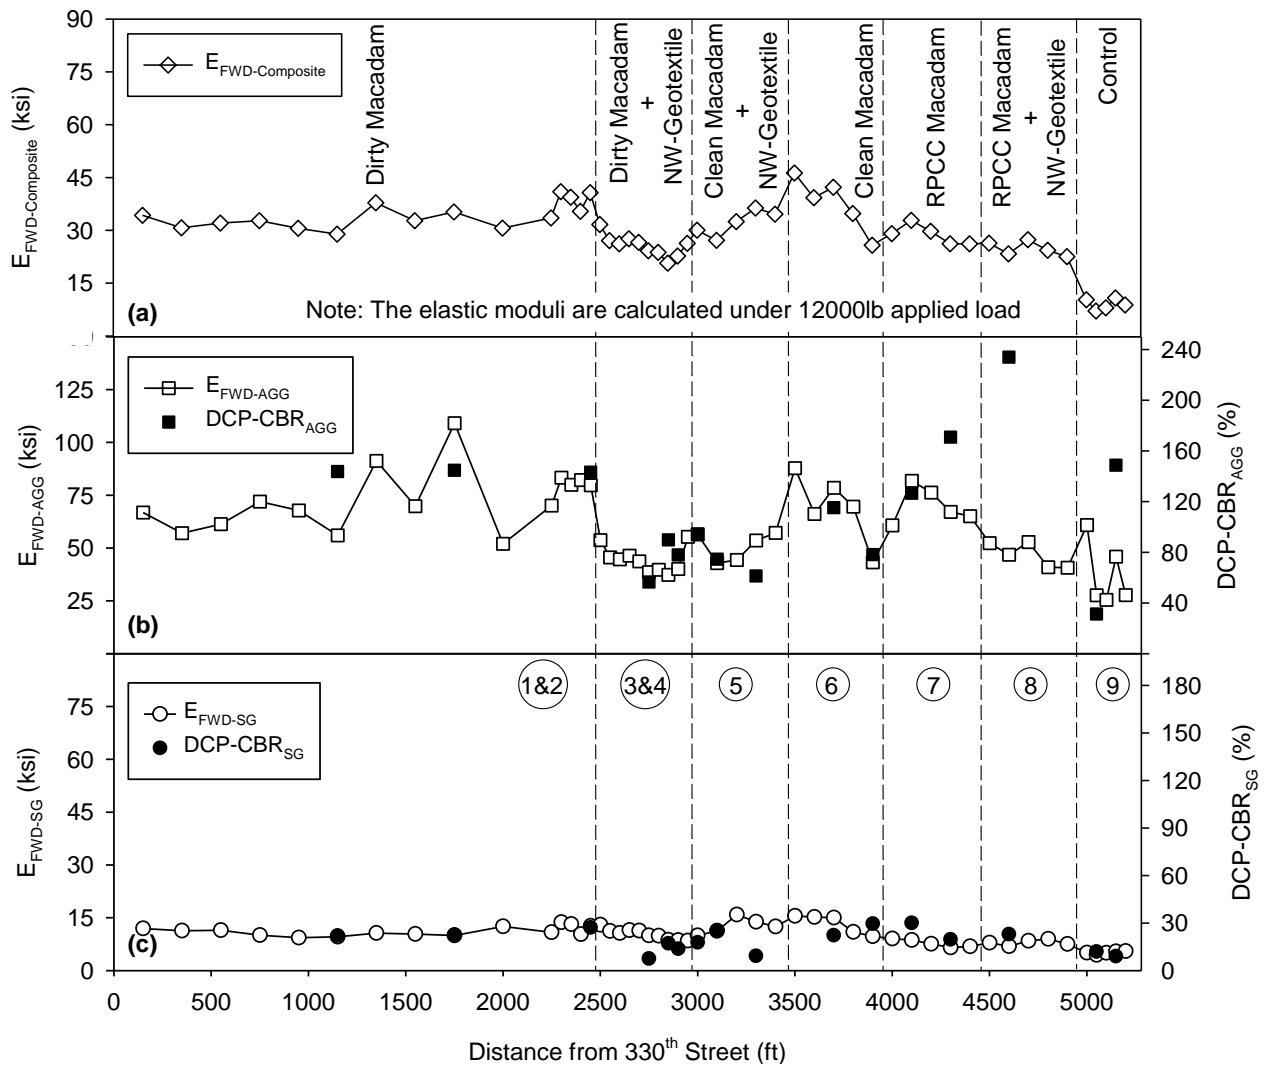
Figure 58. 2013 FWD and DCP test results for as-constructed first-mile Sections 1–9: (a) $E_{FWD-Composite}$, (b) $E_{FWD-AGG}$ and $DCP-CBR_{AGG}$ of combined surface course, and (c) E_{FWD-SG} and $DCP-CBR_{SG}$ of subgrade

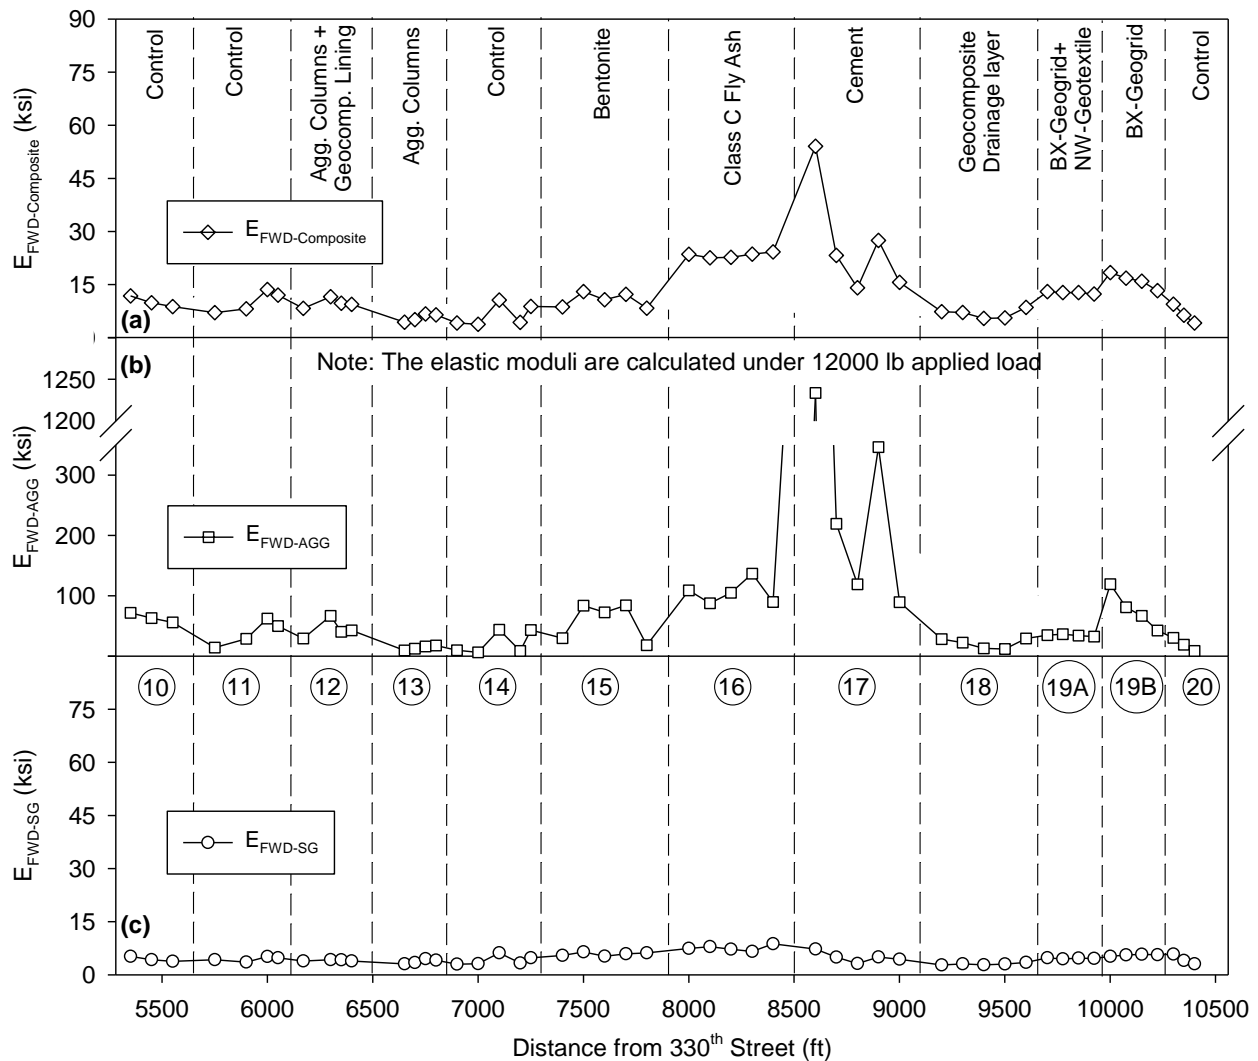
Figure 61. 2014 FWD test results for second-mile Sections 10–20: (a) $E_{FWD-Composite}$, (b) $E_{FWD-AGG}$, and (c) E_{FWD-SG}

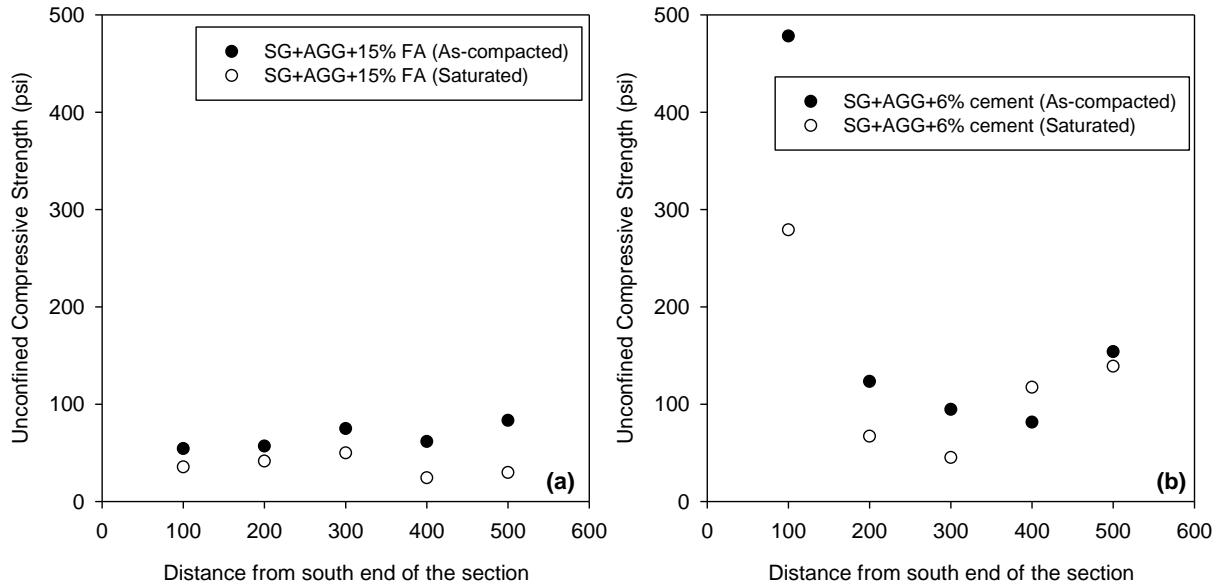
Figure 69. UCS test results of field-compacted (a) fly ash-stabilized and (b) cement-stabilized SG+AGG specimens at 7 days curing

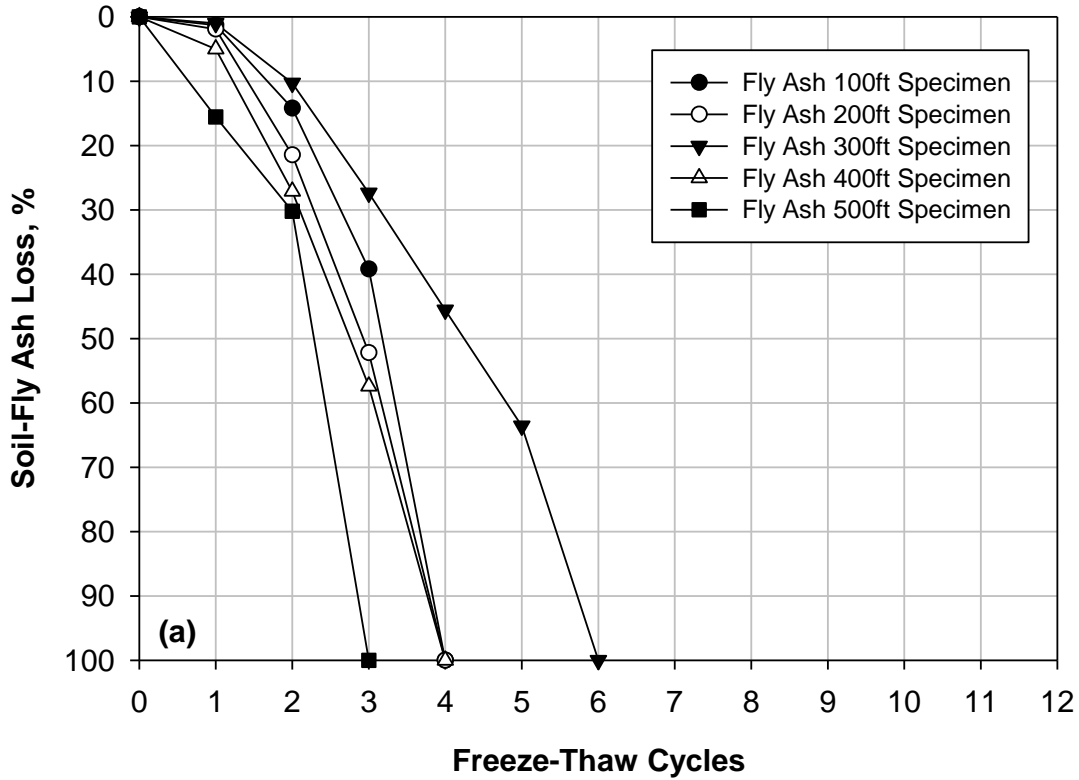
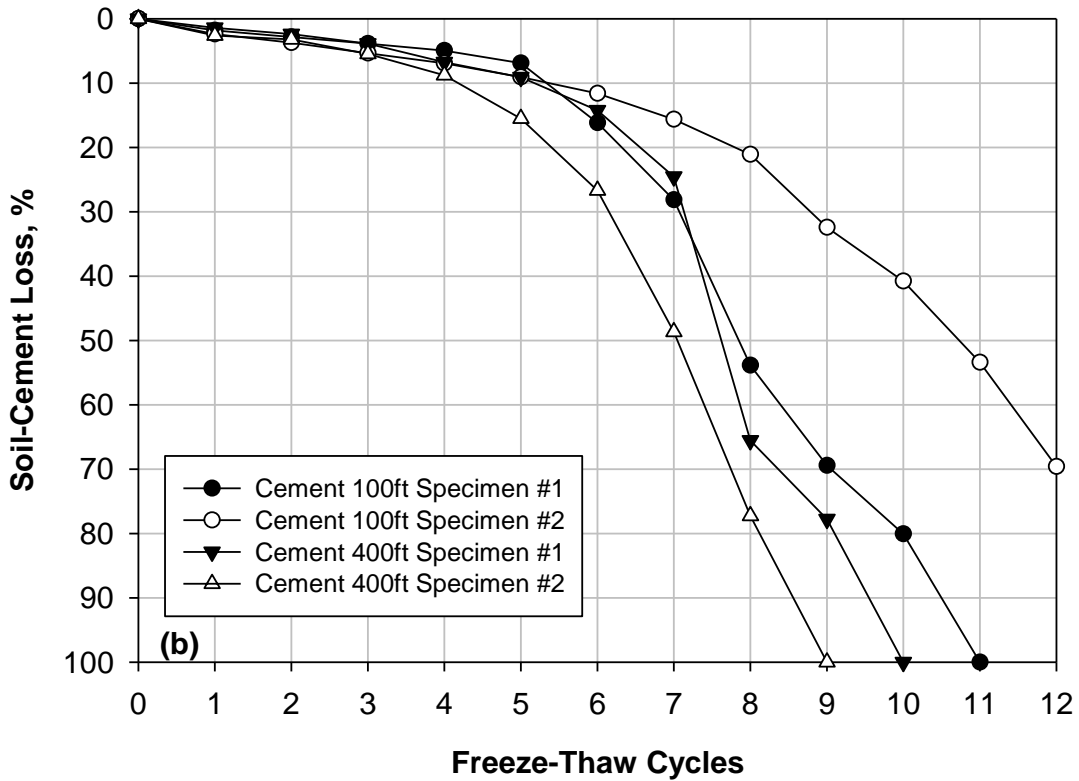
Figure 73. Mass changes of (a) fly ash-stabilized and (b) cement-stabilized aggregate-subgrade mixture specimens during freeze-thaw cycling

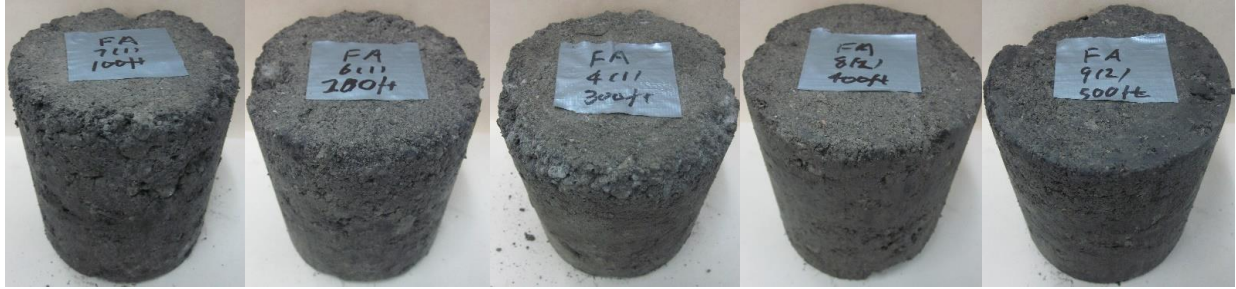
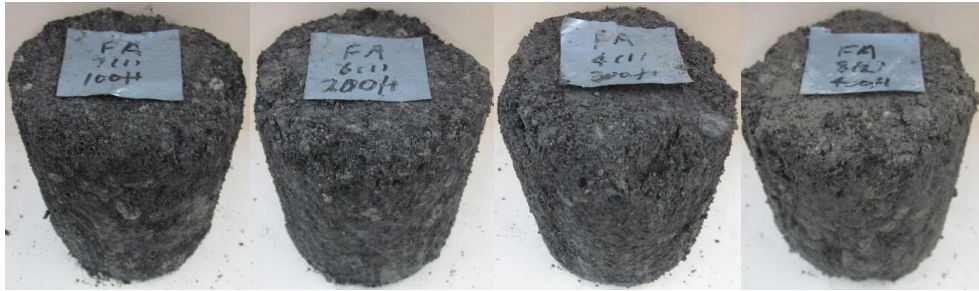
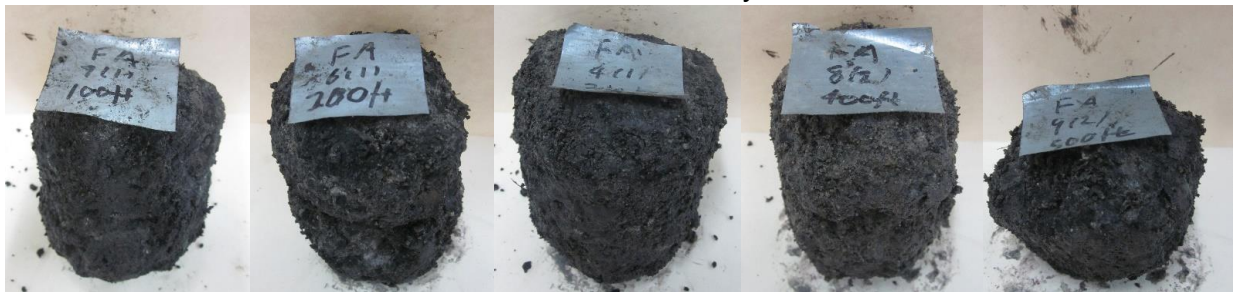
Before Test

After 1st freeze-thaw cycle

After 3rd freeze-thaw cycle

Figure 75. Photos of fly ash-stabilized specimens after freeze-thaw cycles

The percent mass changes during freeze-thaw and wet-dry cycling of the fly ash- and cement-stabilized specimens are shown in Figure 73 and Figure 74, respectively. The results show that the cement-stabilized aggregate-subgrade mixture specimens provide better durability than the fly ash-stabilized specimens as expected. Photographs of each specimen after each freeze-thaw or wet-dry cycle are shown in Figure 75 through Figure 78.

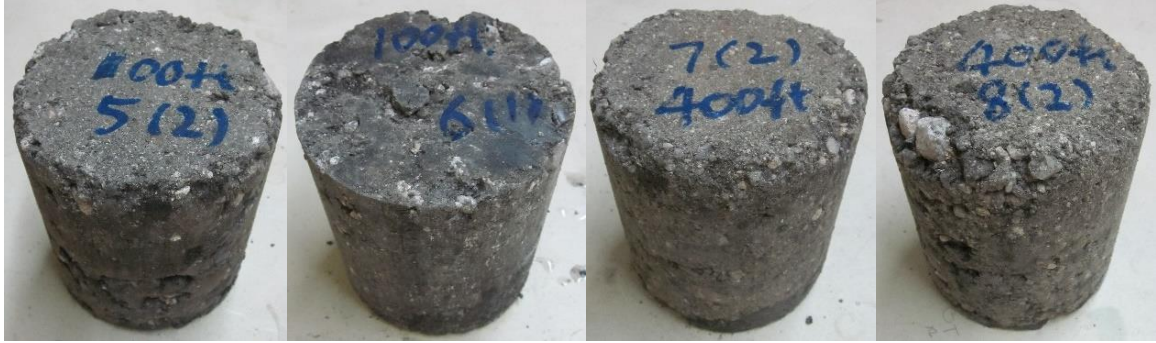
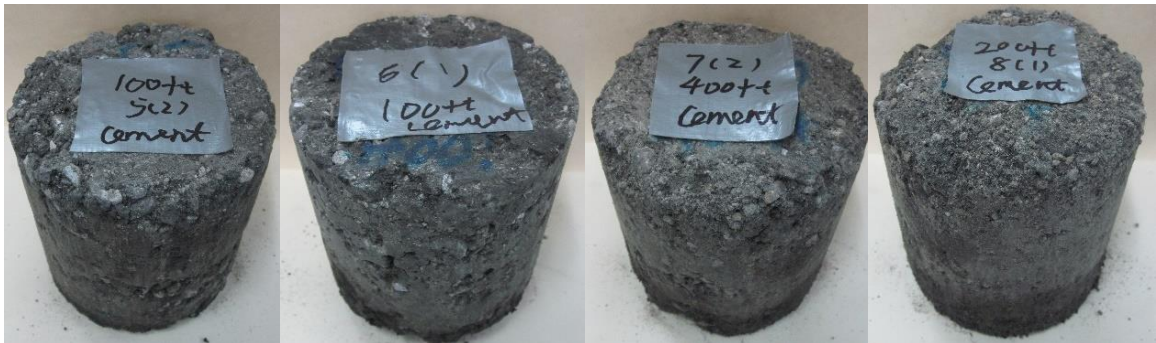
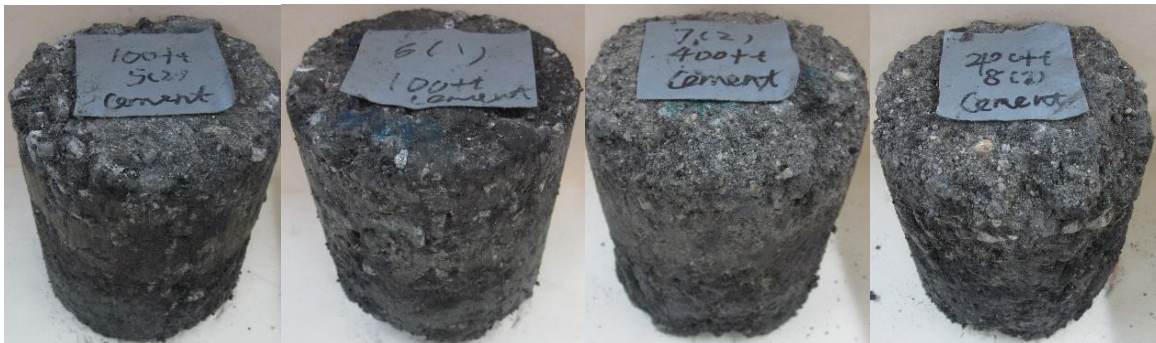
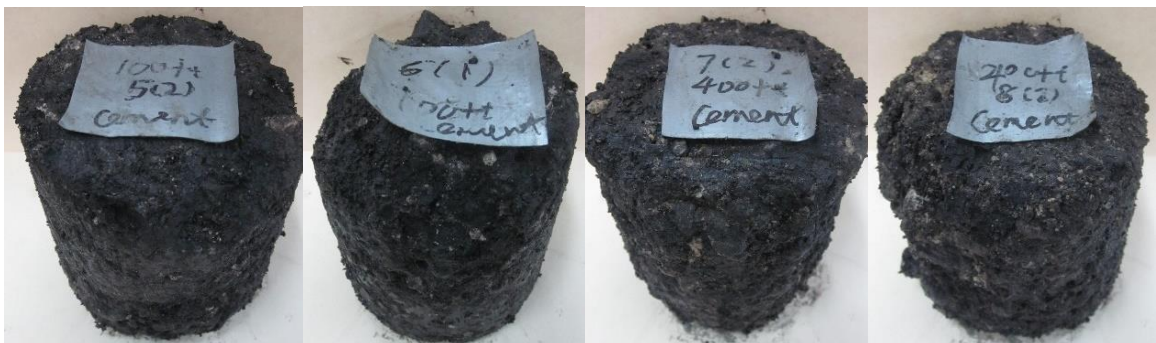
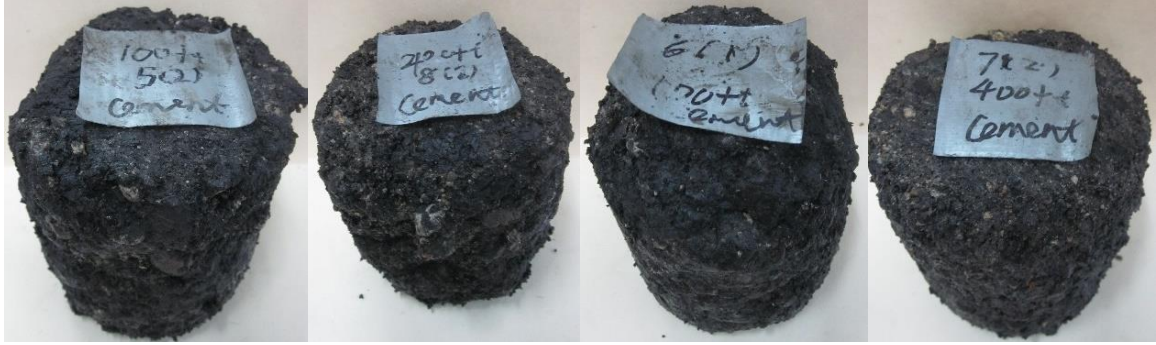
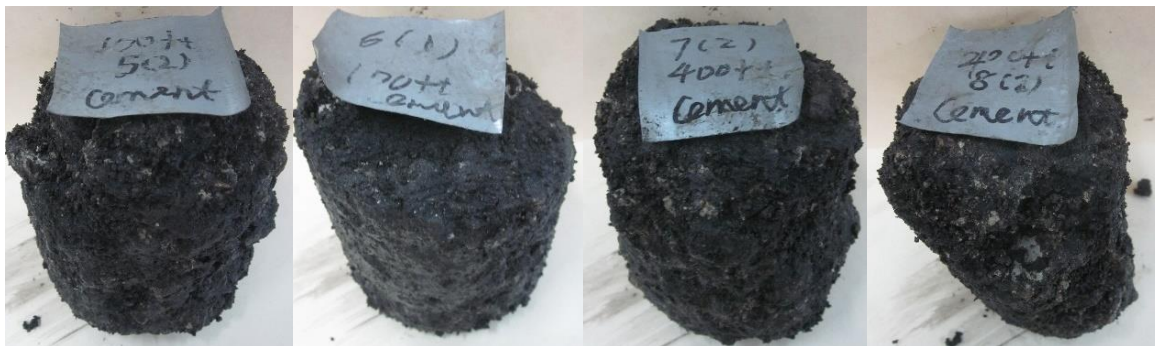
Before Test

After 1st freeze-thaw cycle

After 2nd freeze-thaw cycle

After 4th freeze-thaw cycle

Figure 76. Photos of cement-stabilized specimens after freeze-thaw cycles

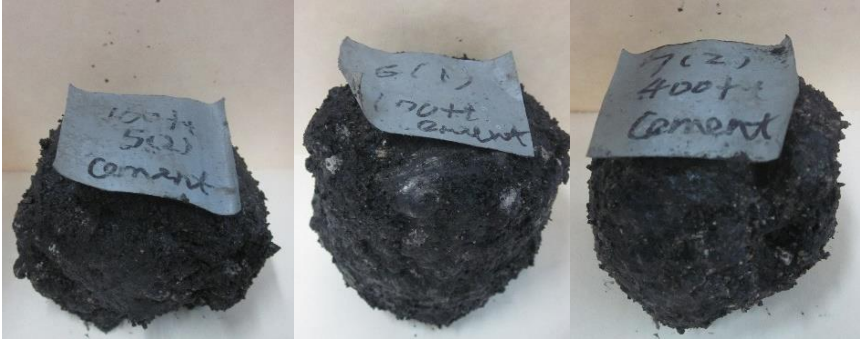
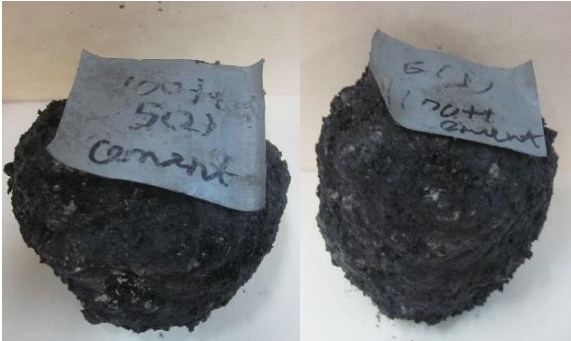
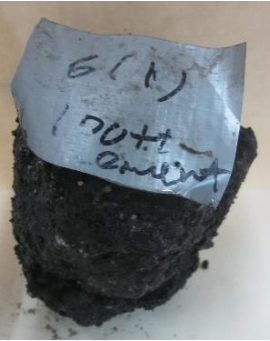
After 9th freeze-thaw cycle

After 10th freeze-thaw cycle

After 12th freeze-thaw cycle

Figure 76 (continued). Photos of cement-stabilized specimens after freeze-thaw cycles

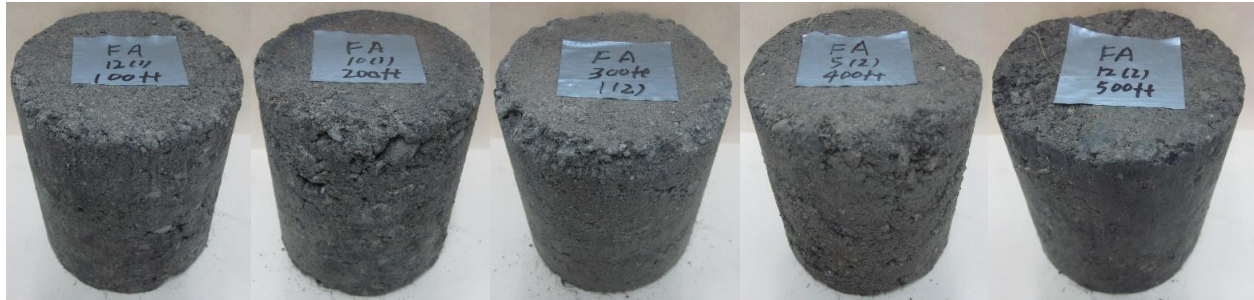
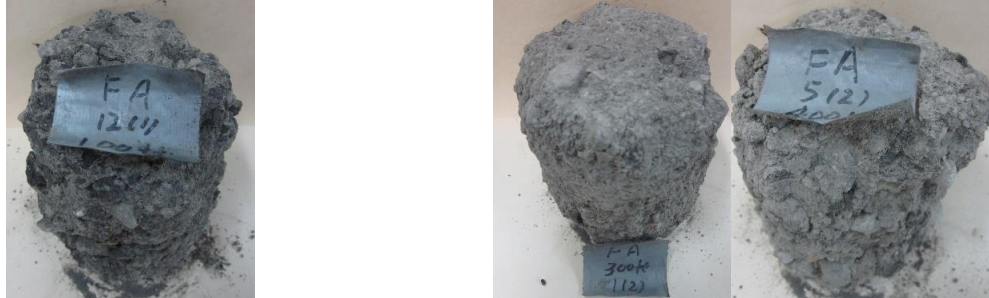
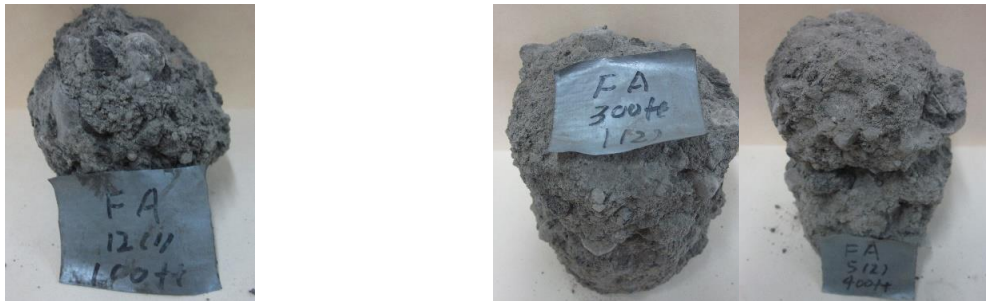
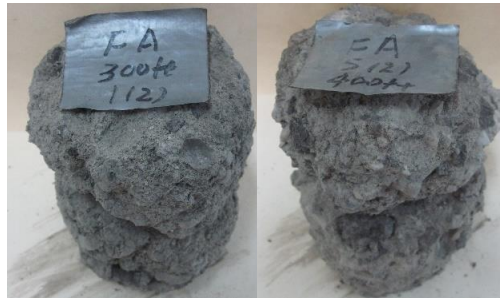
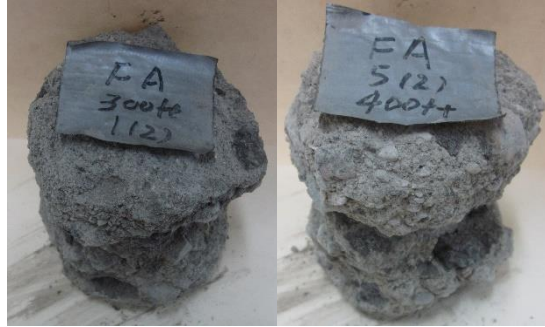
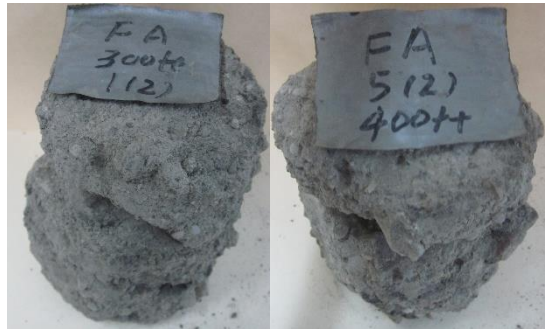
Before test

After 2nd wet-dry cycle

After 3rd wet-dry cycle

After 4th wet-dry cycle

Figure 77. Photos of fly ash-stabilized specimens after wet-dry cycles

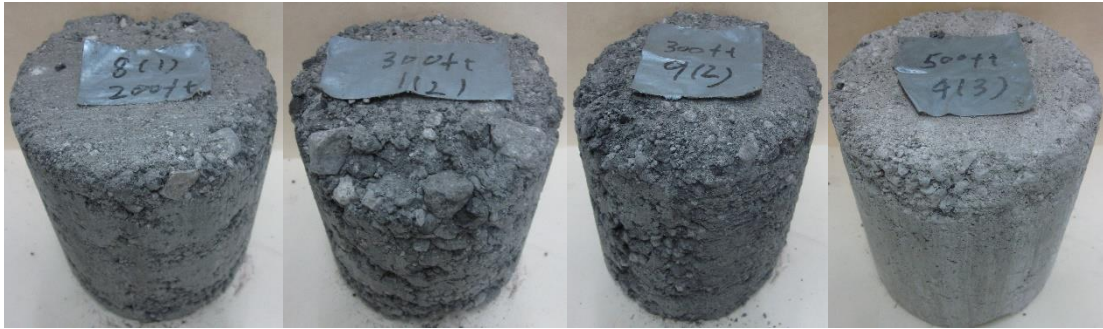
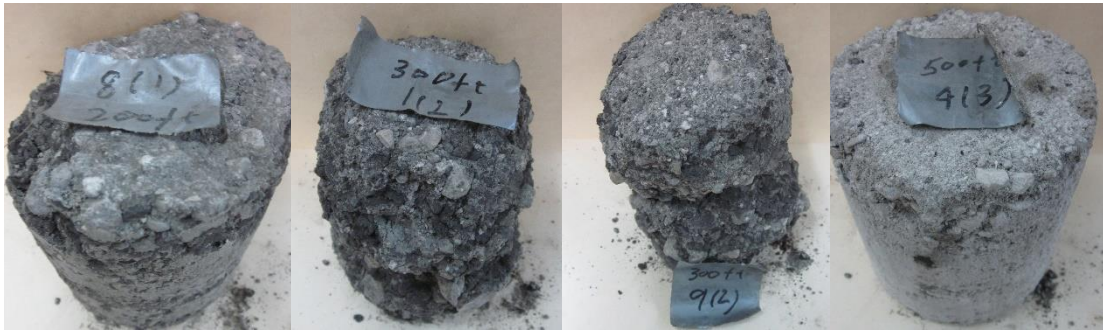
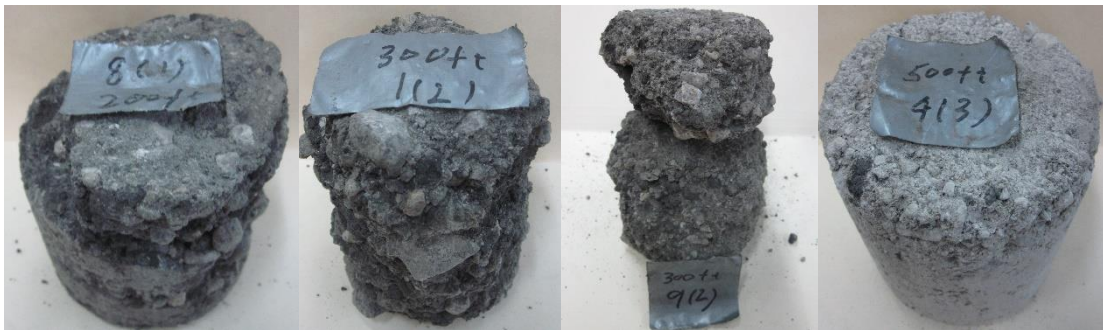
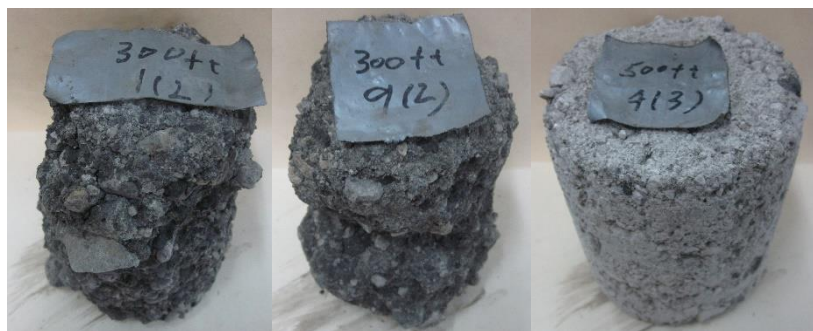
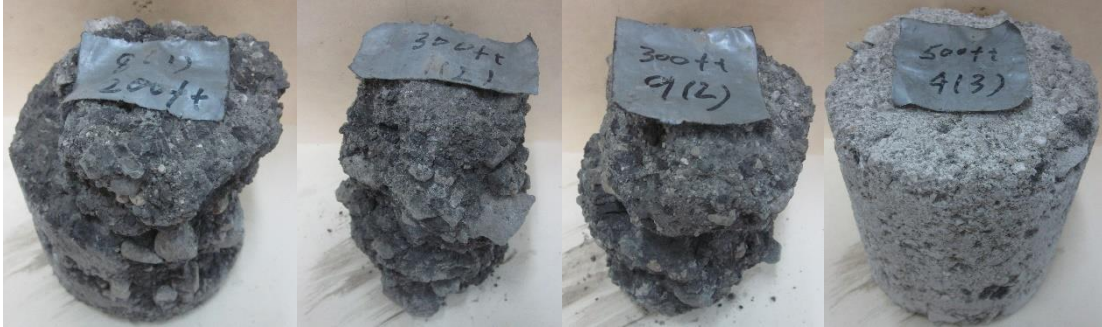
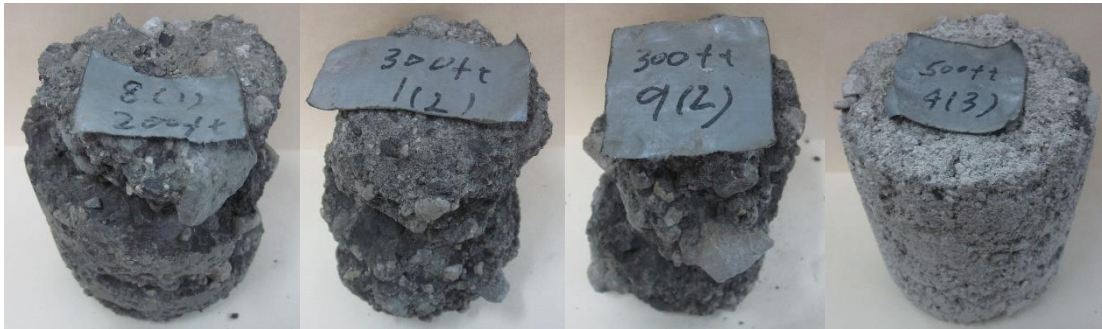
After 1st wet-dry cycle

After 3rd wet-dry cycle

After 4th wet-dry cycle

After 5th wet-dry cycle

Figure 78. Photos of cement-stabilized specimens after wet-dry cycles

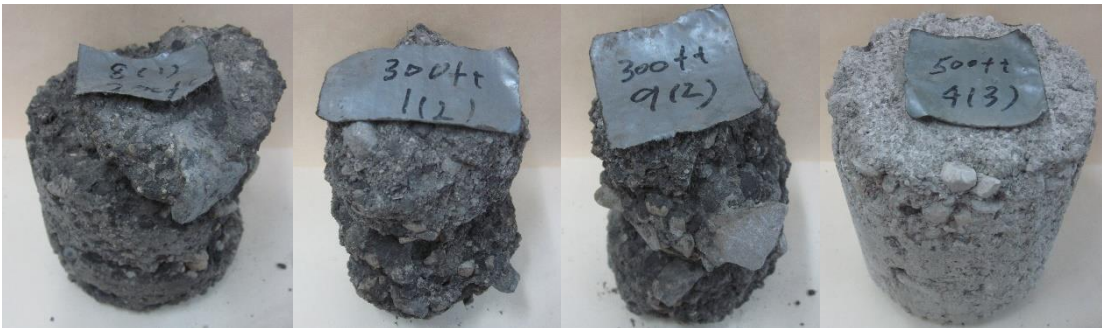
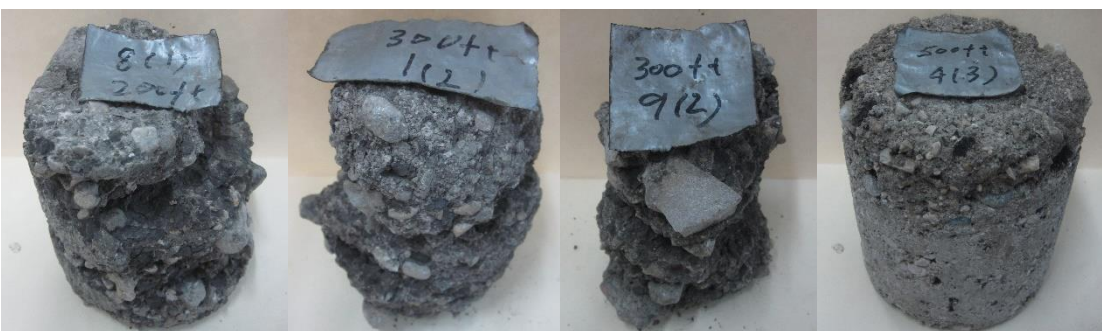
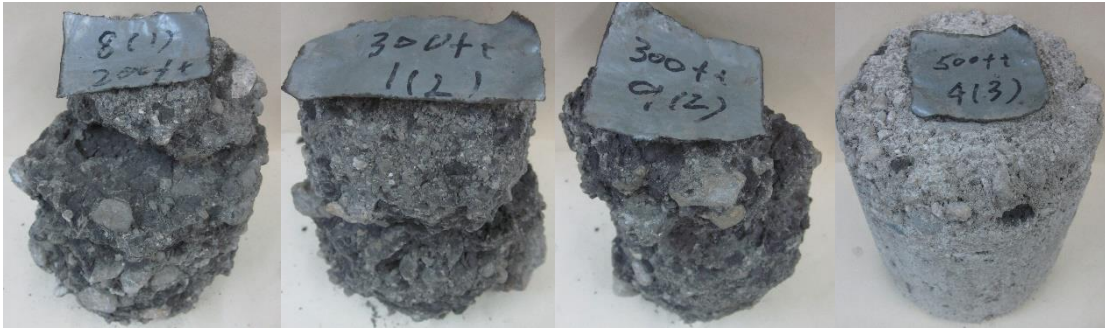
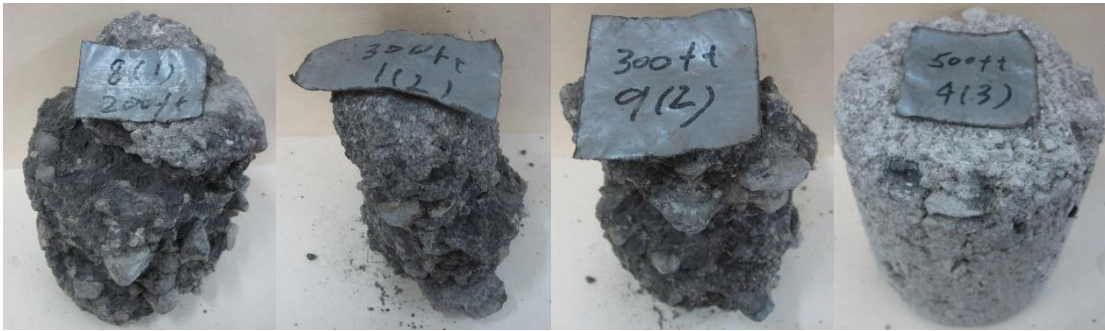
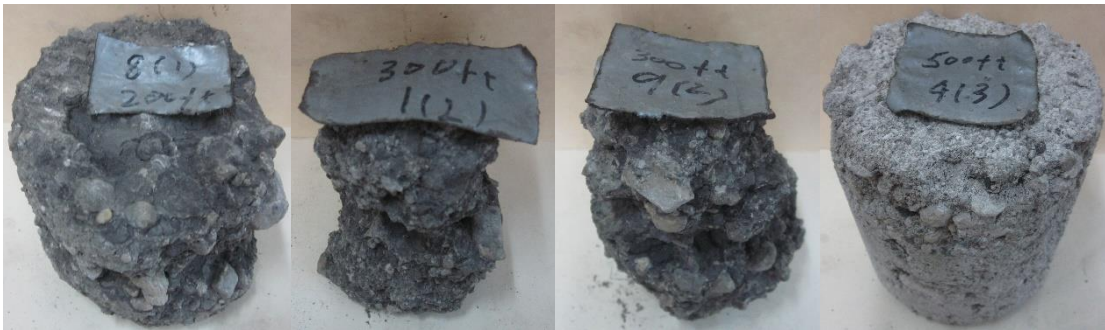
After 8th wet-dry cycle

After 9th wet-dry cycle

Figure 78 (continued). Photos of cement-stabilized specimens after wet-dry cycles

After 10th wet-dry cycle

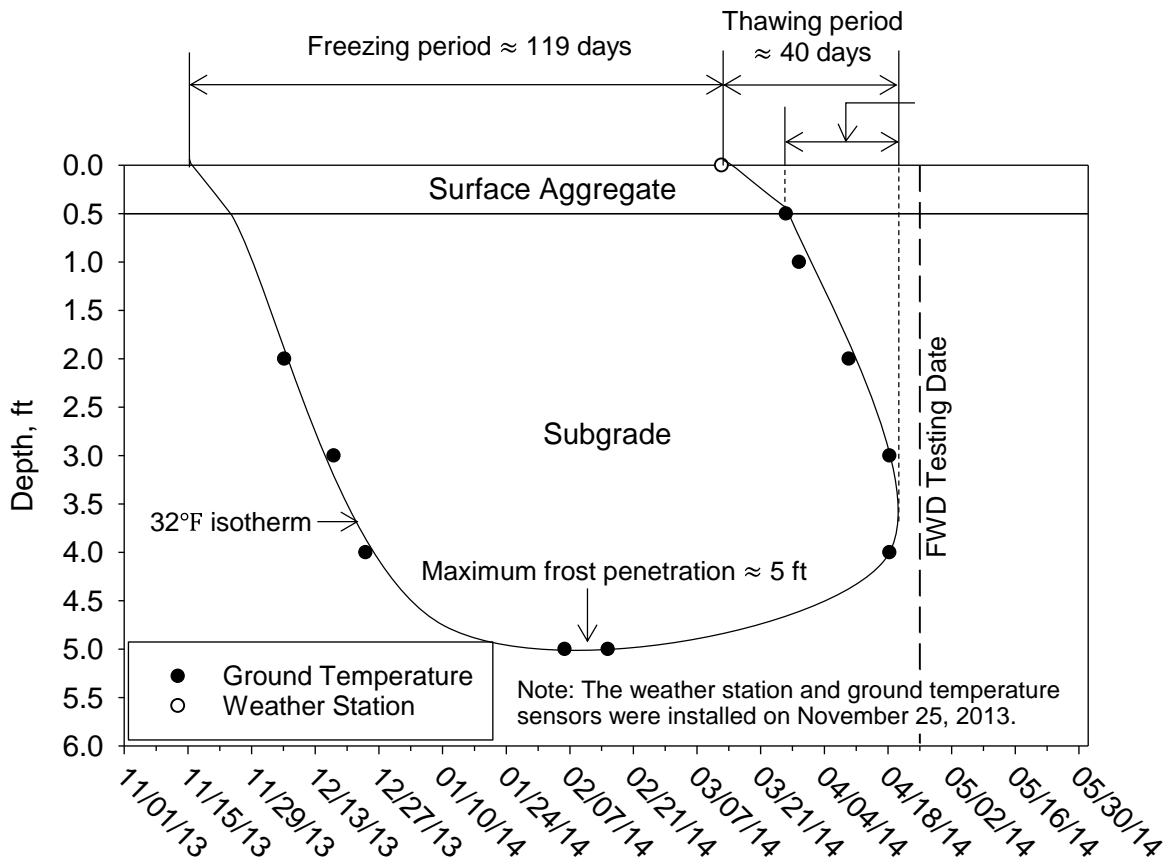
Figure 81. 2013–2014 ground freezing-thawing period of the project site

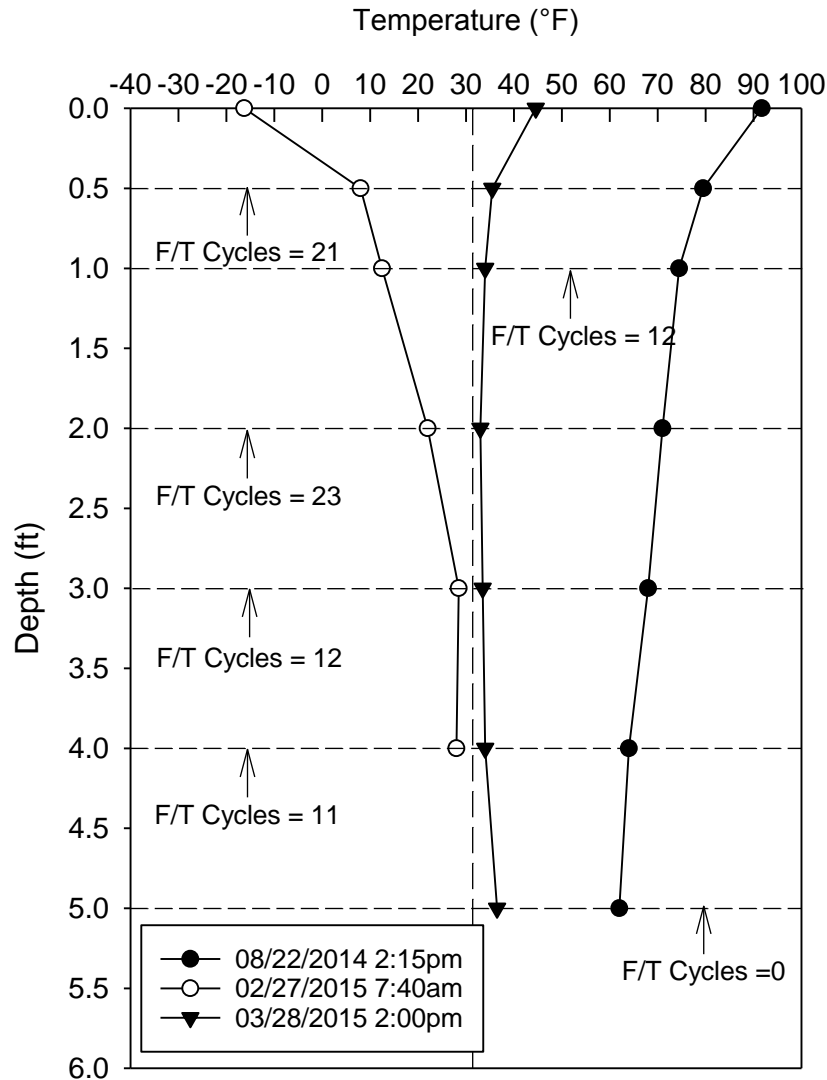
Figure 94. Ground temperature profiles at three different dates during 2014-2015 seasonal freeze-thaw period

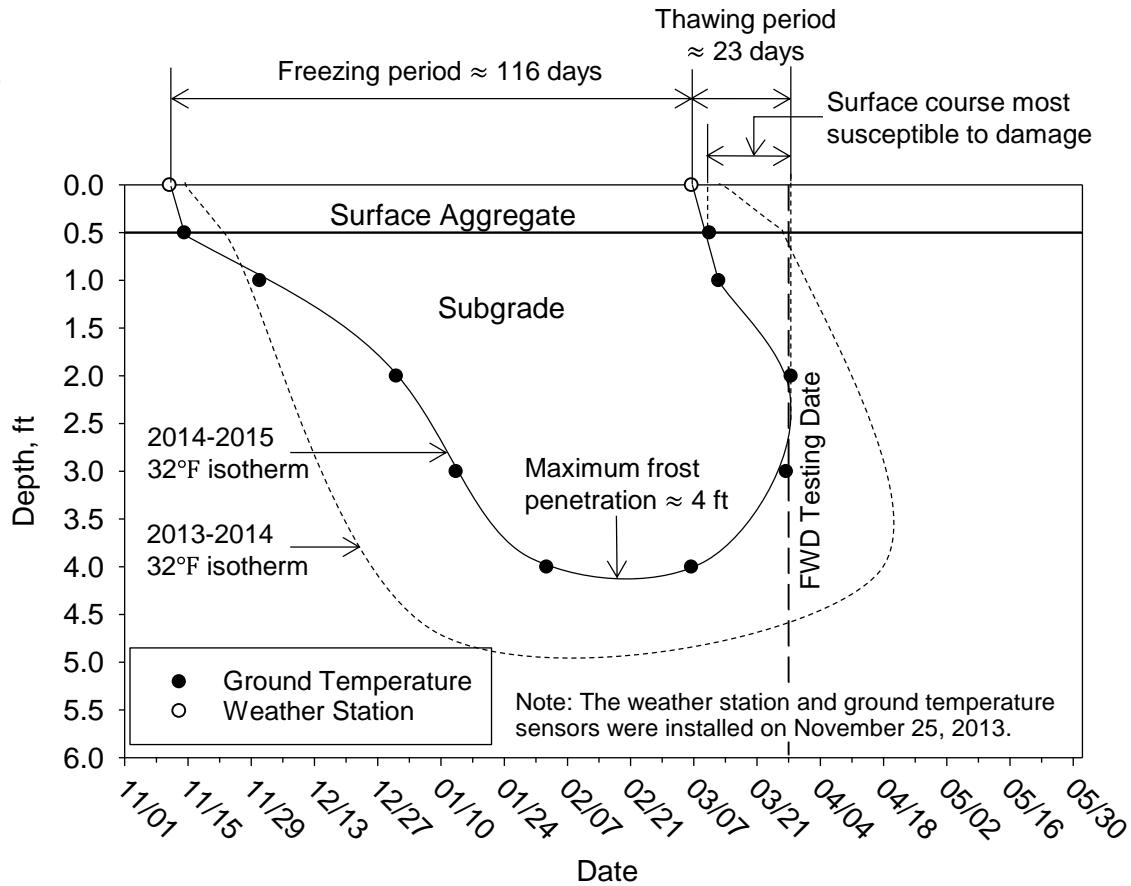
Figure 95. 2014–2015 ground freezing-thawing period of the project site compared with the 2013-2014 period

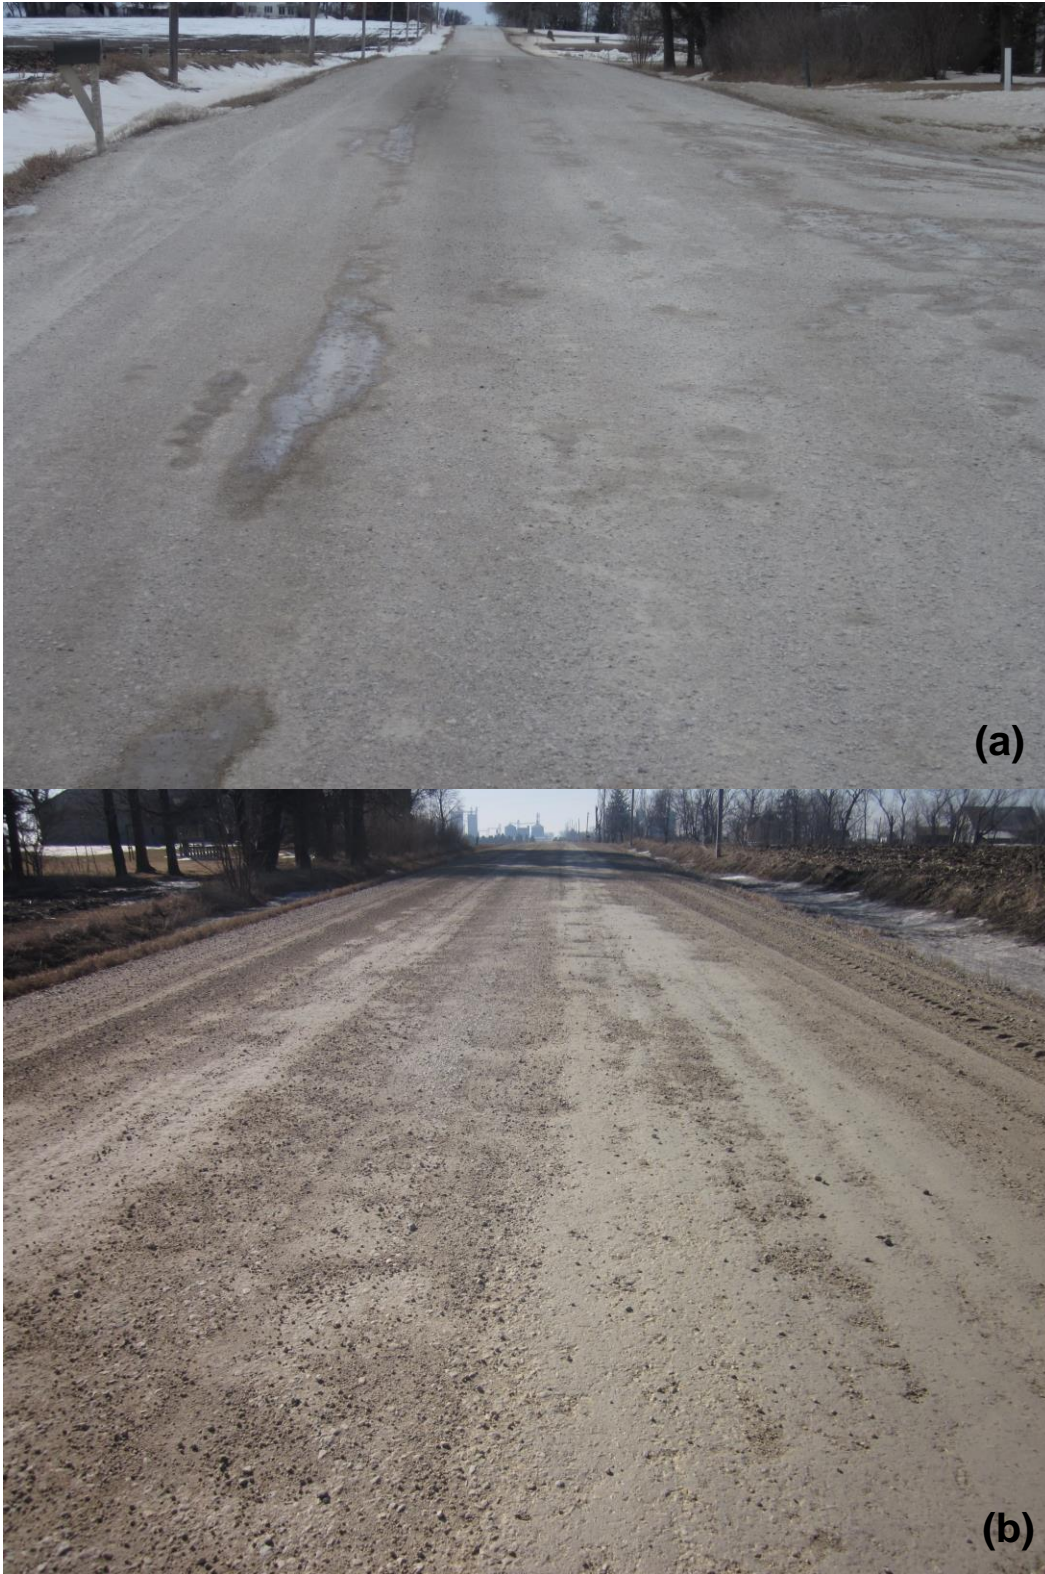
Figure 101. Surface conditions of dirty macadam plus chloride Section 2 during (a) freezing period (February 24, 2015) and (b) thawing period (March 10, 2015)

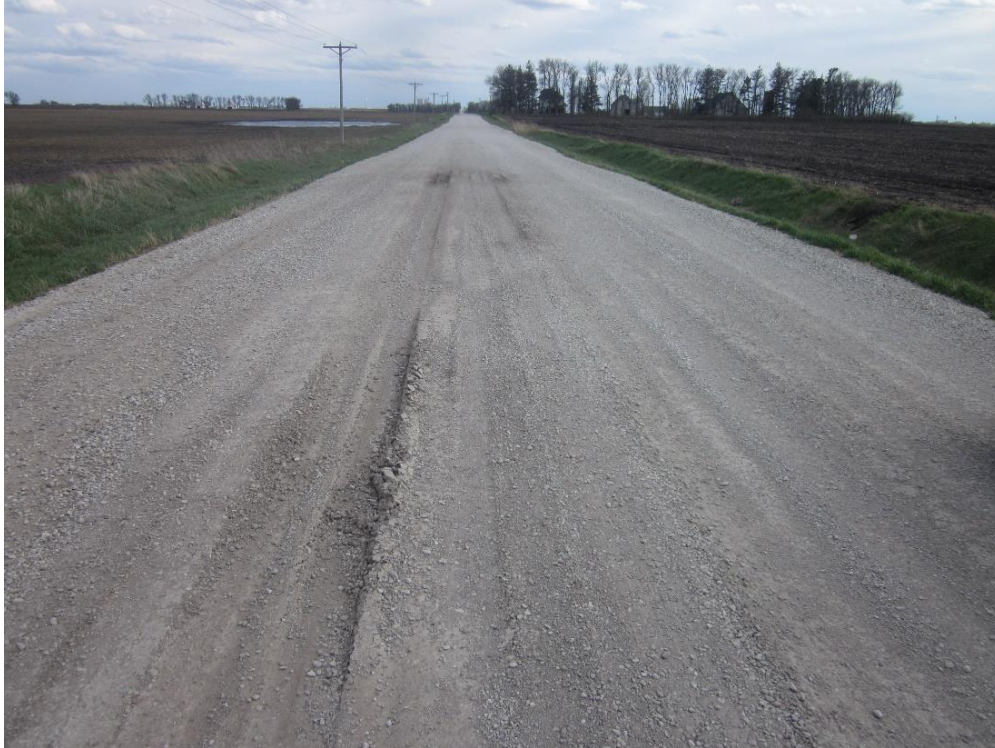
Figure 102. Surface condition of geocomposite drain Section 18 showing rutting (April 21, 2015)

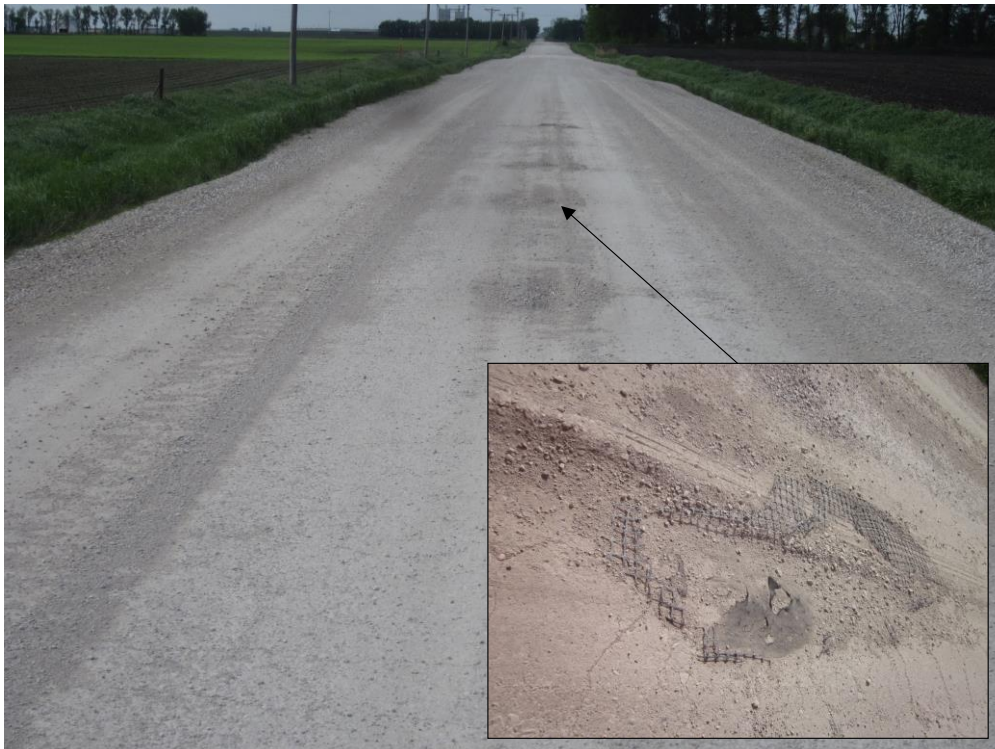
Figure 103. Surface condition of BX-geogrid+NW-geotextile Section 19A showing exposed geosynthetics (May 20, 2015)
