Low-Cost Rural Surface Alternatives: Demonstration Project

**Final Report
June 2015**

IOWA STATE UNIVERSITY
Institute for Transportation

Sponsored by
Iowa Highway Research Board
(IHRB Project TR-664)
Iowa Department of Transportation
(InTrans Project 13-479)

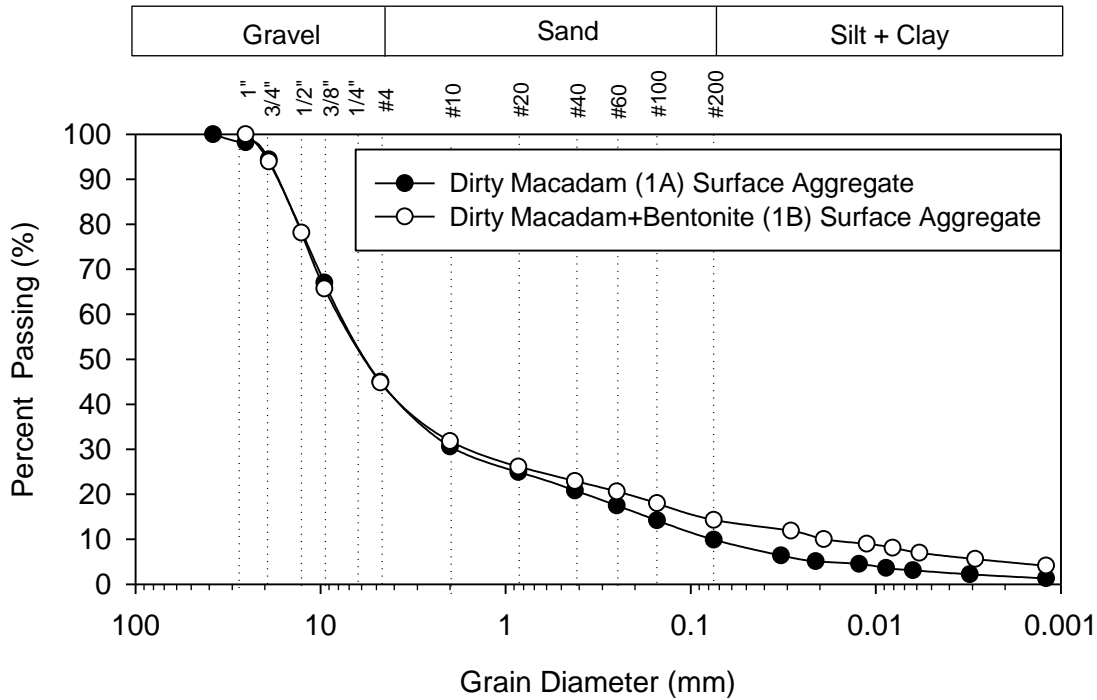
Figure 105. Particle size distribution curves of surface aggregate from dirty macadam Section 1A and dirty macadam with bentonite Section 1B

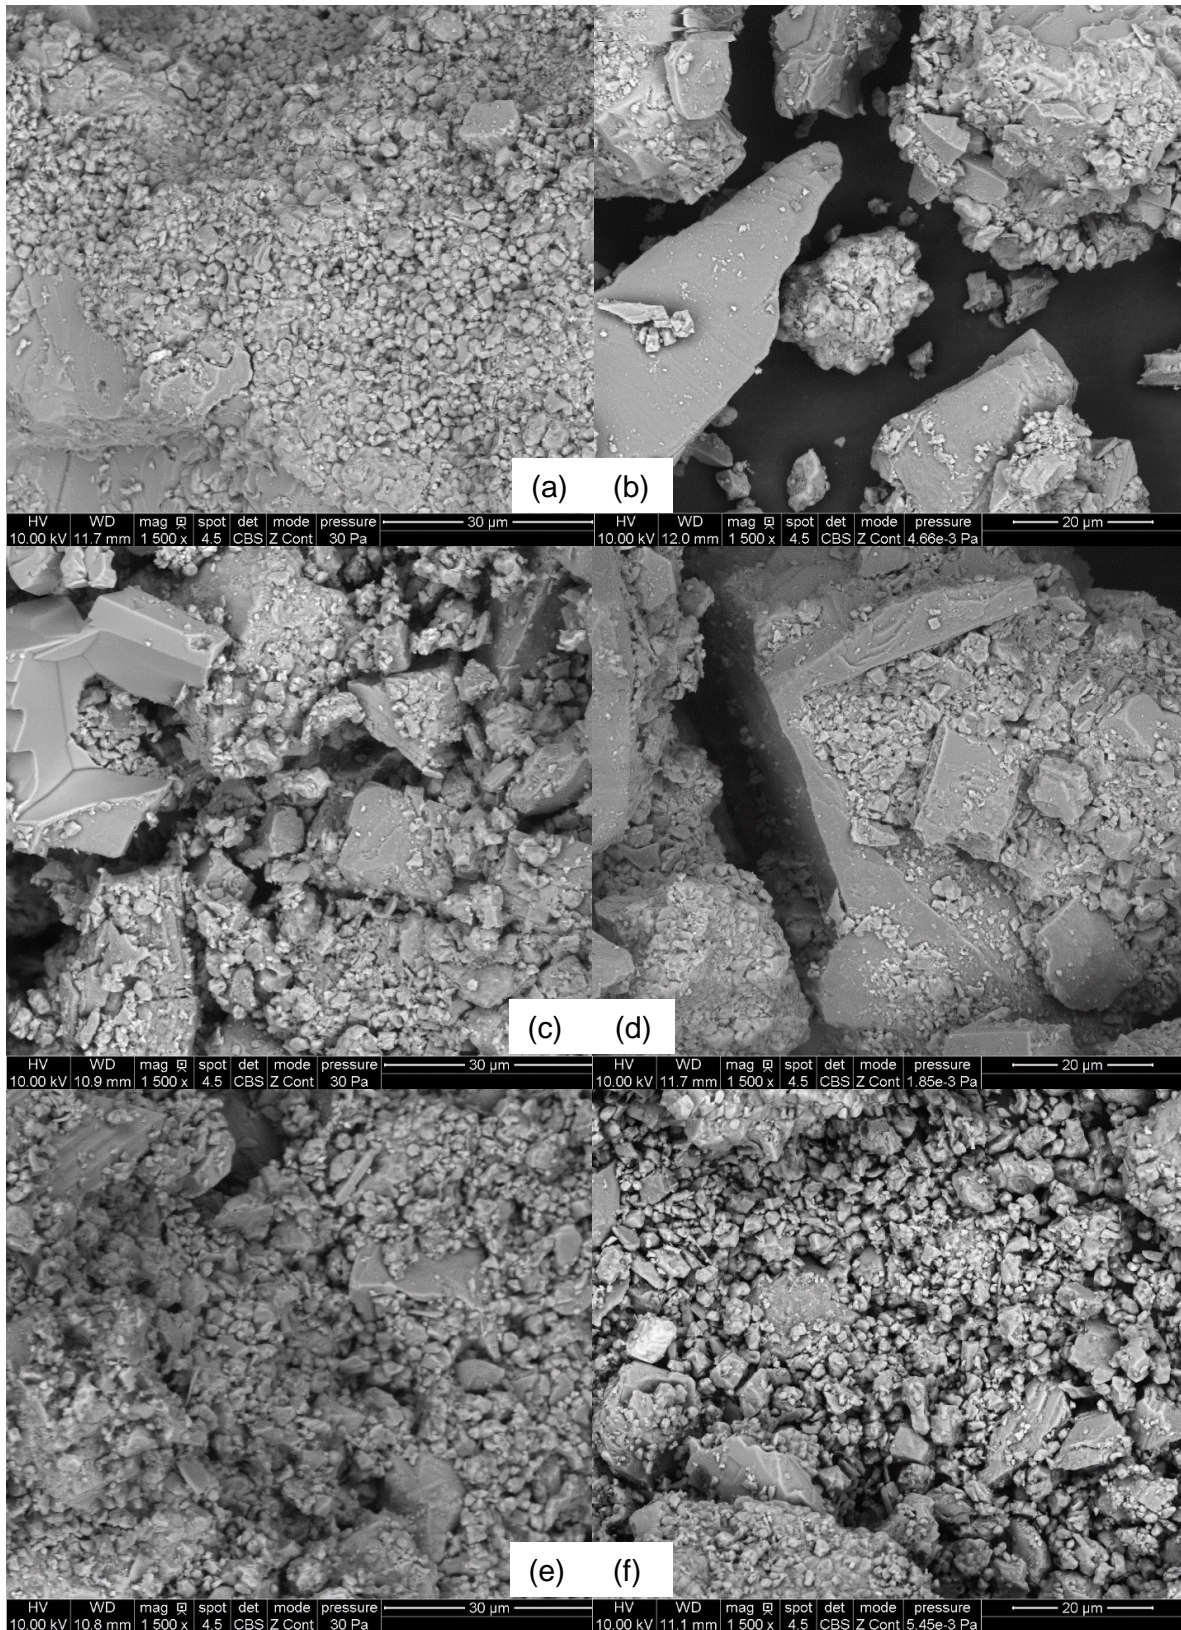
Figure 107. SEM images (1500x magnification) of (a and b) dirty macadam, (c and d) dirty macadam with chloride, and (d and e) bentonite-treated surface course samples

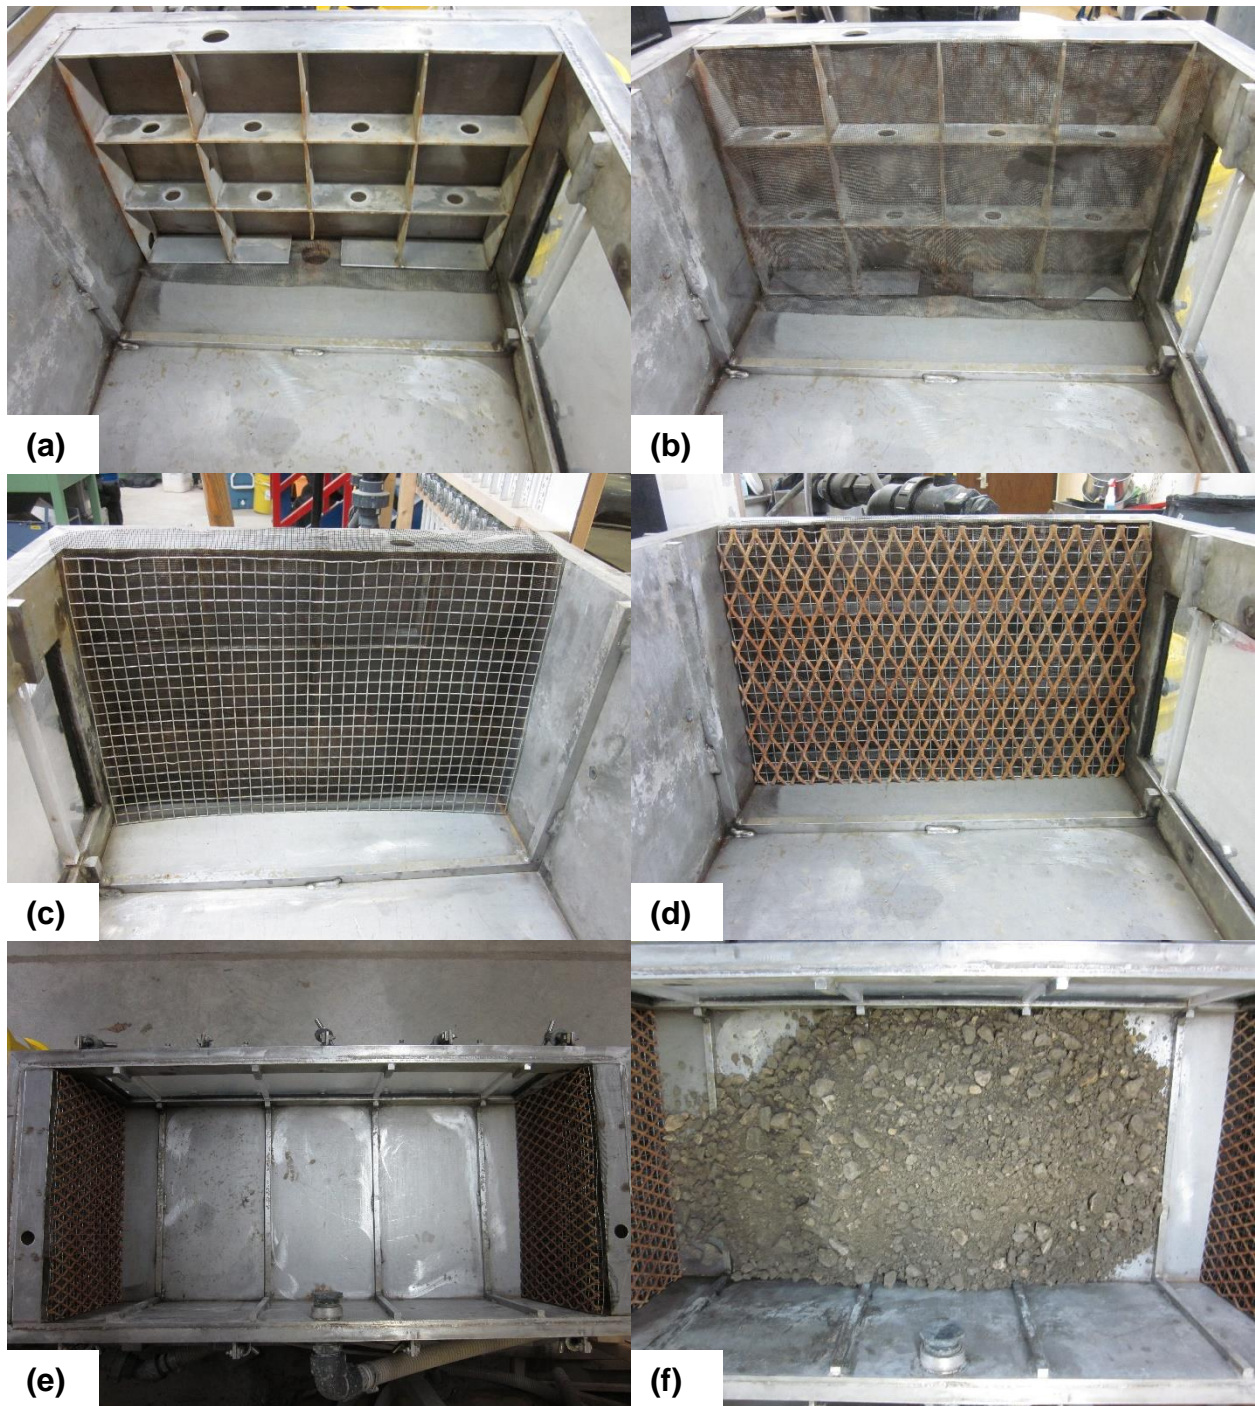
Figure 119. HPT soil tank set up: (a) place fine screen and screen support on top of inlet and outlet, (b, c, d, and e) place three screens with different opening sizes next to the screen support, (e) place specimen material in soil tank

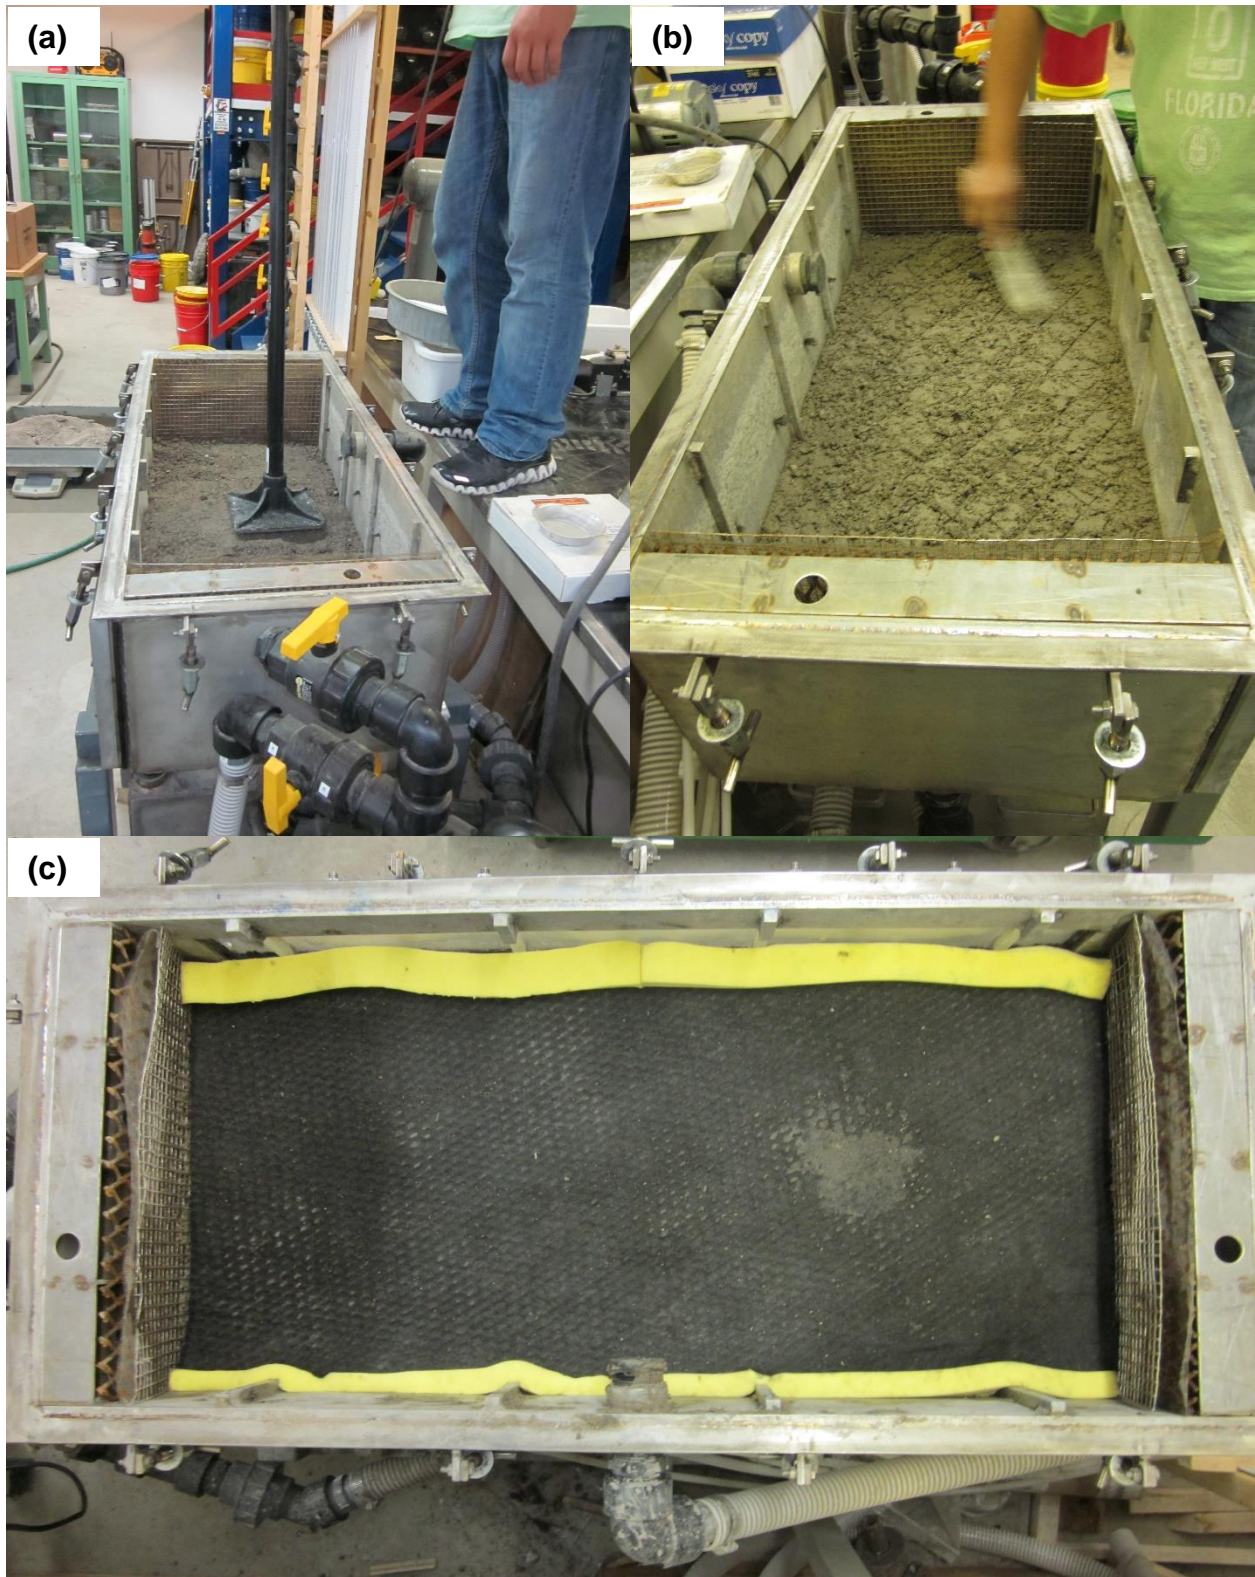
Figure 120. HPT specimen compaction: (a) compact specimen in several lifts, (b) scarify surface after each compaction lift, and (c) place geocomposite at middle of specimen and seal gaps between geocomposite and soil tank using closed-cell foam

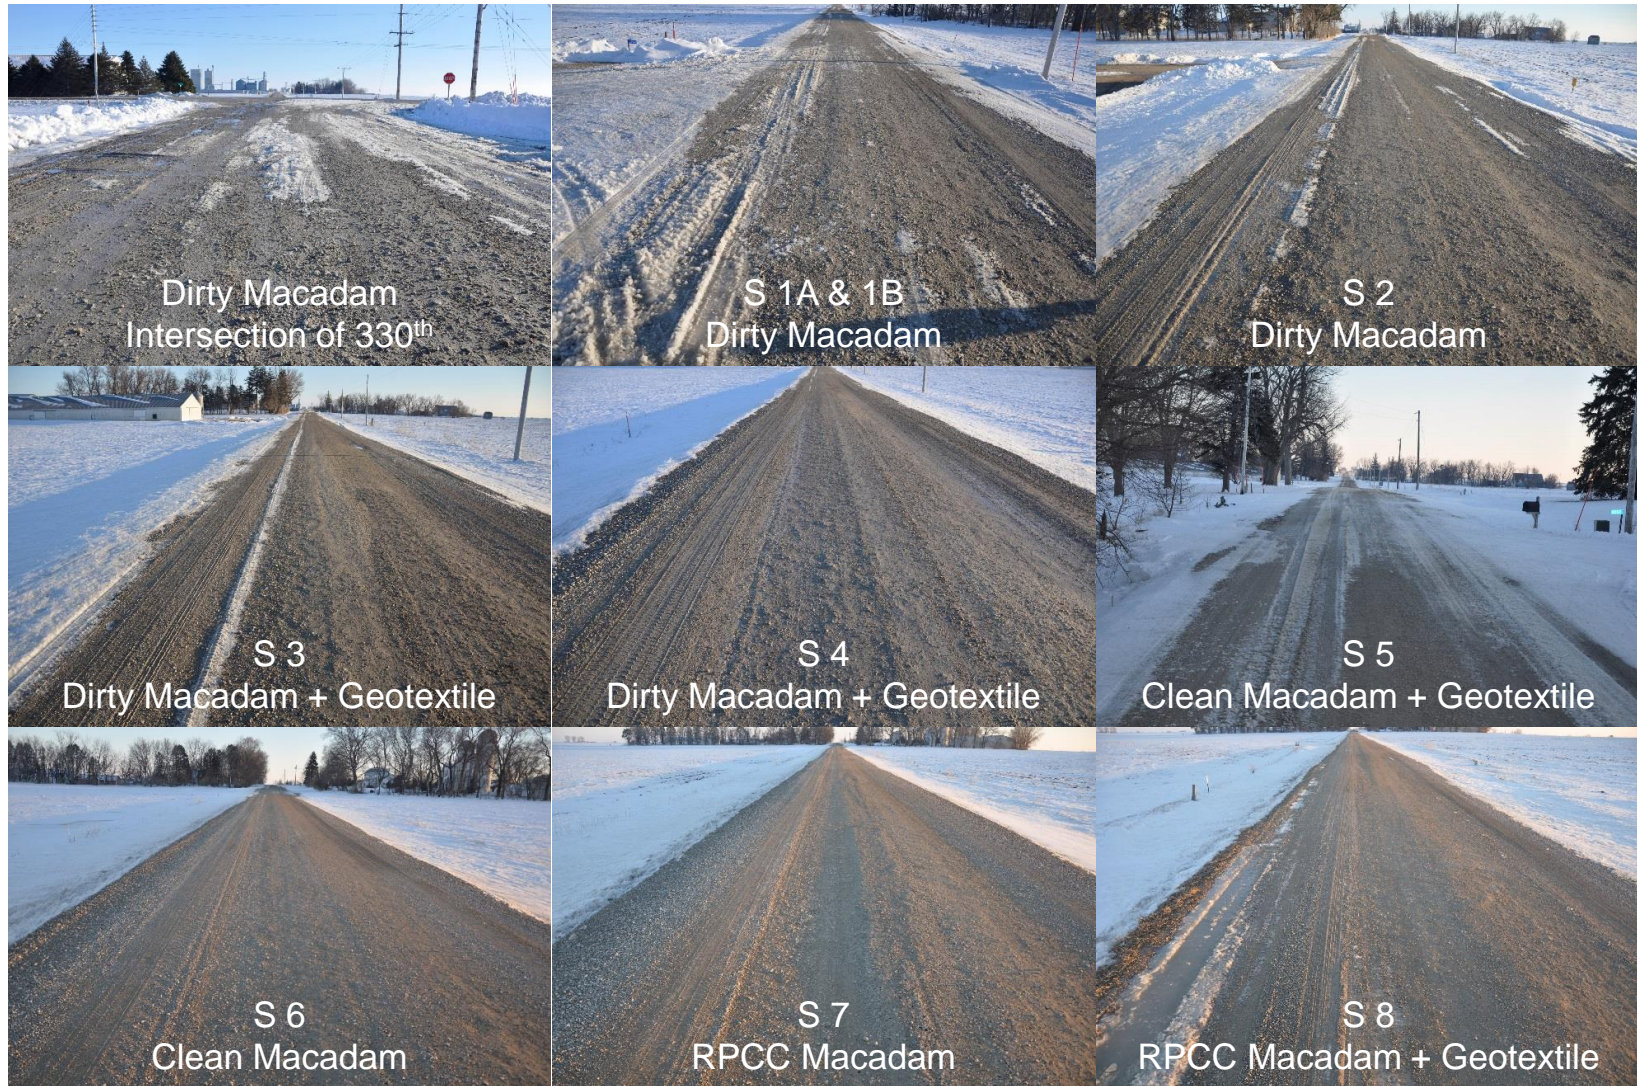
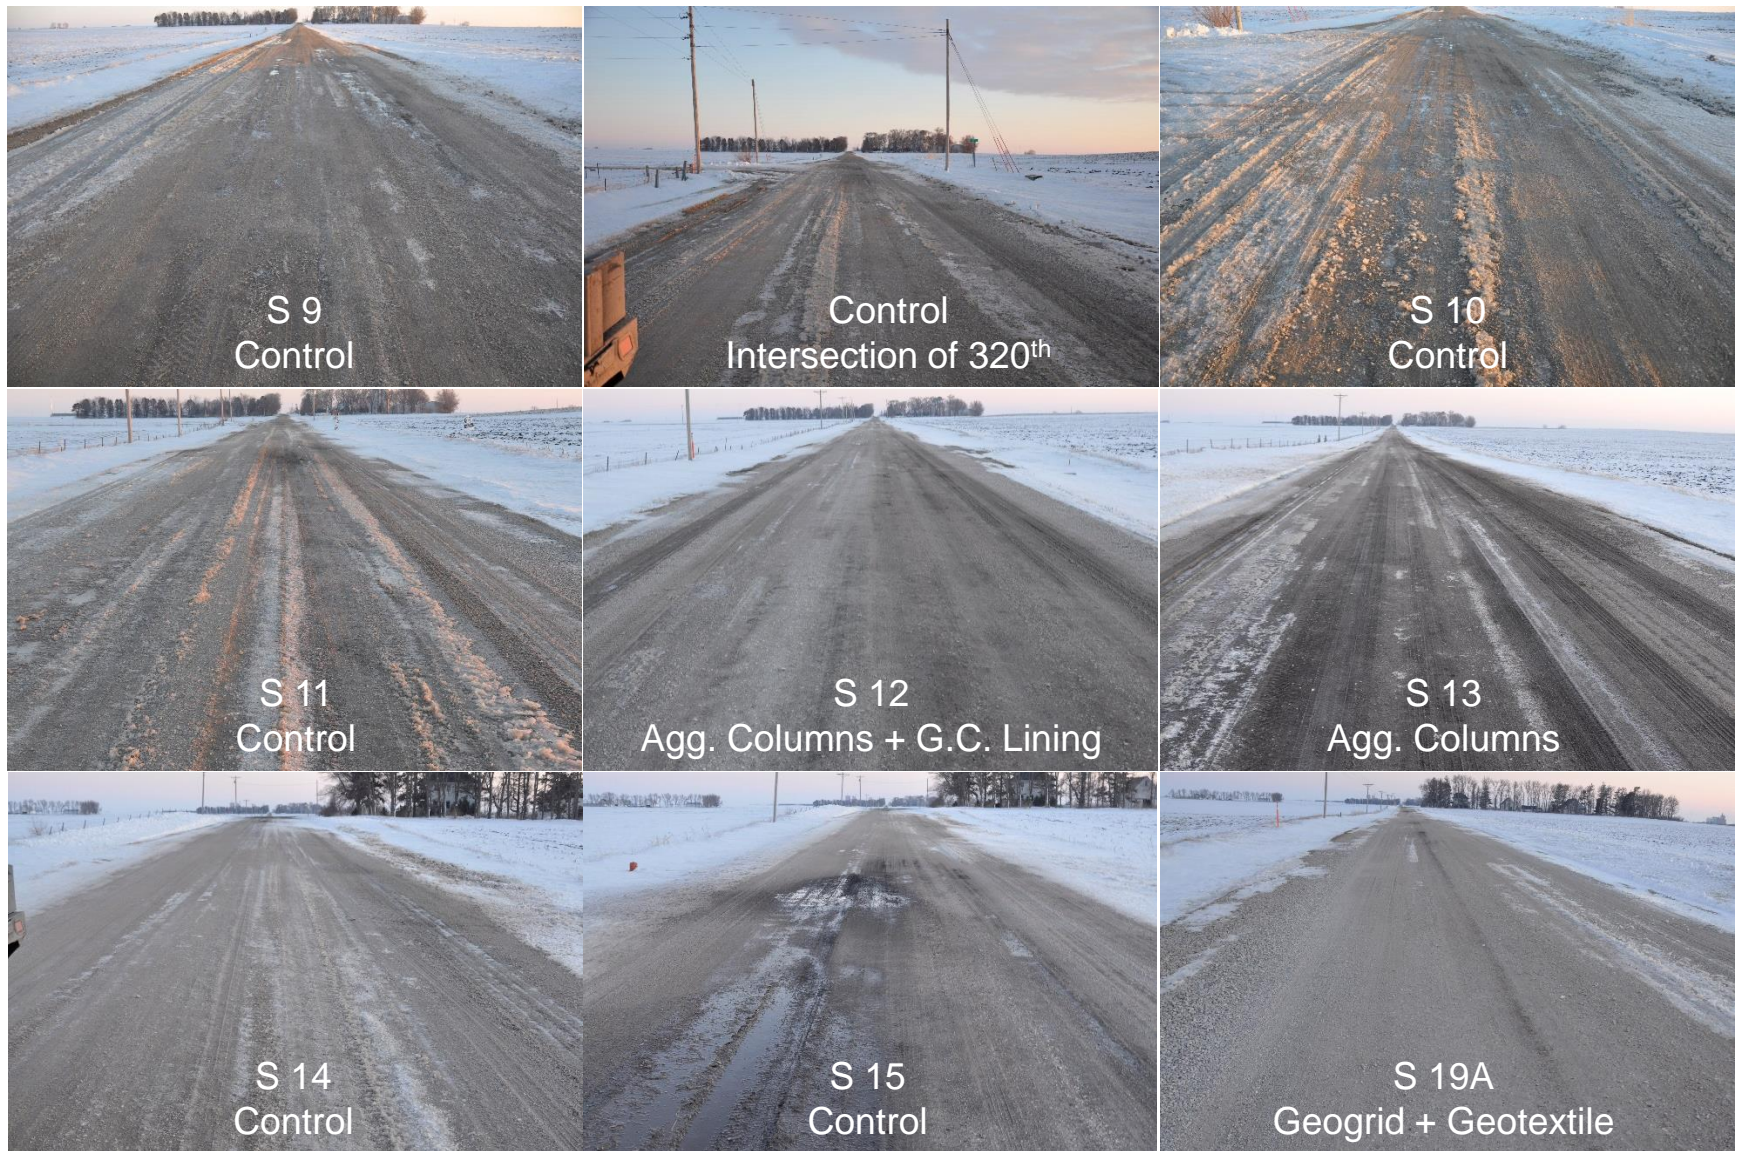
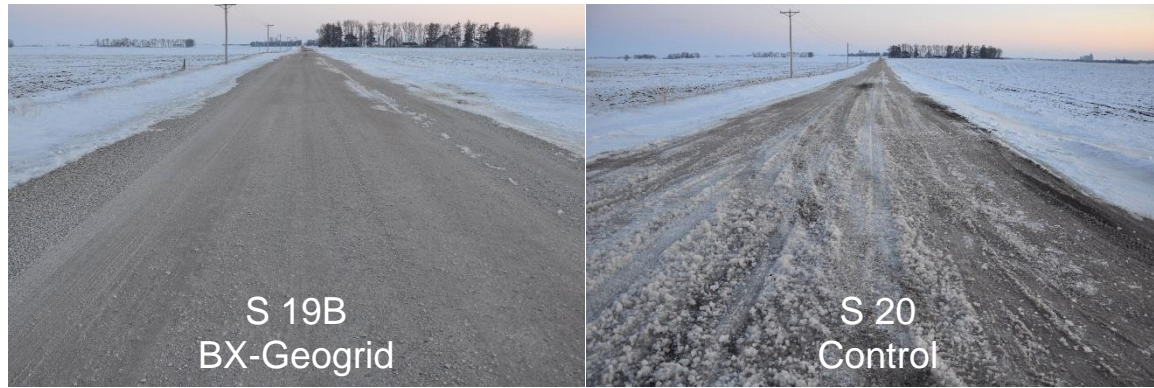
Figure 123. Survey photos of Vail Avenue demonstration sections (March 8, 2014)

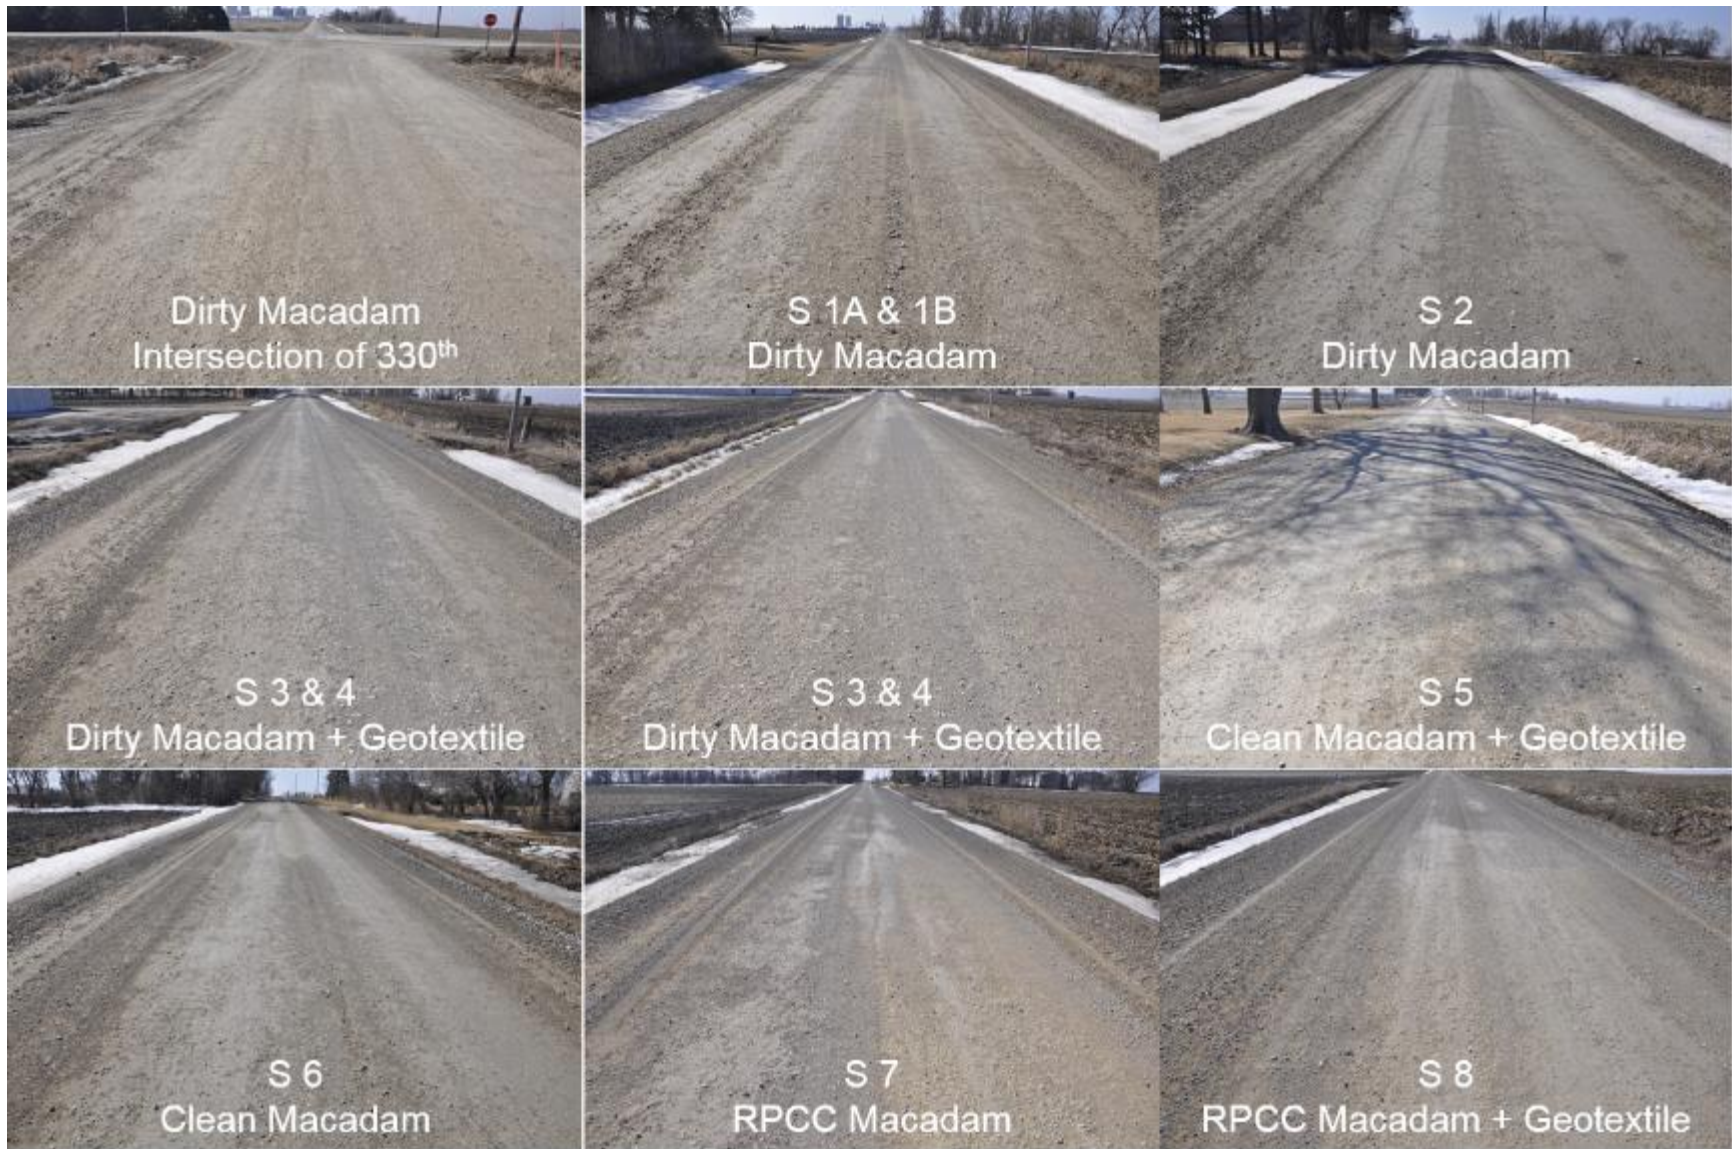
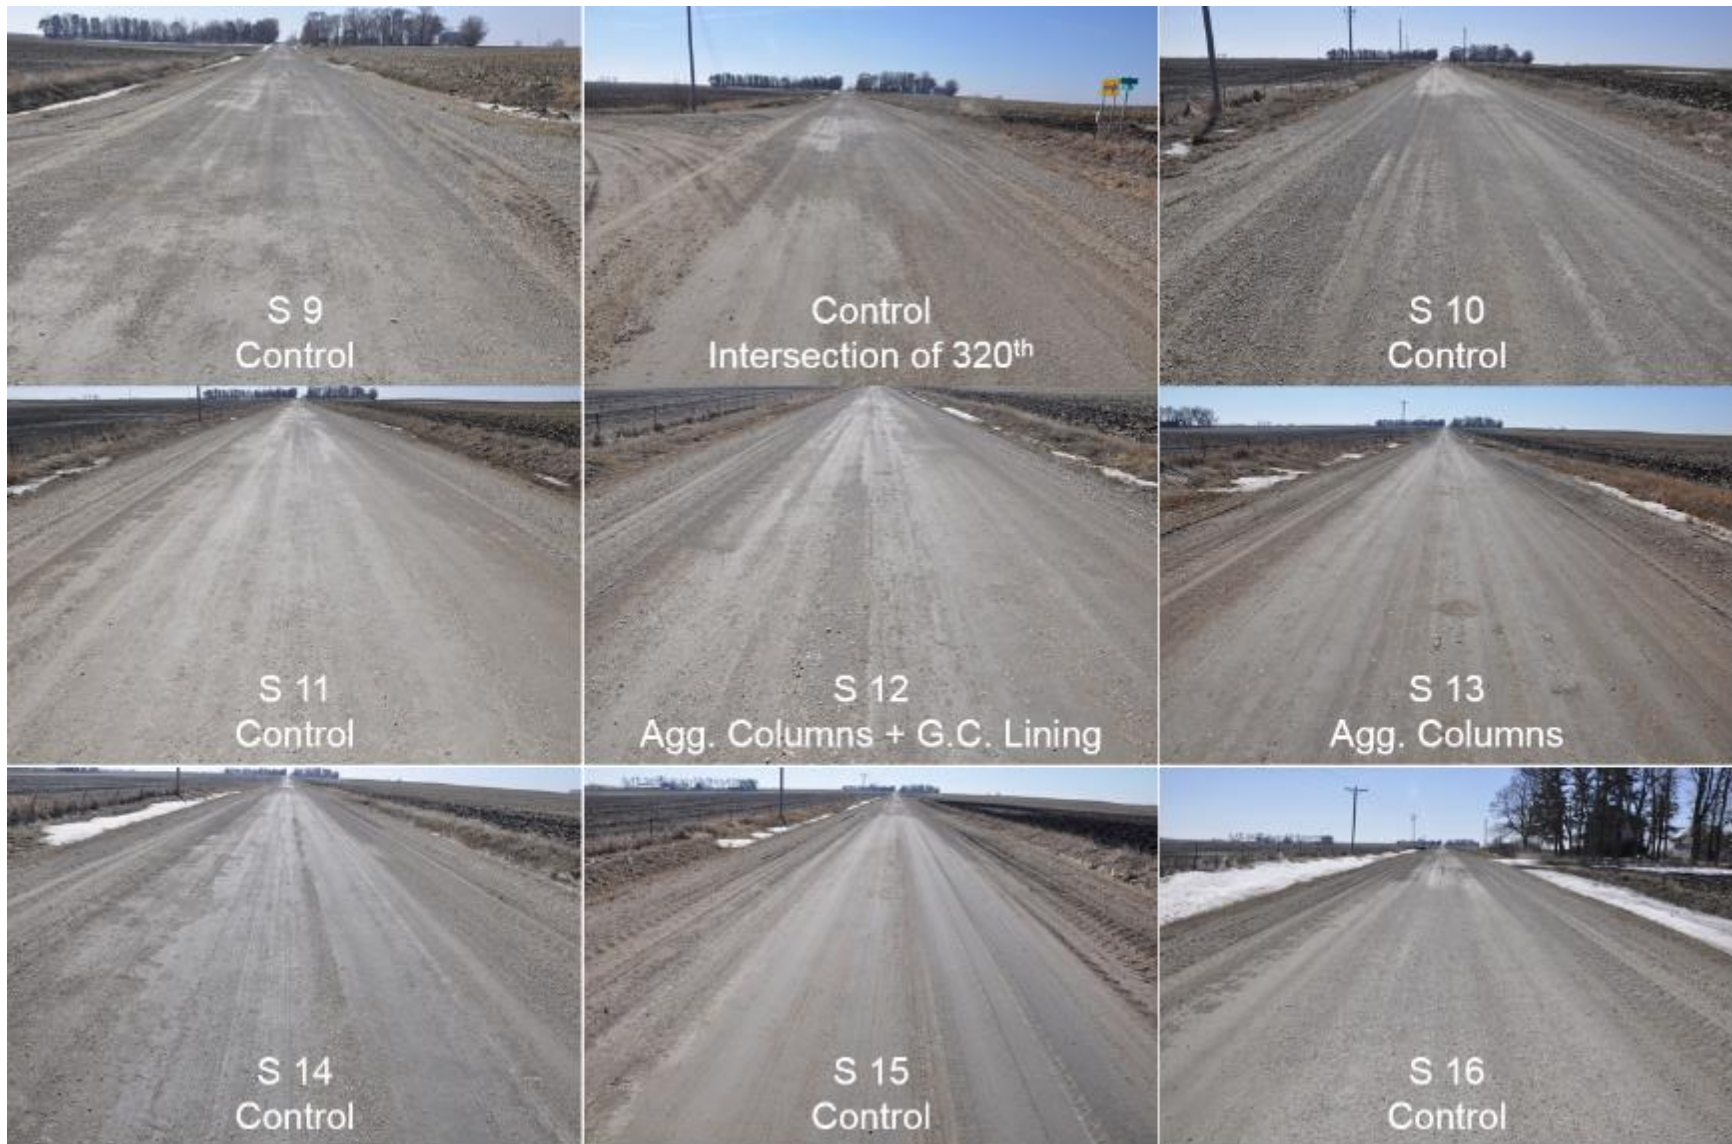
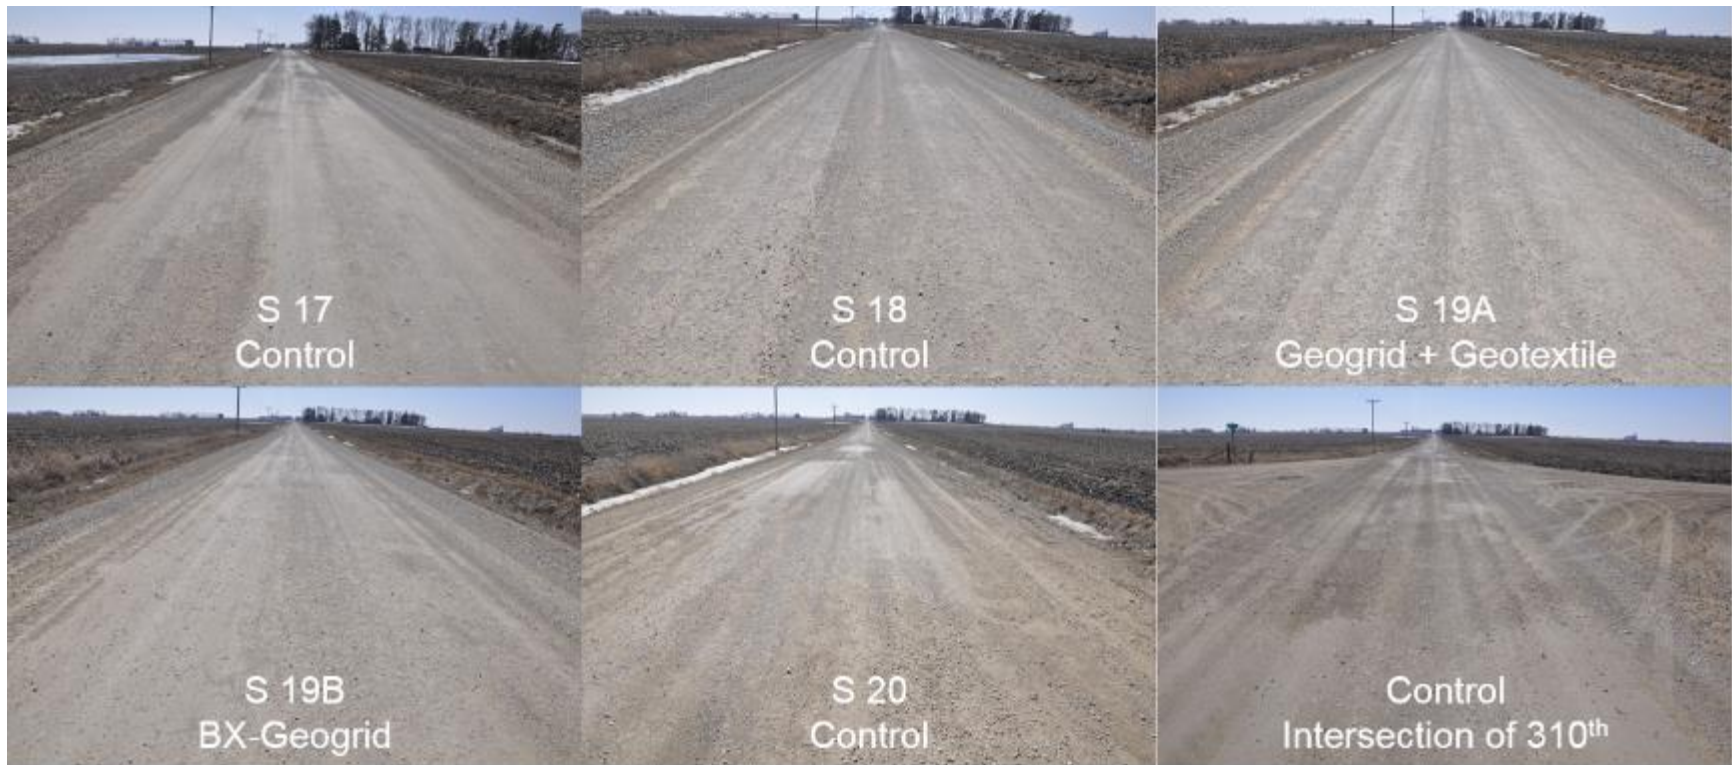
Figure 124. Survey photos of Vail Avenue demonstration sections (March 20, 2014)

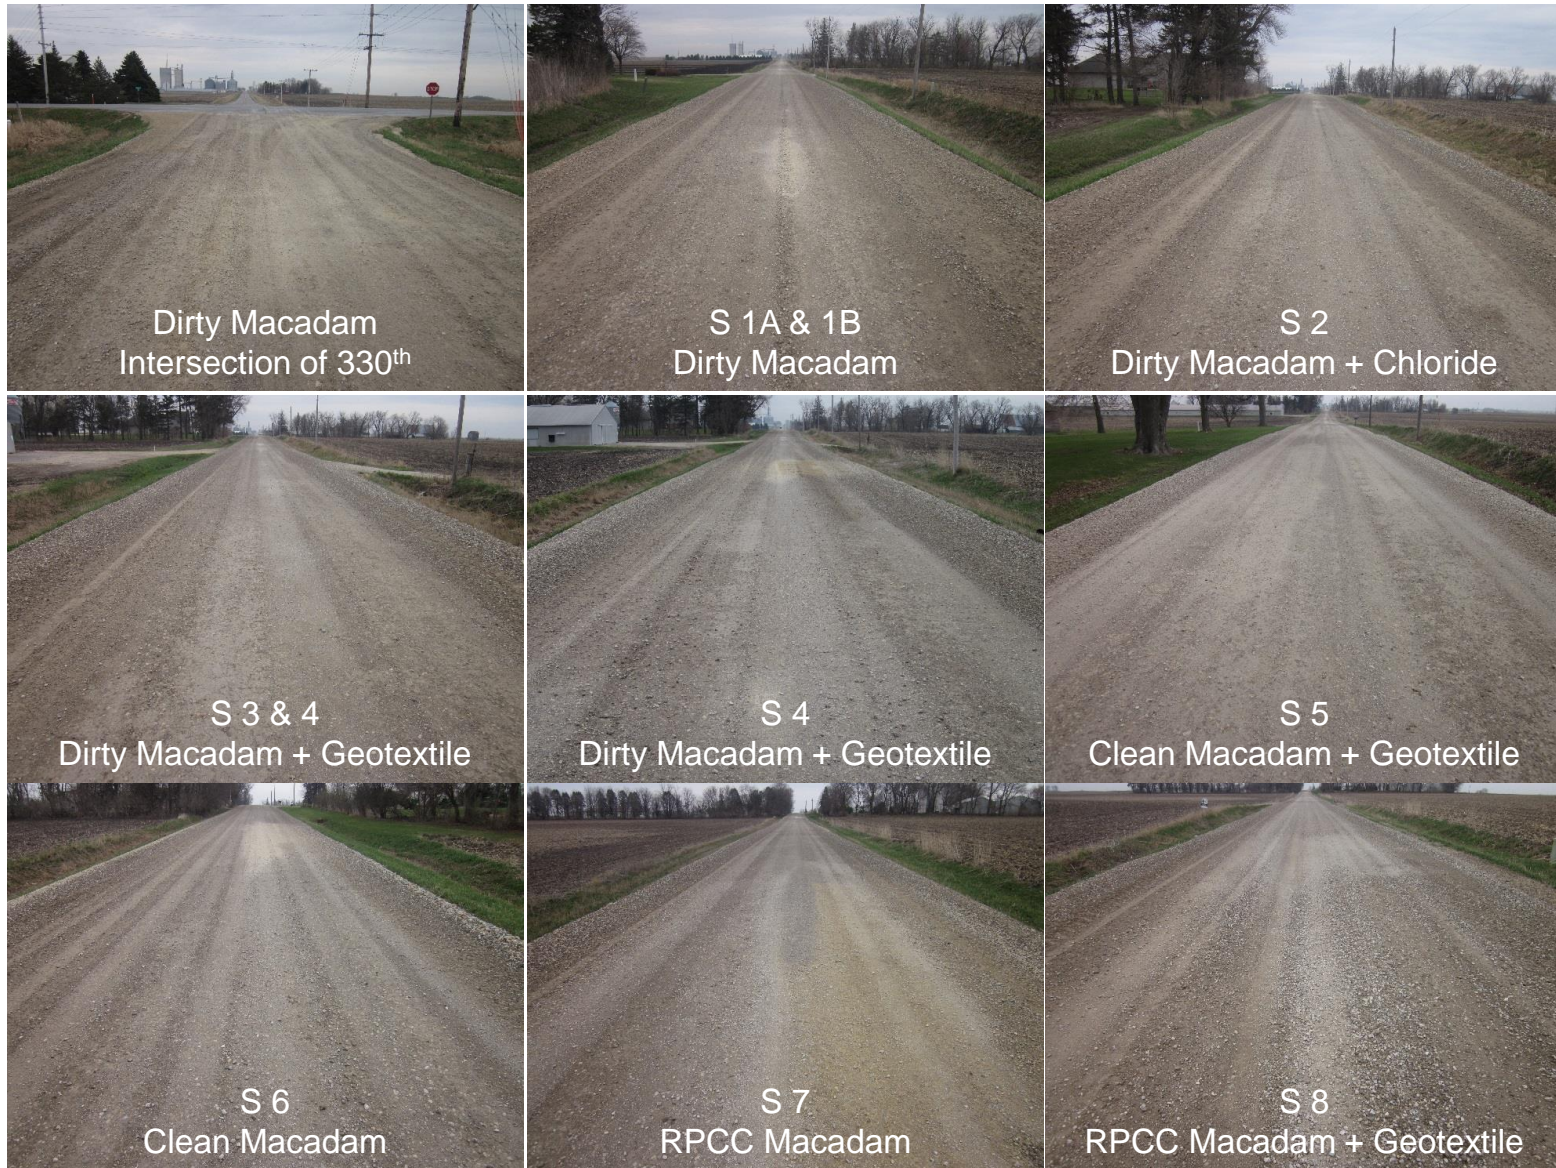
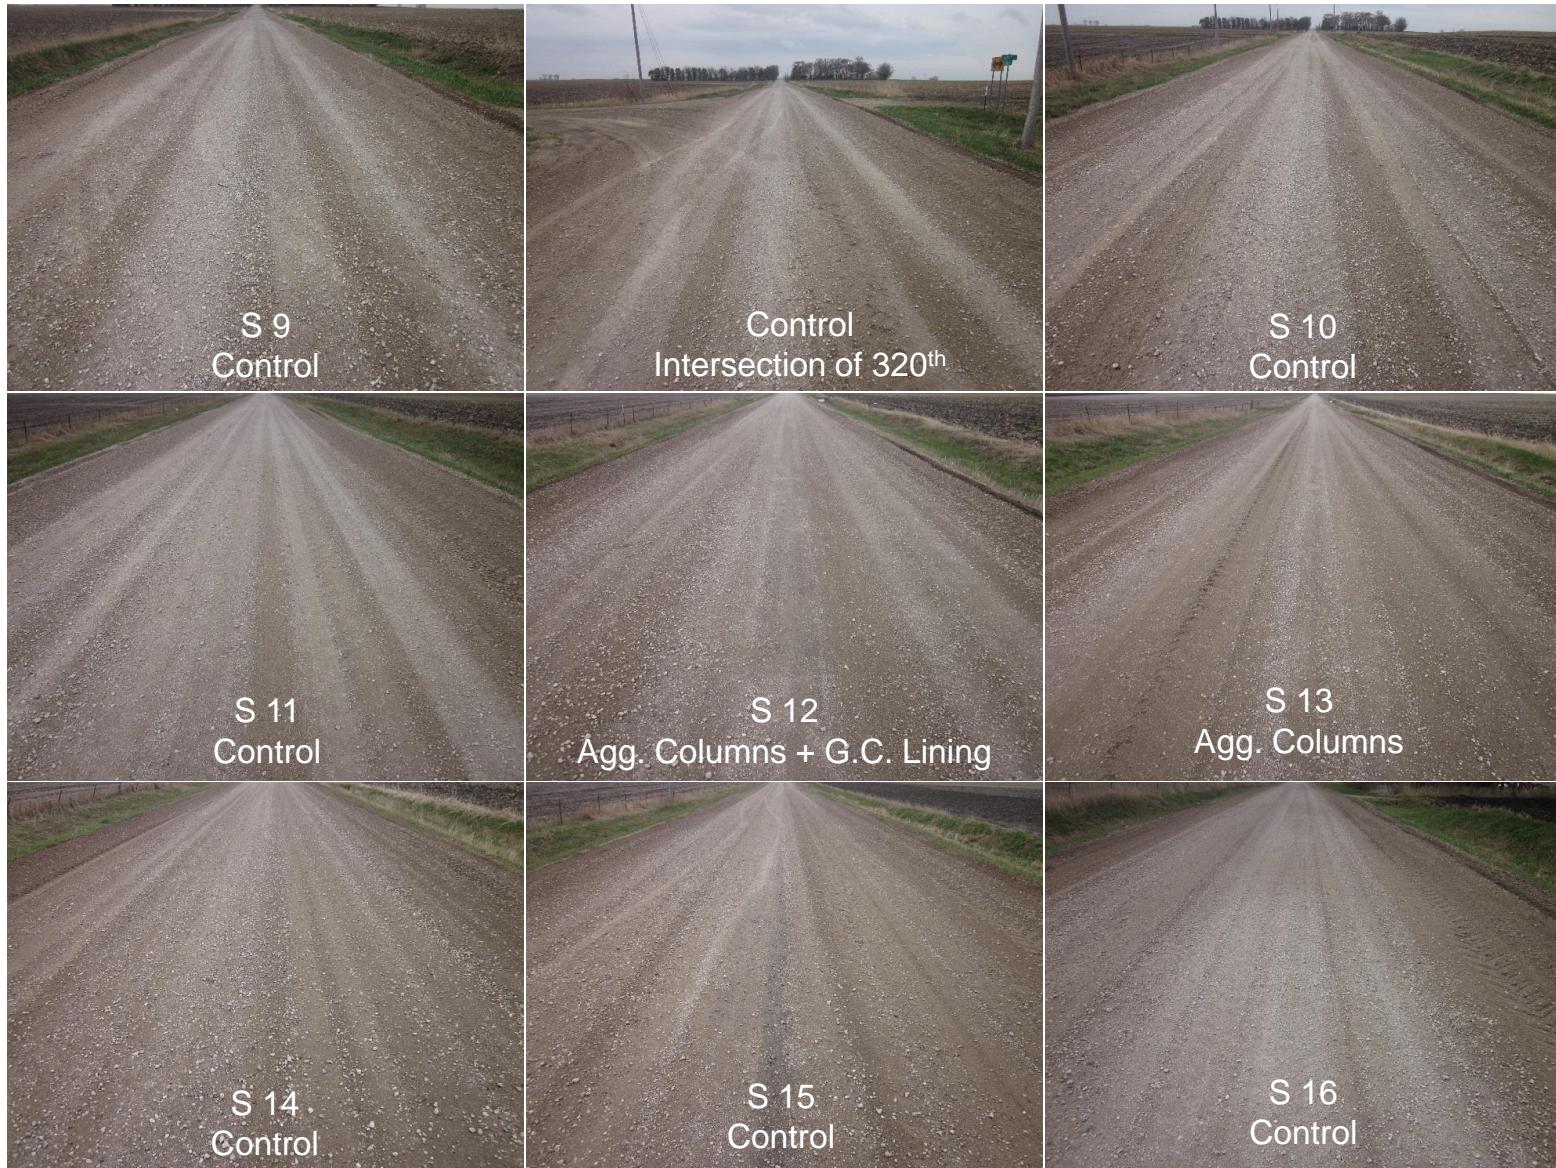
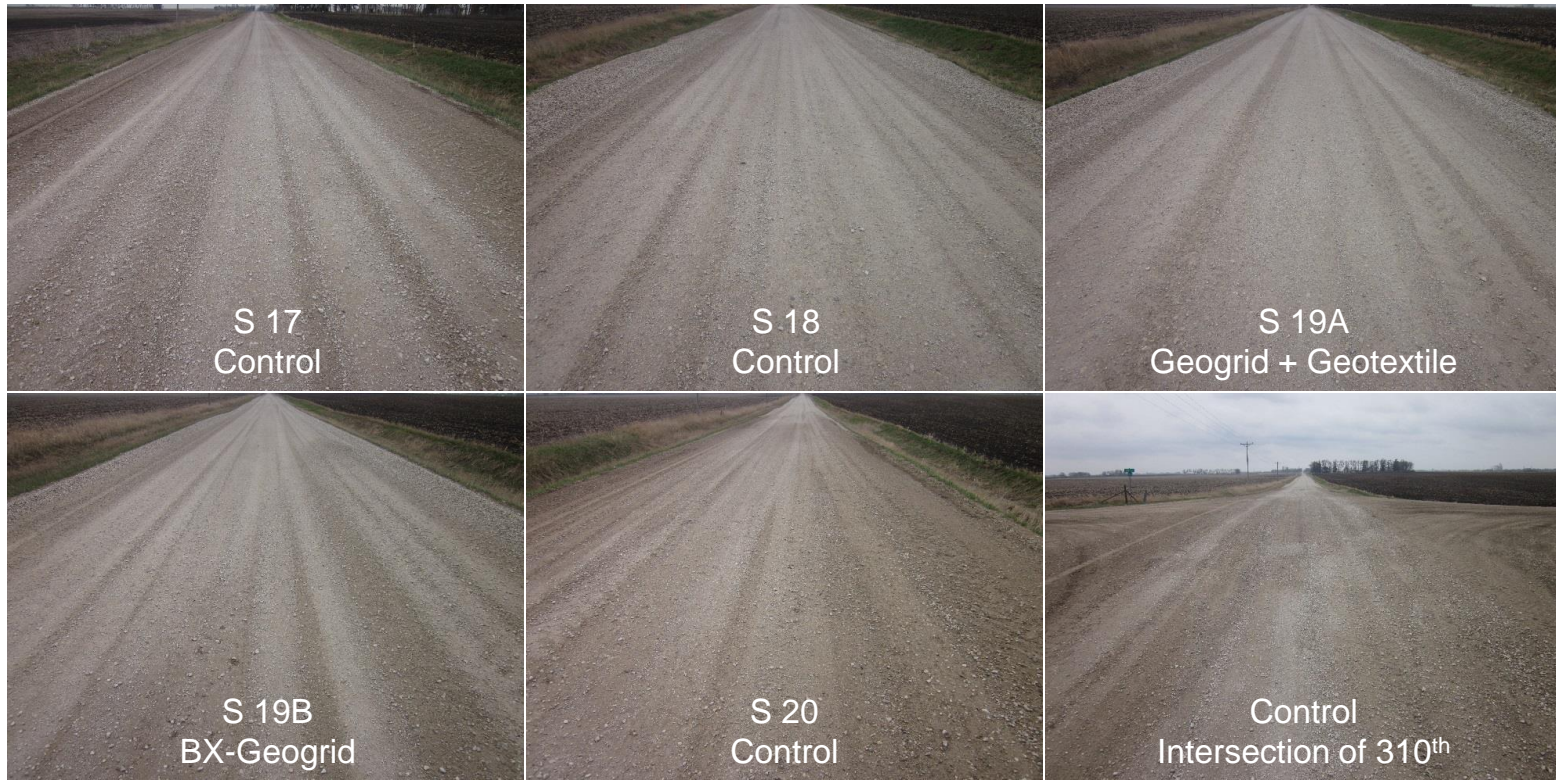
Figure 125. Survey photos of Vail Avenue demonstration sections (April 21, 2014)
