Low-Cost Rural Surface Alternatives: Demonstration Project

**Final Report
June 2015**

IOWA STATE UNIVERSITY
Institute for Transportation

Sponsored by
Iowa Highway Research Board
(IHRB Project TR-664)
Iowa Department of Transportation
(InTrans Project 13-479)

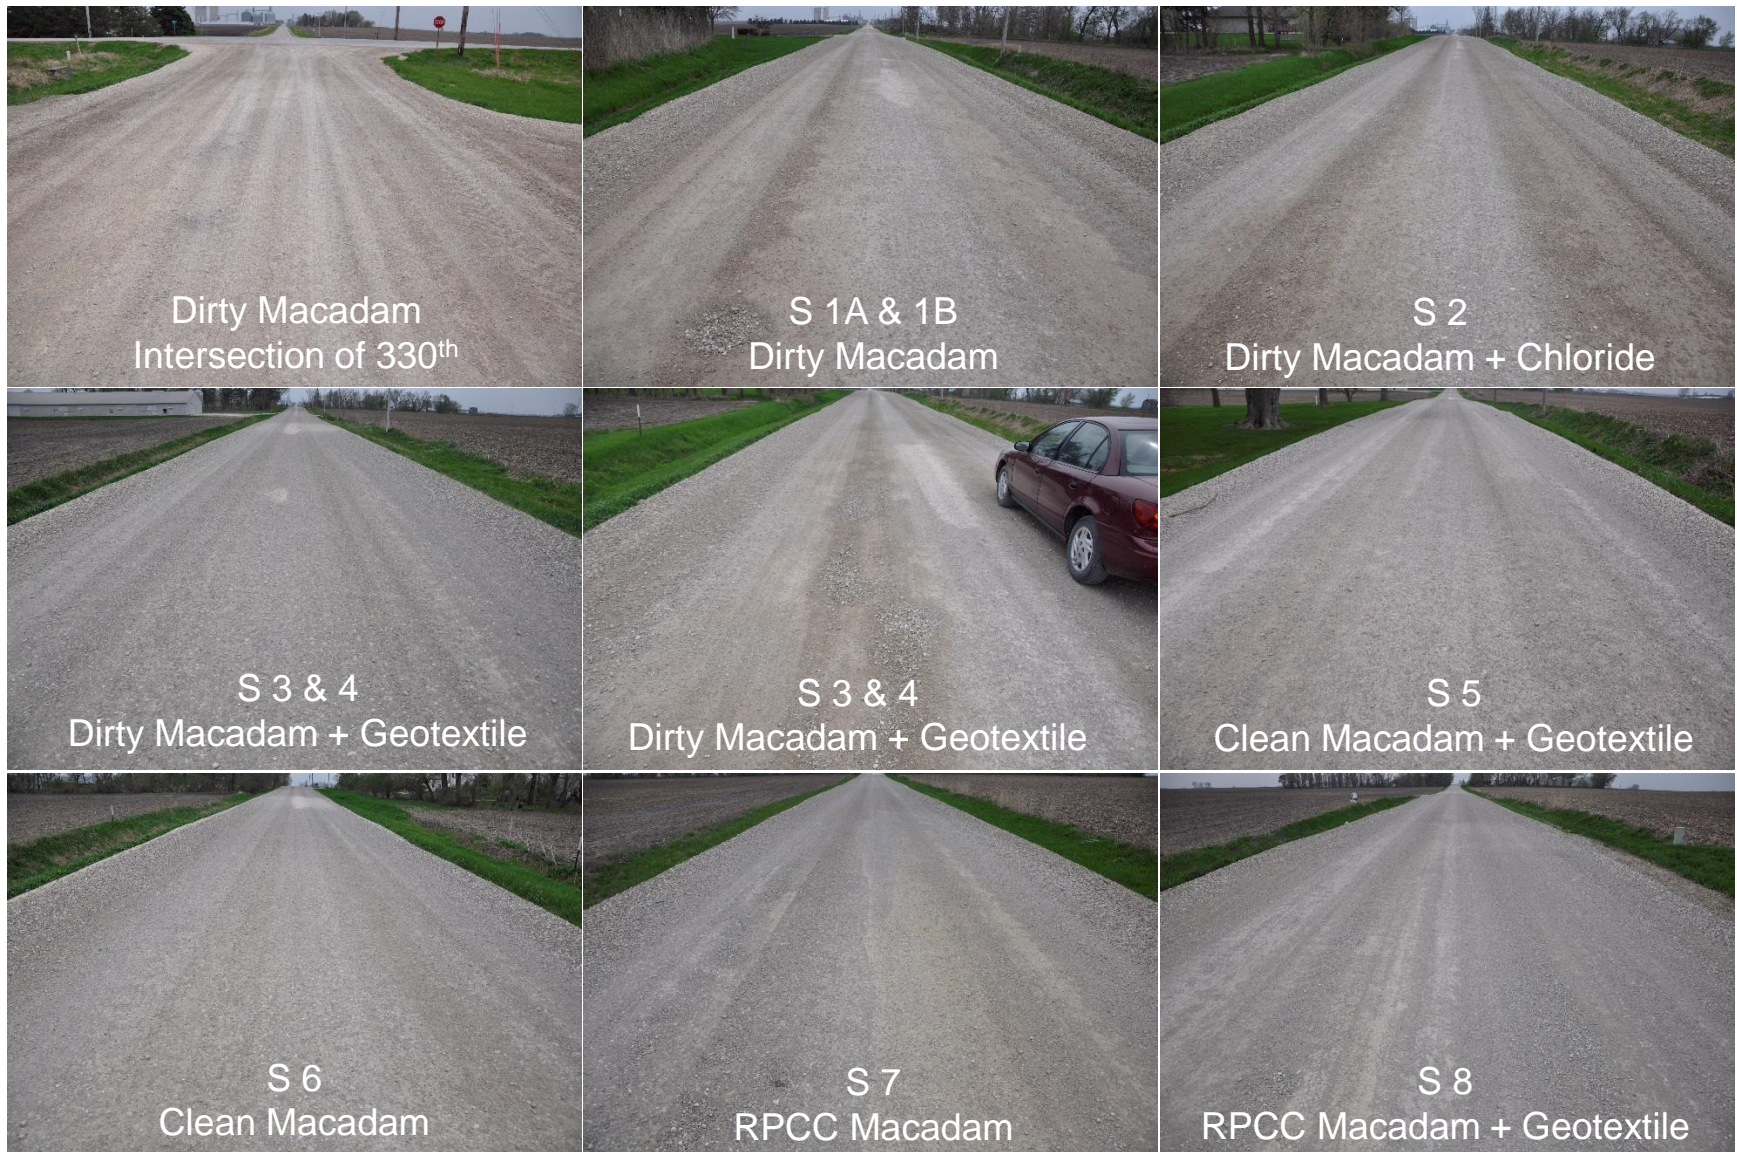
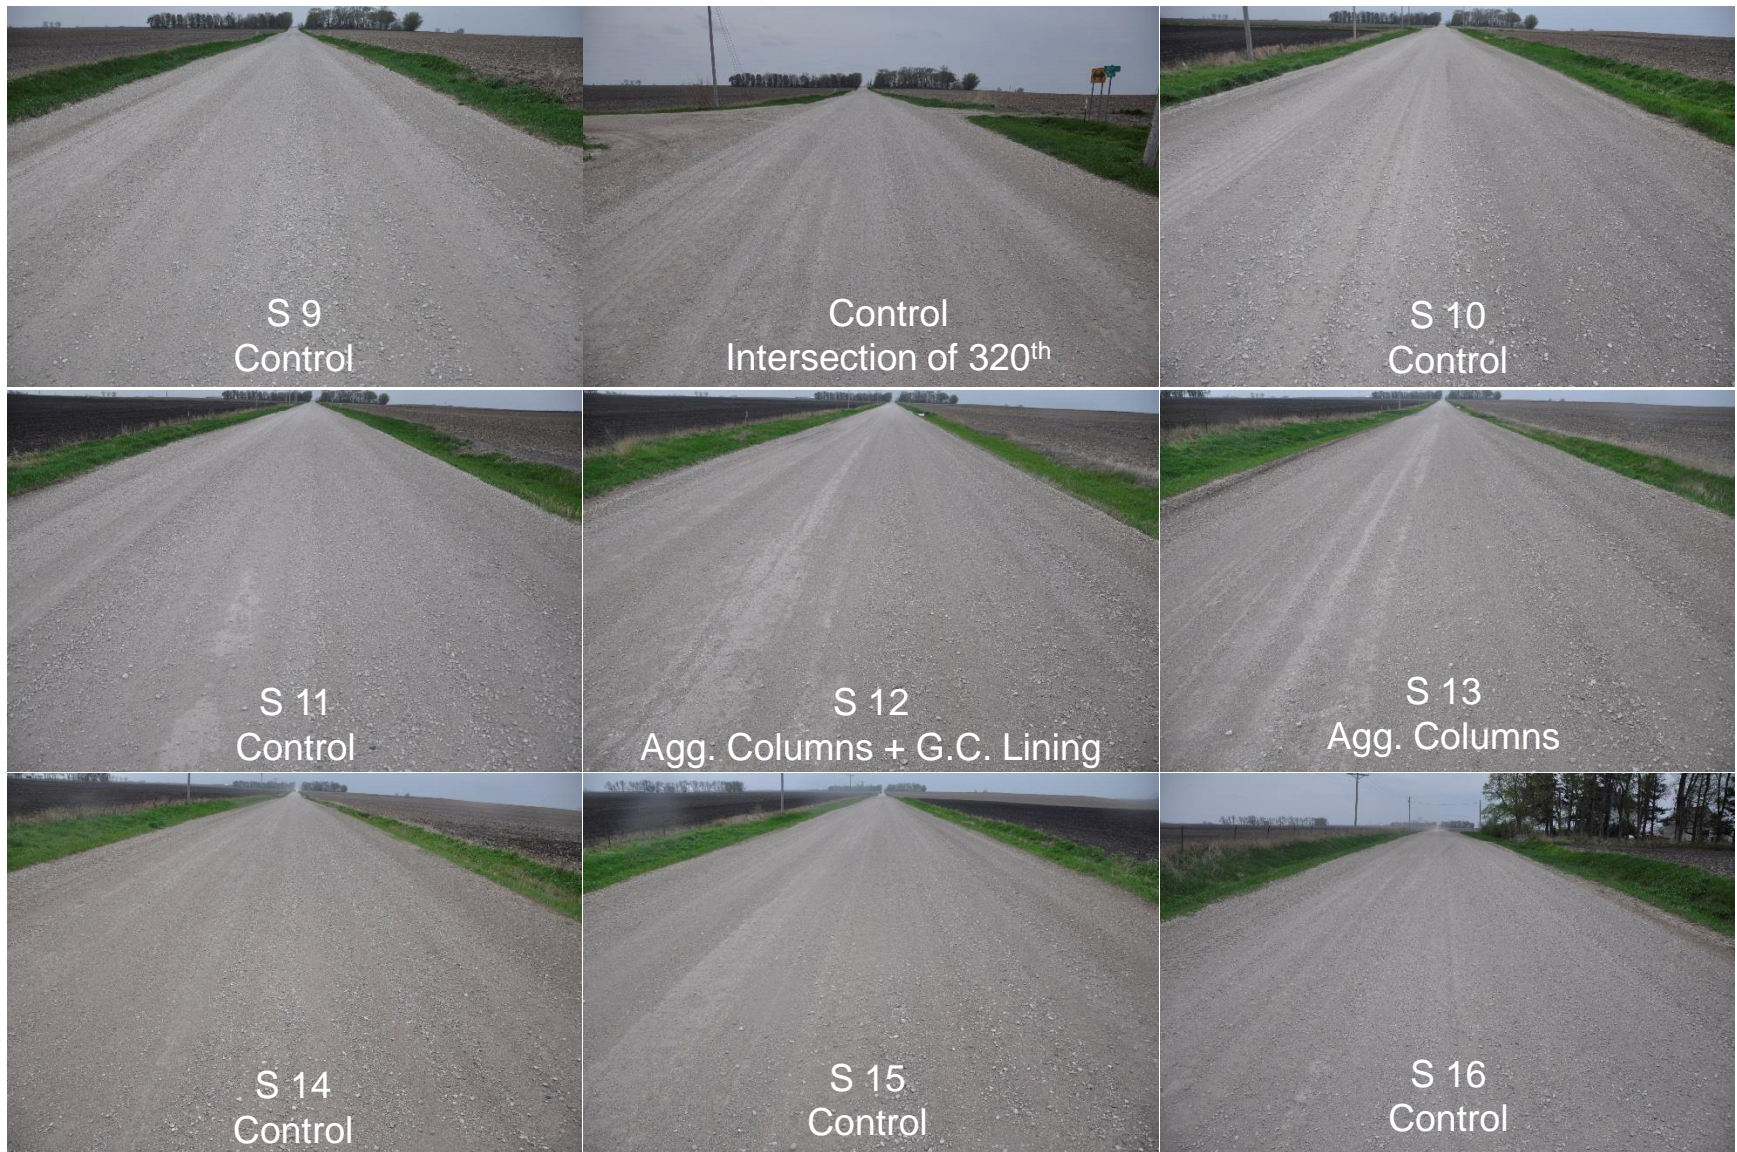
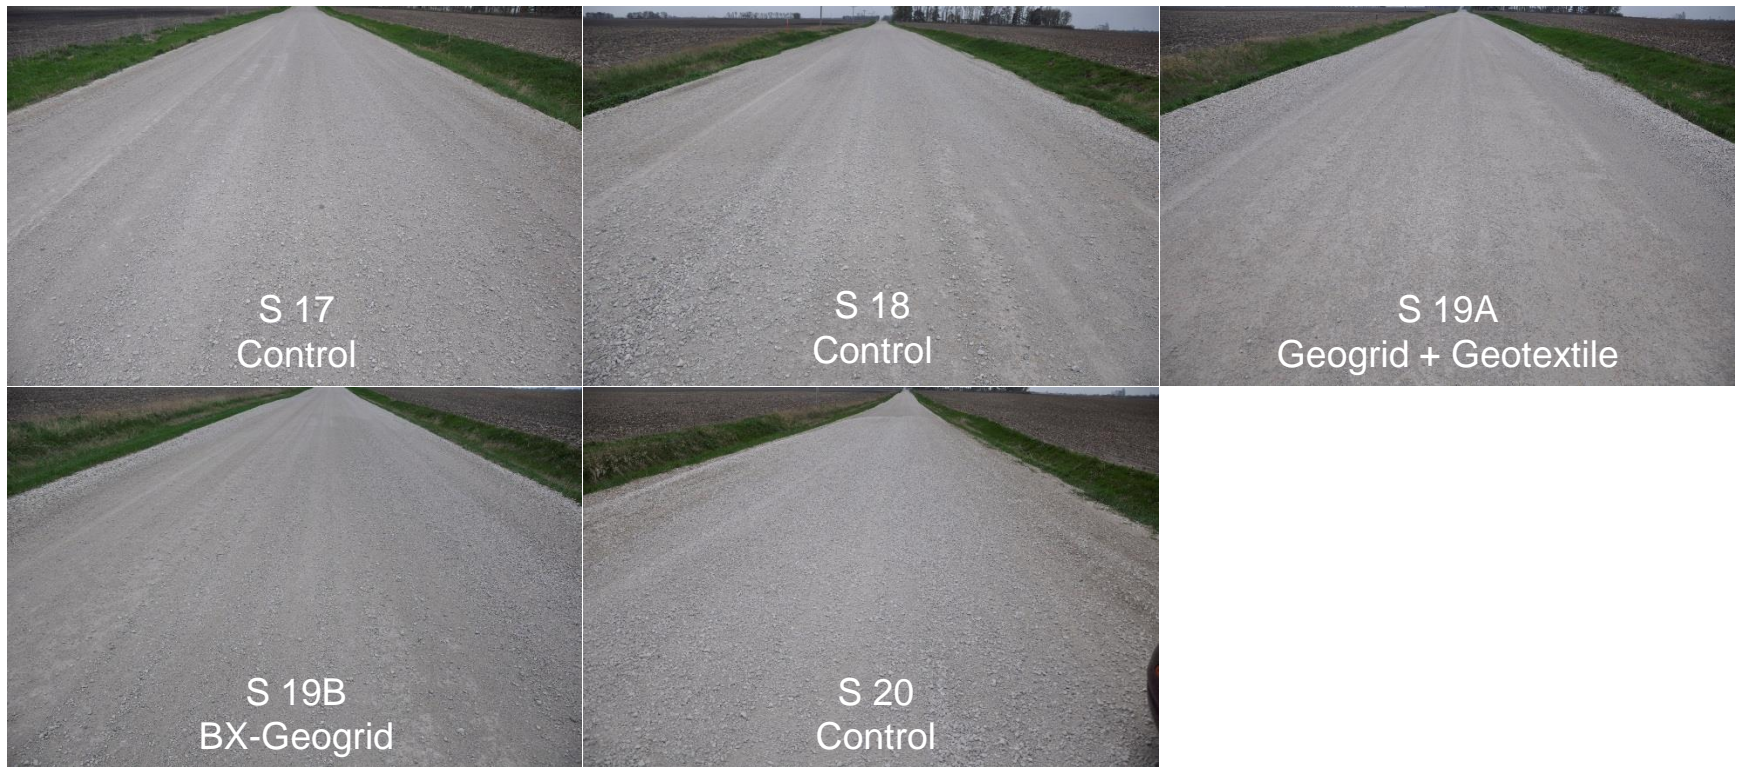
Figure 126. Survey photos of Vail Avenue demonstration sections (May 8, 2014)

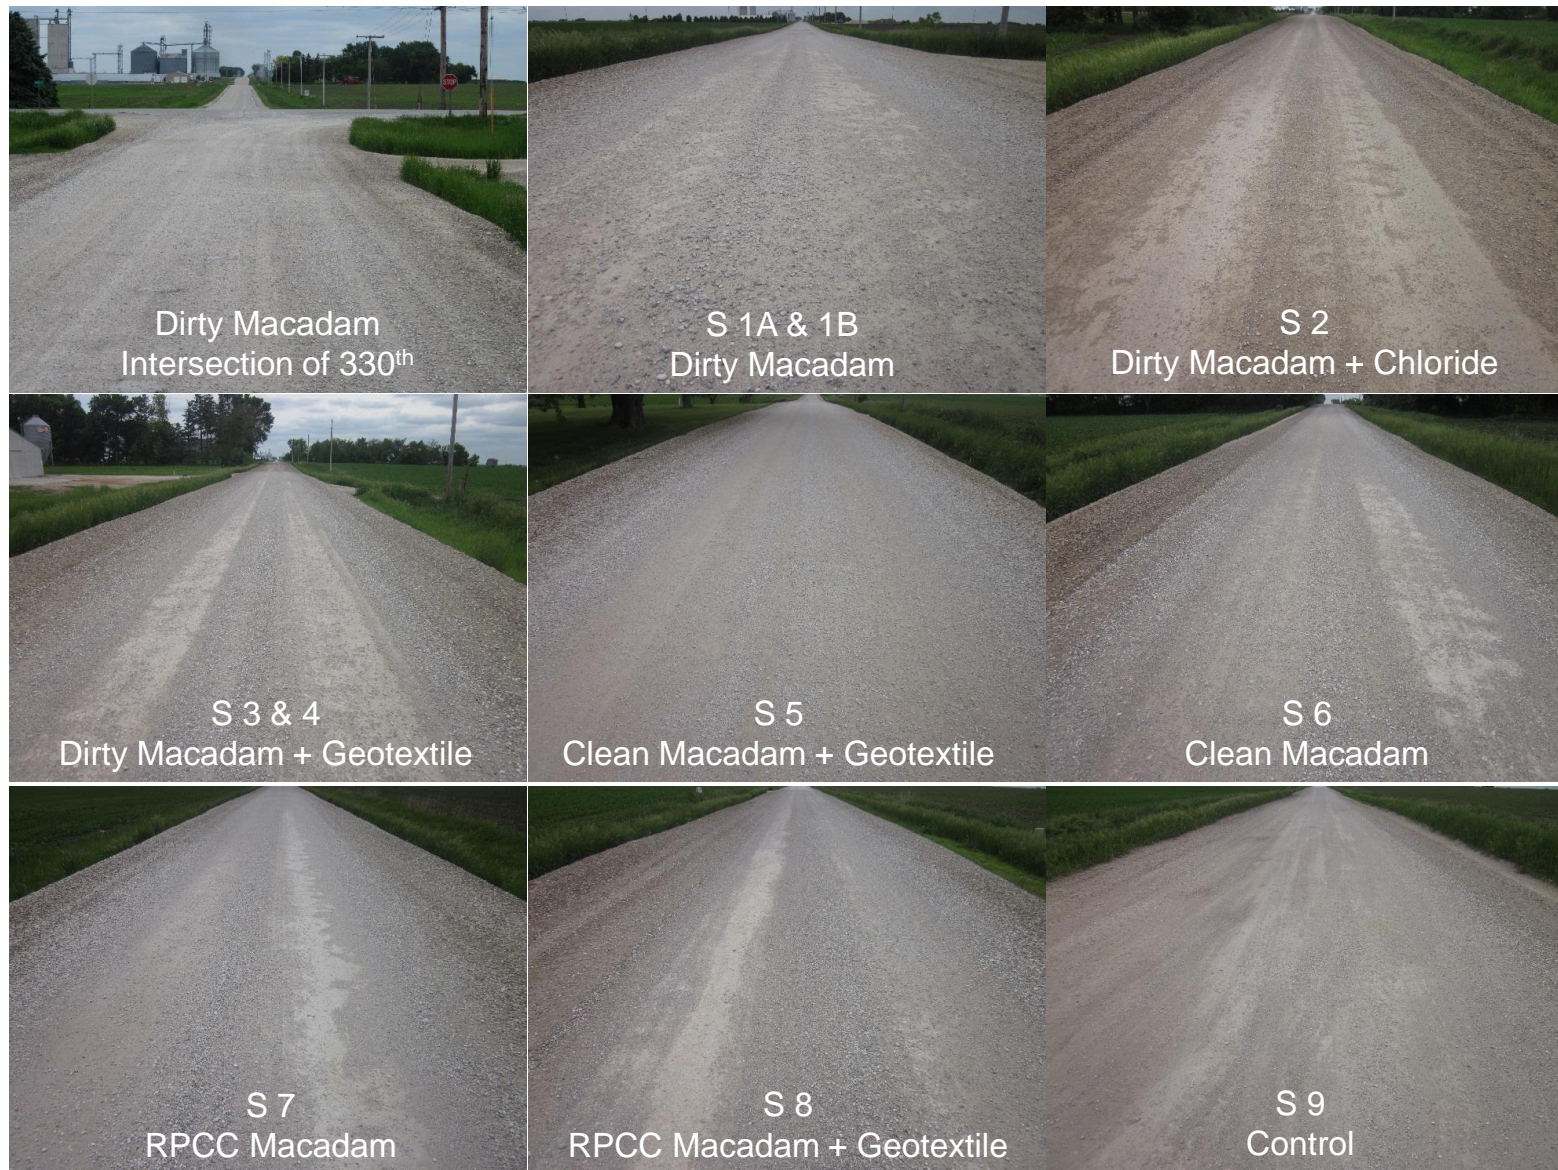
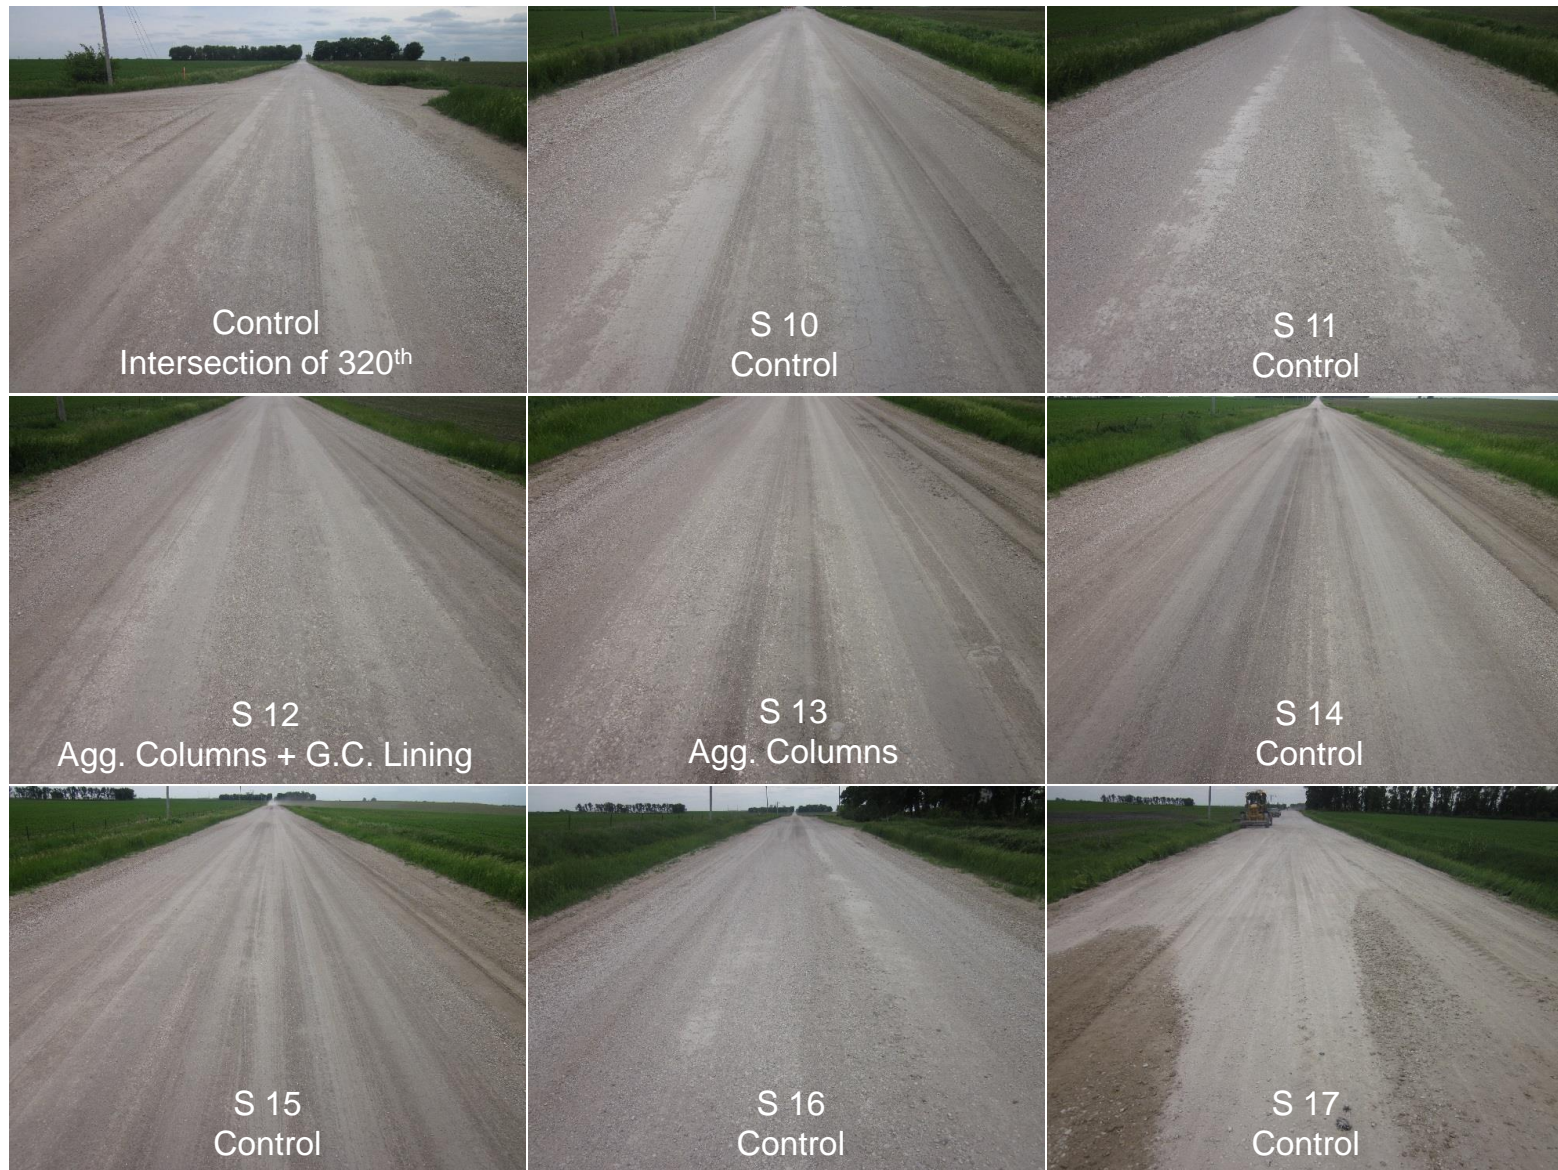
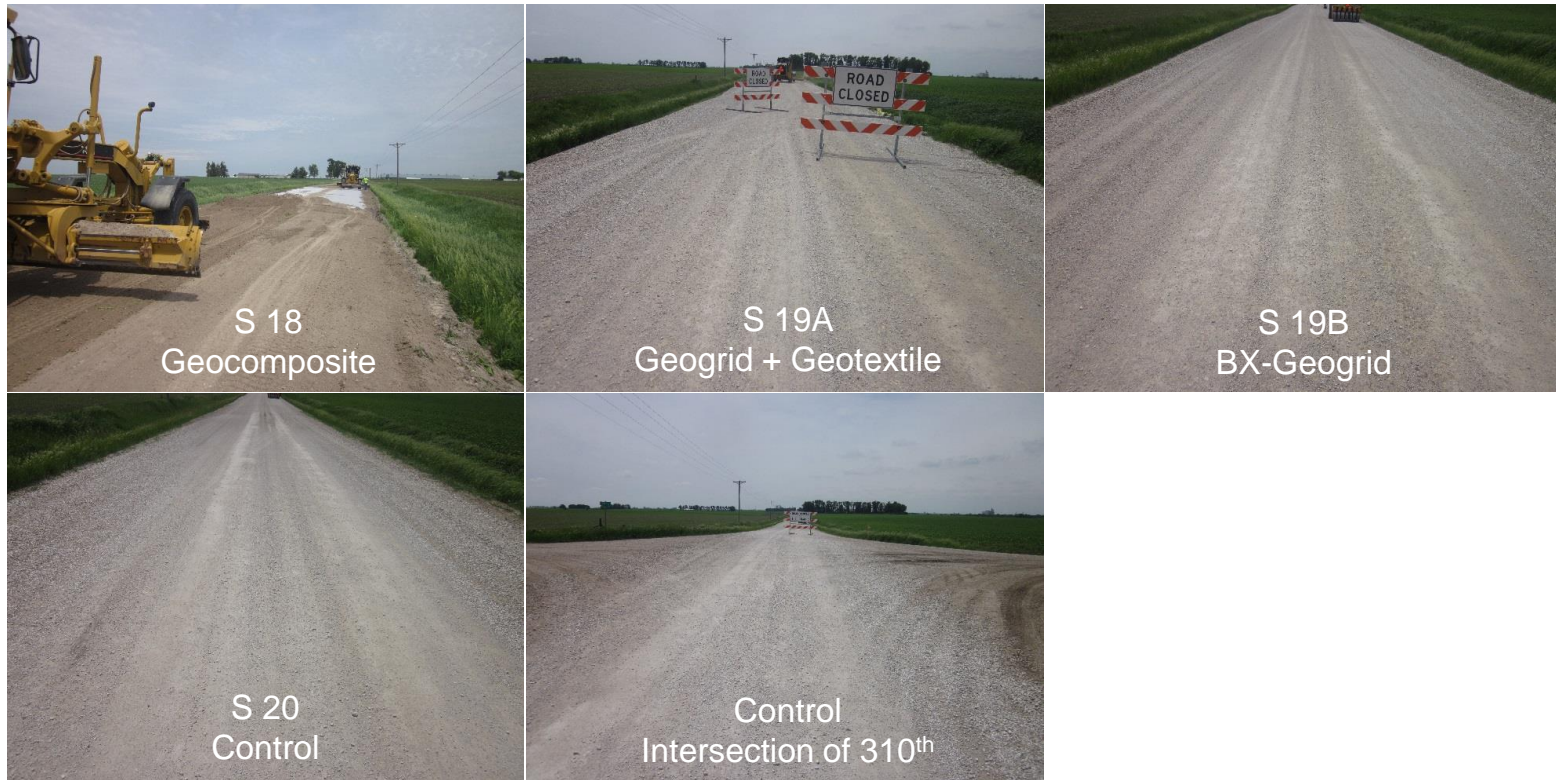
Figure 127. Survey photos of Vail Avenue demonstration sections (June 6, 2014)

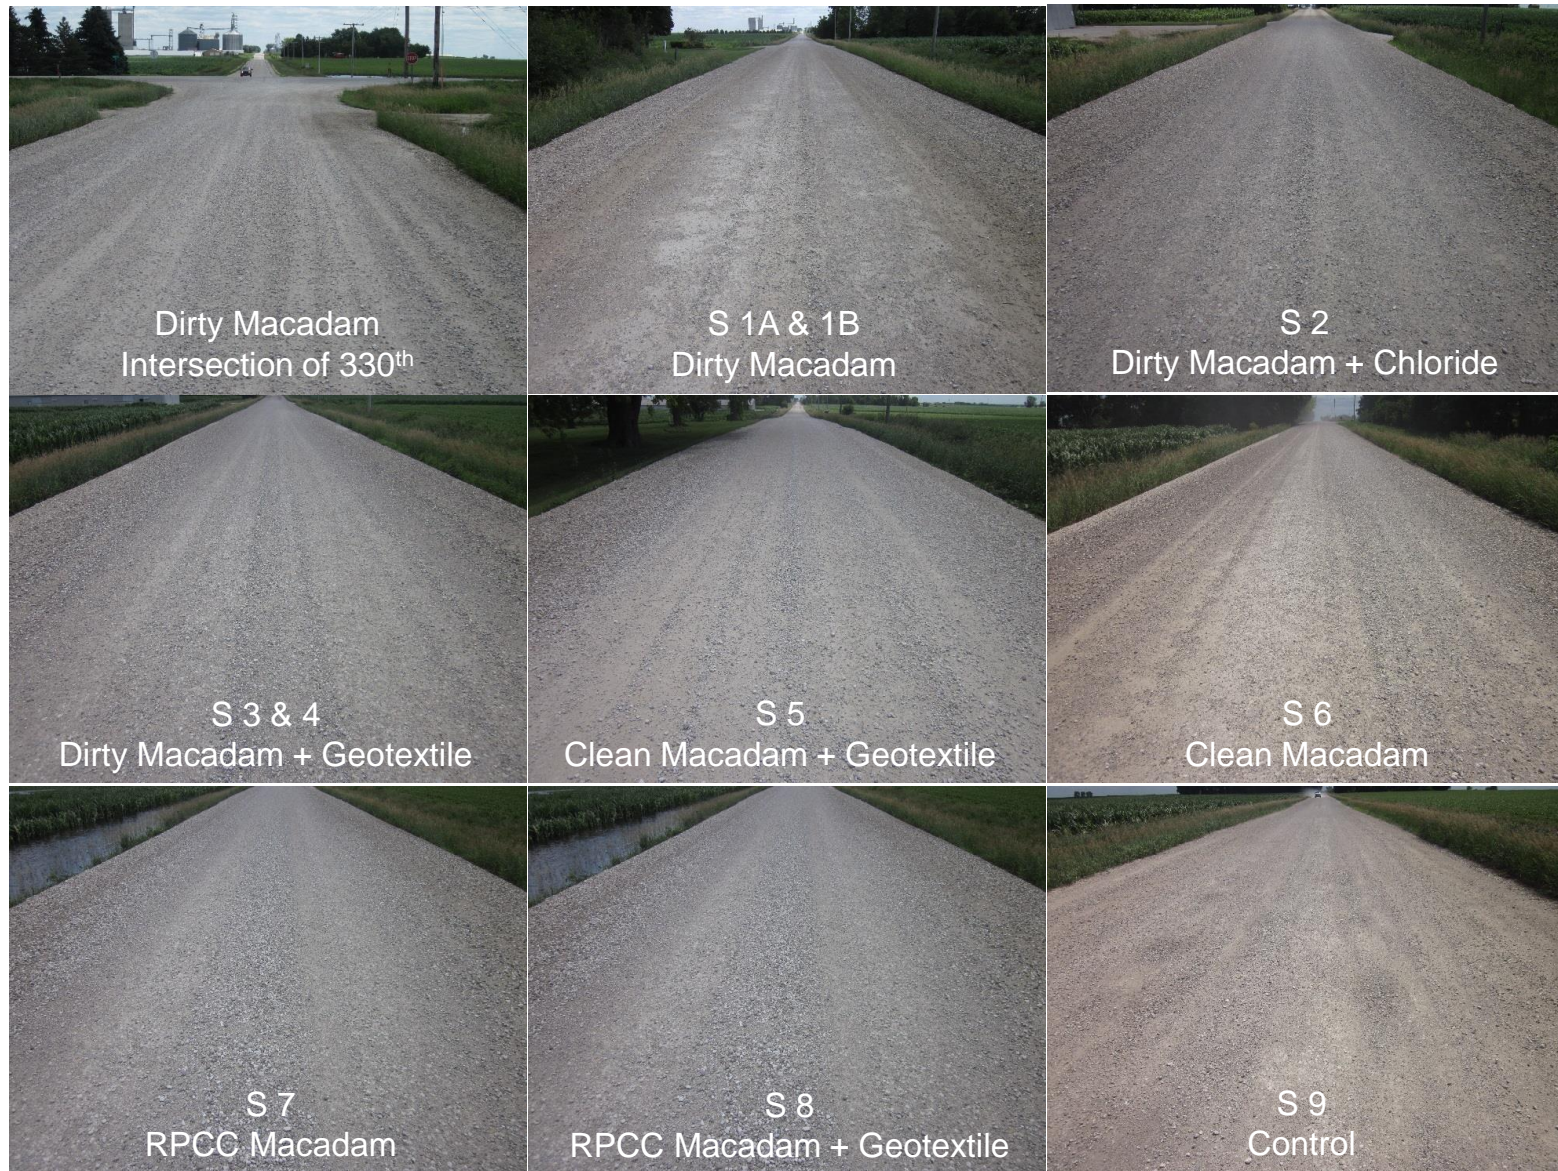
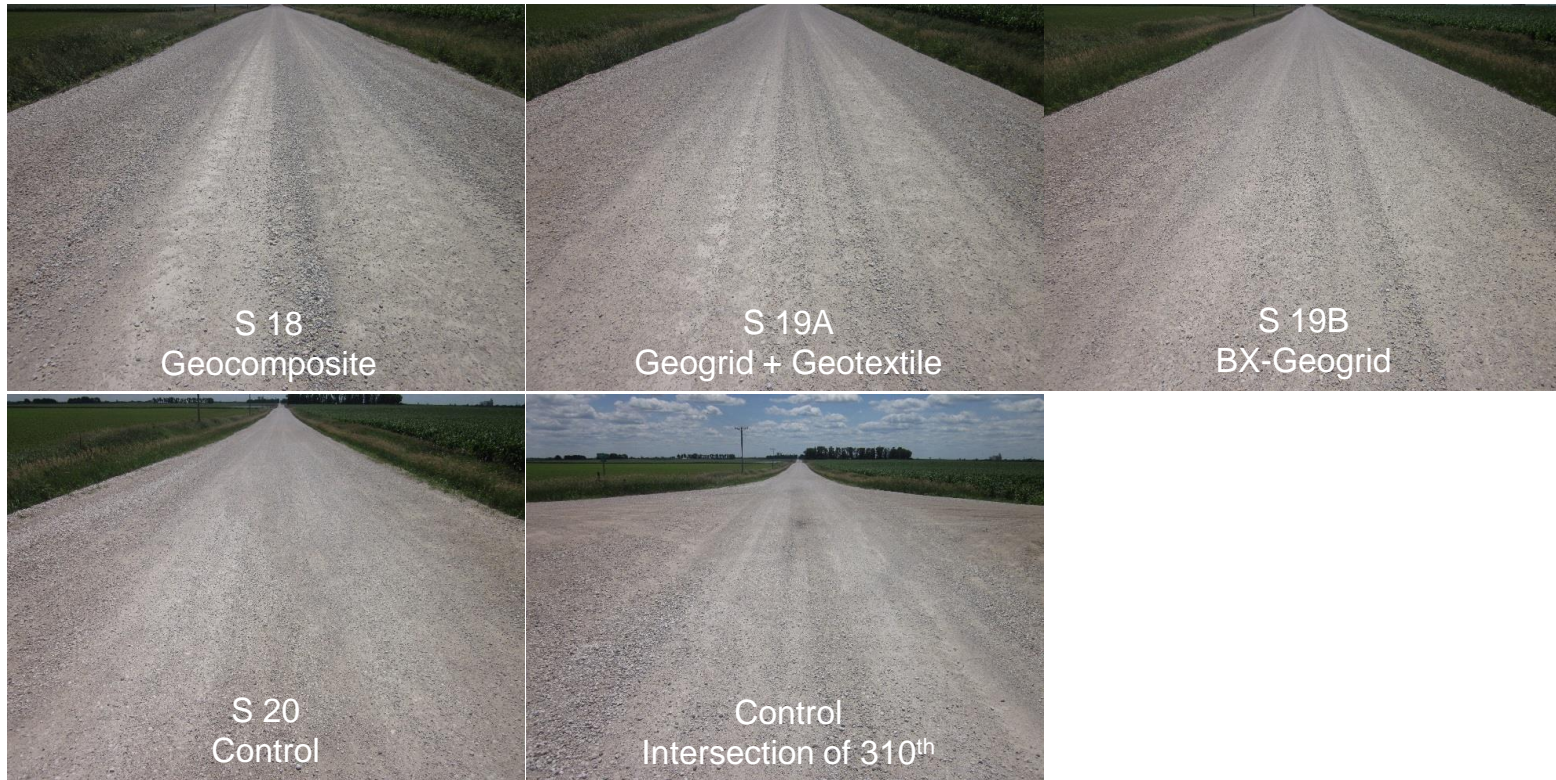
Figure 128. Survey photos of Vail Avenue demonstration sections (July 3, 2014)

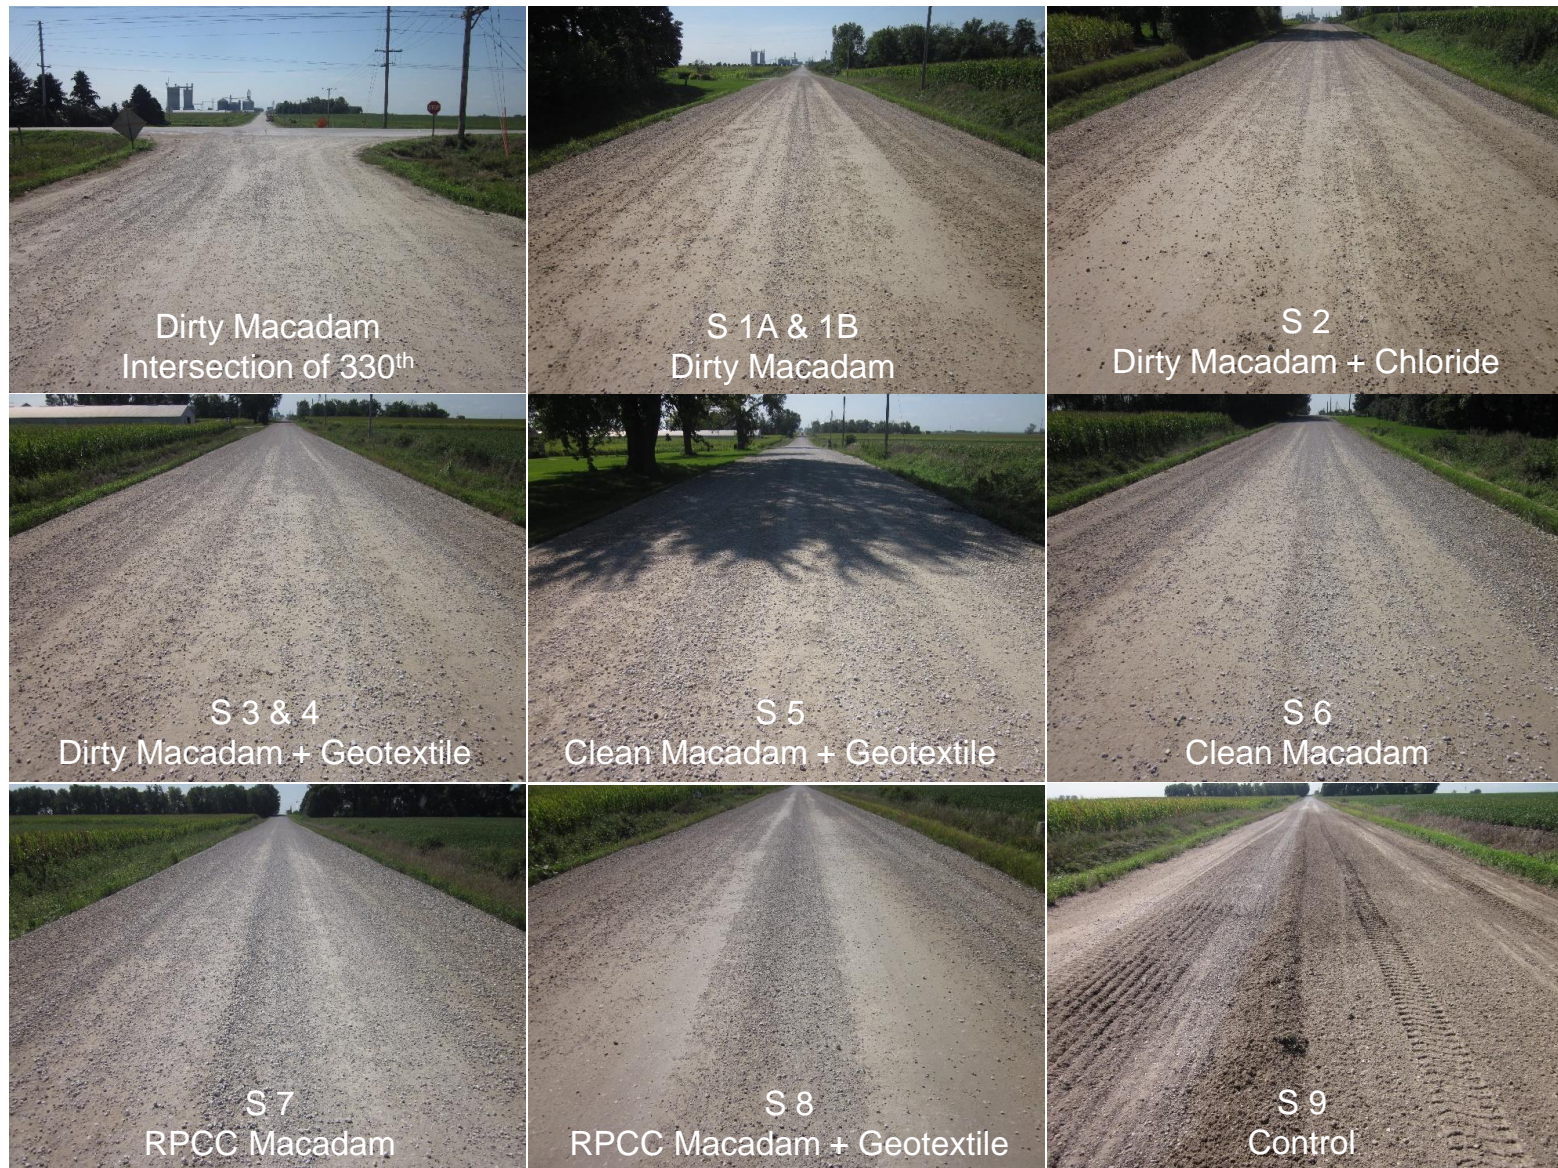
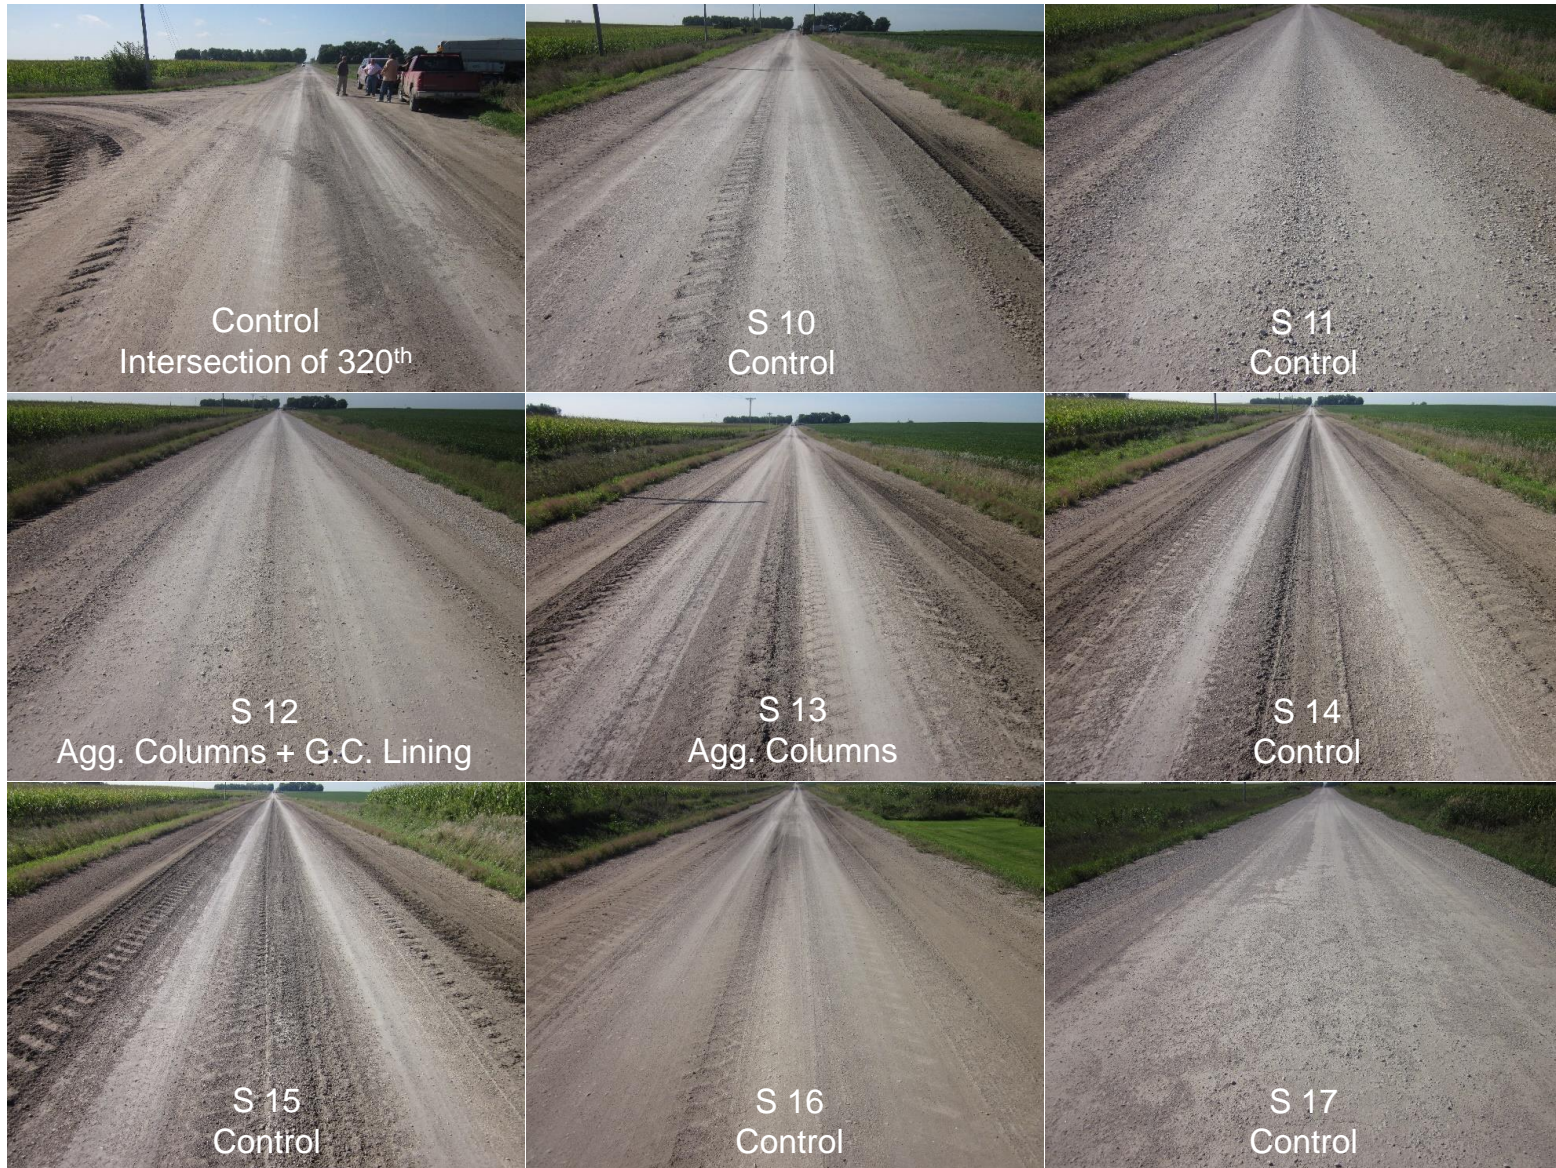
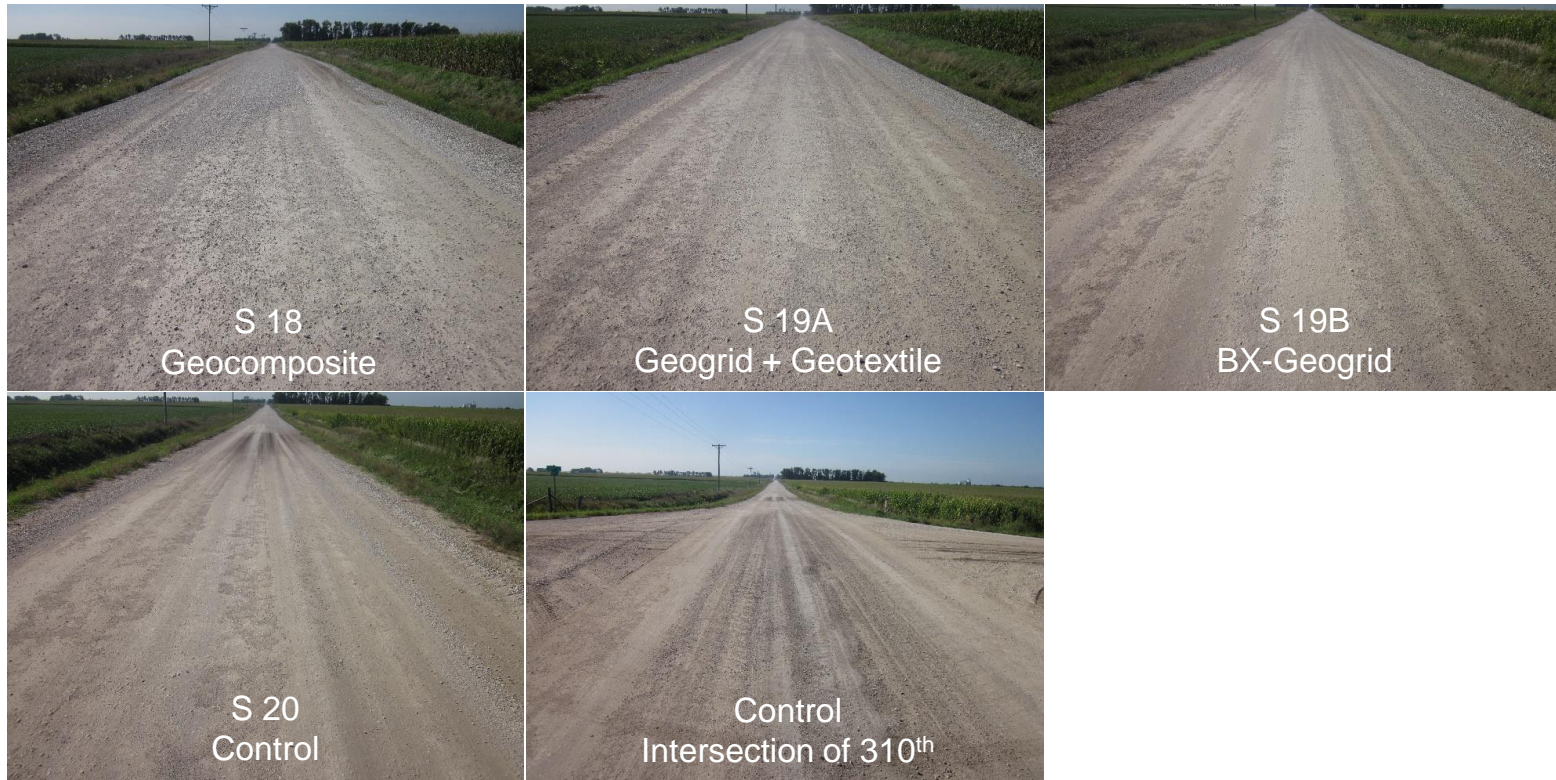
Figure 129. Survey photos of Vail Avenue demonstration sections (September 2, 2014)

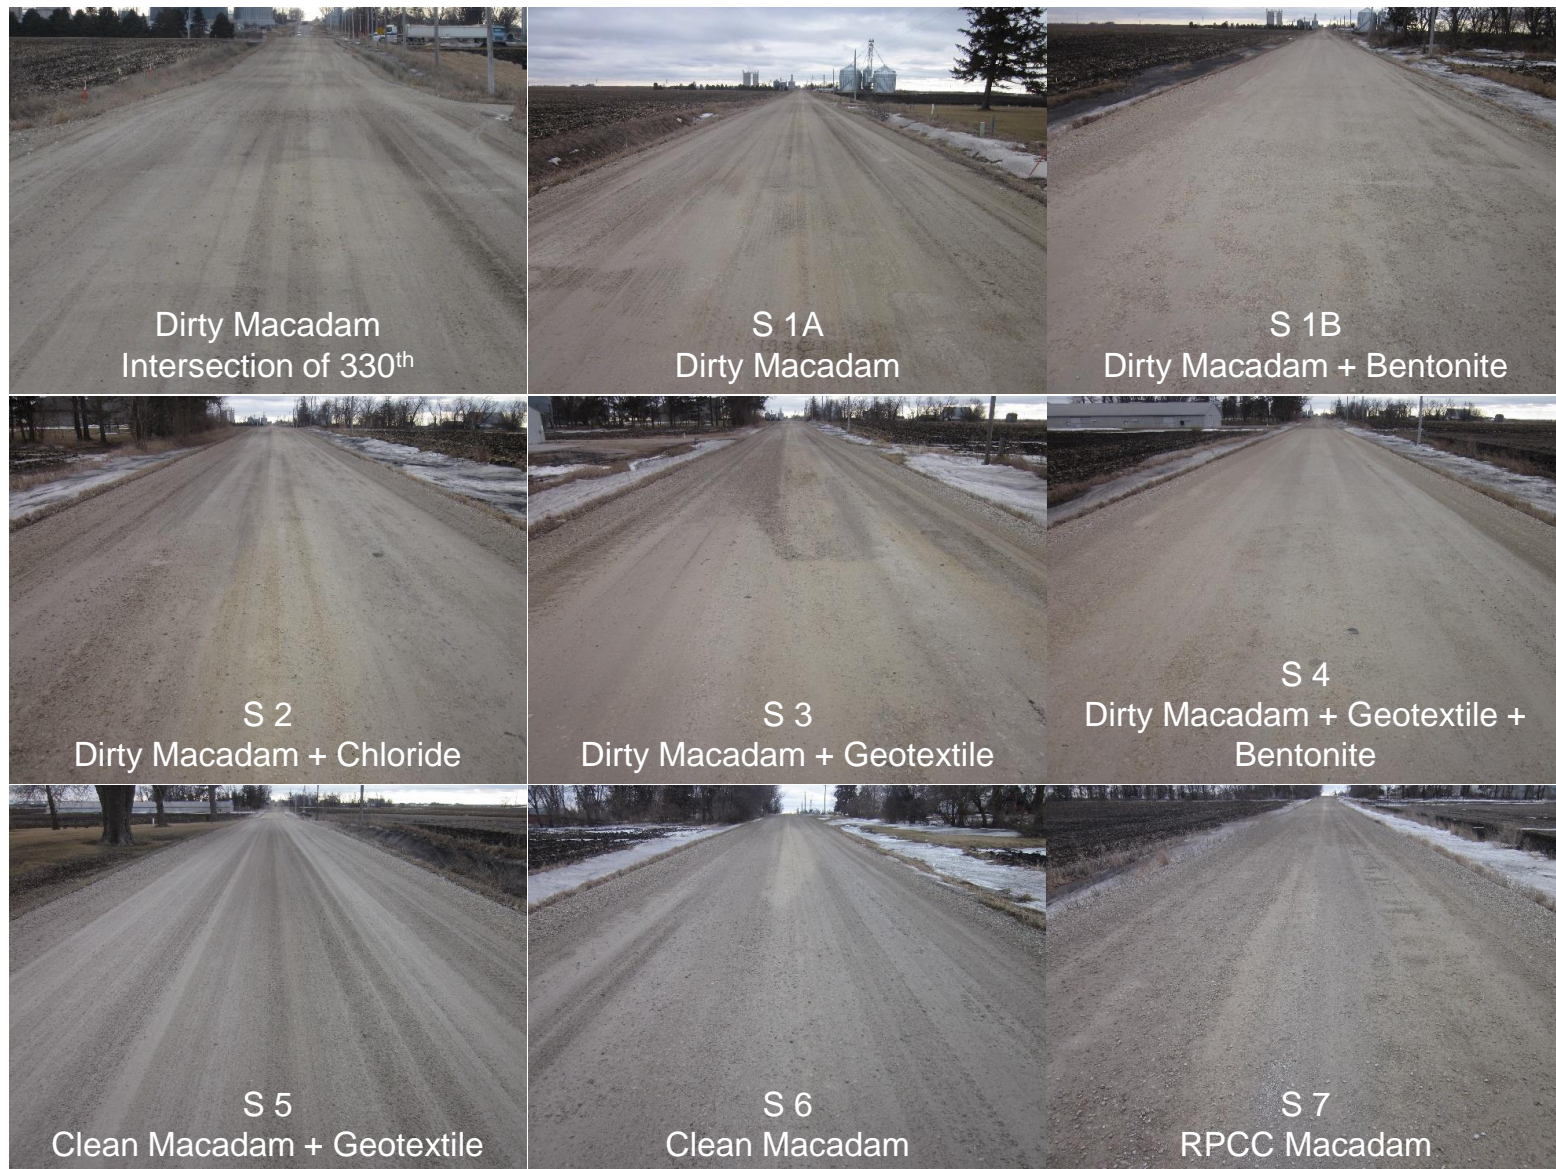
Figure 130. Survey photos of Vail Avenue demonstration sections (January 20, 2015)

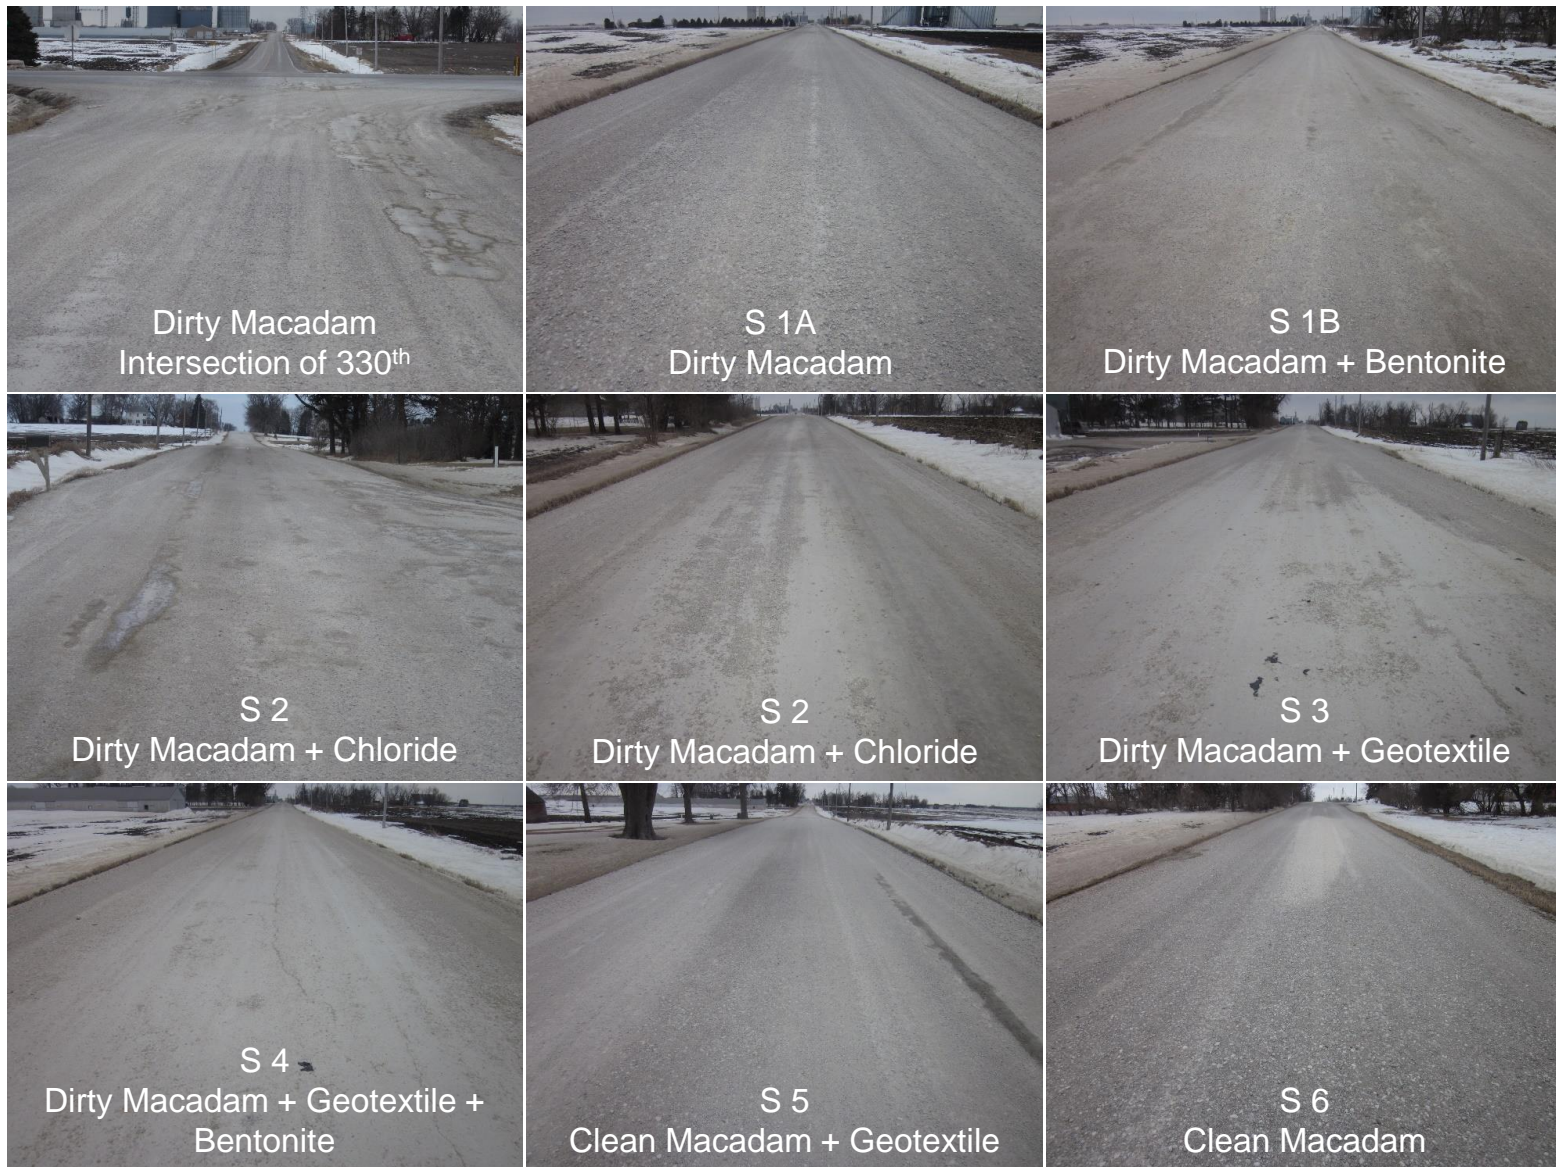
Figure 131. Survey photos of Vail Avenue demonstration sections (February 24, 2015)
