Low-Cost Rural Surface Alternatives: Demonstration Project

**Final Report
June 2015**

IOWA STATE UNIVERSITY
Institute for Transportation

Sponsored by
Iowa Highway Research Board
(IHRB Project TR-664)
Iowa Department of Transportation
(InTrans Project 13-479)

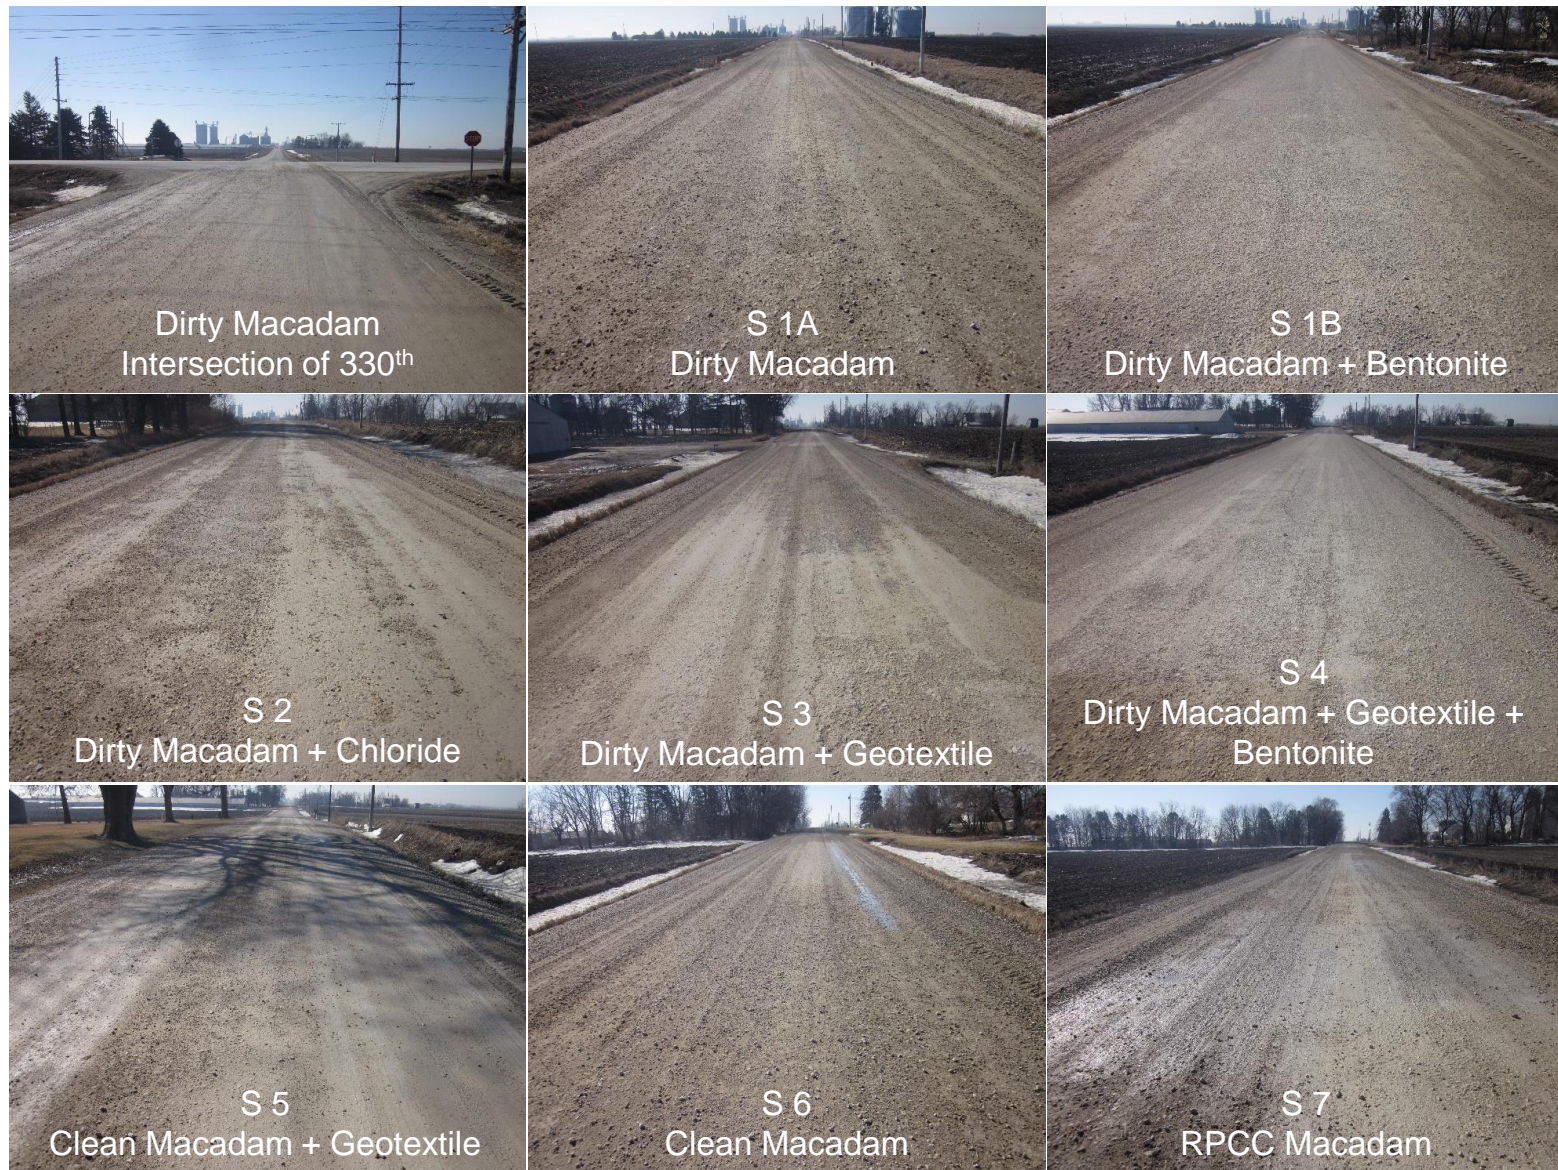
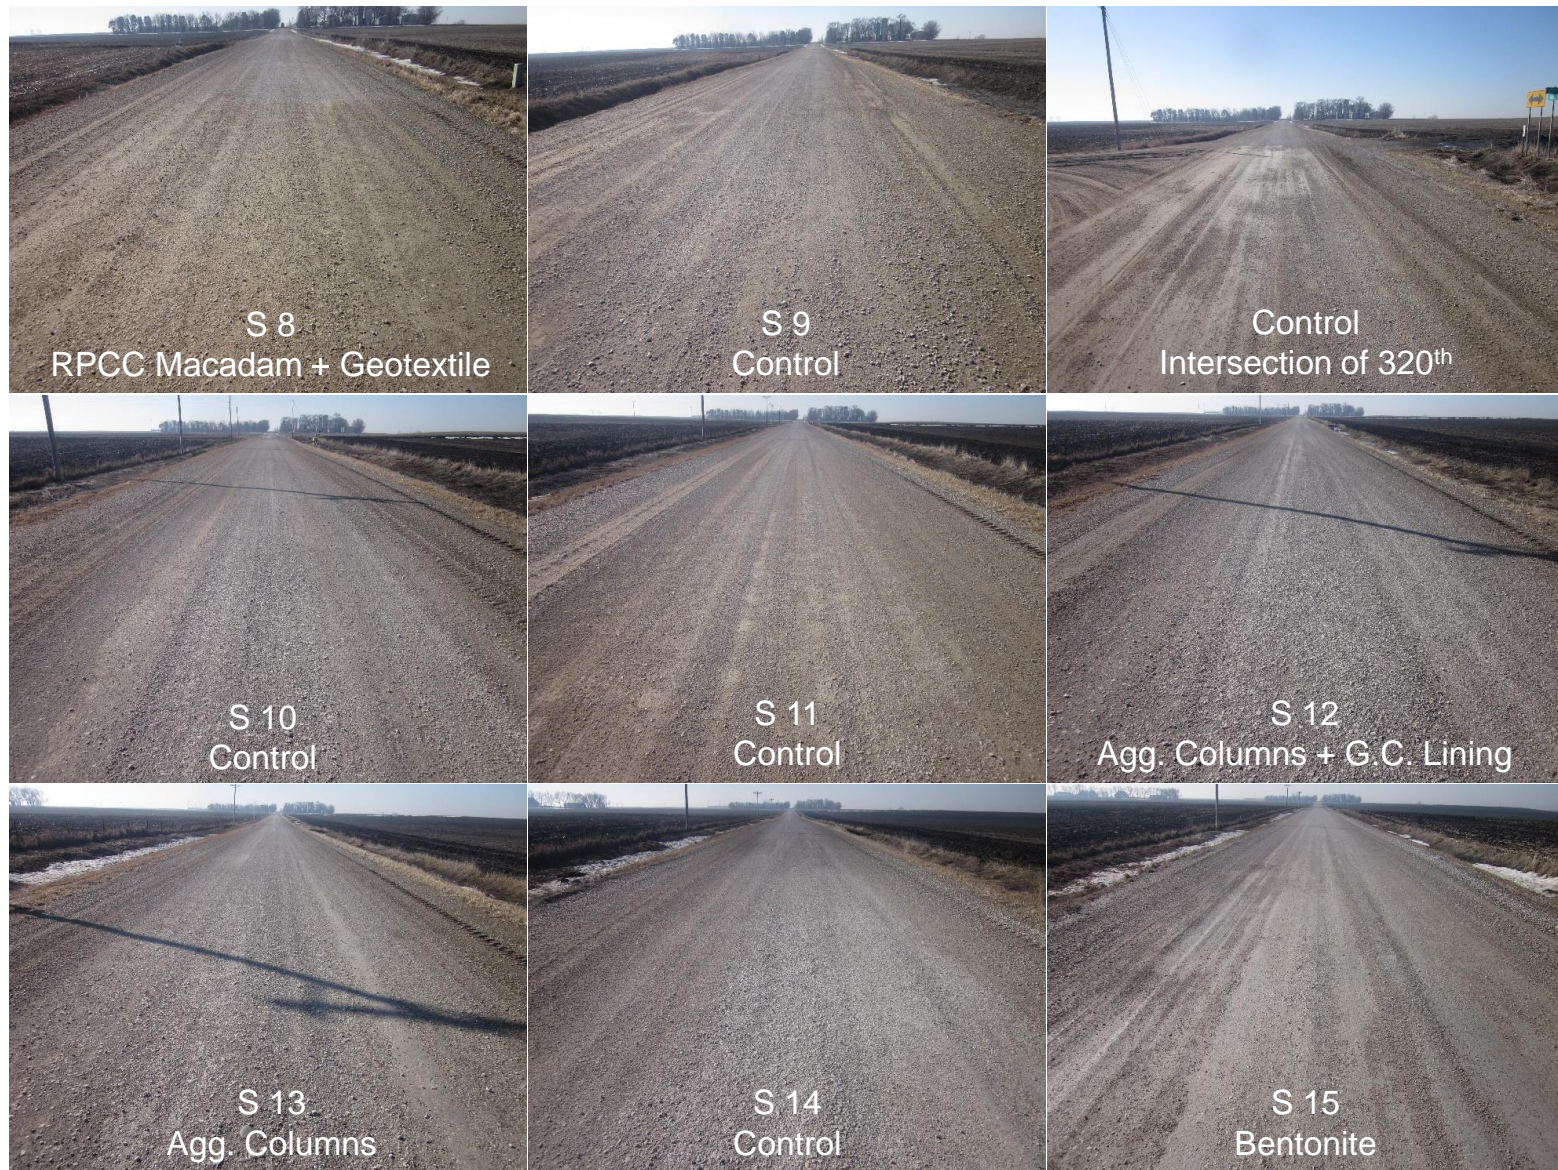
Figure 132. Survey photos of Vail Avenue demonstration sections (March 10, 2015)

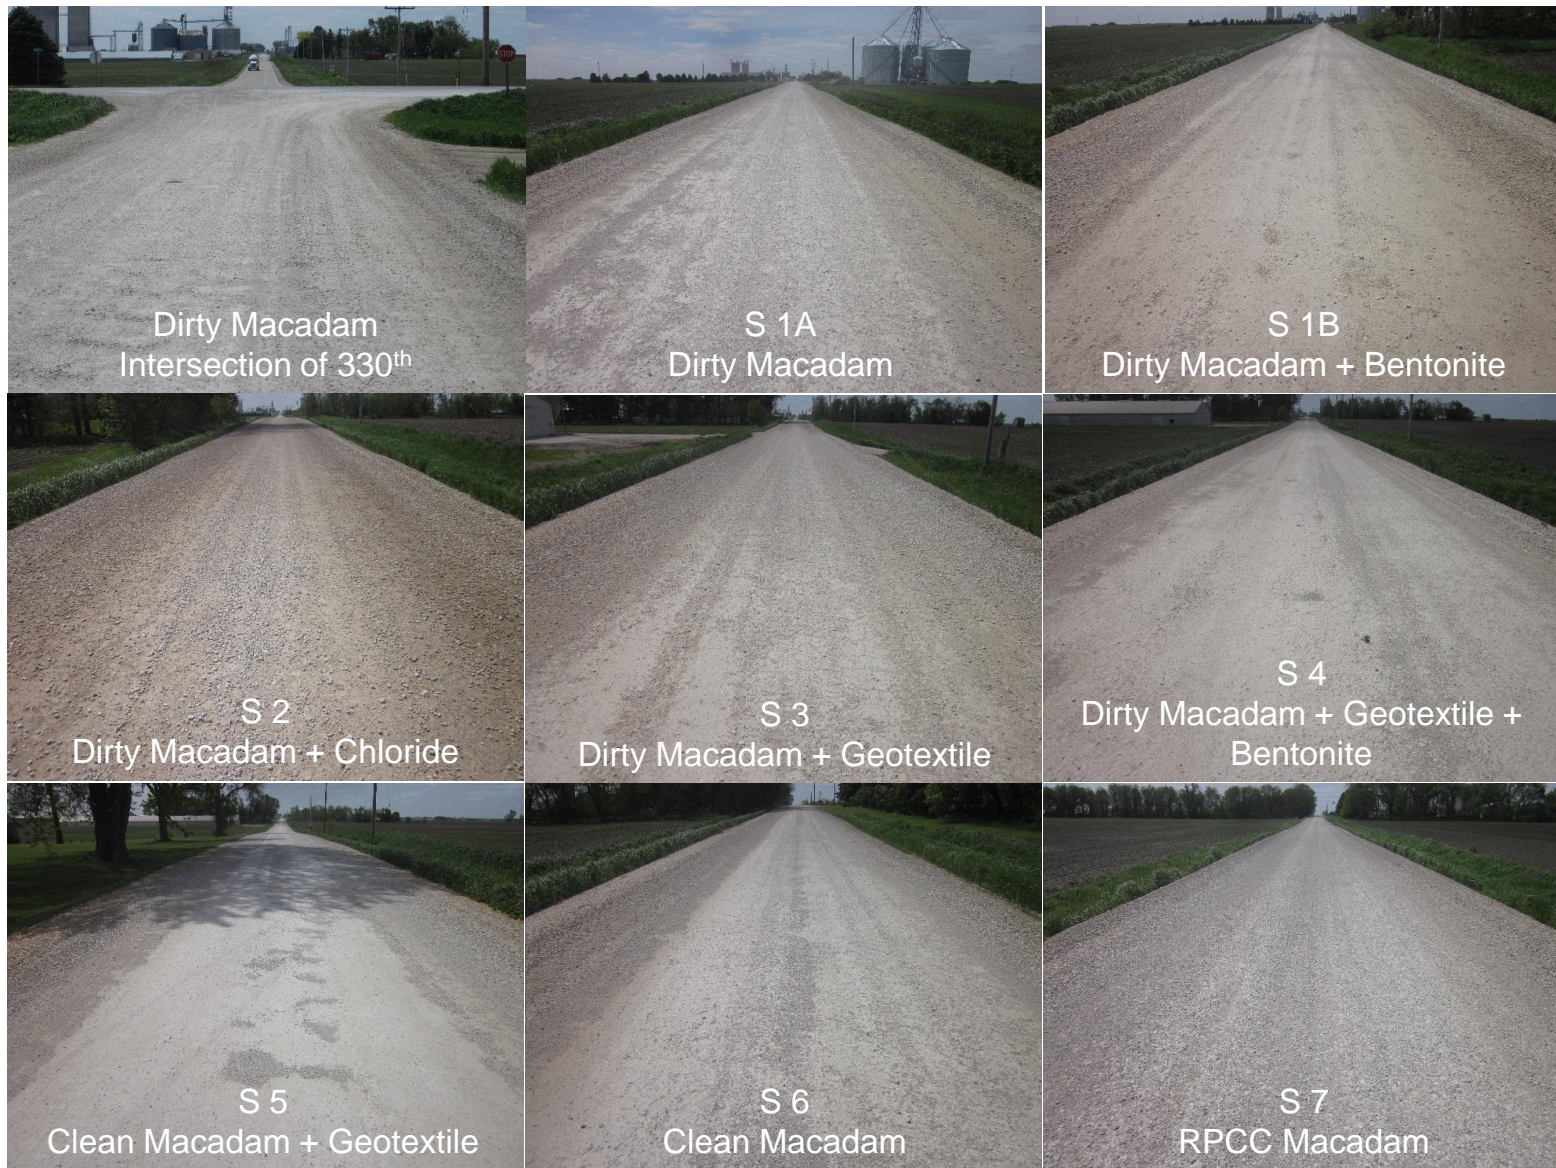
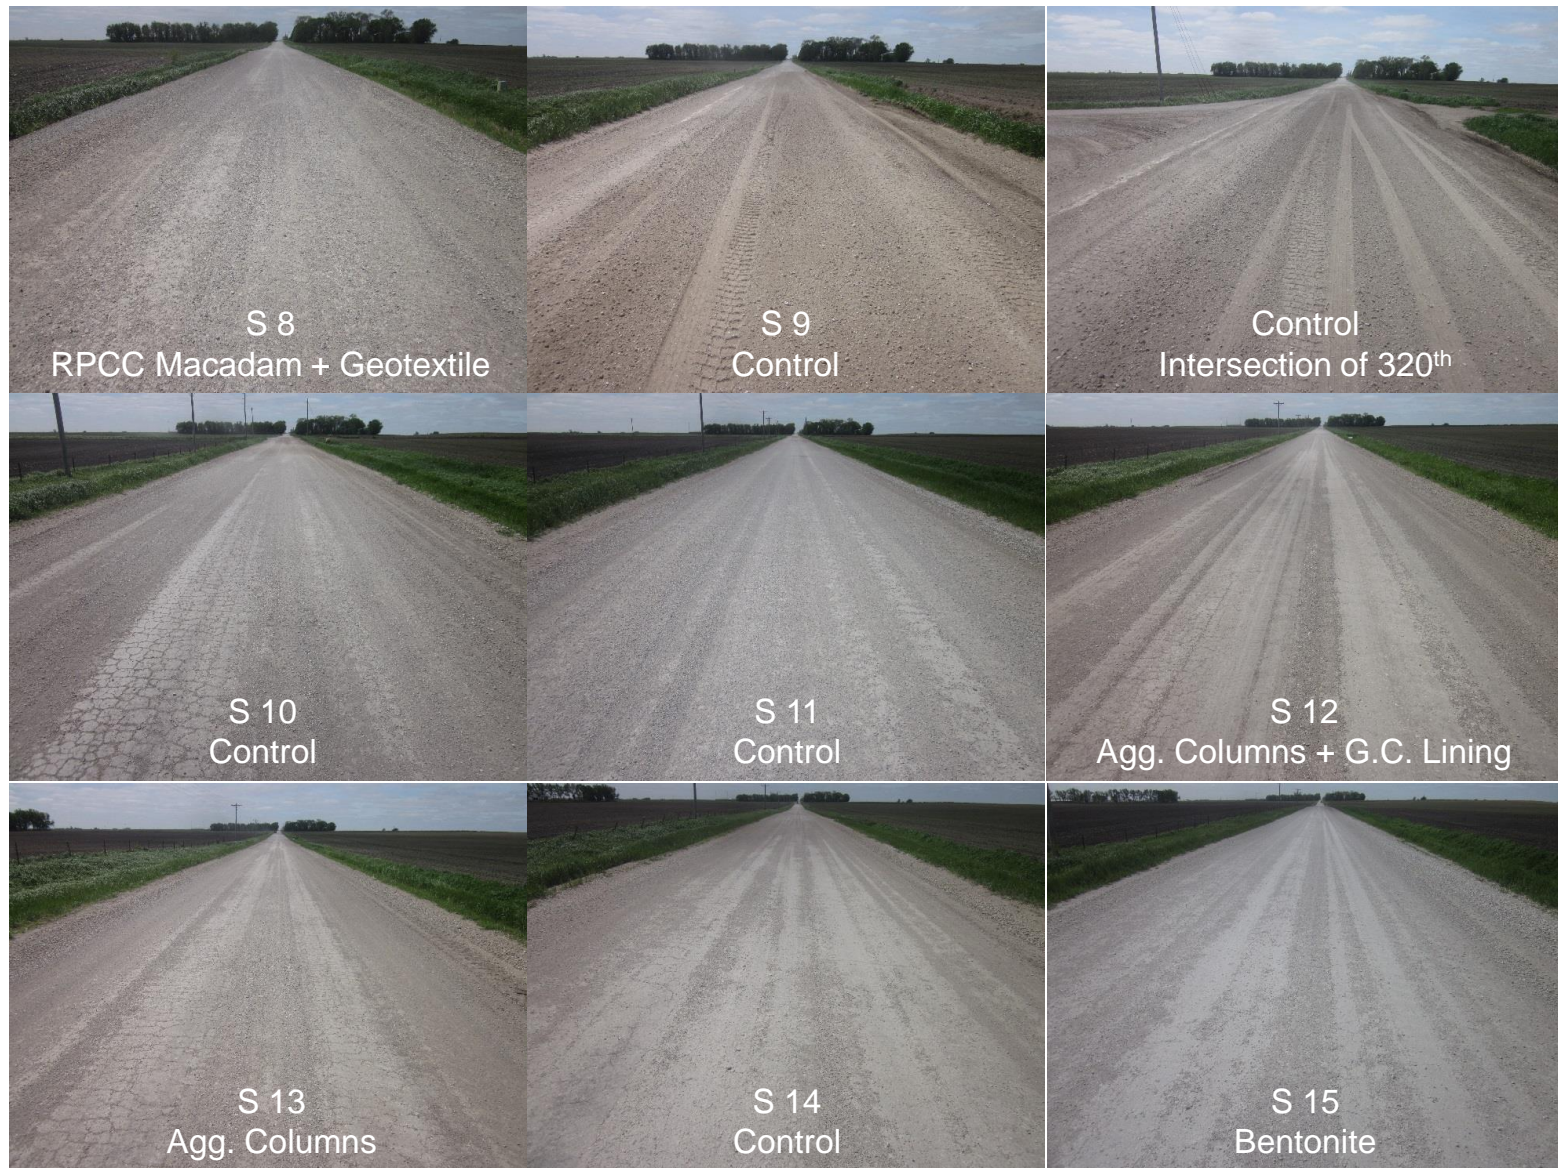
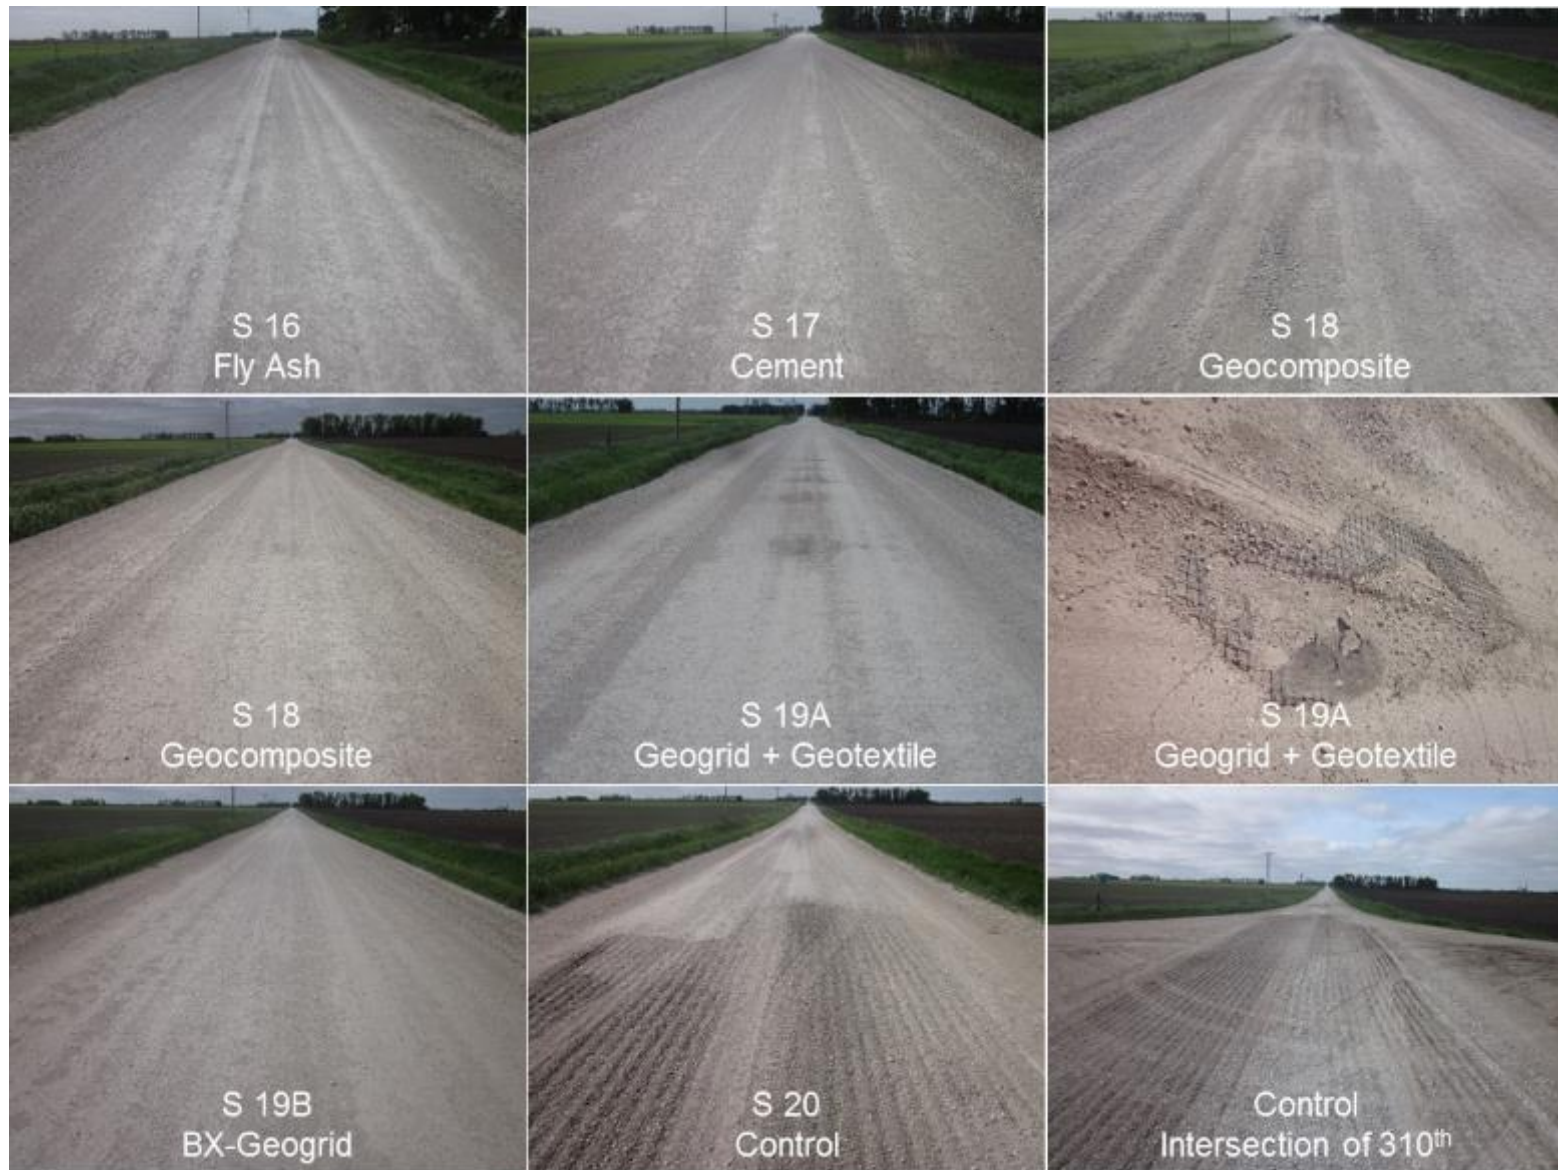
Figure 134. Survey photos of Vail Avenue demonstration sections (May 19, 2015)
