Southeast Michigan Local Road Concrete Pavement Durability Study

Final Report
July 2006

**National Concrete Pavement
Technology Center**

**Sponsored by
the Michigan Concrete Paving Association**

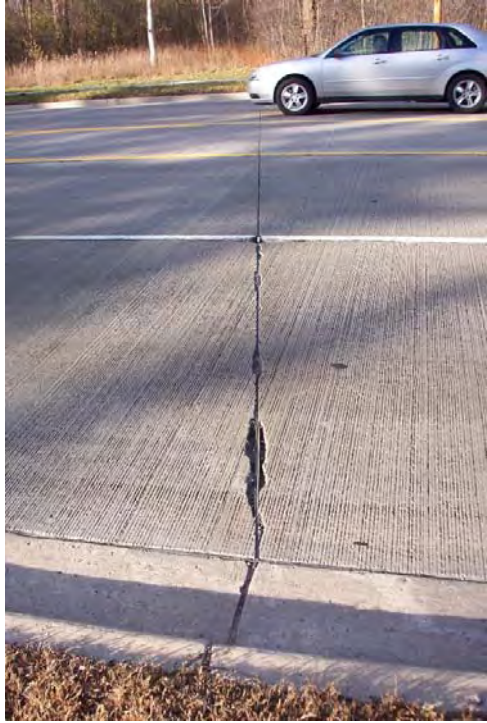
Figure 1. 12 Mile Road in Franklin, six years old

A field review of each project was performed to evaluate the condition of the pavements that were a part of this study. Examples are presented in Figures 1 and 2. Cores were taken from each project and evaluated petrographically in order to determine the condition and identify deterioration mechanisms. These two observations, the visual field observation of the concrete pavement and the microscopic analysis of the concrete pavement core, were not always consistent.

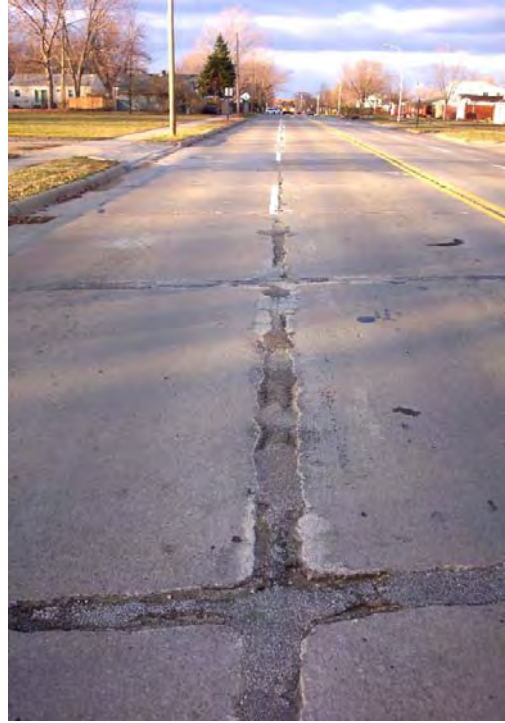
Figure 2. Campbell Road in Madison Heights, twenty-one years old

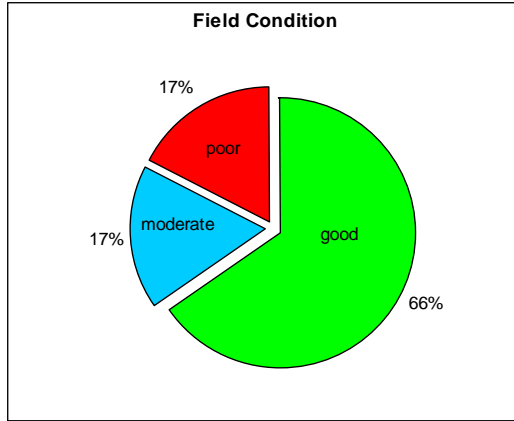
Figure 3 (a). Condition of the concrete pavement based on visual field observation

Table 2 and Figure 3 present the condition of the concrete pavement based on visual field observation and petrographic core analysis.

Condition Rating		
	Good	Moderate	Poor
Concrete condition by field observation	79%	4%	17%
Concrete condition by core analysis	26%	13%	61%

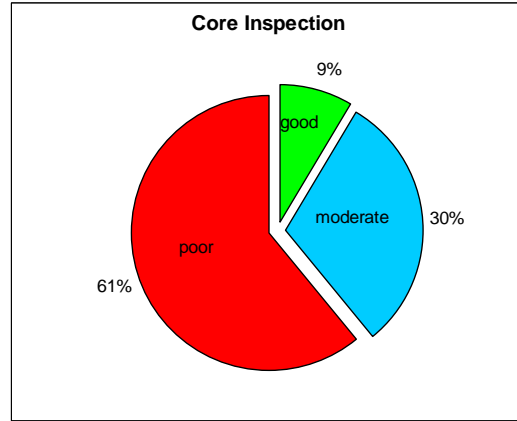
Figure 3 (b). Condition of the concrete pavement based on core inspection and analysis

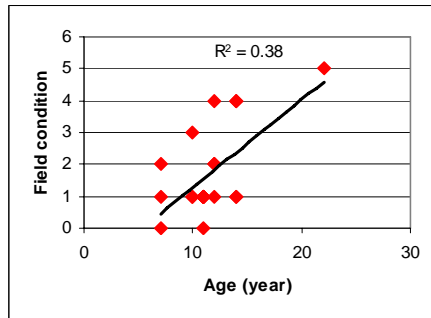
Figure 4 (a). Age vs. concrete pavement condition as determined by field observation

A correlation of the age of the projects to the condition of the concrete pavements shows a very minor relationship between age of the pavement and its condition when determined by field observation, but no relationship of age to condition when determined by core analysis (see Figure 4).

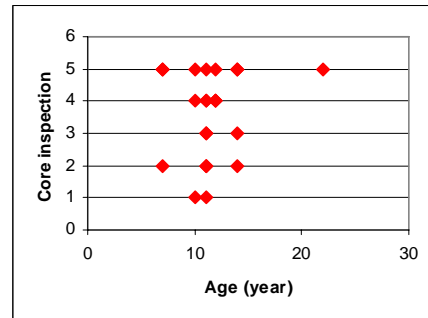
Figure 4 (b). Age vs. concrete pavement condition as determined by core analysis

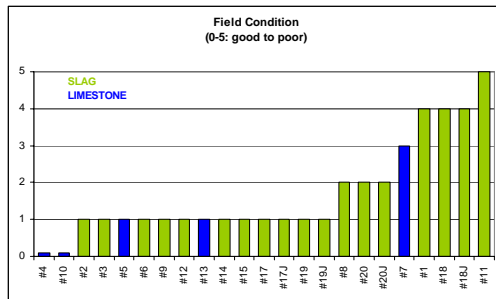
Figure 5 (a). Field-determined concrete pavement condition showing type of coarse aggregate

The slag aggregate has long been used in concrete pavements in Michigan. There were very few limestone aggregate projects included in this study. Only four pavements out of the twelve that were studied contained limestone coarse aggregate. Therefore, it is not possible to make any statistically valid conclusions from the data. Concrete pavement condition data by aggregate type are presented in Figure 5.

Problems were observed in the limestone concrete as well as the slag concrete. The two pavements that were in the best condition, as determined by visual observation, contained limestone. The other two limestone pavements, though, were in no better condition than a number of pavements made with slag aggregate. The two projects with concrete in the best condition, as determined by core analysis, contained slag aggregate. Therefore, it was determined that the cause of the distress was not specifically a coarse aggregate issue.

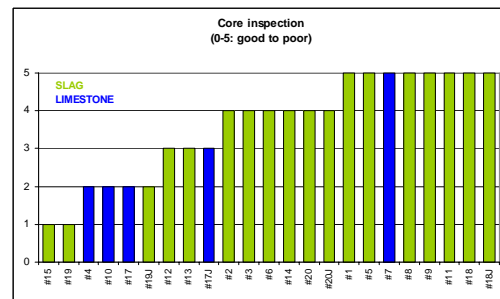
Figure 5 (b). Core-determined concrete pavement condition showing type of coarse aggregate

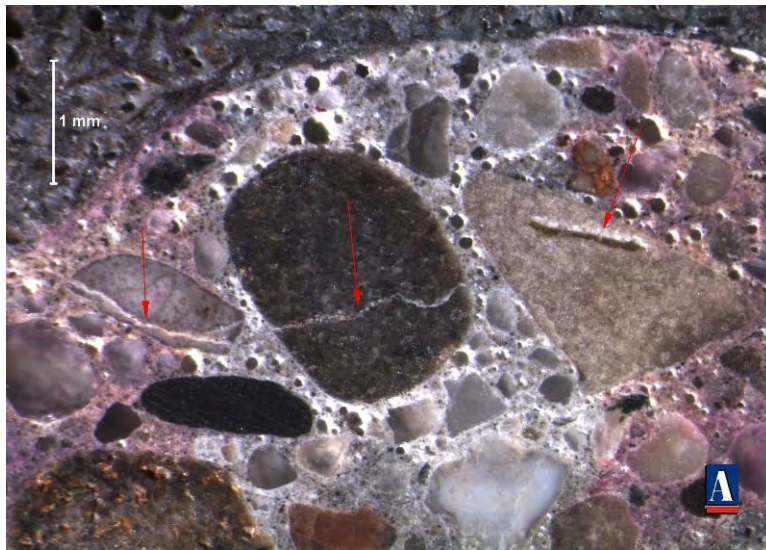
Alkali silica reactivity (ASR) and the expansive product formed by this reaction causes cracking in concrete. This cracking allows water to ingress into the concrete. If the air void system is marginal, this ingress of water will exacerbate freeze-thaw damage and result in continued and progressive cracking. It is not possible to tell whether ASR or freeze-thaw expansion was the initiating cause of the cracking in the pavements studied, but either mechanism, or a combination of the two, is the most likely source of the expansive forces that have led to the spalling found at many joints. Figure 6 shows the ASR jell within the cracks and around the aggregate particles.

Figure 6. ASR filled cracks and rims

ASR was found, to some degree, in all twenty-three cores. A significant amount of chert was found in the fine aggregate. This material is very reactive and was determined to be the predominate cause of this deterioration mechanism. Unfortunately, that material is predominant in the sand available in the Detroit area. Therefore, alternative sand sources are not a practical alternative. Mitigation of this destructive force must lie in the use of cementitious materials, supplementary cementitious materials (SCMs), or admixtures that can be effective in stopping the ASR.

The use of a low alkali cement to reduce the total alkali loading is a positive step. But as was seen in Core 10, this was not sufficient to overcome the degree of reactivity found in the local sands. The total alkali in the system is the key factor. The amount of cement in the mix, along with the amount of alkali in the cement, determines how much alkali is available to react with the sand. Therefore, a lower cement content in the mix, along with substituting SCMs for a portion of the cement, would be very beneficial.

1. The greatest materials issue appears to be ASR related to sand. This was found, to some degree, in every core. Class F fly ash, GGBFS, and silica fume are the most likely materials that could be used in a practical way to mitigate the ASR. Even though their availability in the Detroit area has been minimal in the past, a fresh look at how they may be obtained, through discussions with cementitious suppliers, is essential. Since they will be used in place of some of the cement in a mix, and because some are less expensive than cement, they may be more practical than many would first think. Blended cements are used regularly in many parts of the country. The cement companies should be approached as partners to assist in this effort to solve this durability problem.

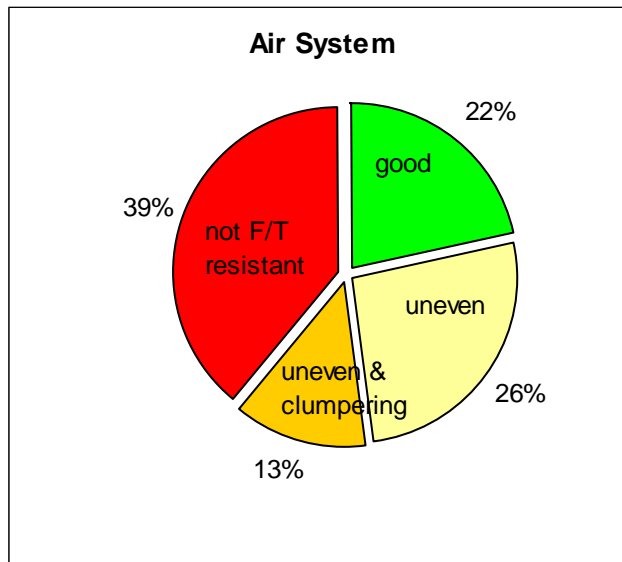
The air systems of the pavements examined in this study are summarized in Figures 7, 8, and 9. The air system was not adequate to protect the concrete in 39% of the cores, based on bubble spacing factor. The air system analysis found only 22% of the cores to have an adequate, well-developed air system. The

remaining cores had air systems with adequate spacing but had anomalies that put the pavement at risk of early deterioration. There was an uneven distribution of the air bubbles found in 22%, and 13% displayed the uneven disruption and also experienced clumping or coalescing of the air bubbles. One core was reported to have a coarse air system but this was not determined to be a concern. Overall, more than three quarters of the cores were vulnerable to cracking caused by freeze-thaw damage.

Figure 7. Air system quality of pavements studied

2. The other major deterioration mechanism is the air system within the concrete. A number of air issues were identified. Mixing is often the first place to look when problems of either inadequate bubble spacing or uneven distribution arise. Compliance with minimum mixing time specifications needs to be emphasized. As mentioned above, absorptive aggregate can adversely affect the air system, so preventing this situation is critical. Synthetic or non-vinsol air entraining agents were present in the cores showing clustering. Assistance from the technical representatives of the admixture companies in the area need to be obtained to address problems that arise with unstable air, nonuniform air or coalescing of the air bubbles.

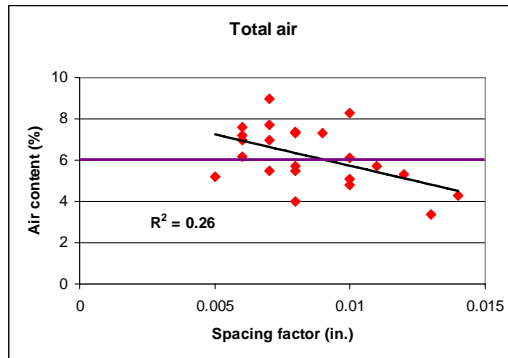
Figure 8. Total air in the concrete vs. spacing factor

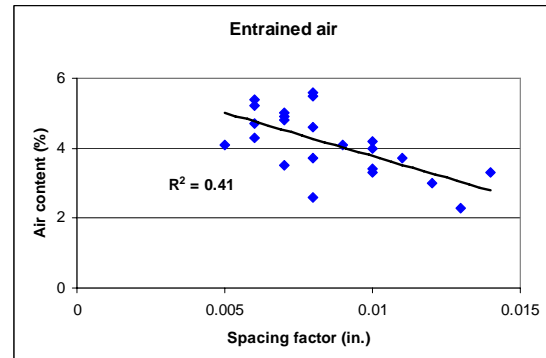
Figure 9. Entrained air in the concrete vs. spacing factor

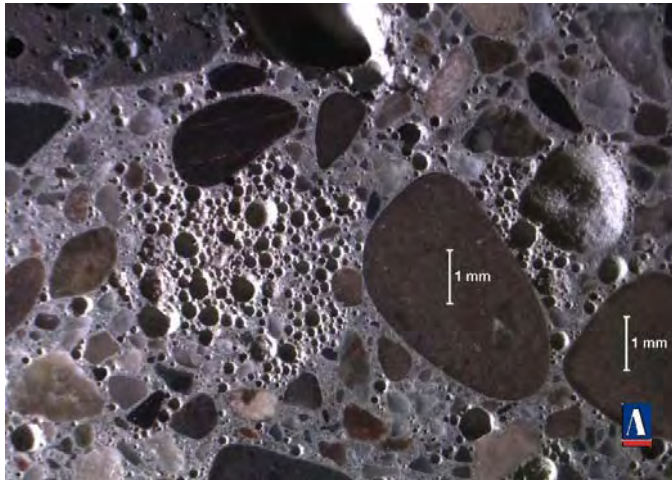
The coalescing may also be associated with the problem of absorptive or dry aggregate. Water moves toward absorptive aggregate and carries the admixture with it. Non vinsol resins are not as soluble as vinsol resins so they may accumulate at the aggregate surface as water is absorbed. This would cause a disproportionate amount of admixture and thereby create bubbles near the surface of the aggregate as the mixing continues. Others believe that the movement of water toward the aggregate may carry the bubbles toward the aggregate surface, resulting in coalescing. Either way, dry aggregate can play a part in this phenomenon. Figure 10 shows air bubble coalescence.

Figure 10. Air bubble coalescence in Core 6

Numerous problems have been identified relative to the air system in the pavements studied. The excessive spacing factor may relate to inadequate mixing, the dry aggregate, or an admixture problem. The clustering or coalescing may be caused by the admixture itself, mixing issues, or the dry aggregate. The

entrapped air is a sign of inadequate consolidation. Most of these causes are construction related, and therefore an examination of current practices should be undertaken.

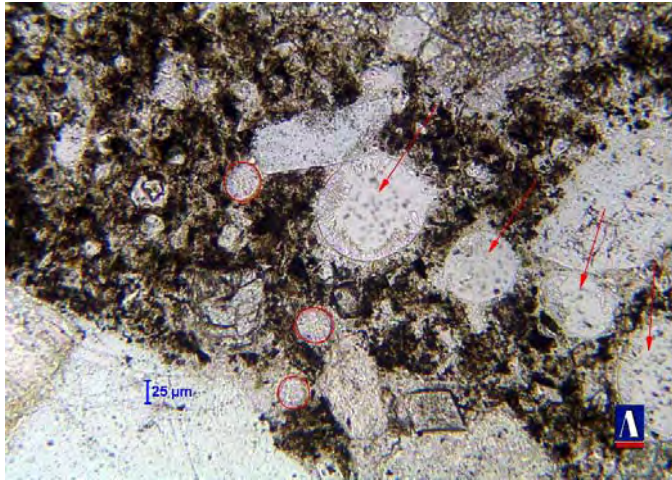
The petrographic analysis identified ettringite deposits filling air voids to some degree in every core (see example in Figure 11). Although ettringite is a normal reaction product of the cement hydration process, when excessive amounts are formed or are produced at later ages, they can fill some of the air and pore spaces. Ettringite is not considered an expansive mechanism by most experts but can be a deterrent to concrete durability if it adversely affects the air system. There is no clear evidence that filling of the air voids was the initiating cause of the deterioration or that it plays a significant role in the continuing cracking that has been observed. The likely scenario is that the cracks were caused by one of the expansive mechanisms, which allowed water into the concrete. The water then “accelerates the rate at which ettringite leaves its original location in the paste to go into solution and recrystallize in larger spaces such as air voids or cracks.” (Kosmatka, Kerkhoff, and Panarese 2002). With ettringite being identified in every core, though, its presence can not to be ignored.

Figure 11. Ettringite-filled air voids

Type II cements can be used to reduce the amount of aluminates in the cement. In the cores investigated, even though ettringite is present in every core, it is not filling all the pores in any core and only the smallest in many cores. However, it would appear that other deterioration mechanisms play a much greater role in compromising the pavements’ durability. Therefore, it would be prudent to take actions that deal with those issues before extra money is spent on Type II cement.

Reducing the potential for ettringite growth is important but not critical since it is likely that this problem will be minor if the other deterioration mechanisms are dealt with.

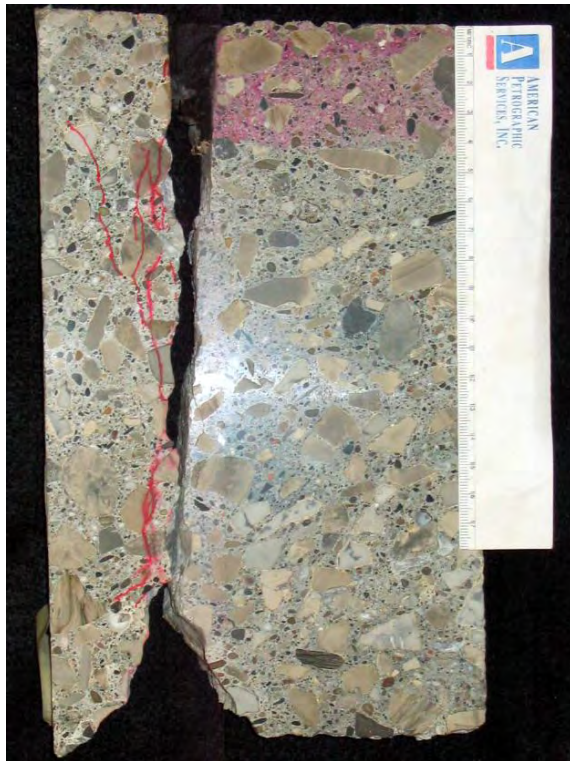
Core 17J was taken through a construction joint. The two halves of the core were constructed at different times. The photos of the core show significantly more deterioration on one side of the joint than on the other side. See Figure 12. The petrographer indicated that the water cement ratio was much greater on the side with the extensive cracking, likely in excess of 0.50. Water cement ratios that high may have a reduced resistance to freeze-thaw deterioration and in this case did show extensive cracking.

Figure 12. High water-cement ratio and cracking left half of the cold joint

It is not unusual to find a higher water content in the concrete in the area of a construction joint. If it is excessive, it can and in this case did lead to early deterioration or exacerbate the problem if something else initiated the cracking.

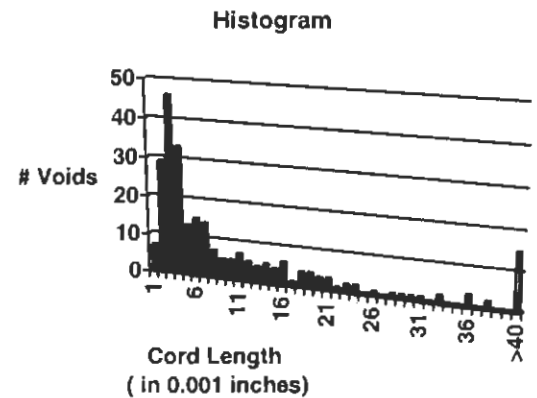
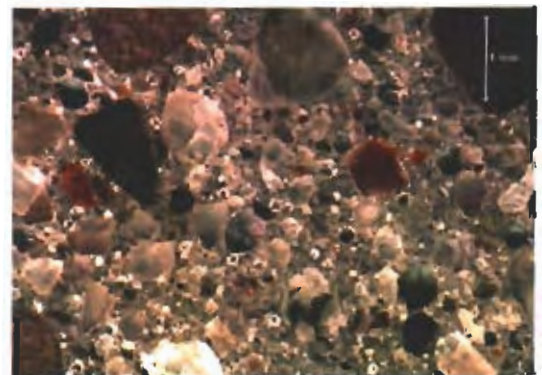
Air Void Content %	5.3
Entrained, % $\leq 0.040''$	3.0
Entrapped, % $> 0.040''$	2.3
Air Voids/inch	5.00
Specific Surface, in ² /in ³	377
Spacing Factor, inches	0.012
Paste Content, % estimated	27.0
Magnification	50x
Traverse Length, inches	96
Test Date	12/19/2005

Magnification: 30x
Description: Overall hardened air content, 5.3% total

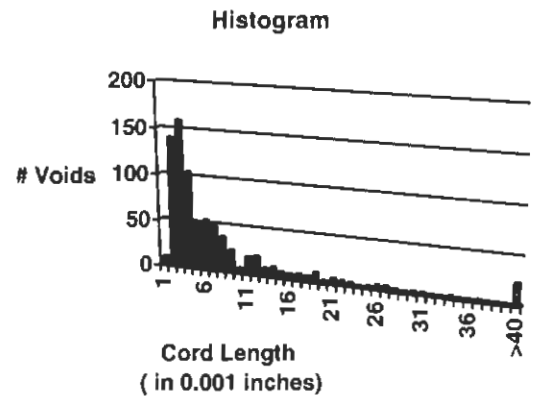
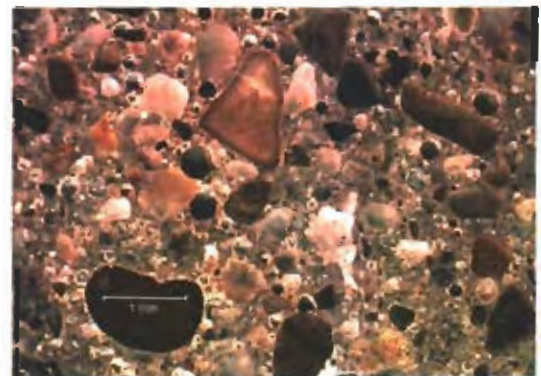
Air Void Content %	7.4
Entrained, % ≤ 0.040 "	5.6
Entrapped, % > 0.040 "	1.8
Air Voids/inch	8.66
Specific Surface, in ² /in ³	470
Spacing Factor, inches	0.008
Paste Content, % estimated	26.0
Magnification	50x
Traverse Length, inches	90
Test Date	12/20/2005

Magnification: 30x
Description: Overall hardened air content, 7.4% total

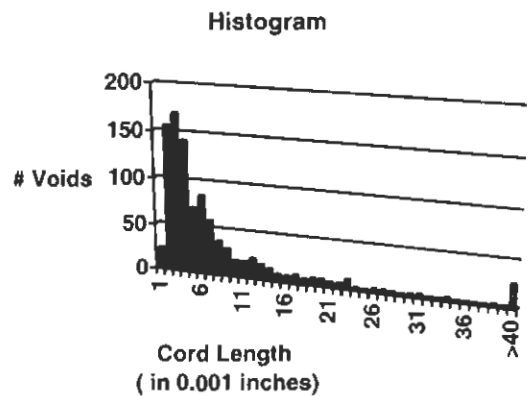
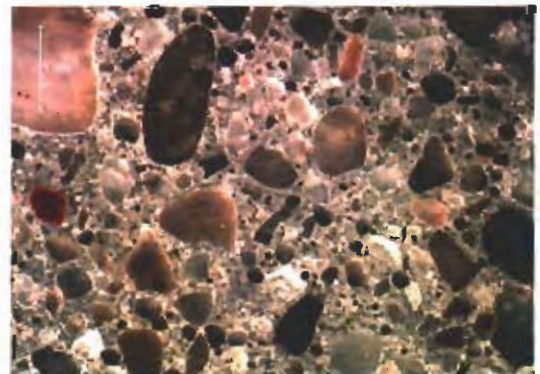
Air Void Content %	5.7
Entrained, % ≤ 0.040"	4.6
Entrapped, % > 0.040"	1.1
Air Voids/inch	7.18
Specific Surface, in ² /in ³	510
Spacing Factor, inches	0.008
Paste Content, % estimated	23.0
Magnification	50x
Traverse Length, inches	133
Test Date	12/20/2005

Magnification: 30x
Description: Overall hardened air content, 5.7% total

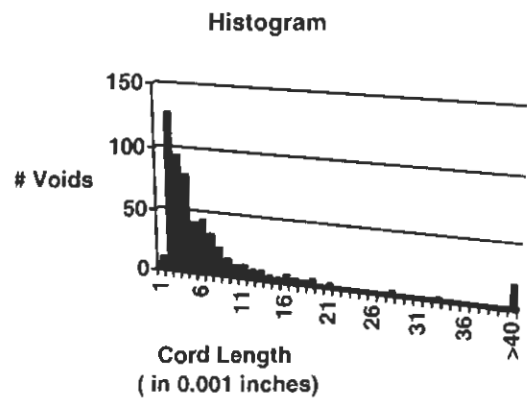
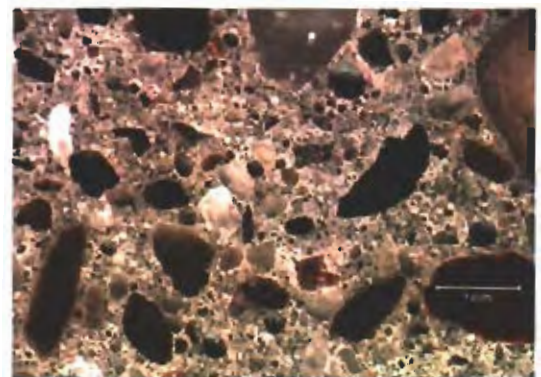
Air Void Content %	4.8
Entrained, % $\leq 0.040''$	3.3
Entrapped, % $> 0.040''$	1.5
Air Voids/inch	5.86
Specific Surface, in ² /in ³	490
Spacing Factor, inches	0.010
Paste Content, % estimated	26.0
Magnification	50x
Traverse Length, inches	95
Test Date	12/21/2005

Magnification: 30x
Description: Overall hardened air content, 4.8% total

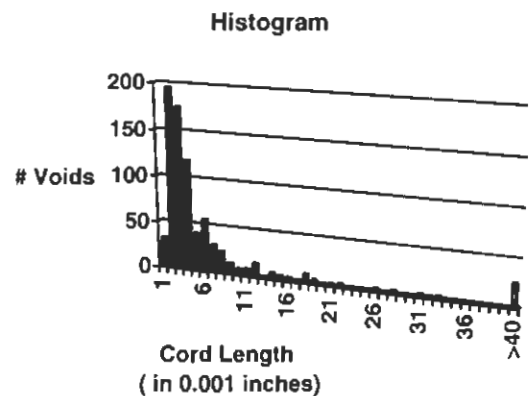
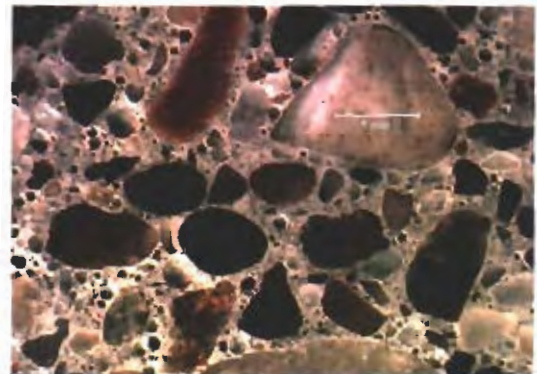
Air Void Content %	7.3
Entrained, % $\leq 0.040''$	4.1
Entrapped, % $> 0.040''$	3.2
Air Voids/inch	8.18
Specific Surface, in ² /in ³	450
Spacing Factor, inches	0.009
Paste Content, % estimated	26.0
Magnification	50x
Traverse Length, inches	96
Test Date	12/22/2005

Magnification: 30x
Description: Overall hardened air content, 7.3% total

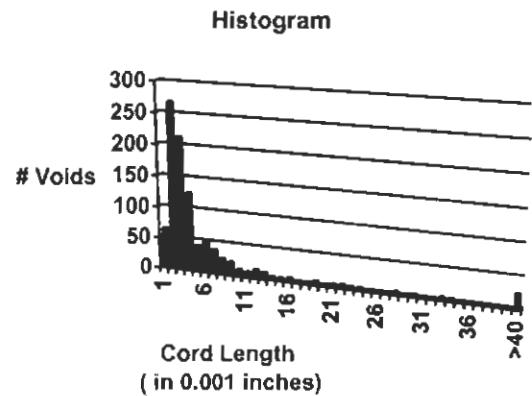
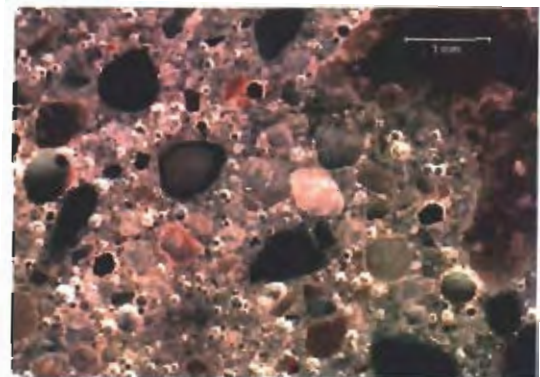
Air Void Content %	7.0
Entrained, % ≤ 0.040"	4.9
Entrapped, % > 0.040"	2.1
Air Voids/inch	9.99
Specific Surface, in ² /in ³	570
Spacing Factor, inches	0.007
Paste Content, % estimated	27.0
Magnification	50x
Traverse Length, inches	96
Test Date	12/22/2005

Magnification: 30x
Description: Overall hardened air content, 7.0% total

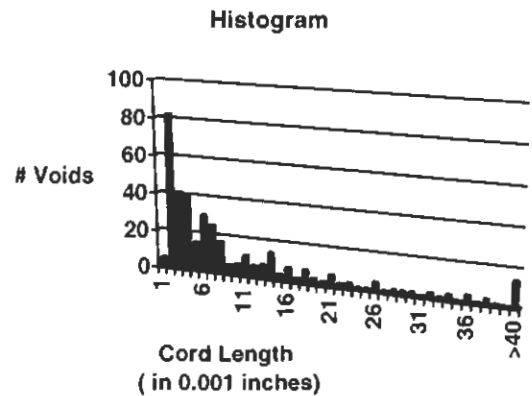
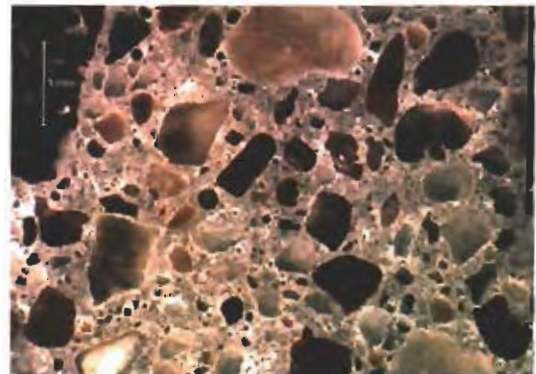
Air Void Content %	4.3
Entrained, % ≤ 0.040"	3.3
Entrapped, % > 0.040"	1.0
Air Voids/inch	3.98
Specific Surface, in ² /in ³	370
Spacing Factor, inches	0.014
Paste Content, % estimated	26.0
Magnification	50x
Traverse Length, inches	96
Test Date	01/03/2006

Magnification: 30x
Description: Overall hardened air content, 4.3% total

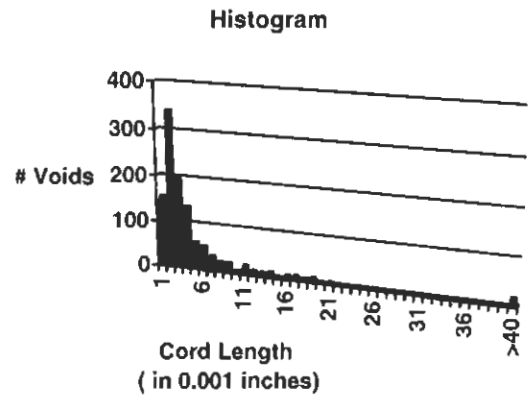
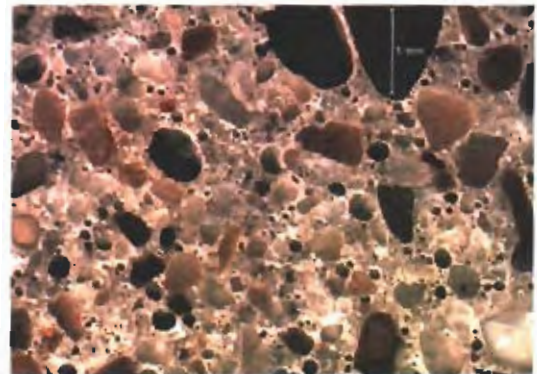
Air Void Content %	7.2
Entrained, % ≤ 0.040 "	5.4
Entrapped, % > 0.040 "	1.8
Air Voids/inch	11.97
Specific Surface, in ² /in ³	670
Spacing Factor, inches	0.006
Paste Content, % estimated	23.0
Magnification	50x
Traverse Length, inches	95
Test Date	01/04/2006

Magnification: 30x
Description: Overall hardened air content, 7.2% total

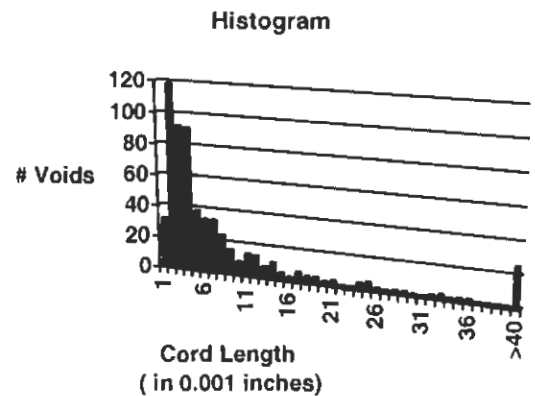
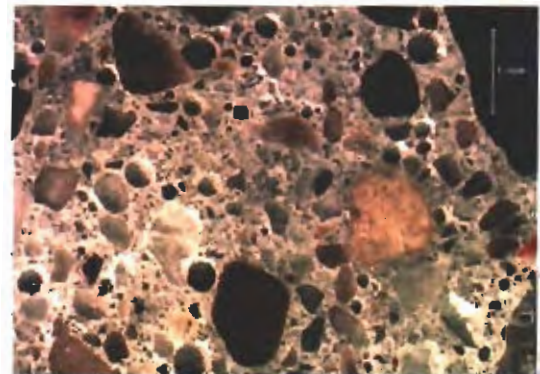
Air Void Content %	6.1
Entrained, % $\leq 0.040''$	4.0
Entrapped, % $> 0.040''$	2.1
Air Voids/inch	6.33
Specific Surface, in ² /in ³	420
Spacing Factor, inches	0.010
Paste Content, % estimated	22.0
Magnification	50x
Traverse Length, inches	96
Test Date	01/04/2006

Magnification: 30x
Description: Overall hardened air content, 6.1% total

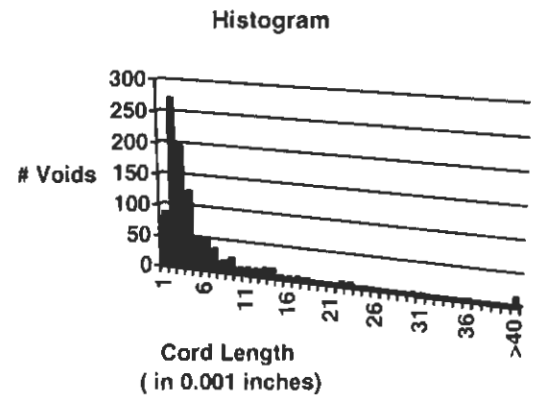
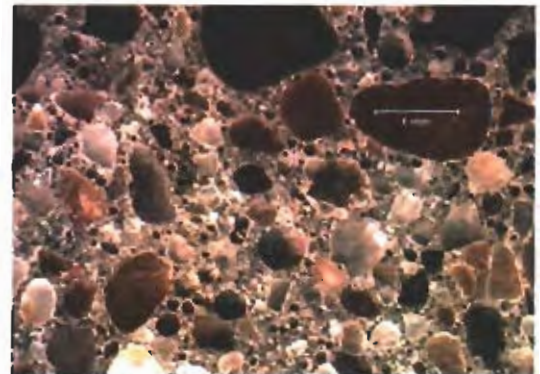
Air Void Content %	6.2
Entrained, % ≤ 0.040"	5.2
Entrapped, % > 0.040"	1.0
Air Voids/inch	10.21
Specific Surface, in ² /in ³	660
Spacing Factor, inches	0.006
Paste Content, % estimated	25.0
Magnification	50x
Traverse Length, inches	96
Test Date	01/05/2006

Magnification: 30x
Description: Overall hardened air content, 6.2% total

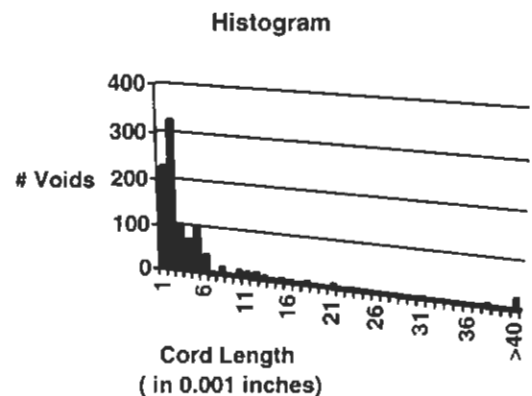
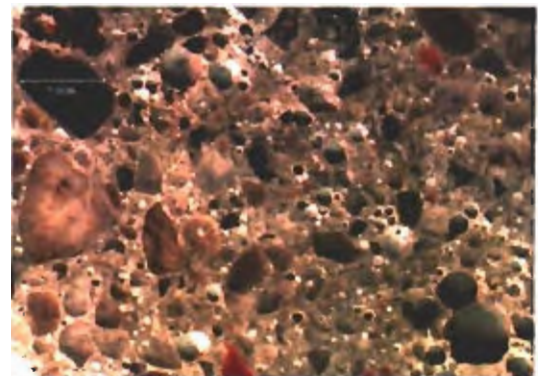
Air Void Content %	7.0
Entrained, % \leq 0.040"	4.7
Entrapped, % $>$ 0.040"	2.3
Air Voids/inch	10.58
Specific Surface, in ² /in ³	610
Spacing Factor, inches	0.006
Paste Content, % estimated	22.0
Magnification	50x
Traverse Length, inches	96
Test Date	01/04/2006

Magnification: 30x
Description: Overall hardened air content, 7.0% total

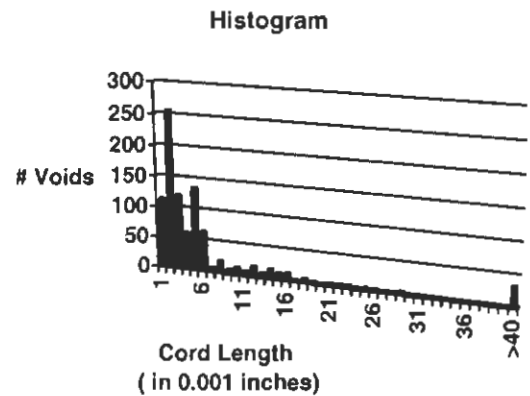
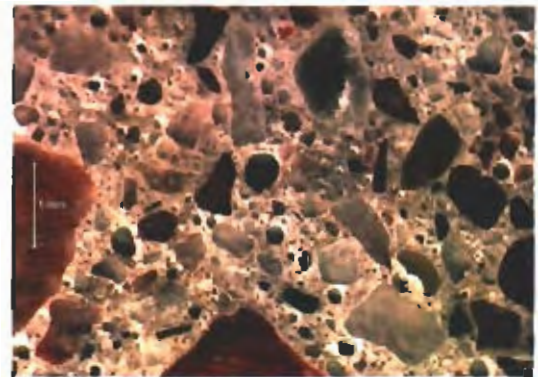
Air Void Content %	7.7
Entrained, % $\leq 0.040''$	5.0
Entrapped, % $> 0.040''$	2.7
Air Voids/inch	10.08
Specific Surface, in ² /in ³	520
Spacing Factor, inches	0.007
Paste Content, % estimated	23.0
Magnification	50x
Traverse Length, inches	92
Test Date	12/22/2005

Magnification: 30x
Description: Overall hardened air content, 7.7% total

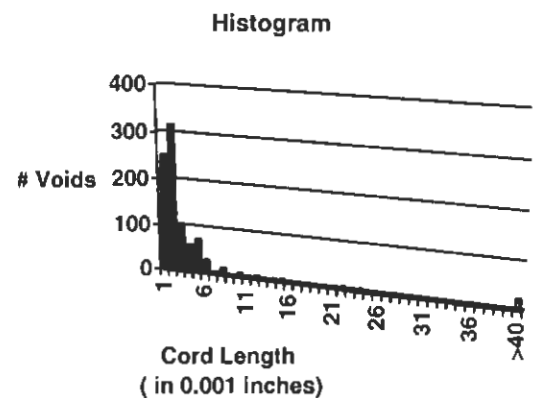
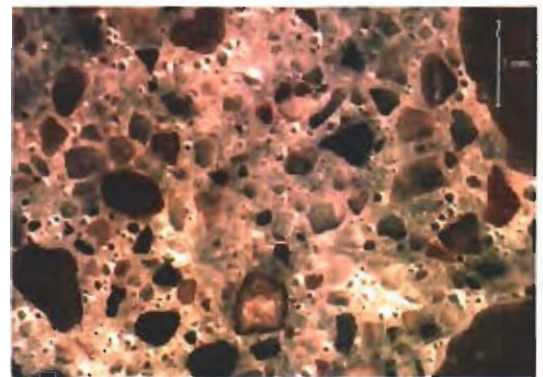
Air Void Content %	5.5
Entrained, % $\leq 0.040''$	3.5
Entrapped, % $> 0.040''$	2.0
Air Voids/inch	9.65
Specific Surface, in ² /in ³	700
Spacing Factor, inches	0.007
Paste Content, % estimated	26.0
Magnification	50x
Traverse Length, inches	96
Test Date	12/22/2005

Magnification: 30x
Description: Overall hardened air content, 5.5% total
