**MIDWEST SMART WORK ZONE DEPLOYMENT INITIATIVE**

NEBRASKA

## ADAPTIR

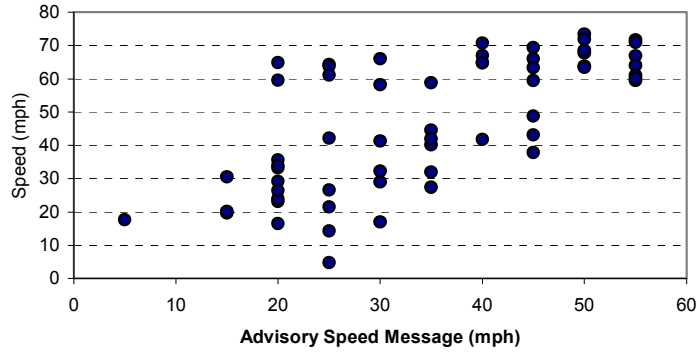
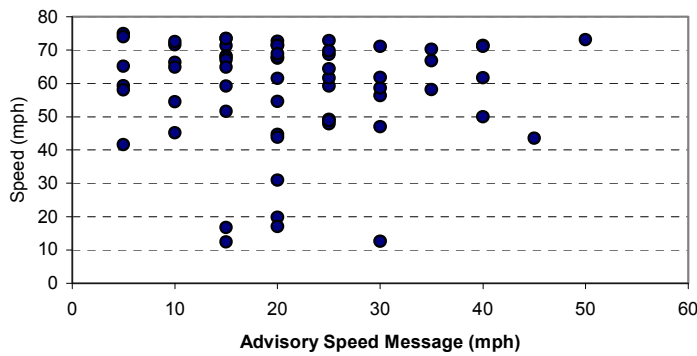
**FIGURE 5-13 Average speed at camera locations versus advisory speed message**

The average speeds at the downstream camera location versus the advisory speeds displayed are shown for each VMS in Figure 5-13. These data suggest the advisory speed messages had little or no effect on the average speeds at the downstream camera locations. However, the density of traffic flow must be considered because of its effect on speed as illustrated by the speed-density curves for the camera locations shown in Figure 5-14. The volume-density relationships at the camera locations in Figure 5-14 indicate that densities below 25 vehicles per mile were representative of uncongested flow conditions. Densities above 25 vehicles per mile were indicative of congested flow conditions.

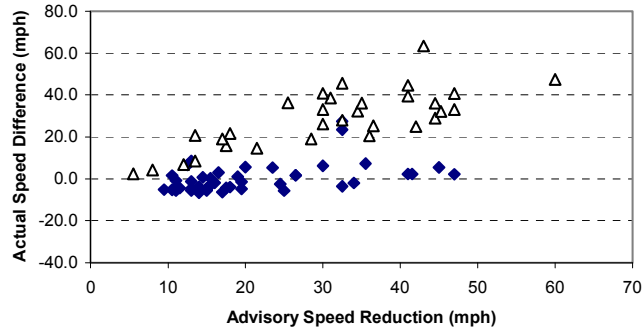
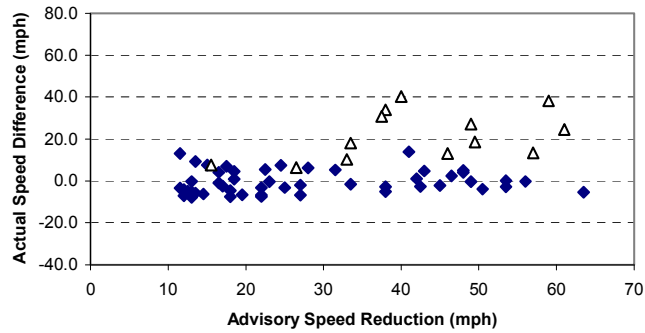
**FIGURE 5-15 Actual speed reduction versus advisory message speed reduction.**

The difference between the mean speed at a VMS and the speed in the advisory speed message it displays was the speed reduction indicated by the message. The difference between the mean speed at the VMS and the mean speed at the downstream camera location was the actual speed reduction. The actual speed reductions versus the speed reductions indicated by the speed advisory messages are shown for each camera location in Figure 5-15. These plots indicate that during uncongested flow conditions the actual speed reductions were typically at or below zero, regardless

of the speed reduction indicated by the speed advisory message. However, during congested flow conditions, the actual speed reductions were usually above zero, and in some cases, equal or greater than the speed reduction indicated by the speed advisory message.

The results of the multiple regression analysis of the data are presented in Table 5-19. The p-values indicate the regression equation for each location accounted for a statistically significant amount of the variation and the regression coefficients in each equation were statistically significant ( $\alpha = 0.05$ ). The actual speed reduction at each location was found to be directly related to density; the higher the density of traffic flow at the camera location, the greater the difference between the average speed at the VMS and the camera location.

At the two camera locations closest to the work zone, the speed reduction indicated by the advisory speed message displayed by the VMS upstream also influenced the actual speed reductions between the VMS and the camera location. At the camera location closest to the work zone, approximately 50 percent of the speed reduction indicated by the advisory speed message was included in the actual speed reduction. Therefore, if the speed advisory message displayed by VMS #1 was REDUCED SPD AHD 20 MPH when the average speed at VMS #1 was 60 mph, the speed reduction indicated by the speed advisory message would be 40 mph, which would increase the actual speed reduction by about 20 mph. At the camera location downstream of VMS #2, which was the second closest to the work zone, approximately 25 percent of the speed reduction indicated by the advisory speed message was included in the actual speed reduction according to the regression equation. Therefore, if the speed advisory message displayed by VMS #2 was REDUCED SPD AHD 20 MPH when the average speed at VMS #2 was 60 mph, the speed reduction indicated by the speed advisory message would be 40 mph, which would increase the actual speed reduction by about 10 mph. However, at the camera location downstream of VMS #3, which was farthest from the work zone, the speed advisory message on VMS #3 had no effect on the actual speed reduction.
