MIDWEST SMART WORK ZONE DEPLOYMENT INITIATIVE

FHWA POOLED FUND STUDY

Comparison of Rumbler and Asphalt Rumble Strips

Eric Meyer, Ph.D., P.E.

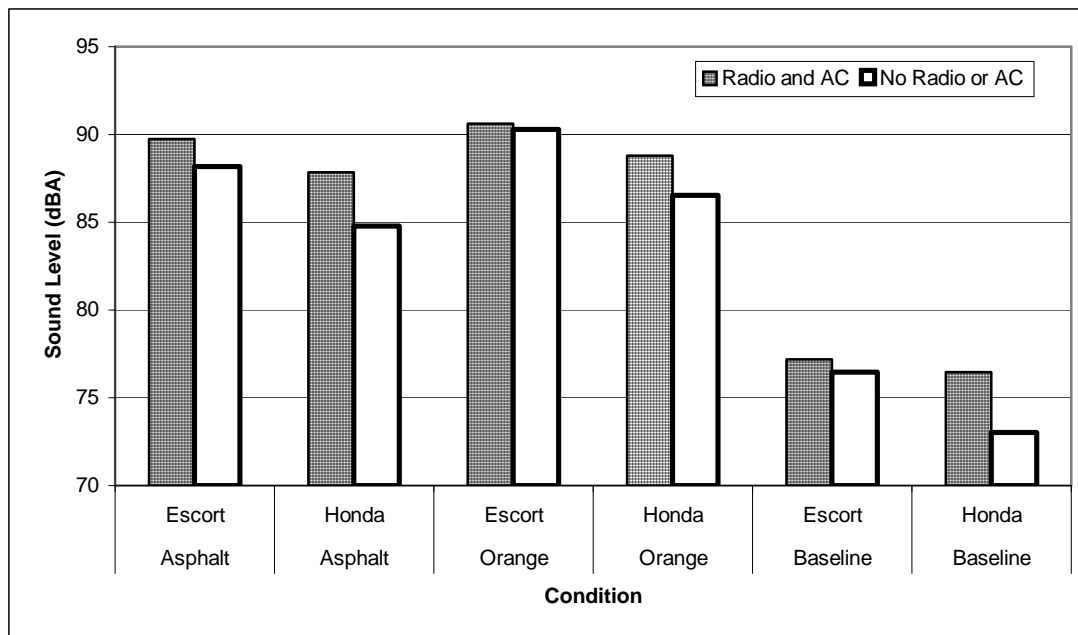
Figure 10 - Sound Levels with and without the Radio and Air Conditioner

The in-vehicle sound data were recorded by placing the microphone on a tripod with the microphone oriented horizontally forward, centered between the driver and passenger seats, 19 cm (7.5 in) below the ceiling, and even with the joint between the seat back and seat bottom of the driver's seat. The location was intended to approximate the position of the ear of a typical driver. All measurements used in the analysis were taken with the windows rolled up and the air-conditioner and stereo turned off. Measurements were also taken to compare the sound generated by the rumble strips with the sound generated by the radio (at a moderate volume setting) and the air-conditioner (on the highest fan setting). Figure 10 shows a comparison of the measurements collected with and without the radio and air conditioner. The chart shows that the increase in the sound levels caused by the added noise affected the sound levels on both the baseline data point and on the strips by approximately the same amount. This indicates that while the stereo and air conditioner do affect the sound levels, they do not affect the difference between the baseline levels and the levels produced by the strips. Since the differences in sound levels observed without the radio and the air conditioner are quite similar to the differences in the sound levels that would be experienced with the radio and air conditioner, it is reasonable to assume that the differences determined under these ideal conditions are representative of the differences that would be experienced in more realistic situations.

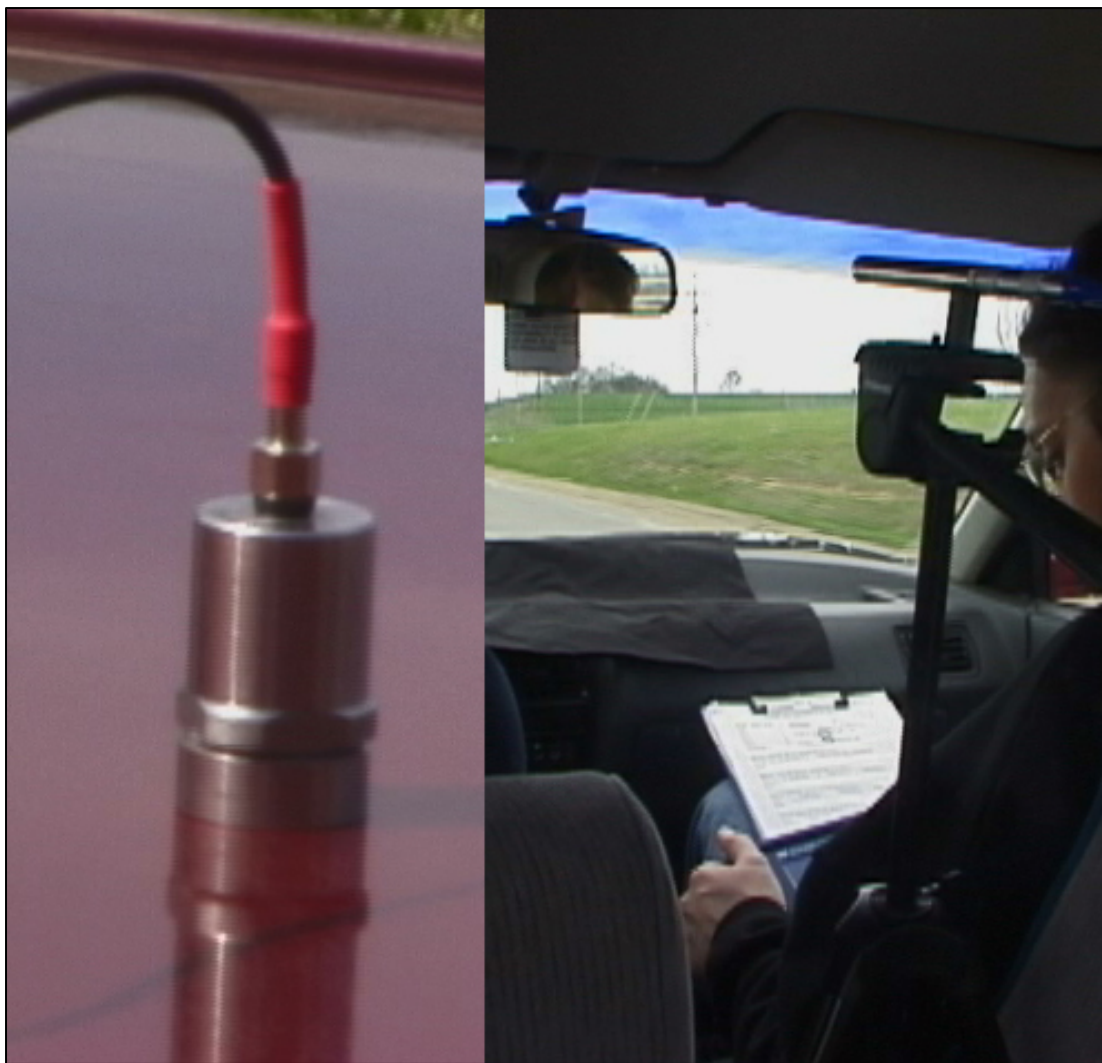
Figure 11 - Accelerometer (Left) and Microphone (Right)

Because this study is a comparison between a new device and a typical device, it is only necessary that a measurement be taken whose relative magnitude varies similarly to driver-perceived vibration. Toward this end, *vehicle body vibration* was use as the comparative measure. The implied assumption is that as vehicle body vibration increases, the vibratory energy propagating through the vehicle to the driver would be increased for every propagation mechanism. The vehicle body vibration was measured using an accelerometer that was magnetically mounted to the roof of the vehicle, directly above the mounting location of the microphone. Figure 11 shows the accelerometer mounted to the roof of a test vehicle (left) and the microphone on a tripod inside of a test vehicle (right).

The Federal Highway Administration's standards were followed for the roadside noise measurements. The microphone was mounted on a tripod and placed at the roadside 15.2 m (50 ft) from the center of the lane in which the test vehicle would be driven and 1.5 m (5 ft) above the road surface. [4] The microphone was oriented perpendicular to the road and was covered with a foam windscreen in order to reduce the effect of wind noise on the data.

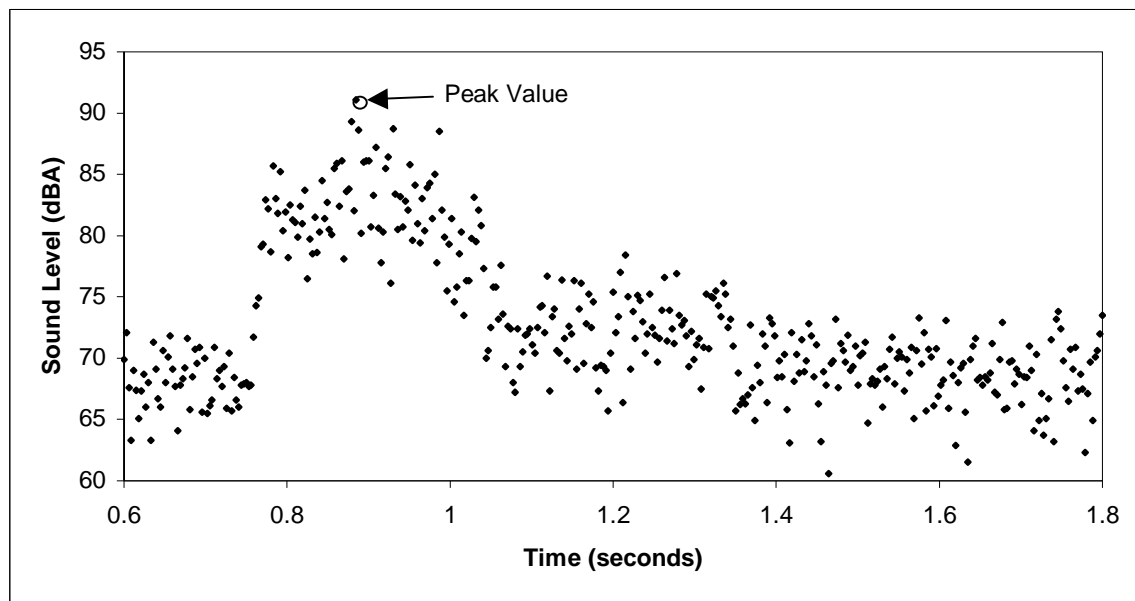
Figure 12 - Typical Sound Level Measurements

Comparisons of both sound and vibration were based on the maximum of the L_{eq} values measured over 3 ms intervals while crossing the rumble strips. When multiple observations of the same condition were made, the average was used. The measure used to compare data from different sites was the difference between the maximum L_{eq} values observed while traversing the rumble strips and the maximum L_{eq} observed while traversing smooth pavement under the same conditions. By using the difference in maximum L_{eq} relative to smooth pavement, differences between locations such as wind speed, temperature, and atmospheric pressure can be removed from the data, assuming these factors remained constant during the data collection. The relative values measured for the different types of rumble strips can be directly compared.

To help simplify and expedite the data analysis process, a computer program was developed. The program was used to find the maximum L_{eq} values using certain default parameters and limited user interaction. The maximum L_{eq} values were then exported to a file with additional data indicating the condition for which the maximum was obtained. Figure 12 shows a plot of the data recorded for a typical sound level measurement, and Figure 13 shows a screenshot of the data analysis program.

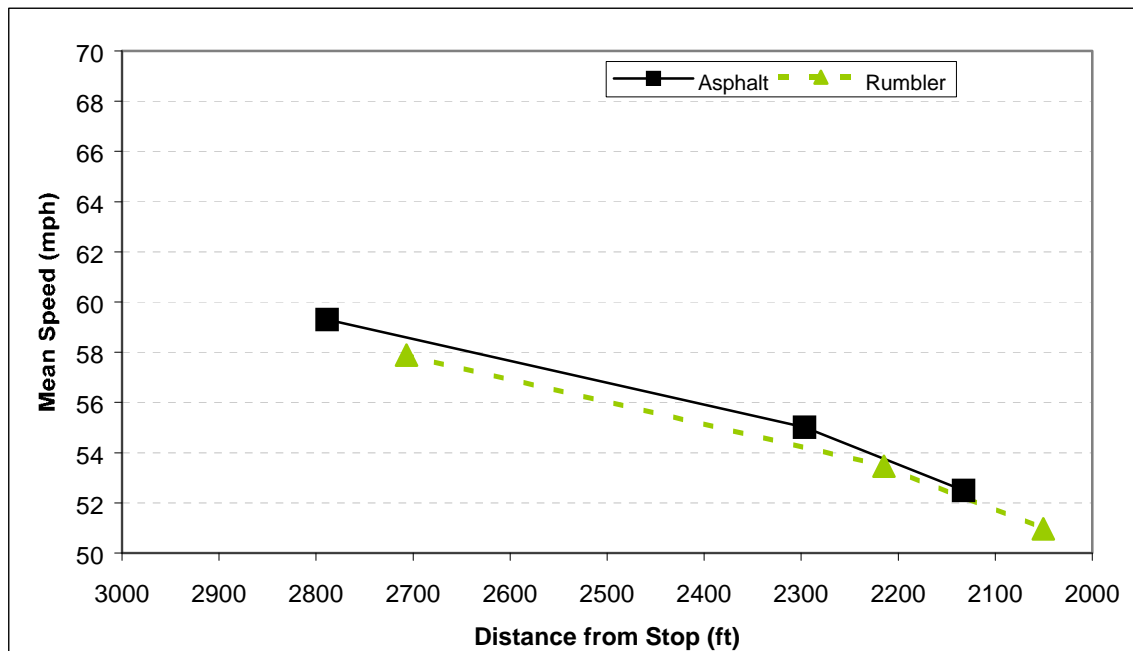
Figure 15 - Mean Speeds Comparison (Passenger Cars, 24 Hours)

Figure 15 and Figure 16 show plots of the mean and 85th percentile speeds, respectively. Figure 17 shows a plot of the speed reductions. Statistical descriptions of the collected speed data for the rumble strips are located in Table 7. The speeds observed on the asphalt strips are a little higher, especially the 85th percentile speeds, than those observed on the Rumbler approach. These high initial speeds may have been due to a downgrade located just upstream of the asphalt rumble strips. Both types of rumble strips show a speed reduction that is statistically significant at the 99% level. However, it is not possible to determine what portion of the reduction is attributable to which traffic control measures since all measures were in place for the duration of the construction. Similar levels of speed reduction were observed on both types of rumble strips.

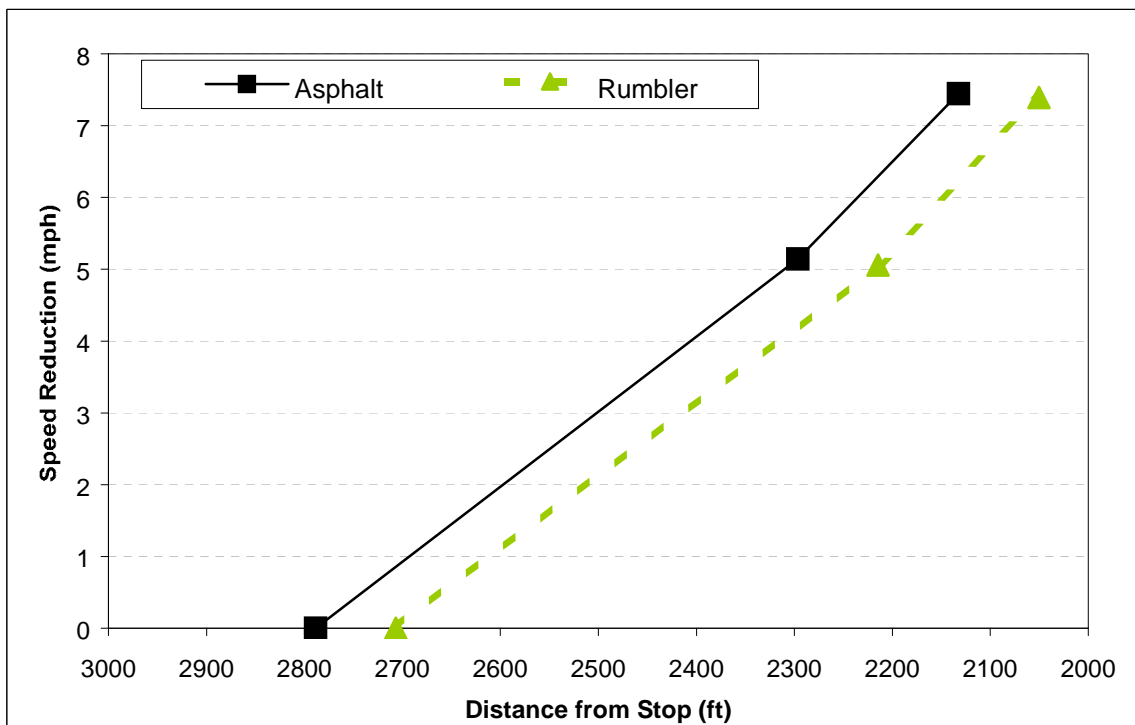
Figure 17 - Speed Reductions (All Vehicles, 24 Hours)

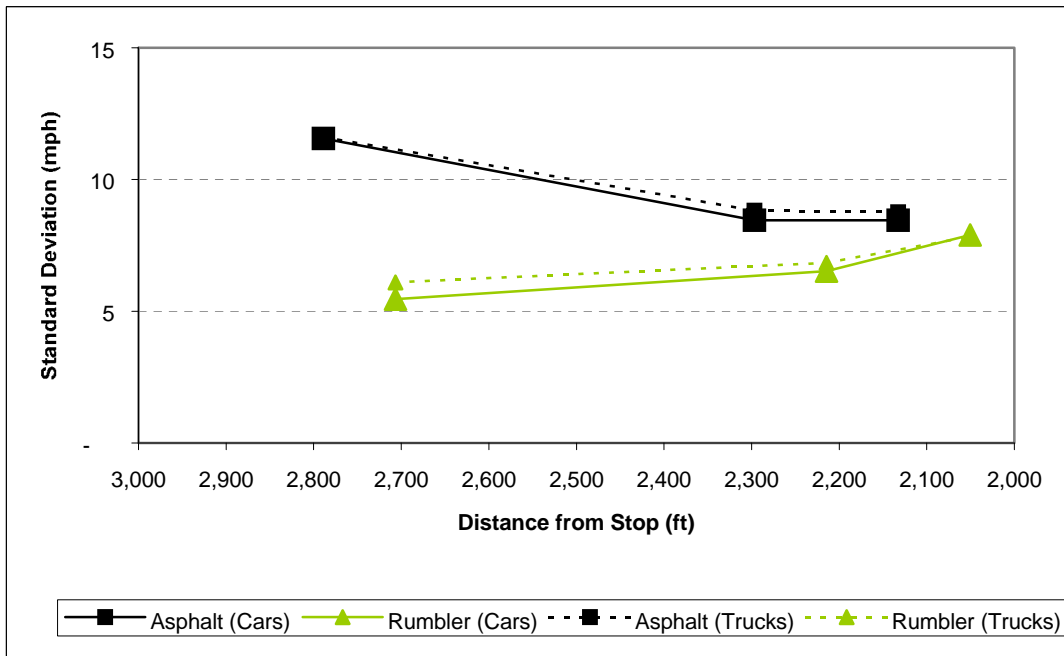
**Standard Deviations for day and night, and first and second data sets.*

Figure 18 - Standard Deviation of Speeds

When a large variation in the speeds of vehicles traveling the same path exists, an increase in the frequency of accidents can be expected. [14] The standard deviation of speeds found in Table 7 is an indication of speed uniformity. For the Rumbler, the standard deviation increased from the baseline point (101) to the most downstream data collection point (103), whereas the standard deviation observed on the asphalt strips decreased. Figure 18 shows the standard deviation of speeds observed on the two types of strips. While the asphalt strips seemed to cause a decrease in the speed variation, the standard deviation of the observed speeds was always greater on the asphalt strips. Figure 19, Figure 20, and Figure 21 show the speed distributions observed on the rumble strips for the most upstream data point, the first point on the rumble strips, and the most downstream data point, respectively. The higher standard deviations on the asphalt strips may be attributable to the downgrade upstream of the asphalt rumble strip approach. At each successive data point, the speed distributions become increasingly similar.

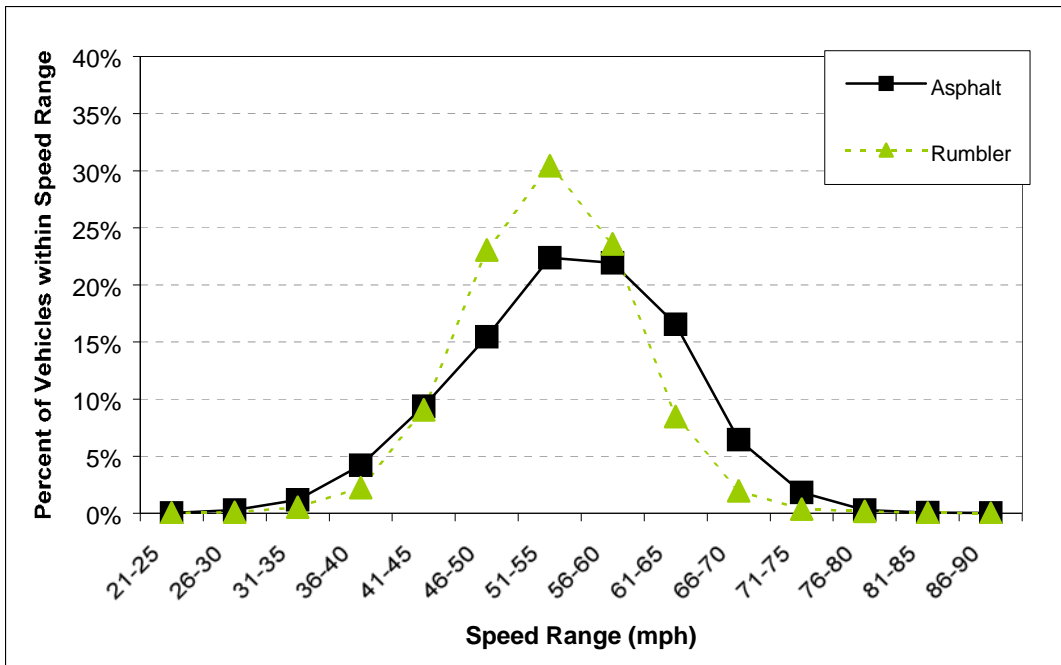
**Distribution for passenger cars, day and night, first and second data sets.*

Figure 20 - Speed Distribution Comparison for Second Data Point (Cars)

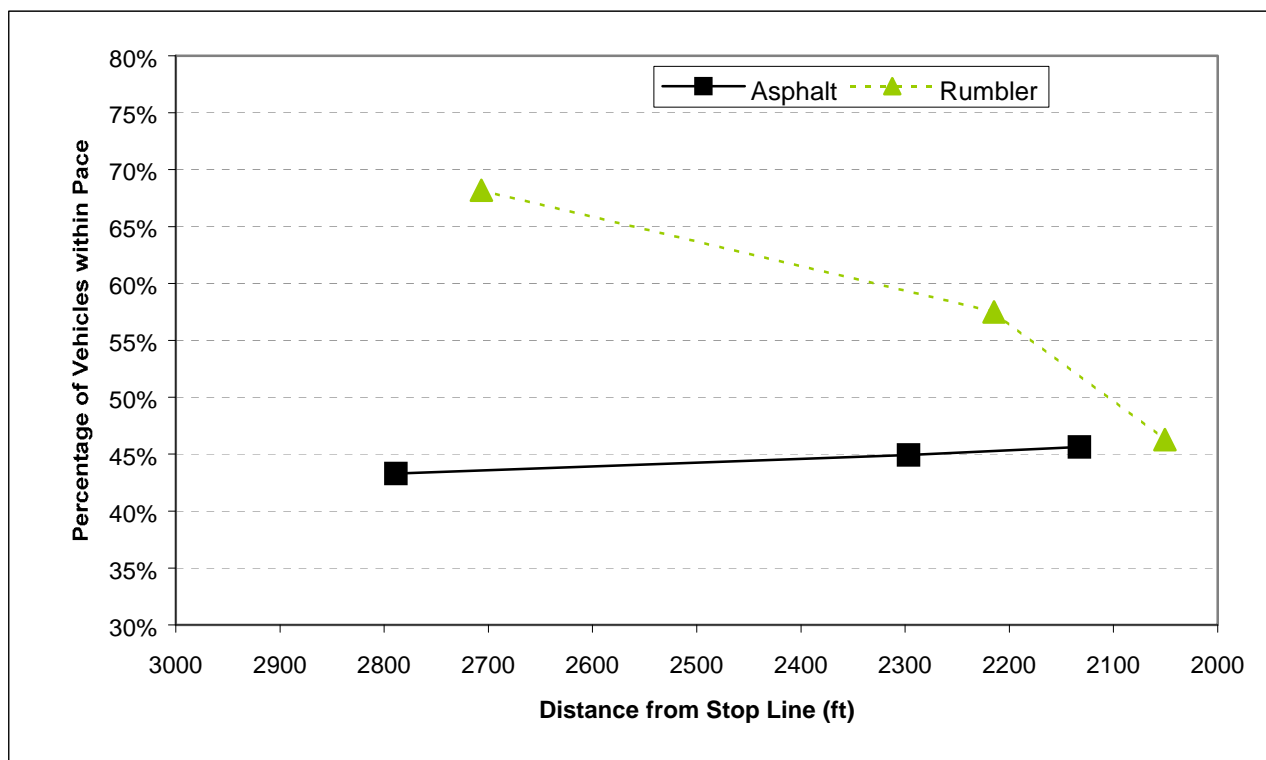
*Plotted data includes passenger cars data for day and night, and first and second data sets.

Figure 22 - Percent of Passenger Cars within the 16 kph (10 mph) Pace

The 16-kph (10-mph) pace at each data point is shown in Table 7. In all cases, the percentage of vehicles within the pace was greater for the temporary rumble strips than for the asphalt rumble strips. However, the percentage was decreasing on the temporary rumble strips and increasing on the asphalt strips. Figure 22 shows the percent of passenger cars within the pace. A similar pattern was observed for trucks. The decrease observed from point 2 to point 3 on the Rumbler approach may be attributable to turning vehicles, as this location was just upstream of a turning lane for an intersection with a county road. Because the intersection was downstream of the last counter, there was no way of identifying which were turning vehicles and which were through vehicles. A similar pattern was observed for trucks.

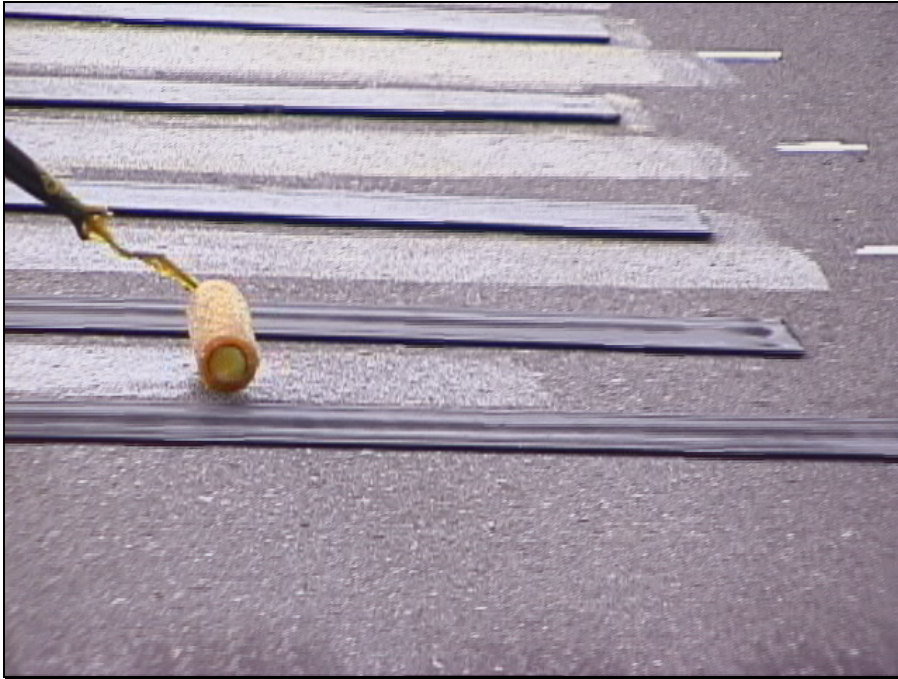
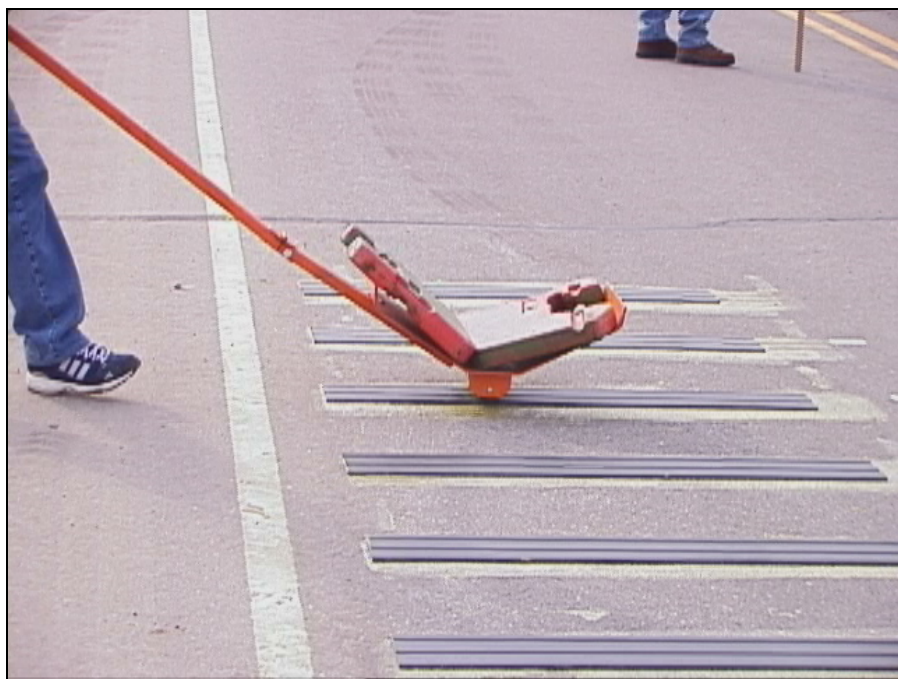
Figure 24 - Installation of Rumbler Rumble Strips

Applying adhesive with paint roller

Rolling the strips with the tamper cart

For proper installation of the Rumbler strips, the pavement must be clean, dry, and warmer than 10° C (50° F). During both installations involved in this study, the pavement was dry, and its temperature just before installation was 32° C (90° F). The pavement was swept with a push broom to remove loose debris. Once the pavement was clean, it was marked using masking tape to indicate the proper placement for the strips. Adhesive was then applied to the pavement with a paint roller and allowed to set for approximately 3 minutes. A second coat of adhesive was applied to the pavement and a single coat was applied to the underside of the strip. Both were allowed to set for 3 minutes. The strip was placed and rolled with a 22 kg (48 lb) tamper cart carrying an additional 90 kg (198 lb). The profile of the strips is best accommodated with a tamper cart using a wheel with a customized shape, provided by the manufacturer. Figure 1 shows the tamper cart being used on the Rumbler rumble strips.

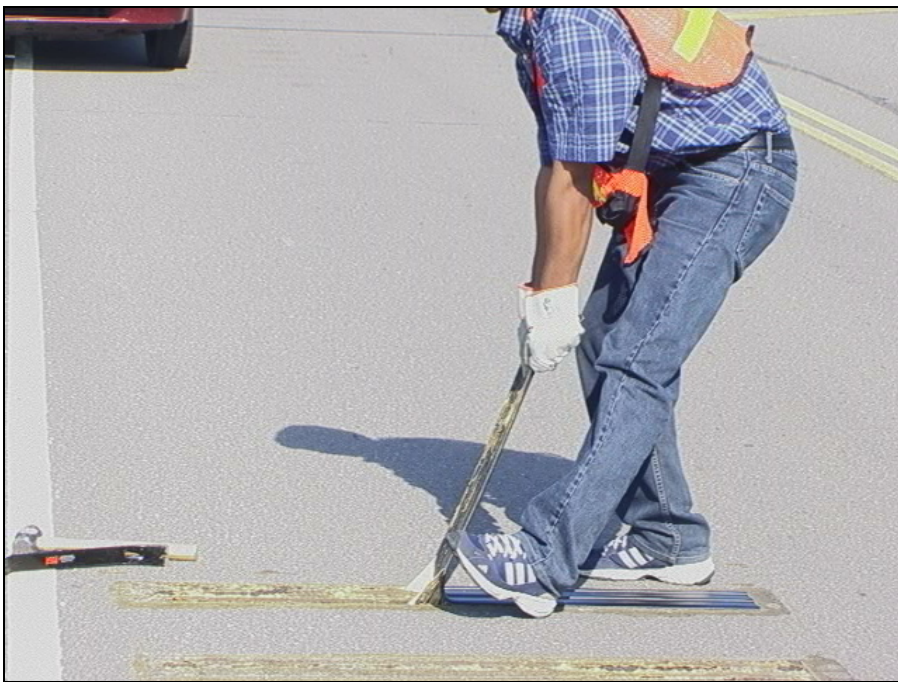
Figure 25 - Removing the Rumbler Rumble Strips

Prying corner of strip off of the pavement with a crow bar

Peeling strip off of the pavement by hand

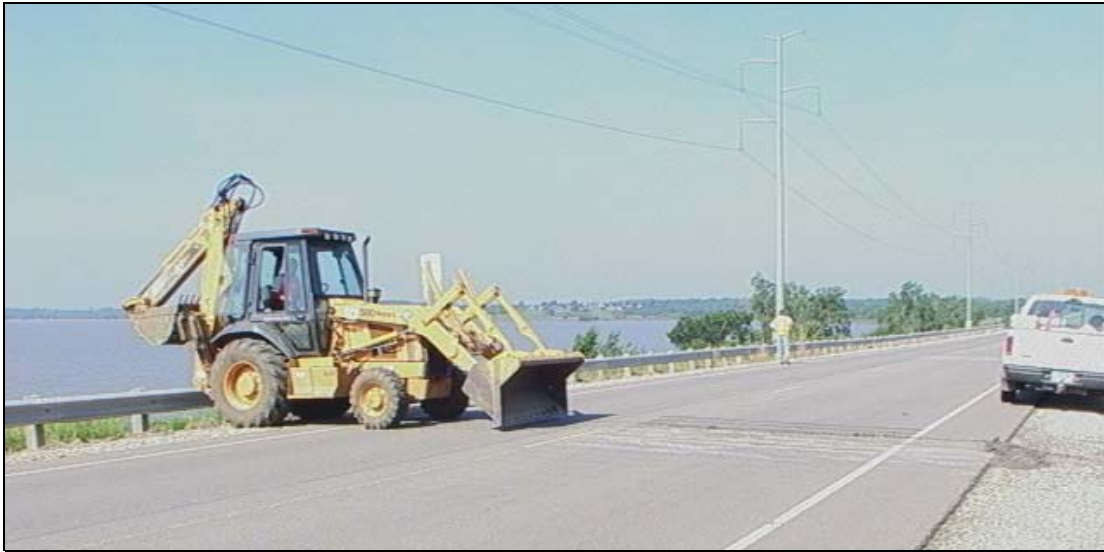
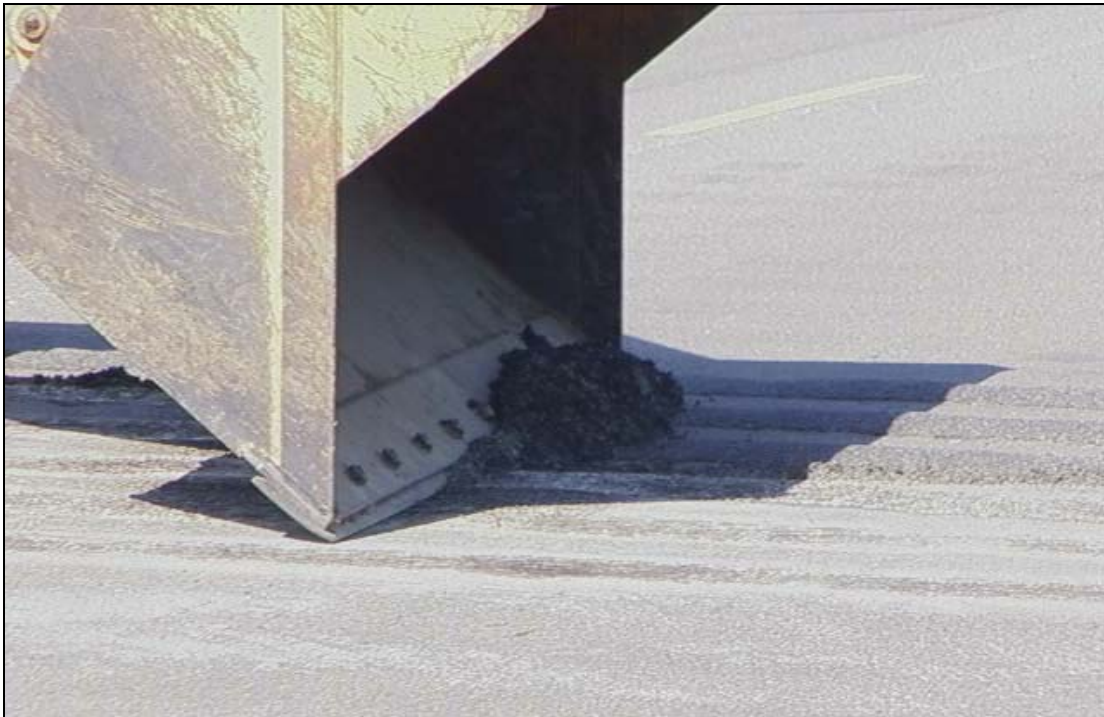
Figure 26 - Removal of the Asphalt Strips

Removal of asphalt strips with Loader/Backhoe

Bucket scraping up the asphalt strips

The removal of the asphalt rumble strips required more than 5 times the labor required to remove the temporary rumble strips, and it required heavy equipment. The asphalt rumble strips were removed using a Skid Steer Loader or a Loader/Backhoe to scrape the raised asphalt strips off of the pavement. Two additional workers, equipped with shovels and brooms, removed the loose pieces of asphalt and gravel from the roadway. The loaders had to back into the other lane of traffic in order to be able to scrape off the strips starting at the center of the lane, requiring that traffic in both directions be temporarily stopped. Removal required approximately 15 minutes per group of strips with 5 workers.

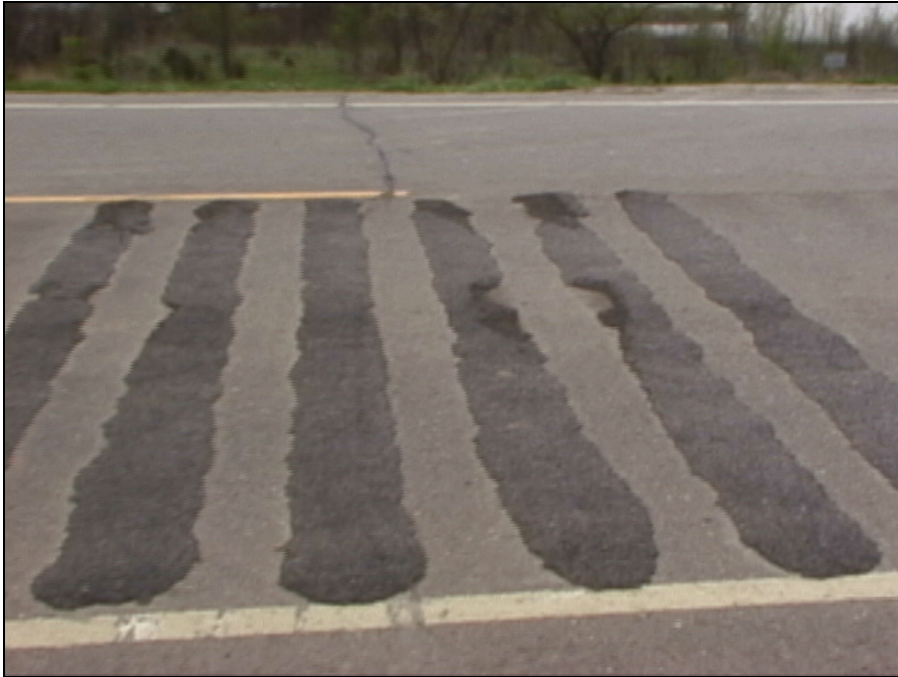
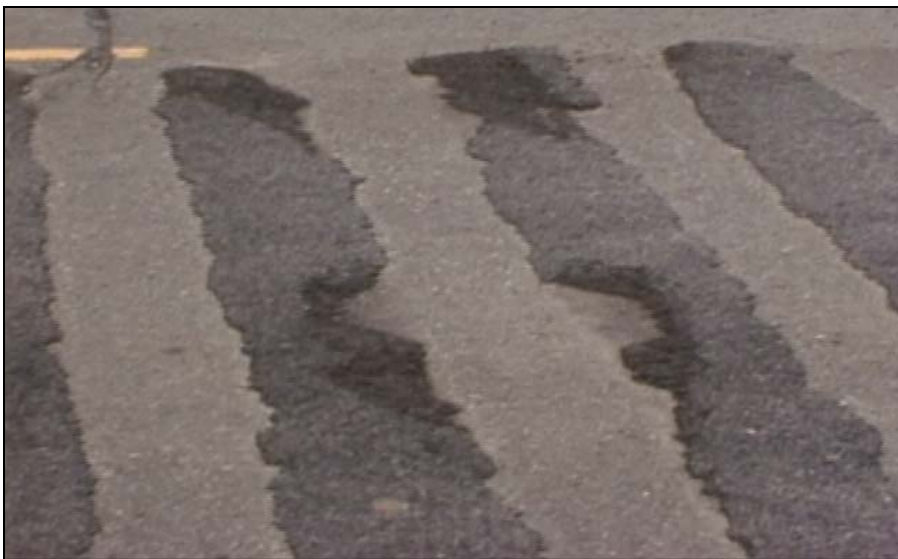
Figure 27 - Damaged Asphalt Rumble Strips

Damaged asphalt strips

Close-up of damage

The asphalt rumble strips were damaged as well. None of the strips were entirely removed from the pavement, but many had pieces of significant size removed from the strips. Pictures of the damaged strips can be found in the Appendix on page 48.

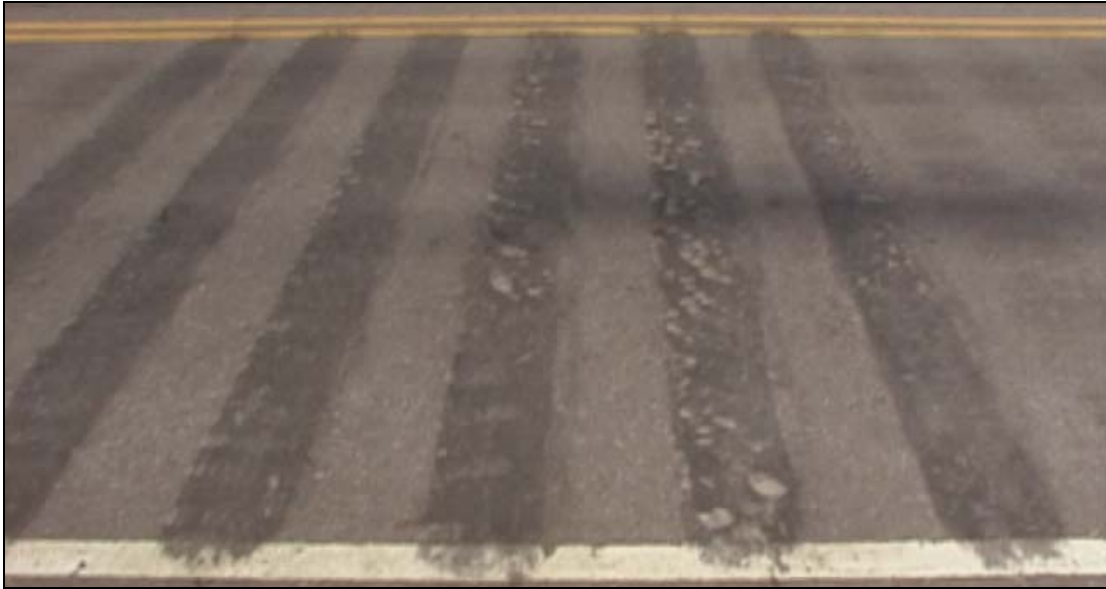
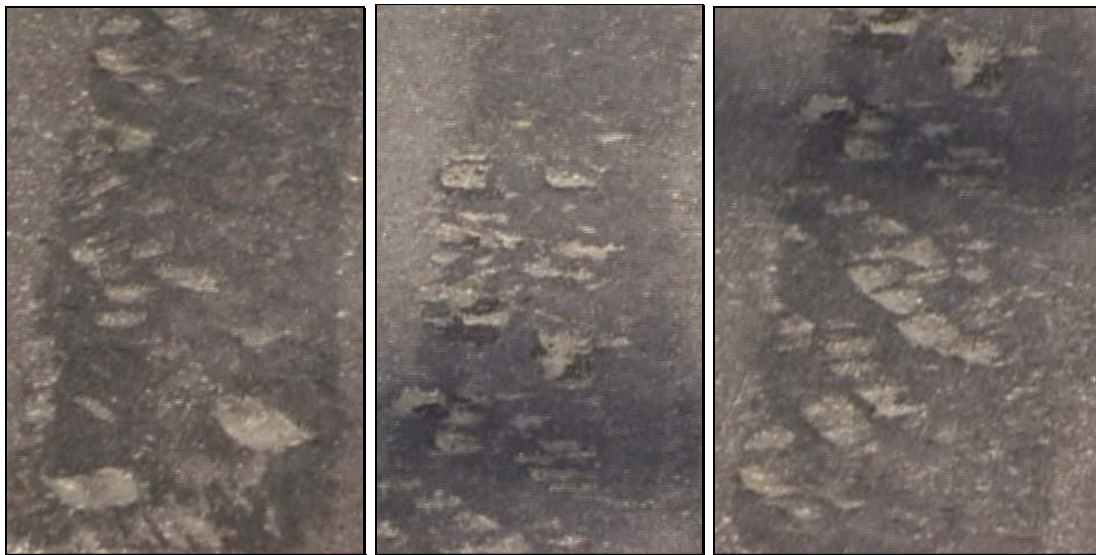
Figure 29 - Pavement Damage from Asphalt Strips

Overview

Close-ups

was not significantly damaged by removing the temporary rumble strips. The remaining adhesive only slightly discolored the pavement, and it quickly wore away under normal traffic and weather conditions. The removal of the asphalt strips damaged the pavement more than the temporary rumble strips. Pictures of the pavement after removal of the strips can be seen in the Appendix on pages 50 and 51. Both locations had asphalt pavement. Results on concrete pavement may differ.

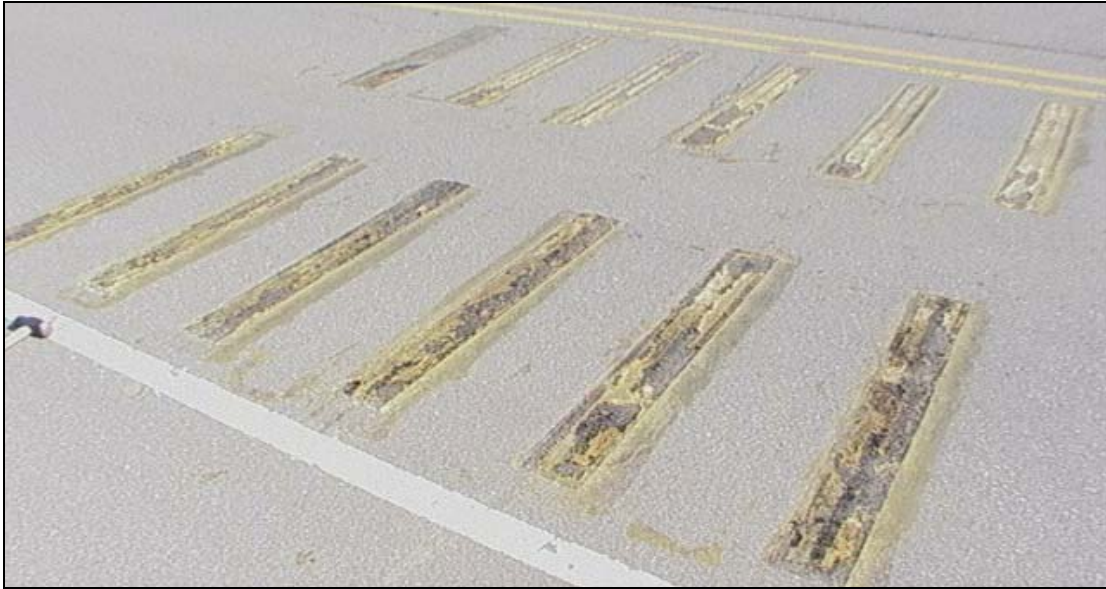
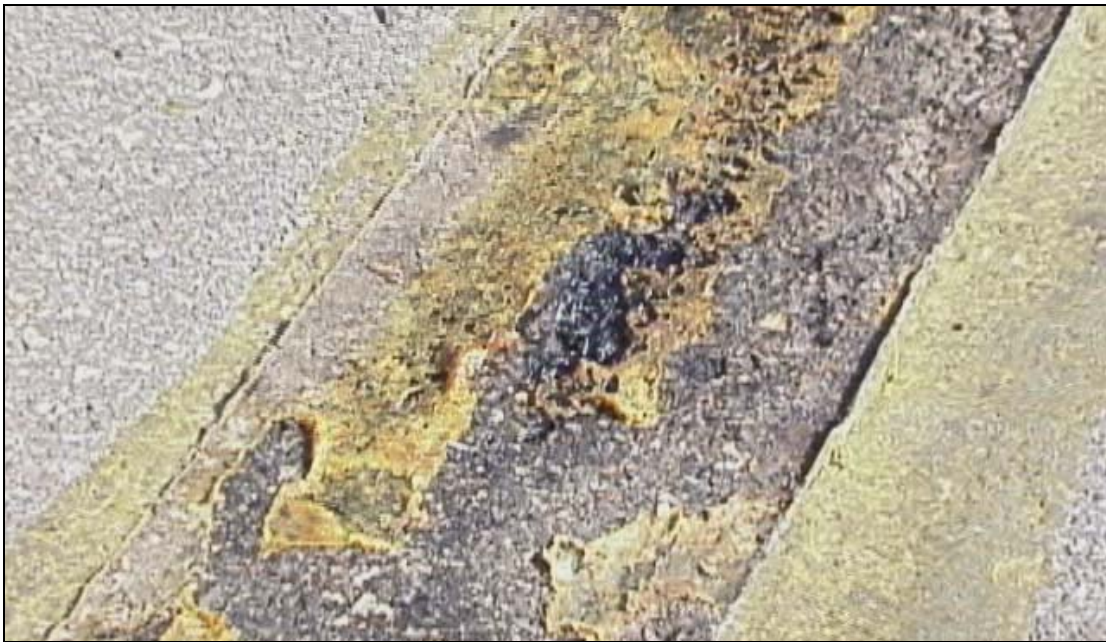
Figure 30 – Pavement Following Removal of Rumbler Strips

Condition of pavement upon removal

Pavement close-up

Part of the motivation to use temporary rumble strips is that they cause less damage to the pavement than asphalt rumble strips upon removal. Although small bits of gravel remained on the back of the rumble strips, and some of the adhesive remained on the pavement, the pavement

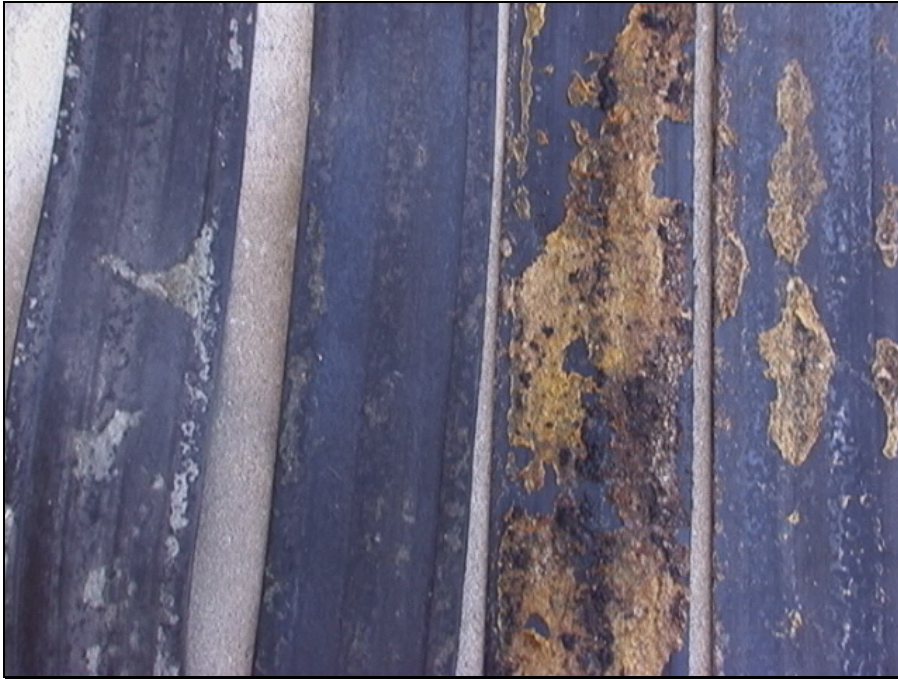
Figure 31 - Temporary Strips After Removal

Underside of Rumbler rumble strips
