MIDWEST SMART WORK ZONE DEPLOYMENT INITIATIVE

FHWA POOLED FUND STUDY

Comparison of ORS and Asphalt Rumble Strips

Eric Meyer

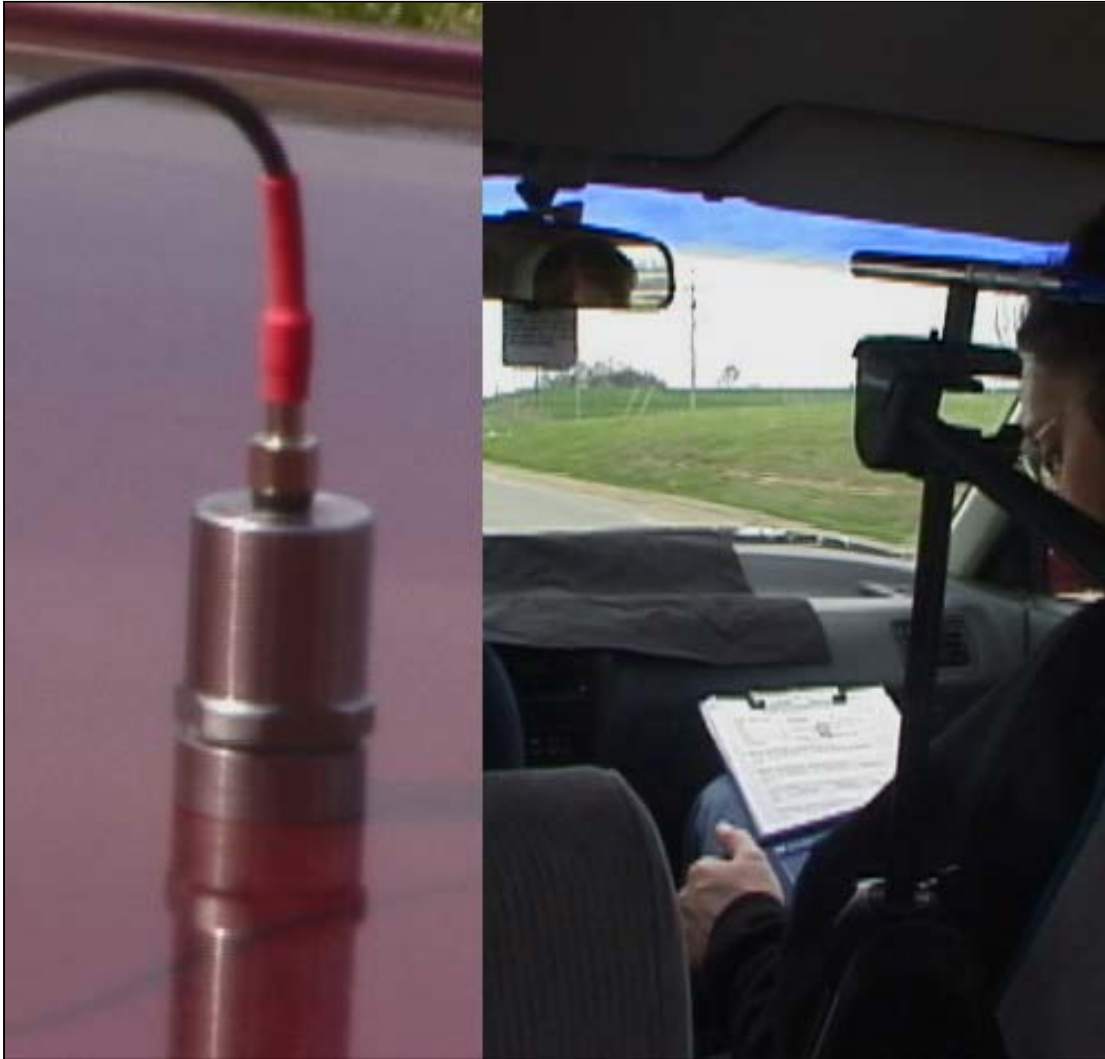
Figure 10 - Accelerometer (Left) and Microphone (Right)

Because this study is a comparison between a new device and a typical device, it is only necessary that a measurement be taken whose relative magnitude varies similarly to driver-perceived vibration. Toward this end, *vehicle body vibration* was use as the comparative measure. The implied assumption is that as vehicle body vibration increases, the vibratory energy propagating through the vehicle to the driver would be increased for every propagation mechanism. The vehicle body vibration was measured using an accelerometer that was magnetically mounted to the roof of the vehicle, directly above the mounting location of the microphone. Figure 10 shows the accelerometer mounted to the roof of a test vehicle (left) and the microphone on a tripod inside of a test vehicle (right).

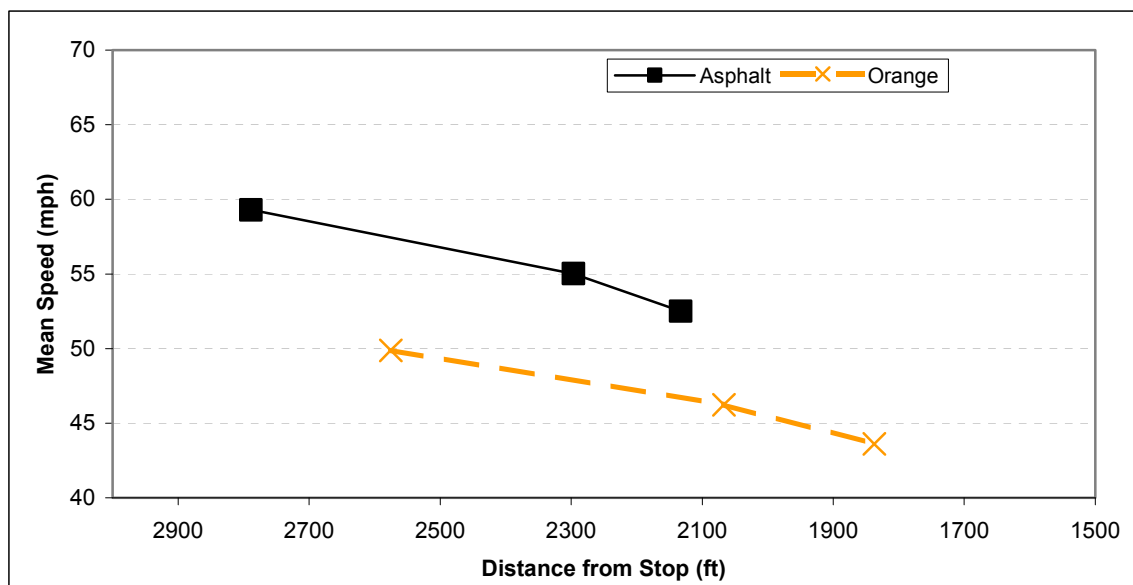
Figure 14 - Mean Speeds Comparison (Passenger Cars, 24 Hours)

Figure 14 and Figure 15 show plots of the mean and 85th percentile speeds, respectively. Figure 16 shows a plot of the speed reductions observed on the different strips. Statistical descriptions of the collected speed data for the rumble strips are located in Table 7 and Table 8. The speeds observed on the orange rumble strips are generally lower because the posted speed was 89 kph (55 mph) upstream of the orange rumble strip test location. Both types of rumble strips show speed reductions that are statistically significant at the 99% level. However, it is not possible to determine what portion of the reduction is attributable to which traffic control measures since all measures were in place for the duration of the construction. Similar levels of speed reduction were observed on both types of rumble strips.

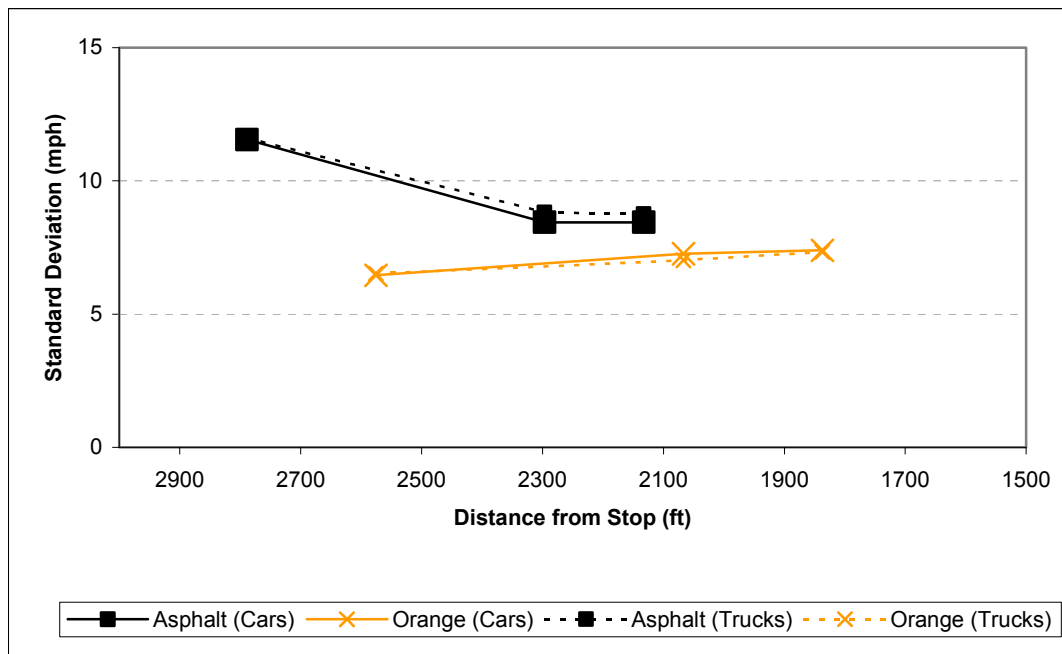
Figure 17 - Standard Deviation of Speeds

When a large variation in the speeds of vehicles traveling the same path exists, an increase in the frequency of accidents can be expected [15]. The standard deviation of speeds found in Table 7 and Table 8 is an indication of speed uniformity. The standard deviation did not vary much from the baseline point to the most downstream point for the orange rumble strips. Figure 17 shows the standard deviation of speeds observed on the two types of strips. While the asphalt strips seemed to have a decreasing affect on the speed variance, the standard deviation of the observed speeds was always greater on the asphalt strips. Figure 18, Figure 19, and Figure 20 show the speed distributions observed on the rumble strips for the most upstream data point, the first point on the rumble strips, and the most downstream data point, respectively. The higher standard deviations on the asphalt strips may be attributable to the downgrade upstream of the asphalt rumble strip approach. At each successive data point, the speed distributions become increasingly similar.

**Standard Deviations for day and night, and first and second data sets.*

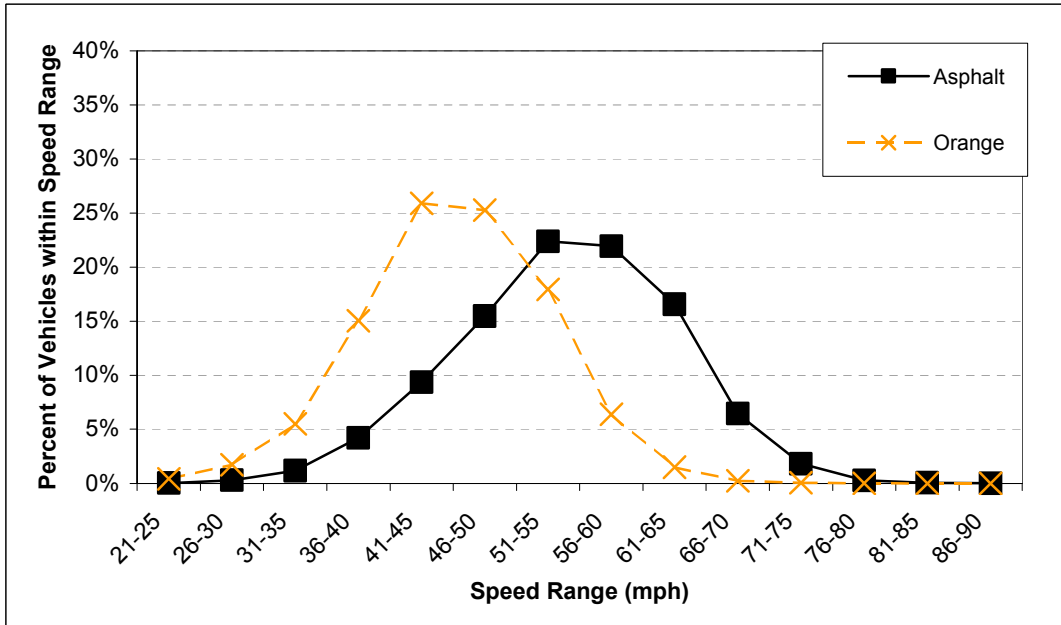
Figure 19 - Speed Distribution Comparison for Second Data Point (Cars)

**Distribution for passenger cars, day and night, first and second data sets.*

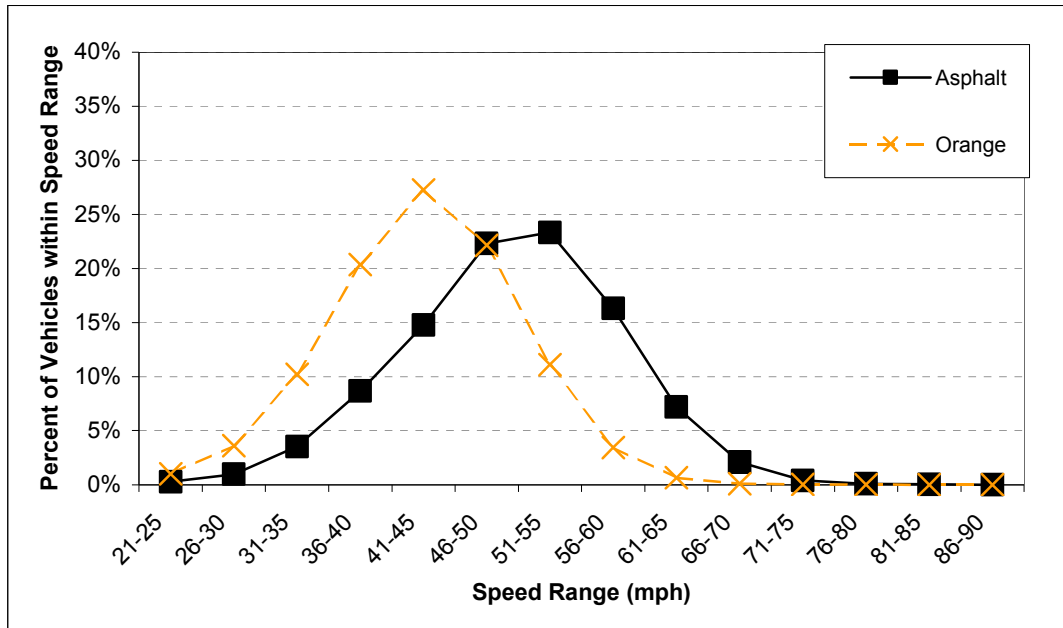
Figure 20 - Speed Distribution Comparison for Third Data Point (Cars)

**Distribution for passenger cars, day and night, first and second data sets.*

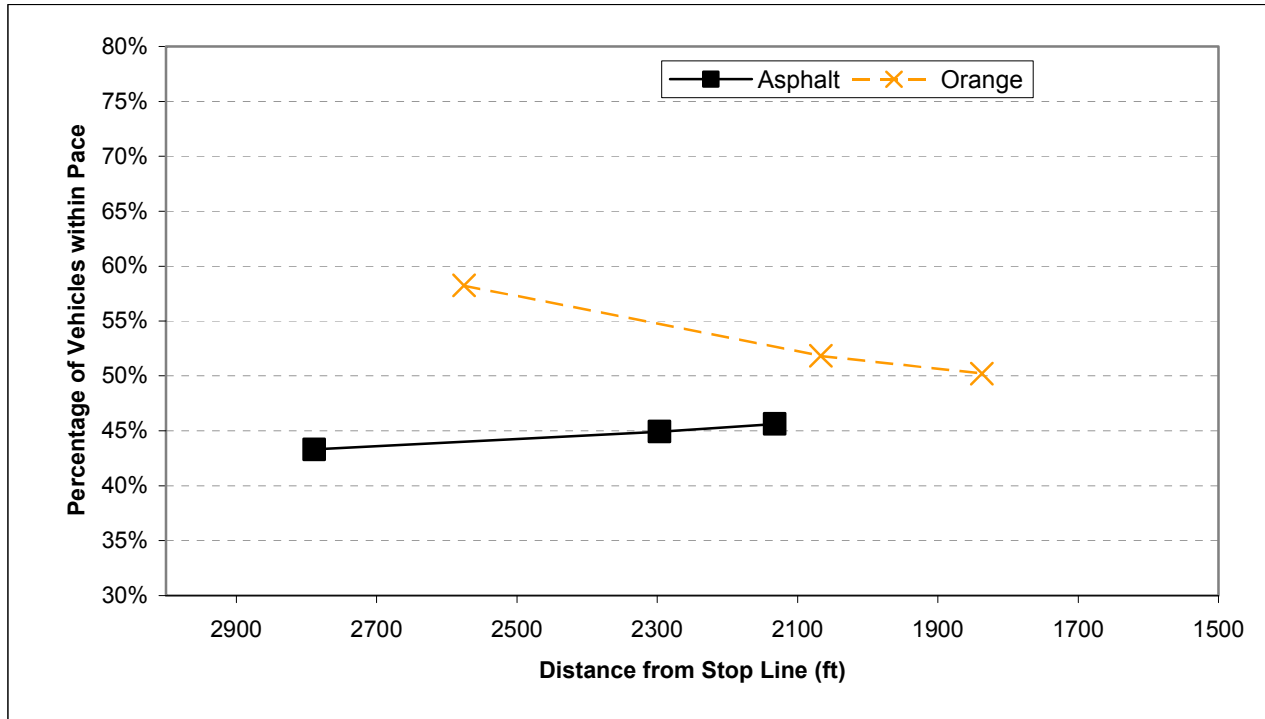
Figure 21 - Percent of Passenger Cars within the 16 kph (10 mph) Pace

The 16-kph (10-mph) pace at each data point is shown in Table 7 and Table 8. In all cases, the percentage of vehicles within the 16 kph (10 mph) pace is greater for the temporary rumble strips than it is for the asphalt rumble strips. However, the percentage was decreasing on the temporary rumble strips and increasing on the asphalt strips. Figure 21 shows the percent of passenger cars within the 16 kph (10 mph) pace. A similar pattern was observed for trucks.

*Plotted data includes passenger cars data for day and night, and first and second data sets.

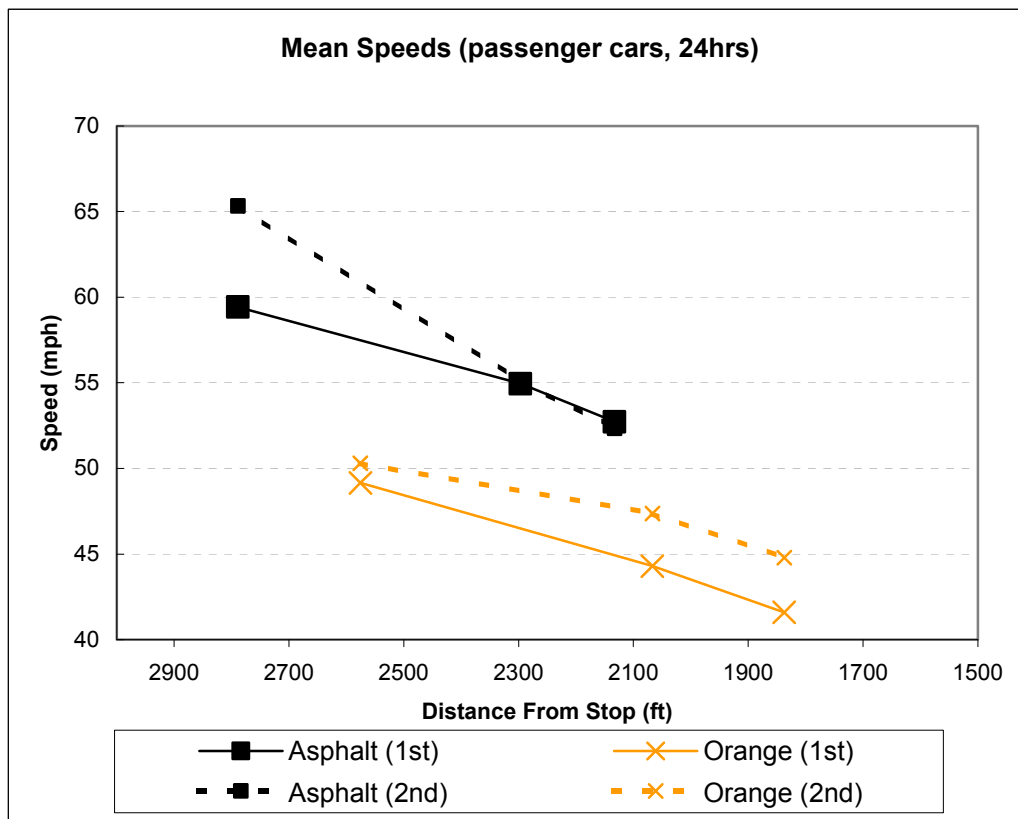
Figure 22 - Change in Speed Reduction Patterns Over Time

The pattern of vehicle speeds observed on the orange rumble strips did change from the first data set to the second. The first half of the data, which is essentially the speeds measured during the first week after the deployment, indicates that the largest changes in speed occurred between the baseline data point (upstream of the first set of strips) and the second data point (on the first set of orange rumble strips). A few weeks later, when the second half of the data was collected, this pattern was no longer observed. The speed decreases were more gradual, and occurred over the entire length of the rumble strip deployment. This suggests that there was a novelty effect for the orange rumble strips, most likely due to their high visibility. However, speed decreases observed in the second data set on the orange strips more closely resembled the patterns observed on the other types of strips. Most likely, the orange color of the strips is responsible for the novelty effect, providing additional speed reduction during the first few days following deployment.

Since the orange rumble strips are not reflective, there is some concern about how visible they are at night. The speed patterns observed during nighttime hours exhibited this same pattern, although to a lesser extent. This indicates that while the strips are visible at night, they are less visible than they are during daylight hours. Table 10 shows the 85th percentile and means speeds observed on the orange rumble strips for the first and second data set separately, for day, night, and overall. Figure 22 shows the mean speeds of passenger cars for both types of strips. The patterns observed for all subgroups were almost identical to the patterns seen in Figure 22 and are therefore not shown.

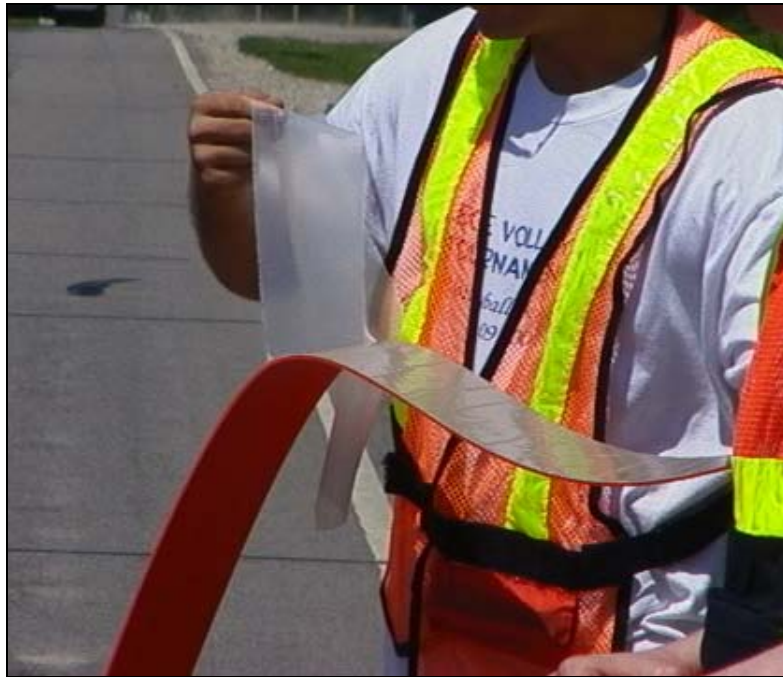
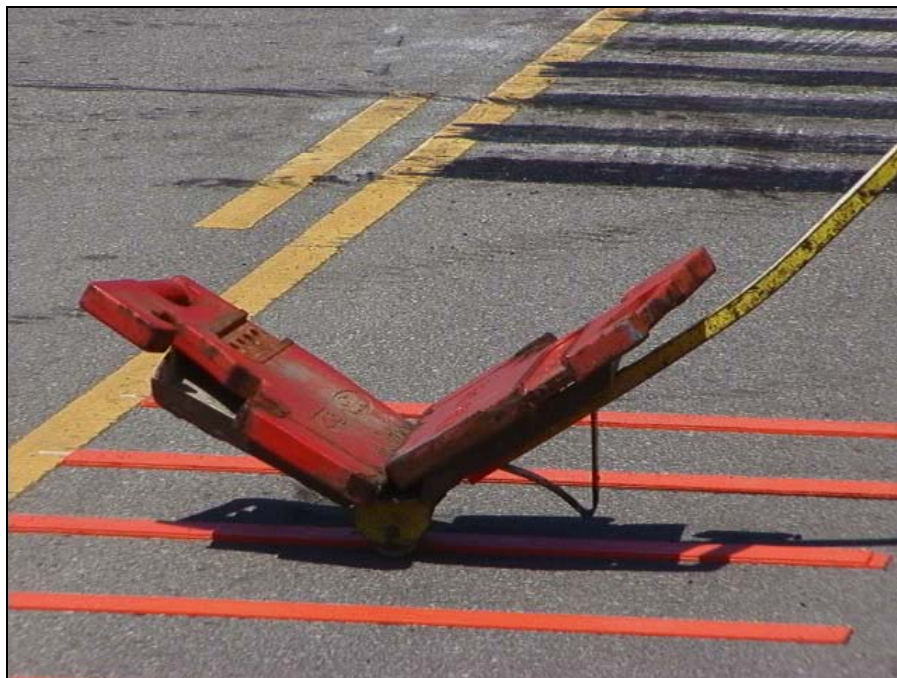
Figure 23 - Installation of the Orange Rumble Strips

Peeling the plastic backing from the strip

Rolling the strips with a tamper cart

The orange rumble strips were first cut to the appropriate length, 1.2 m (4 ft), using tin snips. The pavement temperature was 45° C (113° F), and the pavement was completely dry. The pavement surface was swept clear of debris using a push broom. The placement of the rumble strips was determined using a tape measure and marked using masking tape. The adhesive, which is pre-applied to the strip by the manufacturer, was exposed by the removal of the protective backing. The strip was then positioned on the pavement and rolled with a 22 kg (48 lb) tamper cart carrying an additional 90 kg (198 lb). The plastic backing tore on approximately one out of every five pieces, significantly increasing the effort required for installation. This was reported to the manufacturer who was able to identify the cause of the problem within the manufacturing process and affirmed the problem would be addressed. The orange rumble strips are 3.8 mm (0.150 in) thick. Based on previous research concluding that a single thickness was insufficient to produce sufficiently noticeable noise and vibration [1, 4], two pieces were laid down, one on top of another, in order to double the thickness, effectively doubling the installation time as well.

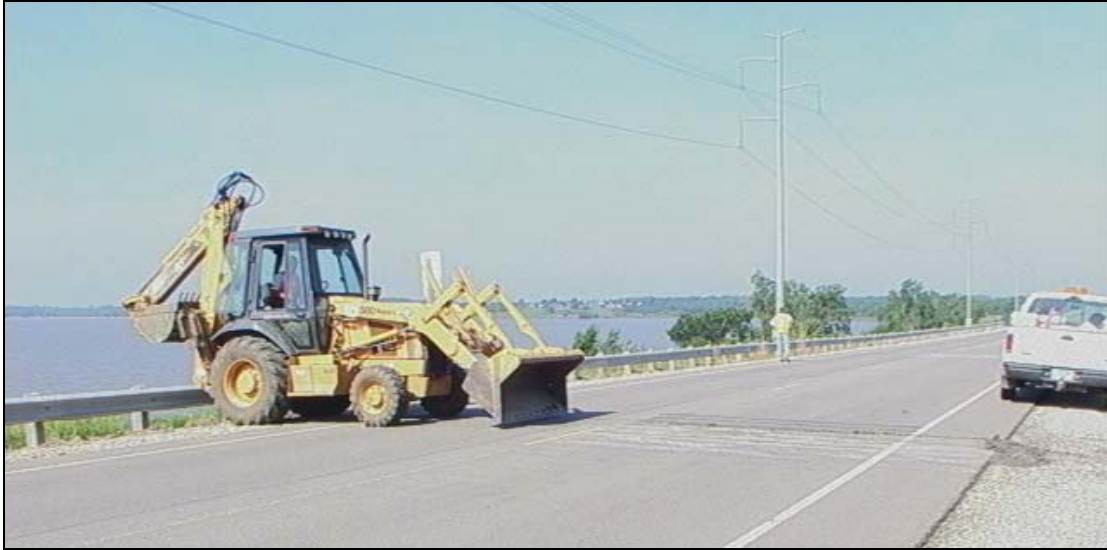
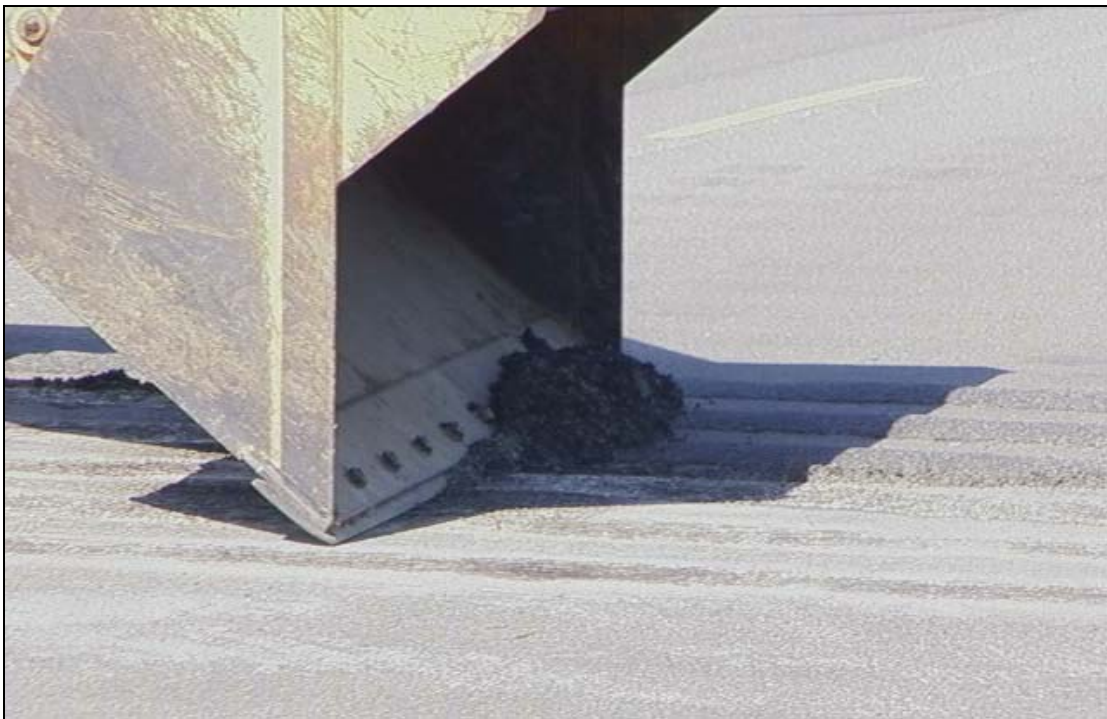
Figure 24 - Removal of the Asphalt Strips

Removal of asphalt strips with Loader/Backhoe

Bucket scraping up the asphalt strips

The removal of the asphalt rumble strips required more than 5 times the labor required to remove the temporary rumble strips, and it required heavy equipment. The asphalt rumble strips were removed using a Skid Steer Loader or a Loader/Backhoe to scrape the raised asphalt strips off of the pavement. Two additional workers, equipped with shovels and brooms, removed the loose pieces of asphalt and gravel from the roadway. The loaders had to back into the other lane of traffic in order to be able to scrape off the strips starting at the center of the lane, requiring that traffic in both directions be temporarily stopped. Removal required approximately 15 minutes per group of strips with 5 workers.

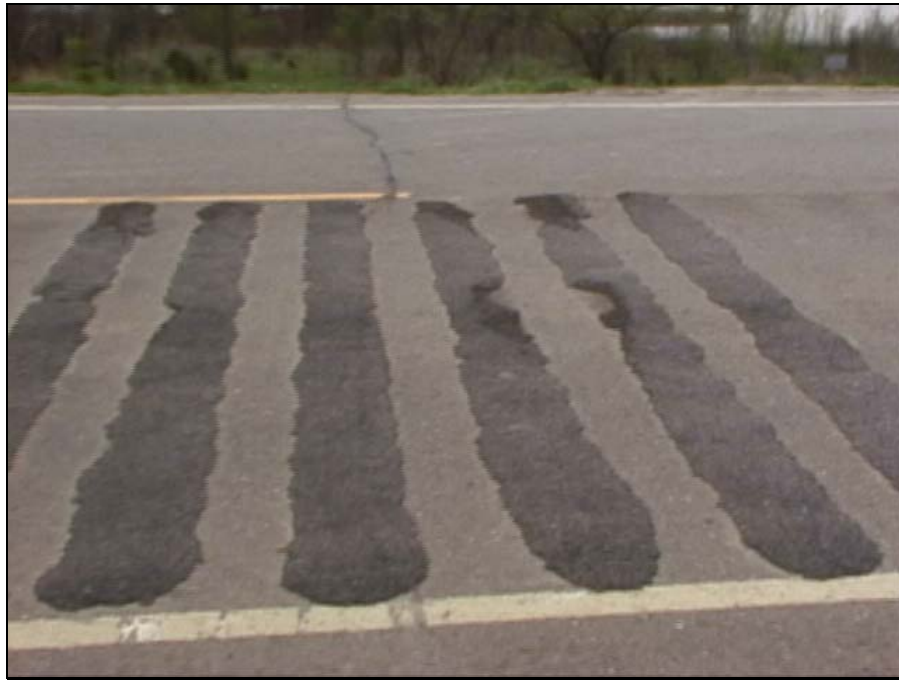
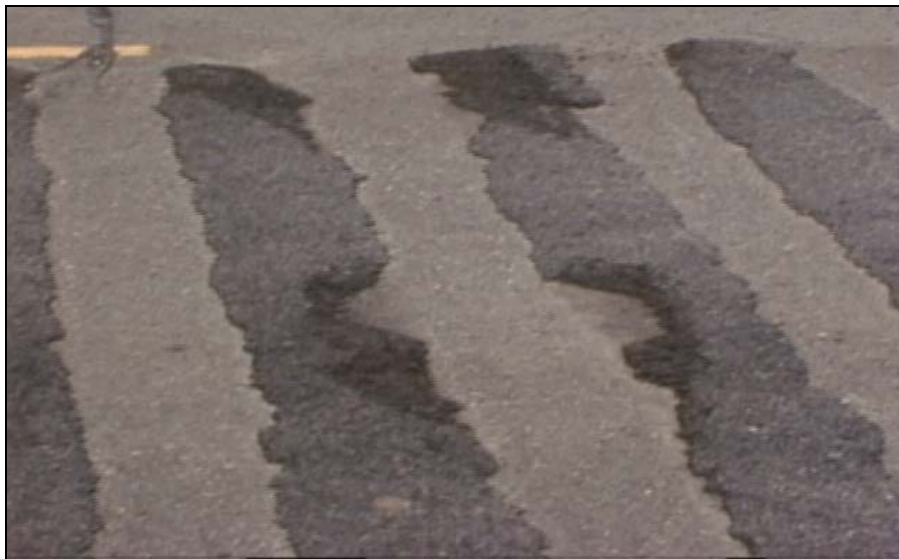
Figure 25 - Damaged Asphalt Rumble Strips

Damaged asphalt strips

Close-up of damage

The asphalt rumble strips were damaged. None of the strips were entirely removed from the pavement, but many had pieces of significant size removed from the strips, totaling as much as about 10% of the entire strip. Pictures of the damaged strips can be found in the Appendix on page 48.

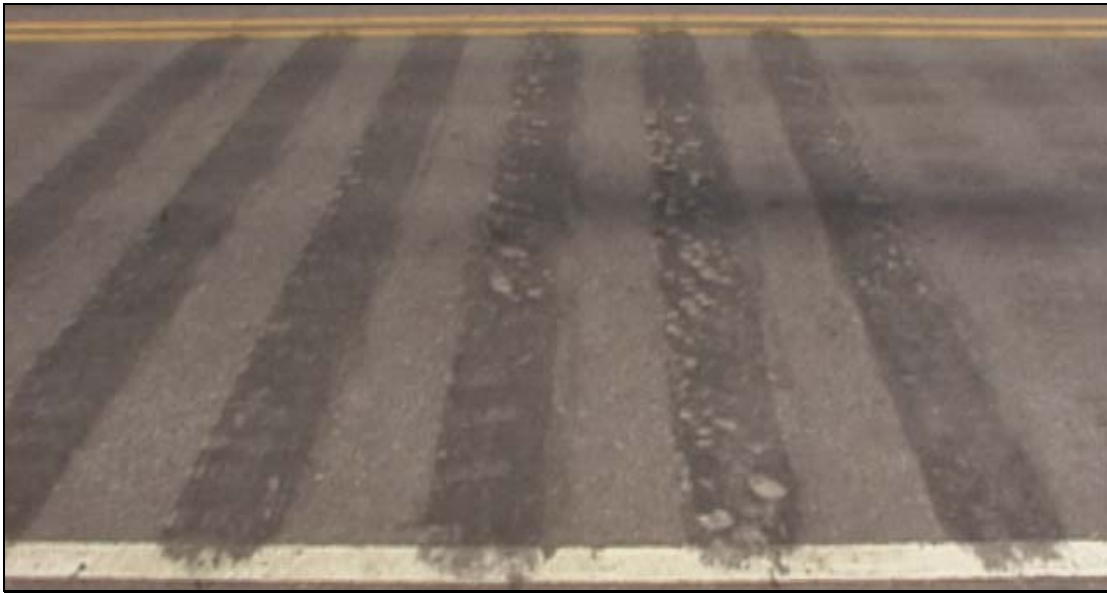
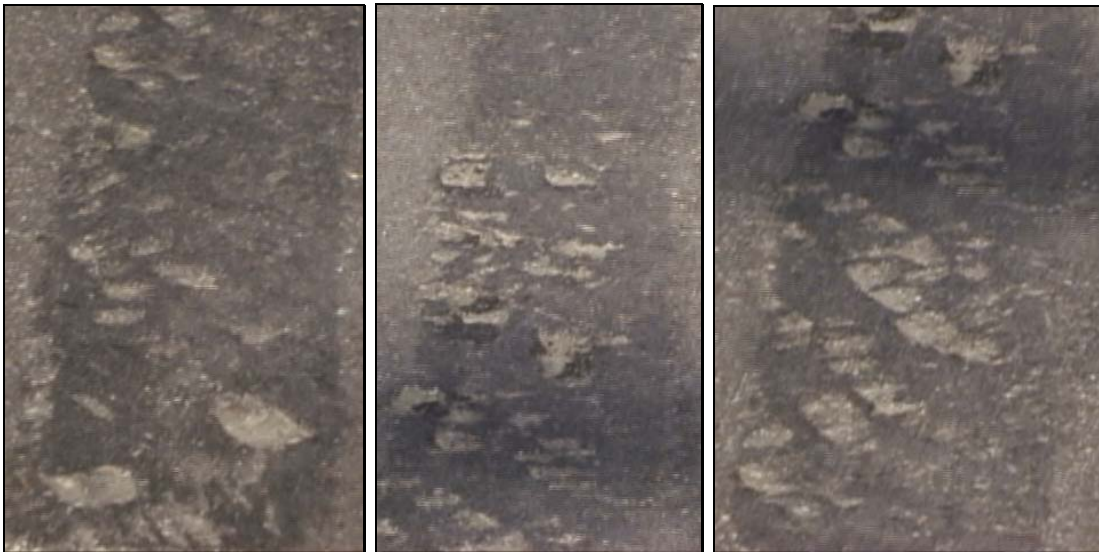
Figure 26 - Pavement Damage from Asphalt Strips

Overview

Close-ups

Part of the motivation to use temporary rumble strips is that they cause less damage to the pavement than asphalt rumble strips upon removal. Although small bits of gravel remained on the back of the rumble strips, and some of the adhesive remained on the pavement, the pavement was not significantly damaged by removing the temporary rumble strips. The remaining adhesive only slightly discolored the pavement, and it quickly wore away under normal traffic and weather conditions. The removal of the asphalt strips damaged the pavement more than the temporary rumble strips. Pictures of the pavement after removal of the strips can be seen in the Appendix on page 49. Both locations had asphalt pavement. Results on concrete pavement may differ.

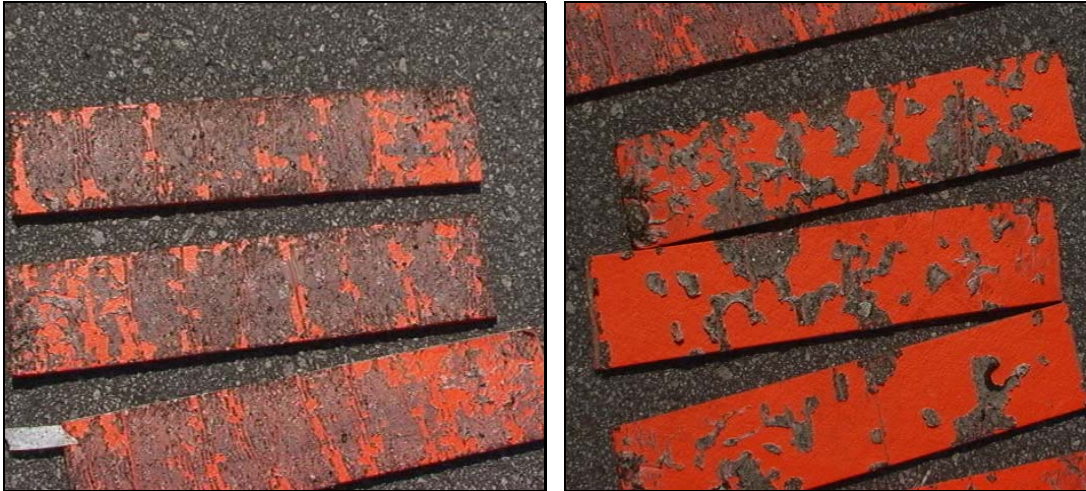
Figure 27 - Temporary Strips After Removal

Underside of orange test strips

Since the orange rumble strips are self-adhesive, the damage done to the adhesive backing makes the strips no longer usable with the same adhesive. The orange rumble strips could be reused if they were nailed to pavement or cleaned and then attached using another adhesive. However, there are drawbacks with both of these installation methods, and neither method is
