Report Title			Report Date: 2002
	Brown Real-Time CMS Con	ntrol and Iteris Wireles	ss Detection
Principle Inv Name Affiliation Address	vestigator Pesti, Geza Texas Transportation Institute CE/TTI, Room 405-H 3135 TAMU College Station, TX 77843-3135	Vendor Name and Addre Brown Traffic	ess
Phone Fax Email	979-845-9878 G-Pesti@ttimail.tamu.edu		
Author(s) ar	nd Affiliation(s)		
Supplement	al Funding Agency Name and Address (if applic	cable)	
Supplement	al Notes		
Abstract

### Chapter 4

### **REAL-TIME CMS CONTROL**

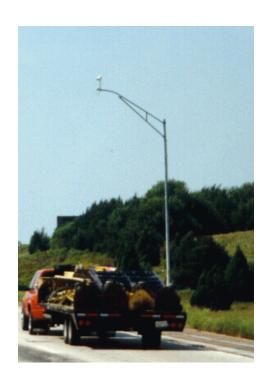
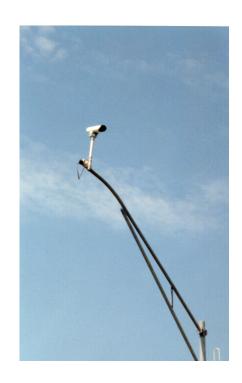
The video detection camera of the RTCMSC was mounted on the mast arm of a pole located on the roadside. The camera was focused on the single open lane following the lane closure taper and in advance of the median crossover and head-to-head traffic. The camera installation is shown in Figure 4-4.

FIGURE 4-4 Video camera installation.

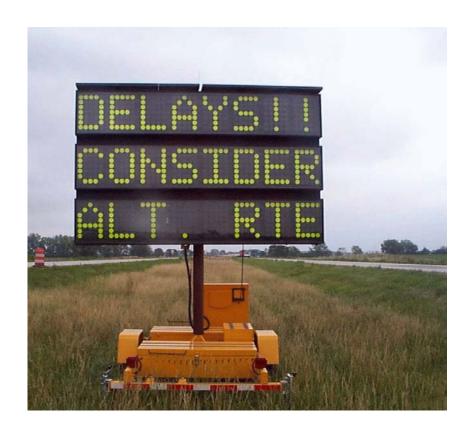
The portable CMS was located on the median of eastbound I-80 about one mile before the Highway 6 interchange. Highway 6 connects with Highway 31 which returns to I-80, providing an alternate route around the work zone. The placement of the portable CMS is shown in Figure 4-5.

FIGURE 4-5 CMS placement.

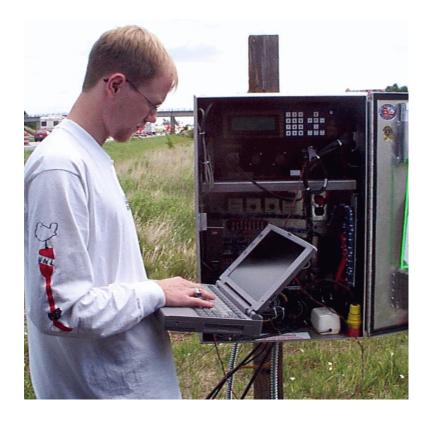
Traffic counts on the entry and exit ramps were taken using two traffic counter/classifier units deployed and operated by the NDOR. The traffic on I-80 eastbound was monitored using the video camera of the RTCMSC at the beginning of the lane closure taper, approximately one mile downstream of the diversion point at the Highway 6 interchange. Volume data at this location were determined by Brown Traffic's video image processing system, and stored in a log file. Because of limited storage capacity of the controller unit, the log files were downloaded daily as shown in Figure 4-7. Traffic volume data were collected over a 12-day period, from June 1 through June 12, 2000.

FIGURE 4-7 Retrieval at the Camera Location on I-80 Eastbound.
