EFFECTIVENESS OF SWARCO RUMBLER[®] ON US 65 IN SPRINGFIELD, MISSOURI

Deepak Manjunath, Graduate Research Assistant Mark R. Virkler, P.E., Ph.D., Professor University of Missouri-Columbia (573) 882-7434

August 2002

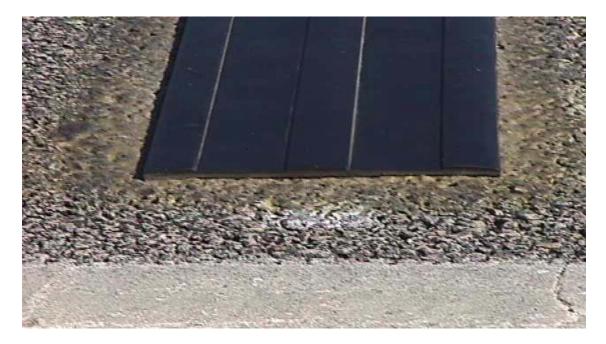
FIGURE 20 Rumble strip condition four weeks after installation

Photographs taken four weeks after the installation of the rumble strips show that the strips were in good condition. As shown in Figure 20, no wear and tear or curling of the edges was observed. According to the District Engineer's Office, the rumble strips remained functional and in place until removed by snow plows in March of 2002.
