Evaluation of Work Zone Split Traffic Symbol Sign

Final Report
February 2018

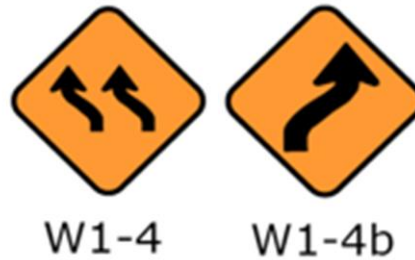
Section 6F.16 of the MUTCD (FHWA 2009) provides guidance on the function, design, and application of warning signs in TTC zones. Warning signs notify users of specific situations or conditions on or adjacent to a roadway that might not otherwise be apparent. W1-4 and W1-4b (see Figure 1.1) are part of this family of warning signs directing traffic through work zones.

Figure 1.1. Horizontal alignment warning signs from MUTCD Section 6F

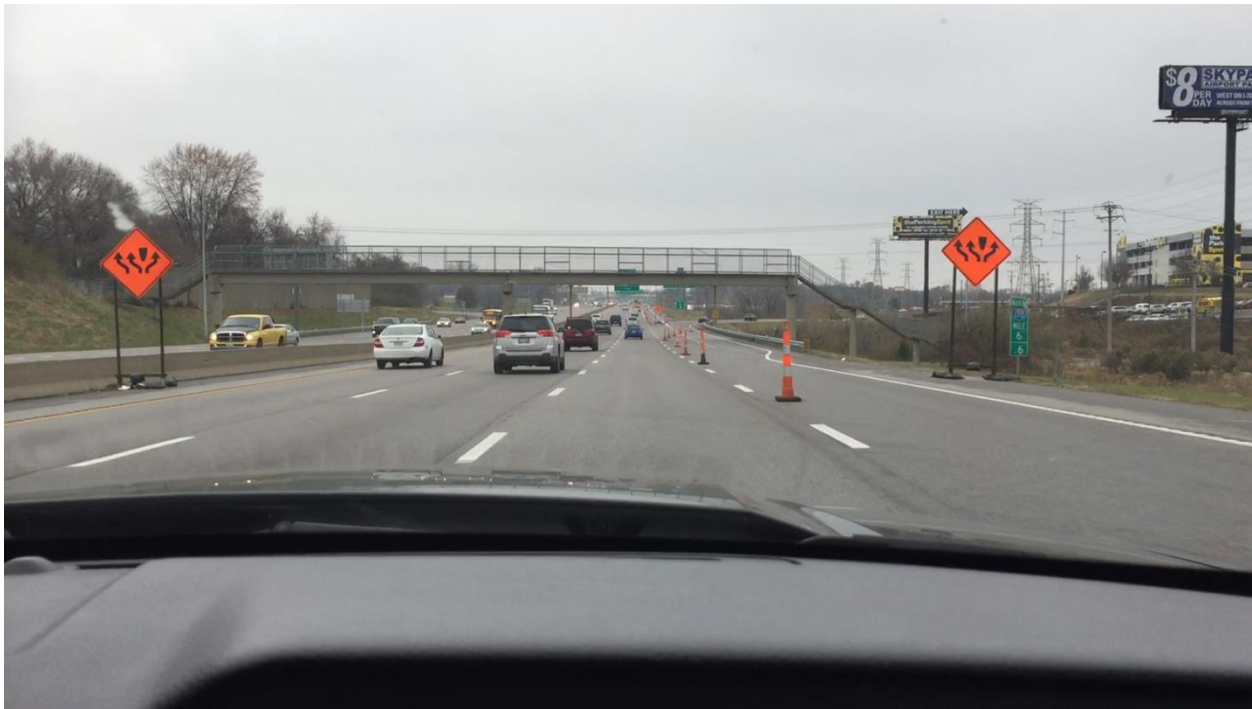
The split sign was placed in advance of the gore point (Figure 1.6), while an arrow board was placed near the split itself in the northbound direction (Figure 1.7).

Figure 1.6. Work zone split sign on northbound I-170

In the field deployment, the optional sign shown in Figure 1.2.b was not utilized. The lanes tapered over a length of 840 ft at the beginning of the split.

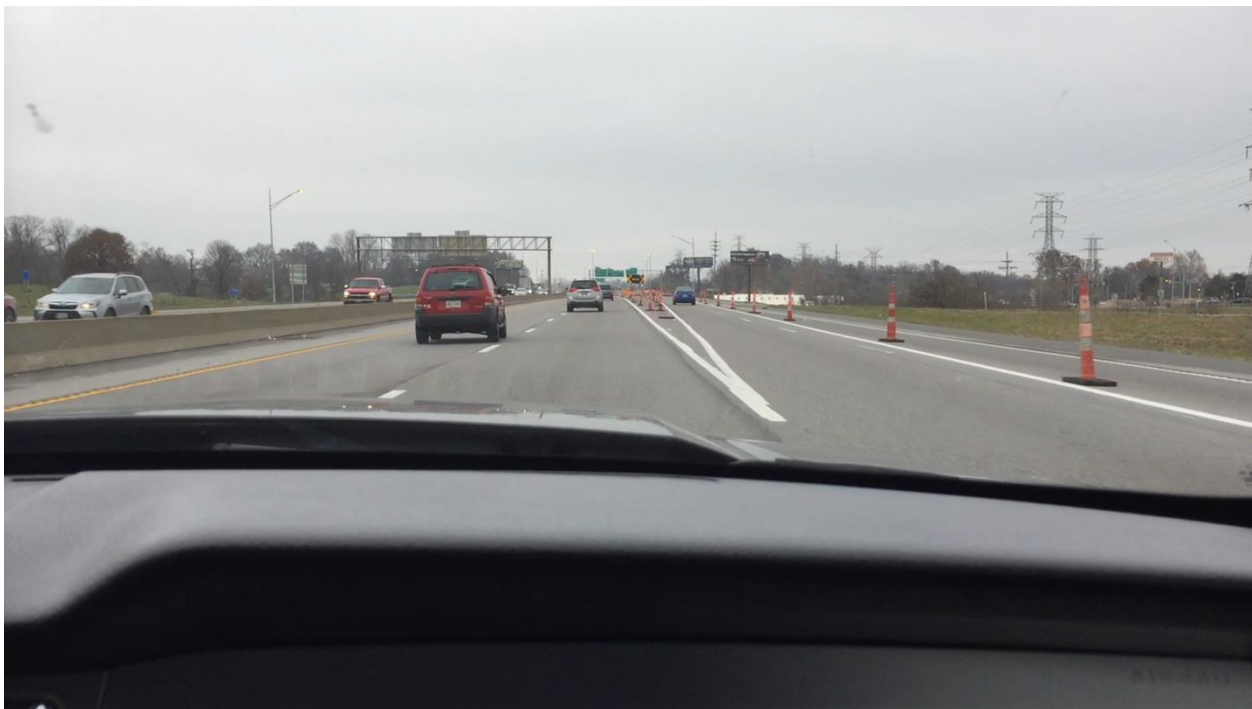
Figure 1.7. Gore point on northbound I-170

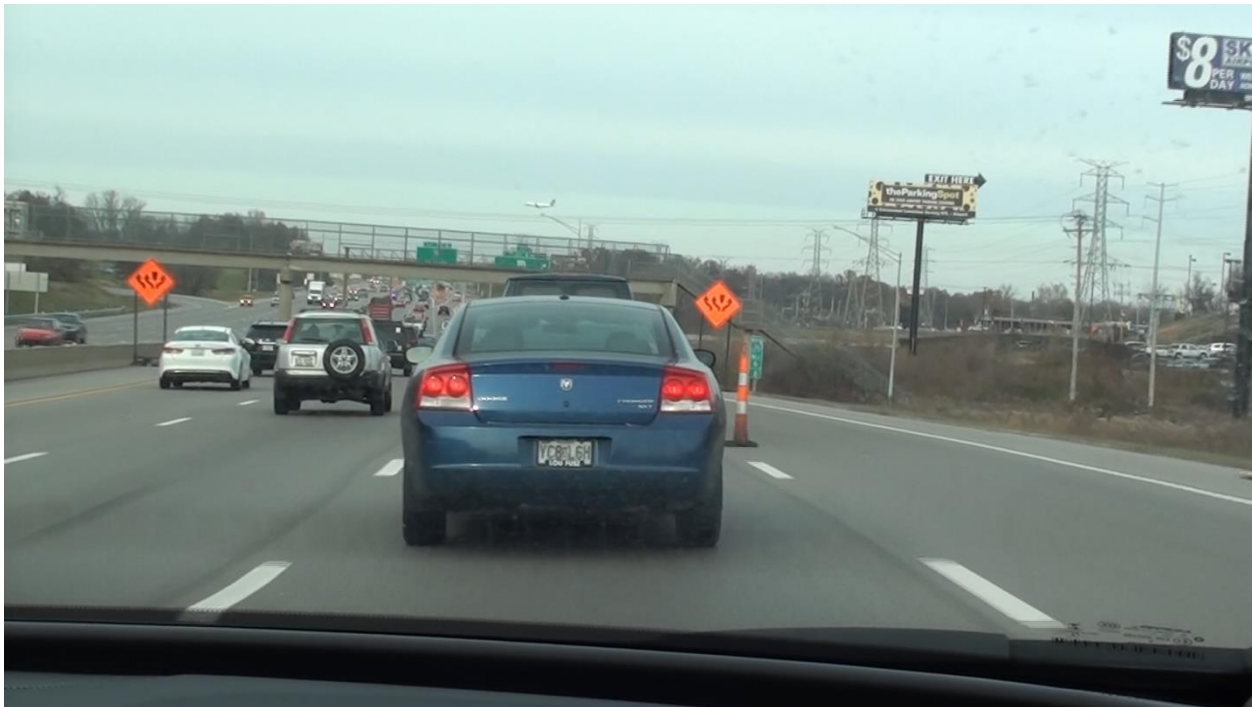
Figure 2.6. Screenshot of front view northbound drive-through video

In addition to the stationary cameras, two cameras were mounted inside a test vehicle to capture views of drivers travelling through the work zone. A GoPro HERO5 Black 4K Ultra HD Action Camera was mounted to the center rear view mirror inside the vehicle to capture a side view of vehicles progressing through the work zone, and a handheld recording camera was mounted to the passenger seat to capture a driving view of vehicles progressing through the work zone. A minimum of two drive-through videos per scenario were captured. A total of 60 drive-through videos were collected during the earlier construction period, while 48 drive-through videos were collected during the later construction period. Sample screenshots for the videos can be seen in Figures 2.6 through 2.9.

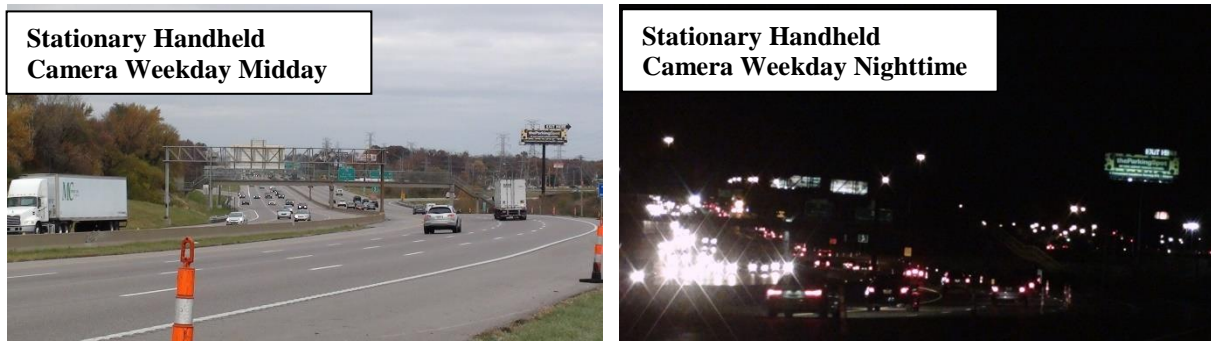
Figure 2.10. Screenshots from northbound cameras before split sign placement (11/30/2016)

During this session, approximately 20 hours of stationary video recordings and 47 drive-through video runs were collected. Figures 2.10, 2.11, and 2.12 show screenshot examples of videos collected during each data collection period in the northbound direction. The receding field of view shows the traffic traveling away from the camera.

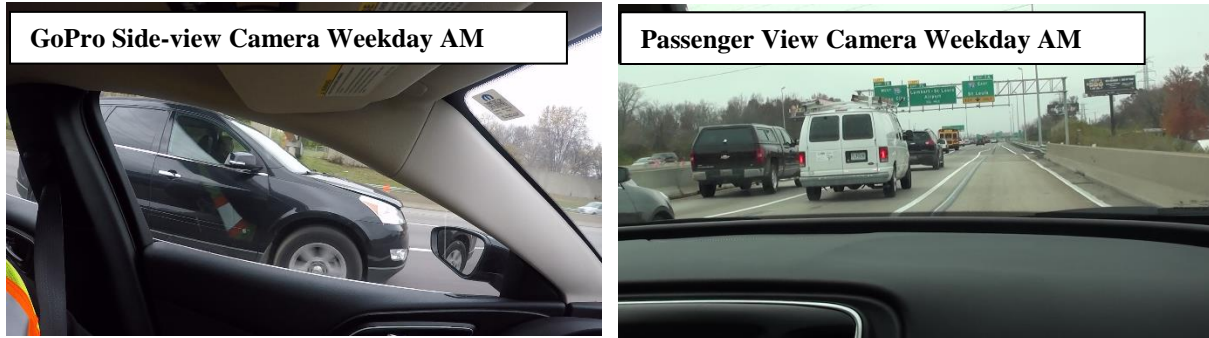
Figure 2.13. Screenshots from northbound drive-through cameras before split sign placement (12/6/2016)

Figure 2.13 shows screenshot examples of the drive-through camera views during the northbound a.m. peak commute period.

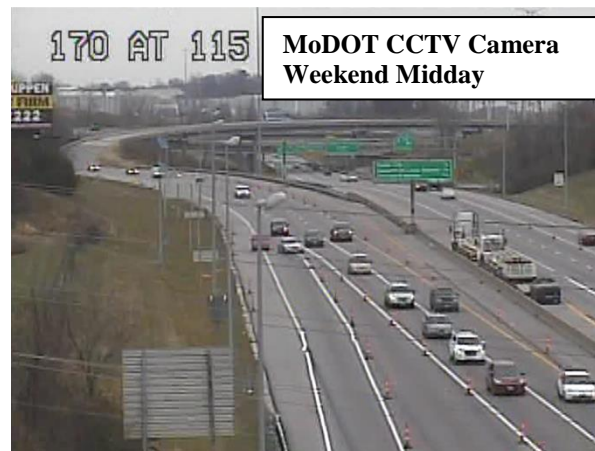
Figure 2.15. Screenshots from southbound cameras during early construction with split signs (12/10/2016)

During this session, approximately 20 hours of stationary video recordings and 60 drive-through video runs were collected. Figures 2.14 and 2.15 are screenshot examples of traffic during each data collection period from the southbound direction camera position. The approaching field of view shows traffic traveling towards the camera.

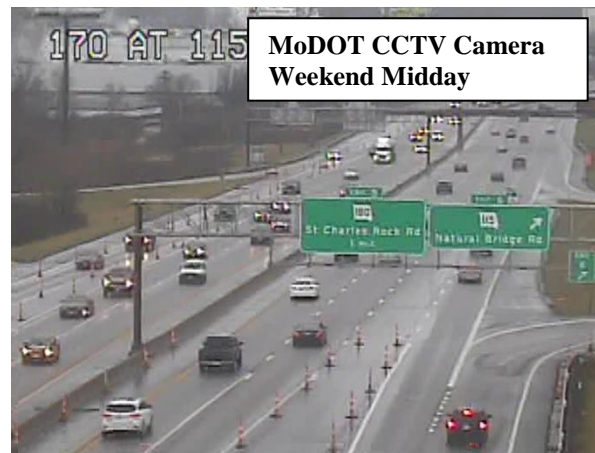
Figure 2.18. Screenshots from northbound cameras during late construction with split signs (12/17/2016)

During this session, approximately 21 hours of stationary video recordings and 48 drive-through video runs were collected. Figures 2.17 and 2.18 show screenshot examples of traffic during each data collection period from the northbound camera position. The receding field of view shows the traffic traveling away from the camera.

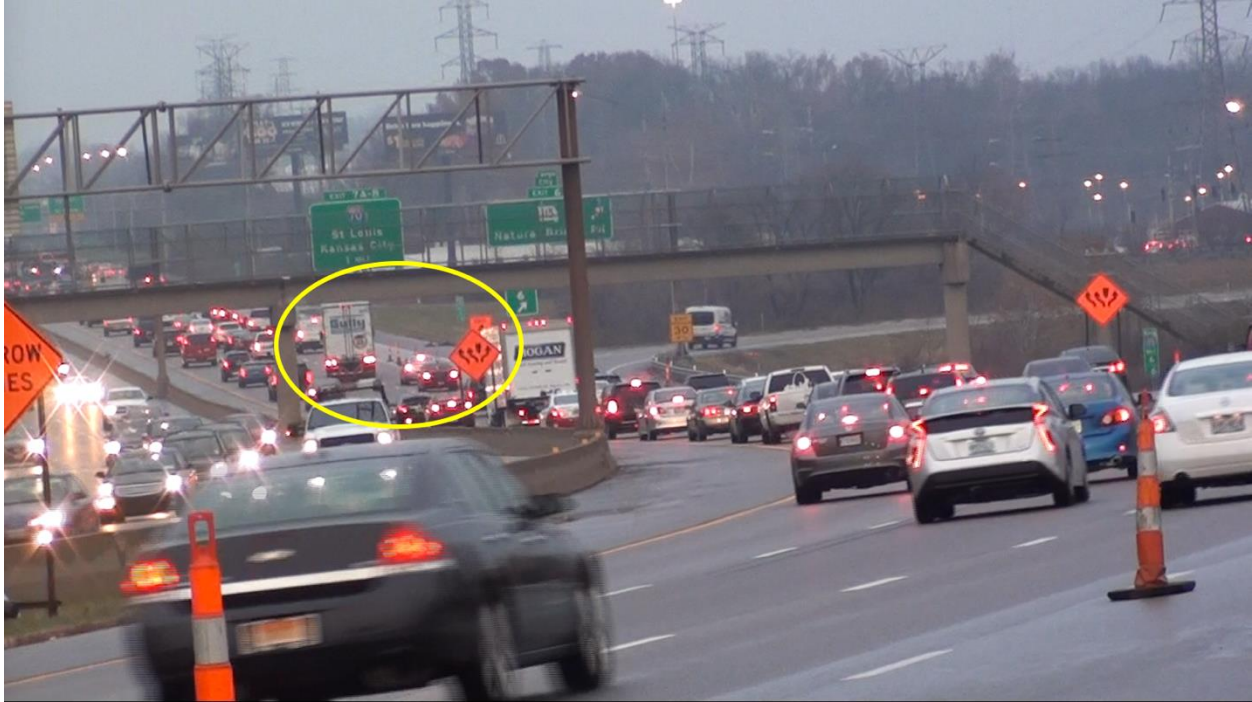
Figure 2.21. Tractor-trailer making aggressive lane change causing following vehicle to change lanes (early construction, northbound, morning peak)

In the event shown in Figure 2.20, a tractor-trailer made an aggressive lane change from the outside lane to middle lane and caused a vehicle queue to develop. In another event (Figure 2.21), a tractor-trailer suddenly changed lanes and applied the brakes, causing the vehicle following behind to move into a different lane.

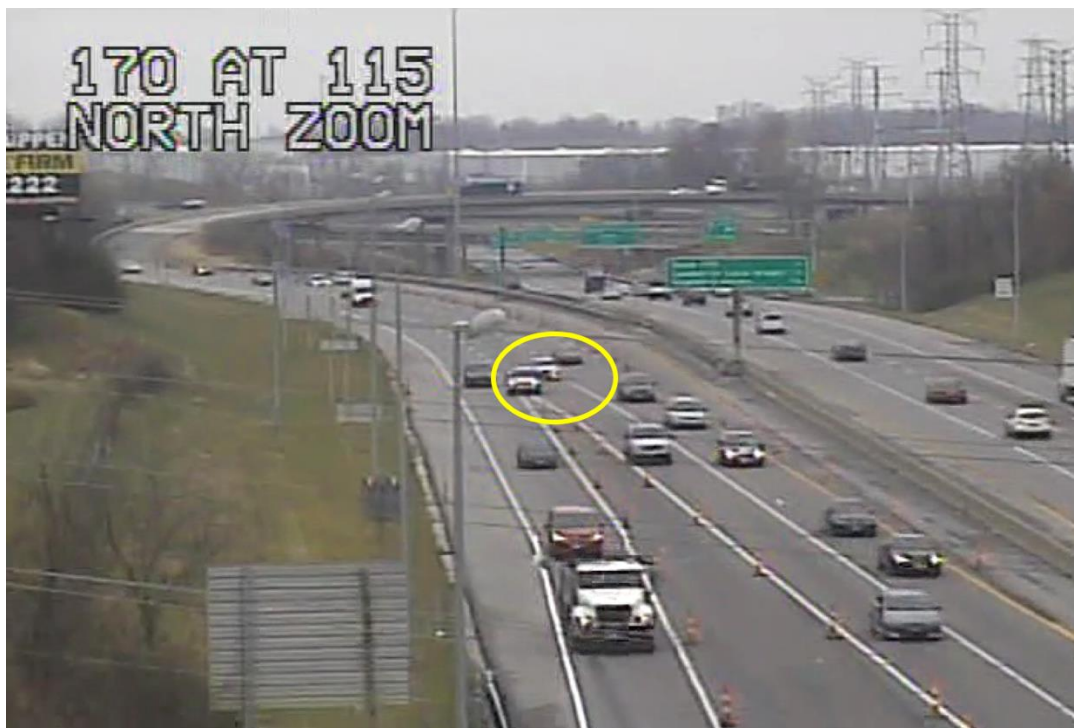
Several aggressive lane changes near the gore were captured in the videos. Examples of these events are shown in Figures 2.22 and 2.23. In both examples, vehicles traveled within the triangular gore area by traversing solid white lines.

Figure 2.23. Lane change near the gore example 2 (late construction, southbound, midday)

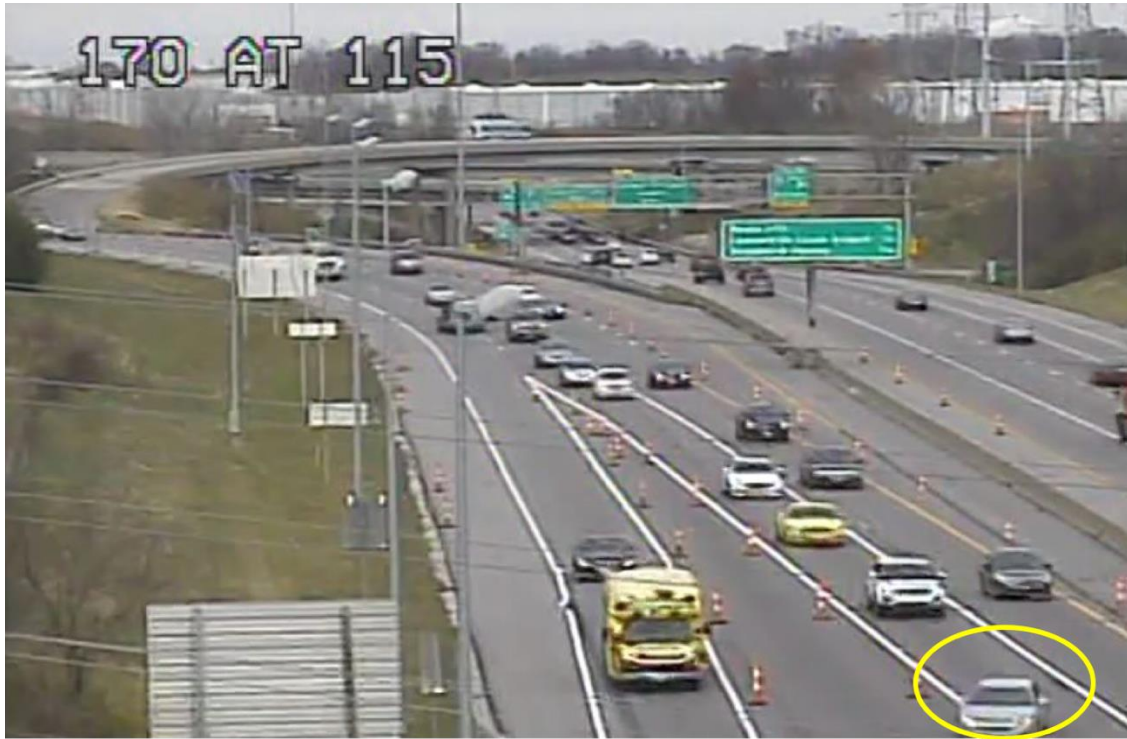
Several events in which vehicles drove through the lane closure area were observed in the videos. Examples of these events are shown in Figures 2.24 through 2.26. Multiple vehicles can be seen driving through the lane closure area in Figure 2.26.

Figure 2.24. Vehicle driving through lane closure area to outside lane (early construction, southbound, midday)

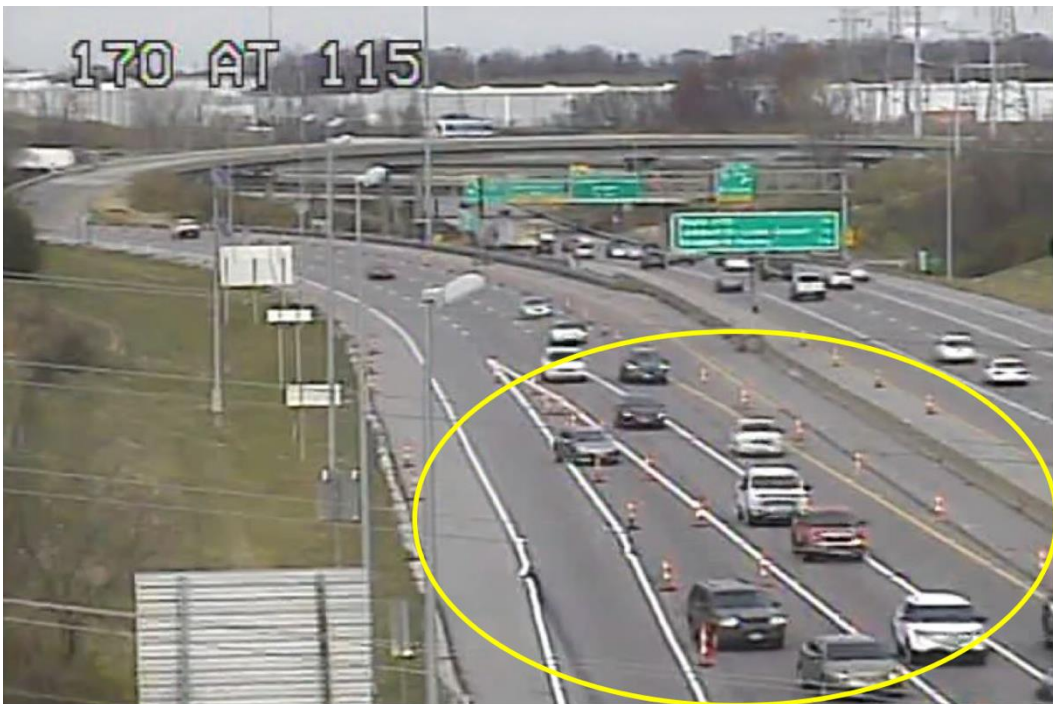
Figure 2.26. Multiple vehicles driving through lane closure area (early construction, southbound, midday)

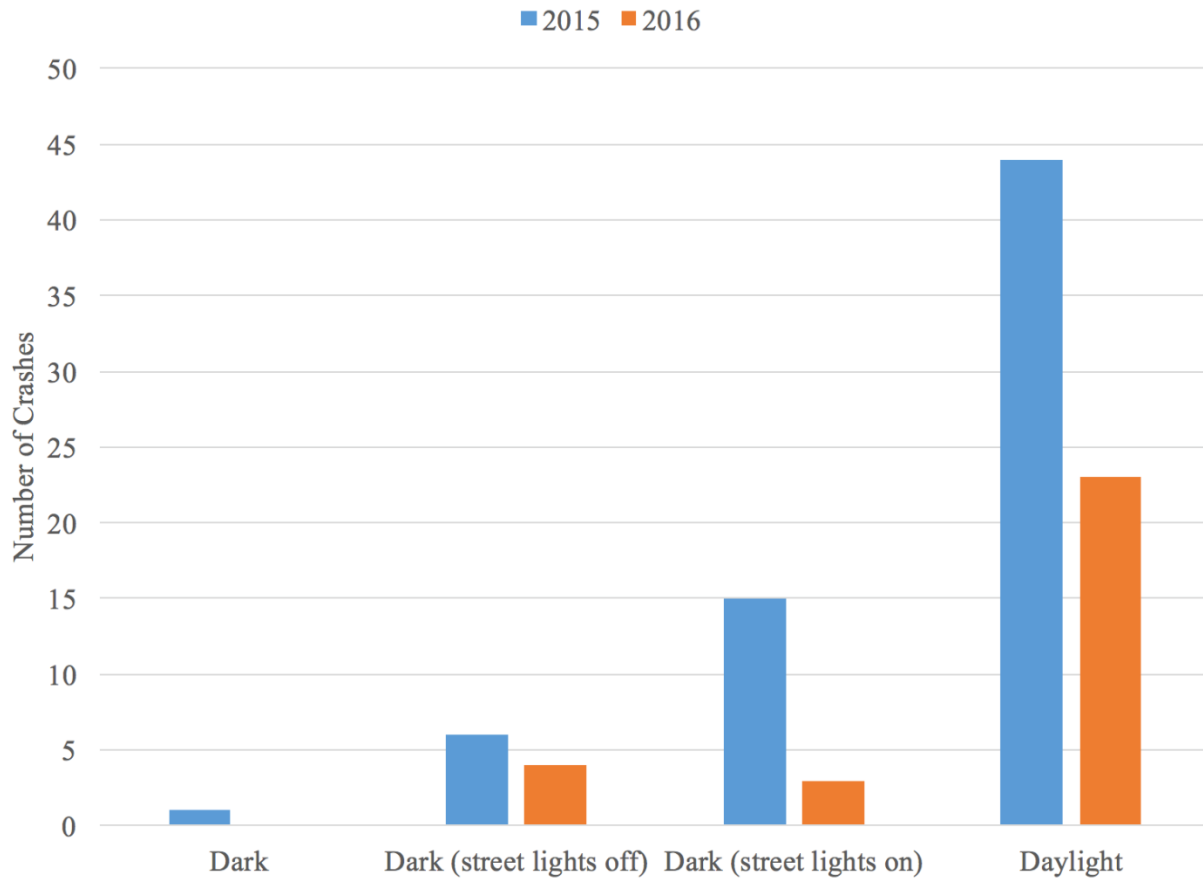
The distribution of crashes by light condition is shown in Figure 5.8. Most of the crashes occurred in daylight.

Figure 5.8. Crashes by light condition for I-170 southbound

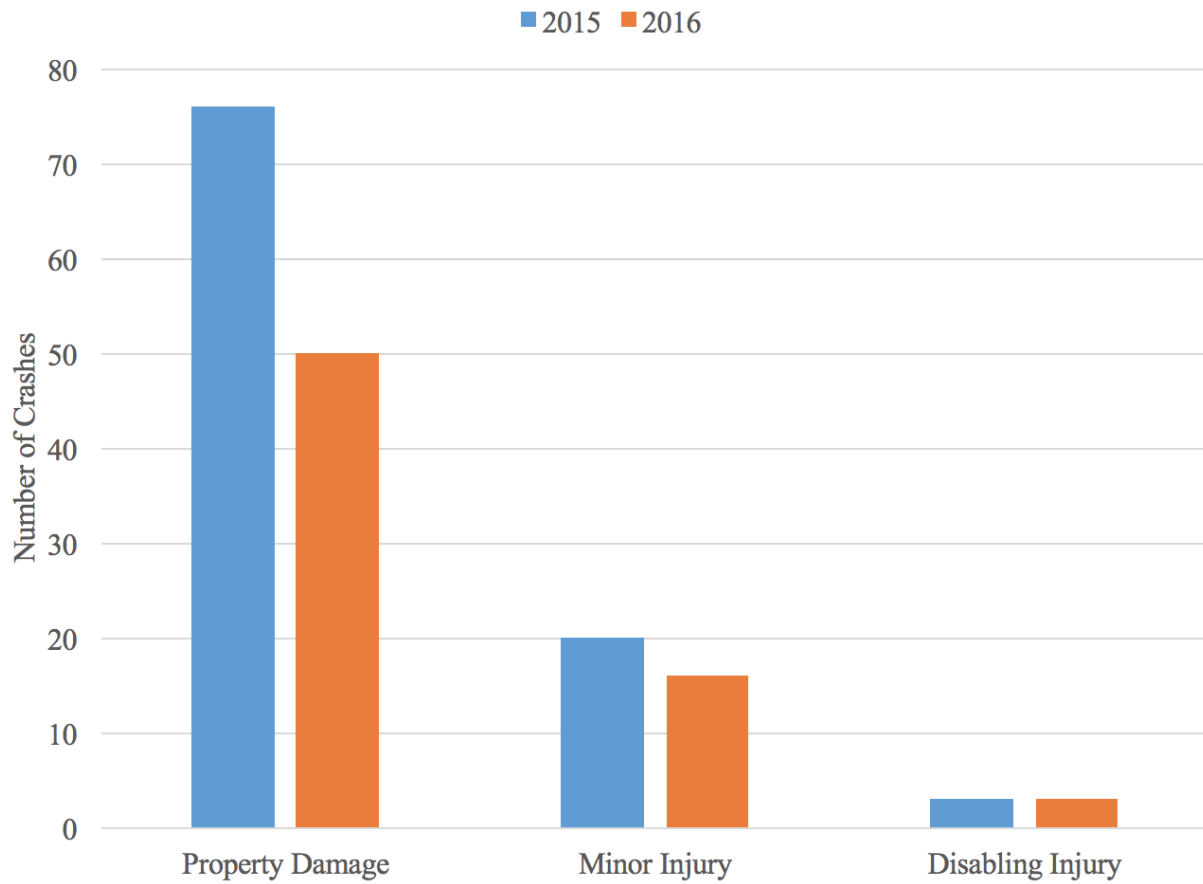
Figure 5.12 shows a graph of crashes by severity. Approximately 75 percent of crashes were PDO crashes. There were three disabling injury crashes in both 2015 and 2016.

Figure 5.12. Crashes by severity for I-170 northbound
