# **The Aurora Consortium**

## ***Laboratory and Field Studies of Pavement Temperature Sensors***

### **Final Report**

Prepared by:  
SRF Consulting Group, Inc.

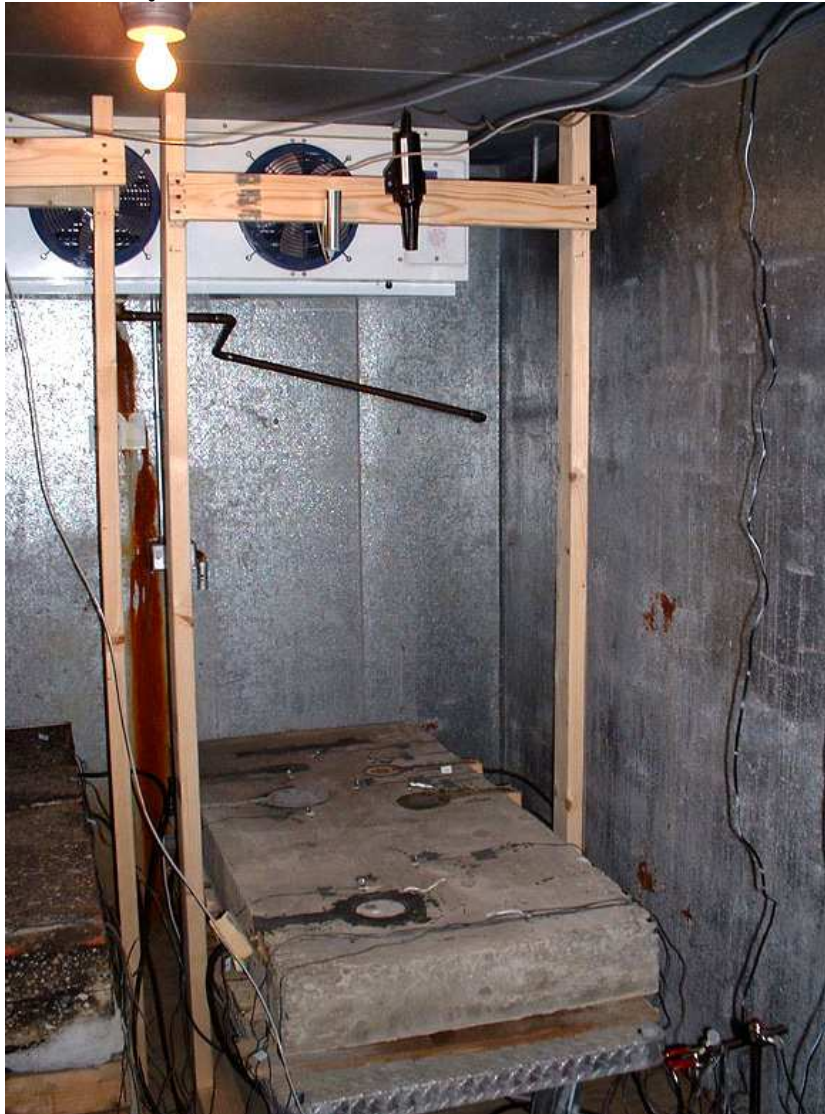
**Figure 14**  
**Laboratory Test Chamber**

*\*Note the mobile sensor installation above the test sections*

Mobile sensors were installed on a framework centered above the test sections at a height of four feet in all cases except the varied height tests described in Objective 1-4. This height was chosen because it represented a typical installation height on a deployed vehicle. This height also conformed to each manufacturers' recommended installation height; Sprague required the sensor to be mounted a minimum of 20 inches above the pavement surface. Control Products stated that the sensor could be installed at any height. See Figure 4 for a schematic diagram and Figure 14 for placement in the test chamber.

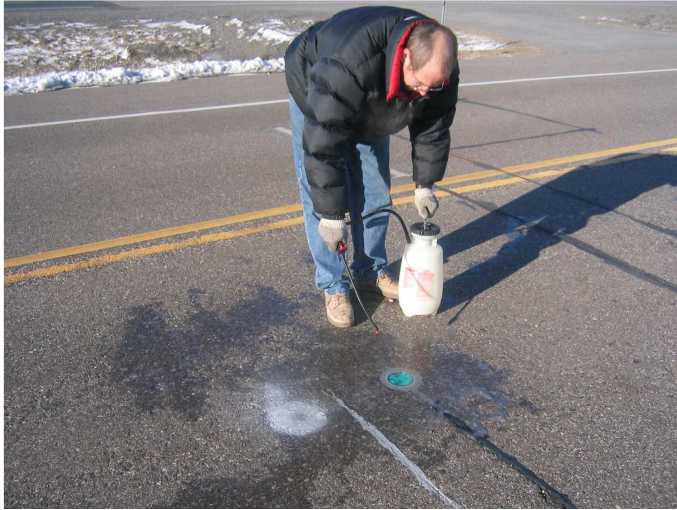
**Figure 22**  
**Cold Pavement With Simulated Rainfall Test**

This test was conducted when the ambient air temperature was approximately -12° C (9° F) and the pavement was clear of snow and ice. A spray tank was filled with distilled water and was cooled to a stable temperature of 2° C (35° F). Next, a fine mist was sprayed over the pavement test-sections to simulate a light rain. Refer to Figure 22 for a picture of the rainfall test.

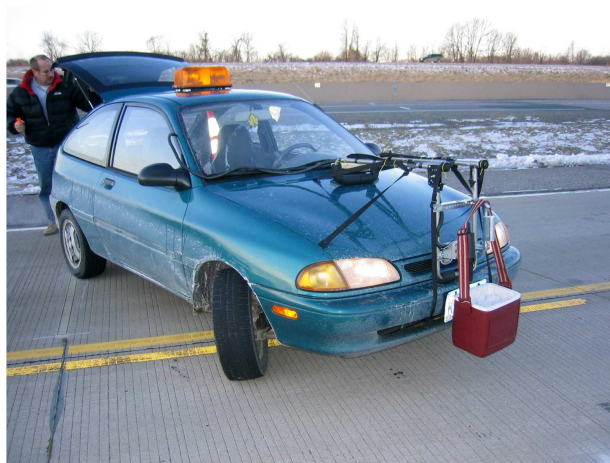
**Figure 23**  
**Mobile Ice-bath Set-up for Field Testing**

Mobile sensor performance was evaluated in the field by mounting the sensors to a platform that was then attached to the front bumper of a passenger vehicle. See Figures 23 and 24 for pictures of the mobile sensor set-up; these pictures were taken during an ice bath test.

An ice bath was used to check for proper calibration of the Control Products sensor before the start of each day of testing. The calibration check was performed once the Control Products sensor had been exposed to the ambient air temperature for at least 90 minutes. The calibration procedure provided in the owner's manual was followed. It should be noted that there was no manufacturer provision for Sprague field calibration.

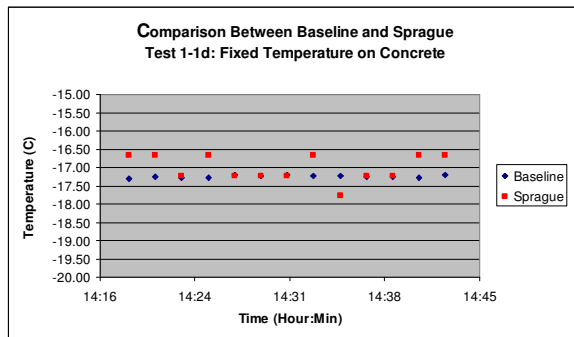
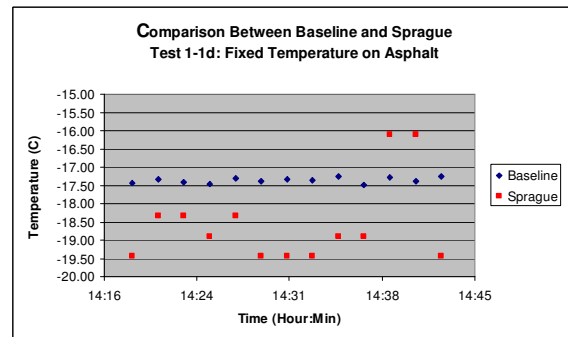
For both the concrete and asphalt portions of the test, the individual baseline temperatures were constant, ranging between -16.9 and -17.6° C. The Aanderaa, Boschung, Point Six and Vaisala reported mean absolute errors less than 0.3° C. It should be noted that the Point Six had six bad data points on the concrete test that were eliminated from the analysis. The Lufft and SSI reported mean absolute errors were less than 0.8° C. The Control Products sensor reported mean absolute errors of 1.2 and 0.3° C on the asphalt and concrete tests respectively. The Sprague reported a mean absolute error of 0.3° C on the concrete test. On the asphalt test the Sprague reported a wide variation in temperatures with values ranging from -16.0 to -19.5° C as shown in the following graphs.

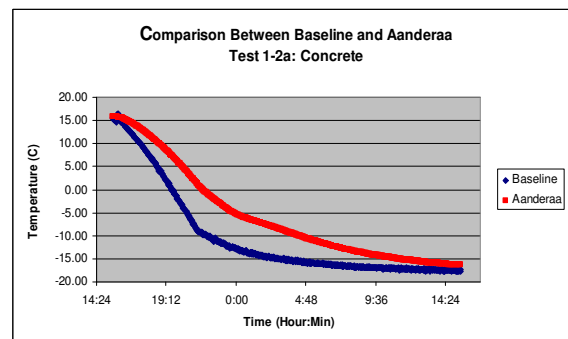
In contrast, the graph on the right shows that the Aanderaa sensor was slower to respond to the temperature change. This discrepancy is caused by the placement of the Aanderaa sensor's temperature sensing element. Because the sensing element is deeper in the pavement section, it does not respond as quickly to temperature change. Because the primary measure for sensor performance is the difference between subject sensors and baseline sensors attached to the surface of the pavement, these sensors appear to be in error during sudden changes in temperature. It is evident from the data at the end of the testing period that after the pavement section has stabilized the Aanderaa sensor reaches the stable temperature. Thus, while the Aanderaa sensor is accurate, the test simply shows that it does not respond as quickly as other sensors.

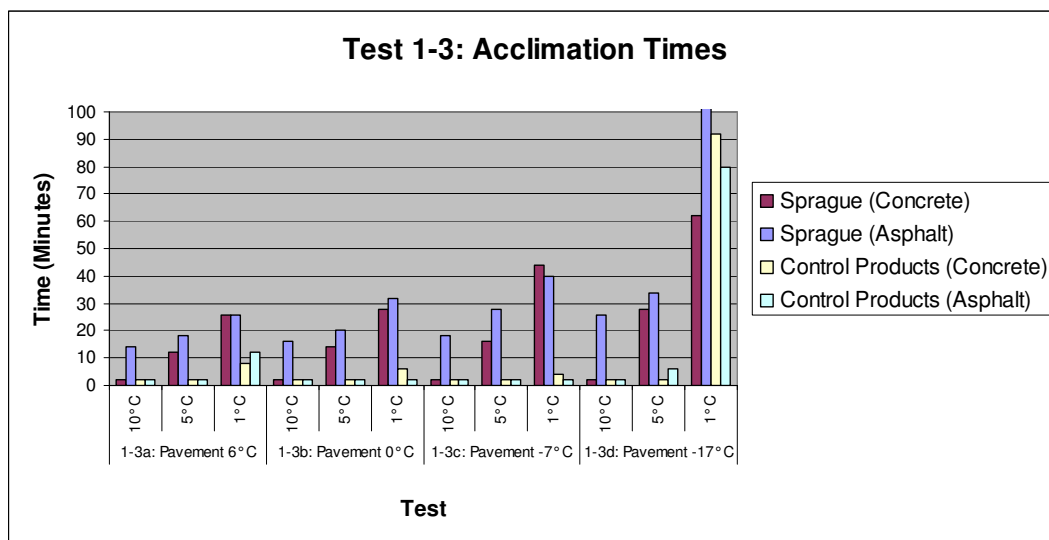
The approximate average acclimation times for the Control Products sensor were 2.5 and 20 minutes to achieve accuracy within 5 and 1° C respectively. The Sprague sensor consistently reported significantly longer acclimation times than the Control Products sensor, approximately 19 minutes longer to achieve accuracy within 1 and 5° C. Also, as might be expected, the greater the initial temperature contrast between the pavement and sensor, the greater the acclimation time. The graphs below present sample data and Table 6 presents the test data.

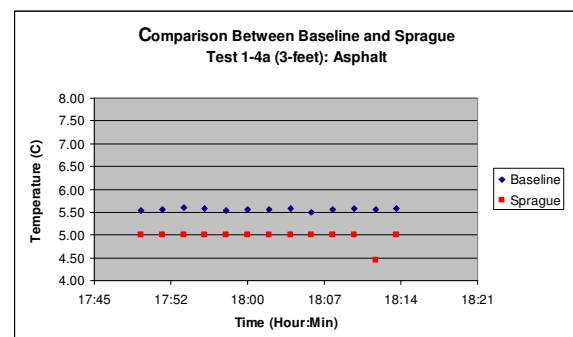
Inspection of the combined Control Products and Sprague data suggested that mobile sensor accuracy increased as the test temperature increased. The averages of the mean absolute errors decreased from  $0.83$  to  $0.34$  as the test temperatures increased from  $-17$  to  $+6^{\circ}\text{C}$ . A sample accuracy comparison is presented below. The  $-17^{\circ}\text{C}$  test is on the left and the  $+6^{\circ}\text{C}$  test is on the right.

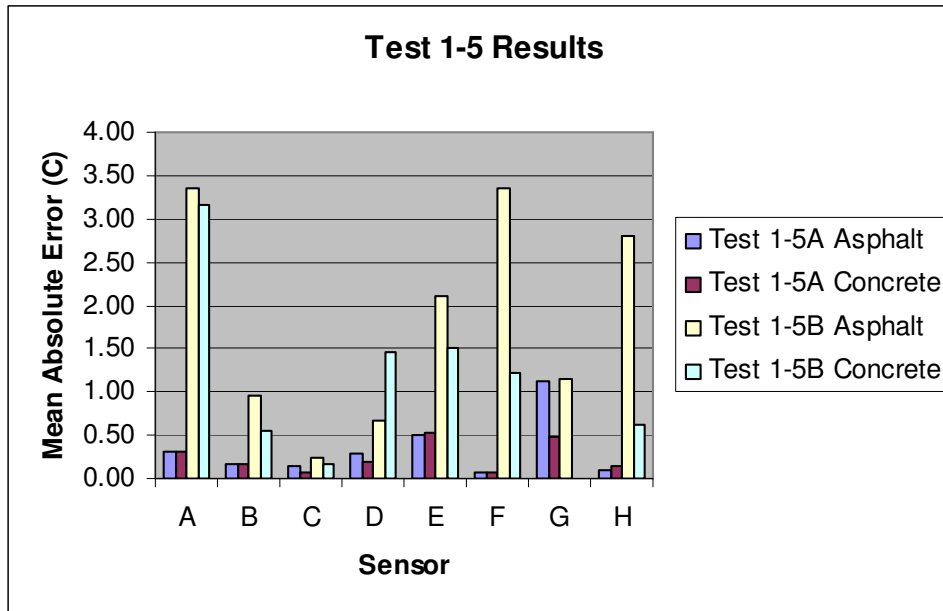
Without direct solar impact (Test 1-5a), the average mean absolute error was 0.3° C. However, with direct solar impact (Test 1-5b), results varied with several sensors reporting errors greater than 1.0° C. The average mean absolute error for Test 1-5b was 1.6° C. Apparently, each sensor reacted differently to direct solar exposure of Test 1-5b. Since the sensors had significantly lower errors without solar impact (Test 1-5a) and in Test 1-2b (increasing temperature test), the direct solar heating of the pavement surface is likely the cause of the varied readings. Both the precise depth of each sensor's temperature "sensing element" and an uneven distribution of heat from the lamp could have caused the varied results from this test. The key finding from this test is that the addition of a heat source makes the baseline surface temperature deviate from the sensor's measured temperature more than if there was no additional heat source.

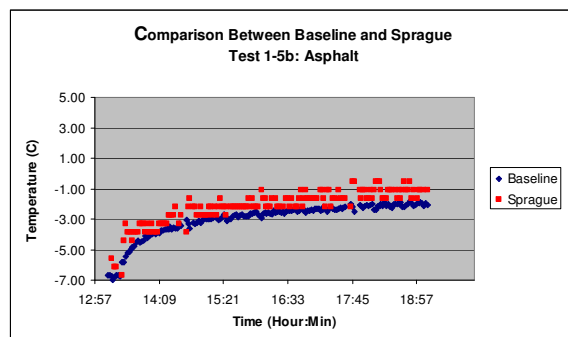
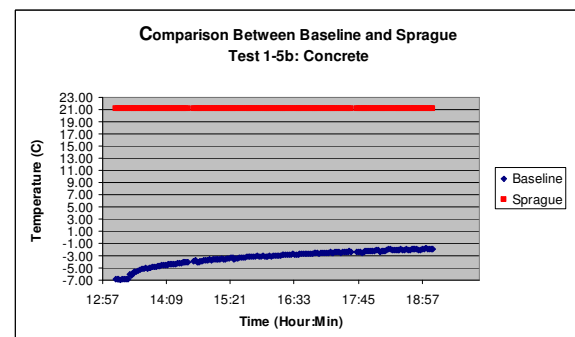
The Lufft and Boschung sensors most closely followed their respective baselines with mean absolute errors less than 1.0° C. The SSI and Point Six sensors reported mean absolute errors less than 2.1° C. The Vaisala reported mean absolute errors of 3.4 and 1.2° C on the asphalt and concrete tests respectively. The Aanderaa reported mean absolute errors less than 3.4° C. The Control Products sensor reported a mean absolute error of 0.6° C on the concrete test and a 2.8° C mean absolute error on the asphalt test. On asphalt, the Sprague sensor had a mean error of 1.15° C. However, the Sprague had a malfunction during the concrete test, reporting a constant reading of 21.1° C (70° F). The cause of the Sprague malfunction is unknown, but it is possible that the sensor was erroneously reporting the ambient temperature from hours earlier; the 21° C reading corresponds to the temperature at which the sensor was stored at prior to the testing. The following graphs show Sprague data on asphalt and concrete.

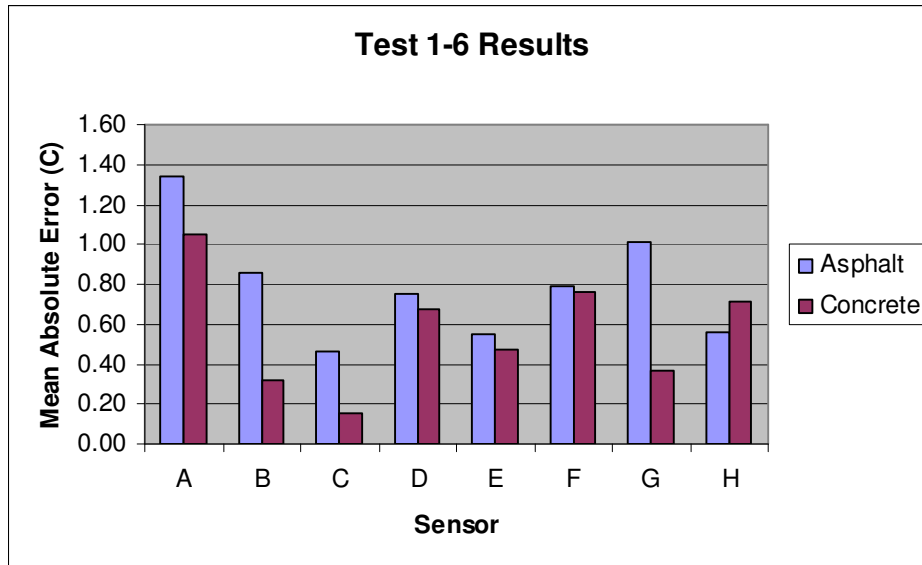
This test was conducted to determine the effects of the situation where recently fallen snow melts when it contacts the pavement. The initial stabilized pavement temperature was 4.6° C. After the application of snow, the pavement underwent a rapid temperature drop, and the pavement stabilized at 0° C. The baseline sensors reported the duration of this 4.6° C temperature drop to be less than two minutes.
