# **Long-Term Performance of Overlays: Thin Epoxy Overlay versus Traditional Rigid Overlay**

**Final Report  
February 2020**

**IOWA STATE UNIVERSITY**  
**Institute for Transportation**

**Sponsored by**  
Iowa Department of Transportation  
(InTrans Project 17-627)

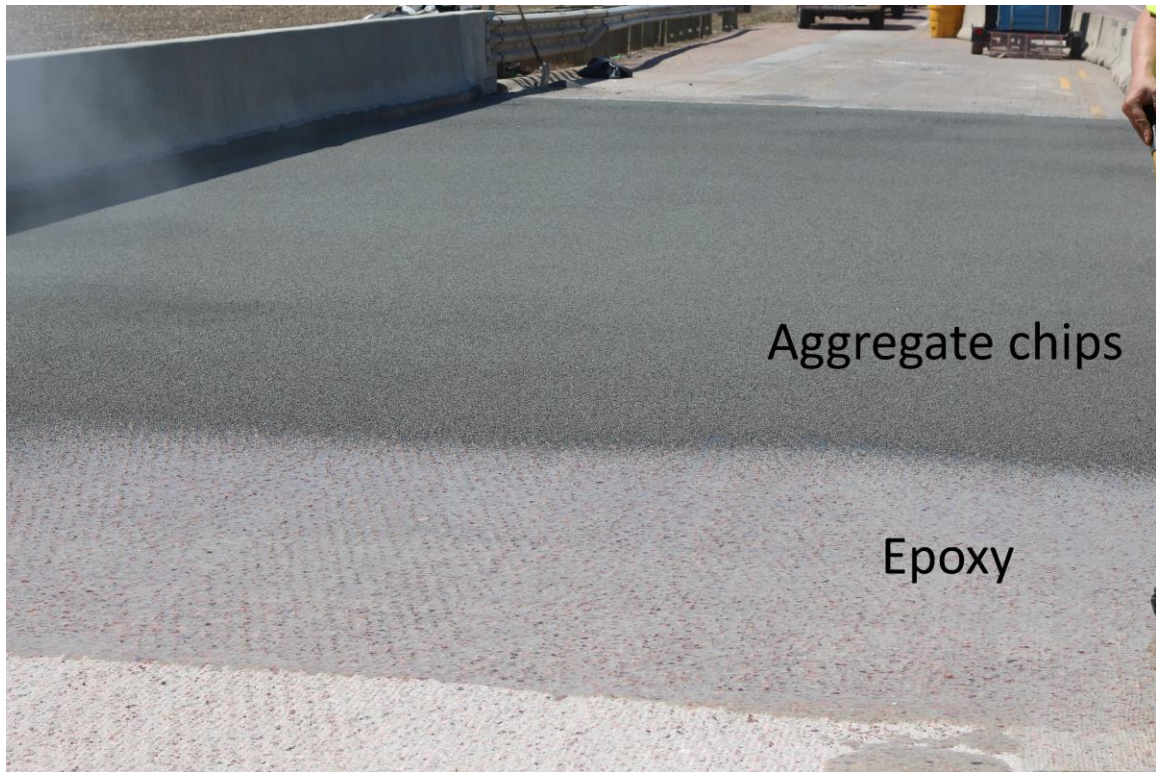
**Figure 1. First coating of epoxy overlay**

The epoxy overlay studied in this project is a thin-bonded epoxy overlay. To apply this type of overlay, a layer consisting of a hot, freshly mixed epoxy coat is first spread on the milled concrete surface, immediately followed by a layer of broadcast aggregate chips. A single coat typically results in a thickness of 0.125 in., and a double-coat system was applied for this project, which resulted in a thickness of 0.375 in. Figure 1 shows the first coating.

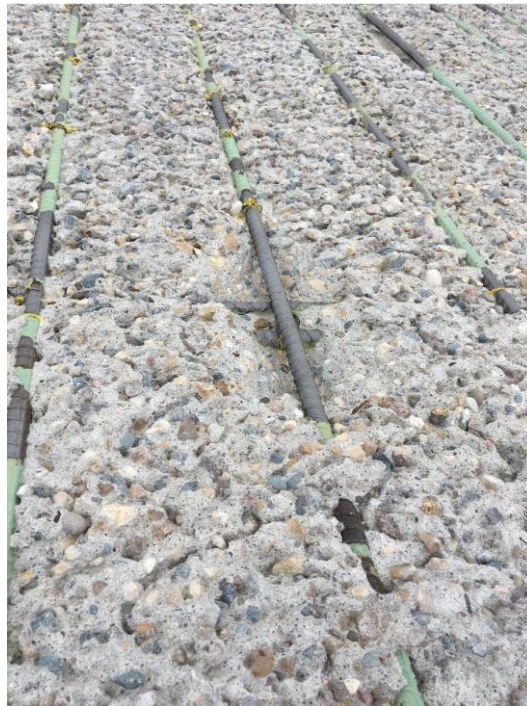
**Figure 4. Substrate surface conditions for Site C1**

Field investigations of Site C1 were conducted prior to overlay application on May 22, 2018 and June 13, 2018. Photos and measurements were taken to document the substrate surface condition of the deck. An average of 1.75 in. of the original deck was removed by hydro-demolition, though some areas of degraded concrete were further removed. Figure 3 shows the depth of removal achieved prior to the overlay placement, and Figure 4 illustrates the surface roughness achieved.

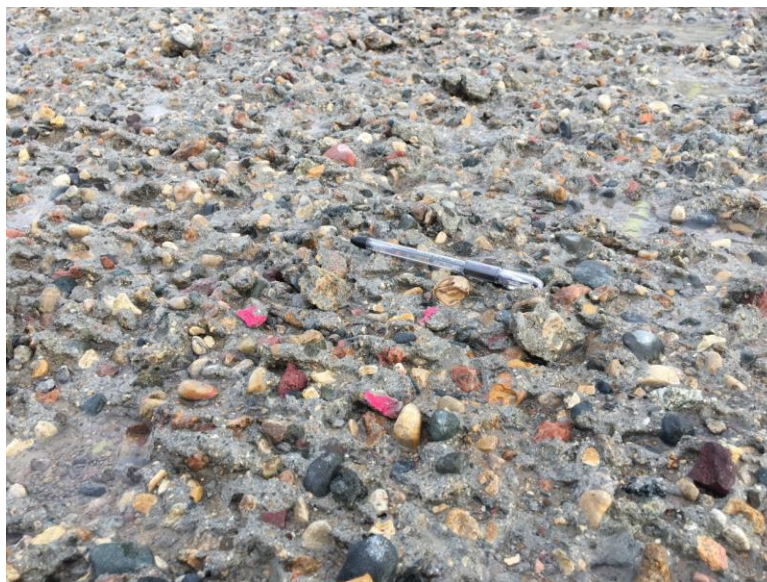
**Figure 8. Substrate surface conditions for Site C3**

of the deck. An average of 1.75 in. of the original deck was removed by hydro-demolition, though some areas of degraded concrete were further removed. Figure 7 shows the depth of removal achieved prior to the overlay placement, and Figure 8 illustrates the surface roughness achieved.

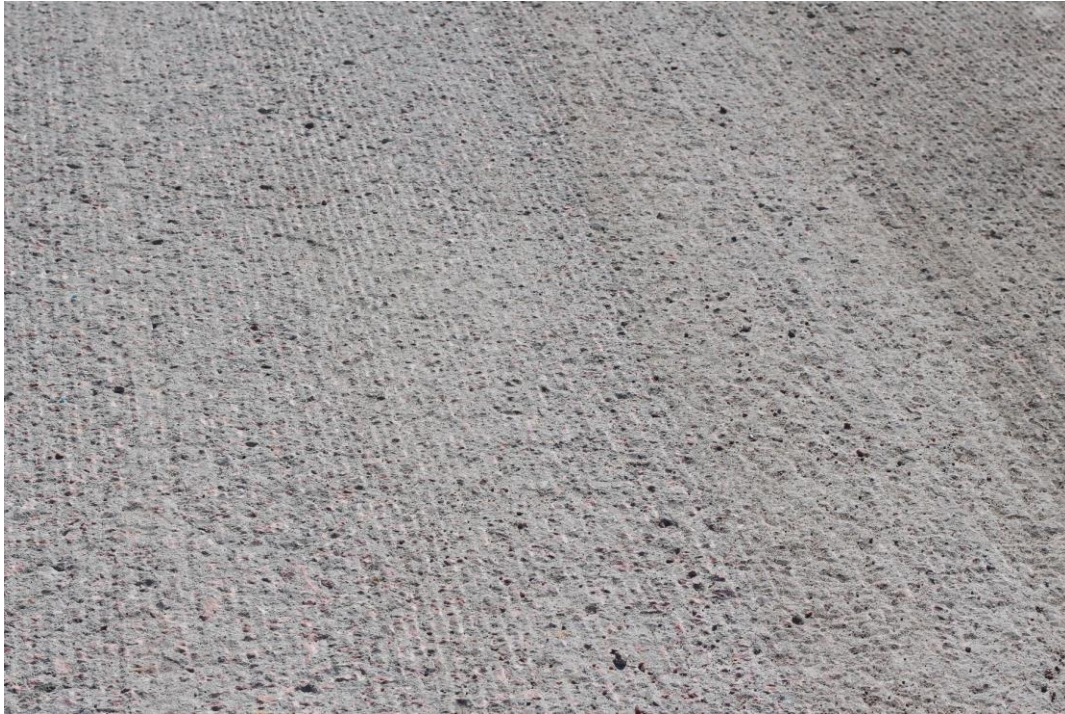
**Figure 12. Substrate surface conditions for Site E3**

Field investigations of Site E3 were conducted prior to overlay application on April 23, 2018. Photos and measurements were taken to document the substrate surface condition of the deck. An average of 1.75 in. of the original deck was removed by milling. Figure 11 shows the depth of removal achieved prior to the overlay placement, and Figure 12 illustrates the surface roughness achieved.

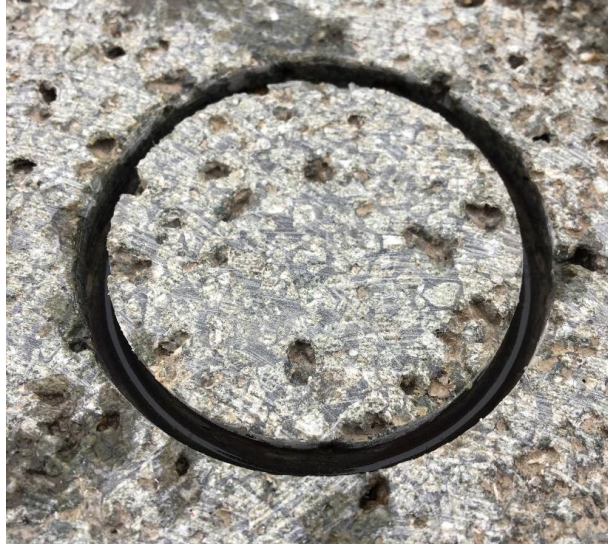
**Figure 13. One of the circular cuts at Site C2**

The procedure for testing involves cutting through the overlay and substrate layers with a circular drill (Figure 13), attaching a steel disk to the overlay surface using epoxy, and then pulling on this surface with a tensile force (Figure 14) once proper adhesion is achieved.

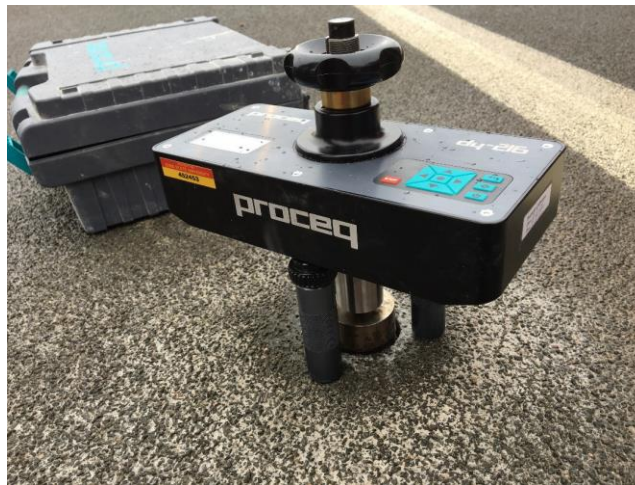
**Figure 14. Pull-off test mounting device**

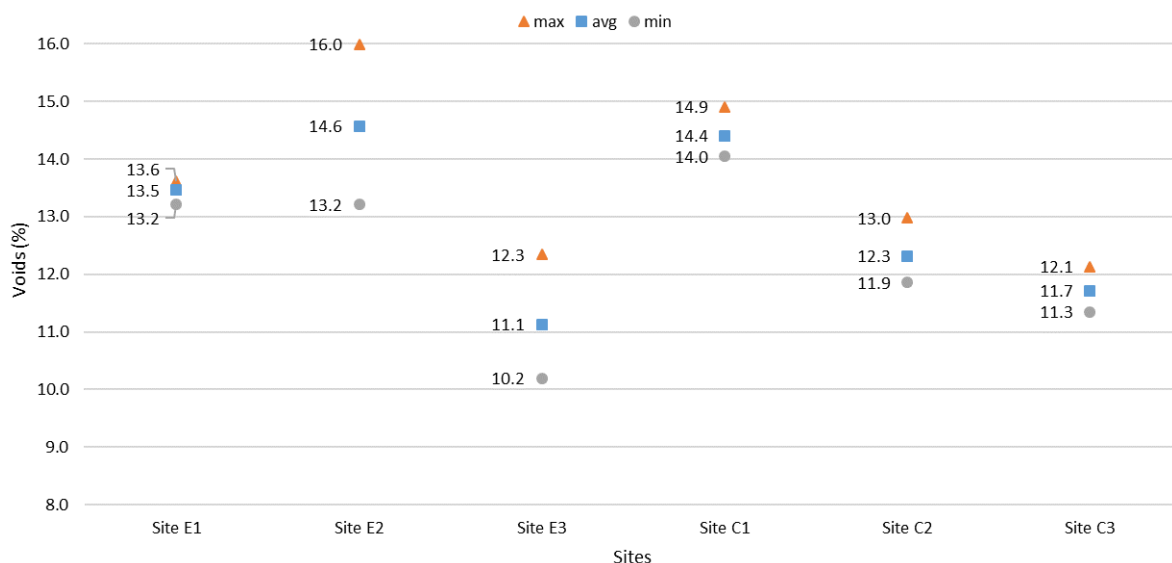
**Figure 18. Porosity test results for the substrate cores of the six bridges**

ASTM C642, Standard Test Method for Density, Absorption, and Voids in Hardened Concrete, was performed on the 18 cores, and the results are shown in Figure 18.

It can be observed that the cores from Site E3 generally have the smallest percentage of voids, possibly due to the bridge's short service age, while the cores from Sites E2 and C1 have the largest percentage of voids, which might lead to poor freeze-thaw durability. There is a significant amount of scatter in the results for Sites E2 and E3, which might be due to a random sampling error.

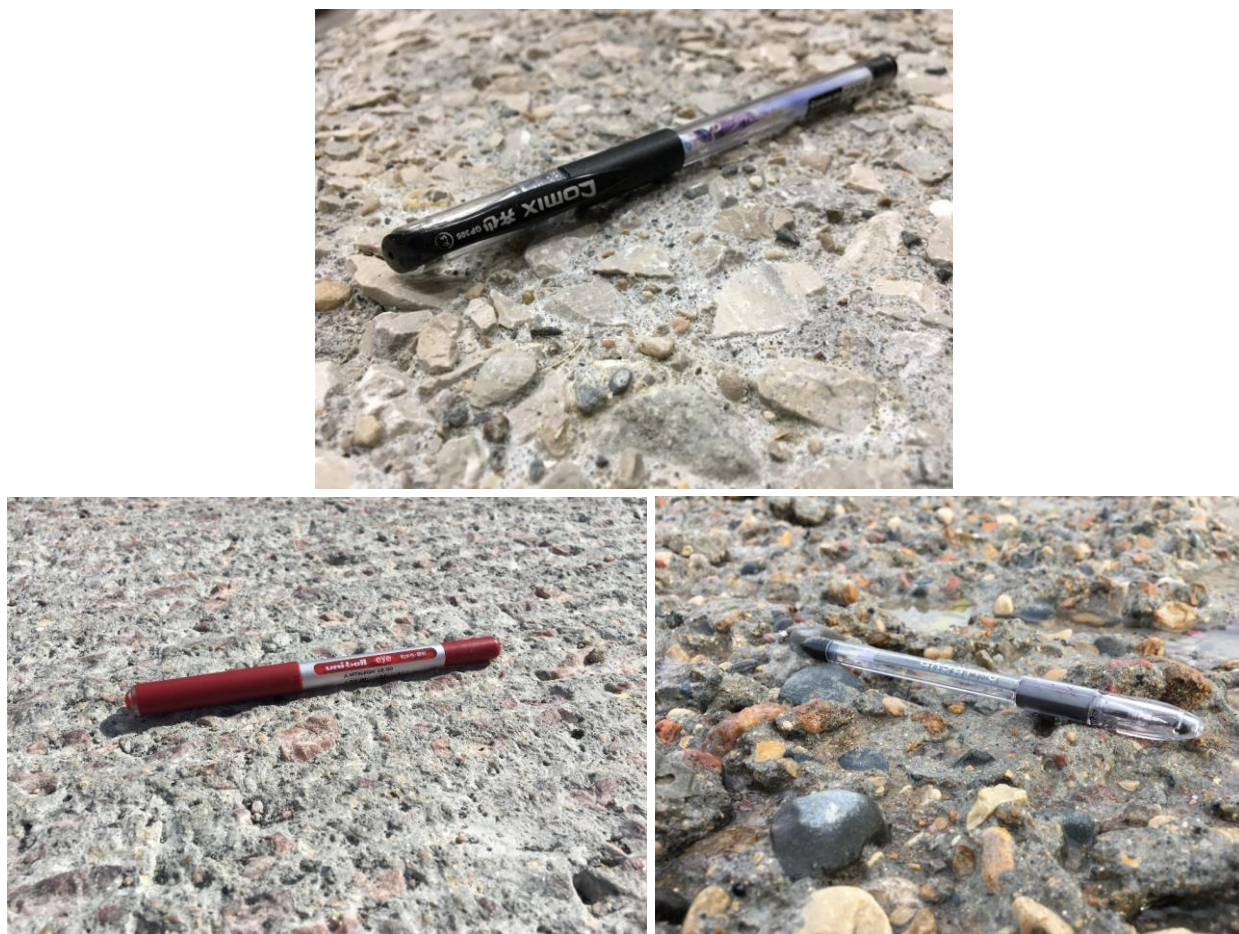
**Figure 23. Textures of the laboratory substrate slabs (top) and bridge deck substrates after milling (bottom left) and hydro-demolition (bottom right)**

The bottoms of the molds were first painted with formwork retarder to prevent the bottom surfaces of the slabs from curing. After seven days of moist curing, the slabs were demolded, and the uncured mortar on the bottom surfaces of the slabs was washed and brushed away with a steel brush to expose part of the aggregates and thereby mimic the surface roughness of the substrates of the bridge decks, which were rough as a result of milling. After moist curing the substrate slabs in the laboratory for another 21 days, the surface roughness of the substrate slabs was assessed. The concrete surface profile (CSP) number of the substrate slabs was seven, which was similar to that resulting from milling the bridge deck substrates. For comparison purposes, the textures of the laboratory substrate slabs and the bridge deck substrates treated by milling and hydro-demolition are shown in Figure 23.

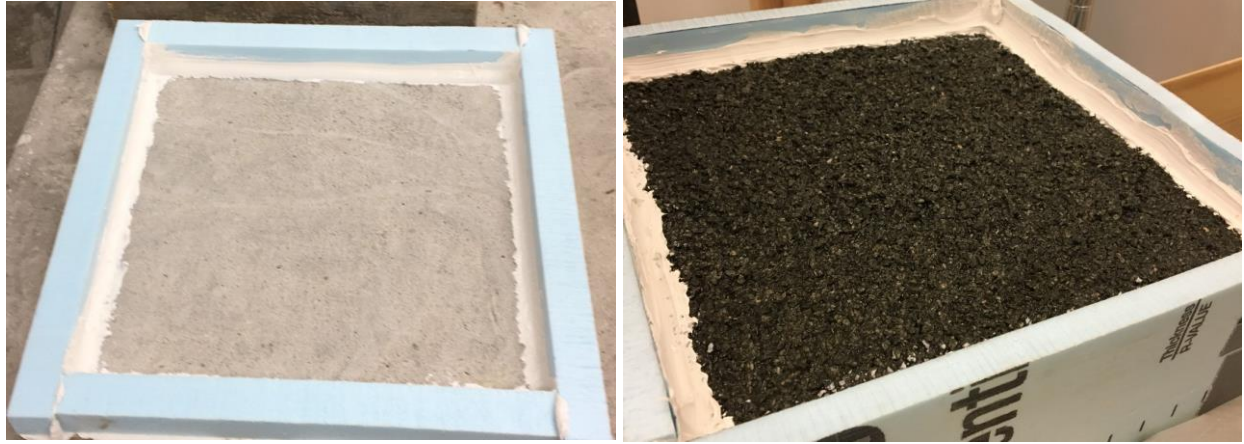
**Figure 24. Surface conditions of the concrete-overlaid (left) and epoxy-overlaid (right) slabs**

The overlays were then applied to the substrate slabs in the field using the same materials as those used for the actual bridge deck overlays. For the concrete-overlaid slabs, the surface was covered with wet cloth and plastic sheeting for seven days before the slabs were retrieved from the field and demolded. The slabs were kept outdoors and cured for another 21 days before testing again to simulate field conditions. For the epoxy-overlaid slabs, the slabs were cured for more than 24 hours before testing. The surfaces of the concrete-overlaid and epoxy-overlaid slabs are shown in Figure 24.

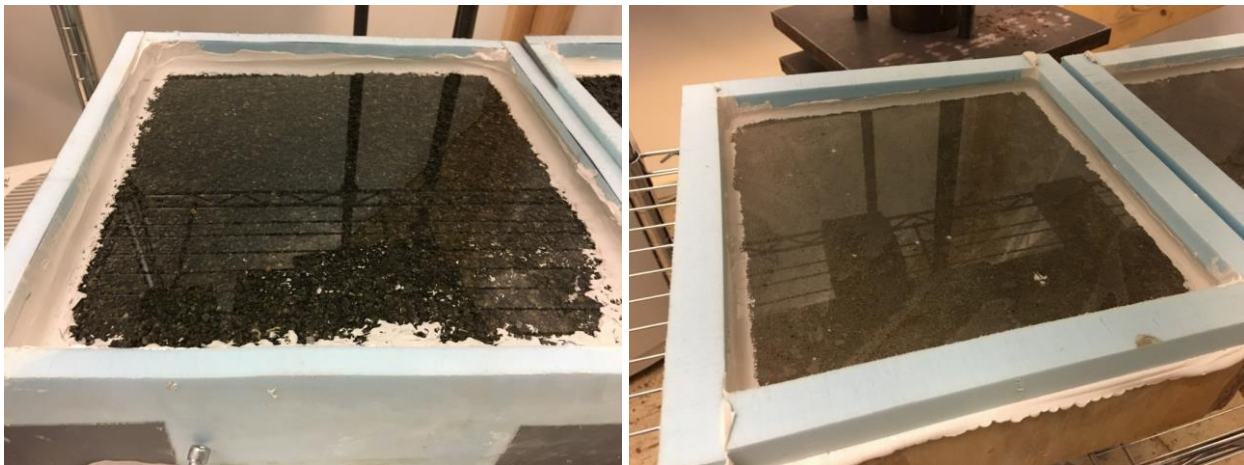
**Figure 25. Two slabs during ponding: an epoxy-overlaid slab (left) and a concrete-overlaid slab (right)**

The salt ponding test was employed to compare the chloride permeability of the epoxy and concrete overlays. In accordance with AASHTO T 259, two of the concrete-overlaid slabs and two of the epoxy-overlaid slabs prepared earlier were ponded for 90 days. Figure 25 shows the slabs during ponding.

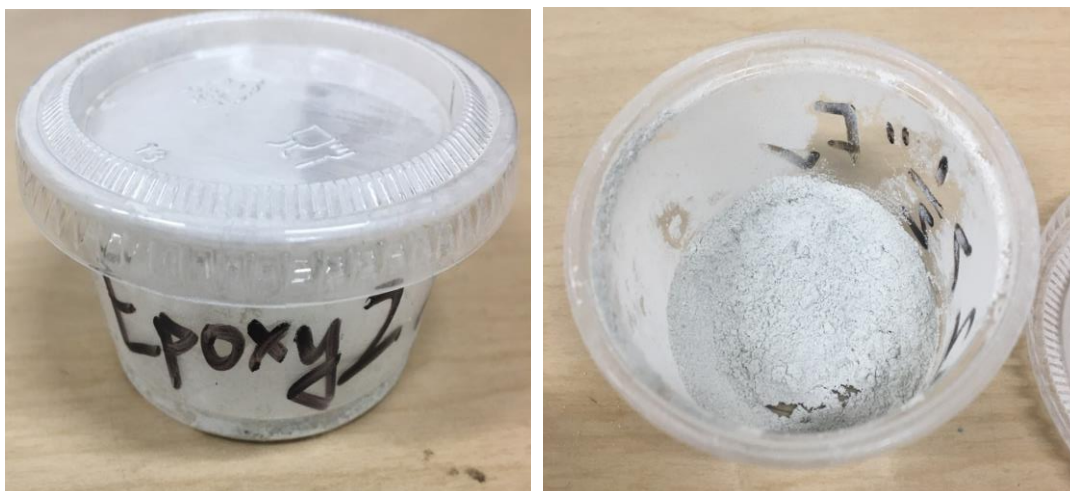
**Figure 26. Powdered sample from one of the epoxy-overlaid slabs**

After ponding, chloride determination was conducted in accordance with AASHTO T 260. Samples were extracted from four depths, namely, 1/8 in., 3/8 in., 5/8 in., and 7/8 in., to provide a profile of chloride concentration for each slab. Figure 26 shows one of the powdered samples, and Figure 27 briefly illustrates the procedures for chloride determination.

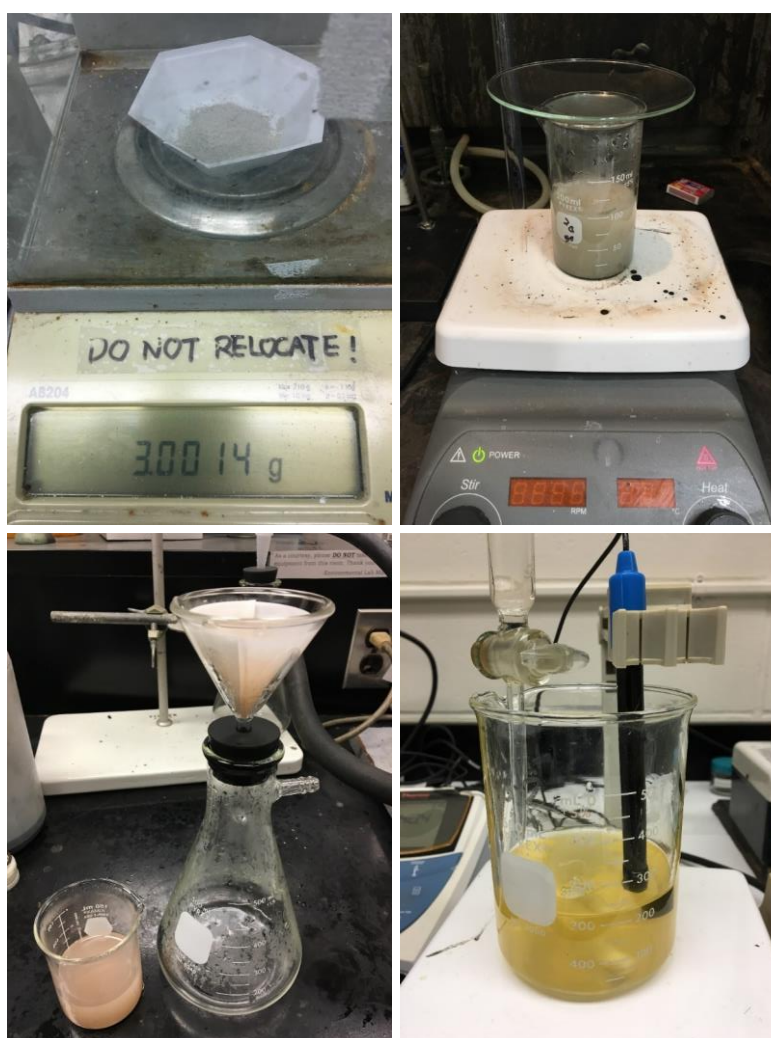
**Figure 27. Chloride content determination process: weighing (upper left), boiling (upper right), filtration (bottom left), titration (bottom right)**

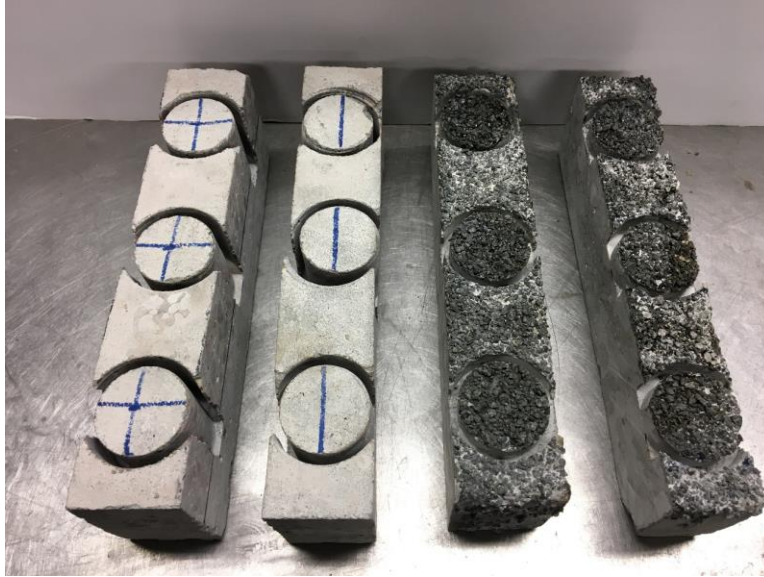
**Figure 29. Concrete-overlaid (left) and epoxy-overlaid (right) beams for pull-off test**

To determine the effect of freeze-thaw cycles on bond performance, additional laboratory tests were performed on the four remaining overlay slabs. The slabs were cut into a total of 12 beams with dimensions of 12 by 3 by 3.5 in. The beams were divided into three groups, with each group consisting of two epoxy-overlaid beams and two concrete-overlaid beams. The three groups of beams were subjected to cyclic freeze-thaw conditions and were tested using the direct pull-off test when they had been through 0, 100, and 300 freezing-thawing cycles, respectively. The direct pull-off strength test followed ASTM C1583, which evaluates the tensile strength of the bond between the concrete substrate and the surface repair material. Examples of the epoxy-overlaid and concrete-overlaid beams are shown in Figure 29.

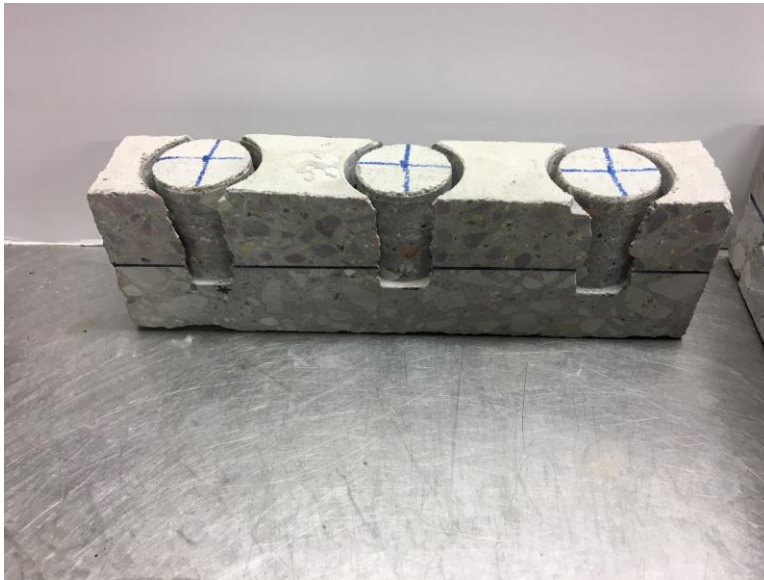
**Figure 30. Concrete-overlaid beam with two-inch circular cuts**

Each of the beams was cut with a two-inch core drill bit, which penetrated through the entire depth of the overlay and 0.75 in. into the substrate, as shown in Figure 30.

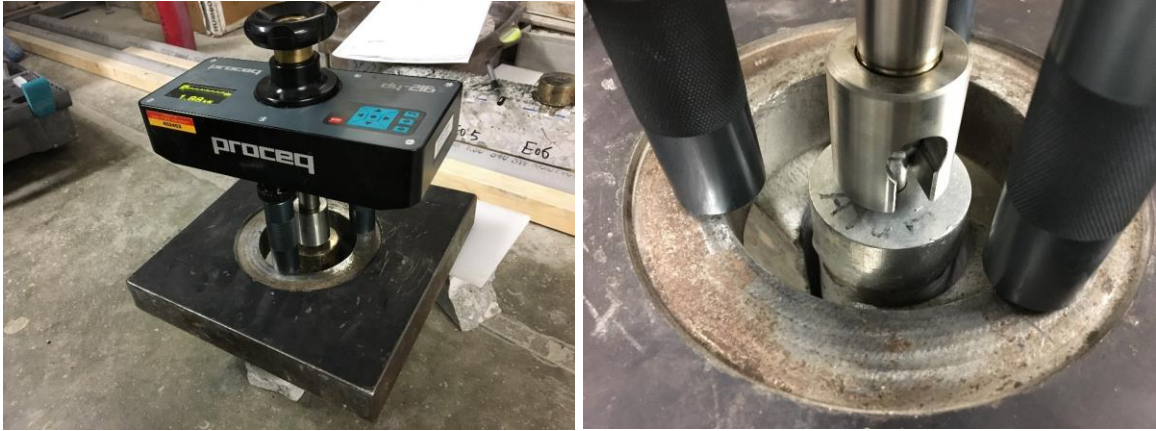
**Figure 31. Pull-off test mounting device (Proceq DY-216, left) and the details of the mounting (right)**

The same pull-off test procedure that was used in the field was followed, as shown in Figure 31. Since the beams were too narrow for the mounting device to stand on, a steel plate with a hole in the center was placed on the beam being tested so that the device could stand and be mounted steadily.

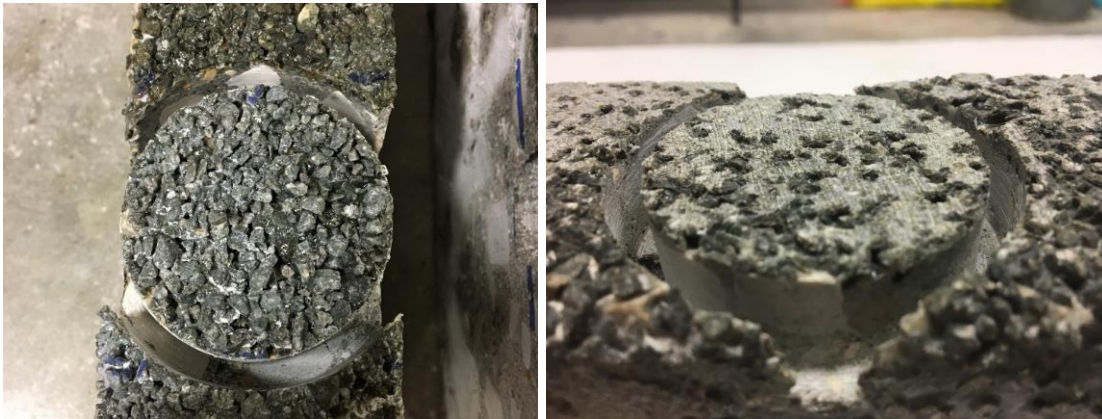
**Figure 32. Top surface of the epoxy-overlaid beams for the pull-off test before grinding (left) and after grinding (right)**

Since the aggregates associated with the epoxy overlay created a rough surface that was not suitable for the application of the two-part adhesive epoxy, the top surface of the epoxy-overlaid beams were slightly ground with a grinder. The surface before and after grinding is shown in Figure 32.

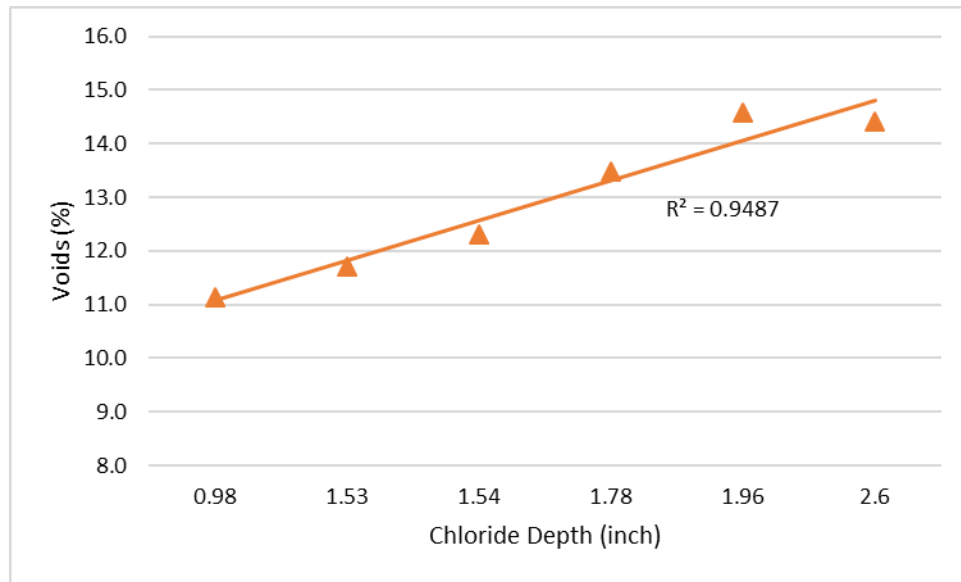
**Figure 36. Relationship between percentage of air voids and critical chloride content depth**

Figure 36 shows that the R-squared value of the fitted line and the data points for the percentage of air voids and the critical chloride content depth is 0.9487. This indicates that there is a strong linear relationship between the percentage of air voids in concrete and chloride resistance.

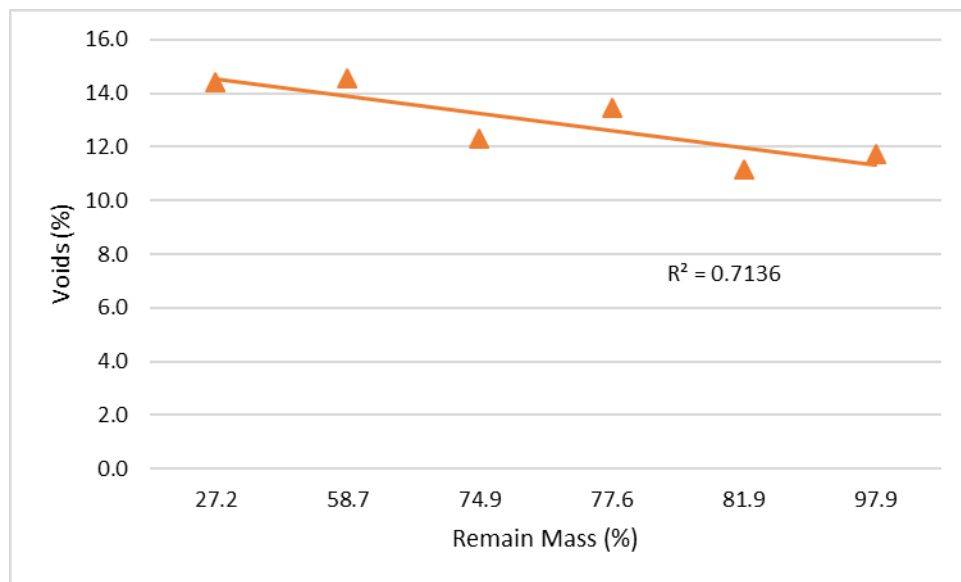
**Figure 37. Relationship between percentage of air voids and remaining mass**

The remaining mass after 510 freeze-thaw cycles measured by the freeze-thaw test reflects the durability of the concrete to freezing and thawing conditions. Figure 37 shows that the R-squared value of the fitted line and the data points for the percentage of air voids and the remaining mass is 0.7136, which indicates that the percentage of air voids in concrete has a linear relationship with durability to freezing and thawing cycles.

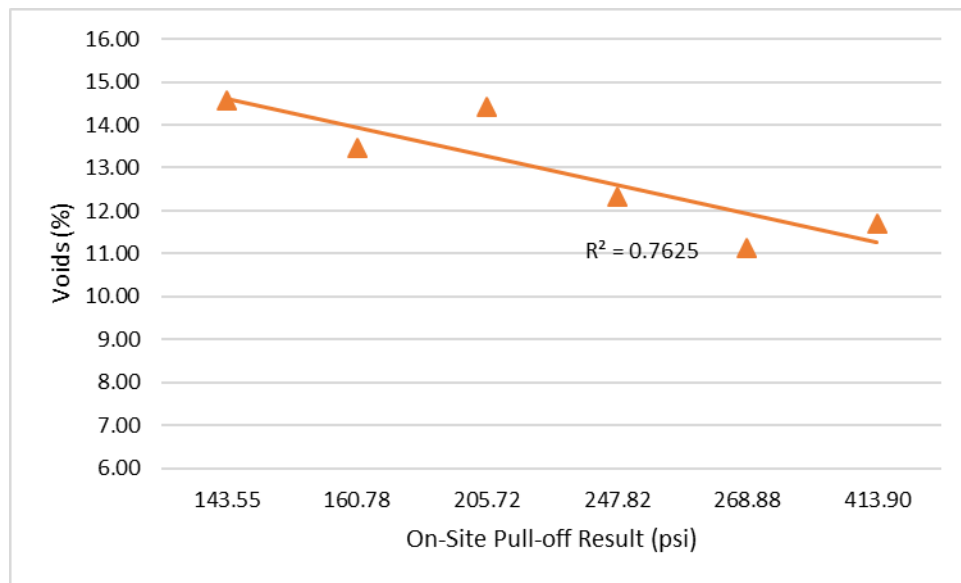
**Figure 38. Relationship between percentage of air voids and on-site pull-off test results**

relationship between the percentage of air voids in the substrate and the substrate's integrity, in that the pull-off test results reflect the integrity of the substrate.

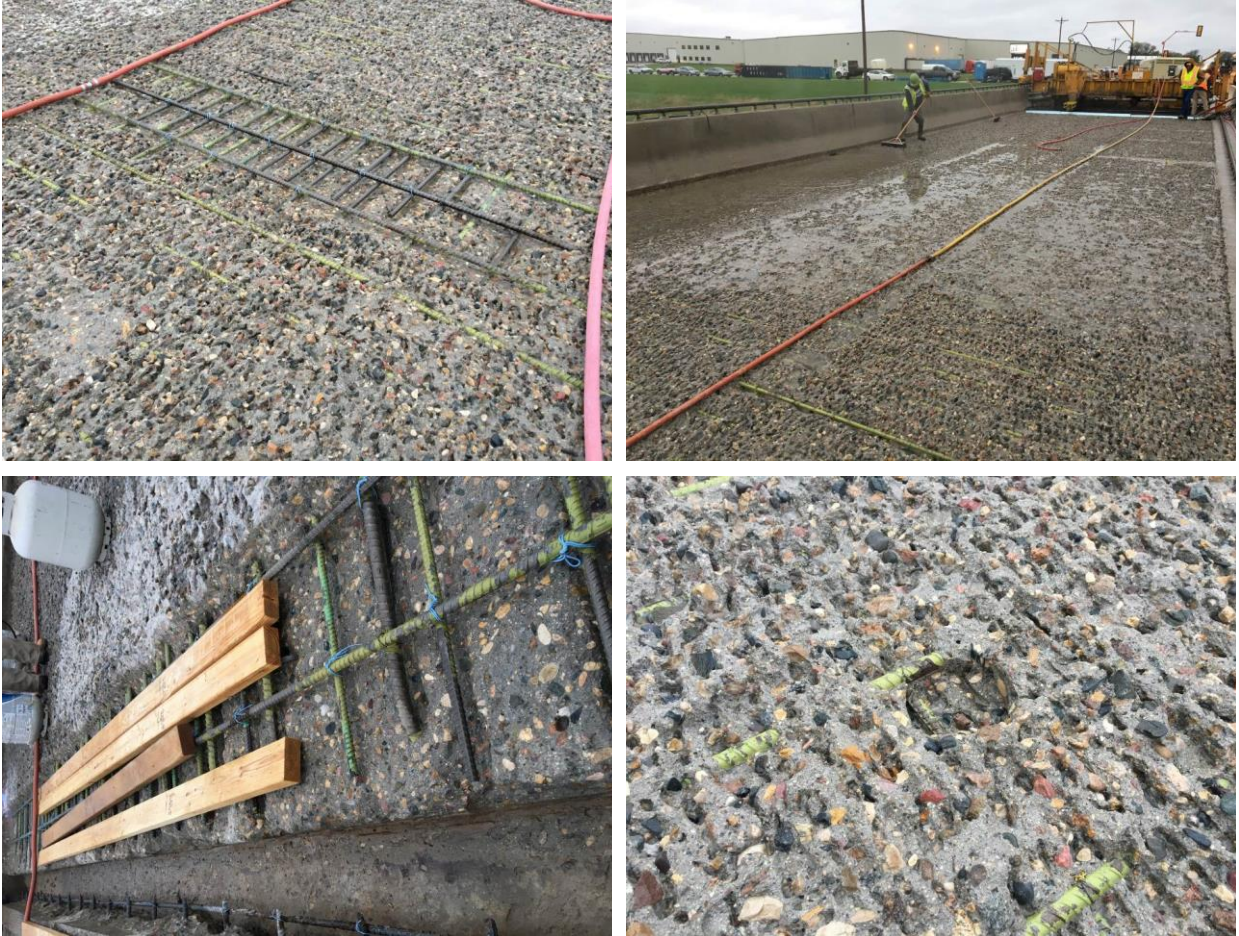
**Figure 45. Surface condition of bridge deck of Site C3 prior to overlay**

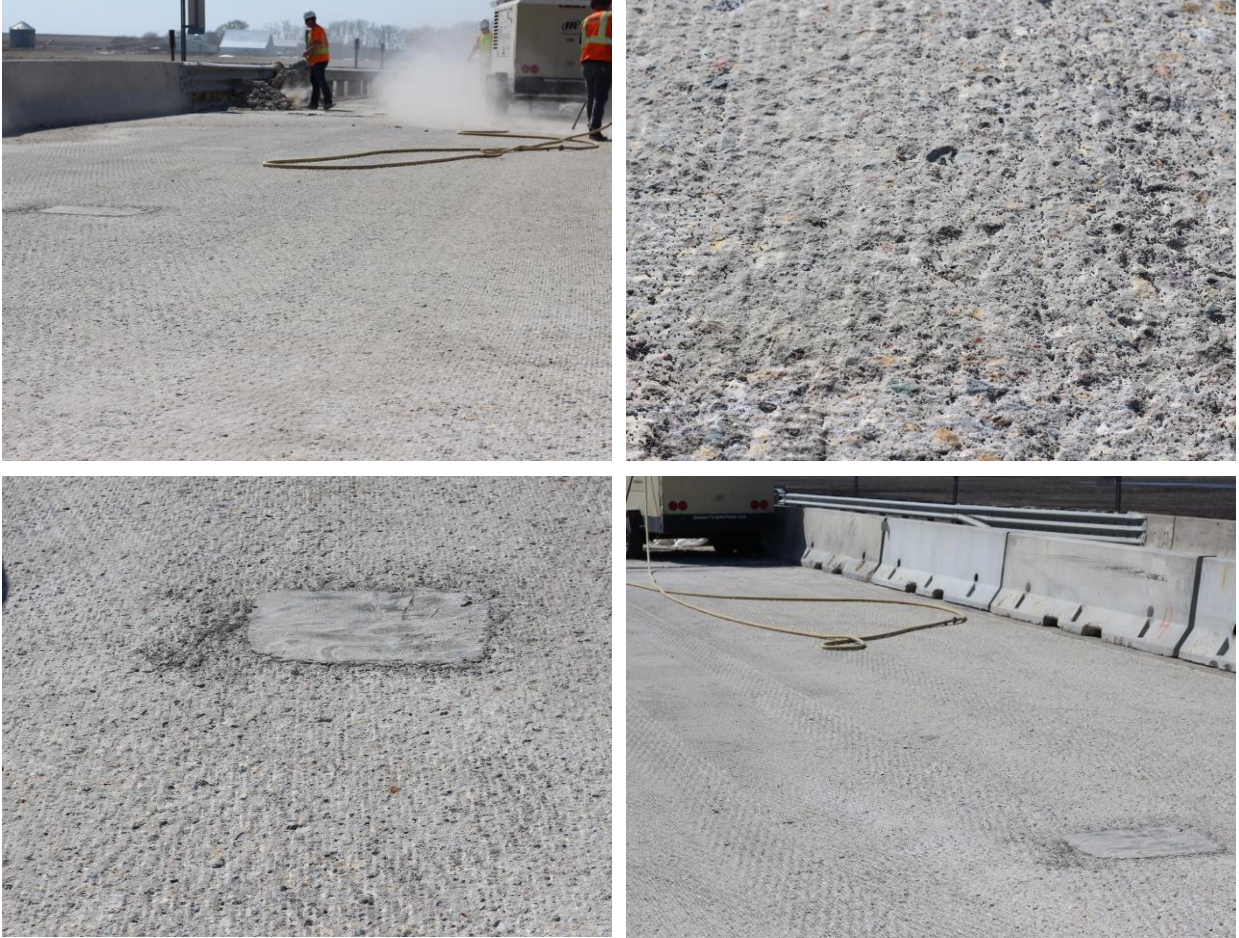
**Figure 46. Surface condition of bridge deck of Site E1 prior to overlay**

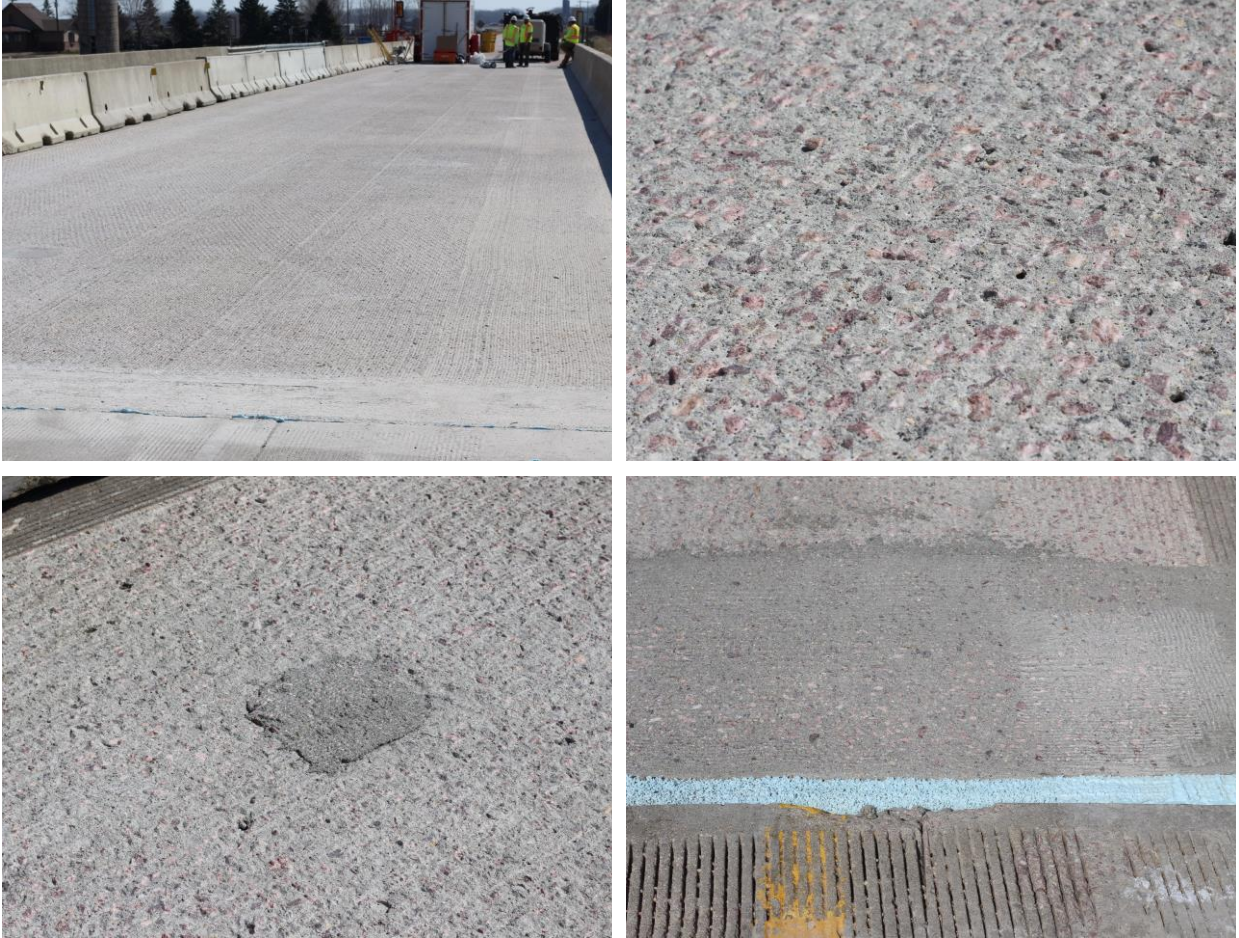
**Figure 47. Surface condition of bridge deck of Site E3 prior to overlay**
