Performance of Thin Roller Compacted Concrete Pavement under Accelerated Loading

Moving Advancements into Practice (MAP) Briefs describe innovative research and promising technologies that can be used now to enhance concrete paving practices. The May 2016 MAP Brief provides information relevant to Track 8 of the CP Road Map: Concrete Pavement Construction, Reconstruction, and Overlays.

### **MAP Brief May 2016**

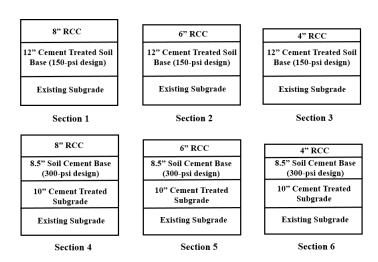
Figure 4. Test sections as designed

To meet the objectives, six test sections were constructed (figure 4). Two base designs were utilized: a 150 psi unconfined compressive strength (UCS) cement treated soil base with a thickness of 12 in. (sections 1, 2, and 3) and a 300 psi UCS soil cement base with a thickness of 8.5 in. over a 10-in. cement-treated subgrade (sections 4, 5, and 6). The 10-in. cement-treated subgrade contains a cement content of about 4%, or just enough to provide a dried stable working platform on which to build the stronger base. Over each base, a 4-, 6-, and 8-in. RCC pavement section was constructed. The RCC mix consisted of a well-graded aggregate blend using #67 limestone and manufactured sand with a Type I Portland cement of 11.4% and optimum moisture content of 6.5%. Each section is about 72 ft long and 13 ft wide. The finished lanes are shown in figure 5.

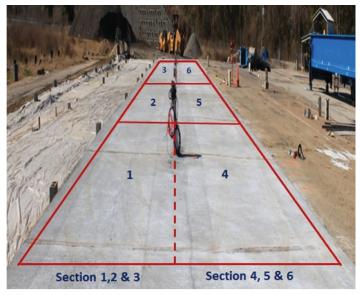
Figure 5. Test sections as constructed

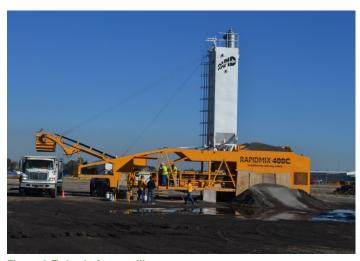
Figure 6. Twin shaft pugmill

All RCC layers were constructed in one day on two separated test lanes, each 215 feet long and 13 feet wide. RCC production was accomplished using a twin shaft pugmill operation on the paving site (figure 6). A high density asphalt paver was used to place the RCC and achieve initial density (figure 7). A 10-ton steel drum roller was used for final compaction of the RCC pavement structure.

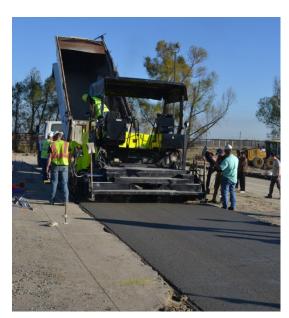
Figure 7. High density asphalt paver

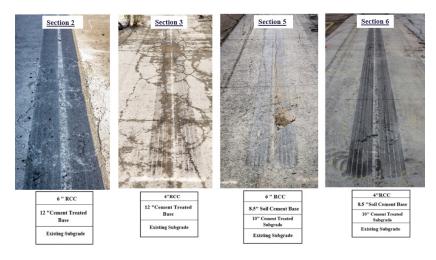
Figure 9. Failed RCC sections

Table 1 presents the ATLaS30 loading passes with various load magnitudes applied on each of the RCC test sections tested in the center of the lanes. Four RCC sections (sections 2, 3, 5, and 6) were successfully loaded to a cracking failure in the end; whereas, testing of the two 8-in. RCC sections (sections 1 and 4) was discontinued after a limited number of loading cycles due to the projected time it will take to fail the sections. Figure 9 shows the final pavement surfaces of the four failed RCC sections.

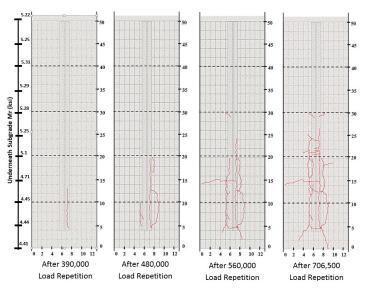
Figure 10. Cracks vs. load repetitions for Section 6

Figure 10 shows the cracking development of section 6 (4-in. RCC over 8.5-in. soil cement test section). As seen in Figure 10, a hairline longitudinal surface crack was first noticed along a centerline of the right tire print after 390,000 ATLaS30 wheel load repetitions (approximately 8 million ESALs). It was observed that fine materials (possibly from the soil cement base) were pumped out through the crack opening and some saw-cut joints when loading under a wet weather condition.

The first longitudinal crack initiated inside of one tire print seems to be due to high tensile stresses at the bottom of the thin (4-in.) RCC slab. Under the continuously wheel trafficking, the longitudinal crack started to extend and propagate resulting in more pumping-out of materials onto the pavement surface. After about 480,000 load repetitions (approximately 16 million ESALs) additional longitudinal cracks developed along the outsides of tire-print paths.

The inside and outside longitudinal cracks were gradually extended and connected to each other and finally more than 50% of the loading area developed a significant surface cracking failure at the end of 706,500 load repetitions (approximately 19.2 million ESALs). A spalling/punch-out type failure was noticed at the end of testing (figure 9). It is interesting to note that the observed cracking failure on this section was largely confined to one-half of the whole loading area. This may be attribute to a relatively weaker subgrade support when referred to the subgrade moduli plotted on the left vertical axis of figure 10.

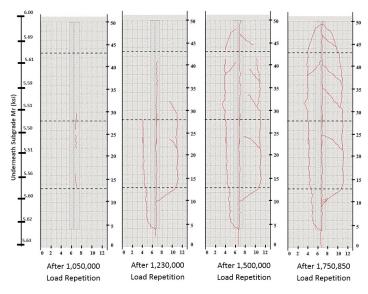
Figure 11. Cracks vs. load repetitions for Section 5

Figure 11 shows the cracking development observed on section 5 (6-in. RCC over 8.5-in. soil cement test section). Similar to section 6, the development of surface cracking started in a longitudinal direction and the longitudinal cracks became noticeable after 1,050,000 load repetitions (approximately 23.4 million ESALs). Under the continuous ALTLaS30 wheel loading, the first group of longitudinal cracks extended and merged into a major longitudinal crack closely located at one edge of the right tire print after 1,230,000 load repetitions (approximately 34.6 million ESALs).

Meanwhile, two other longitudinal cracks outside from the tire prints were also developed. The longitudinal cracks gradually propagated and merged into each other diagonally under loading, and eventually resulted in a significant surface cracking failure after 1,750,850 load repetitions (approximately 87.4 million ESALs). The final cracking pattern was found much wider in section 5 than that in section 6, presumably due to the better load spreading of the thicker RCC slab used on this section.
