Fatigue Evaluation of Reinforced and Unreinforced Hand Holes in High-Mast Lighting Towers

**Final Report
September 2021**

IOWA STATE UNIVERSITY
Institute for Transportation

Sponsored by
Iowa Department of Transportation
(InTrans Project 17-597)

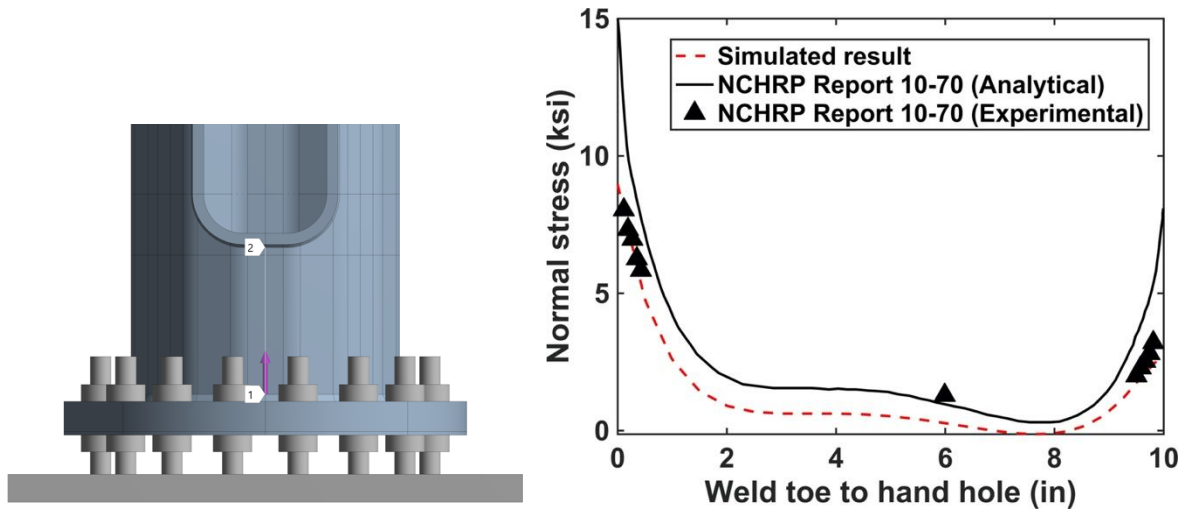
Figure 2.4. Stress response from the weld toe of the base-to-tube connection to the hand hole

Figure 2.4 shows the 11 data points measured by the strain gauges during a static test in Roy et al. (2011), and the simulated stress response of Specimen C from the weld toe of the base-to-tube connection to the hand hole.

The simulated stress response showed strong agreement with the readings from the strain gauges, which indicated that the finite element model was accurately designed and the mesh quality around the location of interests was good enough.

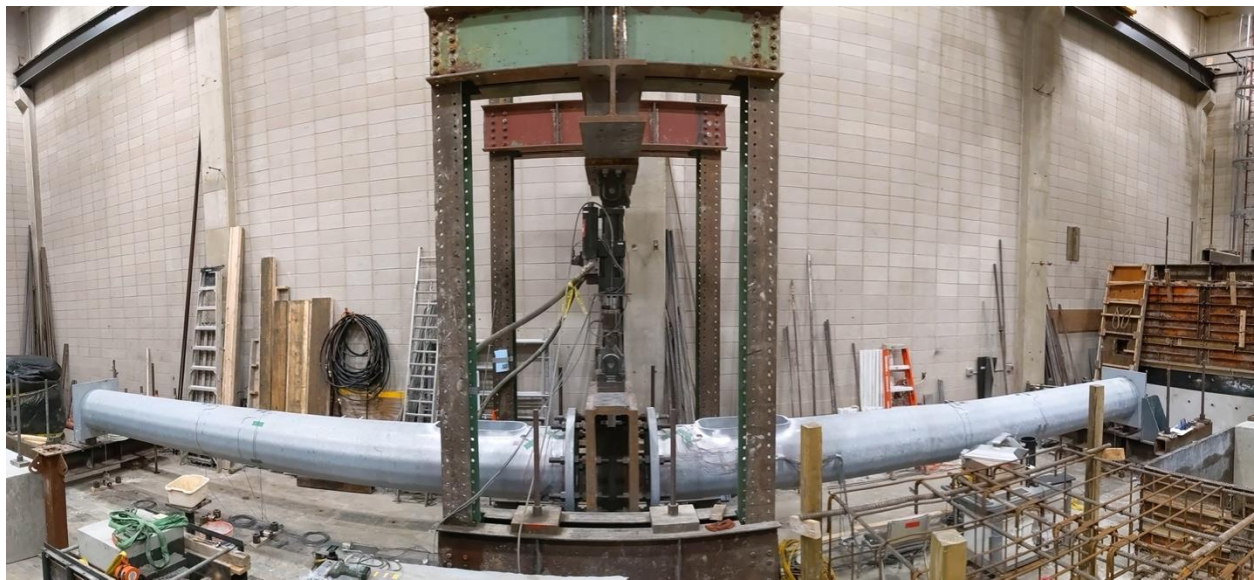
Figure 3.1. Fatigue experiment setup (bottom) and model (top)

Two test specimens were connected to a loading box, and two ends of the setup were designed as cylinder supports. An actuator was attached to the top of the loading box to provide the fatigue load and create fatigue stress cycles at the base of both specimens. Figure 3.1 shows the model and a photograph of the entire fatigue experiment setup, and Figure 3.2 provides photographs of the details.

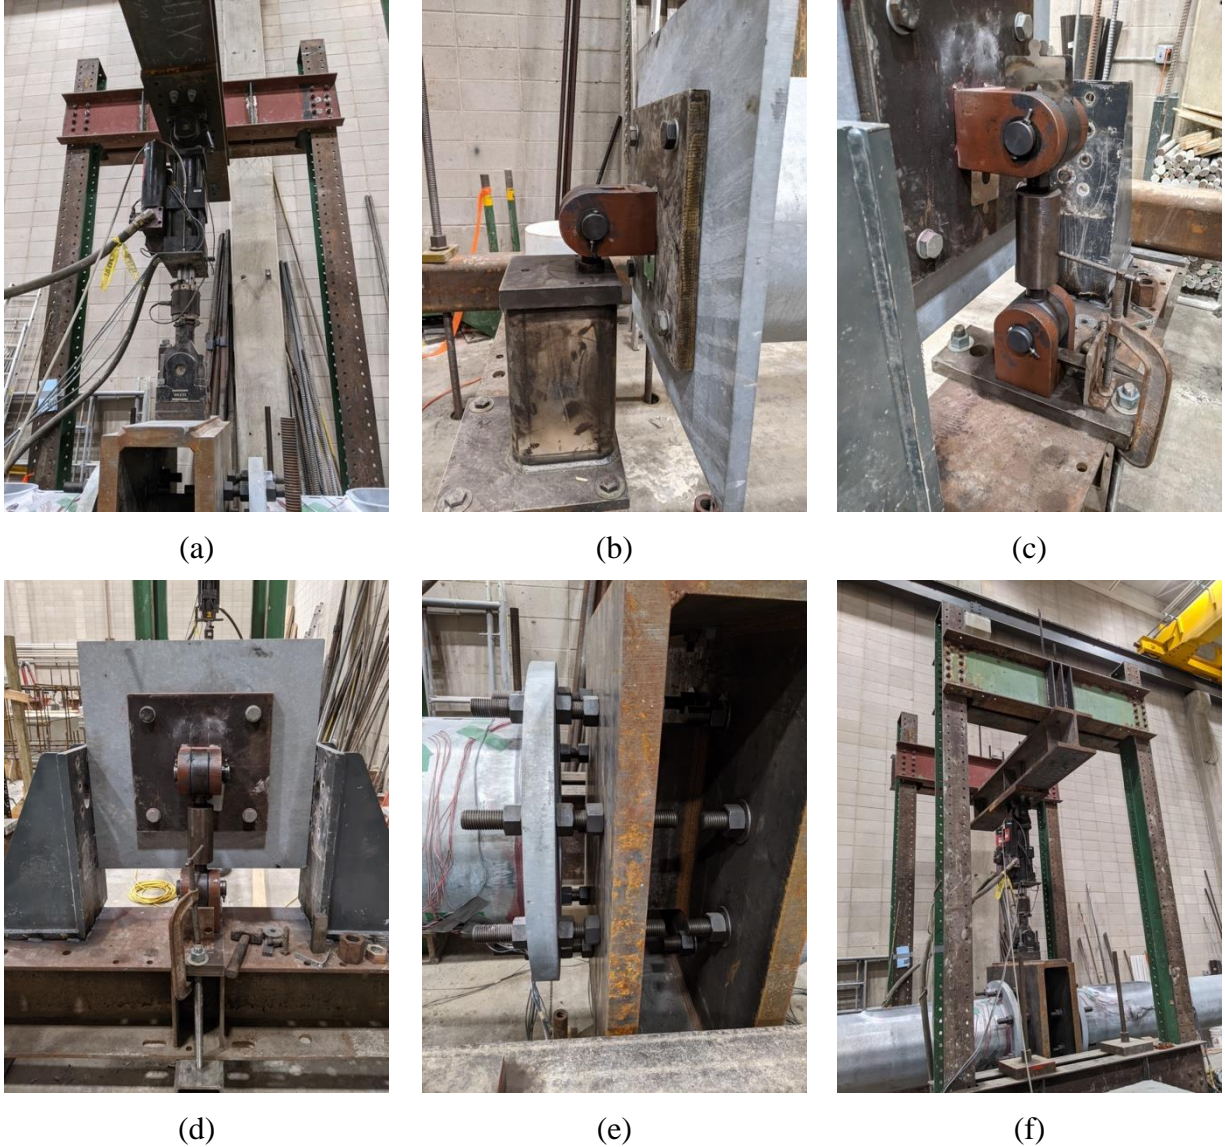
Figure 3.2. Fatigue experiment setup details

The actuator, Figure 3.2 (a), was installed on a steel frame, Figure 3.2 (f), and connected with the top plate of the loading box. It is capable of both displacement and load control. The load cell of the actuator used MTS Model 661, for which the maximum capacity is 55 kips.

Nuts and washers were placed on both sides of the side plates of the loading box and both sides of the base plate of the test specimens. According to the Iowa DOT, the minimum torque requirement for a Grade 105 1.75 in. anchor bolt is 796 ft-lb. A hydraulic wrench was used to tighten the nuts to meet the required torque.

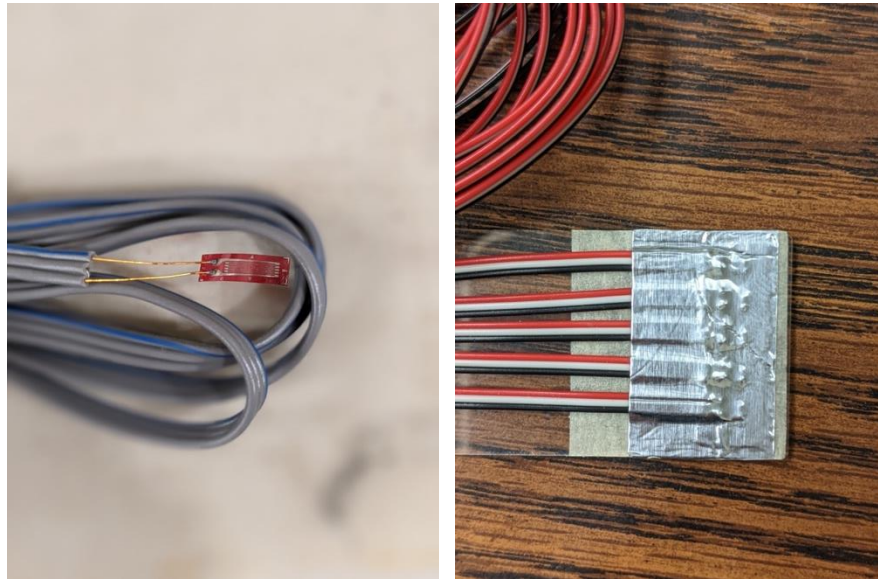
Figure 3.4. Axial gauge (left) and gradient gauge (right)

Two types of strain gauges were used: axial gauge and gradient gauge (see Figure 3.4).

An axial gauge can measure the surface strain in one direction and returns only one strain value. A gradient gauge contains five axial gauges. It also measures the surface strain in one direction but is able to return five strain values along one direction, which gives more information about a location of interest.

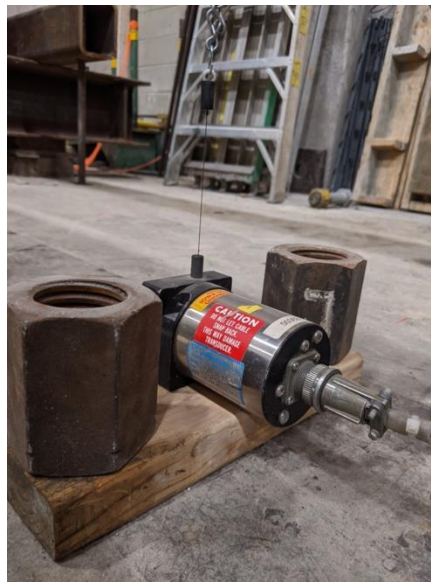
Figure 3.8. Displacement sensor

The research team chose to use the HX-PA-10-NJC from UniMeasure for displacement sensors. The measurement range of this sensor is 10 in. Displacement sensors were screwed to a wood brick, and two weights were placed on the wood brick to make it steady (see Figure 3.8).

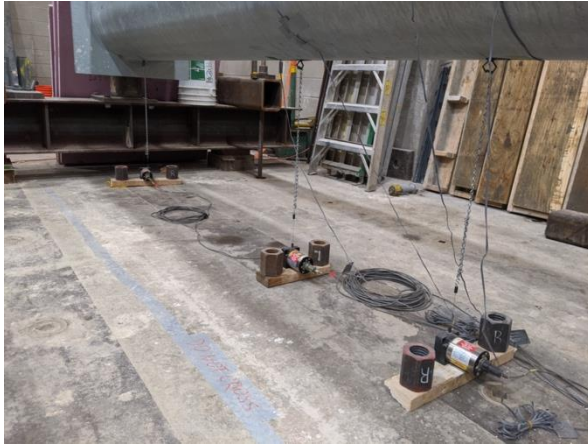
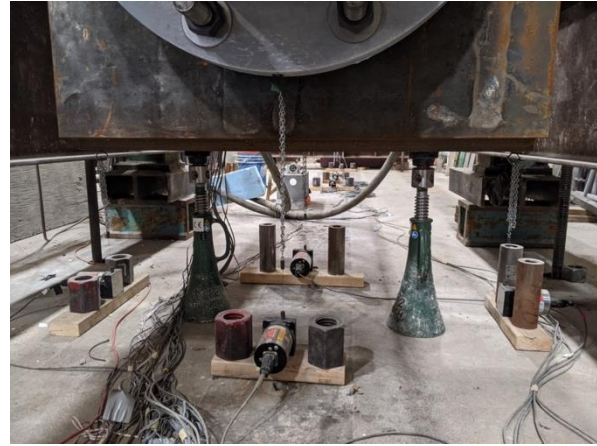
Figure 3.9. Locations (top) and displacement sensors (bottom)

To install the displacement sensors, a chain was dropped from the locations of interest and hooked to a ring at the tip of the wire rope (see Figure 3.9 (b) and (c)). A total of 10 displacement sensors were installed to measure the displacement at different locations along the experiment setup (see Figure 3.9 (a)).

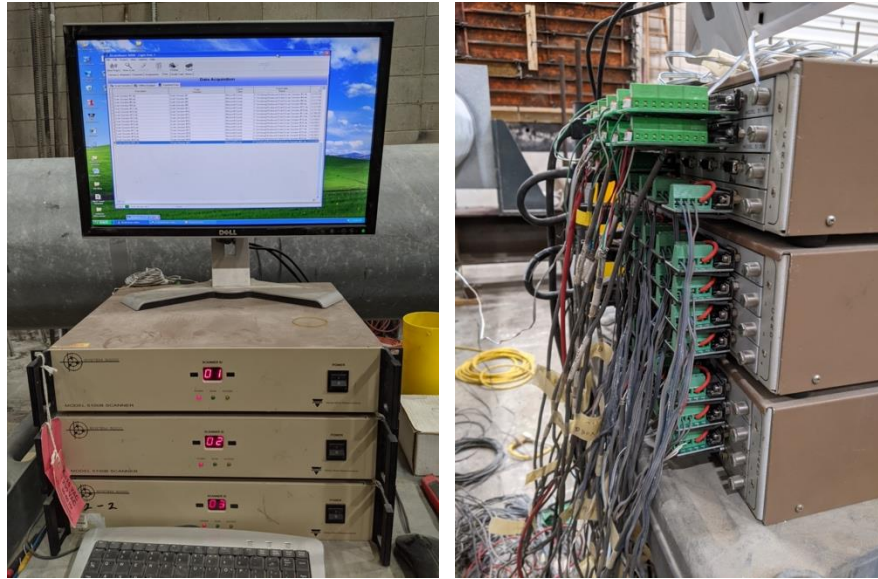
Figure 3.10. Data acquisition system

The data acquisition system chosen was the Model 5100B Scanner from Vishay Intertechnology (see Figure 3.10).

All the sensors were connected to the scanners, and the scanners were connected to a computer. A software package called StrainSmart 5000 was installed in the computer and provided a user interface to configure the data from all the sensors. Strain data was recorded in microstrain ($\mu\epsilon$). Displacement data was recorded in 0.001 in. The displacement and load signals from the actuator were also recorded. During the fatigue experiment, the sampling rate was set to 50 Hz, and the data was recorded for 1 minute in every 15 minutes.

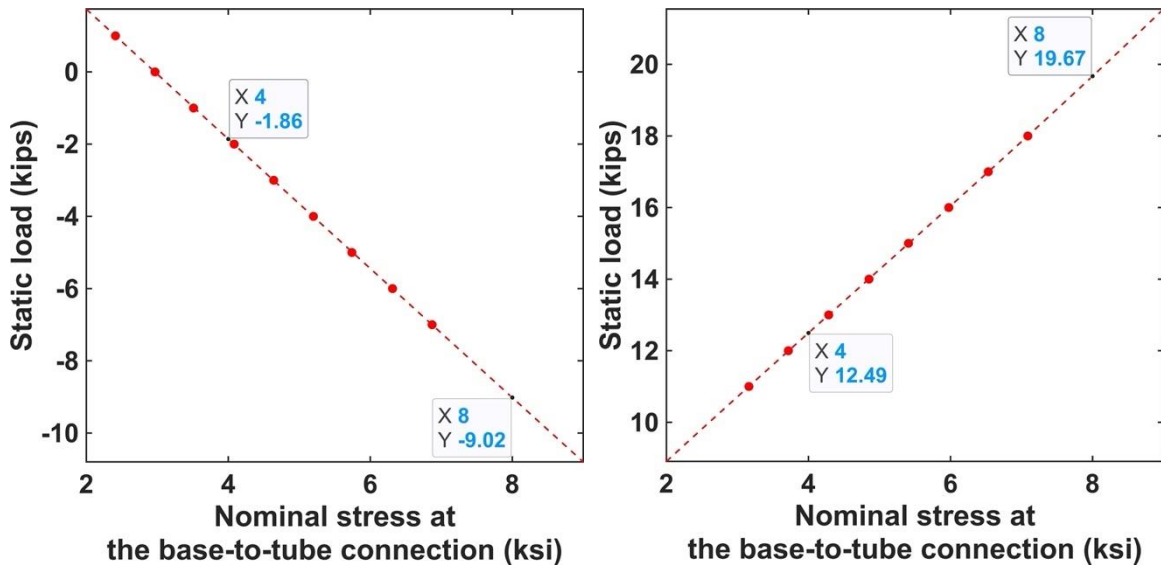
**Figure 3.12. Static load at the loading box vs. nominal stress at the base-to-tube connection**

At this point, the relationship between the static load and the nominal stress at the base-to-tube connection found by using the stress concentration factor in the first approach has been validated by the data from the control gauges and the displacement sensors. Finally, the relationship between the static load and the nominal stress at the base-to-tube connection was approximated by a polynomial function (see Figure 3.12).

The required fatigue loads were finally determined as 12.5 kips and -1.9 kips to create the nominal stress range of 8 ksi at the base-to-tube connection and 19.7 kips and -9.0 kips to create the nominal stress range of 16 ksi at the base-to-tube connection.

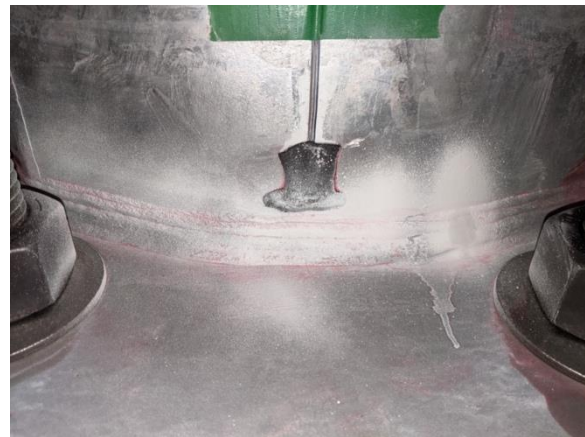
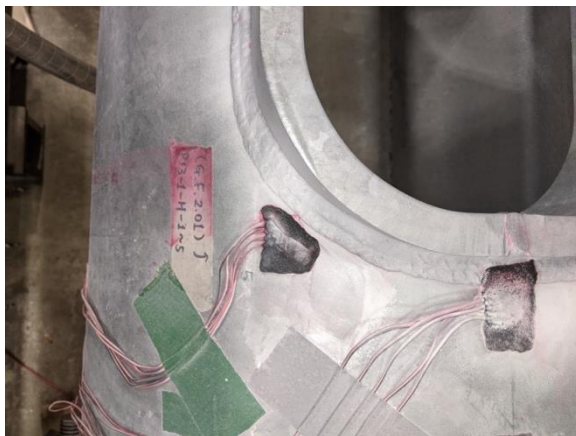
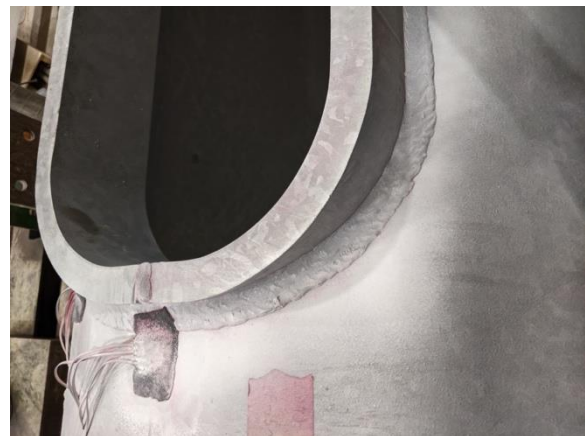
Figure 3.15. Dye penetrant test result of Specimen A-1

On Specimen A-1, no indications were found at the base-to-tube connection and the hand-hole-to-tube connection at 1,000,000 cycles from both the dye penetrant test and magnetic particle test. See Figure 3.15 for the results of the dye penetrant test on Specimen A-1 at 1,000,000 cycles.

(a) Hand-hole side of the base-to-tube connection

(b) Back side of the base-to-tube connection

(c) Left bottom corner of the hand hole

(d) Right bottom corner of the hand hole

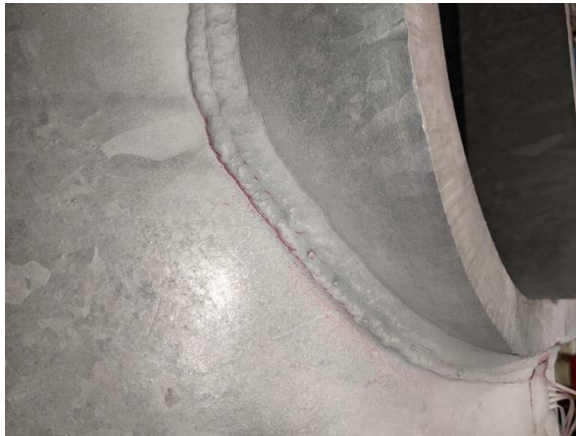
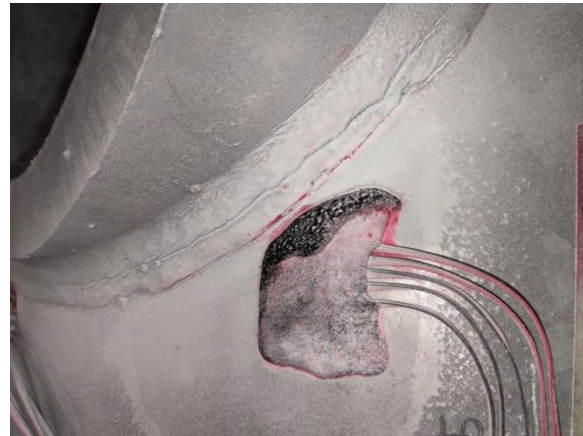
Figure 3.16. Dye penetrant test result of Specimen B-1

On Specimen B-1, small red indications were found at the bottom corners of the hand hole, and no red indications were found at the base-to-tube connection from the dye penetrant test at 1,000,000 cycles (see Figure 3.16).

(a) Hand-hole side of the base-to-tube connection

(b) Back side of the base-to-tube connection

(c) Left bottom corner of the hand hole

(d) Right bottom corner of the hand hole

Therefore, the small red indications from the dye penetrant test might be due to the poor cleaning of the surface and might not be through-thickness fatigue cracks.

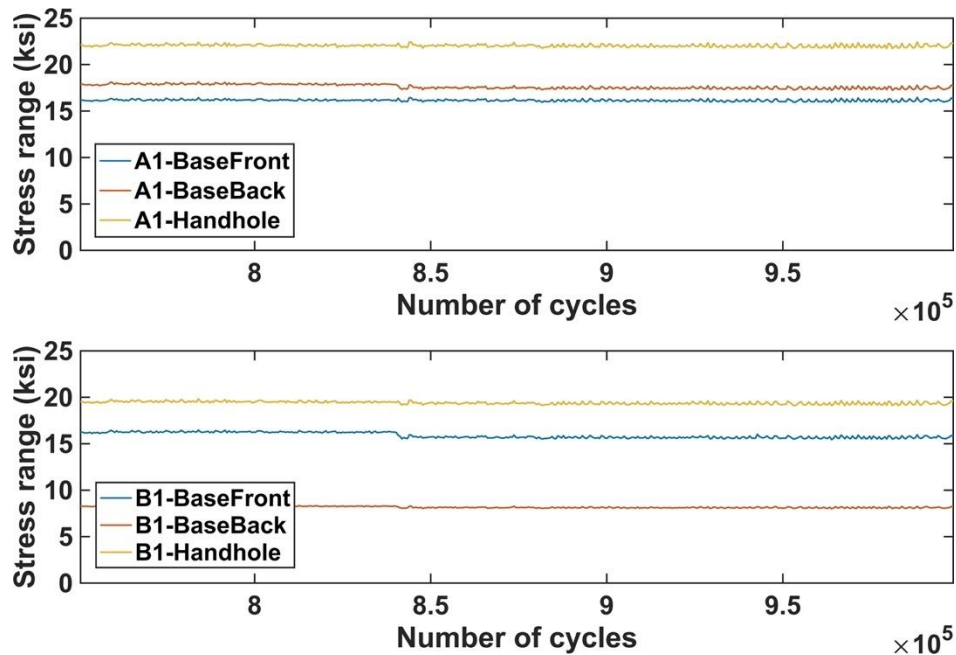
Figure 3.17. Stress ranges from hot-spot gauges of Specimen A-1 and Specimen B-1

However, the magnetic particle test at 1,000,000 cycles showed no indication at both the bottom corners of the hand hole and the base-to-tube connection. Also, from the readings of the hot-spot gauges, no obvious change was found in the stress range as the number of cycles reached 1,000,000 (see Figure 3.17).

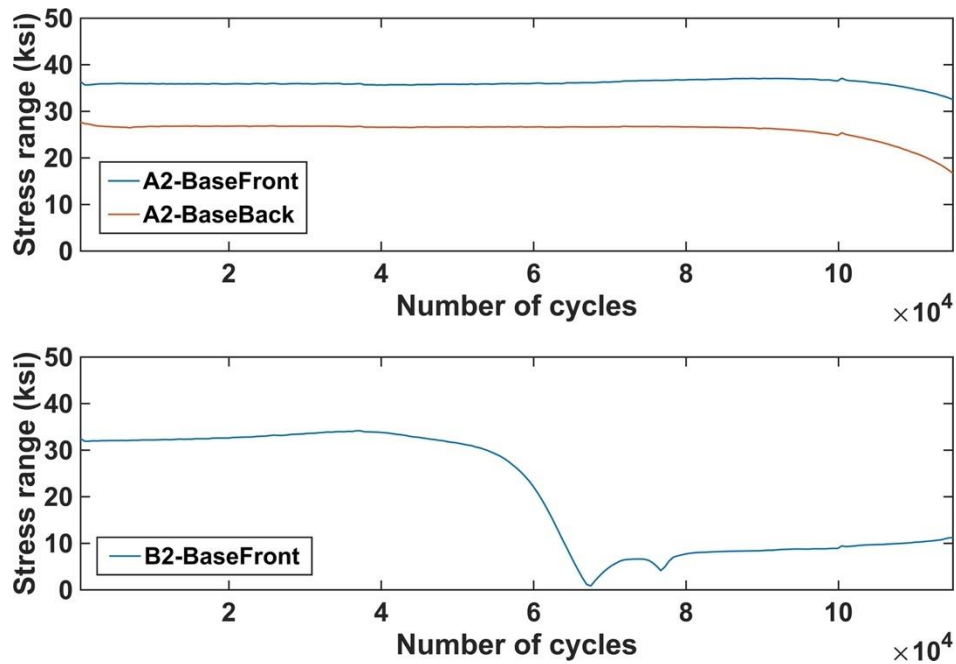
Figure 3.18. Stress ranges from the hot-spot gauges of Specimen A-2 and Specimen B-2

On Specimen A-2, no indications were found at the base-to-tube connection and the hand-hole-to-tube connection from both the dye penetrant test and magnetic particle test at 115,000 cycles. However, the readings from the hot-spot gauges at the base-to-tube connection showed a slightly decaying trend at about 110,000 cycles (see Figure 3.18).

This might indicate that a fatigue crack might be about to occur at the base-to-tube connection on Specimen A-2.

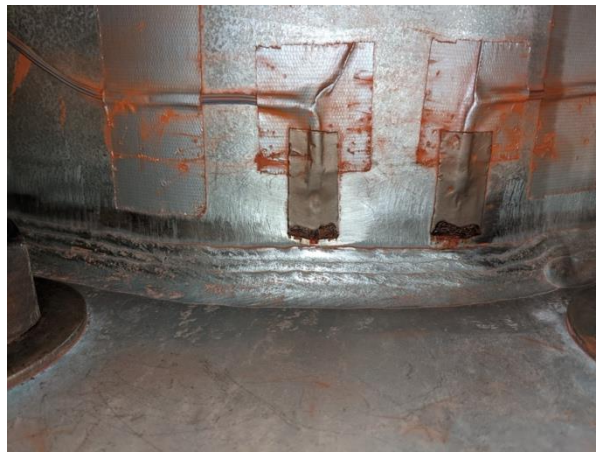
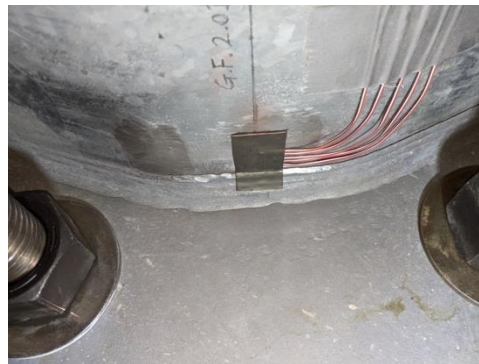
Figure 3.19. Inspection result of Specimen B-2 at (a) 100,000 cycles and (b) 115,000 cycles

On Specimen B-2, a small indication with a length of about 4 in. at the hand-hole side of the base-to-tube connection was found by the magnetic particle test at 100,000 cycles (see Figure 3.19 (a)).

(a) 100,000 cycles

(b) 115,000 cycles

A large fatigue crack with a length of more than 20 in. at the back side of the base-to-tube connection was observed at 115,000 cycles. A fatigue crack with a length of more than 20 in. at the top of the backing ring was also observed (see Figure 3.19 (b)). In Figure 3.18, the hot-spot gauge at the hand-hole side of the base-to-tube connection showed that the stress range decreased dramatically at about 60,000 cycles, which indicates that the fatigue crack might have occurred at somewhere between 60,000 and 100,000 cycles.

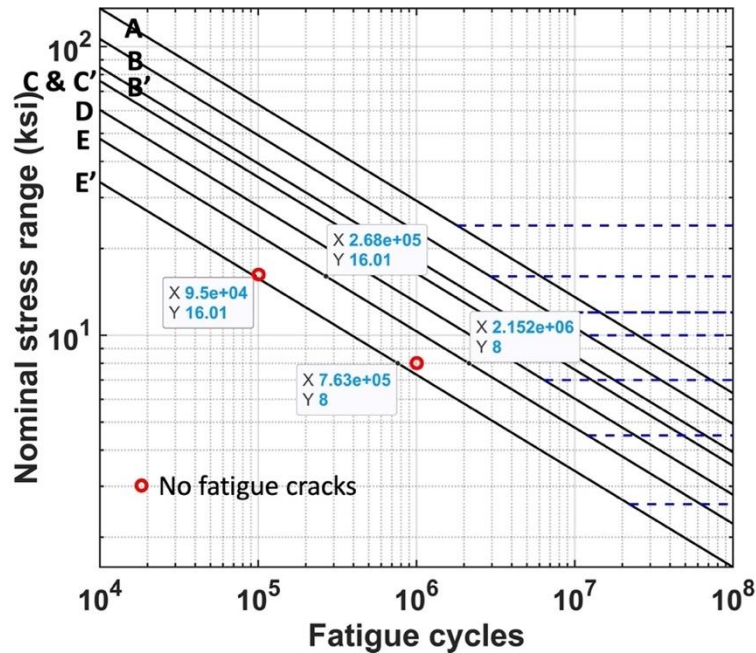
Figure 3.20. Fatigue test result of Specimen A

Figure 3.20 shows the fatigue test result of Specimen A-1 and Specimen A-2.

The base-to-tube connection of Specimen A was shown to have a fatigue resistance for finite life higher than Category E'. Also, according to the decaying trend of the stress range at the base-to-tube connection observed at around 110,000 cycles, the base-to-tube connection might have a fatigue resistance for finite life lower than Category E. The test result of specimen Type XI in Roy et al. (2011) also showed that the fatigue resistance of its base-to-tube connection was between Category E' and Category E. No cracks were found around the hand-hole-to-tube connection; therefore, the fatigue resistance for finite life of the hand-hole-to-tube connection of Specimen A was identified as higher than Category E'.

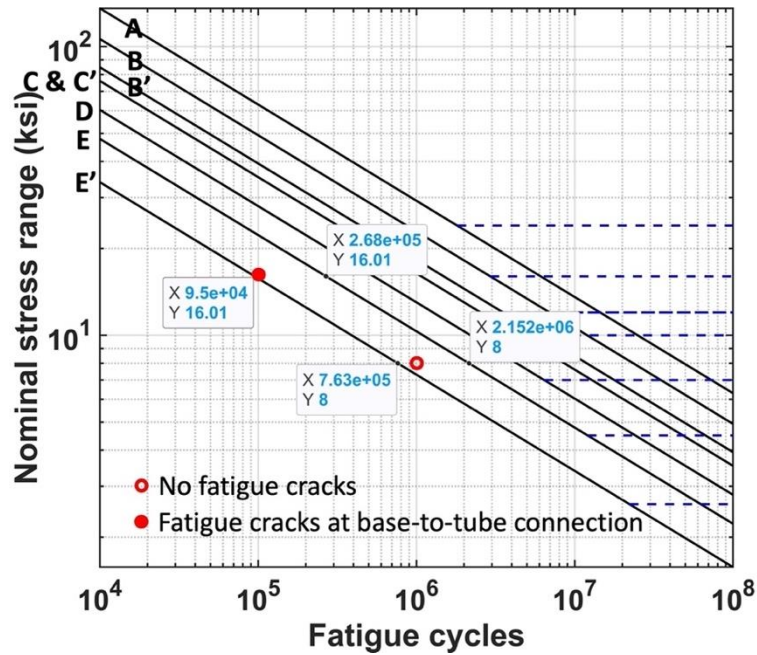
Figure 3.21. Fatigue test result of Specimen B

Figure 3.21 shows the fatigue test result of Specimen B-1 and Specimen B-2.

The base-to-tube connection of Specimen B was shown to have a fatigue resistance for finite life near the lower limit of Category E'. No cracks were found around the hand-hole-to-tube connection; therefore, the fatigue resistance for finite life of the hand-hole-to-tube connection was identified as higher than Category E'.

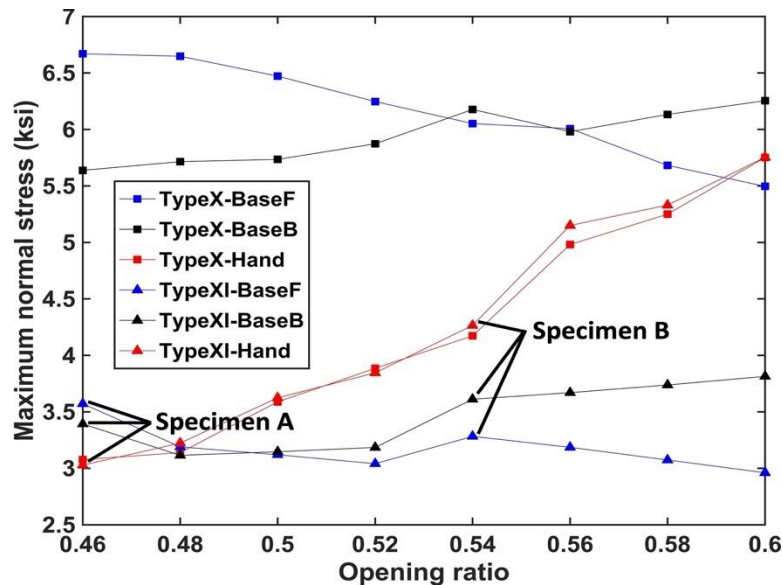
Figure 4.1. Maximum normal stress at the pole base vs. opening ratio

Figure 4.1 shows the maximum normal stress at the pole base of the models with different opening ratios.

Square markers represent the results of specimen Type X, and triangle markers represent the results of specimen Type XI. Blue represents the stress at the front side of the base-to-tube connection, black represents the stress at the back side of the base-to-tube connection, and red represents the stress at the hand hole corners.

Several things can be observed in Figure 4.1.

Second, specimen Type X generally had higher stress at the base-to-tube connection than at the hand hole corners when the opening ratio is smaller than 0.58. Based on this result, specimen Type X might have a higher chance of having fatigue cracks at the base-to-tube connection. Specimen Type X in Roy et al. (2011), which had an opening ratio of 0.46, showed fatigue cracks at the base-to-tube connection and no cracks around the hand hole during the previous fatigue experiment. Similarly, specimen Type XI in Roy et al. (2011), which had an opening ratio of 0.46 and is identical to Specimen A of the present study, was tested in the previous fatigue experiment. The result also showed that fatigue cracks occurred at the base-to-tube connection and no cracks were found around the hand hole. From the stress response in Figure 4.1 and the observations from the previous fatigue experiment, it seems that fatigue cracks might occur at the location with the highest stress.

Third, specimen Type XI generally showed lower stress at the base-to-tube connection than at the hand hole corners when the opening ratio is larger than 0.48. This might be because the backing ring increases the wall thickness at the base-to-tube connection and lowers the stress. Based on the hypothesis mentioned previously, specimen Type XI might have a higher chance of observing fatigue cracks around the hand hole at the base-to-tube connection when the opening ratio is larger than 0.48. This hypothesis can be examined through the fatigue test on Specimen B, which had an opening ratio of 0.54, and is discussed in Section 4.2.
