# Partially Grouted Revetment for Low-Volume Road Bridges

**Final Report**  
**March 2024**

**Sponsored by**  
Iowa Highway Research Board  
(IHRB Project TR-710)  
Iowa Department of Transportation  
(InTrans Project 16-579)

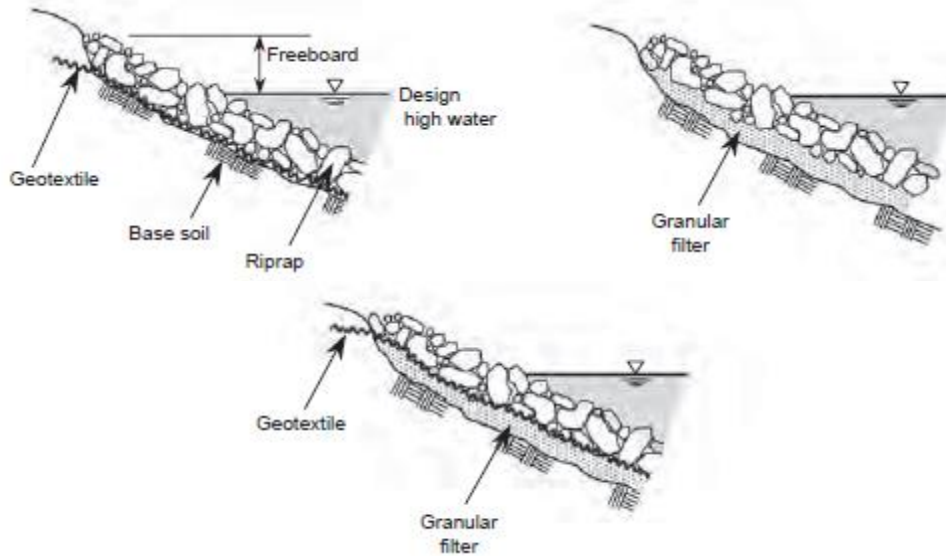
All of the countermeasures discussed in the previous sections are most effective when used in conjunction with a filter layer of some type. Possible filter layers include a geotextile filter, granular filter, or combination of the two to form a composite filter. These three types of filters are illustrated in Figure 13.

**Figure 13. Riprap filter layers: geotextile filter (upper left), granular filter (upper right), and combination of the two to form a composite filter (bottom)**

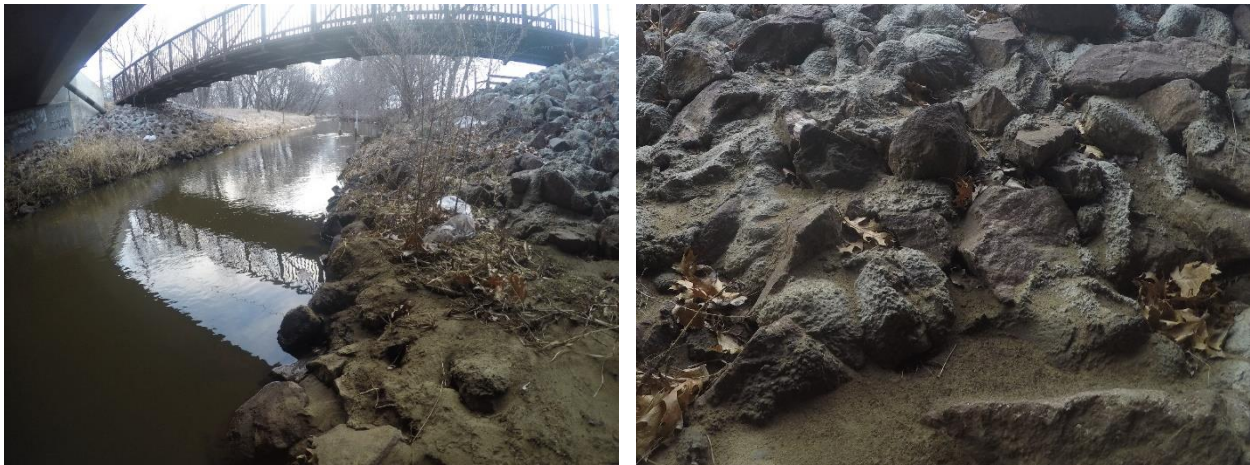
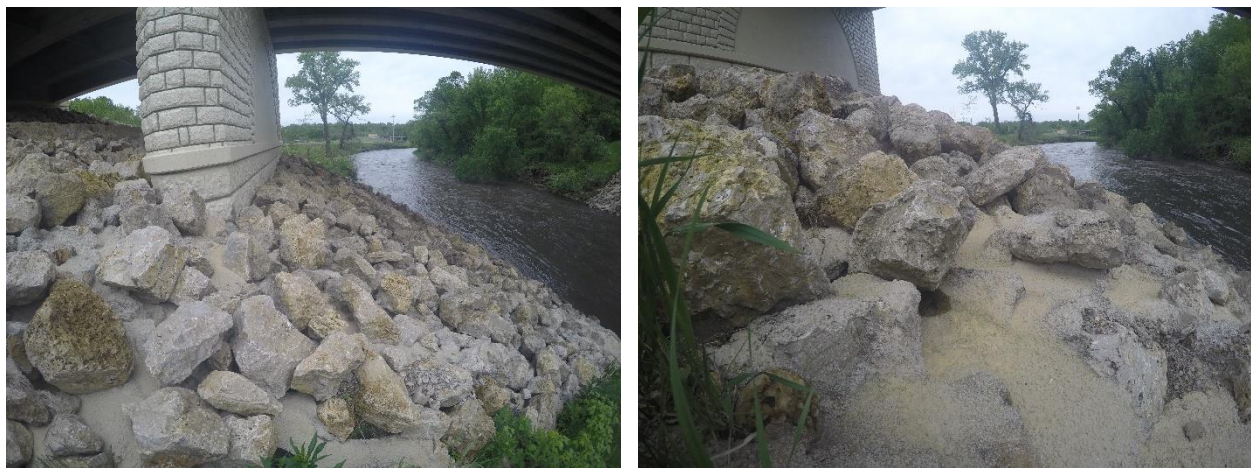
**Figure 16. Minnesota Site 1: Partially grouted riprap**

**Figure 17. Minnesota Site 2: Partially grouted riprap**

**Figure 18. Minnesota Site 3: Partially grouted riprap—thin grout**

**Figure 19. Minnesota Site 4: Partially grouted riprap—splash of grout**

Overall, partially grouted riprap was seen to perform well when it is grouted correctly. This same finding was conveyed via conversations with the Minnesota Department of Transportation (MnDOT). All of the systems were approximately five years old at the time of the field visits.

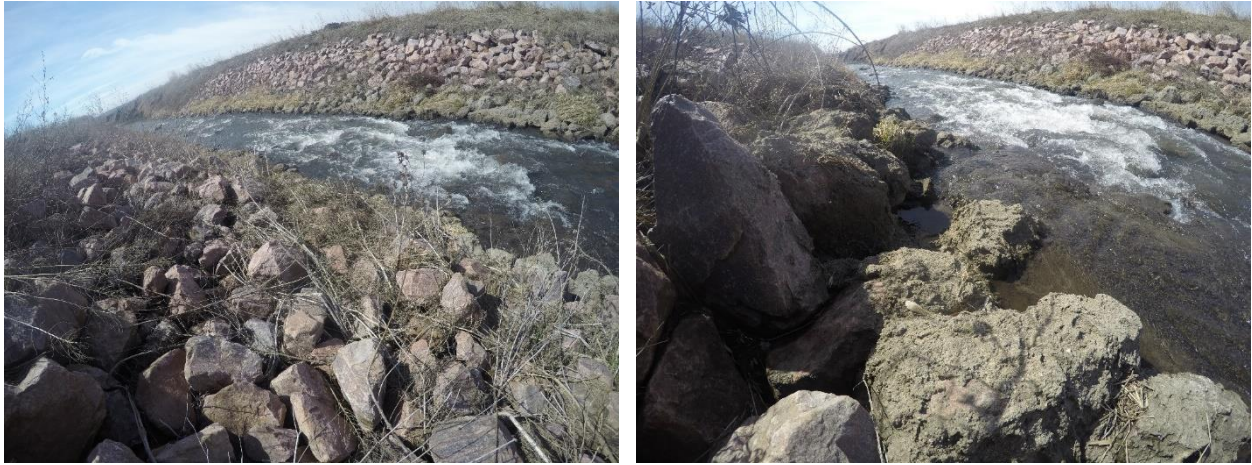
**Figure 24. Partially grouted riprap in Woodbury County, Iowa**

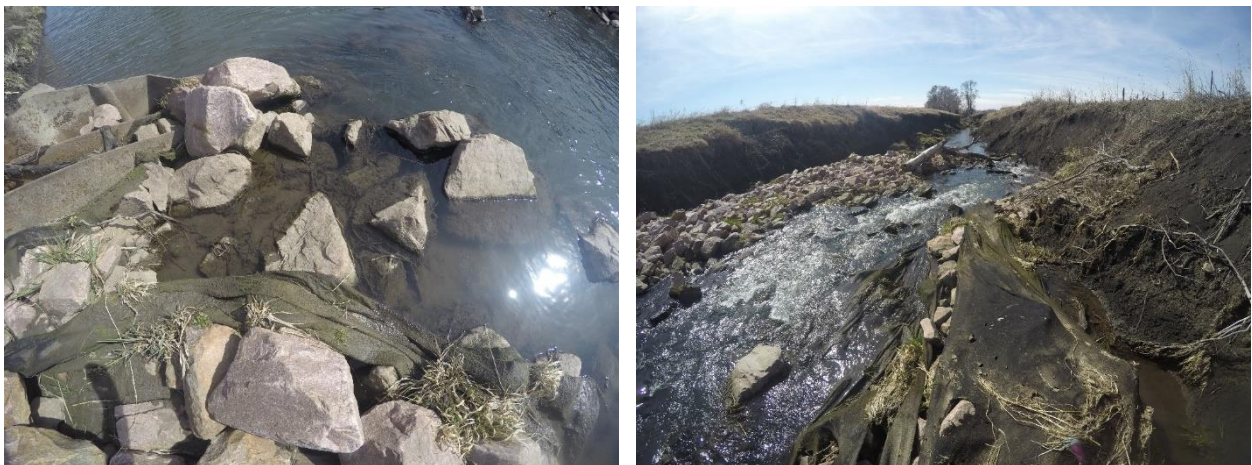
**Figure 25. Failing stream grade control in Woodbury County, Iowa**

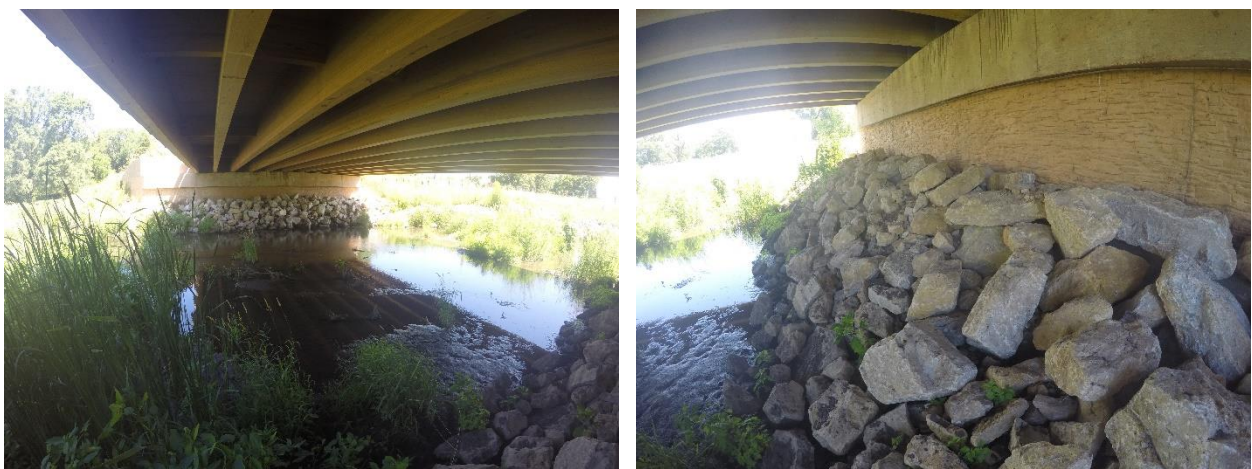
**Figure 26. Loose riprap in Buchanan County, Iowa**

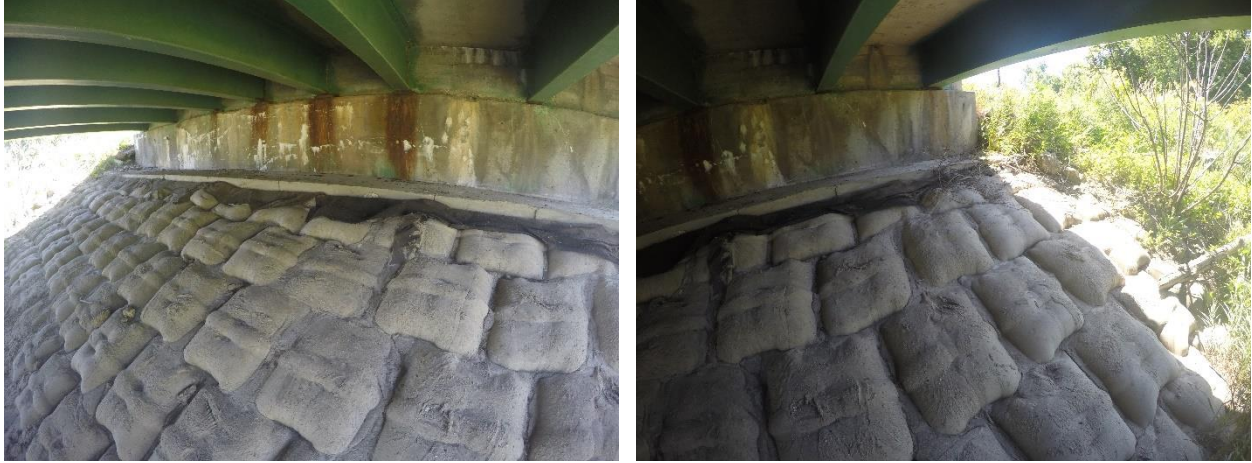
**Figure 27. Grout-filled blankets in Buchanan County, Iowa**

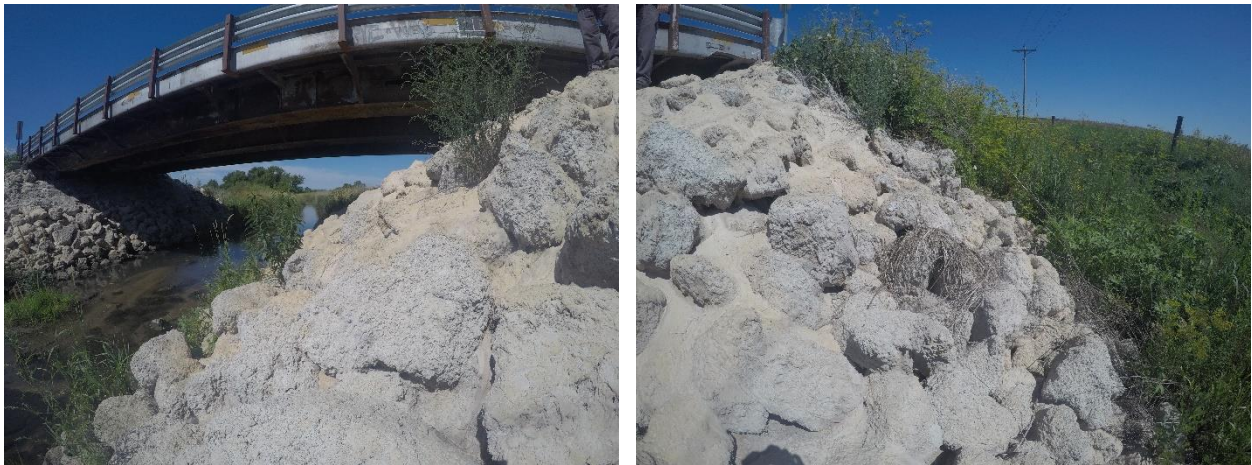
**Figure 28. Grouted riprap in Buchanan County, Iowa**

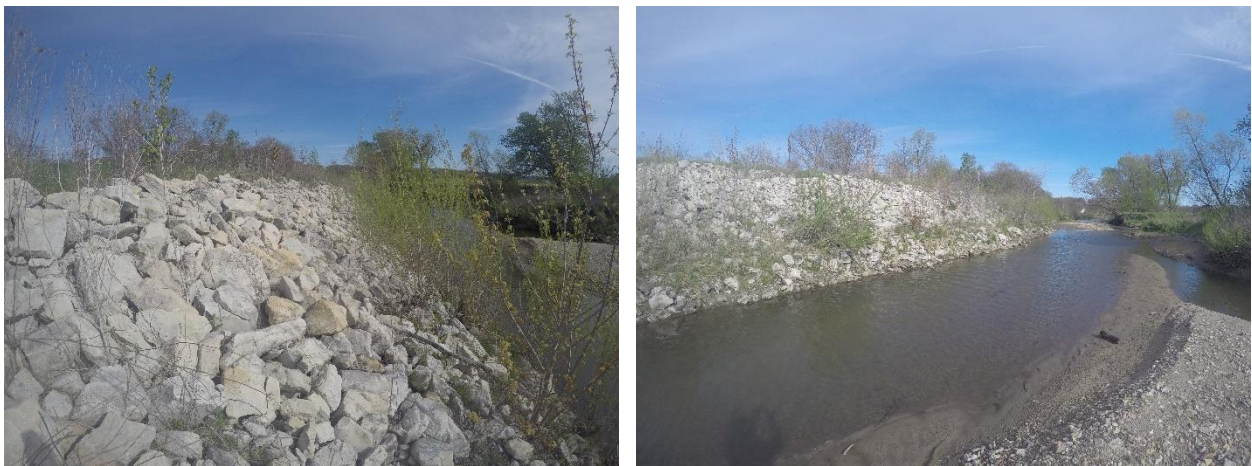
**Figure 29. Loose riprap during low water levels in Madison County, Iowa**

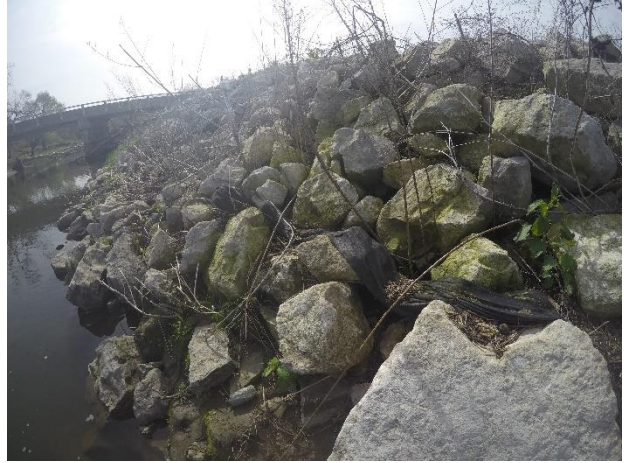
**Figure 30. Loose riprap and failing fabric in poor condition in Madison County, Iowa**

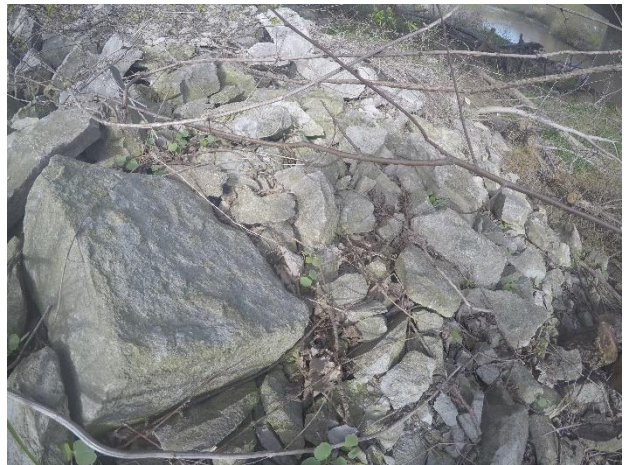
**Figure 31. Undersized loose riprap in Madison County, Iowa**

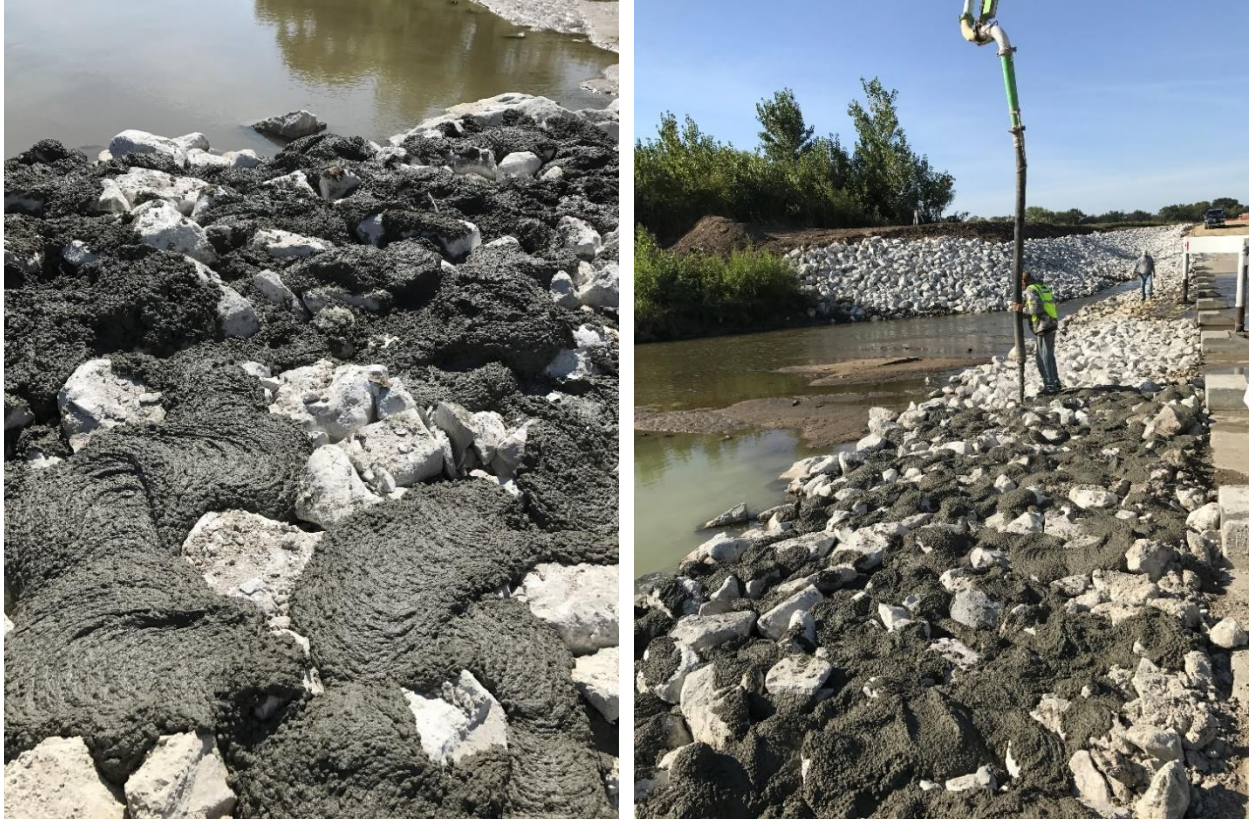
Figure 38 shows the grouting that was achieved as part of this pilot installation.

**Figure 38. Madison County pilot installation grouting**

There was initially some splash on the stones, and it took a few trucks before the mix consistency was right where desired. While the 4 in. hose size was needed due to other project constraints, it was observed that the hose size was too large for controlled placement and would not be advised for future projects whenever possible.

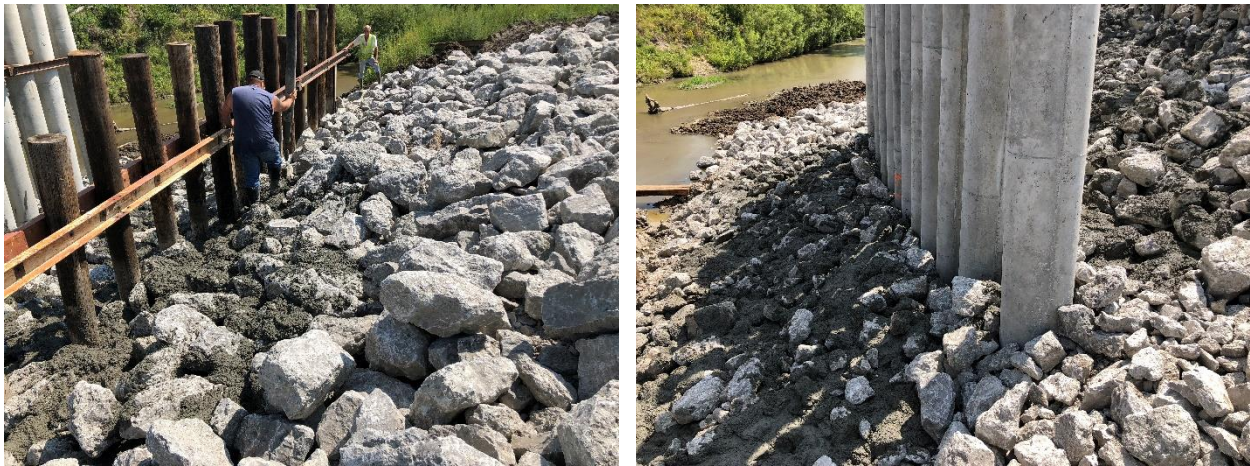
**Figure 41. Wayne County pilot installation grouting**

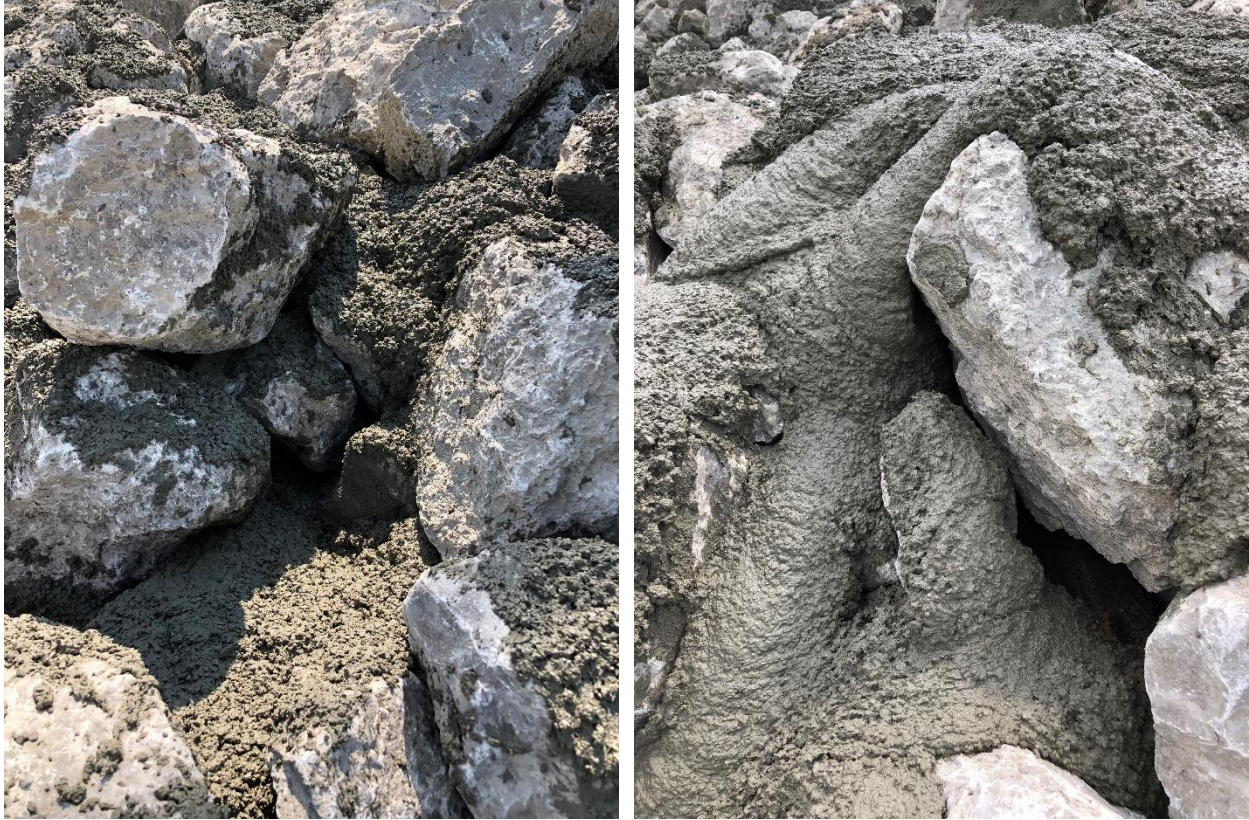
**Figure 42. Initial grout consistency (left) and desired grout consistency (right) in Wayne County**

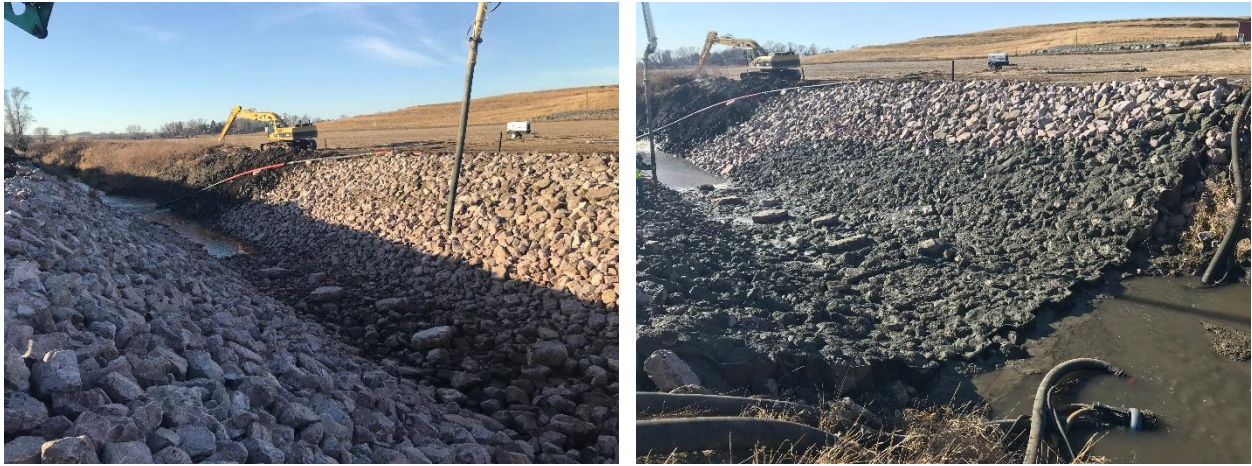
**Figure 43. Woodbury County site before (left) and after grouting (right)**

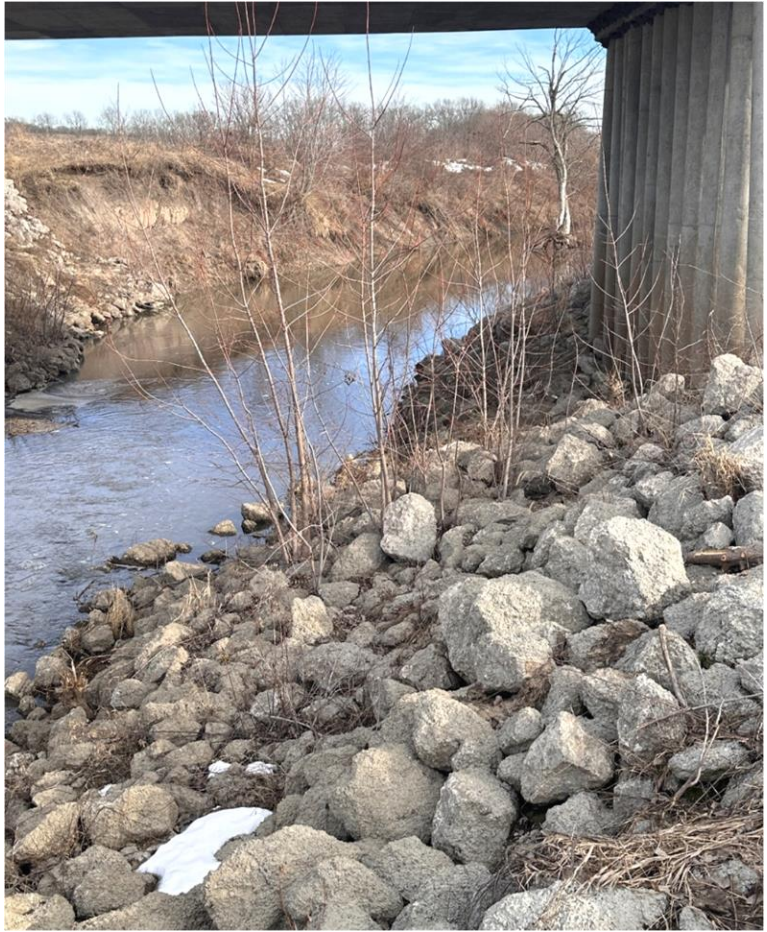
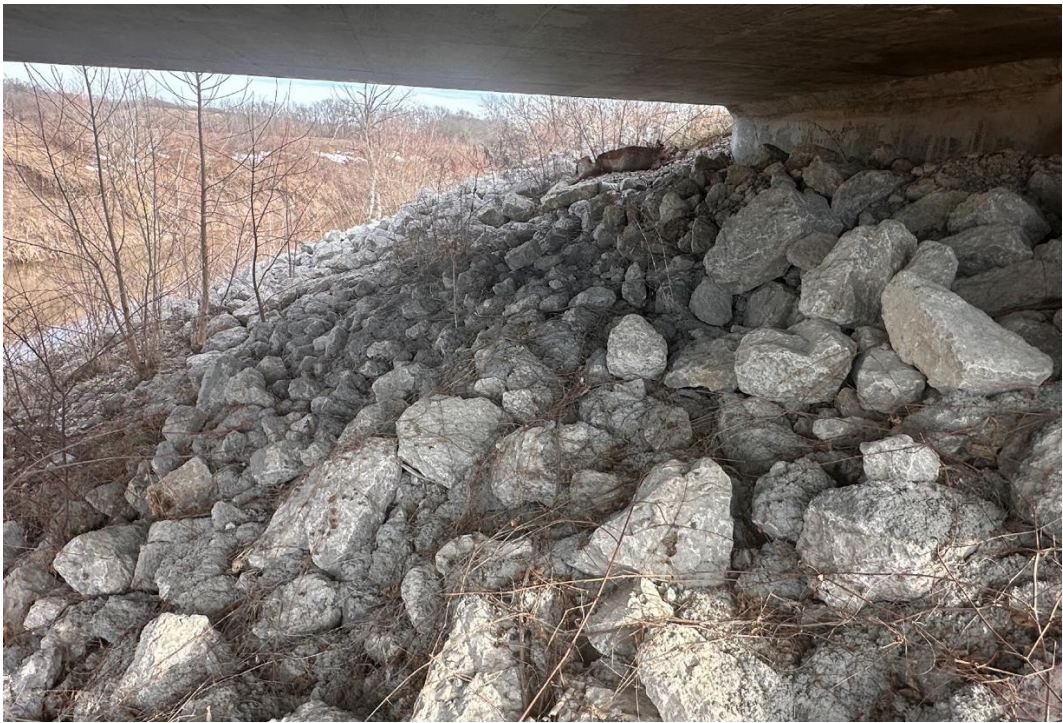
**Figure 47. Wayne County Pilot installation as of February 2024**

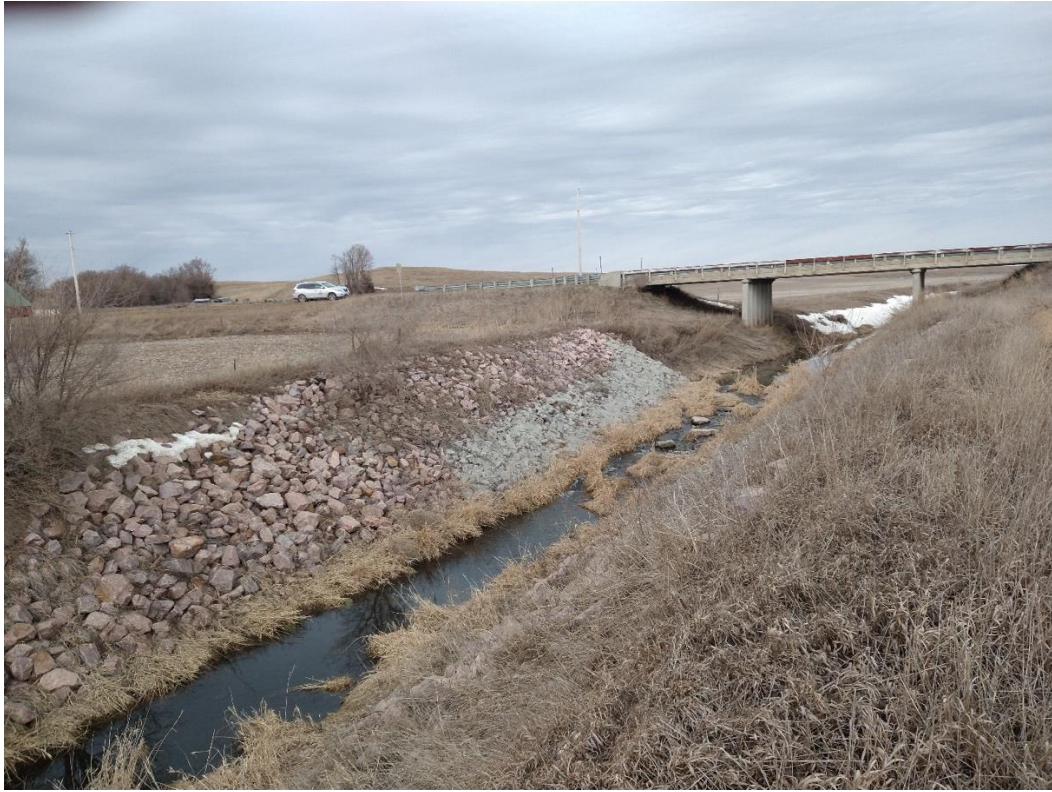
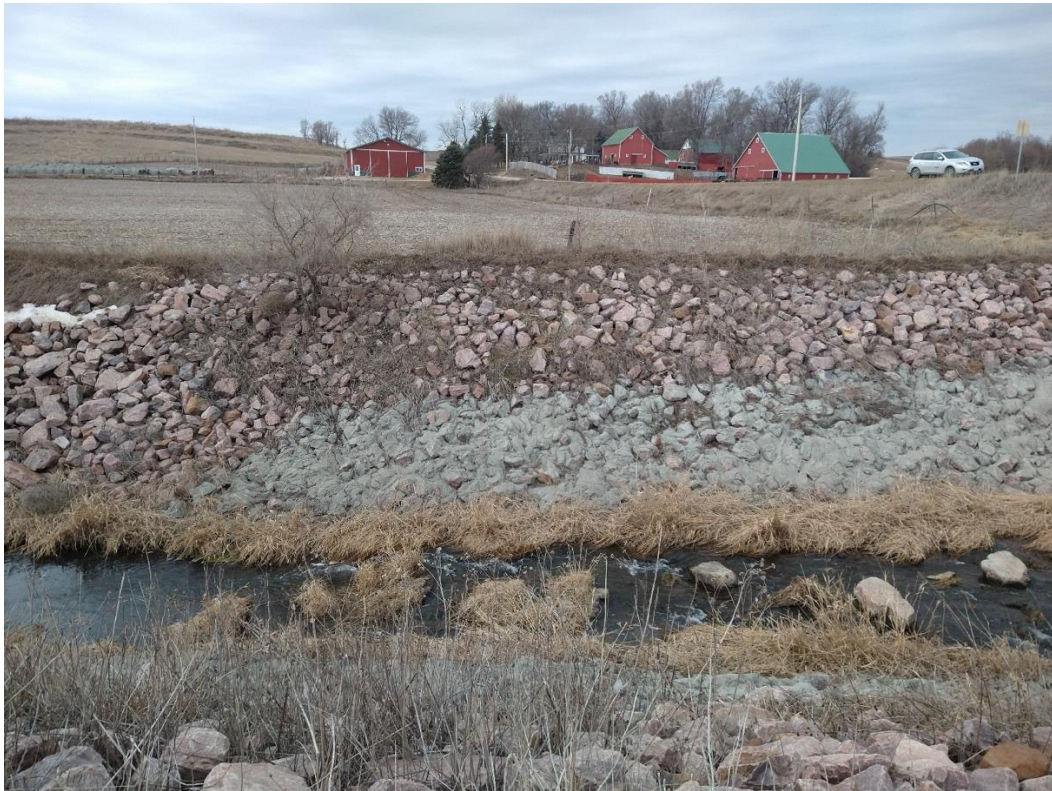
**Figure 48. Woodbury County Pilot installation as of February 2024**
