Rapid Replacement of Bridge Deck Expansion Joints Study – Phase I

**Interim Report
December 2014**

Sponsored by
Iowa Department of Transportation
Federal Highway Administration
(InTrans Project 13-451)

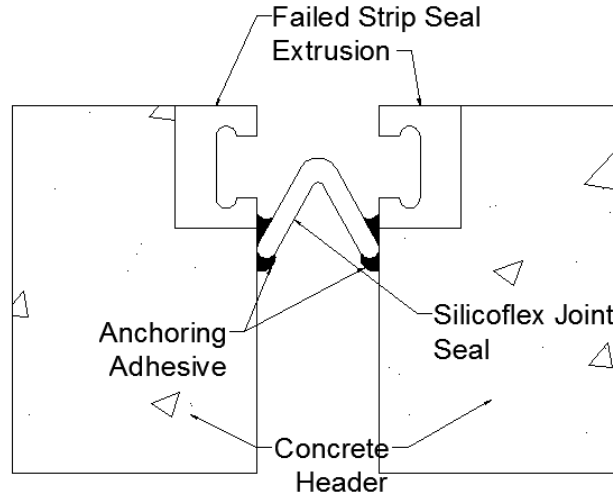
Figure 2.10. Silicoflex expansion joint example

Recently, the Iowa DOT has been experimenting with the use of a Silicoflex joint sealing system from R.J. Watson, Inc. as a repair measure for damaged expansion joints. A Silicoflex seal is essentially an inverted strip seal held in place by an adhesive instead of an extrusion. The use of an adhesive makes Silicoflex ideal for joint repairs involving damaged strip seal extrusion sections. An example of a repair done with a Silicoflex Joint is shown in Figure 2.10.

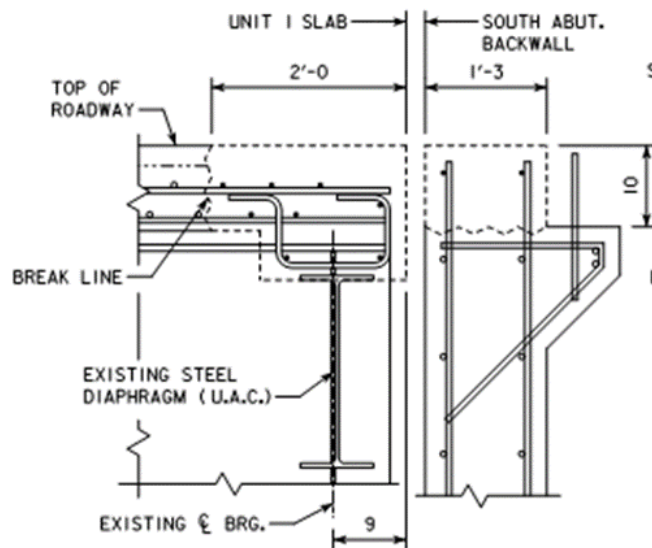
Figure 3.3 Typical I-380 concrete removal cross section

section of plate had broken loose. However, when the top steel plate was removed, it revealed a considerable amount of rust that had built up. There was enough rust between the plates of the expansion joint that both the Iowa DOT inspector and the author doubted that the joint had been properly functioning in years. Not surprisingly, this rust buildup conforms to the joint deterioration patterns discussed previously in section 2.4.1 Other joints in this project, and Joint E in particular, exhibited much more severe failures that ultimately prompted the replacement.

The old sliding plate joint was to be replaced with a new strip seal expansion joint. Concrete removal would consist of the top of the backwall from the existing riding surface to the top of the paving notch and the end two feet of roadway concrete (see Figure 3.3).

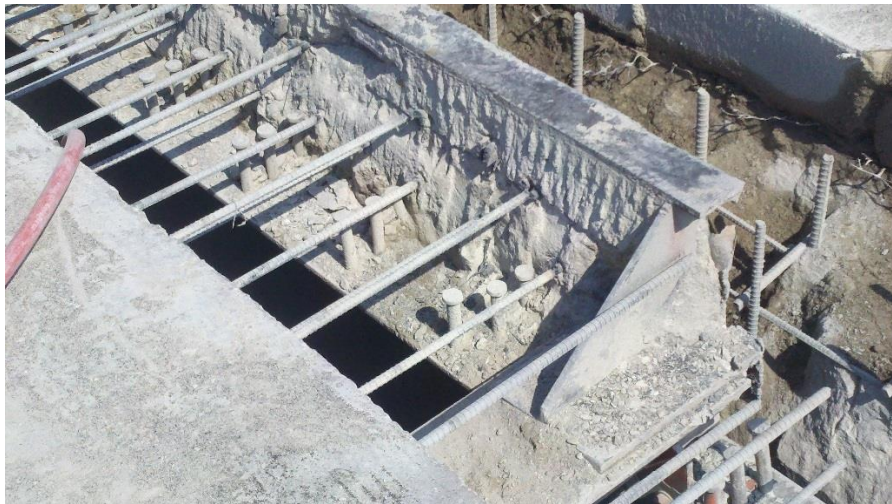
Figure 3.5. Joint A after hydrodemolition

The aqua cutter had a demolition width of about 5 ft. After completing the removal between the required limits, the machine was moved to the side, realigned with the previous sections of demolition, and restarted. Hydrodemolition of Joint A took place for about 14 hours (see Figure 3.5).

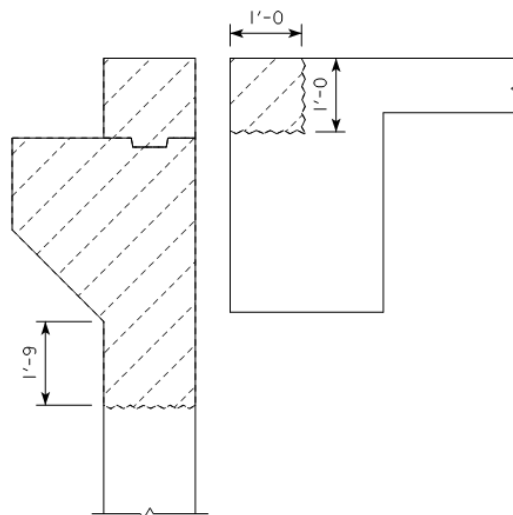
Figure 3.9. Typical US 18 removal cross section

Concrete removal was to consist of a 1-ft by 1-ft square section of concrete on the deck side of the joint along with the removal of the backwall to 1 ft 9in. below the bottom of the existing paving notch (see Figure 3.9).

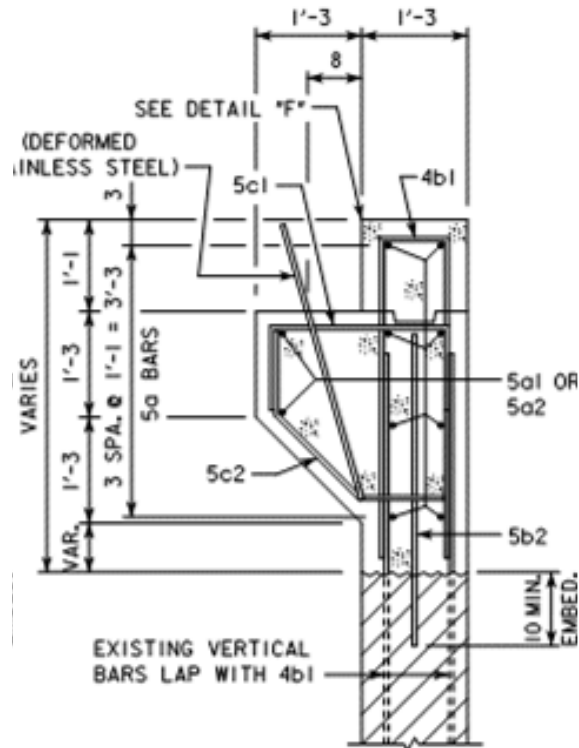
Figure 3.10. Replacement paving notch plan

On the deck side, any embedded longitudinal rebar was to be left in place for lap splices. On the abutment side, any embedded vertical bars were to remain. There was also an additional row of rebar doweled and epoxied into the remaining abutment to provide extra support (see Figure 3.10).

Figure 3.10 above labeled as bar 5b2. In similar designs, there would be no additional step in the construction process, merely a step that would be lengthened while another is made shorter.
