# Investigation of Deterioration of Joints in Concrete Pavements:

# Field Study of Penetrating Sealers

**Technical Report**  
**March 2016**

**National Concrete Pavement  
Technology Center**

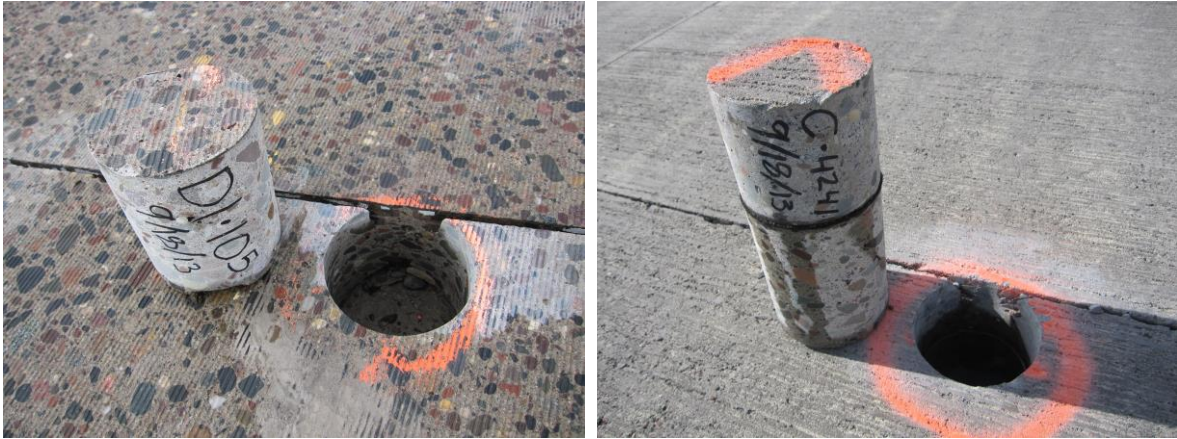
**Figure 4. Example cores retrieved in 2013 showing the relationship of the core next to the joint: Joint 105, Cell 9 (left) and Joint 4241, Cell 505 with fabric bond-breaker (right)**

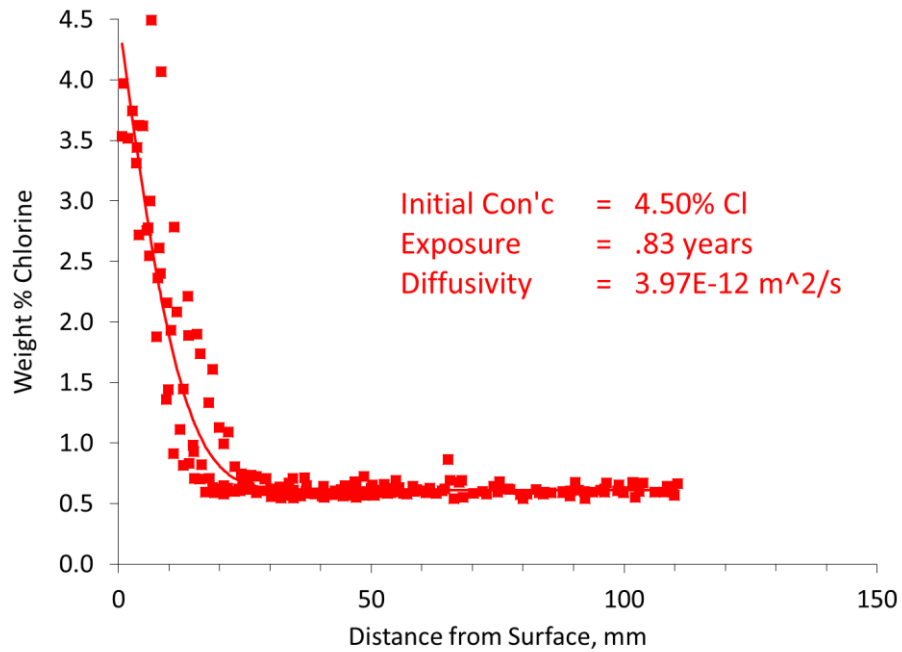
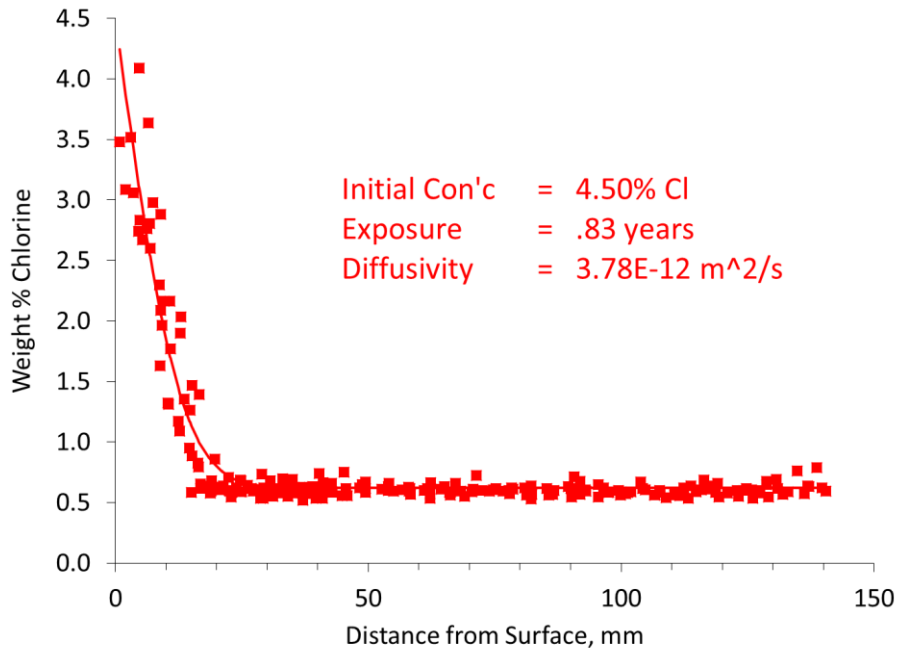
**Figure 12. Cumulative chlorine profile in the vertical direction, Cell 505, 2013**

**Figure 13. Cumulative chlorine profile in the horizontal direction, Cell 505, 2013**

Both the horizontal and vertical profiles in the four-year-old unbonded concrete overlay in Cell 505 are nicely fit by Fick's second law. Inflection occurs in both the vertical and horizontal directions at a distance of approximately 20 mm from the exposed surfaces. These profiles are predictably steep and uniformly have higher initial concentrations than those found in the pavement in Cells 8 and 9. In contrast to the 23-year-old pavement, the initial concentration in the horizontal direction is the same as that found in the vertical direction, suggesting the dilution evident in the older pavements does not take place in Cell 505. The joints in Cell 505 were not sealed with silicone or hot pour asphalt, and the concrete overlay was placed over a separation fabric. The lack of sealing permits free entry of salt solution and debris from the wearing surface into the joint.

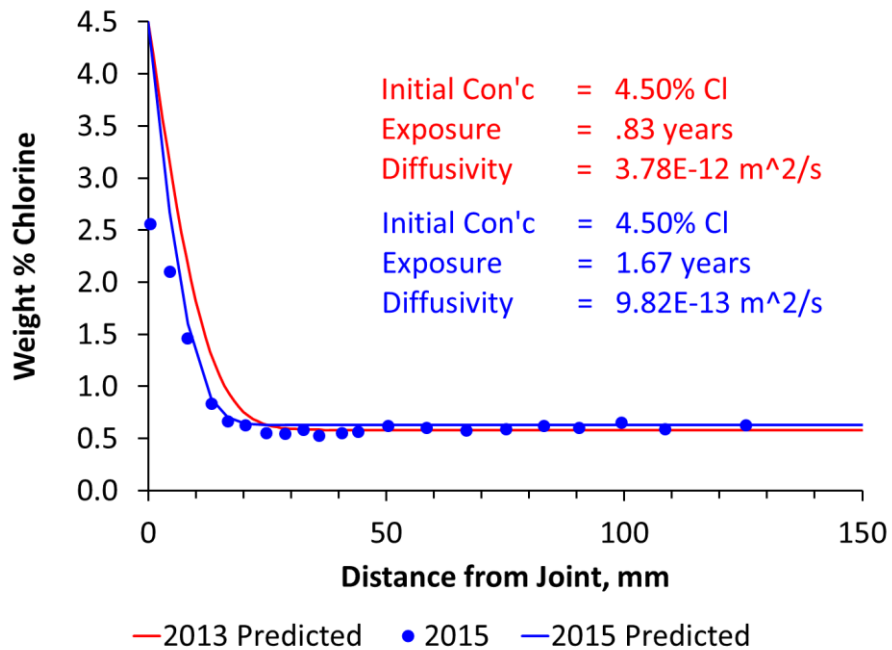
**Figure 41. Chlorine profile in the horizontal direction from Joint 4240 Cell 505 treated with sealer S1, August 19, 2013**

In all cases, the curve and associated text in the charts represent the baseline pre-application profile and exposure and diffusivity values, respectively. The points represent point

concentrations, and the line associated with those points represents the predicted profile using the exposure and diffusivity conditions indicated by the text.

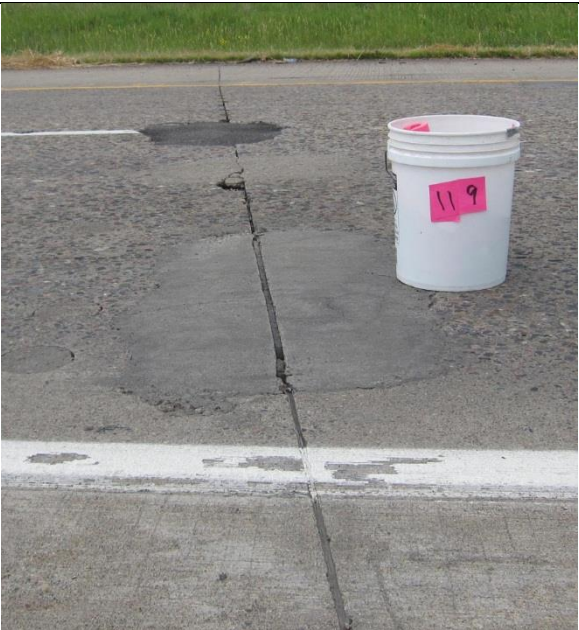
| Joint | 2013 | 2015 |
|---|---|---|
| 119 | N/A | A photograph showing a joint in an asphalt road. A white bucket with a pink label '119' is placed on the right side of the joint. The joint shows some wear and a small hole. |

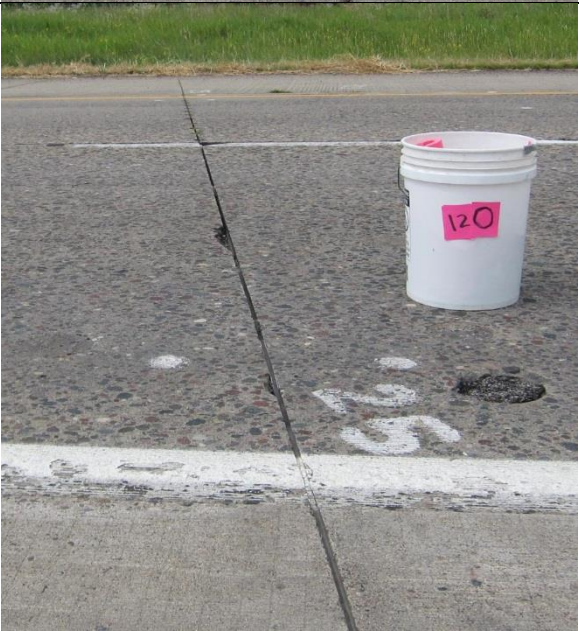
| Joint | 2013 | 2015 |
|---|---|---|
| 120 | N/A | A photograph showing a joint in an asphalt road. A white bucket with a pink label '120' is placed on the right side of the joint. The joint shows some wear and a small hole. |

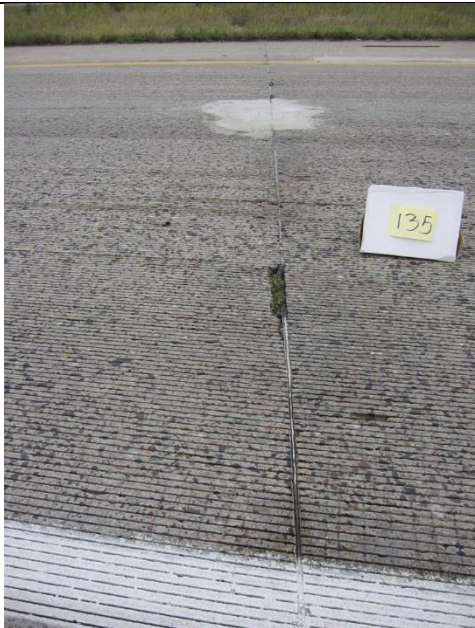
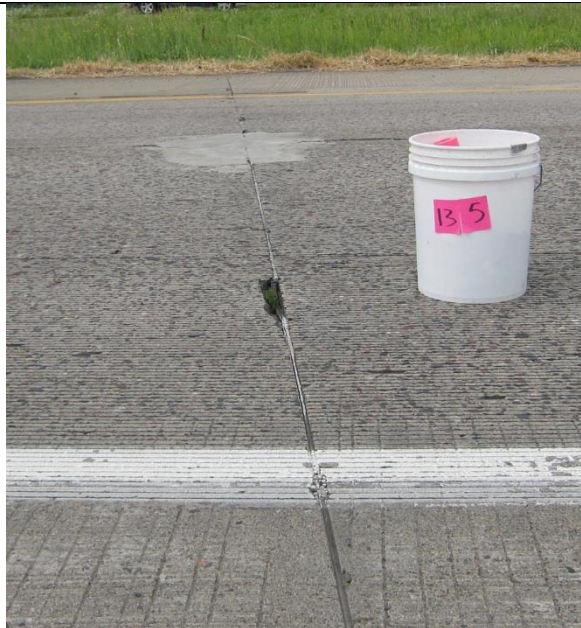
| Joint | 2013 | 2015 |
|---|--|--|
| 135 | <p>A photograph of a concrete joint on a road surface in 2013. A yellow tag with the number '135' is placed on the right side of the joint. The joint shows some weathering and a small amount of vegetation growth.</p> | <p>A photograph of the same concrete joint in 2015. A white bucket with a pink tag labeled '135' is placed on the right side of the joint. The joint shows significant weathering and a larger area of vegetation growth.</p> |

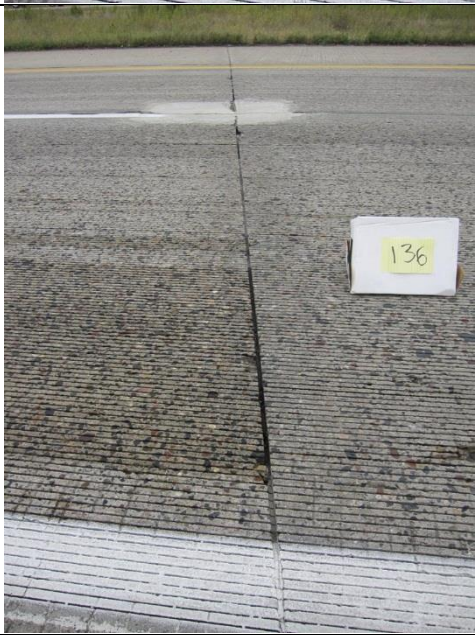
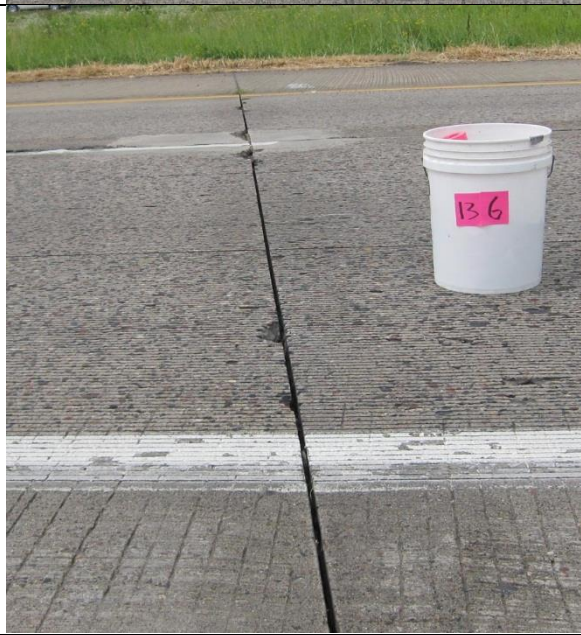
| Joint | 2013 | 2015 |
|---|--|--|
| 136 | <p>A photograph of a concrete joint on a road surface in 2013. A yellow tag with the number '136' is placed on the right side of the joint. The joint appears relatively clean and well-maintained.</p> | <p>A photograph of the same concrete joint in 2015. A white bucket with a pink tag labeled '136' is placed on the right side of the joint. The joint shows some weathering and a small amount of vegetation growth.</p> |

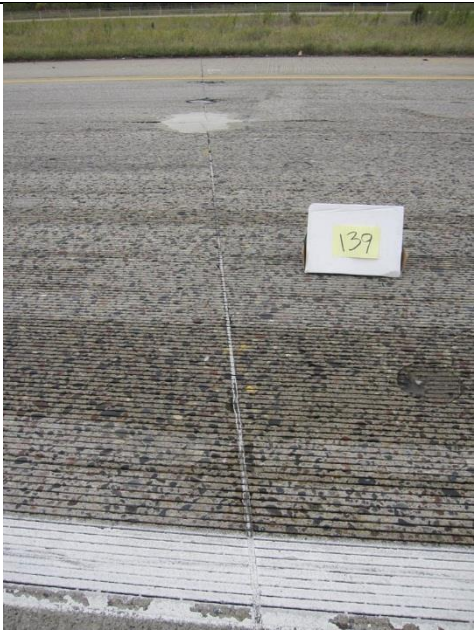
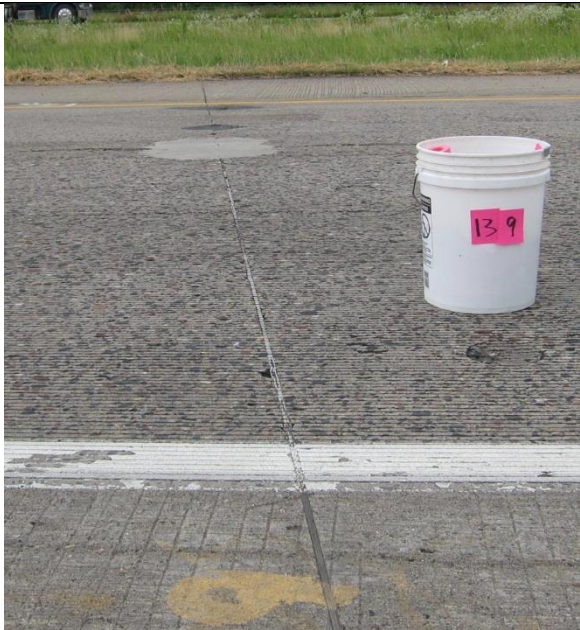
| Joint | 2013 | 2015 |
|---|---|--|
| 139 | <p>A photograph of a road joint labeled 139 in 2013. A yellow tag with the number '139' is placed on the asphalt surface to the right of the joint. The joint shows some wear and a small circular patch.</p> | <p>A photograph of the same road joint labeled 139 in 2015. A white bucket with a pink tag labeled '139' is placed on the asphalt surface to the right of the joint. The joint shows more significant wear and a larger circular patch.</p> |

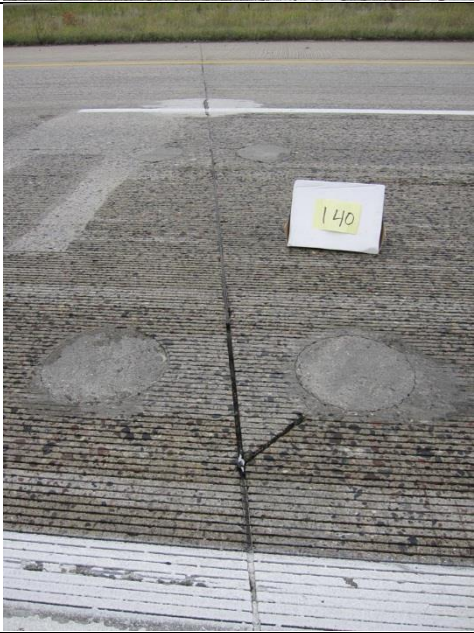
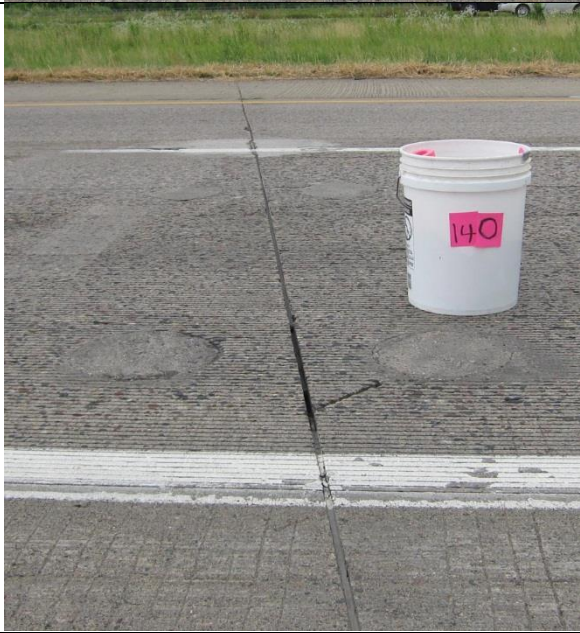
| Joint | 2013 | 2015 |
|---|---|--|
| 140 | <p>A photograph of a road joint labeled 140 in 2013. A yellow tag with the number '140' is placed on the asphalt surface to the right of the joint. The joint shows some wear and two circular patches.</p> | <p>A photograph of the same road joint labeled 140 in 2015. A white bucket with a pink tag labeled '140' is placed on the asphalt surface to the right of the joint. The joint shows more significant wear and two circular patches.</p> |

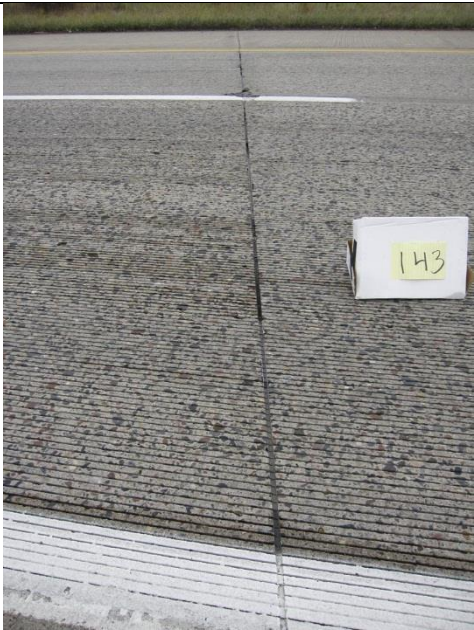
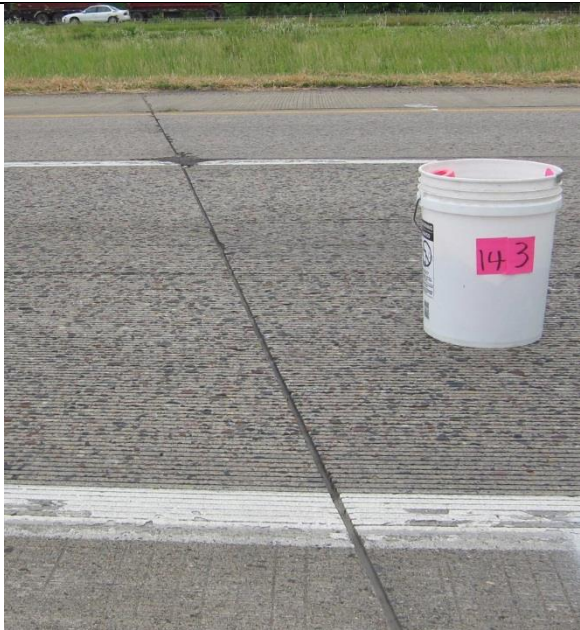
| Joint | 2013 | 2015 |
|---|--|--|
| 143 | <p>A photograph of a concrete joint on a road surface. A yellow tag with the number '143' is placed on the right side of the joint. The joint is a narrow, dark line.</p> | <p>A photograph of the same concrete joint on a road surface. A white bucket with a pink tag labeled '143' is placed on the right side of the joint. The joint is a narrow, dark line.</p> |

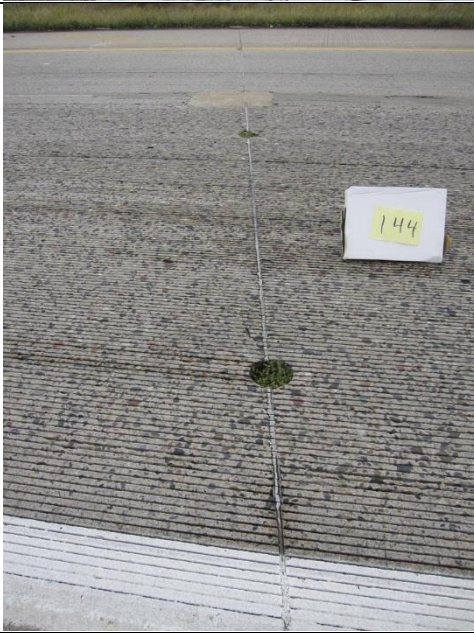
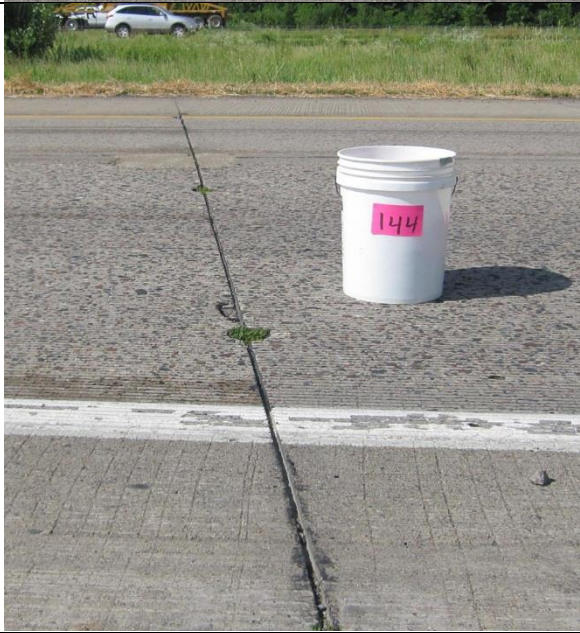
| Joint | 2013 | 2015 |
|---|--|--|
| 144 | <p>A photograph of a concrete joint on a road surface. A yellow tag with the number '144' is placed on the right side of the joint. There is a small patch of grass growing in the joint.</p> | <p>A photograph of the same concrete joint on a road surface. A white bucket with a pink tag labeled '144' is placed on the right side of the joint. There is a small patch of grass growing in the joint.</p> |

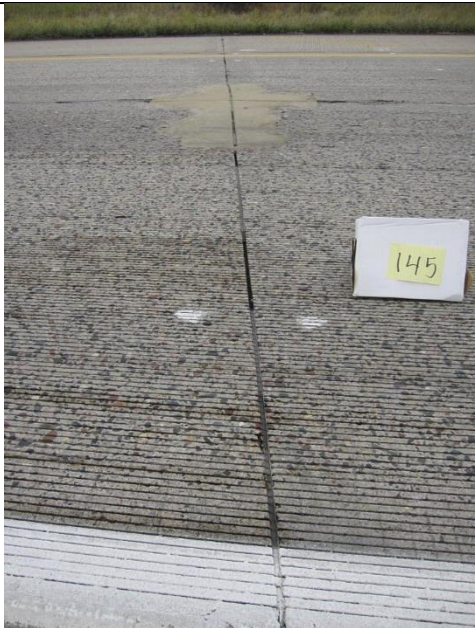
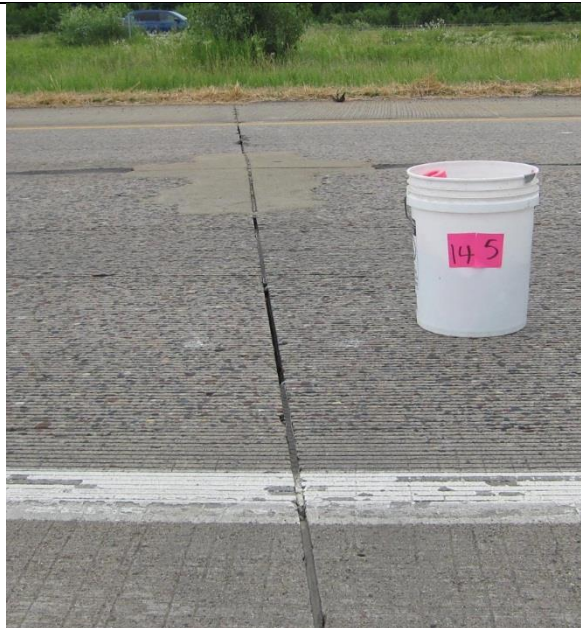
| Joint | 2013 | 2015 |
|---|--|--|
| 145 | <p>A photograph of a road joint in 2013. A vertical crack runs down the center of the frame. To the right of the crack, a small white tag with a yellow sticker labeled '145' is placed on the asphalt. The asphalt surface shows some staining and a white curb is visible at the bottom.</p> | <p>A photograph of the same road joint in 2015. A white bucket with a pink sticker labeled '145' is placed on the asphalt to the right of the crack. The crack appears slightly wider and more defined than in 2013. The background shows green grass and a blue car.</p> |

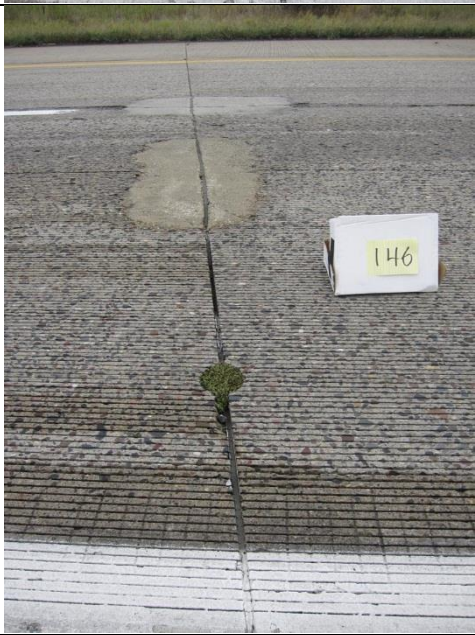
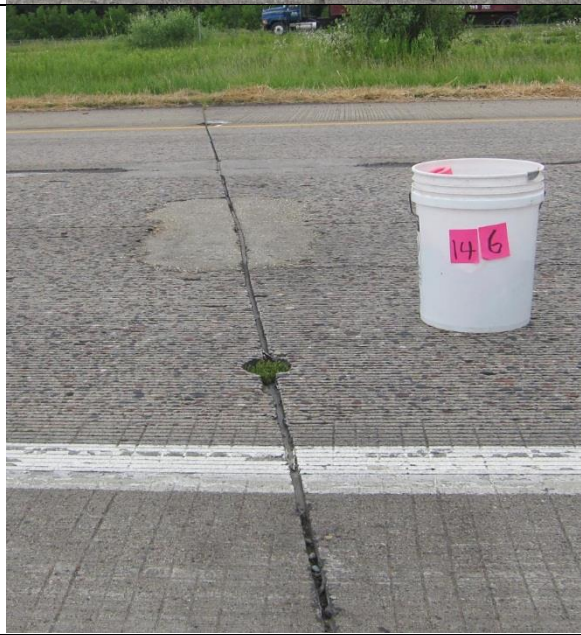
| Joint | 2013 | 2015 |
|---|--|--|
| 146 | <p>A photograph of a road joint in 2013. A vertical crack runs down the center. A small tuft of green moss or vegetation is growing from the crack. To the right, a white tag with a yellow sticker labeled '146' is placed on the asphalt. A white curb is visible at the bottom.</p> | <p>A photograph of the same road joint in 2015. The white bucket with a pink sticker labeled '146' is placed to the right of the crack. The tuft of vegetation in the crack is more prominent. The background shows green grass and a blue truck.</p> |

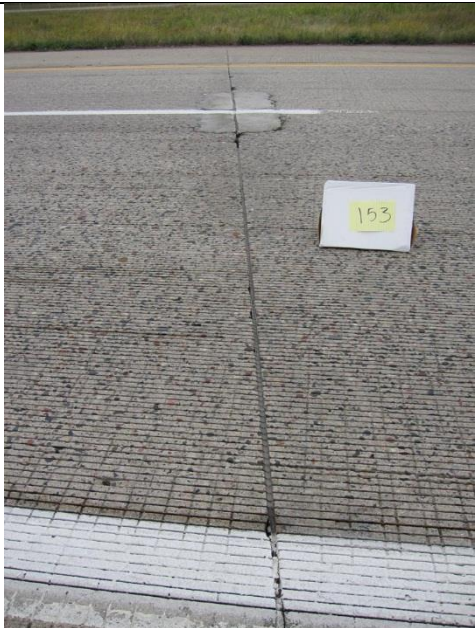
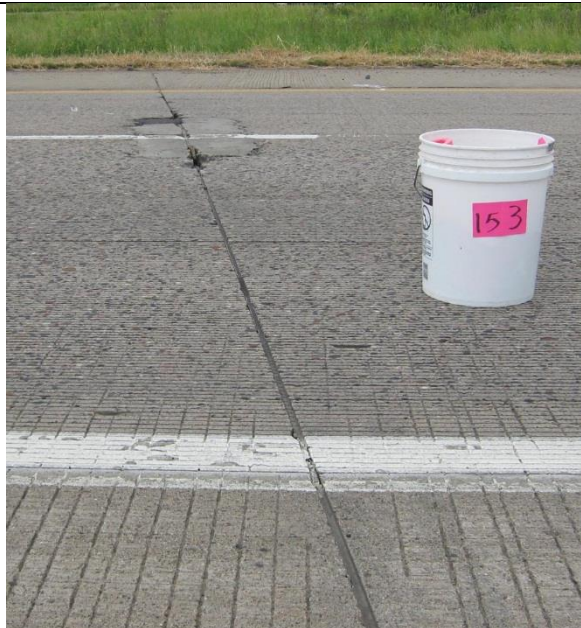
| Joint | 2013 | 2015 |
|---|---|--|
| 553 | <p>A photograph of a road joint labeled 553 in 2013. A yellow tag with the number 153 is placed on the asphalt surface to the right of the joint. The joint shows some cracking and a small amount of material loss.</p> | <p>A photograph of the same road joint labeled 553 in 2015. A white bucket with a pink tag labeled 153 is placed on the asphalt surface to the right of the joint. The joint shows significant deterioration, including a large hole and extensive cracking.</p> |

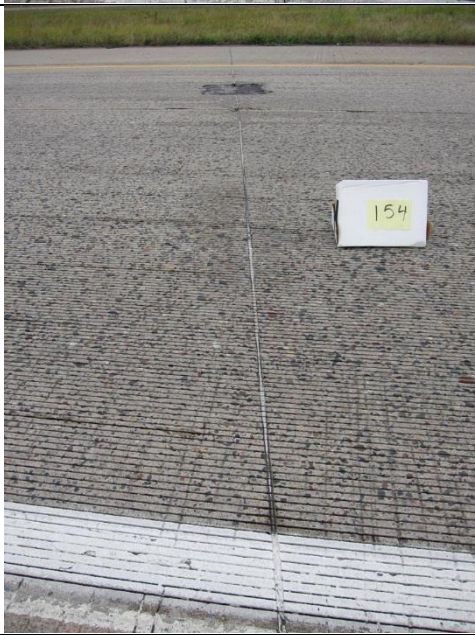
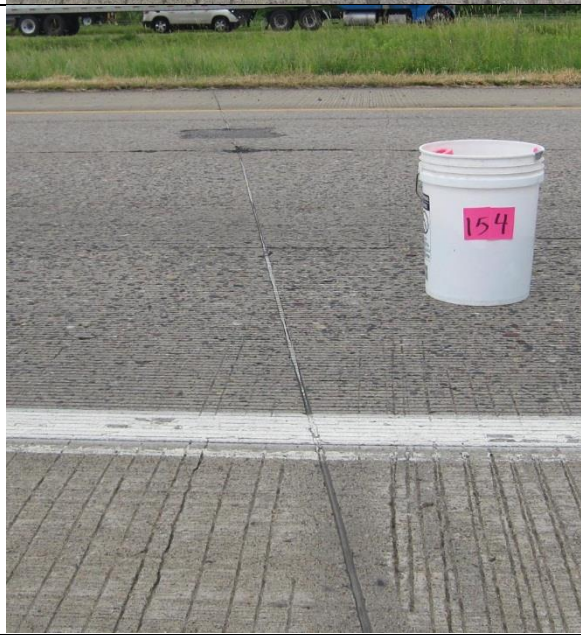
| Joint | 2013 | 2015 |
|---|---|--|
| 154 | <p>A photograph of a road joint labeled 154 in 2013. A yellow tag with the number 154 is placed on the asphalt surface to the right of the joint. The joint shows some cracking and a small amount of material loss.</p> | <p>A photograph of the same road joint labeled 154 in 2015. A white bucket with a pink tag labeled 154 is placed on the asphalt surface to the right of the joint. The joint shows significant deterioration, including a large hole and extensive cracking.</p> |

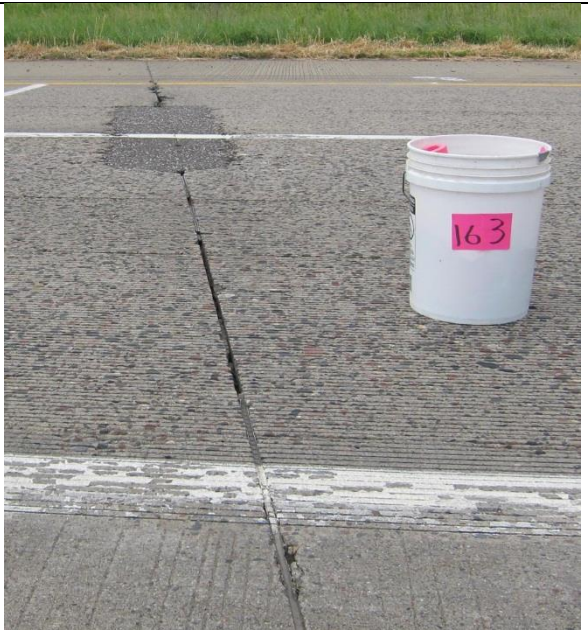
| Joint | 2013 | 2015 |
|---|---|--|
| 163 | N/A | A photograph showing a joint in a paved surface. A white bucket with a pink label '163' is placed on the right side of the joint. The joint shows some wear and a dark patch of material. |

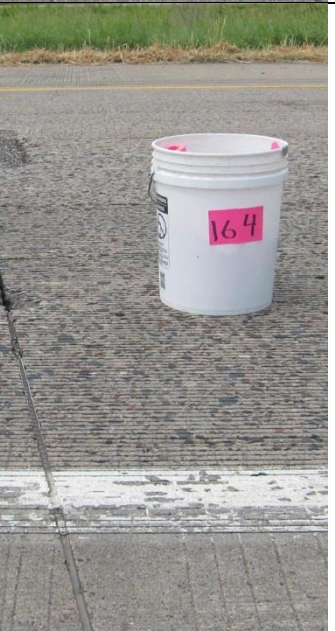
| Joint | 2013 | 2015 |
|---|---|--|
| 164 | N/A | A photograph showing a joint in a paved surface. A white bucket with a pink label '164' is placed on the right side of the joint. The joint shows some wear and a dark patch of material. |
