Evaluating Roadway Subsurface Drainage Practices

Final Report
May 2013

IOWA STATE UNIVERSITY
Institute for Transportation

Sponsored by
Iowa Highway Research Board
(IHRB Project TR-643)
Iowa Department of Transportation
(InTrans Project 12-428)

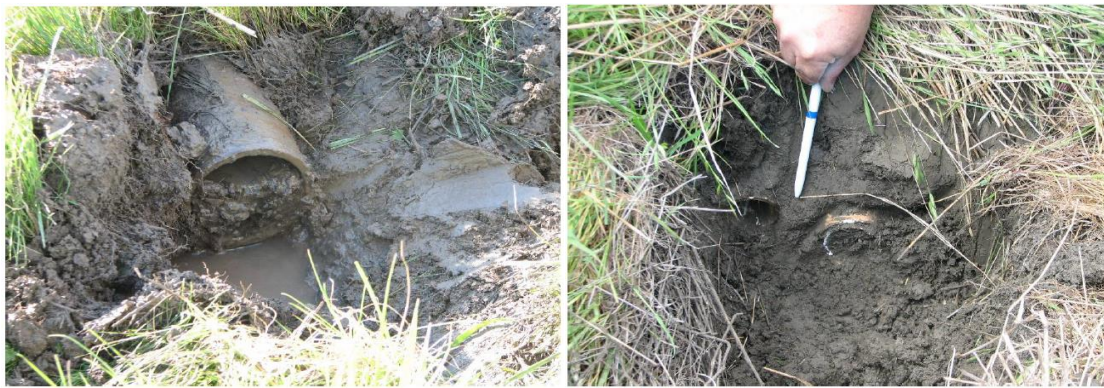
Figure 7. Clogging of edge drain outlet pipes in California PCC pavements (Bhattacharya et al. 2009)

A total of 24 projects in 15 different counties were surveyed and 9 were selected for further evaluation by excavating the shoulder. Field investigations revealed that fewer than 30 percent of the evaluated edge drains, which were generally in the areas of higher rainfall, were operating in an acceptable manner. The majority of the remaining sites revealed little or no maintenance and the drain pipes were clogged with soil from both roadbed drainage and the shoulder area (see Figure 7).

The lack of end wall protection further exacerbated the clogging of outlet pipes. However, in many of the pavement sections, no significant correlation was found between observed pavement distresses and clogged edge drains, probably due to recent pavement rehabilitation activities.

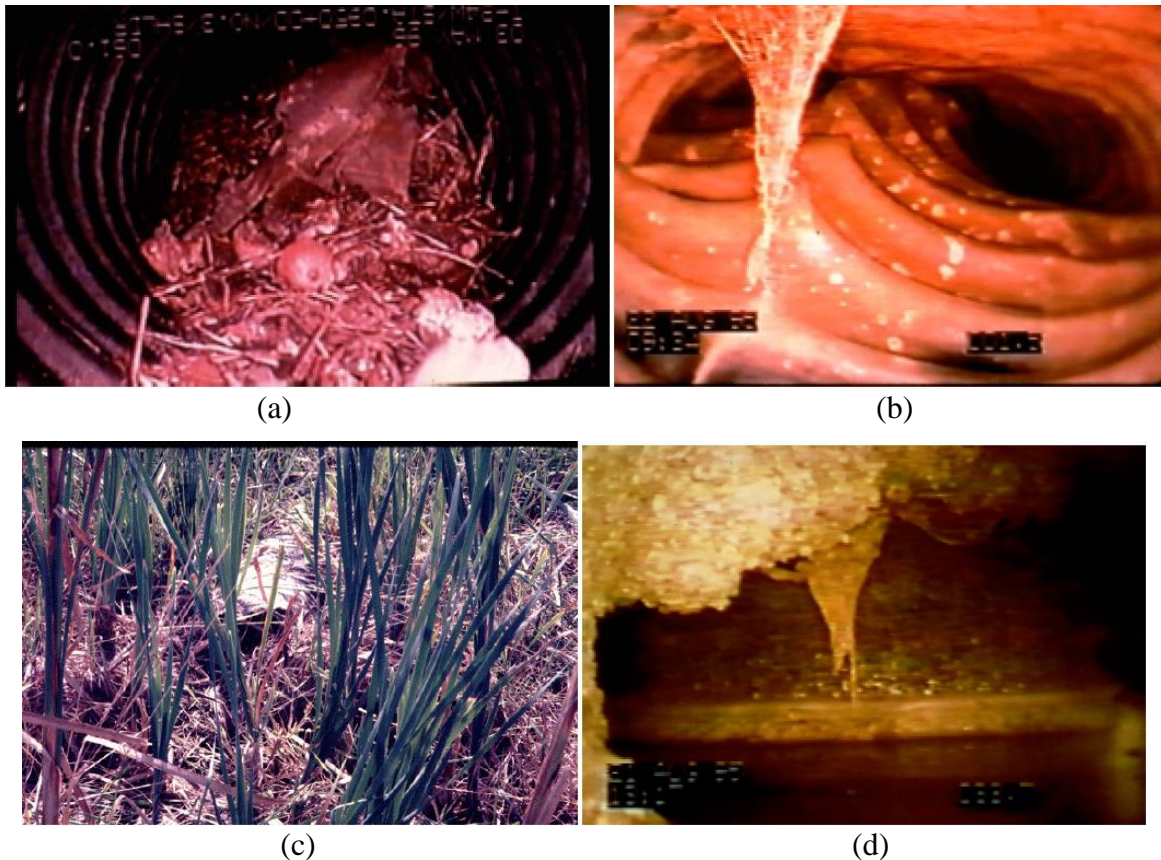
Figure 8. Common subsurface drainage system maintenance problems encountered by SHAs: (a) rodent nest, (b) crushed pipes during construction, (c) hidden outlet pipe, and (d) ninety-degree tee (Baumgardner 2002)

Baumgardner (2002) presented several visual examples and case histories to document FHWA attempts at stressing the importance of maintenance of pavement subsurface drainage maintenance to SHAs. Some common maintenance problems encountered by SHAs are shown in Figure 8.

According to Baumgardner (2002), the use of headwalls, reference markers, signs on fences, reflector disks in the shoulder, or painted arrows on the shoulder help SHAs greatly in providing maintenance. Even a simple arrow painted on the edge of the shoulder serves as a good reference marker for maintenance personnel. The FHWA also recommends the use of larger headwalls given that it has the following advantages: easier for maintenance personnel to locate the drainage outlet pipe, roadside vegetation is located away from the outlet, reduces erosion at the pipe outlet, and prevents crushing of the outlet pipe during construction and mowing operations (Baumgardner 2002). In summary, Baumgardner's synthesis study concluded that an SHA should not use permeable bases if it is unwilling to make a maintenance commitment because it will increase the rate of pavement damage.

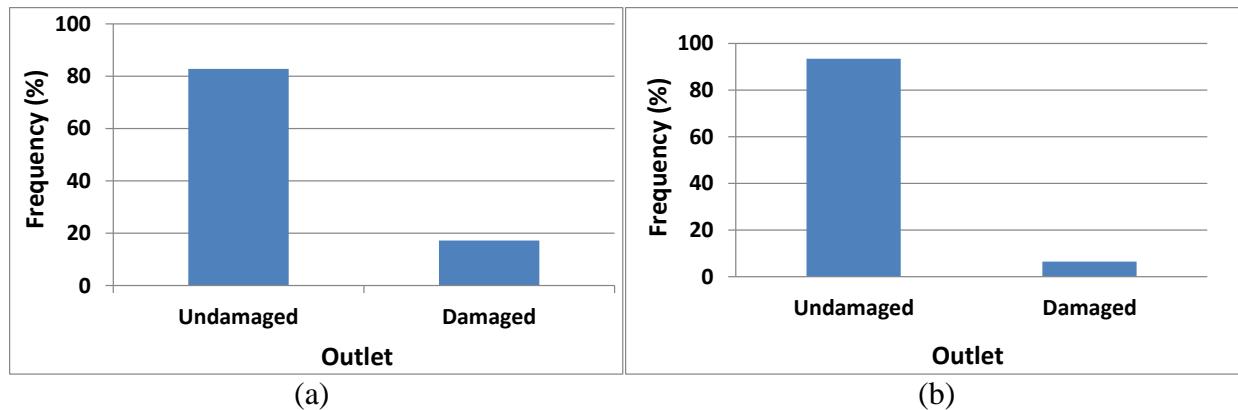
Figure 17. Undamaged and damaged subsurface drainage outlet in Iowa pavements investigated: (a) JPCP and (b) HMA

Figure 17 compares undamaged and damaged (broken outlet pipeline) subsurface drainage outlets among the ones that were investigated. Less than 20 percent of the investigated JPCP drainage outlets were damaged while less than 10 percent of HMA pavement drainage outlets were broken.

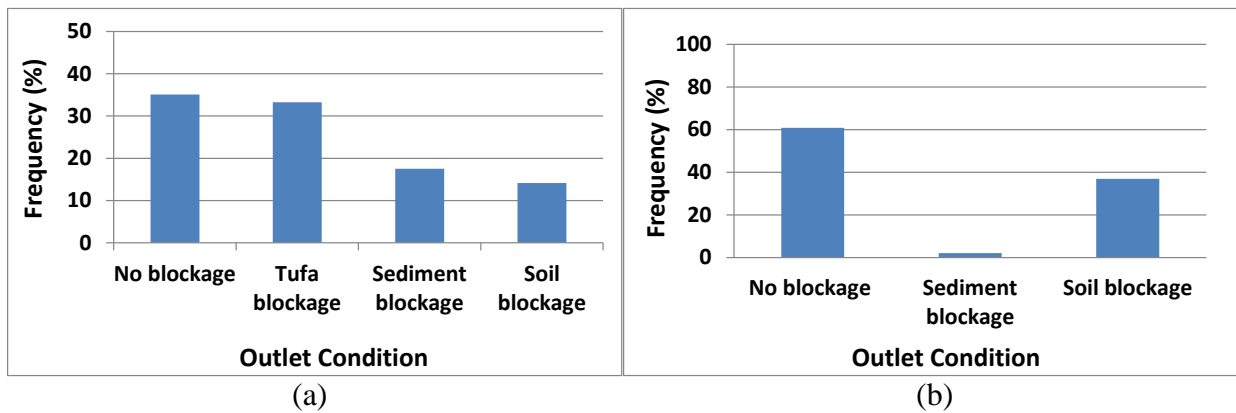
Figure 19. Distribution of Iowa roadway subsurface drainage outlet condition categories: (a) JPCP and (b) HMA

Figure 19 presents the distributions of these four drainage outlet conditions observed in JPCPs and HMA pavements. About 35 percent of the outlets in JPCPs and 60 percent of outlets in HMA pavements were not blocked by any materials. About 35 percent of outlets in JPCPs were blocked by tufa, about 17 percent were blocked by sediment, and about 14 percent were blocked by soil deposits. However, most of the blocked outlets in HMA pavements were blocked by soil deposits (see Figure 19b). Only 2 percent of outlets in HMA pavements were blocked by sediment.

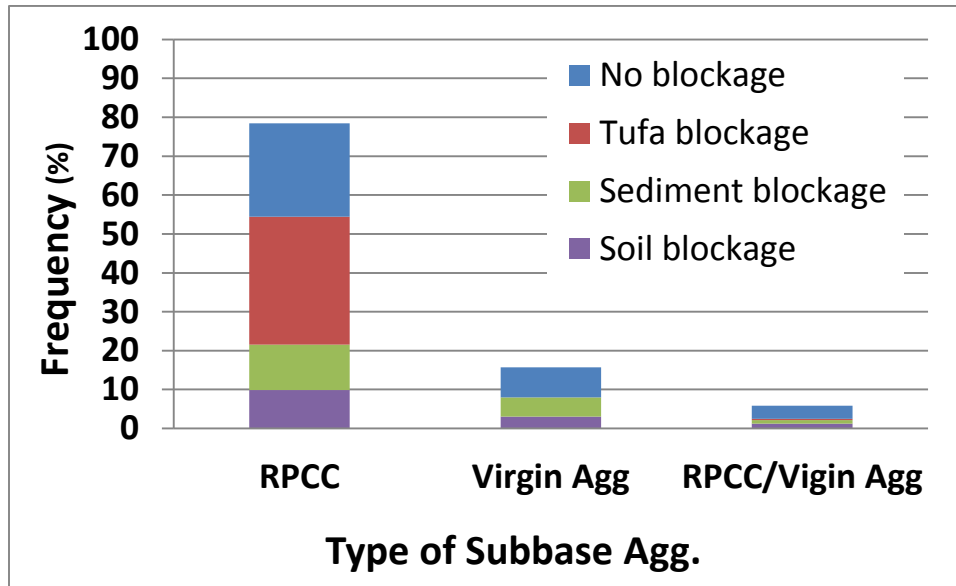
Figure 20. Subsurface drainage outlet conditions distribution with respect to Iowa JPCP subbase aggregate type

Figure 20 presents distributions of drainage outlet conditions with respect to JPCP subbase aggregate material types. As seen in this figure, tufa formation and drain outlet blockage were observed mainly in JPCP with RPCC subbase materials. Few drain outlets with tufa blockage were observed in JPCP with blended RPCC and virgin aggregate subbase materials (10 spots on US 151/S/MP 67.57 to MP 67.57 and 9 spots on US 151/N/MP 62.55 to MP 67.48).

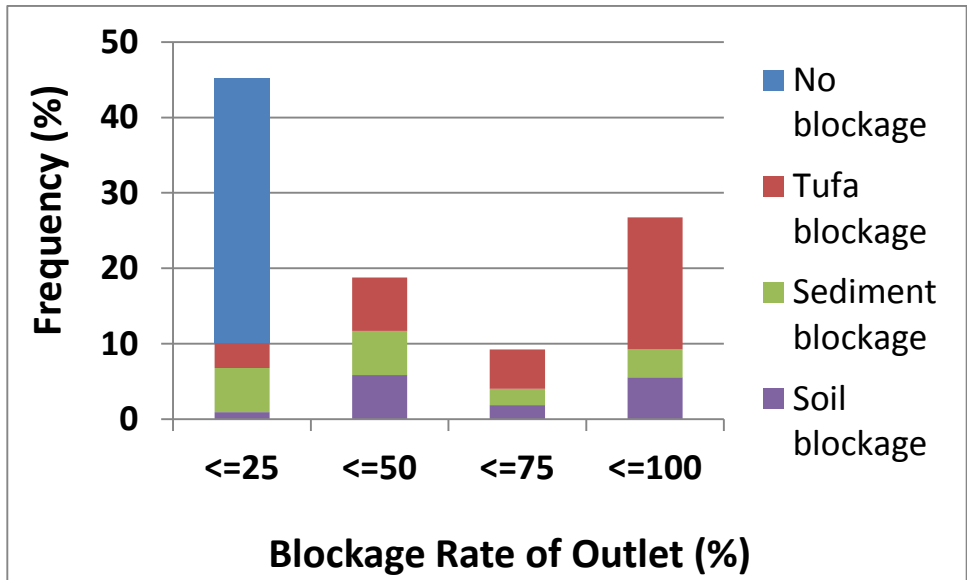
Figure 21. Blockage rate and type of Iowa JPCP subsurface drainage outlets

Figure 21 and Figure 22 present blockage rates of drainage outlet conditions in JPCPs and HMA pavements, respectively. As seen in Figure 21, at higher blockage rates, JPCP drain outlets are blocked primarily by tufa rather than soil and sediment. However, irrespective of the blockage rate, the HMA pavement subdrainage outlets are blocked primarily by soil.

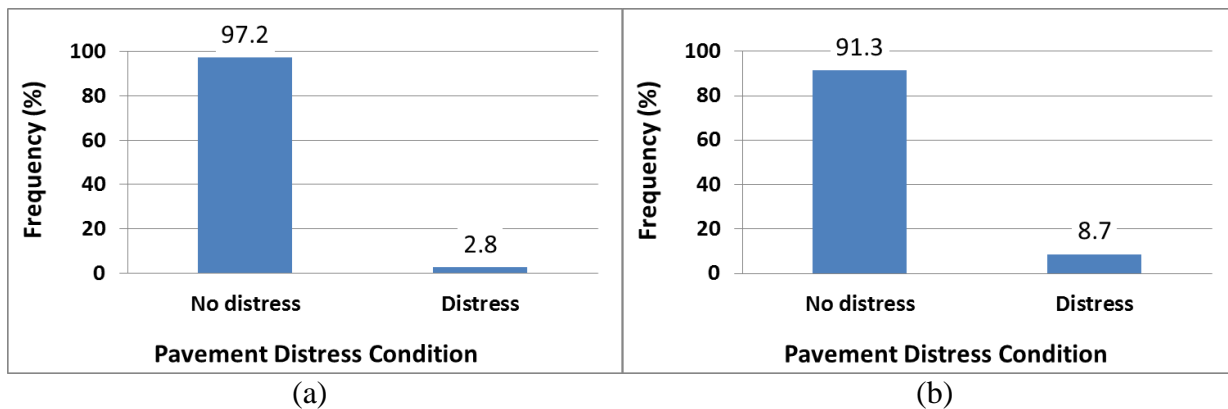
Figure 26. Distress condition in investigated Iowa pavements: (a) JPCP and (b) HMA

Figure 26 presents distributions of pavement surface distress observed on Iowa JPCPs and HMA pavements. More than 90 percent of investigated spots do not have any surface distress on both pavement types. The distress types observed in JPCP are transverse cracking, longitudinal cracking, and corner cracking. The only relevant distress observed for HMA pavement is transverse cracking.

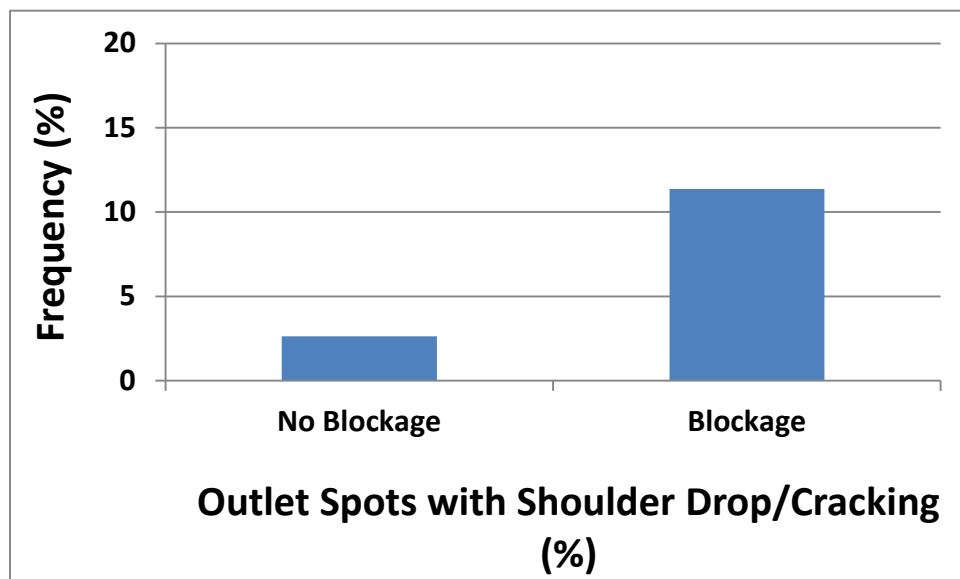
Figure 31. Outlet spots with shoulder drop/cracking in Iowa JPCP

Rather than surface distresses, more shoulder distresses (shoulder drop or cracking) as shown in Figure 30 were observed near blocked drainage outlet spots. Note that the opened outlet captured in Figure 30 was newly installed to replace the 100 percent blocked outlet. Figure 31 compares frequency of outlet spots with observed shoulder distress under opened and blocked outlet conditions. More than 10 percent of the blocked drainage outlet spots have shoulder distresses while only 2 percent among opened drainage outlets have shoulder distresses.

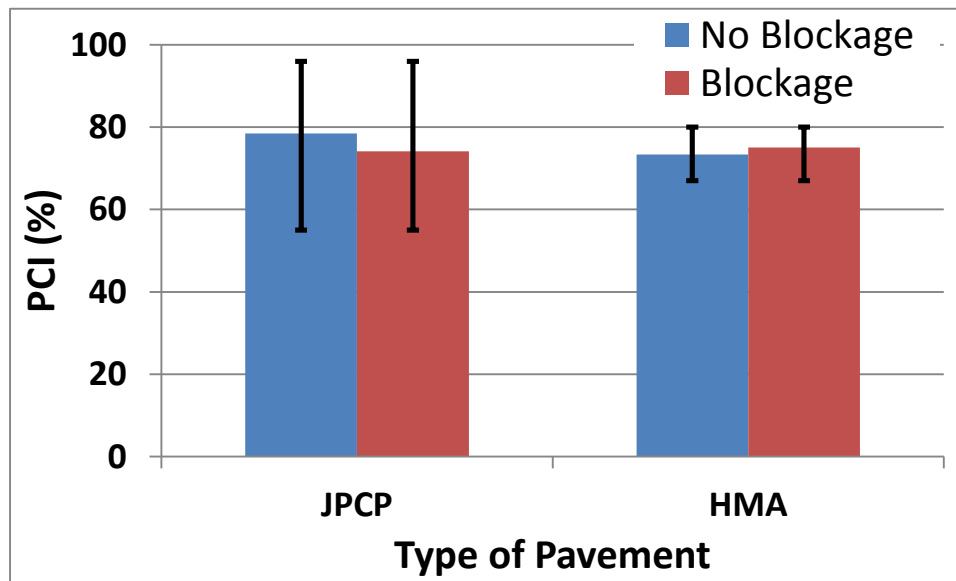
Figure 32. PCI distribution for investigated Iowa pavements with respect to drainage outlet condition

The PCI from the Iowa DOT PMIS was utilized as a performance indicator of the pavement's structural integrity and pavement surface condition. The PCI is a numerical index ranging from 0 for a failed pavement to 100 for a pavement in perfect condition. Figure 32 compares PCI of pavements at the opened drainage outlet spots and at the blocked drainage outlet spots for both JPCP and HMA pavement types.

Opened drainage outlet spots in JPCP show a little better performance than blocked drainage outlet spots while both outlet conditions have almost similar influences on HMA performance. However, these comparisons could not explain whether drainage outlet condition can affect pavement performance given that both opened and blocked drainage outlet spots have different traffic, pavement age, and pavement structure, which can all contribute to pavement performance.
