Deicer Scaling Resistance of Concrete Pavements, Bridge Decks, and Other Structures Containing Slag Cement

Phase 1: Site Selection and Analysis of Field Cores

Final Report September 2008

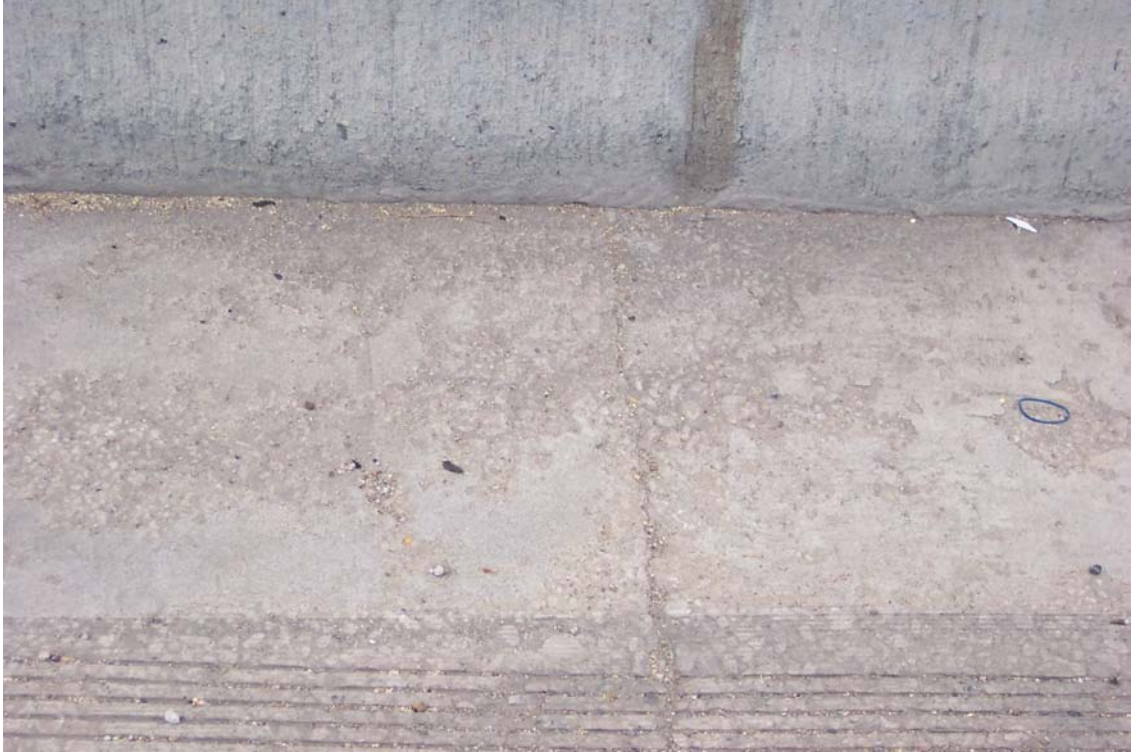
Figure 6. Euclid bridge, eastbound

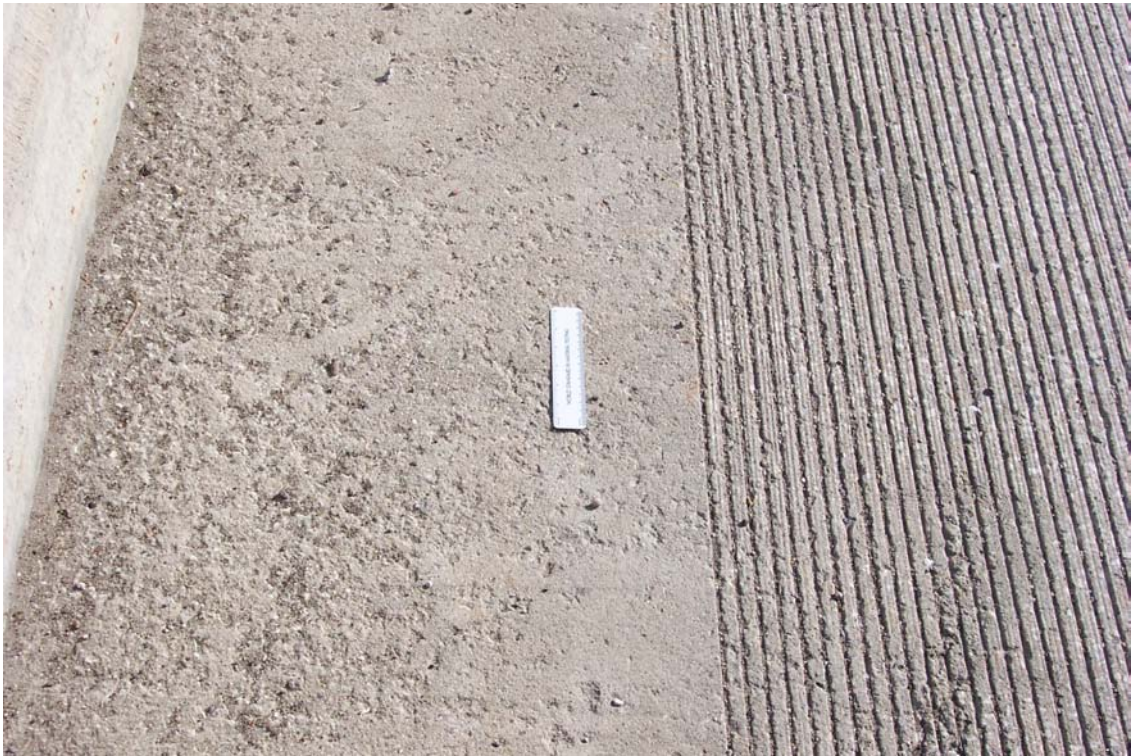
The bridge over Euclid Avenue is about 300 ft long and consists of four driving lanes, two exit ramps, a pedestrian walkway, and an island that separates eastbound and westbound traffic. The project was constructed in two stages. The first stage (westbound deck, two driving lanes, and one exit ramp) was poured in June 2003. Temperatures on the days the stage one deck was poured ranged from lows near 65°F to highs near 90°F. The second stage (eastbound deck) was poured in November 2003. Temperatures on the days the stage two deck was poured ranged from lows near 25°F to highs near 50°F. Scaling was noted in the gutter region of both of the decks. However, the eastbound deck appeared to be considerably worse than the westbound deck (see Figures 6 through 9). The scaling on the eastbound deck occasionally was observed to continue into the driving lane of the pavement (Figure 8) and was estimated to cover about 10%–20% of the deck. In contrast, the scaling on the westbound deck was primarily observed in the gutter region, and the rest of the deck appeared to be sound, as shown in Figure 9 (note the sharp edges on the longitudinal tines that were cut into the deck). Macrocracks (apparently structural but possibly shrinkage-related) were noted on approximately 4 ft spacing near the mid-span of the eastbound deck. Some of the cracks continued up the parapet wall and through the pedestrian walkway. No structural cracks were noted on the westbound deck.

Figure 7. Euclid bridge, westbound

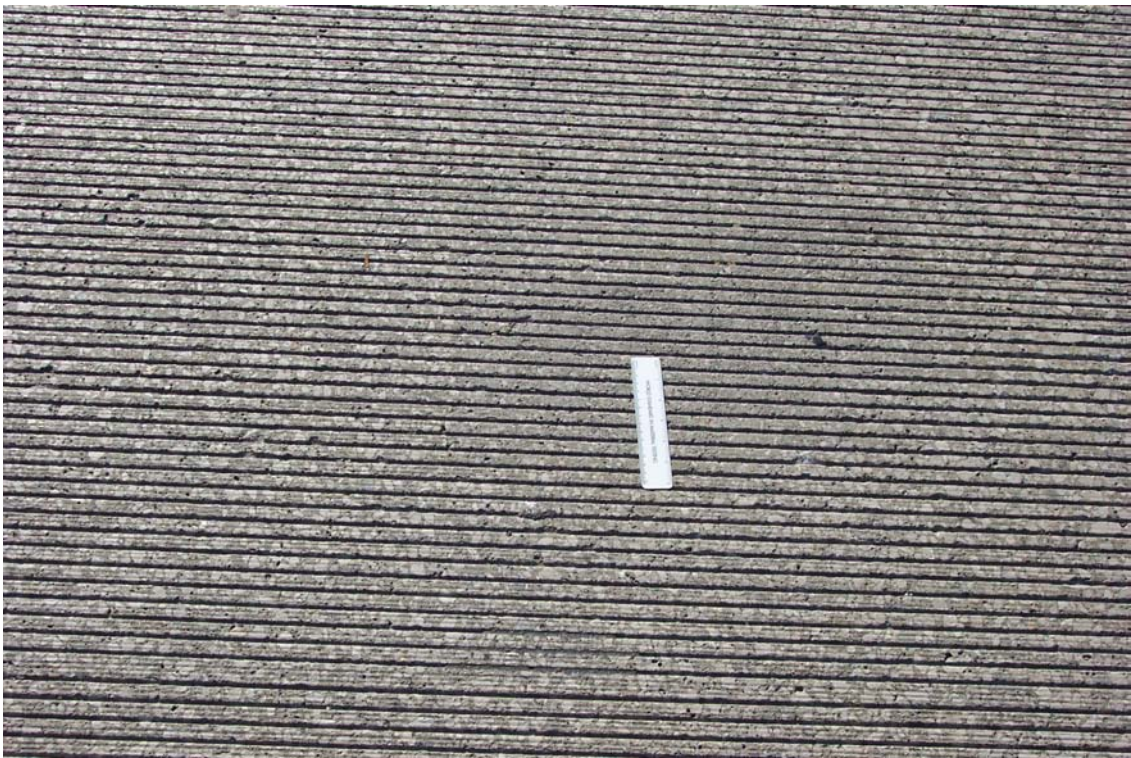
Figure 9. Euclid bridge, westbound driving lane

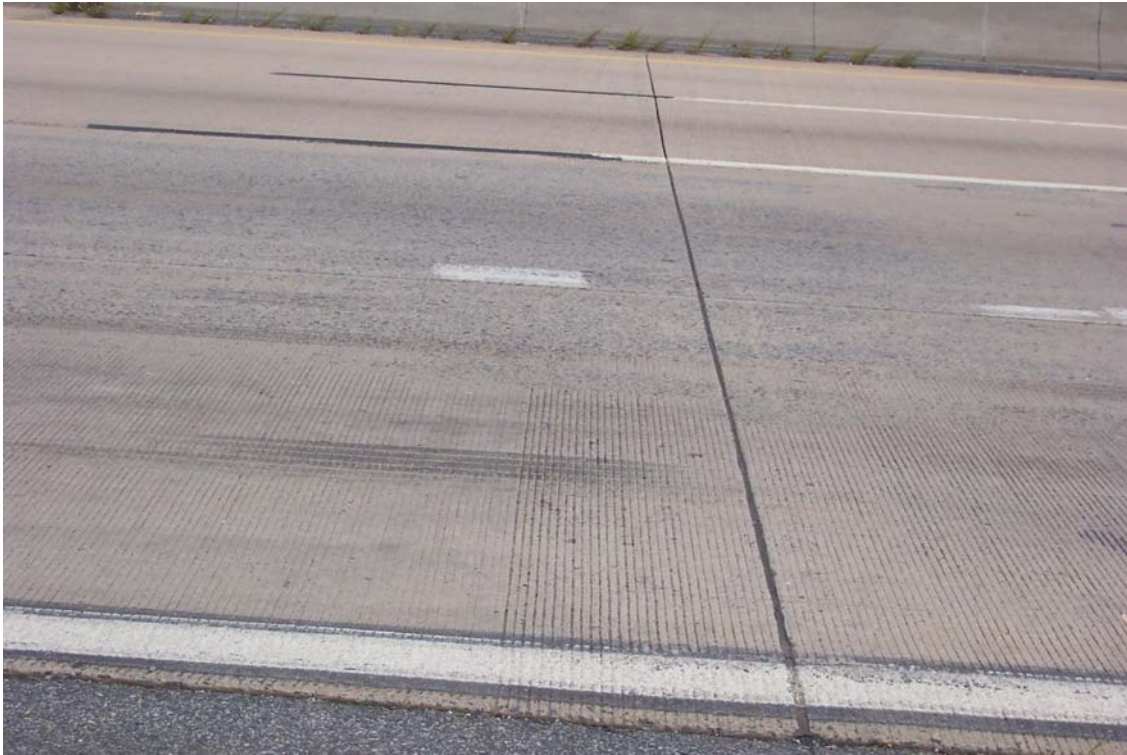
Each panel was 22 ft long, and dowel bars were present for load transfer. Scaling was difficult to assess at this site because the surface of the pavement was highly abraded and had received diamond grinding in many areas (see Figure 14). Some of the panels exhibited features that suggested scaling, but the surface texture changed so much between adjacent lanes and adjacent slabs that no definitive answer could be reached.

Figure 14. I-495 (between 9th Street and 12th Street, Wilmington, Delaware)

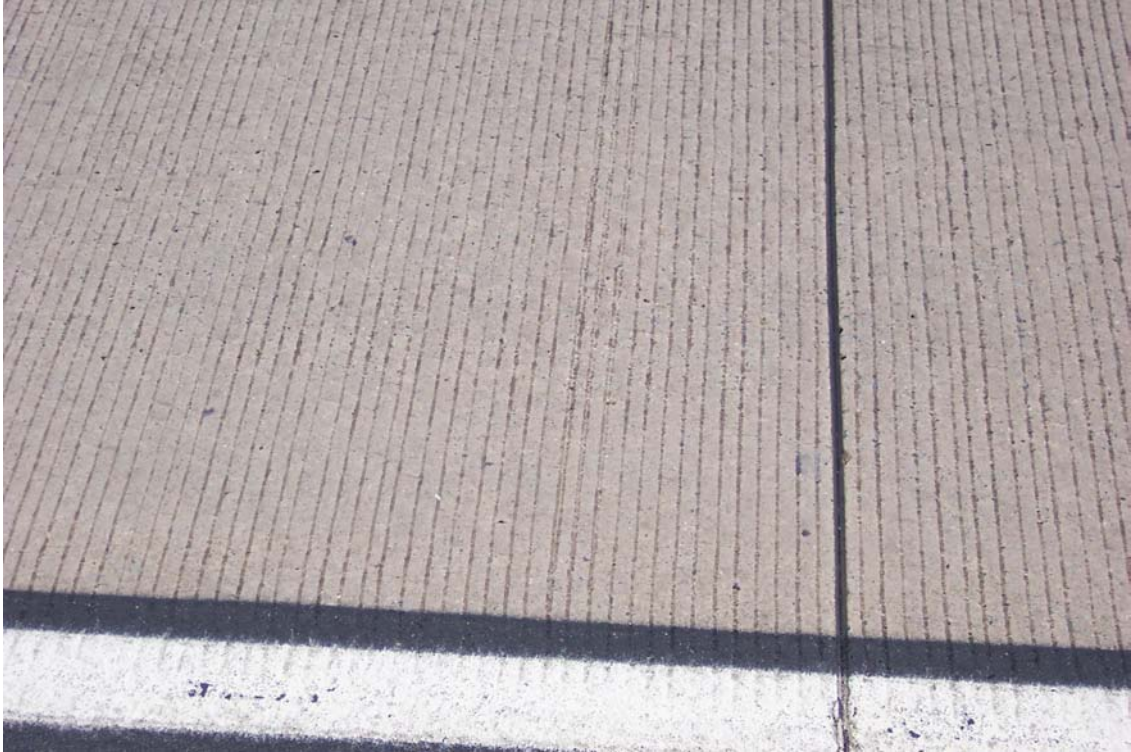
This section of SR 896 is a four-lane roadway that runs for about three miles between I-95 and US 40. Only the southbound driving lanes were surveyed due to traffic constraints. Pavement at this site was placed approximately 12 years ago. The cementitious materials used consisted of portland cement plus 35% slag. The pavement was a jointed concrete pavement (22 ft joint spacing) with dowel bars for load transfer. At first glance, the pavement appears to be in excellent condition (Figure 15). The joints were cleanly cut and the transverse tines appear to be very uniform across the panels. No scaling was evident on the panels. However, closer inspection indicated that some faint longitudinal cracking was present in the slabs (Figure 16). These very fine cracks were typically observed near the joints of the slabs.

Figure 15. Delaware SR 896 southbound (between I-95 and US 40)

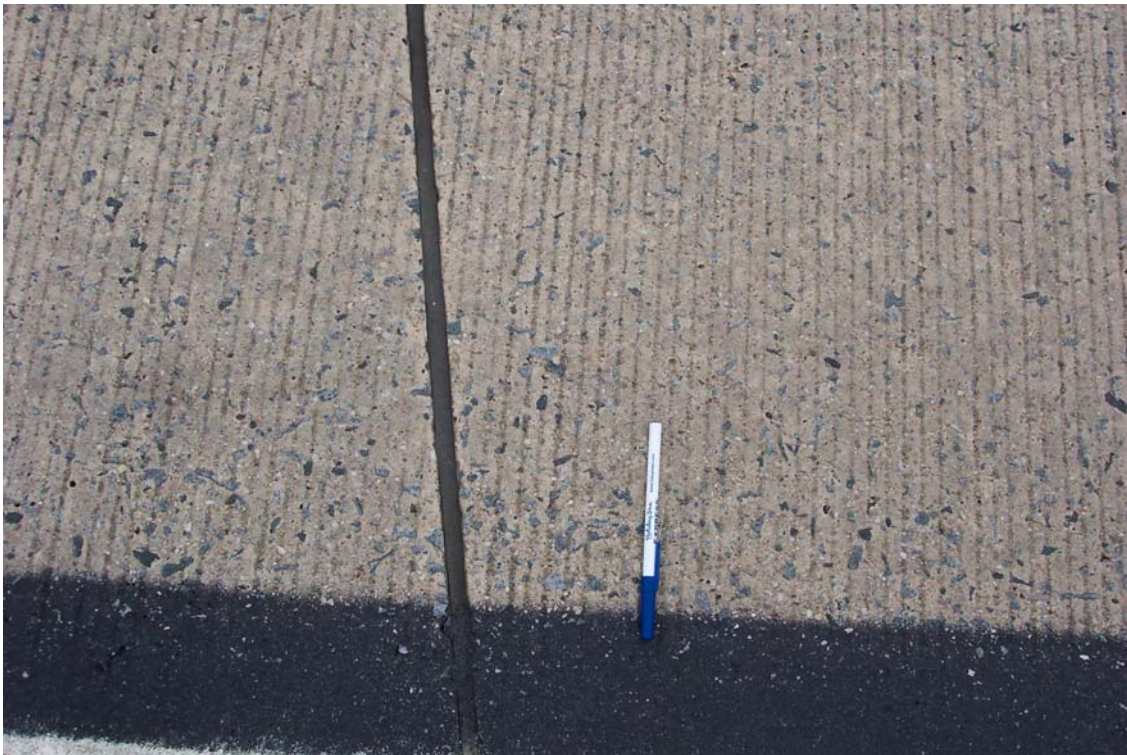
This section of SR 896 is a four-lane roadway that runs south of US 40 and eventually turns into Highway 71. Again, the focus of the survey was on the southbound driving lane due to traffic constraints. However, this site also had a concrete shoulder that was poured after the main line had been paved. Pavement at this site was placed approximately 16 to 17 years ago. The cementitious materials used consisted of a ternary mixture of portland cement, 10% to 15% fly ash, and 25% slag. The pavement was a jointed concrete pavement with dowel bars for load transfer. The pavement appeared to be in good condition (Figure 17), the joints were clean and sound, and there was no evidence of faulting or spalling. The top surface of the concrete was highly eroded, and coarse aggregate particles were clearly evident on the panels. During the field inspection it was difficult to determine whether this was due to traffic abrasion (the pavement was nearly 20 years old) or surface scaling.

Figure 17. Delaware SR 896 southbound (between US 40 and Highway 71)

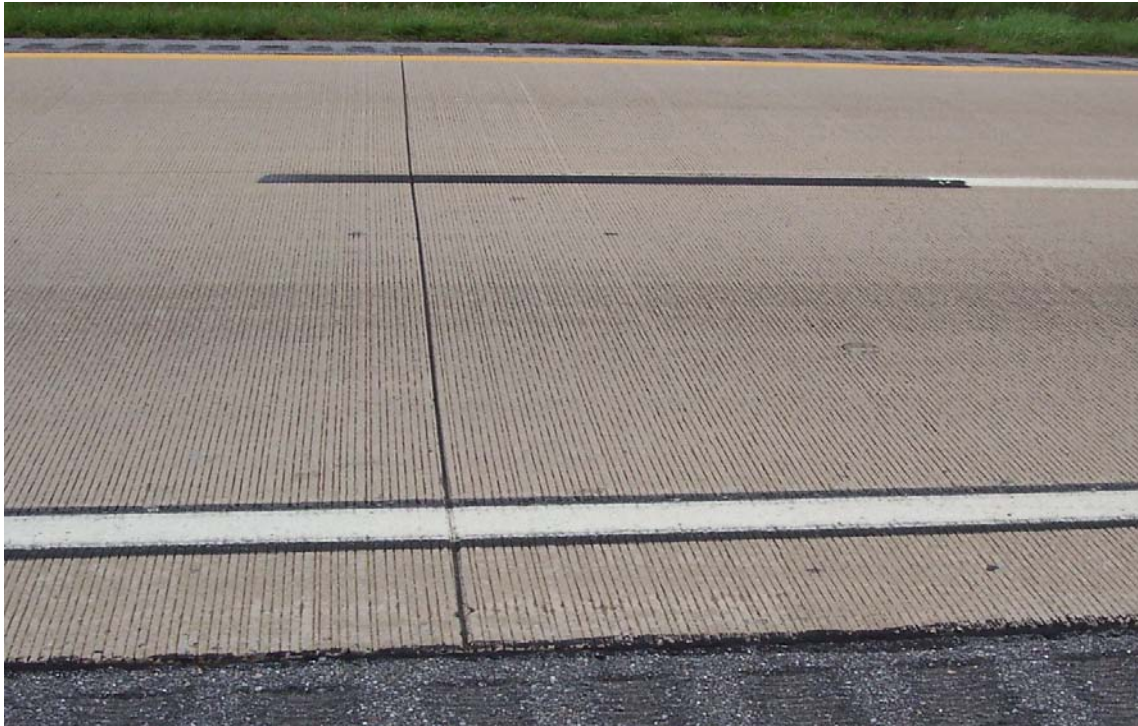
pavement (20 ft panels, straight joints) with dowel bars for load transfer. The overall condition of pavement at this site appeared to be good, with some evidence of surface abrasion and/or scaling.

Figure 18. Delaware SR1, southbound (between Smyrna and Dover, north of MP 73)

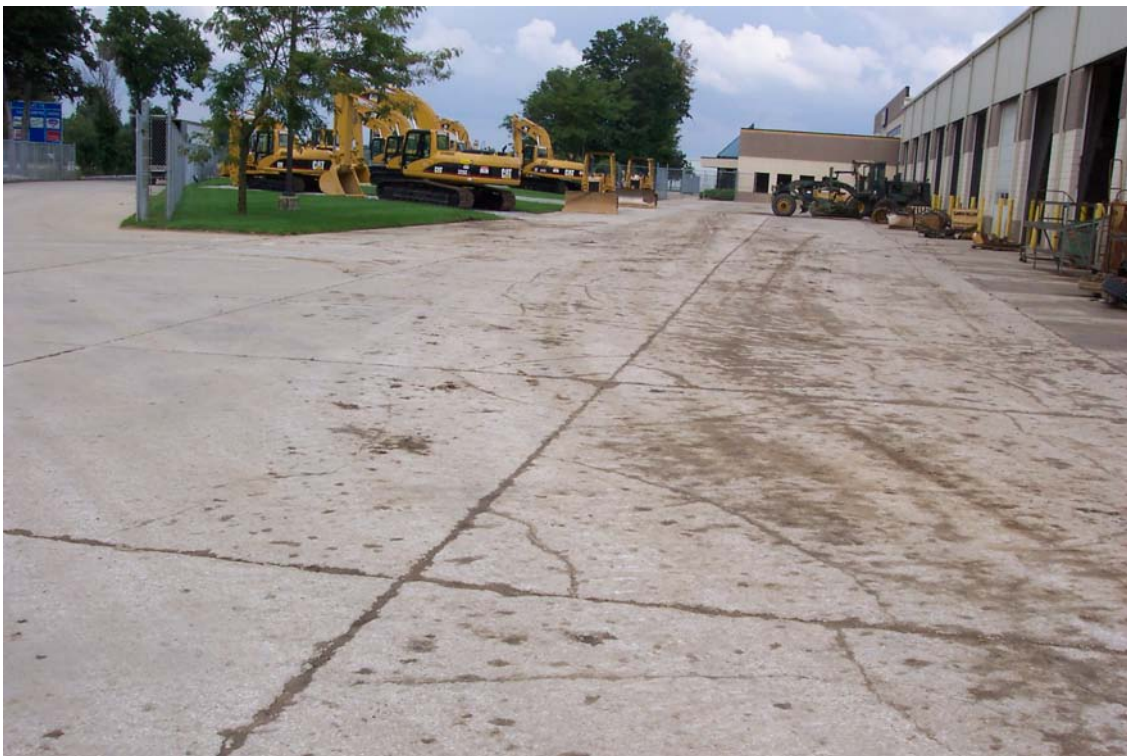
Michigan Caterpillar Company is located on the south side of Grand Rapids. This site consisted of the driveway and main service yard for the company. The slabs for the facility were poured in 1996, and performance appeared to vary considerably depending on traffic volume (see Figure 23). The driveway to the facility was in excellent shape. However, the slabs in the main yard exhibited many edge breaks and were highly abraded (also see Figure 24) due to the traffic of steel-tracked equipment. It was difficult to evaluate this site for scaling due to the high amount of surface abrasion present on the slabs. The nominal slab thickness was 9 in. The cementitious materials used in the project consisted of portland cement with 25% slag. Steel and poly fiber reinforcement were included in the concrete mixture to enhance the toughness of the slab and to hold it together under such a tough traffic loading. The company was pleased with the performance of the slabs, and the same concrete mixture was used for the construction of an addition to the plant in 2006.

Figure 23. Entrance and main yard of the Michigan Caterpillar Company

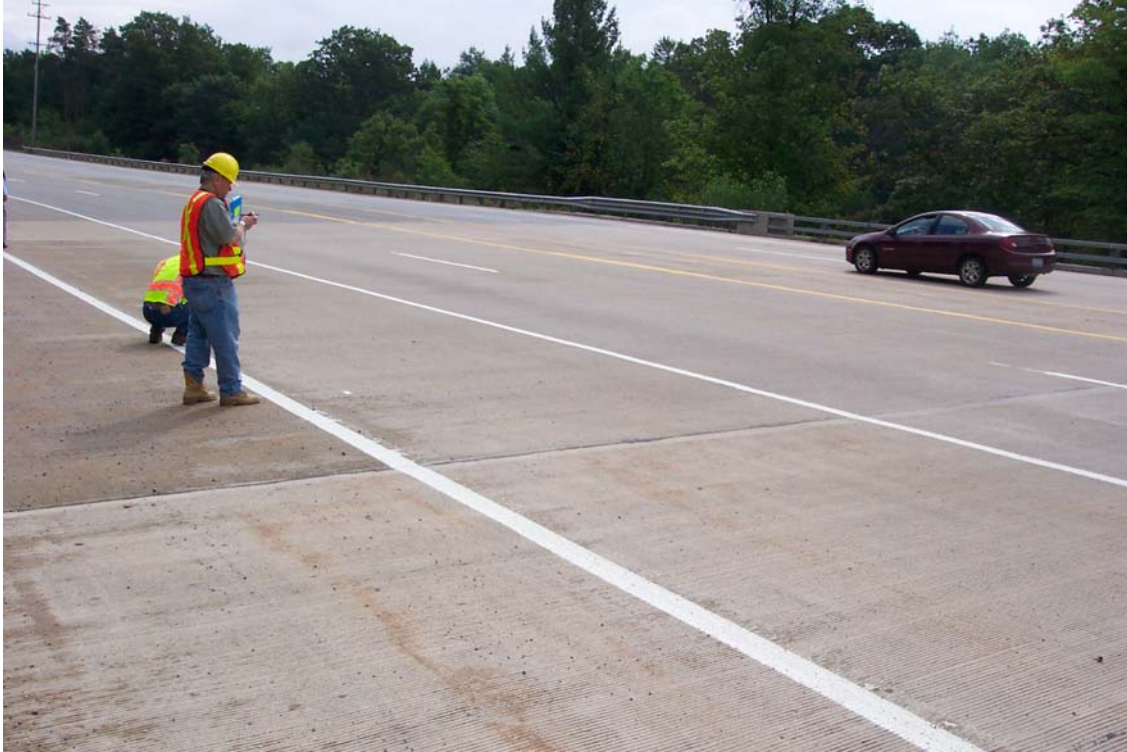
A short, multilane bridge was constructed over Sand Creek in the summer of 2001. This construction project used a mixture design that had been proposed for the much larger bridges that were to be constructed over the Grand River. Hence, this project could be considered a “trial run” for the larger project. The bridge was about 100 ft long by 100 ft wide and consisted of four traffic lanes and two shoulders (see Figure 25). Due to traffic control constraints, only the westbound deck and shoulder were surveyed. The nominal deck thickness was 9 in. The cementitious materials used in the project consisted of portland cement with 30% slag. The deck was tined while the concrete was plastic (transverse to the direction of traffic), and it appeared that the contractor was having some trouble estimating the timing for the process because the depth of the tines varied considerably across the deck (see Figure 26). There were a few sections with exposed coarse aggregate noted on the driving lane of the westbound side of the deck. However, snow plow–related abrasion was also noted in this area, which suggests that the exposed aggregate could have been caused by abrasion or scaling.

Figure 25. Overview of the short bridge on M-45 over Sand Creek

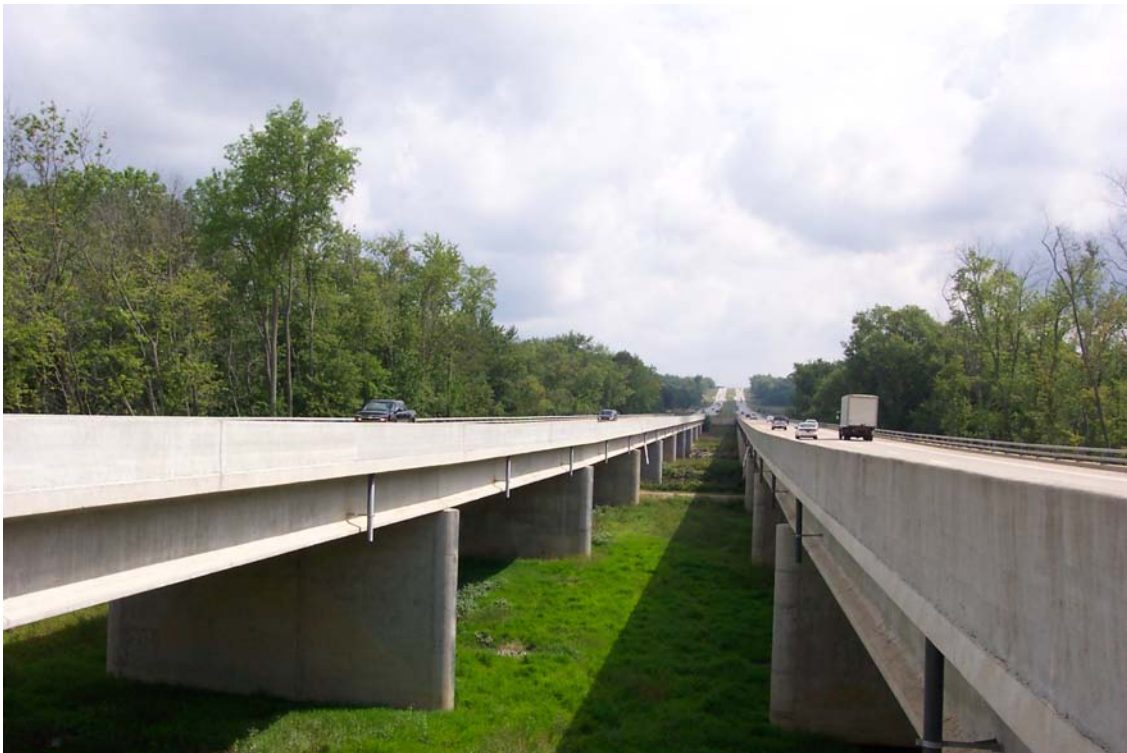
This pair of bridge decks was in excellent condition. Some structural cracks were noted over each set of pier supports, but other defects were minimal. Typically, neither deck exhibited scaling in the gutters, near the drains, or on the hand-finished edges of the decks. A small area of scaling was noted on the westbound deck. However, this was limited to a single 6 ft wide transverse band in the driving lane. The scaling appeared to be related to deep tining that was also observed in that region of the deck.

Figure 27. Long bridges on M-45 over the Grand River (looking east)

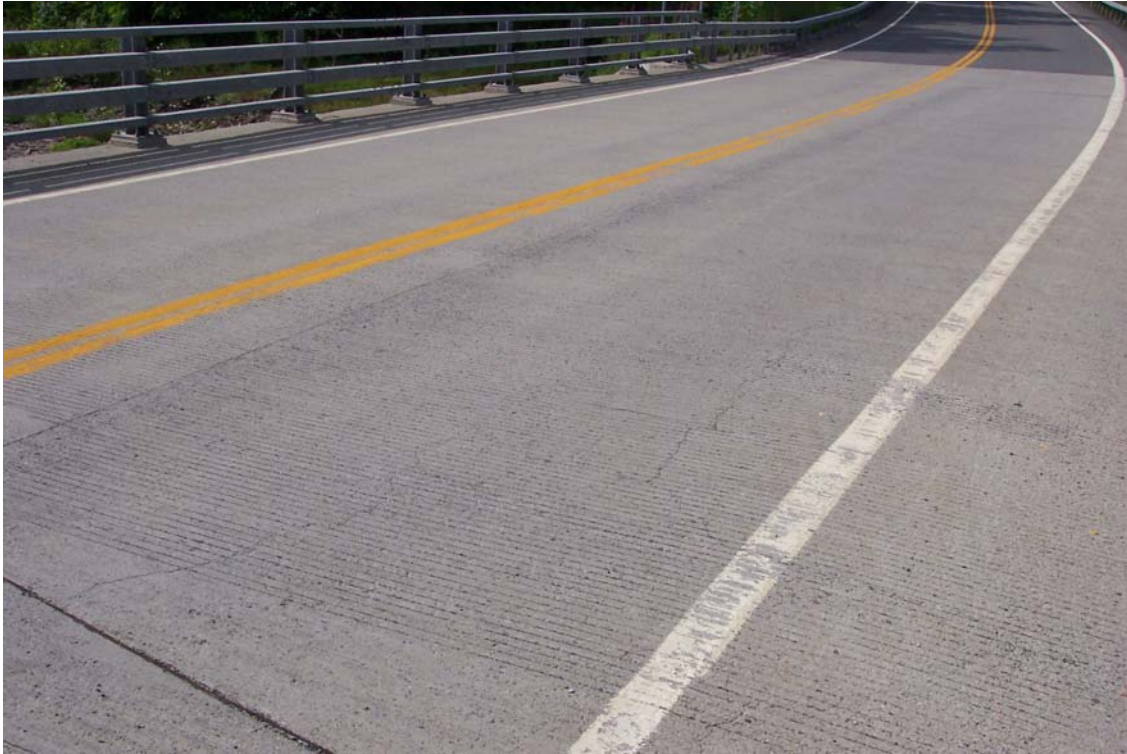
This was a two-lane deck, about 50 ft long. The bridge deck was constructed using a staged pour, and then a center pour was made to tie the two halves together (see Figure 29). The tines were milled into the surface of the deck (transverse to the traffic flow), and some distress appeared to be related to this construction operation.

Figure 29. Overview of the Route 397 bridge over the Bozenkill

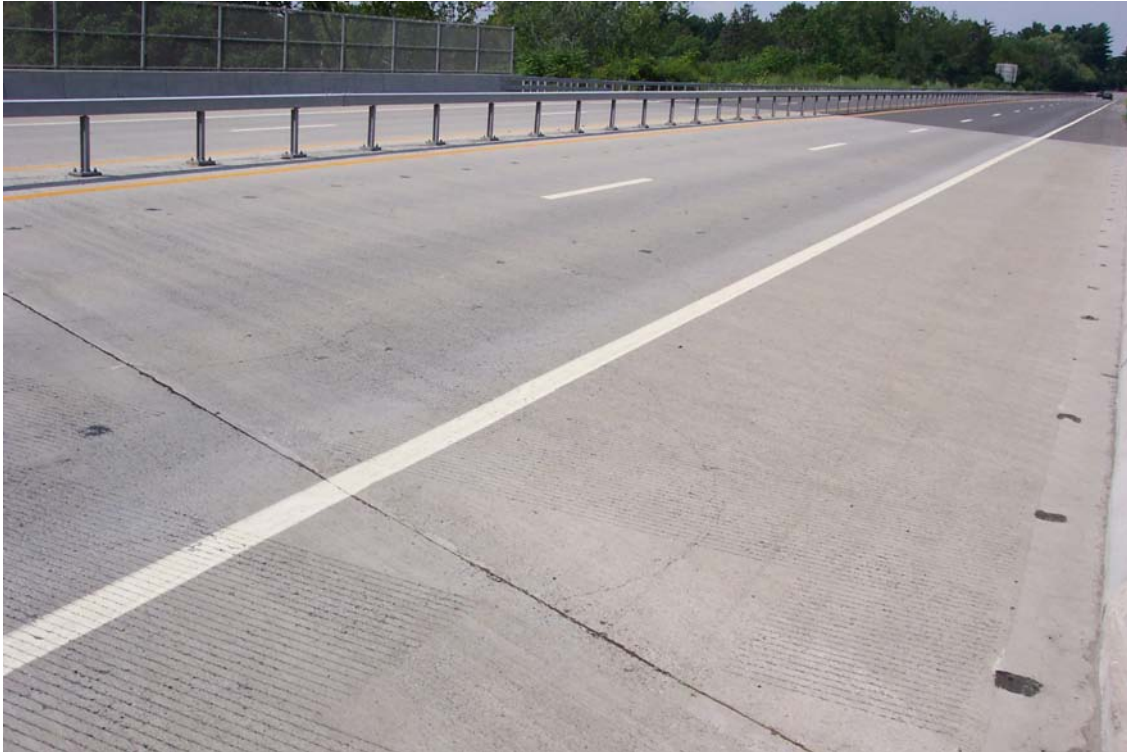
Little evidence of scaling was observed in the driving lanes or the north gutter region of the deck. However, some small areas were noted that did show exposed aggregate (see Figure 33), but this may have been caused by snow plows. Random cracking was noted over sections of the surface of the driving lanes. However, this cracking became less evident in the shoulder and gutter region. This seemed odd because the shoulder and driving lanes were poured together, but the cracking may also be related to structural restraint. The westbound lanes appeared to contain some cracks, primarily longitudinal. This was in contrast to the random cracks that were noted in the eastbound lanes.

Figure 32. Overview of the Route 378 bridge over the D&H Railroad

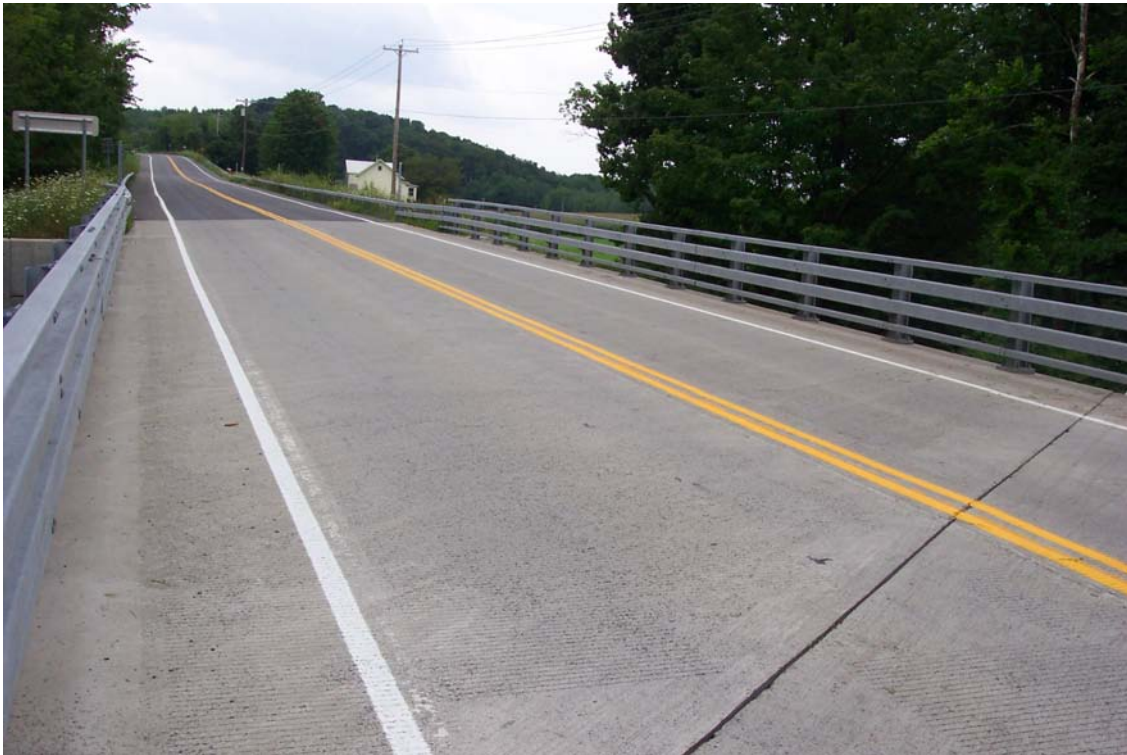
This bridge was in good condition. Scaling was observed in the main deck, but it was difficult to distinguish this from tire erosion or from deck abrasion due to snow removal equipment. Very little evidence of scaling was observed in the gutter region of the deck. Random cracking was observed over much of the surface of the deck (see Figure 35). This random cracking was not observed on the bridge approaches, even though they used the same mixture design.

Figure 34. Overview of Route 351 bridge over the Quackenkill

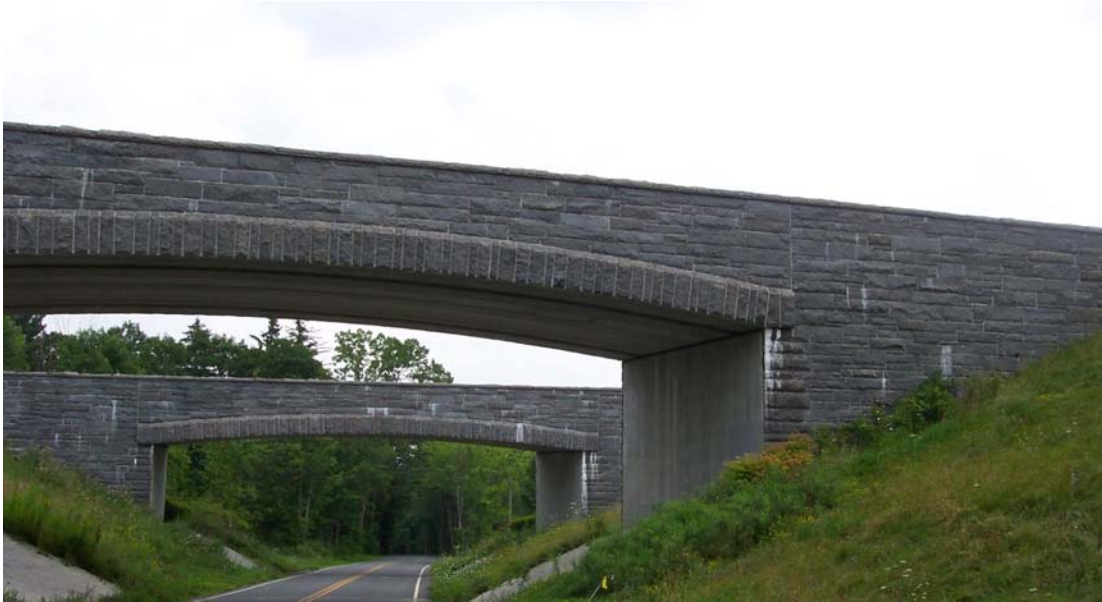
This pair of bridge decks was in good condition. Scaling was observed in several areas on the southbound deck. This became quite pronounced at the south end of the deck (see Figure 38), where the scaling depth had approached the depth of the deck tines (about 0.25 in.). It was estimated that about 10% of the southbound deck had scaled. However, this estimate was complicated due to tire abrasion, which was also noted on the deck. The scaling continued into the concrete approach to the deck. Close inspection of the gutter regions on the northbound deck failed to provide any evidence of scaling. Again, some random cracking was noted on the surface of each deck. However, the northbound deck appeared to be more affected than the southbound bridge.

Figure 36. Overview of the Taconic St. Parkway bridges over Angel Hill Road

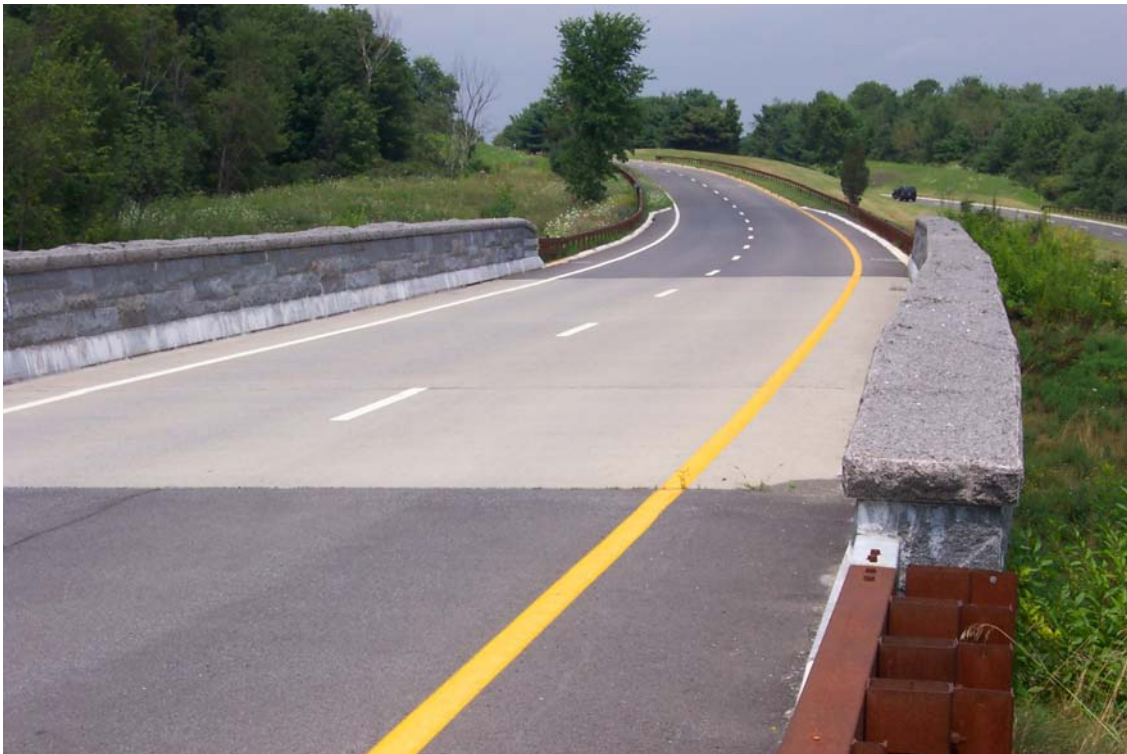
Figure 37. Overview of Taconic St. Parkway bridge, southbound deck (looking north)

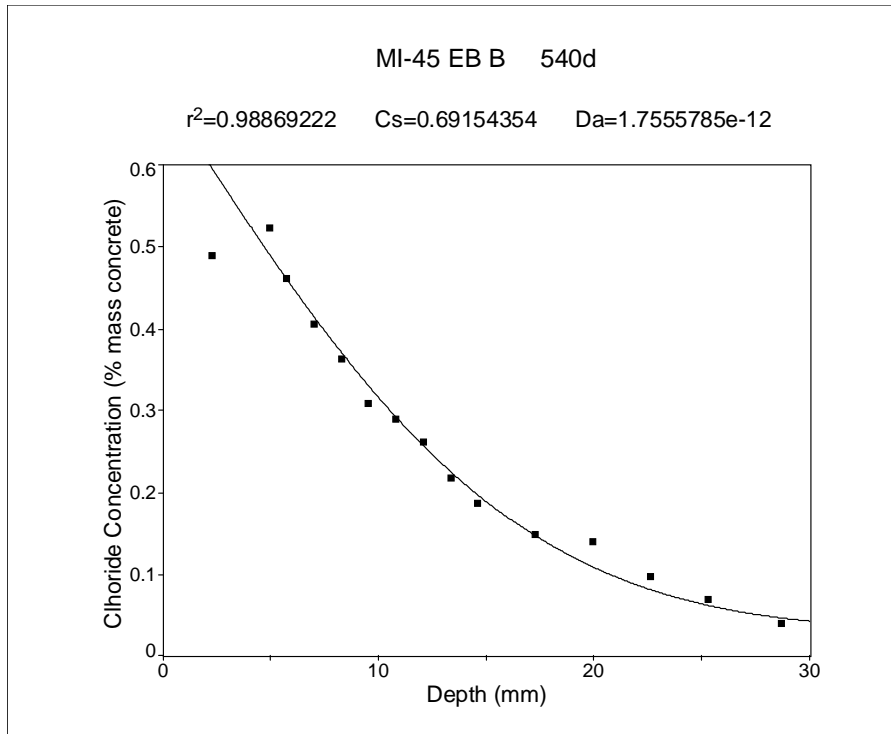
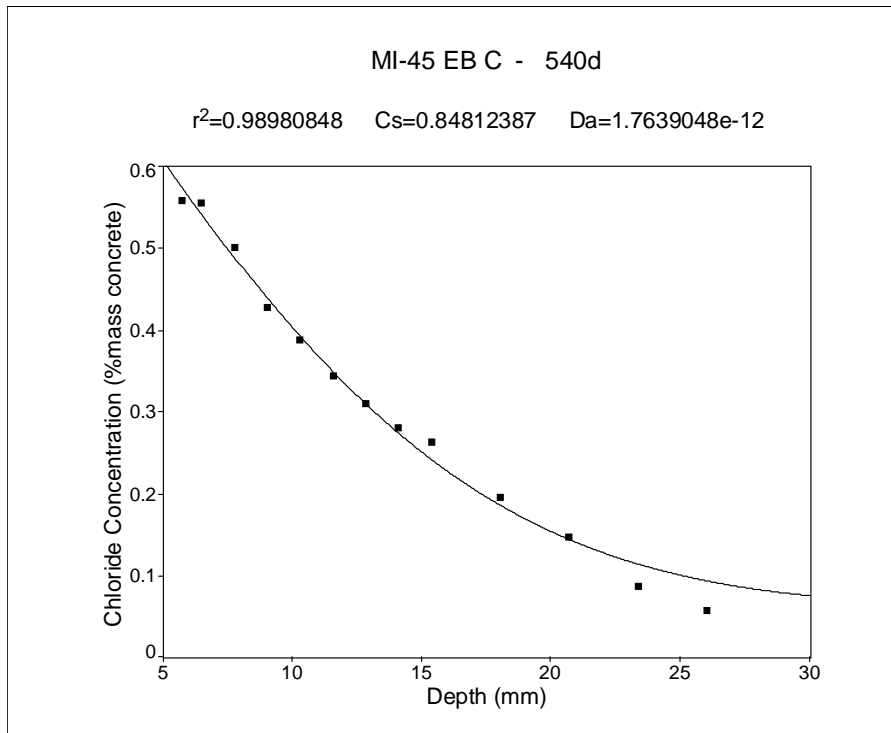
Figure 40. Example of chloride profile test results (before and after scaling tests)

Typical test results from the surface chloride profile tests are illustrated in Figure 40. The figure illustrates both the raw data and the nonlinear regression that was performed to determine the diffusion coefficient and surface concentration for each core. The upper graph in Figure 40 illustrates the test results obtained from a virgin core, while the lower graph illustrates the results after the sample had been subjected to the deicer scaling test.

The surface chloride profile tests were in general agreement with the RCP tests. Both tests indicated that the concrete core specimens tended to be dense and nearly impenetrable. Chloride diffusion coefficients commonly ranged from about 10^{-12} to 10^{-13} . After the scaling tests, the surface chloride concentrations (Cs, %) tended to increase. However, the diffusion coefficients typically remained roughly the same.

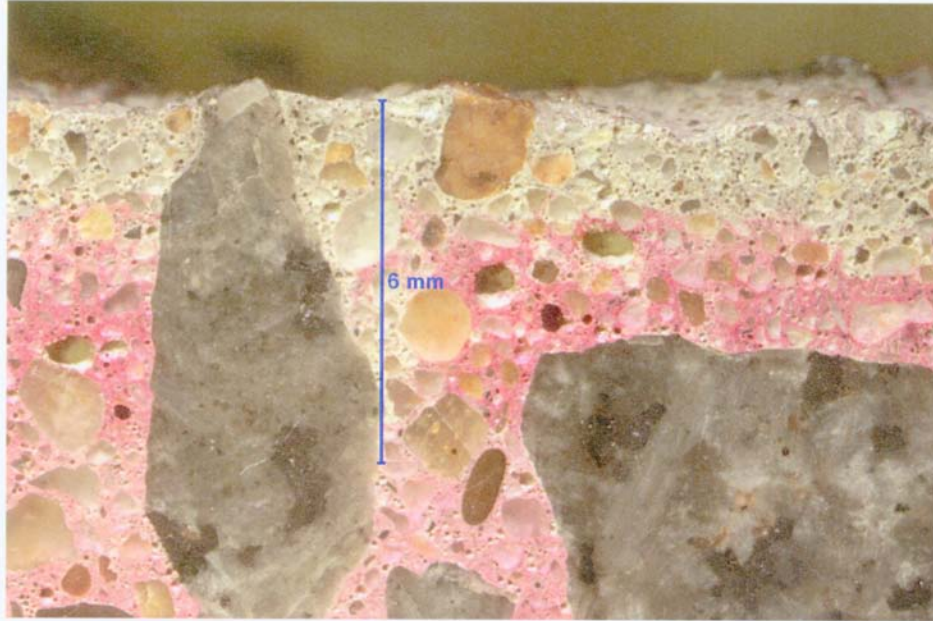
Figure 41. Example of depth-of-carbonation determinations

In general, the two different investigative techniques tended to produce reasonably consistent test results. An exception to this was in the depth-of-carbonation measurements. Both labs used freshly ground samples that had been stained with phenolphthalein (see Figure 41). However, the APS technique tended to follow cracks (shrinkage, etc.) down into the concrete, and this tended to increase the reported range of values (typically given as a “low-high” range). In contrast, the

ISU determinations simply measured the depth from the top of the core to the pink stain at five or six different locations on the polished section. The low and high values were selected from those values. This is the reason that the ISU depth-of-carbonation values always tend to be smaller than the values reported by APS.

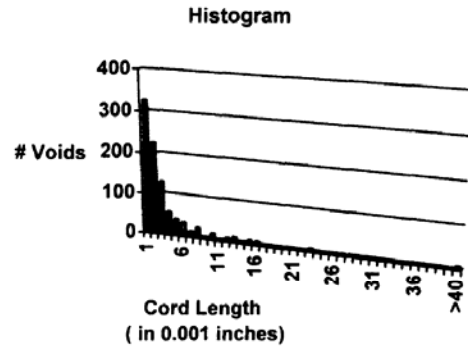
Approximately 70% of the present top surface was ground away during coring. The original top surface has undergone moderate mortar erosion exposing several coarse aggregate surfaces. Several subvertical drying shrinkage microcracks proceed from the present top surface up to 12 mm (1/2") depth. Carbonation ranged from negligible up to 12 mm (1/2") depth from the top surface along subvertical microcracking. The concrete was purposely air entrained and contains an air void system considered freeze thaw resistant. Fair to good overall condition.

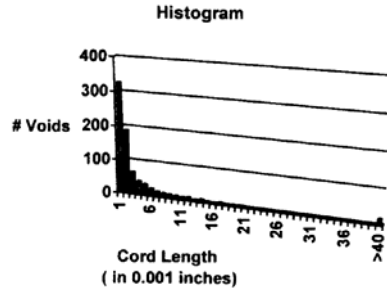
The screeded top surface has undergone minor mortar erosion exposing many fine aggregate surfaces. The screeded top surface was overlain by a coating system approximately 3 mm (1/8") thick. The coating was comprised of two layers of a very soft, white, cementitious paste with mostly rounded, clear to cloudy, transparent, glass fine aggregate particles. The glass fine aggregate, when hit by light, appears to have a high reflective nature. The coating was fairly bonded to the top surface of the sample. Several, very fine, subvertical, drying shrinkage microcracks proceed from the top surface up to 6 mm (1/4") depth. One subvertical drying shrinkage microcrack proceeds from the top surface up to 31 mm (1-1/4") depth. Carbonation ranged from negligible up to 12 mm (1/2") depth from top surface along subvertical microcracking. The concrete was purposely air entrained and contains an air void system generally considered freeze-thaw resistant. Several large entrapped void spaces were observed scattered throughout the sample. Microcracking was observed along the perimeter and within many deleterious fine shale aggregate particles. White to clear silica gel was observed partially lining a few air voids and microcracks proximate to and within a few reactive fine aggregate particles. The offending particles are fine shale aggregate particles. Many irregular shaped air voids were observed within the paste throughout the sample. Good overall condition.

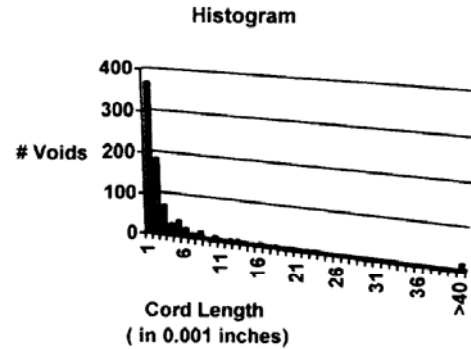
The broomed top surface has undergone moderate mortar erosion/traffic wear exposing many fine aggregate particles. Remnants of a coating system were concentrated within the topographic lows on the broomed top surface. The coating appears to be comprised of two layers of a very soft, white, paint(?) with mostly rounded, clear to cloudy, transparent, glass fine aggregate particles. Many subvertical drying shrinkage microcracks proceed from the top surface up to 14 mm (9/16") depth. Carbonation ranged from negligible up to 8 mm (5/16") depth from the top surface along subvertical microcracking. The concrete was purposely air entrained and contains an air void system generally considered freeze-thaw resistant. Microcracking was observed along the perimeter and within many deleterious fine shale aggregate particles. Good overall condition.

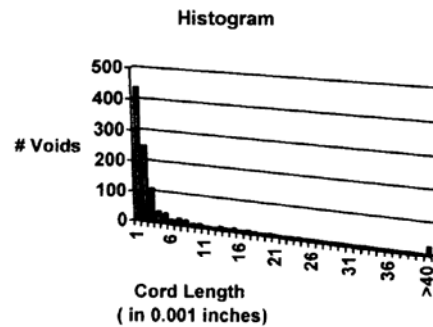
The screeded top surface has undergone minor mortar erosion exposing many fine aggregate surfaces. The screeded top surface was overlain by a coating system approximately 3 mm (1/8") thick. The coating was comprised of three layers of a very soft, white, paint(?) with carbonate fines and mostly rounded, clear to cloudy, transparent, glass fine aggregate particles. The glass fine aggregate, when hit by light, appears to have a high reflective nature. The coating was fairly bonded to the top surface of the sample. Several, very fine, subvertical, drying shrinkage microcracks proceed from the top surface up to 8 mm (5/16") depth. Carbonation ranged from negligible up to 8 mm (5/16") depth from the top surface along subvertical microcracking. The concrete was purposefully air entrained and contains an air void system generally considered freeze-thaw resistant. Several large entrapped void spaces were observed scattered throughout the sample. Microcracking was observed along the perimeter and within many deleterious fine shale aggregate particles. Fair to good overall condition.

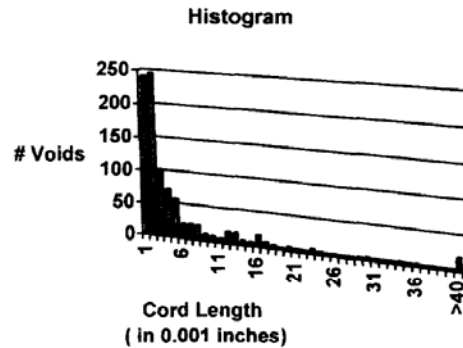
The top surface has undergone moderate mortar erosion exposing many fine aggregate particles. Remnants of a coating system were concentrated within the topographic lows on the broomed top surface. The coating appears to be comprised of two layers of a very soft, white, cementitious paste with mostly rounded, clear to cloudy, transparent, glass fine aggregate particles. Many, subvertical drying shrinkage microcracks proceed from the top surface up to 12 mm (1/2") depth. Carbonation ranged from 1 mm (1/32") up to 8 mm (5/16") depth from the top surface along subvertical microcracking. The concrete was purposely air entrained and contains an air void system considered freeze-thaw resistant. Microcracking was observed along the perimeter and within many deleterious fine shale aggregate particles. Fair to good overall condition.

7. Paste proportions: 20% to 22%
8. Microcracking: Many, subvertical drying shrinkage microcracks proceed from the top surface up to 12 mm (1/2") depth. Numerous microcracks were observed scattered throughout the paste at various depths and orientations in a shrinkage type pattern. Microcracking was observed along the perimeter and within many deleterious fine shale aggregate particles.

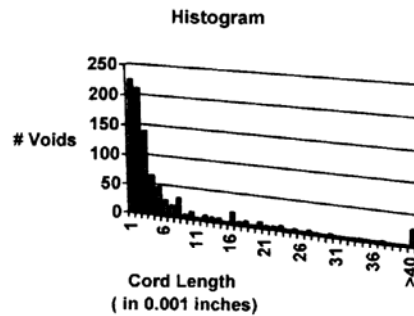
The screeded top surface has undergone minor mortar erosion exposing many fine aggregate surfaces. The screeded top surface was overlain by a coating approximately 1 mm (1/32") thick. The coating was comprised of a very soft, white, paint(?) with carbonate fines and mostly rounded, clear to cloudy, transparent, glass fine aggregate particles. The glass fine aggregate, when hit by light, appears to have a high reflective nature. The coating was fairly bonded to the top surface of the sample. Several, very fine, subvertical, drying shrinkage microcracks proceed from the top surface up to 29 mm (1-1/8") depth. Carbonation ranged from 1 mm (1/32") up to 22 mm (7/8") depth from the top surface along subvertical microcracking. The concrete was purposefully air entrained and contains an air void system considered freeze-thaw resistant. Several large entrapped void spaces were observed scattered throughout the sample. Microcracking was observed along the perimeter and within many deleterious fine shale aggregate particles. White to clear silica gel was observed partially lining a few air voids and microcracks proximate to and within a few fine aggregate particles. The offending particles are fine shale aggregate particles.

6. Paste hardness: Medium
7. Paste proportions: 23% to 25%
8. Microcracking: Several, very fine, subvertical, drying shrinkage microcracks proceed from the top surface up to 29 mm (1-1/8") depth. A few, fine microcracks were observed scattered throughout the paste at various depths and orientations. Microcracking was observed along the perimeter and within many deleterious fine shale aggregate particles.

9. Secondary deposits: White to clear silica gel was observed partially lining a few air voids and microcracks proximate to and within a few fine aggregate particles. The offending particles are fine shale aggregate particles.

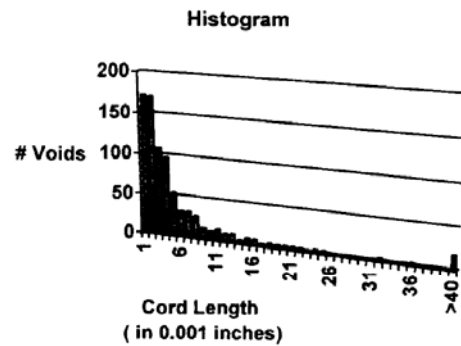
The top surface has undergone moderate mortar erosion exposing numerous fine aggregate particles. A few, subvertical drying shrinkage microcracks proceed from the top surface up to 22 mm (7/8") depth. Carbonation ranged from 1 mm (1/32") up to 9 mm (3/8") depth from top surface along subvertical microcracking. The concrete was purposely air entrained and contains an air void system considered freeze-thaw resistant. Numerous microcracks were observed scattered throughout the paste at various depths and orientations in a shrinkage type pattern. Microcracking was observed along the perimeter and within many deleterious fine shale aggregate particles. White, acicular ettringite was observed lining to partially filling several air voids below 37 mm (1-7/16") depth from the top surface. Good overall condition.

6. Paste hardness: Hard
7. Paste proportions: 25% to 27%
8. Microcracking: A few, subvertical drying shrinkage microcracks proceed from the top surface up to 22 mm (7/8") depth. Numerous microcracks were observed scattered throughout the paste at various depths and orientations in a shrinkage type pattern. Microcracking was observed along the perimeter and within many deleterious fine shale aggregate particles.

9. Secondary deposits: White, acicular ettringite was observed in lining to partially filling several air voids below 37 mm (1-7/16") depth from the top surface.

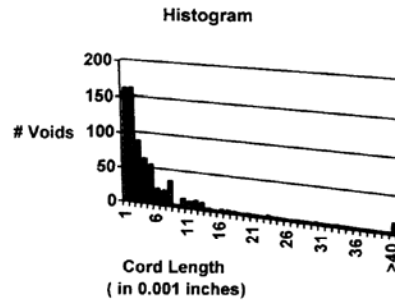
Site 3 – IA, Euclid Bridge, East Bound deck, core from cracked area

The top surface has undergone moderate traffic wear exposing a few coarse and several fine aggregate particles. Approximately 5 mm (3/16") wide and 3 mm (1/8") depth tines were observed saw cut into the top surface. A subvertical macrocrack was observed bisecting the entire depth of the core, proceeding through several coarse aggregate particles rather than around them. Several, fine, subvertical drying shrinkage microcracks proceed from the top surface up to 14 mm (9/16") depth. Carbonation ranged from 1 mm (1/32") up to 9 mm (3/8") depth from the top surface along subvertical microcracking. The concrete was purposefully air entrained and contains an air void system generally considered freeze-thaw resistant. Several fine microcracks were observed scattered throughout the paste at various depths and orientations in a shrinkage type pattern. Microcracking was observed along the perimeter and within many deleterious fine shale aggregate particles. Darker colored, denser paste was observed in several coarse aggregate notches suggest the sample may have undergone retempering or multiple stage batching. Fair to good overall condition.

6. Paste hardness: Medium
7. Paste proportions: 26% to 28%
8. Microcracking: A subvertical macrocrack was observed bisecting the entire depth of the core, proceeding through several coarse aggregate particles rather than around them. Several, fine, subvertical drying shrinkage microcracks proceed from the top surface up to 14 mm (9/16") depth. Several fine microcracks were observed scattered throughout the paste at various depths and orientations in a shrinkage type pattern. Microcracking was observed along the perimeter and within many deleterious fine shale aggregate particles.

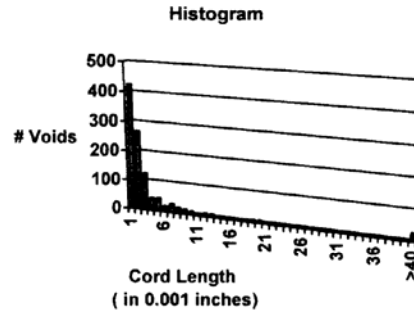
The present top surface has undergone moderate mortar erosion exposing many fine and a few coarse aggregate particles. Approximately 20% of the top surface has spalled away due to procurement of sample. Approximately 3 mm (1/8") wide and 7 mm (1/4") depth tines were observed saw cut into top surface. Many, subvertical drying shrinkage microcracks proceed from the top surface up to 27 mm (1-1/16") depth. Carbonation ranged from negligible up to 14 mm (9/16") depth from the top surface along subvertical microcracking. The concrete was purposefully air entrained and contains an air void system generally considered freeze-thaw resistant. Microcracking was observed along the perimeter and within many deleterious fine shale aggregate particles. White, bladed calcium hydroxide was observed partially lining to partially filling many air voids within the top 27 mm (1- 1/16") of the sample. Darker colored, denser paste was observed in several coarse aggregate notches suggest the sample may have undergone retempering or multiple stage batching. Good overall condition.

6. Paste hardness: Medium
7. Paste proportions: 23% to 25%
8. Microcracking: Many, subvertical drying shrinkage microcracks proceed from the top surface up to 27 mm (1- 1/16") depth. A few, fine microcracks were observed scattered throughout the paste at various depths and orientations in a shrinkage type pattern. Microcracking was observed along the perimeter and within many desiccated shale aggregate particles.

9. Secondary deposits: White, bladed calcium hydroxide was observed partially lining to partially filling many air voids within the top 27 mm (1-1/16") of the sample.
