Deicer Scaling Resistance of Concrete Pavements, Bridge Decks, and Other Structures Containing Slag Cement

Phase 1: Site Selection and Analysis of Field Cores

Final Report September 2008

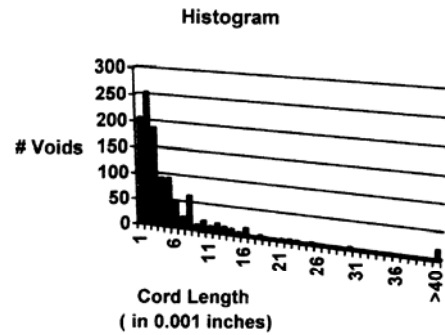
The present top surface has undergone moderate mortar erosion/traffic wear exposing many fine aggregate particles. Approximately 5% of the top surface has shallowly scaled away directly over the coarse aggregate particles (mortar flaking). A few subvertical drying shrinkage microcracks proceed from the top surface up to 11 mm (7/16") depth. A subvertical drying shrinkage microcrack proceeds from the top surface up to 41 mm (1- 5/8") depth. Carbonation ranged from negligible up to 8 mm (5/16") depth from the top surface and up to 22 mm (7/8") depth intermittently along subvertical microcracking. The concrete was purposely air entrained, and contains an air void system considered freeze thaw resistant. Reduced air entrainment was observed within the top 2 mm (1/16") of the sample. Fair to good overall condition.

6. Paste hardness: Medium
7. Paste proportions: 19% to 21%
8. Microcracking: A few subvertical drying shrinkage microcracks proceed from the top surface up to 11 mm (7/16") depth. A subvertical drying shrinkage microcrack proceeds from the present top surface up to 41 mm (1-5/8") depth. A few microcracks were observed scattered throughout the paste at various depths and orientations in a shrinkage type pattern.

9. Secondary deposits: White, acicular ettringite was observed partially lining many air voids below 10 mm (3/8") depth from the present top surface.
10. Slump: Estimated, medium (2 to 4")

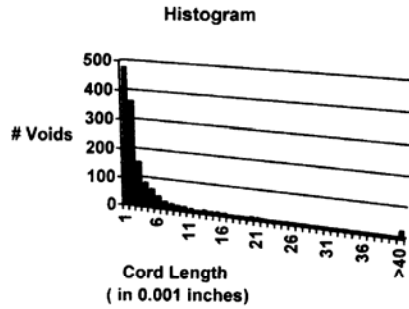
The present top surface has undergone moderate mortar erosion/traffic wear exposing many fine aggregate particles. A few subvertical drying shrinkage microcracks proceed from the top surface up to 6 mm (1/4") depth. Carbonation ranged from 1 mm (1/32") up to 6 mm (1/4") depth from the top surface along subvertical microcracking. The concrete was purposely air entrained, and contains an air void system considered freeze thaw resistant. The air void system was poorly distributed throughout the sample (clumping of entrained air voids) with higher concentrations within the top 2 mm (1/16") of the sample. Fair to good overall condition.

8. Microcracking: A few subvertical drying shrinkage microcracks proceed from the top surface up to 6 mm (1/4") depth. A few microcracks were observed scattered throughout the paste at various depths and orientations in a shrinkage type pattern.

9. Secondary deposits: White to clear alkali silica gel was observed lining a few air voids proximate to reactive fine and coarse aggregate particles.
10. Slump: Estimated, medium (2 to 4")

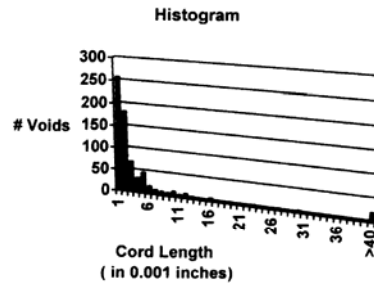
Approximately 25% of the rough, screeded and tined top surface has shallowly scaled away. Approximately 3 mm (1/8") wide and 7 mm (1/4") depth tines were observed sawcut into top surface. Several subvertical drying shrinkage microcracks proceed from the present top surface up to 10 mm (3/8") depth. One subvertical microcrack proceeds from the present top surface up to 1 mm (2") depth. Many microcracks were observed within the paste and proceeding through many coarse aggregate particles at various depths and orientations. Carbonation ranged from negligible up to 5 mm (3/16") depth from the present top surface. The concrete was purposely air entrained and contains an air void system considered freeze thaw resistant. However, a loss of entrained air was observed within the top 2 mm (1/16") of the sample. White, tabular calcium hydroxide was observed lining many to filling a few entrained air voids within the top 5 mm (3/16") of the sample. White, acicular ettringite was observed lining and filling several air voids and microcracks below 5 mm (3/16") depth from the present top surface. Darker colored, denser paste was observed in several coarse aggregate notches suggest the sample may have undergone retempering. Many deleterious fine shale and siltstone particles were observed scattered throughout the sample. Fair to good overall condition.

3. Pozzolan presence: None observed
4. Paste/aggregate bond: Poor
5. Paste color: Medium gray
6. Paste hardness: Hard
7. Paste proportions: 29% to 31%
8. Microcracking: Several subvertical drying shrinkage microcracks proceed from the present top surface up to 10 mm (3/8") depth. One subvertical microcrack proceeds from the present top surface up to 51 mm (2") depth. Many microcracks were observed within the paste and proceeding through many coarse aggregate particles at various depths and orientations.

9. Secondary deposits: White, tabular calcium hydroxide was observed lining many to filling a few entrained air voids within the top 5 mm (3/16") of the sample. White, acicular ettringite was observed lining and filling several air voids and microcracks below 5 mm (3/16") depth from the present top surface.

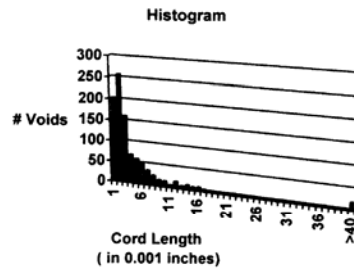
The screeded top surface has undergone minor mortar erosion/traffic wear exposing many fine aggregate surfaces. Many subvertical drying shrinkage microcracks proceed from the present top surface up to 20 mm (13/i 6") depth. A few subvertical plastic shrinkage microcracks were observed within the top 1 mm (1/32") of the sample. A few subhorizontal microcracks were observed within the top approximately 9 mm (3/8") of the sample. Many microcracks were observed within the paste and proceeding through many coarse aggregate particles at various depths and orientations. Carbonation ranged from 1 mm (1/32") up to 8 mm (5/16") depth from the present top surface along subvertical microcracking. The concrete was purposely air entrained and contains an air void system considered freeze-thaw resistant. White, tabular calcium hydroxide was observed lining to filling several air voids within the top 4 mm (5/32") of the sample. White acicular ettringite was observed lining many to filling a few air voids below 1 mm (1/32") depth from the present top surface. Darker colored, denser paste was observed in several coarse aggregate notches suggest the sample had undergone retempering. Many deleterious fine shale and siltstone particles were observed scattered throughout the sample. Fair to good overall condition.

8. Microcracking: Many subvertical drying shrinkage microcracks proceed from the present top surface up to 20 mm (13/16") depth. A few subvertical plastic shrinkage microcracks were observed within the top 1 mm (1/32") of the sample. A few subhorizontal microcracks were observed within the top approximately 9 mm (3/8") of the sample. Many microcracks were observed within the paste and proceeding through many coarse aggregate particles at various depths and orientations.

9. Secondary deposits: White, tabular calcium hydroxide was observed lining to filling several air voids within the top 4 mm (5/32") of the sample. White acicular ettringite was observed lining many to filling a few air voids below 1 mm (1/32") depth from the present top surface.

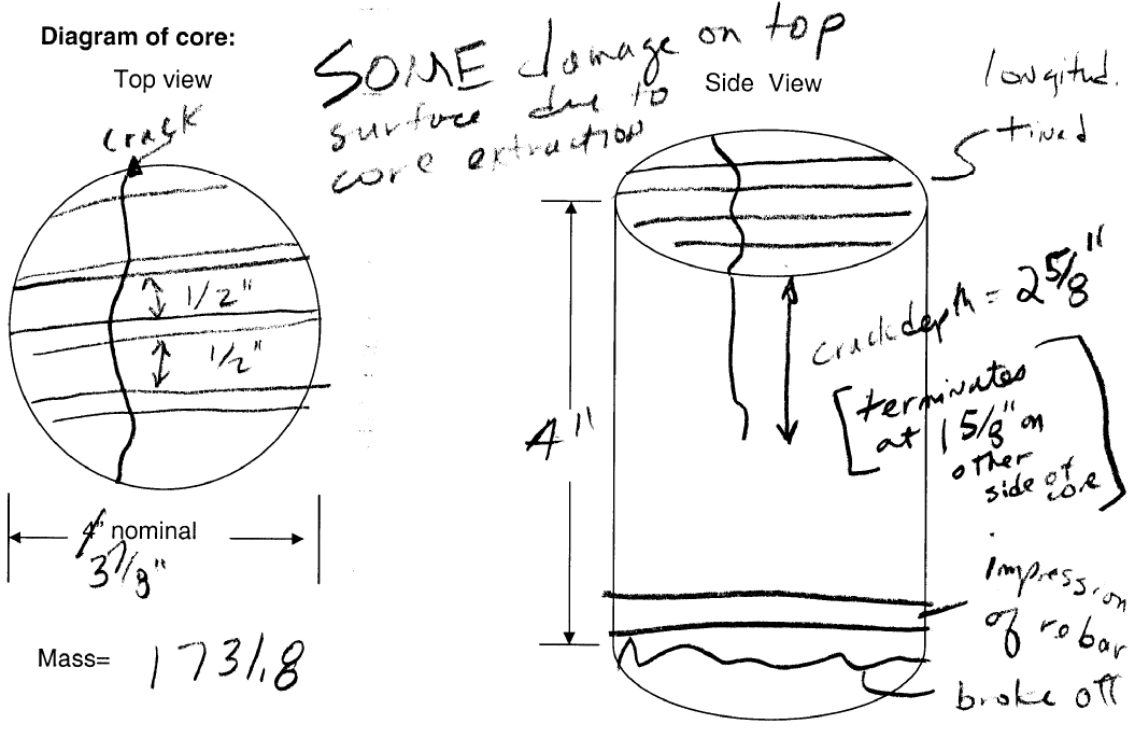
Cracks, comments: crack width varies from 0.1 to 0.4 mm

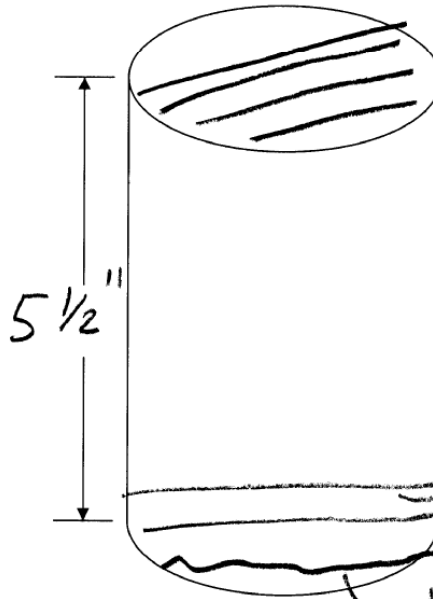
Side View

Long, fine
2 to 4mm

impression
of rebar
broke off

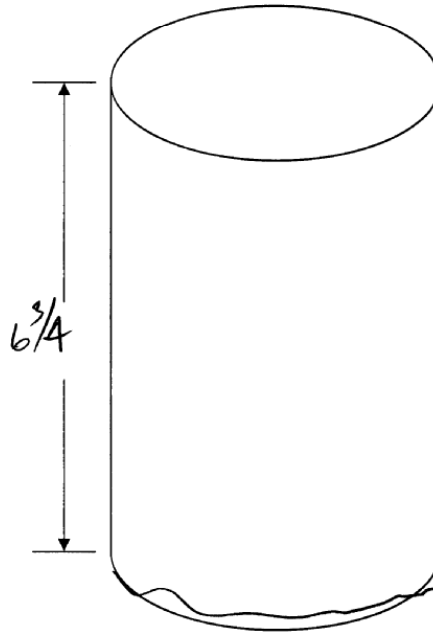
Side View

core broke
 10G bottom

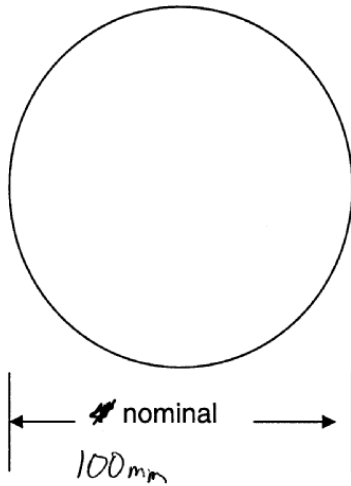
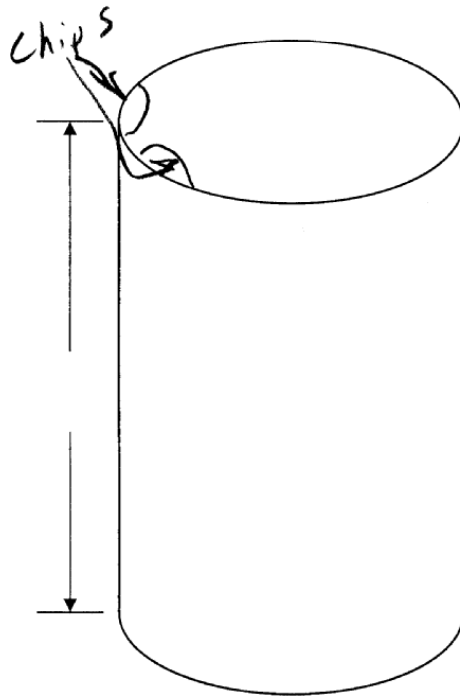
Surface conditions: Two Chips

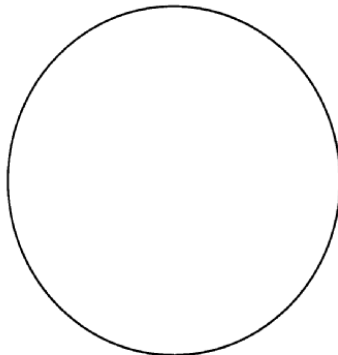
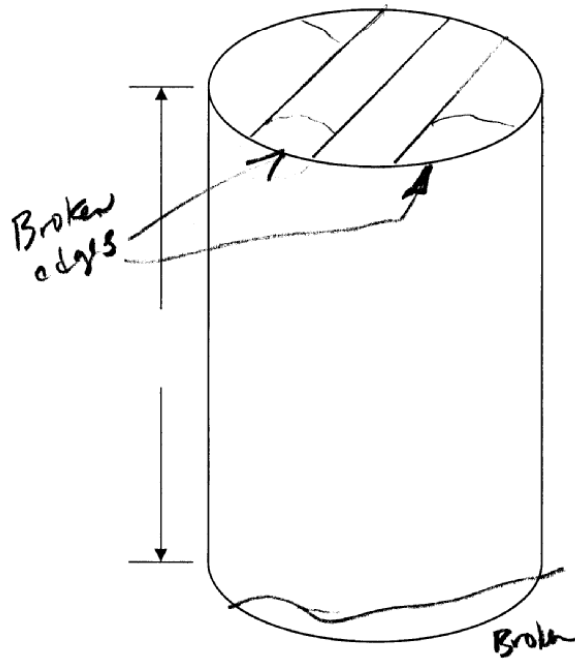
Surface conditions: Some chips, cuts

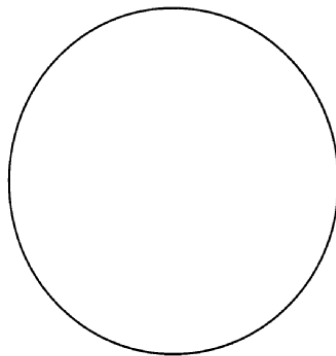
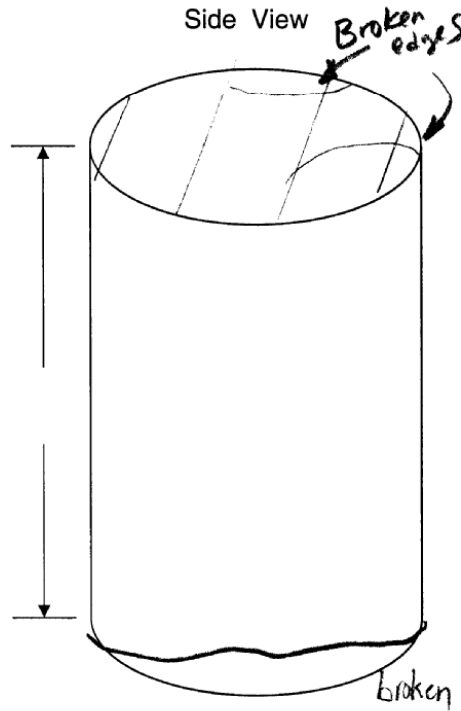
Surface conditions: Cuts and chips on edges

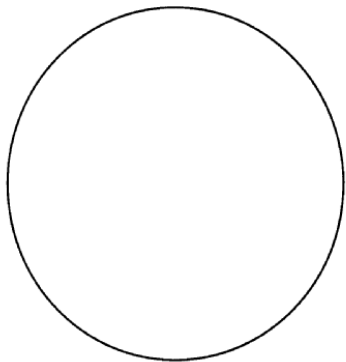
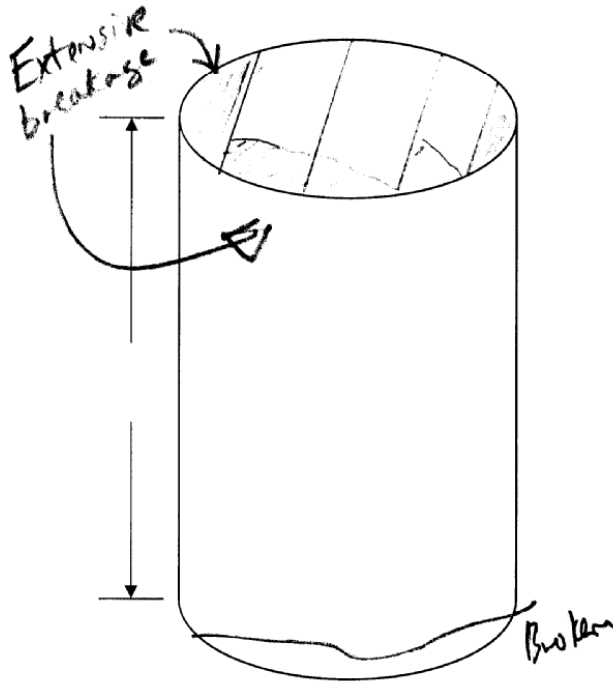
Surface conditions: cuts, chips

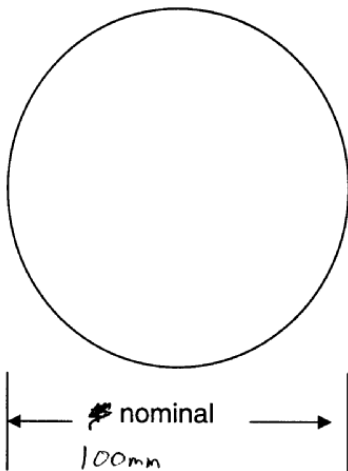
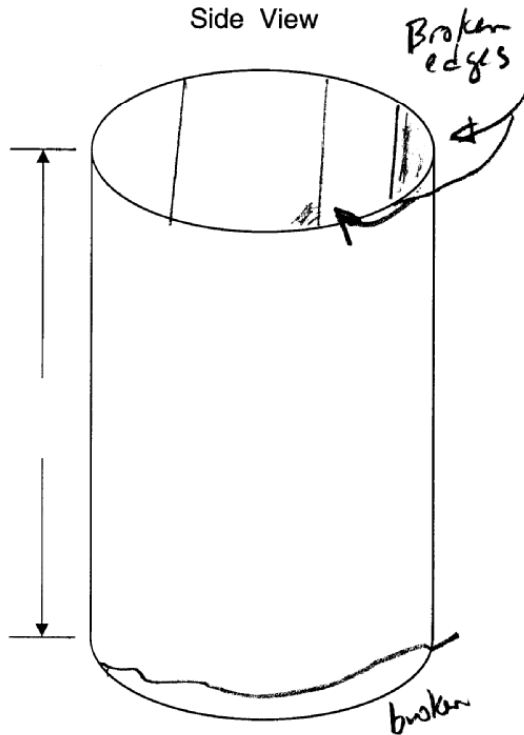
Surface conditions: small chips, cuts

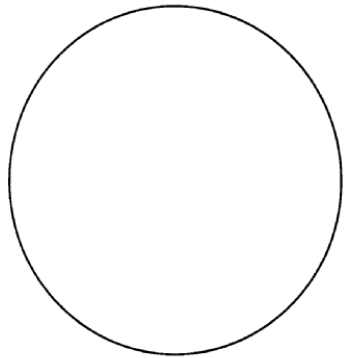
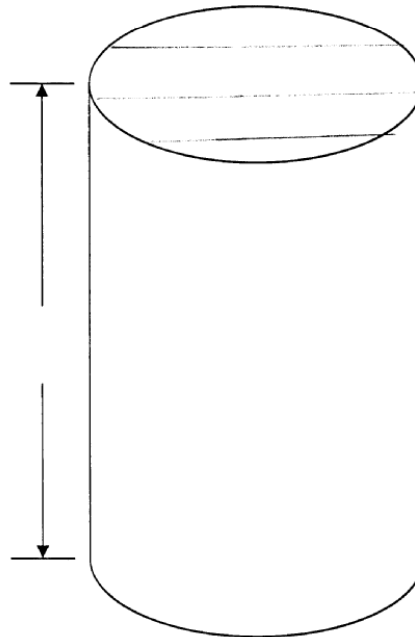
Surface conditions: cuts

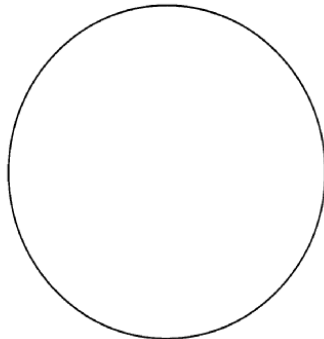
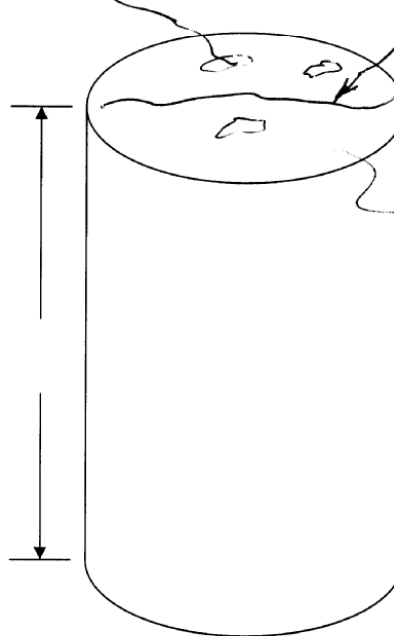
scaling - 1-2mm deep
 Side View
 cracks across core
 (very faint)

surface shows
~~water~~
 fine aggregate exposed

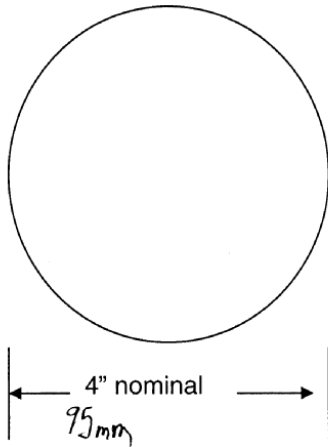
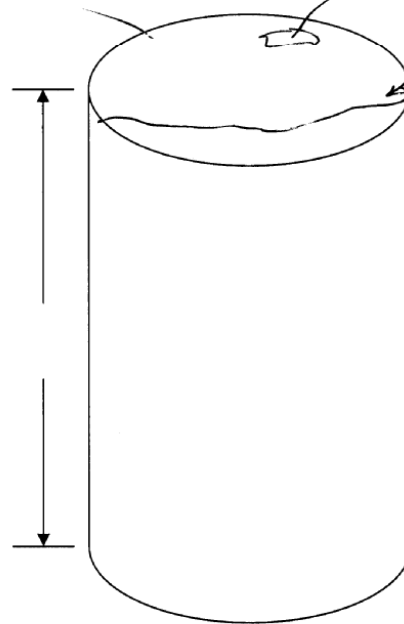
Crack across core (more noticed than in LR#1)
