IDENTIFICATION OF THE BEST PRACTICES FOR DESIGN, CONSTRUCTION, AND REPAIR OF BRIDGE APPROACHES

Iowa DOT Project TR-481
CTRE Project 02-118

Final Report

January 2005

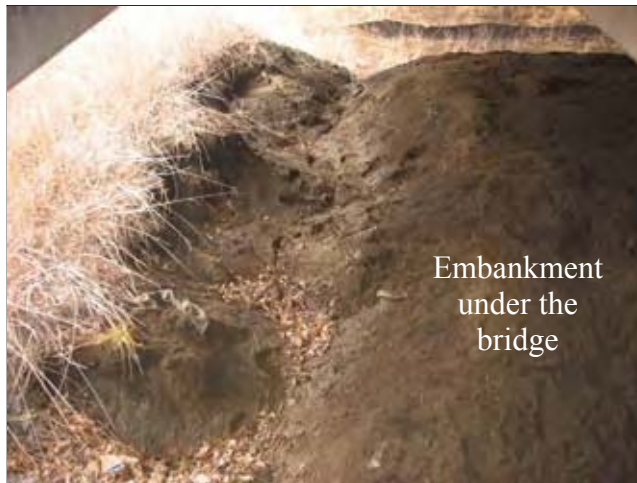
This bridge was constructed in 1999 with non-integral abutments. At the north end of the north bound approaches, significant settlement was observed. Soil erosion of the embankment under the bridge was also observed (Figure 17). Moreover, concrete spalling was noted at the ends of the bridge deck.

Figure 17. Soil erosion of the embankment under the bridge (South end of North bound)

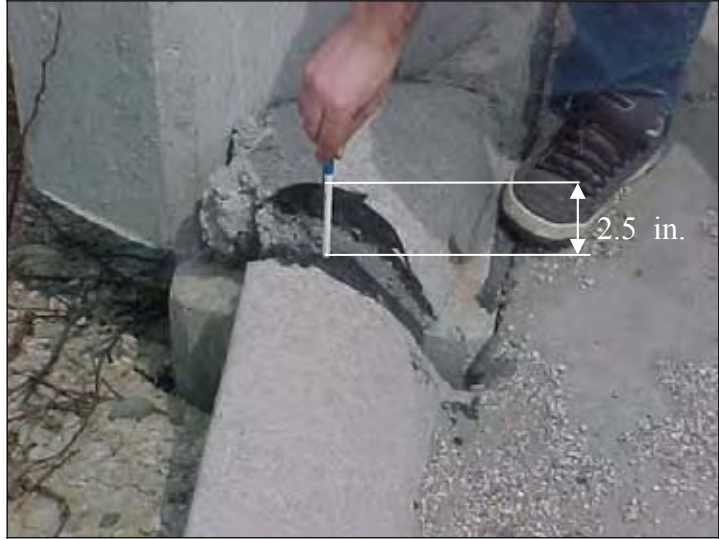
At the south end of the southbound lane (SBL), a 1 inch gap was measured between the abutment and embankment. The soil of the embankment under the bridge was very wet. The differential settlement of the approach slab at the end of the abutment wingwall was approximately 2.5 in., as shown in Figure 19. The width of the expansion joint was 5.0 and 5.3 inches at the north and south ends, respectively, and the width of the 'CF' joint was 4.1 and 4.4 inches at the north and south ends, respectively.

Figure 19. Differential settlement of 2.5 inches at the end of the abutment wingwall (South end SBL)

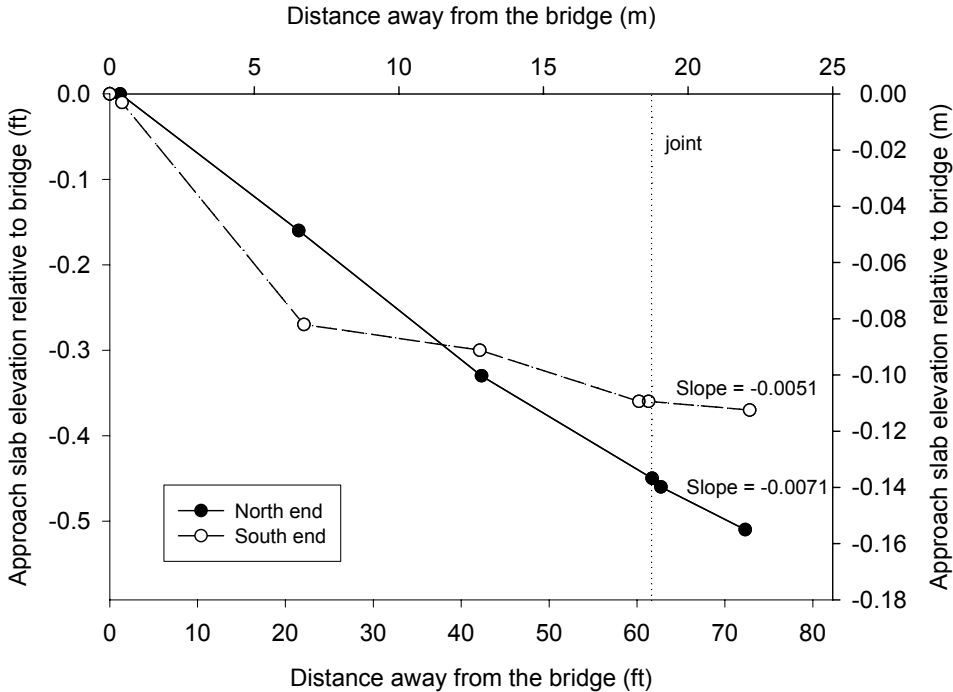
The bridge approach profiles for both ends of the northbound lane were obtained in spring 2003 and are shown in Figure 20. The profiles show that the south end approach slab has experienced more settlement compared to the north end. Further, the slope gradients of both the south and north ends are -0.0071 and -0.0051 (i.e., sloping away), which indicates either compression of the embankment fill material or settlement of the embankment foundation soil.

Figure 20. Elevation of bridge approaches relative to bridge slab

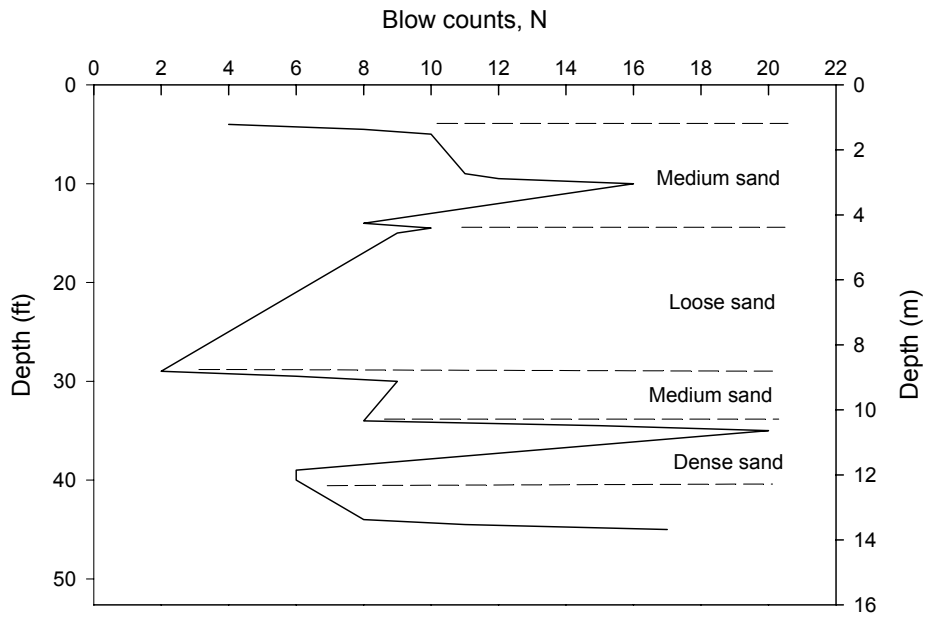
To investigate and characterize the embankment soils, Standard Penetration Tests (SPTs) were conducted at the north end of the northbound lane, as indicated in Figure 21. The soil was classified as loose to medium dense sand with a moisture content varying from 12% to 17%. The SPT blow counts provided in Figure 22 range from 5 at the surface to 20 at about 35 ft. According to the drillers, the water table was located at a depth of 25 ft immediately after completing the boring. The height of the embankment was approximately 20 ft.

Figure 22. Results of SPT and classification of the embankment soil

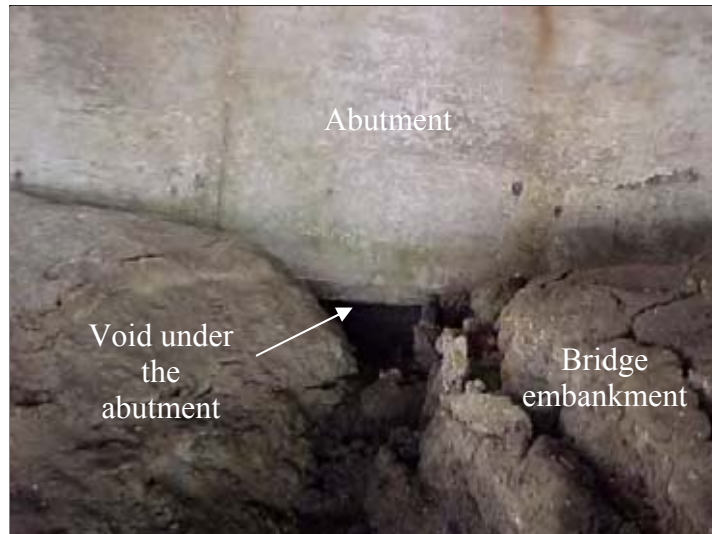
This bridge has non-integral abutments. Water was observed running through the expansion joints and under the bridge abutment. Soil erosion was severe at both ends of the bridge. Severe soil erosion shown in Figure 23 was observed at the north end of the northbound lane. At the south end of the northbound lane, the approach slab at the guardrail settled about 6 inches from its original elevation, as shown in Figure 24. At both the north and south ends of the southbound lane, severe erosion and settlement of the embankment was noted. The embankments were constructed using sandy soils which are considered highly erodible (Figures 25 to 27).

Figure 23. Erosion of soil under abutment (North end of NBL)

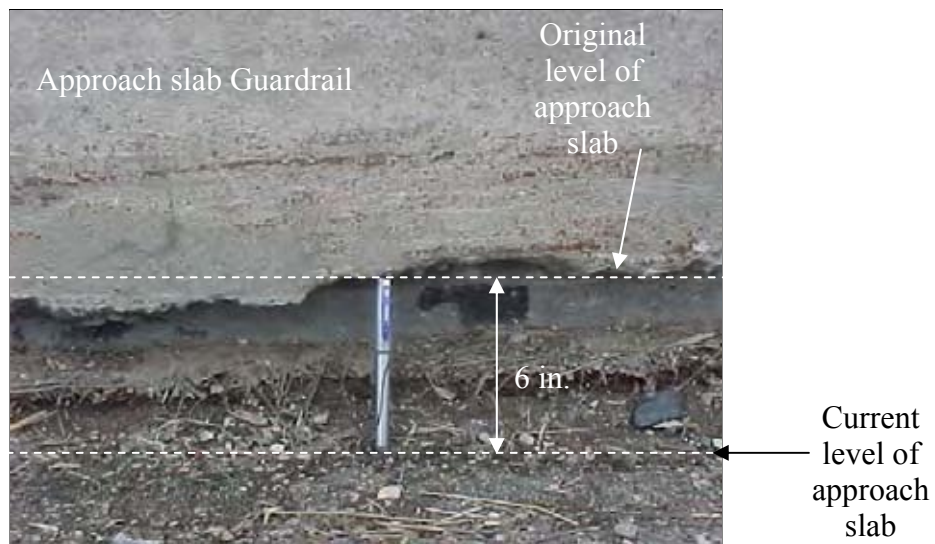
Figure 24. Settlement of bridge approach slab at the guardrail (South end of NBL)

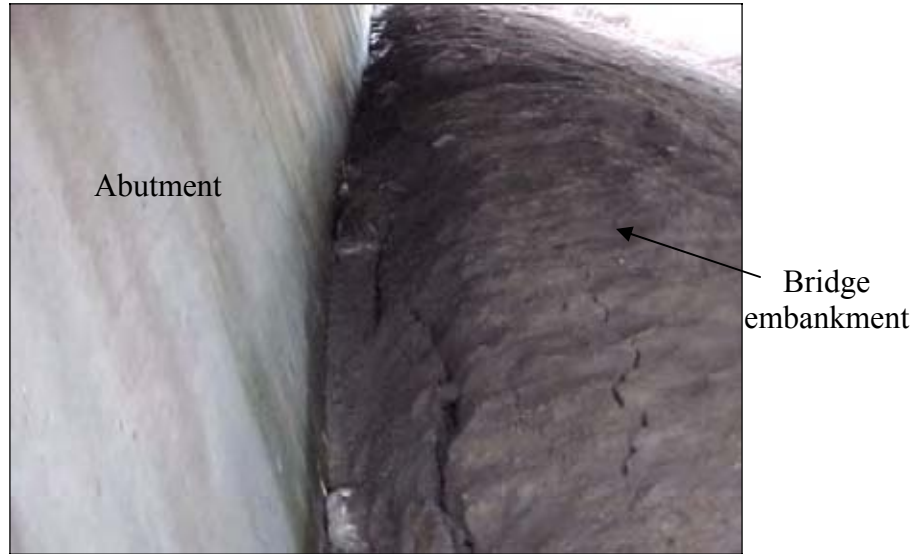
Figure 25. Erosion between abutment and embankment (North end of SBL)

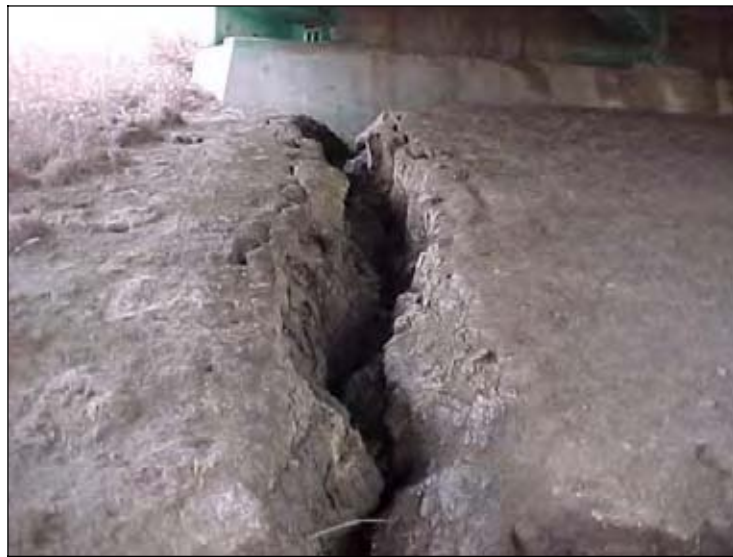
Figure 26. Erosion of the soil under the bridge (North end of SBL)

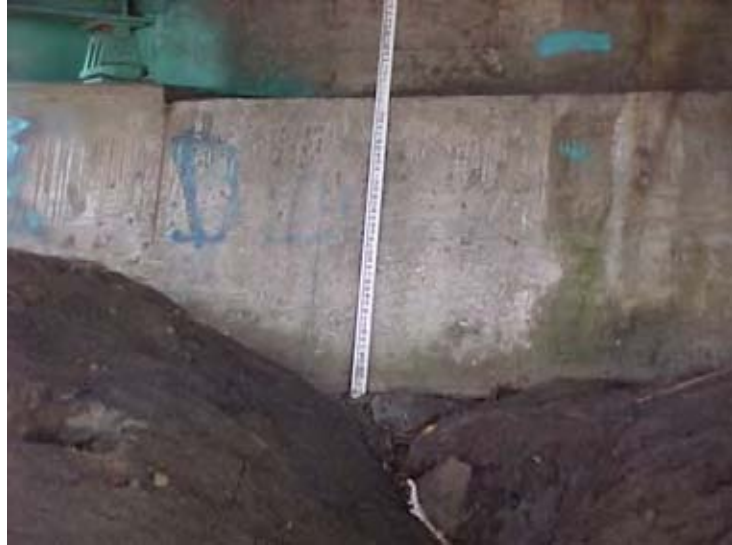
Figure 27. Erosion of the soil under the bridge (South end of SBL)

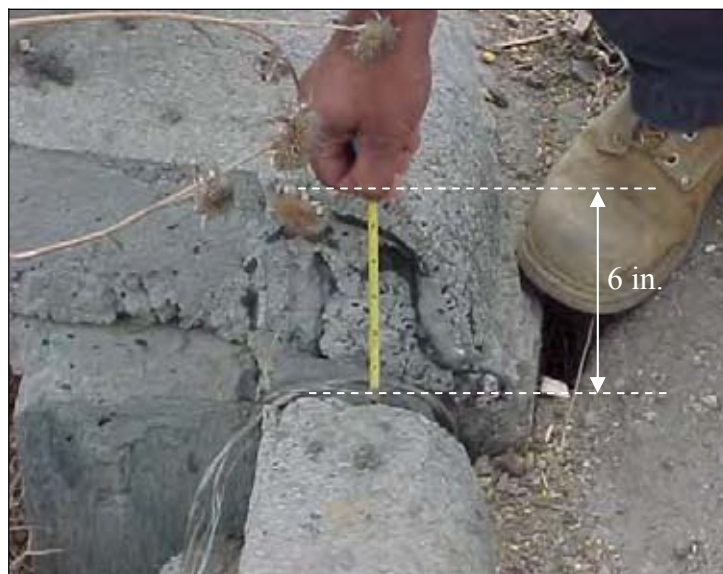
This bridge has integral abutments and concrete girders. The embankment under the bridge settled about 3.5 inches from its original level, as shown in Figure 28. Figure 29 shows the differential settlement at the end of the wingwall at the north end of the northbound lane, which is approximately 6 inches. Figure 30 shows cracks near both expansion joints at the northbound lane. Moreover, at the south end of the northbound lane, differential settlement of 2 inches was measured between the bridge deck and the end of the approach slab.

Figure 29. Differential settlement at the approach slab (North end of NBL)

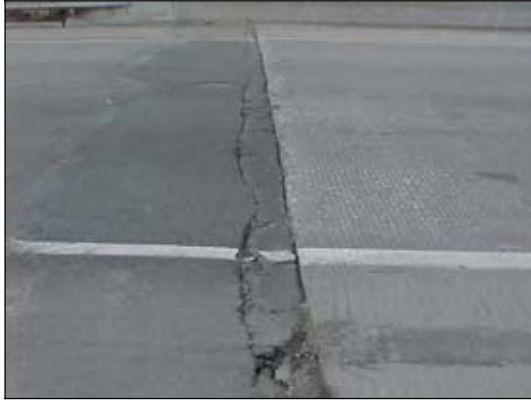
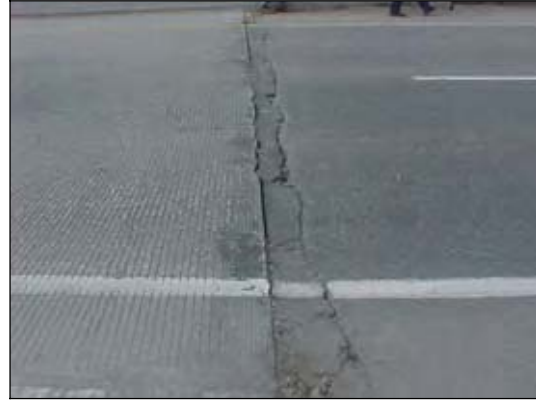
Figure 30. Cracks and concrete spalling at the expansion joints

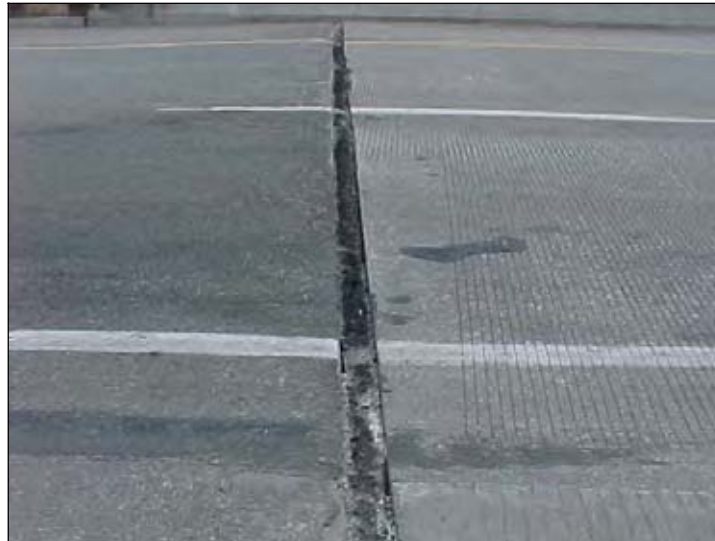
Differential settlement between bridge deck and the end of the approach slab was observed at the north end of the southbound lane. The width of the expansion joint was approximately 5 inches, which is wider than the designed joint width of 4 inches. This could be due to concrete deterioration or thermal contraction of the bridge. At the north end of the southbound lane, fewer cracks at the expansion joint were observed (Figure 31).

Figure 31. Poorly filled expansion joint with recycled tires used as a joint filler (North end SBL)

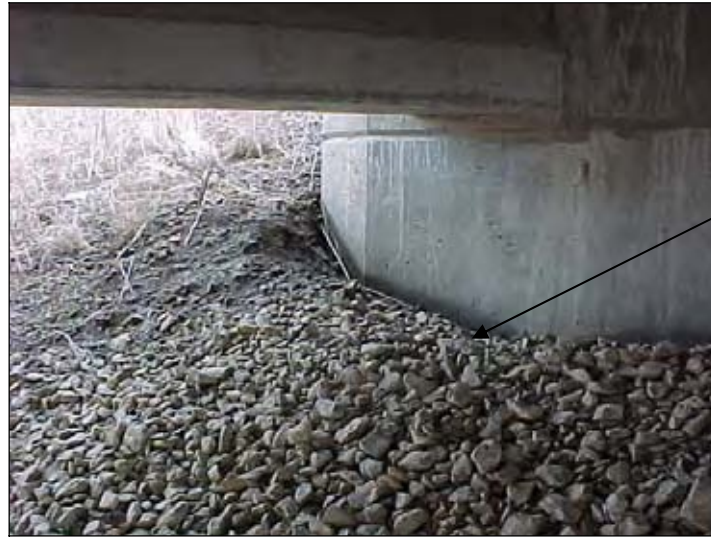
This bridge has an integral abutment and concrete girders. Aggregate was used under the bridge as slope protection, as shown in Figure 32. Significant soil erosion was observed between the embankment and the backwall at both the north and south bounds lanes. Figure 33 shows a 3-inch void that developed under the approach slab.

Erosion
between the
abutment and
the embankment

Figure 32. Aggregate used as slope protection at the embankment under the bridge

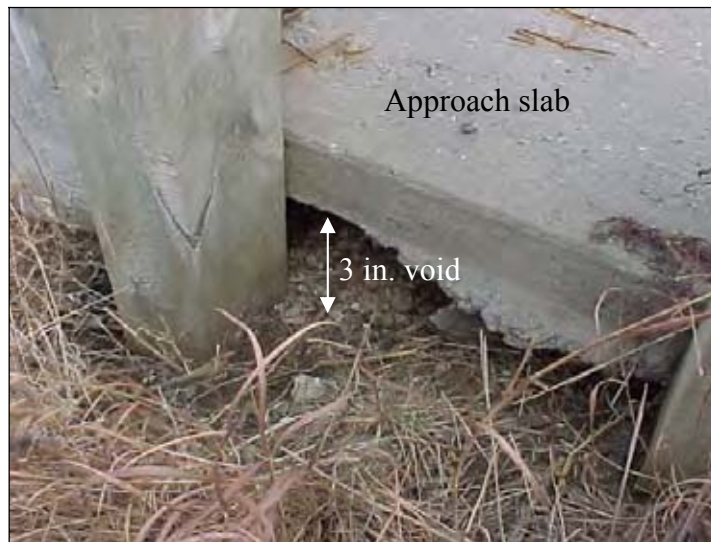
3 in. void

Figure 33. Void developed under the approach slab (South end of North bound bridge)

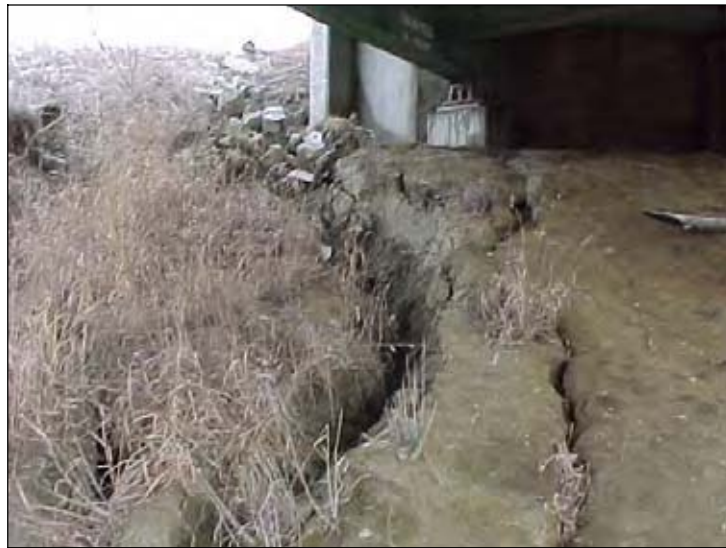
This bridge has non-integral abutments. The east bound bridge is supported on concrete girders, while the west bound bridge is supported on steel girders. Soil erosion was observed, as shown in Figure 35. No other major problems were noticed.

Figure 35. Soil erosion of the embankment under the bridge

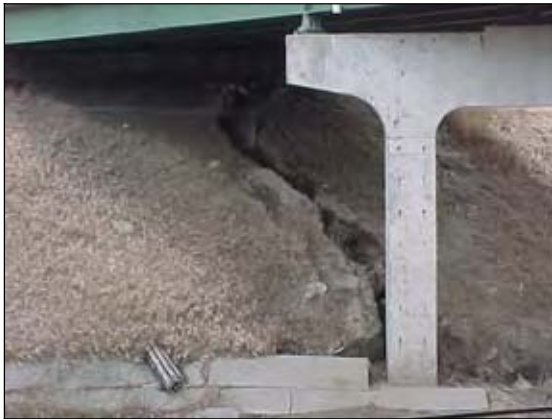
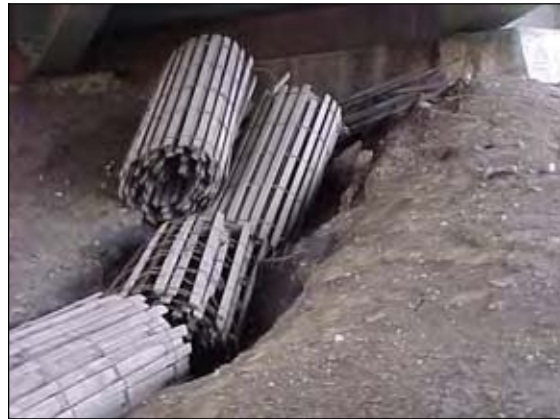
This bridge has non-integral abutments and steel girders. Significant erosion was observed under the bridge at both the east and the westbound lanes, as shown in Figure 36. However, the approach slab appeared to be in a good condition.

Figure 36. Soil erosion of the embankment under the bridge

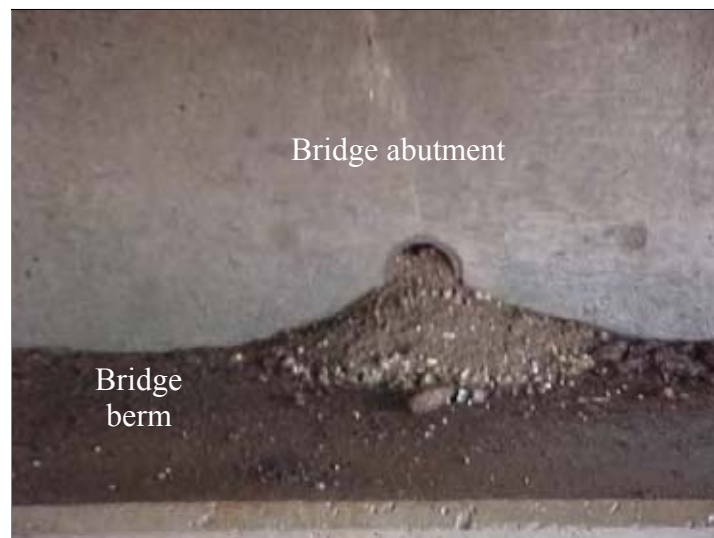
This bridge has steel girders and non-integral abutments. No significant settlement of the bridge approach was noted. Soil erosion of the embankments under the bridge was observed. The abutment weep holes were filled with eroded backfill material, as shown in Figure 37.

Figure 37. Weep holes filled with backfill material

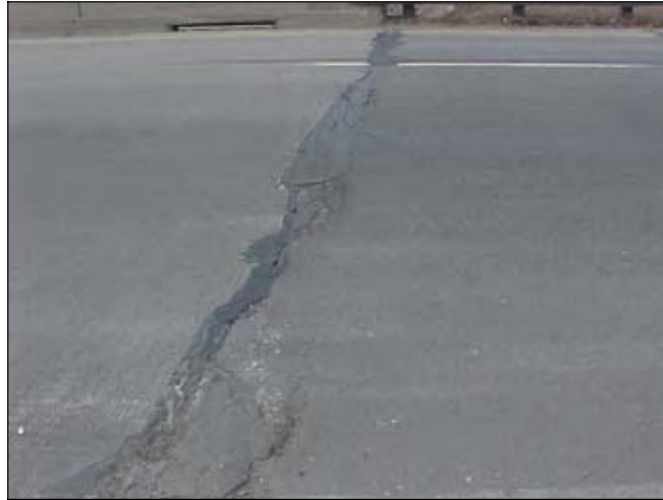
This bridge has non-integral abutments with concrete girders. Concrete spalling was observed at the girder ends. Figure 38 shows a damaged expansion joint that was paved over during a previous maintenance effort. A dip in the original approach slab of about 4 inches was observed between the approach slab and the wingwall.

Figure 38. Expansion joint covered after placing the approach slab overlay (EBL)

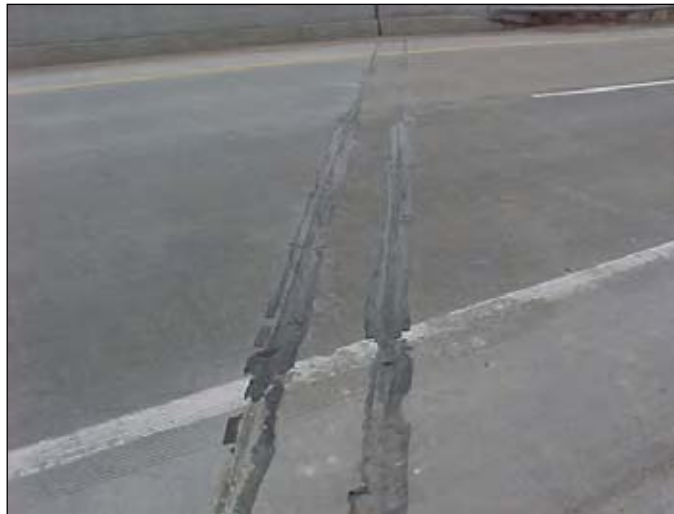
This bridge has non-integral abutments and steel girders. Differential settlement of 4 inches was measured at the end of the wingwall. No other major problems were observed. Figure 39 shows deterioration of the expansion joint sealer.

Figure 39. Deteriorated sealer at the expansion joint

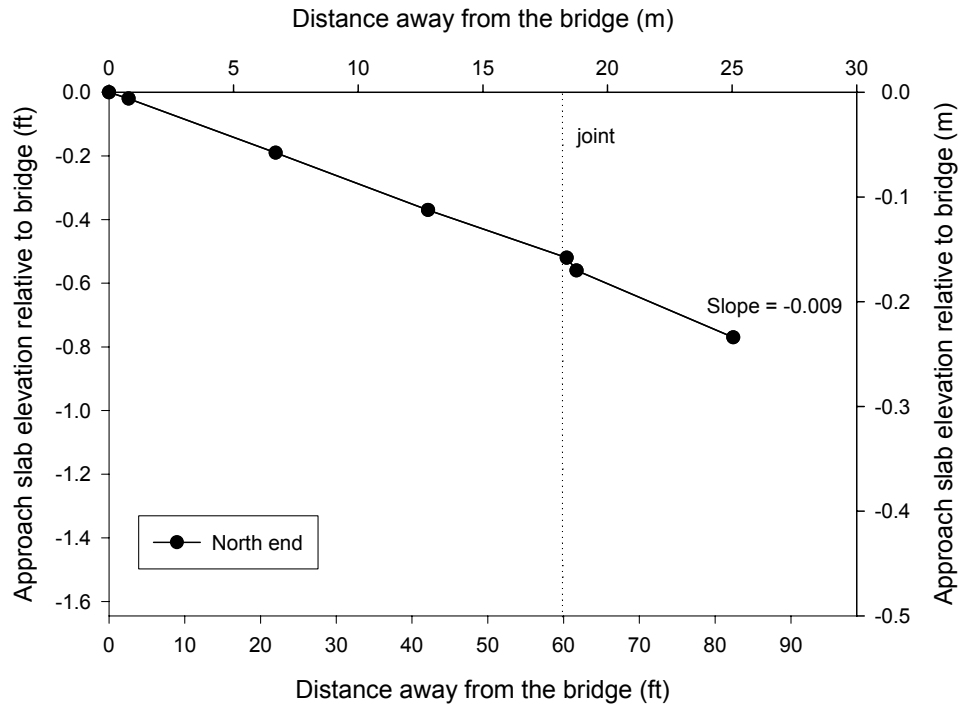
This bridge has integral abutments and concrete girders. Profiles of both ends of the northbound lane were measured in fall 2002. Figure 40 shows the profiles collected at the centerline for both approaches. About 0.5 in. of elevation difference was measured between the end of the approach slab and the pavement at the EF joint at the north end of the northbound lane. The north end approach slab appears to be in a good condition. The slope of the bridge approach is -0.009.

Figure 40. Profile of bridge approaches relative to bridge deck

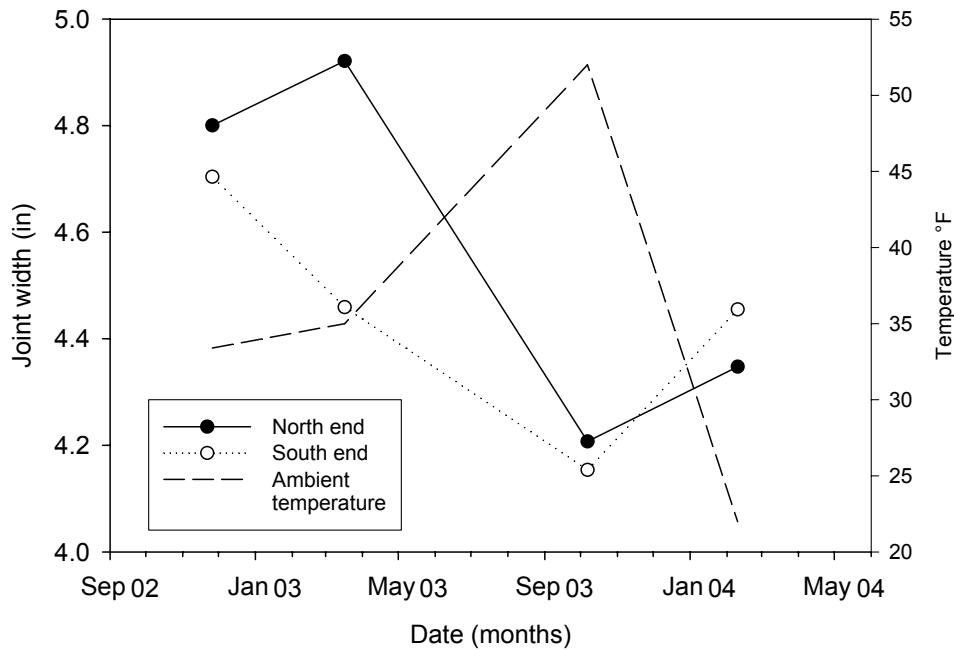
The width of the expansion joint at both ends of the bridge and the corresponding ambient temperature were measured over 15 months (Figure 41). As the air temperature increased, the joint width decreased. The largest variation in joint width was about 0.8 in. (2.0 cm) at temperatures ranging from 22 °F to 55 °F. Greater variation in temperatures could result in larger joint width changes.

Figure 41. Change in expansion joint width with respect to thermal variation

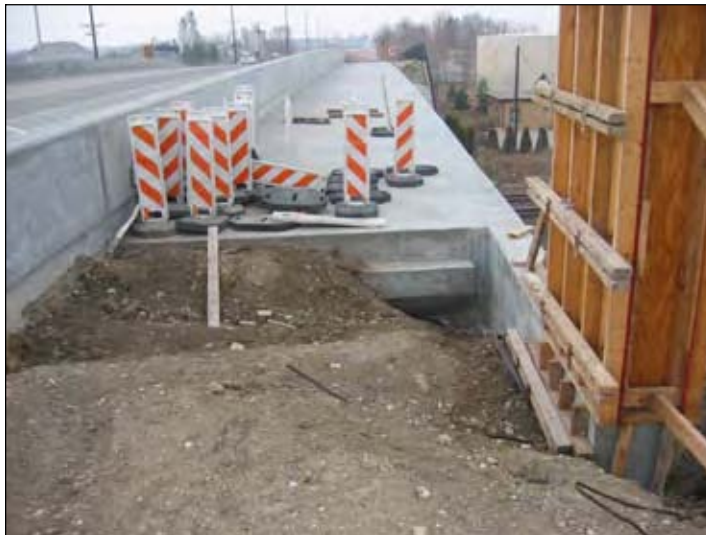
This bridge has integral abutments with concrete girders. Although the bridge is newly constructed, a dip in the approach slab could be seen. No measurement was made. Figure 42 shows non-compacted granular backfill behind the abutment.

Figure 42. Non-compacted granular backfill behind the bridge abutment

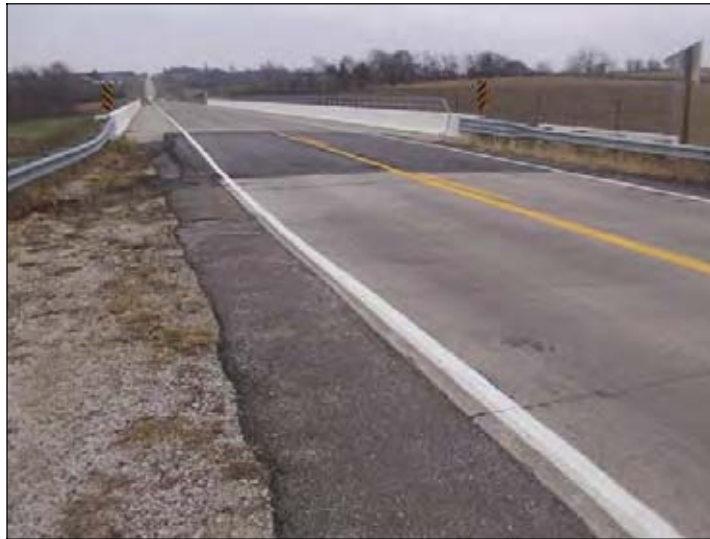
This bridge is a four-span bridge with integral abutments and concrete girders. Asphalt overlays were placed at both ends of the bridge (Figure 43). Figure 44 shows some cracks in the overlay. Differential settlement at the bridge approach of about 3 inches was measured at the approach slab shoulder. Minor erosion of the embankment under the bridge and the abutment sides was noted. Furthermore, the 4 inches expansion joints were poorly filled at the east end (Figure 45). As shown in Figure 46, aggregate was used as slope protection for the embankments under the bridge.

Figure 43. A view of the bridge showing recently placed asphalt overlay at the bridge approach (East end)

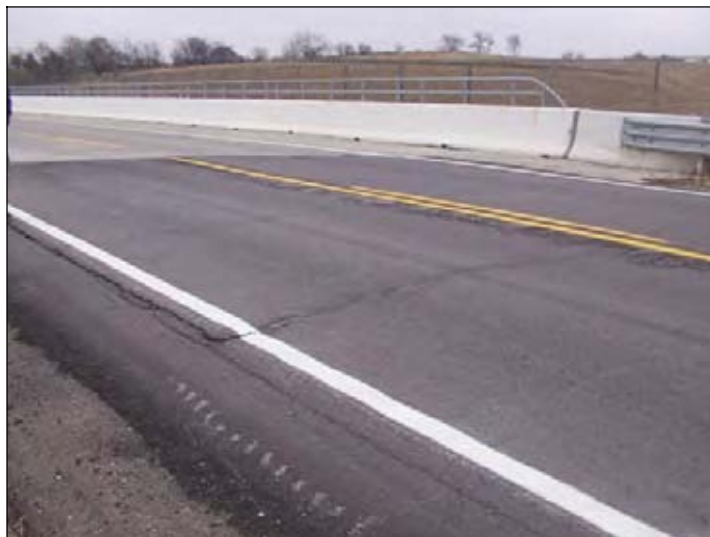
Figure 44. Cracking of the asphalt overlay (East end)

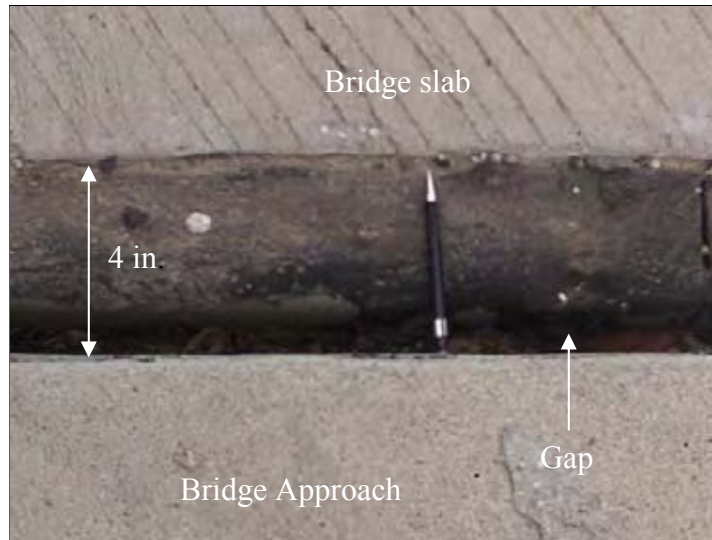
Figure 45. Poorly filled expansion joint (East end)

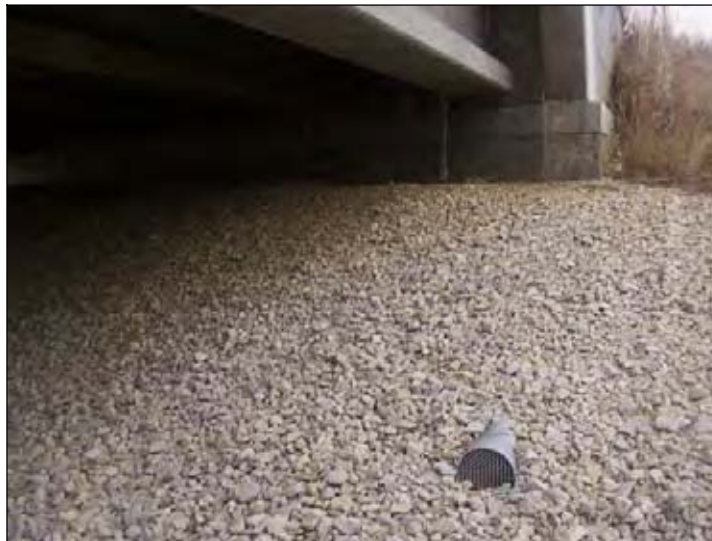
Figure 46. Aggregate used as a slope protection at the embankment under the bridge

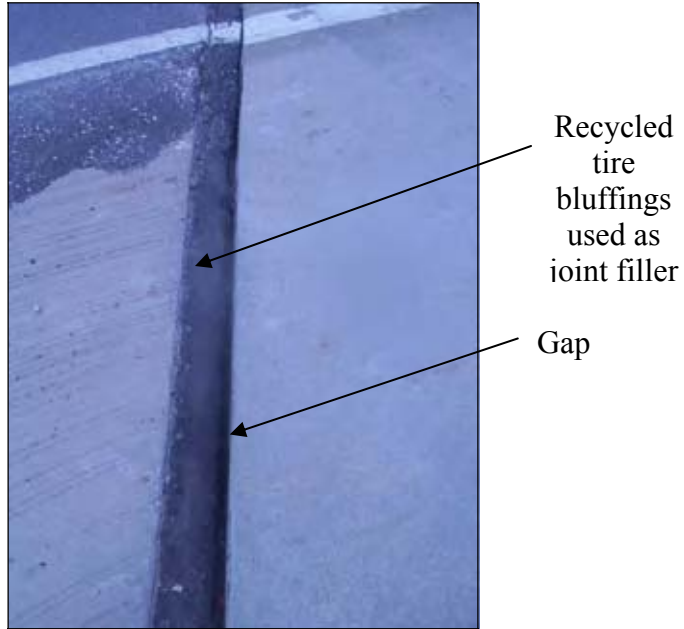
The bridge was visited again in summer 2004. At the east end, differential settlement of 6.5 inches at the guardrail at the approach slab and a void depth of 5.5 inches under the approach slab were observed. The width of the expansion joint was 5.5 inches (Figure 47). More transverse cracks were noted on the asphalt overlay, as shown in Figure 48.

Figure 47. Poorly sealed expansion joint (East end)

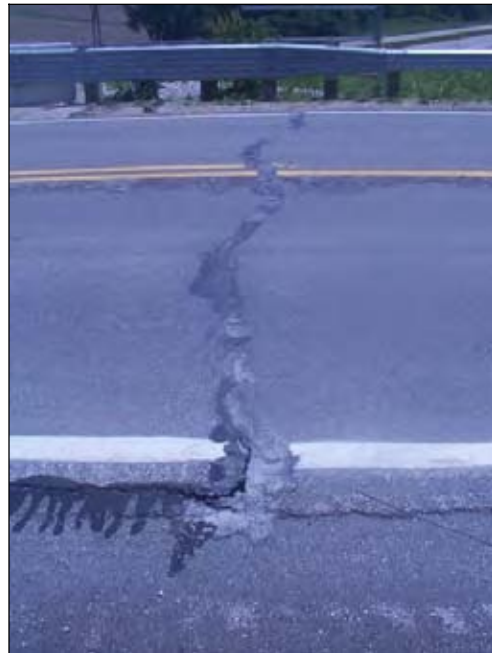
Figure 48. Transverse cracks of asphalt overlay (East end)

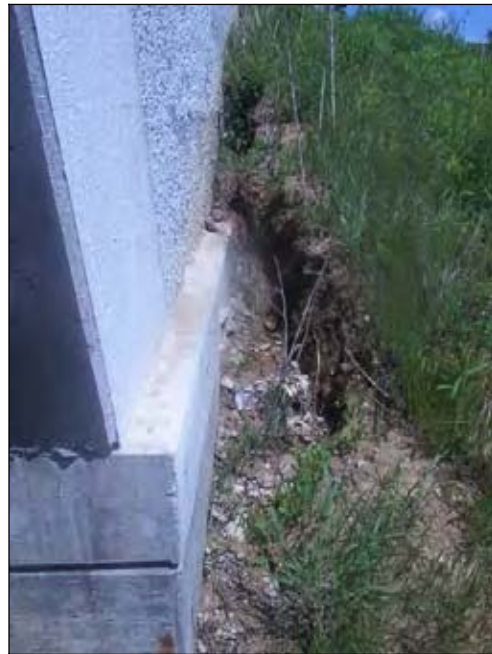
At the west end, a void has developed under the approach slab. The void was 5.5 inches at the expansion joint and 4.5 inches at the end of the wingwall (Figure 49). Furthermore, soil erosion at the abutment side was observed (Figure 50). Soil near the abutment sides is silty sand and is considered highly erodible. An aggregate slope protection cover was used at the embankment under the bridge and appeared to be in good condition.

Figure 50. Soil erosion at the abutment side (West end)

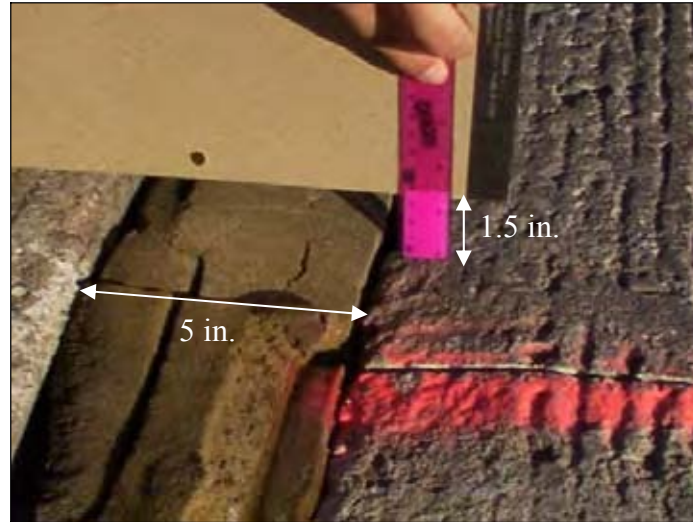
The bridge has integral abutments and concrete girders. Differential settlement between the bridge deck and the approach slab of 1.5 inches was measured at the east end (Figure 51). The embankment under the bridge has settled 3.5 inches and a gap of 3 inches was measured between the abutment and the embankment under the bridge (Figure 52). The width of the expansion joint, which has flexible foam filler, was approximately 5 inches.

Figure 51. Differential settlement of 1.5 in. at the bridge approach (East end of WBL)

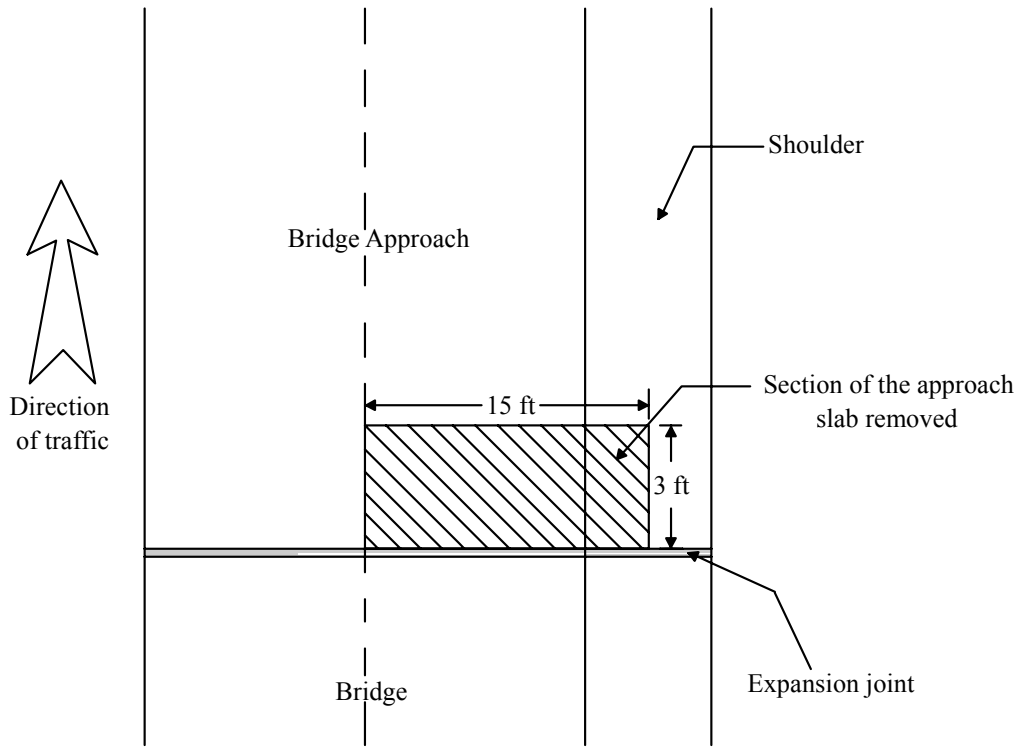
Part of the approach slab at the east end of the westbound lane was removed by Iowa DOT personnel as part of their endeavor to determine the cause of differential settlement between the end of approach slabs and bridge decks. A 3-foot-long by 15-foot-wide section extending from the centerline of the approach slab to the center of the shoulder was removed (Figures 53 to 55). After removing the approach slab segment, an 8-inch void was measured under the approach slab (Figure 56). Also, the base material appeared to be poorly placed and not compacted. Upon inspection of the paving notch, it was observed that about 1.5 inches of fine sand was under the joint filler (Figure 57). The thickness of the approach slab was 7 inches over the paving notch and 8.5 inches over the approach slab embankment (Figure 58). The difference in thickness is attributed to poorly cleaning the paving notch prior to placement of the approach slab. The width of the paving notch is 10 inches. As shown in Figure 59, flexible foam was used as a joint filler material.

Figure 53. Top view of the bridge with the location of removed approach slab for inspection

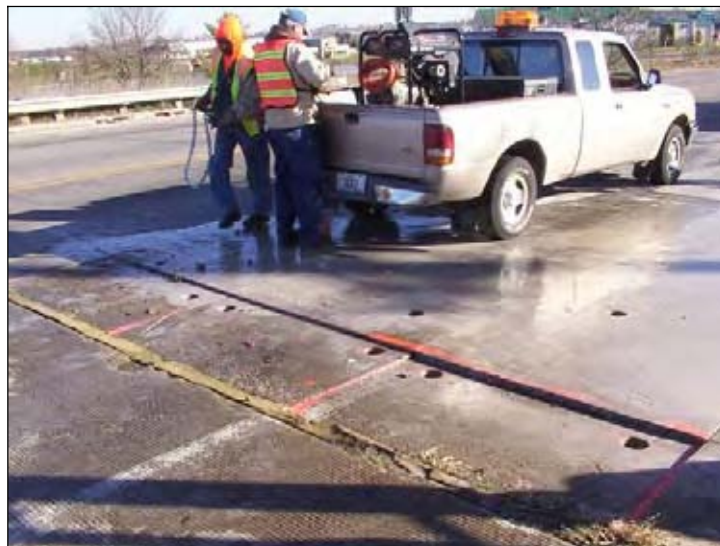
Figure 54. Section of the approach slab cut and ready to be removed

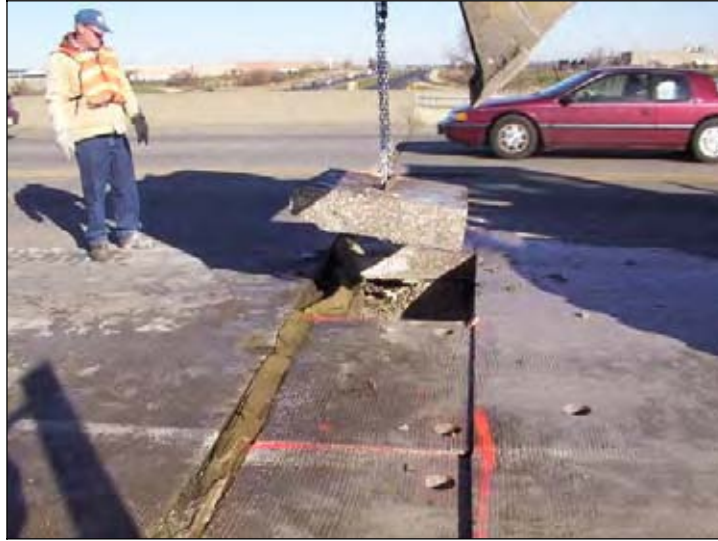
Figure 55. Removing a segment of the bridge approach

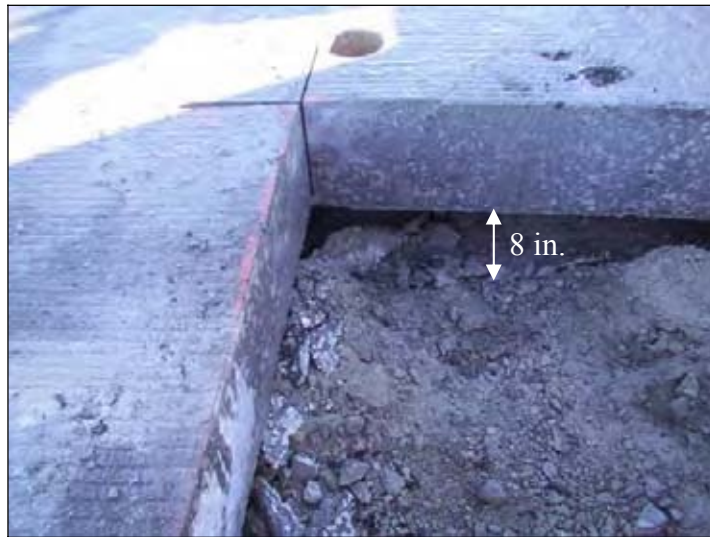
Figure 56. Eight-inch void observed under the approach slab

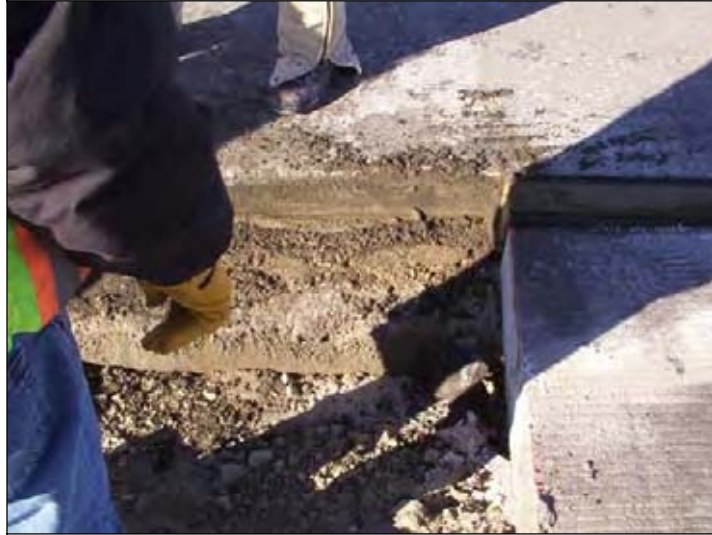
Figure 57. Layer of fine sand covering the paving notch

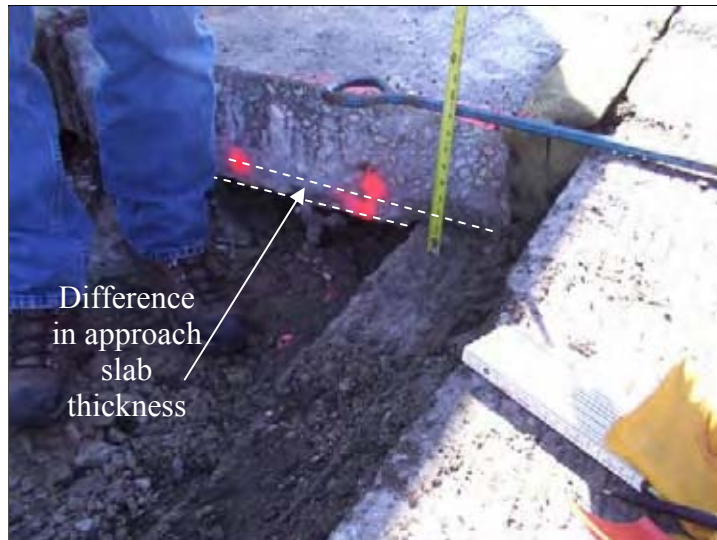
Figure 58. Non-uniform approach slab thickness with 1.5 in. increase over the backfill compared with the thickness over the paving notch

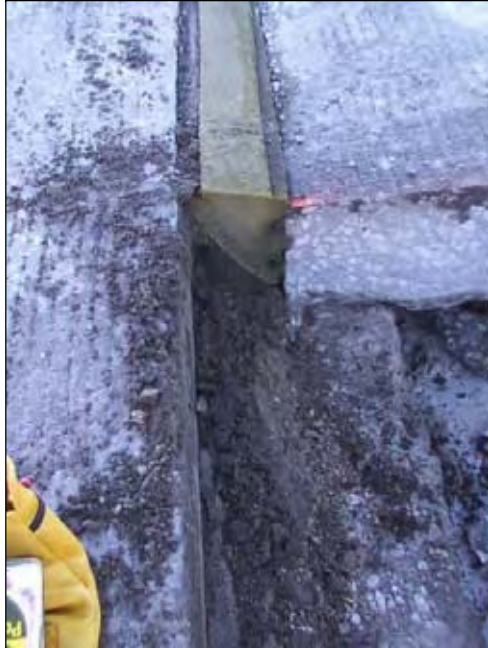
Figure 59. Contaminated expansion joint

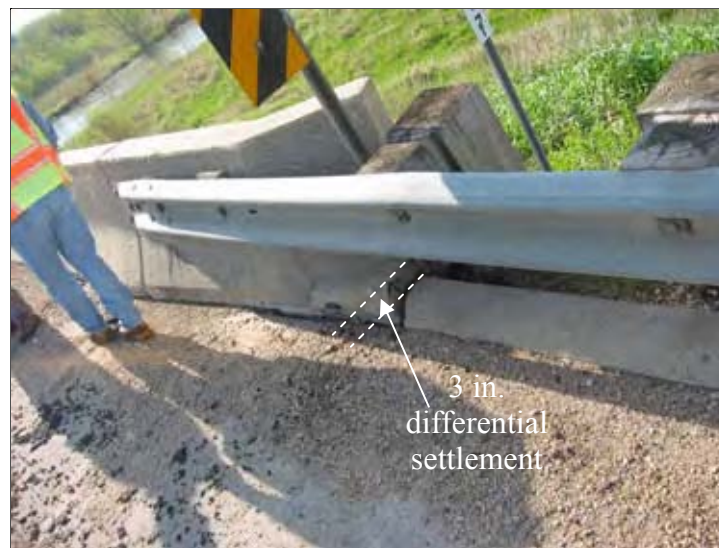
This bridge was constructed in 1984 and has three spans with integral abutments. Figure 60 shows 3 inches of differential settlement between the bridge slab and the bridge approach at the end of the south-west wingwall. Figure 61 shows concrete deterioration at the west end CF joint, as well as longitudinal cracks in the approach slab. A crack developed between the bridge approach and the wingwall due to the settlement of the approach relative to the wingwall. The width of the crack was 1.5 inches and extended to a length of 4.5 feet. No major erosion was observed at this bridge.

Figure 60. Differential settlement of 3 in. at the south-west corner

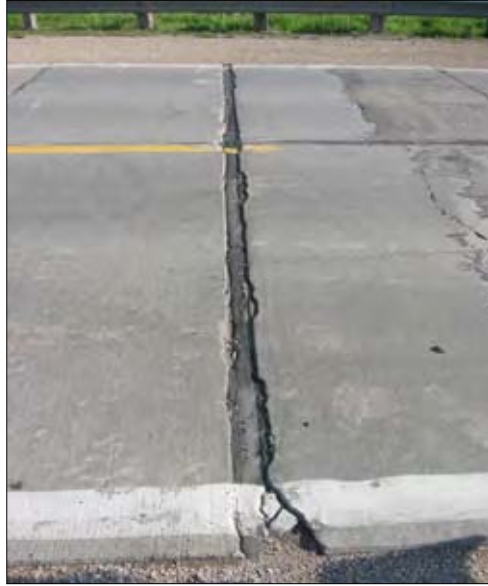
Figure 61. Concrete deterioration at the EF joint (West end)

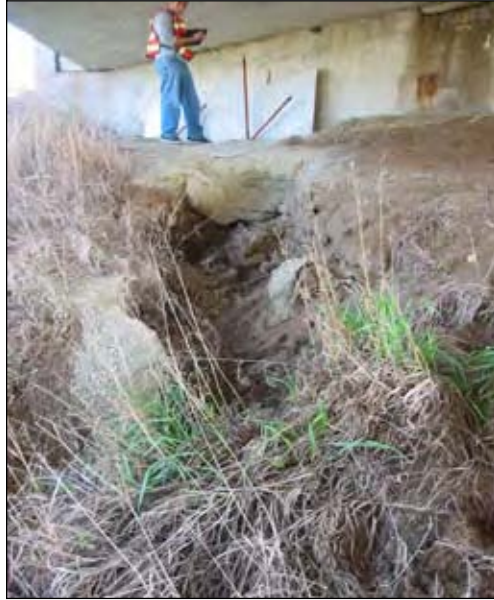
This bridge is a three-span concrete slab bridge (Figure 62). Figure 63 shows erosion of the embankment under the bridge. Cracks were observed in the asphalt overlay around the expansion joint (Figure 64).

Figure 63. Erosion of the embankment soil under the bridge

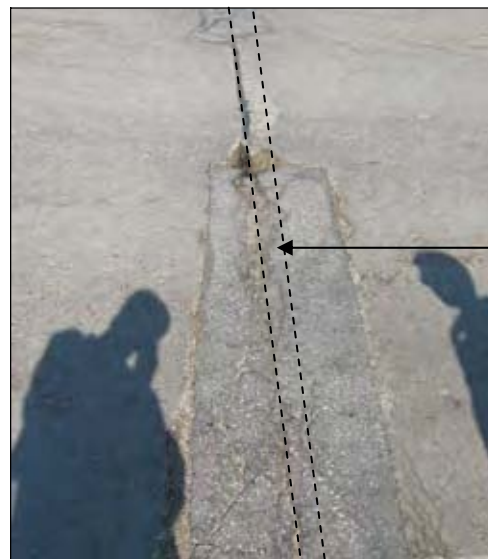
Original
location of
the
expansion
joint

Figure 64. Cracked asphalt patch covering the expansion joint
