IDENTIFICATION OF THE BEST PRACTICES FOR DESIGN, CONSTRUCTION, AND REPAIR OF BRIDGE APPROACHES

Iowa DOT Project TR-481
CTRE Project 02-118

Final Report

January 2005

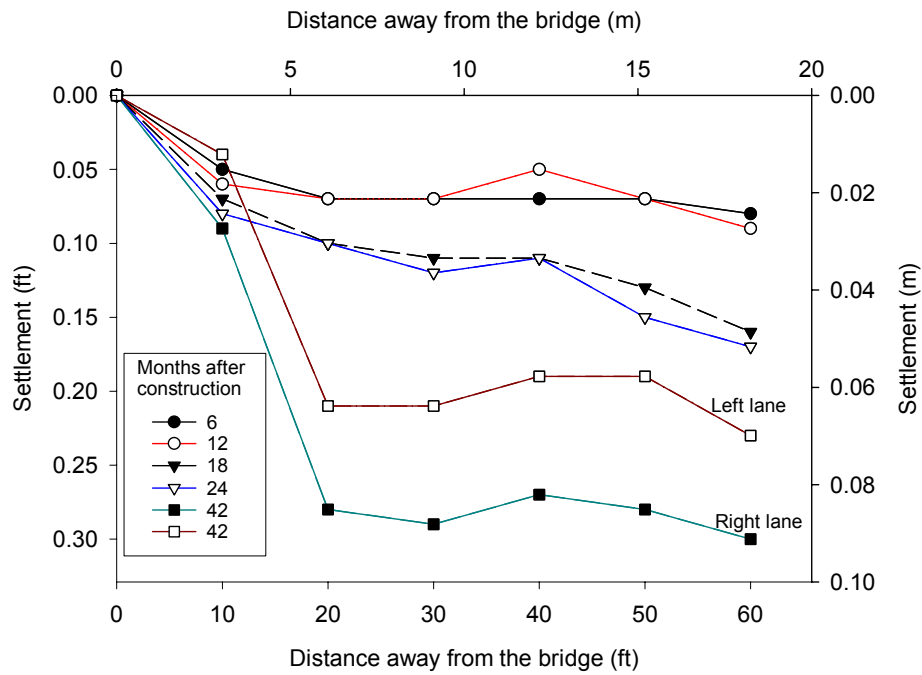
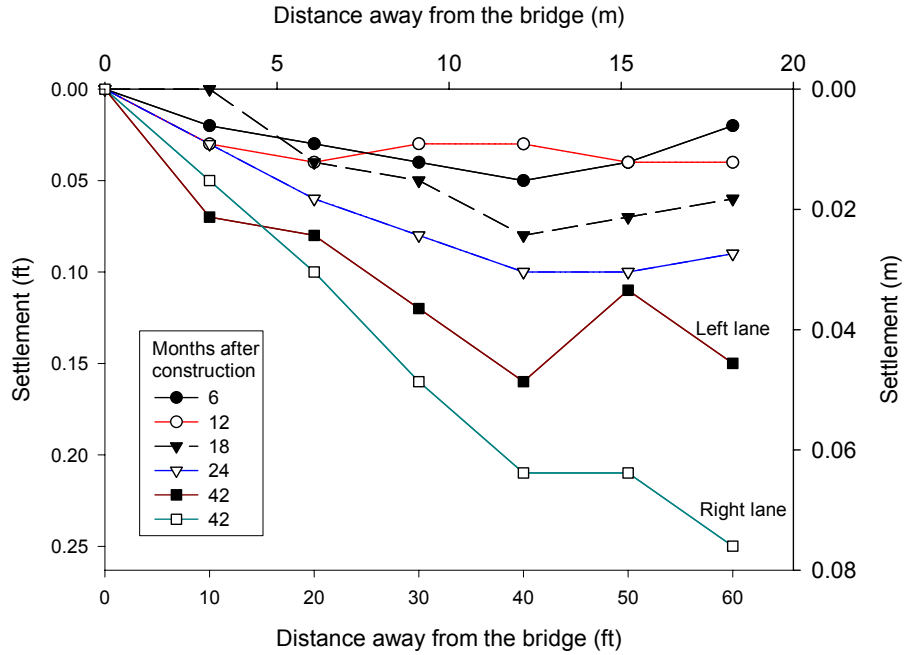
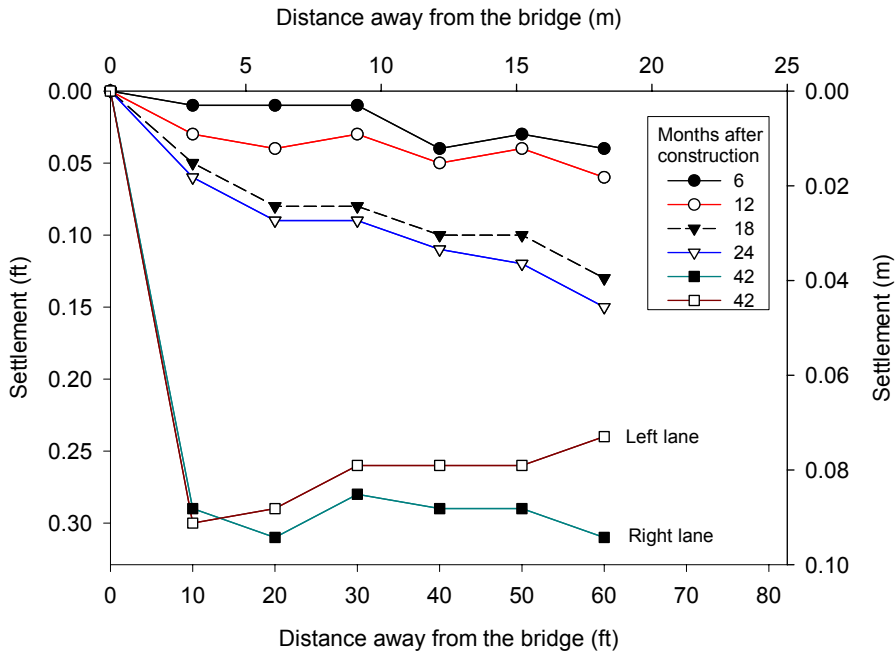
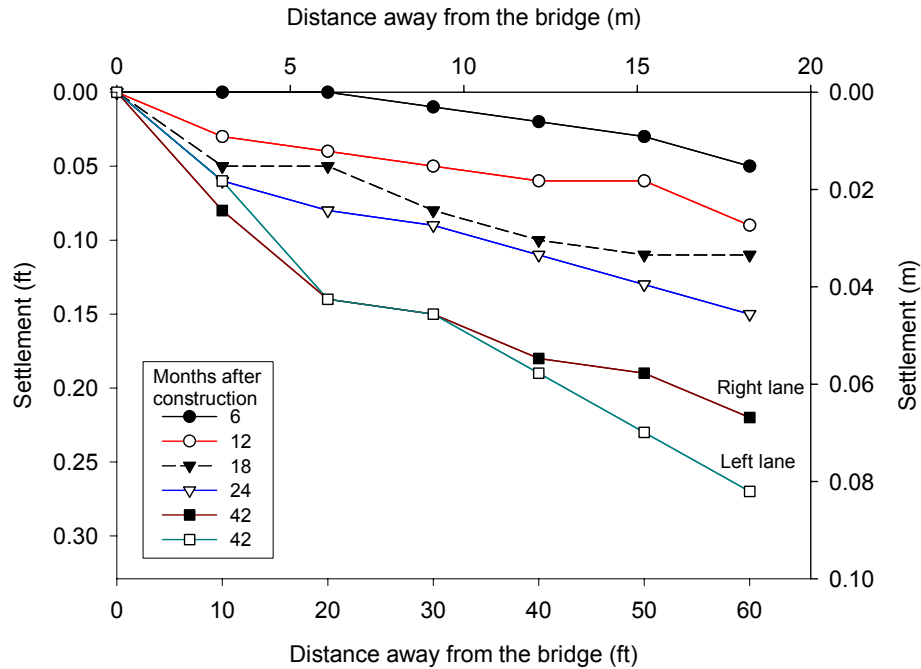
Figures 67 and 68 show the settlement for the bridge approaches at both the north and south ends of the northbound bridge, respectively. Settlement was measured in 10 ft. increments away from the bridge end. Settlement data for both approaches indicate that the approach slab settlement has been increasing with time.

Figures 69 and 70 show the settlement of the bridge approaches of the north and south ends of the southbound bridge, respectively. It is observed that approach slab settlement increases with time at both approaches. Figures 67 through 70 show no settlement difference between approach slabs supported on Geopier elements or embankment fill. This suggests that the embankment fill

is not the contributor to differential settlement and that perhaps settlement of the embankment foundation is the contributing factor.

Figure 67. Settlement of the approach slab supported on Geopier elements (North end of NB bridge)

Figure 68. Settlement of the approach slab supported on Geopier elements (South end of NB bridge)

Figure 69. Settlement of bridge approach supported on the embankment soil (North end of SB bridge)

Figure 70. Settlement of bridge approach supported on embankment soil (South end of SB bridge)

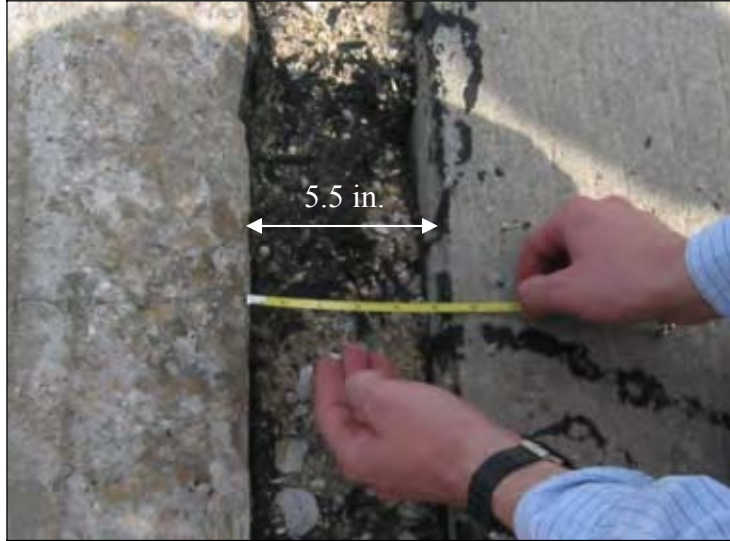
This bridge has integral abutments and concrete girders. Figure 71 shows that the width of the expansion joint is about 5.5 inches. Recycled tire chips were used as filler material at the expansion joint. Deterioration of the concrete at the expansion joint was also observed. Figure 72 shows about 1 inch differential settlement between the approach slab and the bridge deck. In the summer 2003, profiles of all approach slabs were measured and are shown in Figures 73 and 74. All four approach slabs show nonlinear profiles indicating settlement of the approach slab. Approximately 3.9 inches of differential settlement was measured at the west end of the eastbound bridge approach at the end of the wingwall. The slopes of the eastbound lane approach slabs are -0.009 and 0.017 for the east end and west end, respectively, and -0.009 and 0.02 for the east and west end approach slabs of the westbound lane, respectively.

Figure 71. Expansion joint with recycled tire filler and a width of 5.5 in. (top view)

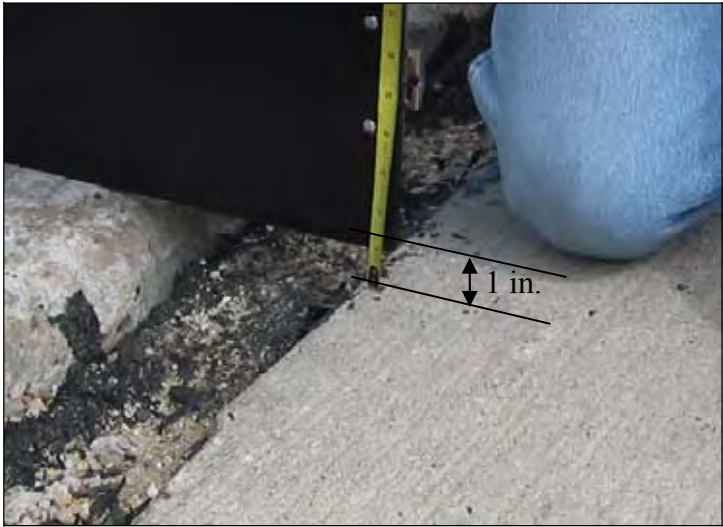
Figure 72. Differential settlement of 1 inch at the bridge approach

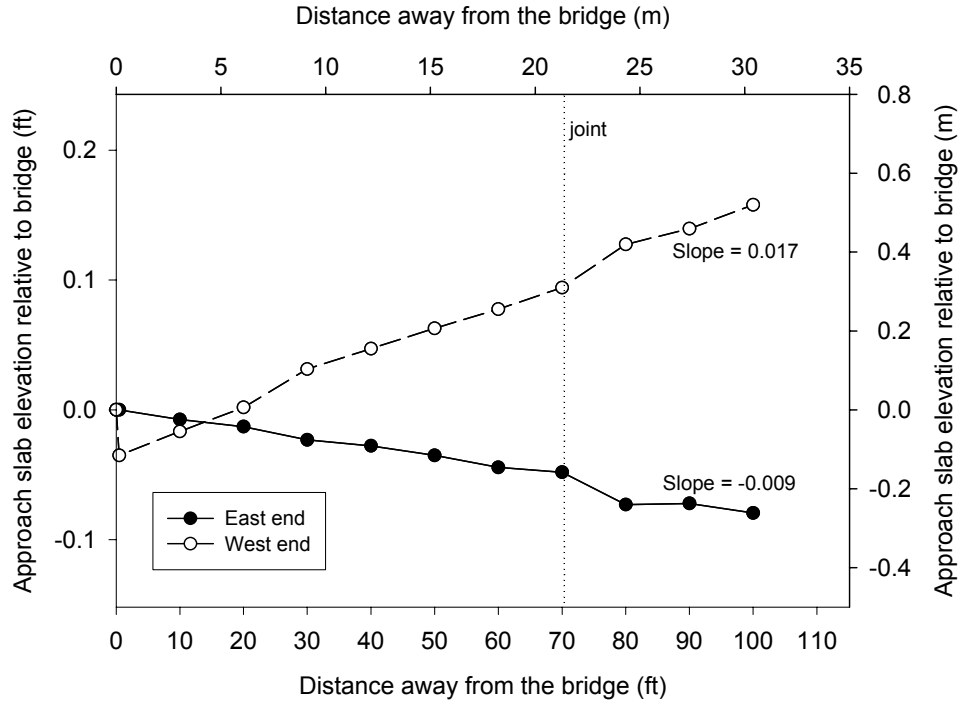
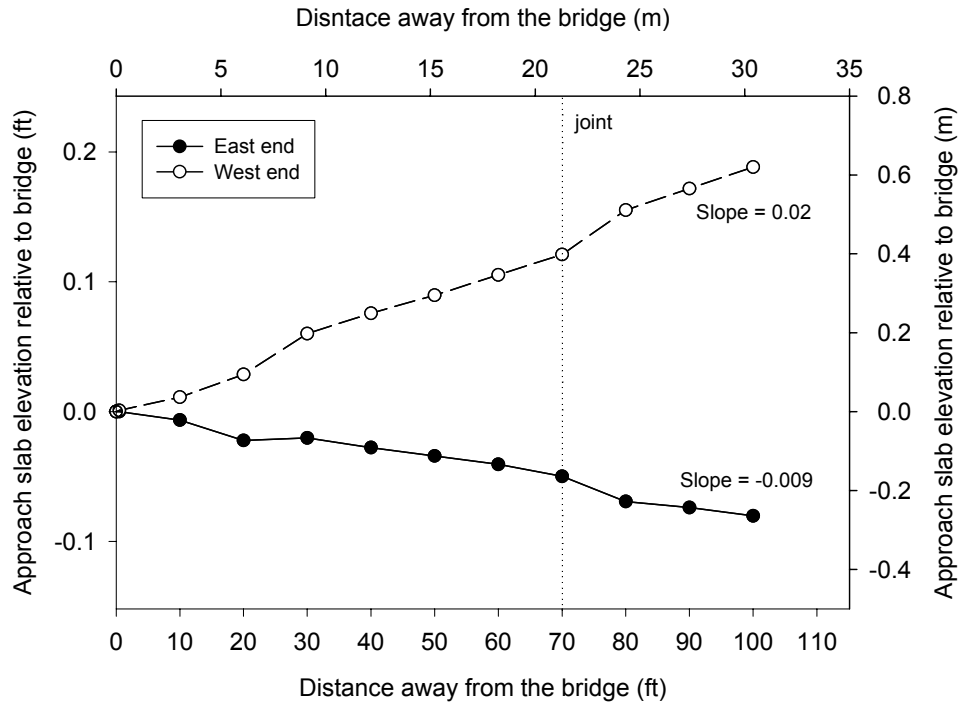
Figure 73. Profiles of the approach slab relative to bridge deck (EBL)

Figure 74. Profiles of the approach slab relative to bridge deck (WBL)

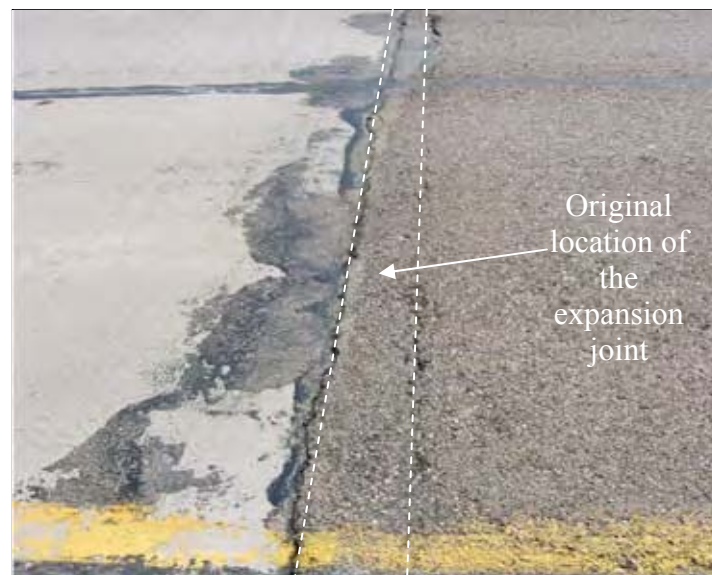
This bridge was constructed in 1976 with integral abutments. Currently, an asphalt resurfaced approach slab covers the expansion joint, as shown in Figure 75. According to the maintenance reports, the approach slab has been resurfaced more than once.

Figure 75. Asphalt overlay covering the expansion joint at the bridge approach

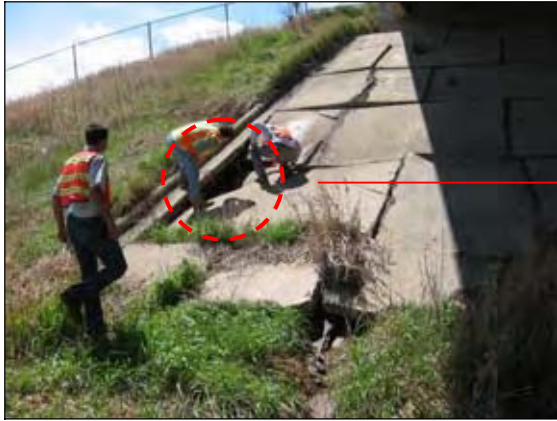
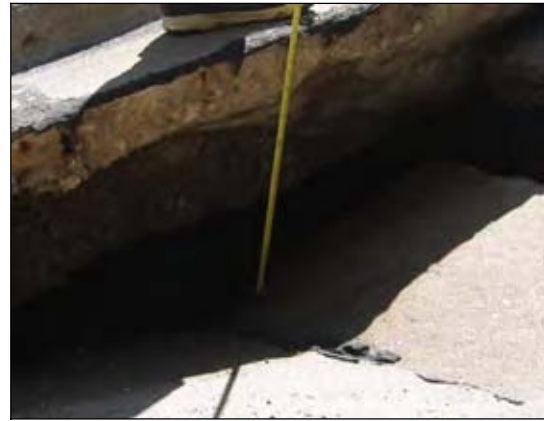
This bridge approach was also resurfaced with an asphalt overlay. The embankment has concrete slope protection. Figures 76 and 77 show damage of the concrete slope protection at the south

end of the northbound lane. The depth of the void under the concrete slope protection was approximately 1.6 feet. Figure 78 shows the settlement of the embankment under the bridge. A gap was also observed between the abutment and embankment. The width of the gap between the abutment and the embankment was 6.5 in. In addition, water was running over the concrete slope protection, indicating poor drainage.

(a) Damaged slope protection

(b) Closer image of the damaged concrete

Figure 76. Failure of slope protection due to loss of support (south end NBL)

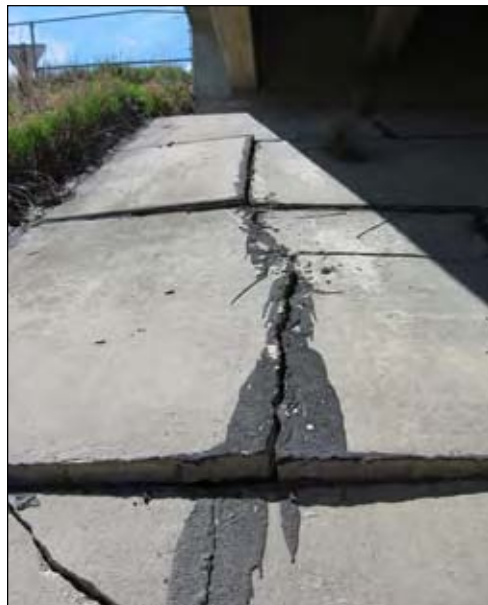
Figure 77. Fractured concrete slope protection

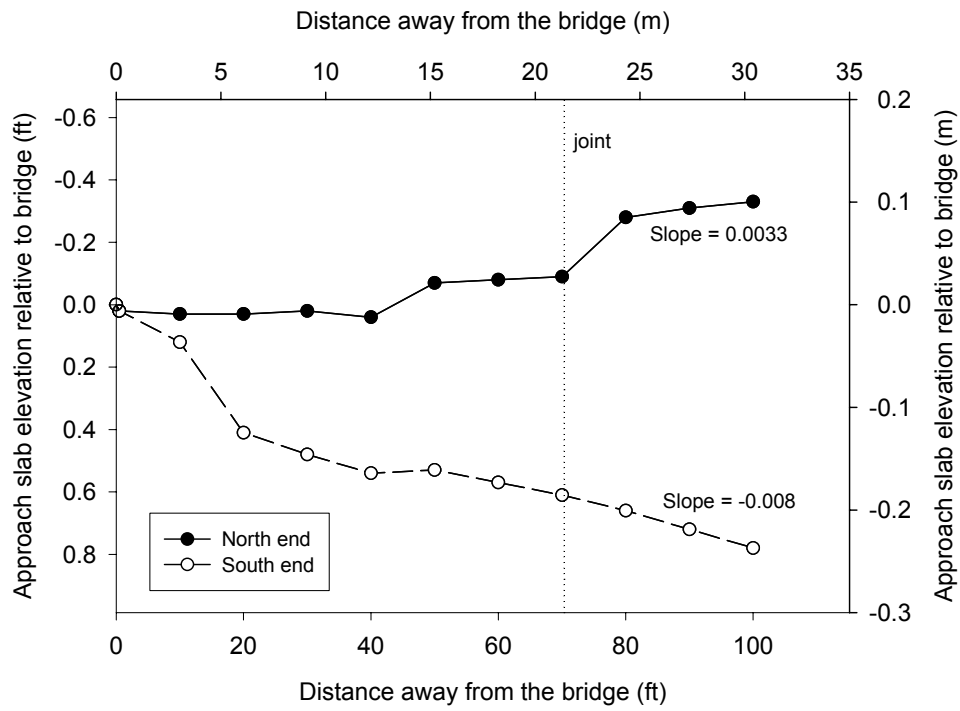
This bridge was constructed in 1971 and has concrete girders with integral abutments. According to maintenance reports, grout was pumped at the bridge ends to fill the void under the approach slab. Cracking in the bridge deck concrete is shown in Figure 79. Bridge approach profiles were obtained in summer 2003 (Figure 80) and show the elevation of the approach slab relative to the bridge deck. A settlement of approximately 2 inches was measured between the approach slab and the wingwall at the north end approach slab. The south end approach slab settled about 4 inches between 15 and 50 feet away from the bridge. The gradient of the north and south end approach slabs are 0.003 and -0.008, respectively. Figure 81 shows the inlet of the bridge approach surface drain, which appeared to be effective since no soil erosion around the bridge was observed.

Figure 80. Profile of the approach slab relative to the bridge deck

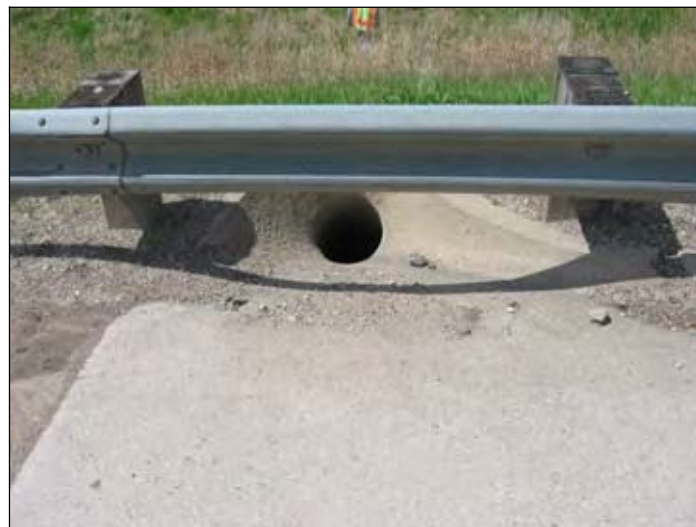
Figure 81. Surface drainage inlet at the bridge approach

- Some bridges do not have a surface drain. The current Iowa DOT surface drain detail shown in Figure 94 is not effective. The surface drain observed at 5596.2S169 bridge (Figure 81) is effective and is believed to have helped in reducing erosion around the bridge abutment.

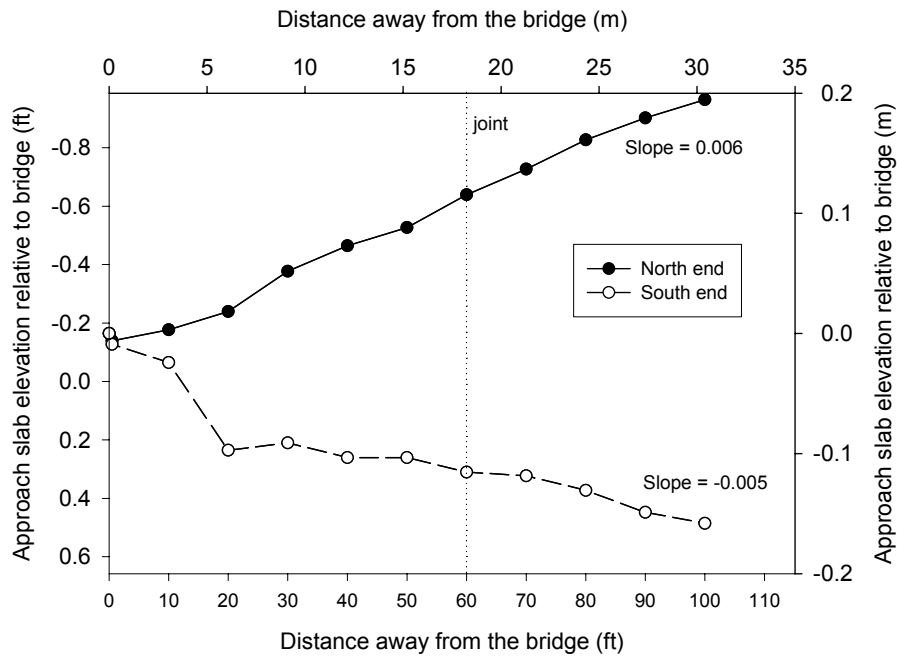
This bridge was constructed in 1971 and has concrete girders with integral abutments. The approach slab was resurfaced with an asphalt overlay. Cracks were observed at the expansion joints at the south end of the bridge. Soil erosion along the sides of the abutment was also observed, but no soil erosion of the embankment under the bridge was noted. Figure 82 shows the profiles of the bridge approaches over a distance of 100 ft. at the centerline of both the north and the south ends of the bridge, measured in summer of 2003. The south end approach slab settled about 3 in. between 10 and 20 ft. away from the bridge. The slopes of the north and south end approach slabs are 0.006 and -0.005, respectively.

Figure 82. Profile of the bridge approach relative to bridge slab

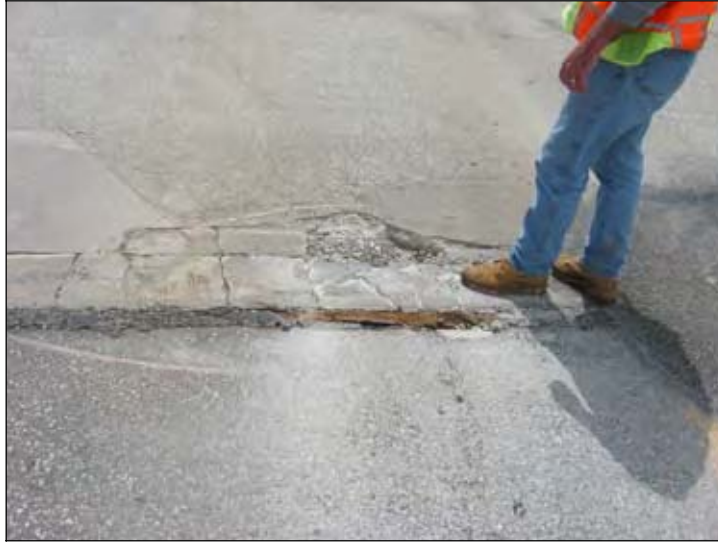
This bridge has integral abutments and concrete girders. Similar to the previous two bridges, cracks developed at the bridge slab (Figure 83). No soil erosion was observed at the embankment under the bridge; however, erosion along the abutment sides was visible.

Figure 83. Cracks in the bridge deck concrete

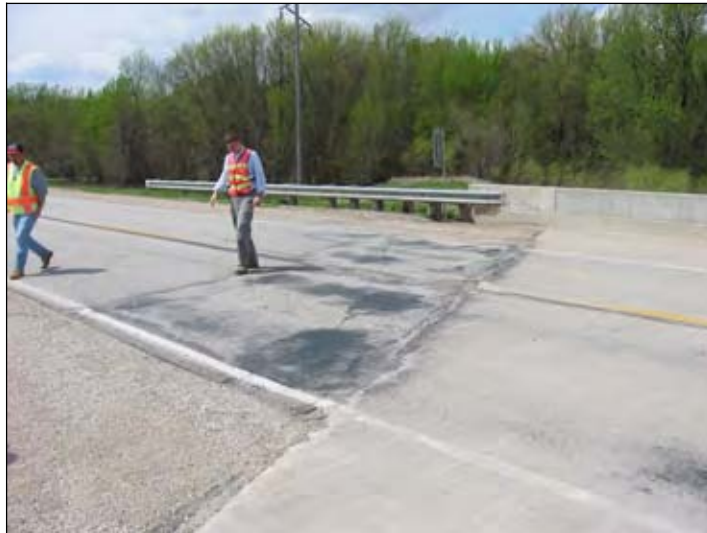
This bridge has integral abutments with concrete girders. No significant soil erosion was observed. Settlement of the embankment of 4.5 inches under the bridge was measured. Both approach slabs had been patched; however, deterioration and cracks were observed on both approach slabs (Figure 84).

Figure 84. Cracking of asphalt overlay (East end)

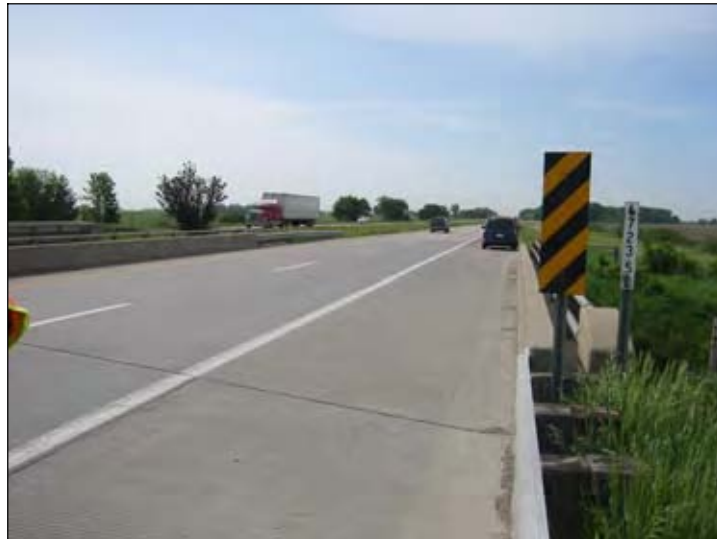
This bridge was constructed in 1960. The approach slab had been recently replaced for the south bound bridge lanes and no major problems were observed (Figure 85).

Figure 85. Recently replaced bridge approach slab (SBL)

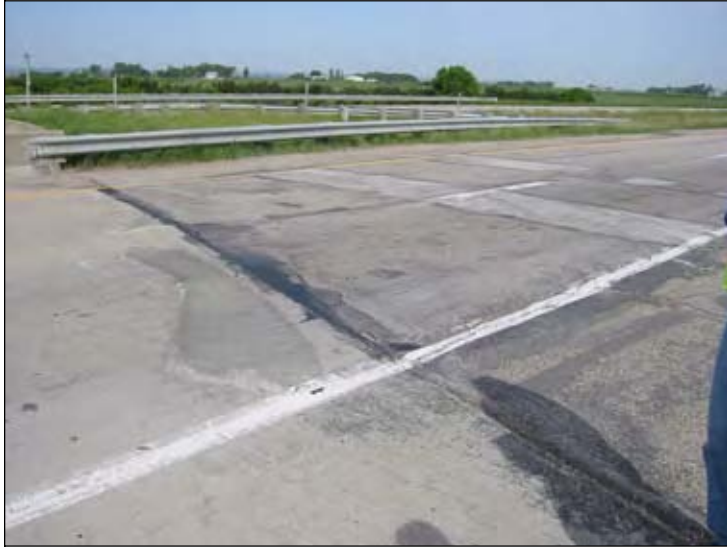
Approach slabs for the north bound bridge were resurfaced with asphalt overlays at both ends. However, wavy approach slabs, longitudinal cracks, and differential settlement of 4 inches relative to the wingwall were observed at both ends (Figures 86 to 88). Figure 88 shows differential settlement and cracks at the bridge slab. The cracks were similar to the ones observed at District 2 (See Bridge no. 5596S169). Figure 88 also shows an asphalt patch that was placed over the crack at the bridge slab while inspecting the bridge.

Figure 86. Significant damage of the asphalt overlay on the approach slab (NBL)

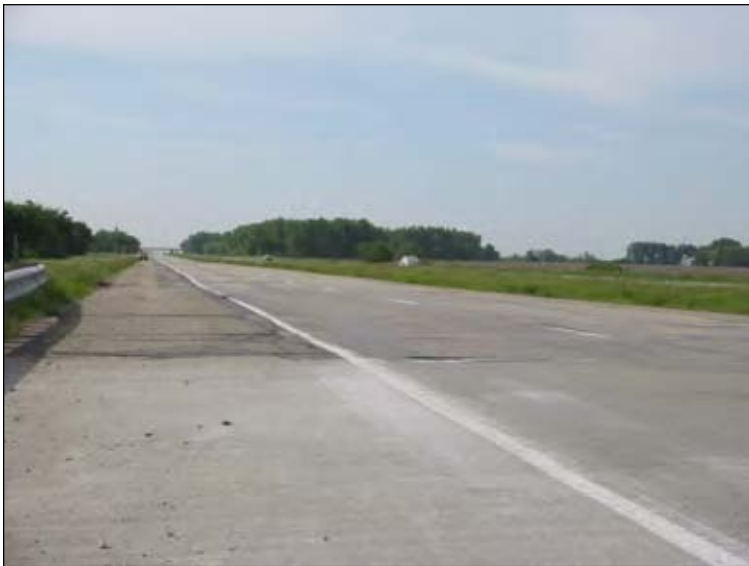
Figure 87. Wavy approach slab (NBL)

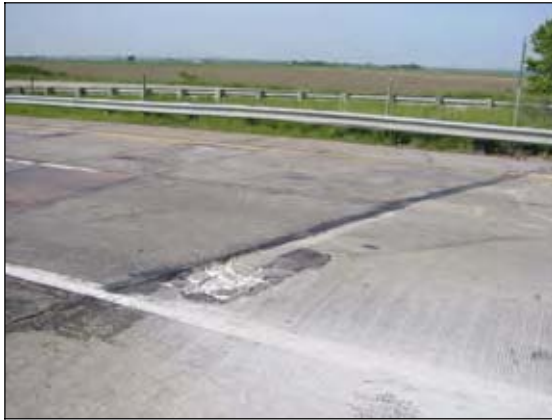
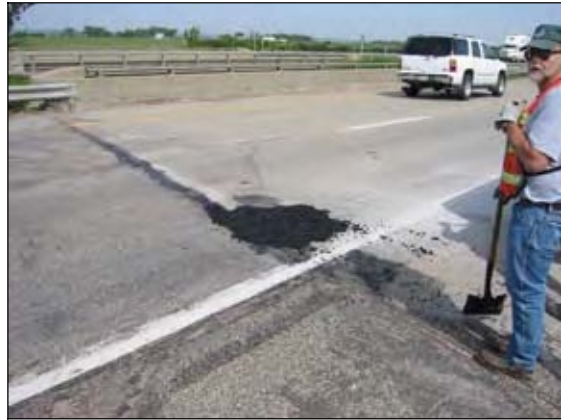
(a) Cracks on the bridge deck

(b) Asphalt patch covering the cracks

Figure 88. Asphalt patch placed over cracked bridge slab (NBL)

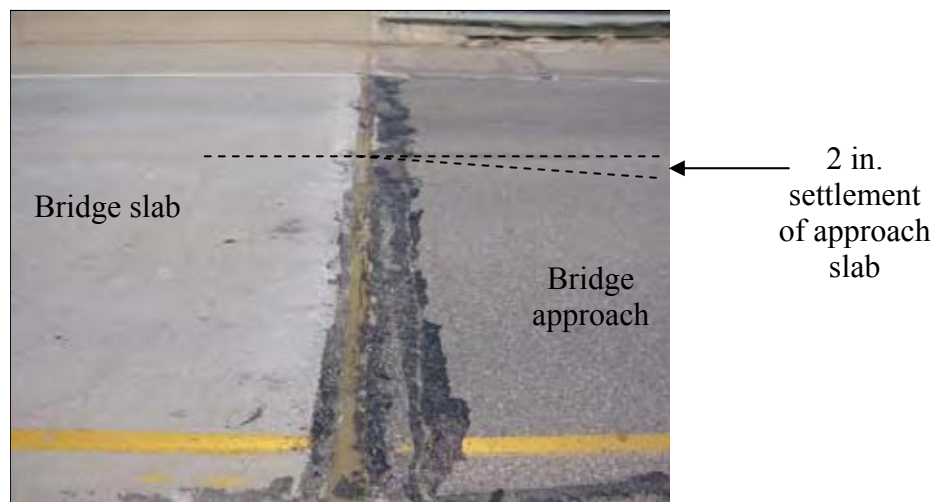
This bridge has an integral abutment and concrete girders. Damage to the expansion joint and 2-inch differential settlement, which was measured at the expansion joint, were observed (Figure 89). The bridge has an asphalt overlay. The slope protection at the embankment under the bridge settled about 3 inches relative to the abutment. Grout, which was pumped to fill the void developed under the approach slab, was observed seeping out between the concrete panels of the slope protection (Figure 90). This suggests that the void extended under the abutment.

Figure 89. Differential settlement between bridge slab and bridge approach

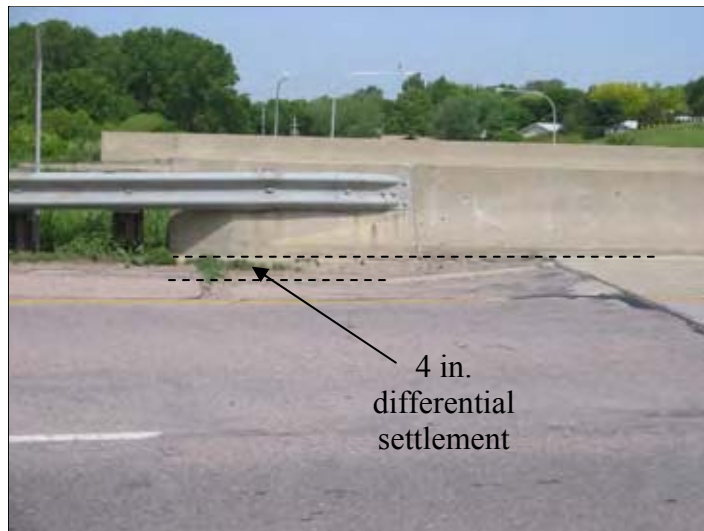
This bridge has integral abutments and concrete girders. The embankments under the bridge had a slope protection. The expansion joint at this bridge was 2 inches wide. Figure 91 shows the 4 inches of differential settlement measured between the bridge deck and the shoulder of the bridge approach. This figure also shows alligator cracking at the bridge shoulder. Grout was pumped behind the abutment at the west end of the eastbound lane and under the embankment slope protection cover. The concrete slope protection settled about 6.5 inches relative to the abutment (Figures 92 and 93).

Figure 91. Differential settlement between the bridge deck and the approach slab

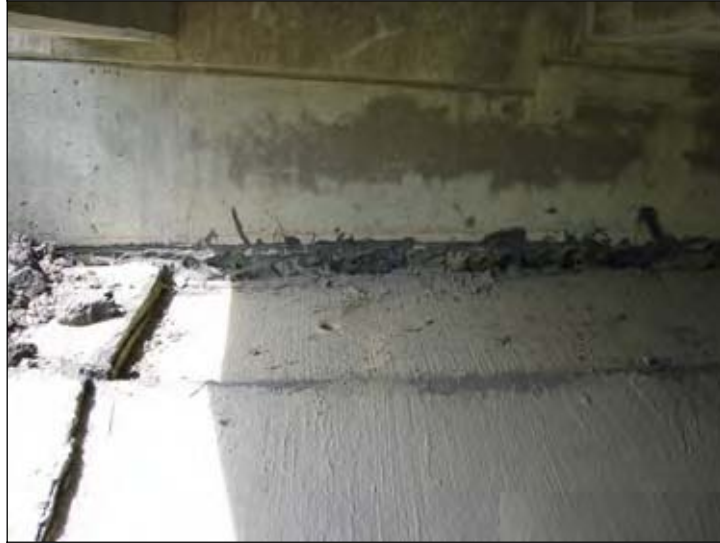
Figure 92. Uneven settlement of concrete slope protection

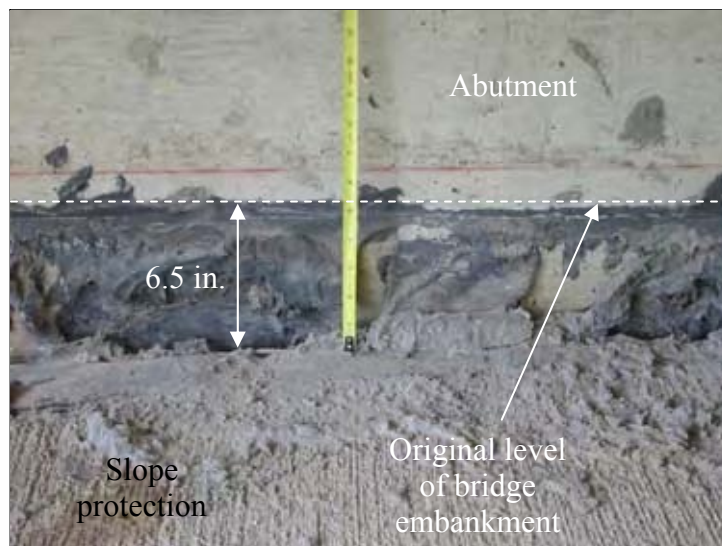
Figure 93. Settlement of the embankment slope protection of 6.5 inches

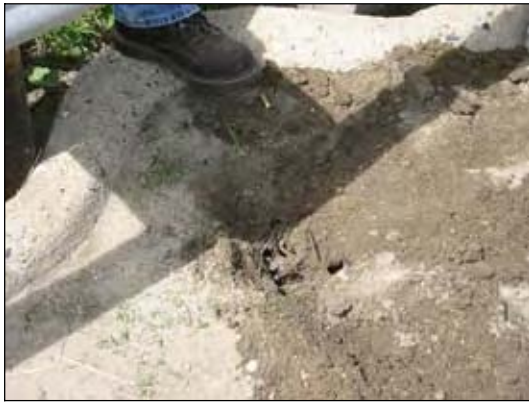
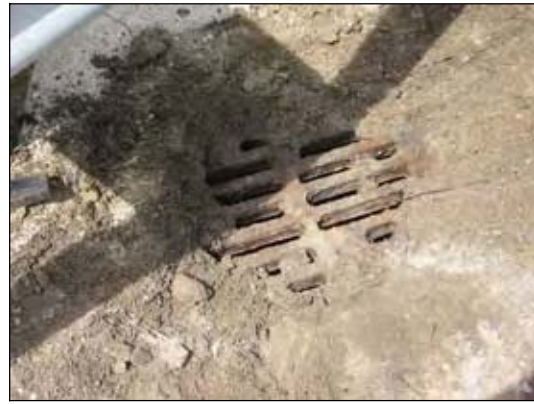
This bridge has non-integral abutments and concrete girders. The approach slab was grouted to prevent water infiltration. This caused water to run along the bridge shoulder to the other end of the bridge. Although surface drainage was used on the west side of the bridge, it was plugged (Figure 94). As a result, water eroded the approach slab shoulder, as shown in Figure 95. With no slope protection under the bridge and silty soil used for the embankment, severe erosion was also observed (Figure 96).

(a) Bridge approach surface drain blocked by debris

(b) Bridge approach surface drain after debris removal

Figure 94. Drainage intake before and after debris removal

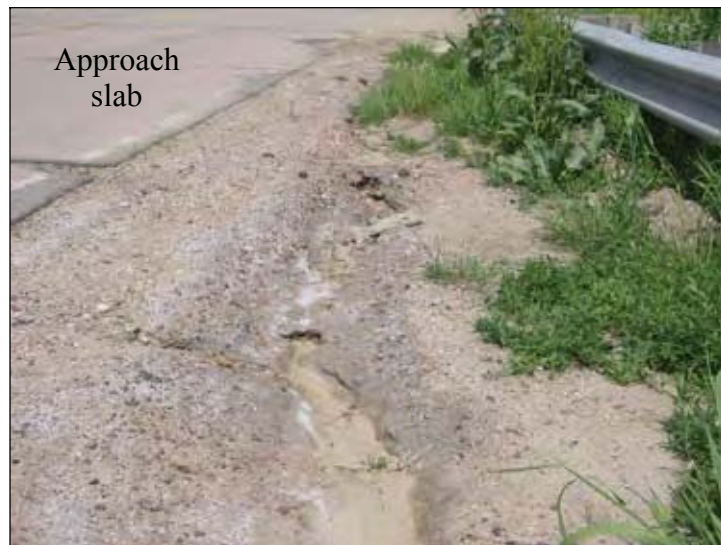
Figure 95. Erosion caused by runoff water at the approach slab shoulder

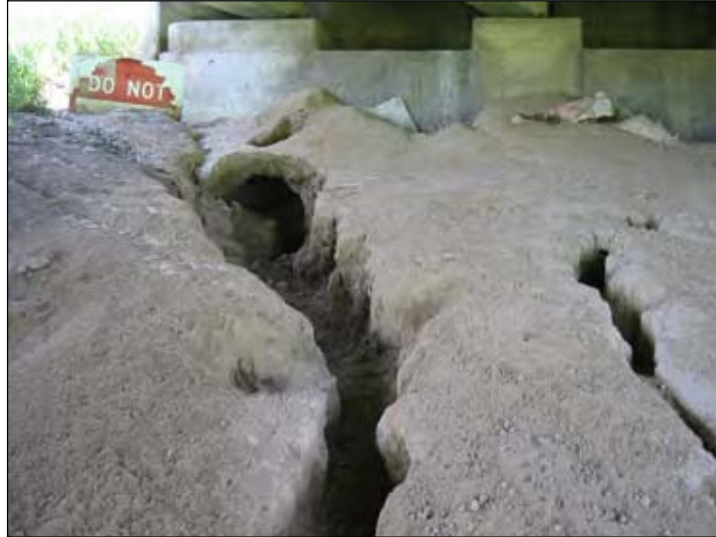
Figure 96. Severe erosion under the bridge

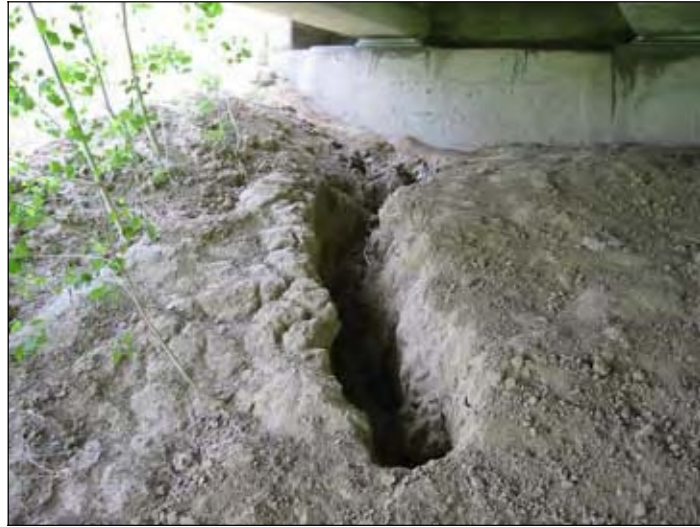
Figure 98. Soil erosion of the embankment under the bridge

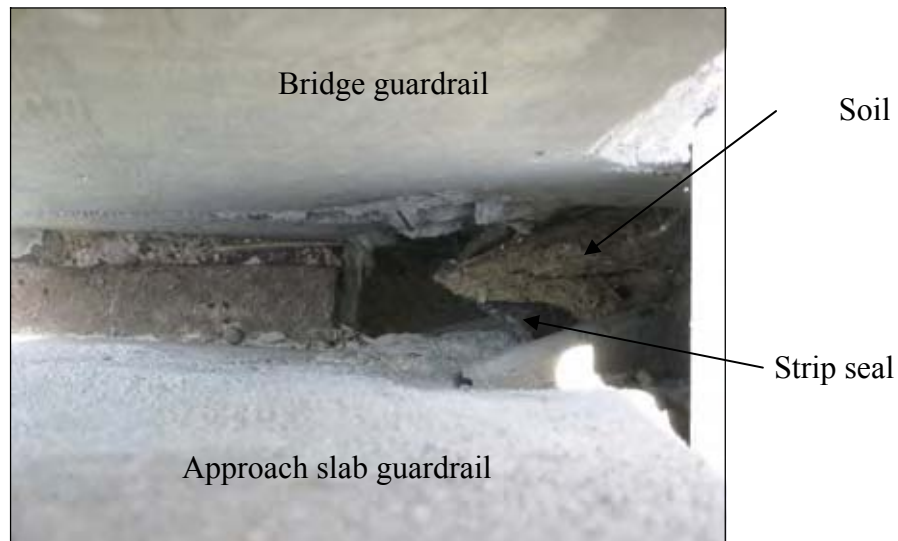
The bridge was constructed in 2000 with non-integral abutments. The foundation soils at this bridge were allowed to consolidate under the embankment weight for one year prior to construction. No differential settlement was observed at the approach slabs. Erosion of the soil under the bridge was observed because the strip seal of the expansion joint was cut short at both sides of the north bound lane, causing water to run down the sides of the bridge (Figures 98 and 99). At the opposite end of the bridge, the same strip seal problem was noticed and erosion of the embankment soil was observed.

Figure 99. Top view of the strip seal cut short (North bound)

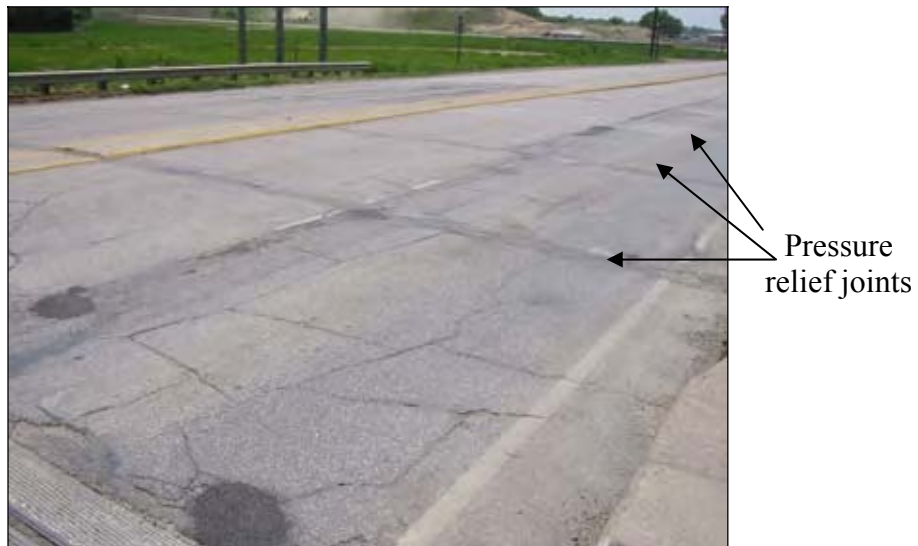
This bridge was constructed in the 1960s and has steel girders with non-integral abutments. Longitudinal and transverse cracks were visible on the approach slab. Figure 101 shows the aggregate that was used as a slope protection under the bridge. After overlaying the approach slab with asphalt, which also covered the expansion joint, a pressure relief joint was made by cutting the approach slab. More pressure relief joints were made as previous joints were deemed non-functional due to debris. The additional joints provide opportunity for water to infiltrate into the subgrade under the approach slab (Figure 102).

Figure 102. Pressure relief joints cut at the approach slab

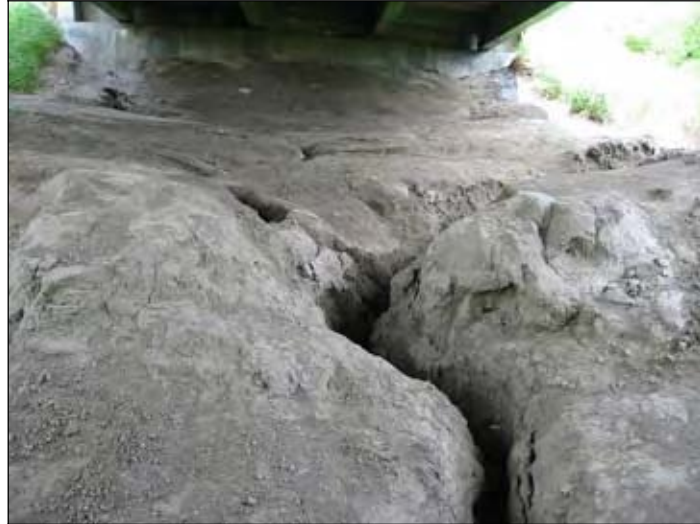
This bridge has steel girders with non-integral abutments. About 2 inches of settlement of the approach slab was measured at the wingwall. Although the soil of the embankment was silty, no embankment slope protection was used under the bridge. As a result, soil erosion was observed, as shown in Figure 103.

Figure 103. Soil erosion of the embankment under the bridge

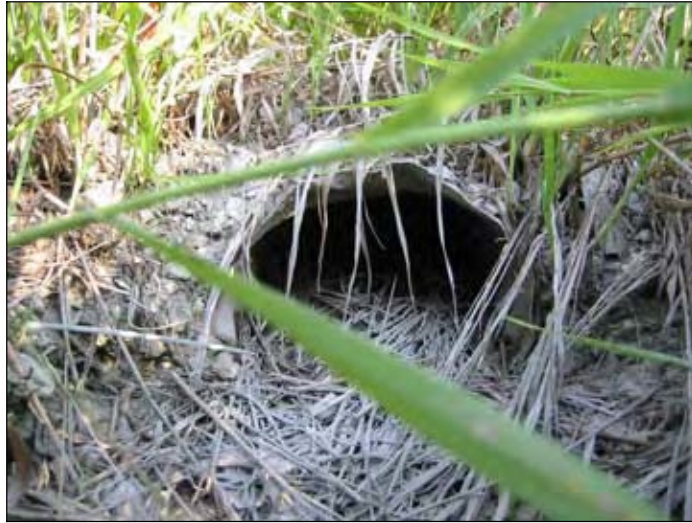
Figure 108. End drain plugged with soil

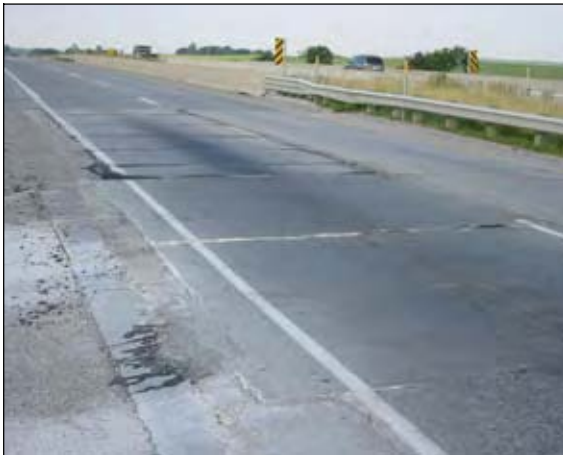
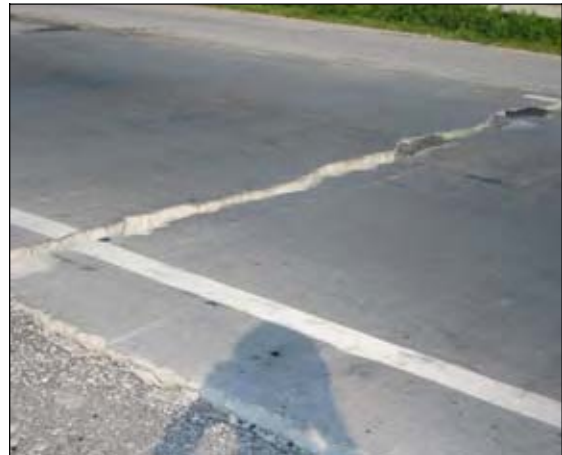
This bridge was constructed in 1968 and has four spans with non-integral abutments. Figure 109 shows severe faulting of the bridge approach panels. Maintenance records indicate that this approach slab had been previously repaired with the most recent patch places in spring 2003. The outlet of the end drain could not be located (Figure 110), which may be blocked with soil that caused the observed cracking and faulting of the approach slab. Cracked concrete slope protection of the embankment under the bridge was also observed (Figure 111).

(a) Cracked approach slab panels

(b) Closer image of faulted approach slab

Figure 109. Faulting of bridge approach panels

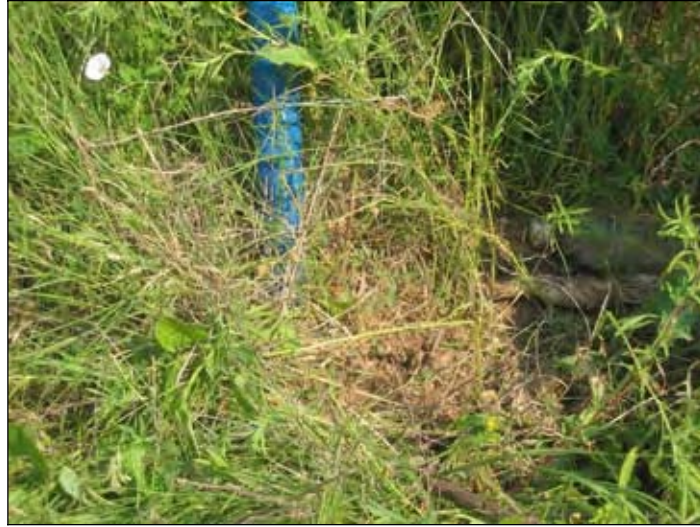
Figure 110. Drainage outlet could not be located

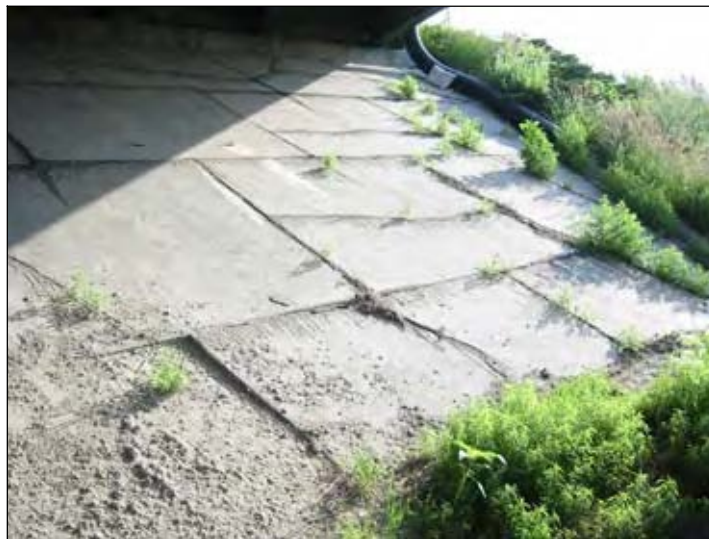
Figure 111. Cracking of concrete slope protection

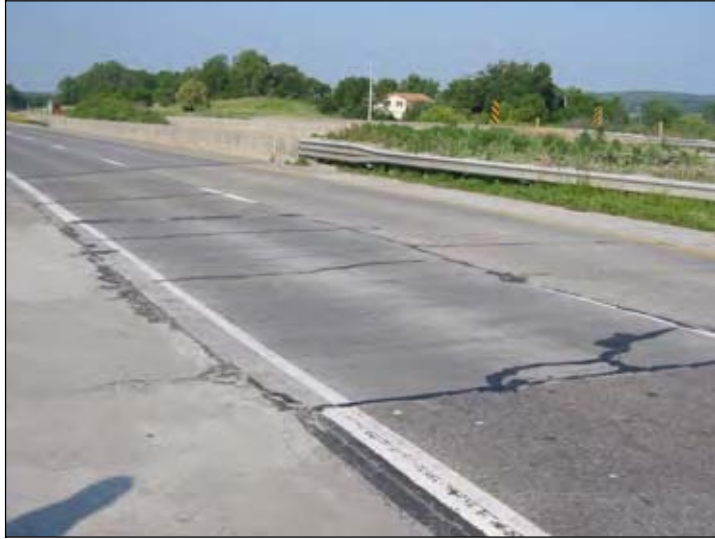
This bridge was constructed in the late 1960s and has three steel spans with non-integral abutments. According to interviews with Iowa DOT field personnel, the approach slab has been replaced 5 times in the last 13 years and, and although it was recently replaced, transverse cracks and settlement were observed (Figure 112). The outlet of the end drain was dry with no signs of water or fine soil particles at the time of the inspection (Figure 113). With no slope protection and loess soils used as embankment soil (Figure 114), erosion was observed around the bridge.

Figure 112. Cracking and settlement of recently replaced approach slab

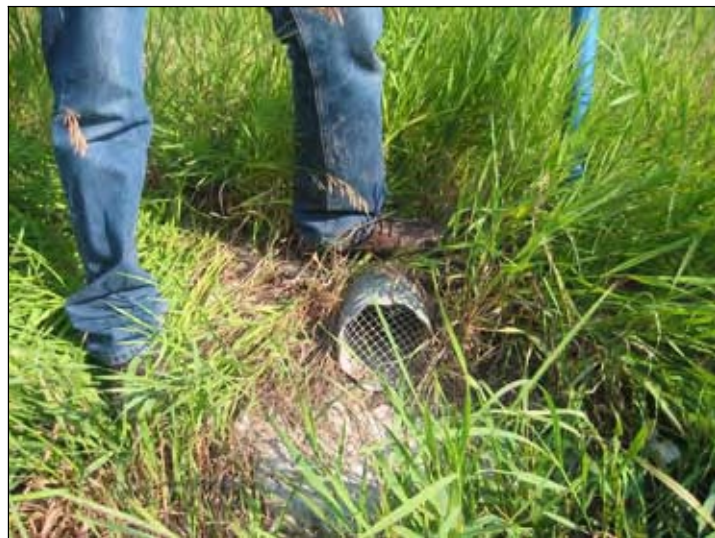
Figure 113. Dry end drain with no indication of water flowing out

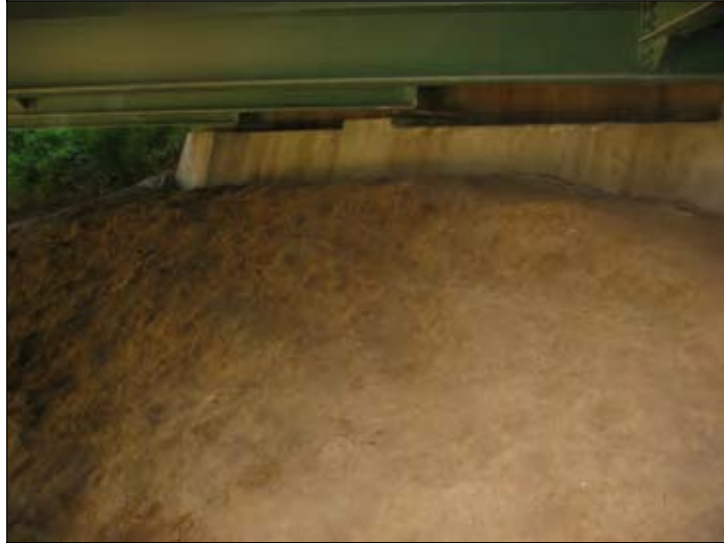
Figure 114. Loess soil used for the embankment

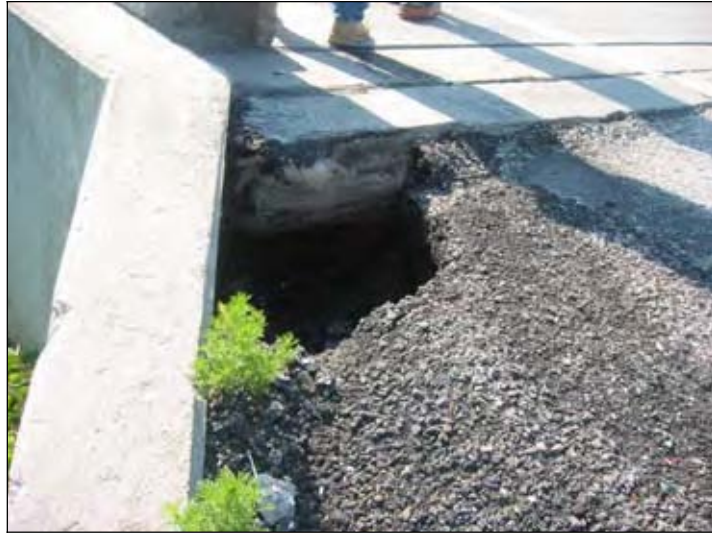
The bridge has three spans with non-integral abutments. At the westbound end, the expansion joint was poorly sealed and erosion at the shoulder of the approach slab (Figure 118) was observed. Figure 119 shows map and longitudinal cracks developed at the expansion joint. Differential settlement of 2 inches between the approach slab and the wingwall was also noted. There was no slope protection under the bridge. Soil erosion and settlement of the embankment were observed.

Figure 118. Failure at the shoulder of the approach slab (WBL)

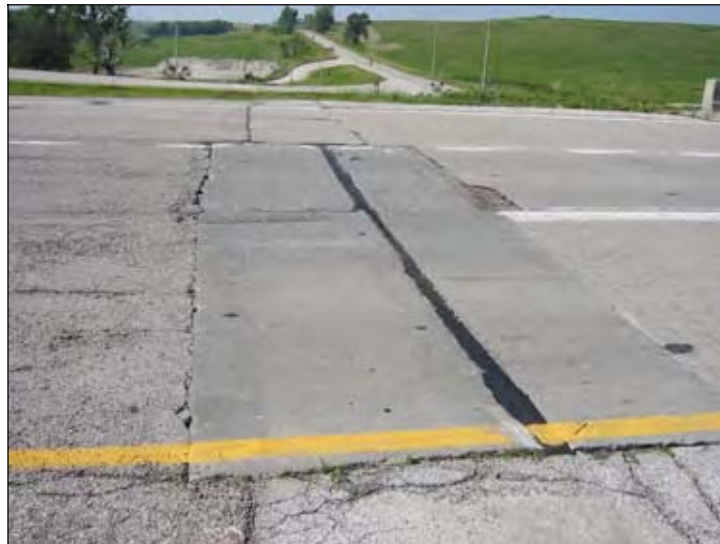
Figure 119. Various cracking at the bridge approach (EBL)

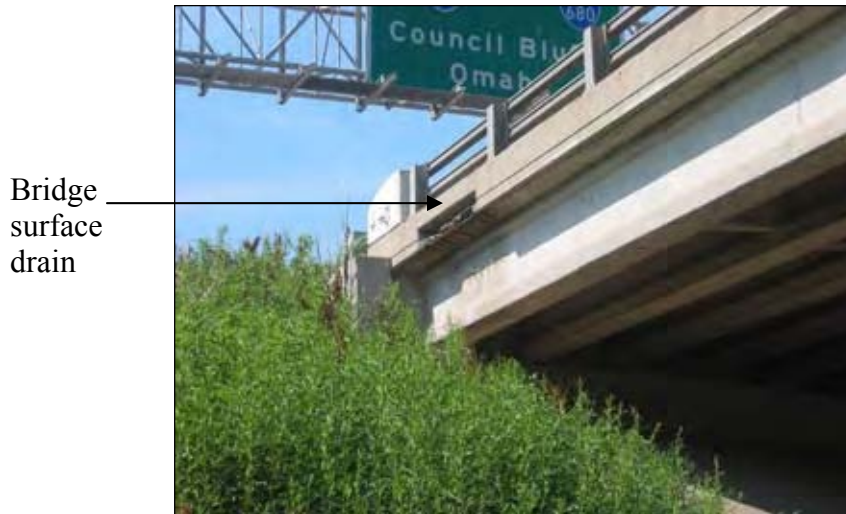
This bridge has integral abutments and concrete girders. Damage of the expansion joint was visible. Figure 120 shows the bridge surface drain at the northbound lane. This figure illustrates that no drainage pipe was used to direct the water collected on the bridge deck away from the embankment, which may have caused soil erosion under the concrete slope protection. Excessive erosion led to failure of the slope protection at both ends of the bridge and the exposure of H-piles supporting the abutments (Figures 121 and 122). Settlement of the embankment under the bridge at the southbound lane of 10.5 inches was measured (Figure 123). Ponding water was observed at the bottom of the bridge embankment (Figure 124).

Figure 120. Surface drain of the bridge deck allowing water to fall on the embankment

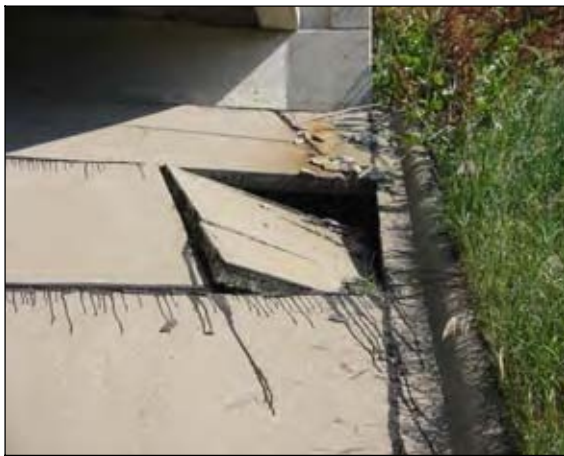
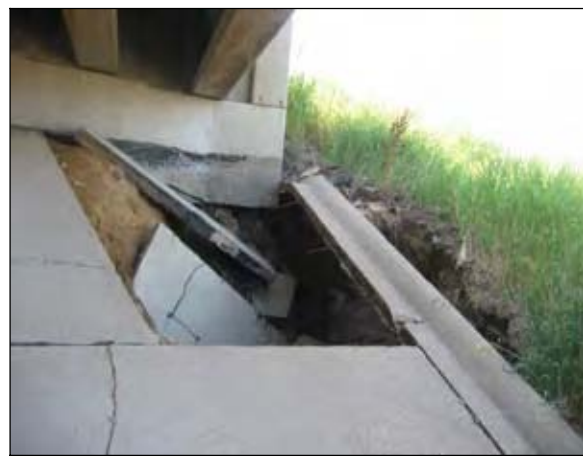
(a) NBL

(b) SBL

Figure 121. Failure of concrete slope protection
