IDENTIFICATION OF THE BEST PRACTICES FOR DESIGN, CONSTRUCTION, AND REPAIR OF BRIDGE APPROACHES

Iowa DOT Project TR-481
CTRE Project 02-118

Final Report

January 2005

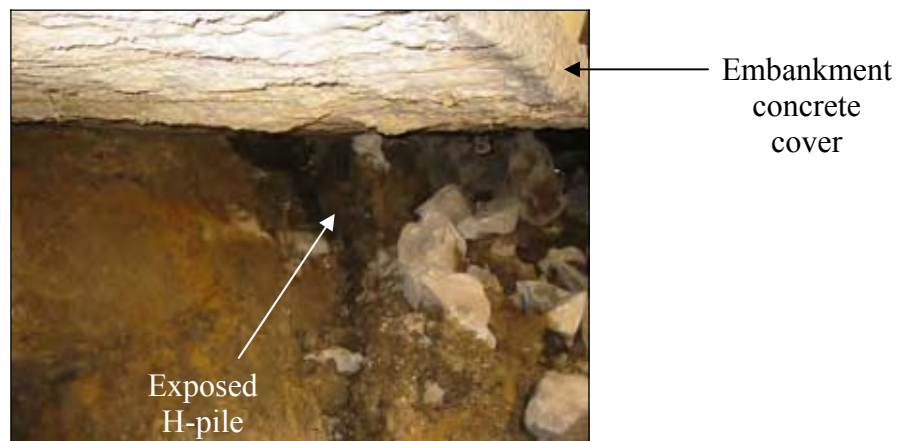
Figure 122. Exposed H-pile (side view)

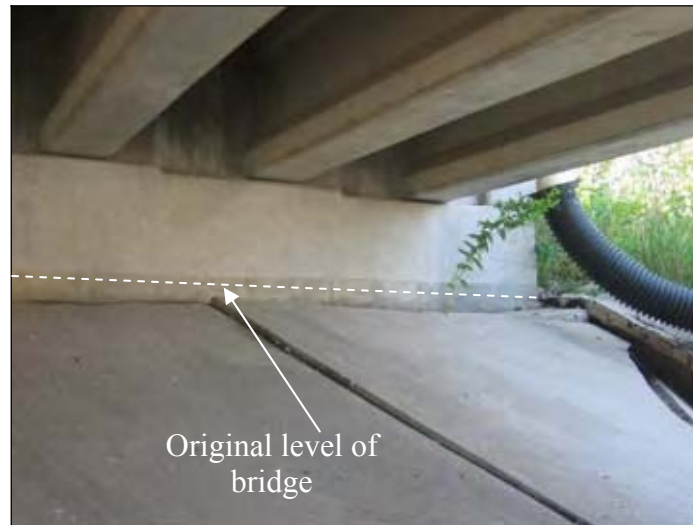
Figure 123. Concrete cover settlement of 10.5 in.

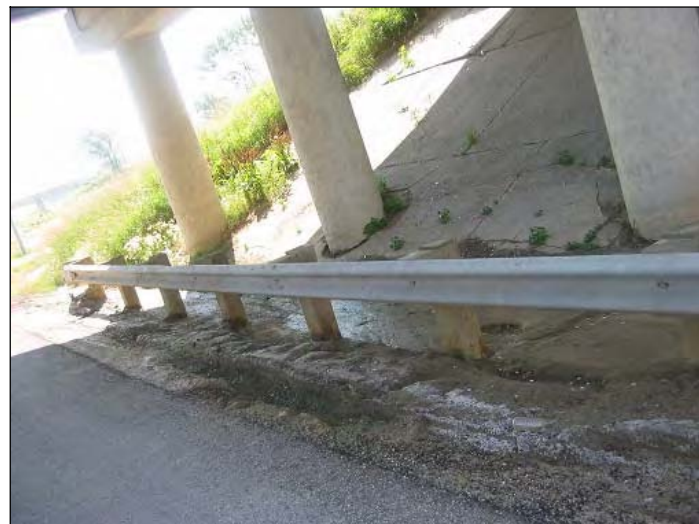
Figure 124. Ponding water and debris observed at the bottom of the embankment

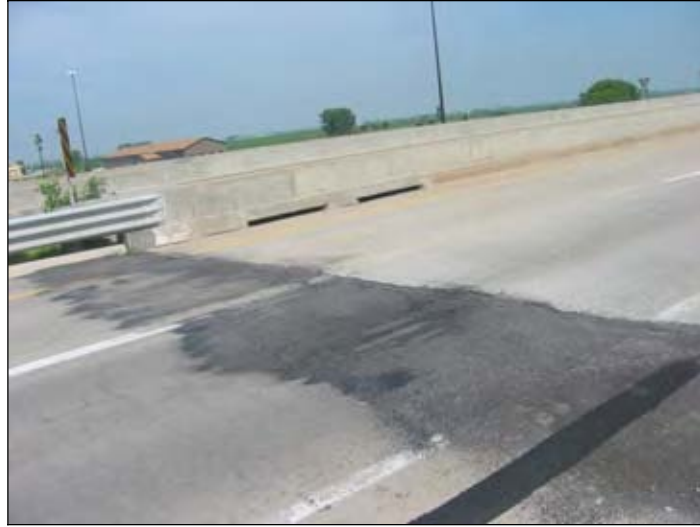
This bridge has four spans and non-integral abutments. Figure 125 shows the asphalt overlay placed at the bridge approach to compensate for the approach slab settlement relative to the bridge deck. In spite of the asphalt overlay, 3 inches of differential settlement was still observed at the end of the wingwall. The concrete slope protection on the embankment under the bridge had been replaced with aggregate. Where recycled tires were used as a filler material, the expansion joint was in a satisfactory condition (Figure 126).

Figure 125. Asphalt patch placed at the approach slab

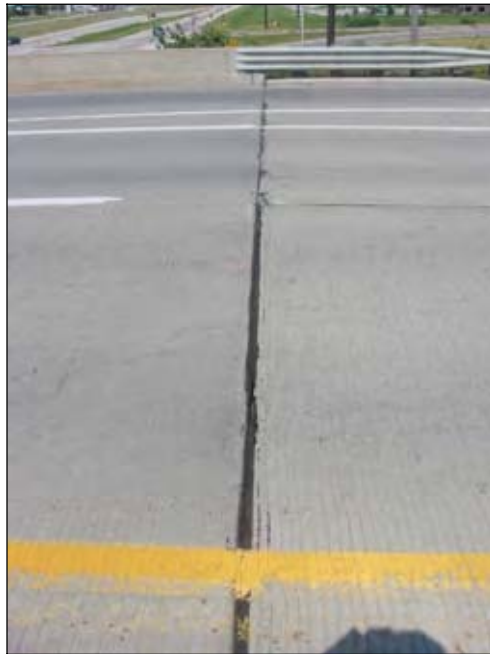
Figure 126. Expansion joint 2 inches wide and in good condition

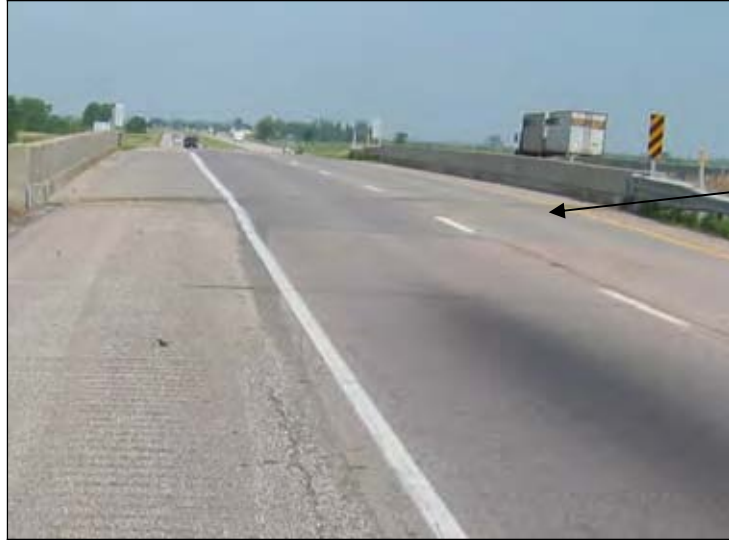
This is a three-span concrete bridge with non-integral abutments. Figure 127 shows settlement of the approach slab. Concrete spalling and cracking at the expansion joints were observed (Figure 128). Faulting of the bridge approach panels was also noted (Figure 129). The voids developed around the abutments were grouted. The embankments under the bridge had no slope protection and soil erosion was observed.

Approach
slab
settlement

Figure 127. Settlement of bridge approach

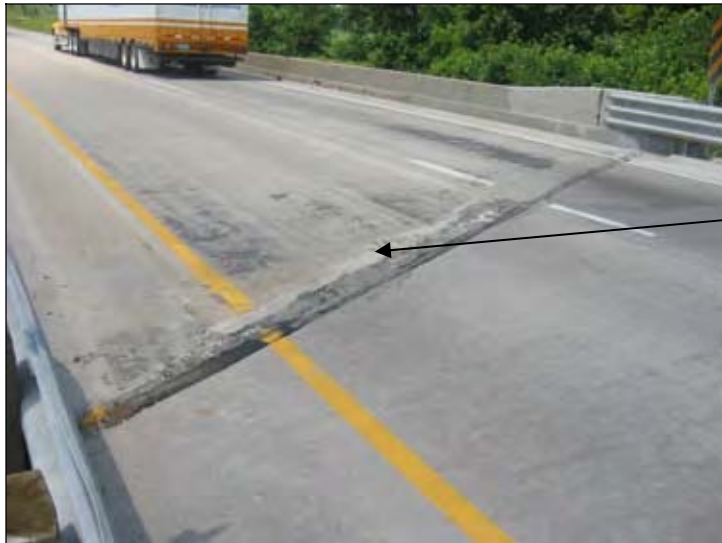
Concrete
spalling

Figure 128. Concrete spalling at the expansion joint

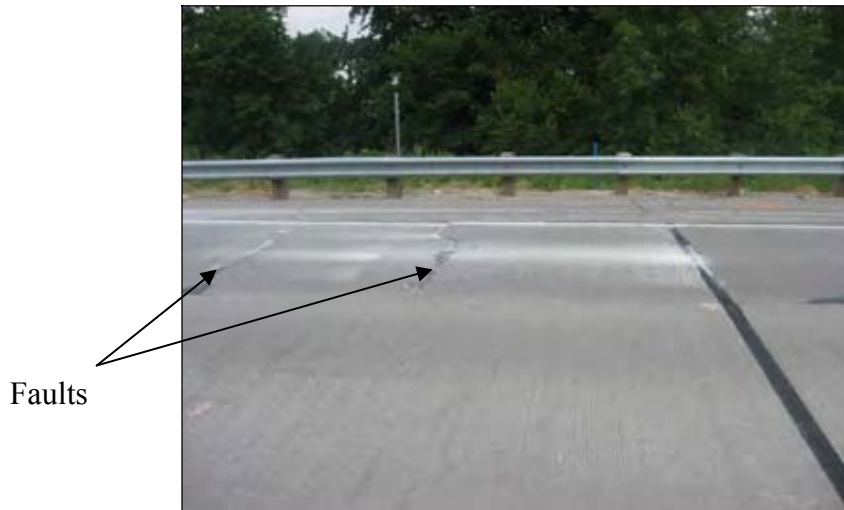
Figure 129. Faulting of approach slab panels

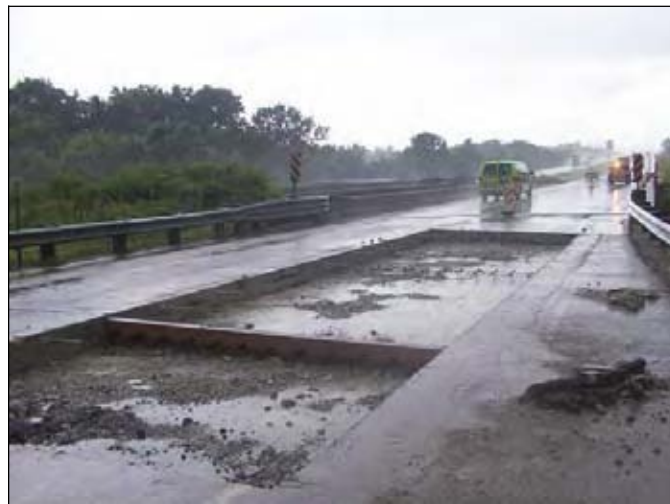
Due to the significant damage of the approach slab, the approach slab panels were replaced in July 2003. Figure 130 shows the exposed subgrade after removing the old pavement. Two sections at both ends of the westbound lane were replaced. These sections were at the right lane starting 15 feet away from the bridge and extended over 40 feet. After removal, it rained and saturated the underlying subgrade. A subgrade sample was obtained from the exposed subgrade and was classified as well-graded gravel (GW) (see Appendix B for detailed results).

Figure 130. Bridge approach panel removed for replacement

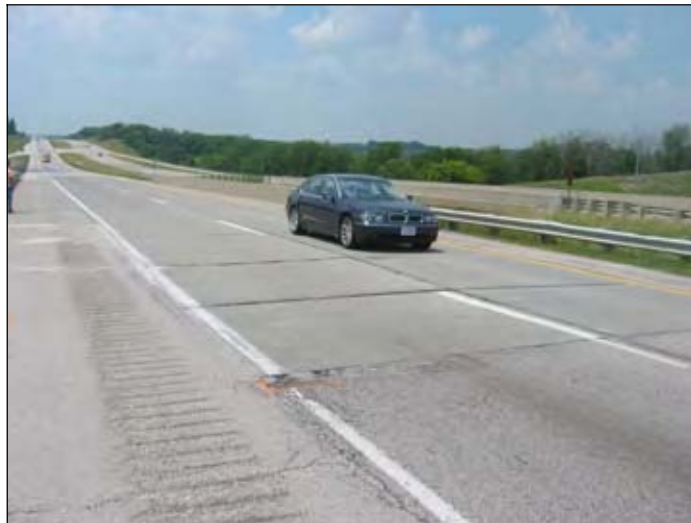
This is a three-span concrete bridge with non-integral abutments. Settlement and damage of the approach slab and damage of the expansion joint were observed (Figure 131). The embankment under the bridge has concrete slope protection. In addition, the end of drain outlet was blocked with soil.

Figure 131. Damage of the approach slab section

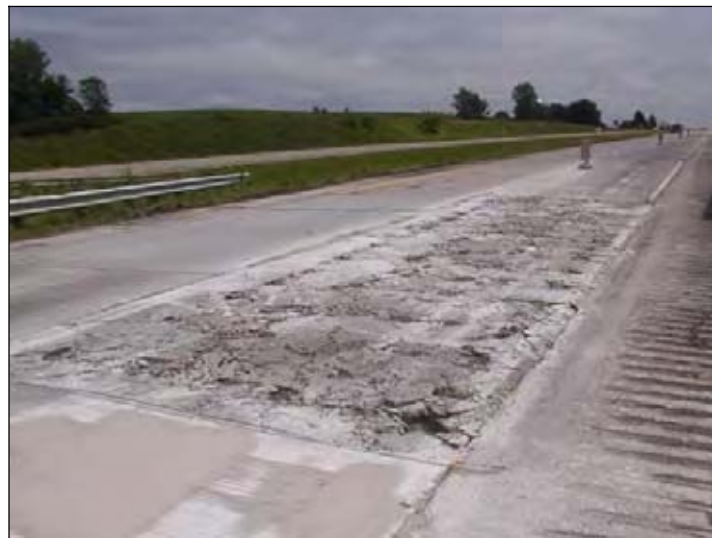
The approach slab of this bridge was replaced in summer 2003. This section, which is on the right lane at the east end of the eastbound lane, was 30 feet long and approximately 15 feet away from the bridge. Figure 132 shows the broken approach slab pavement before removal and replacement. Figure 133 shows the approach slab section being replaced after removing the old pavement. A sample of the base material was tested in the laboratory and classified as well-graded gravel (GW) according to the Unified Classification System (See Appendix B for results).

Figure 132. Approach pavement broken before replacement

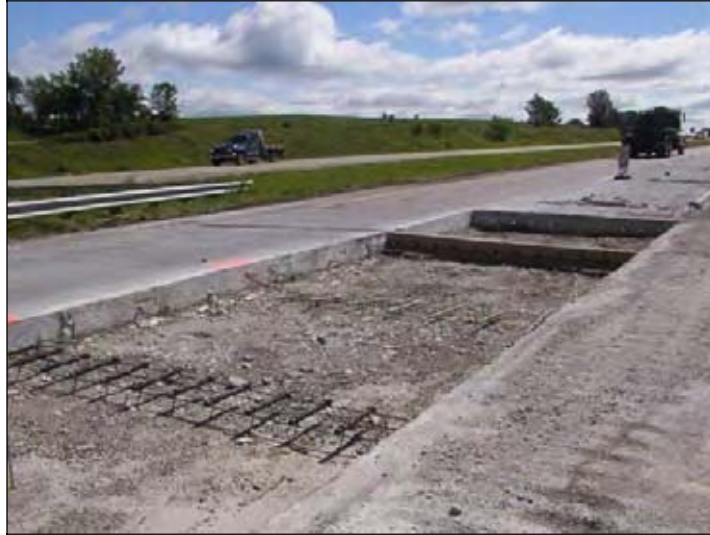
Figure 133. Replacing the bridge approach slab section

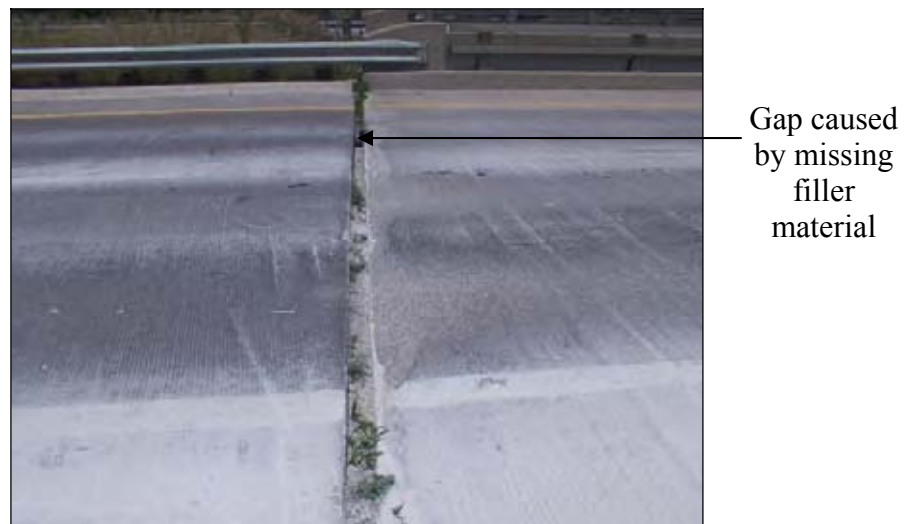
This bridge has four spans with non-integral abutments. The expansion joint was not properly sealed and cracks around the joint were observed at both the east and westbound lanes (Figure 134). Faulting of the approach slab was noticed at the west end of the eastbound lane, as shown in Figure 135, and replaced in summer 2003 (Figure 136). The embankments of the bridge had an aggregate slope protection cover.

Figure 134. Expansion joint poorly sealed and filled with fines (West end of EBL)

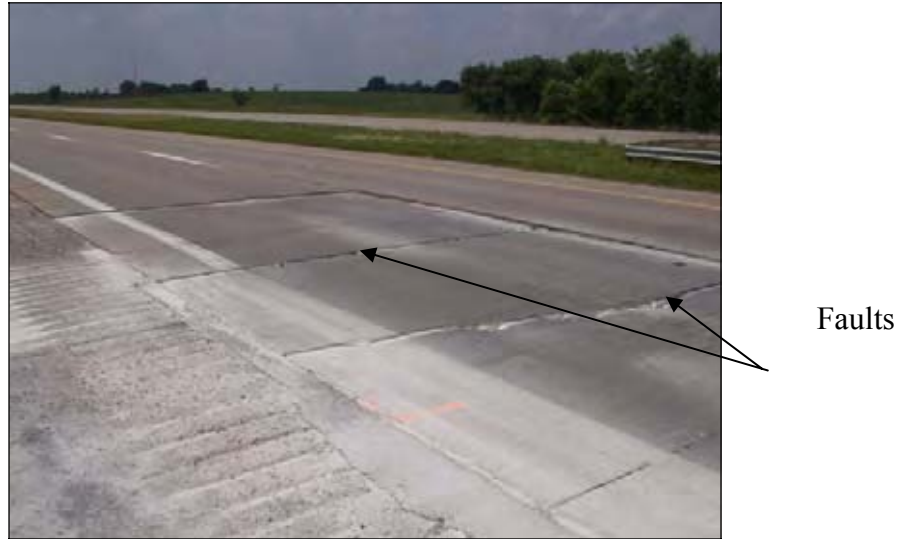
Figure 135. Faulting of bridge approach concrete panels (West end of EBL)

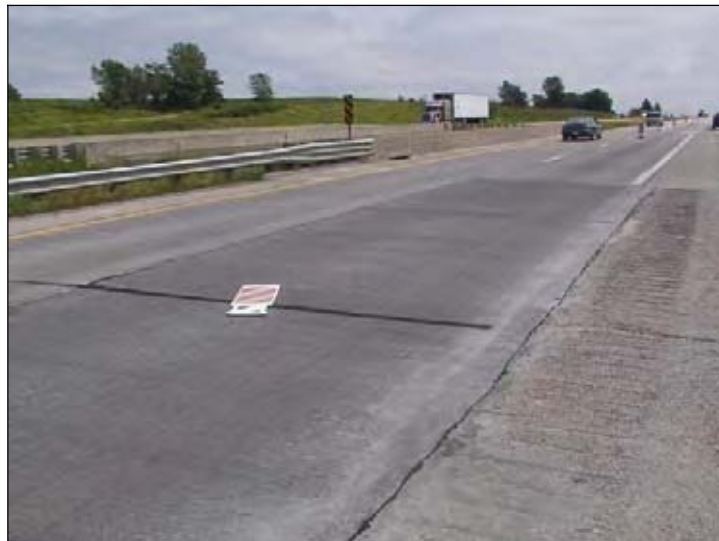
Figure 136. Replaced bridge approach slab

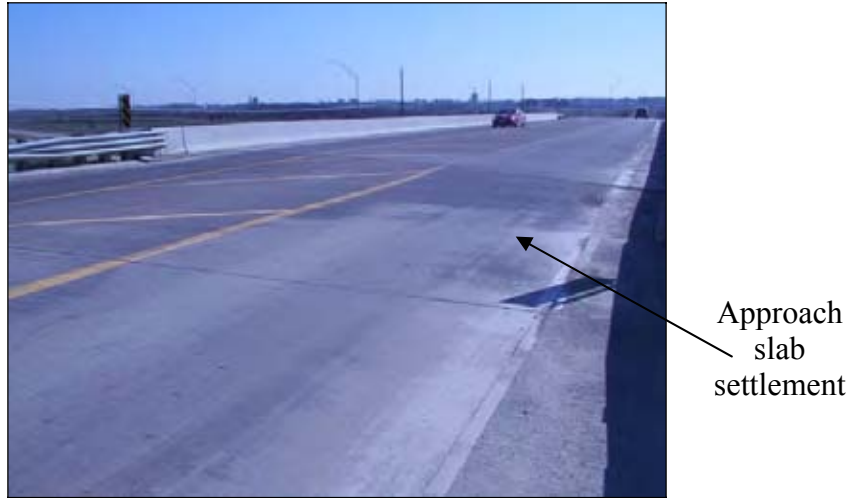
At the west end, differential settlement of 3 inches was observed between the approach slab and wingwall (Figures 137 and 138). The width of the expansion joint at the west end was 5.5 inches. Part of the joint filler material was missing (Figure 139), allowing water to flow behind the bridge abutment, which contributed to increasing soil erosion. As a result, a void developed under the approach slab was 11 inches deep at the abutment and extended to 6 feet away from the abutment (Figure 140). The end drain at the west end was observed to be in good working condition.

Figure 137. Settlement of approach slab

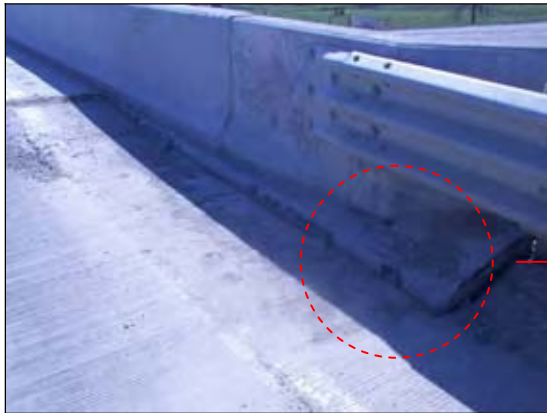
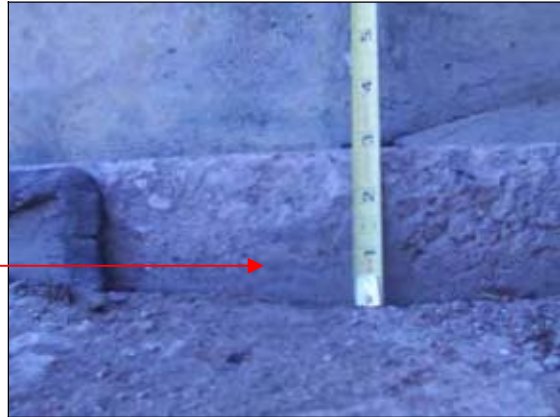
(a) Settlement of approach slab

(b) Closer image of approach settlement

Figure 138. Settlement of approach slab relative to wingwall

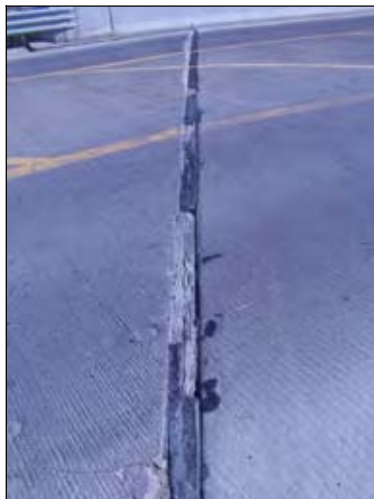
Figure 139. Deteriorated expansion joint filler

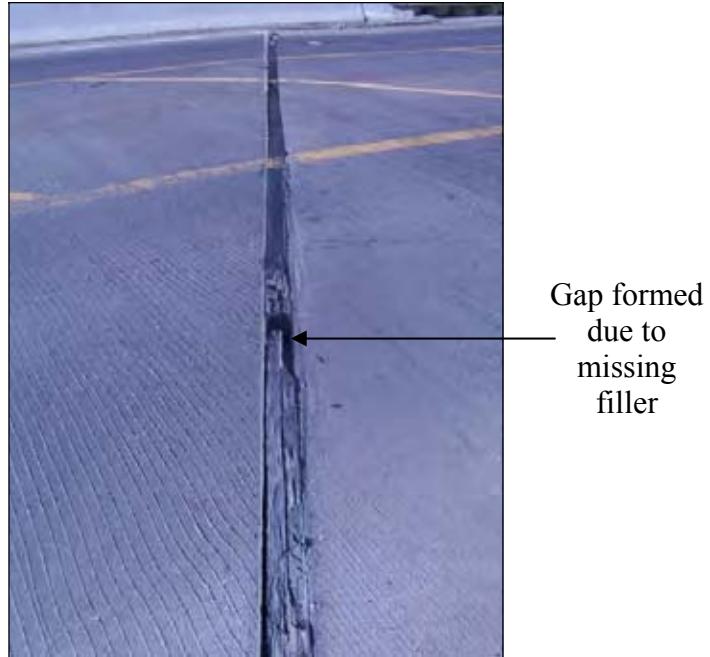
At the east end, differential settlement of about 1 inch between the approach slab and the bridge deck was measured (Figure 141). The expansion joint width was 5 inches. The sealer used to keep the joint filler in place deteriorated shortly after construction, and the forks used to hold the joint material in place were not found. As a result, the joint filler was missing leaving a large gap (Figure 142) allowing water to erode the backfill material under the approach slab. The void developed under the approach slab was about 4 inches deep (Figure 143). Another indication of poor water management was the observed erosion at the sides of the abutment (See Figure 144). Furthermore, concrete spalling was observed at the expansion joint.

Figure 142. Missing and deteriorated filler material at the expansion joint (East end)

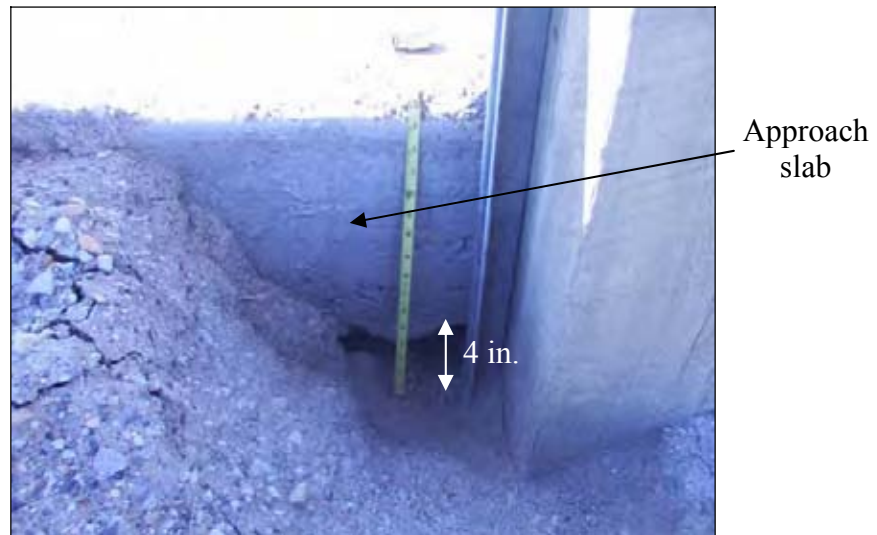
Figure 143. Void developed under the approach slab (East end)

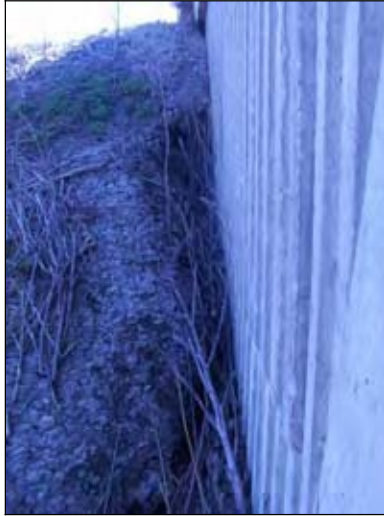
Figure 144. Erosion around the abutment (East end)

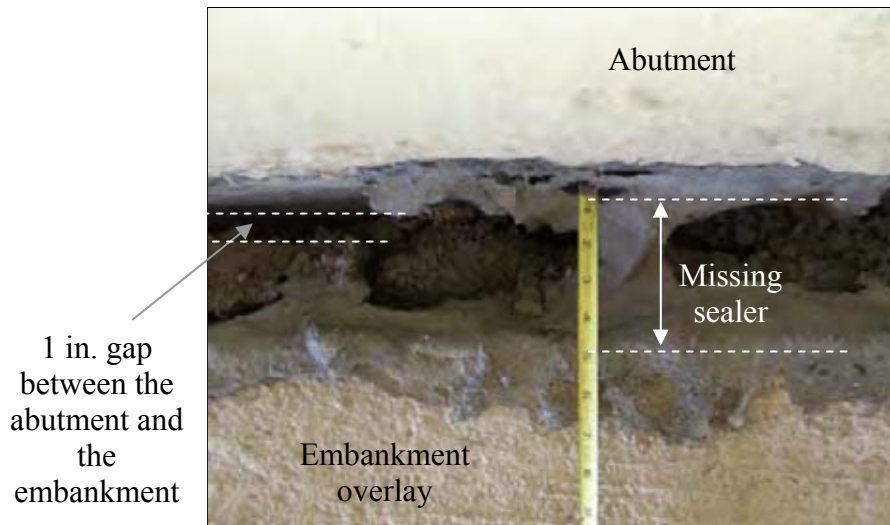
This is a three-span bridge with integral abutments. The approaches were replaced in May 2004 due to the failure of the paving notch. After replacing the approaches, the new expansion joints were 2.5 inches wide. Differential settlement between the bridge deck and the approach slab was observed (Figure 145). At the south end of the bridge, a gap 1 inch wide was observed between the abutment and slope cover (Figure 146), while the embankment settled 3 inches. At the north end of the bridge, concrete slope protection panels were removed for replacement due to uneven settlement, cracking, and failure. The soil used at the embankment under the bridge was silty clay. Aggregate were used at the sides of the abutment to minimize erosion. Similar to other bridges inspected in District 5, this bridge reportedly does not have a subdrain around the abutment.

Figure 146. Lateral movement of the abutment (Top view)

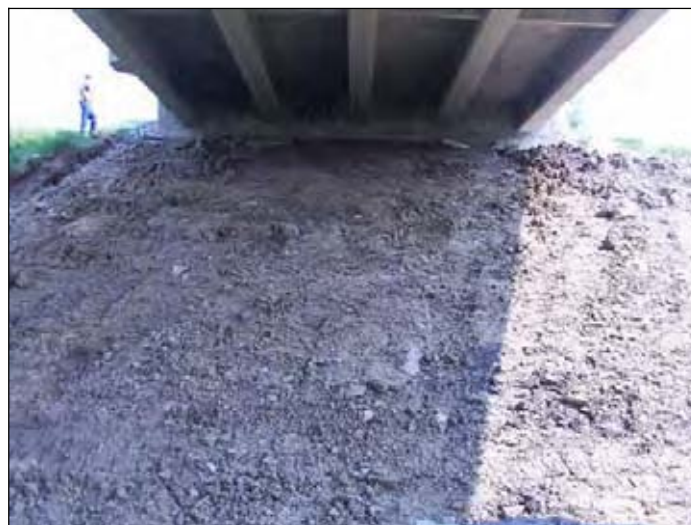
Figure 147. Bridge embankment prior to placing the new overlay

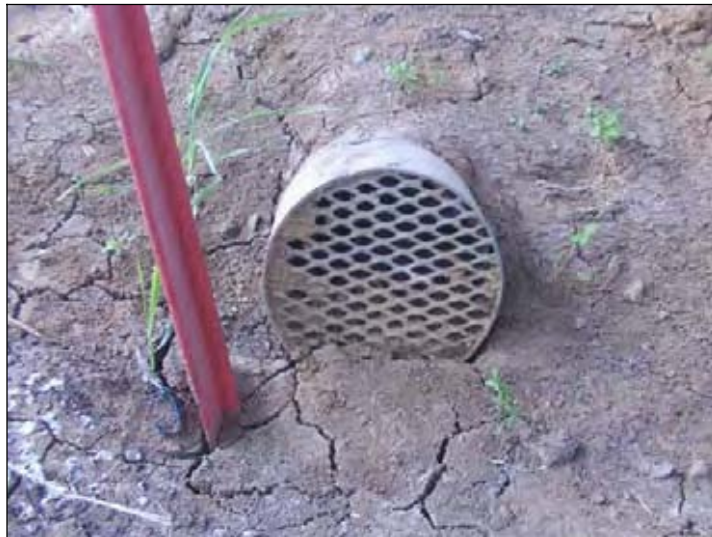
This is a five-span bridge with concrete girders at the south bound and steel girders at the north bound. The bridge has non-integral abutments. Glacial till soil was used to build the embankment with no slope protection under the bridge. At the south end of the south bound bridge, the approach slab was not yet constructed at the time of inspection. It was observed that the strip seal at the expansion joint was cut short which would allow water to flow downward to the embankment under the bridge (Figure 148). Perforated drain tile were used during embankment construction to allow for faster consolidation of the foundation soil. These drains were observed filled with soil (Figure 149). At the north end of the north bound, erosion of the embankment under the bridge was observed (Figure 150).

Figure 149. Perforated drain tile filled with soil (South end of SBL)

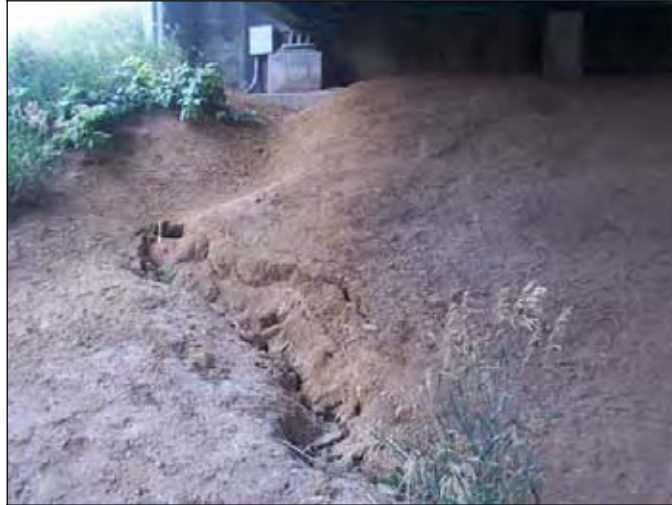
Figure 150. Erosion of the embankment under the bridge (North end of NBL)

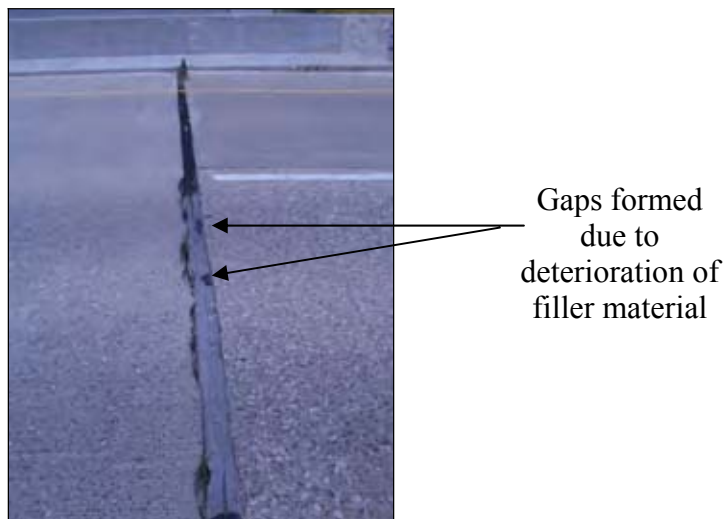
This is a two-span bridge with steel girders and integral abutments. Aggregate was used as slope protection for the embankment under the bridge. At the north end of the northbound bridge, a void under the approach slab that ranged from 3 to 8 inches developed and may have contributed to approach slab faulting. The void was grouted and the approach slab panels were replaced. After replacement, the expansion joint was 3 inches wide and flexible foam was used as joint filler. The joint was poorly sealed, as shown in Figure 151, and concrete spalling was still noticeable. No surface drain on the bridge was constructed; however, water was directed away from the bridge by sloping the shoulders away from the bridge. This led to erosion along the sides of the abutment. At the south end of the northbound bridge, differential settlement of 3 inches was measured. A 4-inch void developed under the approach that was grouted (Figure 152). Erosion at the sides of the abutment was also noted.

Figure 151. Deteriorated flexible foam which was used as joint filler (North end of NBL)

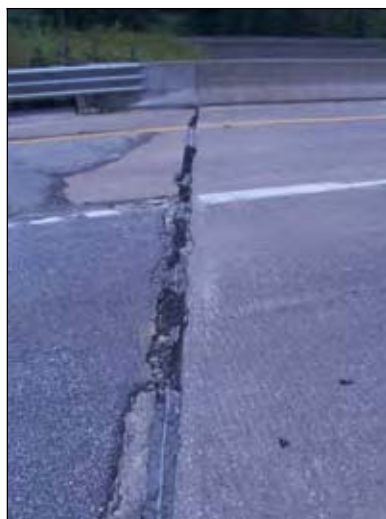
This is a three-span bridge with concrete girders and integral abutments. The bridge approach was resurfaced with an asphalt overlay at the west end of the west bound bridge, which was significantly deteriorated and cracked, as shown in Figures 153 and 154. The width of the expansion joint was 4 inches and consisted of flexible foam. Differential settlement between the approach slab and the bridge deck of 1 inch was measured. Grout was pumped under the approach slab due to void development. Glacial till was used as embankment material with no slope protection. Erosion between the embankment and abutment backwall was noticeable (See Figure 155). The subdrain outlet was blocked with soil (Figure 156).

Figure 153. Poor performing resurfaced bridge approach (West end of WBL)

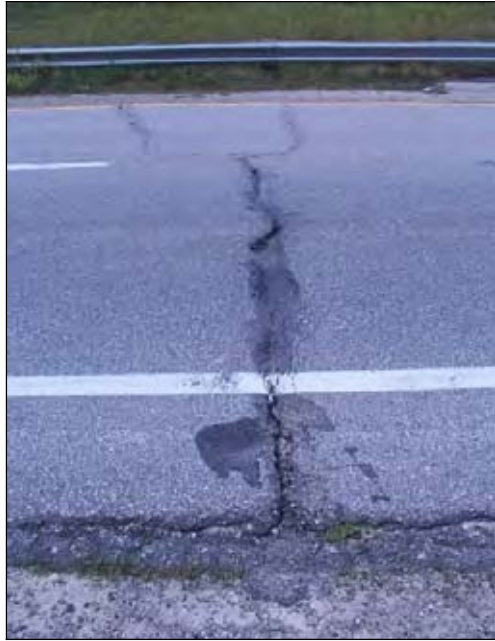
Figure 154. Transverse cracking of asphalt overlay (West end of WBL)

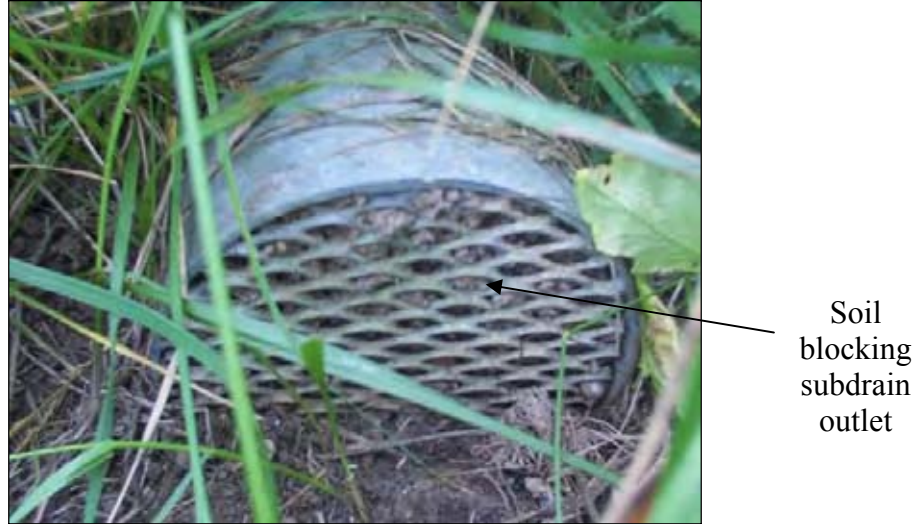
Figure 156. Subdrain outlet blocked with soil (West end of WBL)

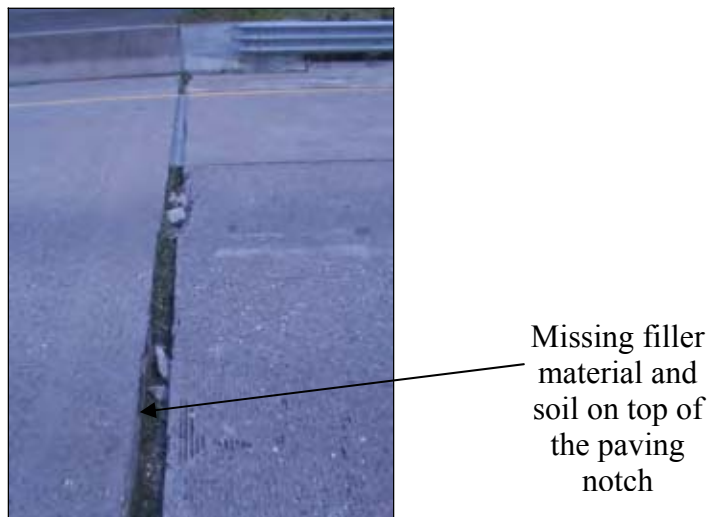
This is a three-span bridge with integral abutments. At the east end of the bridge, differential settlement between the approach slab and the wingwall of 1 inch was measured. The width of the expansion joint was 4.5 inches. Parts of the flexible foam joint filler completely came out exposing the paving notch (Figure 157), which was covered with about 3 inches of soil debris. Grout was pumped under the approach slab to fill a void developed behind the abutment. Furthermore, erosion between the embankment under the bridge and the backwall was observed (Figure 158a) where rip-rap was used to control erosion (Figure 158b).

Figure 157. Missing filler material exposing the paving notch (East end of WBL)

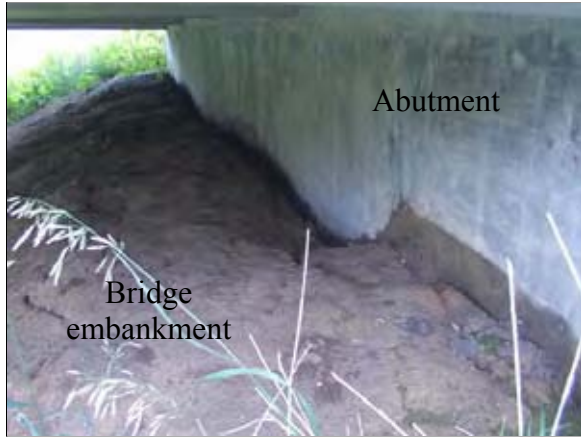
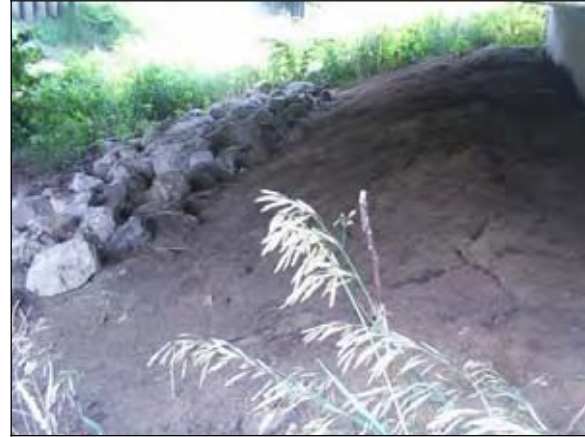
(a) Erosion at the abutment

(b) Rip-rap used to control erosion

Figure 158. Erosion between the embankment under the bridge and the abutment, and the rocks used to control erosion (East end of WBL)

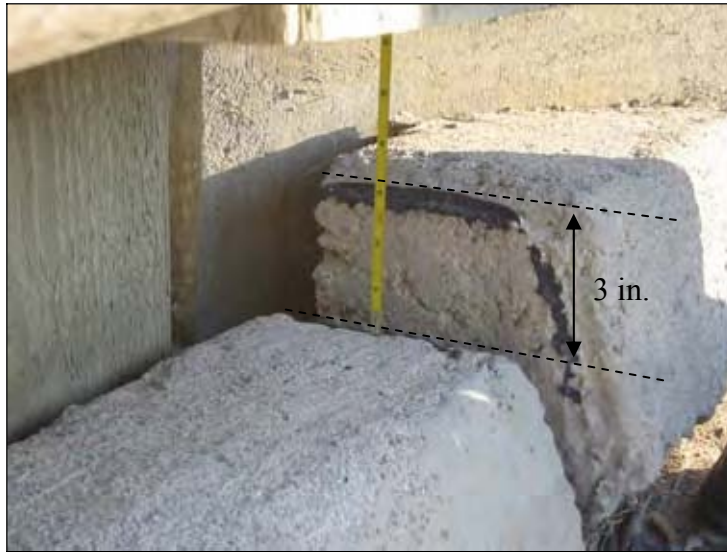
This bridge was constructed in 1992 and has concrete girders with non-integral abutments. Three inches of differential settlement was observed at the bridge approach guardrails (Figures 159). The strip seal was cut short. The embankment under the bridge was built with loess soil with no slope protection (Figure 160). Water appeared to be flowing through the expansion joint to the embankment under the bridge. To fill the void developed behind the abutment, the bridge was grouted in 2003.

Figure 159. Differential settlement at the bridge approach (South bound)

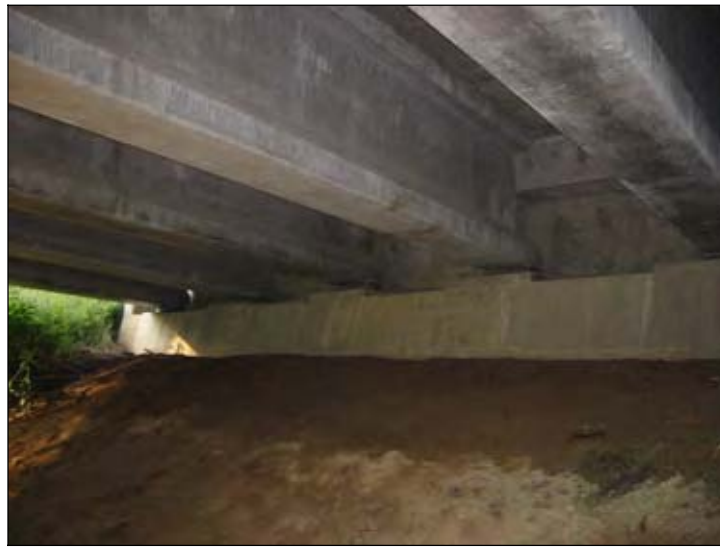
Figure 160. Wet loess soil observed at the embankment under the bridge

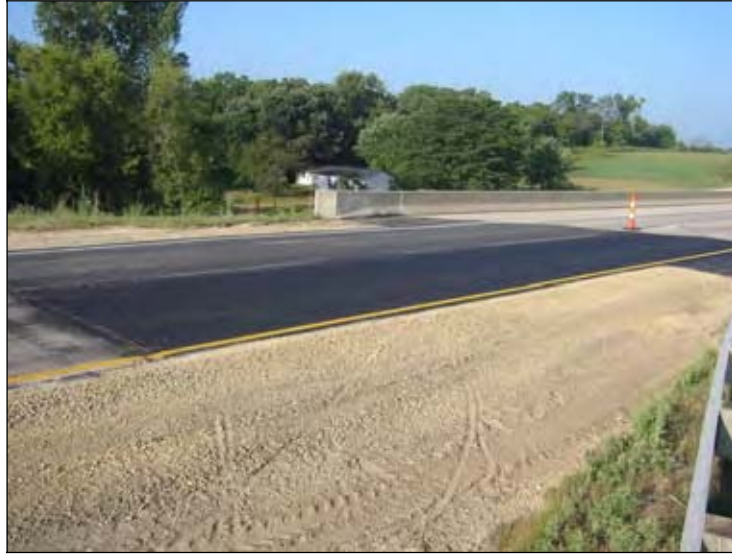
This bridge was constructed in 1992 and has three spans with integral abutments. No slope protection was used under the bridge and wet embankment soil was observed. Erosion along the sides of the abutment was also observed. According to the maintenance reports, a void developed around the abutment and has been grouted twice in the last 10 years. The second grouting was performed in June 2003. The approach slabs were also overlaid with 2 inches of asphalt to alleviate the differential settlement at the bridge approach, as shown in Figure 161.

Figure 161. Approach slab asphalt overlay

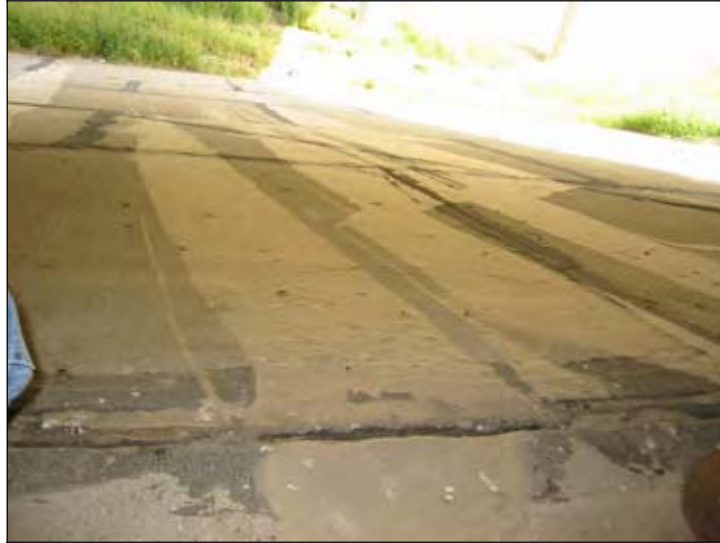
This bridge was constructed in 1983 and has three spans with integral abutments. Although maintenance reports indicate that grouting was performed twice to fill the void developed under all approach slabs (Figures 162 and 163), additional settlement and loss of material lead to a void forming under the approach slab. Noticeable vibration occurred on the approach slab as vehicles passed. The approach slab shoulder was drilled by Iowa DOT personnel during inspection to measure the depth of the void. The three drilled holes indicated a 2-inch gap under the bridge approach. Figure 164 shows that the distance between the approach slab surface and the base material was about 14 inches. The void development may have accounted for about 2 in. differential settlement between the bridge deck and the bridge approach (Figure 165) and significant cracks and faulting of the approach slab (Figure 166). Flexible foam was used as expansion joint filler (Figure 167).

Figure 162. Grout seeping from under the concrete cover

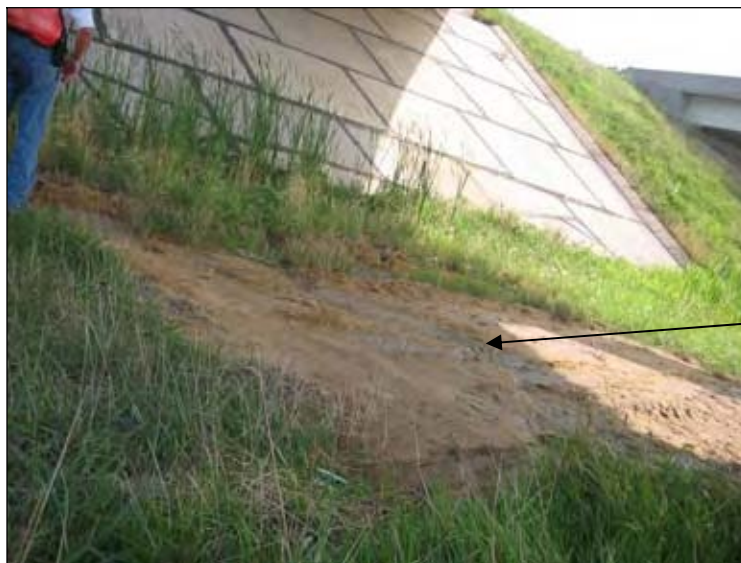
Figure 163. Grout seeping from the bottom of the embankment

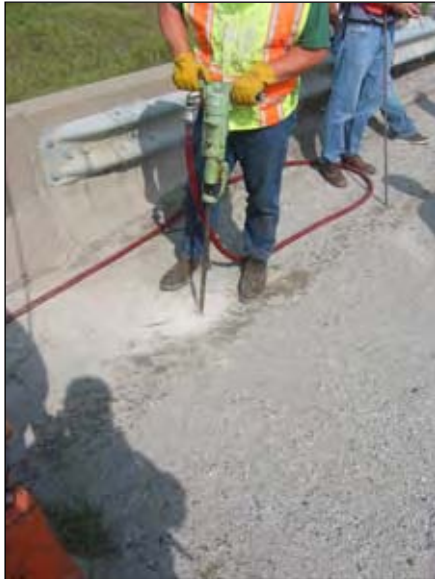
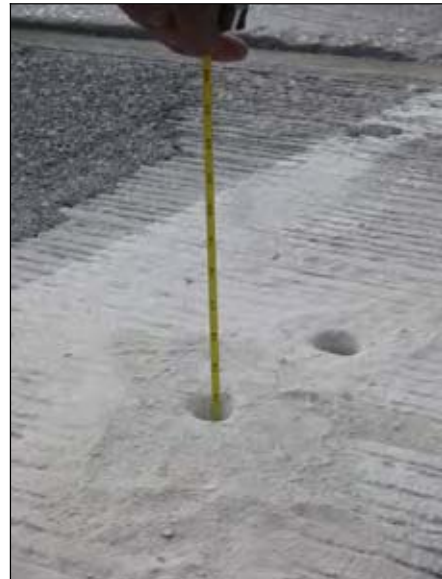
(a) Drilling at the approach slab

(b) Measuring the void

Figure 164. Drilling at the approach slab shoulder indicating 2 in. deep void

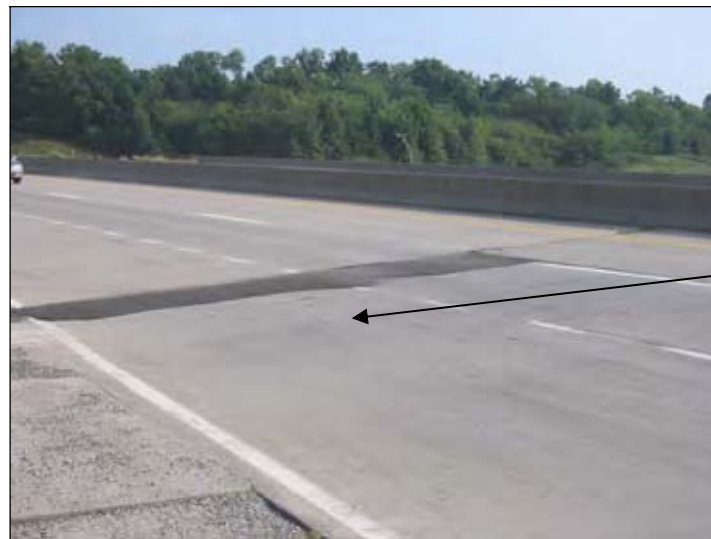
Settlement
of approach
slab

Figure 165. Differential settlement at approach slab

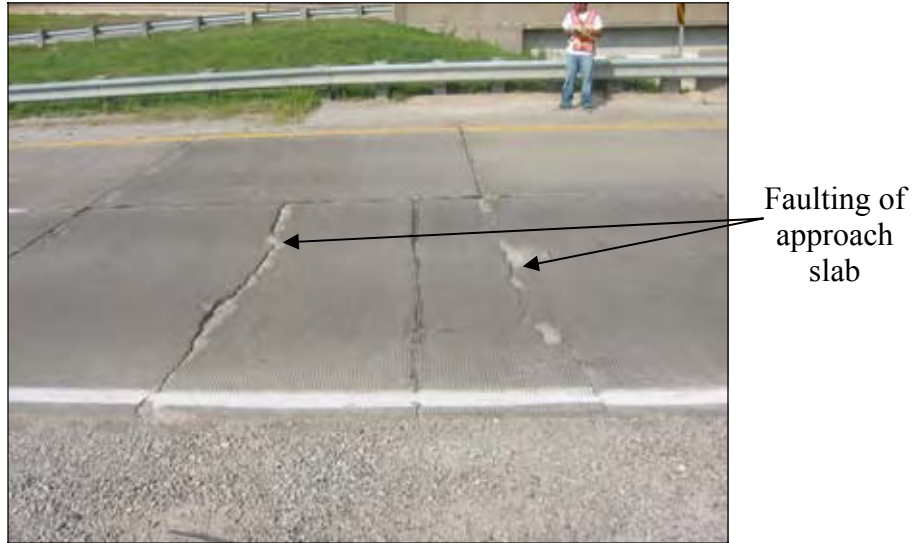
Figure 166. Faulting of approach slab concrete panels

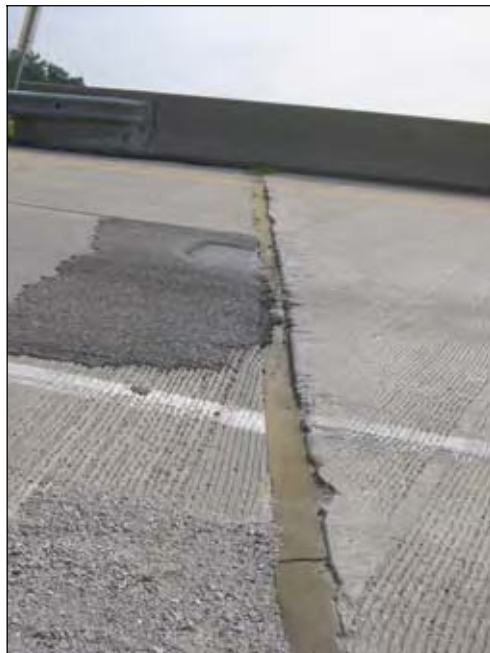
Figure 167. Flexible foam used as joint filler

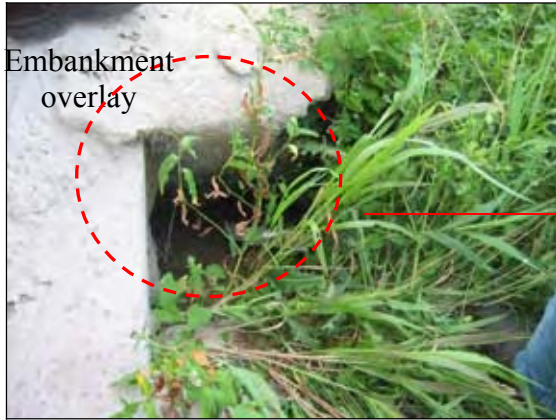
A void under the concrete slope protection (Figure 168) and uneven settlement and cracking of the concrete slope protection panels were observed (Figure 169). Furthermore, the embankment under the bridge settled 4.5 inches relative to the abutment. A 1.5 in. wide by 4.5 ft. deep void was observed on the downslope side of the abutment (Figure 170).

(a) Void under slope protection

Figure 168. Void created by erosion and settlement after grouting

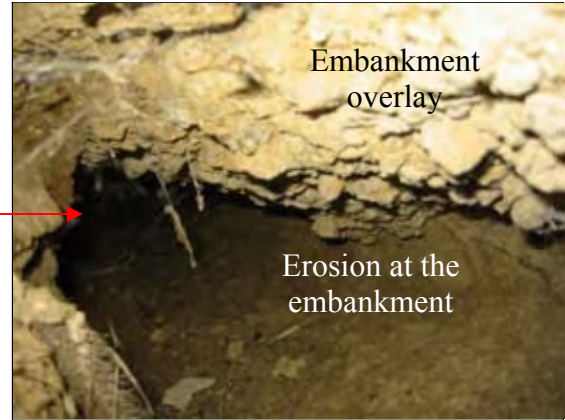
(b) Closer image of the developed void

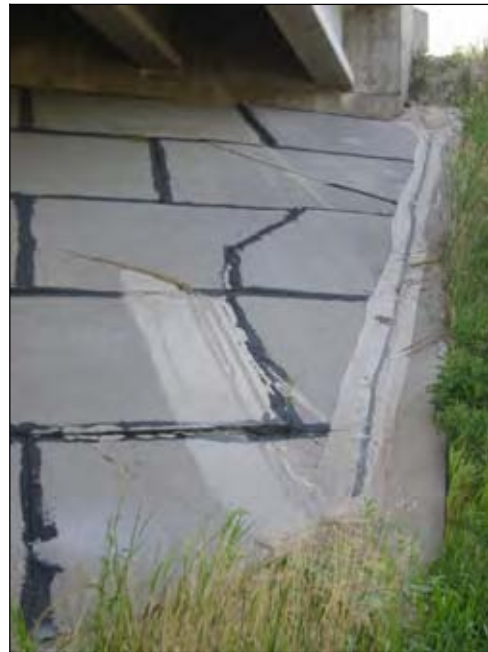
Figure 169. Cracking of the concrete slope protection overlay

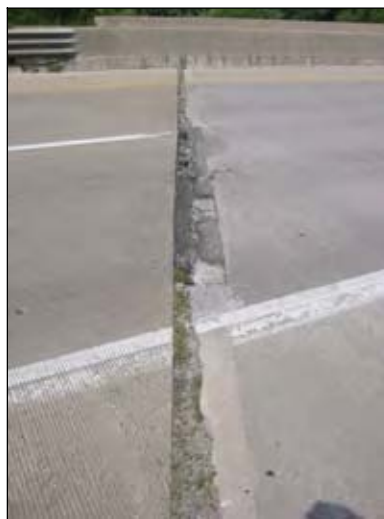
This bridge was constructed in 1971 and has three spans with integral abutments. Cracks and concrete spalling were observed around the expansion joint (Figure 171). Soil erosion and ponding of water were noted on the embankment under the bridge (Figures 172 and 173). Aggregate and an erosion blanket were used for slope stabilization, as shown in Figure 174. According to the maintenance records for this bridge, the near end of the right lane of the bridge approach was grouted using 5 cubic yards of flowable mortar in fall 2002.

Figure 171. Concrete spalling and cracking at the expansion joint

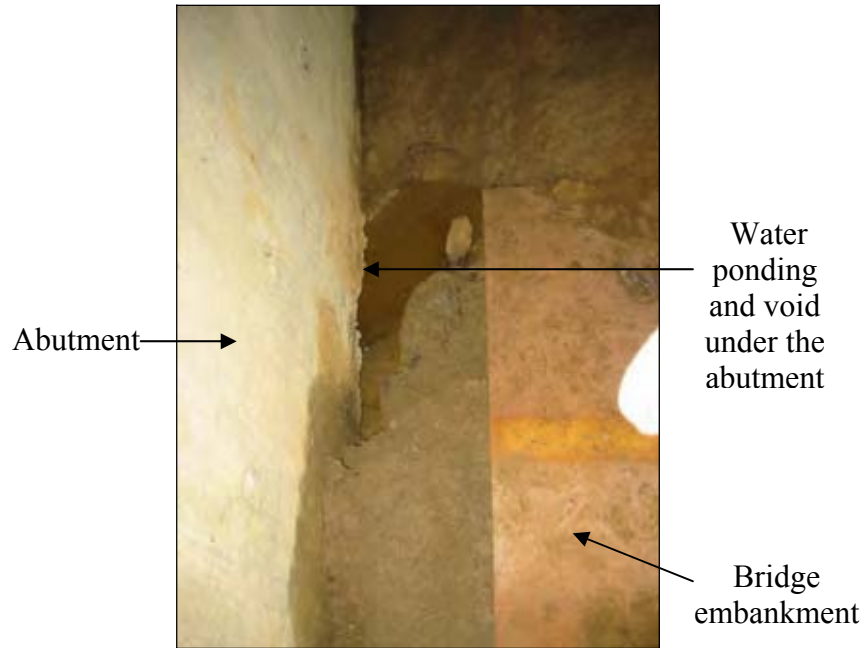
Figure 173. Water ponding at the embankment (Top view)

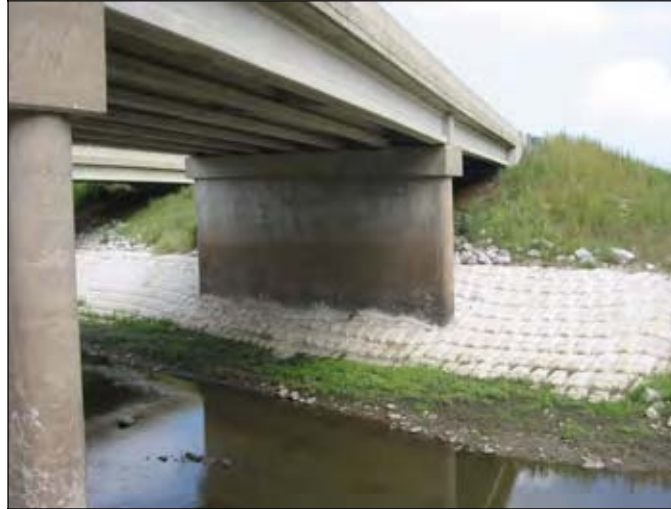
Figure 174. Rocks and pillows used for embankment stabilization

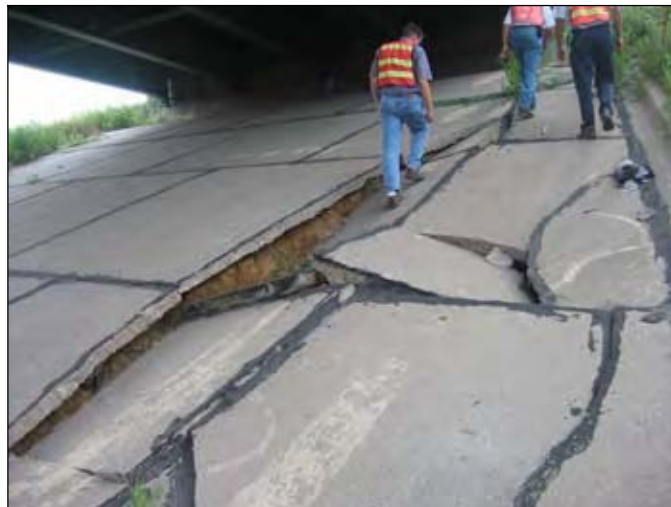
This bridge was constructed in 1970 and has three spans with steel girders and non-integral abutments. The concrete slope protection of the embankments at both ends of the bridge was significantly damaged, as shown in Figure 175, due to erosion. Furthermore, the embankment under the bridge experienced about 5 inches of settlement relative to the abutment. A 2 inches wide gap was measured between the abutment and embankment. No differential settlement was observed between the bridge slab and the bridge approach, and the expansion joints were in a satisfactory condition. Maintenance report for this bridge indicated that flowable mortar was used to fill a void developed at the far end of the left lane in fall 2002. Flowable fill was used again in July 2003 to fill an additional void developed at the same approach slab.

Figure 175. Severe damage of concrete slope protection due to erosion

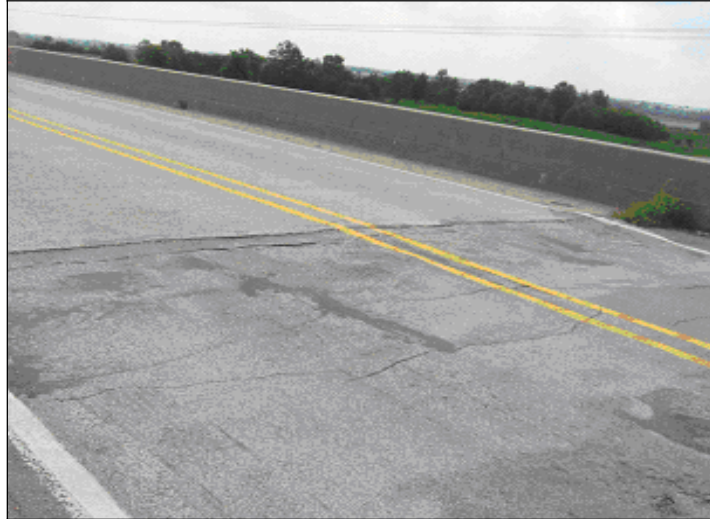
This bridge was constructed in 1972 and has four spans with integral abutments. Figure 176 shows the observed transverse and map cracks at the approach slab. The bridge approach slab had been grouted and overlaid. The asphalt overlay was deteriorated, as shown in Figure 177. Differential settlement between the approach slab and wingwall of about 3 inches was measured. Severe cracking near the expansion joint was also observed. A 3-inch wide gap was observed between the abutment and embankment.

Figure 176. Transverse and map cracking at the approach slab
