IDENTIFICATION OF THE BEST PRACTICES FOR DESIGN, CONSTRUCTION, AND REPAIR OF BRIDGE APPROACHES

Iowa DOT Project TR-481
CTRE Project 02-118

Final Report

January 2005

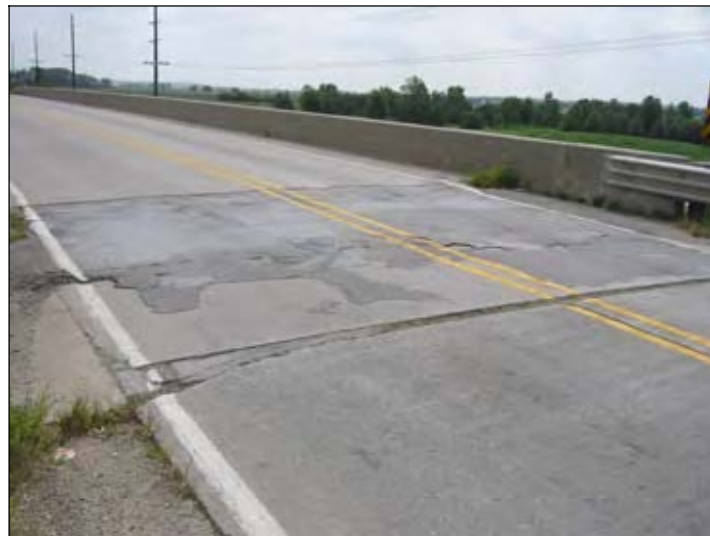
This bridge was constructed in 1972 and has four spans with integral abutments. Figure 176 shows the observed transverse and map cracks at the approach slab. The bridge approach slab had been grouted and overlaid. The asphalt overlay was deteriorated, as shown in Figure 177. Differential settlement between the approach slab and wingwall of about 3 inches was measured. Severe cracking near the expansion joint was also observed. A 3-inch wide gap was observed between the abutment and embankment.

Figure 177. Deterioration of asphalt overlay at bridge approach

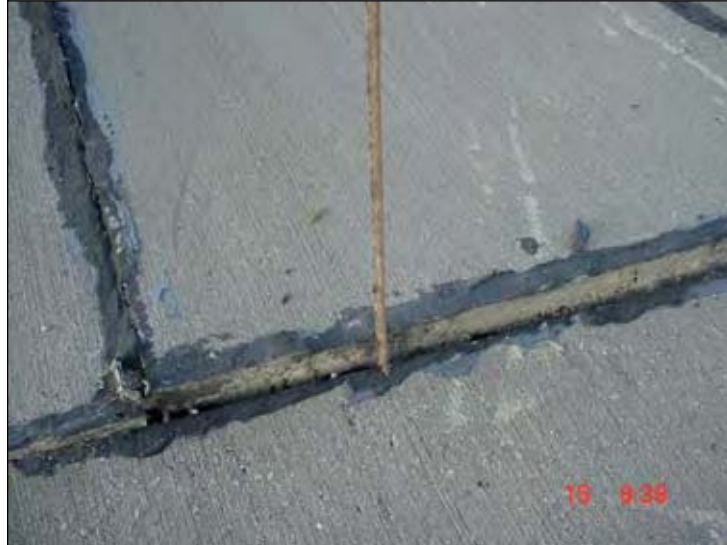
This bridge was not inspected during the field visit; however, some figures and maintenance reports were provided by Iowa DOT. This bridge has four spans with non-integral abutments. Figure 178 shows uneven settlement of the concrete slope protection of the embankment under the bridge. The near end of the right lane of the bridge was grouted in August 2003 to fill the void developed behind the abutment, which exposed the H-piles (Figures 179 to 182).

Figure 178. Uneven concrete slope protection

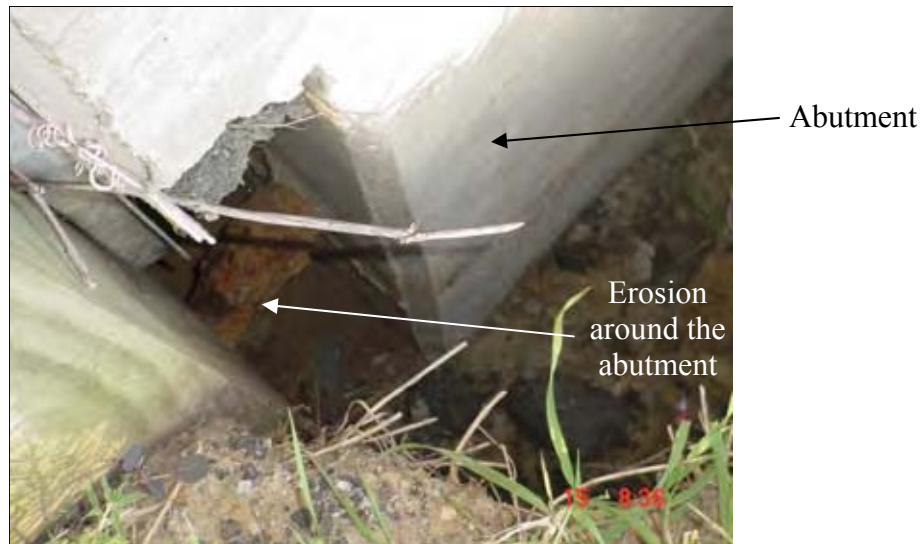
Figure 179. Soil erosion around the abutment

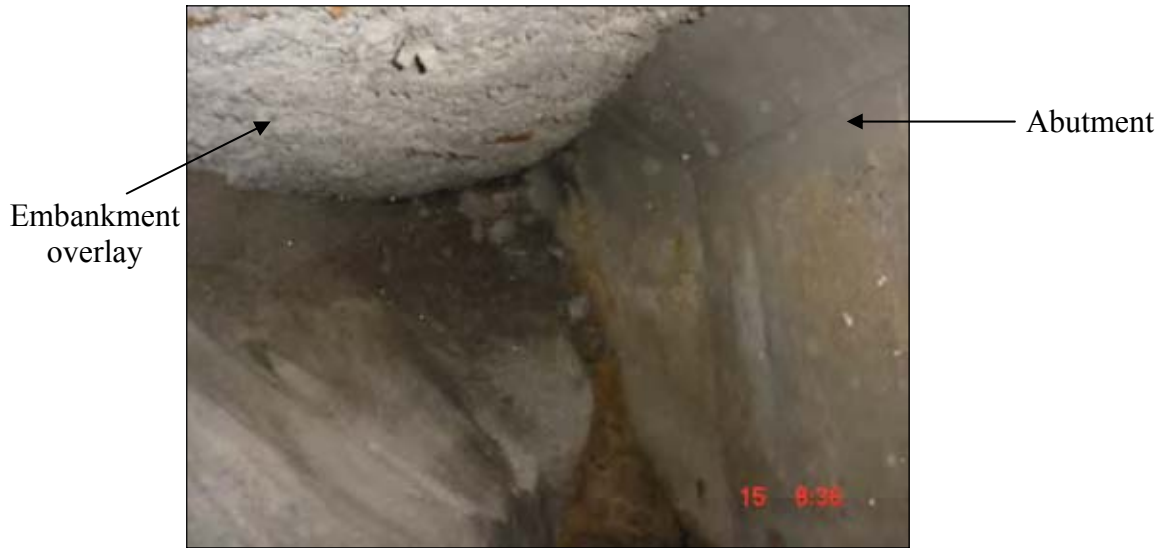
Figure 180. Erosion under the concrete slope protection (Side view)

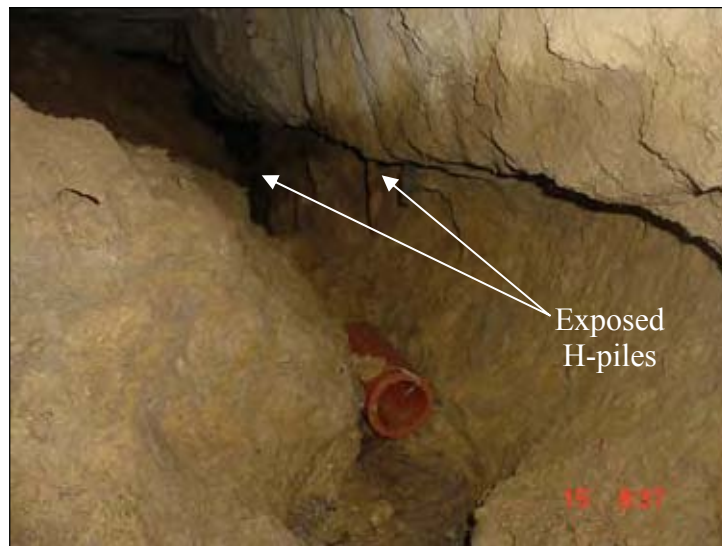
Figure 181. Void created under bridge approach exposing H-piles (Side view)

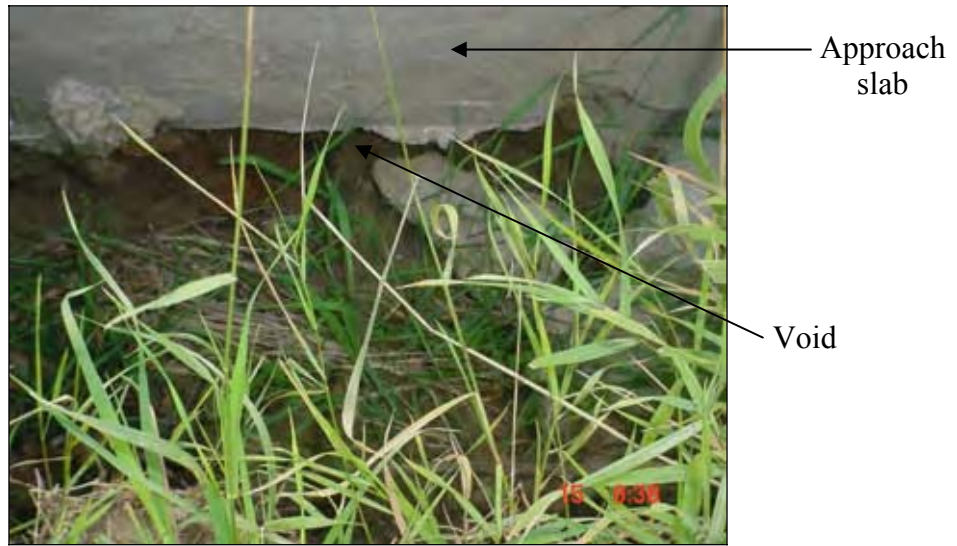
Figure 182. Void developed under the approach slab

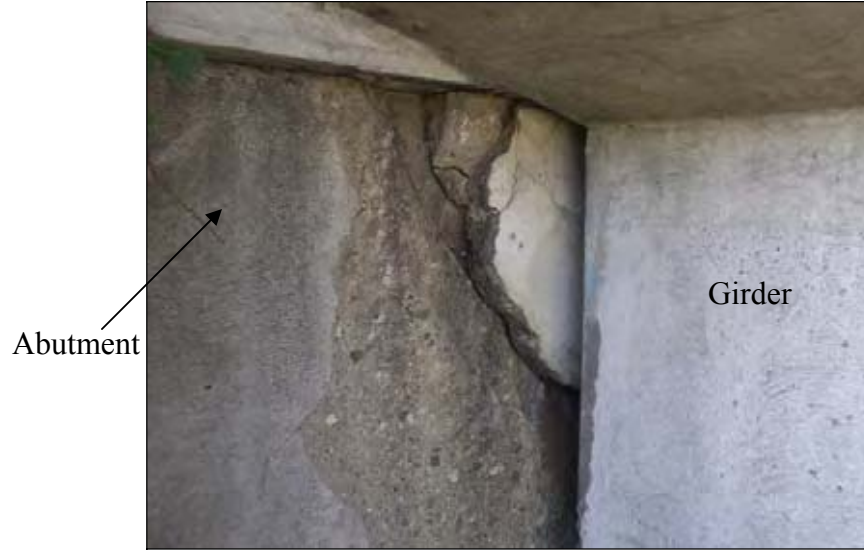
This bridge was inspected four times—twice in June, once in July, and once in October of 2003. At this location, the old bridge was being replaced and widened. The new bridge has concrete girders with integral abutments. During the first inspection, the old bridge at the north bound had been removed and the center pier of the new lane was being constructed (Figures 192 and 193). The old southbound lane bridge was still open for traffic and had non-integral abutments. At the southbound lane, concrete spalling of the abutment was observed (Figure 194). This bridge had a concrete slope protection cover for the embankment under the bridge.

Figure 194. Concrete spalling at the abutment (SBL)

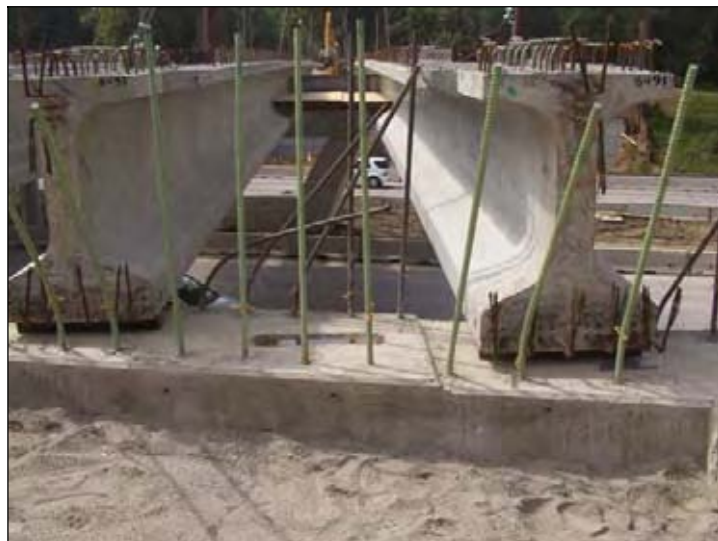
Figure 197. Sand used as granular backfill material

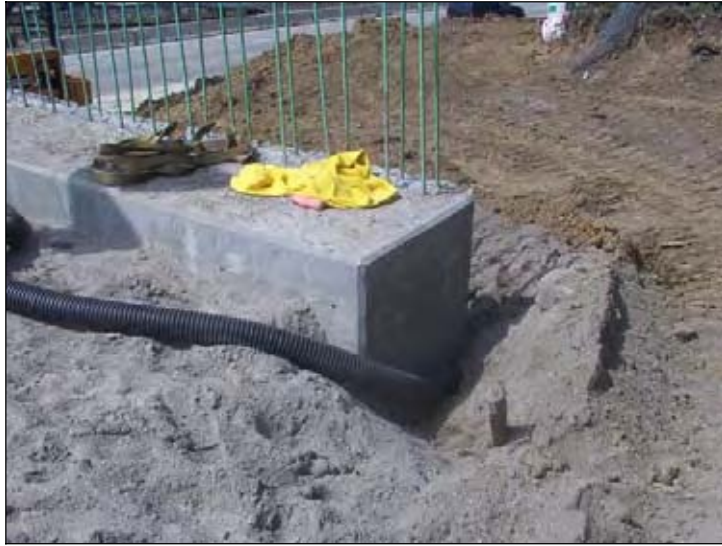
The bridge was inspected again in June 2003. During this field visit, the H-piles were being installed at the north end of the northbound lane, as shown in Figure 195. In July 2003, the bridge was visited again where retaining wall construction was taking place at the south end of the northbound lane (Figure 196). At the north end, the backwall was already constructed. Granular backfill material was used behind the abutment, as shown in Figure 197. No porous backfill was observed around the subdrain (Figure 198). When examined, the perforated drainage pipe was filled with sand particles.

Figure 198. No porous fill surrounding the subdrain (North end NBL)

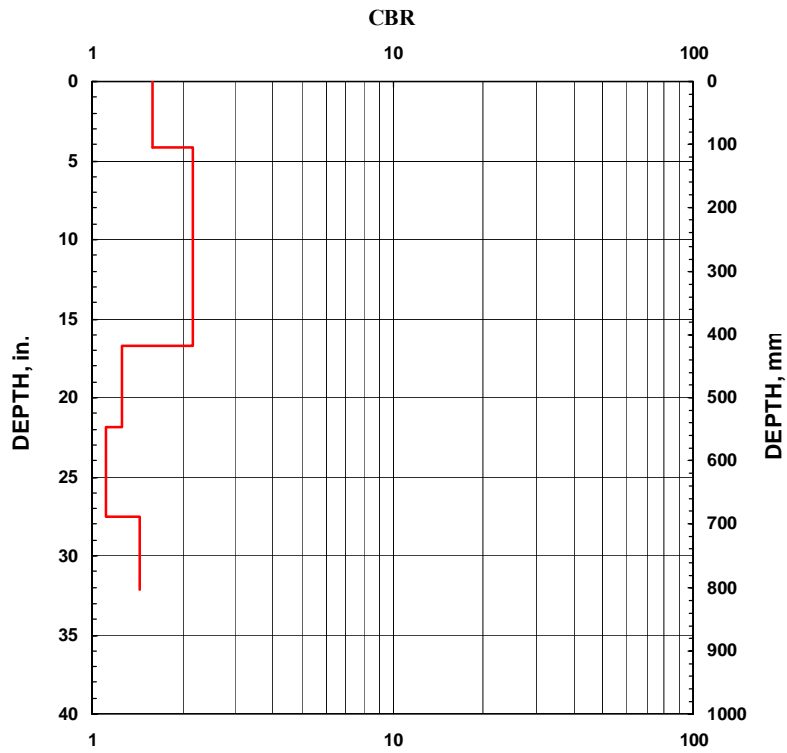
Dynamic Cone Penetration (DCP) tests were performed at three locations behind the backwall at the north end of the north bound. Estimated California Bearing Ratio (CBR) values ranged from 1 to 8 at all test locations (Figures 202 through 205) indicating a soft/loose backfill material. Nuclear gage tests were also conducted at two locations behind the north end backwall. The average measured dry density was 105 pcf and the moisture content was 4.7%.

Figure 203. DCP test results (Location 1 North end of NBL)

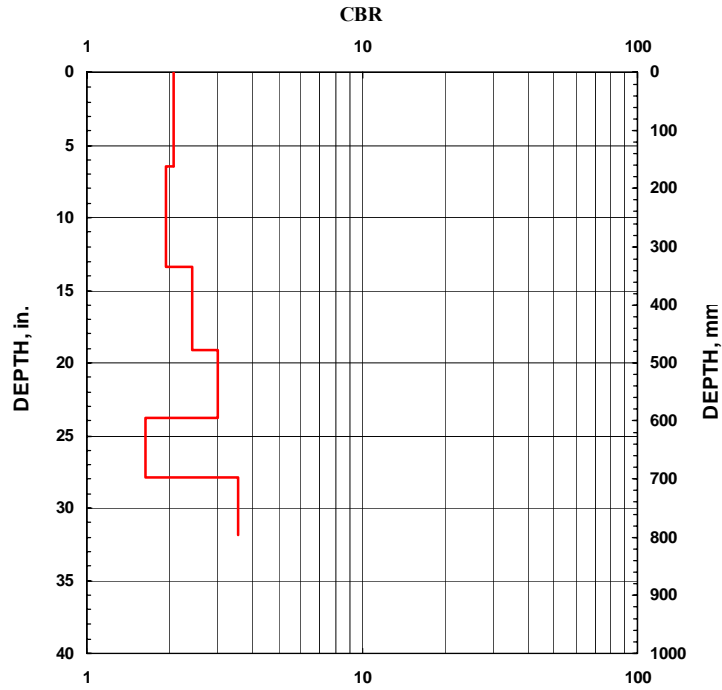
Figure 204. DCP test results (Location 2 North end of NBL)

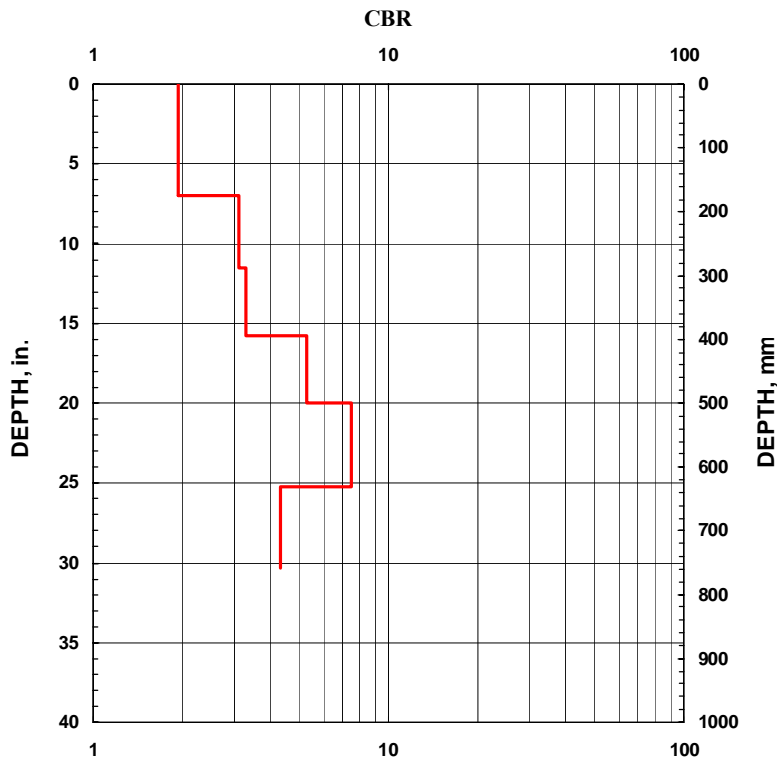
Figure 205. DCP test results (Location 3 North end of NBL)

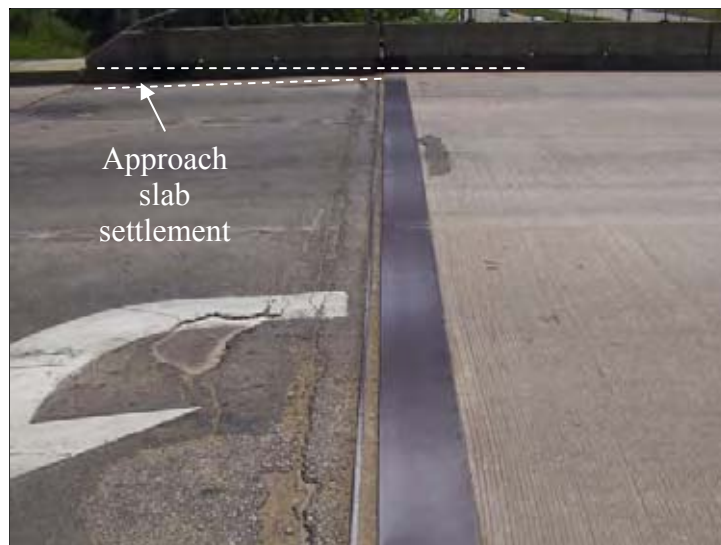
This bridge site was inspected in June 2003. When the bridge was inspected, the old bridge was still open for traffic. This bridge has three spans and concrete slope protection of the embankment. Two inches of differential settlement was observed at both ends of the bridge. Both ends of the bridge have an asphalt approach with visible longitudinal cracks (Figure 208). When the bridge was visited again in October 2003, the girders and the backwall of the southbound lane were constructed (Figure 209). Backfill material samples were collected to perform laboratory tests.

Figure 208. Cracks at asphalt approach with visible differential settlement

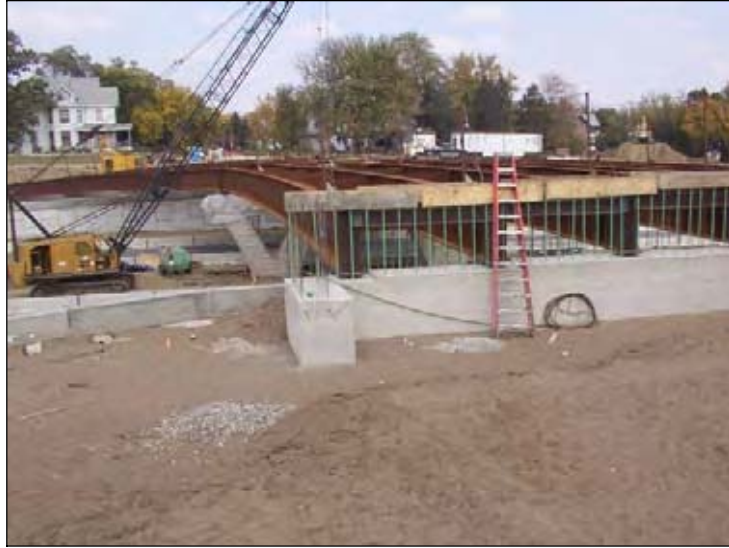
Figure 209. Construction of steel girders and backwall

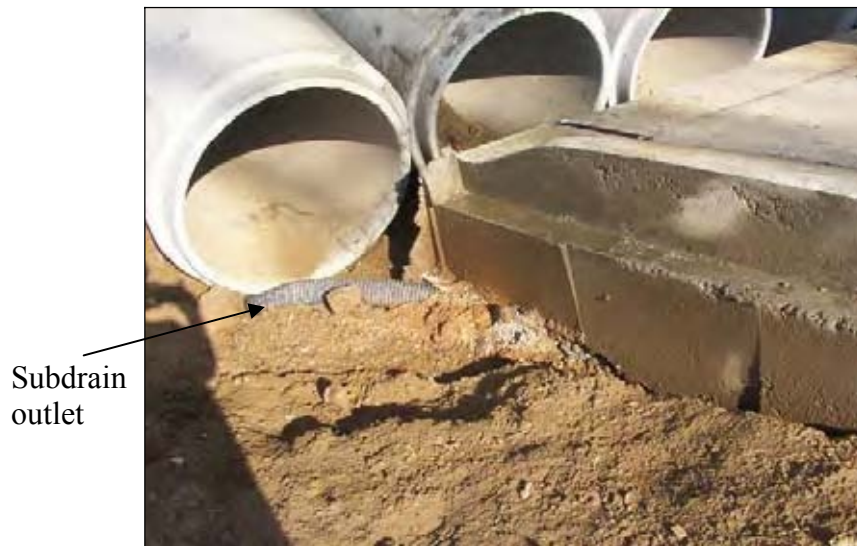
This bridge was inspected in June and October 2003. In June, the center piers were still under construction, as shown in Figure 212. In October, the concrete slope protection for the embankment under the bridge was constructed (Figure 213). No porous backfill was placed around the subdrain. Figure 214 shows the outlet of the subdrain at the bottom of the embankment surrounded by granular backfill. When inspected, the subdrain was filled with soil.

Figure 214. Subdrain outlet at the bottom of the embankment

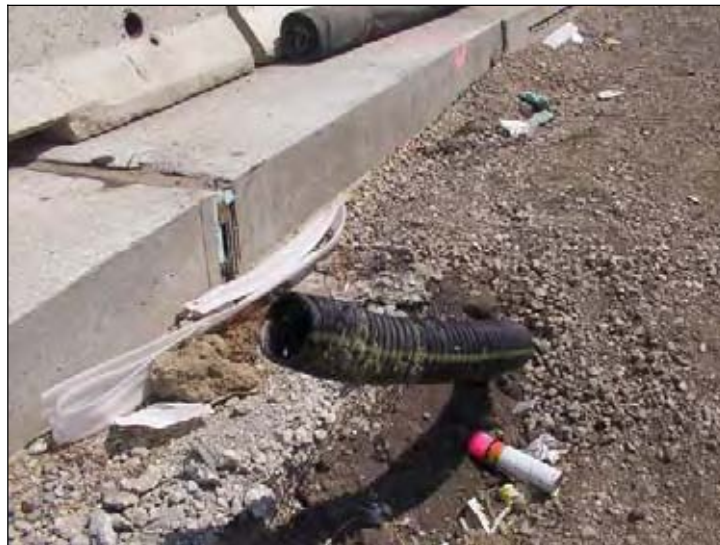
This bridge was also inspected twice in August 2003. During the first inspection, construction of the north bound was completed and construction of the south bound was taking place, as shown in Figure 222. Figure 223 shows the end drain filled with soil. Construction of the backwall was taking place, as shown in Figures 224 and 225. During the second inspection in August 2003, construction of the abutment was still underway. Poor construction of the approach slab at the north bound, which was recently completed and opened for traffic, was observed. When the south bound was removed for replacement, the loose backfill behind the northbound abutment collapsed as a result of removing the sheet piles supporting the backfill creating a void (Figures 226 and 227).

Figure 223. End drain outlet filled with soil

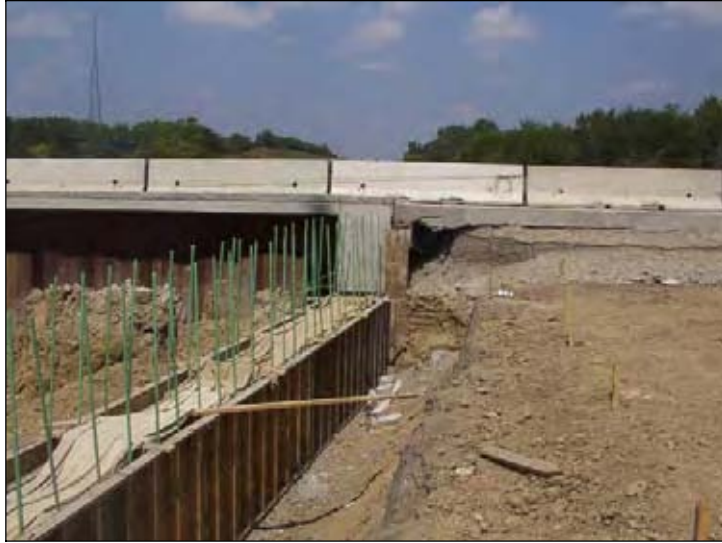
Figure 226. Abutment reinforcement and backfill placed at the northbound approach slab

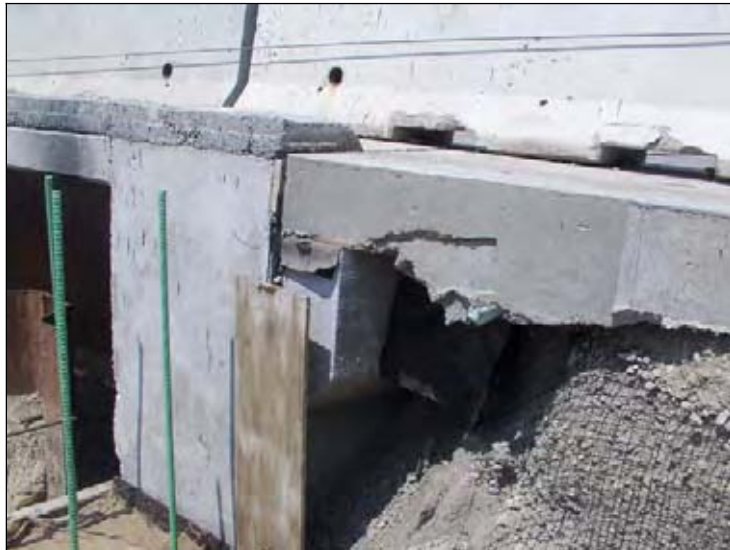
Figure 227. A closer image of the poorly-placed granular backfill (NBL)

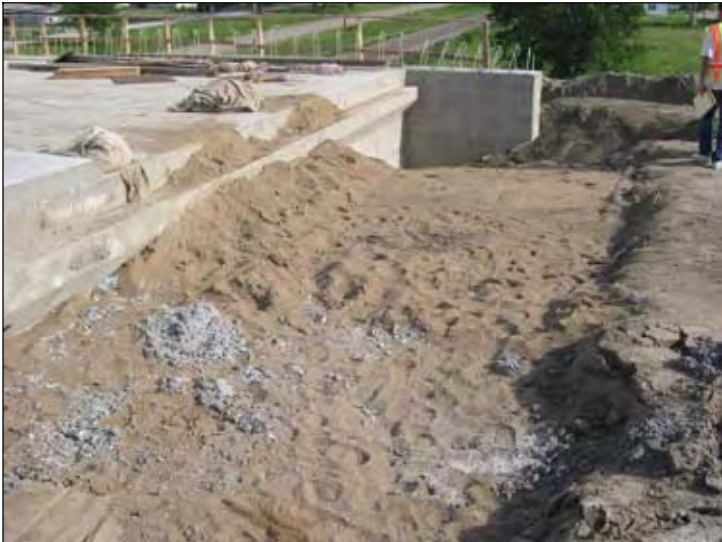
This bridge was constructed with integral abutments and concrete girders. Aggregate was used as slope protection on the embankment under the bridge. The foundation soil of this bridge was allowed to consolidate under the embankment weight for one year prior to construction of the bridge superstructure. Figure 230 shows the granular backfill poorly placed behind the abutment. As shown in Figure 231, no porous backfill was used around the subdrain. Figure 232 illustrates the poor construction of the paving notch with poorly consolidated concrete.

Figure 230. Poorly placed granular backfill

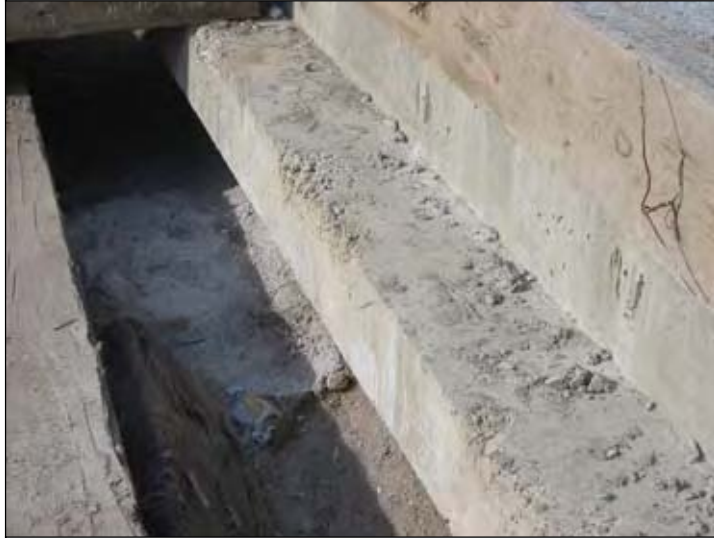
Figure 232. Poor construction of bridge paving notch

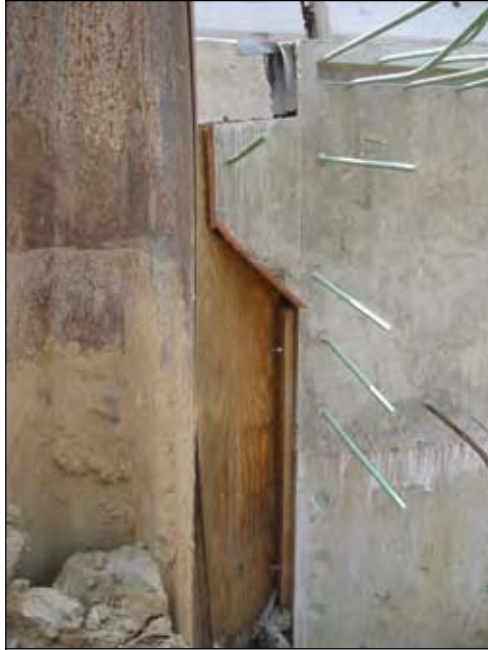
This bridge was still under construction when inspected in August 2003. The paving notch was observed to be declined in the direction of the approach slab (See Figure 234). Figure 235 shows the grain-size distribution of the granular backfill material used at this bridge. The granular backfill classifies as SP according to the USCS.

Figure 234. Declined paving notch

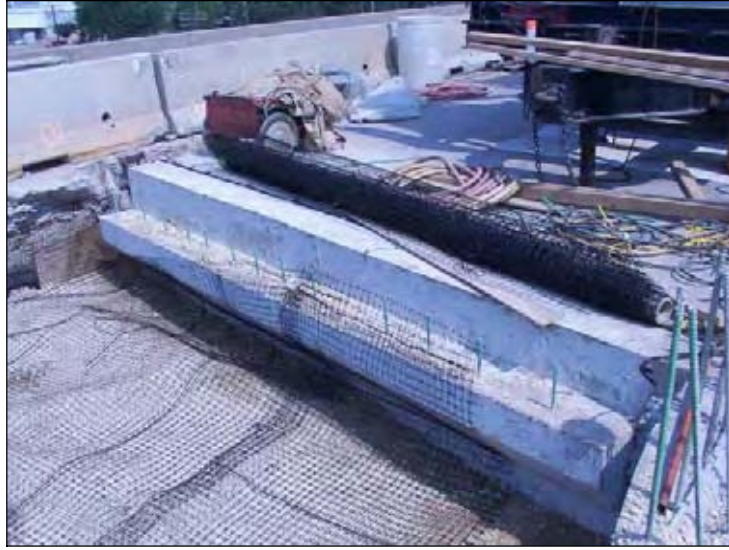
This bridge has three spans with steel girders and non-integral abutments. The bridge approach was grouted to fill a void (see Figure 236). During the field inspection, replacement of both approach slabs and the paving notch of the northbound lanes were in progress. The approach slabs were replaced due to excessive settlement and cracking, which is believed to be a result of severe erosion and subsequent void development. At the south end of the bridge, new granular backfill was placed and compacted in 8-inch-loose lifts using a vibratory base plate. The width of the newly constructed paving notch was 12 inches, with an expansion joint width of 2.5 inches (Figure 237). The bridge did not have subdrains and none were installed. The bridge embankment soil is mostly silty clay with no slope protection. At the north end of the bridge, reconstruction of the abutment was still in progress (Figure 238).

Figure 237. Construction of new bridge approach (South end of NBL)

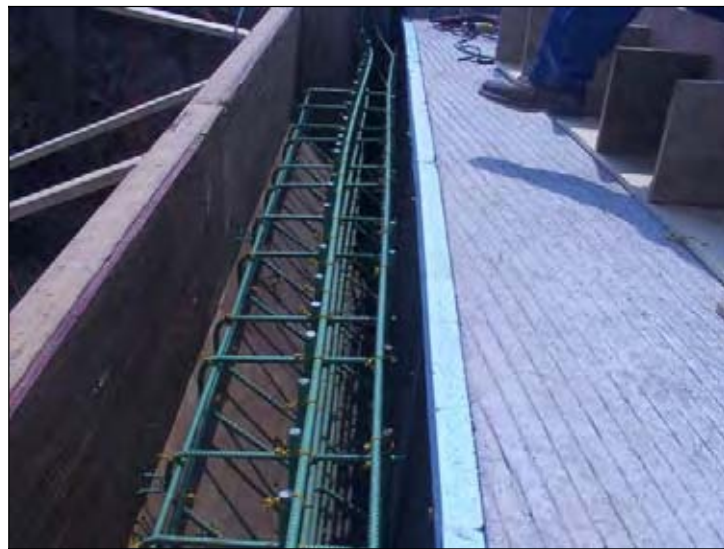
Figure 238. Abutment reinforcement (North end of NBL)

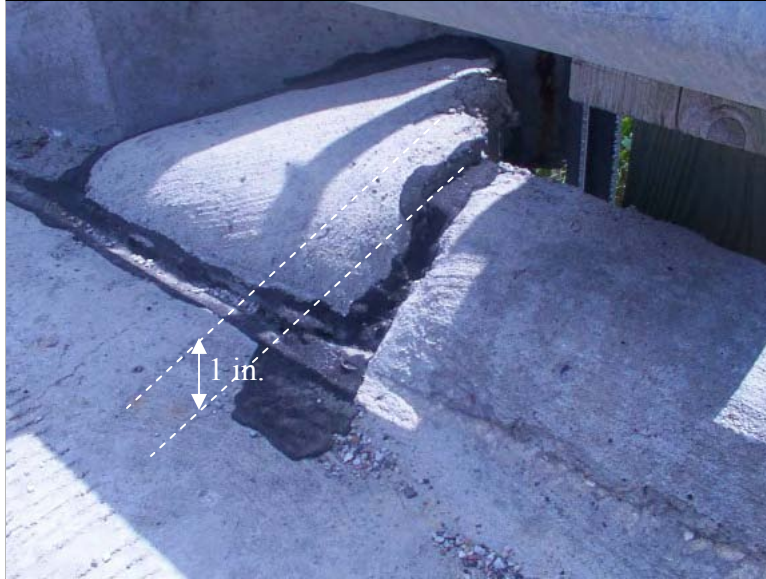
At the south end of the southbound bridge, differential settlement of 1 inch was measured relative to the wingwall (Figure 240), and a 2-inch void was observed under the approach slab. The embankment under the bridge was covered with aggregate and showed no signs of erosion or differential settlement. Aggregate cover was also used along the sides of the abutment to control erosion (Figure 241). The end drain was in a satisfactory condition, as shown in Figure 242.

Figure 240. Differential settlement of 1 inch between the bridge slab and the bridge approach (South end of SBL)

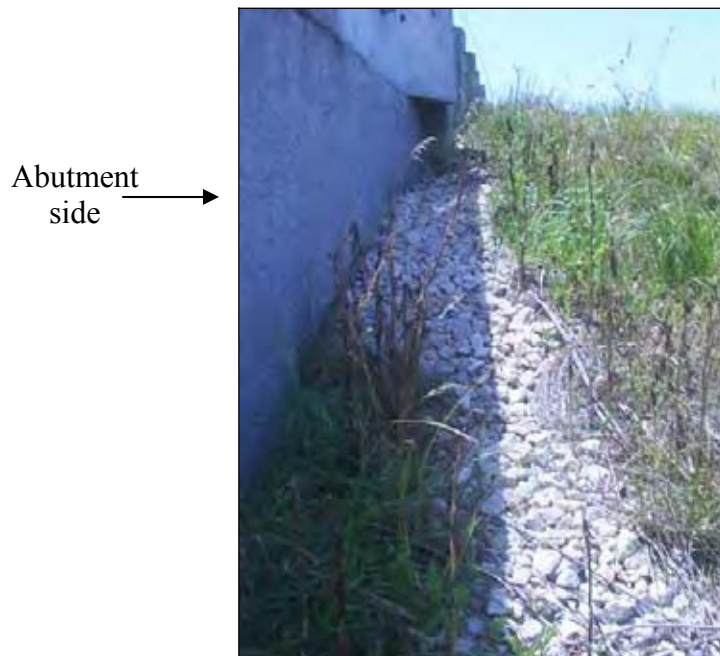
Figure 241. Aggregate placed at the sides of the abutment to control erosion (South end of SBL)

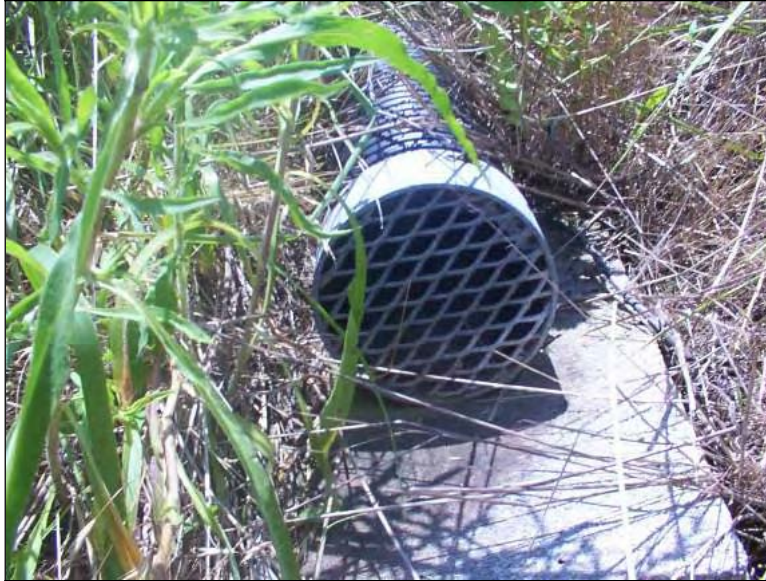
Figure 242. End drain in a satisfactory condition (South end of SBL)

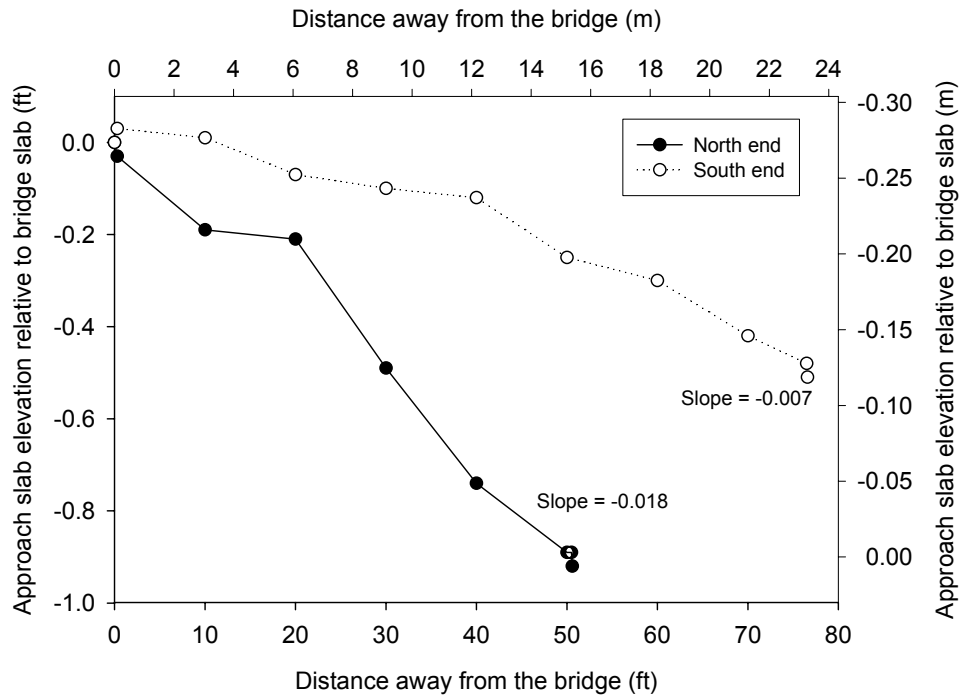
At this bridge, profiles of the north and south ends of the southbound lane are shown in Figure 243. Differential settlement of 0.5 inches was estimated between the approach slab and the roadway at both ends of the southbound lanes. The slopes for the north and south end approach slabs are -0.007 and -0.018. The approach slabs are sloping away from the bridge, which may indicate settlement of the foundation soil or compression of the embankment material. According to the Iowa DOT repair recommendation, only the approach slab at the north end was replaced.

Figure 243. Profiles of the approach slab relative to bridge slab (SBL)

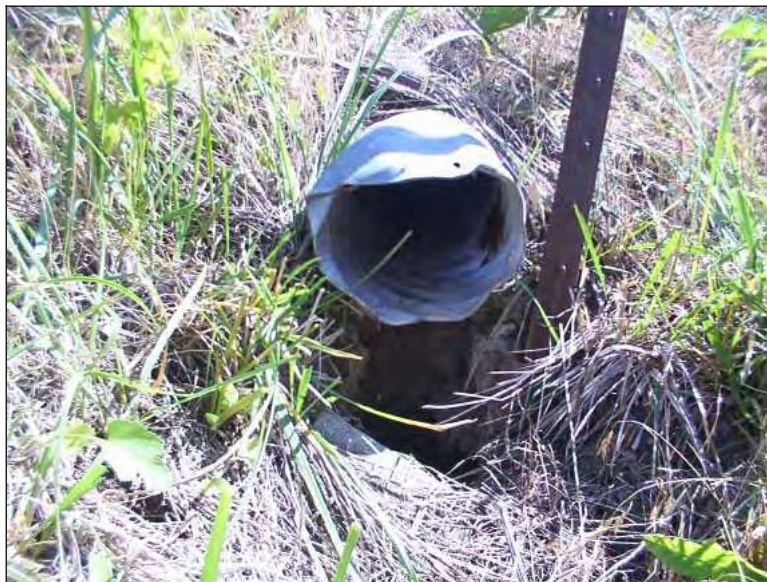
The subdrains of the northbound lanes were inspected using the Iowa DOT snake camera (Figures 244 and 245). At the north end, water and mud were observed within the first 9 ft. inside the subdrain (Figures 246 and 247). The snake camera was pulled out, cleaned, and

Figure 246. Subdrain prior to insertion of snake camera (North end of NBL)

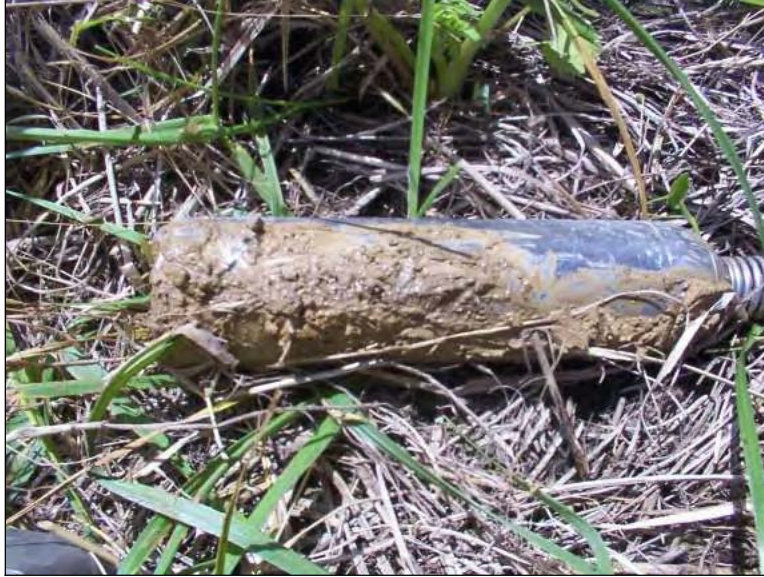
reinserted. However, the camera could not be pushed beyond 14.4 ft., where the subdrain had collapsed. At the south end, the subdrain was completely dry and did not have any observed water or soil debris. The camera, however, could not be pushed beyond 9.8 ft. into the subdrain because of subdrain collapse.

Figure 247. Snake camera covered with mud (North end of NBL)

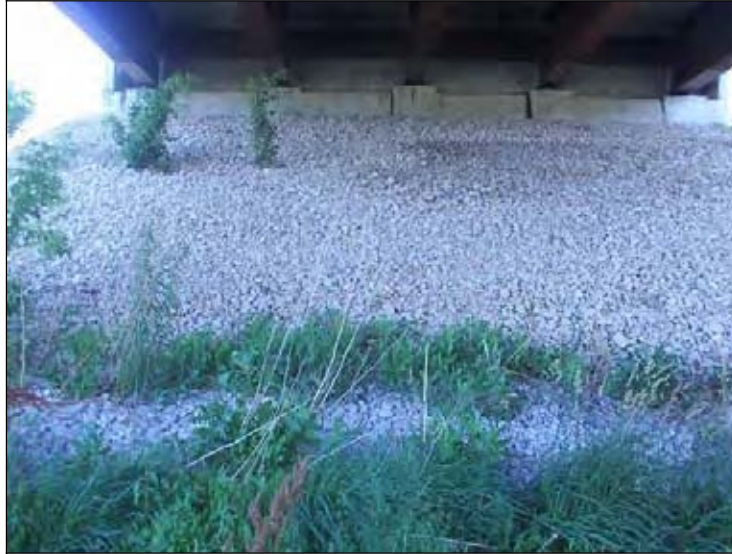
This bridge is a three-span bridge with steel girders and non-integral abutments. At the north end of the southbound lanes, bridge approach differential settlement of 1 inch was measured relative to the wingwall. No settlement of the embankment under the bridge, which was covered by aggregate, was observed (Figure 248). At the south end, differential settlement at the bridge approach was observed. In addition, water ponding at the bottom of the embankment under the bridge was noted. The inlet of the surface drain was in a satisfactory condition.

Figure 248. Aggregate slope protection at the bridge embankment (North end of NBL)

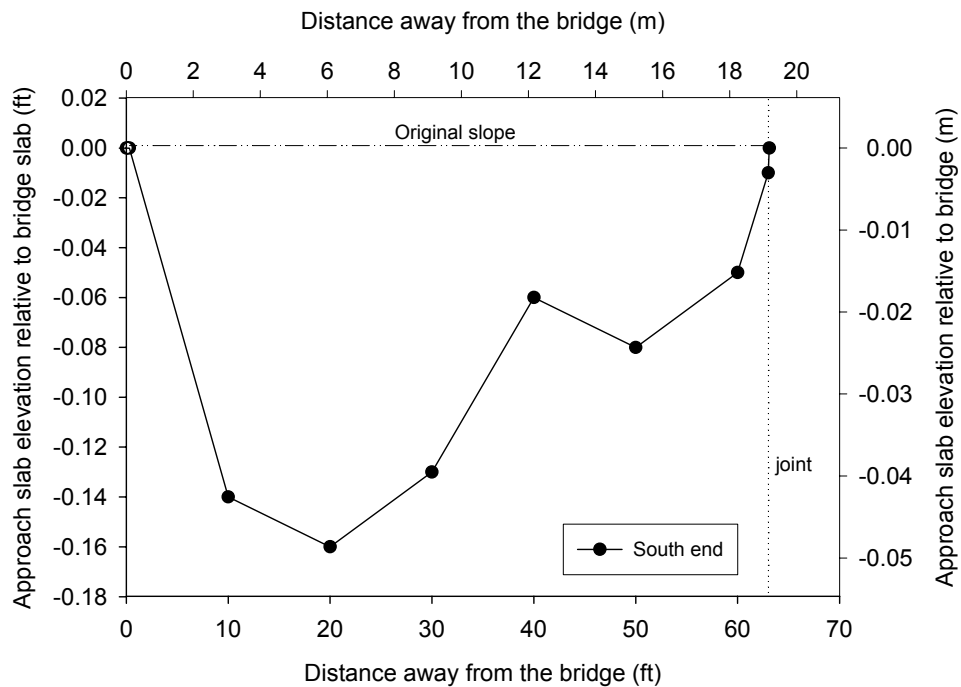
Approach slab coring at the south end of the south bound indicated a 0.5-inch void at both the center line and the edge line of the right lane. The profile of the south end approach slab revealed a non-uniform pavement elevation. The profile shows a maximum settlement of 1.9 inch at 20 feet from the bridge abutment. The original slope of the approach slab is horizontal (Figure 249).

Figure 249. Profile of the bridge approach relative to the bridge slab (South end of SBL)

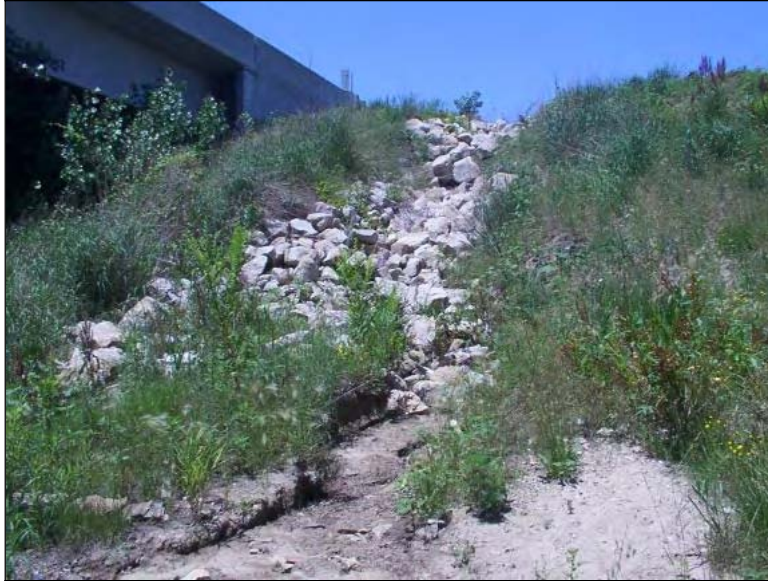
This bridge is a seven-span bridge with concrete girders and non-integral abutments. At the north end of the northbound lanes, the embankment consists of silty sand and has no slope protection. Some erosion of the bridge embankment was observed. At the sides of the abutment, large rip-rap had been placed to reduce erosion, as shown in Figure 250.

Figure 250. Rocks placed at the abutment side to prevent erosion (North end of NBL)

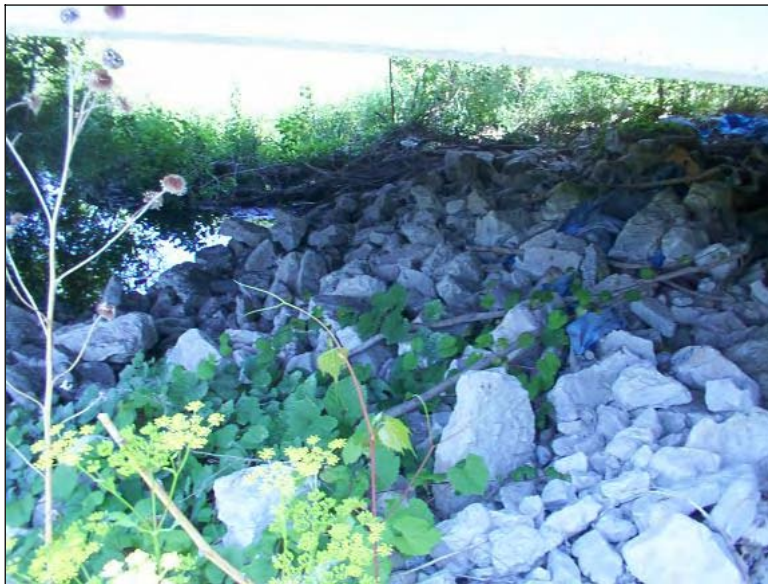
At the south end of the northbound lanes, differential settlement of 1.5 inches was measured at the end of the wingwall. The expansion joint was in satisfactory condition. Large rip-rap covered the embankment under the bridge as shown in Figure 251. Some erosion was observed along the side of the abutment.

Figure 251. Rocks placed at the embankment under the bridge to prevent further erosion (South end of NBL)

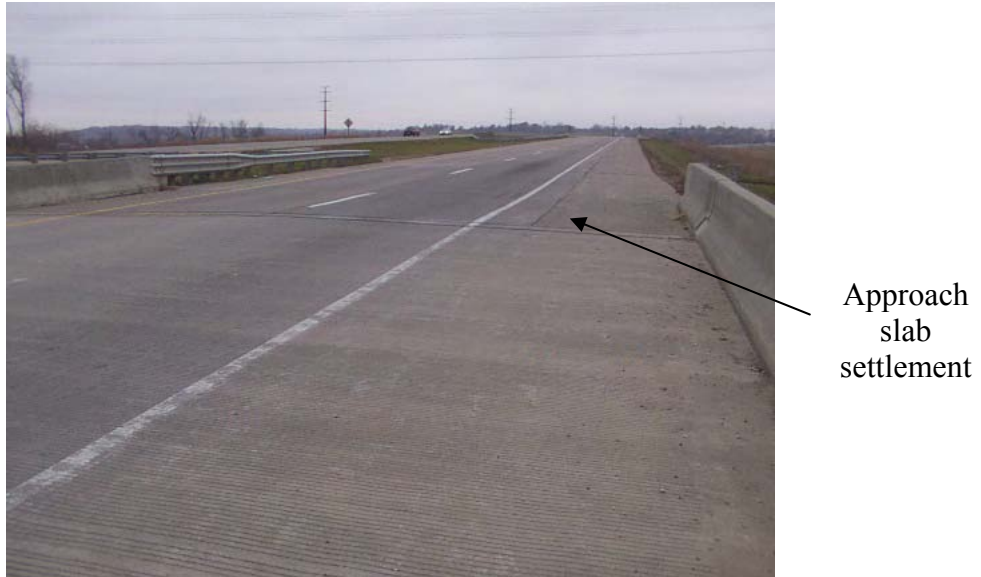
At the south end of the southbound lanes, the strip seal was cut short causing erosion at side of the abutment. Settlement and erosion of the bridge embankment was also observed. At the north end of the southbound lanes, 3.5 inches of differential settlement was measured (Figure 252). No slope protection was used and erosion of the embankment was observed.

Figure 252. Settlement of approach slab (North end NBL)

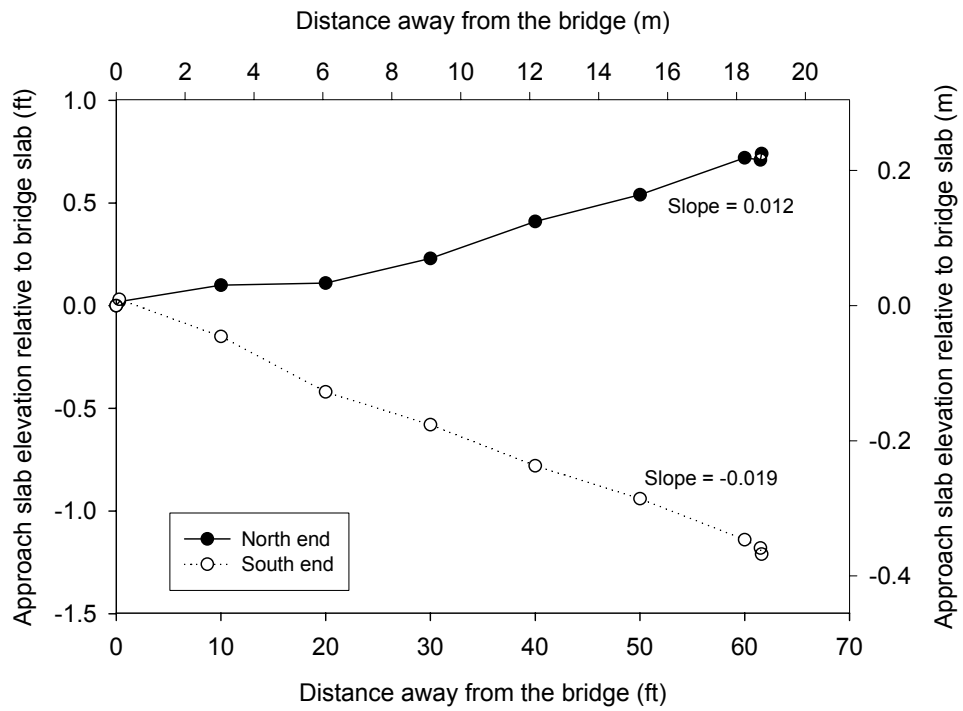
The approach slab elevation profiles for north and southbound lanes are shown in Figures 253 and 254. Differential settlement of the approach slab at the north end of the southbound lanes was about 1.2 inches at 5 ft. from the bridge abutment, while the south end approach slab settled about 3.5 inches at 50 ft. away from the bridge abutment. The slopes of the north and south end approach slabs of the southbound lane are 0.01 and -0.019. Differential settlement between the approach slab and the roadway of both ends of the northbound lanes was about 0.5 inches. The slopes of the north and south end approach slabs of the northbound lane are 0.012 and -0.019, respectively.

Figure 253. Profiles of the approach slab relative to bridge slab (NBL)

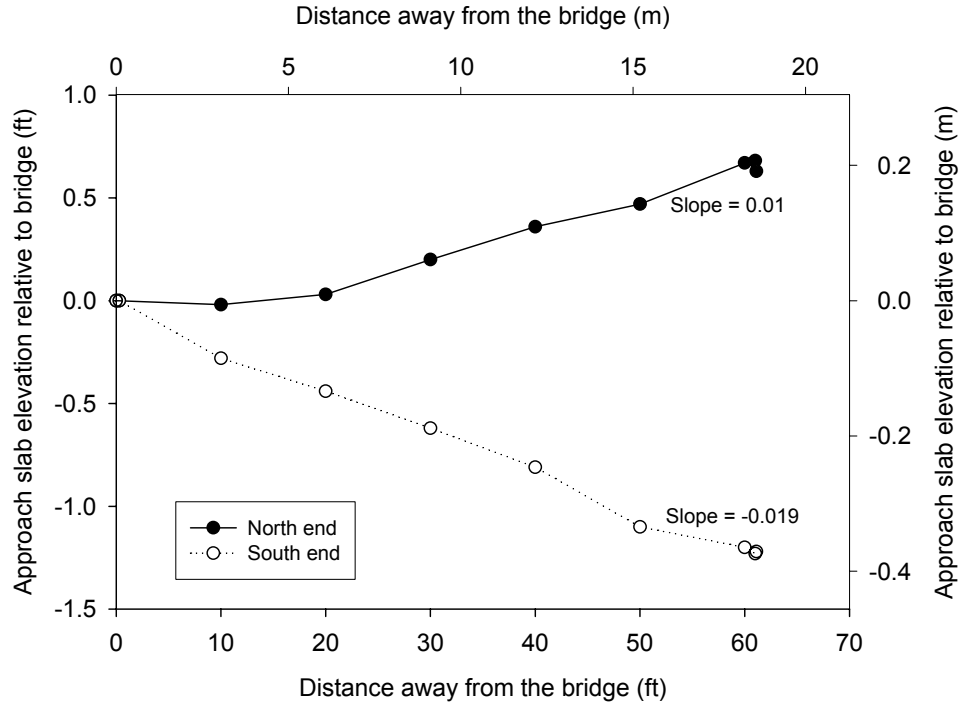
Figure 254. Elevation of the bridge approach relative to the bridge slab (SBL)

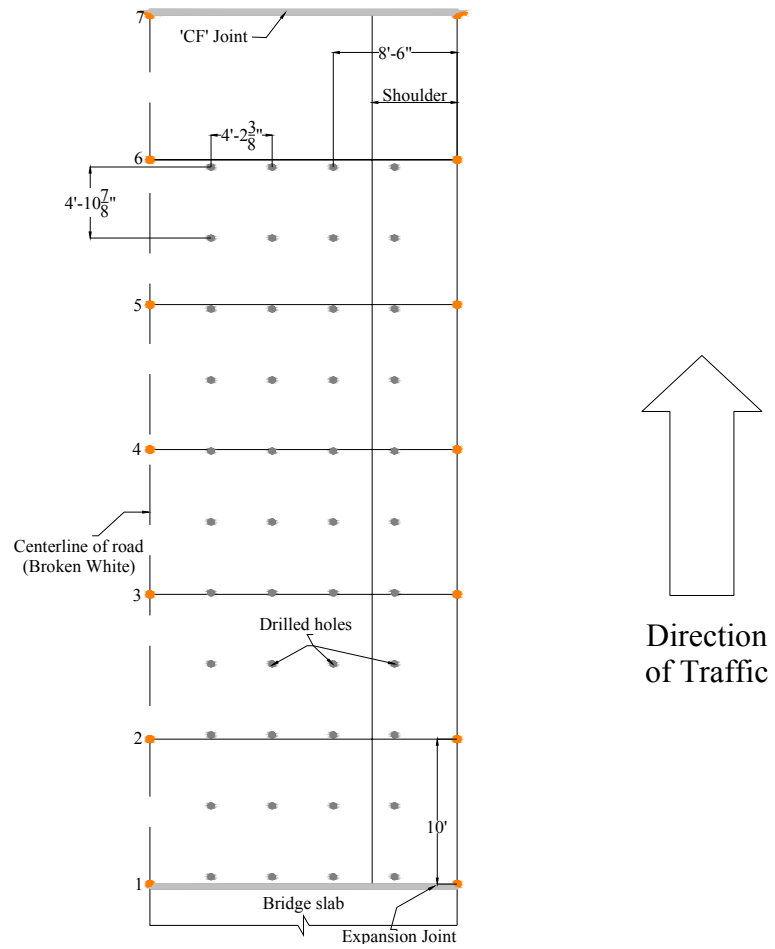
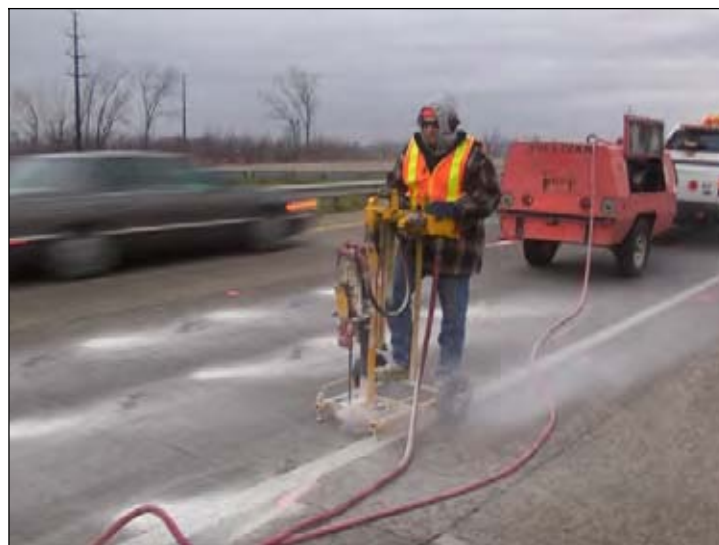
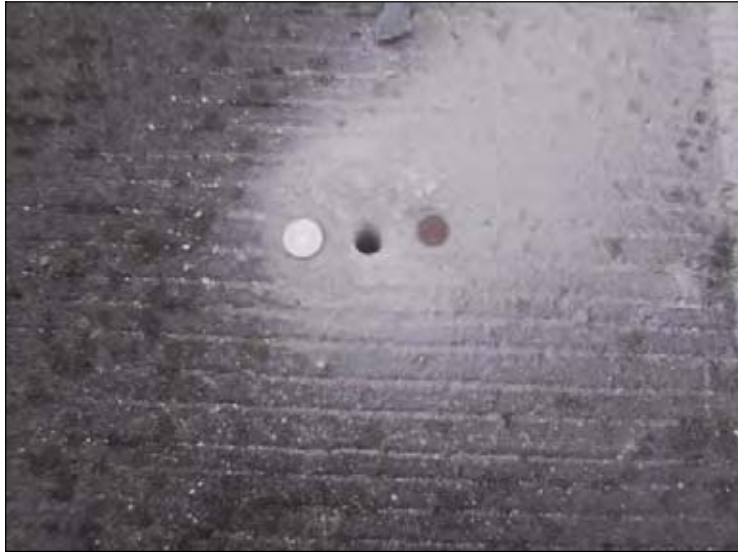
Figure 255. Location of holes drilled on the bridge approach slab

Figure 256. Holes drilled on the approach slab

Figure 257. Holes drilled for injecting expansive material under the approach

As a demonstration at this bridge site, URETEK, Inc., repaired the right lane of the north end of the northbound lanes. Figure 255 shows the locations where the URETEK expanding foam was injected through 5/8 inch drill holes in the slab. The drill holes were spaced about 4 to 5 feet apart (Figures 256 and 257). A dial gauge was placed just past the ‘CF’ joint, located 60 feet from the abutment, to monitor elevation changes in the approach slab pavement (Figure 258). After drilling was completed, pumping of the high density polyurethane was performed. Some holes were re-drilled after the material had hardened to inject additional material as needed (Figures 259 and 260).
