IDENTIFICATION OF THE BEST PRACTICES FOR DESIGN, CONSTRUCTION, AND REPAIR OF BRIDGE APPROACHES

Iowa DOT Project TR-481
CTRE Project 02-118

Final Report

January 2005

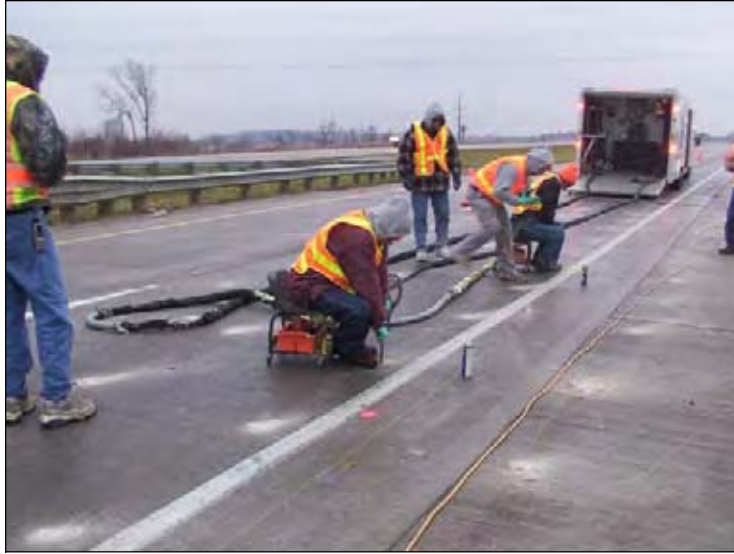
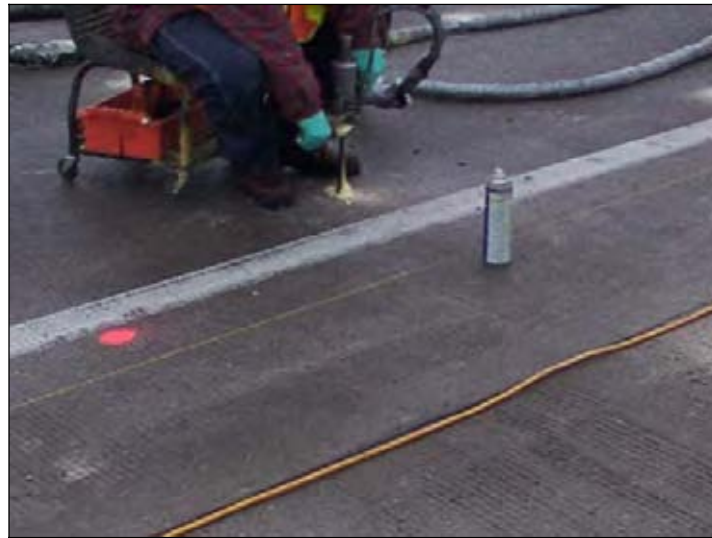
Figure 259. Injecting high-density polyurethane under the approach slab

Figure 260. Steady injection until material leaks out of hole

As a demonstration at this bridge site, URETEK, Inc., repaired the right lane of the north end of the northbound lanes. Figure 255 shows the locations where the URETEK expanding foam was injected through 5/8 inch drill holes in the slab. The drill holes were spaced about 4 to 5 feet apart (Figures 256 and 257). A dial gauge was placed just past the ‘CF’ joint, located 60 feet from the abutment, to monitor elevation changes in the approach slab pavement (Figure 258). After drilling was completed, pumping of the high density polyurethane was performed. Some holes were re-drilled after the material had hardened to inject additional material as needed (Figures 259 and 260).

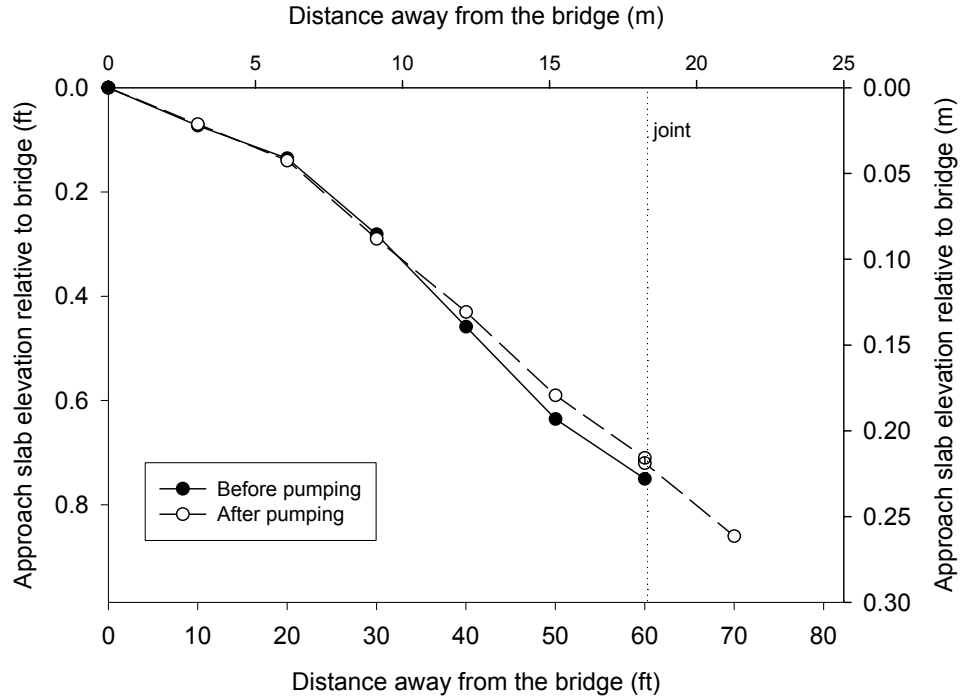
The research team measured the profile of the approach at 10 ft. intervals before and after injecting the expanding foam. The approach slab was raised approximately 0.25 inches at 40 to 60 ft. from the abutment. Unfortunately, due to bad weather, the URETEK crew was not able to inject the material from 0 to 30 ft (Figure 261).

Figure 261. Elevation of approach relative to expansion joint before and after pumping

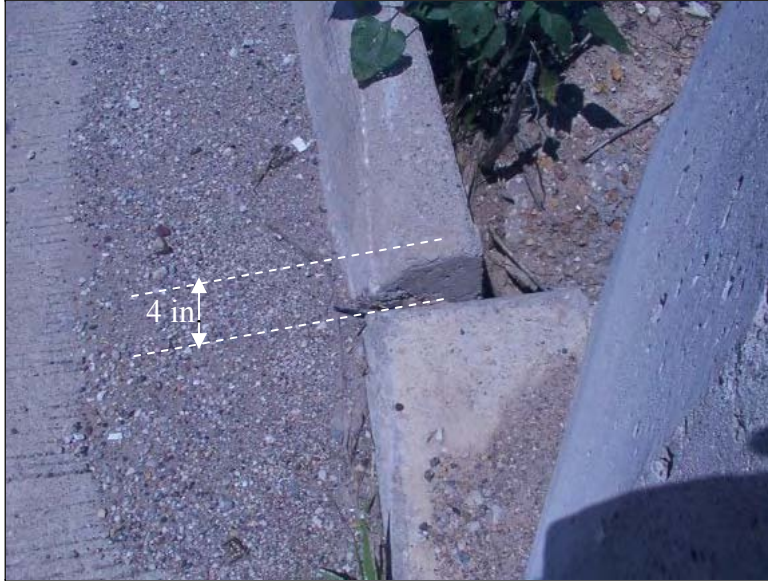
This bridge is a five-span bridge with integral abutments and concrete girders. At the north end of the northbound lanes, about 4 inches of differential settlement was measured at the end of the wingwall (Figure 262). A 6-inch void developed under the approach slab, as shown in Figure 263. Flexible foam was used as filler of the expansion joint—gaps were observed and concrete deterioration was observed at the expansion joint. Although the embankment under the bridge had an aggregate cover, erosion was observed between the abutment and the bridge embankment.

Figure 262. Differential settlement at the bridge approach (North end of NBL)

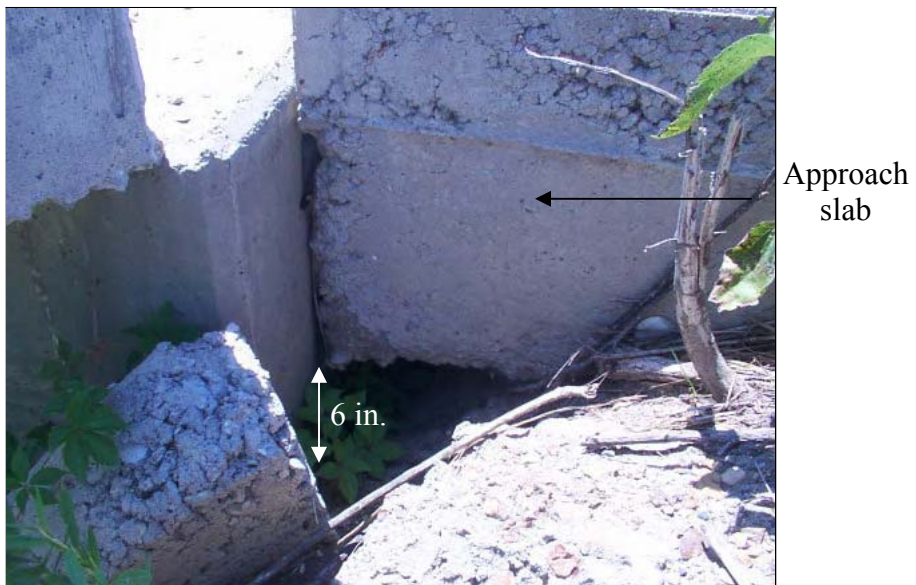
Figure 263. A 6 in. void developed under the approach slab (North end of NBL)

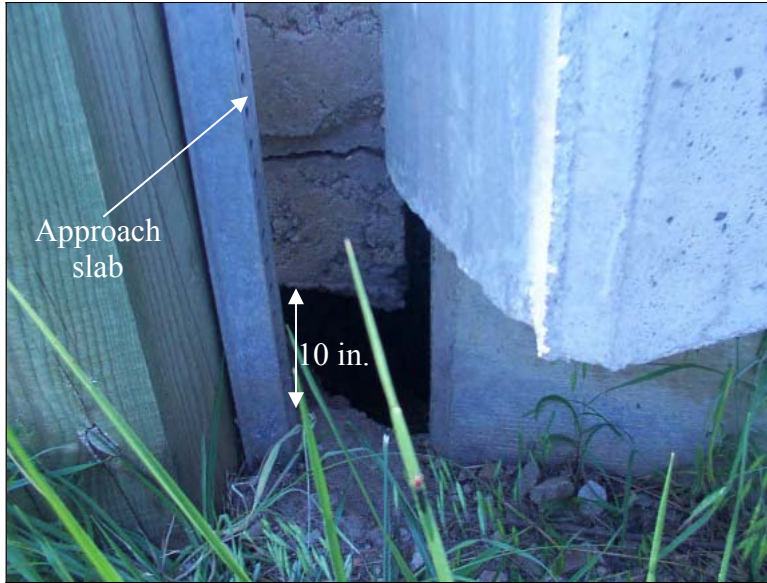
At the south end of the northbound lanes, a 10-inch void was observed under the approach slab (Figure 264). Figure 265 shows 1.5 inches of differential settlement between the approach slab and wingwall. The expansion joint was deteriorated, as shown in Figure 266. Furthermore, erosion along the abutment sides was observed (Figure 267). The embankment has concrete slope protection which appeared to be in relatively good condition. The embankment, however, had settled about 7 inches (Figure 268), and a 1-inch horizontal gap was measured between the embankment and abutment face (Figure 269).

Figure 264. A 10 in. void developed under the approach slab (South end of NBL)

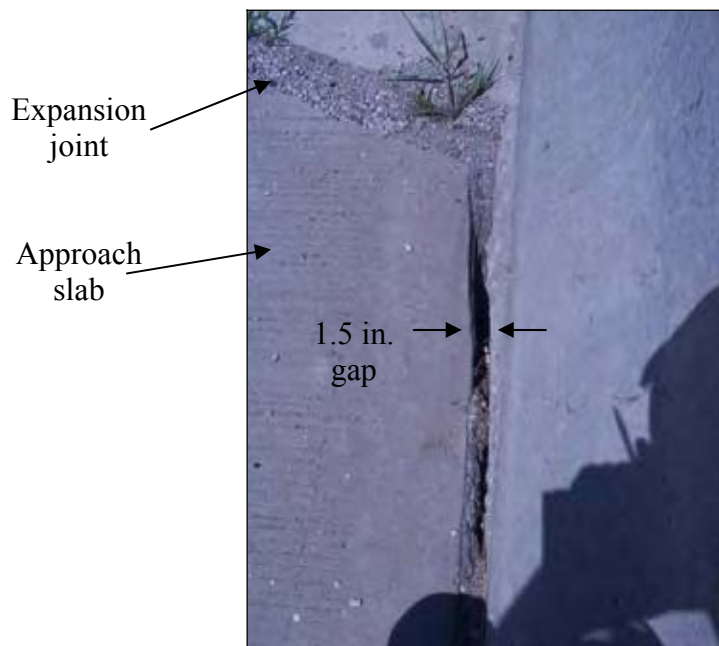
Figure 265. Gap between the approach slab and the wingwall (South end of NBL)

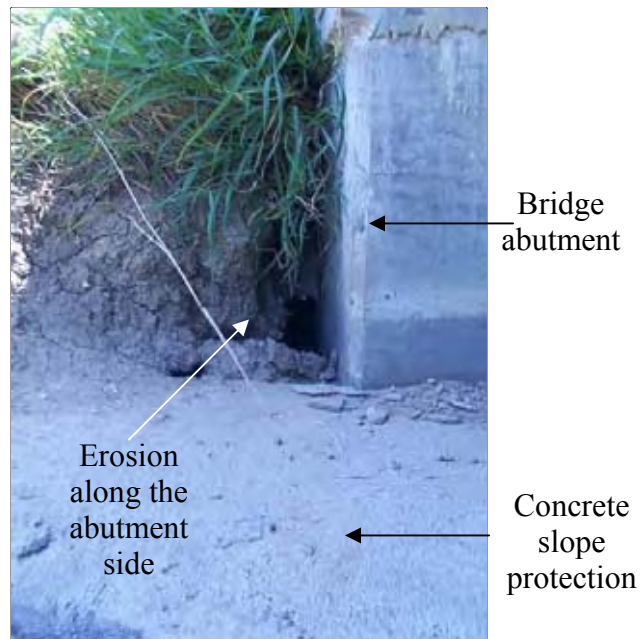
Figure 267. Erosion along the abutment sides (South end of NBL)

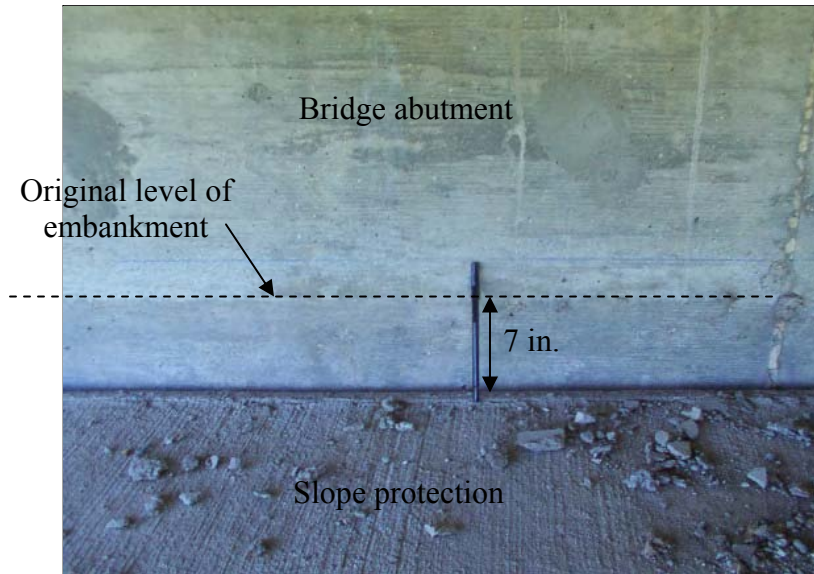
Figure 268. Settlement of the embankment under the bridge (South end of NBL)

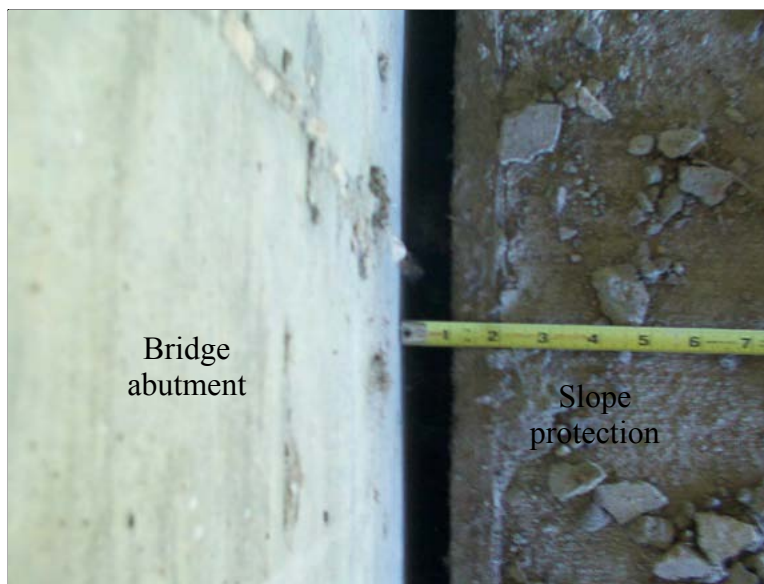
Figure 269. Top view showing the 1 in. gap between the abutment and concrete slope cover (South end of NBL)

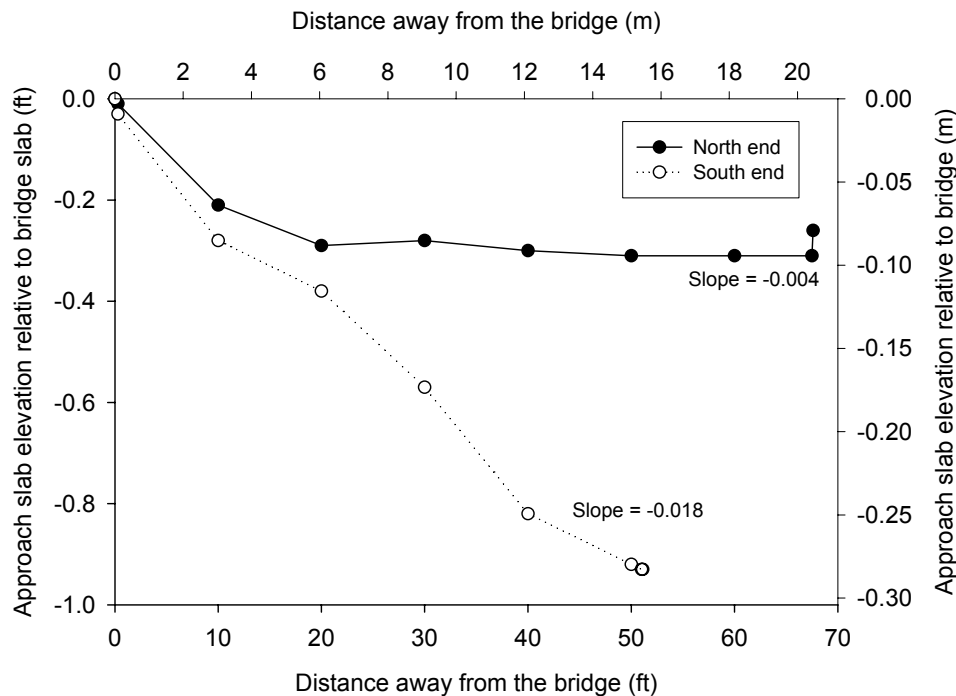
Bridge approach profiles were obtained for both ends of the northbound bridge, as shown in Figure 270. When compared with the assumed original profiles, differential settlement at the north end was about 1.5 inches at 20 feet from the bridge abutment and 0.6 inches between the approach slabs at 68 feet. The maximum settlement of the south end approach slab was 1.3 inches at 40 feet away from the bridge. The slopes of the north and south end approach slabs are -0.004 and -0.018, respectively. Both approach slabs are sloping away from the bridge, which may indicate settlement of the foundation soil or compression of the embankment material.

Figure 270. Profile of the bridge approach relative to bridge slab (NBL)

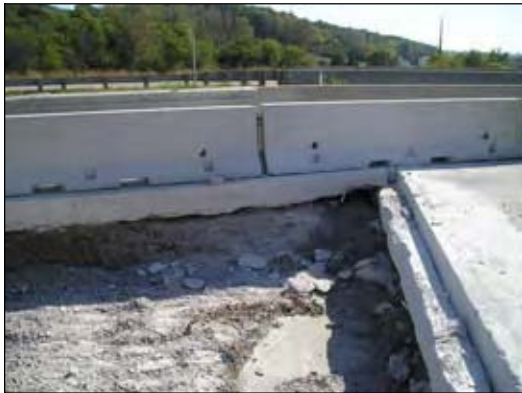
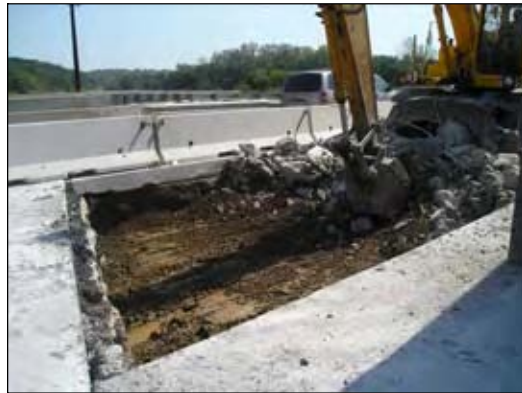
Figure 271. Replacement of approach slabs at the south bound

inspection, replacement of the right lane approach slabs at the south bound bridge was in progress (Figure 271). The left lane was still opened to traffic. The north end approach slab was removed while the south end approach slab was torn down and being removed.

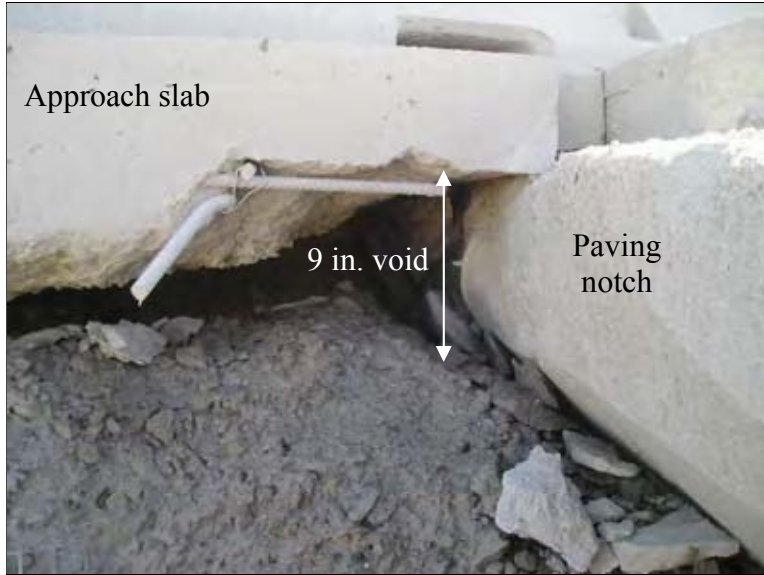
A void was observed under the left lane of the north end, as shown in Figure 272. The void was 9 inches deep at the abutment and about 1 inch at 4 feet away. Figure 273 shows that shear failure of portions of the paving notch of the left lane occurred such that the approach slab was only resting on about 0.5 inches of the paving notch (Figure 274).

Figure 272. A 9 in. void developed under the left lane approach slab (North end of SBL)

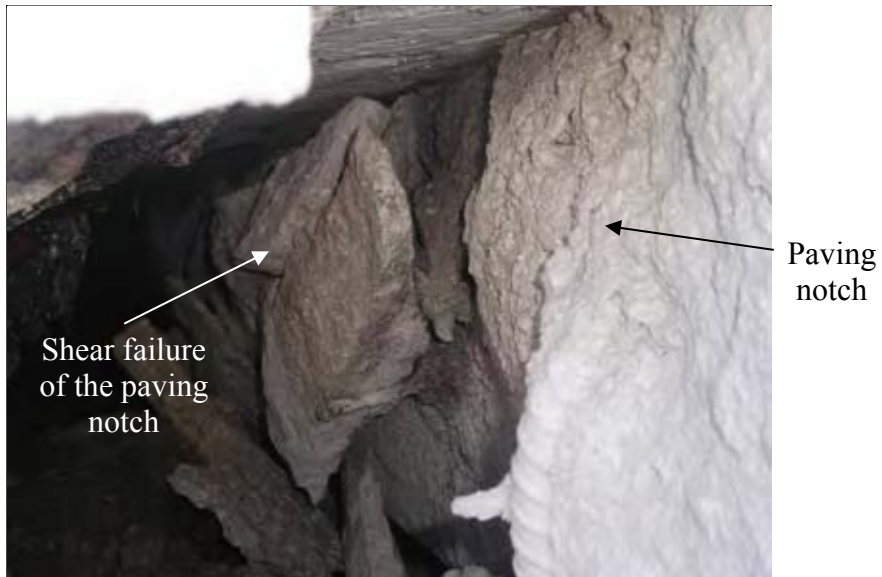
Figure 273. Shearing of paving notch (North end of SBL)

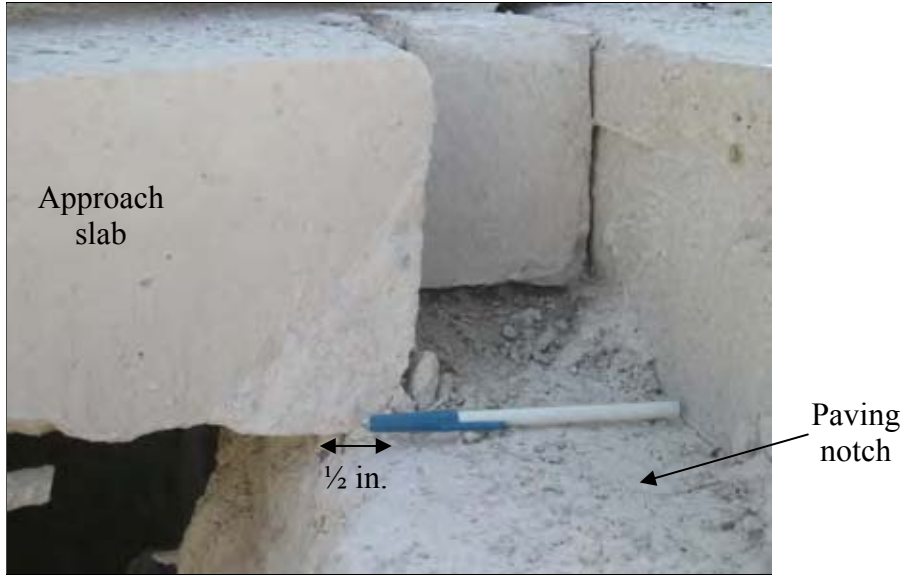
Figure 274. The approach slab resting on 0.5 in. of the paving notch (north end of SBL)

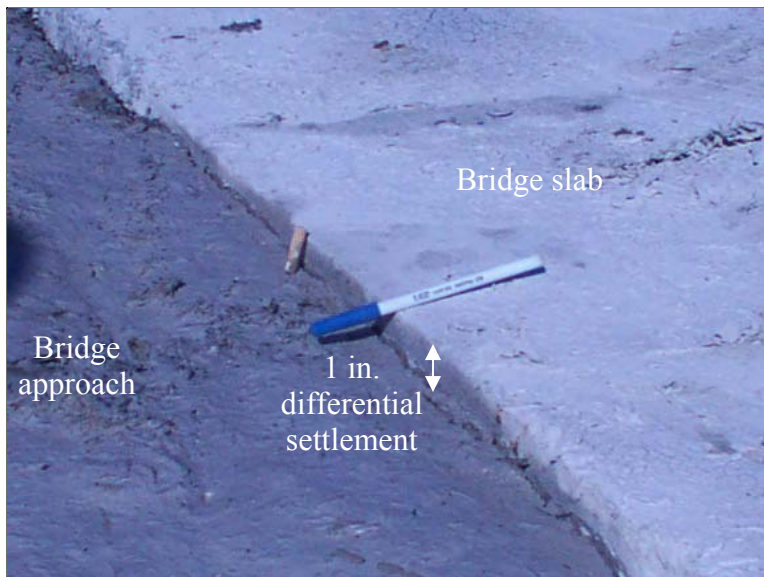
At the south end approach slab, about 1 inch of slab drop at the bridge deck was observed (Figure 275). Recycled tire chips were used as a joint filler material at the expansion joint. Similar to the north end, the approach slab at the south end was resting on only 1 inch of the paving notch, as shown in Figure 276. Under the approach slab, a 10-inch-deep void was measured at the abutment and extended 5 feet away from the bridge.

Figure 275. Differential settlement between the bridge slab and the bridge approach (South end of SBL)

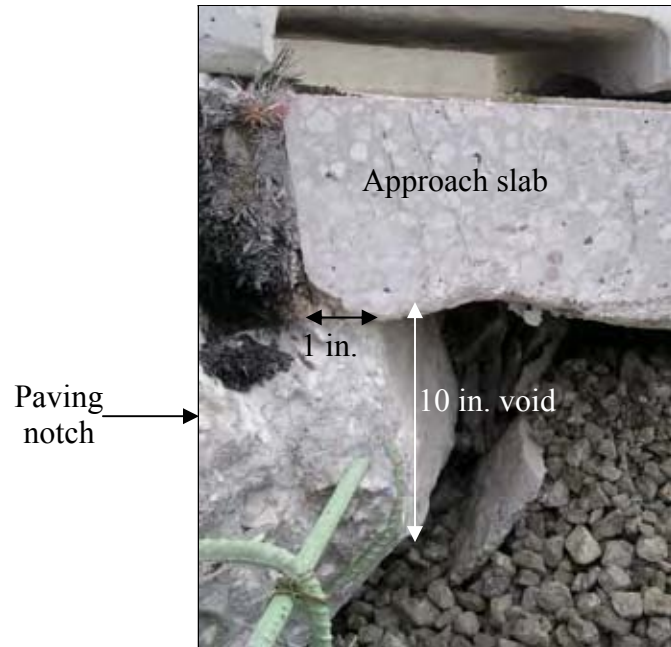
Figure 276. Approach slab resting on 1 inch of the paving notch, and a 10-inch-void developed under the approach slab (South end of SBL)

The study also examined the potential failure of an unreinforced concrete segment in the pavement notch and the approach slab independently as a result of transferring loads through this segment. The unreinforced segments may be found at the end of an approach slab and/or in the end region of a pavement notch. This condition occurs mainly due to inaccurate placement of the reinforcing steel during construction (e.g., see Figures 276 and 413).

In this failure case, it was assumed that the approach slab was supported over a reduced width on the notch, as shown in Figure 412. This condition can be attributed to poor construction practice, thermal effects, or a combination thereof (see an example of this condition in Figure 276 – HW65 bridge). The width of the failure segment was conservatively taken as 2 in. from the free edge of the pavement notch. This small segment of the notch was assumed to have no steel reinforcement. Because the shear plane runs in the direction of the bridge is very small, SLC2 governs this failure case by producing a lower capacity to demand ratio.

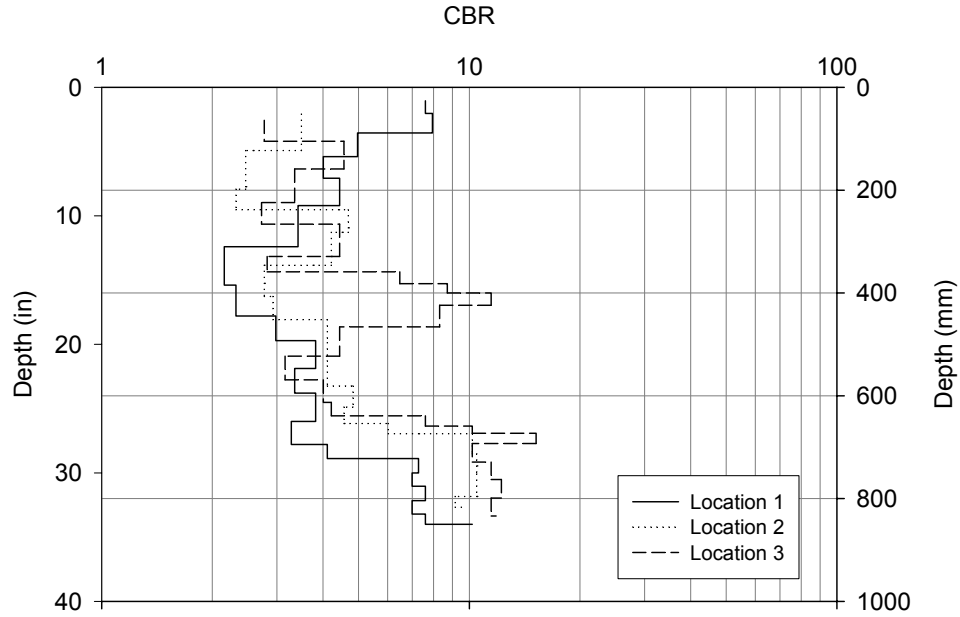
To evaluate subgrade strength, DCP tests were performed at the north and south ends of the southbound bridge at 2 feet from the abutment. At the north end, the DCP test was conducted on the old special backfill material. At the south end, the DCP test was conducted on the new compacted special backfill (Figure 277). The results of the DCP testing conducted on the old backfill material showed that the CBR values ranged from 2 to 15, as shown in Figure 278. DCP test results conducted on the new compacted special backfill shows that the CBR values range from 1.5 to 15. No significant difference was measured between the CBR values of both the old and the new compacted special backfill (Figure 279).

Figure 278. Results of DCP tests conducted on the old backfill material (North end of SBL)

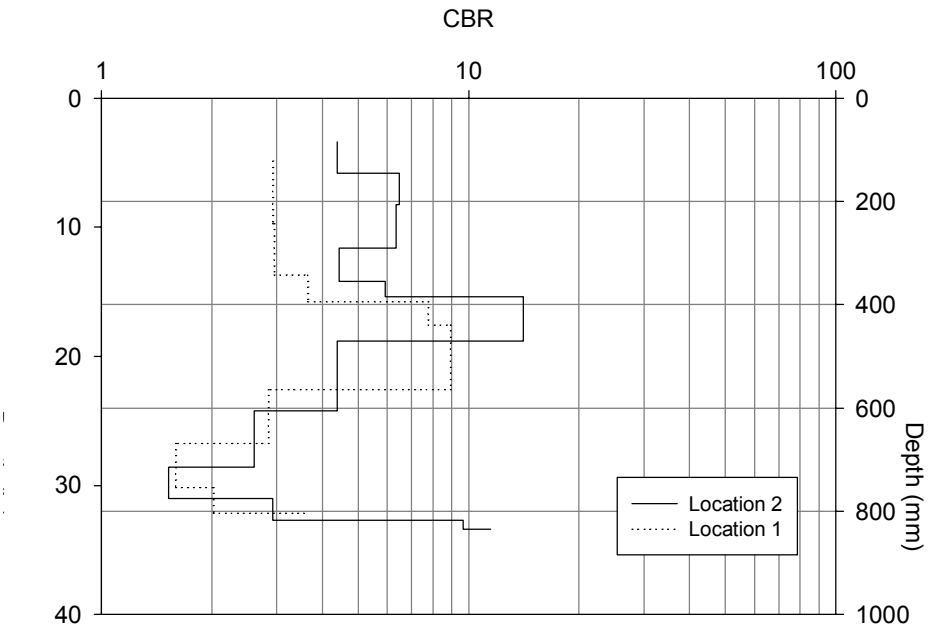
Figure 279. DCP test conducted on the replaced special backfill (South end of SBL)

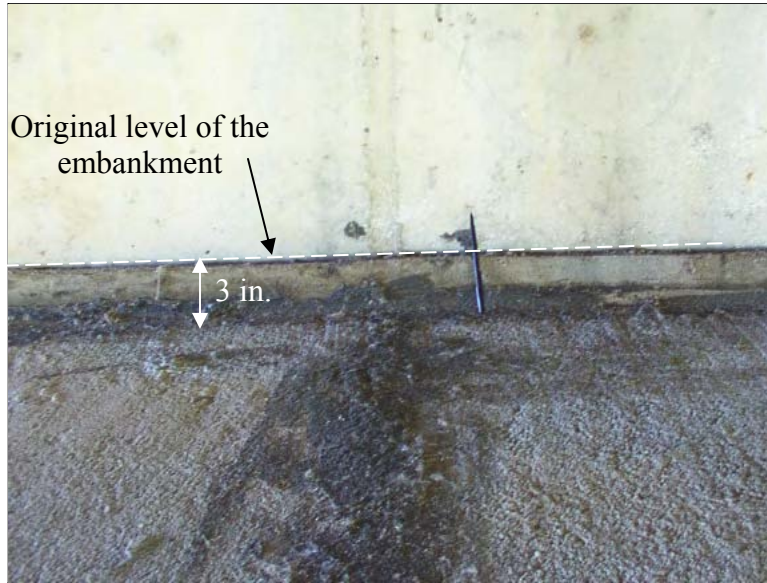
erosion along the sides of the abutment. The embankment has a slope protection which appeared to be in good condition with no settlement. At the north end of the northbound bridge, erosion along the abutment sides was also observed. The embankment had settled about 3 inches, as shown in Figure 280. The embankment has a slope protection that appeared to be in good condition.

Figure 280. Settlement of the embankment under the bridge (North end of NBL)

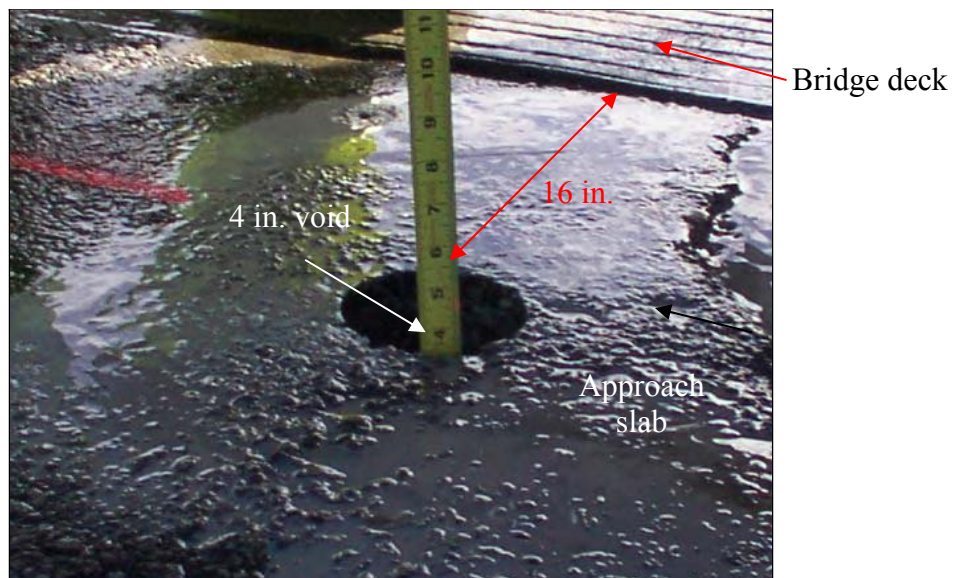
Figures 282 and 283 show how coring by the Iowa DOT was used to determine void size at the north end of the southbound bridge. The pavement thickness was 15.5 inches, which was determined by measuring the length of the core obtained at the white line (Figure 284). Table 17 summarizes the void sizes. The south end of the southbound lanes was not cored because no significant bridge approach pavement distress was observed.

Figure 282. A 4-inch-void under the approach slab estimated by measuring the distance the core dropped (North end of SBL, center line)

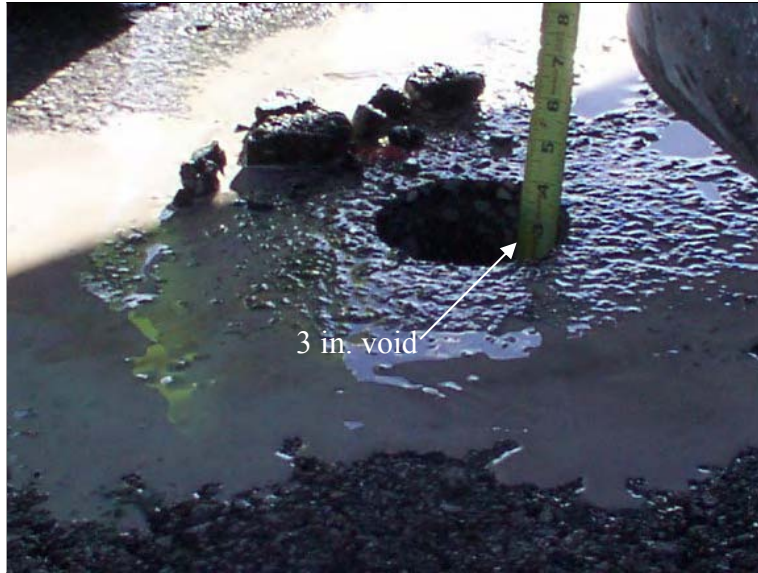
Figure 283. A 3-inch-void under the approach slab estimated by measuring the distance the core dropped (North end of SBL, edge line)

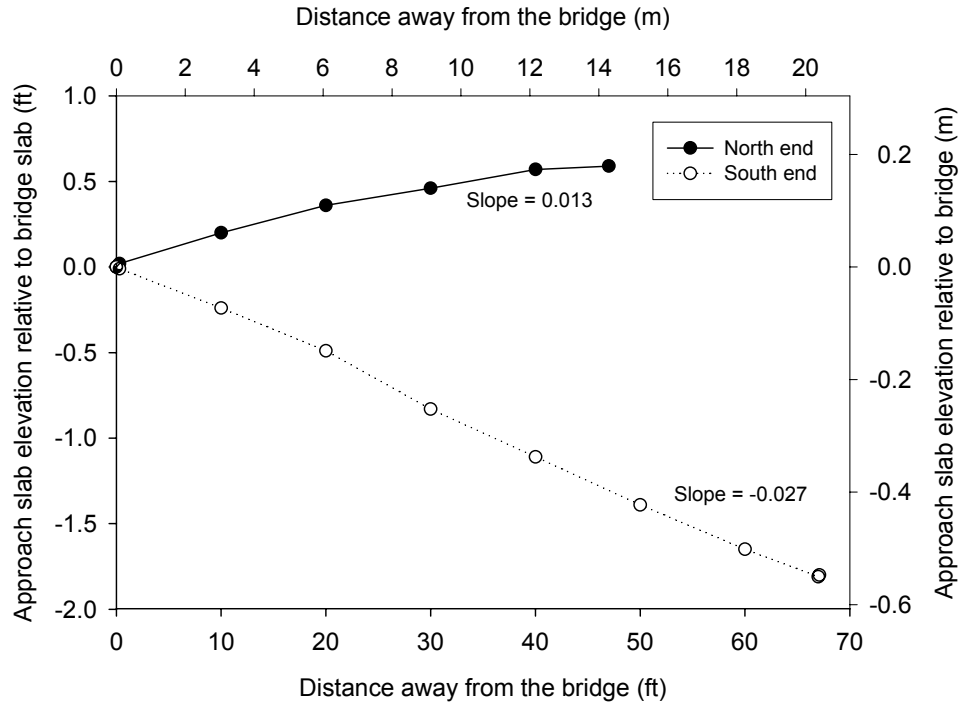
Elevation profiles of the bridge approaches are shown in Figures 285 and 286. Both the north and south approaches of the northbound lanes settled about 2.5 inches relative to the original slope at distances of 50 feet and 60 feet away from the bridge abutment. The slopes of the north and south end approach slabs are 0.012 and -0.027, respectively (Figure 285). The approach slab settled about 1.5 inches relative to the pavement past the CF joint. Settlement along the approach slab varied from 1 to 1.5 inches relative to the original slope. The slope of the north end approach slab is 0.017 (Figure 286).

Figure 285. Profile of the bridge approach relative to bridge slab (NBL)

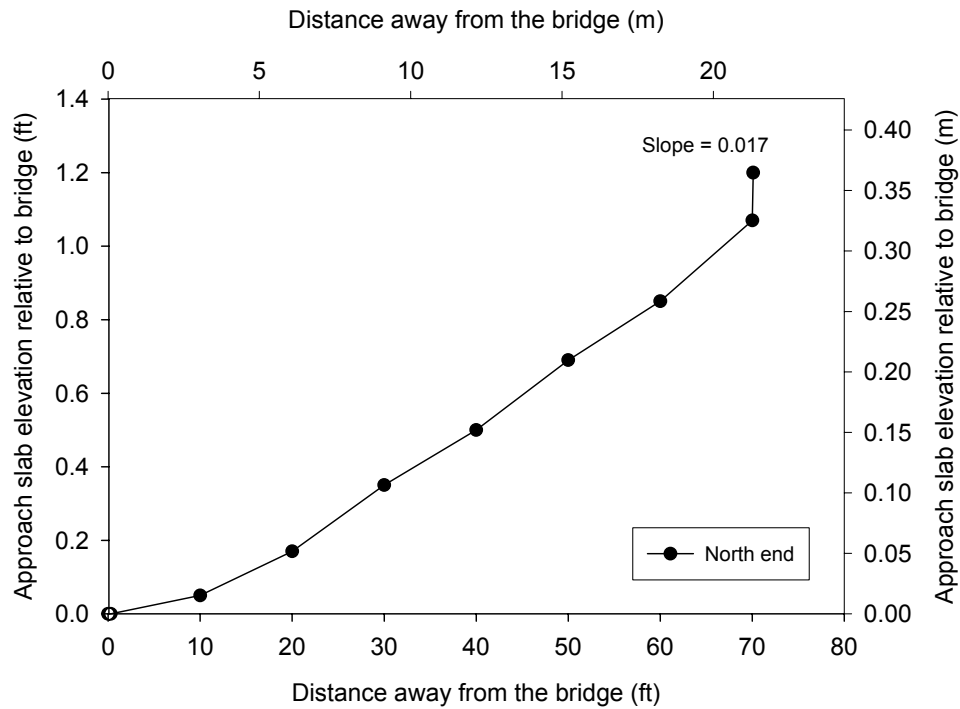
Figure 286. Profile of the bridge approach relative to bridge slab (SBL)

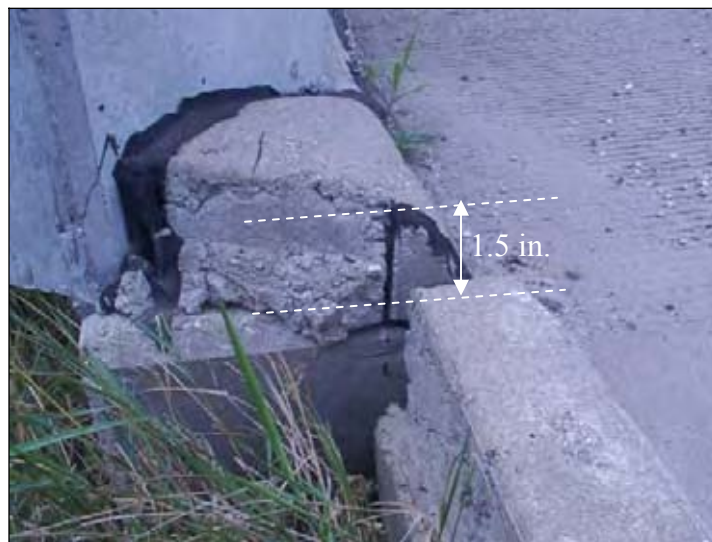
This bridge is a three-span bridge with concrete girders and integral abutments. At the north end of the northbound lanes, 1.5 inches of differential settlement was observed at the end of the wingwall (Figure 287). The width of the expansion joint was about 5.5 inches and poorly filled. The concrete slope protection of the embankment under the bridge was in good condition; however, the embankment had settled about 2 inches relative to the abutment (Figure 288).

Figure 287. Differential settlement between the bridge slab and the bridge approach (North end of NBL)

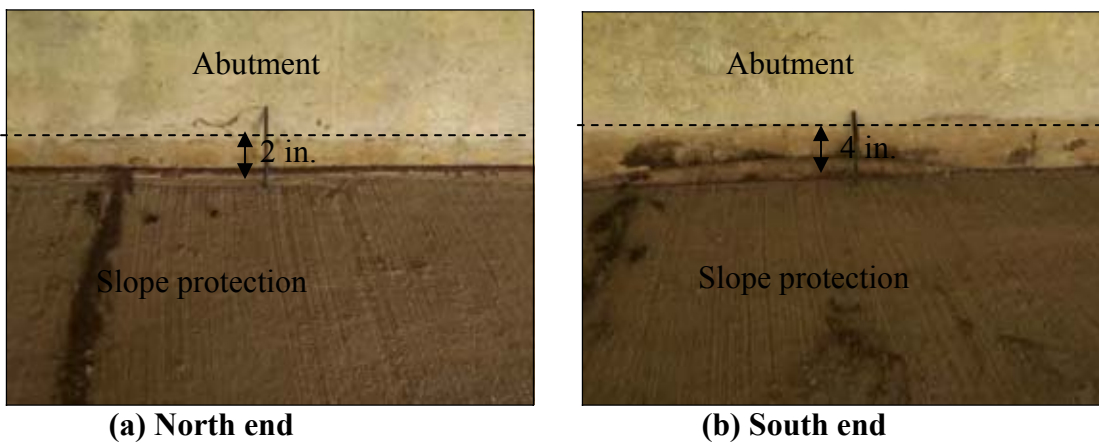
At the south end of the northbound lanes, erosion along the sides of the abutment was observed. Furthermore, the embankment under the bridge had settled about 4 inches relative to the abutment and a 1.5-inch horizontal gap existed between the abutment face and slope protection (Figures 288 and 289).

Figure 288. Settlement of the embankment under the bridge (NBL)

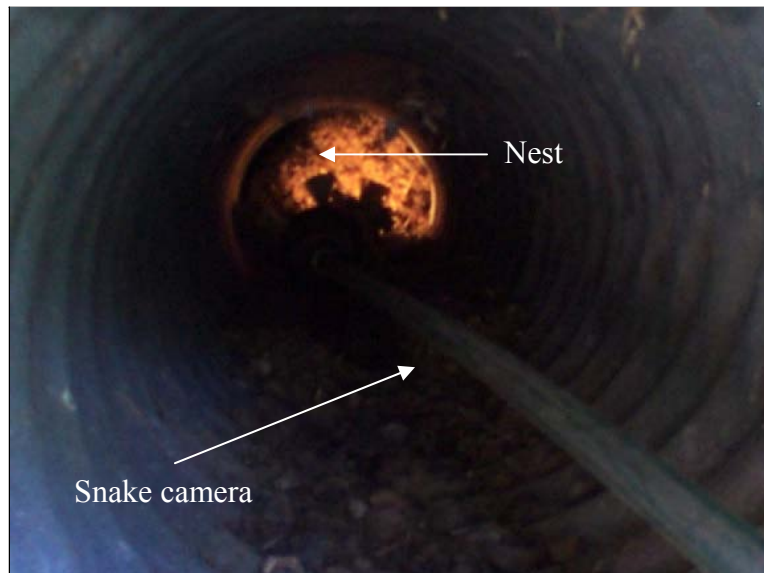
The snake camera was used to inspect the subdrains of both ends of the north bound. At the north end, the subdrain was dry. At 5 feet inside the subdrain, a rodent nest was observed blocking the subdrain (Figure 290). At the south end, the subdrain was completely dry with some fines at the bottom of the drain (Figure 291).

Figure 290. Rodent nest blocking the subdrain at 5 feet from the outlet

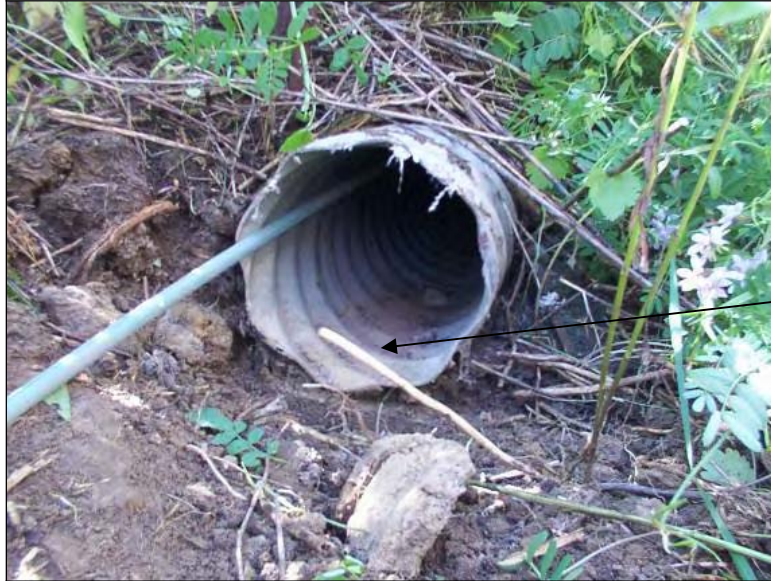
Fine soil particles at the bottom of the subdrain

Figure 291. Iowa DOT snake camera inserted inside the subdrain

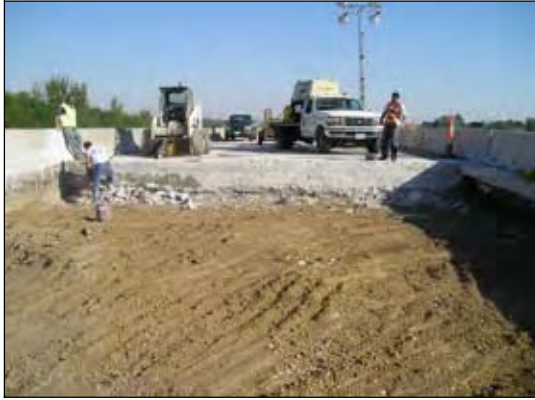
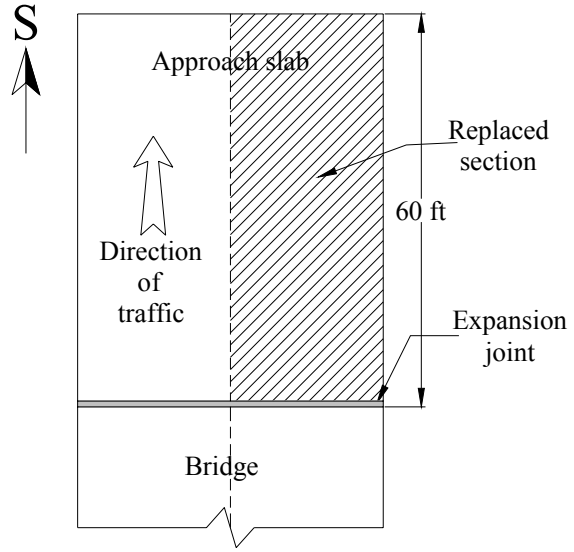
This bridge was also inspected in September 2004 while major maintenance operations were underway. During inspection, replacement of the approach slab at the south end of the southbound lanes was in progress. The replaced section was on the right lane, while the left lane approach slab was still open to traffic (Figure 292). Figure 293 shows removal of the existing 10-inch-wide paving notch. The void under the existing approach (left lane) was approximately 18 inches deep at the abutment and 6 inches deep at 3 feet from the abutment (Figure 294). A new subdrain pipe was installed behind the bridge abutment. The subdrain was connected to the end drain. Figure 295 shows the trench excavation to place the subdrain and end drain. Porous backfill was placed around the new drains.

Figure 292. Replacement of the right lane approach slab (South end of SBL)

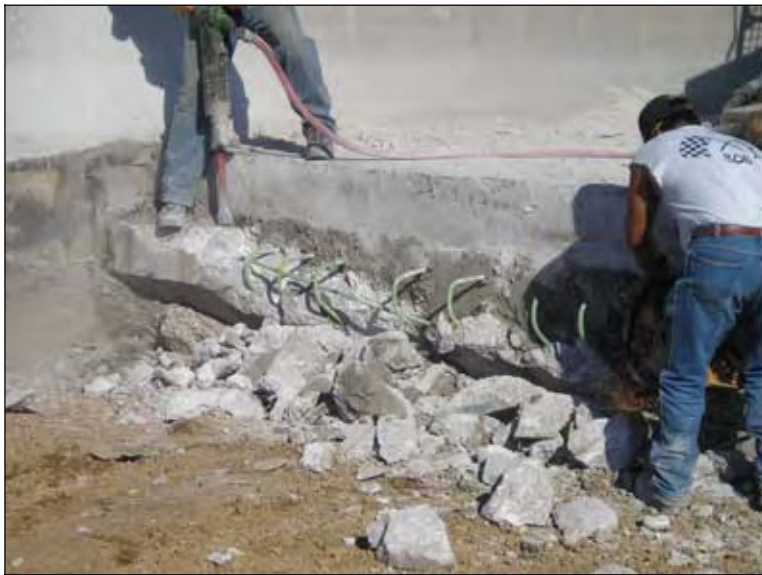
Figure 293. Tearing down the old pavement notch (South end of SBL)

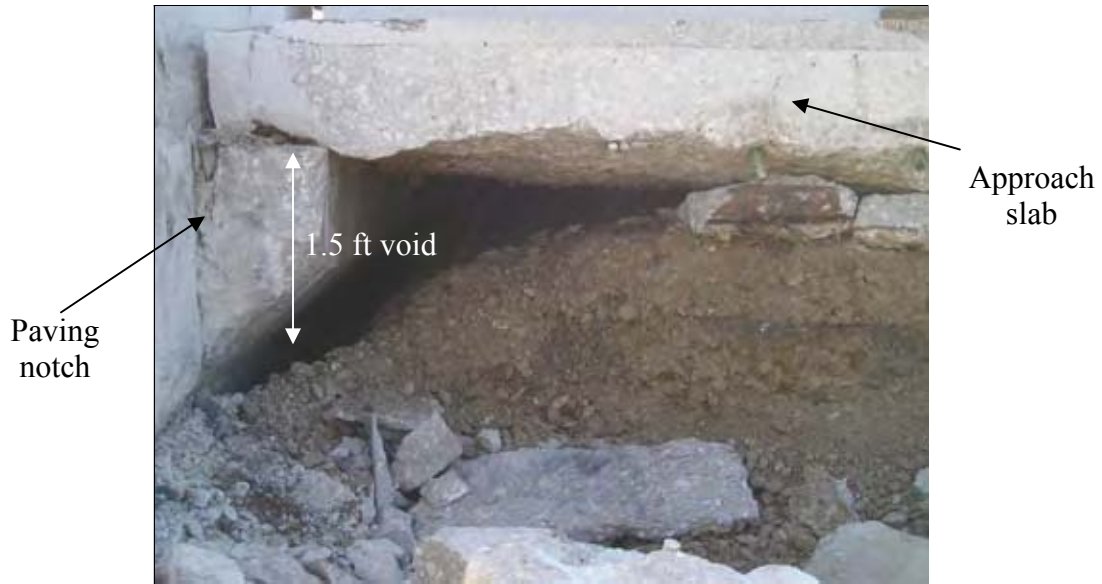
Figure 294. A void developed under the left lane approach slab which was 1.5-foot-deep at the bridge abutment (South end of SBL)

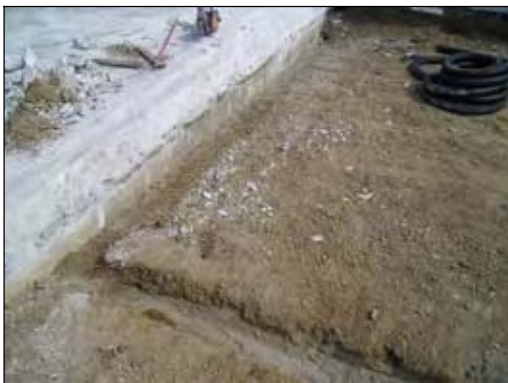
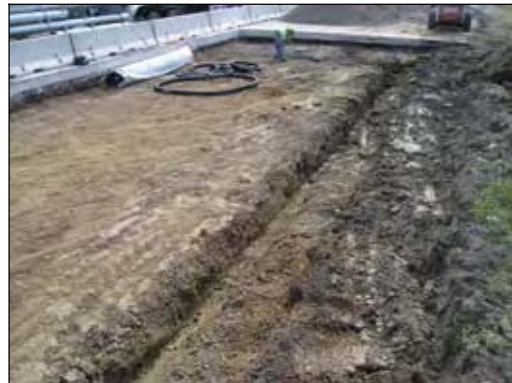
Figure 295. Installing a drainage system under the right lane approach slab

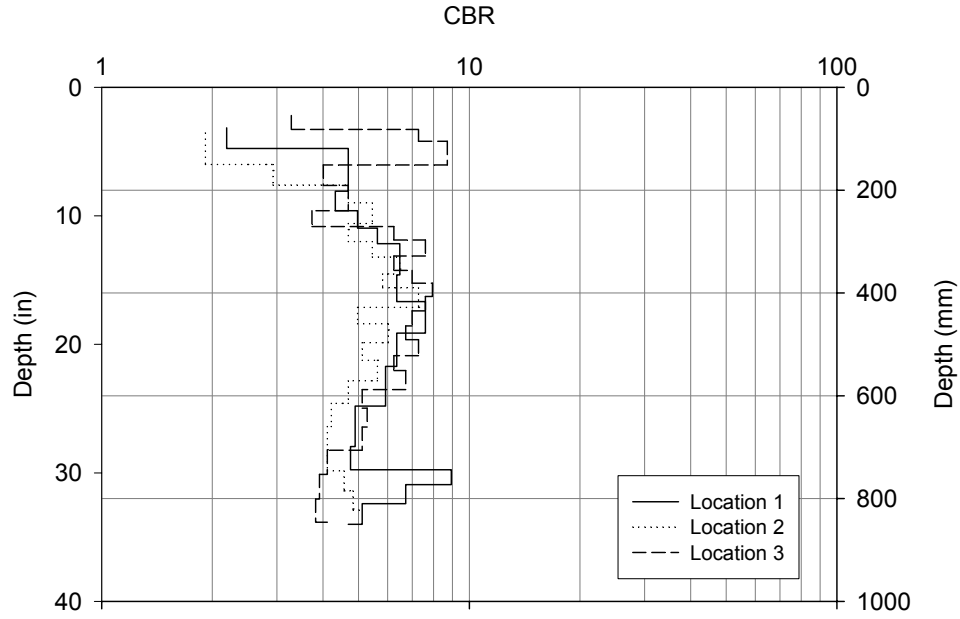
To measure subgrade strength, DCP tests were conducted at three locations about 2 feet from the abutment. Tests were performed before excavating the old special backfill and after placing the new special backfill. DCP test results presented in Figures 296 and 297 show that the old special backfill CBR values ranged from 2 to 9. The new special backfill CBR values ranged from 3 to 18. It did not appear that the new special backfill had been compacted.

Figure 296. Results of DCP test conducted on special backfill material before excavation (South end of SBL)

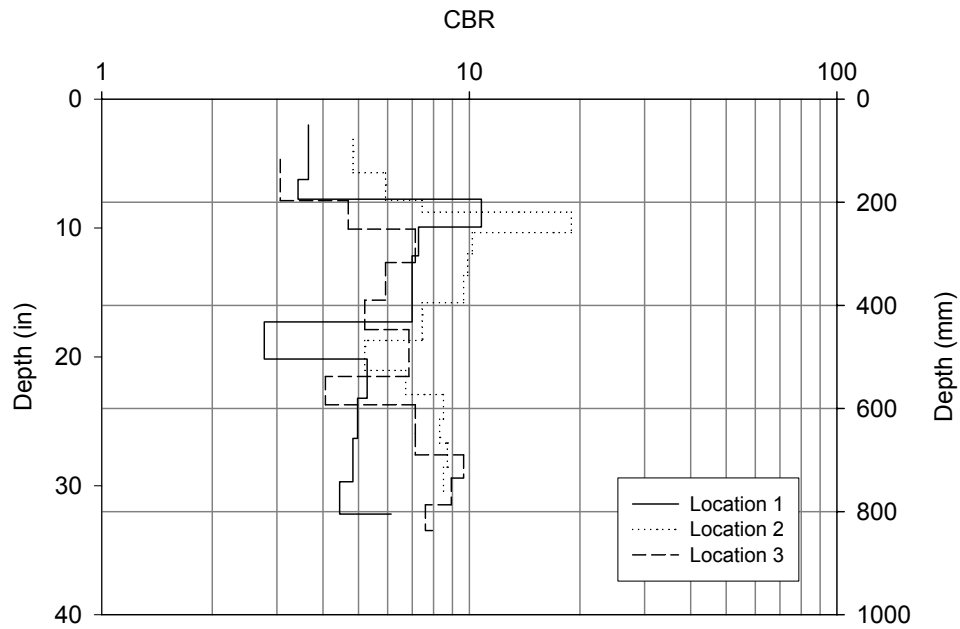
Figure 297. Results of DCP test conducted on special backfill material after replacement (South end of SBL)

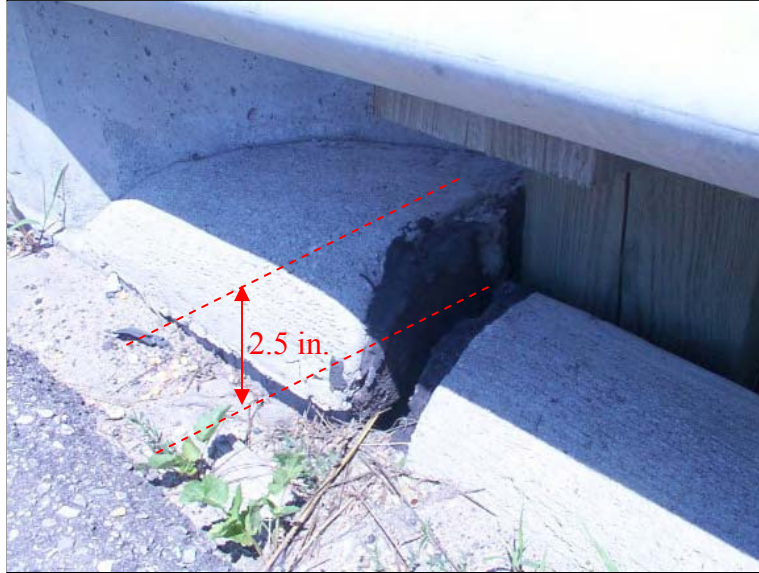
At the south end of the northbound lanes, differential settlement of 2.5 inches was measured at the end of the wingwall (Figure 298). Concrete spalling and cracking of the asphalt overlay were observed at the expansion joint (Figure 299). Concrete slope protection of the embankment under the bridge was in good condition; however, it settled about 3.5 inches relative to the abutment (Figure 300) and had a 0.5-inch gap at the abutment face.

Figure 298. Differential settlement at the bridge approach (South end of NBL)

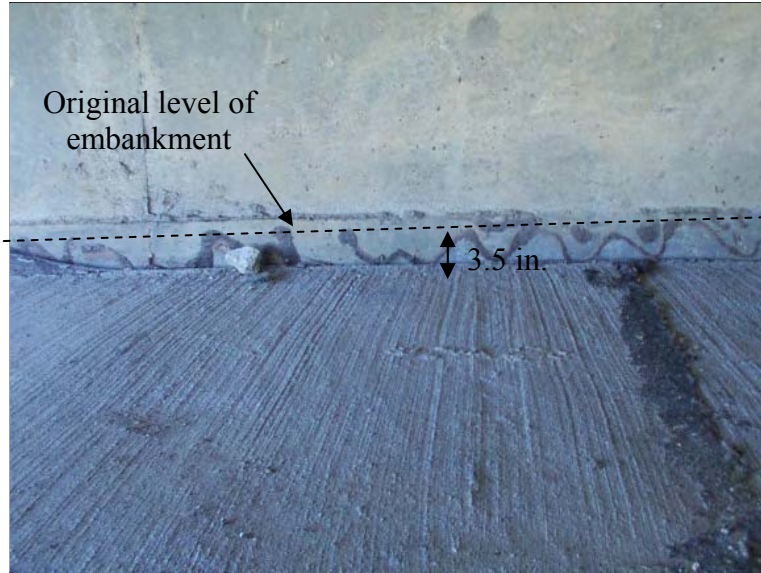
Figure 300. Settlement of the embankment at distance of 3.5 in. (South end of NBL)

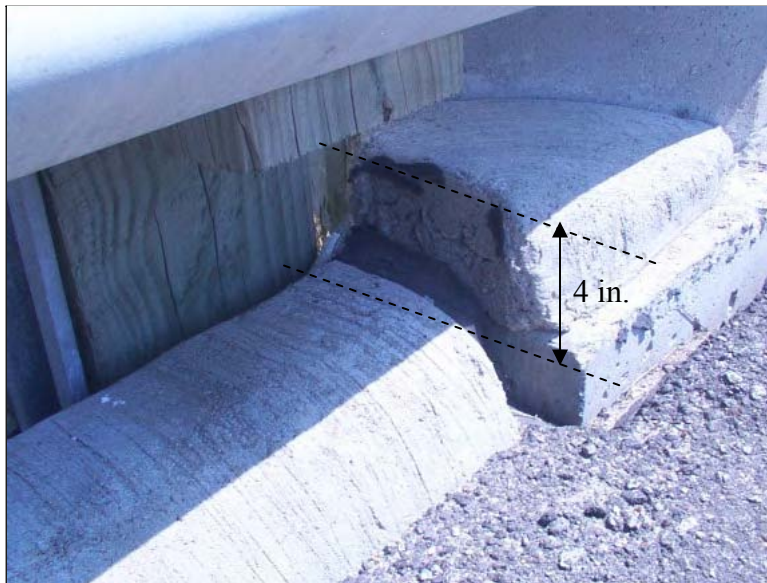
At the north end of the southbound lanes, 4 inches of differential settlement at the bridge approach was measured at the end of the wingwall (Figure 301). Recycled tire chips were used as joint filler for the expansion joint, as shown in Figure 302. The width of the expansion joint was about 5 inches. The concrete slope protection was in good condition.

Figure 301. A 4 in. differential settlement at the bridge approach (North end of SBL)

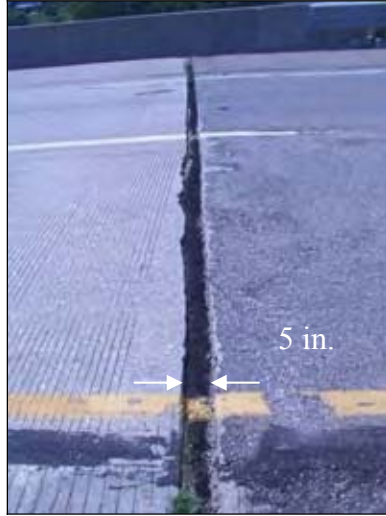
Figure 302. Recycled tires used as joint filler

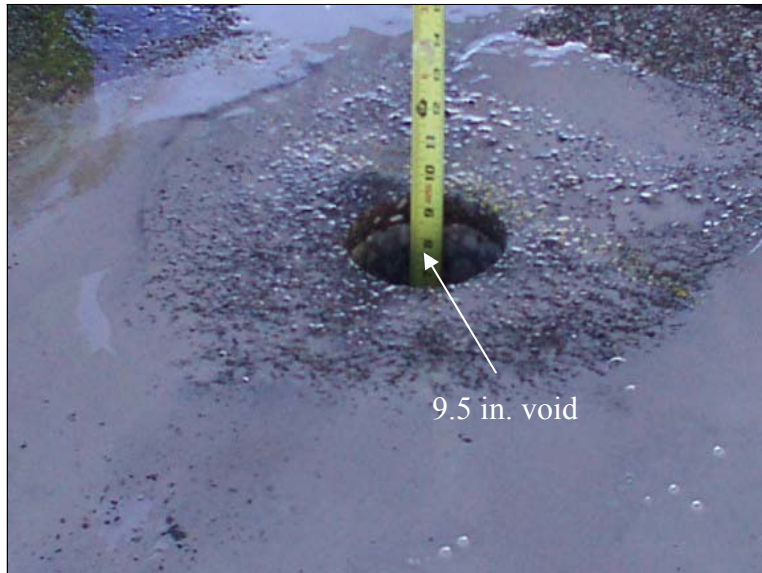
Approach slabs at both ends of the southbound lane were cored. Table 18 summarizes the measured void size, pavement thickness, and paving notch dimensions at the approach slabs. The void under the approach slab was about 9.5 inches at the edge line of the north end approach slab (Figure 303).

Figure 303. A 9.5 in. void under the approach slab estimated by measuring the distance the core dropped (North end of SBL)
