IDENTIFICATION OF THE BEST PRACTICES FOR DESIGN, CONSTRUCTION, AND REPAIR OF BRIDGE APPROACHES

Iowa DOT Project TR-481
CTRE Project 02-118

Final Report

January 2005

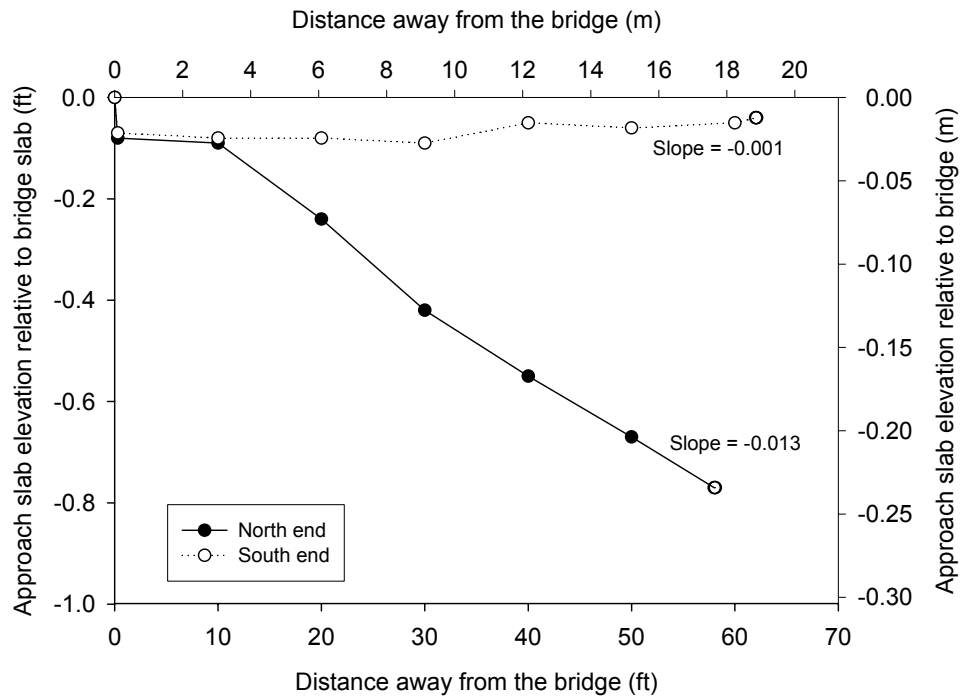
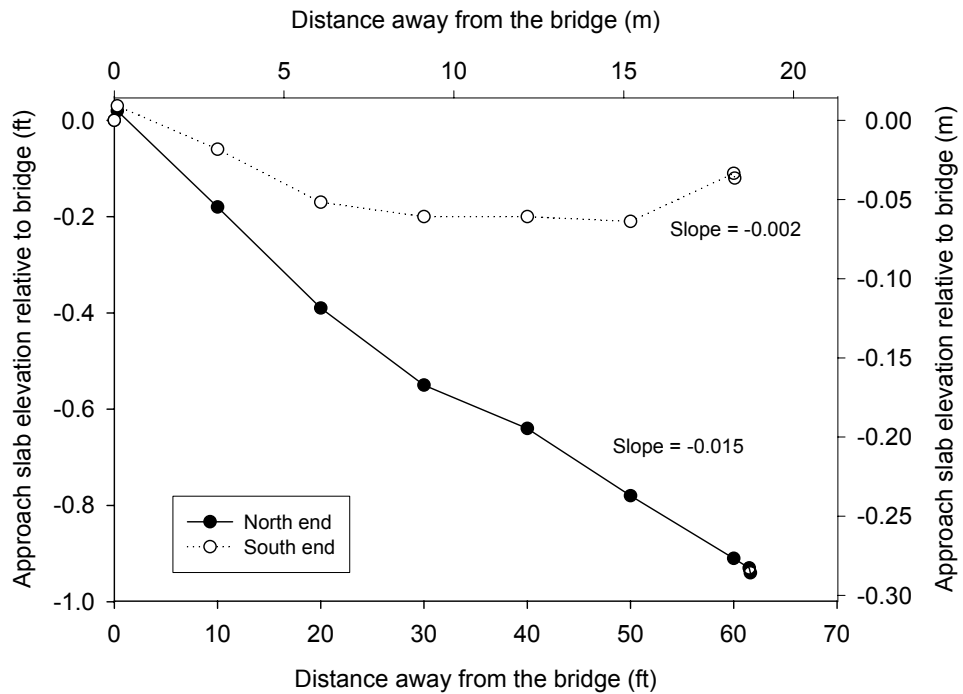
Profiles were obtained for all four ends of the bridge approach pavements (Figures 304 and 305). Differential settlement of the approach slab relative to the bridge slab for both ends of the northbound lane was about 1 inch. The slopes are -0.013 and -0.001 for the north and south end approach slabs, respectively. For the southbound lanes, the maximum settlement relative to the original profile was about 2 inches and 1.8 inches for the north and south end approaches, respectively. The slopes for the north and south ends approach slabs of the southbound lane are -0.015 and -0.002, respectively. Both approach slabs are sloping away from the bridge, which may indicate settlement of foundation soil or compression of the embankment material.

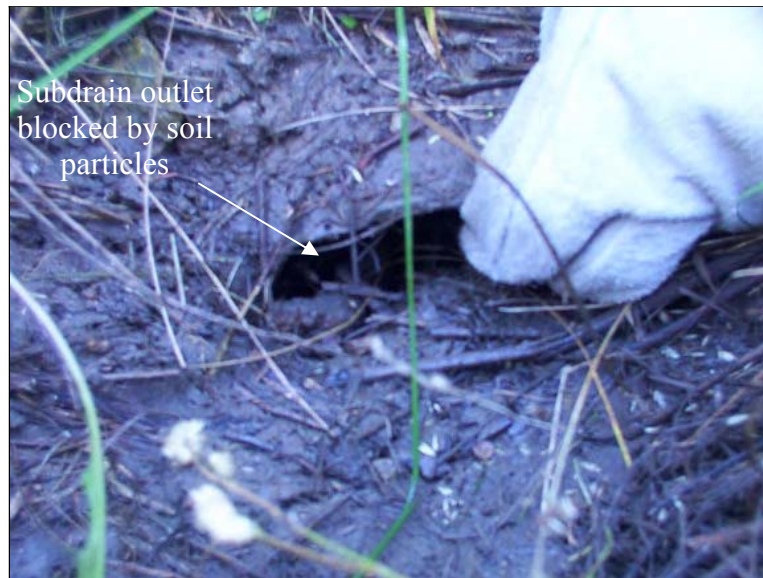
By using the snake camera at the north end of the northbound subdrain outlet, it was revealed that the subdrain was blocked with soil debris (Figure 306). Unlike other bridges where the subdrain outlet was day-lighted horizontally away from the abutment, this outlet was located at the bottom of the downslope embankment.

Figure 306. Subdrain outlet, located at the bottom of the embankment, blocked by soil debris

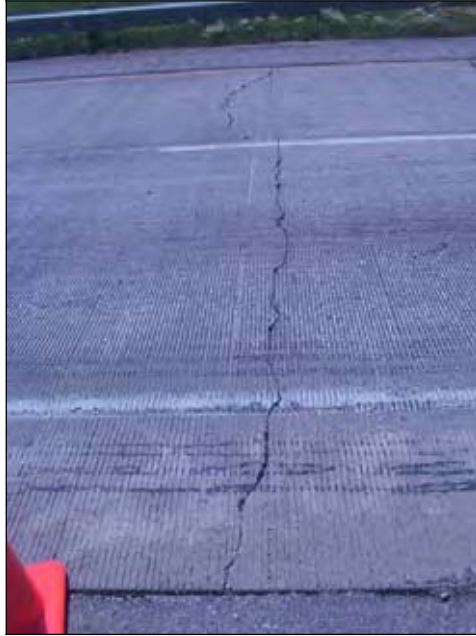
This bridge is a three-span bridge with concrete girders and integral abutments. At the north end of the northbound lanes, differential settlement of 2.5 inches was measured relative to the wingwall. Transverse cracks at the approach slab were visible (Figure 307). The expansion joint was 3.25 inches wide and filled with flexible foam filler, but not sealed. No settlement was observed at the embankment under the bridge, and the concrete slope protection appeared to be in a good condition. The outlet of the subdrain was in a satisfactory condition but was dry.

Figure 307. Transverse cracks at the bridge approach

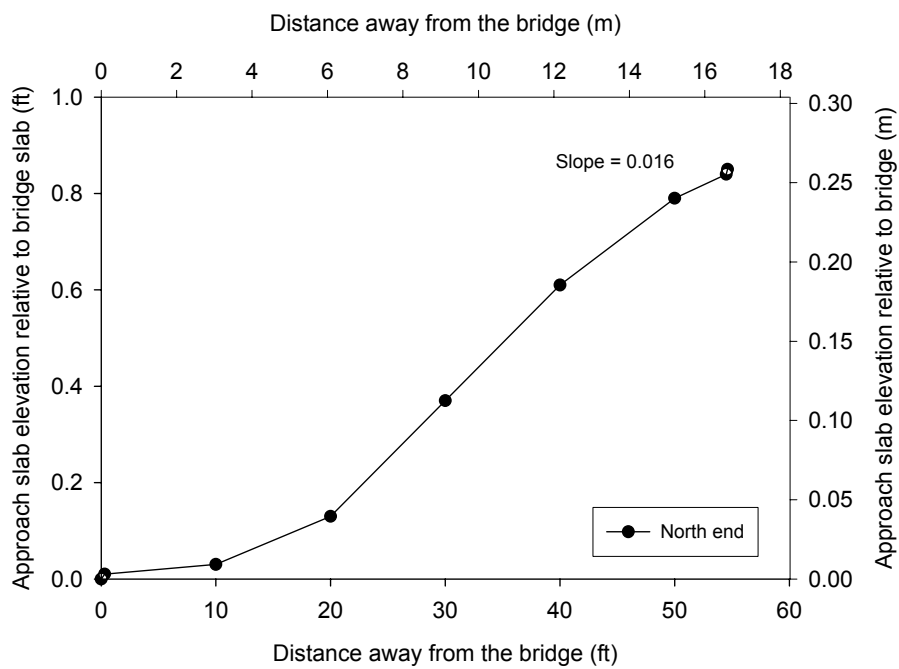
Elevation profile measurements are shown in Figure 308. The maximum settlement relative to the original profile was about 2 inches at 20 feet from the bridge abutment. The slope of the approach slab is 0.016.

Figure 308. Profile of the bridge approach relative to bridge slab (North end of NBL)

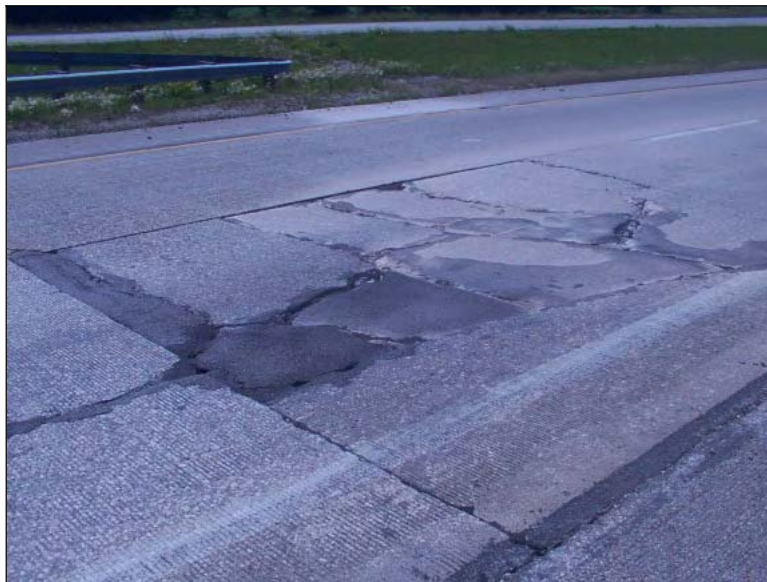
Significant damage to the approach pavement was observed (Figure 309). Although, the expansion joint condition was satisfactory, the strip seal was cut short allowing water to erode soil from around the abutment. At the embankment under the bridge, the unprotected slope was moderately eroded. The outlet of the end drain was damaged and appeared to be dry and not functioning (Figure 310).

Figure 309. Severe cracking at the bridge approach pavement (North end of NBL)

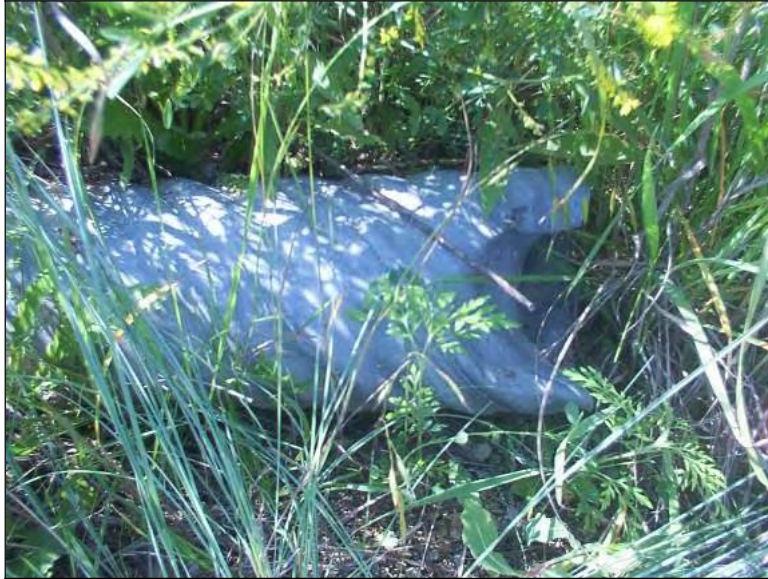
Figure 310. Damaged end drain (North end of NBL)

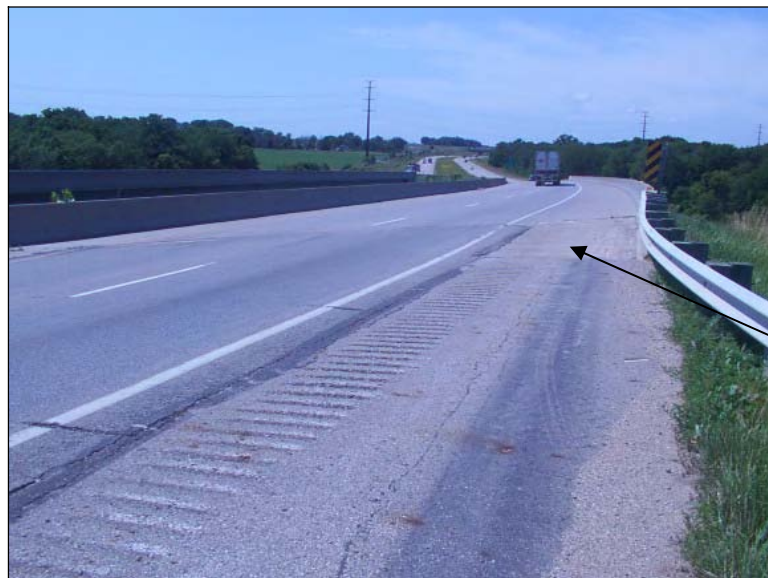
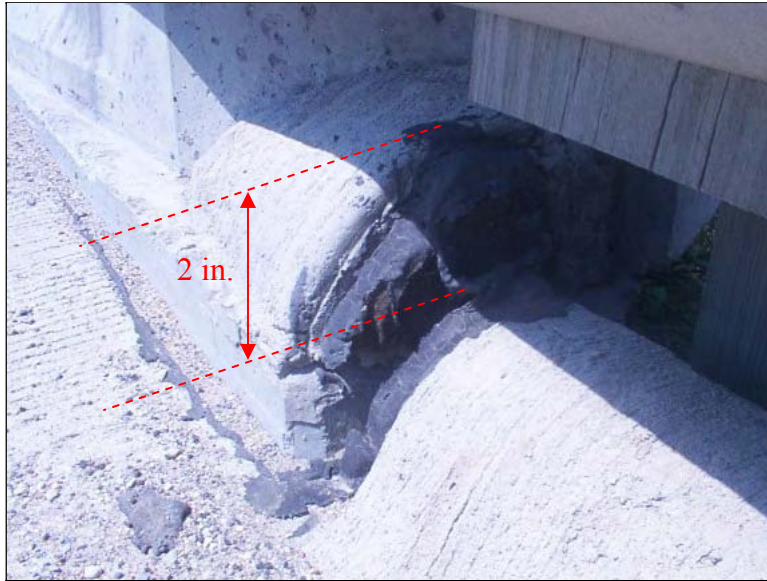
At the south end, an asphalt overlay had been previously placed because of differential settlement at the bridge approach. Nonetheless, differential settlement of 2 inches was observed relative to the wingwall (Figures 311 and 312). The end drain appeared to be in good condition.

Figure 311. Settlement of bridge approach (South end of NBL)

Figure 312. Differential settlement at the bridge approach (South end of NBL)

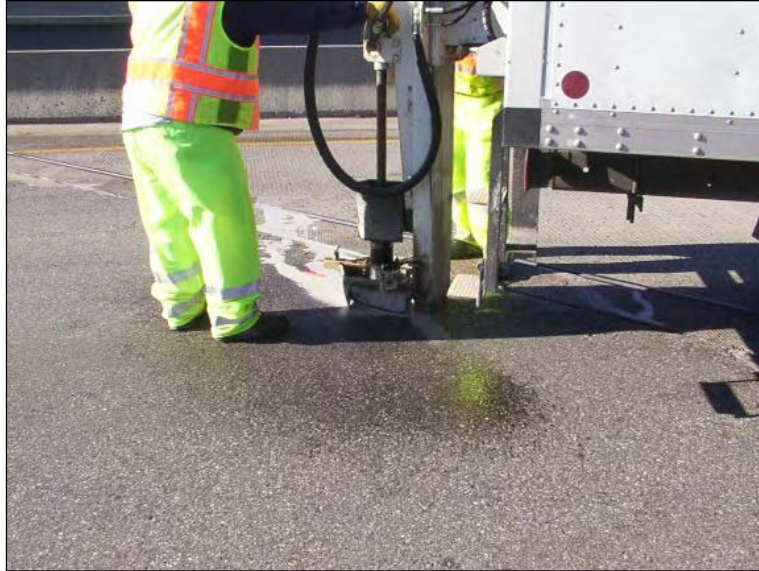
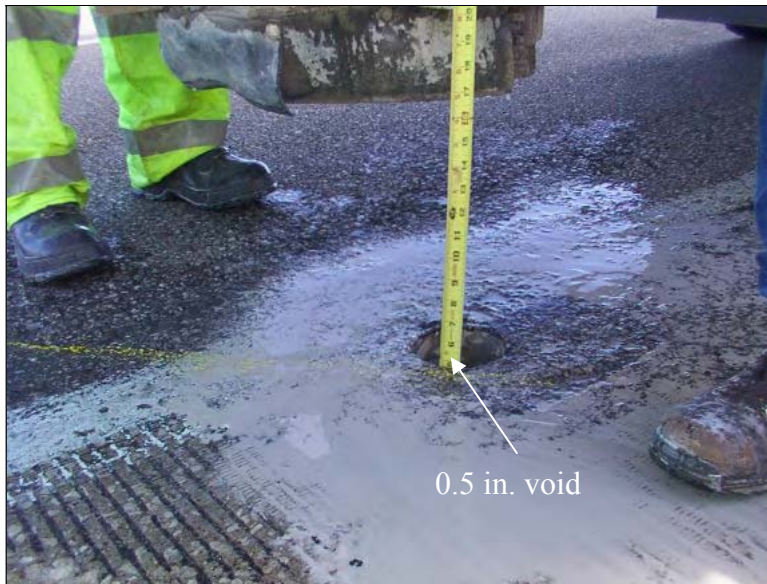
Figure 313 shows the approach slab cores at both bounds. Table 19 presents the void sizes measured under each approach slab. The maximum voids measured at the north and south end approach slabs were 4.5 and 5 inches at the edge line, respectively. The void under the north end of the southbound approach slab was about 0.5 inches, as shown in Figure 314. As performed at other bridges, expanding foam was placed after obtaining cores to plug the core hole, as shown in Figure 315.

Figure 313. Coring at bridge approach (NBL)

Figure 314. Measuring the void under the approach slab (North end of SBL)

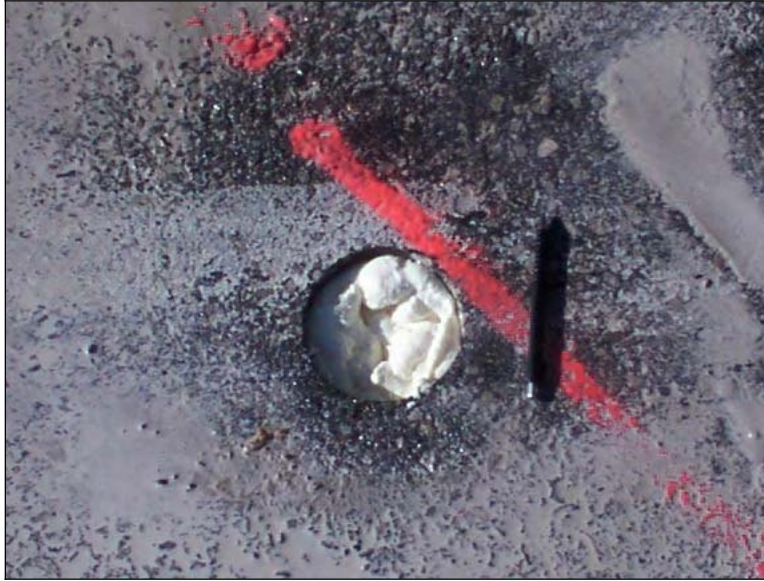
Figure 315. Expanding foam placed in the core hole of the approach slab (NBL)

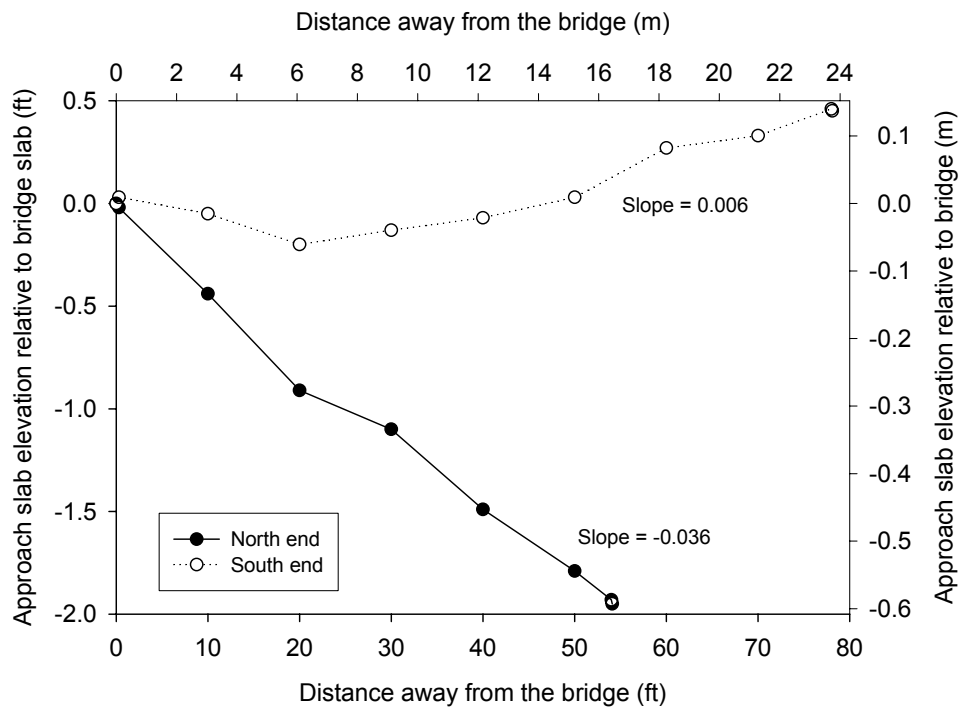
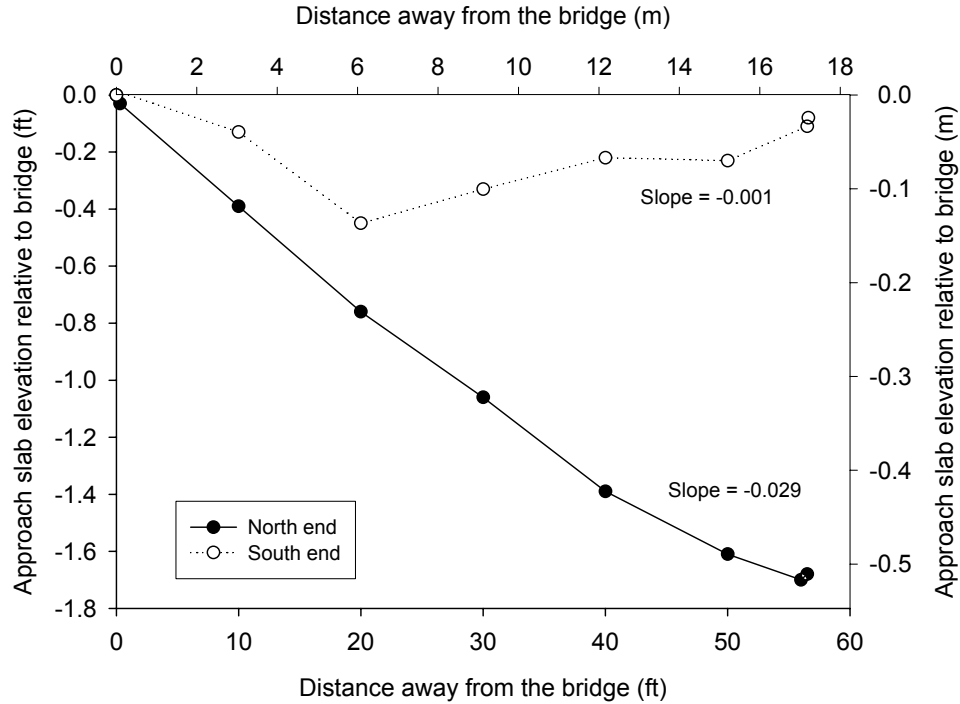
Figures 316 and 317 show the bridge approach profiles at all four ends. The approach slab at the north end of the north bound settled about 2 inches at 20 feet from the bridge abutment. The south end approach slab settled about 4 inches at 20 feet from the bridge abutment. The slopes for the north and south end approach slabs are -0.036 and 0.006, respectively. At the southbound lanes, the north end approach slab settled about 1 inch at 40 feet away from the bridge relative to the original profile, and the south end settled about 5 inches at 20 feet from the bridge abutment. The slopes for the north and south ends approach slabs are -0.029 and -0.001, respectively.

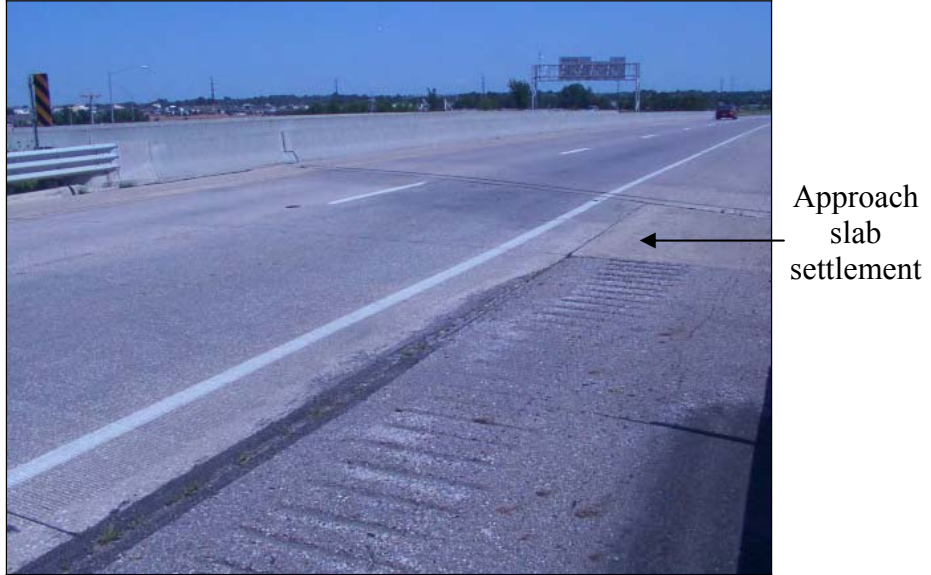
This bridge is a three-span bridge with steel girders and non-integral abutments. At the north end of the southbound lanes, differential settlement at the approach slab was observed (Figure 318). Transverse cracking across the approach slab was also noted (Figure 319). The expansion joint was not sealed. The strip seal was also observed filled with soil particles and cut short. Concrete slope protection of the embankment was in good condition.

Figure 318. Settlement of bridge approach (North end of SBL)

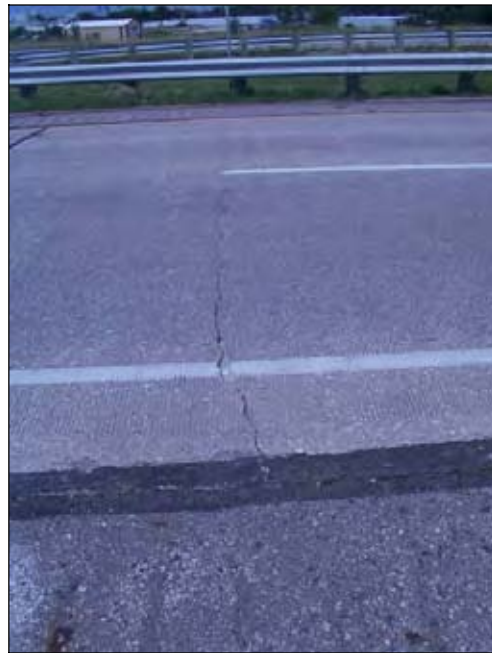
Figure 319. Transverse cracking at the bridge approach (North end of SBL)

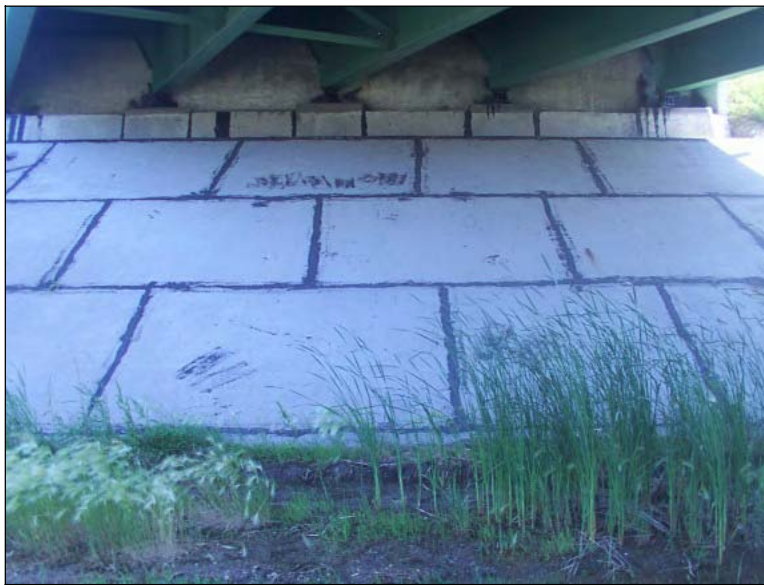
At the south end of the southbound lanes approach slab settlement was observed as shown in Figure 320. The strip seal was filled with soil particles, but the overall condition of the expansion joint was satisfactory. The concrete slope protection was in good condition with no observed settlement (Figure 321).

Figure 321. Bridge embankment in a satisfactory condition

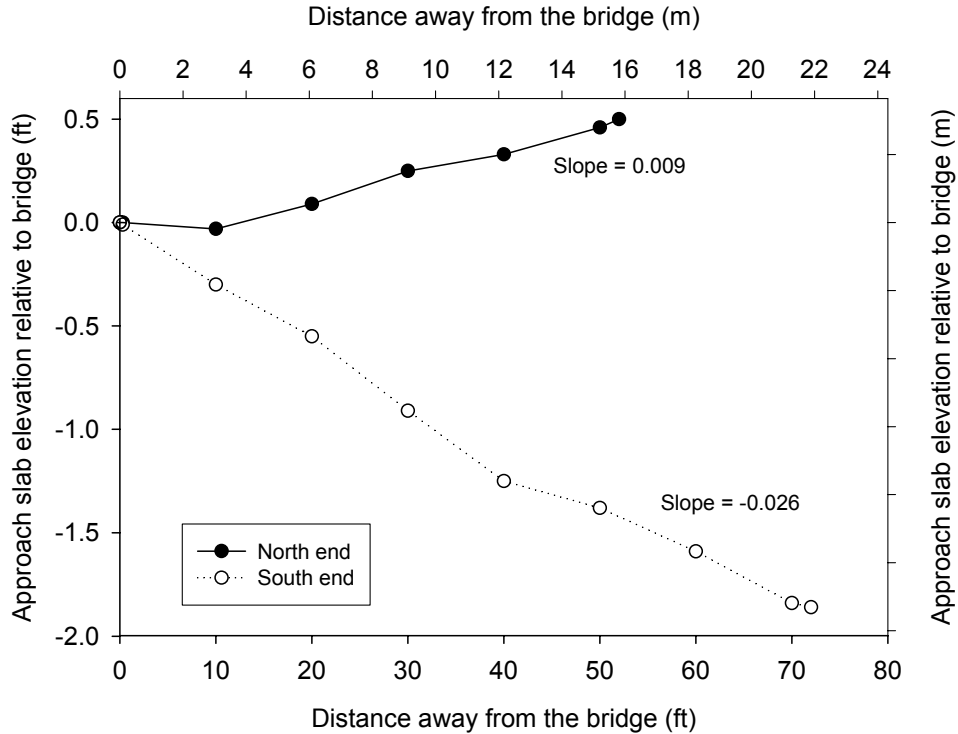
Profiles of both approaches at the edge line of southbound lane are shown in Figure 322. The maximum settlement of the north end approach slab relative to the original profile was 1.2 inches at 10 feet from the bridge abutment. The maximum settlement of the south end approach slab relative to the original profile was about 3 inches at 40 feet from the bridge abutment. The slope of the north and south end approach slabs are 0.009 and -0.026, respectively.

Figure 322. Profile of the bridge approach relative to bridge slab (SBL)

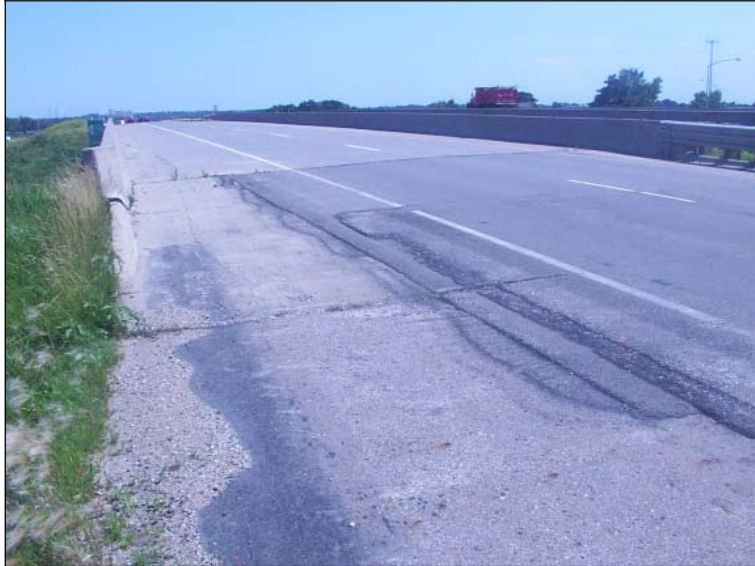
This bridge is a four-span bridge with concrete girders and integral abutments. Although the north end of the northbound lane was overlaid with asphalt, differential settlement of 2 inches was measured at the end of the wingwall (Figure 323). A 2-inch gap between the bridge approach and the wingwall developed due to settlement of the approach slab relative to the wingwall (Figure 324). Recycled tire chips were used as joint filler in the expansion joint. The embankment had settled about 4 inches and a 2-inch horizontal gap had formed between the abutment and embankment, as shown in Figure 325. The slope protection, however, was still in a satisfactory condition.

Figure 323. Asphalt overlay placed to compensate for the differential settlement (North of end NBL)

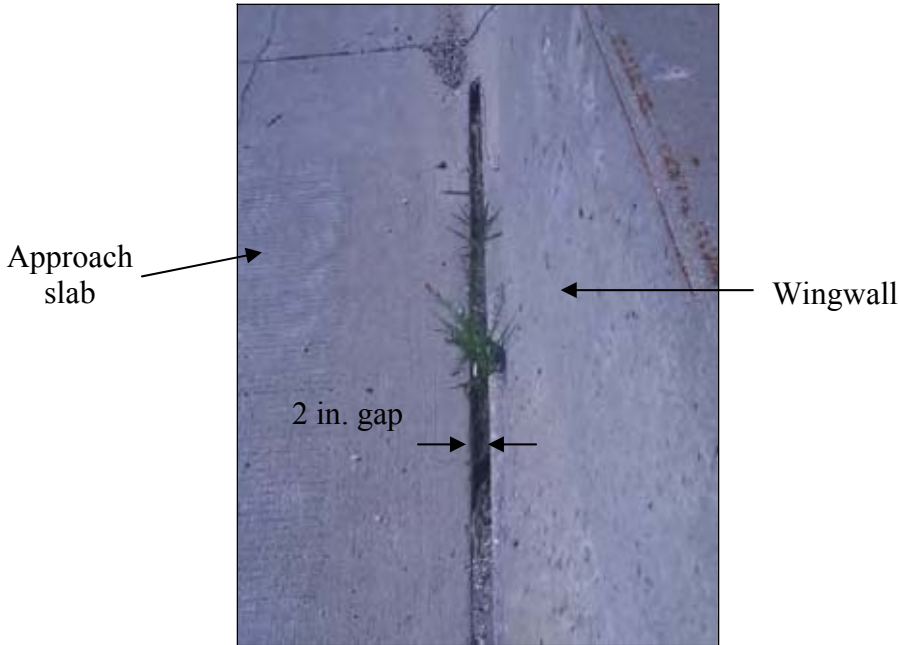
Figure 324. A 2-inch gap formed between the approach slab and the wingwall due to settlement of the approach slab (North end of NBL)

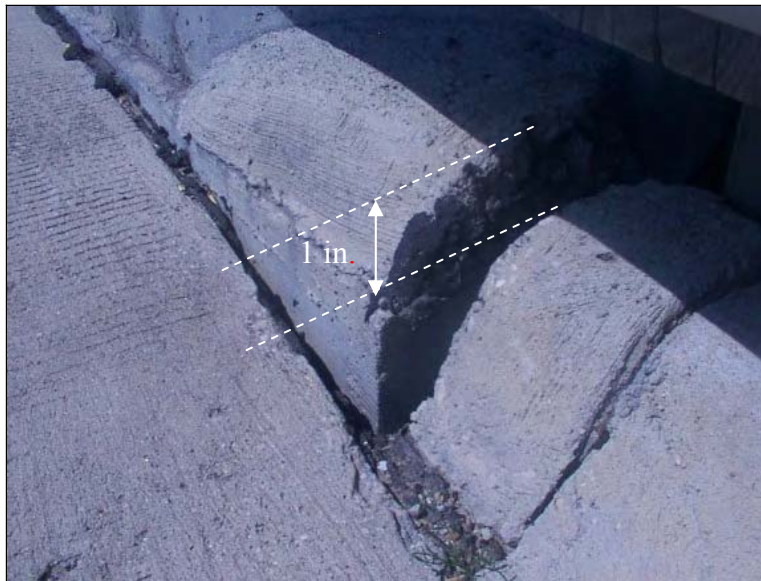
At the south end of the northbound lanes, differential settlement of 1 inch was measured at the end of the wingwall (Figure 326). The width of the expansion joint was about 5 inches. Recycled tire chips were used as joint filler and did not seal the joint. Settlement of the embankment was 4 inches. The end drain was observed to be damaged and not functioning.

Figure 326. Differential settlement at the bridge approach (South end of NBL)

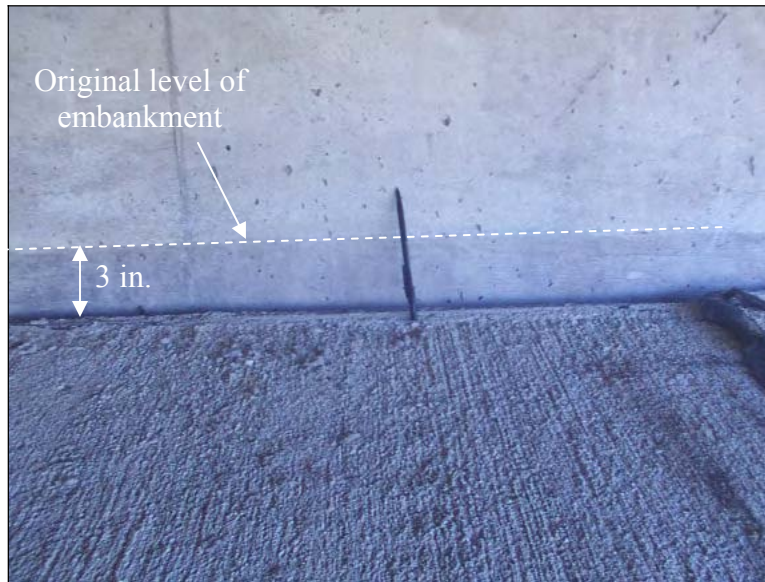
At the north end of the southbound lanes, differential settlement was about 2 inches. Moderate erosion along the sides of the abutment was observed. The concrete slope protection of the embankment under the bridge was in a good condition; however, the embankment settled 3 inches, and a 2-inch gap had developed between the embankment and the abutment (Figure 327).

Figure 327. Settlement of embankment at distance of 3 inches

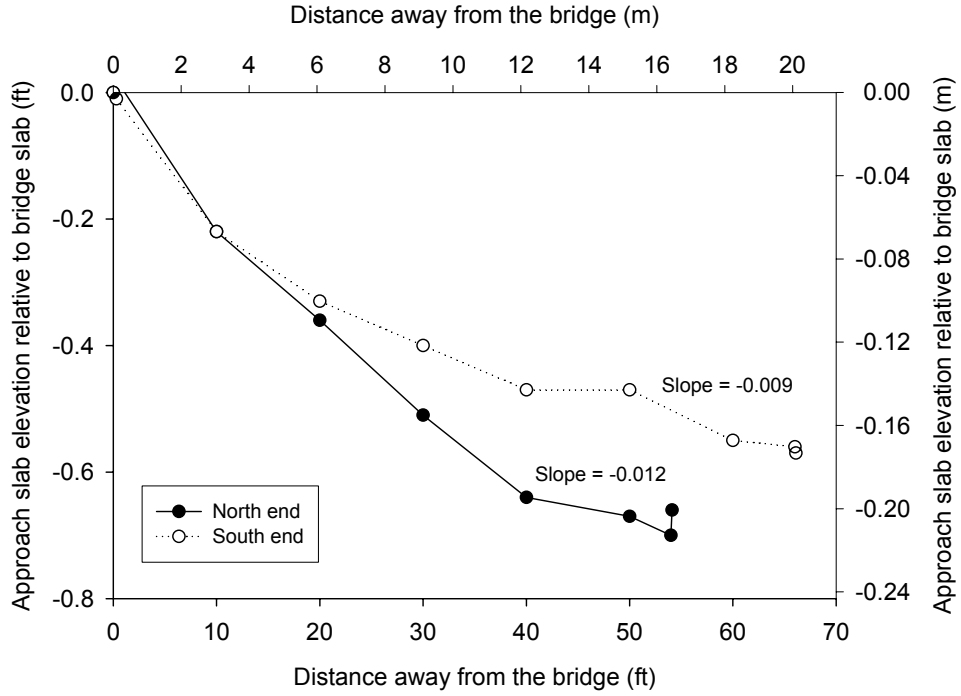
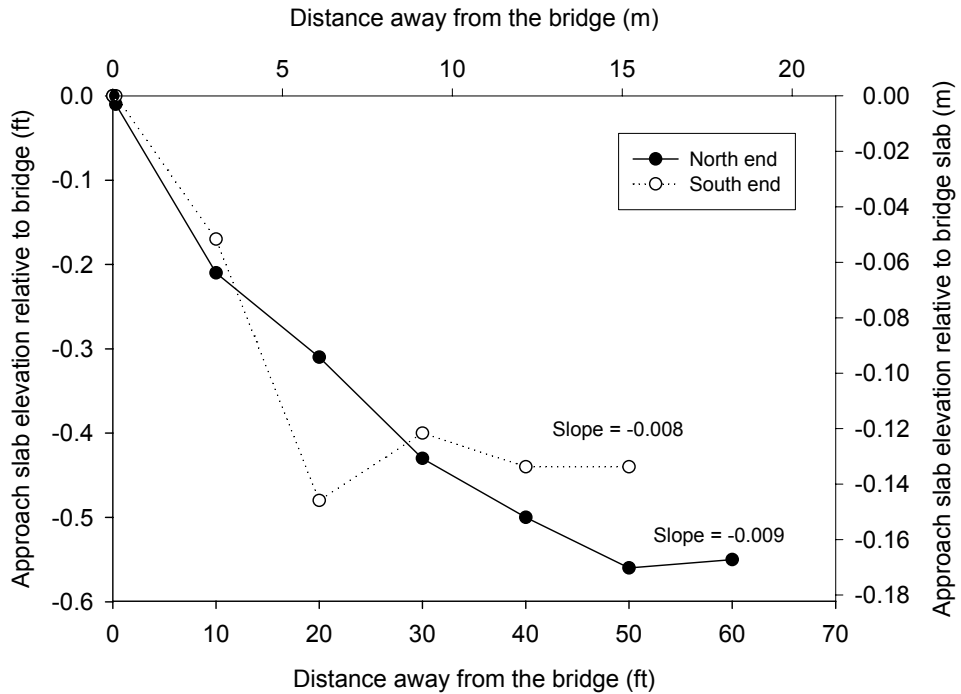
Elevation profiles for all four approaches were obtained from the edge line of the right lane and are shown in Figures 328 and 329. At the northbound lanes, differential settlement between the north end approach slab and the roadway was approximately 0.5 inches and the maximum settlement relative to the original profile was 1.5 inches at 40 feet from the bridge abutment. At the south end, the maximum settlement relative to the original profile was about 1 inch at 40 feet from the bridge abutment. The slopes of the north and south end approach slabs are -0.012 and -0.009, respectively.

At the south bound, the maximum differential settlement at the north end approach slab relative to the original profile was 1.5 inches at 30 feet from the bridge, while at the south end approach slab, the maximum settlement was 3 inches at 20 feet from the bridge abutment. The slopes of the north and south end approach slabs are -0.009 and -0.008, respectively. All four approach slabs at this bridge slope away from the bridge, which may indicate compression of the embankment soil or settlement of the foundation soil.

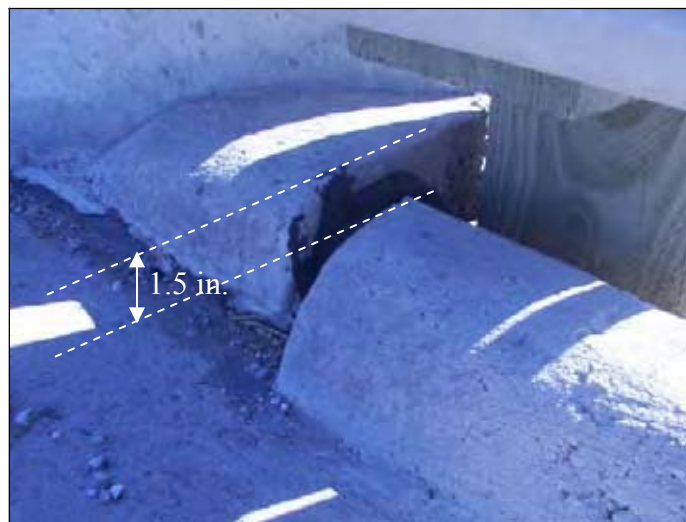
At the west end of the eastbound lane, differential settlement between the bridge approach and the bridge deck at the wingwall was approximately 1.5 inches (Figure 330). Furthermore, the expansion joint sealer was deteriorated exposing the flexible foam filler material, which was poorly sealing the expansion joint leaving a gap for water to flow around the bridge, as shown in Figure 331. The bridge embankment has a slope protection, which was in good condition; however, the embankment settled 3.5 inches, as shown in Figure 332. A 1-inch gap between the bridge embankment and the bridge abutment was measured (Figure 333).

Figure 330. Differential settlement between the bridge approach and the approach slab (West end of EBL)

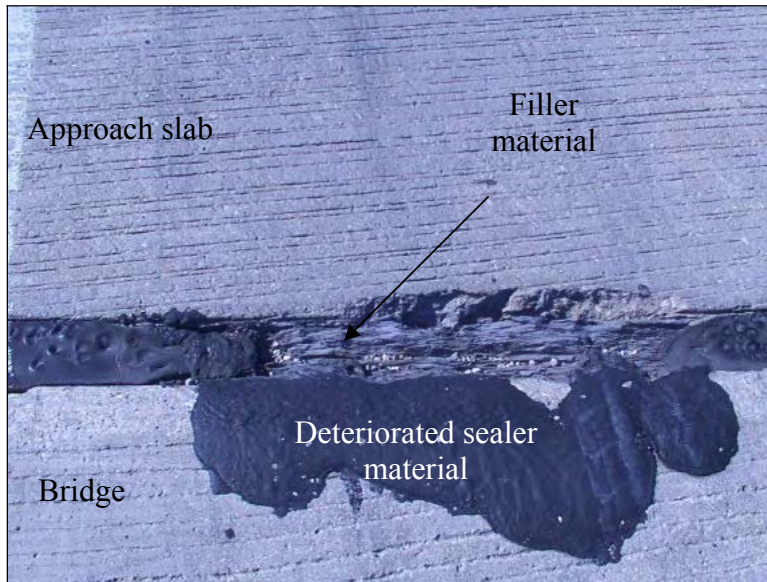
Figure 331. Deterioration of the expansion joint sealer (West end of EBL)

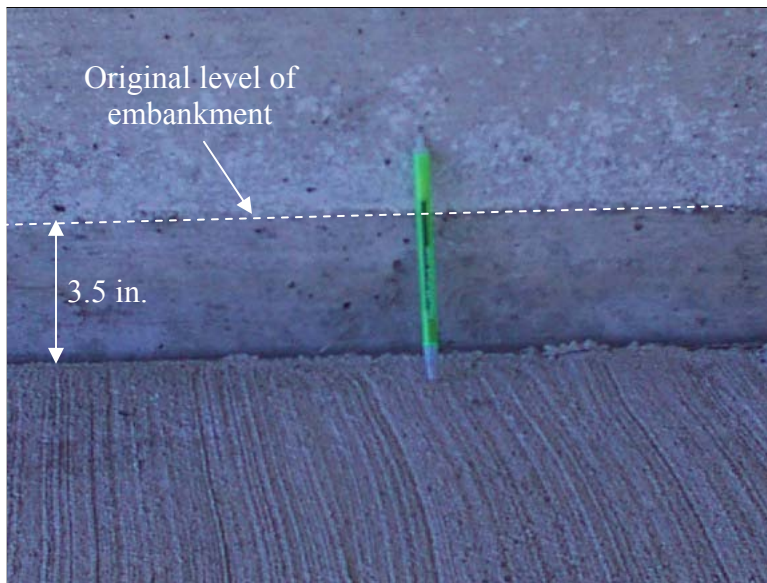
Figure 332. Settlement of the bridge embankment (West end of EBL)

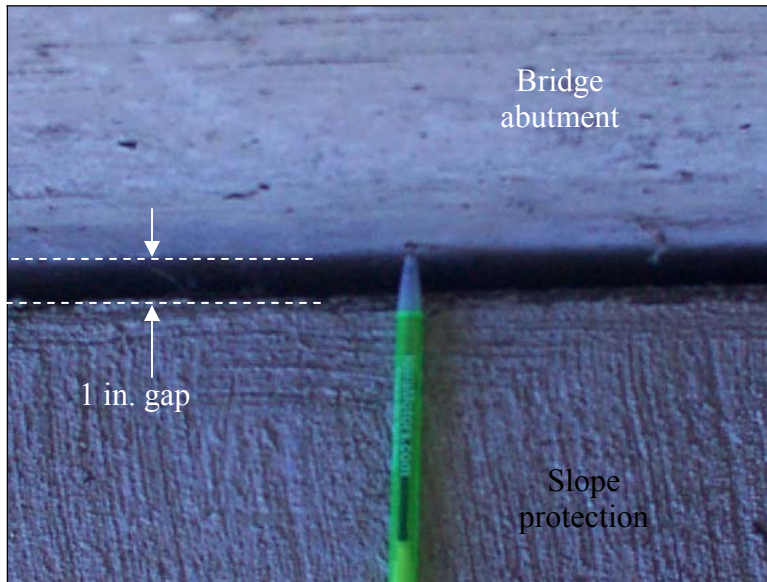
Figure 333. Top view showing a gap between the bridge embankment and the bridge abutment (West end of EBL)

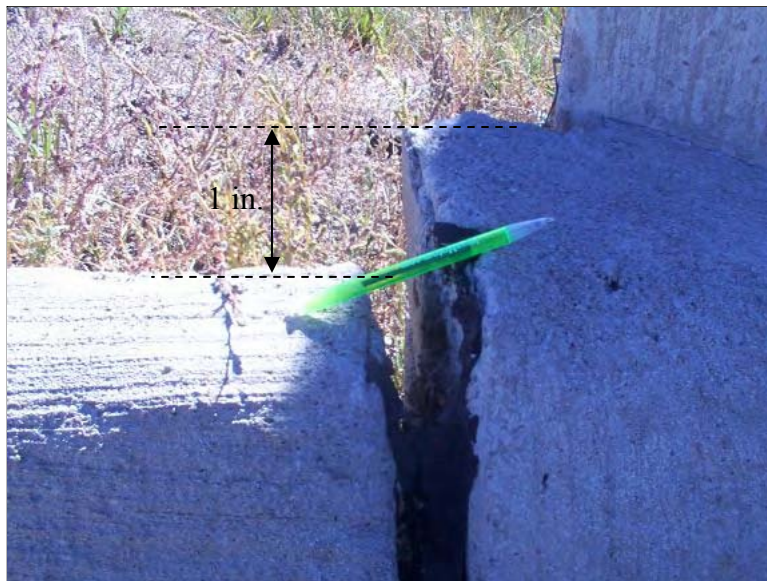
At the east end of the eastbound lane, differential settlement at the wingwall was 1 inch (Figure 334). Similar to the west end, the sealer material at the expansion joint was deteriorated exposing the flexible foam material, which poorly sealed the expansion joint. In addition, concrete spalling near the expansion joint was observed (See Figure 335).

Figure 334. Differential settlement between the bridge approach and the approach slab (East end of EBL)

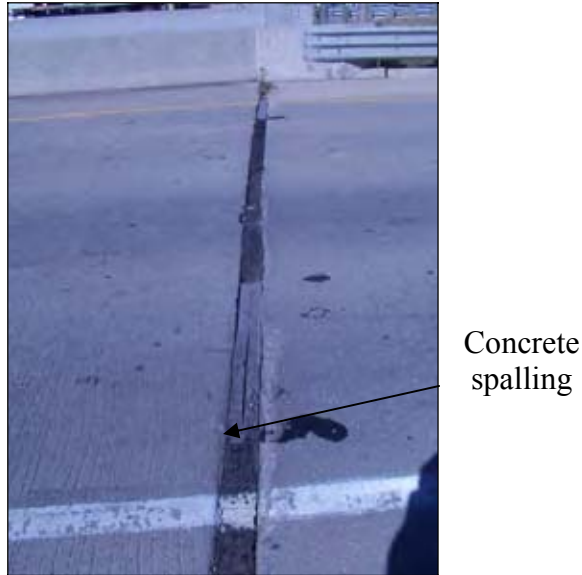
Figure 335. Poorly sealed expansion joint with concrete spalling (East end of EBL)

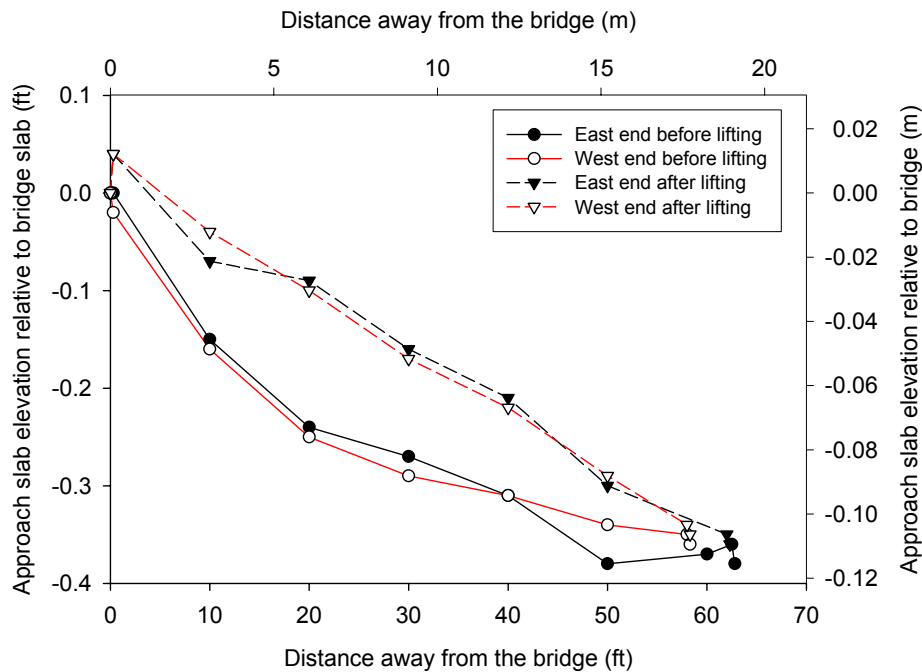
Figure 336. Approach slabs elevations before and after injecting the expansive polyurethane (EBL)

URETEK, Inc., injected polyurethane material under both approach slabs at the eastbound lane to alleviate the bump caused by excessive settlement. The profiles of the approach slabs before and after injecting the expansive polyurethane were measured. Both approaches were lifted approximately 1.8 inches at 20 feet away from the bridge; however, both approach slabs were lifted approximately 0.5 inch higher than the bridge deck level, creating a bump.

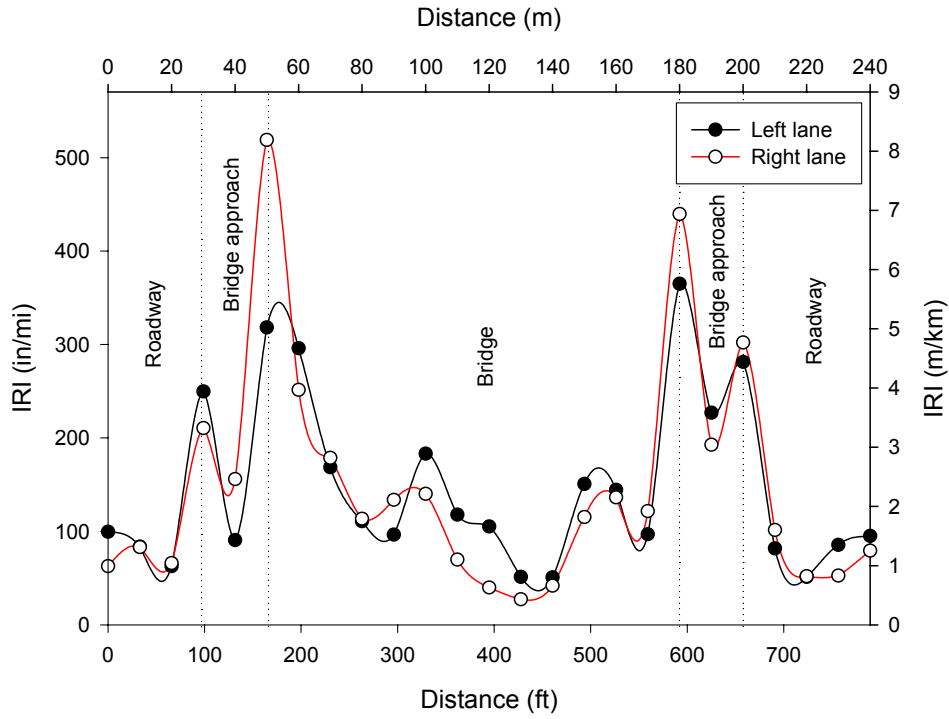
IRI results obtained from the Center for Transportation Research and Education (CTRE) at Iowa State University were from measurements made between 2001 and 2003. The IRI data was provided for 10 bridges and 27 bridge approaches (see Appendix D for all profiles). A sample of IRI profiles is shown in Figure 337. The transition between the roadway and the approach slab, and the transition between the approach slab and the bridge have significantly higher IRI values. These values ranged from 3.9 to 11.8 m/km.

Figure 337. IRI graph; Bridge no. 7777.0065 SBL

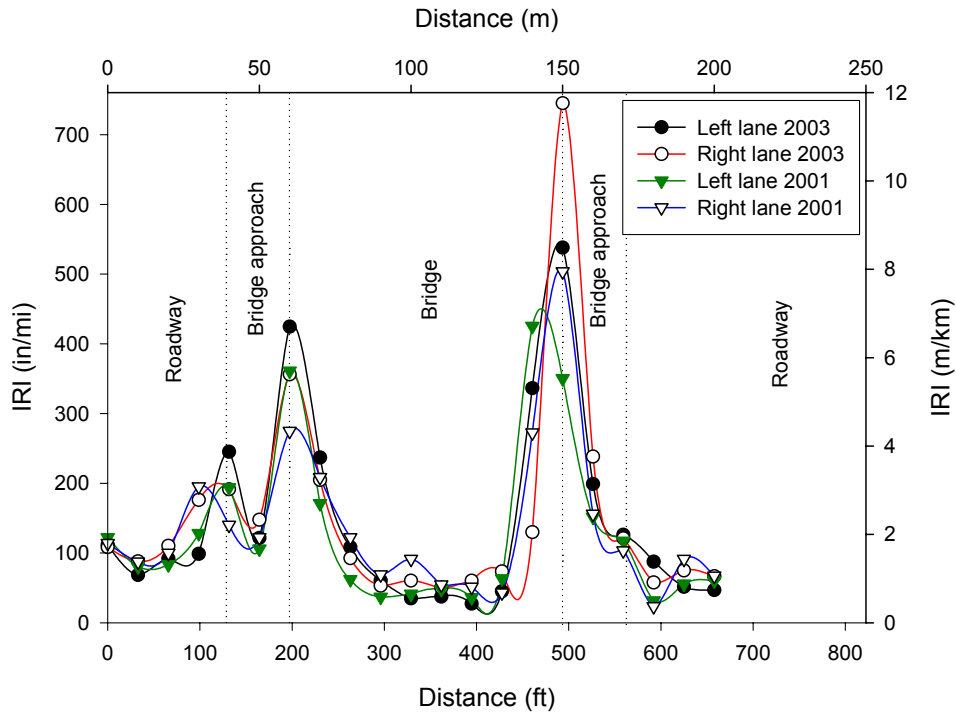
The 2001 IRI values of the bridges on U.S. 65 were compared to the 2003 data. A sample of this comparison is shown in Figure 338. Results show that the high IRI values at the two transition locations (i.e., the transition between the road and the approach slab and the transition between the approach slab and the bridge) increase with time, which indicates approach slab deterioration with time. It was determined that IRI values could provide useful information for characterizing bridge approach performance.

Figure 338. Increase of International Roughness Index with time; Bridge no. 7773.0065 NBL

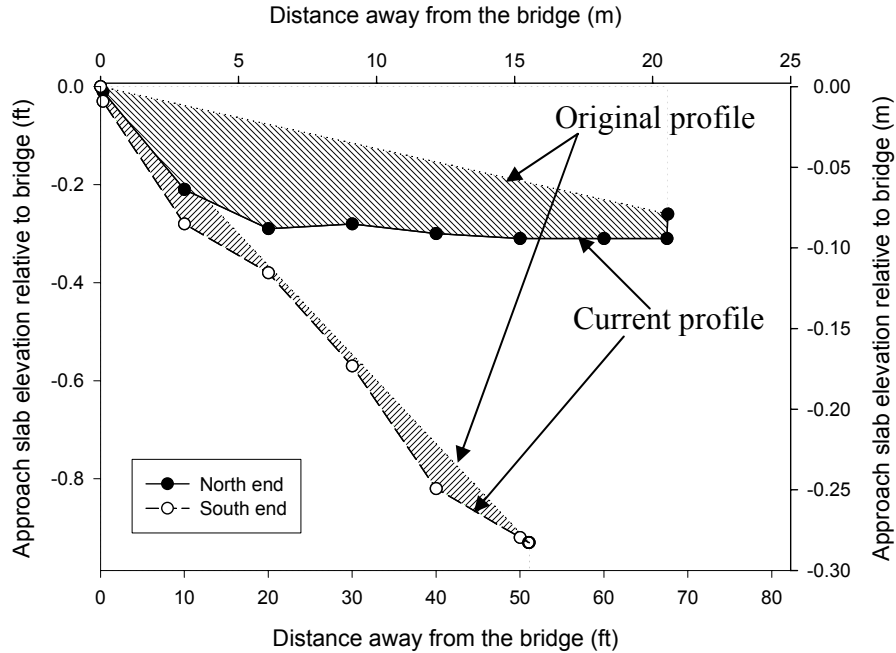
Figure 340 shows the profiles of two approach slabs relative to the original profile. As shown, the north end settled more than the south end, which is reflected in the higher area calculation between the original and existing profile. The area calculated for the north end was 50.2 ft² (4.7 m²), while the area calculated for the south end was 28.4 ft² (2.6 m²). After dividing by the length, the BI values for these two approaches were 0.822 and 0.557, respectively.

Figure 340. Elevation of two approach slabs relative to bridge; Bridge no. 7777.0065 NBL

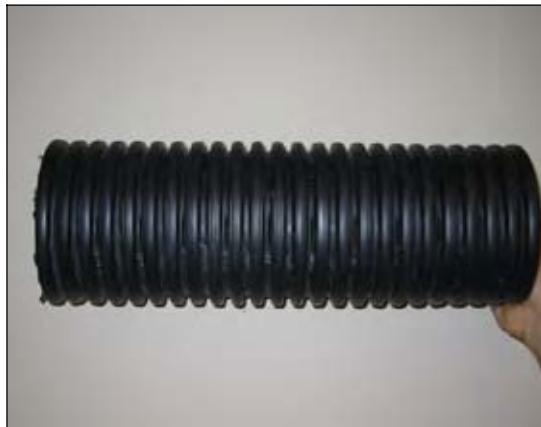
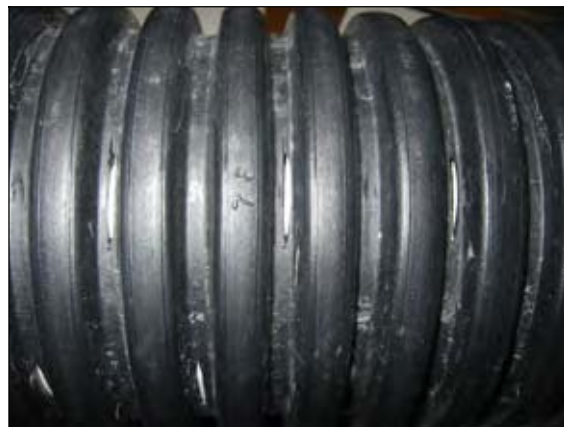
Even though it was specified, at many bridge sites it was observed that no porous backfill was placed around the subdrain. Generally, granular backfill was used in lieu of porous backfill. Iowa DOT specifies that granular backfill material must have 20% to 100% passing the No. 8 sieve and up to 10 % passing the No. 200 sieve. Figure 342 shows a typical perforated drainage pipe used for subdrain construction. The width of ten random pipe perforations was measured to compare to the size of granular backfill particles. The largest measured pipe opening was 0.09 in. (2.3 mm) and the average pipe opening was 0.07 in. (2.0 mm), which is similar to the No. 8 sieve opening (2.36 mm). Further, it was found that the majority of granular backfill soil particles are smaller than the subdrain perforation size, which possibly lead to plugged drains. Table 24 shows that the percentage of granular backfill soil particles smaller than the average subdrain perforation is about 80%.

Figure 342. Perforated drainage pipe used around Iowa bridges

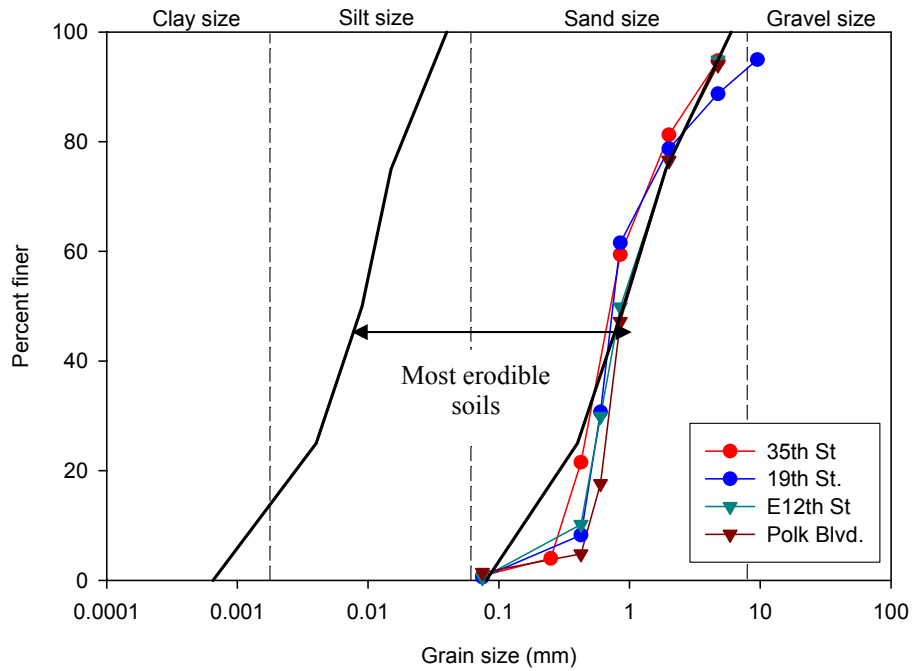
Erosion was one of the major problems observed at the inspected bridge site in Iowa. Briaud et al. (1997) reported that soils with silt and fine sand are more erodible than other soil types and provided a range of most erodible soils (Figure 347). This erodible soil range was compared with the Iowa DOT granular backfill gradation requirement (Figure 348) and backfill materials collected at four bridge sites (Figure 349). Both gradations have a common region with the range of most erodible soils. Changing Iowa DOT specification of granular backfill material from 20% to 100% to 20% to 60% passing sieve number 8 (2.36 mm) would shift the backfill material gradation out of the most erodible soil region.

Figure 349. Granular backfill obtained from bridge sites compared to the range of most erodible soils
