IDENTIFICATION OF THE BEST PRACTICES FOR DESIGN, CONSTRUCTION, AND REPAIR OF BRIDGE APPROACHES

Iowa DOT Project TR-481
CTRE Project 02-118

Final Report

January 2005

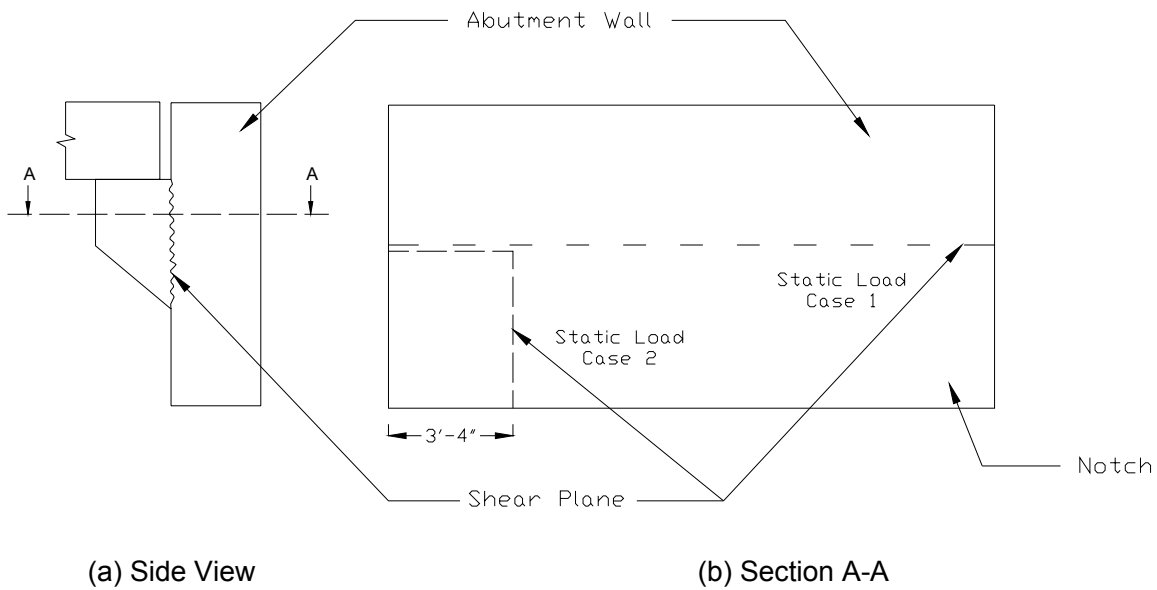
Figure 411. Direct shear failure – Case 1

The entire pavement notch was considered to experience shear failure at the notch-to-abutment wall interface, as shown in Figure 411, under a uniformly distributed vertical load on the notch resulting from the dead and live loads. The failure check was performed considering a one-foot-wide segment of the notch in the transverse direction using SLC1. As detailed in Figure 411, shear failure due to SLC2 involves at least two shear planes, which makes this load case less critical when compared to SLC1.

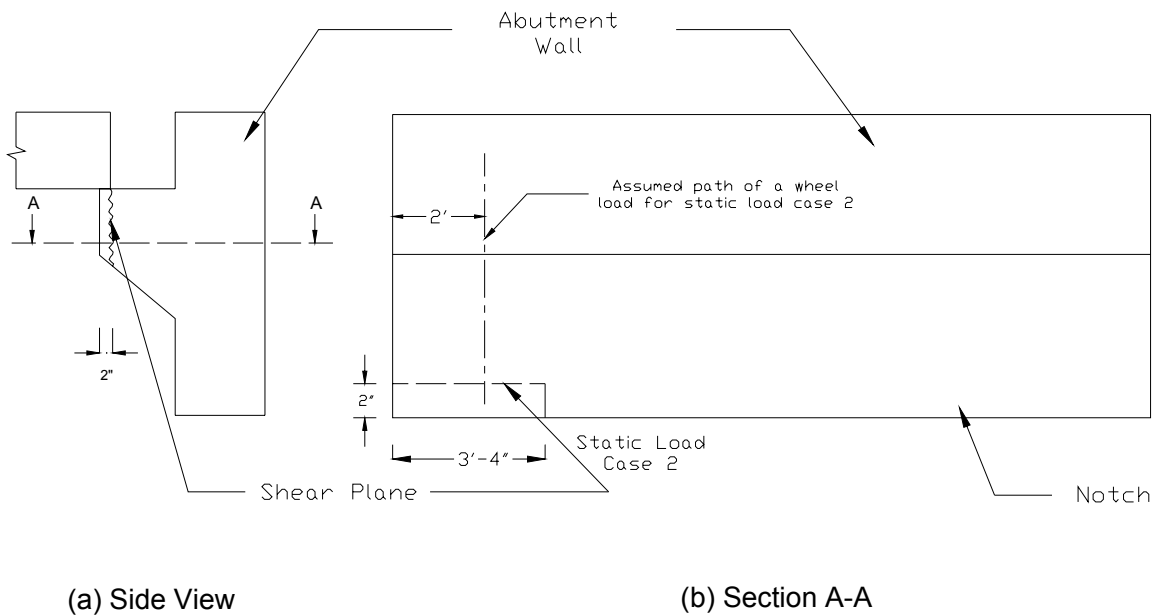
Figure 412. Direct shear failure – Case 2

In this failure case, it was assumed that the approach slab was supported over a reduced width on the notch, as shown in Figure 412. This condition can be attributed to poor construction practice, thermal effects, or a combination thereof (see an example of this condition in Figure 276 – HW65 bridge). The width of the failure segment was conservatively taken as 2 in. from the free edge of the pavement notch. This small segment of the notch was assumed to have no steel reinforcement. Because the shear plane runs in the direction of the bridge is very small, SLC2 governs this failure case by producing a lower capacity to demand ratio.

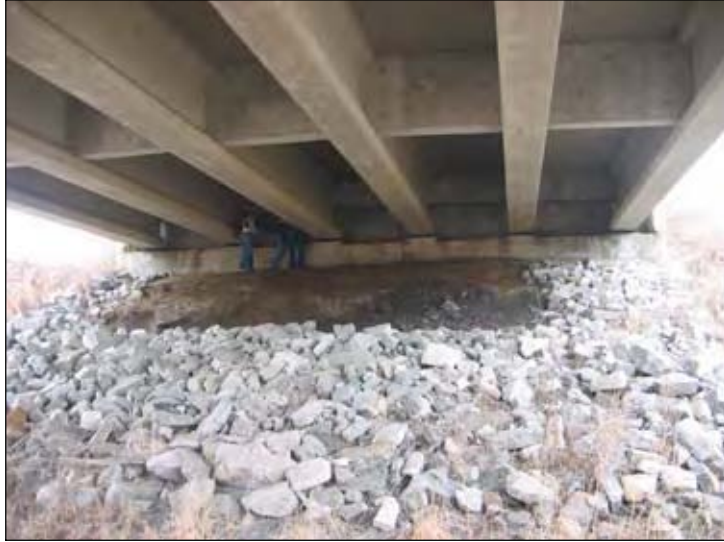
Bridge at US 65 over South Skunk river (Mile: 92)

Figure A1. Rocks used to decrease erosion at the embankment

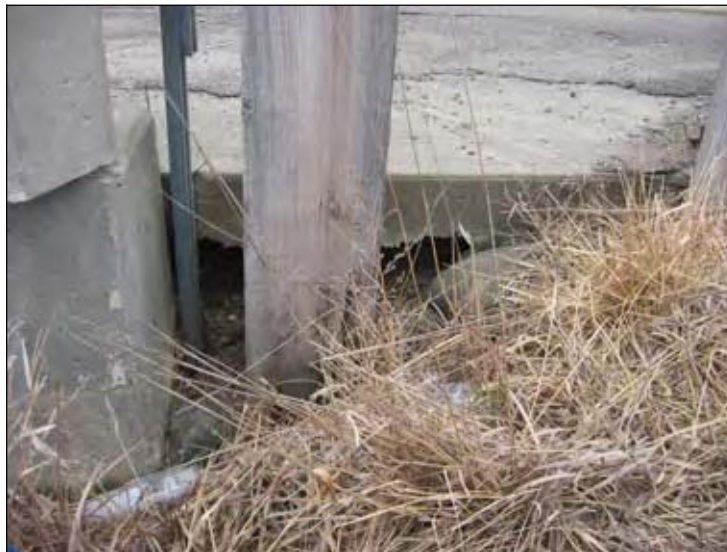
Bridge at US 65 over Rail Road (Mile: 89)

Figure A2. Void developed under approach slab

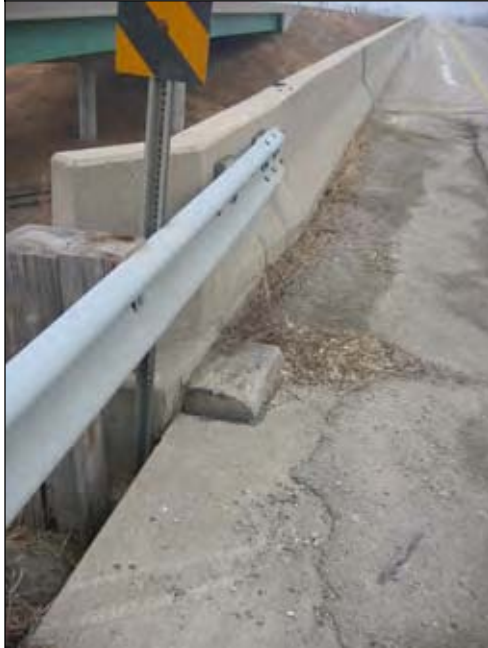
Figure A3. Differential settlement

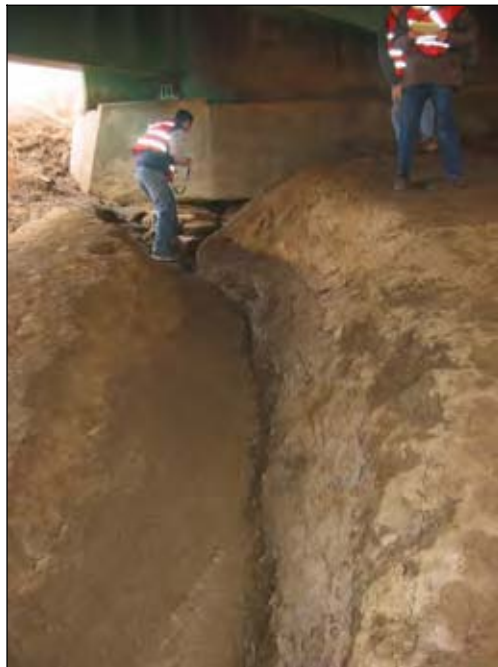
Figure A4. Soil erosion at the bridge embankment

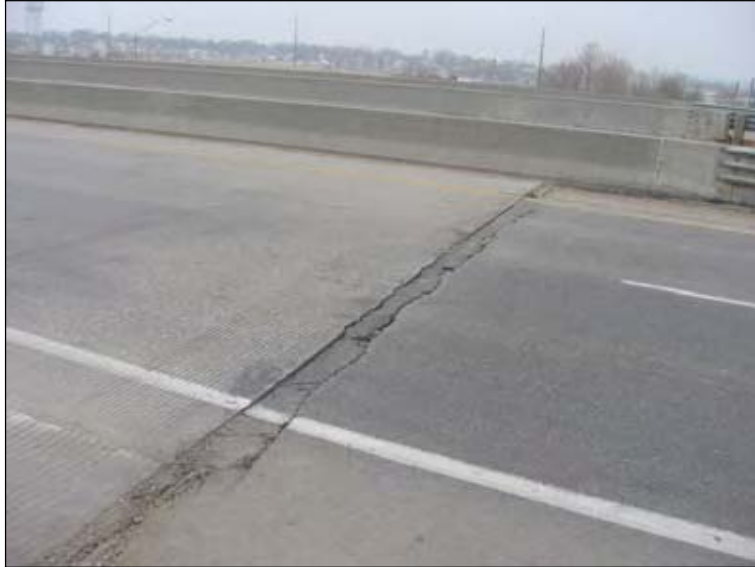
Bridge at US 65 over 163

Figure A5. Cracks near the expansion joint

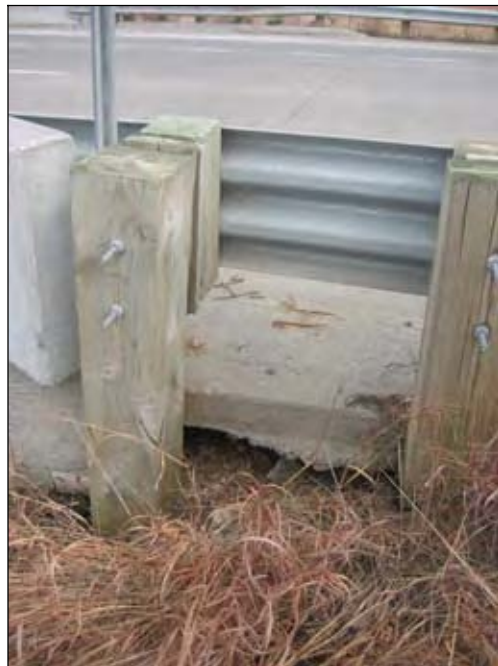
Bridge at US 65 over Pleasant Hill Road

Figure A6. Void developed under the approach slab

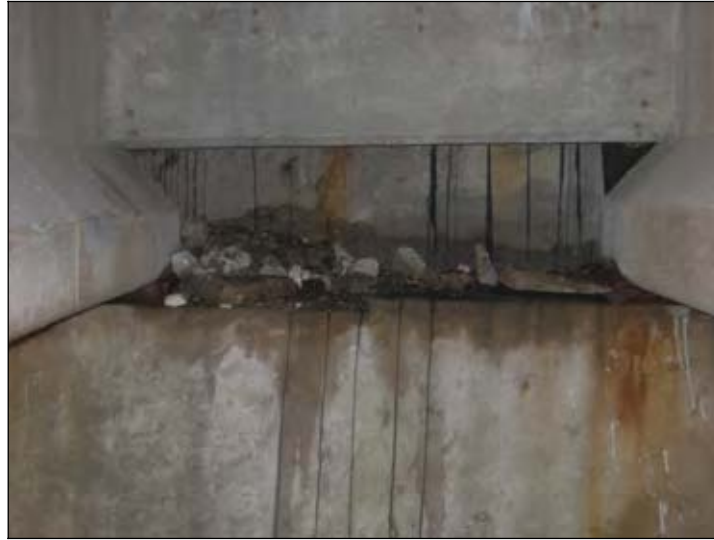
Bridge at Highway 30 over Duff Ave

Figure A7. Water flowing down the bridge abutment

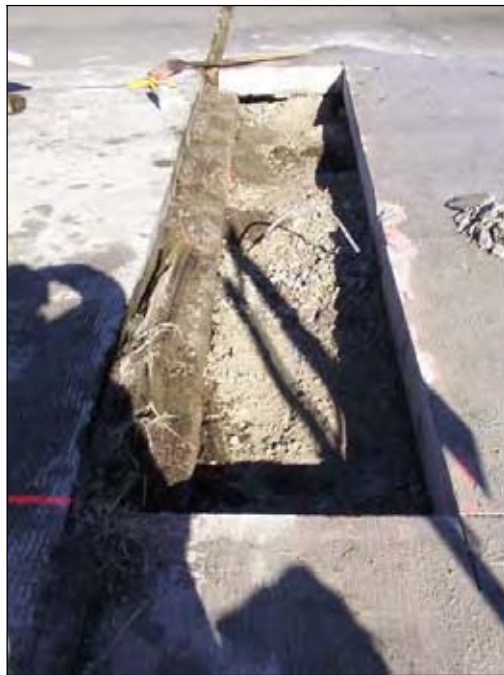
Bridge carrying 160 over I-35

Figure A8. Removed section of the approach slab
