Thin Maintenance Surfaces for Municipalities

Final Report
May 2007

Sponsored by
the Iowa Highway Research Board
(IHRB Project TR-507)
and
the Iowa Department of Transportation
(CTRE Project 03-161)

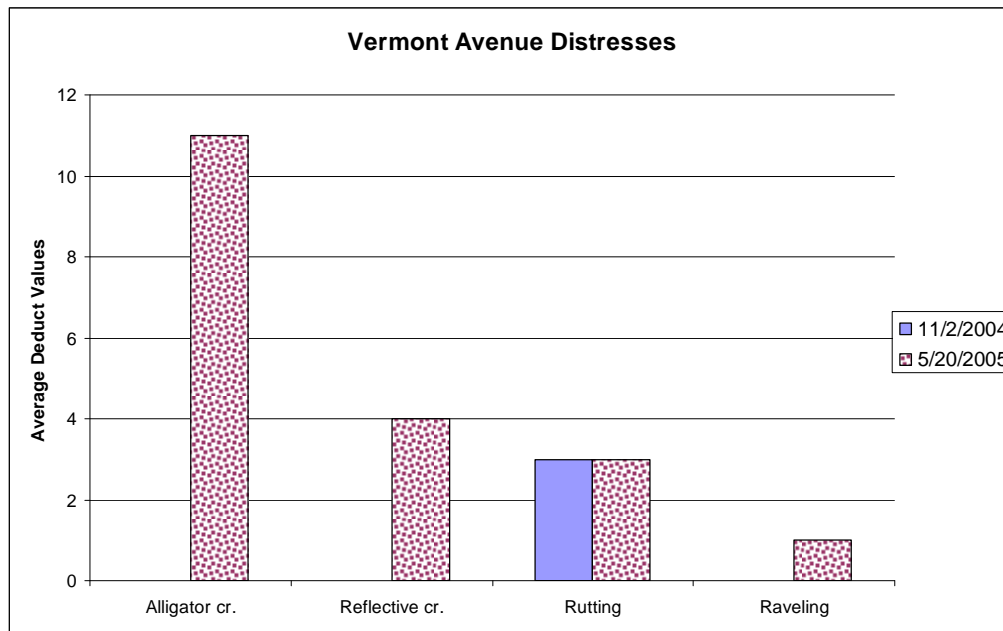
Figure 26. Vermont Avenue deduct values

The post-construction survey revealed that the pavement condition index (PCI) for Vermont Avenue was 72, which places it in the rating category of “very good.” A conservative estimate of the original PCI is 56, which falls in the rating category of “good.” (The estimate was based on a photo log and on estimated percentages of L&T cracking and alligator cracking.) This means that there was an estimated increase of 16 points for the PCI. At the time of the post-construction survey, the seal coat was in very good condition with no raveling or bleeding. The main distress was light-severity reflective cracking from the previous seal coat. The chipmat also performed very well. There was no reflective cracking in the areas where the chipmat was placed (see Figure 24). Researchers chose not to place fabric over some areas of alligator cracking in order to provide a comparison. In those places, the alligator cracking quickly reflected through to the new seal coat, even before the start of the subsequent winter (see Figure 25). The average deduct values for the test section are displayed in Figure 26.

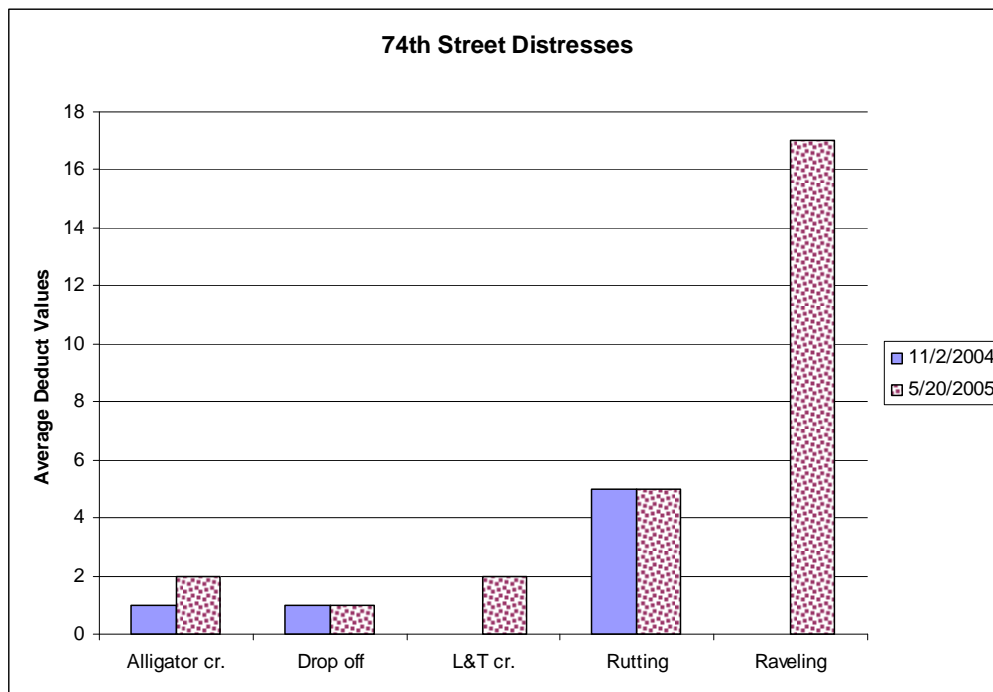
Figure 27. 74th Street deduct values

The post-construction survey revealed that the overall PCI for 74th Street was 72 (very good). A conservative estimate of the original PCI is 62 (good). This estimate was based on a photo log of the test section. The estimated increase in the PCI value is 10. As was expected, results

varied with each of the various types of aggregates. This “very good” rating is a strong indicator of a pavement with good structural stability. Examination of the actual distress deduct scores indicate very low amounts of cracking, rutting, and alligator cracking, which are all structural-related distresses. However, the test section appears to be in very poor condition because of surface distresses such as raveling and bleeding. These distresses are not weighted as heavily in the calculation of the PCI because they are only surface distresses and are not indicative of a pavement with poor structural stability. The average deduct values for the test section are shown in Figure 27.

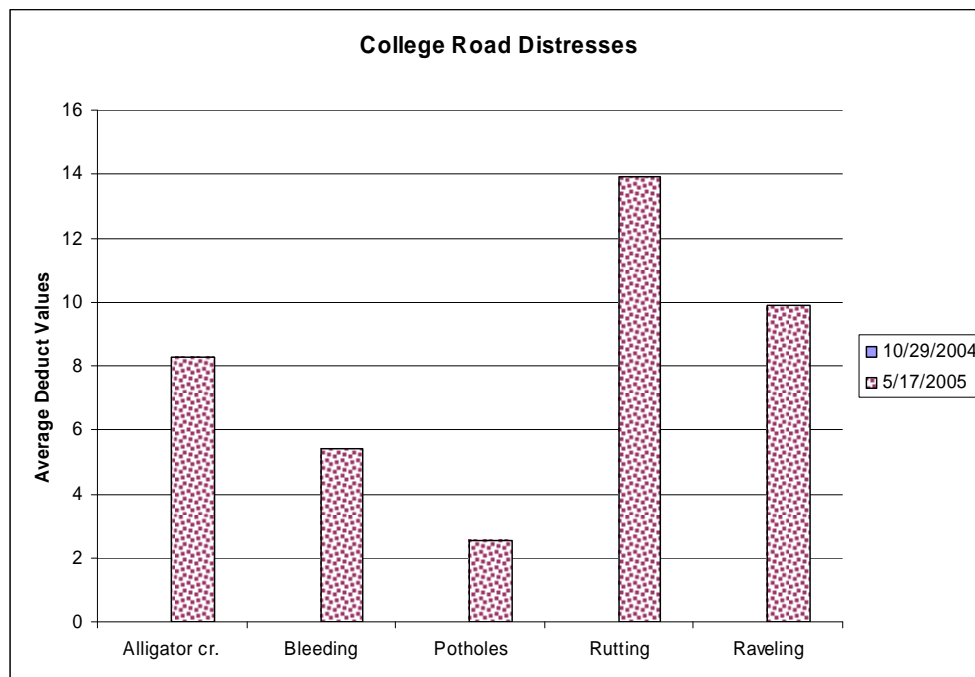
Figure 33. College Road deduct values
(The 10/29/2004 survey had zero deduct values.)

The fall 2004 post-construction survey indicated that the road was in “excellent” condition with a PCI near 100. However, by the time the spring 2005 survey was conducted, the road had deteriorated so that there was little to no improvement in comparison to the pre-construction condition of College Road. The new PCI of the road was 48, which is a “fair” condition rating, and the estimated previous PCI was approximately 30–50. The new PCI value does not include the portion of the test section adjacent to the north construction site (mentioned later) where earthwork was occurring and the resulting truck traffic caused a total failure of the pavement. This portion was left out because it did not represent the condition of the rest of the pavement. (The PCI values for these two sections were 29, which is

categorized as poor, and 11, which is categorized as very poor). The average deduct values for College Road, not including the failed sections, are found in Figure 33. It should be noted that, when performing PCI surveys on seal coat roads, the surveyor did not consider construction defects as distresses, because the investigation was attempting to focus on how structure and surface of a well-constructed road would perform. An example of a construction defect is a series of grooves left from a motor grader's ripper teeth before the application of the first seal coat; although the grooves could be considered rutting, they are not a sign of structural distress or of a surface distress and they were thus not included in the survey.

The distresses in the new seal coat were similar to that of the pre-construction condition (see Figure 34). Low- to high-severity rutting, alligator cracking, bleeding, and potholes had developed. When researchers compared a photo log of the test section before construction to the condition of the test section after construction, it was determined that the distresses in the new seal coat were located in the same regions as those of the original seal coat even though the entire road was re-stabilized. As with the original seal coat, the majority of the distresses were located in the outer lane, especially in the outer wheel path. The area adjacent to the entrance of the construction site had failed due to the heavy truck traffic. High-severity rutting, alligator cracking, bleeding, and raveling were the most prominent distresses near the entrance. Interestingly, the areas that were in excellent condition before construction were the same areas that were in good condition for the post-construction survey.

The most probable cause for the various structural failures located throughout the test section was overloading of the pavement caused by the extra truck traffic. After discussions with the city engineer, the college adjacent to the test section removed approximately 350,000 cubic yards of earth, all of which was hauled by tandem-axle dump trucks that used the test section as a part of their haul route. Figure 35 shows the truck route (dashed line) that was used to access Interstate 35. The trucks entered the test section at its south end and drove north to the on-ramp for Interstate 35. The trucks used the test section as a return road as well. It can be reasonably assumed that each truck carried approximately 10–12 cubic yards of earth, which means that in the months after construction, the test section was traversed by approximately

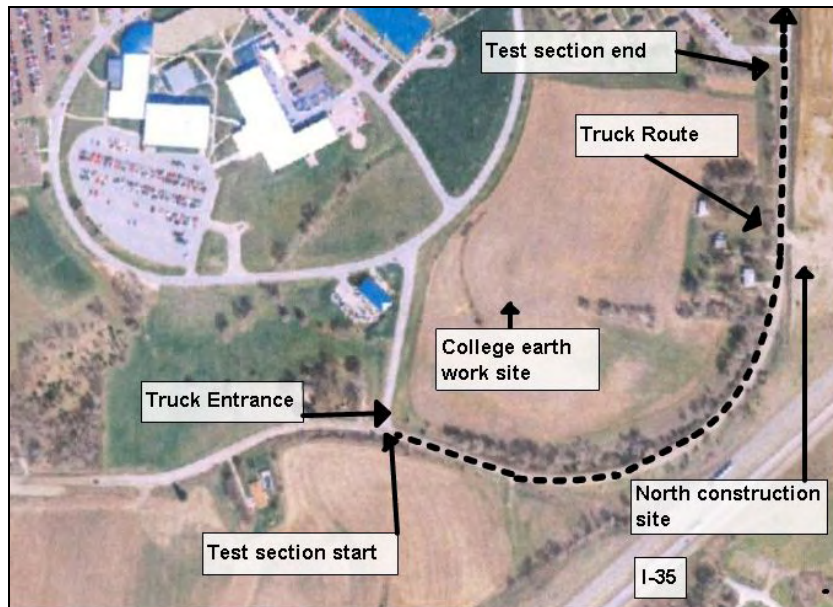
Figure 35. College Road construction map

35,000 fully loaded dump trucks. This number does not include traffic to and from the north construction site, which also included dump trucks removing an unknown amount of earth and using College Road to access Interstate 35. According to the city engineer, Iowa Western Community College plans to remove another one million cubic yards, and the test section will be traversed by all of this truck traffic as well.

An analysis was conducted to assess the ability of the College Road pavement to withstand the truck traffic that was imposed on it (see Appendix D). The analysis indicated that an emulsion-mixed base with coarse aggregate six inches deep would be required for the truck traffic. This base requires a structural number of 1.8. (The structural number is an index of the strength of base required to carry a defined load of traffic.) It seems likely that the design and quality control requirements contemplated in the analysis exceed those that were applied to the base for College Road. The existing base was approximately six inches of pulverized seal coat and base material that was wet compacted in lifts with no additive emulsion. The mix did contain some binder from previous seal coats and the emulsion binder from previous stabilization projects. This base likely had a structural number ranging from 0.42 to 0.66. This range is much lower than the required number of 1.8 and is insufficient for the truck traffic. This shows that the existing pavement's structure should not have been expected to support the truck traffic that the pavement experienced.

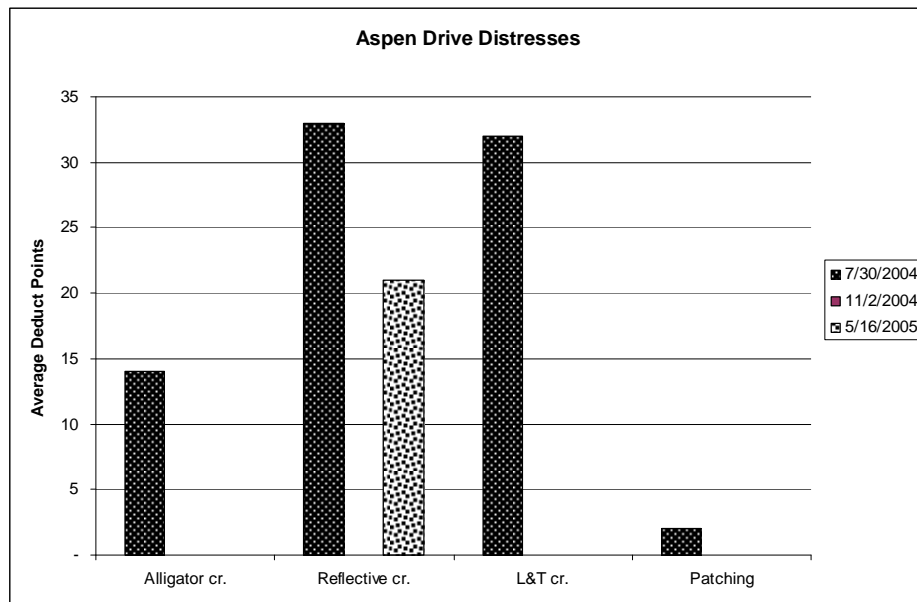
Figure 36. Aspen Drive deduct values

The post-construction survey revealed that there was considerable improvement in the condition of the road. The original PCI of the Aspen Drive was 49 and the new PCI was 82, an increase of 33 points to a “very good” rating. Figure 36 shows the average deduct values for the various surveys performed on Aspen Drive. Various reflected cracks were the only distresses present in the new micro-surfacing. Many of the original reflected cracks in the overlay also reflected through the new micro-surfacing treatment. This section was the only section for which researchers had the original surveys. (Recall that the others were lost in an auto theft). The original total for all of the cracks on six sample survey sections was 2,802 feet, which includes low-, medium-, and high-severity reflective and L&T cracking (see Figure 37). As of May 16, 2005, the total amount of cracking is 1,605 feet—a 43% decrease in cracking. This number only includes reflective cracking, because the PCC joint cracks as well as the L&T cracks in the overlay reflected through the micro-surfacing but no new L&T cracks will form in the micro-surfacing. This crack reflection is typical of micro-surfacing treatments. The only other distress in the original overlay was light-severity alligator cracking. As of May 16, 2005, none of the alligator cracking had reflected through the micro-surfacing. The micro-surfacing appears to be performing well (see Figure 38). In a few high spots, a snowplow sheared off the high parts of the limestone aggregate, but enough aggregate still remains to cover the original pavement.

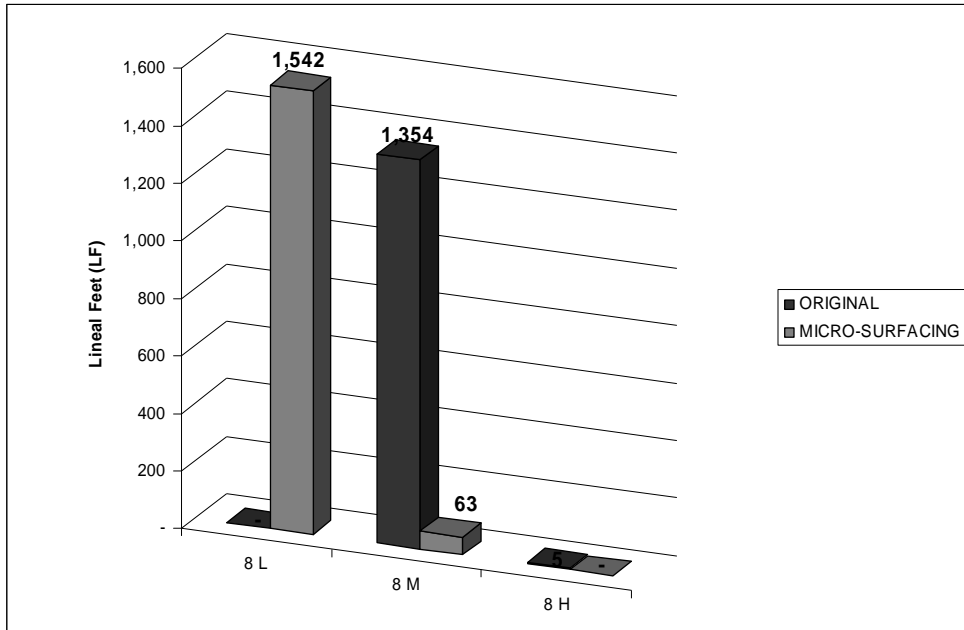
Figure 37. Reflective cracking on Aspen Drive by severity level

Similar to Aspen Drive, the primary distress for both Fourth Street and Vine Street was reflected cracking. Vine Street had experienced some light-severity rutting before construction, and the micro-surfacing did not fill in the ruts. (Rut filling was not specified in the contract.) The graphs do not include pre-construction data.

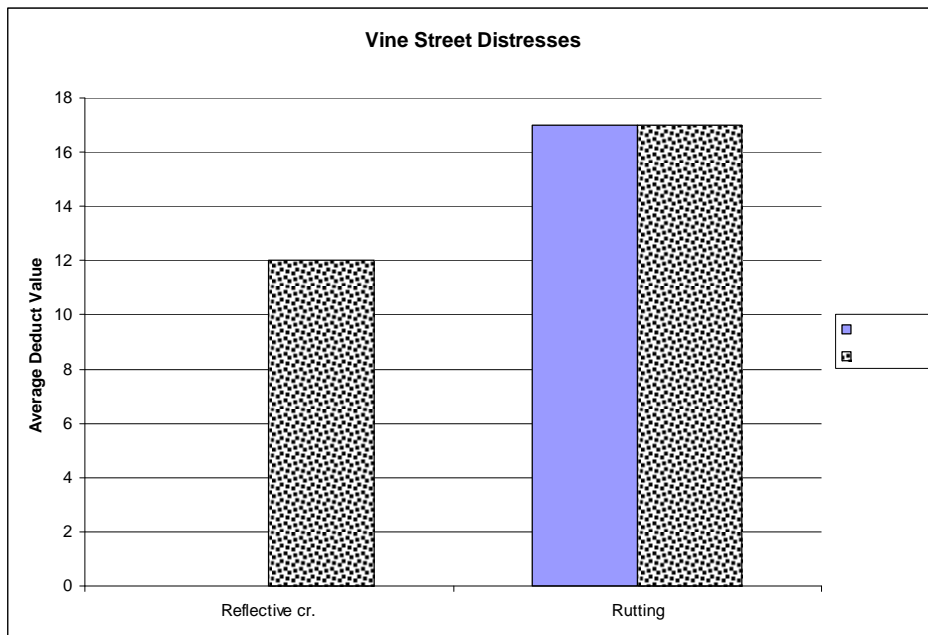
Figure 39. Vine Street deduct values

The post-construction survey revealed that the PCI for Fourth Street increased from an estimated pre-construction PCI of 81 (very good) to 86 (excellent). Because preconstruction survey data was lost in the previously mentioned auto theft, the pre-construction PCI was estimated by surveying Maple Street, a pavement with a condition similar to that of Fourth Street and Vine Street before the application of the micro-surfacing. However, unlike Fourth and Vine Streets, Maple Street not have any rutting, which makes comparison challenging. In order to adjust for rutting, the rutting deduct values from the Vine Street survey (see Figure 39) were included in the Maple Street survey (see Figure 40) to draw a more accurate estimate of the pre-construction condition of Vine Street. The PCI value for Maple Street with the Vine Street rutting adjustment was 70 (good). The final PCI for Vine Street was 80, with a rating of “very good” and a PCI increase of 10.

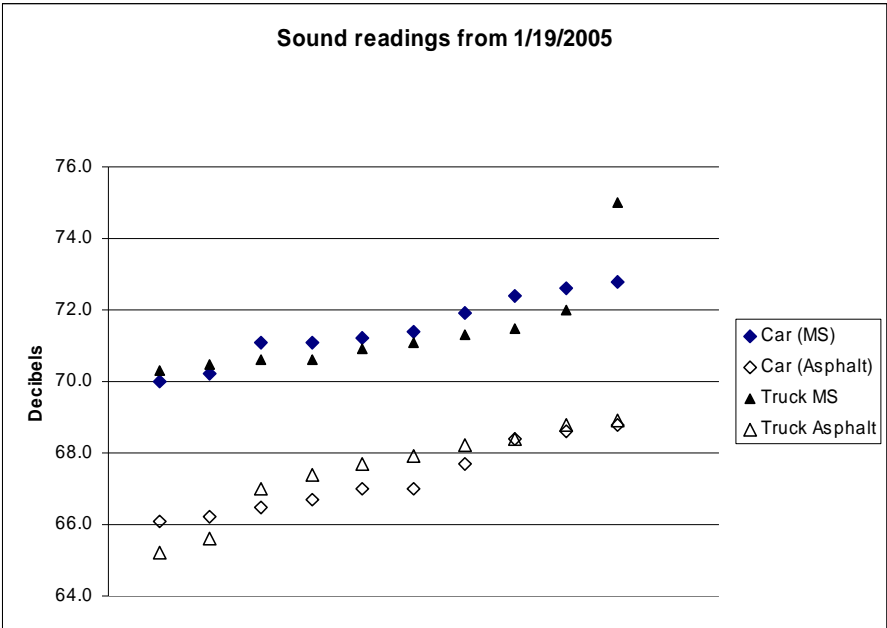
Figure 43. First sound readings (in order of intensity)

January 19, 2005			June 10, 2005		
	Car	Truck	Inside car	Car	Truck	Inside car
Asphalt	67.5	67.3	61.2	72.8	64.8	54.9
Micro-surfacing	71.4	71.5	66.0	73.2	66.0	62.1
Difference	3.9	4.2	4.8	0.4	1.3	7.2

The average sound intensity for the test vehicles during the test in March cannot be compared to the sound intensity during the test in June because the temperature was notably different—36°F for the January 19, 2005 test and 80°F for the June 10, 2005 test—and different vehicles were used for the testing. The reason that different test vehicles were used was that it was not possible to get the same exact vehicles from the Iowa State University Motor Pool. The difference in loudness for each of the test vehicles on each of the surfaces on one test day shows the difference in loudness (see Figure 43 and Figure 44). The chunk sampling of cars, trucks, and buses passing by also showed no difference in the decibel level, with the average decibel level of the micro-surfacing being 1.5 dB higher than that of the asphalt (see Figure 45).

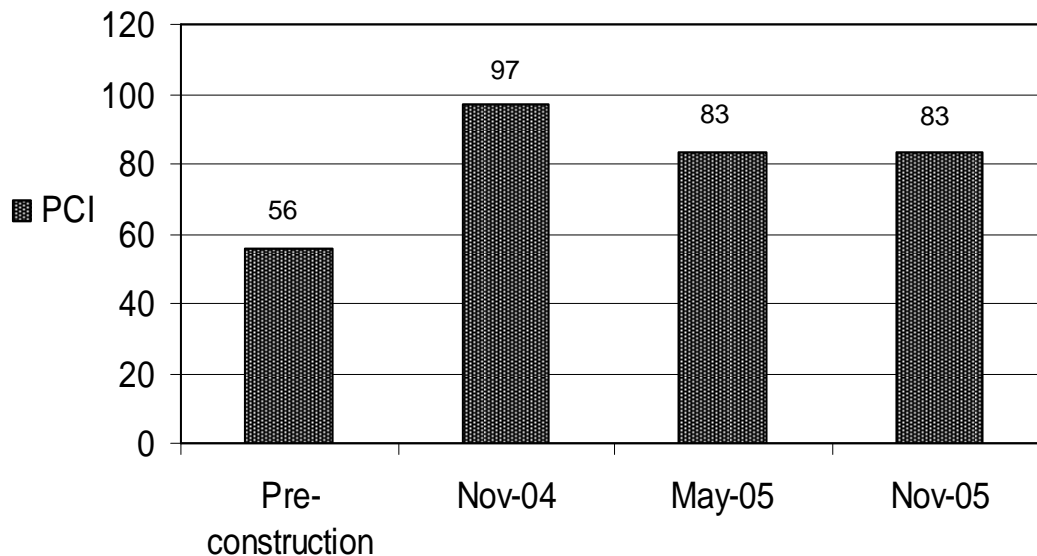
Figure F.1. Changes in PCI for Vermont Avenue

The PCI of Vermont Avenue in November of 2005 was 83, unchanged from that of May 2005. Figure F.1 summarizes how the PCI changed over the pre- through post-construction cycle. As the November 2005 survey was being conducted, the researchers noted the locations of the chipmat repairs and noted that alligator cracking had not yet reflected through in these locations. In contrast, the May 2005 survey had indicated that alligator cracks had reflected through in locations where chipmat was not applied (Figure F.2).

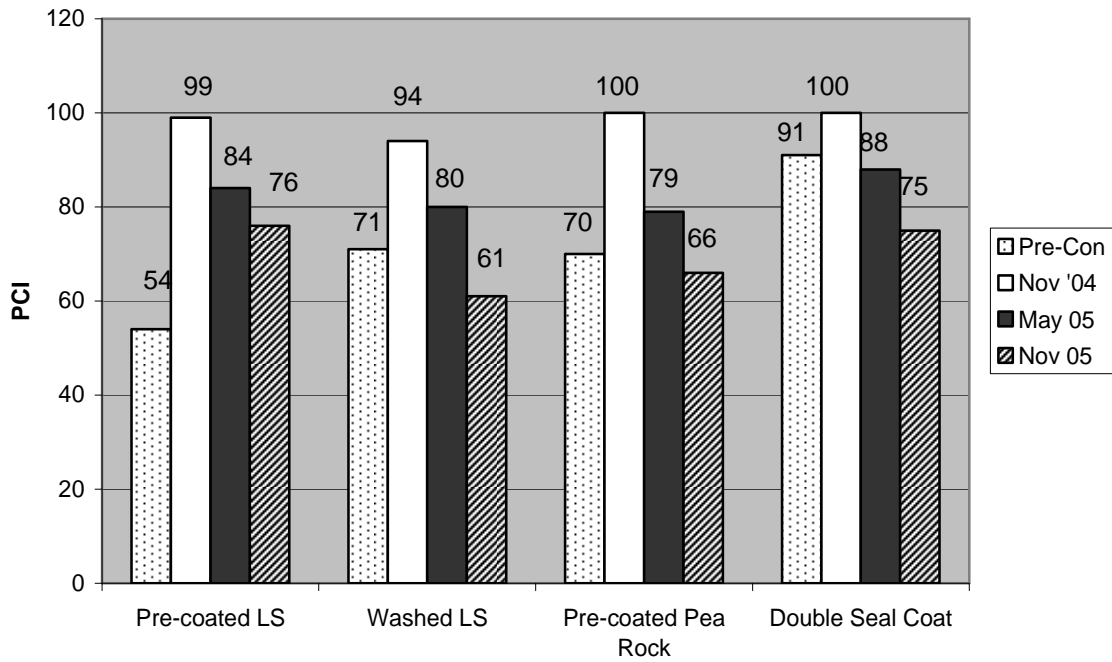
Figure F.3. Changes in PCI for 74th Street

By November of 2005, the PCI of all the demonstration sections on 74th Street had decreased from the values observed in May of 2005. The most prominent distress that increased was bleeding, which was heavy in places, especially in locations that withstood the forces of turning and stopping vehicles. In some cases, the bleeding occurred in places where the aggregate was stripped off by snow plows. For the purposes of PCI calculations, these areas were designated with a combination of raveling and bleeding. A few patches had been placed since the last survey.

The washed limestone and pre-coated pea rock had the lowest PCIs (61 and 68, respectively), while the single pre-coated limestone and the double seal coat had the highest (76 and 75 respectively). Figure F.3 summarizes how the PCIs changed over the pre- through post-construction cycle, while Figures F.4 through F.7 provide representative images of each of the sections. In comparing these sections, the effects that rutting had on the PCI calculation were not included. This is because a seal coat is not intended to improve road performance with regard to rutting and because there were noticeable differences in the amount of rutting from one road section to another, which would have made comparisons difficult.

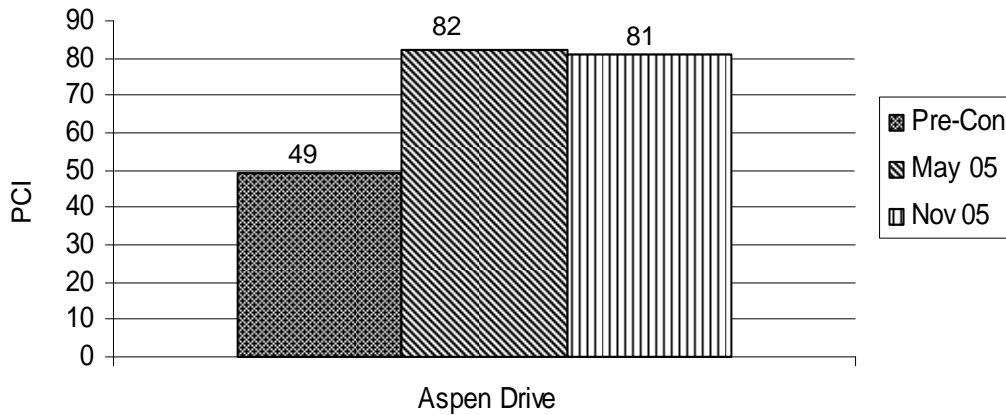
Figure F.8. Changes in PCI for Aspen Drive

The PCI for Aspen Drive essentially remained the same (changed from 82 to 81) during the period from May to November of 2005. Figure F.8 summarizes how the PCI changed over the pre- through post-construction cycle.

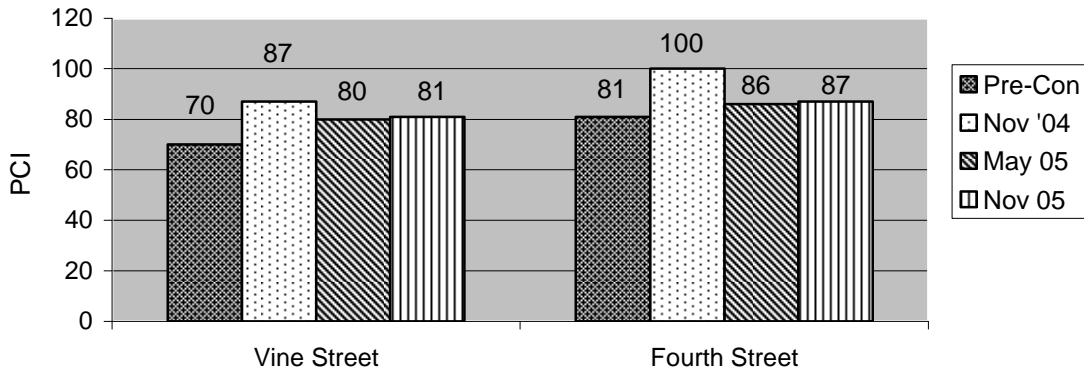
F.9. Changes in PCI for Vine Street and Fourth Street

As with Aspen Drive, Fourth Street and Vine Street only experienced slight changes in PCI during the period from May to November of 2005. Figure F.9 summarizes how the PCI changed over the pre- through post-construction cycle.
