Pilot Construction Project for Granular Shoulder Stabilization

Final Report
September 2013

Sponsored by
Iowa Highway Research Board
(IHRB Project TR-634)
Iowa Department of Transportation
(InTrans Project 11-405)

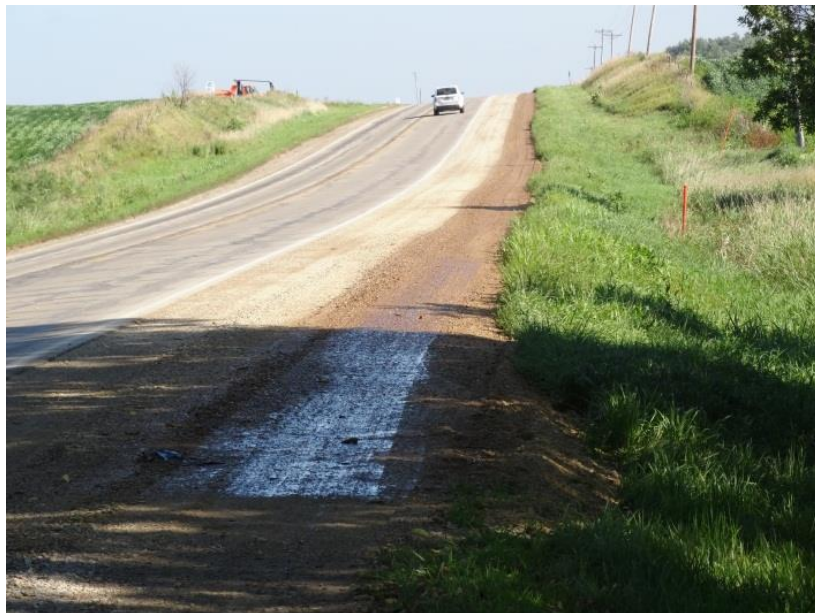
Figure 9. Soapstock applied on the shoulder of US 69 up the hill near Leland, Iowa

Usually, the width of sprayed soapstock was 4 ft, which required two nozzles working simultaneously. North of Leland, soapstock was applied at full width going up to the hill, because gullies caused by water erosion tended to developed near the grass line (they had been filled in with new compacted aggregate before soapstock application commenced). The result of this application is shown in Figure 9.

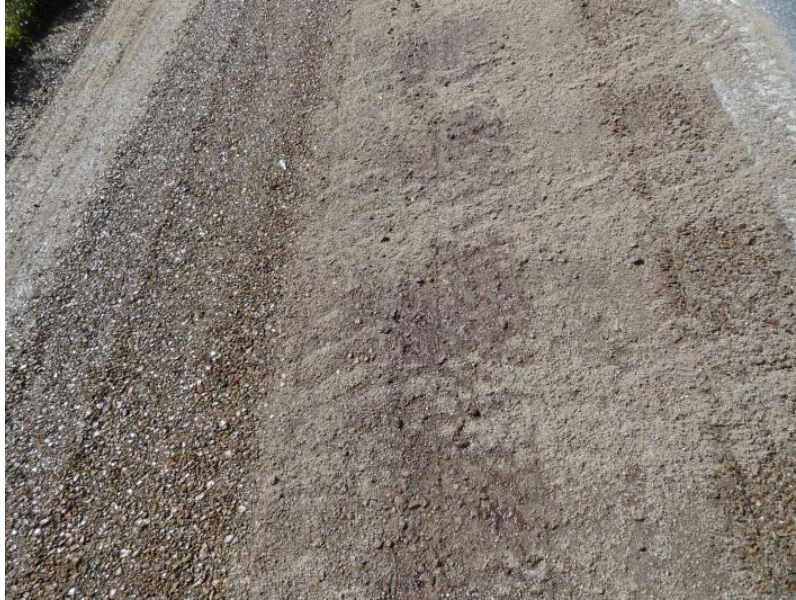
Figure 11. Soapstock and sand applied to recycled asphalt paving materials

In one place, recycled asphalt paving material was newly spread on the shoulder. After the soapstock and sand was applied to it, the mixed material looked much like dense-graded aggregate, with a noticeably greater amount of fine particles (Figure 11).

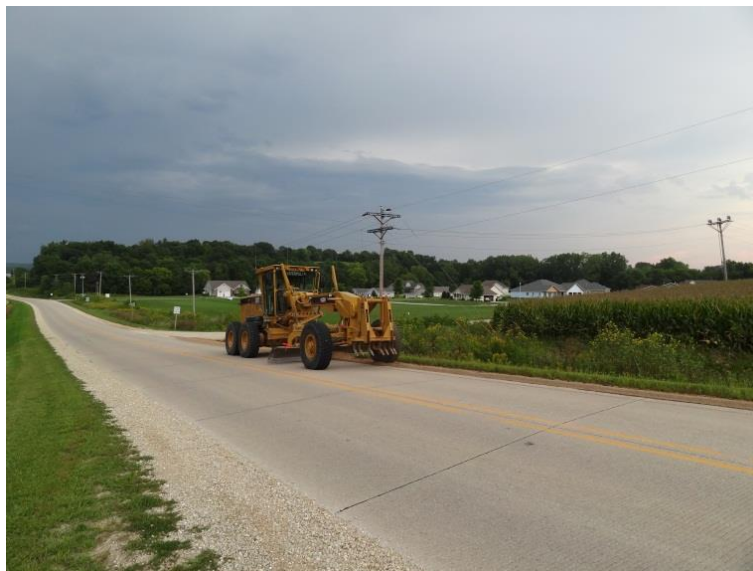
Figure 18. Grader bladed over the shoulder applied with sand

While applying soapstock onto Fayette County Road (CR) W-51, the county maintenance crew developed an alternate method for placing sand over the soapstock. A county truck placed sand on the white line by using an edge rut chute. Then, the motor grader bladed sand over the surface on which the soapstock was applied (Figure 18).

This procedure worked well for places where the shoulder surface was lower than the pavement, but not for places where the shoulder surface was higher than the pavement. The newly-applied soapstock on higher shoulder surfaces was scraped off the shoulder by the motor grader blade.

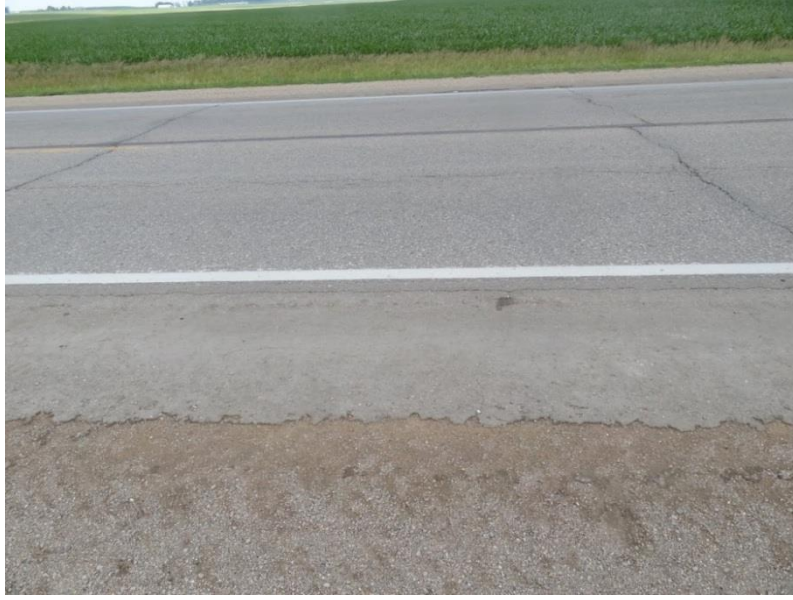
Figure 21. Eastbound shoulder of US 18 near Garner, Iowa

Figure 20 provides an example of good shoulder performance for this area. This shows a section of the US 169 shoulder adjacent to the SB lane just south of Algona, where a thin layer of soapstock remained firmly on the shoulder. Another example is shown in Figure 21. The shoulder section was on US 18 near Garner with a thicker layer of soapstock on surface.

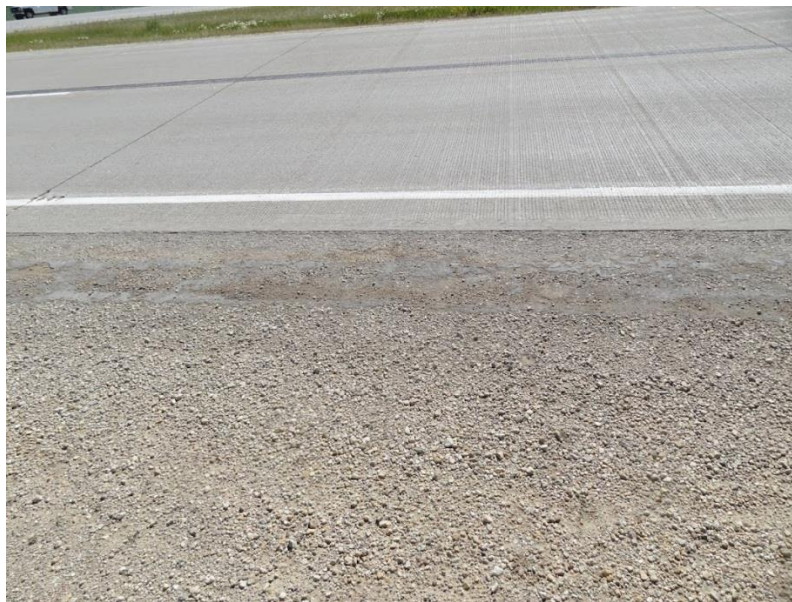
Figure 25. Southbound outside shoulder of US 63 near Denver, Iowa

Figure 24 provides an example of good shoulder performance for this area. This shows a shoulder section of IA 3 on adjacent to the EB lanes just east of Waverly, where a thick layer of soapstock remained firmly on the shoulder. Another example is shown in Figure 25. This shoulder section was on US 63 near Denver, where soapstock had penetrated into the shoulder and could not be seen easily.

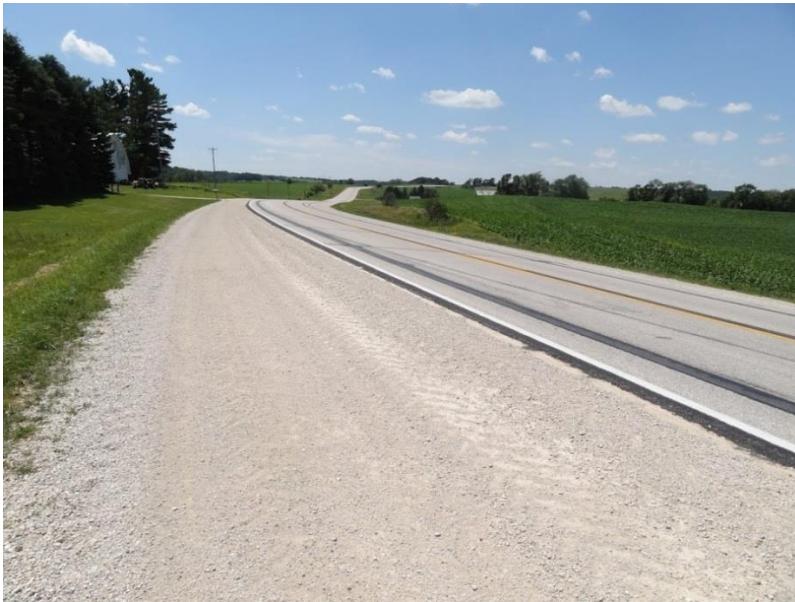
Figure 29. Shoulder of US 18 on eastbound west of Clermont, Iowa

Figure 28 shows one shoulder section of US 18 EB east of West Union. Although the shoulder had been regraded, the hard surface resulting from the soapstock could still be observed. Another example is shown in Figure 29. The shoulder was also along US 18, west of Clermont, where the whole section was regraded with new gravel.
