# Evaluation of the Buena Vista IBRD Bridge: A Furthering of Accelerated Bridge Construction in Iowa

### Final Report February 2012

**Institute for Transportation**

Iowa Highway Research Board (IHRB Project TR-605) Iowa Department of Transportation (InTrans Project 08-342)

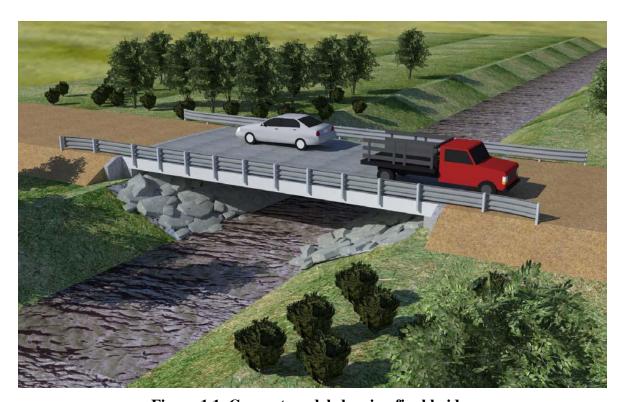
Figure 1.1. Concept model showing final bridge

The BVC Bridge is a nominal 50 ft long and 28 ft wide. (A complete set of plans for this bridge is included in Appendix A.) Several three-dimensional (3D) images were also created by Nielsen to assist the contractor in visualizing the accelerated bridge construction process. An overall view of the concept model of the bridge is shown in Figure 1.1.

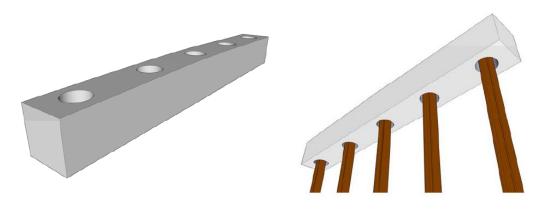
Figure 1.2. Schematic of precast abutment cap

Abutments were a combination of piling driven in the field (5 for each abutment) and precast abutment caps (3 ft x 3 ft x 28 ft), which were cast with five voids (21 in. in diameter to accommodate the piling (Figure 1.2a). The combination of the piling and precast abutment cap is shown in Figure 1.2b.

a.) Precast abutment

b.) Precast abutment on piles

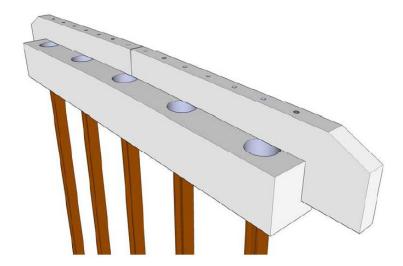
Figure 1.3. Precast backwall and abutment

Precast abutment caps were used on two previous accelerated bridge construction projects—one in Madison County (Phares et al. 2009) and one in Boone County (Klaiber et al. 2009). As a result of these successful applications, they were used on this bridge. This is, however, the first accelerated bridge project in which precast backwalls were used (Figure 1.3).

As shown in Figure 1.3, the precast backwall units were attached to the abutment caps with dowels. The backwalls were actually placed after the seven precast box beams (Figure 1.4) were set.

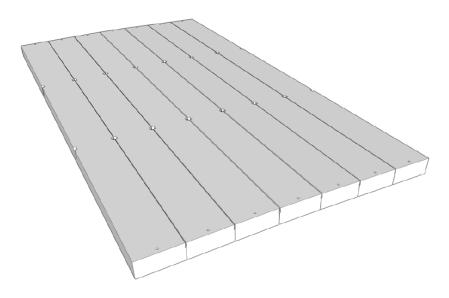
Figure 1.4. Voided slab precast deck beams

The box beam units (4 ft x 1 ft 9 in x 50 ft 10 in) were connected to the precast abutments with 1.5 in diameter dowels; they were connected transversely at the third points with 1 in. diameter thread rods.

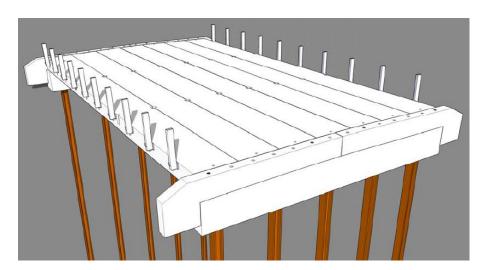
Figure 1.5. Guardrail posts

A schematic of the various precast elements assembled and the guardrail posts and piling are shown in Figure 1.5.

The guardrail posts were attached to the exterior box beams using anchor bolts that had been cast in these units. In this report, the terms box beam, deck beam, and simple beam have been used to describe the flexural elements.

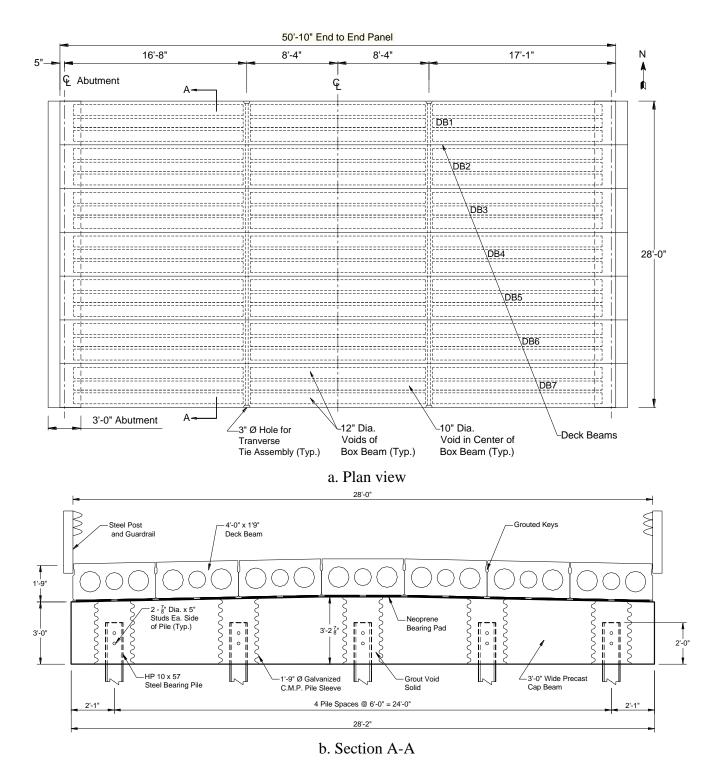
Figure 2.4. Plan and section of bridge

Overall dimensions of the bridge (shown in Figure 2.4) are out-to-out deck width of 28 ft and out-to-out length of 50 ft 10 in.

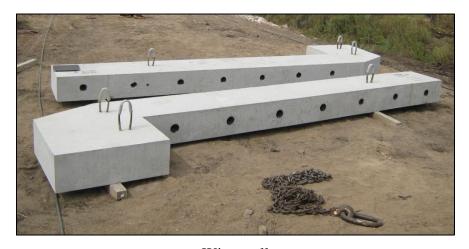
Figure 2.5. Abutment backwall details

As previously mentioned, this bridge had several precast elements: two abutment caps, four backwall segments, and seven precast, prestressed box beams. Details of the abutment backwalls are shown in Figure 2.5. Each backwall was comprised of two precast segments.

c. Wing wall segments

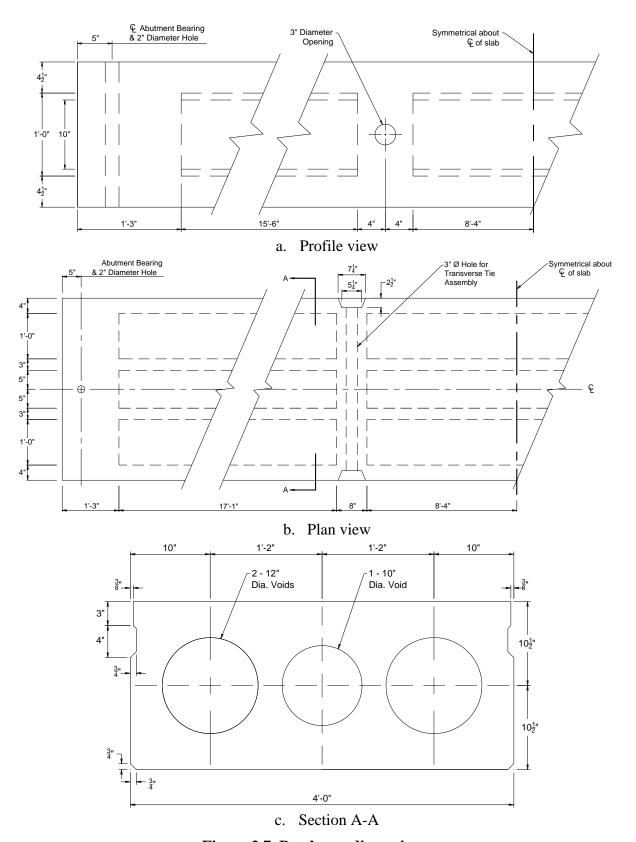
Figure 2.7. Box beam dimensions

Details on the seven box beams in the bridge are shown in Figures 2.7 and 2.8. Overall dimensions of the box beams, as shown in Figure 2.7, are 50 ft 10 in. long, 4 ft wide, and 21 in. deep. Each unit has three circular voids—two 12 in. in diameter and one 10 in. in diameter.

As shown in Figure 2.7a, the box beams were solid concrete 1 ft 3 in. from each end and for 8 in. around the two transverse tie regions. The 12 in. and 10 in. diameter voids created top and bottom slab thicknesses varying between 4 1/2 and 5 1/2 in., and a total nominal web thickness of 14 in., which is divided among the four webs that vary in thickness due to the circular voids.

Shear keys (4 in. x 3/4 in.) in the vertical faces of the box girders are shown in Figure 2.7c. As the purpose of the shear keys is to transfer a portion of the load between adjustment units, only interior beam units have shear keys in both vertical faces. The two exterior beams only have shear keys on their interior faces. However, exterior units do have inserts in the exterior face for attachment of the guardrails.

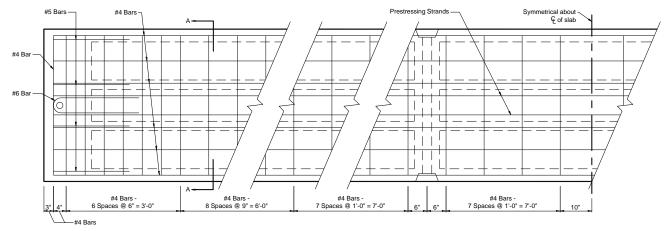
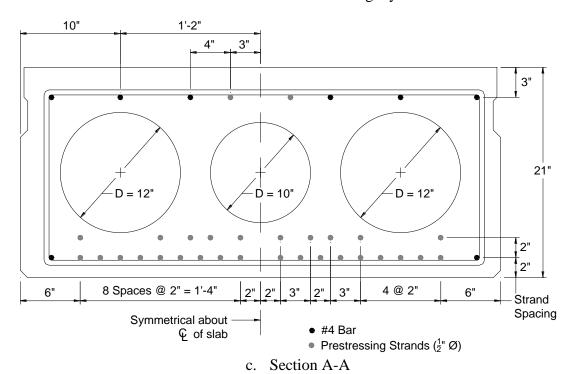
Figure 2.8. Box beam details

Reinforcement details for the box girders are shown in Figure 2.8. One-half inch diameter, seven-wire, uncoated, low-relaxation, prestressing strand plus mild #4 (Grade 60) reinforcing bars were used for the flexural reinforcement. Twenty-eight strands were in the bottom of the slab and two strands were in the top of the slab; and, a total initial prestress of 900.5 kips was applied to the straight strands.

Shear reinforcement consisted of overlapping #4 U-shaped bars. These stirrups were on 6 in. centers in the region 3 ft from the beam ends, then on 9 in. centers for the next 6 ft, and then on 12 in. centers in the remaining portion of the beams, except in the vicinity of the transverse tie where the spacing was reduced to 6 in. (see Figures 2.8a and 2.8b).

#### a. Top slab reinforcement

#### b. Profile view of reinforcing layout

As illustrated, the corner #4 bars, as well as the corner #4 bars in the bottom layer, were replaced with 1/2 in. diameter prestressing strand tensioned to 3,000 lbs. The reason for replacing the four #4 bars (shown in Figure 2.8c) was to create more rigidity at the corners to simplify tying the shear reinforcement. Thus, reinforcement in the top layer was four prestressing strands (two fully-stressed and two stressed to 3,000 lbs) and four #4 bars.

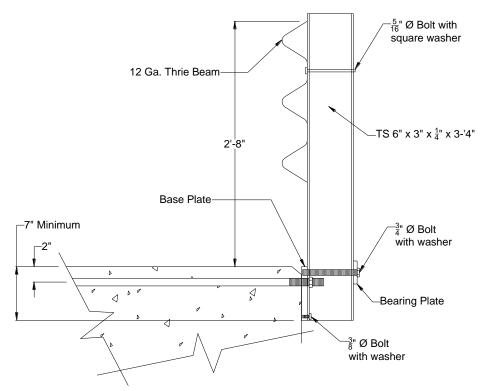
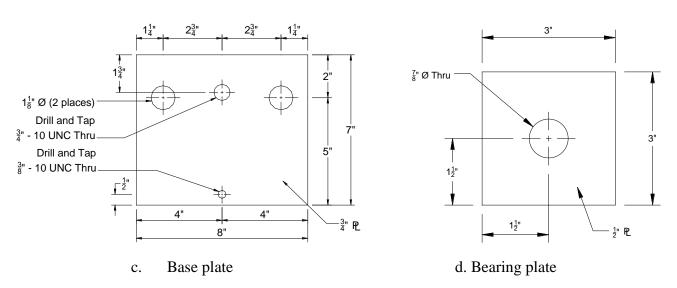
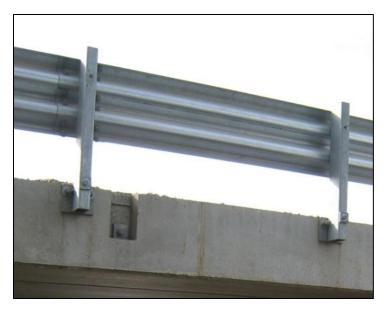
Figure 2.9. Box beam guardrail system

The two exterior box beams were fabricated with 1 in. diameter anchor bolts on their exterior sides for connecting the eight guardrail posts. The posts were spaced uniformly on 6 ft 3 in. centers as shown in Figure 2.9.

Two anchor bolts (spaced 2 3/4 in. off the post centerline) were required for attaching each post. Guardrail posts (3 ft 4 in. long) were fabricated from TS 6 x 3 x 1/4 in. sections; a 12 gauge thrie beam was used for the guardrail. Each post is connected to a 3/4 in. thick steel base plate (8 in. x 7 in.) with a 3/4 in. diameter A325 bolt and a 3/8 in. diameter bolt. This assembly was connected to the bridge using the two 1 in. diameter anchor bolts described previously.

#### a. Plan view of guardrail post spacing

b. Profile view of guardrail and connection

e. Guardrail system

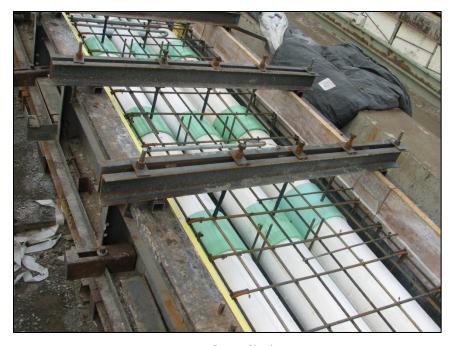
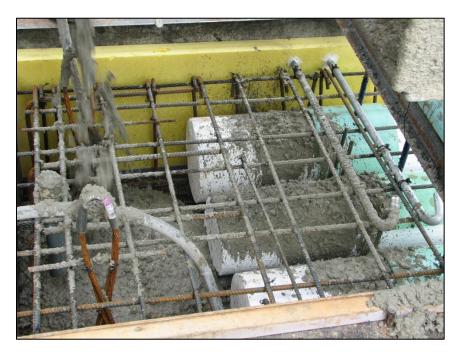
Figure 2.10. Box beam fabrication

As may be observed, concrete strengths in all elements exceeded the design target values. For convenience, box girders were cast two at a time in one prestressing bed with bulkheads separating the two girders. Because seven box girders were required for the project, only one girder was cast in one of the pours. Figure 2.10 shows the top reinforcement in the box beams.

a. Overall view

b. Placement of concrete in box beam forms

Also shown in this figure are the Styrofoam cylinders used to create the voids in the box girders. Hold-downs to keep the Styrofoam from floating are shown in Figure 2.10a. As shown in Figure 2.10b, the Styrofoam cylinders were terminated 1 ft 3 in. from the beam ends to create the solid beam ends. Two other items, which can be seen in Figure 2.10b, are the guardrail post anchor rods and the cable-lifting loops, which are cut off after the box beams are placed in the field.

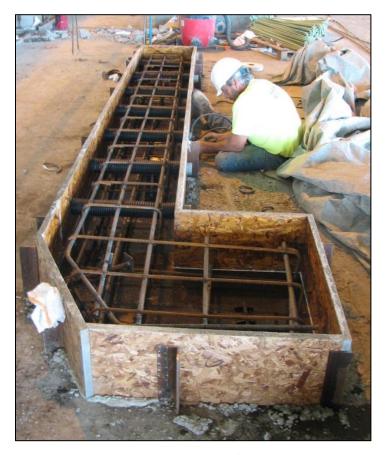
Figure 2.11. Backwall formwork

Backwall elements were cast one at a time; formwork, as well as the reinforcement for these elements, are shown in Figure 2.11. For installation, each of the backwall panels had three cable lifting loops and two screw inserts for additional lifting points.

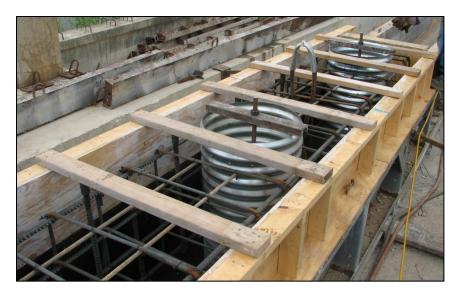
Figure 2.12. Abutment cap forms

The two abutment caps were also cast one at a time. Figure 2.12 shows the abutment cap form work, one of the two required cable lifting loops, reinforcement, and two of the five pieces of CMP, required to create voids for the piling.

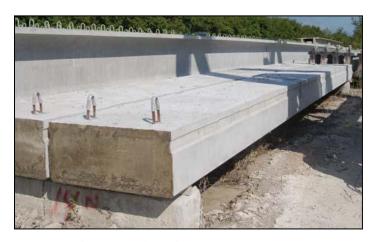
Figure 2.14. Voided precast beams

The fit between two adjacent box beams is shown in Figure 2.14. In this setup, the trueness of the elements, as well as the alignment of the transverse tie assembly, could be checked.

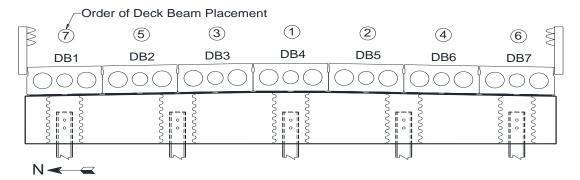
Figure 2.17. Order of box beam placement

The superstructure and guardrail installations (except for approach guardrails) were completed in one day (September 14, 2009). The order of the precast beam placement is shown in Figure 2.17; as can be seen in the middle box beam (Bm #4) was placed first and the two exterior beams (Bms #1 and #7) were placed last.

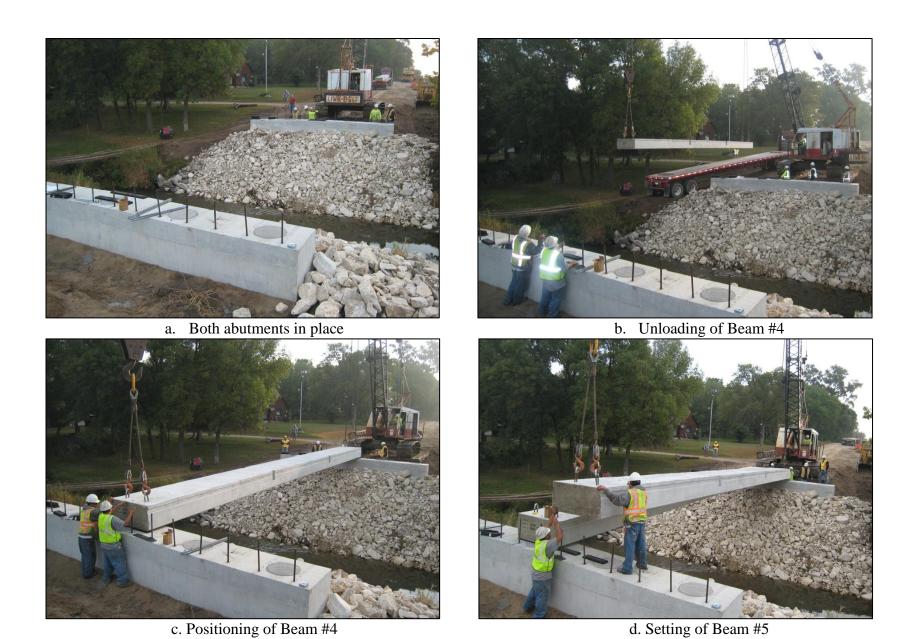
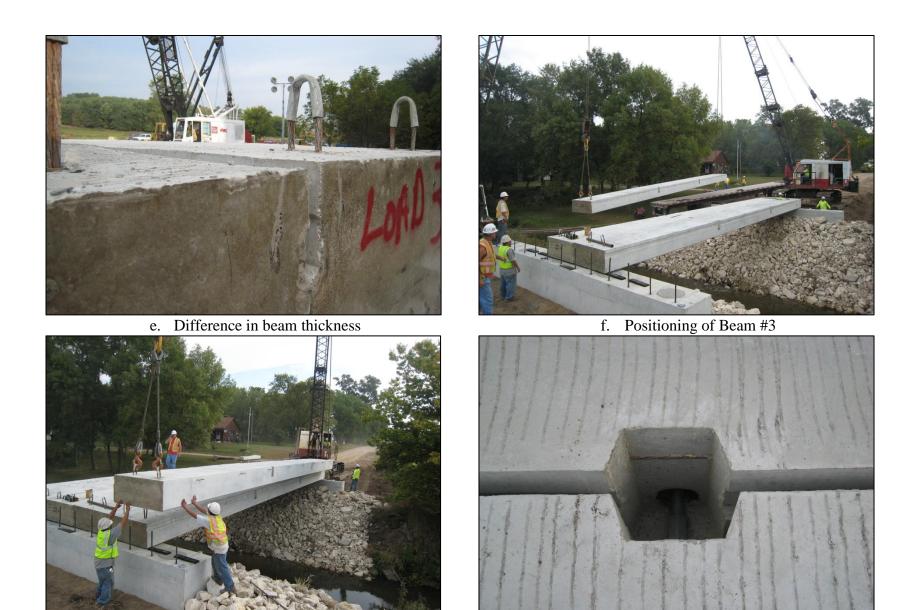
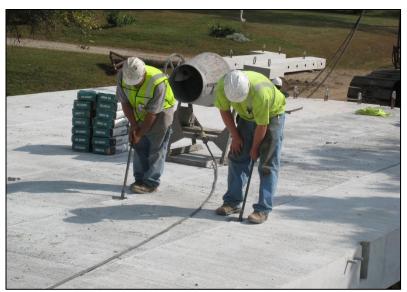
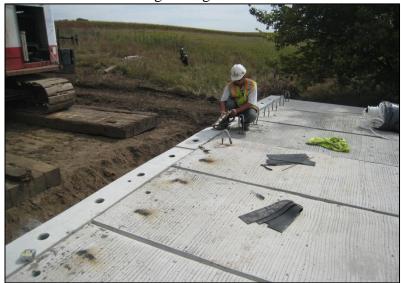
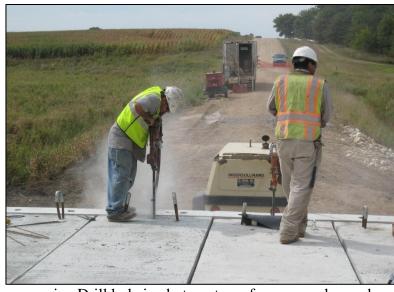
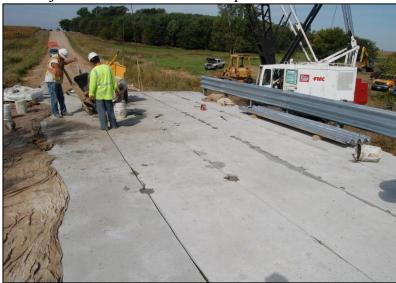
Figure 2.18. Construction of the superstructure

Two backwall sections were transported on Truck #4 and two on Truck #5. Upon arrival at the project site, they were unloaded and placed on dunnage until installation. Images of the various steps completed during the construction of the superstructure are shown in Figure 2.18. Details of the steps are described briefly in Table 2.4.

g. Positioning of exterior Beam #7

h. Tie rod block out

i. Tightening interior tie rods

k. Cutting off beam lift cables

j. Drill hole in abutment cap for new anchor rods

1. Placement of non-shrink grout

1	Workers shown placing non-shrink, non- metallic grout (NS Grout manufactured by The Euclid Chemical Company) in the joints between the adjacent beams and the pockets required for tightening the transverse tie assembly. Prior to placement of the grout, polystyrene backer rod was placed in the joint where required. Note the joint between Beams 6 and 7 has been completed and has been covered with wet burlap for curing.

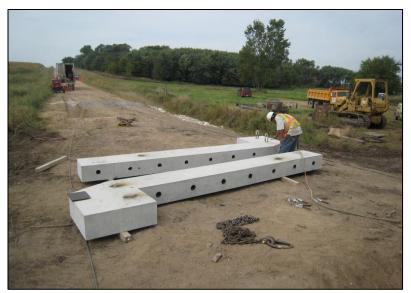
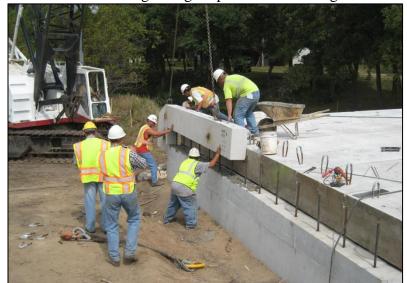
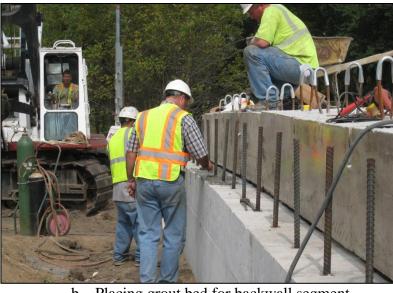
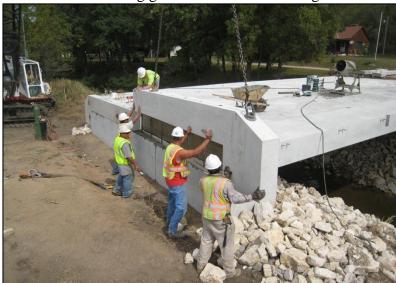
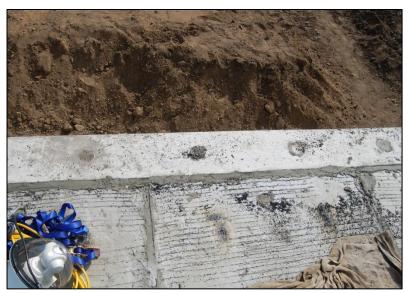
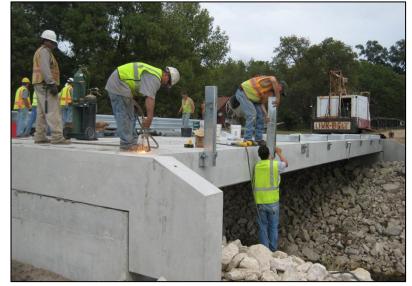
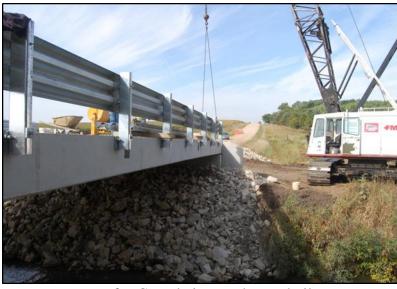
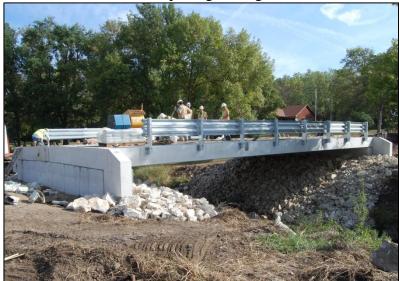
Figure 2.19. Installation of precast backwalls and guardrail system

Details on the installation of the backwalls and guardrails are presented in Figure 2.19 and Table 2.5.

a. Removing lifting loops on backwall segments

c. Placement of a backwall segment

b. Placing grout bed for backwall segment

d. Placement of second backwall segment at west end

e. Grouting of various voids and joints

g. Installation of guardrail post on south side of bridge
Figure 2.19 Continued

f. Completing north guardrail

h. "Completed" bridge

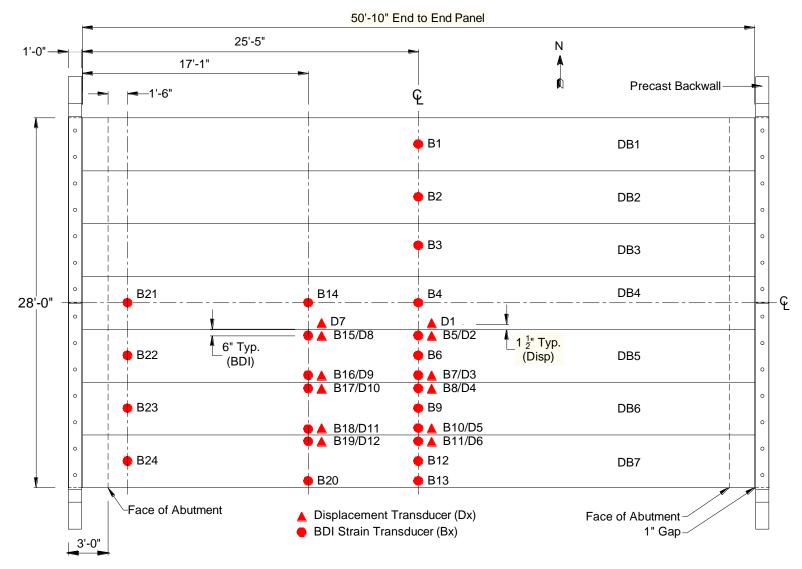
Figure 3.1. Instrumentation layout

a. 2009 Instrumentation

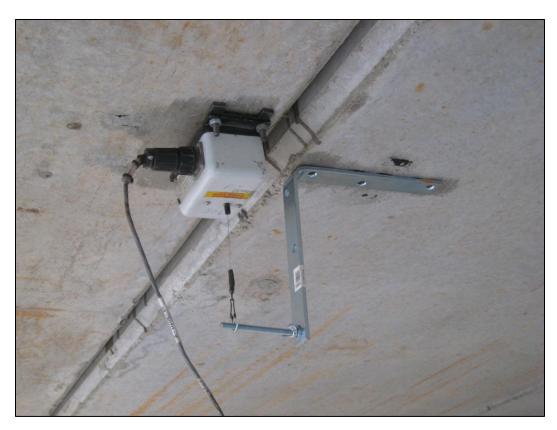
Figure 3.2. Relative displacement transducer between DBs 5 and  $\boldsymbol{6}$

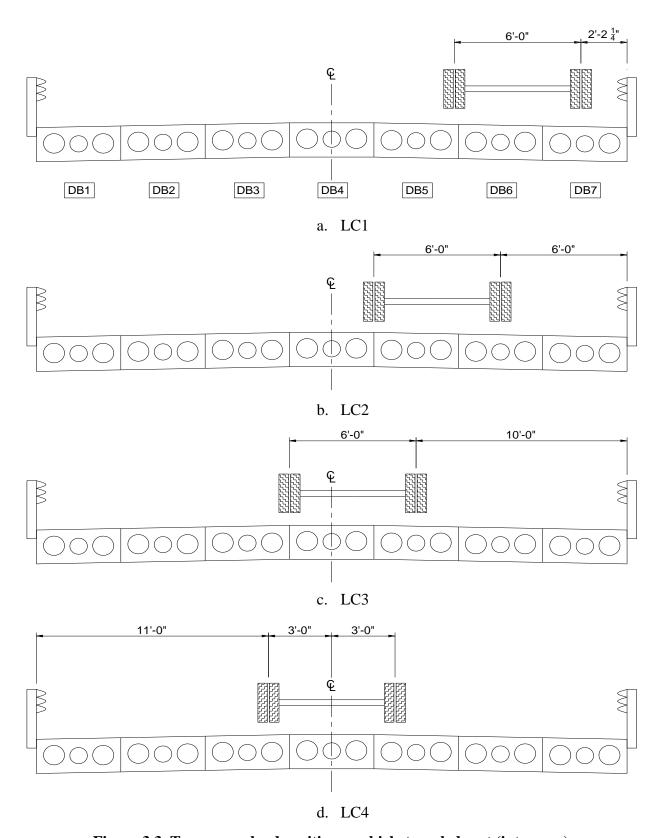
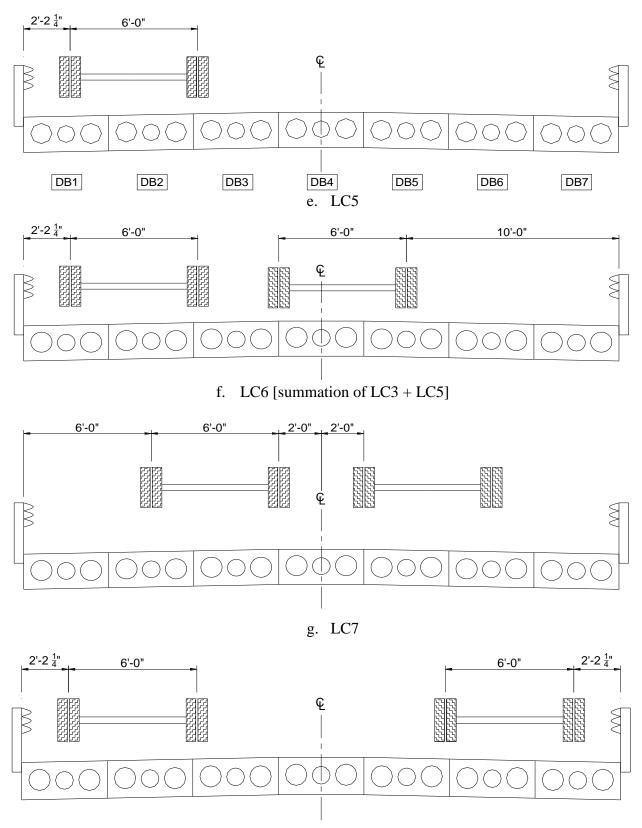
Figure 3.3. Transverse load positions: vehicle traveled east (into page)

A total of seven load cases, shown in Figure 3.3 (LC1 through LC7), in which the transverse position of the truck(s) was varied, were used in 2009. Note that in LC6 and LC7, there were two trucks on the bridge. In the 2010 tests, the same load cases (shown in Figure 3.3) were used, except that LC6 was omitted.

h. LC8 (2009, 2010: [summation of LC1 + LC5]) **Figure 3.3. Continued**

As noted previously, only static tests were performed (slow moving truck when one truck was on the bridge and stationary trucks when two trucks were on the bridge) each year on the bridge. In Figure 3.3, eight load cases are shown: five cases with one truck on the bridge and three cases with two trucks on the bridge. In 2010, LC6 was not ran and results for this load case were obtained by adding the results from 2010 LC3 and LC5.

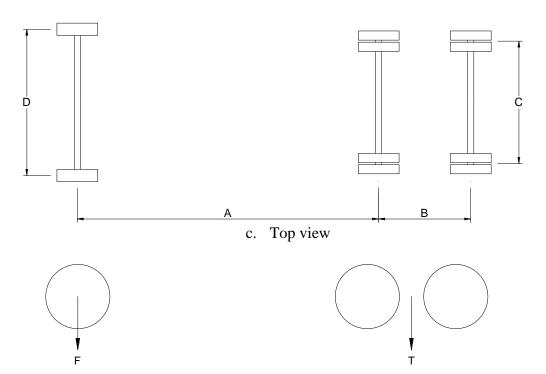
a. Truck 28

b. Truck 13 (same as Truck 12)

d. Side view

Dimen	sions	]	Load (lbs	)	
Year	Truck	A	В	C	D	F	T	Gross
2009	28	14'-9"	4'-6"	6'-0"	7'-2"	18,800	38,140	56,940
2009	13	15-2"	4'-5"	6'-0"	7'-2"	17,600	37,820	55,420
2010	28	14'-9"	4'-6"	6'-0"	7'-2"	17,000	39,340	56,380
	12	15-2"	4'-5"	6'-0"	7'-2"	17,540	41,000	58,540

Figure 3.4. Dimensions and weights of test trucks used in 2009 and 2010 bridge field tests

The dimensions and weights of the test trucks used each year are presented in Figure 3.4. Truck 28 was used both years and was the truck used in the single truck load cases (LC1-LC5). Based on total weight, the weight of the truck was approximately the same each year; however, there was some difference in the axle weight distribution.

In 2009, Truck 13 was the second truck on the bridge in LC6 and LC7, while, in 2010, Truck 12 was used with Truck 28 in the two truck load tests (LC7). As Figure 3.4 shows, Truck 12's weight (used in the 2010 test) was about 3,000 lbs greater than Truck 13 (used in the 2009 test); however, the axle spacing in the two trucks is the same. An image of the two trucks on the bridge during LC7 in 2010 is shown in Figure 3.5.

Considering the slight difference in the truck weights between 2009 and 2010 (Figure 3.4) and the variation in the transverse distribution of the gravel in the trucks used in the 16 different tests (eight in 2009 and eight in 2010), there is very good agreement in the magnitudes of strains measured each year, as well as their distribution in the seven box beams.

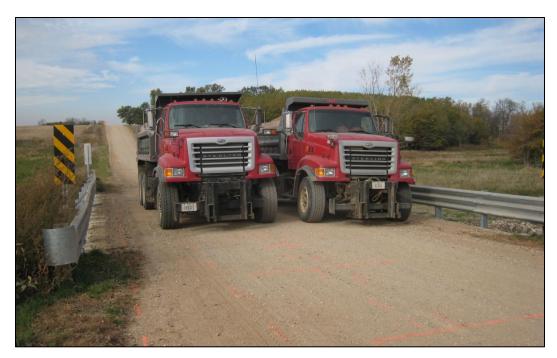
Figure 3.5. Trucks on bridge during 2010 LC7 test

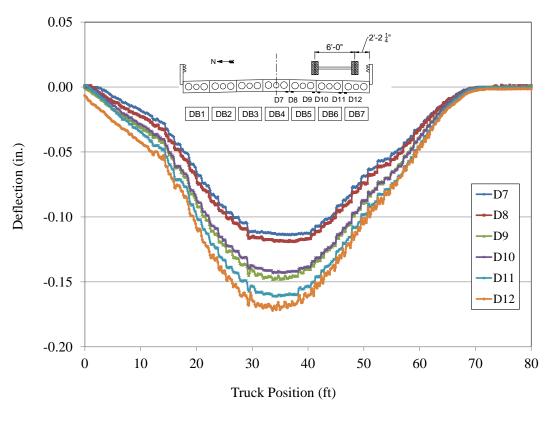
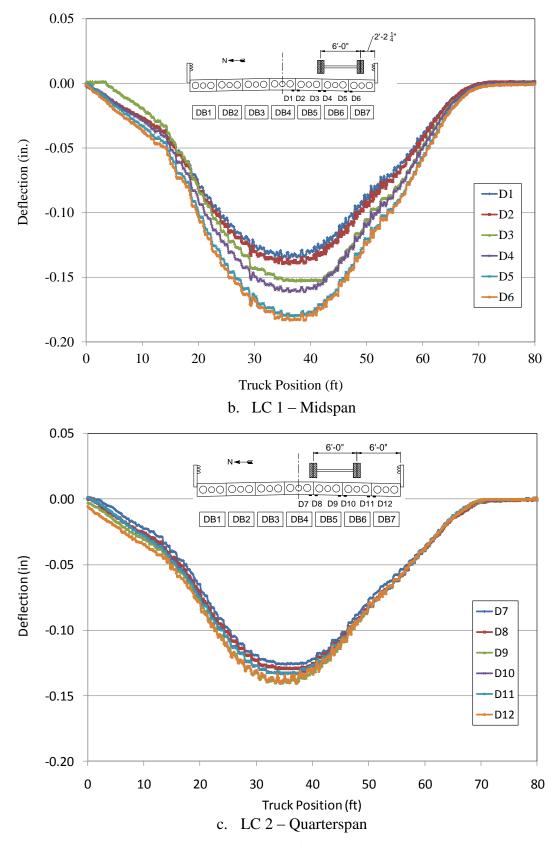
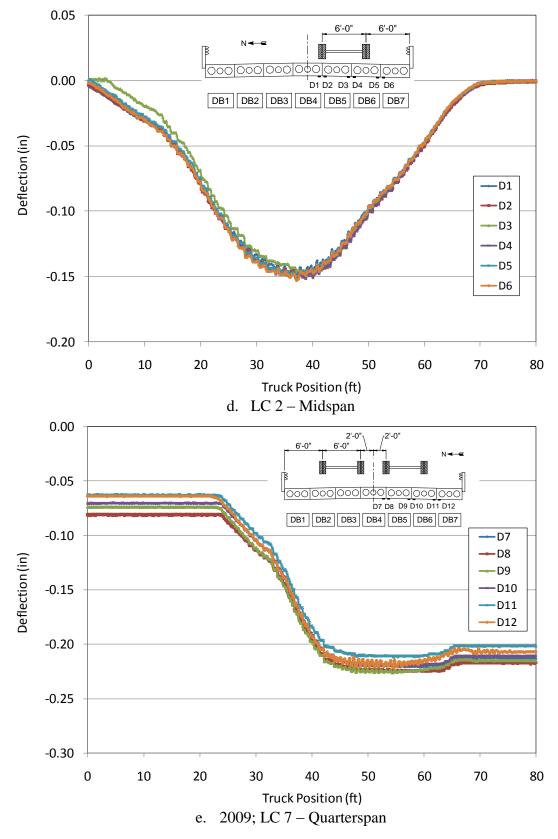
The various time history plots show deflections at midspan and quarter span at the edges of deck beams DB4, DB5, DB6, and DB7. With these data, the differential deflection between the four deck beams can be determined. A review of this deflection data indicates the differential movement between the adjacent deck beams for LC2 and LC7 is very small. In general, the deck beams that had the largest deflections were located closest to the applied load.

a. LC 1 – Quarterspan

Figure 4.1. Representative time history – 2009 deflections

Representative time-history deflections for 2009 LC1, LC2, and LC7 are presented in Figure 4.1.

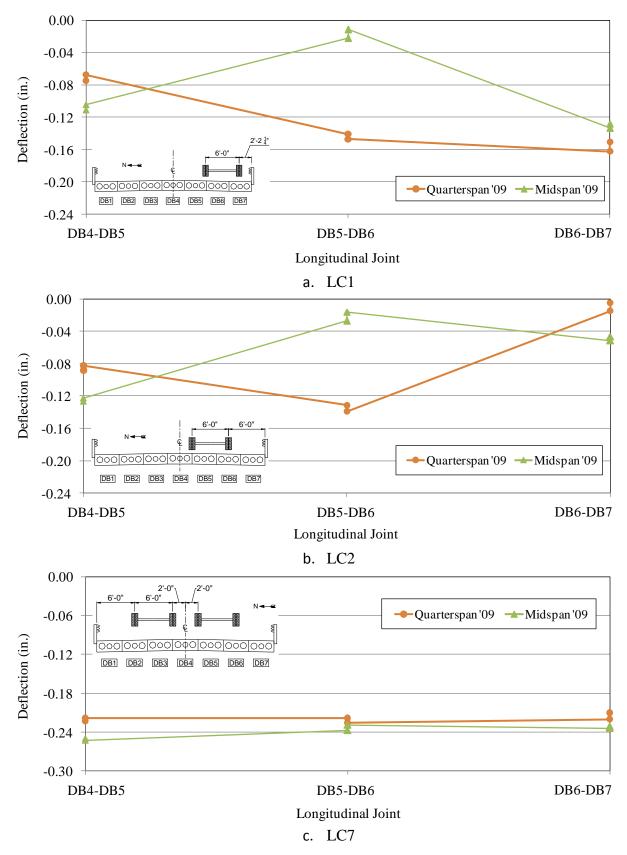
As noted previously, LC1 and LC7 produced the maximum deflections for one and two trucks, respectively. Transverse load distribution is evident as shown in this figure, as the deck beams adjacent to directly-loaded deck beams also deflect, creating a continuous deflected shape. Although not the actual behavior, for illustration, the various deflection points have been connected with straight lines.

Figure 4.2. 2009 Transverse deflected shape at midspan and quarterspan

Partial (since displacements were only measured on one-half of the bridge) transverse deflections for the same three load cases (LC1, LC2, and LC7) are presented in Figure 4.2.

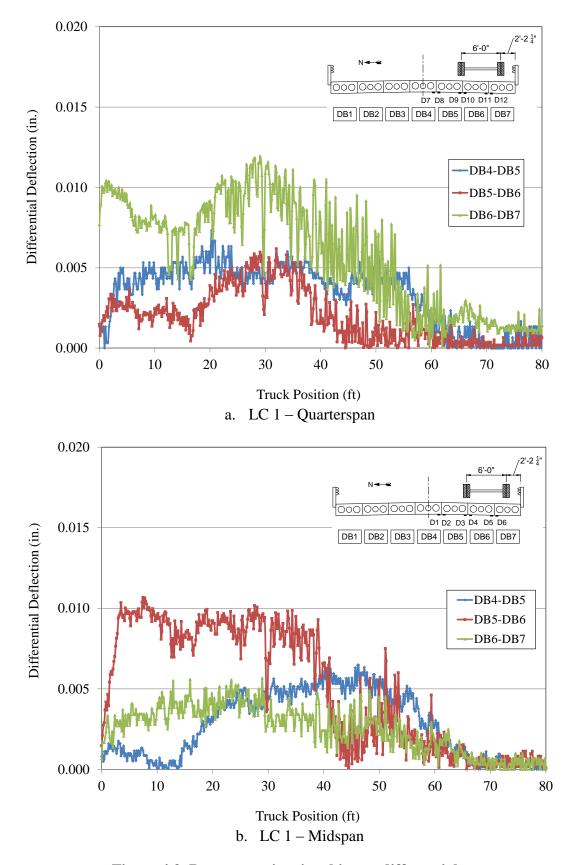
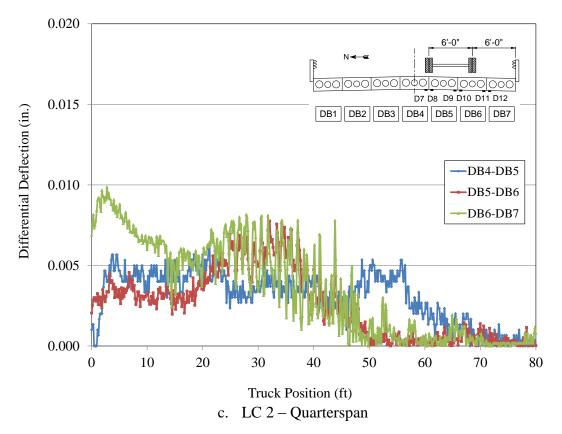
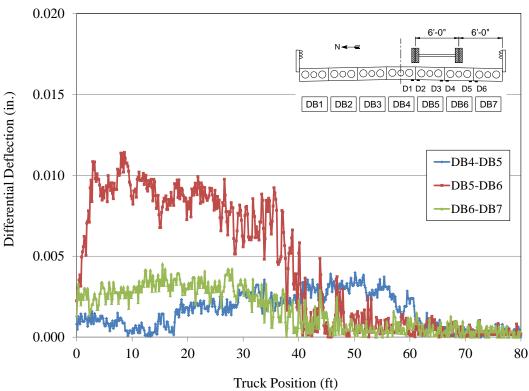
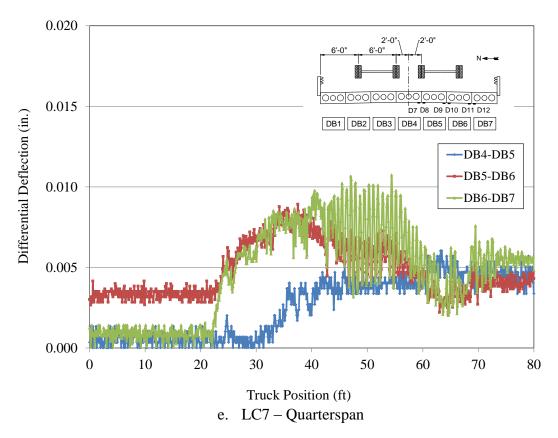
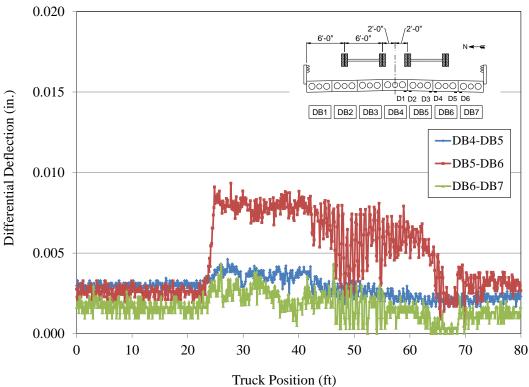
Figure 4.3. Representative time history differentials

d. LC 2 – Midspan

f. LC7 - Midspan

Differential movements that occurred during the 2009 load tests for LC1, LC2, and LC7 (representative load cases), at the quarterspan and the midspan are presented in Figure 4.3. Maximum values shown in these figures are presented in Table 4.2.

In 2010, the transducer (shown in Figure 3.2), which measures differential displacements between adjacent units, was used to determine differential displacements directly. When reviewing the data in Figure 4.3, note that two different vertical scales were used.

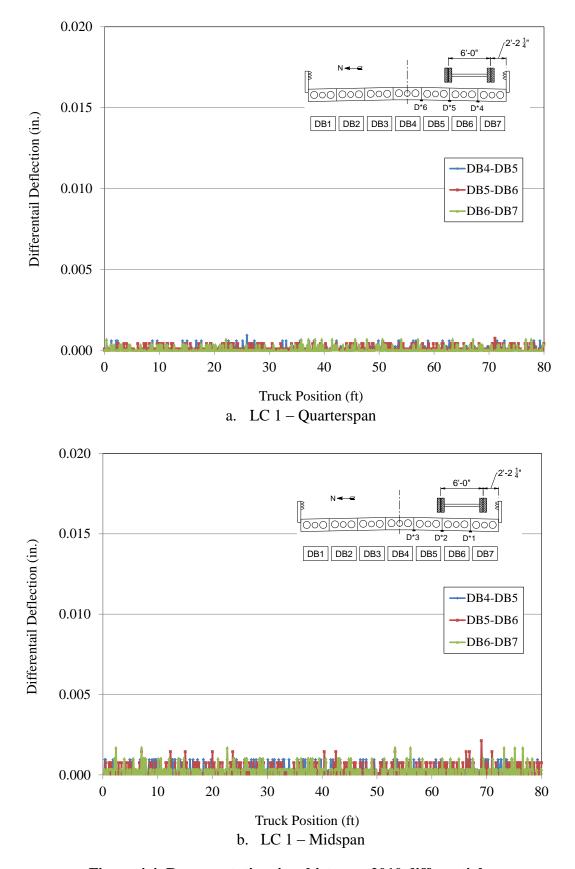
Figure 4.4. Representative time history – 2010 differentials

As was noted previously, the differential movements measured during the bridge test in 2010 were very small (approximately 1/10 the values measured during the 2009 tests. For this reason, only the 2010 differential movements measured during one load case, LC1, are presented in this report (see Figure 4.4).

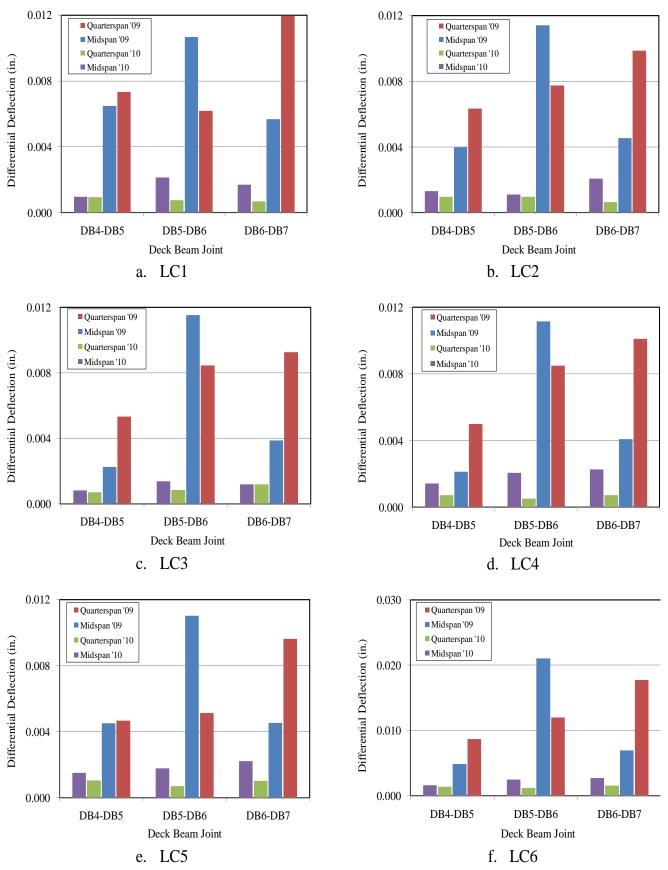
Figure 4.5 presents the absolute maximum differential deflections at midspan and quarterspan for each of the 2009 and 2010 load cases. Given the differential deflections were so small and the variation in truck weights from year to year were also small, direct comparison of differential displacements were made without normalizing for the truck weight differences.

Figure 4.5. 2009 and 2010 Differential deflections

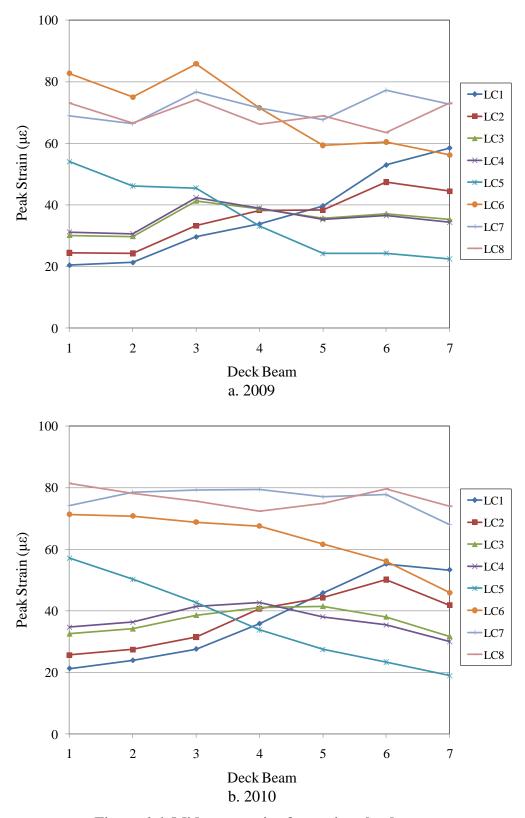
Distributions of midspan box beam strains measured in the seven box beams for each of the eight load cases completed in 2009 and 2010 are shown in Figure 4.6.

Figure 4.6. Midspan strains for various load cases

A review of the strains measured in 2009 indicates that, more than likely, there was a problem with the BDI or its installation on DB3 and DB5. Maximum values observed in this figure were tabulated and shown previously in Tables 4.4 and 4.5 (2009 and 2010 test data, respectively).

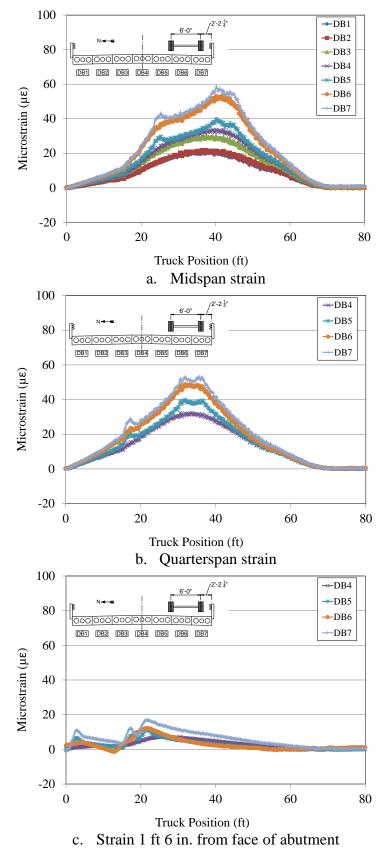
Distribution of box beam strains for a representative load case, LC1, as the test vehicle crosses the bridge are presented in Figures 4.7 and 4.8 for the 2009 and 2010 tests, respectively. In 2009, three sections were instrumented: midspan (Figure 4.7a), quarterspan (Figure 4.7b), and near the bridge end (1 ft 6 in. from the face of the abutment in Figure 4.7c).

Figure 4.7. 2009 Experimental strains for LC1

A review of the strains in the box beams instrumented (DB4, DB5, DB6, and DB7) – small tensile strains – indicated minimal end restraint. It is interesting to note that the magnitude of strains measured each year were essentially the same although maximum values in 2010 occurred when the truck's front axle was approximately 10 ft farther from the end of the bridge.

Similar results were seen at midspan (Figures 4.7a and 4.8a), with essentially the same magnitude of strain occurring in 2009 and 2010; however, the maximum strain in 2010 occurred when the truck was approximately 10 ft farther from the end of the bridge. The only possible explanation the researchers have for this behavior is there may have been an error in determining the location of the truck on the bridge in 2009 or 2010.

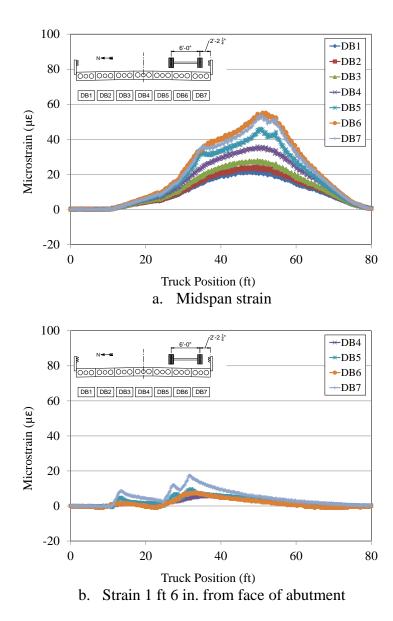
In 2010, two sections were instrumented: midspan (Figure 4.8a) and near the end (as in 2009, 1 ft 6 in. from the face of the abutment in Figure 4.8b). The end span sections were instrumented to determine if there was significant end restraint due to construction details.

Figure 4.8. 2010 Experimental strains for LC1

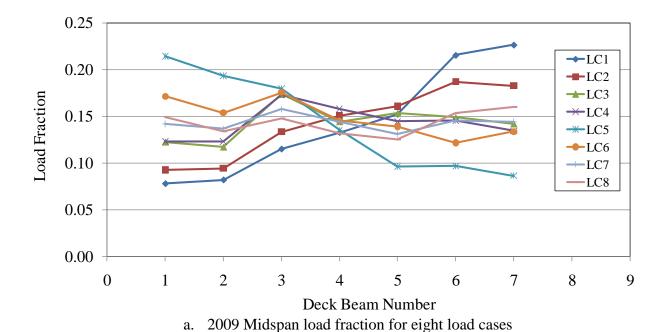
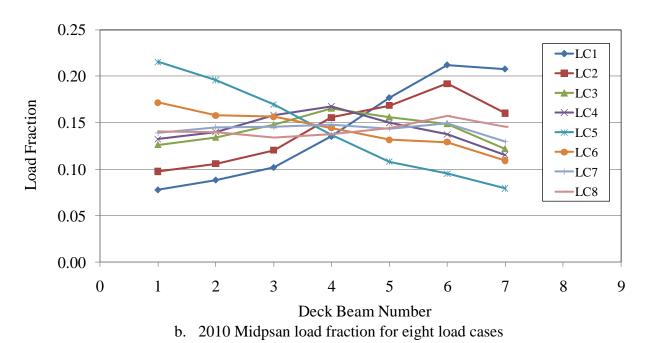
The load fractions determined for the 2009 and 2010 tests are shown in Figure 4.9.

Figure 4.9. Experimentally-determined load fractions

The largest load fraction (0.23) in 2009 occurred in DB7 while the smallest load fraction (0.07) occurred in DB1. Both of these values occurred during LC1.

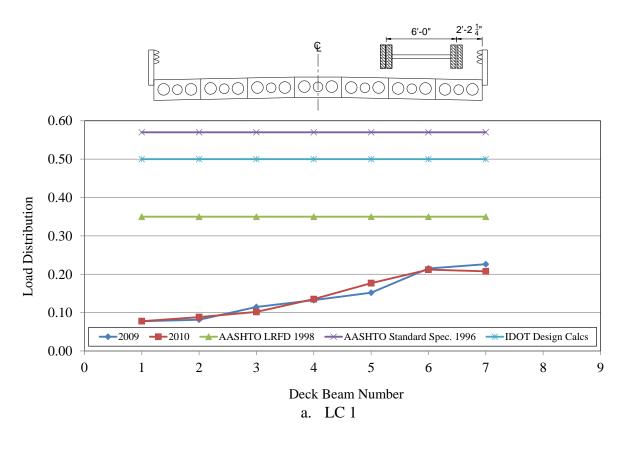
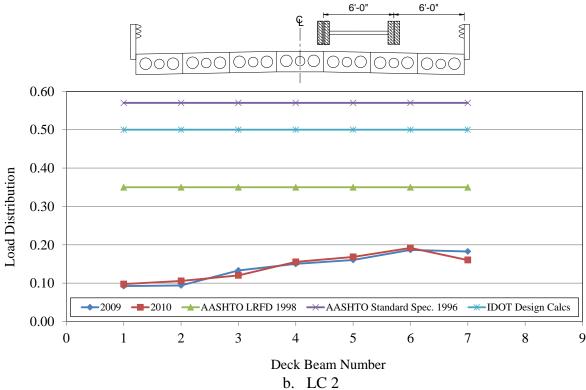
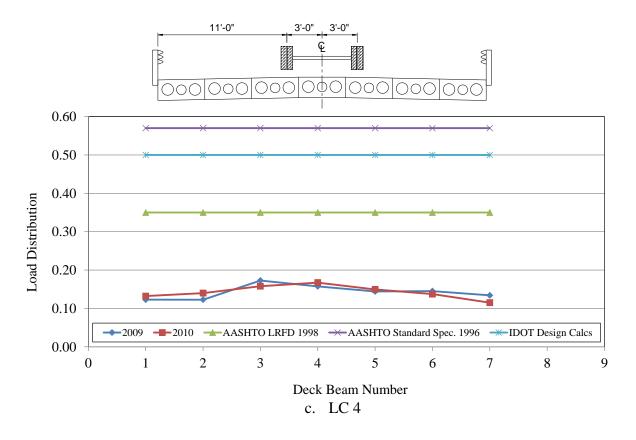
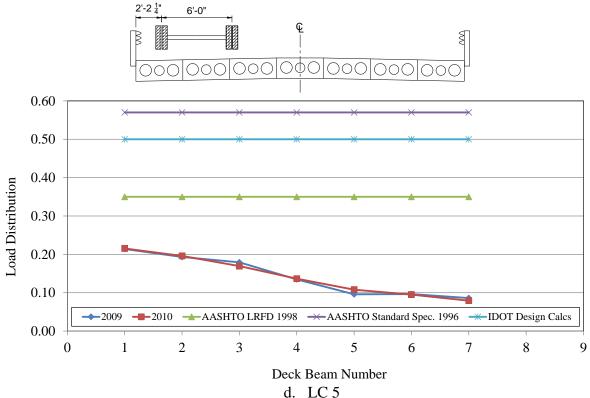
Representative load fraction determined for one truck on the bridge for LC1, LC2, and LC5 are compared to code values, and the values used by the Iowa DOT in their design calculations in Figure 4.10. As shown, the values determined using experimental data are significantly smaller than the code and design calculation values.

Figure 4.10. Experimental and codified load distributions for one truck on bridge

As shown in Figure 4.10, there is excellent agreement between the distribution results obtained in 2009 and 2010 for the three load cases in the figure. Although the results for the other load cases have not been included in this report, there was excellent agreement between values from the two years.

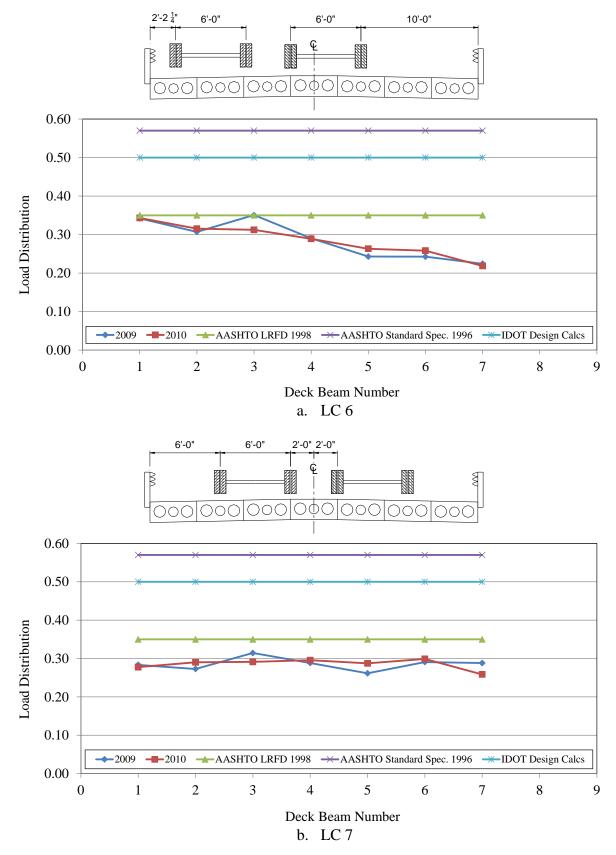
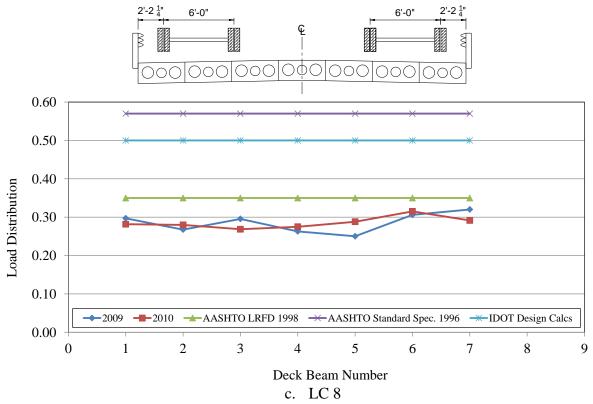
To obtain an approximation of lane load distribution, data from two trucks on the bridge were used. In 2009, this involved LC6 and LC7. Data for LC8 (shown in Figure 3.3) was obtained by adding the results from LC1 and LC5. In 2010, only LC7 was actually completed in the field. Results for LC6 and LC8 were obtained by adding the results for having one truck on the bridge (LC6 = LC3 + LC5; LC8 = LC1 + LC5). Load fraction for these three combination load cases are shown in Figure 4.11.

Figure 4.11. Experimental and codified load distribution for lane loading

In this figure, as was the case in Figure 4.10, the experimental values obtained in 2009 and 2010, which are essentially the same, are compared to the design values used by the Iowa DOT, code distribution factors from the 1998 AASHTO LRFD, and code distribution factors from the 1996 AASHTO standard specifications.

A review of the three graphs in this figure (i.e., comparing the experimental values, AASHTO values, and the Iowa DOT values) show the bridge's performance is conservative.
