# DEVELOPMENT OF BRIDGE LOAD TESTING PROCESS FOR LOAD EVALUATION

Iowa DOT Project TR-445  
CTRE Project 00-65

Final Report • April 2003

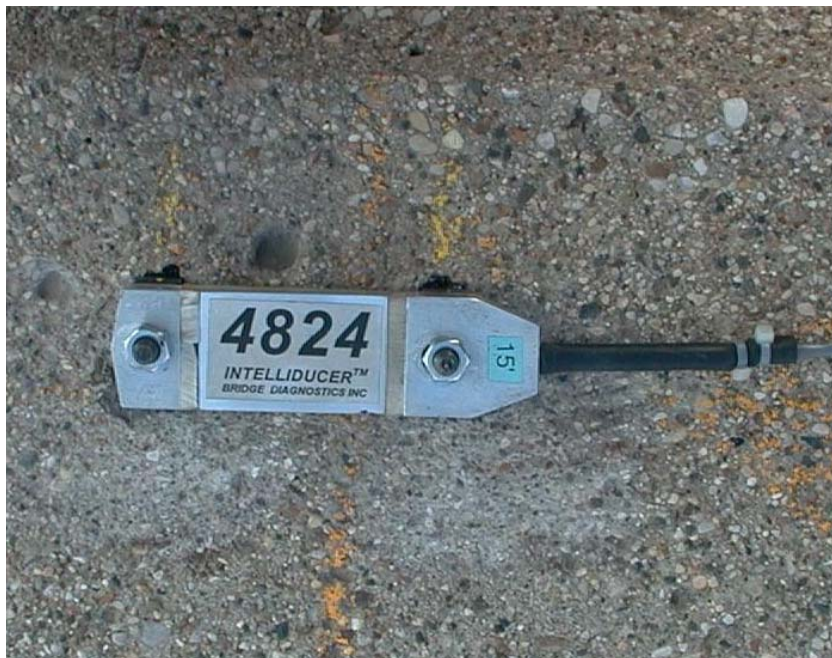
Figure 3.1. A BDI Intelliducer in use on top of a concrete curb.

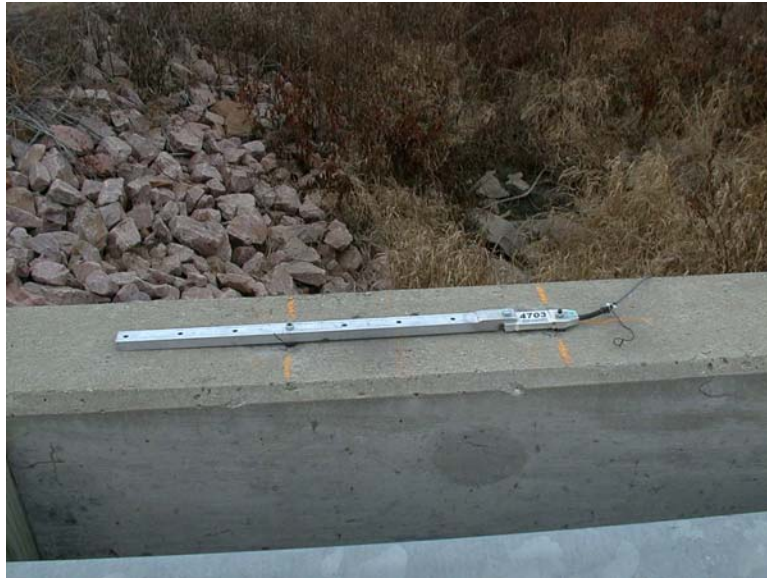
For gage placement on reinforced concrete structures, gage extensions should be implemented (see Fig. 3.2) to increase the 3-inch gage length; the longer length enables surface strains to be averaged over a greater distance, thus reducing the effects of cracks in the concrete. BDI has prescribed a set of standards for the use of gage extensions. A gage length of  $1.0 \times d$ , where  $d$  is the member depth, and  $L/20$ , where  $L$  is the span length, are given as lower and upper bounds, respectively, for reinforced concrete slabs and rectangular beams. For T-beams, the lower and upper bounds are given as  $1.5 \times d$  and  $L/20$ , respectively.

Figure 3.2. An Intelliducer with gage extensions in use.

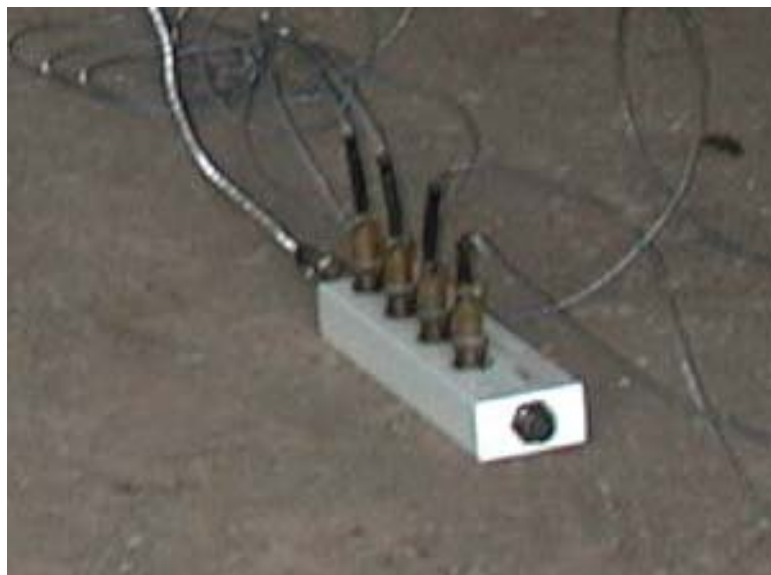
Figure 3.3. BDI STS Units in use during a load test.

The BDI STS Unit, shown in Fig. 3.3, transfers the data collected from the Intelliducers to the Power Unit (described in the following section). Each STS Unit is capable of collecting data from four Intelliducers. An STS Unit has the capability of storing 50,000 data points during a single test. At the conclusion of a test, the data are transferred to the Power Unit (described subsequently).

Each STS Unit measures 2.3 in. x 3.0 in. x 11.0 in. and weighs 1.8 lbs. The unit is equipped with six connection points, four transducer connections, a “line out”, and a “line in”. All of the connections are quick-lock, military-style. The “line out” or P/C end of the unit transmits data to the Power Unit and P/C. The “line in” connection is designed to attach to other units in series and/or parallel through the use of Y-cables. This wiring configuration is a significant advantage over traditional transducer wiring in that only a single cable is connected to the Power Unit.

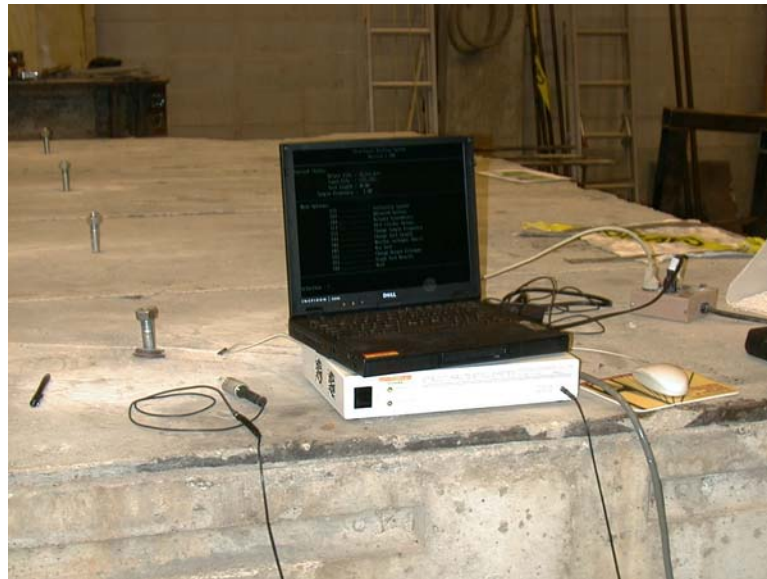
Figure 3.4. BDI Power Unit connected and ready for use.

The Power Unit, shown in Fig. 3.4, powers the intelliducers and transmits commands to the system during the test. Each transducer requires a 5-volt excitation voltage that is provided by the Power Unit. The unit has the ability to operate under two different energy sources, DC current from an automobile battery or AC current from a small portable generator or inverter.

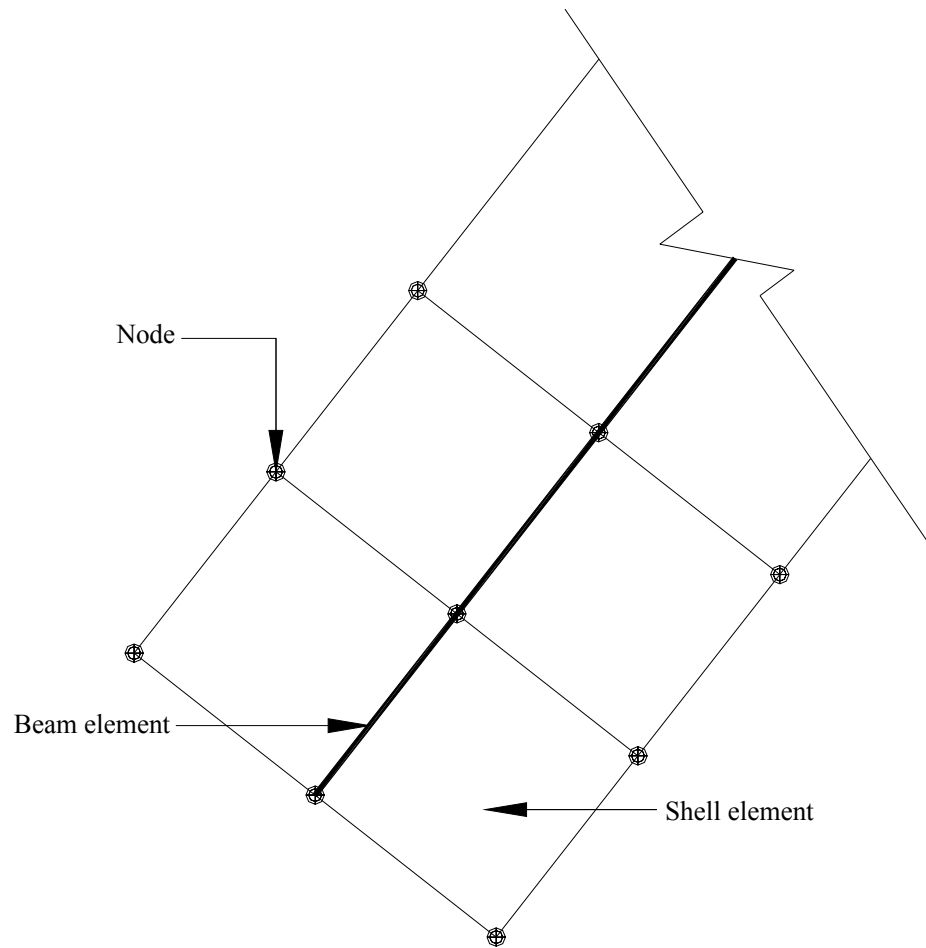
Figure 3.7. Schematic of typical mesh generated with WinGEN.

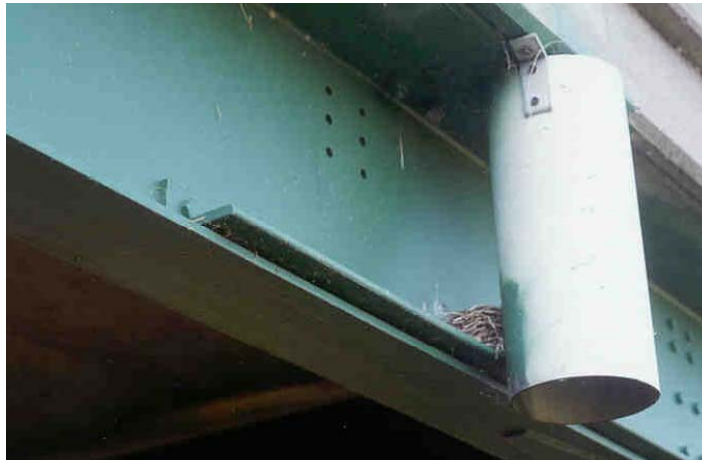
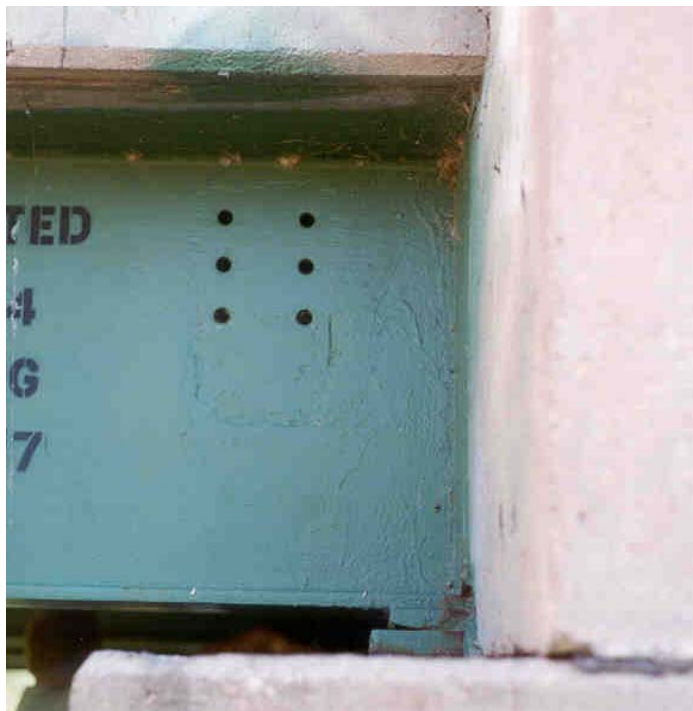
Figure 4.1. Cedar Creek Bridge: Photographs provided by BDI .

a. Exterior beam at midspan.

b. Abutment.

The deck consists of a Portland Cement (P.C.) overlay and a reinforced concrete-slab deck slightly arched in a parabolic curve with an average thickness of 8.29 in. The superstructure is comprised of two exterior and two interior girders (primary members) and two diaphragm lines (secondary members). The substructure is a reinforced concrete abutment with fixed steel bearings and a reinforced-concrete backwall (shown in Fig. 4.1b). The exterior girders (shown in Figs. 4.4a and 4.4b) consist of two different sections. Over the center 26 ft – 11 in. there is an angle bolted to the outside of the web and a cover-plate welded to the bottom flange. The interior girders (shown in Figs. 4.4c and 4.4d) also consist of two different sections; the section at midspan includes a 26 ft – 11 in. long cover-plate. All girders were instrumented at sections 2 ft from the abutment centerline and at midspan as shown in Fig. 4.2. Each instrumented section had a gage installed on the bottom surface of the top and bottom flanges as shown in Fig. 4.4 (six gages were installed on each girder for a total of 24 gages on the bridge).

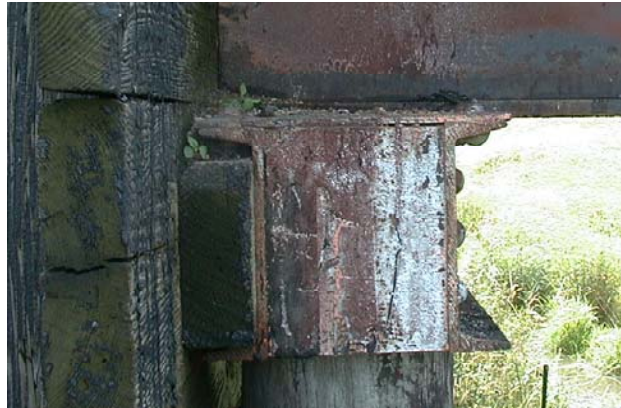
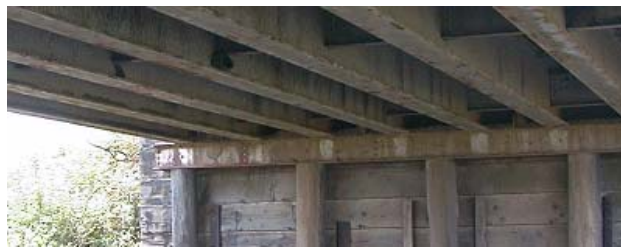
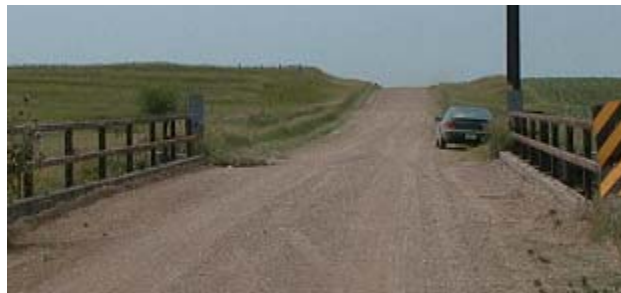
Figure 4.6. Photographs of Bridge #1.

a. Abutment.

b. Girders and the West side of abutment.

c. End view of bridge.

Bridge #1, Boone County Bridge #99, located in western Boone County, IA, is a non-composite, simple-span, steel-girder bridge with a timber deck and no skew carrying 230th Street over a small stream (half a mile East of D. Ave.). Based on a cursory visual inspection and photographic documentation (shown in Fig. 4.6), all steel-girders and the timber deck appear to be in good condition. As can be seen in Fig. 4.6a, it was anticipated that the bridge would not exhibit significant end restraint as the beams are not integral with the abutments. This bridge, shown in plan view in Fig. 4.7 and in cross-section in Fig. 4.8, has a span length of 44 ft – 8 in. from centerline to centerline of abutment bearings with a roadway width of 19 ft and an overall width of 19 ft – 8 in. (one 12 ft traffic lane and two 3 ft – 6 in. shoulders).

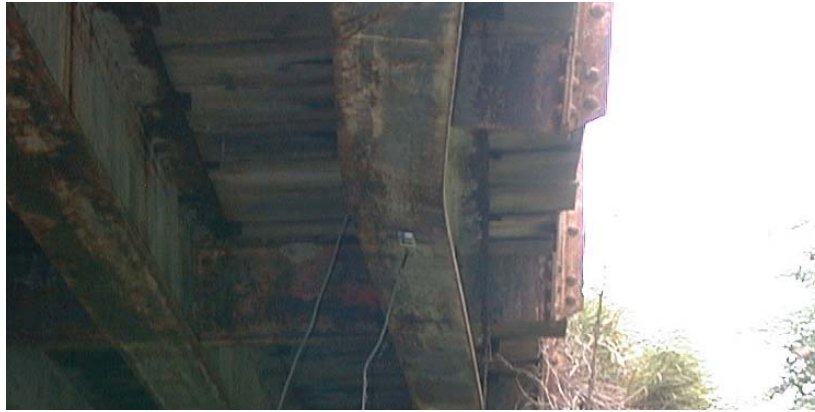
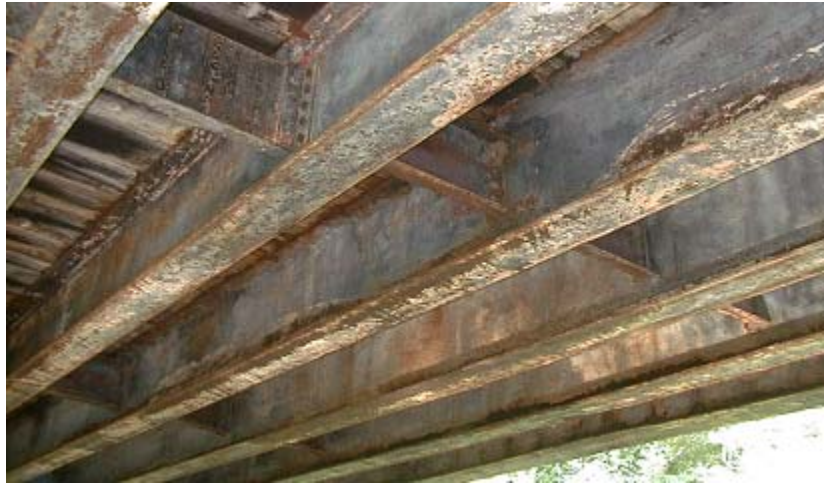
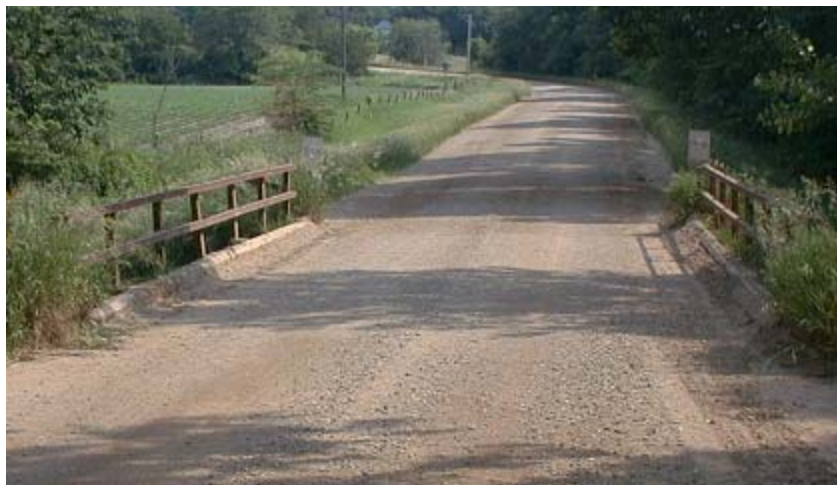
Figure 4.10. Bridge #2: Photographs of the bridge.

a. Bent girder on far West side at midspan.

b. Girders on East side at midspan.

c. End view of the bridge.

Bridge #2, Boone County Bridge #11, located in northern Boone County, IA, is a non-composite, simple-span, steel-girder bridge with a timber deck and no skew carrying L Rd. over a small stream one mile North of 130th Street. Based on a cursory visual inspection and photographic documentation, all steel-girders except one appeared to be, with the exception of some light rust, in good condition. The girder on the far West side was bent at midspan (possibly hit by a large object during a flood). The timber deck is in good condition. Photographs of the bridge including the damaged girder are illustrated in Fig. 4.10, where Fig. 4.10a shows the damaged girder section at midspan, Fig. 4.10b illustrates the superstructure system at midspan, and Fig. 4.10c shows the end view of the bridge. It was anticipated that the bridge would not exhibit significant end restraint as the beams are not integral with the abutments (the same conditions at the abutments as for Bridge #1 as shown previously in Fig. 4.6a). This bridge, shown in plan view in Fig. 4.11 and in cross-section in Fig. 4.12, has a span length of 38 ft – 10 in from centerline to centerline of bearings with a roadway width of 17 ft and an overall width of 19 ft – 9 in. (one 12 ft traffic lane and two 2 ft – 6 in. shoulders).

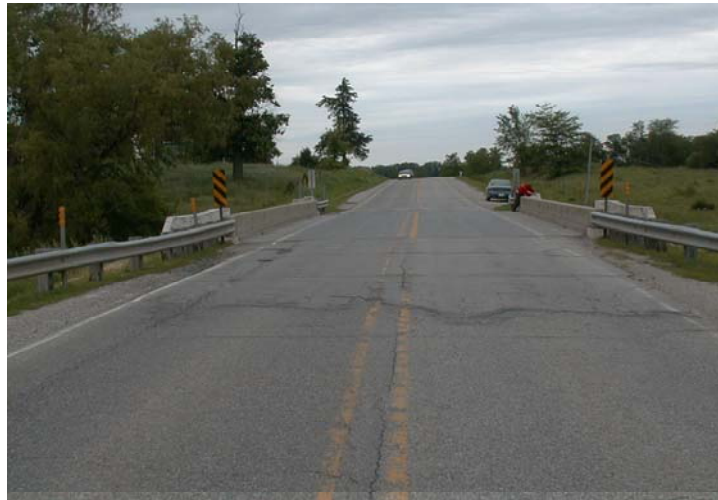
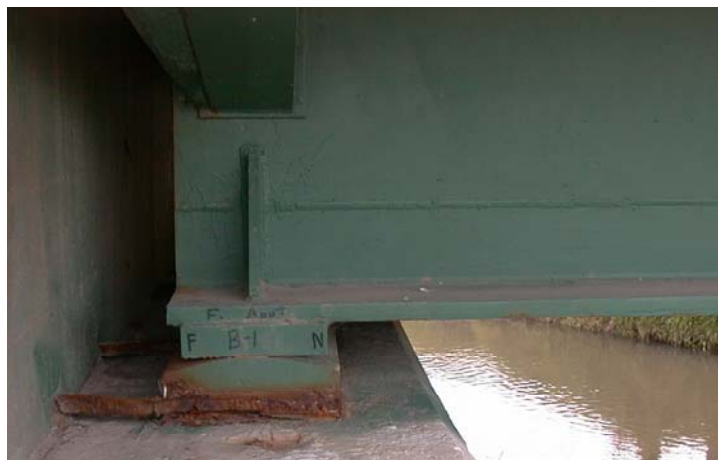
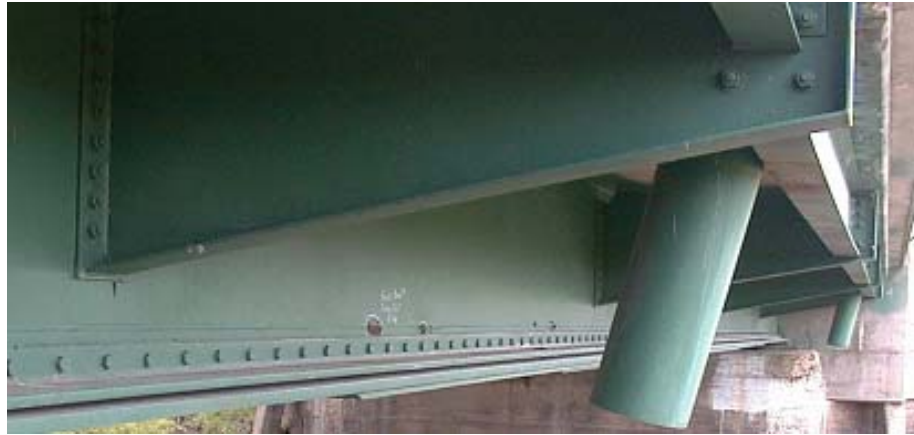
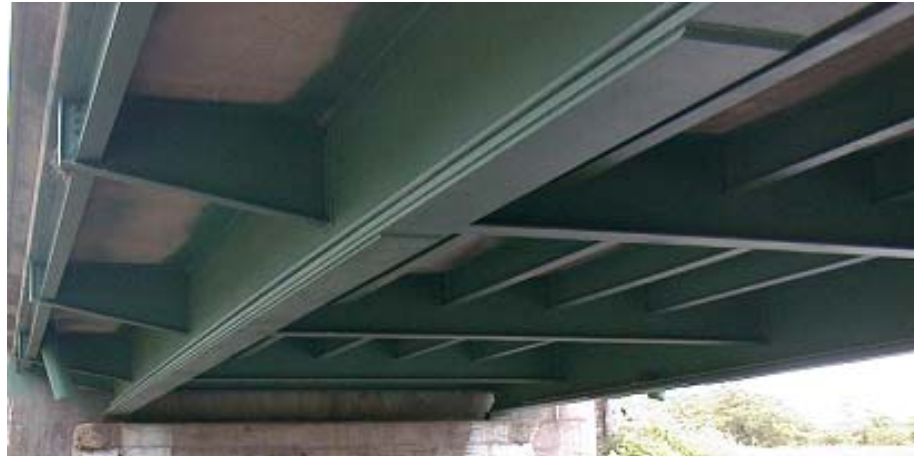
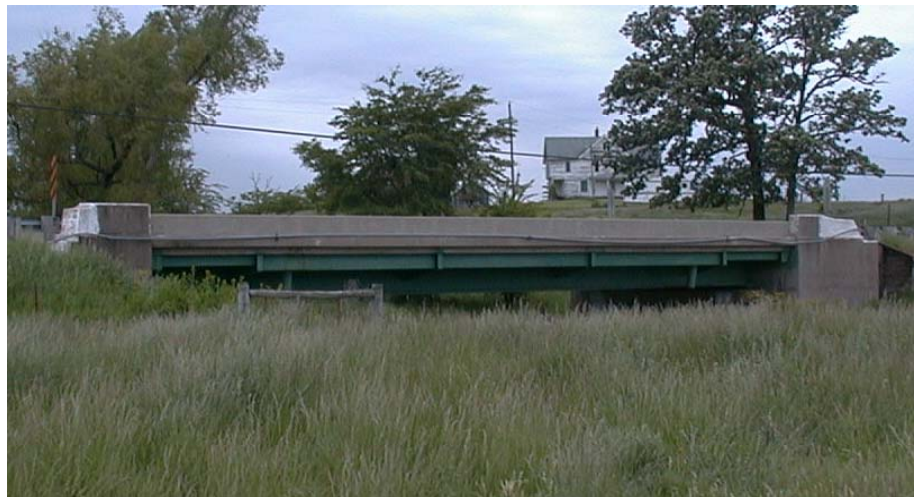
Figure 4.14. Bridge #3: Photographs of the bridge.

a. End view of bridge

b. Abutment.

c. The non-uniform section bolted to the main girder.

c. Superstructure system.

d. Side view of bridge.

Bridge #3, Iowa DOT Bridge Number 4824.1S 006 located in Iowa County, IA and built in 1929, is a composite, simple-span, steel-girder bridge with a concrete deck and no skew carrying US Highway 6 over a small natural stream. Based on a cursory visual inspection and photographic documentation, all steel sections appear to be in good condition with the exception of some light rust. As can be seen in Fig. 4.14b, it was anticipated that the bridge would not exhibit significant end restraint as the beams are not integral with the abutments. This bridge, shown in plan view in Fig. 4.15 and in cross-section in Fig. 4.16, has a span length of 70 ft from centerline to centerline of abutment bearings with a roadway width of 29 ft – 6 in. (two 12 ft lanes and two 2 ft – 9 in. shoulders).

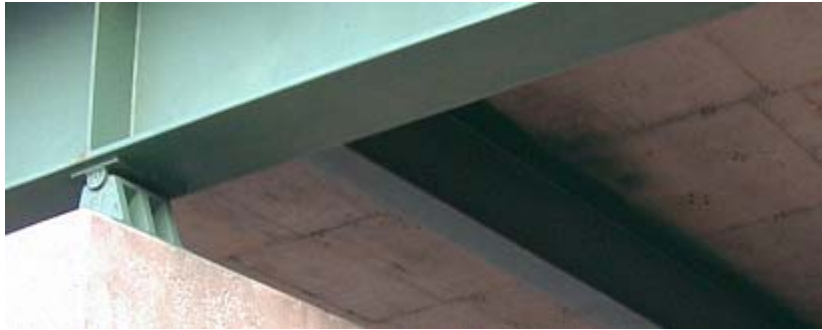
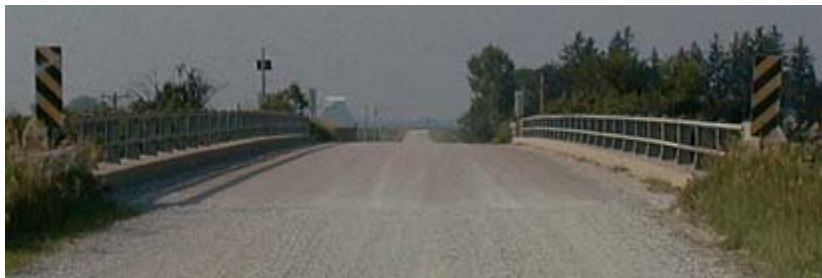
Figure 4.18. Bridge #4: Photographs of the bridge.

a. First pier.

d. End view of bridge.

Bridge #4, Iowa DOT Bridge Number 4821.90 080, located in Iowa County, IA, carries FM W-16 (2.1 miles East of Jct. 149) over Interstate 80. This bridge, which was built in 1963, is a no skew, composite, four-span, steel-girder bridge with a concrete deck. Based on a visual inspection and photographic documentation, all structural elements appear to be in good condition (shown in Fig. 4.18). It was anticipated that the bridge would not exhibit significant end restraint as the beams are not integral with the abutments. Since this bridge is symmetric about the centerline, only half of this bridge is shown in plan view in Fig 4.19; a cross-section of the bridge is presented in Fig. 4.20. The total length of this bridge is 216 ft: Span 1 and Span 4 are 46 ft – 6 in. while Span 2 and Span 3 are 61 ft – 6 in. measured from centerline to centerline of bearings. This bridge has a roadway width of 24 ft and an overall width of 26 ft – 4 in. (two 12 ft traffic lanes and two 1 ft – 2 in. shoulders).

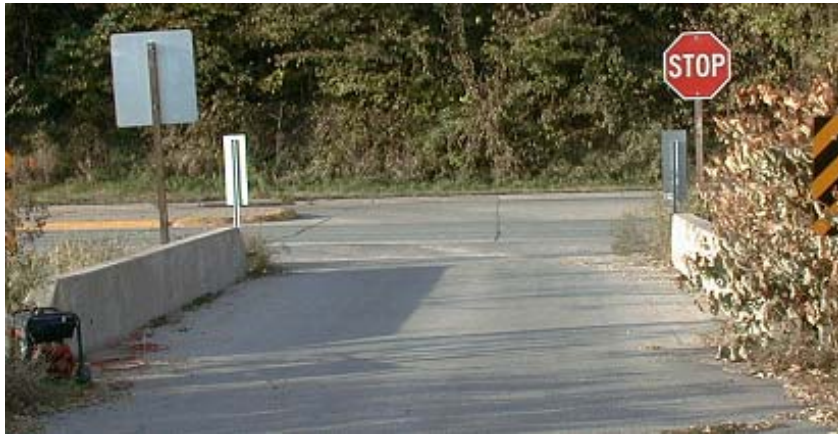
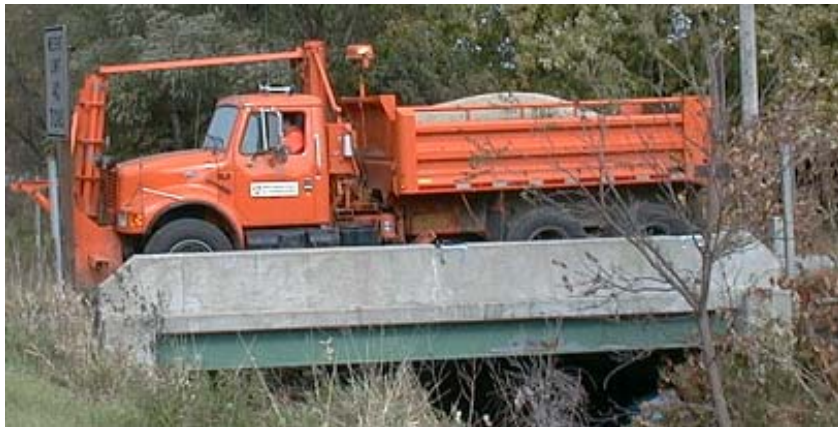
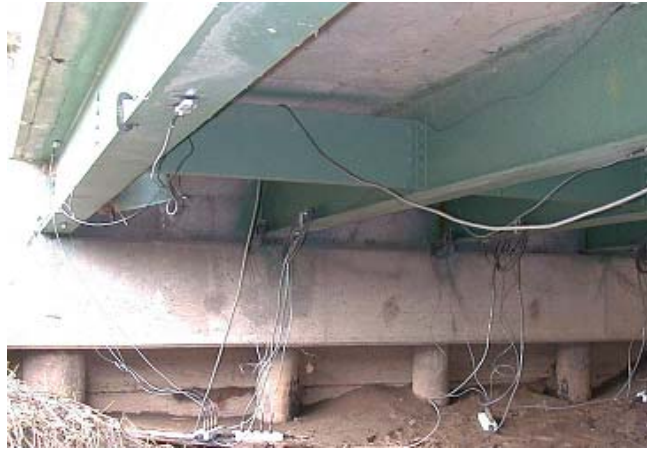
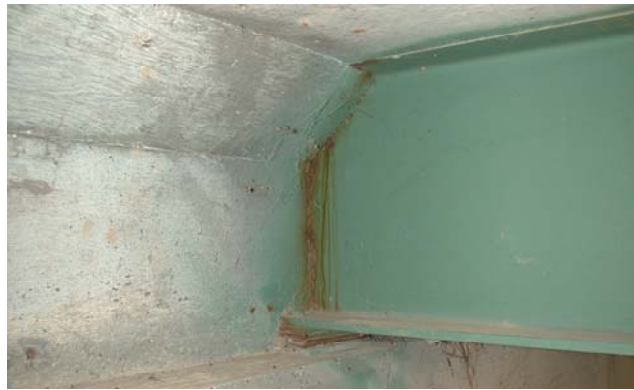
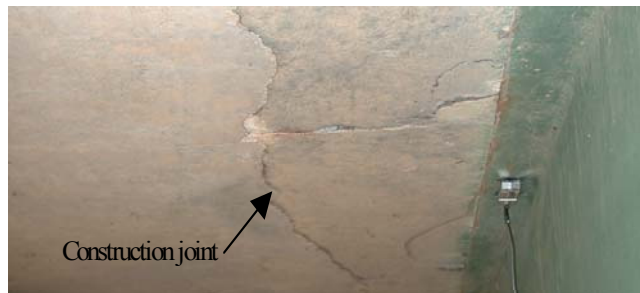
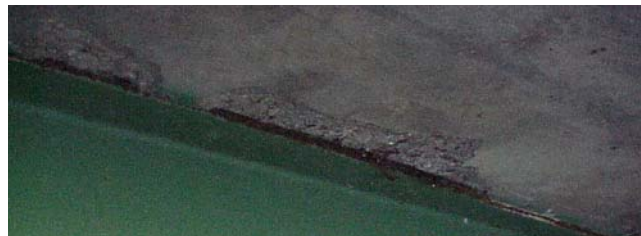
Figure 4.22. Bridge #5: Photographs of the bridge.

a. End view of bridge.

b. Side view of bridge

c. Abutment, superstructure system, and gage installation.

d. Abutment.

e. Concrete cracks.

f. Concrete deterioration.

The deck consists of an 8-in. thick reinforced cast-in-place concrete-slab with an original 0.25-in. P.C. overlay and an additional 1.5-in. P.C. overlay that was placed in 1994 (see Fig. 4.24a). The superstructure is comprised of five girders and three diaphragm lines. The substructure is a reinforced-concrete abutment with fixed steel bearings and a reinforced-concrete backwall. Originally, the bridge only had four girders. However, it was widened in 1984 with a new girder added to the East side of the bridge. The new girder (shown in Fig. 4.24a) was tied in on the East side of the bridge with the construction joint shown in Fig. 4.22e. The cross-sections of the girders are

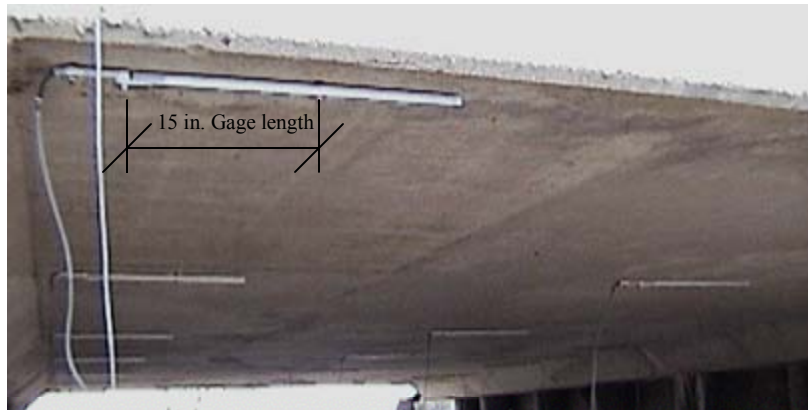
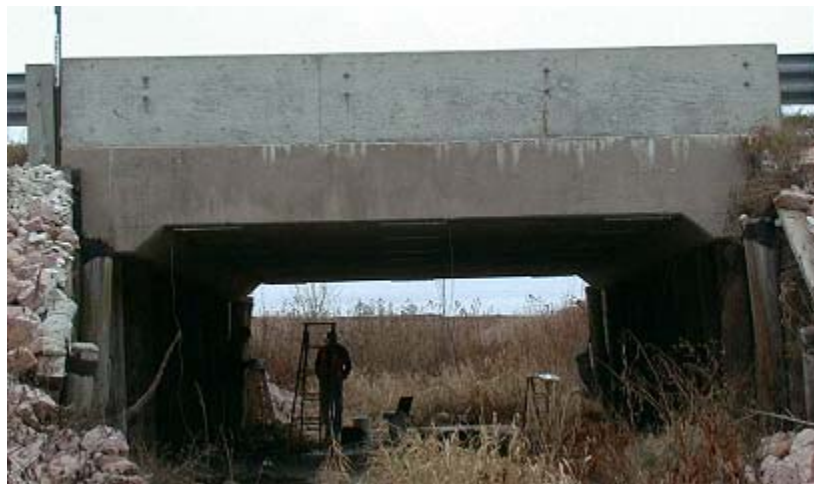
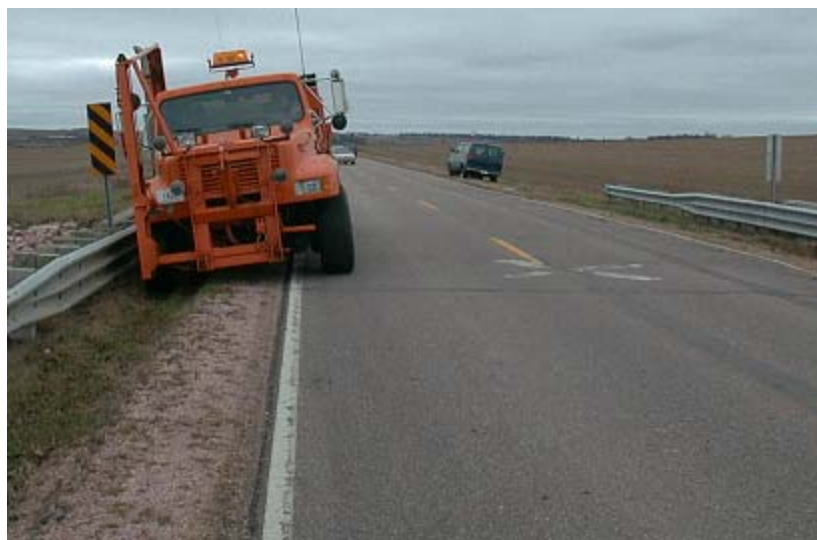
Figure 4.26. Bridge #6: Photographs of the bridge.

a. Gage installation on the bottom of the slab.

b. Side view of bridge.

c. End view of bridge with truck path Y4.

Bridge #6, Iowa DOT Bridge Number 7530.7A 140, located in Plymouth County, IA, is a simple-span, concrete-slab bridge with no skew. This bridge, which was built in 1957, carries Iowa State Highway 140 over a drainage ditch 3.8 miles North of Kingsley. Based on a cursory visual inspection and photographic documentation (shown in Fig. 4.26) all structural elements appeared to be in good condition. It was anticipated that the bridge would exhibit significant end restraint since there are no abutment deck expansion joints. This bridge, shown in plan view in Fig. 4.27 and in cross-section in Fig. 4.28 has a span length of 20 ft from centerline to centerline of the abutment bearings with a roadway width of 38 ft and an overall structure width of 40 ft (two 12 ft traffic lanes and two shoulders – one 8 ft wide and the other 6 ft wide).

The deck consists of a uniform 15-in. thick P.C concrete deck with earth fill and Asphaltic Concrete (A.C) pavement over it. The superstructure is a single span concrete-slab structure. The substructure consists of wood pile abutments with wood backing plank and concrete caps. The roadway is offset 1 ft to the East of the bridge centerline as shown in Fig. 4.28. Only one gage was installed at each instrumented sections (placed on the bottom surface of the slab) because the fill on top of the deck made the placement of transducers on top of the slab difficult. As a result, locating the neutral axis locations for this bridge is difficult. Three gages were installed on top of the West curb so the location of the neutral axis at these locations (L1, L2, and L3) could be determined. Thus, there were a total of 24 gages on the bridge installed at 21 locations, as shown in Fig. 4.27b. Gage extensions (15 in. in length) were used for all gages.

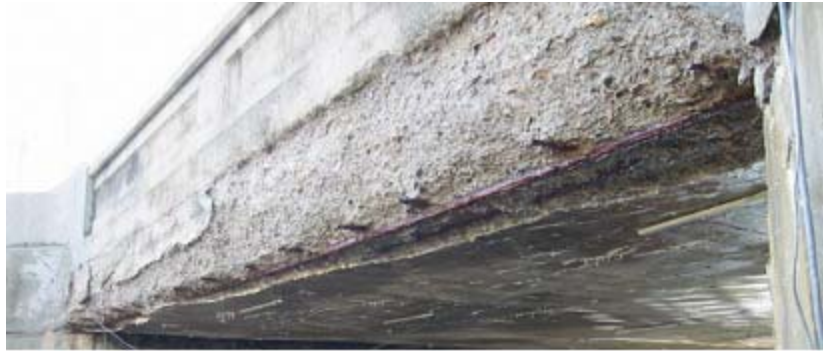
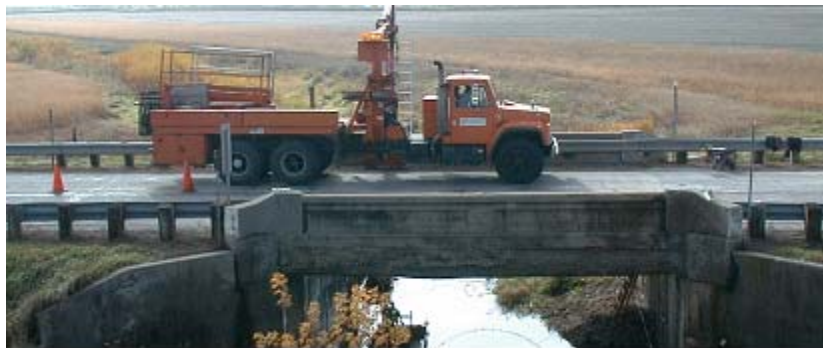
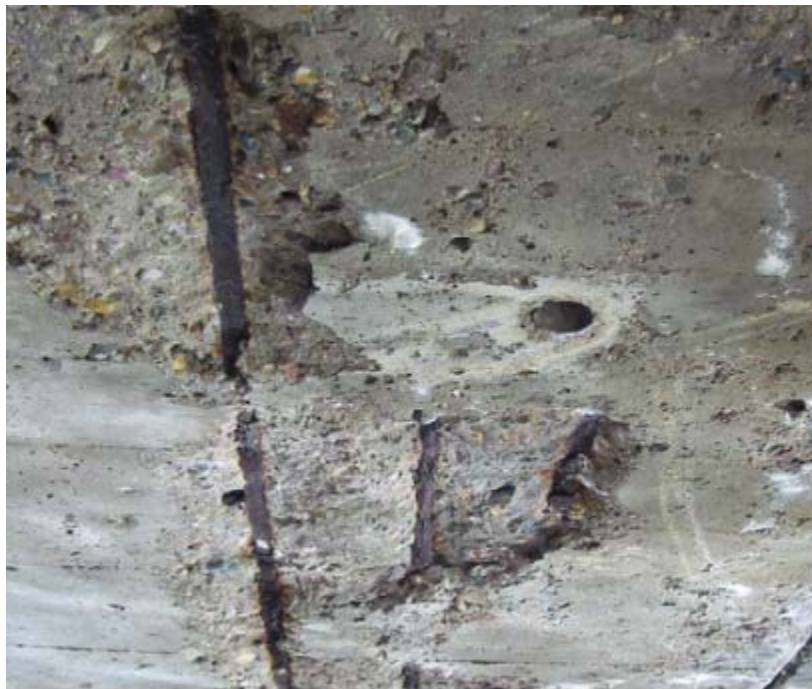
a. Spalling and heavy deterioration at edge.

b. Side view of bridge.

c. Reinforcing steel bars exposed on bottom of slab.

Bridge #7, Iowa DOT Bridge Number 3718.7S 030, located in Boone County, IA, is a simple-span, concrete-slab bridge with no skew. This bridge, which was built in 1921, carries US Highway 30 over Little Beaver Creek. Based on a cursory visual inspection, there are many concerns with the bridge. The top of the deck has many hairline to wide longitudinal cracks, several hairline to narrow transverse cracks, and a few spalls along both ends of the deck. Two of the wide longitudinal cracks extend the full length of the deck, and both curbs have a few hairline vertical cracks. Photographs of this bridge are presented in Fig. 4.30: showing spalling and heavy deterioration at the edge (shown in Fig. 4.30a), a side view of bridge (shown in Fig. 4.30c), and the reinforcing steel bars exposed on bottom of the slab (shown in Fig. 4.30c). It was anticipated that the bridge would not
