# Measuring Pavement Profile During Construction

tech transfer summary

Measuring Pavement Profile at the Slip-Form Paver

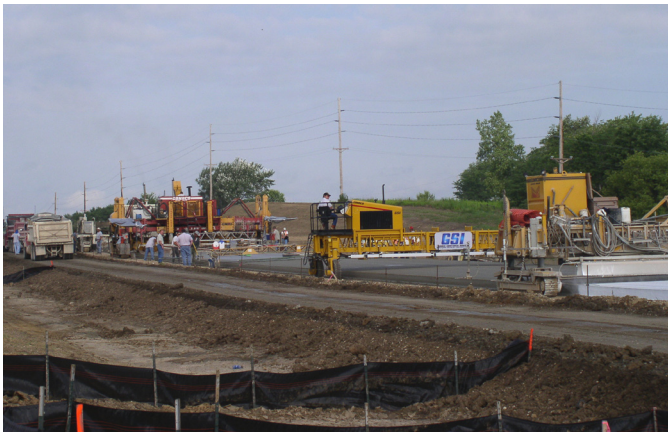
*Measuring pavement profile during construction using the GOMACO Smoothness Indicator (GSI)*

The GSI is a noncontact pavement profiler that can be used to measure the pavement profile of either wet or hardened concrete. The system includes a computer and wheel path sensors that can be mounted on the slip-form paver or on a GSI vehicle that follows the paver. The computer displays and records the data as they are collected by the sensors. The GSI provides the data in a variety of useful formats, including as International Roughness Index (IRI) and Profilograph Index (PI) values.

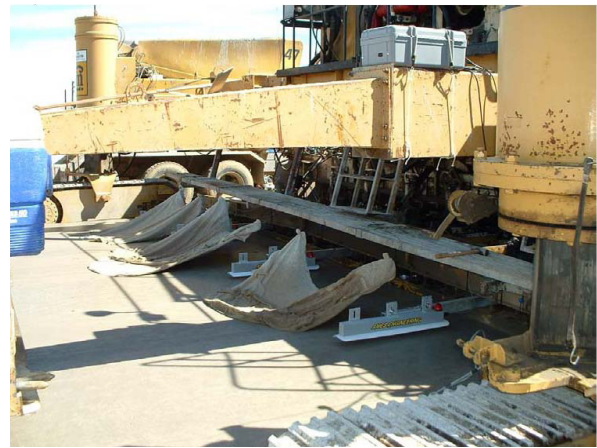
*Measuring pavement profile during construction using the Ames Engineering Real Time Profiler (RTP)*

The RTP is a laser-based profiler system that uses wheel path sensors and a computer to measure and record the pavement profile during construction. The sensors can be mounted on the slip-form paver or other equipment such as the curing and tining machine in a number of different arrangements. A laptop computer on the paver displays and records the data as they are collected. The RTP provides the data in a variety of useful formats, including as International Roughness Index (IRI) and Profilograph Index (PI) values.
