DEMONSTRATION *in Progress*

Construction of a Field Test Bridge for Evaluating Deck Design Details

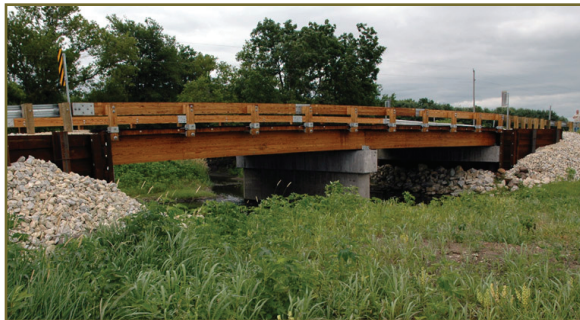
Demonstration bridge located in Delaware County, Iowa.

This work will consist of constructing and evaluating a glued-laminated timber bridge in Delaware County, Iowa.
